NPS Guardwall/Rail Inventory Program Delaware Water Gap National Recreation Area

**Federal Lands Highway
Road Inventory Program**

Federal Highway Administration
Eastern Federal Lands Highway Division
Road Inventory Program (RIP)

Data Collection Date: October 2010
Report Date: December 2015

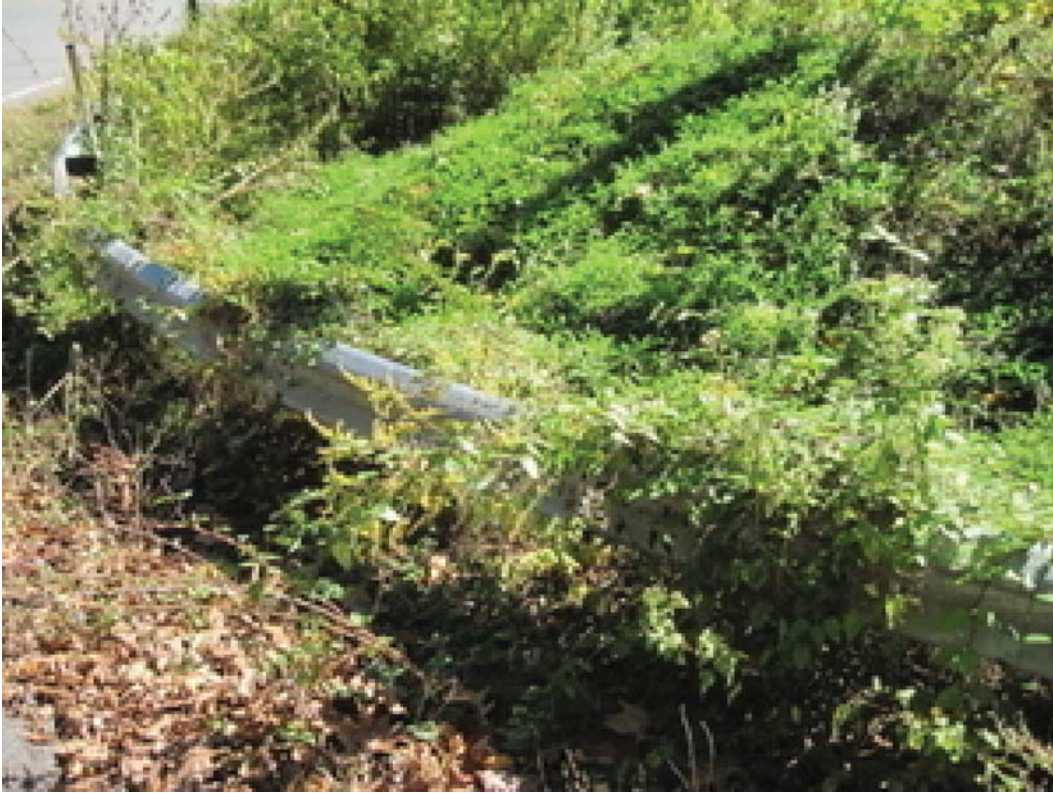
DEWA_0014_18.171_L_1.jpg

Barrier ID:	DEWA-0014-18.171-L				
Route Name:	US ROUTE 209				
Inspection Date:	10/08/2010	Barrier Rating:	34.20		
Barrier Description					
Type:	W-BEAM STRONG POST	Barrier Function:	TRAFFIC		
Barrier Material:	GALVANIZED STEEL	Post Material:	GALVANIZED STEEL		
Blockout Type:	STEEL	Length (ft.):	110		
Speed Limit (MPH):	45	Placement with Respect to Road:	TANGENT		
Hazard Behind Barrier:	HIGH				
Barrier Crashworthiness					
Appropriate Test Level:	TL-2	Barrier Test Level:	TL-3	Is Barrier Crashworthy?:	YES
Beg. End Trtmt Type:	NONE	Is Beg. End Trtmt Crashworthy?:	N/A	Approach Transition Type:	NONE
Ending End Trtmt Type:	NONE	Ending End Trtmt Crashworthy?:	N/A		
Average Measurements					
Design Height (In.):	27	Width (In.):	0.0	Post Spacing (In.):	78.3
Height (In.):	27.7	Lateral Offset (In.):	112.3	Road Grade (%):	3.10
Physical Condition					
Barrier	Alignment and Height:	Alignment deflects greater than 12 in for a 20 ft section due to impact. Height ranges from 1 in below 27 in design height to 2in over.

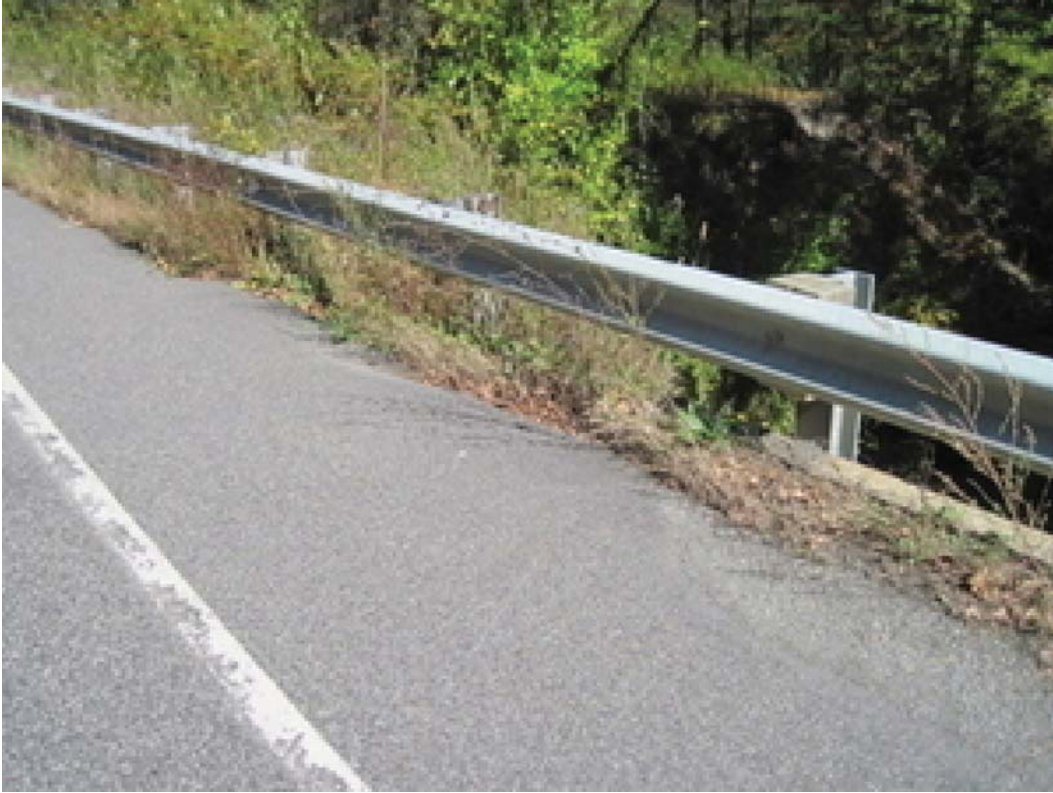
DEWA_0014_18.201_R_1.jpg

Barrier ID:	DEWA-0014-18.201-R				
Route Name:	US ROUTE 209				
Inspection Date:	10/08/2010	Barrier Rating:	32.50		
Barrier Description					
Type:	W-BEAM STRONG POST	Barrier Function:	TRAFFIC		
Barrier Material:	GALVANIZED STEEL	Post Material:	GALVANIZED STEEL		
Blockout Type:	STEEL	Length (ft.):	84		
Speed Limit (MPH):	45	Placement with Respect to Road:	TANGENT		
Hazard Behind Barrier:	MEDIUM				
Barrier Crashworthiness					
Appropriate Test Level:	TL-2	Barrier Test Level:	TL-3	Is Barrier Crashworthy?:	YES
Beg. End Trtmt Type:	NONE	Is Beg. End Trtmt Crashworthy?:	N/A	Approach Transition Type:	NONE
Ending End Trtmt Type:	W-BEAM FLARED 350 COMPLIANT	Ending End Trtmt Crashworthy?:	YES		
Average Measurements					
Design Height (In.):	27	Width (In.):	0.0	Post Spacing (In.):	75.3
Height (In.):	24.7	Lateral Offset (In.):	63.0	Road Grade (%):	1.50
Physical Condition					
Barrier	Alignment and Height:	No alignment deflection observed. Height ranges between 1 and 3 in below the 27 in design height along the entire length.

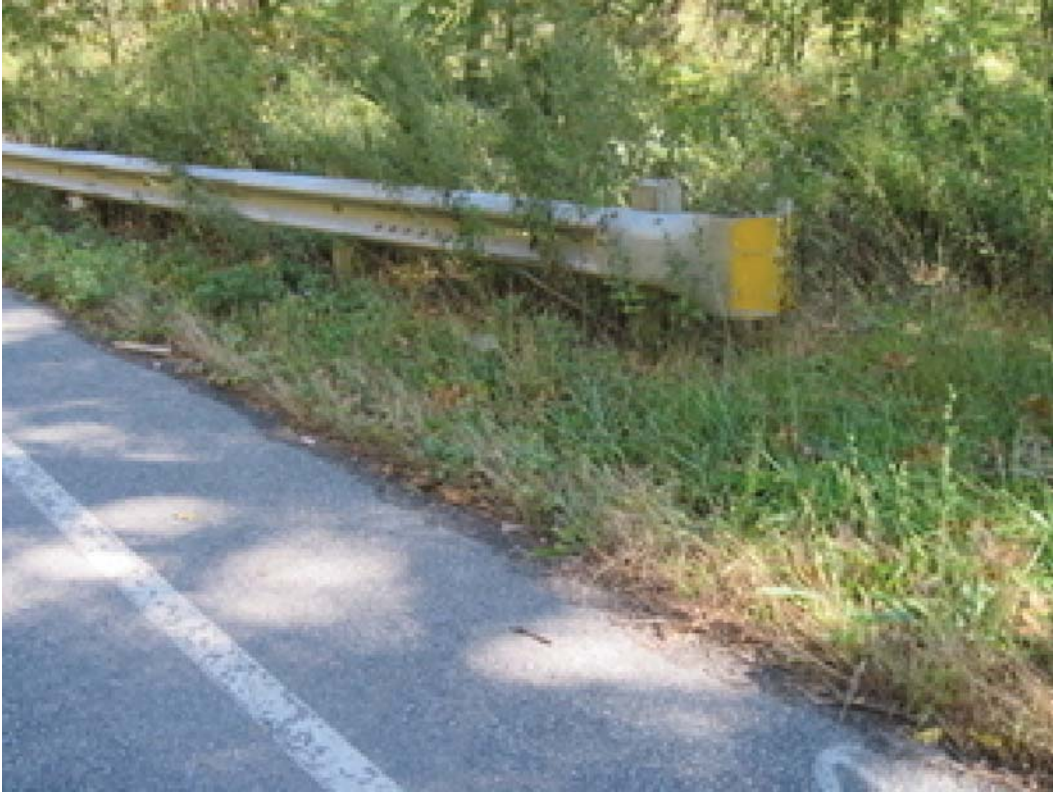
DEWA_0014_18.524_R_1.jpg

Barrier ID:	DEWA-0014-18.524-R				
Route Name:	US ROUTE 209				
Inspection Date:	10/08/2010	Barrier Rating:	41.50		
Barrier Description					
Type:	W-BEAM STRONG POST	Barrier Function:	TRAFFIC		
Barrier Material:	GALVANIZED STEEL	Post Material:	GALVANIZED STEEL		
Blockout Type:	STEEL	Length (ft.):	2333		
Speed Limit (MPH):	45	Placement with Respect to Road:	INSIDE OF CURVE		
Hazard Behind Barrier:	LOW				
Barrier Crashworthiness					
Appropriate Test Level:	TL-2	Barrier Test Level:	TL-3	Is Barrier Crashworthy?:	YES
Beg. End Trtmt Type:	W-BEAM FLARED 350 COMPLIANT	Is Beg. End Trtmt Crashworthy?:	YES	Approach Transition Type:	NONE
Ending End Trtmt Type:	W-BEAM TANGENT 350	Ending End Trtmt Crashworthy?:	YES		
Average Measurements					
Design Height (In.):	27	Width (In.):	0.0	Post Spacing (In.):	75.5
Height (In.):	26.0	Lateral Offset (In.):	40.2	Road Grade (%):	0.20
Physical Condition					
Barrier	Alignment and Height:	Barrier is deflected by more than 12 in along 30 ft and by 6 - 12 in along 30 ft. 730 ft was 1-3in. below the 27-in. design height.

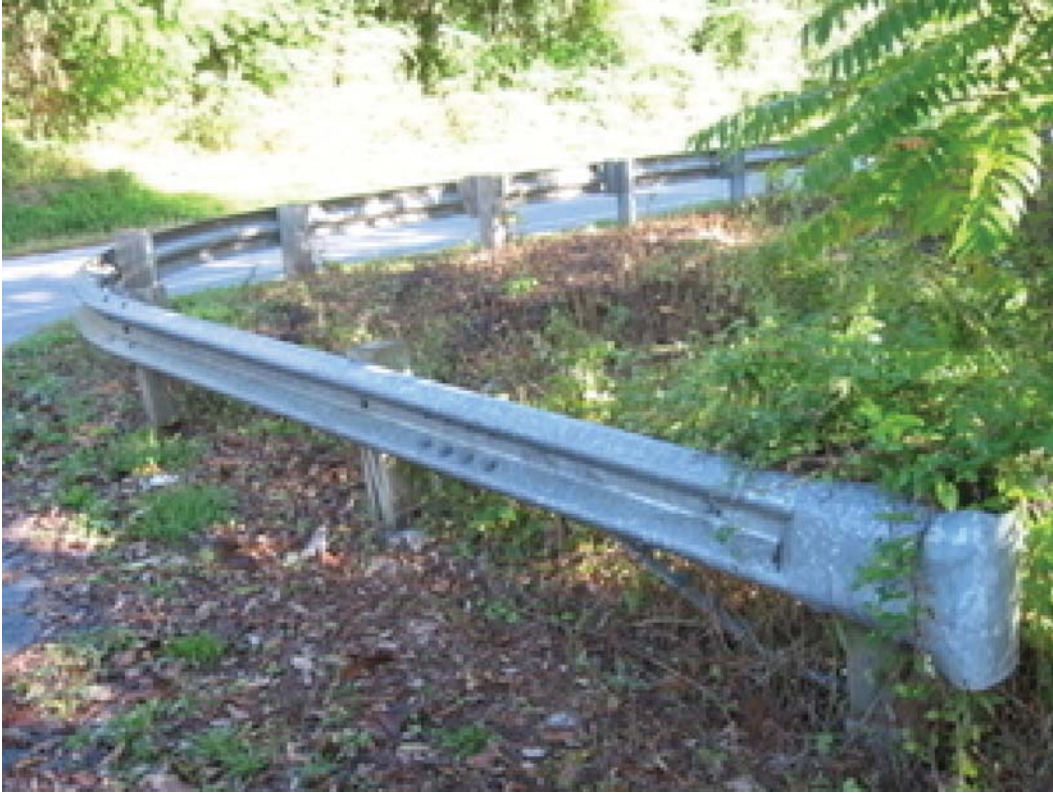
DEWA_0014_19.877_R_1.jpg

Barrier ID:	DEWA-0014-19.877-R				
Route Name:	US ROUTE 209				
Inspection Date:	10/08/2010	Barrier Rating:	38.20		
Barrier Description					
Type:	W-BEAM STRONG POST	Barrier Function:	TRAFFIC		
Barrier Material:	GALVANIZED STEEL	Post Material:	GALVANIZED STEEL		
Blockout Type:	STEEL	Length (ft.):	617		
Speed Limit (MPH):	45	Placement with Respect to Road:	TANGENT		
Hazard Behind Barrier:	MEDIUM				
Barrier Crashworthiness					
Appropriate Test Level:	TL-2	Barrier Test Level:	TL-3	Is Barrier Crashworthy?:	YES
Beg. End Trtmt Type:	W-BEAM TANGENT 350	Is Beg. End Trtmt Crashworthy?:	YES	Approach Transition Type:	NONE
Ending End Trtmt Type:	W-BEAM BCT	Ending End Trtmt Crashworthy?:	NO		
Average Measurements					
Design Height (In.):	27	Width (In.):	0.0	Post Spacing (In.):	74.3
Height (In.):	26.2	Lateral Offset (In.):	38.0	Road Grade (%):	0.90
Physical Condition					
Barrier	Alignment and Height:	Alignment deflects greater than 12 in for a 24ft section that has been impacted. 100 ft is 1-3 in below 27 in design height.

Breaking and Cracking:	24 ft of rail has been impacted and bent. The supporting post was also bent.			
	Missing Elements:	No missing elements observed.			
	Corrosion and Weathering:	No loss of cross section or erosion around posts observed.			
End Treatments	Alignment and Height:	Alignment acceptable. Height is within 1-in. of 27-in. design height.			
	Breaking and Cracking:	No twisting bending tears or cracking observed.			
	Missing Elements:	No missing elements observed.			
	Corrosion and Weathering:	No loss of cross section or erosion around posts observed.

Repair Action:	REPAIR	FMSS Work Type:	DEFERRED MAINTENANCE	Repair Cost:	\$3492
Brief Workorder:	Raise 100 feet of guardrail to 27 inch design height. Replace 1 post and a 24 foot section of rail.				
Workorder:	Adjust Guardrail at \$10- per -Lin. Ft. for 100 LF = \$1000. Raise 100 ft of guardrail to 27 inch design height. Replace Rail at \$25- per -Lin. Ft. for 24 LF = \$600. Replace Post at \$100- per -Each for 1 Post(s) = \$100. Low Speed Traffic Control at \$1475- per -Day for 1 Day(s) = \$1475.

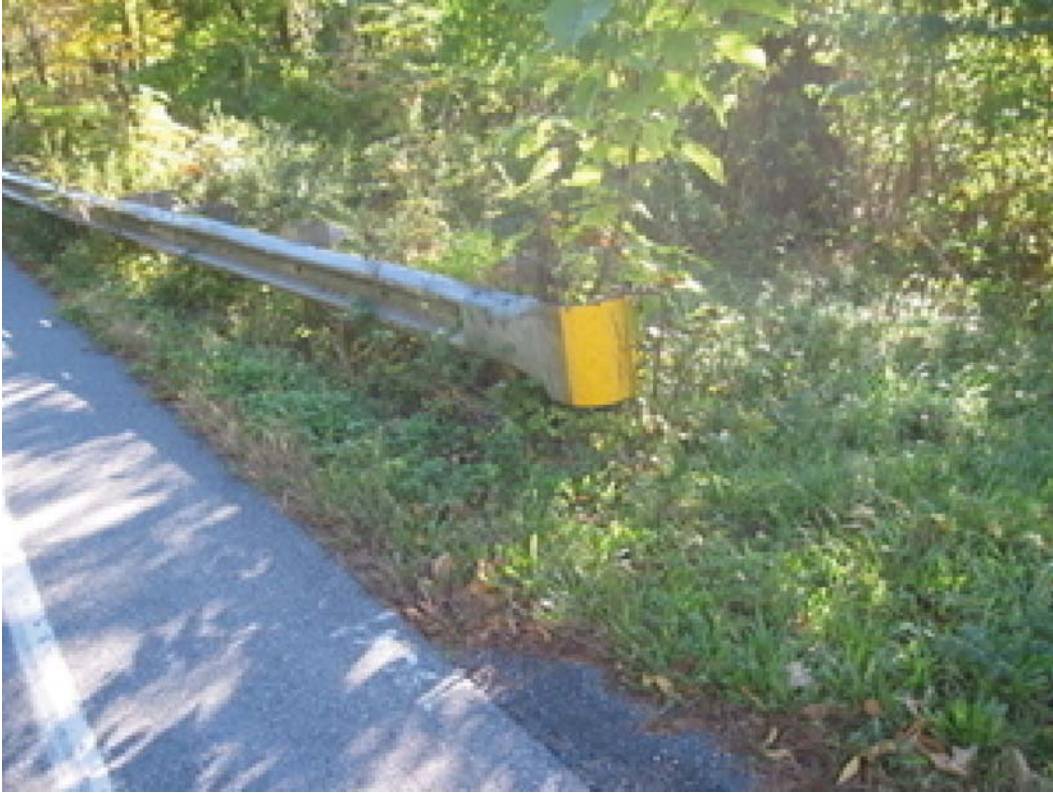
DEWA_0014_20.022_R_1.jpg

Barrier ID:	DEWA-0014-20.022-R				
Route Name:	US ROUTE 209				
Inspection Date:	10/08/2010	Barrier Rating:	38.70		
Barrier Description					
Type:	W-BEAM STRONG POST	Barrier Function:	TRAFFIC		
Barrier Material:	GALVANIZED STEEL	Post Material:	GALVANIZED STEEL		
Blockout Type:	STEEL	Length (ft.):	838		
Speed Limit (MPH):	35	Placement with Respect to Road:	TANGENT		
Hazard Behind Barrier:	LOW				
Barrier Crashworthiness					
Appropriate Test Level:	TL-2	Barrier Test Level:	TL-3	Is Barrier Crashworthy?:	YES
Beg. End Trtmt Type:	W-BEAM FLARED 350 COMPLIANT	Is Beg. End Trtmt Crashworthy?:	YES	Approach Transition Type:	NONE
Ending End Trtmt Type:	W-BEAM FLARED 350 COMPLIANT	Ending End Trtmt Crashworthy?:	YES		
Average Measurements					
Design Height (In.):	27	Width (In.):	0.0	Post Spacing (In.):	74.3
Height (In.):	25.0	Lateral Offset (In.):	42.0	Road Grade (%):	1.10
Physical Condition					
Barrier	Alignment and Height:	No alignment deflection observed. Height is between 1 and 3 in below 27 in design height along entire length.

Breaking and Cracking:	A 12 ft section of rail has been damaged from impact.			
	Missing Elements:	No missing elements observed.			
	Corrosion and Weathering:	No loss of cross section or erosion around posts observed.			
End Treatments	Alignment and Height:	Alignment acceptable. Height is within 1-in. of 27-in. design height.			
	Breaking and Cracking:	No twisting bending tears or cracking observed.			
	Missing Elements:	No missing elements observed.			
	Corrosion and Weathering:	No loss of cross section or erosion around posts observed.

Repair Action:	REPAIR	FMSS Work Type:	DEFERRED MAINTENANCE	Repair Cost:	\$16038
Brief Workorder:	Raise 838 feet of guardrail to 27 inch design height and replace 12 feet of rail.				
Workorder:	Adjust Guardrail at \$10- per -Lin. Ft. for 838 LF = \$8380. Raise 838 feet of barrier to 27 inch design height. Replace Rail at \$25- per -Lin. Ft. for 12 LF = \$300. Replace a 12 foot section of rail. Low Speed Traffic Control at \$1475- per -Day for 4 Day(s) = \$5900.

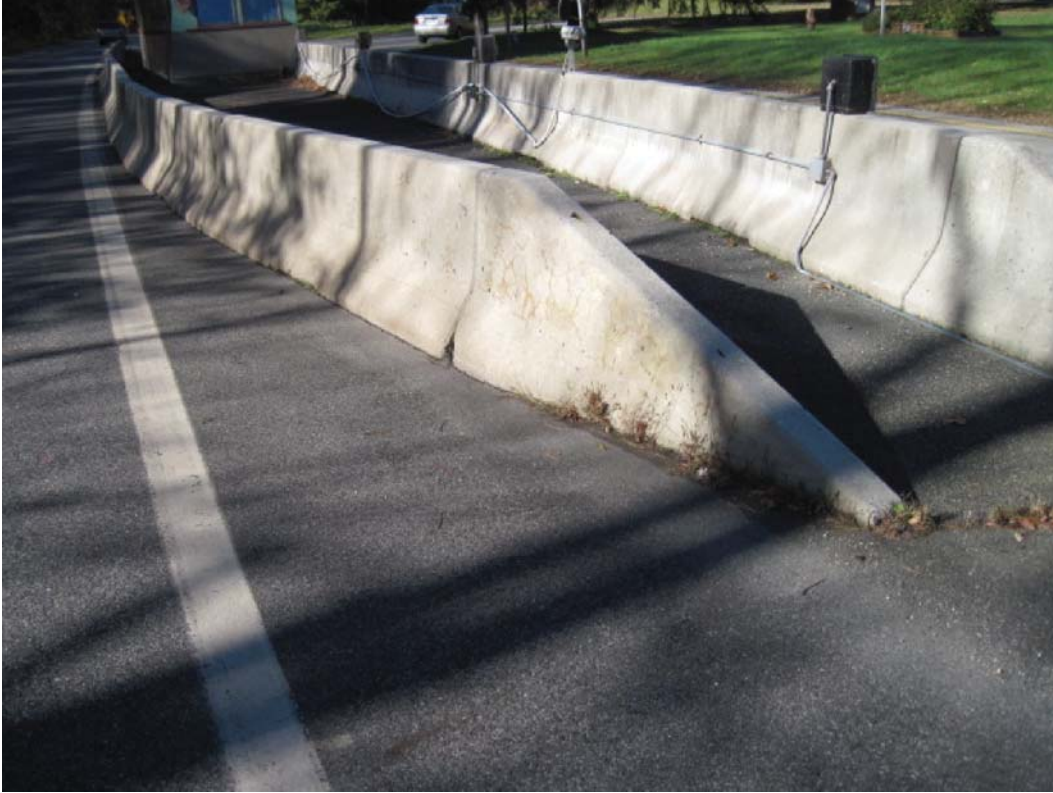
DEWA_0014_20.297_L_1.jpg

Barrier ID:	DEWA-0014-20.297-L				
Route Name:	US ROUTE 209				
Inspection Date:	10/08/2010	Barrier Rating:	31.30		
Barrier Description					
Type:	CONCRETE BARRIER	Barrier Function:	TRAFFIC		
Barrier Material:	CONCRETE	Post Material:	N/A		
Blockout Type:	N/A	Length (ft.):	220		
Speed Limit (MPH):	35	Placement with Respect to Road:	TANGENT		
Hazard Behind Barrier:	LOW				
Barrier Crashworthiness					
Appropriate Test Level:	TL-2	Barrier Test Level:	TL-3	Is Barrier Crashworthy?:	YES
Beg. End Trtmt Type:	NONE	Is Beg. End Trtmt Crashworthy?:	N/A	Approach Transition Type:	NONE
Ending End Trtmt Type:	NONE	Ending End Trtmt Crashworthy?:	N/A		
Average Measurements					
Design Height (In.):	32	Width (In.):	6.0	Post Spacing (In.):	0.0
Height (In.):	30.0	Lateral Offset (In.):	14.6	Road Grade (%):	0.60
Physical Condition					
Barrier	Alignment and Height:	No alignment deflection was observed. Height was 2 in below 32-in design height.

Breaking and Cracking:	No cracks greater than 1/4 in width observed.			
	Missing Elements:	No missing elements were observed.			
	Corrosion and Weathering:	No surface corrosion or spalling observed. No erosion or undermining around base observed.			
End Treatments	Alignment and Height:				
	Breaking and Cracking:				
	Missing Elements:				
	Corrosion and Weathering:

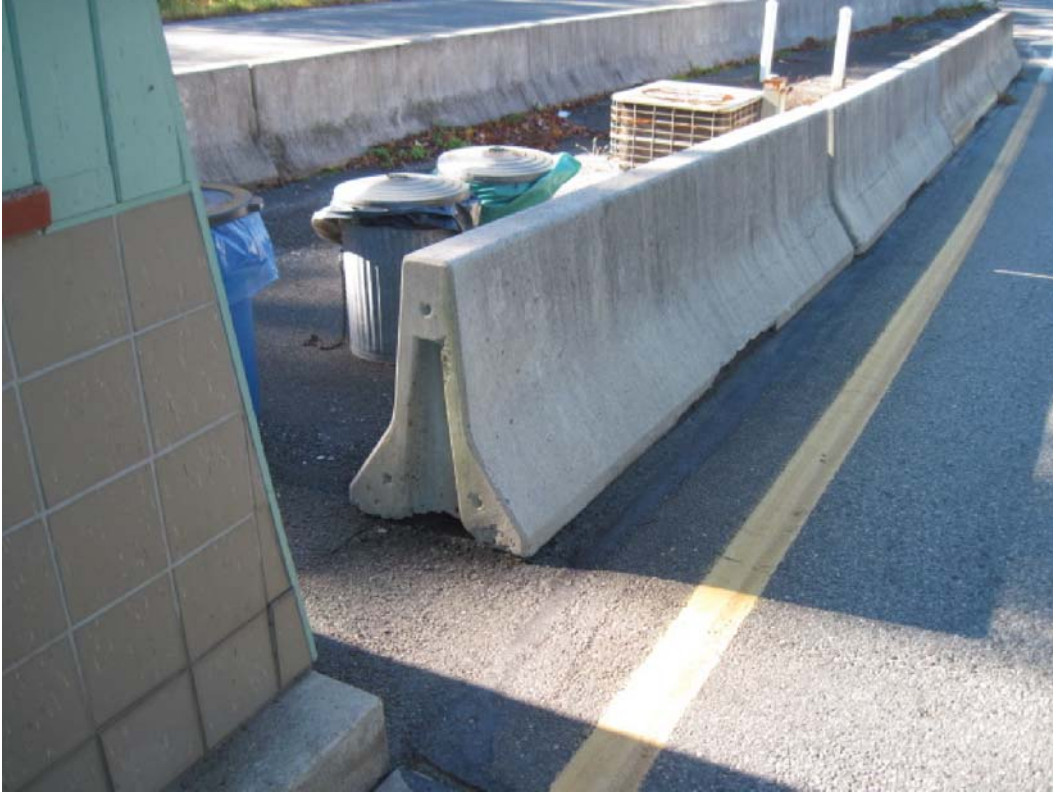
DEWA_0014_20.307_L_1.jpg

Barrier ID:	DEWA-0014-20.307-L				
Route Name:	US ROUTE 209				
Inspection Date:	10/08/2010	Barrier Rating:	27.00		
Barrier Description					
Type:	CONCRETE BARRIER	Barrier Function:	TRAFFIC		
Barrier Material:	CONCRETE	Post Material:	N/A		
Blockout Type:	N/A	Length (ft.):	49		
Speed Limit (MPH):	35	Placement with Respect to Road:	TANGENT		
Hazard Behind Barrier:	LOW				
Barrier Crashworthiness					
Appropriate Test Level:	TL-2	Barrier Test Level:	TL-3	Is Barrier Crashworthy?:	YES
Beg. End Trtmt Type:	NONE	Is Beg. End Trtmt Crashworthy?:	N/A	Approach Transition Type:	NONE
Ending End Trtmt Type:	NONE	Ending End Trtmt Crashworthy?:	N/A		
Average Measurements					
Design Height (In.):	32	Width (In.):	6.0	Post Spacing (In.):	0.0
Height (In.):	31.0	Lateral Offset (In.):	16.7	Road Grade (%):	0.70
Physical Condition					
Barrier	Alignment and Height:	No alignment deflection observed. Entire barrier is 1 in below 32-in design height.

Breaking and Cracking:	No cracks greater than 1/4 in width observed.			
	Missing Elements:	No missing elements observed.			
	Corrosion and Weathering:	No surface corrosion or spalling observed. No erosion or undermining around base observed.			
End Treatments	Alignment and Height:				
	Breaking and Cracking:				
	Missing Elements:				
	Corrosion and Weathering:

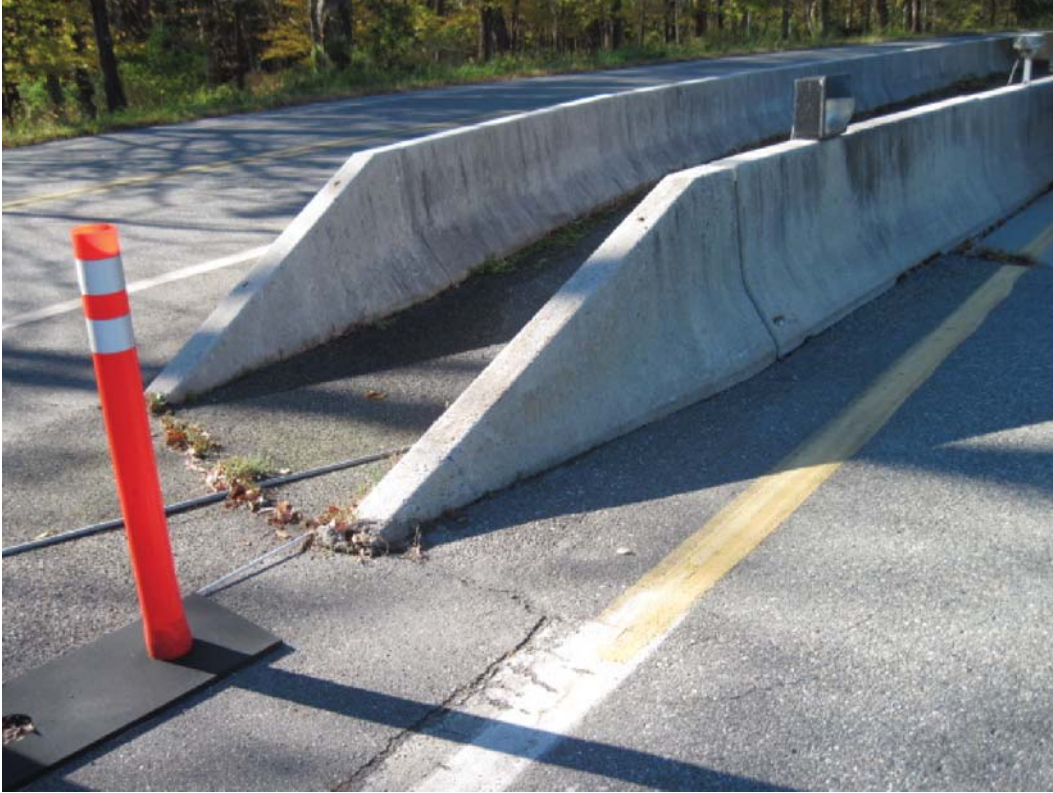
DEWA_0014_20.325_L_1.jpg

Barrier ID:	DEWA-0014-20.325-L				
Route Name:	US ROUTE 209				
Inspection Date:	10/08/2010	Barrier Rating:	27.00		
Barrier Description					
Type:	CONCRETE BARRIER	Barrier Function:	TRAFFIC		
Barrier Material:	CONCRETE	Post Material:	N/A		
Blockout Type:	N/A	Length (ft.):	80		
Speed Limit (MPH):	35	Placement with Respect to Road:	TANGENT		
Hazard Behind Barrier:	LOW				
Barrier Crashworthiness					
Appropriate Test Level:	TL-2	Barrier Test Level:	TL-3	Is Barrier Crashworthy?:	YES
Beg. End Trtmt Type:	NONE	Is Beg. End Trtmt Crashworthy?:	N/A	Approach Transition Type:	NONE
Ending End Trtmt Type:	NONE	Ending End Trtmt Crashworthy?:	N/A		
Average Measurements					
Design Height (In.):	32	Width (In.):	6.0	Post Spacing (In.):	0.0
Height (In.):	31.0	Lateral Offset (In.):	20.2	Road Grade (%):	0.60
Physical Condition					
Barrier	Alignment and Height:	No alignment deflection observed. Height is 31 in which is 1 in below 32-in design height.

Breaking and Cracking:	No cracks greater than 1/4 in width observed.			
	Missing Elements:	No missing elements observed.			
	Corrosion and Weathering:	No surface corrosion or spalling observed. No erosion or undermining around base observed.			
End Treatments	Alignment and Height:				
	Breaking and Cracking:				
	Missing Elements:				
	Corrosion and Weathering:

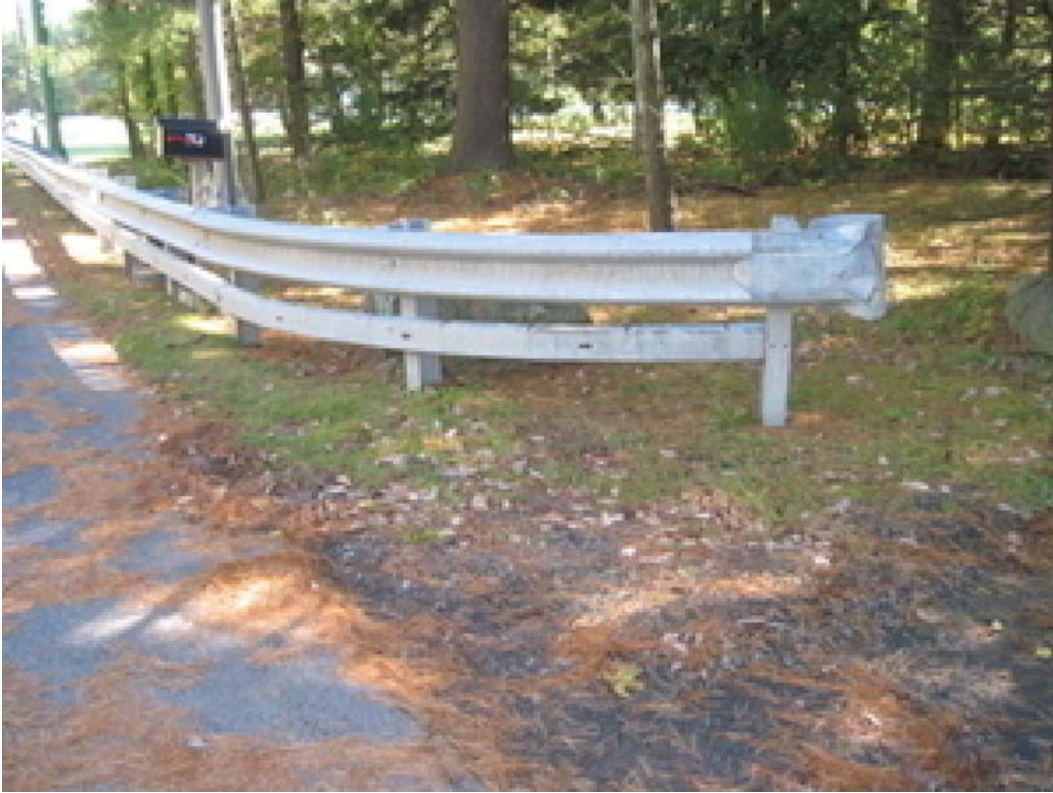
DEWA_0014_20.515_R_1.jpg

Barrier ID:	DEWA-0014-20.515-R				
Route Name:	US ROUTE 209				
Inspection Date:	10/08/2010	Barrier Rating:	21.20		
Barrier Description					
Type:	W-BEAM STRONG POST	Barrier Function:	TRAFFIC		
Barrier Material:	GALVANIZED STEEL	Post Material:	GALVANIZED STEEL		
Blockout Type:	STEEL	Length (ft.):	117		
Speed Limit (MPH):	35	Placement with Respect to Road:	TANGENT		
Hazard Behind Barrier:	LOW				
Barrier Crashworthiness					
Appropriate Test Level:	TL-2	Barrier Test Level:	TL-3	Is Barrier Crashworthy?:	YES
Beg. End Trtmt Type:	NONE	Is Beg. End Trtmt Crashworthy?:	N/A	Approach Transition Type:	NONE
Ending End Trtmt Type:	NONE	Ending End Trtmt Crashworthy?:	N/A		
Average Measurements					
Design Height (In.):	27	Width (In.):	0.0	Post Spacing (In.):	74.6
Height (In.):	32.0	Lateral Offset (In.):	151.3	Road Grade (%):	0.50
Physical Condition					
Barrier	Alignment and Height:	No alignment deflection was observed. Height is 5 in above 27-in design height.

Breaking and Cracking:	No twisting bending tears or cracking observed.			
	Missing Elements:	No missing elements were observed.			
	Corrosion and Weathering:	No loss of cross section or erosion around posts observed.			
End Treatments	Alignment and Height:				
	Breaking and Cracking:				
	Missing Elements:				
	Corrosion and Weathering:

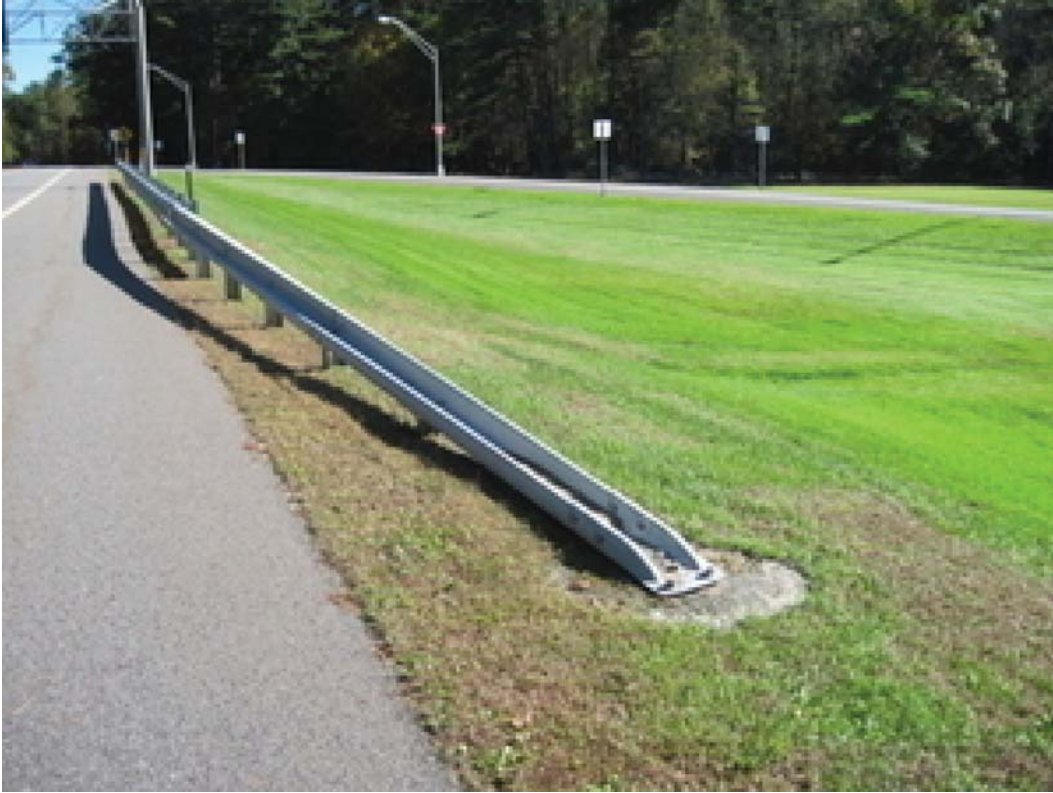
DEWA_0014_20.613_R_1.jpg

Barrier ID:	DEWA-0014-20.613-R				
Route Name:	US ROUTE 209				
Inspection Date:	10/08/2010	Barrier Rating:	21.20		
Barrier Description					
Type:	W-BEAM STRONG POST	Barrier Function:	TRAFFIC		
Barrier Material:	GALVANIZED STEEL	Post Material:	GALVANIZED STEEL		
Blockout Type:	STEEL	Length (ft.):	155		
Speed Limit (MPH):	35	Placement with Respect to Road:	TANGENT		
Hazard Behind Barrier:	LOW				
Barrier Crashworthiness					
Appropriate Test Level:	TL-2	Barrier Test Level:	TL-3	Is Barrier Crashworthy?:	YES
Beg. End Trtmt Type:	W-BEAM TURN DOWN	Is Beg. End Trtmt Crashworthy?:	NO	Approach Transition Type:	NONE
Ending End Trtmt Type:	NONE	Ending End Trtmt Crashworthy?:	N/A		
Average Measurements					
Design Height (In.):	27	Width (In.):	0.0	Post Spacing (In.):	74.6
Height (In.):	31.7	Lateral Offset (In.):	115.6	Road Grade (%):	0.30
Physical Condition					
Barrier	Alignment and Height:	No alignment deflection observed. Height is between 4 and 5 in above 27 in design height along entire length.

Breaking and Cracking:	No twisting bending tears or cracking observed.			
	Missing Elements:	No missing elements observed.			
	Corrosion and Weathering:	No loss of cross section or erosion around posts observed.			
End Treatments	Alignment and Height:	Alignment acceptable. Height is within 1-in. of 27-in. design height.			
	Breaking and Cracking:	No twisting bending tears or cracking observed.			
	Missing Elements:	No missing elements observed.			
	Corrosion and Weathering:	No loss of cross section or erosion around posts observed.

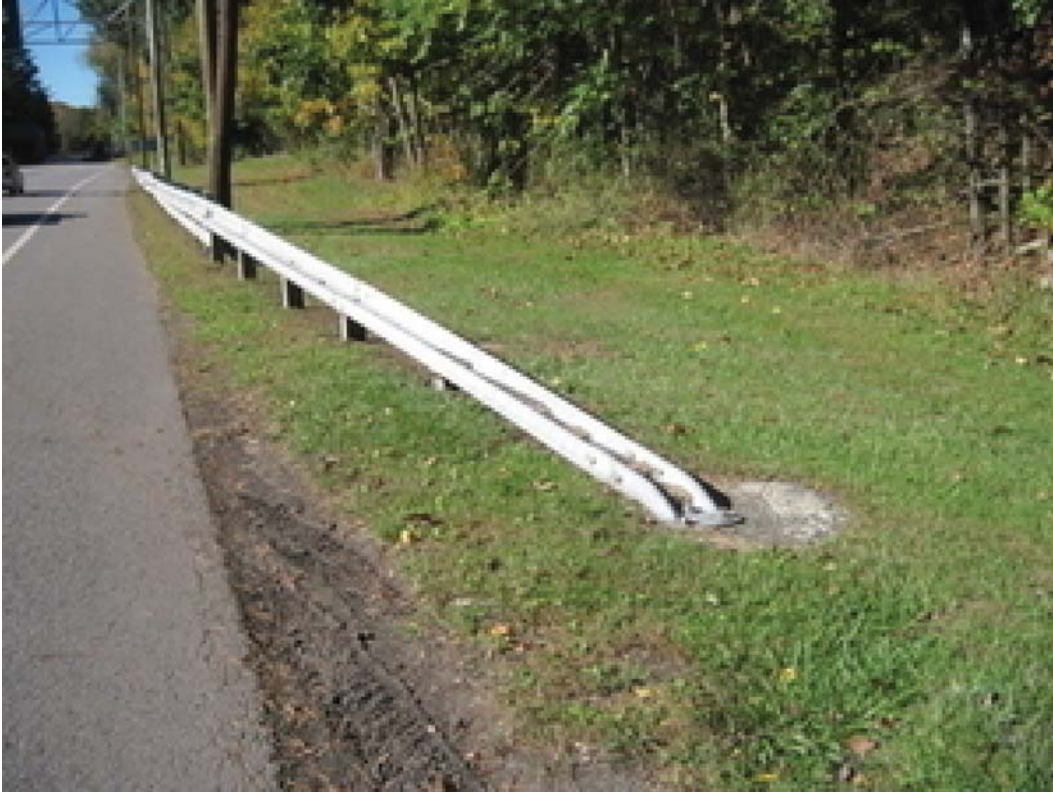
DEWA_0014_20.629_L_1.jpg

Barrier ID:	DEWA-0014-20.629-L				
Route Name:	US ROUTE 209				
Inspection Date:	10/08/2010	Barrier Rating:	21.20		
Barrier Description					
Type:	W-BEAM STRONG POST	Barrier Function:	TRAFFIC		
Barrier Material:	GALVANIZED STEEL	Post Material:	GALVANIZED STEEL		
Blockout Type:	STEEL	Length (ft.):	153		
Speed Limit (MPH):	35	Placement with Respect to Road:	TANGENT		
Hazard Behind Barrier:	LOW				
Barrier Crashworthiness					
Appropriate Test Level:	TL-2	Barrier Test Level:	TL-3	Is Barrier Crashworthy?:	YES
Beg. End Trtmt Type:	NONE	Is Beg. End Trtmt Crashworthy?:	N/A	Approach Transition Type:	NONE
Ending End Trtmt Type:	W-BEAM TURN DOWN	Ending End Trtmt Crashworthy?:	NO		
Average Measurements					
Design Height (In.):	27	Width (In.):	0.0	Post Spacing (In.):	75.0
Height (In.):	31.2	Lateral Offset (In.):	98.0	Road Grade (%):	0.30
Physical Condition					
Barrier	Alignment and Height:	Alignment deflects greater than 12 in for 24 ft due to impact. Height ranges from 3 in to 5 in above 27 in design height.

Breaking and Cracking:	Two rails and two posts are bent from impact.			
	Missing Elements:	No missing elements observed.			
	Corrosion and Weathering:	No loss of cross section or erosion around posts observed.			
End Treatments	Alignment and Height:	Alignment acceptable. Height is within 1-in. of 27-in. design height.			
	Breaking and Cracking:	No twisting bending tears or cracking observed.			
	Missing Elements:	No missing elements observed.			
	Corrosion and Weathering:	No loss of cross section or erosion around posts observed.

Repair Action:	REPAIR	FMSS Work Type:	DEFERRED MAINTENANCE	Repair Cost:	\$2502
Brief Workorder:	Replace 24 feet of rail and two posts.				
Workorder:	Replace Rail at \$25- per -Lin. Ft. for 24 LF = \$600. Replace Post at \$100- per -Each for 2 Post(s) = \$200. Low Speed Traffic Control at \$1475- per -Day for 1 Day(s) = \$1475.

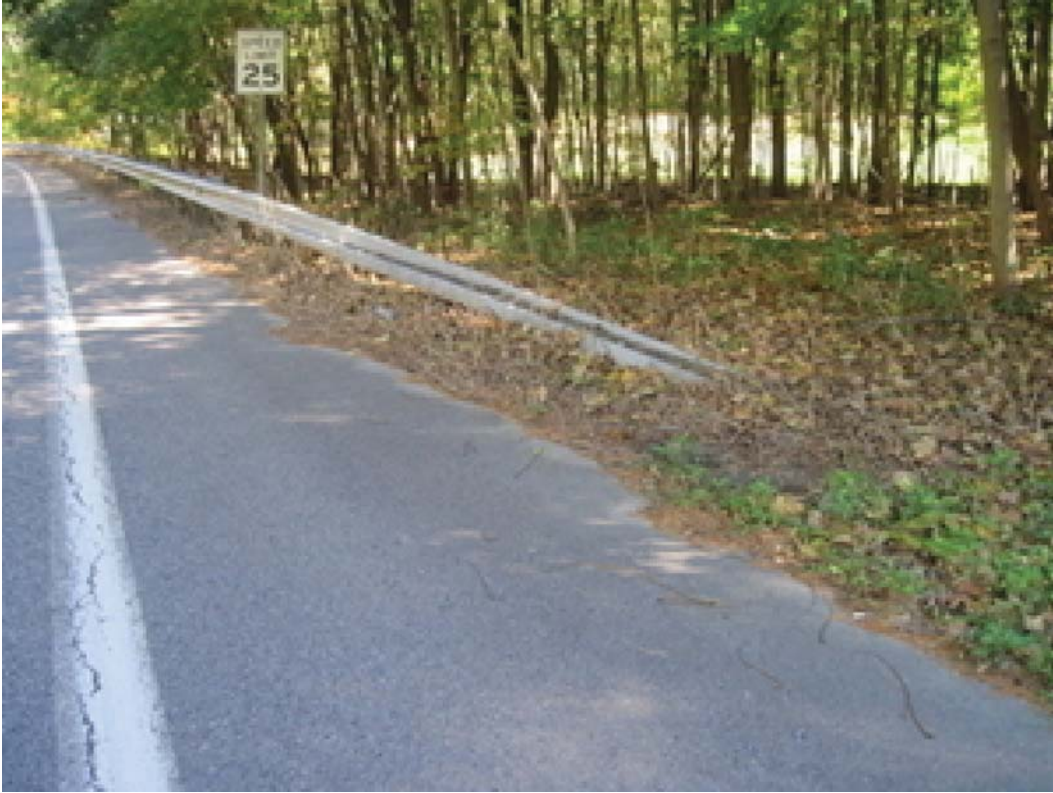
DEWA_0014_20.907_R_1.jpg

Barrier ID:	DEWA-0014-20.907-R				
Route Name:	US ROUTE 209				
Inspection Date:	10/08/2010	Barrier Rating:	35.20		
Barrier Description					
Type:	W-BEAM STRONG POST	Barrier Function:	TRAFFIC		
Barrier Material:	GALVANIZED STEEL	Post Material:	GALVANIZED STEEL		
Blockout Type:	STEEL	Length (ft.):	298		
Speed Limit (MPH):	25	Placement with Respect to Road:	OUTSIDE OF CURVE		
Hazard Behind Barrier:	MEDIUM				
Barrier Crashworthiness					
Appropriate Test Level:	TL-1	Barrier Test Level:	TL-3	Is Barrier Crashworthy?:	YES
Beg. End Trtmt Type:	W-BEAM TURN DOWN	Is Beg. End Trtmt Crashworthy?:	NO	Approach Transition Type:	NONE
Ending End Trtmt Type:	W-BEAM TURN DOWN	Ending End Trtmt Crashworthy?:	NO		
Average Measurements					
Design Height (In.):	27	Width (In.):	0.0	Post Spacing (In.):	73.6
Height (In.):	26.2	Lateral Offset (In.):	75.0	Road Grade (%):	4.40
Physical Condition					
Barrier	Alignment and Height:	No alignment deflection was observed. Height is 0 - 1 in below 27-in design height.

Breaking and Cracking:	No twisting bending tears or cracking observed.			
	Missing Elements:	No missing elements were observed.			
	Corrosion and Weathering:	No loss of cross section or erosion around posts observed.			
End Treatments	Alignment and Height:	Alignment acceptable. Height is within 1-in. of 27-in. design height.			
	Breaking and Cracking:	No twisting bending tears or cracking observed.			
	Missing Elements:	No missing elements observed.			
	Corrosion and Weathering:	No loss of cross section or erosion around posts observed.

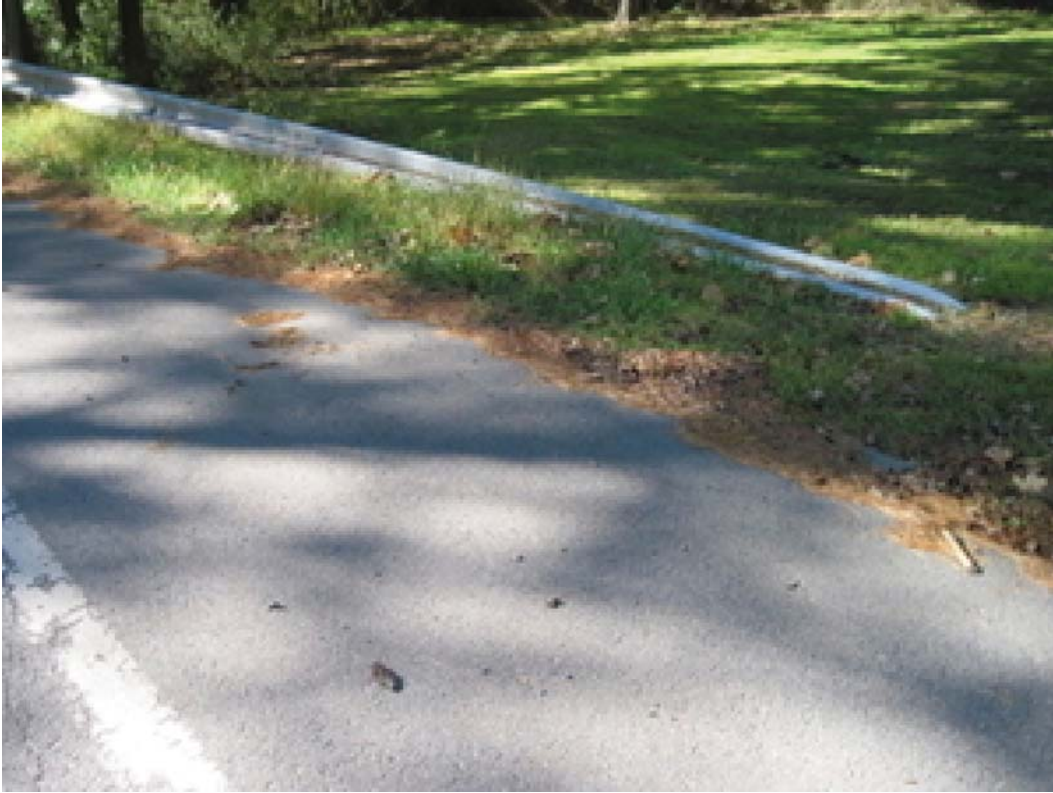
DEWA_0014_20.908_L_1.jpg

Barrier ID:	DEWA-0014-20.908-L				
Route Name:	US ROUTE 209				
Inspection Date:	10/08/2010	Barrier Rating:	22.70		
Barrier Description					
Type:	W-BEAM STRONG POST	Barrier Function:	TRAFFIC		
Barrier Material:	GALVANIZED STEEL	Post Material:	GALVANIZED STEEL		
Blockout Type:	STEEL	Length (ft.):	296		
Speed Limit (MPH):	25	Placement with Respect to Road:	INSIDE OF CURVE		
Hazard Behind Barrier:	LOW				
Barrier Crashworthiness					
Appropriate Test Level:	TL-1	Barrier Test Level:	TL-3	Is Barrier Crashworthy?:	YES
Beg. End Trtmt Type:	W-BEAM TURN DOWN	Is Beg. End Trtmt Crashworthy?:	NO	Approach Transition Type:	NONE
Ending End Trtmt Type:	W-BEAM TURN DOWN	Ending End Trtmt Crashworthy?:	NO		
Average Measurements					
Design Height (In.):	27	Width (In.):	0.0	Post Spacing (In.):	75.3
Height (In.):	26.0	Lateral Offset (In.):	67.0	Road Grade (%):	4.20
Physical Condition					
Barrier	Alignment and Height:	No alignment deflection observed. Height is within 1 in of 27 in design height along entire length.

Breaking and Cracking:	No twisting bending tears or cracking observed.			
	Missing Elements:	No missing elements observed.			
	Corrosion and Weathering:	No loss of cross section or erosion around posts observed.			
End Treatments	Alignment and Height:	Alignment acceptable. Height is within 1-in. of 27-in. design height.			
	Breaking and Cracking:	No twisting bending tears or cracking observed.			
	Missing Elements:	No missing elements observed.			
	Corrosion and Weathering:	No loss of cross section or erosion around posts observed.

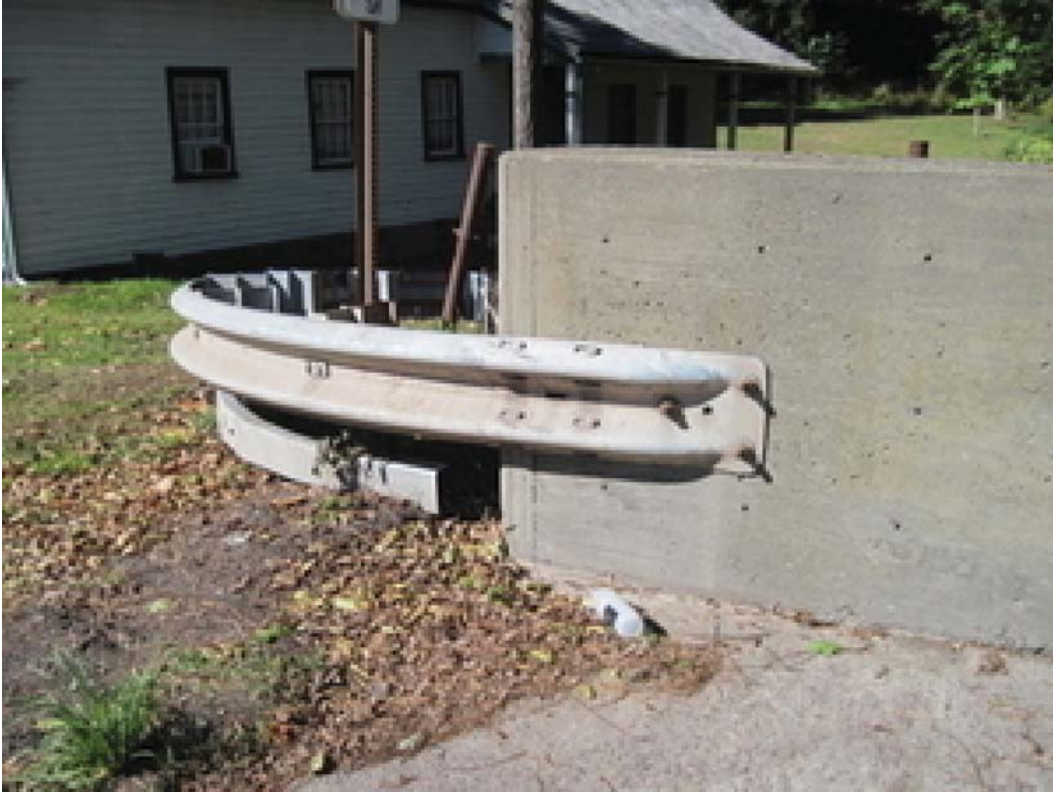
DEWA_0014_20.994_R_1.jpg

Barrier ID:	DEWA-0014-20.994-R				
Route Name:	US ROUTE 209				
Inspection Date:	10/08/2010	Barrier Rating:	21.20		
Barrier Description					
Type:	W-BEAM STRONG POST	Barrier Function:	TRAFFIC		
Barrier Material:	GALVANIZED STEEL	Post Material:	GALVANIZED STEEL		
Blockout Type:	STEEL	Length (ft.):	30		
Speed Limit (MPH):	25	Placement with Respect to Road:	TANGENT		
Hazard Behind Barrier:	HIGH				
Barrier Crashworthiness					
Appropriate Test Level:	TL-1	Barrier Test Level:	TL-3	Is Barrier Crashworthy?:	YES
Beg. End Trtmt Type:	NONE	Is Beg. End Trtmt Crashworthy?:	N/A	Approach Transition Type:	NONE
Ending End Trtmt Type:	NONE	Ending End Trtmt Crashworthy?:	N/A		
Average Measurements					
Design Height (In.):	27	Width (In.):	0.0	Post Spacing (In.):	34.0
Height (In.):	28.7	Lateral Offset (In.):	94.0	Road Grade (%):	0.00
Physical Condition					
Barrier	Alignment and Height:	No alignment deflection observed. Height ranges from 0 in to 3 in above 27 in design height.

Breaking and Cracking:	No twisting bending tears or cracking observed.			
	Missing Elements:	No missing elements observed.			
	Corrosion and Weathering:	No loss of cross section or erosion around posts observed.			
End Treatments	Alignment and Height:				
	Breaking and Cracking:				
	Missing Elements:				
	Corrosion and Weathering:

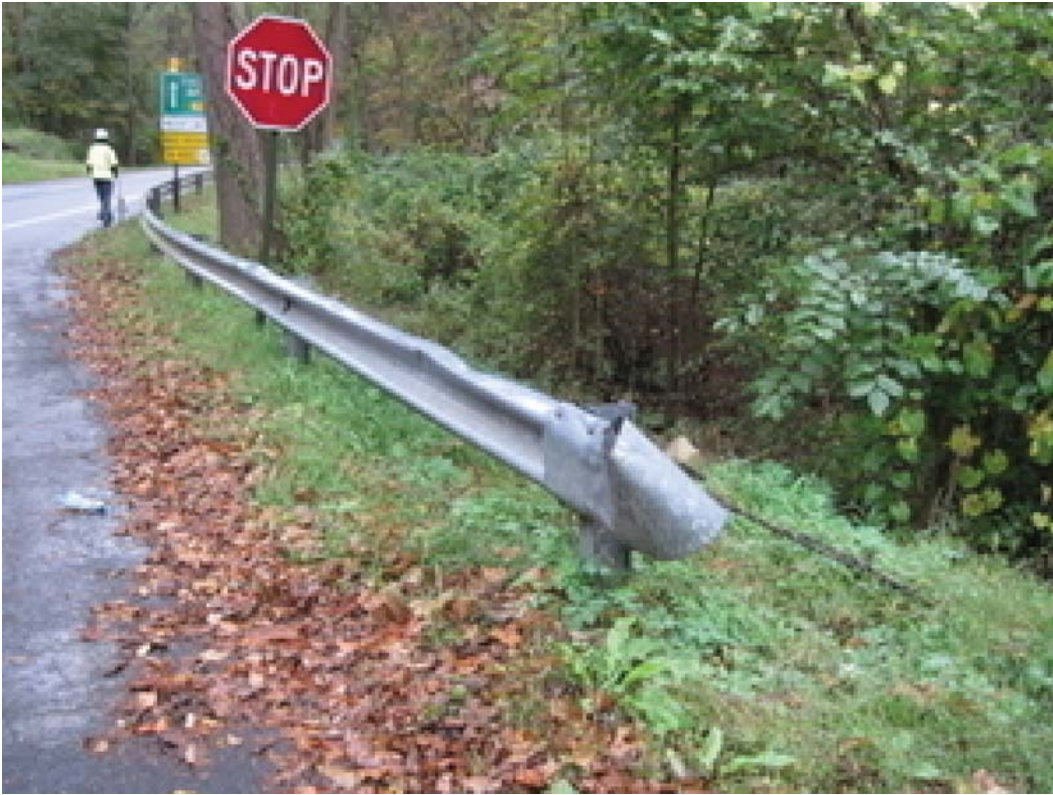
DEWA_0015_0.855_L_1.jpg

Barrier ID:	DEWA-0015-0.855-L				
Route Name:	OLD MINE ROAD (NORTH SECTION)				
Inspection Date:	10/04/2010	Barrier Rating:	19.80		
Barrier Description					
Type:	W-BEAM WEAK POST	Barrier Function:	TRAFFIC		
Barrier Material:	GALVANIZED STEEL	Post Material:	GALVANIZED STEEL		
Blockout Type:	N/A	Length (ft.):	78		
Speed Limit (MPH):	35	Placement with Respect to Road:	TANGENT		
Hazard Behind Barrier:	LOW				
Barrier Crashworthiness					
Appropriate Test Level:	TL-2	Barrier Test Level:	TL-2	Is Barrier Crashworthy?:	YES
Beg. End Trtmt Type:	NONE	Is Beg. End Trtmt Crashworthy?:	N/A	Approach Transition Type:	NONE
Ending End Trtmt Type:	NONE	Ending End Trtmt Crashworthy?:	N/A		
Average Measurements					
Design Height (In.):	27	Width (In.):	0.0	Post Spacing (In.):	149.0
Height (In.):	24.7	Lateral Offset (In.):	57.2	Road Grade (%):	1.40
Physical Condition					
Barrier	Alignment and Height:	No alignment deflection observed. Height ranges from 1 to 4 in below 27 in design height along 50 ft of barrier.

Breaking and Cracking:	No breaking or cracking observed.			
	Missing Elements:	No missing elements observed.			
	Corrosion and Weathering:	No loss of cross section or erosion around posts observed.			
End Treatments	Alignment and Height:	NA			
	Breaking and Cracking:	NA			
	Missing Elements:	NA			
	Corrosion and Weathering:	NA

Repair Action:	REPAIR	FMSS Work Type:	DEFERRED MAINTENANCE	Repair Cost:	\$2172
Brief Workorder:	Raise 50 feet of barrier to 27 inch design height.				
Workorder:	Adjust Guardrail at \$10- per -Lin. Ft. for 50 LF = \$500. Raise 50 feet of barrier to 27 inch design height. Low Speed Traffic Control at \$1475- per -Day for 1 Day(s) = \$1475.

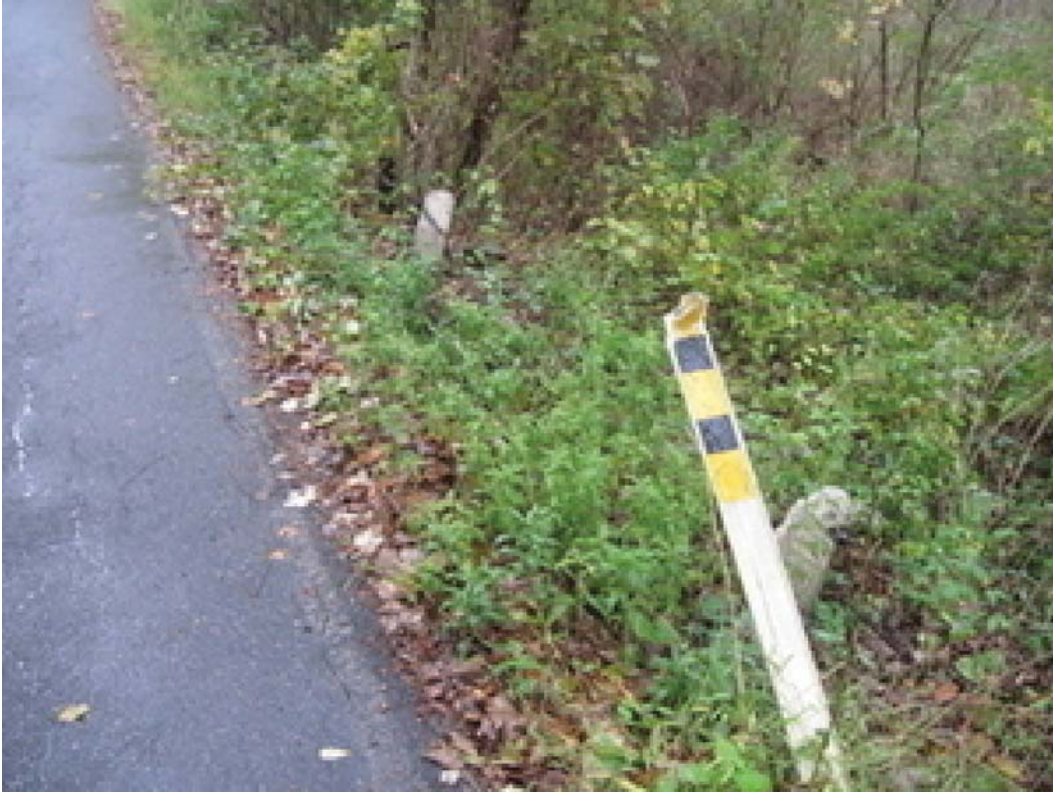
DEWA_0015_0.864_L_1.jpg

Barrier ID:	DEWA-0015-0.864-L				
Route Name:	OLD MINE ROAD (NORTH SECTION)				
Inspection Date:	10/04/2010	Barrier Rating:	21.20		
Barrier Description					
Type:	OTHER: 2-STRAND CABLE	Barrier Function:	TRAFFIC		
Barrier Material:	CABLE	Post Material:	OTHER: CONCRETE		
Blockout Type:	N/A	Length (ft.):	170		
Speed Limit (MPH):	35	Placement with Respect to Road:	TANGENT		
Hazard Behind Barrier:	LOW				
Barrier Crashworthiness					
Appropriate Test Level:	TL-2	Barrier Test Level:	NCW	Is Barrier Crashworthy?:	NO
Beg. End Trtmt Type:	NONE	Is Beg. End Trtmt Crashworthy?:	N/A	Approach Transition Type:	NONE
Ending End Trtmt Type:	NONE	Ending End Trtmt Crashworthy?:	N/A		
Average Measurements					
Design Height (In.):	27	Width (In.):	0.0	Post Spacing (In.):	125.3
Height (In.):	25.0	Lateral Offset (In.):	78.6	Road Grade (%):	4.20
Physical Condition					
Barrier	Alignment and Height:	Alignment deflects 6 in to 12 in for 40 ft of barrier and greater than 12 in for 100 ft. Height ranges from 4 in below 27 in design height to 1 in over.

Breaking and Cracking:	Two posts have been impacted and destroyed. Seven posts are laying on the ground. Excessive slack in both cables.			
	Missing Elements:	No missing elements observed.			
	Corrosion and Weathering:	No loss of cable cross section or erosion around posts observed.			
End Treatments	Alignment and Height:				
	Breaking and Cracking:				
	Missing Elements:				
	Corrosion and Weathering:

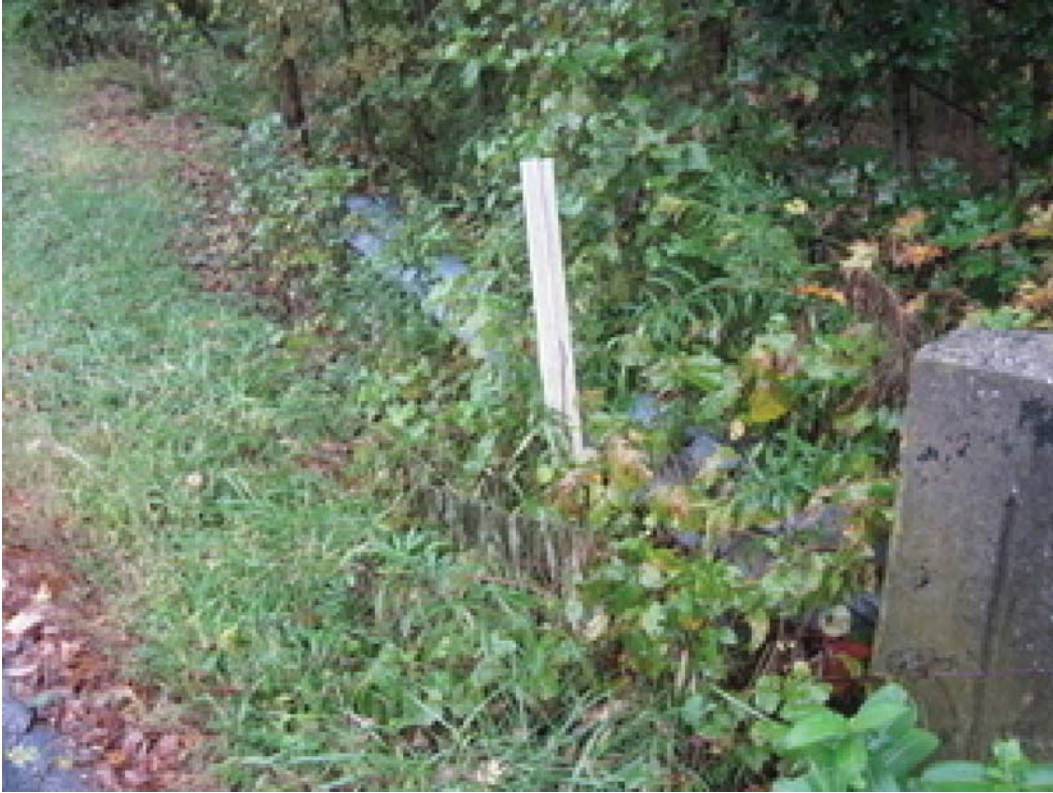
DEWA_0015_4.229_L_1.jpg

Barrier ID:	DEWA-0015-4.229-L				
Route Name:	OLD MINE ROAD (NORTH SECTION)				
Inspection Date:	10/04/2010	Barrier Rating:	14.00		
Barrier Description					
Type:	W-BEAM WEAK POST	Barrier Function:	TRAFFIC		
Barrier Material:	GALVANIZED STEEL	Post Material:	GALVANIZED STEEL		
Blockout Type:	N/A	Length (ft.):	32		
Speed Limit (MPH):	35	Placement with Respect to Road:	INSIDE OF CURVE		
Hazard Behind Barrier:	LOW				
Barrier Crashworthiness					
Appropriate Test Level:	TL-2	Barrier Test Level:	TL-2	Is Barrier Crashworthy?:	YES
Beg. End Trtmt Type:	NONE	Is Beg. End Trtmt Crashworthy?:	N/A	Approach Transition Type:	NONE
Ending End Trtmt Type:	NONE	Ending End Trtmt Crashworthy?:	N/A		
Average Measurements					
Design Height (In.):	27	Width (In.):	0.0	Post Spacing (In.):	150.0
Height (In.):	29.7	Lateral Offset (In.):	99.3	Road Grade (%):	0.20
Physical Condition					
Barrier	Alignment and Height:	No alignment deflection was observed. Height is 1 - 5 in above 27-in design height.

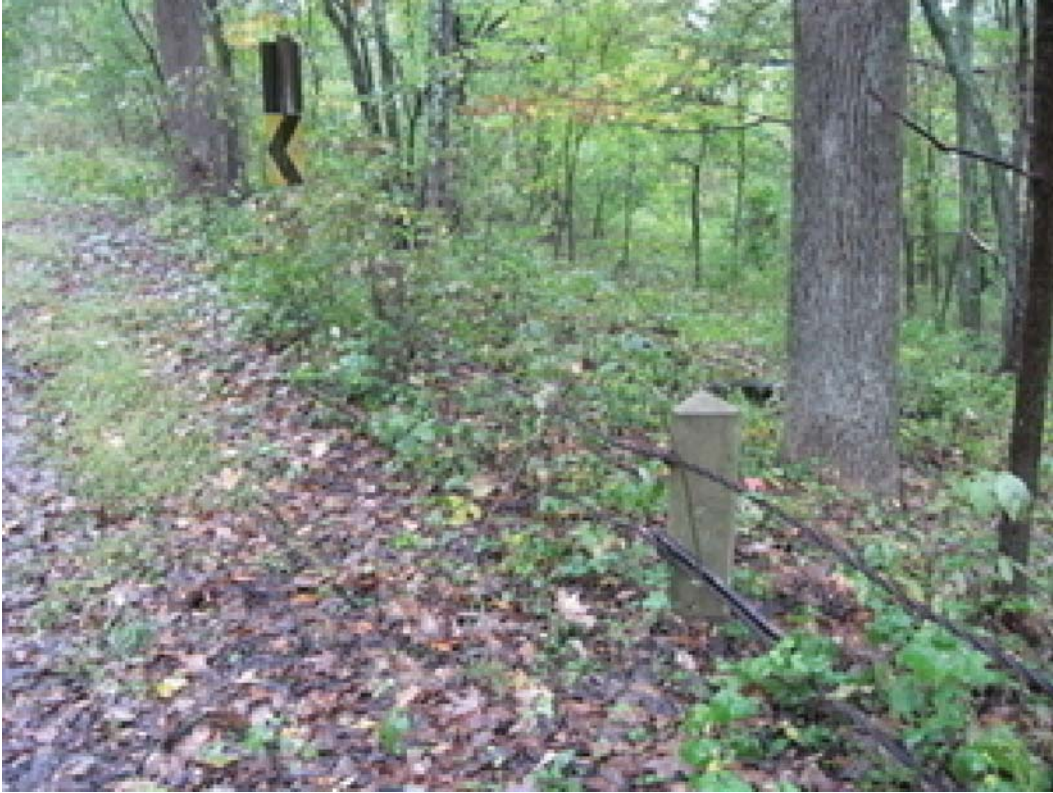
DEWA_0015_5.382_L_1.jpg

Barrier ID:	DEWA-0015-5.382-L				
Route Name:	OLD MINE ROAD (NORTH SECTION)				
Inspection Date:	10/04/2010	Barrier Rating:	32.20		
Barrier Description					
Type:	OTHER: 2-STRAND CABLE	Barrier Function:	TRAFFIC		
Barrier Material:	CABLE	Post Material:	OTHER: CONCRETE		
Blockout Type:	N/A	Length (ft.):	35		
Speed Limit (MPH):	35	Placement with Respect to Road:	OUTSIDE OF CURVE		
Hazard Behind Barrier:	MEDIUM				
Barrier Crashworthiness					
Appropriate Test Level:	TL-2	Barrier Test Level:	NCW	Is Barrier Crashworthy?:	NO
Beg. End Trtmt Type:	NONE	Is Beg. End Trtmt Crashworthy?:	N/A	Approach Transition Type:	NONE
Ending End Trtmt Type:	NONE	Ending End Trtmt Crashworthy?:	N/A		
Average Measurements					
Design Height (In.):	27	Width (In.):	0.0	Post Spacing (In.):	119.3
Height (In.):	20.7	Lateral Offset (In.):	158.6	Road Grade (%):	3.10
Physical Condition					
Barrier	Alignment and Height:	No alignment deflection observed. Height ranges from 4 - 8 in below 27-in design height.
