NPS Guardwall/Rail Inventory Program Delaware Water Gap National Recreation Area

**Federal Lands Highway
Road Inventory Program**

Federal Highway Administration
Eastern Federal Lands Highway Division
Road Inventory Program (RIP)

Data Collection Date: October 2010
Report Date: December 2015

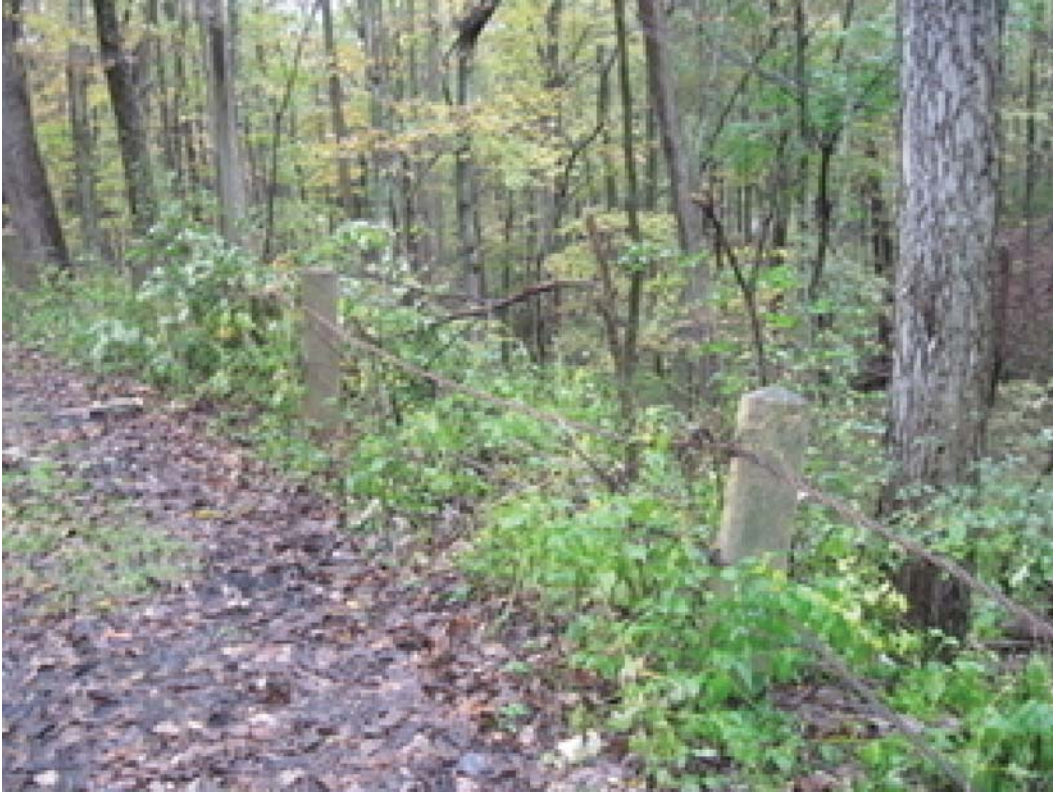
DEWA_0015_5.389_L_1.jpg

Barrier ID:	DEWA-0015-5.389-L				
Route Name:	OLD MINE ROAD (NORTH SECTION)				
Inspection Date:	10/04/2010	Barrier Rating:	12.80		
Barrier Description					
Type:	OTHER: 2-STRAND CABLE	Barrier Function:	NON-TRAFFIC		
Barrier Material:	CABLE	Post Material:	OTHER: CONCRETE		
Blockout Type:	N/A	Length (ft.):	54		
Speed Limit (MPH):	35	Placement with Respect to Road:	NON-TRAFFIC BARRIER		
Hazard Behind Barrier:	N/A				
Barrier Crashworthiness					
Appropriate Test Level:	TL-2	Barrier Test Level:	N/A	Is Barrier Crashworthy?:	N/A
Beg. End Trtmt Type:	NONE	Is Beg. End Trtmt Crashworthy?:	N/A	Approach Transition Type:	NONE
Ending End Trtmt Type:	NONE	Ending End Trtmt Crashworthy?:	N/A		
Average Measurements					
Design Height (In.):	27	Width (In.):	0.0	Post Spacing (In.):	104.0
Height (In.):	23.0	Lateral Offset (In.):	0.0	Road Grade (%):	0.00
Physical Condition					
Barrier	Alignment and Height:	Alignment deflection 6 - 12 in for 20 ft of barrier. Height ranges from 3 - 5 in below 27-in design height.

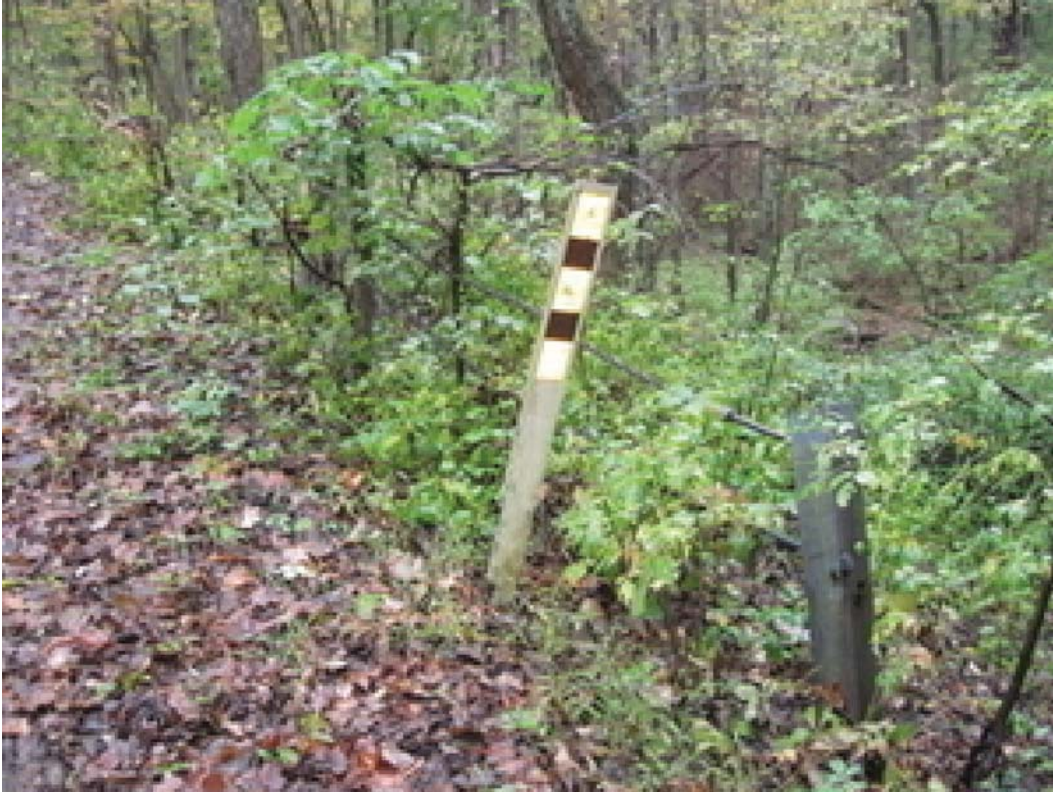
DEWA_0015_5.399_L_1.jpg

Barrier ID:	DEWA-0015-5.399-L				
Route Name:	OLD MINE ROAD (NORTH SECTION)				
Inspection Date:	10/04/2010	Barrier Rating:	29.70		
Barrier Description					
Type:	OTHER: 2-STRAND CABLE	Barrier Function:	TRAFFIC		
Barrier Material:	CABLE	Post Material:	OTHER: CONCRETE		
Blockout Type:	N/A	Length (ft.):	40		
Speed Limit (MPH):	35	Placement with Respect to Road:	OUTSIDE OF CURVE		
Hazard Behind Barrier:	LOW				
Barrier Crashworthiness					
Appropriate Test Level:	TL-2	Barrier Test Level:	NCW	Is Barrier Crashworthy?:	NO
Beg. End Trtmt Type:	NONE	Is Beg. End Trtmt Crashworthy?:	N/A	Approach Transition Type:	NONE
Ending End Trtmt Type:	NONE	Ending End Trtmt Crashworthy?:	N/A		
Average Measurements					
Design Height (In.):	27	Width (In.):	0.0	Post Spacing (In.):	115.0
Height (In.):	27.7	Lateral Offset (In.):	122.0	Road Grade (%):	2.40
Physical Condition					
Barrier	Alignment and Height:	Alignment deflects more than 12 in along entire length. Height meets or exceeds 27 in design height by 1 in throughout.

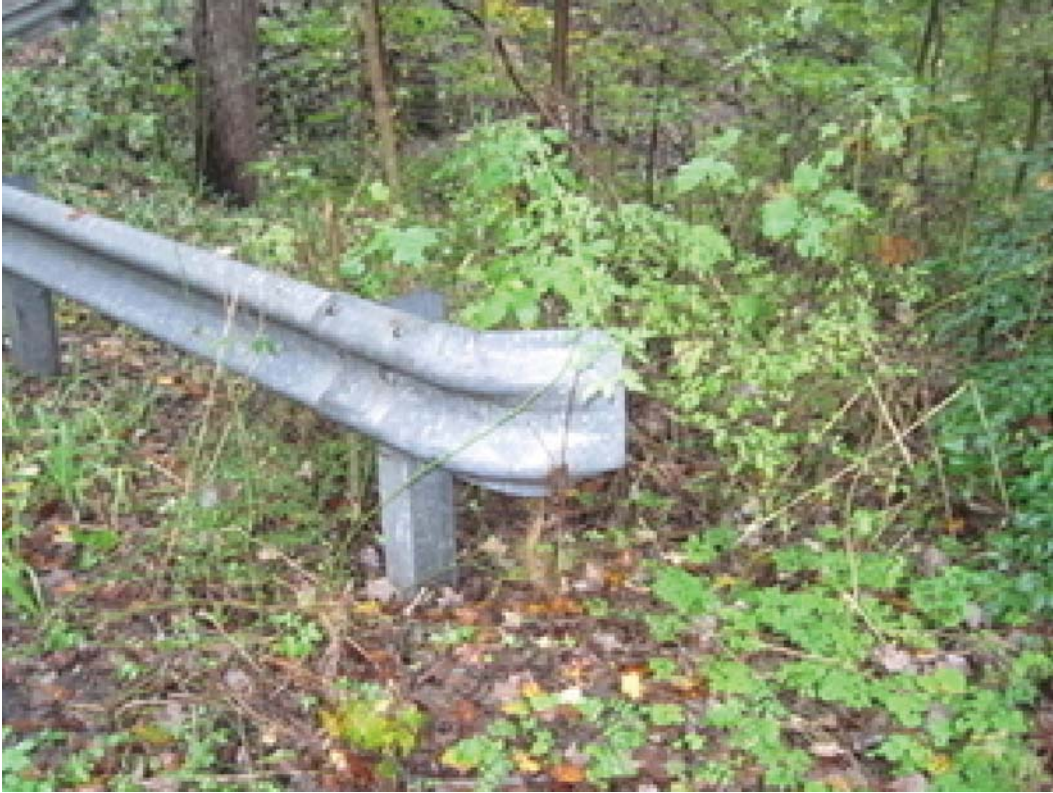
DEWA_0015_5.407_L_1.jpg

Barrier ID:	DEWA-0015-5.407-L				
Route Name:	OLD MINE ROAD (NORTH SECTION)				
Inspection Date:	10/04/2010	Barrier Rating:	25.70		
Barrier Description					
Type:	W-BEAM WEAK POST	Barrier Function:	TRAFFIC		
Barrier Material:	GALVANIZED STEEL	Post Material:	GALVANIZED STEEL		
Blockout Type:	N/A	Length (ft.):	85		
Speed Limit (MPH):	35	Placement with Respect to Road:	INSIDE OF CURVE		
Hazard Behind Barrier:	LOW				
Barrier Crashworthiness					
Appropriate Test Level:	TL-2	Barrier Test Level:	TL-2	Is Barrier Crashworthy?:	YES
Beg. End Trtmt Type:	NONE	Is Beg. End Trtmt Crashworthy?:	N/A	Approach Transition Type:	NONE
Ending End Trtmt Type:	NONE	Ending End Trtmt Crashworthy?:	N/A		
Average Measurements					
Design Height (In.):	27	Width (In.):	0.0	Post Spacing (In.):	76.3
Height (In.):	24.2	Lateral Offset (In.):	33.2	Road Grade (%):	2.40
Physical Condition					
Barrier	Alignment and Height:	Alignment deflects between 6 and 12 in along 30 ft of guardrail. Height ranges from 2 to 7 in below 27 in design height along 70 ft of guardrail.

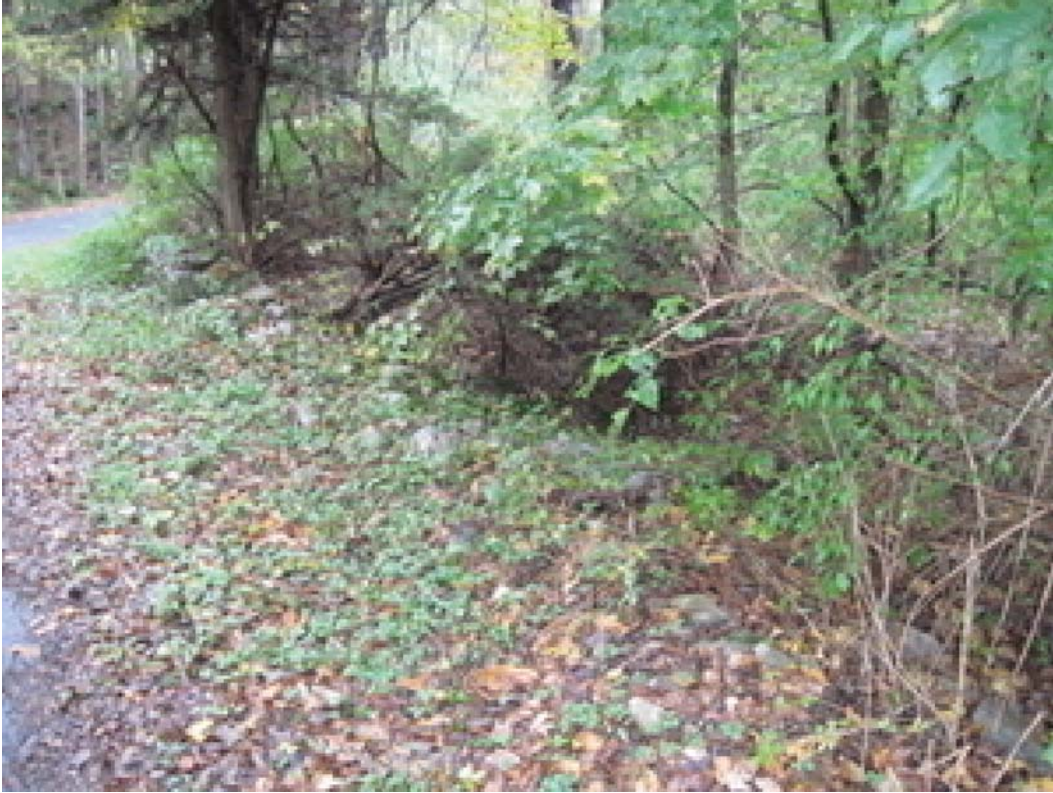
DEWA_0015_5.432_L_1.jpg

Barrier ID:	DEWA-0015-5.432-L				
Route Name:	OLD MINE ROAD (NORTH SECTION)				
Inspection Date:	10/04/2010	Barrier Rating:	44.90		
Barrier Description					
Type:	STONE MASONRY WITHOUT CONCRETE CORE WALL	Barrier Function:	TRAFFIC		
Barrier Material:	STONE	Post Material:	N/A		
Blockout Type:	N/A	Length (ft.):	55		
Speed Limit (MPH):	35	Placement with Respect to Road:	TANGENT		
Hazard Behind Barrier:	LOW				
Barrier Crashworthiness					
Appropriate Test Level:	TL-2	Barrier Test Level:	NCW	Is Barrier Crashworthy?:	NO
Beg. End Trtmt Type:	NONE	Is Beg. End Trtmt Crashworthy?:	N/A	Approach Transition Type:	NONE
Ending End Trtmt Type:	NONE	Ending End Trtmt Crashworthy?:	N/A		
Average Measurements					
Design Height (In.):	24	Width (In.):	22.7	Post Spacing (In.):	0.0
Height (In.):	13.0	Lateral Offset (In.):	75.3	Road Grade (%):	5.10
Physical Condition					
Barrier	Alignment and Height:	No alignment deflection was observed. 23 ft of barrier is 6 in below 24-in design height. 32 ft of barrier is collapsed; height is not applicable.

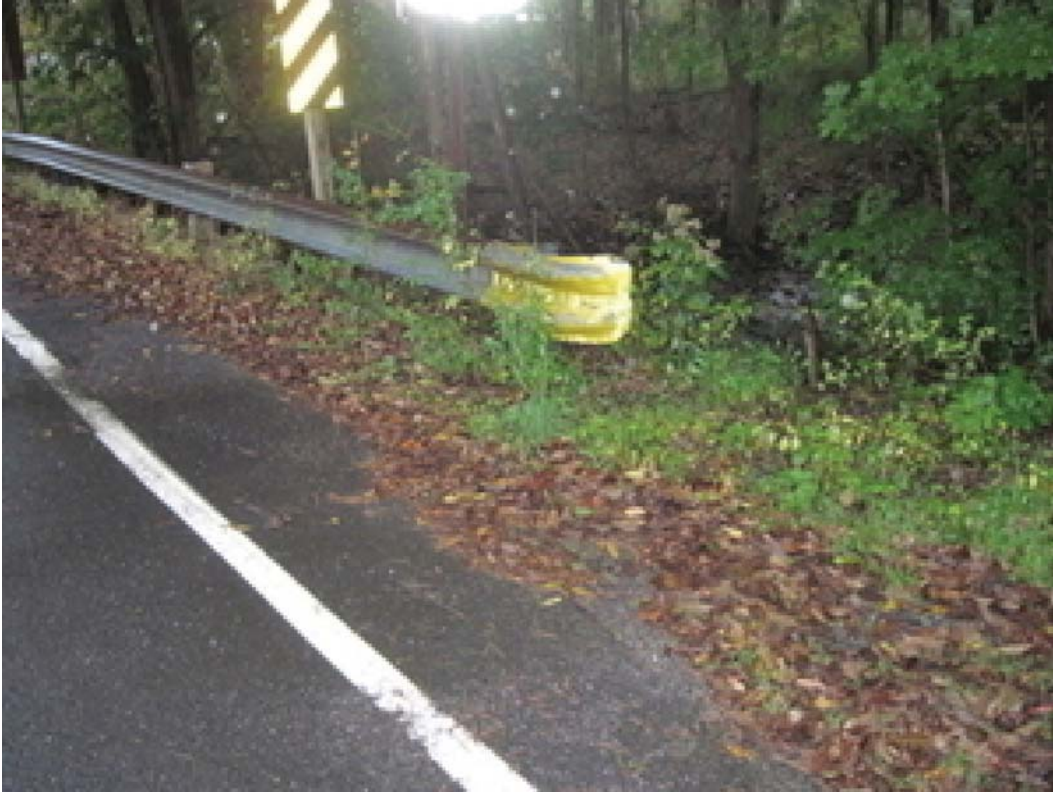
DEWA_0015_7.560_R_1.jpg

Barrier ID:	DEWA-0015-7.560-R				
Route Name:	OLD MINE ROAD (NORTH SECTION)				
Inspection Date:	10/04/2010	Barrier Rating:	34.90		
Barrier Description					
Type:	W-BEAM WEAK POST	Barrier Function:	TRAFFIC		
Barrier Material:	GALVANIZED STEEL	Post Material:	GALVANIZED STEEL		
Blockout Type:	N/A	Length (ft.):	91		
Speed Limit (MPH):	35	Placement with Respect to Road:	TANGENT		
Hazard Behind Barrier:	LOW				
Barrier Crashworthiness					
Appropriate Test Level:	TL-2	Barrier Test Level:	TL-2	Is Barrier Crashworthy?:	YES
Beg. End Trtmt Type:	NONE	Is Beg. End Trtmt Crashworthy?:	N/A	Approach Transition Type:	NONE
Ending End Trtmt Type:	NONE	Ending End Trtmt Crashworthy?:	N/A		
Average Measurements					
Design Height (In.):	27	Width (In.):	0.0	Post Spacing (In.):	151.3
Height (In.):	19.5	Lateral Offset (In.):	55.7	Road Grade (%):	0.50
Physical Condition					
Barrier	Alignment and Height:	No alignment deflection observed. Height is 6-9 in below 27 in design height.

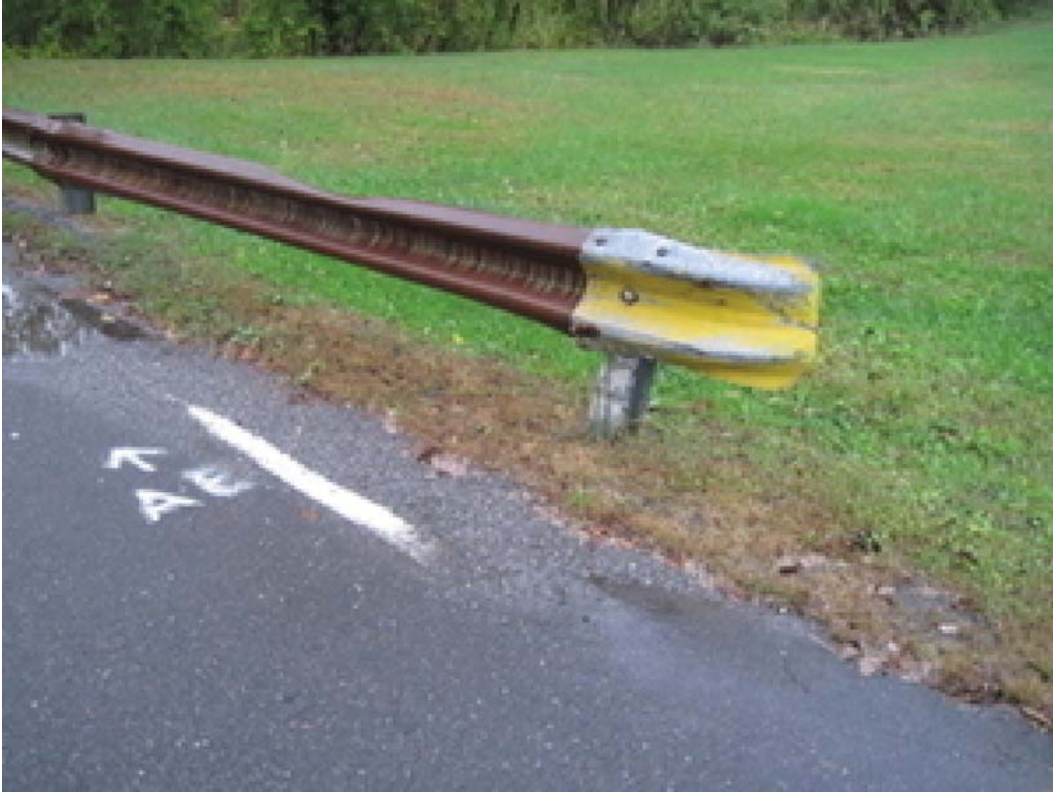
DEWA_0015_7.561_L_1.jpg

Barrier ID:	DEWA-0015-7.561-L				
Route Name:	OLD MINE ROAD (NORTH SECTION)				
Inspection Date:	10/04/2010	Barrier Rating:	33.70		
Barrier Description					
Type:	W-BEAM WEAK POST	Barrier Function:	TRAFFIC		
Barrier Material:	GALVANIZED STEEL	Post Material:	GALVANIZED STEEL		
Blockout Type:	N/A	Length (ft.):	103		
Speed Limit (MPH):	35	Placement with Respect to Road:	TANGENT		
Hazard Behind Barrier:	MEDIUM				
Barrier Crashworthiness					
Appropriate Test Level:	TL-2	Barrier Test Level:	TL-2	Is Barrier Crashworthy?:	YES
Beg. End Trtmt Type:	NONE	Is Beg. End Trtmt Crashworthy?:	N/A	Approach Transition Type:	NONE
Ending End Trtmt Type:	NONE	Ending End Trtmt Crashworthy?:	N/A		
Average Measurements					
Design Height (In.):	27	Width (In.):	0.0	Post Spacing (In.):	151.3
Height (In.):	21.7	Lateral Offset (In.):	33.2	Road Grade (%):	0.70
Physical Condition					
Barrier	Alignment and Height:	No alignment deflection observed. Height ranges from 5 in to 6 in below 27 in design height.

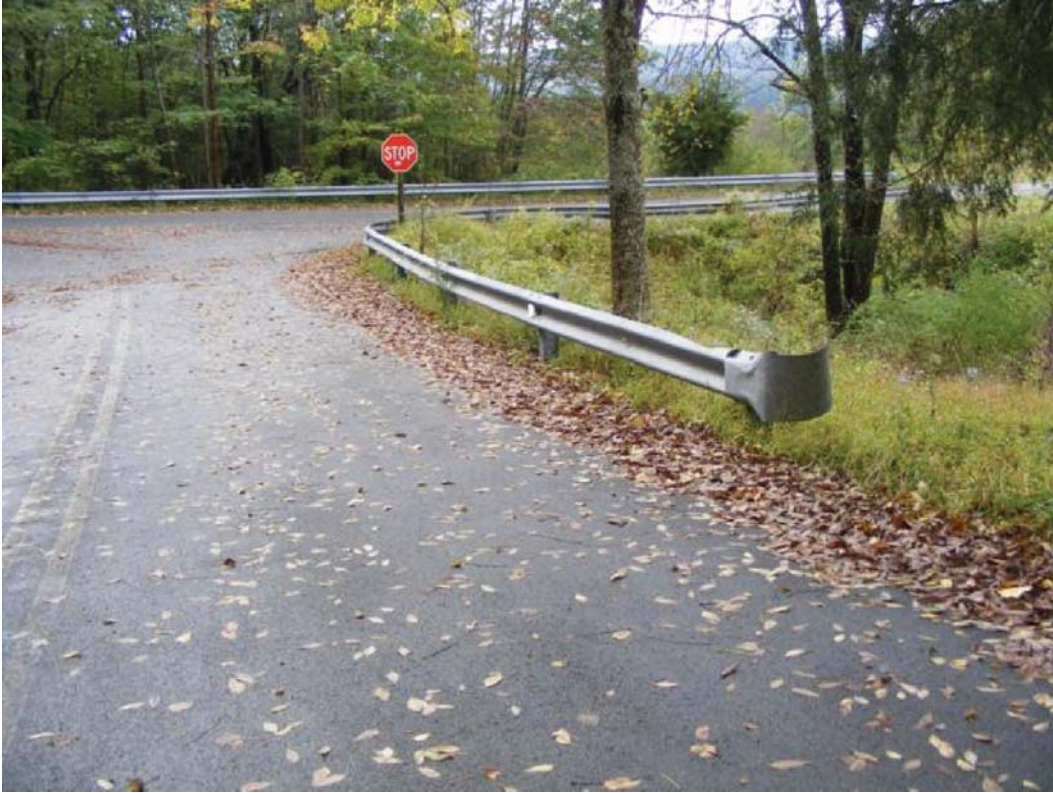
DEWA_0100_0.006_L_1.JPG

Barrier ID:	DEWA-0100-0.006-L				
Route Name:	BLUE MOUNTAIN LAKE ROAD				
Inspection Date:	10/01/2010	Barrier Rating:	31.30		
Barrier Description					
Type:	W-BEAM WEAK POST	Barrier Function:	TRAFFIC		
Barrier Material:	GALVANIZED STEEL	Post Material:	GALVANIZED STEEL		
Blockout Type:	N/A	Length (ft.):	75		
Speed Limit (MPH):	35	Placement with Respect to Road:	TANGENT		
Hazard Behind Barrier:	LOW				
Barrier Crashworthiness					
Appropriate Test Level:	TL-2	Barrier Test Level:	TL-2	Is Barrier Crashworthy?:	YES
Beg. End Trtmt Type:	NONE	Is Beg. End Trtmt Crashworthy?:	N/A	Approach Transition Type:	NONE
Ending End Trtmt Type:	NONE	Ending End Trtmt Crashworthy?:	N/A		
Average Measurements					
Design Height (In.):	27	Width (In.):	0.0	Post Spacing (In.):	150.0
Height (In.):	23.7	Lateral Offset (In.):	29.0	Road Grade (%):	7.10
Physical Condition					
Barrier	Alignment and Height:	No deflections observed in alignment. The height is 3 to 4 in below design height of 27 in.

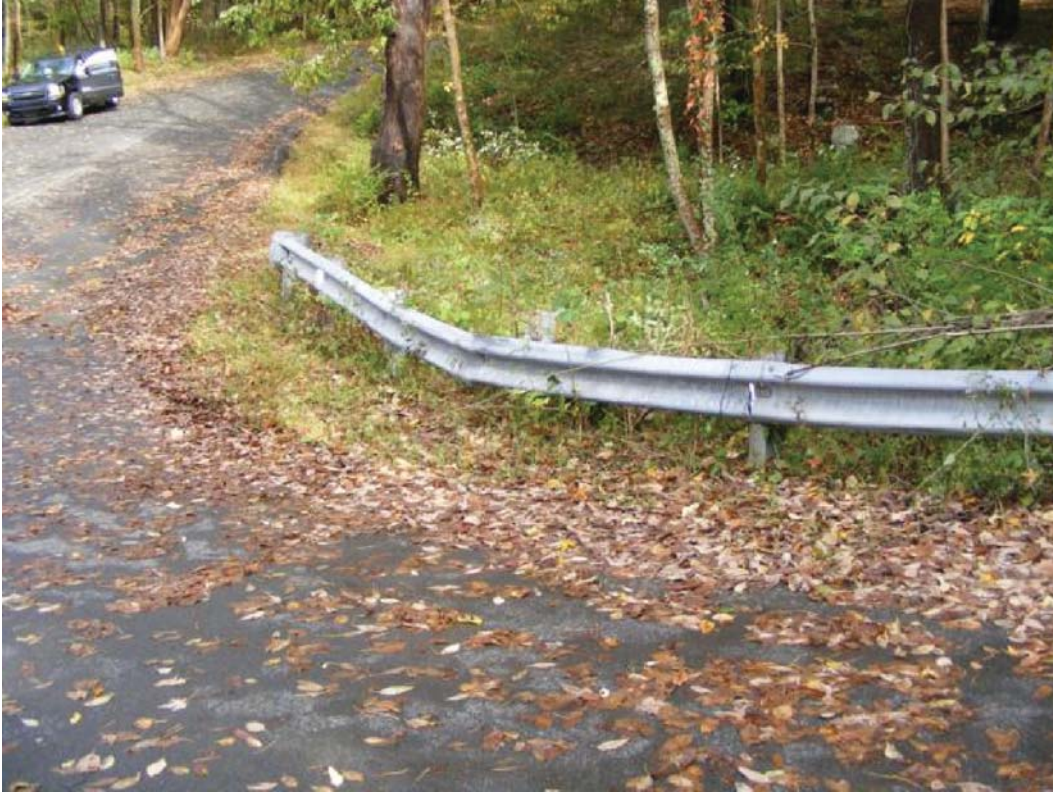
DEWA_0100_0.007_R_1.JPG

Barrier ID:	DEWA-0100-0.007-R				
Route Name:	BLUE MOUNTAIN LAKE ROAD				
Inspection Date:	10/01/2010	Barrier Rating:	14.00		
Barrier Description					
Type:	W-BEAM WEAK POST	Barrier Function:	TRAFFIC		
Barrier Material:	GALVANIZED STEEL	Post Material:	GALVANIZED STEEL		
Blockout Type:	N/A	Length (ft.):	38		
Speed Limit (MPH):	35	Placement with Respect to Road:	INSIDE OF CURVE		
Hazard Behind Barrier:	LOW				
Barrier Crashworthiness					
Appropriate Test Level:	TL-2	Barrier Test Level:	TL-2	Is Barrier Crashworthy?:	YES
Beg. End Trtmt Type:	NONE	Is Beg. End Trtmt Crashworthy?:	N/A	Approach Transition Type:	NONE
Ending End Trtmt Type:	NONE	Ending End Trtmt Crashworthy?:	N/A		
Average Measurements					
Design Height (In.):	27	Width (In.):	0.0	Post Spacing (In.):	75.5
Height (In.):	28.2	Lateral Offset (In.):	49.0	Road Grade (%):	1.80
Physical Condition					
Barrier	Alignment and Height:	No deflections observed in alignment. The height is 1 in below at or up to 3 in above the 27 in design height.

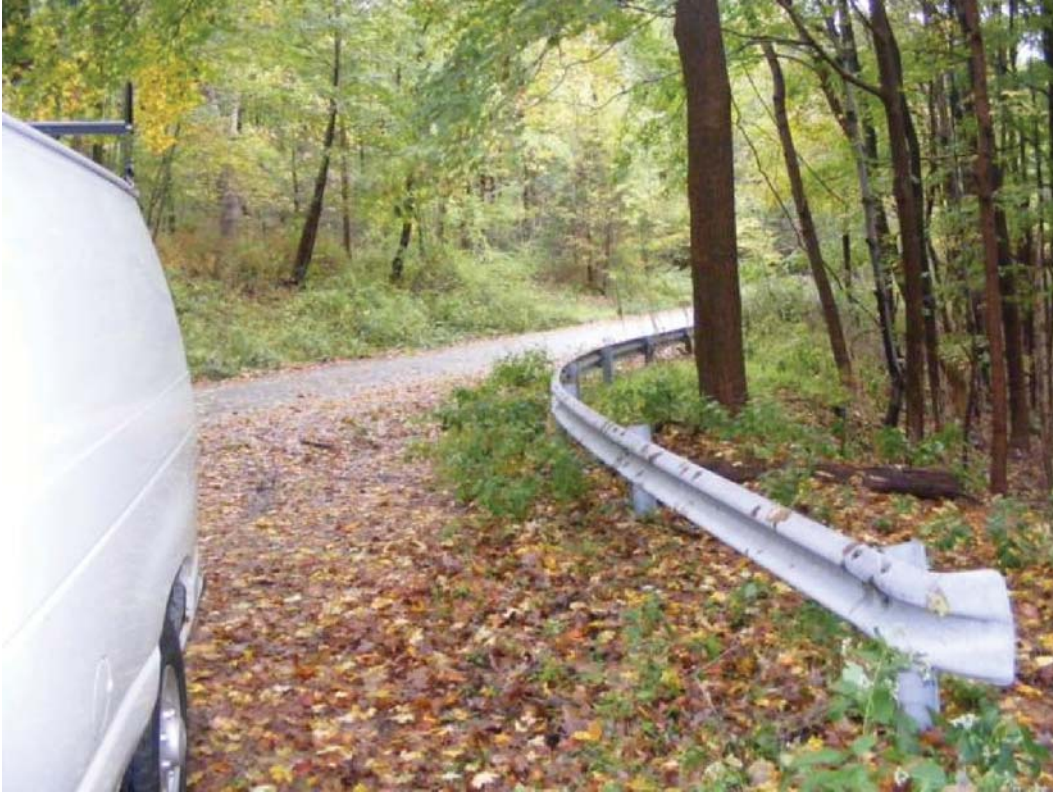
DEWA_0100_0.178_L_1.JPG

Barrier ID:	DEWA-0100-0.178-L				
Route Name:	BLUE MOUNTAIN LAKE ROAD				
Inspection Date:	10/01/2010	Barrier Rating:	56.40		
Barrier Description					
Type:	W-BEAM WEAK POST	Barrier Function:	TRAFFIC		
Barrier Material:	GALVANIZED STEEL	Post Material:	GALVANIZED STEEL		
Blockout Type:	N/A	Length (ft.):	415		
Speed Limit (MPH):	35	Placement with Respect to Road:	INSIDE OF CURVE		
Hazard Behind Barrier:	LOW				
Barrier Crashworthiness					
Appropriate Test Level:	TL-2	Barrier Test Level:	TL-2	Is Barrier Crashworthy?:	YES
Beg. End Trtmt Type:	NONE	Is Beg. End Trtmt Crashworthy?:	N/A	Approach Transition Type:	NONE
Ending End Trtmt Type:	NONE	Ending End Trtmt Crashworthy?:	N/A		
Average Measurements					
Design Height (In.):	27	Width (In.):	0.0	Post Spacing (In.):	149.3
Height (In.):	17.6	Lateral Offset (In.):	26.6	Road Grade (%):	4.90
Physical Condition					
Barrier	Alignment and Height:	No deflections observed in alignment. The height is low by 9 to 10 in from the design of 27 in for 415 linear ft.

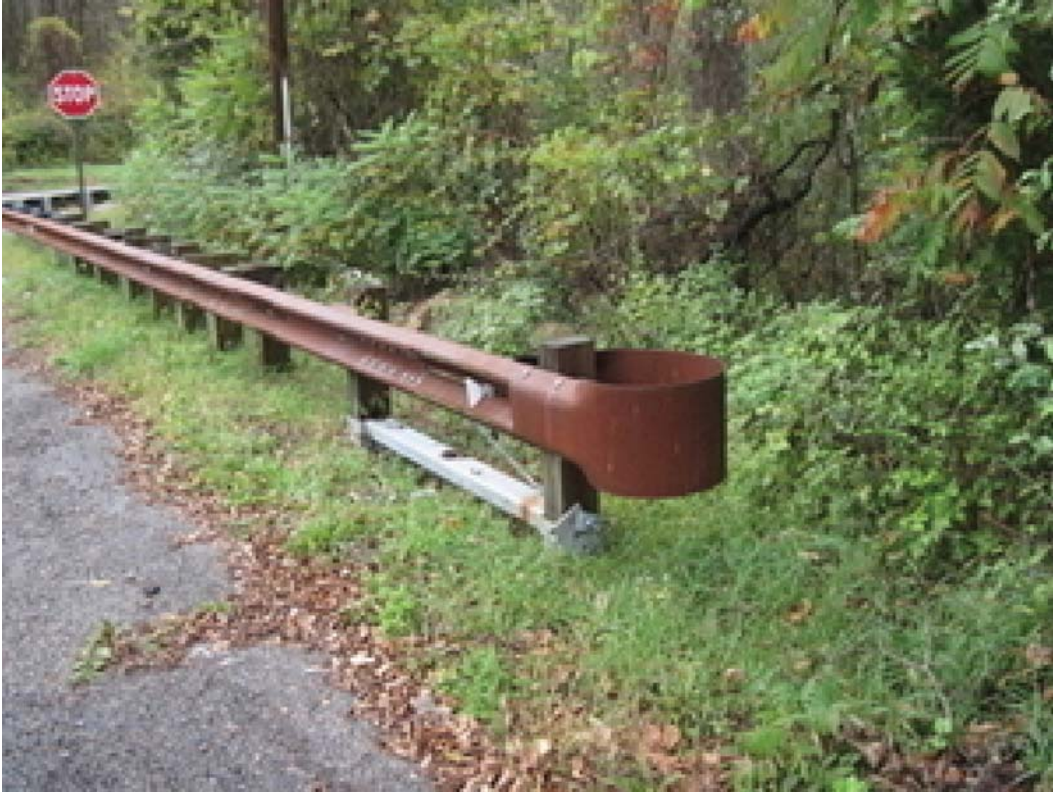
DEWA_0104_0.000_L_1.jpg

Barrier ID:	DEWA-0104-0.000-L				
Route Name:	UPPER RIDGE ROAD				
Inspection Date:	10/04/2010	Barrier Rating:	14.10		
Barrier Description					
Type:	W-BEAM STRONG POST	Barrier Function:	TRAFFIC		
Barrier Material:	WEATHERING STEEL/CORTEN	Post Material:	GALVANIZED STEEL		
Blockout Type:	PLASTIC	Length (ft.):	80		
Speed Limit (MPH):	35	Placement with Respect to Road:	TANGENT		
Hazard Behind Barrier:	LOW				
Barrier Crashworthiness					
Appropriate Test Level:	TL-2	Barrier Test Level:	TL-3	Is Barrier Crashworthy?:	YES
Beg. End Trtmt Type:	NONE	Is Beg. End Trtmt Crashworthy?:	N/A	Approach Transition Type:	NONE
Ending End Trtmt Type:	W-BEAM TANGENT 350	Ending End Trtmt Crashworthy?:	YES		
Average Measurements					
Design Height (In.):	27	Width (In.):	0.0	Post Spacing (In.):	72.6
Height (In.):	29.0	Lateral Offset (In.):	40.0	Road Grade (%):	4.10
Physical Condition					
Barrier	Alignment and Height:	No alignment deflection observed. Height is above design height for barrier length (27 in) by 1 to 4 in.

Breaking and Cracking:	No twisting bending tears or cracking observed.			
	Missing Elements:	No missing elements observed.			
	Corrosion and Weathering:	No loss of cross section or erosion around posts observed.			
End Treatments	Alignment and Height:	Alignment acceptable. Height is within 1-in. of 27-in. design height.			
	Breaking and Cracking:	No twisting bending tears or cracking observed.			
	Missing Elements:	No missing elements observed.			
	Corrosion and Weathering:	No loss of cross section or erosion around posts observed.

Repair Action:	NO ACTION	FMSS Work Type:	N/A	Repair Cost:	\$0
Brief Workorder:	N/A				
Workorder:	No action required.

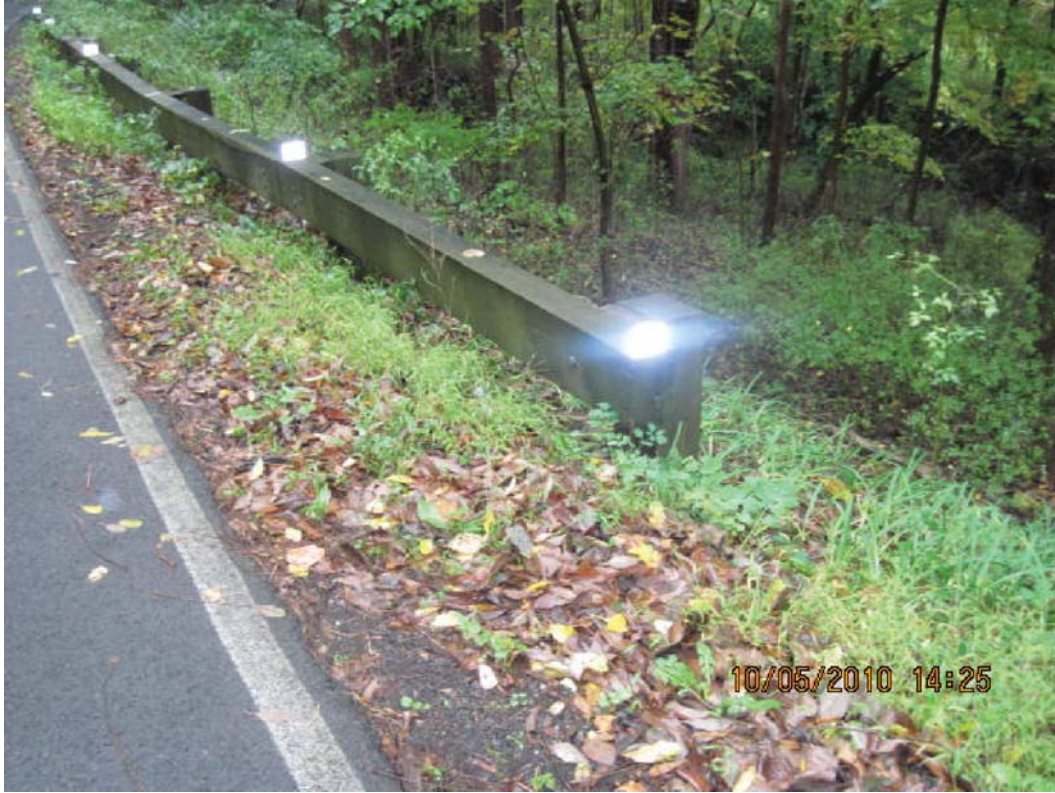
DEWA_0105_1.054_R_1.jpg

Barrier ID:	DEWA-0105-1.054-R				
Route Name:	RIVER ROAD				
Inspection Date:	10/05/2010	Barrier Rating:	45.00		
Barrier Description					
Type:	STEEL-BACKED TIMBER WITH BLOCKOUT	Barrier Function:	TRAFFIC		
Barrier Material:	STEEL-BACKED TIMBER/LOG	Post Material:	WOOD		
Blockout Type:	WOOD	Length (ft.):	133		
Speed Limit (MPH):	30	Placement with Respect to Road:	INSIDE OF CURVE		
Hazard Behind Barrier:	HIGH				
Barrier Crashworthiness					
Appropriate Test Level:	TL-1	Barrier Test Level:	TL-3	Is Barrier Crashworthy?:	YES
Beg. End Trtmt Type:	NONE	Is Beg. End Trtmt Crashworthy?:	N/A	Approach Transition Type:	NONE
Ending End Trtmt Type:	NONE	Ending End Trtmt Crashworthy?:	N/A		
Average Measurements					
Design Height (In.):	27	Width (In.):	0.0	Post Spacing (In.):	120.0
Height (In.):	17.5	Lateral Offset (In.):	33.2	Road Grade (%):	2.70
Physical Condition					
Barrier	Alignment and Height:	Alignment deflection was less than 6 in. The entire barrier was 8-11 in below design height (27 in).

Breaking and Cracking:	No impact related breaking or cracking observed.			
	Missing Elements:	4 reflectors were missing from the barrier.			
	Corrosion and Weathering:	Erosion at the base of the posts has caused the barrier to deflect when pushed.			
End Treatments	Alignment and Height:				
	Breaking and Cracking:				
	Missing Elements:				
	Corrosion and Weathering:

Repair Action:	REPAIR	FMSS Work Type:	DEFERRED MAINTENANCE	Repair Cost:	\$3526
Brief Workorder:	Raise 133 feet of barrier to 27 inch design height and monitor the erosion at the base of the posts.				
Workorder:	Adjust Guardrail at \$10- per -Lin. Ft. for 133 LF = \$1330. Raise 133ft. of barrier to 27-in. design height. Barrier Reflectors at \$100- per -Each for 4 Unit(s) = \$400. Replace 4 missing barrier reflectors. Low Speed Traffic Control at \$1475- per -Day for 1 Day(s) = \$1475.

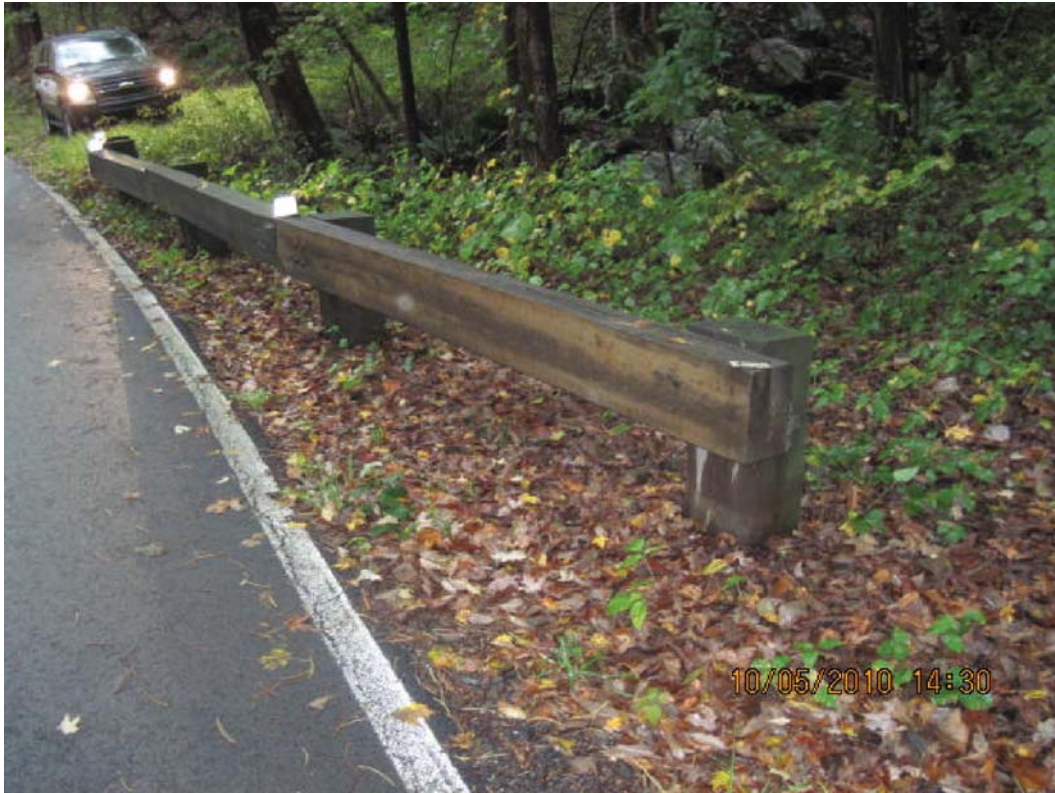
DEWA_0105_1.067_L_1.jpg

Barrier ID:	DEWA-0105-1.067-L				
Route Name:	RIVER ROAD				
Inspection Date:	10/05/2010	Barrier Rating:	32.20		
Barrier Description					
Type:	STEEL-BACKED TIMBER WITHOUT BLOCKOUT	Barrier Function:	TRAFFIC		
Barrier Material:	STEEL-BACKED TIMBER/LOG	Post Material:	WOOD		
Blockout Type:	N/A	Length (ft.):	41		
Speed Limit (MPH):	30	Placement with Respect to Road:	OUTSIDE OF CURVE		
Hazard Behind Barrier:	MEDIUM				
Barrier Crashworthiness					
Appropriate Test Level:	TL-1	Barrier Test Level:	TL-2	Is Barrier Crashworthy?:	YES
Beg. End Trtmt Type:	NONE	Is Beg. End Trtmt Crashworthy?:	N/A	Approach Transition Type:	NONE
Ending End Trtmt Type:	NONE	Ending End Trtmt Crashworthy?:	N/A		
Average Measurements					
Design Height (In.):	27	Width (In.):	0.0	Post Spacing (In.):	120.5
Height (In.):	24.7	Lateral Offset (In.):	11.1	Road Grade (%):	2.70
Physical Condition					
Barrier	Alignment and Height:	2 rails were deflected approximately 6 in. 10 ft of barrier is 1 to 3 in below 27 in design height. 20 ft of barrier is 3 to 4 in below 27 in design height.

Breaking and Cracking:	No breaks or cracks were observed.			
	Missing Elements:	There were 2 reflectors observed to be missing.			
	Corrosion and Weathering:	About 4 bolts are loose at one location due to twisting of steel.			
End Treatments	Alignment and Height:				
	Breaking and Cracking:				
	Missing Elements:				
	Corrosion and Weathering:

Repair Action:	REPAIR	FMSS Work Type:	DEFERRED MAINTENANCE	Repair Cost:	\$2239
Brief Workorder:	Raise 30 feet of barrier to 27 inch design height and tighten loose bolts.				
Workorder:	Adjust Guardrail at \$10- per -Lin. Ft. for 30 LF = \$300. Raise 30 feet of barrier to 27 inch design height. Barrier Reflectors at \$100- per -Each for 2 Unit(s) = \$200. Replace 2 missing barrier reflectors. Labor at \$60- per -Hour for 1 Hrs = \$60. Tighten loose bolts. Low Speed Traffic Control at \$1475- per -Day for 1 Day(s) = \$1475.

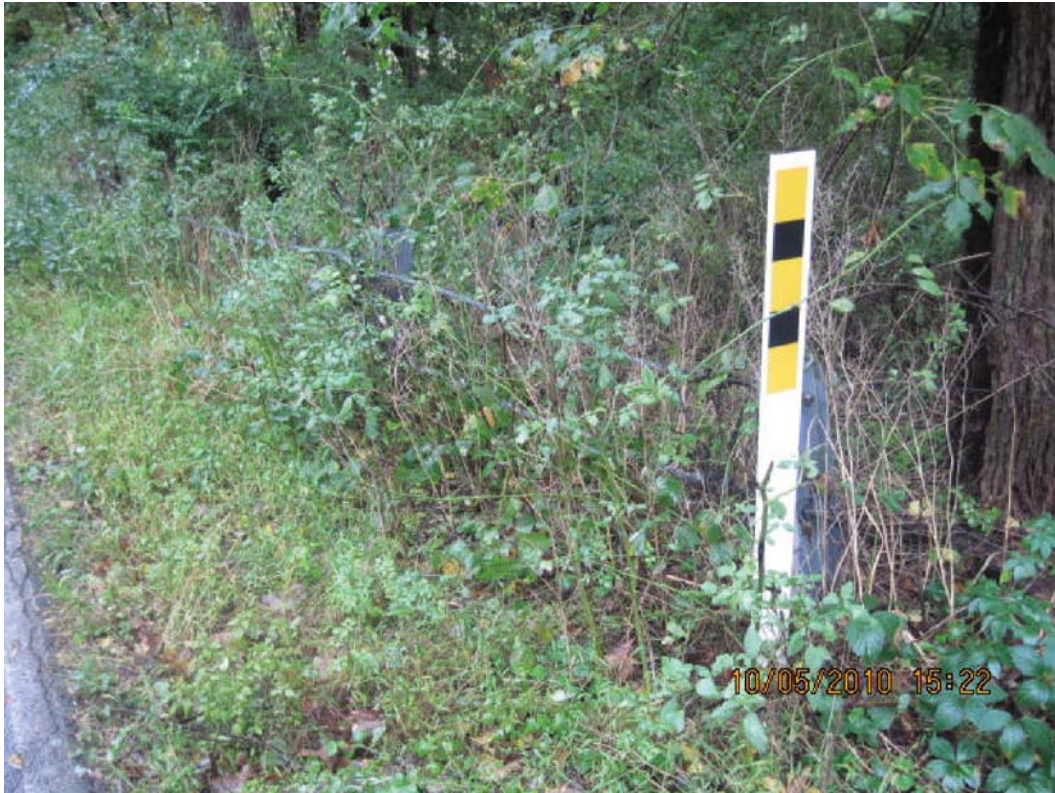
DEWA_0105_2.847_R_1.jpg

Barrier ID:	DEWA-0105-2.847-R				
Route Name:	RIVER ROAD				
Inspection Date:	10/05/2010	Barrier Rating:	55.50		
Barrier Description					
Type:	OTHER: 2-STRAND CABLE	Barrier Function:	TRAFFIC		
Barrier Material:	CABLE	Post Material:	GALVANIZED STEEL		
Blockout Type:	N/A	Length (ft.):	949		
Speed Limit (MPH):	30	Placement with Respect to Road:	OUTSIDE OF CURVE		
Hazard Behind Barrier:	LOW				
Barrier Crashworthiness					
Appropriate Test Level:	TL-1	Barrier Test Level:	NCW	Is Barrier Crashworthy?:	NO
Beg. End Trtmt Type:	NONE	Is Beg. End Trtmt Crashworthy?:	N/A	Approach Transition Type:	NONE
Ending End Trtmt Type:	NONE	Ending End Trtmt Crashworthy?:	N/A		
Average Measurements					
Design Height (In.):	27	Width (In.):	0.0	Post Spacing (In.):	188.0
Height (In.):	19.0	Lateral Offset (In.):	39.7	Road Grade (%):	0.90
Physical Condition					
Barrier	Alignment and Height:	4 individual posts were observed to be bent. The cables had no tension. The barrier height was more than 3 in below the 27 in design height for the entire length ranging from 16 to 21.5 in.

Breaking and Cracking:	No breaking or cracking was observed in the posts and the cables were not frayed broken or severed.			
	Missing Elements:	No elements were observed to be missing.			
	Corrosion and Weathering:	The upper cable was showing severe rust.			
End Treatments	Alignment and Height:				
	Breaking and Cracking:				
	Missing Elements:				
	Corrosion and Weathering:

Repair Action:	REPLACE	FMSS Work Type:	CAPITAL IMPROVEMENT	Repair Cost:	\$87874
Brief Workorder:	Replace cable guardrail with Steel-Backed Timber w/o blockouts and 2 flared end treatments.				
Workorder:	Remove Cable Guardrail at \$5- per -Lin. Ft. for 949 LF = \$4745. Remove 949 feet of Two-Strand Cable guardrail. SBT / Log Flared at \$5000- per -Each for 2 Unit(s) = \$10000. Install two 30 foot Steel-Backed Timber Flared end treatments. Steel-Backed Timber w/o Blockout at \$60- per -Lin. Ft. for 889 LF = \$53340. Install 889 feet of Steel-Backed Timber guardrail without blockout. Low Speed Traffic Control at \$1475- per -Day for 8 Day(s) = \$11800. 4 days removal and 4 days installation.

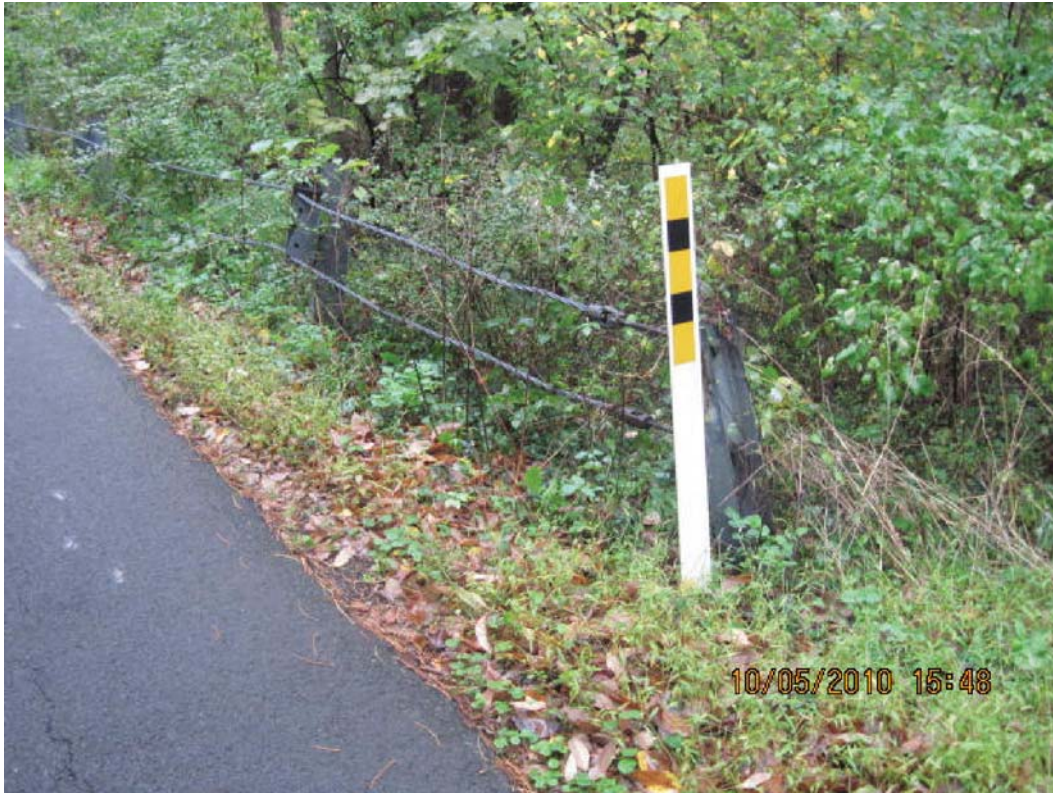
DEWA_0105_3.402_R_1.jpg

Barrier ID:	DEWA-0105-3.402-R				
Route Name:	RIVER ROAD				
Inspection Date:	10/05/2010	Barrier Rating:	59.70		
Barrier Description					
Type:	OTHER: 2-STRAND CABLE	Barrier Function:	TRAFFIC		
Barrier Material:	CABLE	Post Material:	GALVANIZED STEEL		
Blockout Type:	N/A	Length (ft.):	983		
Speed Limit (MPH):	30	Placement with Respect to Road:	OUTSIDE OF CURVE		
Hazard Behind Barrier:	HIGH				
Barrier Crashworthiness					
Appropriate Test Level:	TL-1	Barrier Test Level:	NCW	Is Barrier Crashworthy?:	NO
Beg. End Trtmt Type:	NONE	Is Beg. End Trtmt Crashworthy?:	N/A	Approach Transition Type:	NONE
Ending End Trtmt Type:	NONE	Ending End Trtmt Crashworthy?:	N/A		
Average Measurements					
Design Height (In.):	27	Width (In.):	0.0	Post Spacing (In.):	183.1
Height (In.):	17.7	Lateral Offset (In.):	24.0	Road Grade (%):	1.80
Physical Condition					
Barrier	Alignment and Height:	10 posts were observed to be bent. The cables had little tension. The entire barrier was 7 to 12 in below design height (27 in). A 30 ft section was deflected 1 ft.

Breaking and Cracking:	No breaking or cracking observed in the posts. No fraying breaking or severing of cables observed.			
	Missing Elements:	No elements appeared to be missing.			
	Corrosion and Weathering:	Sections of the cables were rusting.			
End Treatments	Alignment and Height:				
	Breaking and Cracking:				
	Missing Elements:				
	Corrosion and Weathering:

Repair Action:	REPLACE	FMSS Work Type:	CAPITAL IMPROVEMENT	Repair Cost:	\$90304
Brief Workorder:	Replace cable guardrail with Steel-Backed Timber w/o blockouts and 2 flared end treatments.				
Workorder:	Remove Cable Guardrail at \$5- per -Lin. Ft. for 983 LF = \$4915. Remove 983 ft of 2 strand cable. SBT / Log Flared at \$5000- per -Each for 2 Unit(s) = \$10000. Install 2 flared steel backed timber end treatments. Steel-Backed Timber w/o Blockout at \$60- per -Lin. Ft. for 923 LF = \$55380. Install 923 ft of steel backed timber without blockouts Low Speed Traffic Control at \$1475- per -Day for 8 Day(s) = \$11800. 4 days removal and 4 days installation.

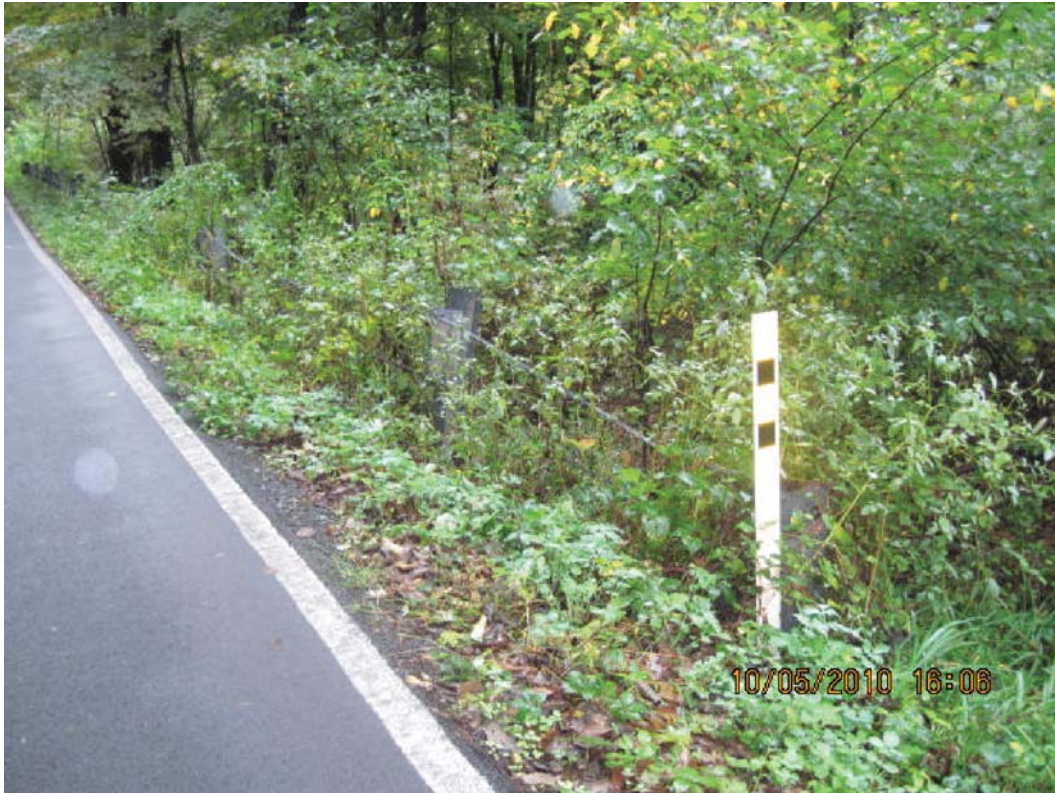
DEWA_0105_3.596_R_1.jpg

Barrier ID:	DEWA-0105-3.596-R				
Route Name:	RIVER ROAD				
Inspection Date:	10/05/2010	Barrier Rating:	38.00		
Barrier Description					
Type:	OTHER: 2-STRAND CABLE	Barrier Function:	TRAFFIC		
Barrier Material:	CABLE	Post Material:	GALVANIZED STEEL		
Blockout Type:	N/A	Length (ft.):	373		
Speed Limit (MPH):	30	Placement with Respect to Road:	TANGENT		
Hazard Behind Barrier:	MEDIUM				
Barrier Crashworthiness					
Appropriate Test Level:	TL-1	Barrier Test Level:	NCW	Is Barrier Crashworthy?:	NO
Beg. End Trtmt Type:	NONE	Is Beg. End Trtmt Crashworthy?:	N/A	Approach Transition Type:	NONE
Ending End Trtmt Type:	NONE	Ending End Trtmt Crashworthy?:	N/A		
Average Measurements					
Design Height (In.):	27	Width (In.):	0.0	Post Spacing (In.):	184.6
Height (In.):	15.5	Lateral Offset (In.):	33.7	Road Grade (%):	5.40
Physical Condition					
Barrier	Alignment and Height:	Cables had very little tension throughout. 6 posts were bent and twisted. Entire barrier is 7.5 to 16 in below 27 in design height.

Breaking and Cracking:	No breaking or cracking observed in posts. No fraying breaking or severing of cables observed.			
	Missing Elements:	No elements were observed to be missing.			
	Corrosion and Weathering:	Cables had no losses more than 5% of cross section. Posts had signs of severe rusting.			
End Treatments	Alignment and Height:				
	Breaking and Cracking:				
	Missing Elements:				
	Corrosion and Weathering:

Repair Action:	REPLACE	FMSS Work Type:	CAPITAL IMPROVEMENT	Repair Cost:	\$40200
Brief Workorder:	Replace cable guardrail with Steel-Backed Timber w/o blockouts and 2 flared Steel-Backed Timber end treatments.				
Workorder:	Remove Cable Guardrail at \$5- per -Lin. Ft. for 373 LF = \$1865. Remove 373 feet of 2-strand cable barrier. SBT / Log Flared at \$5000- per -Each for 2 Unit(s) = \$10000. Install 2 SBT flared end terminals. Steel-Backed Timber w/o Blockout at \$60- per -Lin. Ft. for 313 LF = \$18780. Install 313 of Steel-Backed Timber w/o blockouts guardrail. Low Speed Traffic Control at \$1475- per -Day for 4 Day(s) = \$5900. 2 days removal and 2 days installation.

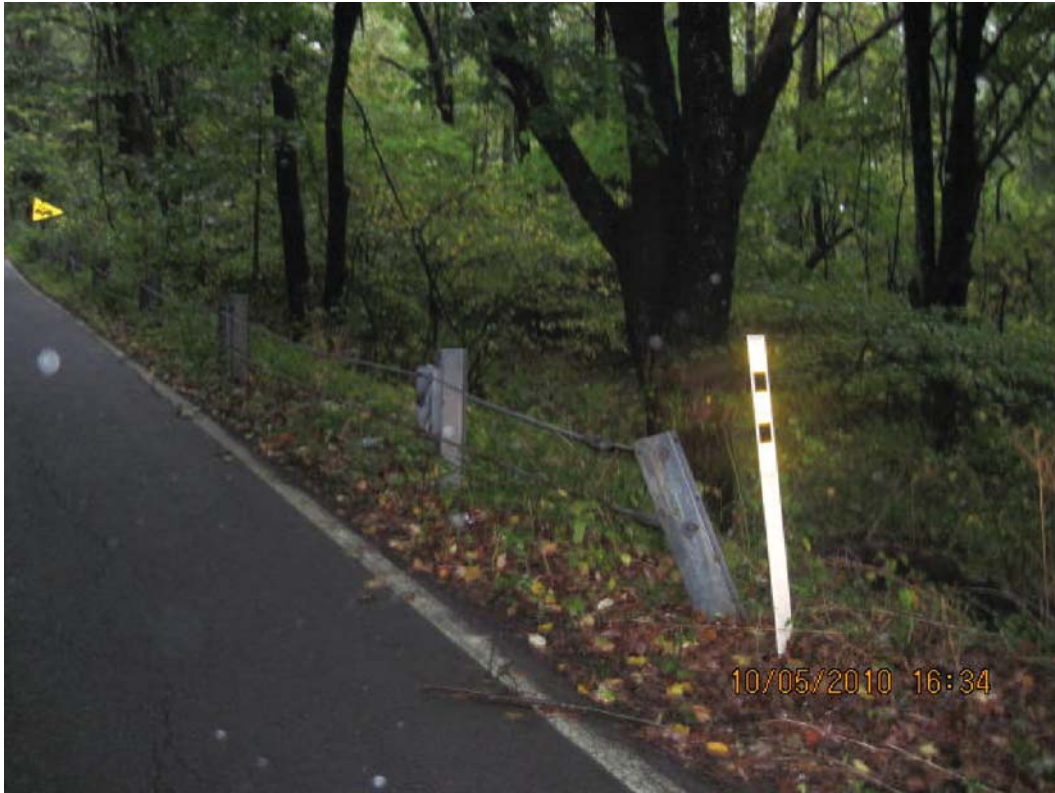
DEWA_0105_3.676_R_1.jpg

Barrier ID:	DEWA-0105-3.676-R				
Route Name:	RIVER ROAD				
Inspection Date:	10/05/2010	Barrier Rating:	45.00		
Barrier Description					
Type:	OTHER: 2-STRAND CABLE	Barrier Function:	TRAFFIC		
Barrier Material:	CABLE	Post Material:	GALVANIZED STEEL		
Blockout Type:	N/A	Length (ft.):	639		
Speed Limit (MPH):	30	Placement with Respect to Road:	TANGENT		
Hazard Behind Barrier:	MEDIUM				
Barrier Crashworthiness					
Appropriate Test Level:	TL-1	Barrier Test Level:	NCW	Is Barrier Crashworthy?:	NO
Beg. End Trtmt Type:	NONE	Is Beg. End Trtmt Crashworthy?:	N/A	Approach Transition Type:	NONE
Ending End Trtmt Type:	NONE	Ending End Trtmt Crashworthy?:	N/A		
Average Measurements					
Design Height (In.):	27	Width (In.):	0.0	Post Spacing (In.):	181.0
Height (In.):	17.0	Lateral Offset (In.):	21.2	Road Grade (%):	1.60
Physical Condition					
Barrier	Alignment and Height:	5 posts were bent and several posts were out of the ground. 110 ft of barrier was laying on the ground. The cables have no tension. The barrier height was 3.5 to 15.5 in below the 27 in design height for the entire length.

Breaking and Cracking:	No breaking or cracking was observed in the posts. The cables were disconnected in two places.			
	Missing Elements:	No elements were observed to be missing.			
	Corrosion and Weathering:	The posts and cables were showing rust.			
End Treatments	Alignment and Height:				
	Breaking and Cracking:				
	Missing Elements:				
	Corrosion and Weathering:

Repair Action:	REPLACE	FMSS Work Type:	CAPITAL IMPROVEMENT	Repair Cost:	\$62464
Brief Workorder:	Replace cable guardrail with Steel-Backed Timber w/o blockouts and 2 flared end treatments.				
Workorder:	Remove Cable Guardrail at \$5- per -Lin. Ft. for 639 LF = \$3195. Remove 639 feet of cable guardrail. SBT / Log Flared at \$5000- per -Each for 2 Unit(s) = \$10000. Install 2 Steel-Backed Timber Flared end treatments. Steel-Backed Timber w/o Blockout at \$60- per -Lin. Ft. for 579 LF = \$34740. Install 579 feet of steel backed timer guardrail without blockout. Low Speed Traffic Control at \$1475- per -Day for 6 Day(s) = \$8850. 3 days removal and 3 days installation.

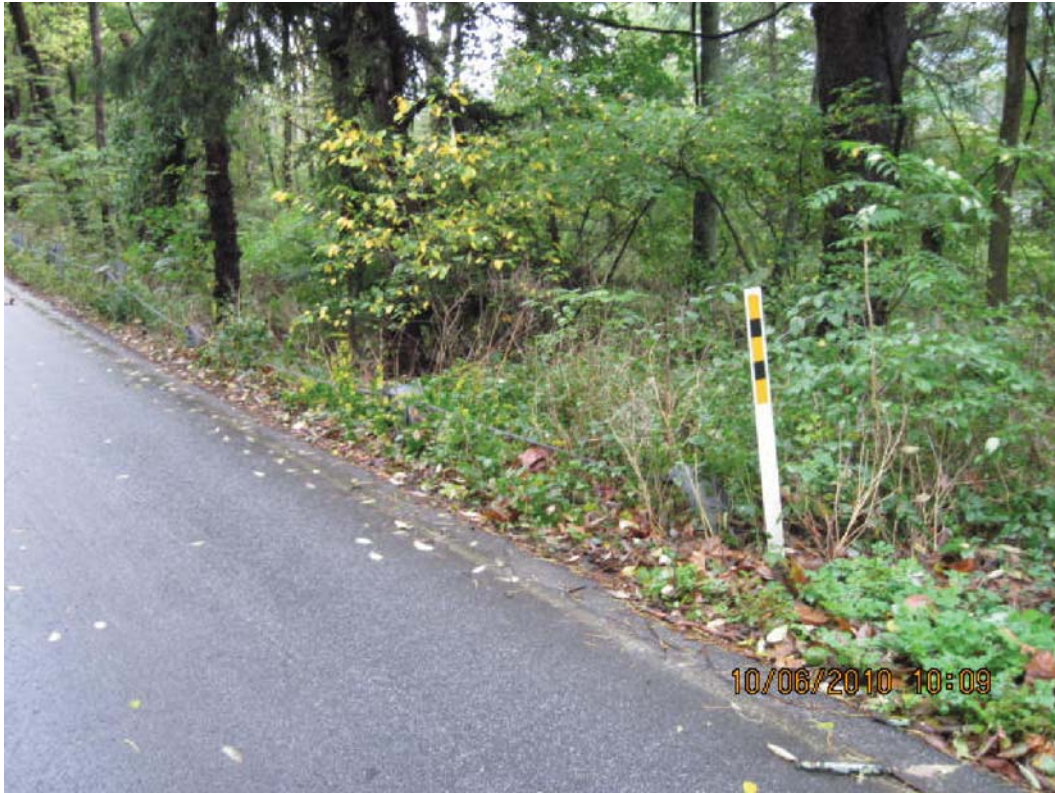
DEWA_0105_3.950_R_1.jpg

Barrier ID:	DEWA-0105-3.950-R				
Route Name:	RIVER ROAD				
Inspection Date:	10/06/2010	Barrier Rating:	42.20		
Barrier Description					
Type:	OTHER: 2-STRAND CABLE	Barrier Function:	TRAFFIC		
Barrier Material:	CABLE	Post Material:	GALVANIZED STEEL		
Blockout Type:	N/A	Length (ft.):	608		
Speed Limit (MPH):	30	Placement with Respect to Road:	TANGENT		
Hazard Behind Barrier:	MEDIUM				
Barrier Crashworthiness					
Appropriate Test Level:	TL-1	Barrier Test Level:	NCW	Is Barrier Crashworthy?:	NO
Beg. End Trtmt Type:	NONE	Is Beg. End Trtmt Crashworthy?:	N/A	Approach Transition Type:	NONE
Ending End Trtmt Type:	NONE	Ending End Trtmt Crashworthy?:	N/A		
Average Measurements					
Design Height (In.):	27	Width (In.):	0.0	Post Spacing (In.):	192.0
Height (In.):	18.3	Lateral Offset (In.):	26.8	Road Grade (%):	2.50
Physical Condition					
Barrier	Alignment and Height:	4 posts were bent and the cable was sagging. The entire barrier was 7 to 10 in below design height (27 in).

Breaking and Cracking:	No posts were cracked or broken. No fraying breaking or severing of cables observed.			
	Missing Elements:	No elements appeared to be missing.			
	Corrosion and Weathering:	Cables had rust but less than 5% of cable cross section was lost.			
End Treatments	Alignment and Height:				
	Breaking and Cracking:				
	Missing Elements:				
	Corrosion and Weathering:

Repair Action:	REPLACE	FMSS Work Type:	CAPITAL IMPROVEMENT	Repair Cost:	\$60247
Brief Workorder:	Replace cable guardrail with Steel-Backed Timber w/o blockouts and 2 flared Steel-Backed Timber end treatments.				
Workorder:	Remove Cable Guardrail at \$5- per -Lin. Ft. for 608 LF = \$3040. Remove 608 ft of 2 strand cable. SBT / Log Flared at \$5000- per -Each for 2 Unit(s) = \$10000. Install 2 Steel-Backed Timber end treatments. Steel-Backed Timber w/o Blockout at \$60- per -Lin. Ft. for 548 LF = \$32880. Install 548 ft of SBT. Low Speed Traffic Control at \$1475- per -Day for 6 Day(s) = \$8850. 3 days removal and 3 days installation.
