NPS Guardwall/Rail Inventory Program Delaware Water Gap National Recreation Area

**Federal Lands Highway
Road Inventory Program**

Federal Highway Administration
Eastern Federal Lands Highway Division
Road Inventory Program (RIP)

Data Collection Date: October 2010
Report Date: December 2015

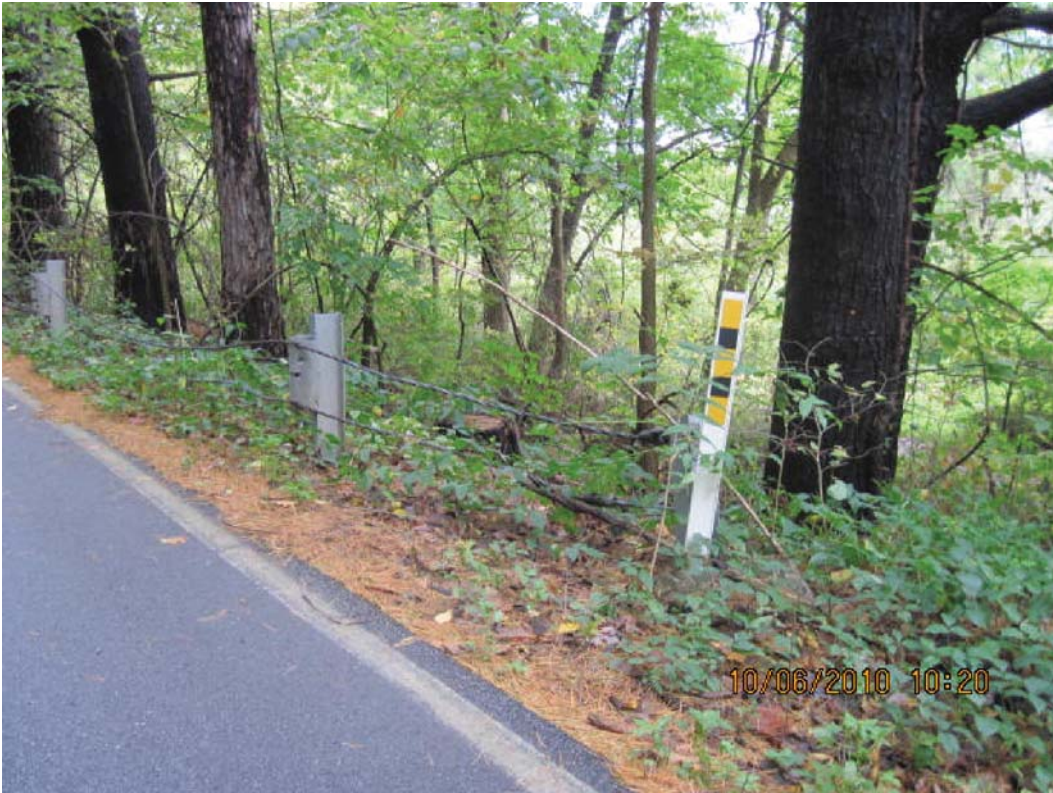
DEWA_0105_4.075_R_1.jpg

Barrier ID:	DEWA-0105-4.075-R				
Route Name:	RIVER ROAD				
Inspection Date:	10/06/2010	Barrier Rating:	46.50		
Barrier Description					
Type:	OTHER: 2-STRAND CABLE	Barrier Function:	TRAFFIC		
Barrier Material:	CABLE	Post Material:	GALVANIZED STEEL		
Blockout Type:	N/A	Length (ft.):	495		
Speed Limit (MPH):	30	Placement with Respect to Road:	BOTH INSIDE AND OUTSIDE		
Hazard Behind Barrier:	MEDIUM				
Barrier Crashworthiness					
Appropriate Test Level:	TL-1	Barrier Test Level:	NCW	Is Barrier Crashworthy?:	NO
Beg. End Trtmt Type:	NONE	Is Beg. End Trtmt Crashworthy?:	N/A	Approach Transition Type:	NONE
Ending End Trtmt Type:	NONE	Ending End Trtmt Crashworthy?:	N/A		
Average Measurements					
Design Height (In.):	27	Width (In.):	0.0	Post Spacing (In.):	185.3
Height (In.):	15.8	Lateral Offset (In.):	30.7	Road Grade (%):	7.50
Physical Condition					
Barrier	Alignment and Height:	There was no tension in either cable. No posts were bent. Entire barrier is 8 to 14 in below 27 in design height.

Breaking and Cracking:	There were no cracked or broken posts. The cable is separated from the posts for a 20 ft section.			
	Missing Elements:	There were no elements observed to be missing.			
	Corrosion and Weathering:	There was no loss of cable cross section. Erosion around posts has only exposed 1 to 2 in of post below original ground line.			
End Treatments	Alignment and Height:				
	Breaking and Cracking:				
	Missing Elements:				
	Corrosion and Weathering:

Repair Action:	REPLACE	FMSS Work Type:	CAPITAL IMPROVEMENT	Repair Cost:	\$48922
Brief Workorder:	Replace cable guardrail with Steel-Backed Timber w/o blockouts and 2 flared end treatments.				
Workorder:	Remove Cable Guardrail at \$5- per -Lin. Ft. for 495 LF = \$2475. Remove 495 feet of 2-strand cable barrier. SBT / Log Flared at \$5000- per -Each for 2 Unit(s) = \$10000. Install 2 Steel-Backed Timber flared end terminals. Steel-Backed Timber w/o Blockout at \$60- per -Lin. Ft. for 435 LF = \$26100. Install 435ft. of Steel-Backed Timber w/o blockouts. Low Speed Traffic Control at \$1475- per -Day for 4 Day(s) = \$5900. 2 days removal and 2 days installation.

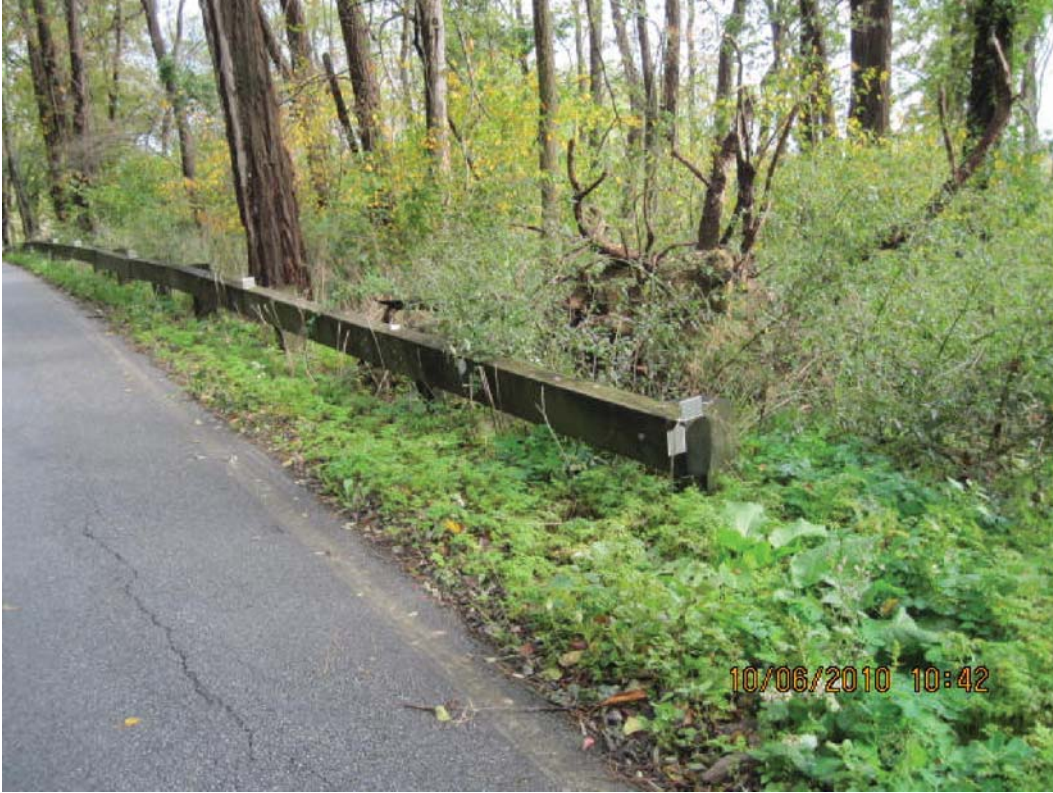
DEWA_0105_4.268_R_1.jpg

Barrier ID:	DEWA-0105-4.268-R				
Route Name:	RIVER ROAD				
Inspection Date:	10/06/2010	Barrier Rating:	49.50		
Barrier Description					
Type:	STEEL-BACKED TIMBER WITH BLOCKOUT	Barrier Function:	TRAFFIC		
Barrier Material:	STEEL-BACKED TIMBER/LOG	Post Material:	WOOD		
Blockout Type:	WOOD	Length (ft.):	606		
Speed Limit (MPH):	30	Placement with Respect to Road:	OUTSIDE OF CURVE		
Hazard Behind Barrier:	MEDIUM				
Barrier Crashworthiness					
Appropriate Test Level:	TL-1	Barrier Test Level:	TL-3	Is Barrier Crashworthy?:	YES
Beg. End Trtmt Type:	NONE	Is Beg. End Trtmt Crashworthy?:	N/A	Approach Transition Type:	NONE
Ending End Trtmt Type:	SBT/LOG FLARED	Ending End Trtmt Crashworthy?:	NO		
Average Measurements					
Design Height (In.):	27	Width (In.):	0.0	Post Spacing (In.):	119.5
Height (In.):	24.1	Lateral Offset (In.):	40.0	Road Grade (%):	3.60
Physical Condition					
Barrier	Alignment and Height:	A 90 ft section was deflected more than 18 in due to impact. No other deflections were observed. The barrier height was within 1 in of the 27 in design height for 30 ft between 1 and 3 in below for 50 ft, and more than 3 in below for 506 ft.

Breaking and Cracking:	No impact related breaking or cracking was observed.			
	Missing Elements:	No elements were observed to be missing.			
	Corrosion and Weathering:	No erosion or loss of cross section was observed.			
End Treatments	Alignment and Height:	Alignment acceptable. Height is within 1-in. of 27-in. design height.			
	Breaking and Cracking:	No breaking or cracking was observed.			
	Missing Elements:	No elements were observed to be missing.			
	Corrosion and Weathering:	No erosion or loss of cross section was observed.

Repair Action:	REPAIR	FMSS Work Type:	DEFERRED MAINTENANCE	Repair Cost:	\$11314
Brief Workorder:	Raise 586 feet of guardrail to the 27 inch design height and correct for horizontal deflection deficiencies.				
Workorder:	Adjust Guardrail at \$10- per -Lin. Ft. for 586 LF = \$5860. Raise 586 feet of guardrail to 27-in. design height and correct horizontal deflection deficiencies. Low Speed Traffic Control at \$1475- per -Day for 3 Day(s) = \$4425.

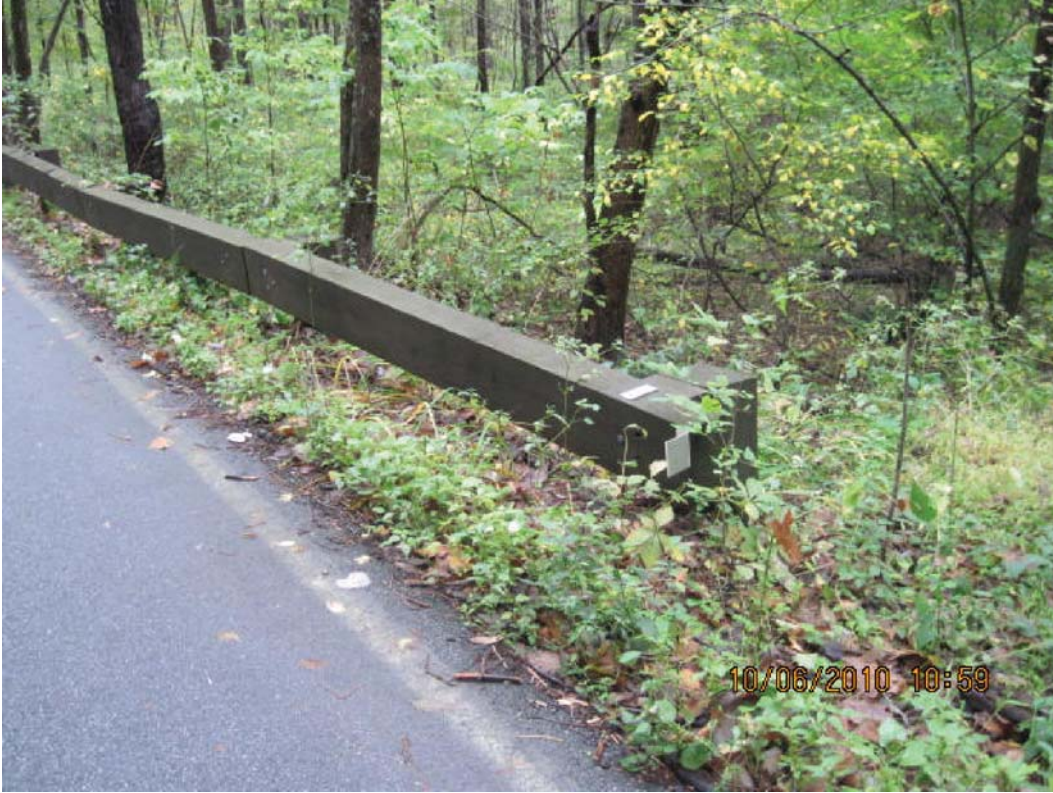
DEWA_0105_4.761_R_1.jpg

Barrier ID:	DEWA-0105-4.761-R				
Route Name:	RIVER ROAD				
Inspection Date:	10/06/2010	Barrier Rating:	41.00		
Barrier Description					
Type:	STEEL-BACKED TIMBER WITH BLOCKOUT	Barrier Function:	TRAFFIC		
Barrier Material:	STEEL-BACKED TIMBER/LOG	Post Material:	WOOD		
Blockout Type:	WOOD	Length (ft.):	597		
Speed Limit (MPH):	30	Placement with Respect to Road:	OUTSIDE OF CURVE		
Hazard Behind Barrier:	MEDIUM				
Barrier Crashworthiness					
Appropriate Test Level:	TL-1	Barrier Test Level:	TL-3	Is Barrier Crashworthy?:	YES
Beg. End Trtmt Type:	NONE	Is Beg. End Trtmt Crashworthy?:	N/A	Approach Transition Type:	NONE
Ending End Trtmt Type:	NONE	Ending End Trtmt Crashworthy?:	N/A		
Average Measurements					
Design Height (In.):	27	Width (In.):	0.0	Post Spacing (In.):	120.0
Height (In.):	23.7	Lateral Offset (In.):	29.1	Road Grade (%):	0.40
Physical Condition					
Barrier	Alignment and Height:	Alignment deflection was less than 6 in. 327 ft of the barrier was between 1 and 3 in below design height (27 ines). 270 ft of the barrier was 3 to 4.5 ines below design height (27 ines).

Breaking and Cracking:	1 rail showed signs of impact and a damaged blockout.			
	Missing Elements:	10 reflectors on the barrier were broke and missing.			
	Corrosion and Weathering:	Loss of less than 5% of cross section observed. No erosion around posts observed.			
End Treatments	Alignment and Height:				
	Breaking and Cracking:				
	Missing Elements:				
	Corrosion and Weathering:

Repair Action:	REPAIR	FMSS Work Type:	DEFERRED MAINTENANCE	Repair Cost:	\$12568
Brief Workorder:	Raise 597 feet of barrier to 27 inch design height and replace 1 blockout.				
Workorder:	Adjust Guardrail at \$10- per -Lin. Ft. for 597 LF = \$5970. Raise 597ft. of guardrail to 27 inch design height. Replace Block at \$30- per -Each for 1 Block(s) = \$30. Replace one broken block out Barrier reflectors @ \$100 Each for 10 = \$1000. Replace 10 missing barrier reflectors. Low Speed Traffic Control at \$1475- per -Day for 3 Day(s) = \$4425.

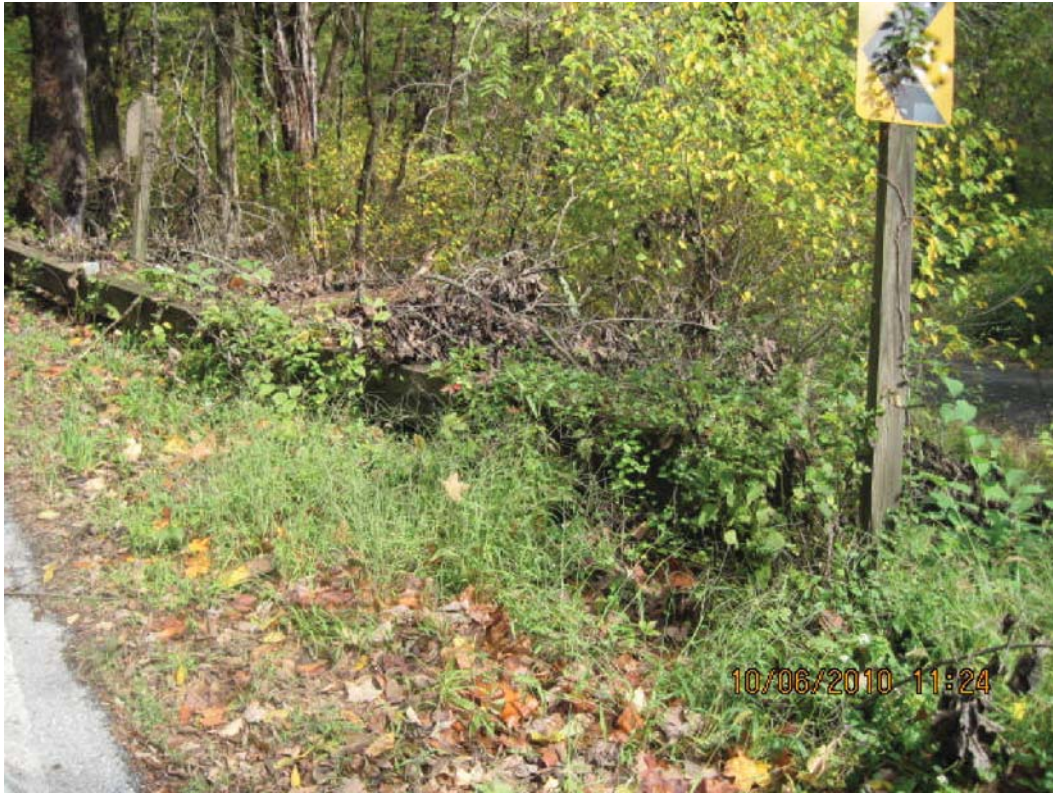
DEWA_0105_4.881_R_1.jpg

Barrier ID:	DEWA-0105-4.881-R				
Route Name:	RIVER ROAD				
Inspection Date:	10/06/2010	Barrier Rating:	46.50		
Barrier Description					
Type:	STEEL-BACKED TIMBER WITH BLOCKOUT	Barrier Function:	TRAFFIC		
Barrier Material:	STEEL-BACKED TIMBER/LOG	Post Material:	WOOD		
Blockout Type:	WOOD	Length (ft.):	302		
Speed Limit (MPH):	30	Placement with Respect to Road:	INSIDE OF CURVE		
Hazard Behind Barrier:	MEDIUM				
Barrier Crashworthiness					
Appropriate Test Level:	TL-1	Barrier Test Level:	TL-3	Is Barrier Crashworthy?:	YES
Beg. End Trtmt Type:	NONE	Is Beg. End Trtmt Crashworthy?:	N/A	Approach Transition Type:	NONE
Ending End Trtmt Type:	SBT/LOG FLARED	Ending End Trtmt Crashworthy?:	NO		
Average Measurements					
Design Height (In.):	27	Width (In.):	0.0	Post Spacing (In.):	120.0
Height (In.):	22.0	Lateral Offset (In.):	19.5	Road Grade (%):	15.00
Physical Condition					
Barrier	Alignment and Height:	40 ft of barrier was deflected up to 16 in due to impact. 237 ft of barrier is more than 3 in below 27 in design height. 30 ft of barrier is 1 to 3 in below 27 in design height.

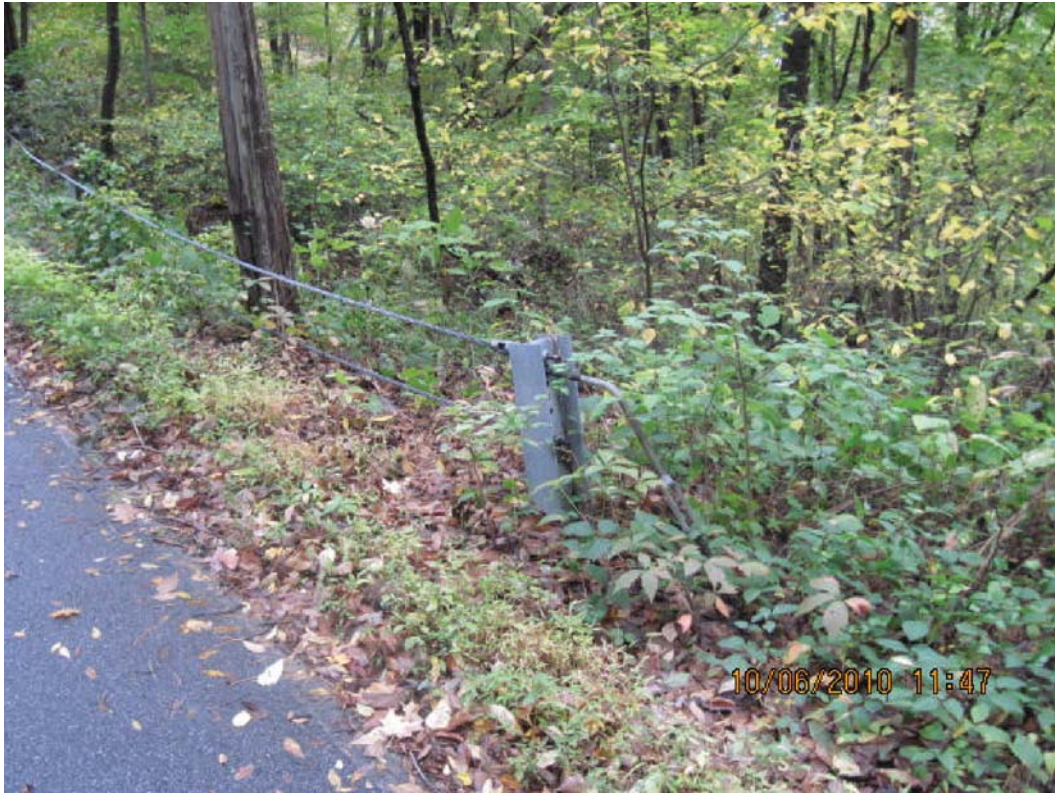
DEWA_0105_5.034_R_1.jpg

Barrier ID:	DEWA-0105-5.034-R				
Route Name:	RIVER ROAD				
Inspection Date:	10/06/2010	Barrier Rating:	35.50		
Barrier Description					
Type:	OTHER: 2-STRAND CABLE	Barrier Function:	TRAFFIC		
Barrier Material:	CABLE	Post Material:	GALVANIZED STEEL		
Blockout Type:	N/A	Length (ft.):	312		
Speed Limit (MPH):	30	Placement with Respect to Road:	INSIDE OF CURVE		
Hazard Behind Barrier:	HIGH				
Barrier Crashworthiness					
Appropriate Test Level:	TL-1	Barrier Test Level:	NCW	Is Barrier Crashworthy?:	NO
Beg. End Trtmt Type:	NONE	Is Beg. End Trtmt Crashworthy?:	N/A	Approach Transition Type:	NONE
Ending End Trtmt Type:	NONE	Ending End Trtmt Crashworthy?:	N/A		
Average Measurements					
Design Height (In.):	27	Width (In.):	0.0	Post Spacing (In.):	197.6
Height (In.):	17.5	Lateral Offset (In.):	59.7	Road Grade (%):	9.60
Physical Condition					
Barrier	Alignment and Height:	4 consecutive posts were bent and the cables had very little tension causing sagging. The barrier height was 3.5 to 13 in below the 27 in design height for the entire length.

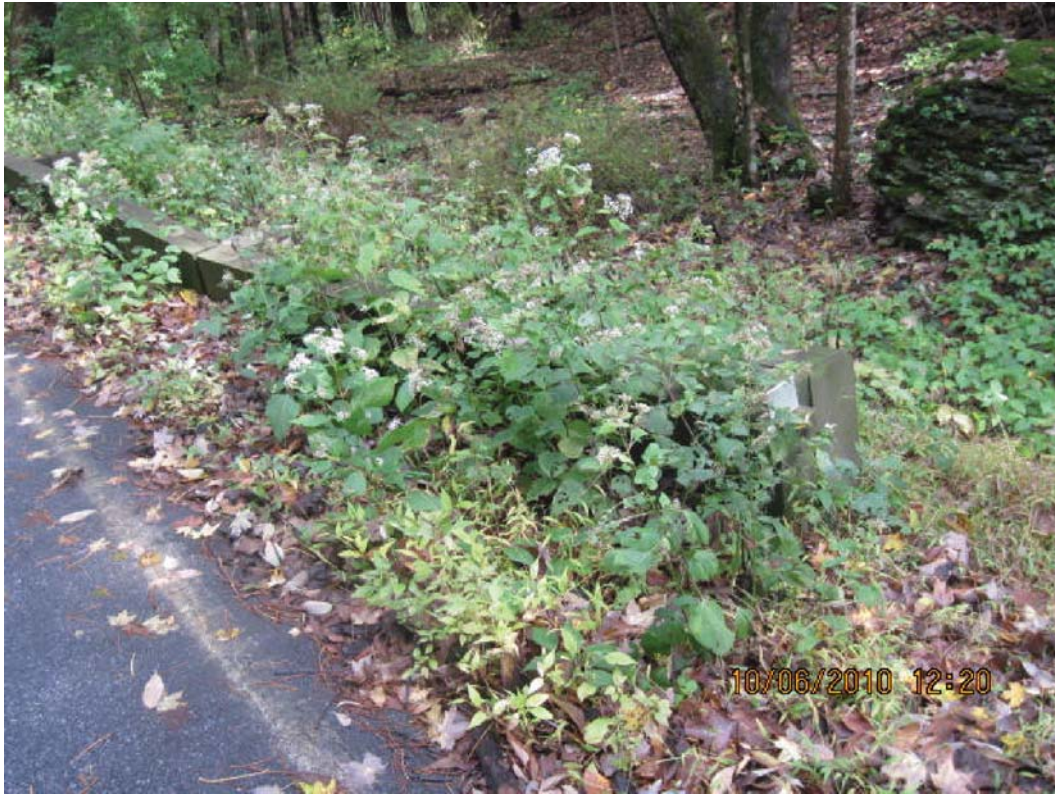
DEWA_0105_5.267_R_1.jpg

Barrier ID:	DEWA-0105-5.267-R				
Route Name:	RIVER ROAD				
Inspection Date:	10/06/2010	Barrier Rating:	43.70		
Barrier Description					
Type:	STEEL-BACKED TIMBER WITH BLOCKOUT	Barrier Function:	TRAFFIC		
Barrier Material:	STEEL-BACKED TIMBER/LOG	Post Material:	WOOD		
Blockout Type:	WOOD	Length (ft.):	353		
Speed Limit (MPH):	30	Placement with Respect to Road:	TANGENT		
Hazard Behind Barrier:	MEDIUM				
Barrier Crashworthiness					
Appropriate Test Level:	TL-1	Barrier Test Level:	TL-3	Is Barrier Crashworthy?:	YES
Beg. End Trtmt Type:	SBT/LOG FLARED	Is Beg. End Trtmt Crashworthy?:	NO	Approach Transition Type:	NONE
Ending End Trtmt Type:	SBT/LOG FLARED	Ending End Trtmt Crashworthy?:	NO		
Average Measurements					
Design Height (In.):	27	Width (In.):	0.0	Post Spacing (In.):	120.1
Height (In.):	21.7	Lateral Offset (In.):	17.0	Road Grade (%):	2.60
Physical Condition					
Barrier	Alignment and Height:	Alignment deflection was less than 6 in. The entire barrier was 4-7 in below design height (27 in).

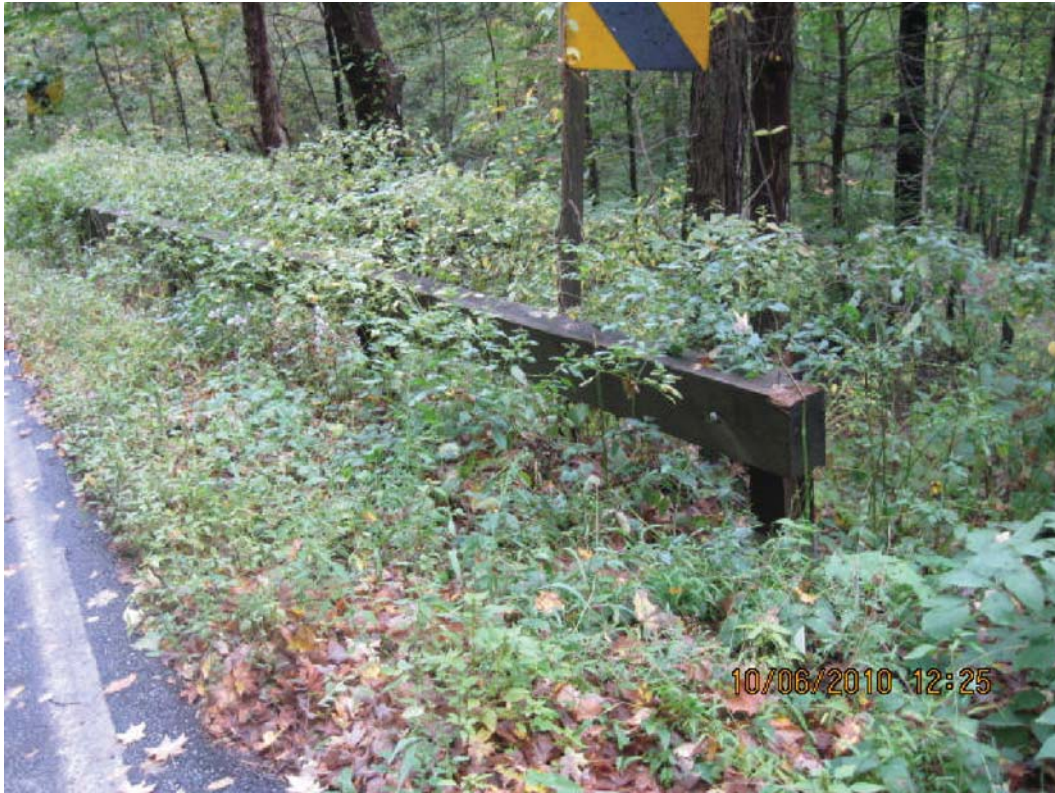
DEWA_0105_5.344_R_1.jpg

Barrier ID:	DEWA-0105-5.344-R				
Route Name:	RIVER ROAD				
Inspection Date:	10/06/2010	Barrier Rating:	41.00		
Barrier Description					
Type:	STEEL-BACKED TIMBER WITH BLOCKOUT	Barrier Function:	TRAFFIC		
Barrier Material:	STEEL-BACKED TIMBER/LOG	Post Material:	CORTEN		
Blockout Type:	WOOD	Length (ft.):	338		
Speed Limit (MPH):	30	Placement with Respect to Road:	OUTSIDE OF CURVE		
Hazard Behind Barrier:	MEDIUM				
Barrier Crashworthiness					
Appropriate Test Level:	TL-1	Barrier Test Level:	TL-3	Is Barrier Crashworthy?:	YES
Beg. End Trtmt Type:	NONE	Is Beg. End Trtmt Crashworthy?:	N/A	Approach Transition Type:	NONE
Ending End Trtmt Type:	SBT/LOG FLARED	Ending End Trtmt Crashworthy?:	NO		
Average Measurements					
Design Height (In.):	27	Width (In.):	0.0	Post Spacing (In.):	120.1
Height (In.):	23.7	Lateral Offset (In.):	37.0	Road Grade (%):	6.60
Physical Condition					
Barrier	Alignment and Height:	No deflections observed in alignment. 110 ft of barrier is 1 to 3 in below 27 in design height. 190 ft of barrier is more than 3 in below 27 in design height.

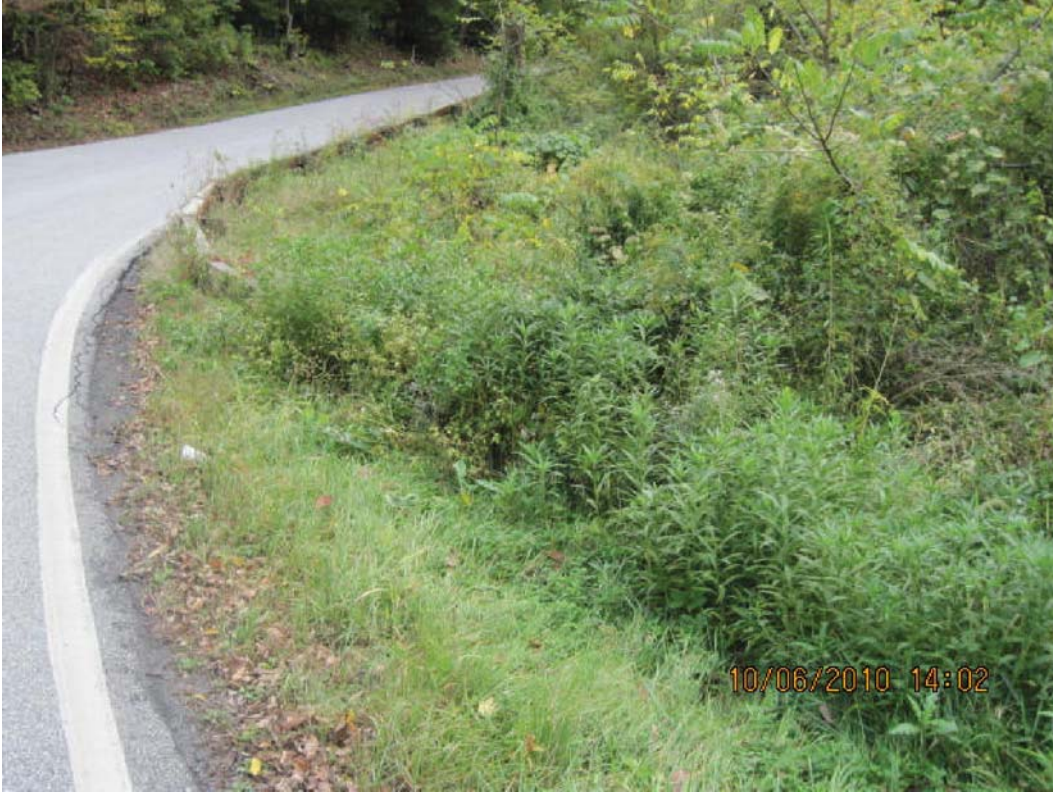
DEWA_0105_5.801_L_1.jpg

Barrier ID:	DEWA-0105-5.801-L				
Route Name:	RIVER ROAD				
Inspection Date:	10/06/2010	Barrier Rating:	36.70		
Barrier Description					
Type:	STEEL-BACKED TIMBER WITH BLOCKOUT	Barrier Function:	TRAFFIC		
Barrier Material:	STEEL-BACKED TIMBER/LOG	Post Material:	WOOD		
Blockout Type:	WOOD	Length (ft.):	176		
Speed Limit (MPH):	30	Placement with Respect to Road:	INSIDE OF CURVE		
Hazard Behind Barrier:	MEDIUM				
Barrier Crashworthiness					
Appropriate Test Level:	TL-1	Barrier Test Level:	TL-3	Is Barrier Crashworthy?:	YES
Beg. End Trtmt Type:	SBT/LOG FLARED	Is Beg. End Trtmt Crashworthy?:	NO	Approach Transition Type:	NONE
Ending End Trtmt Type:	SBT/LOG FLARED	Ending End Trtmt Crashworthy?:	NO		
Average Measurements					
Design Height (In.):	27	Width (In.):	0.0	Post Spacing (In.):	119.1
Height (In.):	20.2	Lateral Offset (In.):	28.2	Road Grade (%):	7.20
Physical Condition					
Barrier	Alignment and Height:	A 30 ft section was observed to have approximately 12 in of horizontal deflection. No other deflections were observed. The barrier height was more than 3 in below the 27 in design height for the entire length down to 10.5 in below.

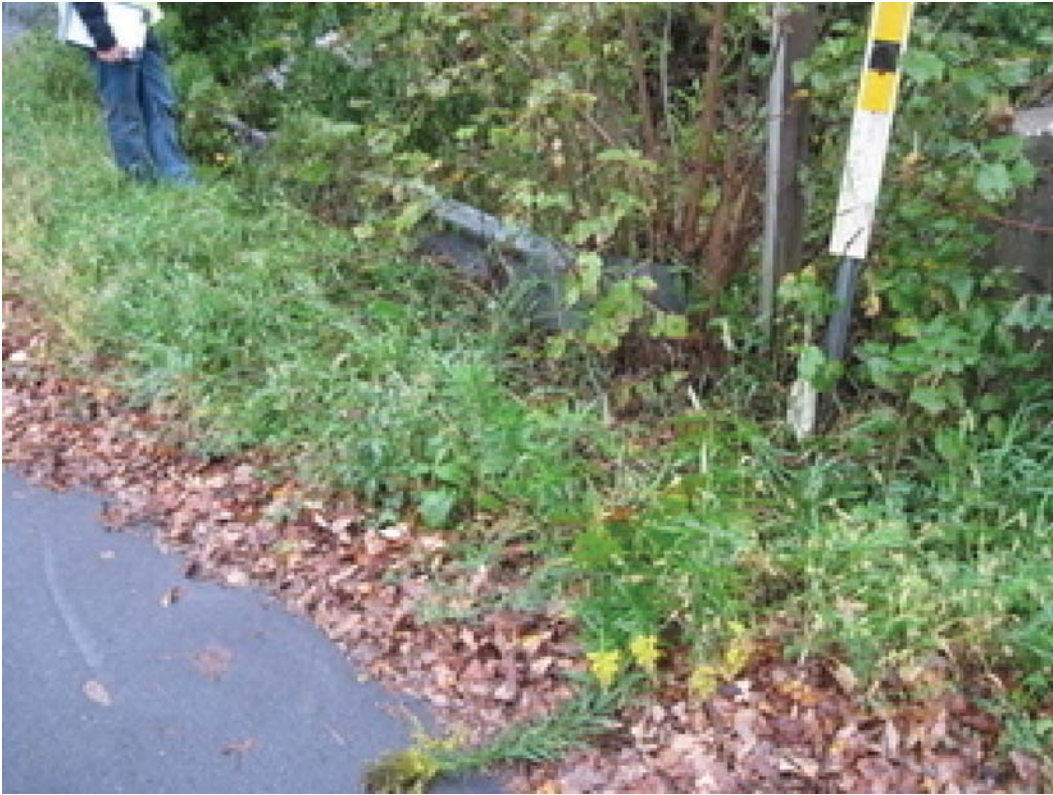
DEWA_0106_0.006_R_1.jpg

Barrier ID:	DEWA-0106-0.006-R				
Route Name:	JAGER ROAD				
Inspection Date:	10/04/2010	Barrier Rating:	33.40		
Barrier Description					
Type:	W-BEAM WEAK POST	Barrier Function:	TRAFFIC		
Barrier Material:	GALVANIZED STEEL	Post Material:	GALVANIZED STEEL		
Blockout Type:	N/A	Length (ft.):	18		
Speed Limit (MPH):	35	Placement with Respect to Road:	TANGENT		
Hazard Behind Barrier:	LOW				
Barrier Crashworthiness					
Appropriate Test Level:	TL-2	Barrier Test Level:	TL-2	Is Barrier Crashworthy?:	YES
Beg. End Trtmt Type:	NONE	Is Beg. End Trtmt Crashworthy?:	N/A	Approach Transition Type:	NONE
Ending End Trtmt Type:	NONE	Ending End Trtmt Crashworthy?:	N/A		
Average Measurements					
Design Height (In.):	27	Width (In.):	0.0	Post Spacing (In.):	144.0
Height (In.):	17.2	Lateral Offset (In.):	64.6	Road Grade (%):	3.20
Physical Condition					
Barrier	Alignment and Height:	No alignment deflection observed. Height is 9-10 in below the 27 in design height.

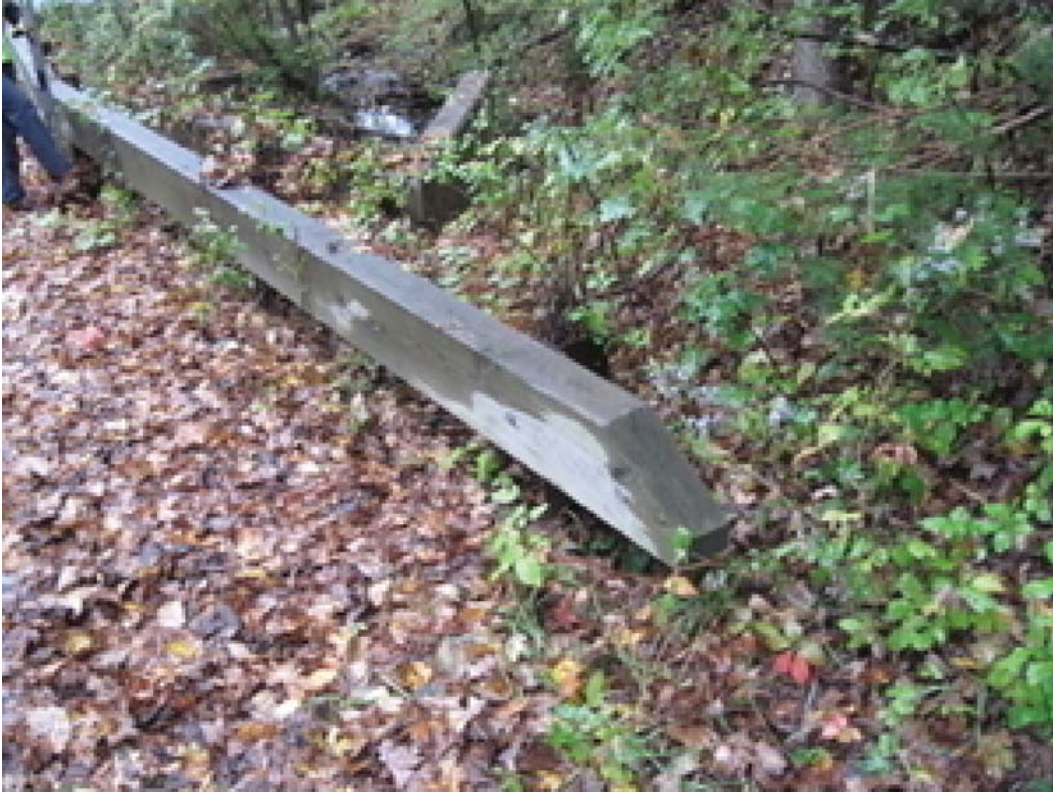
DEWA_0106_0.167_L_1.jpg

Barrier ID:	DEWA-0106-0.167-L				
Route Name:	JAGER ROAD				
Inspection Date:	10/04/2010	Barrier Rating:	40.00		
Barrier Description					
Type:	STEEL-BACKED TIMBER WITHOUT BLOCKOUT	Barrier Function:	TRAFFIC		
Barrier Material:	STEEL-BACKED TIMBER/LOG	Post Material:	CORTEN		
Blockout Type:	N/A	Length (ft.):	62		
Speed Limit (MPH):	35	Placement with Respect to Road:	INSIDE OF CURVE		
Hazard Behind Barrier:	LOW				
Barrier Crashworthiness					
Appropriate Test Level:	TL-2	Barrier Test Level:	TL-2	Is Barrier Crashworthy?:	YES
Beg. End Trtmt Type:	NONE	Is Beg. End Trtmt Crashworthy?:	N/A	Approach Transition Type:	NONE
Ending End Trtmt Type:	NONE	Ending End Trtmt Crashworthy?:	N/A		
Average Measurements					
Design Height (In.):	27	Width (In.):	0.0	Post Spacing (In.):	123.3
Height (In.):	25.2	Lateral Offset (In.):	7.3	Road Grade (%):	8.60
Physical Condition					
Barrier	Alignment and Height:	No alignment deflection observed. 20 ft was between 1 and 3-in. below the 27-in. design height and 22 ft was more than 3-in. below the design height.

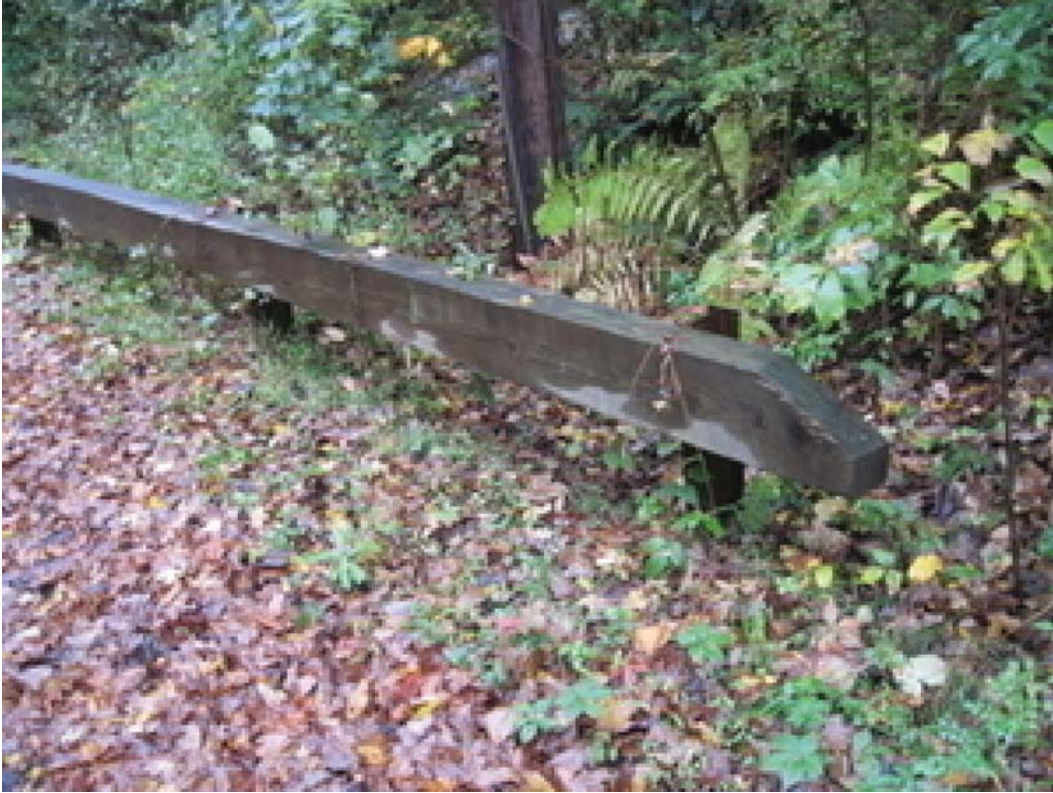
DEWA_0106_0.177_R_1.jpg

Barrier ID:	DEWA-0106-0.177-R				
Route Name:	JAGER ROAD				
Inspection Date:	10/04/2010	Barrier Rating:	31.00		
Barrier Description					
Type:	STEEL-BACKED TIMBER WITHOUT BLOCKOUT	Barrier Function:	TRAFFIC		
Barrier Material:	STEEL-BACKED TIMBER/LOG	Post Material:	CORTEN		
Blockout Type:	N/A	Length (ft.):	133		
Speed Limit (MPH):	35	Placement with Respect to Road:	TANGENT		
Hazard Behind Barrier:	MEDIUM				
Barrier Crashworthiness					
Appropriate Test Level:	TL-2	Barrier Test Level:	TL-2	Is Barrier Crashworthy?:	YES
Beg. End Trtmt Type:	NONE	Is Beg. End Trtmt Crashworthy?:	N/A	Approach Transition Type:	NONE
Ending End Trtmt Type:	NONE	Ending End Trtmt Crashworthy?:	N/A		
Average Measurements					
Design Height (In.):	27	Width (In.):	0.0	Post Spacing (In.):	124.0
Height (In.):	24.2	Lateral Offset (In.):	10.0	Road Grade (%):	5.50
Physical Condition					
Barrier	Alignment and Height:	No alignment deflection was observed. Height is 2 - 3 in below 27-in design height along entire length.

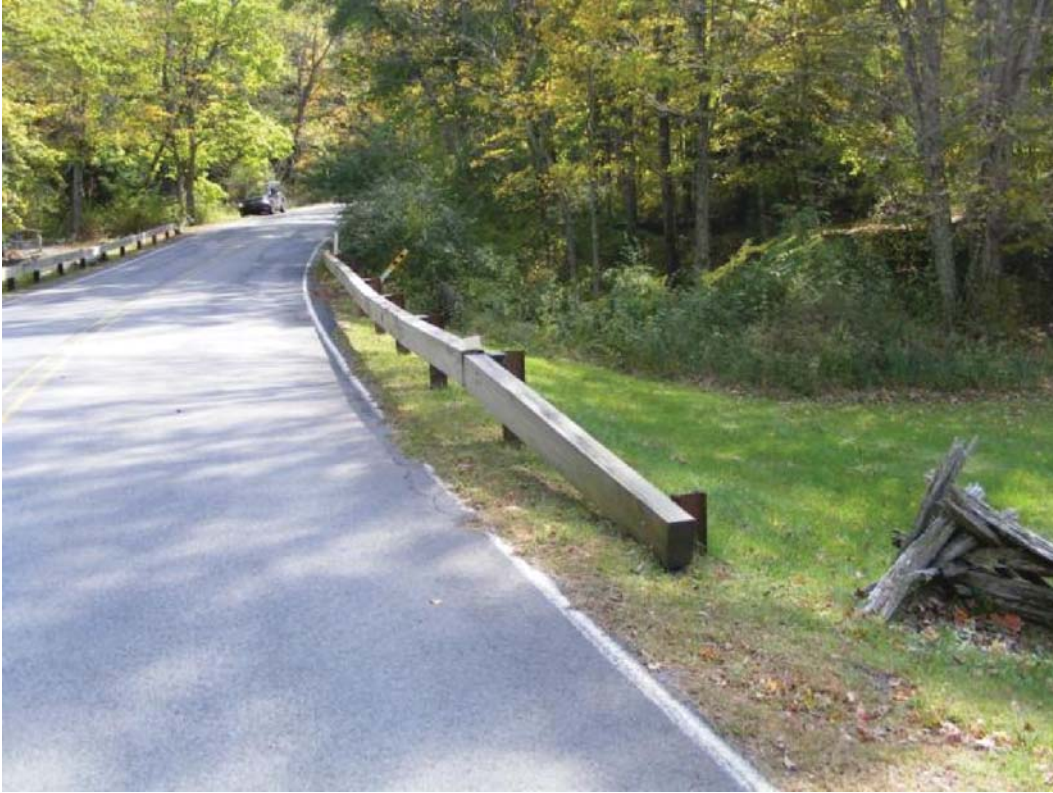
DEWA_0109_0.047_R_1.JPG

Barrier ID:	DEWA-0109-0.047-R				
Route Name:	NPS 602				
Inspection Date:	10/07/2010	Barrier Rating:	26.60		
Barrier Description					
Type:	STEEL-BACKED TIMBER WITH BLOCKOUT	Barrier Function:	TRAFFIC		
Barrier Material:	STEEL-BACKED TIMBER/LOG	Post Material:	CORTEN		
Blockout Type:	WOOD	Length (ft.):	182		
Speed Limit (MPH):	35	Placement with Respect to Road:	INSIDE OF CURVE		
Hazard Behind Barrier:	MEDIUM				
Barrier Crashworthiness					
Appropriate Test Level:	TL-2	Barrier Test Level:	TL-3	Is Barrier Crashworthy?:	YES
Beg. End Trtmt Type:	SBT/LOG FLARED	Is Beg. End Trtmt Crashworthy?:	NO	Approach Transition Type:	NONE
Ending End Trtmt Type:	SBT/LOG FLARED	Ending End Trtmt Crashworthy?:	NO		
Average Measurements					
Design Height (In.):	27	Width (In.):	0.0	Post Spacing (In.):	120.0
Height (In.):	25.2	Lateral Offset (In.):	21.0	Road Grade (%):	6.30
Physical Condition					
Barrier	Alignment and Height:	No deflections observed in alignment. Barrier is 1 to 3 in below 27 in design height for 120 ft.

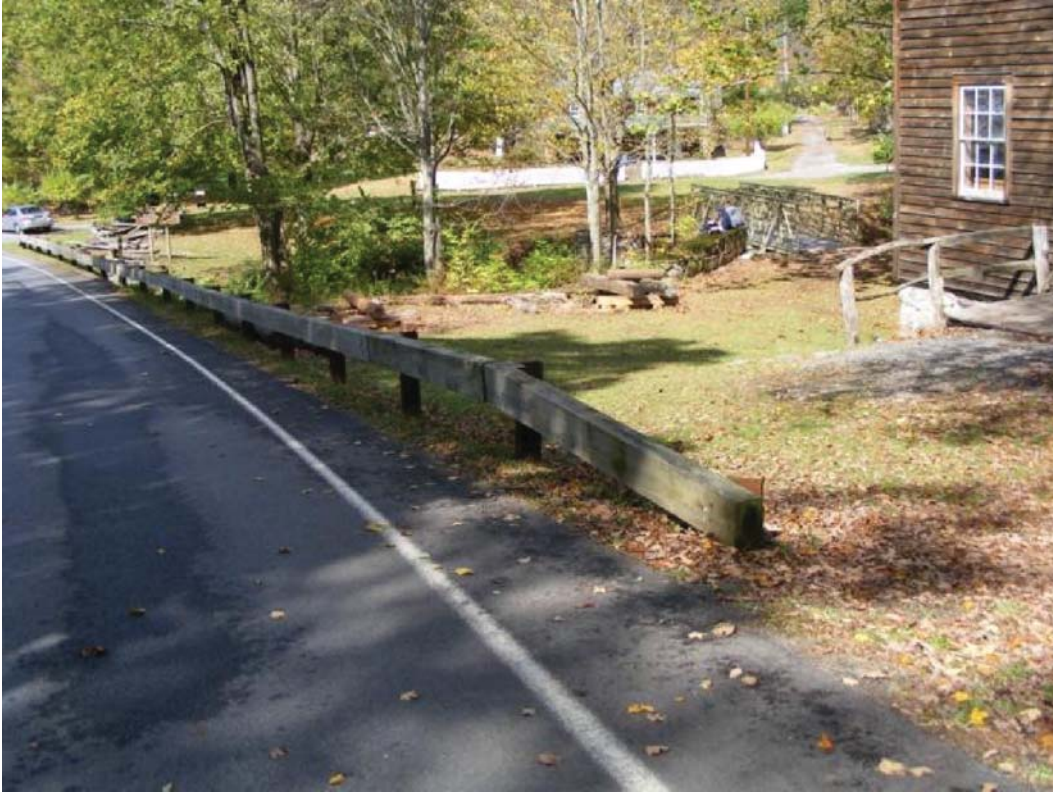
DEWA_0109_0.048_L_1.JPG

Barrier ID:	DEWA-0109-0.048-L				
Route Name:	NPS 602				
Inspection Date:	10/07/2010	Barrier Rating:	29.30		
Barrier Description					
Type:	STEEL-BACKED TIMBER WITH BLOCKOUT	Barrier Function:	TRAFFIC		
Barrier Material:	STEEL-BACKED TIMBER/LOG	Post Material:	CORTEN		
Blockout Type:	WOOD	Length (ft.):	180		
Speed Limit (MPH):	35	Placement with Respect to Road:	OUTSIDE OF CURVE		
Hazard Behind Barrier:	MEDIUM				
Barrier Crashworthiness					
Appropriate Test Level:	TL-2	Barrier Test Level:	TL-3	Is Barrier Crashworthy?:	YES
Beg. End Trtmt Type:	SBT/LOG FLARED	Is Beg. End Trtmt Crashworthy?:	NO	Approach Transition Type:	NONE
Ending End Trtmt Type:	SBT/LOG FLARED	Ending End Trtmt Crashworthy?:	NO		
Average Measurements					
Design Height (In.):	27	Width (In.):	0.0	Post Spacing (In.):	120.3
Height (In.):	26.6	Lateral Offset (In.):	32.2	Road Grade (%):	5.10
Physical Condition					
Barrier	Alignment and Height:	No deflections observed in alignment. The height is low by 1 in or less from the design of 27 in.

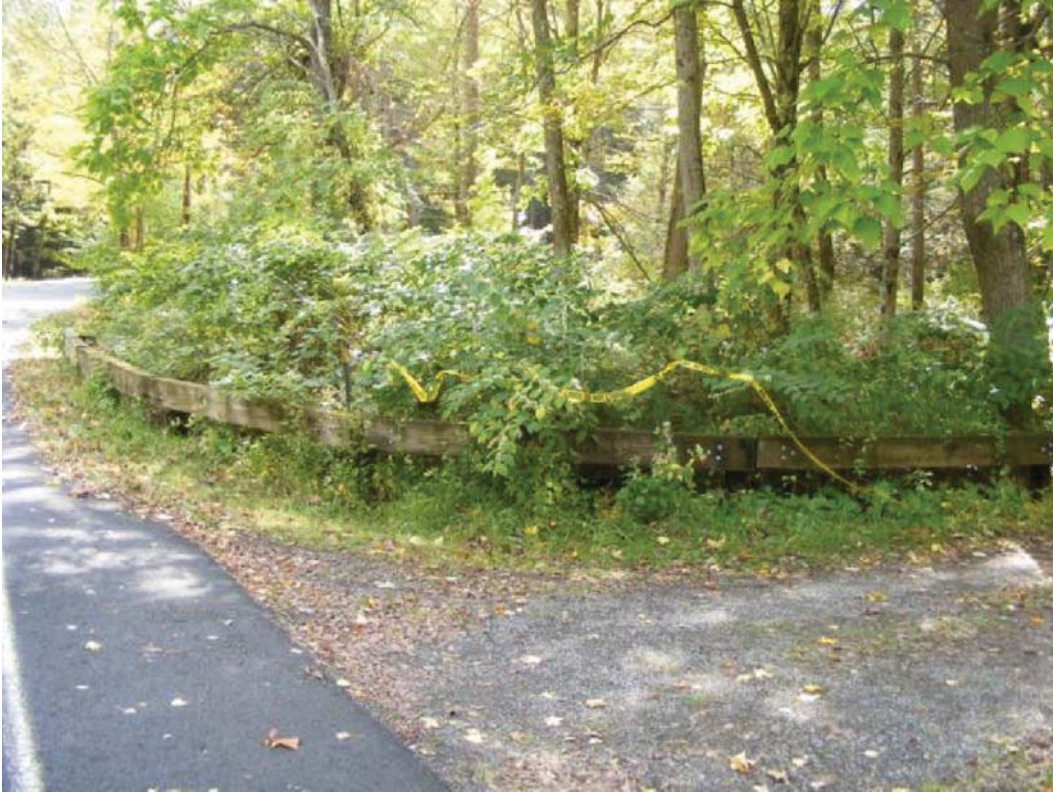
DEWA_0109_0.075_R_1.JPG

Barrier ID:	DEWA-0109-0.075-R				
Route Name:	NPS 602				
Inspection Date:	10/07/2010	Barrier Rating:	16.50		
Barrier Description					
Type:	STEEL-BACKED TIMBER WITH BLOCKOUT	Barrier Function:	TRAFFIC		
Barrier Material:	STEEL-BACKED TIMBER/LOG	Post Material:	CORTEN		
Blockout Type:	WOOD	Length (ft.):	90		
Speed Limit (MPH):	35	Placement with Respect to Road:	INSIDE OF CURVE		
Hazard Behind Barrier:	MEDIUM				
Barrier Crashworthiness					
Appropriate Test Level:	TL-2	Barrier Test Level:	TL-3	Is Barrier Crashworthy?:	YES
Beg. End Trtmt Type:	SBT/LOG FLARED	Is Beg. End Trtmt Crashworthy?:	NO	Approach Transition Type:	NONE
Ending End Trtmt Type:	SBT/LOG FLARED	Ending End Trtmt Crashworthy?:	NO		
Average Measurements					
Design Height (In.):	27	Width (In.):	0.0	Post Spacing (In.):	111.5
Height (In.):	28.0	Lateral Offset (In.):	65.3	Road Grade (%):	8.20
Physical Condition					
Barrier	Alignment and Height:	No deflections observed in alignment. The height is 1 in or less below at or above the design of 27 in by up to 4 in.

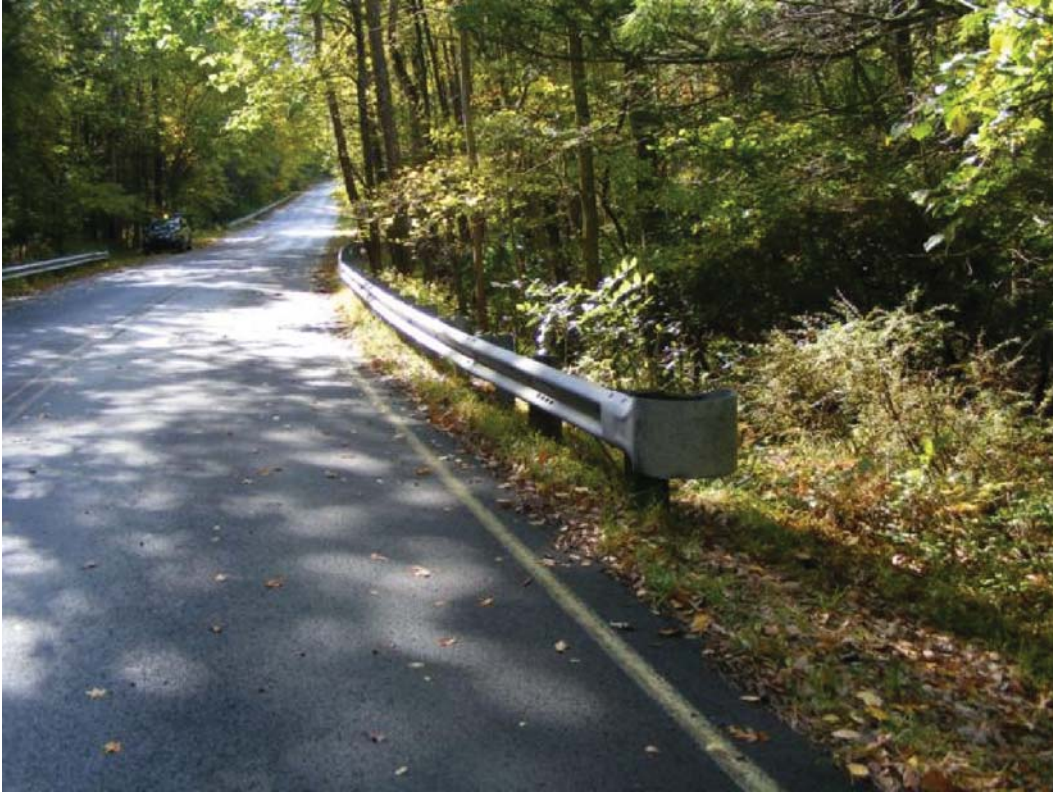
DEWA_0109_0.191_R_1.JPG

Barrier ID:	DEWA-0109-0.191-R				
Route Name:	NPS 602				
Inspection Date:	10/07/2010	Barrier Rating:	25.70		
Barrier Description					
Type:	W-BEAM STRONG POST	Barrier Function:	TRAFFIC		
Barrier Material:	GALVANIZED STEEL	Post Material:	GALVANIZED STEEL		
Blockout Type:	STEEL	Length (ft.):	155		
Speed Limit (MPH):	40	Placement with Respect to Road:	INSIDE OF CURVE		
Hazard Behind Barrier:	LOW				
Barrier Crashworthiness					
Appropriate Test Level:	TL-2	Barrier Test Level:	TL-3	Is Barrier Crashworthy?:	YES
Beg. End Trtmt Type:	W-BEAM BCT	Is Beg. End Trtmt Crashworthy?:	NO	Approach Transition Type:	NONE
Ending End Trtmt Type:	W-BEAM BCT	Ending End Trtmt Crashworthy?:	NO		
Average Measurements					
Design Height (In.):	27	Width (In.):	0.0	Post Spacing (In.):	75.0
Height (In.):	25.2	Lateral Offset (In.):	28.6	Road Grade (%):	9.00
Physical Condition					
Barrier	Alignment and Height:	No deflections observed in alignment. Barrier is 1 to 3 in below 27 in design height for 72 ft. The remaining height ranges from 1 in below to 1 in above the 27 in design height.

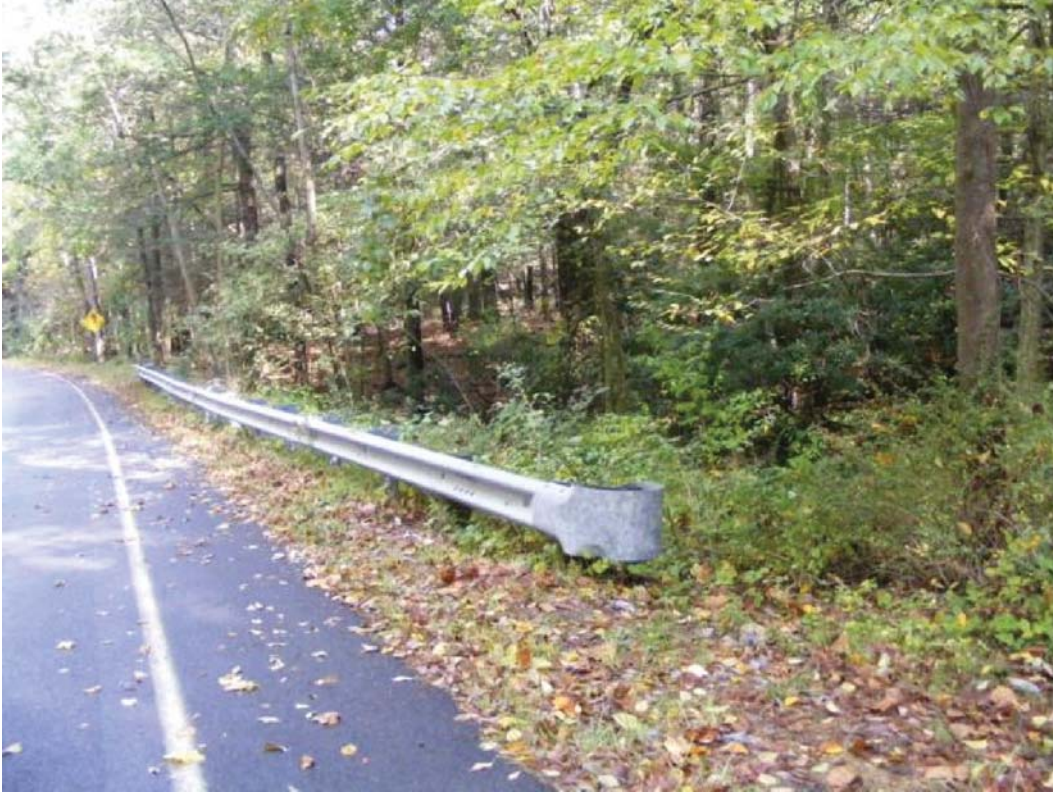
DEWA_0109_0.201_L_1.JPG

Barrier ID:	DEWA-0109-0.201-L				
Route Name:	NPS 602				
Inspection Date:	10/07/2010	Barrier Rating:	30.70		
Barrier Description					
Type:	W-BEAM STRONG POST	Barrier Function:	TRAFFIC		
Barrier Material:	GALVANIZED STEEL	Post Material:	GALVANIZED STEEL		
Blockout Type:	STEEL	Length (ft.):	100		
Speed Limit (MPH):	40	Placement with Respect to Road:	OUTSIDE OF CURVE		
Hazard Behind Barrier:	MEDIUM				
Barrier Crashworthiness					
Appropriate Test Level:	TL-2	Barrier Test Level:	TL-3	Is Barrier Crashworthy?:	YES
Beg. End Trtmt Type:	W-BEAM BCT	Is Beg. End Trtmt Crashworthy?:	NO	Approach Transition Type:	NONE
Ending End Trtmt Type:	W-BEAM BCT	Ending End Trtmt Crashworthy?:	NO		
Average Measurements					
Design Height (In.):	27	Width (In.):	0.0	Post Spacing (In.):	77.6
Height (In.):	27.7	Lateral Offset (In.):	62.7	Road Grade (%):	9.10
Physical Condition					
Barrier	Alignment and Height:	No deflections observed in alignment. Barrier is 1 in or less below at or above 27 in design height by up to 3 in.

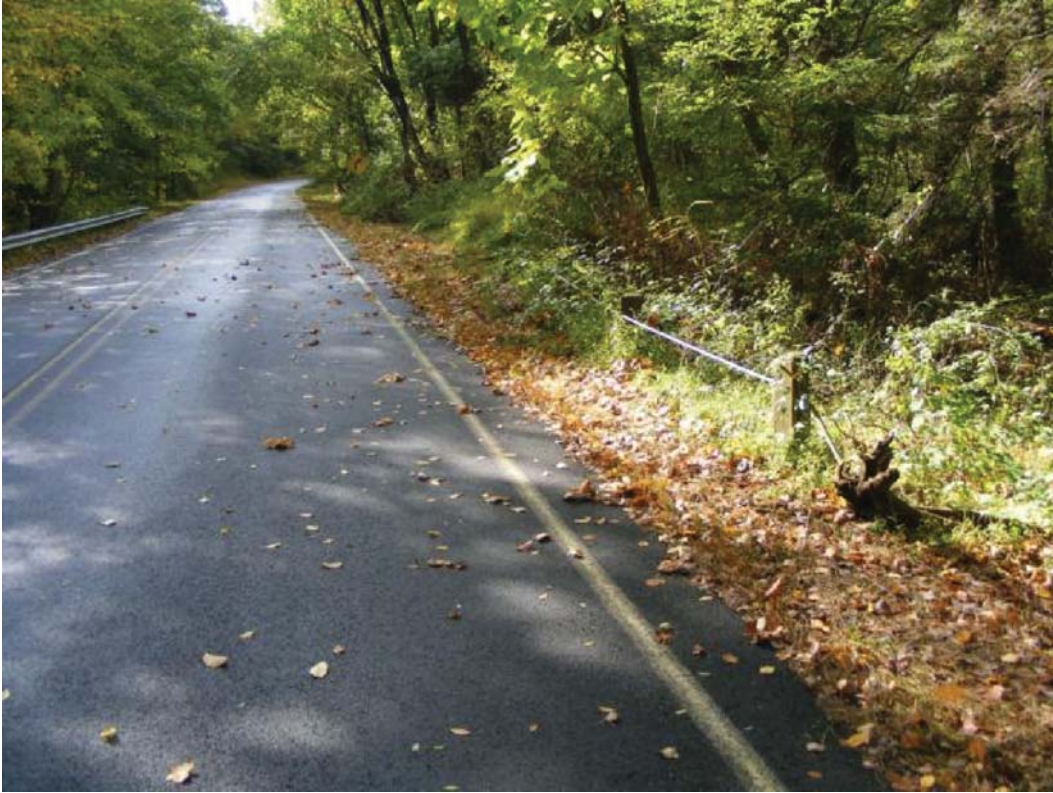
DEWA_0109_0.276_R_1.JPG

Barrier ID:	DEWA-0109-0.276-R				
Route Name:	NPS 602				
Inspection Date:	10/07/2010	Barrier Rating:	21.20		
Barrier Description					
Type:	OTHER: 2-STRAND CABLE	Barrier Function:	TRAFFIC		
Barrier Material:	CABLE	Post Material:	GALVANIZED STEEL		
Blockout Type:	N/A	Length (ft.):	130		
Speed Limit (MPH):	40	Placement with Respect to Road:	TANGENT		
Hazard Behind Barrier:	LOW				
Barrier Crashworthiness					
Appropriate Test Level:	TL-2	Barrier Test Level:	NCW	Is Barrier Crashworthy?:	NO
Beg. End Trtmt Type:	NONE	Is Beg. End Trtmt Crashworthy?:	N/A	Approach Transition Type:	NONE
Ending End Trtmt Type:	NONE	Ending End Trtmt Crashworthy?:	N/A		
Average Measurements					
Design Height (In.):	27	Width (In.):	0.0	Post Spacing (In.):	117.0
Height (In.):	16.6	Lateral Offset (In.):	66.5	Road Grade (%):	13.30
Physical Condition					
Barrier	Alignment and Height:	The barrier alignment is deflected more than 12 in. The height is low by 6 to 16 in from the design of 27 in.

Breaking and Cracking:	6 broken posts observed.			
	Missing Elements:	6 posts observed missing.			
	Corrosion and Weathering:	Cables and posts had losses up to 25% of cross section. No erosion around posts observed.			
End Treatments	Alignment and Height:				
	Breaking and Cracking:				
	Missing Elements:				
	Corrosion and Weathering:

Repair Action:	REPLACE	FMSS Work Type:	CAPITAL IMPROVEMENT	Repair Cost:	\$19580
Brief Workorder:	Replace existing guardrail with Steel-Backed Timber w/o blockouts and 2 flared Steel-Backed Timber end treatments.				
Workorder:	Remove Cable Guardrail at \$5- per -Lin. Ft. for 130 LF = \$650. Remove old 2 strand cable barrier. Steel-Backed Timber w/o Blockout at \$60- per -Lin. Ft. for 70 LF = \$4200. SBT / Log Flared at \$5000- per -Each for 2 Unit(s) = \$10000. Low Speed Traffic Control at \$1475- per -Day for 2 Day(s) = \$2950. 1 day removal and 1 day installation.

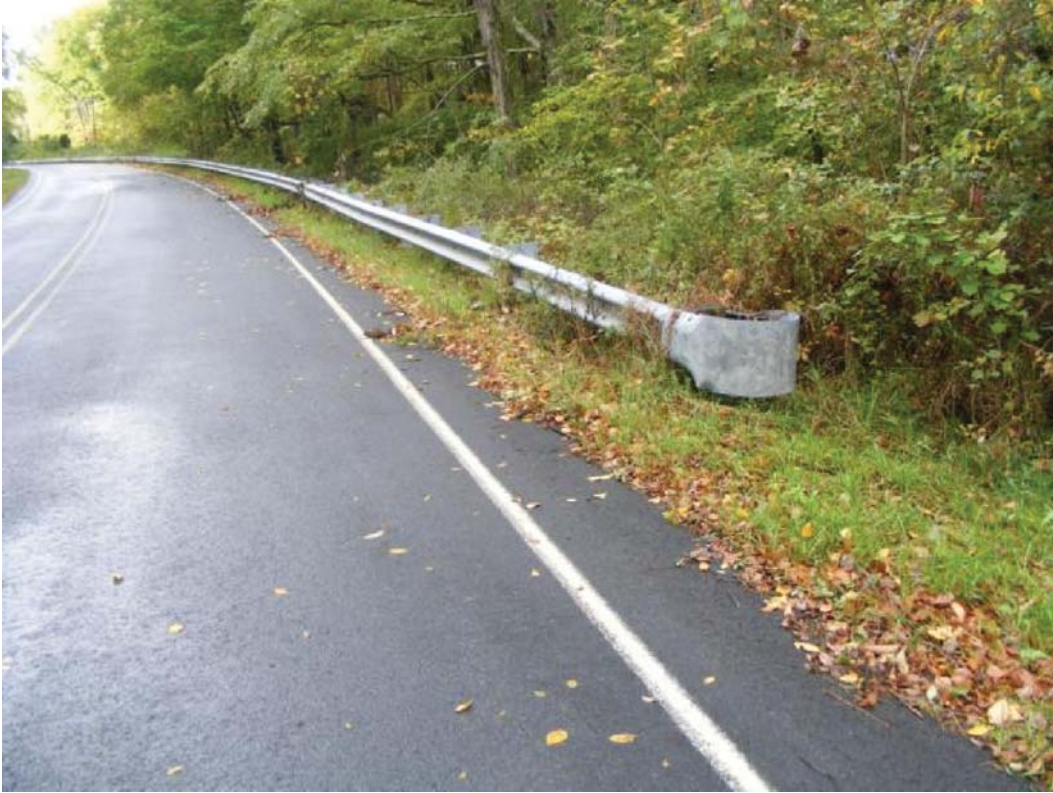
DEWA_0109_0.508_R_1.JPG

Barrier ID:	DEWA-0109-0.508-R				
Route Name:	NPS 602				
Inspection Date:	10/07/2010	Barrier Rating:	45.50		
Barrier Description					
Type:	W-BEAM STRONG POST	Barrier Function:	TRAFFIC		
Barrier Material:	GALVANIZED STEEL	Post Material:	GALVANIZED STEEL		
Blockout Type:	STEEL	Length (ft.):	758		
Speed Limit (MPH):	40	Placement with Respect to Road:	OUTSIDE OF CURVE		
Hazard Behind Barrier:	LOW				
Barrier Crashworthiness					
Appropriate Test Level:	TL-2	Barrier Test Level:	TL-3	Is Barrier Crashworthy?:	YES
Beg. End Trtmt Type:	W-BEAM BCT	Is Beg. End Trtmt Crashworthy?:	NO	Approach Transition Type:	NONE
Ending End Trtmt Type:	W-BEAM BCT	Ending End Trtmt Crashworthy?:	NO		
Average Measurements					
Design Height (In.):	27	Width (In.):	0.0	Post Spacing (In.):	75.5
Height (In.):	23.5	Lateral Offset (In.):	40.0	Road Grade (%):	13.70
Physical Condition					
Barrier	Alignment and Height:	No deflections observed in alignment. Barrier is 1 to 3 in below 27 in design height for 198 ft and is 3 to 4 in below for 560 ft.

Breaking and Cracking:	No breaking or cracking observed.			
	Missing Elements:	No missing elements observed.			
	Corrosion and Weathering:	No loss of cross section or erosion around posts observed.			
End Treatments	Alignment and Height:	Alignment as designed. End treatments are more than 3 in below 27 in design height.			
	Breaking and Cracking:	No breaking or cracking observed.			
	Missing Elements:	No missing elements observed.			
	Corrosion and Weathering:	No loss of cross section or erosion around posts observed.

Repair Action:	REPAIR	FMSS Work Type:	DEFERRED MAINTENANCE	Repair Cost:	\$13206
Brief Workorder:	Raise 758 feet of barrier to 27 inch design height.				
Workorder:	Adjust Guardrail at \$10- per -Lin. Ft. for 758 LF = \$7580. Raise 758ft. of barrier to 27 inch design height. Low Speed Traffic Control at \$1475- per -Day for 3 Day(s) = \$4425.
