NPS Guardwall/Rail Inventory Program Delaware Water Gap National Recreation Area

**Federal Lands Highway
Road Inventory Program**

Federal Highway Administration
Eastern Federal Lands Highway Division
Road Inventory Program (RIP)

Data Collection Date: October 2010
Report Date: December 2015

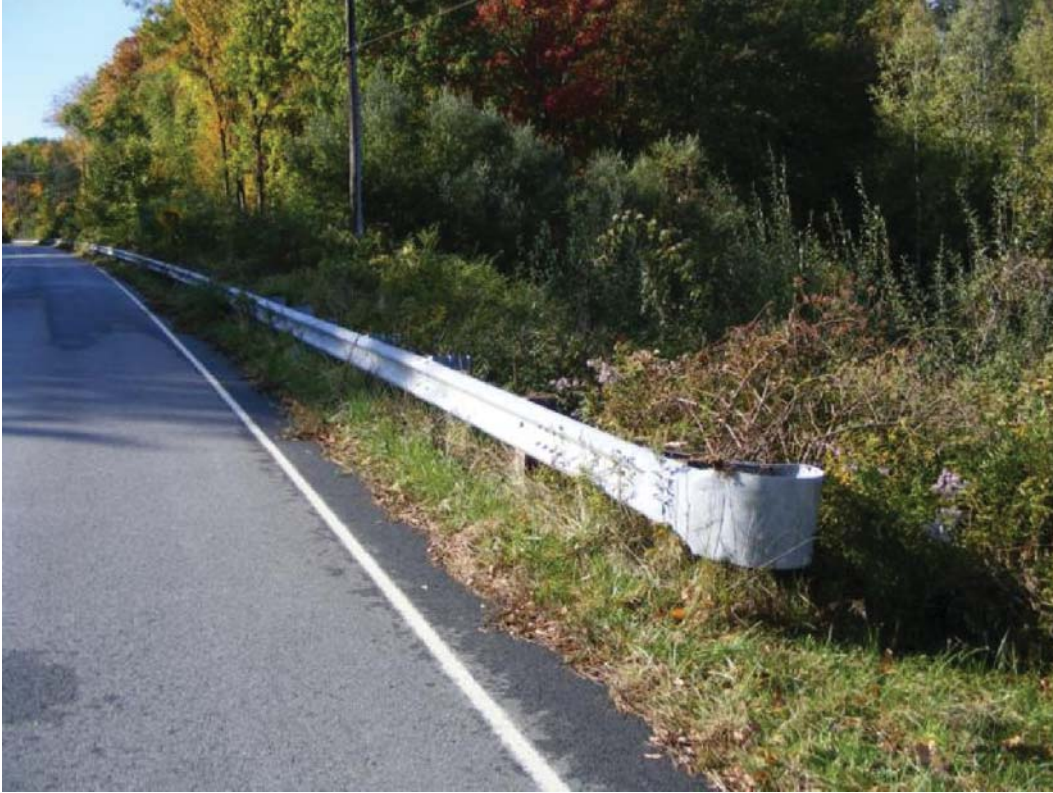
DEWA_0109_0.674_R_1.JPG

Barrier ID:	DEWA-0109-0.674-R				
Route Name:	NPS 602				
Inspection Date:	10/07/2010	Barrier Rating:	28.00		
Barrier Description					
Type:	W-BEAM STRONG POST	Barrier Function:	TRAFFIC		
Barrier Material:	GALVANIZED STEEL	Post Material:	GALVANIZED STEEL		
Blockout Type:	STEEL	Length (ft.):	618		
Speed Limit (MPH):	40	Placement with Respect to Road:	OUTSIDE OF CURVE		
Hazard Behind Barrier:	MEDIUM				
Barrier Crashworthiness					
Appropriate Test Level:	TL-2	Barrier Test Level:	TL-3	Is Barrier Crashworthy?:	YES
Beg. End Trtmt Type:	W-BEAM BCT	Is Beg. End Trtmt Crashworthy?:	NO	Approach Transition Type:	NONE
Ending End Trtmt Type:	W-BEAM BCT	Ending End Trtmt Crashworthy?:	NO		
Average Measurements					
Design Height (In.):	27	Width (In.):	0.0	Post Spacing (In.):	75.1
Height (In.):	26.2	Lateral Offset (In.):	38.7	Road Grade (%):	13.80
Physical Condition					
Barrier	Alignment and Height:	No deflections observed in alignment. The height is low by 1 in or less from the design of 27 in.

Breaking and Cracking:	No breaking or cracking observed.			
	Missing Elements:	No missing elements observed.			
	Corrosion and Weathering:	No loss of cross section or erosion around posts observed.			
End Treatments	Alignment and Height:	Alignment acceptable. Height is within 1-in. of 27-in. design height.			
	Breaking and Cracking:	No breaking or cracking observed.			
	Missing Elements:	No missing elements observed.			
	Corrosion and Weathering:	No loss of cross section or erosion around posts observed.

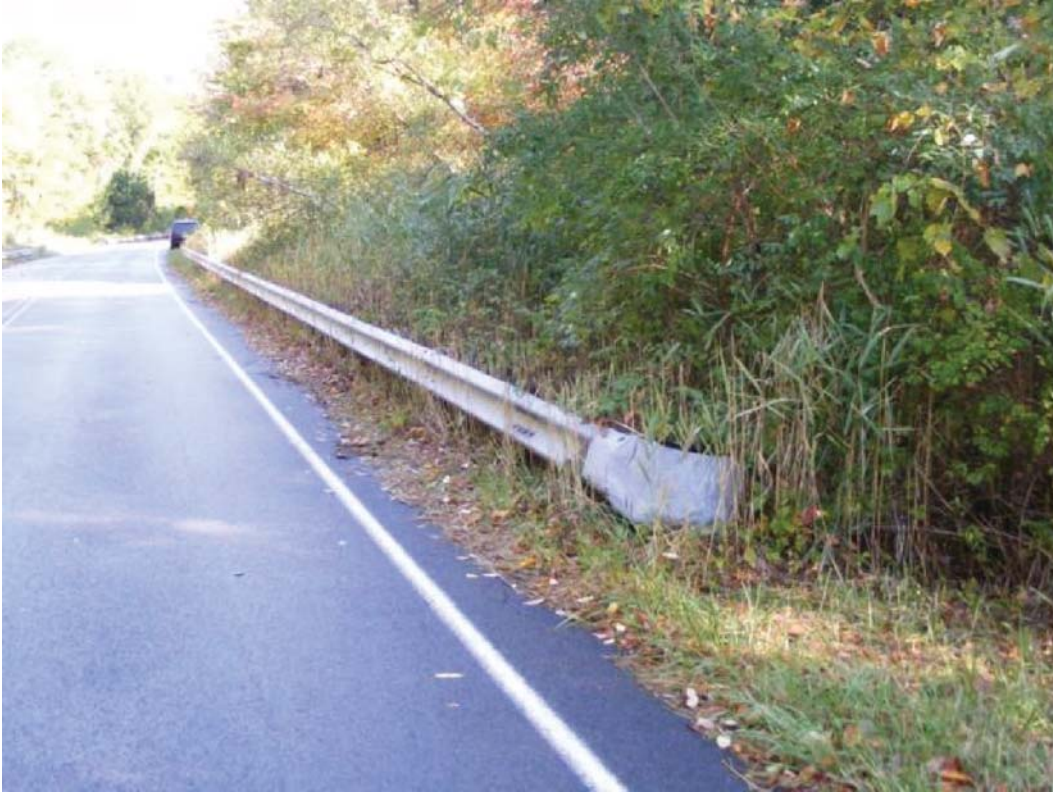
DEWA_0109_0.704_L_1.JPG

Barrier ID:	DEWA-0109-0.704-L				
Route Name:	NPS 602				
Inspection Date:	10/07/2010	Barrier Rating:	25.50		
Barrier Description					
Type:	W-BEAM STRONG POST	Barrier Function:	TRAFFIC		
Barrier Material:	GALVANIZED STEEL	Post Material:	GALVANIZED STEEL		
Blockout Type:	STEEL	Length (ft.):	182		
Speed Limit (MPH):	40	Placement with Respect to Road:	INSIDE OF CURVE		
Hazard Behind Barrier:	LOW				
Barrier Crashworthiness					
Appropriate Test Level:	TL-2	Barrier Test Level:	TL-3	Is Barrier Crashworthy?:	YES
Beg. End Trtmt Type:	W-BEAM BCT	Is Beg. End Trtmt Crashworthy?:	NO	Approach Transition Type:	NONE
Ending End Trtmt Type:	W-BEAM BCT	Ending End Trtmt Crashworthy?:	NO		
Average Measurements					
Design Height (In.):	27	Width (In.):	0.0	Post Spacing (In.):	75.5
Height (In.):	27.0	Lateral Offset (In.):	36.0	Road Grade (%):	13.50
Physical Condition					
Barrier	Alignment and Height:	No deflections observed in alignment. The height is low by 1 in at or 1 in above the 27 in design height.

Breaking and Cracking:	No breaking or cracking observed.			
	Missing Elements:	No missing elements observed.			
	Corrosion and Weathering:	No loss of cross section or erosion around posts observed.			
End Treatments	Alignment and Height:	Alignment acceptable. Height is within 1-in. of 27-in. design height.			
	Breaking and Cracking:	No breaking or cracking observed.			
	Missing Elements:	No missing elements observed.			
	Corrosion and Weathering:	No loss of cross section or erosion around posts observed.

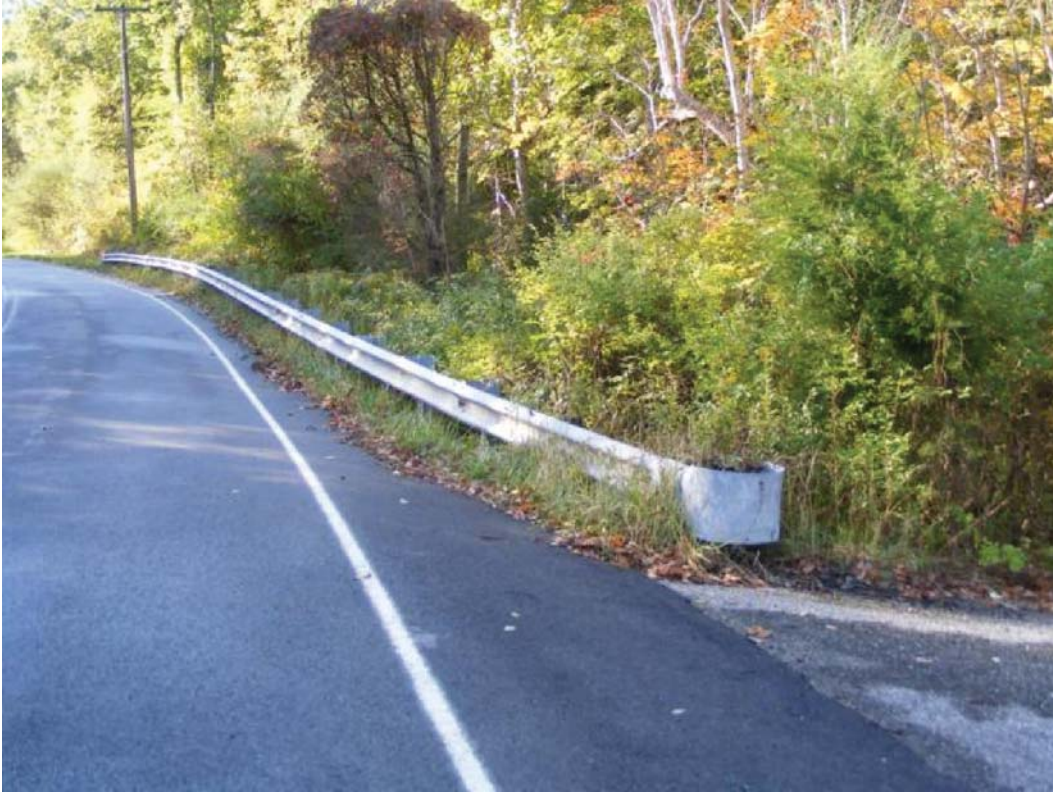
DEWA_0109_0.798_R_1.JPG

Barrier ID:	DEWA-0109-0.798-R				
Route Name:	NPS 602				
Inspection Date:	10/07/2010	Barrier Rating:	27.00		
Barrier Description					
Type:	W-BEAM STRONG POST	Barrier Function:	TRAFFIC		
Barrier Material:	GALVANIZED STEEL	Post Material:	GALVANIZED STEEL		
Blockout Type:	STEEL	Length (ft.):	180		
Speed Limit (MPH):	40	Placement with Respect to Road:	OUTSIDE OF CURVE		
Hazard Behind Barrier:	LOW				
Barrier Crashworthiness					
Appropriate Test Level:	TL-2	Barrier Test Level:	TL-3	Is Barrier Crashworthy?:	YES
Beg. End Trtmt Type:	W-BEAM BCT	Is Beg. End Trtmt Crashworthy?:	NO	Approach Transition Type:	NONE
Ending End Trtmt Type:	W-BEAM BCT	Ending End Trtmt Crashworthy?:	NO		
Average Measurements					
Design Height (In.):	27	Width (In.):	0.0	Post Spacing (In.):	75.6
Height (In.):	26.2	Lateral Offset (In.):	41.0	Road Grade (%):	14.80
Physical Condition					
Barrier	Alignment and Height:	No deflections observed in alignment. The height is low by 3 to 5 in for 65 ft from the 27-in. design height. The remaining height is 0-3in. above the design height.

Breaking and Cracking:	No breaking or cracking observed.			
	Missing Elements:	No missing elements observed.			
	Corrosion and Weathering:	No loss of cross section or erosion around posts observed.			
End Treatments	Alignment and Height:	Alignment as designed. Height is lower than 27 in design by 5 in at approach end.			
	Breaking and Cracking:	No breaking or cracking observed.			
	Missing Elements:	No missing elements observed.			
	Corrosion and Weathering:	No loss of cross section or erosion around posts observed.

Repair Action:	REPAIR	FMSS Work Type:	DEFERRED MAINTENANCE	Repair Cost:	\$2338
Brief Workorder:	Raise 65 feet of barrier to 27 inch design height.				
Workorder:	Adjust Guardrail at \$10- per -Lin. Ft. for 65 LF = \$650. Raise 65ft. of barrier to 27 inch design height. Low Speed Traffic Control at \$1475- per -Day for 1 Day(s) = \$1475.

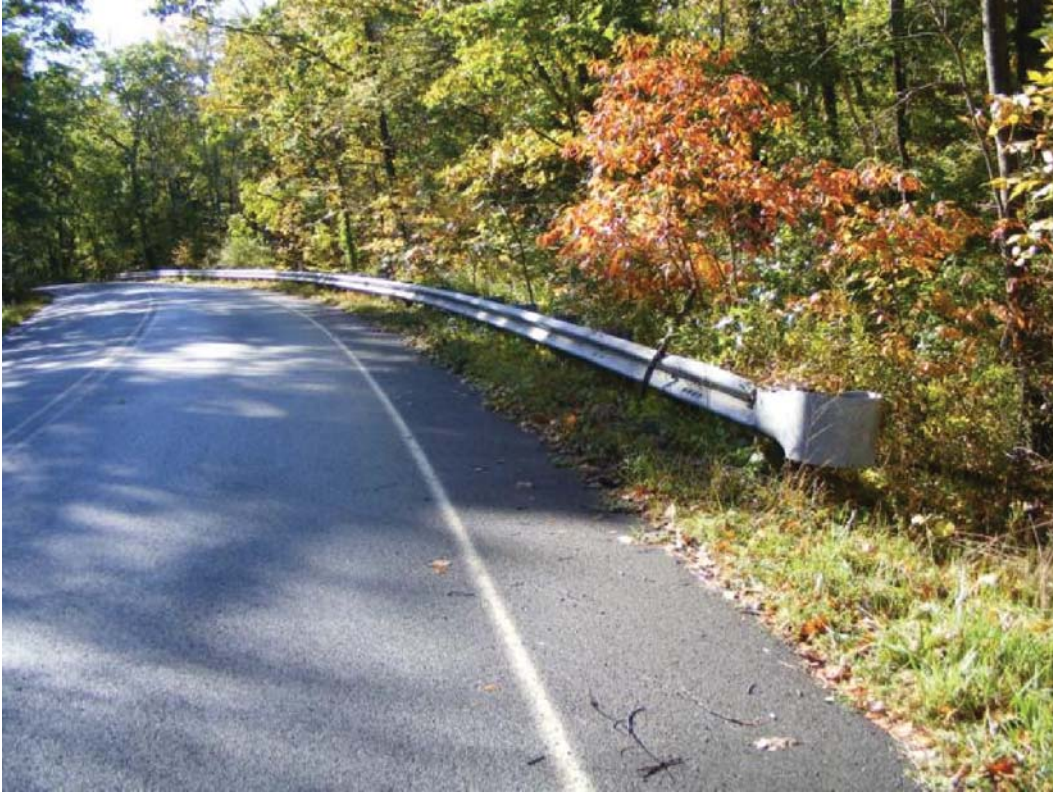
DEWA_0109_1.227_R_1.JPG

Barrier ID:	DEWA-0109-1.227-R				
Route Name:	NPS 602				
Inspection Date:	10/07/2010	Barrier Rating:	25.10		
Barrier Description					
Type:	W-BEAM STRONG POST	Barrier Function:	TRAFFIC		
Barrier Material:	GALVANIZED STEEL	Post Material:	GALVANIZED STEEL		
Blockout Type:	STEEL	Length (ft.):	278		
Speed Limit (MPH):	40	Placement with Respect to Road:	OUTSIDE OF CURVE		
Hazard Behind Barrier:	MEDIUM				
Barrier Crashworthiness					
Appropriate Test Level:	TL-2	Barrier Test Level:	TL-3	Is Barrier Crashworthy?:	YES
Beg. End Trtmt Type:	W-BEAM BCT	Is Beg. End Trtmt Crashworthy?:	NO	Approach Transition Type:	NONE
Ending End Trtmt Type:	W-BEAM BCT	Ending End Trtmt Crashworthy?:	NO		
Average Measurements					
Design Height (In.):	27	Width (In.):	0.0	Post Spacing (In.):	75.0
Height (In.):	26.6	Lateral Offset (In.):	59.5	Road Grade (%):	2.00
Physical Condition					
Barrier	Alignment and Height:	No deflections observed in alignment. Barrier is greater than 3 in below 27 in design height for 25 ft with the majority of the barrier at or 1 in below the 27 in design height.

Breaking and Cracking:	No breaking or cracking observed.			
	Missing Elements:	No missing elements observed.			
	Corrosion and Weathering:	No loss of cross section or erosion around posts observed.			
End Treatments	Alignment and Height:	Alignment acceptable. Height is within 1-in. of 27-in. design height.			
	Breaking and Cracking:	No breaking or cracking observed.			
	Missing Elements:	No missing elements observed.			
	Corrosion and Weathering:	No loss of cross section or erosion around posts observed.

Repair Action:	REPAIR	FMSS Work Type:	DEFERRED MAINTENANCE	Repair Cost:	\$1898
Brief Workorder:	Raise 25 feet of barrier to 27 inch design height.				
Workorder:	Adjust Guardrail at \$10- per -Lin. Ft. for 25 LF = \$250. Raise 25ft. of barrier to 27 inch design height. Low Speed Traffic Control at \$1475- per -Day for 1 Day(s) = \$1475.

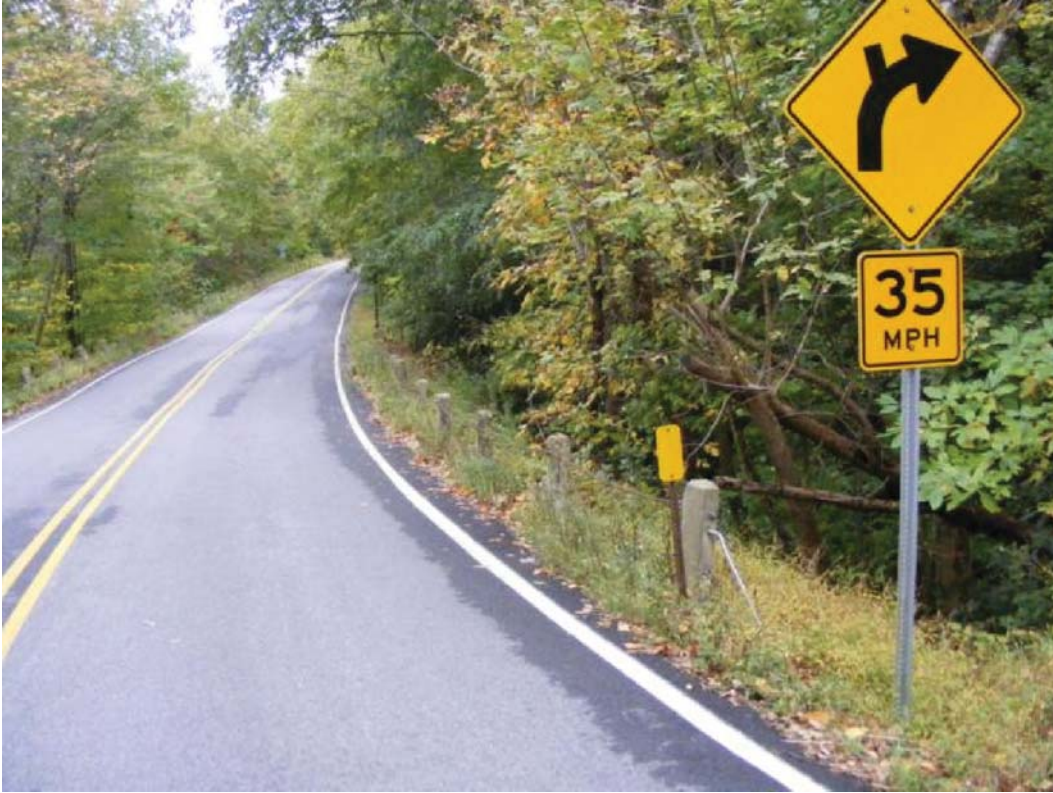
DEWA_0109_1.388_R_1.JPG

Barrier ID:	DEWA-0109-1.388-R				
Route Name:	NPS 602				
Inspection Date:	10/06/2010	Barrier Rating:	35.20		
Barrier Description					
Type:	OTHER: 2-STRAND CABLE	Barrier Function:	TRAFFIC		
Barrier Material:	CABLE	Post Material:	OTHER: CONCRETE		
Blockout Type:	N/A	Length (ft.):	102		
Speed Limit (MPH):	40	Placement with Respect to Road:	TANGENT		
Hazard Behind Barrier:	MEDIUM				
Barrier Crashworthiness					
Appropriate Test Level:	TL-2	Barrier Test Level:	NCW	Is Barrier Crashworthy?:	NO
Beg. End Trtmt Type:	NONE	Is Beg. End Trtmt Crashworthy?:	N/A	Approach Transition Type:	NONE
Ending End Trtmt Type:	NONE	Ending End Trtmt Crashworthy?:	N/A		
Average Measurements					
Design Height (In.):	27	Width (In.):	0.0	Post Spacing (In.):	121.5
Height (In.):	17.6	Lateral Offset (In.):	39.2	Road Grade (%):	8.30
Physical Condition					
Barrier	Alignment and Height:	The barrier alignment is deflected up to 7 in. The height is low by 7 to 12 in from the design of 27 in.

Breaking and Cracking:	1 broken and cracked post.			
	Missing Elements:	No missing elements observed.			
	Corrosion and Weathering:	Cables and posts had losses up to 25% of cross section.			
End Treatments	Alignment and Height:				
	Breaking and Cracking:				
	Missing Elements:				
	Corrosion and Weathering:

Repair Action:	REPLACE	FMSS Work Type:	CAPITAL IMPROVEMENT	Repair Cost:	\$17578
Brief Workorder:	Replace existing guardrail with Steel-Backed Timber w/o blockouts and 2 flared Steel-Backed Timber end treatments.				
Workorder:	Remove Cable Guardrail at \$5- per -Lin. Ft. for 102 LF = \$510. Remove old 2 strand cable barrier. Steel-Backed Timber w/o Blockout at \$60- per -Lin. Ft. for 42 LF = \$2520. SBT / Log Flared at \$5000- per -Each for 2 Unit(s) = \$10000. 30 feet each. Low Speed Traffic Control at \$1475- per -Day for 2 Day(s) = \$2950. 1 day removal and 1 day installation.

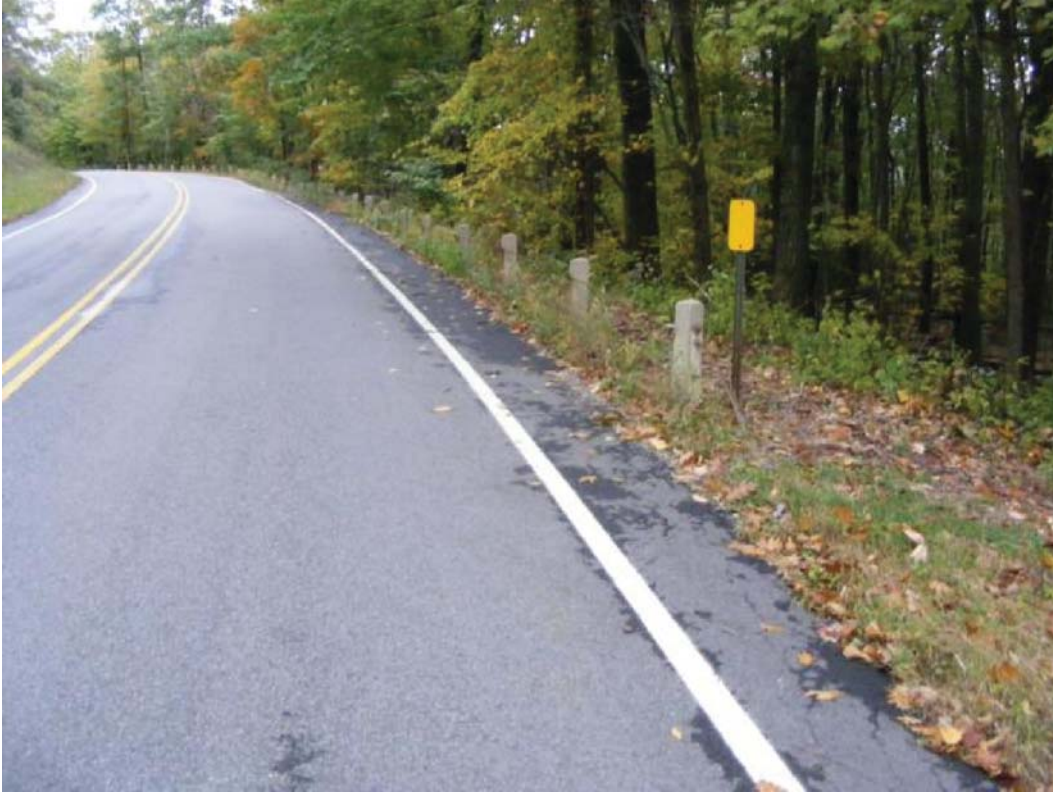
DEWA_0109_1.394_L_1.JPG

Barrier ID:	DEWA-0109-1.394-L				
Route Name:	NPS 602				
Inspection Date:	10/06/2010	Barrier Rating:	58.00		
Barrier Description					
Type:	OTHER: 2-STRAND CABLE	Barrier Function:	TRAFFIC		
Barrier Material:	CABLE	Post Material:	OTHER: CONCRETE		
Blockout Type:	N/A	Length (ft.):	825		
Speed Limit (MPH):	40	Placement with Respect to Road:	OUTSIDE OF CURVE		
Hazard Behind Barrier:	MEDIUM				
Barrier Crashworthiness					
Appropriate Test Level:	TL-2	Barrier Test Level:	NCW	Is Barrier Crashworthy?:	NO
Beg. End Trtmt Type:	NONE	Is Beg. End Trtmt Crashworthy?:	N/A	Approach Transition Type:	NONE
Ending End Trtmt Type:	NONE	Ending End Trtmt Crashworthy?:	N/A		
Average Measurements					
Design Height (In.):	27	Width (In.):	0.0	Post Spacing (In.):	117.0
Height (In.):	16.6	Lateral Offset (In.):	45.2	Road Grade (%):	10.40
Physical Condition					
Barrier	Alignment and Height:	Alignment is deflected up to 11 in. The height is low by 6 to 16 in from the design of 27 ines.

Breaking and Cracking:	No breaking or cracking observed.			
	Missing Elements:	No breaking or cracking observed. No missing elements observed.			
	Corrosion and Weathering:	Cables and posts had losses up to 15% of cross section. No erosion around posts observed.			
End Treatments	Alignment and Height:				
	Breaking and Cracking:				
	Missing Elements:				
	Corrosion and Weathering:

Repair Action:	REPLACE	FMSS Work Type:	CAPITAL IMPROVEMENT	Repair Cost:	\$79008
Brief Workorder:	Replace existing guardrail with Steel-Backed Timber w/o blockouts and 2 flared Steel-Backed Timber end treatments.				
Workorder:	Remove Cable Guardrail at \$5- per -Lin. Ft. for 825 LF = \$4125. Steel-Backed Timber w/o Blockout at \$60- per -Lin. Ft. for 765 LF = \$45900. SBT / Log Flared at \$5000- per -Each for 2 Unit(s) = \$10000. 30ft each Low Speed Traffic Control at \$1475- per -Day for 8 Day(s) = \$11800. 4 days removal and 4 days installation.

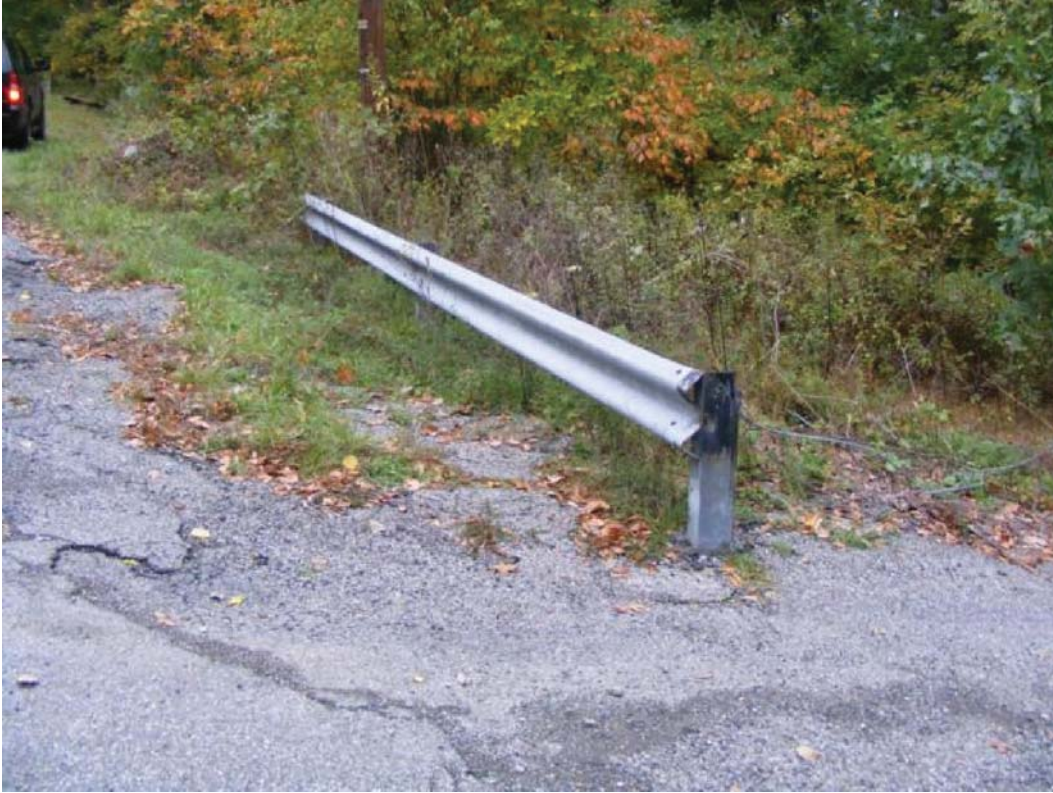
DEWA_0109_1.569_L_1.JPG

Barrier ID:	DEWA-0109-1.569-L				
Route Name:	NPS 602				
Inspection Date:	10/06/2010	Barrier Rating:	8.50		
Barrier Description					
Type:	W-BEAM WEAK POST	Barrier Function:	NON-TRAFFIC		
Barrier Material:	GALVANIZED STEEL	Post Material:	GALVANIZED STEEL		
Blockout Type:	N/A	Length (ft.):	26		
Speed Limit (MPH):	40	Placement with Respect to Road:	NON-TRAFFIC BARRIER		
Hazard Behind Barrier:	N/A				
Barrier Crashworthiness					
Appropriate Test Level:	TL-2	Barrier Test Level:	N/A	Is Barrier Crashworthy?:	N/A
Beg. End Trtmt Type:	NONE	Is Beg. End Trtmt Crashworthy?:	N/A	Approach Transition Type:	NONE
Ending End Trtmt Type:	NONE	Ending End Trtmt Crashworthy?:	N/A		
Average Measurements					
Design Height (In.):	27	Width (In.):	0.0	Post Spacing (In.):	150.3
Height (In.):	26.6	Lateral Offset (In.):	0.0	Road Grade (%):	0.00
Physical Condition					
Barrier	Alignment and Height:	No deflections observed in alignment. The height is low by 1 in or less from the design of 27 in.

Breaking and Cracking:	No breaking or cracking observed.			
	Missing Elements:	No missing elements observed.			
	Corrosion and Weathering:	No loss of cross section or erosion around posts observed.			
End Treatments	Alignment and Height:				
	Breaking and Cracking:				
	Missing Elements:				
	Corrosion and Weathering:

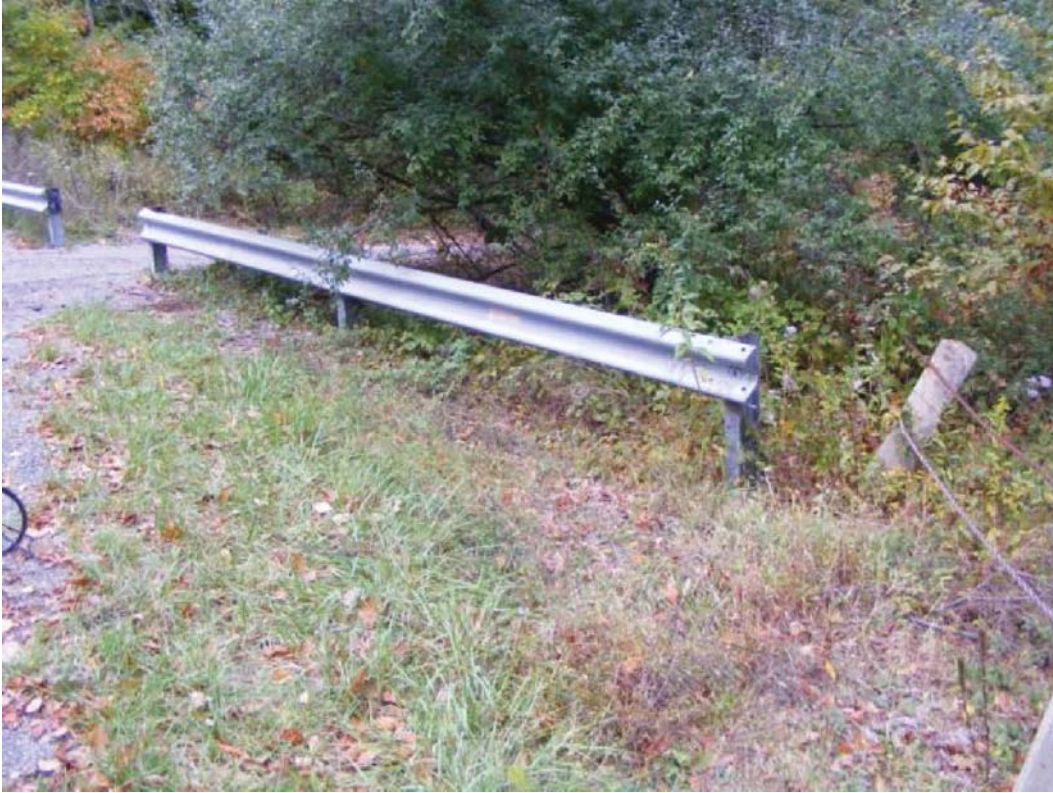
DEWA_0109_1.576_L_1.JPG

Barrier ID:	DEWA-0109-1.576-L				
Route Name:	NPS 602				
Inspection Date:	10/06/2010	Barrier Rating:	8.50		
Barrier Description					
Type:	W-BEAM WEAK POST	Barrier Function:	NON-TRAFFIC		
Barrier Material:	GALVANIZED STEEL	Post Material:	GALVANIZED STEEL		
Blockout Type:	N/A	Length (ft.):	26		
Speed Limit (MPH):	40	Placement with Respect to Road:	NON-TRAFFIC BARRIER		
Hazard Behind Barrier:	N/A				
Barrier Crashworthiness					
Appropriate Test Level:	TL-2	Barrier Test Level:	N/A	Is Barrier Crashworthy?:	N/A
Beg. End Trtmt Type:	NONE	Is Beg. End Trtmt Crashworthy?:	N/A	Approach Transition Type:	NONE
Ending End Trtmt Type:	NONE	Ending End Trtmt Crashworthy?:	N/A		
Average Measurements					
Design Height (In.):	27	Width (In.):	0.0	Post Spacing (In.):	150.0
Height (In.):	28.0	Lateral Offset (In.):	0.0	Road Grade (%):	0.00
Physical Condition					
Barrier	Alignment and Height:	No deflections observed in alignment. The height is at or above the design of 27 in up to 3 in.

Breaking and Cracking:	No breaking or cracking observed.			
	Missing Elements:	No missing elements observed.			
	Corrosion and Weathering:	No loss of cross section or erosion around posts observed.			
End Treatments	Alignment and Height:				
	Breaking and Cracking:				
	Missing Elements:				
	Corrosion and Weathering:

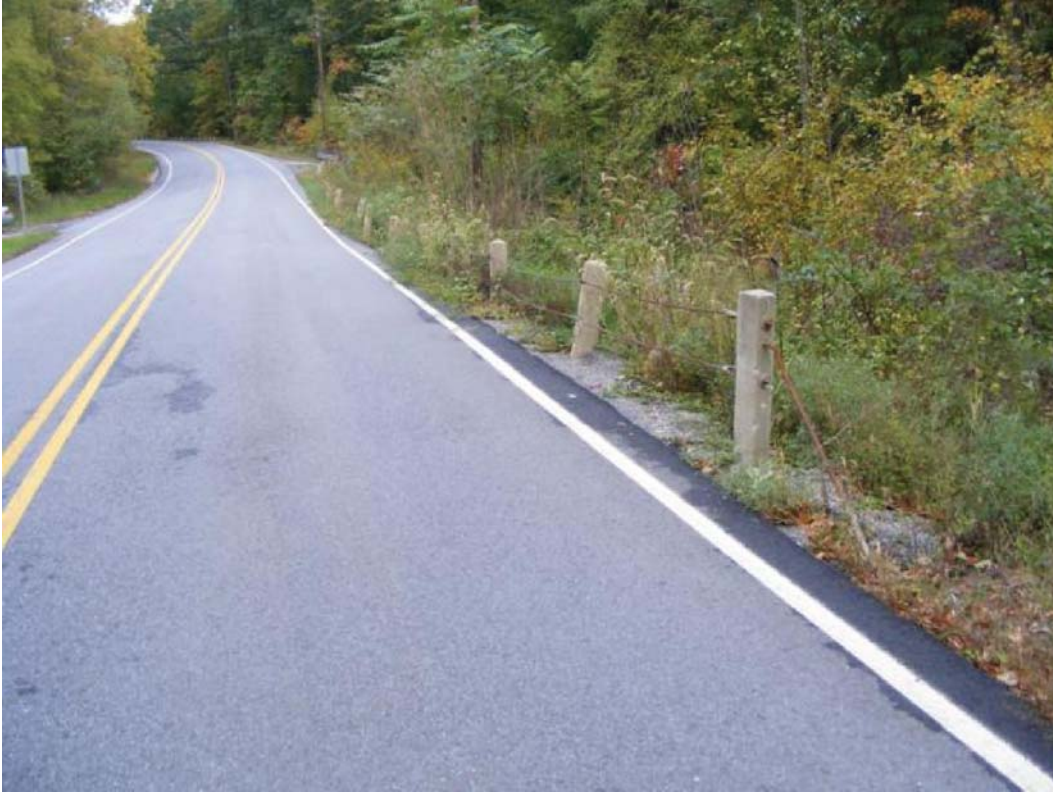
DEWA_0109_1.580_L_1.JPG

Barrier ID:	DEWA-0109-1.580-L				
Route Name:	NPS 602				
Inspection Date:	10/06/2010	Barrier Rating:	33.70		
Barrier Description					
Type:	OTHER: 2-STRAND CABLE	Barrier Function:	TRAFFIC		
Barrier Material:	CABLE	Post Material:	OTHER: CONCRETE		
Blockout Type:	N/A	Length (ft.):	280		
Speed Limit (MPH):	40	Placement with Respect to Road:	TANGENT		
Hazard Behind Barrier:	MEDIUM				
Barrier Crashworthiness					
Appropriate Test Level:	TL-2	Barrier Test Level:	NCW	Is Barrier Crashworthy?:	NO
Beg. End Trtmt Type:	NONE	Is Beg. End Trtmt Crashworthy?:	N/A	Approach Transition Type:	NONE
Ending End Trtmt Type:	NONE	Ending End Trtmt Crashworthy?:	N/A		
Average Measurements					
Design Height (In.):	27	Width (In.):	0.0	Post Spacing (In.):	117.5
Height (In.):	22.2	Lateral Offset (In.):	40.5	Road Grade (%):	4.10
Physical Condition					
Barrier	Alignment and Height:	The barrier alignment is deflected up to 11 in. The height is low by 8 in or less from the design of 27 in.

Breaking and Cracking:	2 broken and cracked posts observed.			
	Missing Elements:	No missing elements observed.			
	Corrosion and Weathering:	Cables and posts had losses up to 25% of cross section. No erosion around posts observed.			
End Treatments	Alignment and Height:				
	Breaking and Cracking:				
	Missing Elements:				
	Corrosion and Weathering:

Repair Action:	REPLACE	FMSS Work Type:	CAPITAL IMPROVEMENT	Repair Cost:	\$33550
Brief Workorder:	Replace existing guardrail with Steel-Backed Timber w/o blockouts and 2 flared Steel-Backed Timber end treatments.				
Workorder:	Remove Cable Guardrail at \$5- per -Lin. Ft. for 280 LF = \$1400. Remove old 2 strand cable barrier. Steel-Backed Timber w/o Blockout at \$60- per -Lin. Ft. for 220 LF = \$13200. SBT / Log Flared at \$5000- per -Each for 2 Unit(s) = \$10000. Low Speed Traffic Control at \$1475- per -Day for 4 Day(s) = \$5900. 2 days removal and 2 days installation.

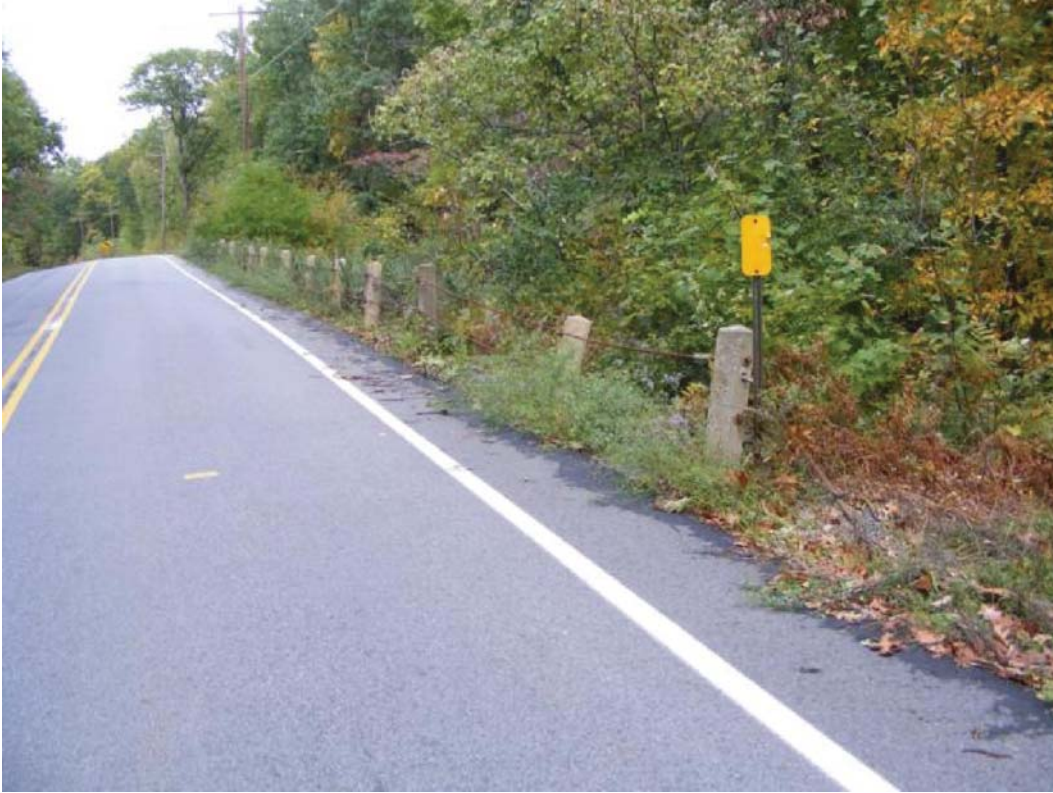
DEWA_0109_1.686_R_1.JPG

Barrier ID:	DEWA-0109-1.686-R				
Route Name:	NPS 602				
Inspection Date:	10/06/2010	Barrier Rating:	26.60		
Barrier Description					
Type:	OTHER: 2-STRAND CABLE	Barrier Function:	TRAFFIC		
Barrier Material:	CABLE	Post Material:	OTHER: CONCRETE		
Blockout Type:	N/A	Length (ft.):	151		
Speed Limit (MPH):	40	Placement with Respect to Road:	TANGENT		
Hazard Behind Barrier:	MEDIUM				
Barrier Crashworthiness					
Appropriate Test Level:	TL-2	Barrier Test Level:	NCW	Is Barrier Crashworthy?:	NO
Beg. End Trtmt Type:	NONE	Is Beg. End Trtmt Crashworthy?:	N/A	Approach Transition Type:	NONE
Ending End Trtmt Type:	NONE	Ending End Trtmt Crashworthy?:	N/A		
Average Measurements					
Design Height (In.):	27	Width (In.):	0.0	Post Spacing (In.):	115.0
Height (In.):	25.6	Lateral Offset (In.):	45.5	Road Grade (%):	7.70
Physical Condition					
Barrier	Alignment and Height:	The barrier alignment is deflected up to 11 in. The height is low by 5 in or less from the design of 27 in.

Breaking and Cracking:	1 possible impact zone 4 posts were observed as breaking and cracking.			
	Missing Elements:	No missing elements observed.			
	Corrosion and Weathering:	Posts had losses up to 15% of cross section exposing rebar in some locations.			
End Treatments	Alignment and Height:				
	Breaking and Cracking:				
	Missing Elements:				
	Corrosion and Weathering:

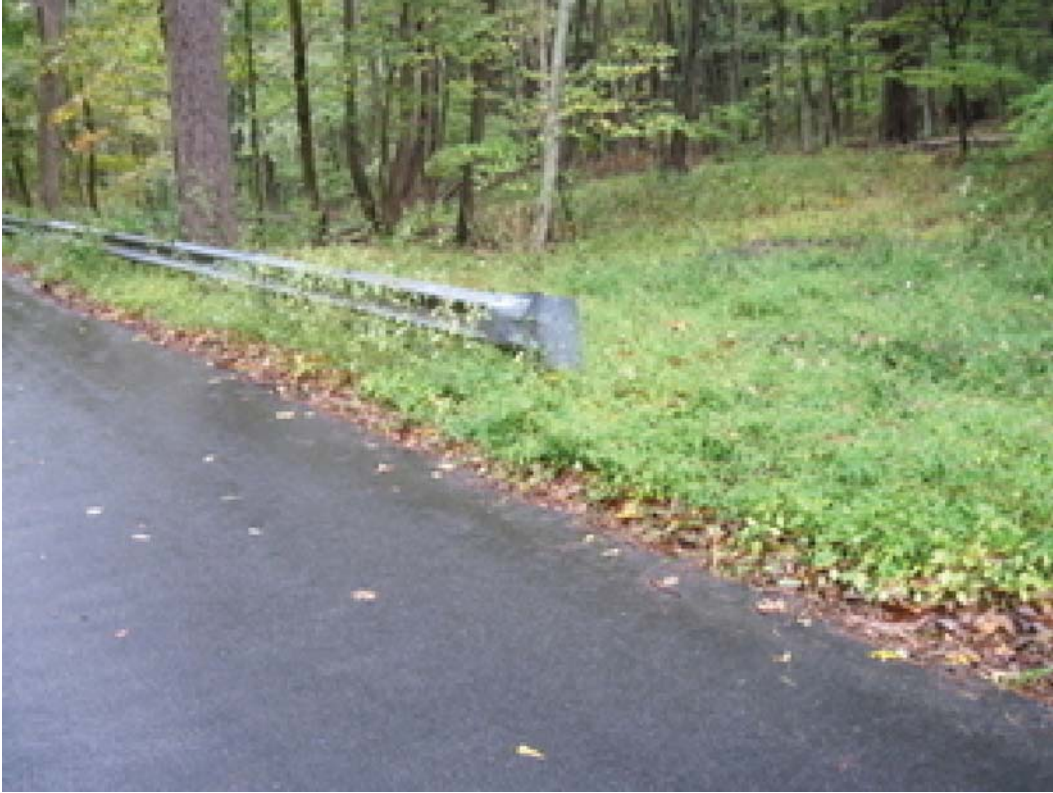
DEWA_0110_0.016_L_1.jpg

Barrier ID:	DEWA-0110-0.016-L				
Route Name:	POMPEY RIDGE ROAD				
Inspection Date:	10/04/2010	Barrier Rating:	71.30		
Barrier Description					
Type:	W-BEAM WEAK POST	Barrier Function:	TRAFFIC		
Barrier Material:	GALVANIZED STEEL	Post Material:	GALVANIZED STEEL		
Blockout Type:	N/A	Length (ft.):	1491		
Speed Limit (MPH):	35	Placement with Respect to Road:	BOTH INSIDE AND OUTSIDE		
Hazard Behind Barrier:	LOW				
Barrier Crashworthiness					
Appropriate Test Level:	TL-2	Barrier Test Level:	TL-2	Is Barrier Crashworthy?:	YES
Beg. End Trtmt Type:	NONE	Is Beg. End Trtmt Crashworthy?:	N/A	Approach Transition Type:	NONE
Ending End Trtmt Type:	NONE	Ending End Trtmt Crashworthy?:	N/A		
Average Measurements					
Design Height (In.):	27	Width (In.):	0.0	Post Spacing (In.):	150.1
Height (In.):	22.2	Lateral Offset (In.):	33.4	Road Grade (%):	8.40
Physical Condition					
Barrier	Alignment and Height:	No alignment deflection observed. Height is 2 in above the 27 in design height to 1 in below for 200 ft between 1 to 3 in below for 200 ft and between 3 to 9 in below for 1091 ft.

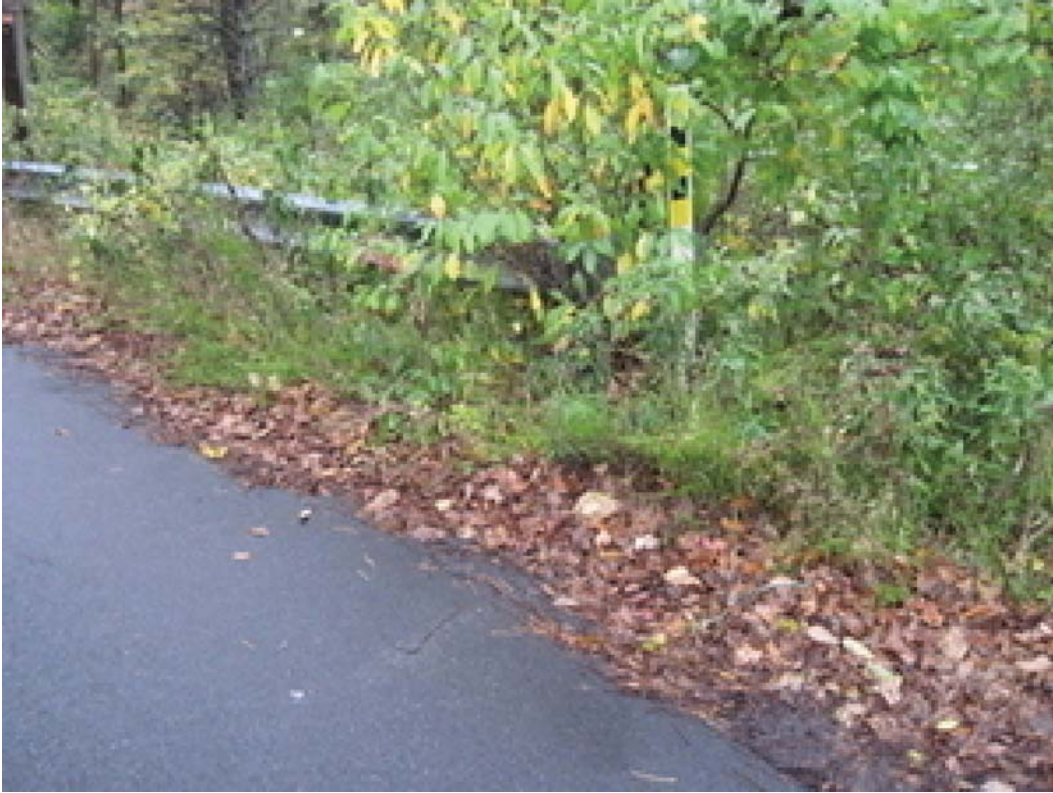
DEWA_0110_0.794_R_1.jpg

Barrier ID:	DEWA-0110-0.794-R				
Route Name:	POMPEY RIDGE ROAD				
Inspection Date:	10/04/2010	Barrier Rating:	65.10		
Barrier Description					
Type:	W-BEAM WEAK POST	Barrier Function:	TRAFFIC		
Barrier Material:	GALVANIZED STEEL	Post Material:	GALVANIZED STEEL		
Blockout Type:	N/A	Length (ft.):	526		
Speed Limit (MPH):	35	Placement with Respect to Road:	BOTH INSIDE AND OUTSIDE		
Hazard Behind Barrier:	MEDIUM				
Barrier Crashworthiness					
Appropriate Test Level:	TL-2	Barrier Test Level:	TL-2	Is Barrier Crashworthy?:	YES
Beg. End Trtmt Type:	NONE	Is Beg. End Trtmt Crashworthy?:	N/A	Approach Transition Type:	NONE
Ending End Trtmt Type:	NONE	Ending End Trtmt Crashworthy?:	N/A		
Average Measurements					
Design Height (In.):	27	Width (In.):	0.0	Post Spacing (In.):	149.6
Height (In.):	20.0	Lateral Offset (In.):	20.2	Road Grade (%):	7.00
Physical Condition					
Barrier	Alignment and Height:	No alignment deflection observed. Height ranges from 6 in to 8 in below 27 in design height.

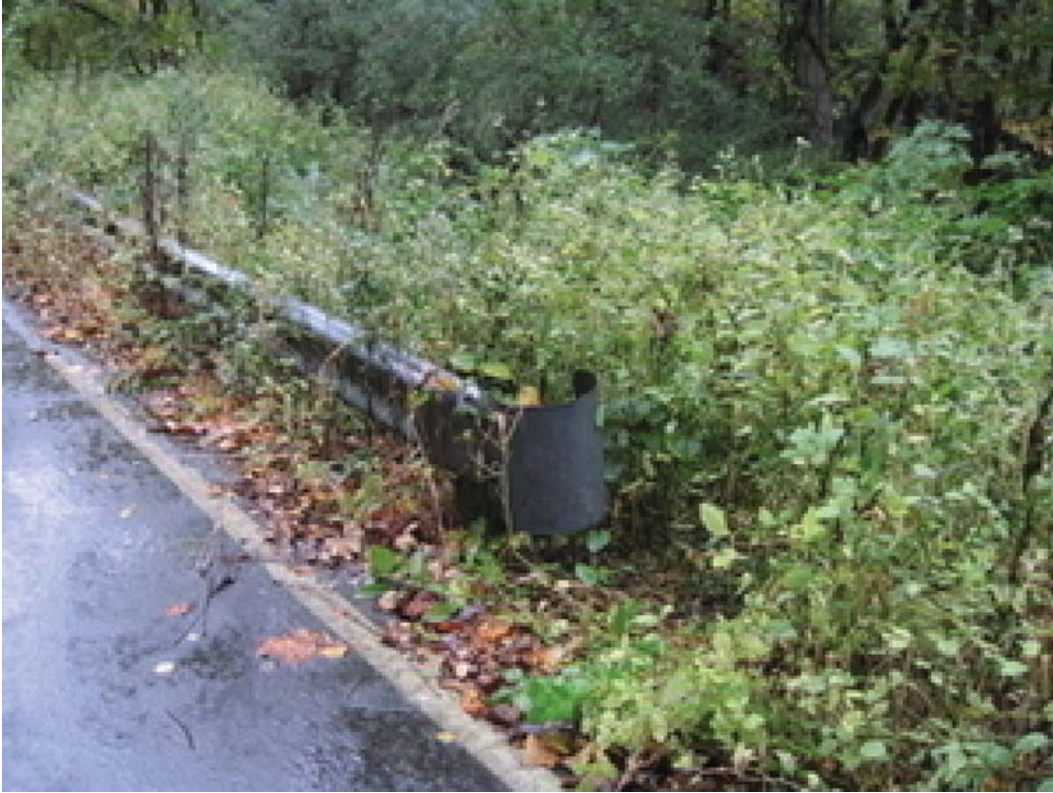
DEWA_0110_0.970_R_1.jpg

Barrier ID:	DEWA-0110-0.970-R				
Route Name:	POMPEY RIDGE ROAD				
Inspection Date:	10/04/2010	Barrier Rating:	40.20		
Barrier Description					
Type:	W-BEAM WEAK POST	Barrier Function:	TRAFFIC		
Barrier Material:	GALVANIZED STEEL	Post Material:	GALVANIZED STEEL		
Blockout Type:	N/A	Length (ft.):	40		
Speed Limit (MPH):	35	Placement with Respect to Road:	TANGENT		
Hazard Behind Barrier:	MEDIUM				
Barrier Crashworthiness					
Appropriate Test Level:	TL-2	Barrier Test Level:	TL-2	Is Barrier Crashworthy?:	YES
Beg. End Trtmt Type:	NONE	Is Beg. End Trtmt Crashworthy?:	N/A	Approach Transition Type:	NONE
Ending End Trtmt Type:	NONE	Ending End Trtmt Crashworthy?:	N/A		
Average Measurements					
Design Height (In.):	27	Width (In.):	0.0	Post Spacing (In.):	150.0
Height (In.):	17.0	Lateral Offset (In.):	27.2	Road Grade (%):	0.60
Physical Condition					
Barrier	Alignment and Height:	No alignment deflection was observed. Height is 9-10 in below 27-in design height.

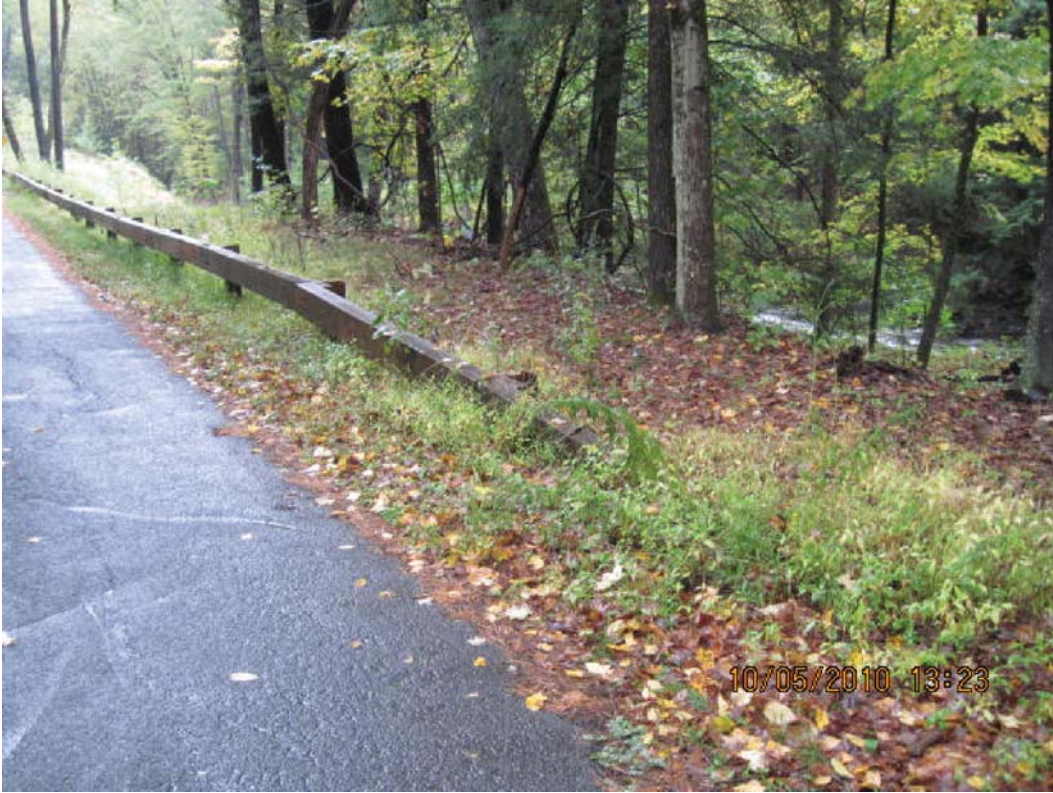
DEWA_0112ZZ_0.371_R_1.jpg

Barrier ID:	DEWA-0112ZZ-0.371-R				
Route Name:	JOHNNY BEE ROADS				
Inspection Date:	10/05/2010	Barrier Rating:	35.50		
Barrier Description					
Type:	STEEL-BACKED TIMBER WITH BLOCKOUT	Barrier Function:	TRAFFIC		
Barrier Material:	STEEL-BACKED TIMBER/LOG	Post Material:	CORTEN		
Blockout Type:	WOOD	Length (ft.):	448		
Speed Limit (MPH):	35	Placement with Respect to Road:	OUTSIDE OF CURVE		
Hazard Behind Barrier:	HIGH				
Barrier Crashworthiness					
Appropriate Test Level:	TL-2	Barrier Test Level:	TL-3	Is Barrier Crashworthy?:	YES
Beg. End Trtmt Type:	SBT/LOG FLARED	Is Beg. End Trtmt Crashworthy?:	NO	Approach Transition Type:	NONE
Ending End Trtmt Type:	NONE	Ending End Trtmt Crashworthy?:	N/A		
Average Measurements					
Design Height (In.):	27	Width (In.):	0.0	Post Spacing (In.):	120.0
Height (In.):	27.2	Lateral Offset (In.):	32.0	Road Grade (%):	5.80
Physical Condition					
Barrier	Alignment and Height:	No deflections greater than 6 in were observed in the alignment. The barrier height was within 1 in of the 27 in design height for the entire length.

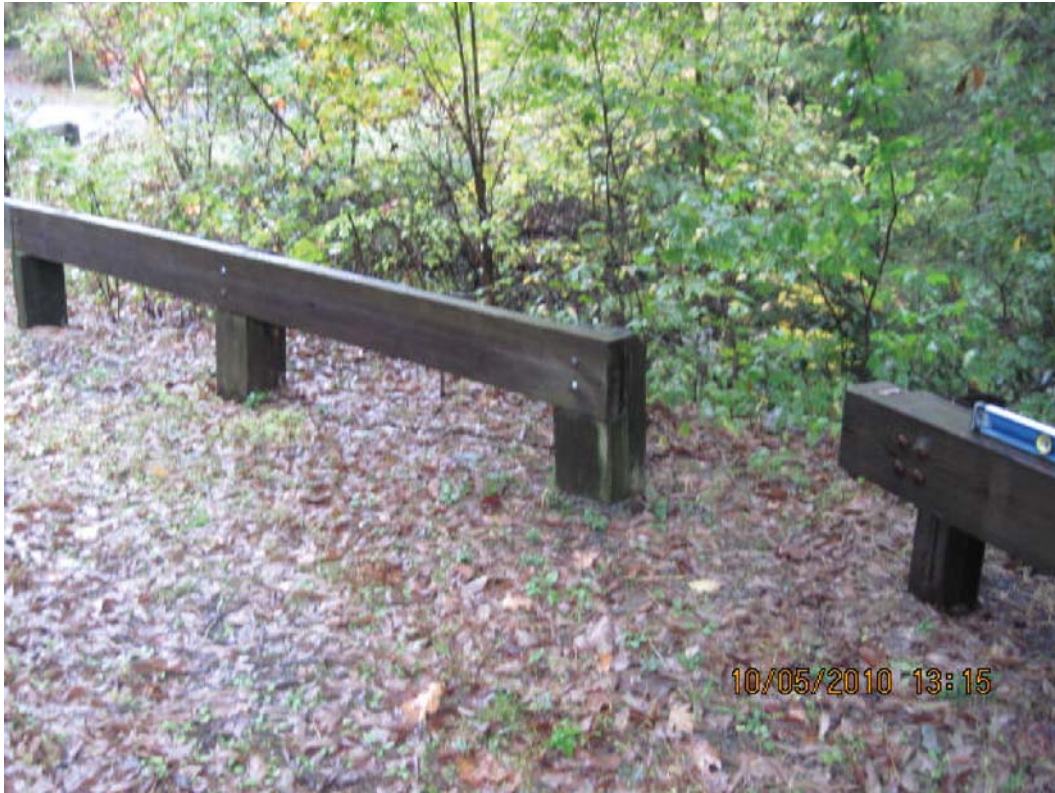
DEWA_0112ZZ_0.456_R_1.jpg

Barrier ID:	DEWA-0112ZZ-0.456-R				
Route Name:	JOHNNY BEE ROADS				
Inspection Date:	10/05/2010	Barrier Rating:	27.80		
Barrier Description					
Type:	OTHER: TIMBER RAIL ON TIMBER POSTS	Barrier Function:	TRAFFIC		
Barrier Material:	LOG/TIMBER/WOOD	Post Material:	WOOD		
Blockout Type:	N/A	Length (ft.):	84		
Speed Limit (MPH):	35	Placement with Respect to Road:	INSIDE OF CURVE		
Hazard Behind Barrier:	MEDIUM				
Barrier Crashworthiness					
Appropriate Test Level:	TL-2	Barrier Test Level:	NCW	Is Barrier Crashworthy?:	NO
Beg. End Trtmt Type:	NONE	Is Beg. End Trtmt Crashworthy?:	N/A	Approach Transition Type:	NONE
Ending End Trtmt Type:	NONE	Ending End Trtmt Crashworthy?:	N/A		
Average Measurements					
Design Height (In.):	27	Width (In.):	0.0	Post Spacing (In.):	94.1
Height (In.):	28.2	Lateral Offset (In.):	48.5	Road Grade (%):	2.00
Physical Condition					
Barrier	Alignment and Height:	No deflections observed in alignment. Entire barrier is less than 1 in below or exceeds 27 in design height by up to 4 in.

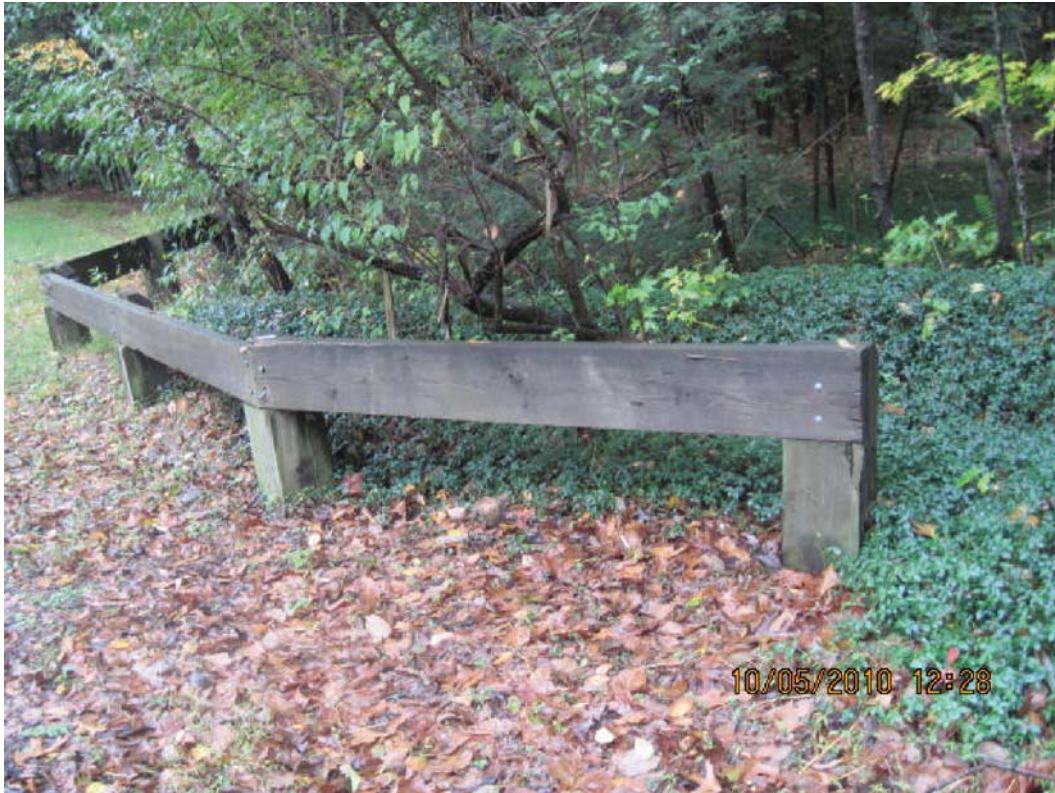
DEWA_0112ZZ_0.475_L_1.jpg

Barrier ID:	DEWA-0112ZZ-0.475-L				
Route Name:	JOHNNY BEE ROADS				
Inspection Date:	10/05/2010	Barrier Rating:	26.70		
Barrier Description					
Type:	OTHER: TIMBER RAIL ON TIMBER POSTS	Barrier Function:	TRAFFIC		
Barrier Material:	LOG/TIMBER/WOOD	Post Material:	WOOD		
Blockout Type:	N/A	Length (ft.):	43		
Speed Limit (MPH):	35	Placement with Respect to Road:	TANGENT		
Hazard Behind Barrier:	LOW				
Barrier Crashworthiness					
Appropriate Test Level:	TL-2	Barrier Test Level:	NCW	Is Barrier Crashworthy?:	NO
Beg. End Trtmt Type:	NONE	Is Beg. End Trtmt Crashworthy?:	N/A	Approach Transition Type:	NONE
Ending End Trtmt Type:	NONE	Ending End Trtmt Crashworthy?:	N/A		
Average Measurements					
Design Height (In.):	27	Width (In.):	0.0	Post Spacing (In.):	95.8
Height (In.):	30.2	Lateral Offset (In.):	69.0	Road Grade (%):	5.80
Physical Condition					
Barrier	Alignment and Height:	Alignment deflection was less than 6 in. The entire barrier exceeded design height (27 in) by 1/2 in to 7 in.

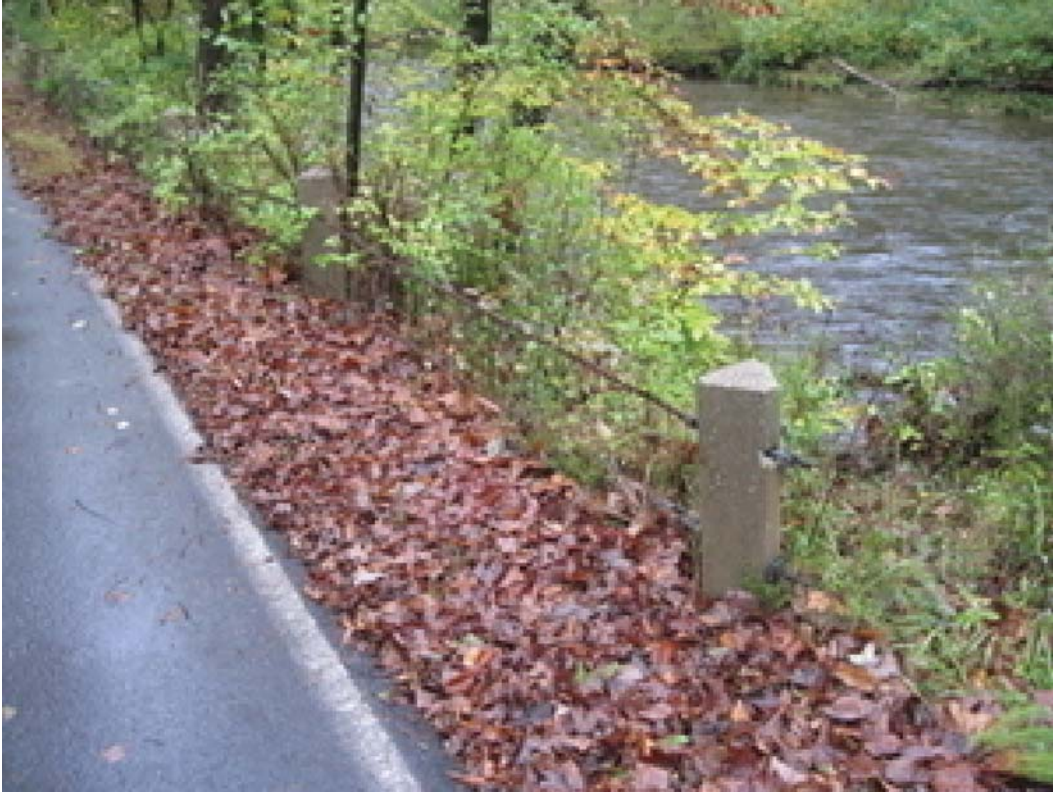
DEWA_0113_0.094_R_1.jpg

Barrier ID:	DEWA-0113-0.094-R				
Route Name:	NPS ROUTE 615				
Inspection Date:	10/05/2010	Barrier Rating:	42.50		
Barrier Description					
Type:	OTHER: 2-STRAND CABLE	Barrier Function:	TRAFFIC		
Barrier Material:	CABLE	Post Material:	OTHER: CONCRETE		
Blockout Type:	N/A	Length (ft.):	688		
Speed Limit (MPH):	15	Placement with Respect to Road:	INSIDE OF CURVE		
Hazard Behind Barrier:	HIGH				
Barrier Crashworthiness					
Appropriate Test Level:	TL-1	Barrier Test Level:	NCW	Is Barrier Crashworthy?:	NO
Beg. End Trtmt Type:	NONE	Is Beg. End Trtmt Crashworthy?:	N/A	Approach Transition Type:	NONE
Ending End Trtmt Type:	NONE	Ending End Trtmt Crashworthy?:	N/A		
Average Measurements					
Design Height (In.):	27	Width (In.):	0.0	Post Spacing (In.):	127.0
Height (In.):	17.6	Lateral Offset (In.):	43.5	Road Grade (%):	2.60
Physical Condition					
Barrier	Alignment and Height:	Alignment deflects more than 12 in along 350 ft. Height ranges from 3 to 14.5 in below 27 in design height. Cable has sufficient tension and no posts were observed to be bent.

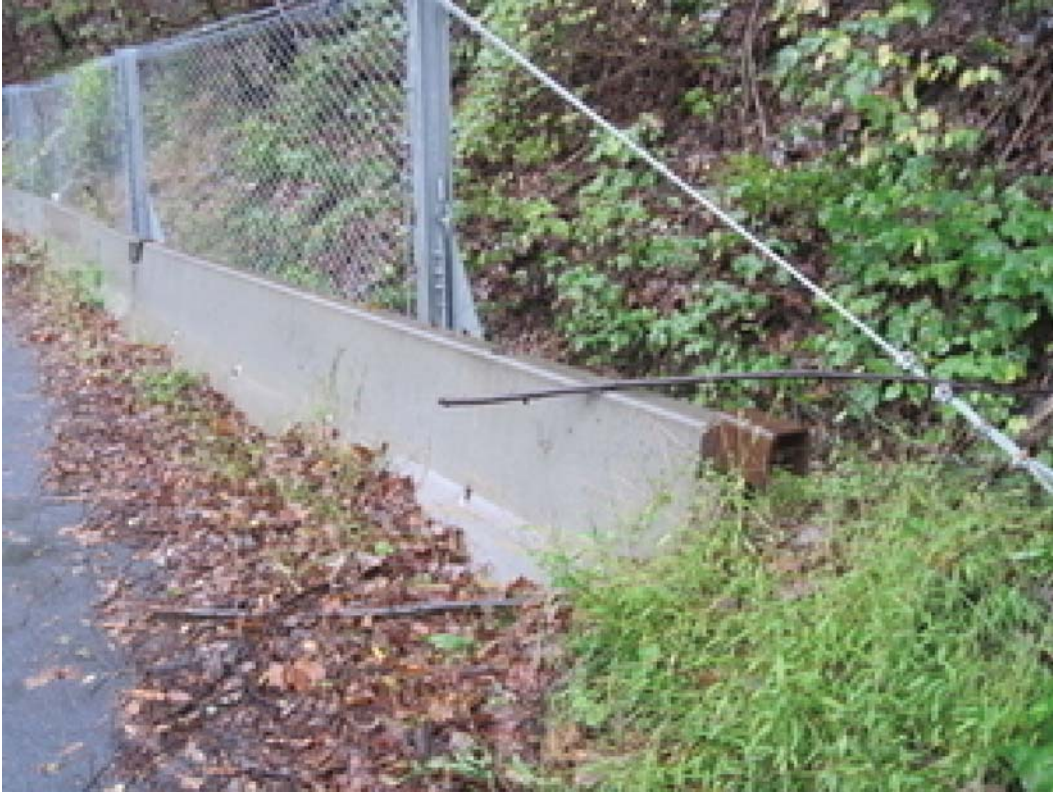
DEWA_0113_0.226_L_1.jpg

Barrier ID:	DEWA-0113-0.226-L				
Route Name:	NPS ROUTE 615				
Inspection Date:	10/05/2010	Barrier Rating:	24.00		
Barrier Description					
Type:	CONCRETE BARRIER	Barrier Function:	TRAFFIC		
Barrier Material:	CONCRETE	Post Material:	N/A		
Blockout Type:	N/A	Length (ft.):	464		
Speed Limit (MPH):	15	Placement with Respect to Road:	OUTSIDE OF CURVE		
Hazard Behind Barrier:	LOW				
Barrier Crashworthiness					
Appropriate Test Level:	TL-1	Barrier Test Level:	TL-3	Is Barrier Crashworthy?:	YES
Beg. End Trtmt Type:	NONE	Is Beg. End Trtmt Crashworthy?:	N/A	Approach Transition Type:	NONE
Ending End Trtmt Type:	NONE	Ending End Trtmt Crashworthy?:	N/A		
Average Measurements					
Design Height (In.):	32	Width (In.):	6.0	Post Spacing (In.):	0.0
Height (In.):	31.0	Lateral Offset (In.):	12.6	Road Grade (%):	0.50
Physical Condition					
Barrier	Alignment and Height:	No alignment deflection was observed. Height was 1 in below the 32 in design height throughout.
