NPS Guardwall/Rail Inventory Program Delaware Water Gap National Recreation Area

**Federal Lands Highway
Road Inventory Program**

Federal Highway Administration
Eastern Federal Lands Highway Division
Road Inventory Program (RIP)

Data Collection Date: October 2010
Report Date: December 2015

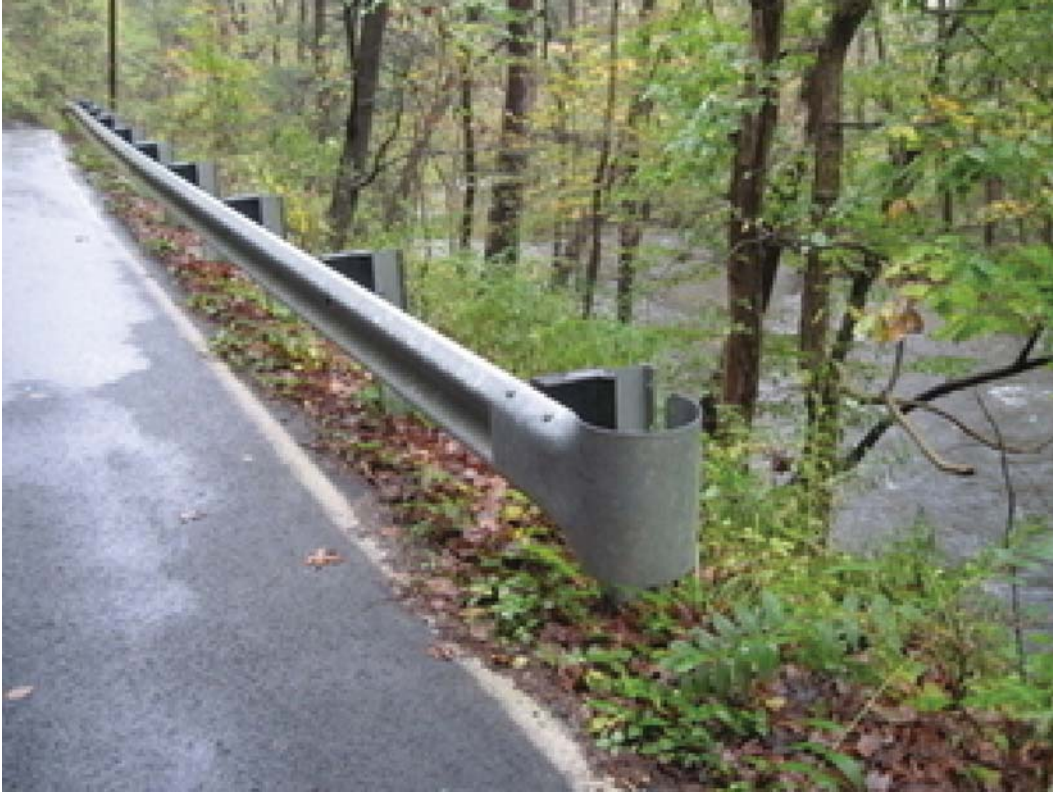
DEWA_0113_0.227_R_1.jpg

Barrier ID:	DEWA-0113-0.227-R				
Route Name:	NPS ROUTE 615				
Inspection Date:	10/05/2010	Barrier Rating:	29.60		
Barrier Description					
Type:	W-BEAM STRONG POST	Barrier Function:	TRAFFIC		
Barrier Material:	GALVANIZED STEEL	Post Material:	GALVANIZED STEEL		
Blockout Type:	PLASTIC	Length (ft.):	454		
Speed Limit (MPH):	15	Placement with Respect to Road:	INSIDE OF CURVE		
Hazard Behind Barrier:	MEDIUM				
Barrier Crashworthiness					
Appropriate Test Level:	TL-1	Barrier Test Level:	TL-3	Is Barrier Crashworthy?:	YES
Beg. End Trtmt Type:	NONE	Is Beg. End Trtmt Crashworthy?:	N/A	Approach Transition Type:	NONE
Ending End Trtmt Type:	NONE	Ending End Trtmt Crashworthy?:	N/A		
Average Measurements					
Design Height (In.):	27	Width (In.):	0.0	Post Spacing (In.):	74.6
Height (In.):	24.7	Lateral Offset (In.):	12.6	Road Grade (%):	0.30
Physical Condition					
Barrier	Alignment and Height:	No alignment deflection was observed. Height is 1 - 3 in below 27-in design height along 300 ft.

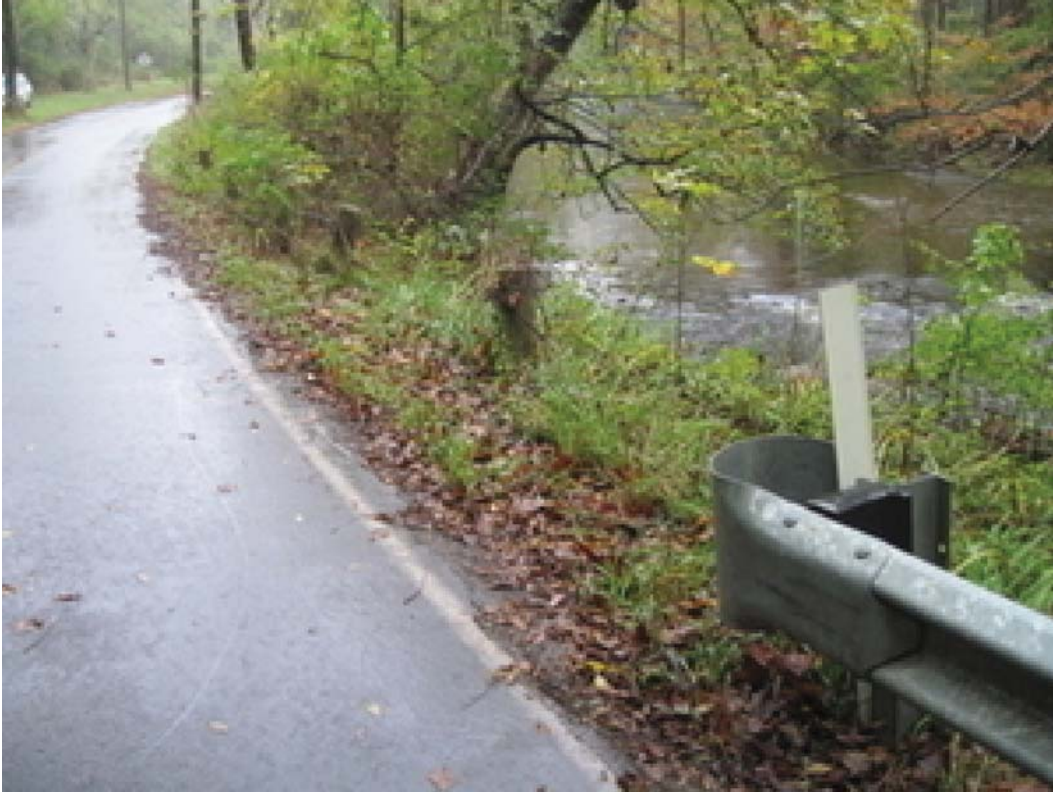
DEWA_0113_0.313_R_1.jpg

Barrier ID:	DEWA-0113-0.313-R				
Route Name:	NPS ROUTE 615				
Inspection Date:	10/05/2010	Barrier Rating:	29.30		
Barrier Description					
Type:	OTHER: 2-STRAND CABLE	Barrier Function:	TRAFFIC		
Barrier Material:	CABLE	Post Material:	OTHER: CONCRETE		
Blockout Type:	N/A	Length (ft.):	229		
Speed Limit (MPH):	15	Placement with Respect to Road:	INSIDE OF CURVE		
Hazard Behind Barrier:	MEDIUM				
Barrier Crashworthiness					
Appropriate Test Level:	TL-1	Barrier Test Level:	NCW	Is Barrier Crashworthy?:	NO
Beg. End Trtmt Type:	NONE	Is Beg. End Trtmt Crashworthy?:	N/A	Approach Transition Type:	NONE
Ending End Trtmt Type:	NONE	Ending End Trtmt Crashworthy?:	N/A		
Average Measurements					
Design Height (In.):	27	Width (In.):	0.0	Post Spacing (In.):	130.6
Height (In.):	18.7	Lateral Offset (In.):	41.2	Road Grade (%):	0.20
Physical Condition					
Barrier	Alignment and Height:	Alignment deflects more than 12 in for 100 ft of barrier. Height ranges from 7 in to 10 in below 27 in design height.

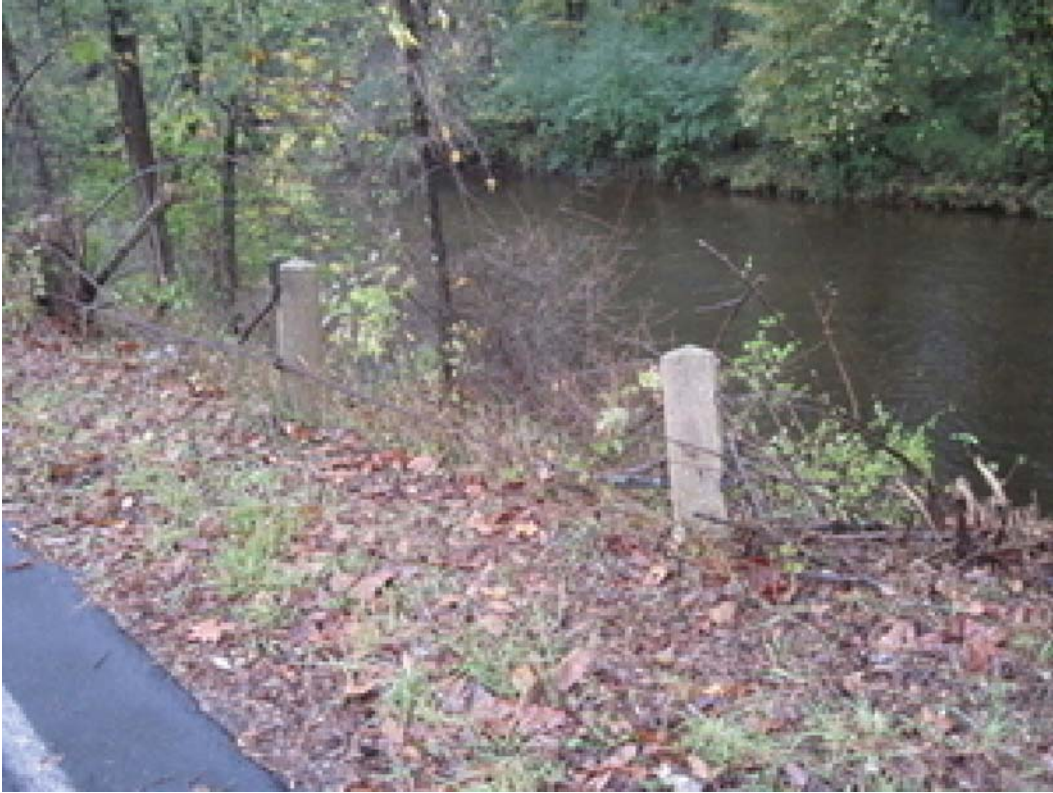
DEWA_0113_0.572_R_1.jpg

Barrier ID:	DEWA-0113-0.572-R				
Route Name:	NPS ROUTE 615				
Inspection Date:	10/05/2010	Barrier Rating:	35.00		
Barrier Description					
Type:	OTHER: 2-STRAND CABLE	Barrier Function:	TRAFFIC		
Barrier Material:	CABLE	Post Material:	OTHER: CONCRETE		
Blockout Type:	N/A	Length (ft.):	484		
Speed Limit (MPH):	35	Placement with Respect to Road:	TANGENT		
Hazard Behind Barrier:	MEDIUM				
Barrier Crashworthiness					
Appropriate Test Level:	TL-2	Barrier Test Level:	NCW	Is Barrier Crashworthy?:	NO
Beg. End Trtmt Type:	NONE	Is Beg. End Trtmt Crashworthy?:	N/A	Approach Transition Type:	NONE
Ending End Trtmt Type:	NONE	Ending End Trtmt Crashworthy?:	N/A		
Average Measurements					
Design Height (In.):	27	Width (In.):	0.0	Post Spacing (In.):	122.6
Height (In.):	27.0	Lateral Offset (In.):	53.2	Road Grade (%):	0.90
Physical Condition					
Barrier	Alignment and Height:	Alignment deflects 6 in to 12 in for 100 ft and greater than 12 in for 250 ft of barrier. Height ranges from 2 in below 27 in design height to 2 in above.

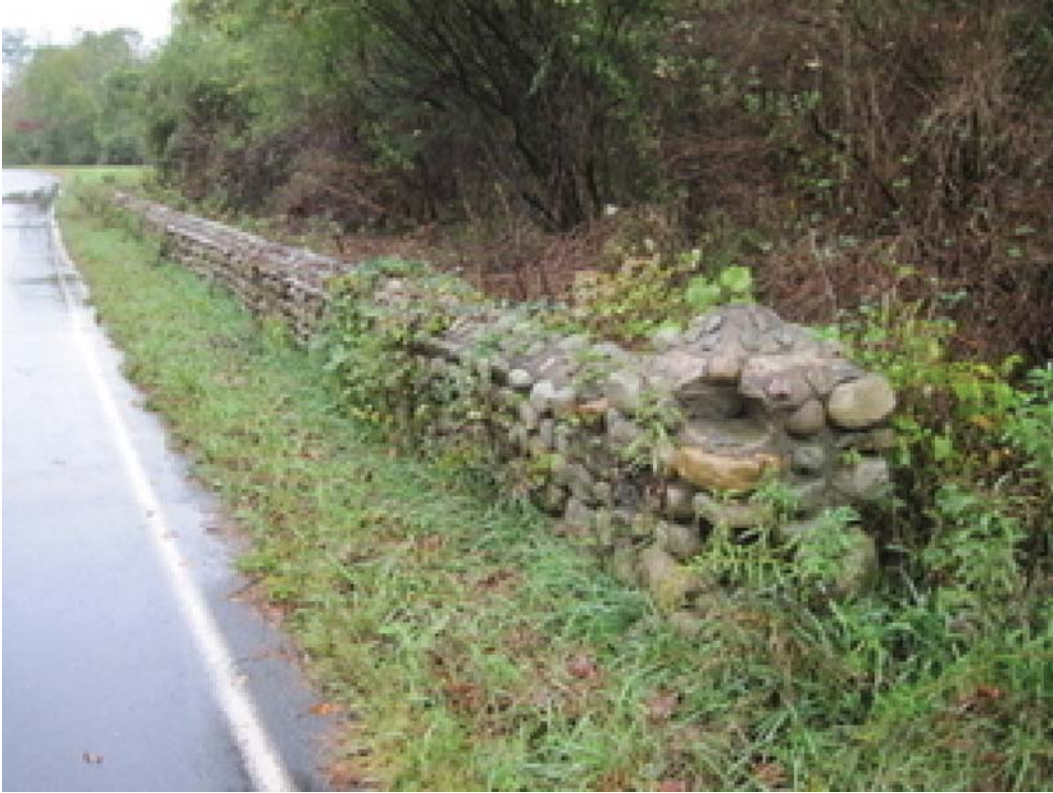
DEWA_0113_0.672_L_1.jpg

Barrier ID:	DEWA-0113-0.672-L				
Route Name:	NPS ROUTE 615				
Inspection Date:	10/05/2010	Barrier Rating:	16.70		
Barrier Description					
Type:	STONE MASONRY WITHOUT CONCRETE CORE WALL	Barrier Function:	TRAFFIC		
Barrier Material:	STONE	Post Material:	N/A		
Blockout Type:	N/A	Length (ft.):	110		
Speed Limit (MPH):	35	Placement with Respect to Road:	TANGENT		
Hazard Behind Barrier:	LOW				
Barrier Crashworthiness					
Appropriate Test Level:	TL-2	Barrier Test Level:	NCW	Is Barrier Crashworthy?:	NO
Beg. End Trtmt Type:	NONE	Is Beg. End Trtmt Crashworthy?:	N/A	Approach Transition Type:	NONE
Ending End Trtmt Type:	NONE	Ending End Trtmt Crashworthy?:	N/A		
Average Measurements					
Design Height (In.):	24	Width (In.):	17.2	Post Spacing (In.):	0.0
Height (In.):	33.7	Lateral Offset (In.):	53.2	Road Grade (%):	0.40
Physical Condition					
Barrier	Alignment and Height:	No deflections observed in alignment. Entire barrier exceeds assumed 32 in design height by up to 4 in.

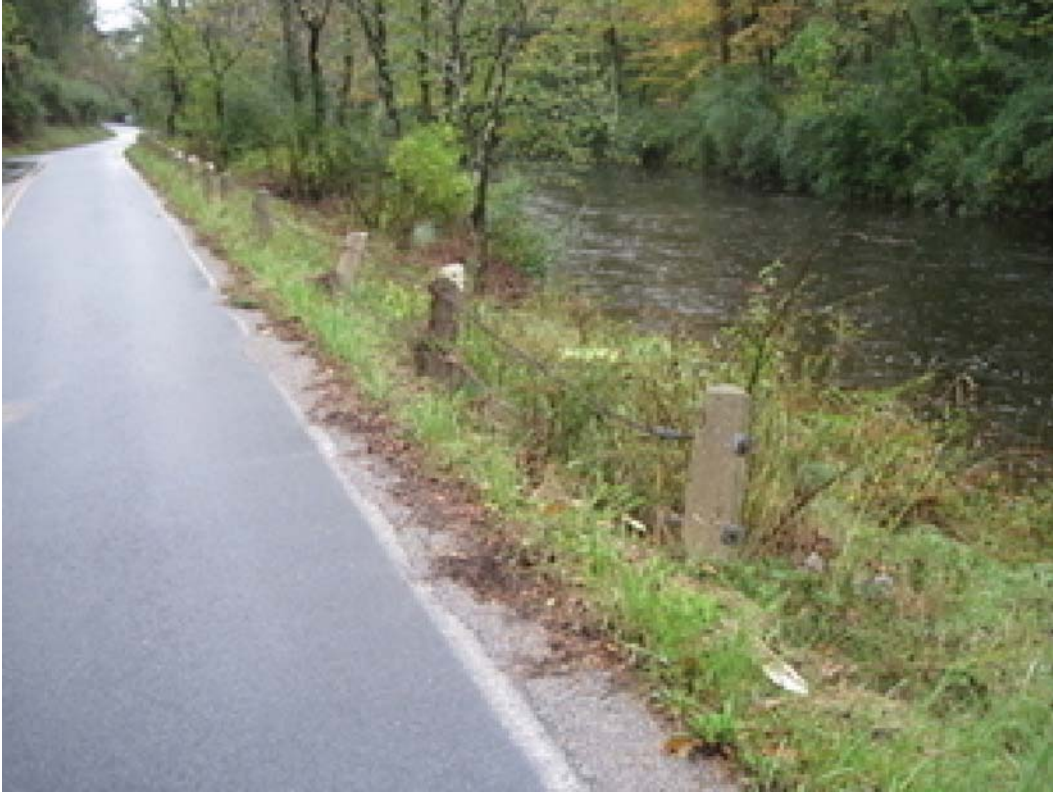
DEWA_0113_0.727_R_1.jpg

Barrier ID:	DEWA-0113-0.727-R				
Route Name:	NPS ROUTE 615				
Inspection Date:	10/05/2010	Barrier Rating:	53.50		
Barrier Description					
Type:	OTHER: 2-STRAND CABLE	Barrier Function:	TRAFFIC		
Barrier Material:	CABLE	Post Material:	OTHER: CONCRETE		
Blockout Type:	N/A	Length (ft.):	777		
Speed Limit (MPH):	35	Placement with Respect to Road:	OUTSIDE OF CURVE		
Hazard Behind Barrier:	MEDIUM				
Barrier Crashworthiness					
Appropriate Test Level:	TL-2	Barrier Test Level:	NCW	Is Barrier Crashworthy?:	NO
Beg. End Trtmt Type:	NONE	Is Beg. End Trtmt Crashworthy?:	N/A	Approach Transition Type:	NONE
Ending End Trtmt Type:	NONE	Ending End Trtmt Crashworthy?:	N/A		
Average Measurements					
Design Height (In.):	27	Width (In.):	0.0	Post Spacing (In.):	117.8
Height (In.):	18.0	Lateral Offset (In.):	37.0	Road Grade (%):	0.80
Physical Condition					
Barrier	Alignment and Height:	Barrier is 6 - 12 in out of alignment along 110 ft. Entire barrier is 7 - 11 in below 27-in design height.

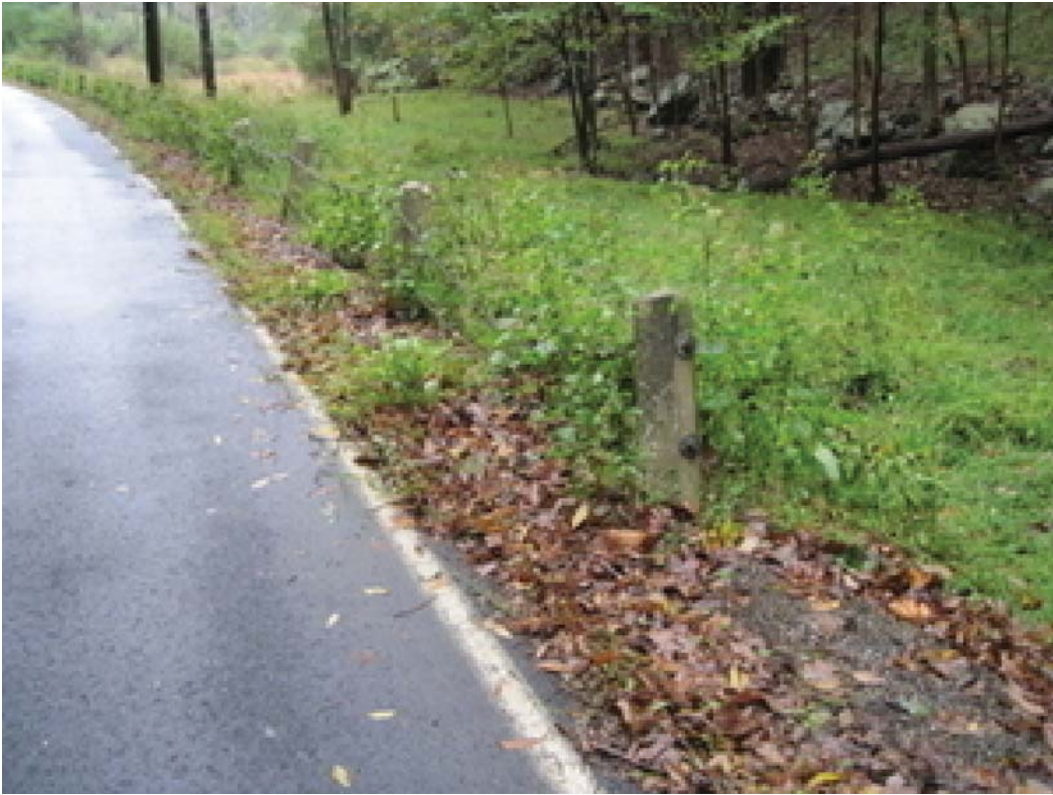
DEWA_0113_1.046_L_1.jpg

Barrier ID:	DEWA-0113-1.046-L				
Route Name:	NPS ROUTE 615				
Inspection Date:	10/05/2010	Barrier Rating:	44.00		
Barrier Description					
Type:	OTHER: 2-STRAND CABLE	Barrier Function:	TRAFFIC		
Barrier Material:	CABLE	Post Material:	OTHER: CONCRETE		
Blockout Type:	N/A	Length (ft.):	487		
Speed Limit (MPH):	35	Placement with Respect to Road:	OUTSIDE OF CURVE		
Hazard Behind Barrier:	LOW				
Barrier Crashworthiness					
Appropriate Test Level:	TL-2	Barrier Test Level:	NCW	Is Barrier Crashworthy?:	NO
Beg. End Trtmt Type:	NONE	Is Beg. End Trtmt Crashworthy?:	N/A	Approach Transition Type:	NONE
Ending End Trtmt Type:	NONE	Ending End Trtmt Crashworthy?:	N/A		
Average Measurements					
Design Height (In.):	27	Width (In.):	0.0	Post Spacing (In.):	131.0
Height (In.):	19.7	Lateral Offset (In.):	35.0	Road Grade (%):	2.80
Physical Condition					
Barrier	Alignment and Height:	Alignment deflects more than 12 in along 150 ft of barrier. Height is 1-13 in below 27 in design height along entire barrier length.

Breaking and Cracking:	No breaking or cracking observed in posts. No fraying breaking or severing of cables observed.			
	Missing Elements:	Bottom cable along 50 feet of barrier has detached and is lying on the ground.			
	Corrosion and Weathering:	No loss of cross section or erosion around posts observed.			
End Treatments	Alignment and Height:	NA			
	Breaking and Cracking:	NA			
	Missing Elements:	NA			
	Corrosion and Weathering:	NA

Repair Action:	REPLACE	FMSS Work Type:	CAPITAL IMPROVEMENT	Repair Cost:	\$48350
Brief Workorder:	Replace cable guardrail with Steel-Backed Timber w/o blockouts and 2 flared end treatments.				
Workorder:	Remove Cable Guardrail at \$5- per -Lin. Ft. for 487 LF = \$2435. Remove 487 feet of cable guardrail Steel-Backed Timber w/o Blockout at \$60- per -Lin. Ft. for 427 LF = \$25620. SBT / Log Flared at \$5000- per -Each for 2 Unit(s) = \$10000. Low Speed Traffic Control at \$1475- per -Day for 4 Day(s) = \$5900. 2 days removal and 2 days installation.

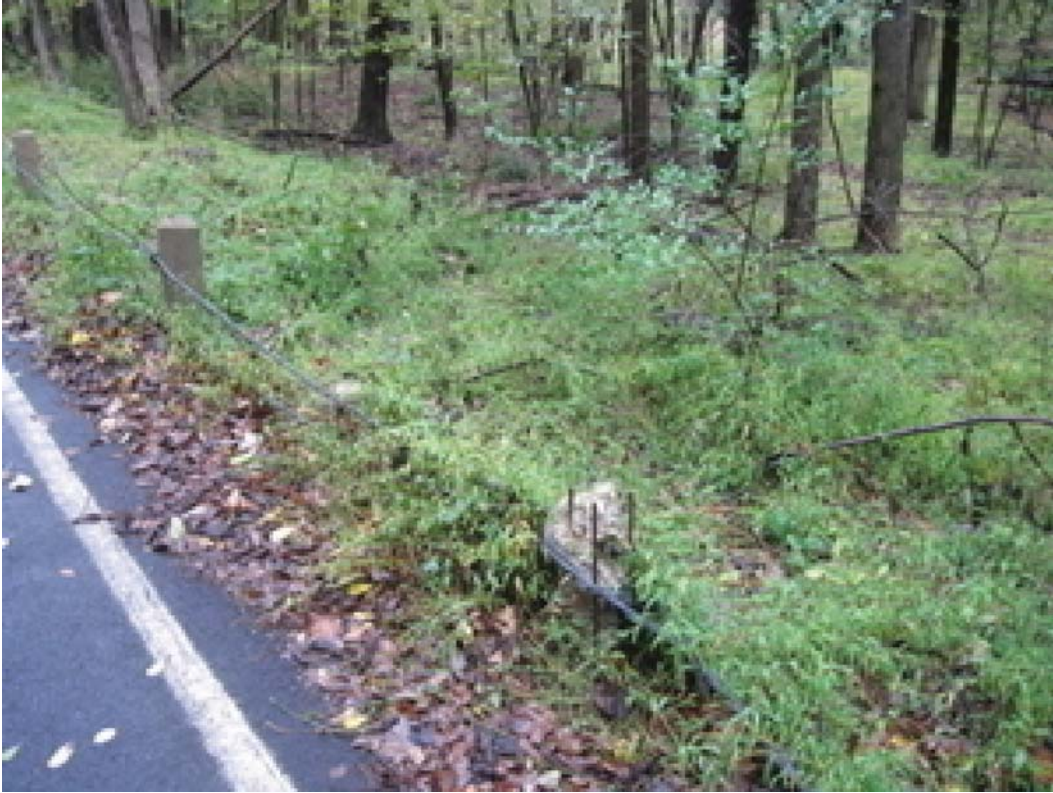
DEWA_0113_1.182_R_1.jpg

Barrier ID:	DEWA-0113-1.182-R				
Route Name:	NPS ROUTE 615				
Inspection Date:	10/05/2010	Barrier Rating:	58.00		
Barrier Description					
Type:	OTHER: 2-STRAND CABLE	Barrier Function:	TRAFFIC		
Barrier Material:	CABLE	Post Material:	OTHER: CONCRETE		
Blockout Type:	N/A	Length (ft.):	2034		
Speed Limit (MPH):	35	Placement with Respect to Road:	BOTH INSIDE AND OUTSIDE		
Hazard Behind Barrier:	MEDIUM				
Barrier Crashworthiness					
Appropriate Test Level:	TL-2	Barrier Test Level:	NCW	Is Barrier Crashworthy?:	NO
Beg. End Trtmt Type:	NONE	Is Beg. End Trtmt Crashworthy?:	N/A	Approach Transition Type:	NONE
Ending End Trtmt Type:	NONE	Ending End Trtmt Crashworthy?:	N/A		
Average Measurements					
Design Height (In.):	27	Width (In.):	0.0	Post Spacing (In.):	127.3
Height (In.):	19.7	Lateral Offset (In.):	30.0	Road Grade (%):	2.00
Physical Condition					
Barrier	Alignment and Height:	150 ft of barrier is out of alignment by 6 - 12 in. 345 ft is deflected by more than 12 in. Height is 1 - 3 in below 27-in design height for 150 ft and 3 - 13 in below along the rest of the barrier.

Breaking and Cracking:	18 posts are broken and have exposed rebar.			
	Missing Elements:	No missing elements were observed.			
	Corrosion and Weathering:	No loss of cross section or erosion around posts observed.			
End Treatments	Alignment and Height:				
	Breaking and Cracking:				
	Missing Elements:				
	Corrosion and Weathering:

Repair Action:	REPLACE	FMSS Work Type:	CAPITAL IMPROVEMENT	Repair Cost:	\$181676
Brief Workorder:	Replace cable guardrail with Steel-Backed Timber w/o blockouts and 2 flared Steel-Backed Timber end treatments.				
Workorder:	Remove Cable Guardrail at \$5- per -Lin. Ft. for 2034 LF = \$10170. Steel-Backed Timber w/o Blockout at \$60- per -Lin. Ft. for 1974 LF = \$118440. SBT / Log Flared at \$5000- per -Each for 2 Unit(s) = \$10000. Low Speed Traffic Control at \$1475- per -Day for 18 Day(s) = \$26550. 9 days removal and 9 days installation.

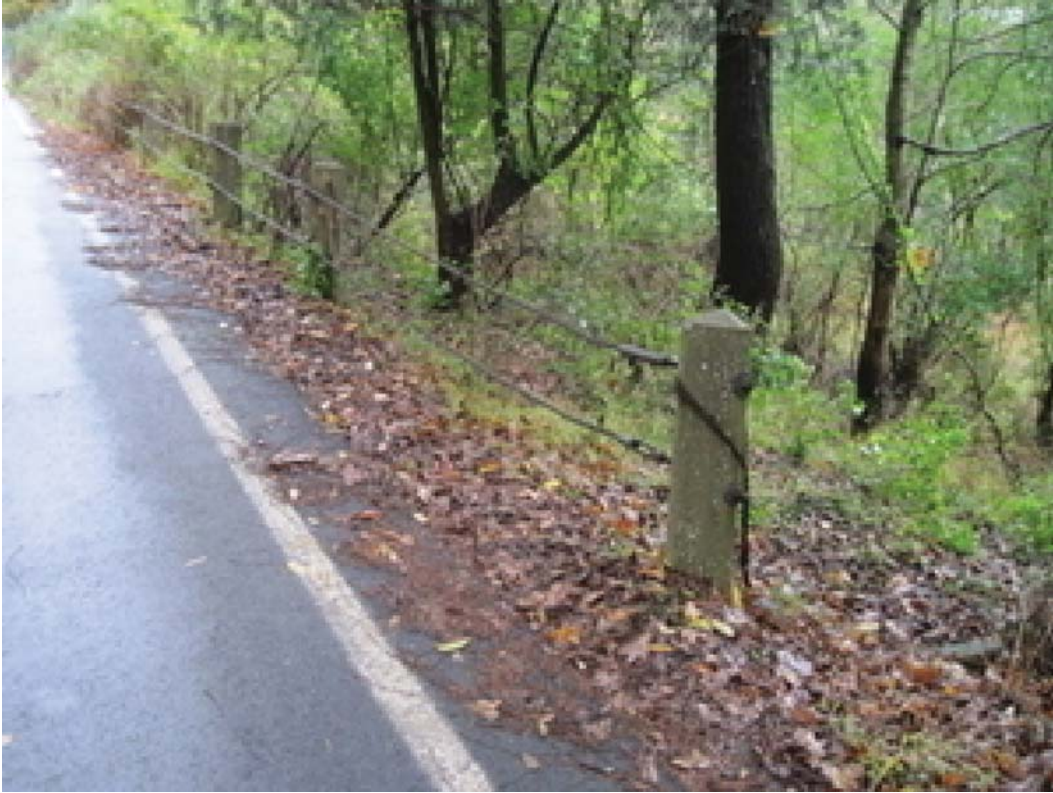
DEWA_0113_1.578_R_1.jpg

Barrier ID:	DEWA-0113-1.578-R				
Route Name:	NPS ROUTE 615				
Inspection Date:	10/05/2010	Barrier Rating:	48.20		
Barrier Description					
Type:	OTHER: 2-STRAND CABLE	Barrier Function:	TRAFFIC		
Barrier Material:	CABLE	Post Material:	OTHER: CONCRETE		
Blockout Type:	N/A	Length (ft.):	640		
Speed Limit (MPH):	35	Placement with Respect to Road:	OUTSIDE OF CURVE		
Hazard Behind Barrier:	LOW				
Barrier Crashworthiness					
Appropriate Test Level:	TL-2	Barrier Test Level:	NCW	Is Barrier Crashworthy?:	NO
Beg. End Trtmt Type:	NONE	Is Beg. End Trtmt Crashworthy?:	N/A	Approach Transition Type:	NONE
Ending End Trtmt Type:	NONE	Ending End Trtmt Crashworthy?:	N/A		
Average Measurements					
Design Height (In.):	27	Width (In.):	0.0	Post Spacing (In.):	112.6
Height (In.):	19.2	Lateral Offset (In.):	34.2	Road Grade (%):	2.20
Physical Condition					
Barrier	Alignment and Height:	Alignment deflects more than 12 in along 90 ft of barrier. Height ranges from 6.5 to 9 in below the 27 in design height along entire barrier length.

Breaking and Cracking:	No breaking or cracking observed in posts. No fraying breaking or severing of cables observed.			
	Missing Elements:	No missing elements observed.			
	Corrosion and Weathering:	No loss of cable cross section or erosion around posts observed.			
End Treatments	Alignment and Height:	NA			
	Breaking and Cracking:	NA			
	Missing Elements:	NA			
	Corrosion and Weathering:	NA

Repair Action:	REPLACE	FMSS Work Type:	CAPITAL IMPROVEMENT	Repair Cost:	\$52305
Brief Workorder:	Replace cable guardrail with Steel-Backed Timber w/ blockouts and a flared end treatment.				
Workorder:	Remove Cable Guardrail at \$5- per -Lin. Ft. for 640 LF = \$3200. Remove 640 feet of cable guardrail. Steel-Backed Timber w/ Blockout at \$50- per -Lin. Ft. for 610 LF = \$30500. SBT / Log Flared at \$5000- per -Each for 1 Unit(s) = \$5000. Low Speed Traffic Control at \$1475- per -Day for 6 Day(s) = \$8850. 3 days removal and 3 days installation.

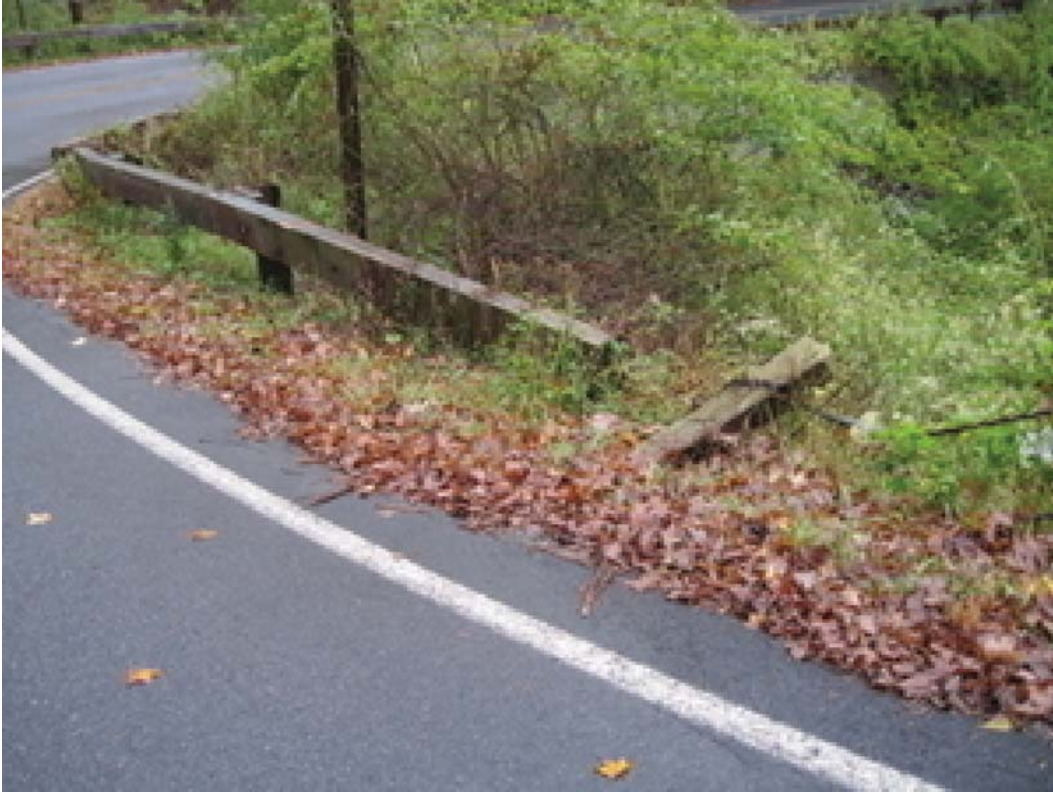
DEWA_0113_1.699_R_1.jpg

Barrier ID:	DEWA-0113-1.699-R				
Route Name:	NPS ROUTE 615				
Inspection Date:	10/05/2010	Barrier Rating:	34.20		
Barrier Description					
Type:	STEEL-BACKED TIMBER WITH BLOCKOUT	Barrier Function:	TRAFFIC		
Barrier Material:	STEEL-BACKED TIMBER/LOG	Post Material:	CORTEN		
Blockout Type:	WOOD	Length (ft.):	228		
Speed Limit (MPH):	35	Placement with Respect to Road:	INSIDE OF CURVE		
Hazard Behind Barrier:	HIGH				
Barrier Crashworthiness					
Appropriate Test Level:	TL-2	Barrier Test Level:	TL-3	Is Barrier Crashworthy?:	YES
Beg. End Trtmt Type:	NONE	Is Beg. End Trtmt Crashworthy?:	N/A	Approach Transition Type:	NONE
Ending End Trtmt Type:	SBT/LOG FLARED	Ending End Trtmt Crashworthy?:	NO		
Average Measurements					
Design Height (In.):	27	Width (In.):	0.0	Post Spacing (In.):	120.3
Height (In.):	24.7	Lateral Offset (In.):	30.2	Road Grade (%):	3.30
Physical Condition					
Barrier	Alignment and Height:	No alignment deflection was observed. Height is 1 - 3 in below 27-in design height throughout length.

Breaking and Cracking:	80 ft of rail is damaged from impact. Rails have 1-in longitudinal cracks and steel backing is deformed.			
	Missing Elements:	No missing elements were observed.			
	Corrosion and Weathering:	No loss of cross section or erosion around posts observed.			
End Treatments	Alignment and Height:	Alignment acceptable. Height is within 1-in. of 27-in. design height.			
	Breaking and Cracking:	No impact related breaking or cracking observed.			
	Missing Elements:	No missing elements were observed.			
	Corrosion and Weathering:	No loss of cross section or erosion around posts observed.

Repair Action:	REPAIR	FMSS Work Type:	DEFERRED MAINTENANCE	Repair Cost:	\$5142
Brief Workorder:	Replace 80 feet of rail and raise 120 feet of guardrail to 27-inch design height.				
Workorder:	Replace Rail at \$25- per -Lin. Ft. for 80 LF = \$2000. Adjust Guardrail at \$10- per -Lin. Ft. for 120 LF = \$1200. Raise 120ft. of guardrail to 27-inch design height. Low Speed Traffic Control at \$1475- per -Day for 1 Day(s) = \$1475.

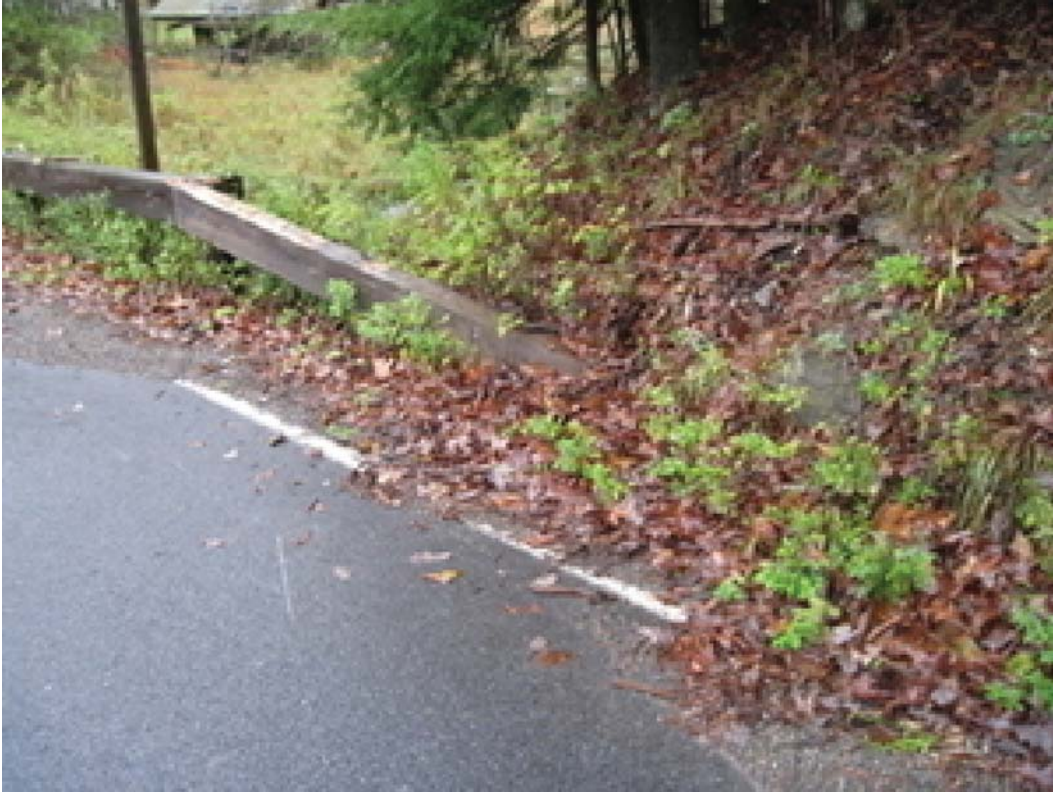
DEWA_0113_1.708_L_1.jpg

Barrier ID:	DEWA-0113-1.708-L				
Route Name:	NPS ROUTE 615				
Inspection Date:	10/05/2010	Barrier Rating:	25.10		
Barrier Description					
Type:	STEEL-BACKED TIMBER WITH BLOCKOUT	Barrier Function:	TRAFFIC		
Barrier Material:	STEEL-BACKED TIMBER/LOG	Post Material:	CORTEN		
Blockout Type:	WOOD	Length (ft.):	87		
Speed Limit (MPH):	35	Placement with Respect to Road:	OUTSIDE OF CURVE		
Hazard Behind Barrier:	MEDIUM				
Barrier Crashworthiness					
Appropriate Test Level:	TL-2	Barrier Test Level:	TL-3	Is Barrier Crashworthy?:	YES
Beg. End Trtmt Type:	SBT/LOG FLARED	Is Beg. End Trtmt Crashworthy?:	NO	Approach Transition Type:	NONE
Ending End Trtmt Type:	SBT/LOG FLARED	Ending End Trtmt Crashworthy?:	NO		
Average Measurements					
Design Height (In.):	27	Width (In.):	0.0	Post Spacing (In.):	117.6
Height (In.):	26.7	Lateral Offset (In.):	35.0	Road Grade (%):	2.50
Physical Condition					
Barrier	Alignment and Height:	No alignment deflection observed. Height ranges from 1 in below 27 in design height to 1 in over.

Breaking and Cracking:	No impact related breaking or cracking observed.			
	Missing Elements:	No missing elements observed.			
	Corrosion and Weathering:	No loss of cross section or erosion around posts observed.			
End Treatments	Alignment and Height:	Alignment acceptable. Height is within 1-in. of 27-in. design height.			
	Breaking and Cracking:	No impact related breaking or cracking observed.			
	Missing Elements:	No missing elements observed.			
	Corrosion and Weathering:	No loss of cross section or erosion around posts observed.

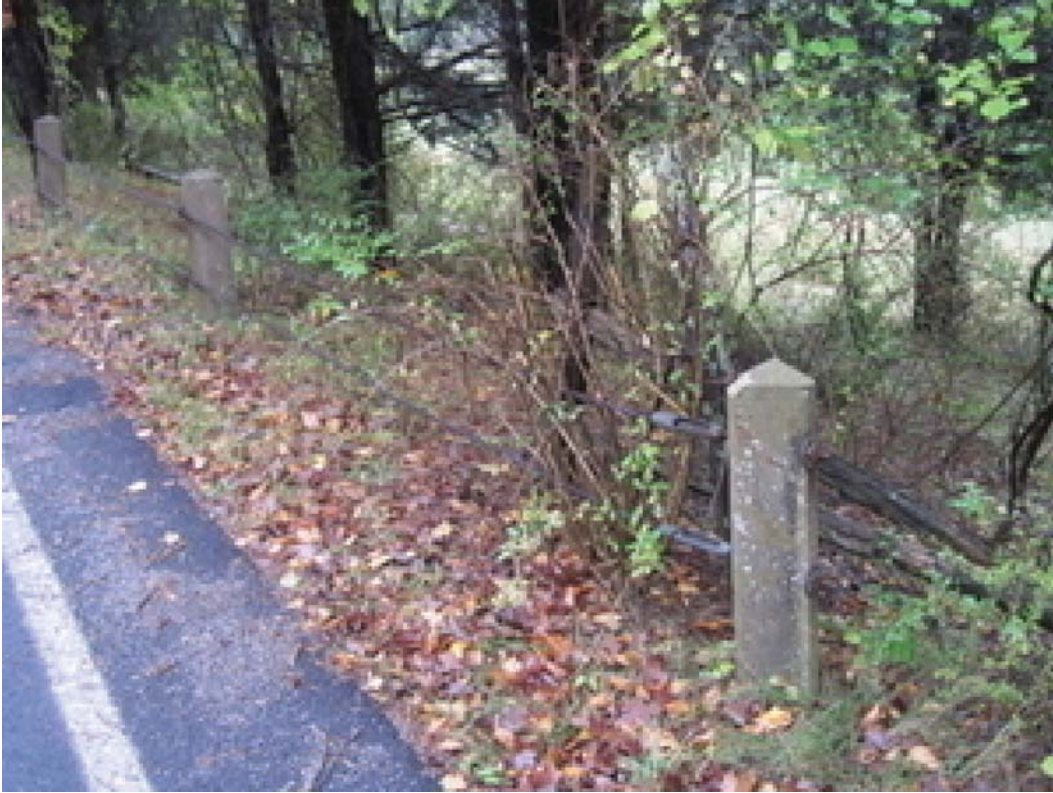
DEWA_0113_1.763_R_1.jpg

Barrier ID:	DEWA-0113-1.763-R				
Route Name:	NPS ROUTE 615				
Inspection Date:	10/05/2010	Barrier Rating:	42.20		
Barrier Description					
Type:	OTHER: 2-STRAND CABLE	Barrier Function:	TRAFFIC		
Barrier Material:	CABLE	Post Material:	OTHER: CONCRETE		
Blockout Type:	N/A	Length (ft.):	362		
Speed Limit (MPH):	35	Placement with Respect to Road:	OUTSIDE OF CURVE		
Hazard Behind Barrier:	MEDIUM				
Barrier Crashworthiness					
Appropriate Test Level:	TL-2	Barrier Test Level:	NCW	Is Barrier Crashworthy?:	NO
Beg. End Trtmt Type:	NONE	Is Beg. End Trtmt Crashworthy?:	N/A	Approach Transition Type:	NONE
Ending End Trtmt Type:	NONE	Ending End Trtmt Crashworthy?:	N/A		
Average Measurements					
Design Height (In.):	27	Width (In.):	0.0	Post Spacing (In.):	121.3
Height (In.):	19.7	Lateral Offset (In.):	29.0	Road Grade (%):	2.40
Physical Condition					
Barrier	Alignment and Height:	Alignment deflects more than 12 in along 250 ft of barrier. Height is between 4 and 12 in below 27 in design height along entire length.

Breaking and Cracking:	No breaking or cracking observed in posts. No fraying breaking or severing of cables observed.			
	Missing Elements:	No missing elements observed.			
	Corrosion and Weathering:	No loss of cable cross section or erosion around posts observed.			
End Treatments	Alignment and Height:				
	Breaking and Cracking:				
	Missing Elements:				
	Corrosion and Weathering:

Repair Action:	REPLACE	FMSS Work Type:	CAPITAL IMPROVEMENT	Repair Cost:	\$39413
Brief Workorder:	Replace cable guardrail with Steel-Backed Timber w/o blockouts and 2 flared Steel-Backed Timber end treatments.				
Workorder:	Remove Cable Guardrail at \$5- per -Lin. Ft. for 362 LF = \$1810. Steel-Backed Timber w/o Blockout at \$60- per -Lin. Ft. for 302 LF = \$18120. SBT / Log Flared at \$5000- per -Each for 2 Unit(s) = \$10000. Low Speed Traffic Control at \$1475- per -Day for 4 Day(s) = \$5900. 2 days removal and 2 days installation.

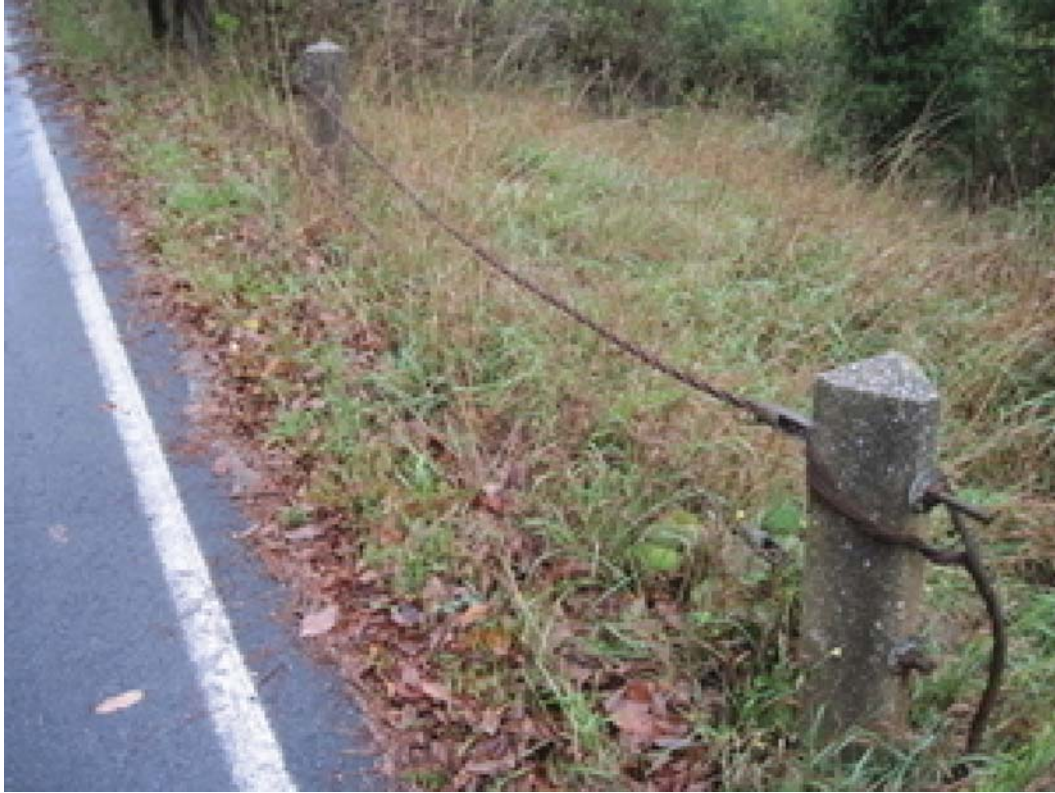
DEWA_0113_1.958_R_1.jpg

Barrier ID:	DEWA-0113-1.958-R				
Route Name:	NPS ROUTE 615				
Inspection Date:	10/05/2010	Barrier Rating:	62.20		
Barrier Description					
Type:	OTHER: 2-STRAND CABLE	Barrier Function:	TRAFFIC		
Barrier Material:	CABLE	Post Material:	OTHER: CONCRETE		
Blockout Type:	N/A	Length (ft.):	1845		
Speed Limit (MPH):	35	Placement with Respect to Road:	BOTH INSIDE AND OUTSIDE		
Hazard Behind Barrier:	MEDIUM				
Barrier Crashworthiness					
Appropriate Test Level:	TL-2	Barrier Test Level:	NCW	Is Barrier Crashworthy?:	NO
Beg. End Trtmt Type:	NONE	Is Beg. End Trtmt Crashworthy?:	N/A	Approach Transition Type:	NONE
Ending End Trtmt Type:	NONE	Ending End Trtmt Crashworthy?:	N/A		
Average Measurements					
Design Height (In.):	27	Width (In.):	0.0	Post Spacing (In.):	122.8
Height (In.):	22.7	Lateral Offset (In.):	39.5	Road Grade (%):	3.60
Physical Condition					
Barrier	Alignment and Height:	Alignment deflects 6 - 12 in for 500 ft and greater than 12 in for 1000 ft. Height drops as low as 9 in below 27 in design height.

Breaking and Cracking:	Two posts and 40 ft of cable is laying on the ground.			
	Missing Elements:	No missing elements observed.			
	Corrosion and Weathering:	No loss of cross section or erosion around posts observed.			
End Treatments	Alignment and Height:				
	Breaking and Cracking:				
	Missing Elements:				
	Corrosion and Weathering:

Repair Action:	REPLACE	FMSS Work Type:	CAPITAL IMPROVEMENT	Repair Cost:	\$164918
Brief Workorder:	Replace cable guardrail with Steel-Backed Timber w/o blockouts and 2 flared Steel-Backed Timber end treatments.				
Workorder:	Remove Cable Guardrail at \$5- per -Lin. Ft. for 1845 LF = \$9225. Steel-Backed Timber w/o Blockout at \$60- per -Lin. Ft. for 1785 LF = \$107100. SBT / Log Flared at \$5000- per -Each for 2 Unit(s) = \$10000. Low Speed Traffic Control at \$1475- per -Day for 16 Day(s) = \$23600. 8 days removal and 8 days installation.

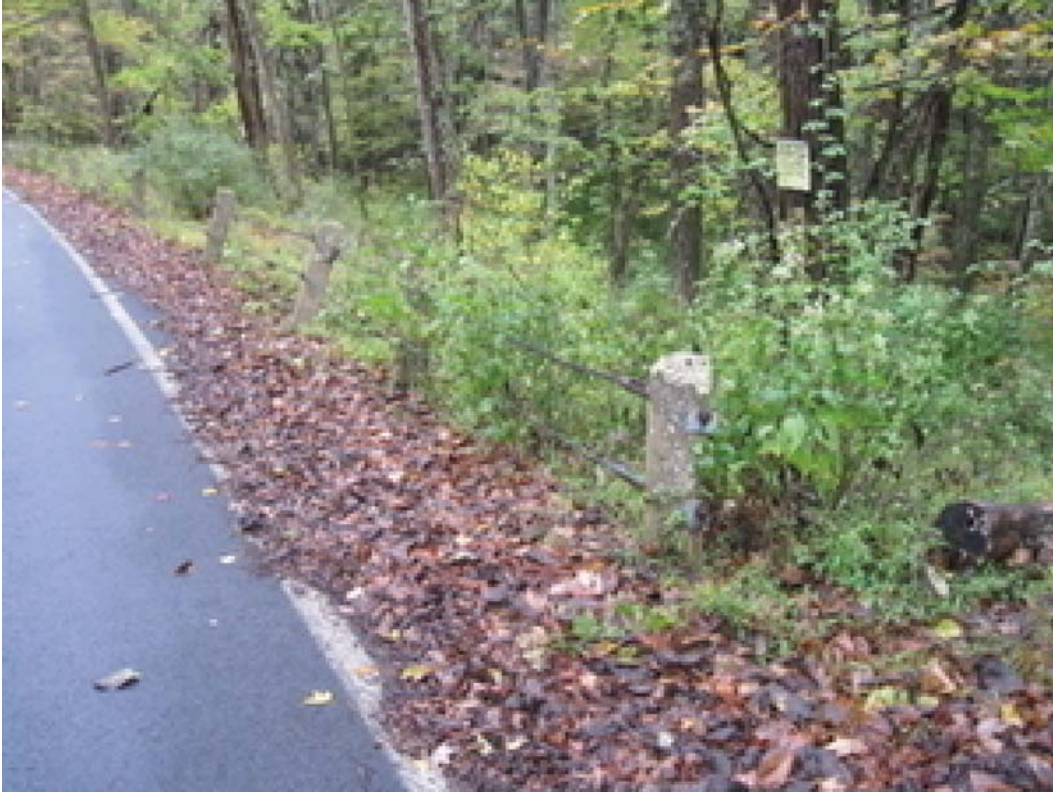
DEWA_0113_2.416_R_1.jpg

Barrier ID:	DEWA-0113-2.416-R				
Route Name:	NPS ROUTE 615				
Inspection Date:	10/05/2010	Barrier Rating:	58.00		
Barrier Description					
Type:	OTHER: 2-STRAND CABLE	Barrier Function:	TRAFFIC		
Barrier Material:	CABLE	Post Material:	OTHER: CONCRETE		
Blockout Type:	N/A	Length (ft.):	1032		
Speed Limit (MPH):	35	Placement with Respect to Road:	BOTH INSIDE AND OUTSIDE		
Hazard Behind Barrier:	MEDIUM				
Barrier Crashworthiness					
Appropriate Test Level:	TL-2	Barrier Test Level:	NCW	Is Barrier Crashworthy?:	NO
Beg. End Trtmt Type:	NONE	Is Beg. End Trtmt Crashworthy?:	N/A	Approach Transition Type:	NONE
Ending End Trtmt Type:	NONE	Ending End Trtmt Crashworthy?:	N/A		
Average Measurements					
Design Height (In.):	27	Width (In.):	0.0	Post Spacing (In.):	118.5
Height (In.):	20.3	Lateral Offset (In.):	43.0	Road Grade (%):	1.60
Physical Condition					
Barrier	Alignment and Height:	160 ft of barrier is out of alignment by 6 - 12 in. 380 ft is deflected by more than 12 in. Height is 4 - 9 in below 27-in design height.

Breaking and Cracking:	14 posts are broken and have exposed rebar.			
	Missing Elements:	No missing elements were observed.			
	Corrosion and Weathering:	No loss of cross section or erosion around posts observed.			
End Treatments	Alignment and Height:				
	Breaking and Cracking:				
	Missing Elements:				
	Corrosion and Weathering:

Repair Action:	REPLACE	FMSS Work Type:	CAPITAL IMPROVEMENT	Repair Cost:	\$97053
Brief Workorder:	Replace cable guardrail with Steel-Backed Timber w/o blockouts and 2 flared Steel-Backed Timber end treatments.				
Workorder:	Remove Cable Guardrail at \$5- per -Lin. Ft. for 1032 LF = \$5160. Steel-Backed Timber w/o Blockout at \$60- per -Lin. Ft. for 972 LF = \$58320. SBT / Log Flared at \$5000- per -Each for 2 Unit(s) = \$10000. Low Speed Traffic Control at \$1475- per -Day for 10 Day(s) = \$14750. 5 days removal and 5 days installation.

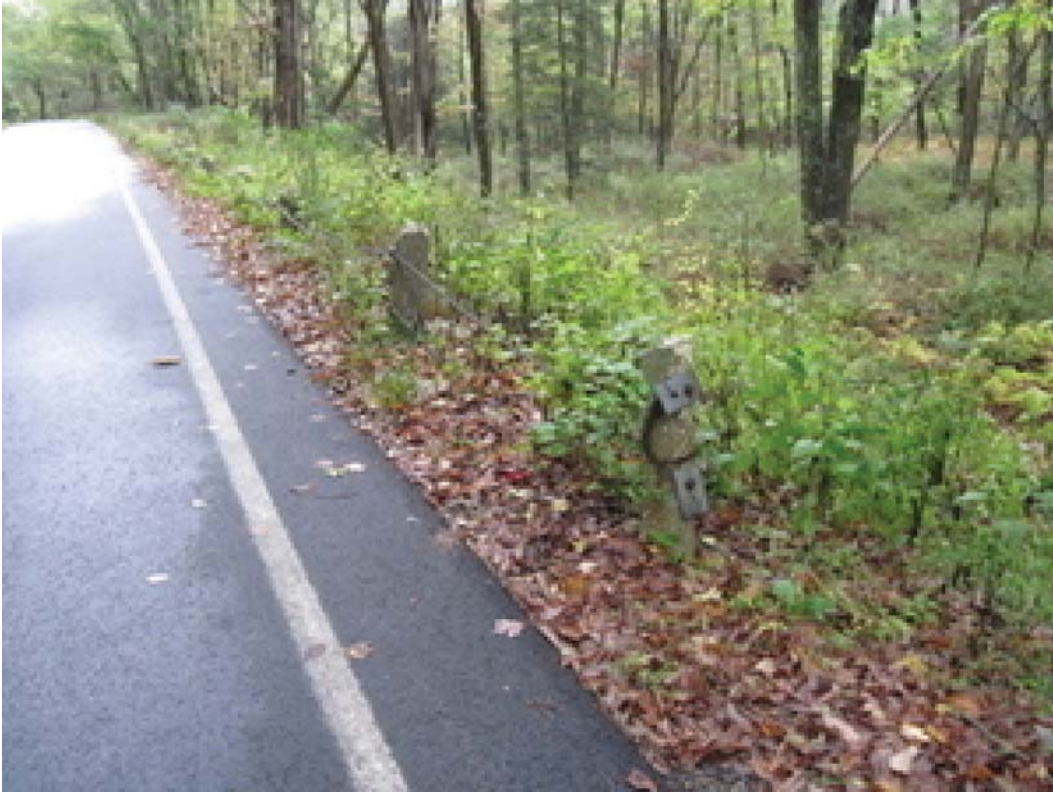
DEWA_0113_2.702_R_1.jpg

Barrier ID:	DEWA-0113-2.702-R				
Route Name:	NPS ROUTE 615				
Inspection Date:	10/05/2010	Barrier Rating:	44.00		
Barrier Description					
Type:	OTHER: 2-STRAND CABLE	Barrier Function:	TRAFFIC		
Barrier Material:	CABLE	Post Material:	OTHER: CONCRETE		
Blockout Type:	N/A	Length (ft.):	550		
Speed Limit (MPH):	35	Placement with Respect to Road:	OUTSIDE OF CURVE		
Hazard Behind Barrier:	LOW				
Barrier Crashworthiness					
Appropriate Test Level:	TL-2	Barrier Test Level:	NCW	Is Barrier Crashworthy?:	NO
Beg. End Trtmt Type:	NONE	Is Beg. End Trtmt Crashworthy?:	N/A	Approach Transition Type:	NONE
Ending End Trtmt Type:	NONE	Ending End Trtmt Crashworthy?:	N/A		
Average Measurements					
Design Height (In.):	27	Width (In.):	0.0	Post Spacing (In.):	118.3
Height (In.):	18.0	Lateral Offset (In.):	37.7	Road Grade (%):	1.40
Physical Condition					
Barrier	Alignment and Height:	Alignment deflects more than 12 in along 150 ft of barrier. Height ranges from 5 to 11 in below the 27 in design height along the entire length.

Breaking and Cracking:	15 posts are broken down and have exposed rebar.			
	Missing Elements:	No missing elements observed.			
	Corrosion and Weathering:	No loss of cable cross section or erosion around posts observed.			
End Treatments	Alignment and Height:	NA			
	Breaking and Cracking:	NA			
	Missing Elements:	NA			
	Corrosion and Weathering:	NA

Repair Action:	REPLACE	FMSS Work Type:	CAPITAL IMPROVEMENT	Repair Cost:	\$56100
Brief Workorder:	Replace cable guardrail with Steel-Backed Timber w/o blockouts and 2 flared Steel-Backed Timber end treatments.				
Workorder:	Remove Cable Guardrail at \$5- per -Lin. Ft. for 550 LF = \$2750. Remove 550 feet of cable guardrail Steel-Backed Timber w/o Blockout at \$60- per -Lin. Ft. for 490 LF = \$29400. SBT / Log Flared at \$5000- per -Each for 2 Unit(s) = \$10000. Low Speed Traffic Control at \$1475- per -Day for 6 Day(s) = \$8850. 3 days removal and 3 days installation.

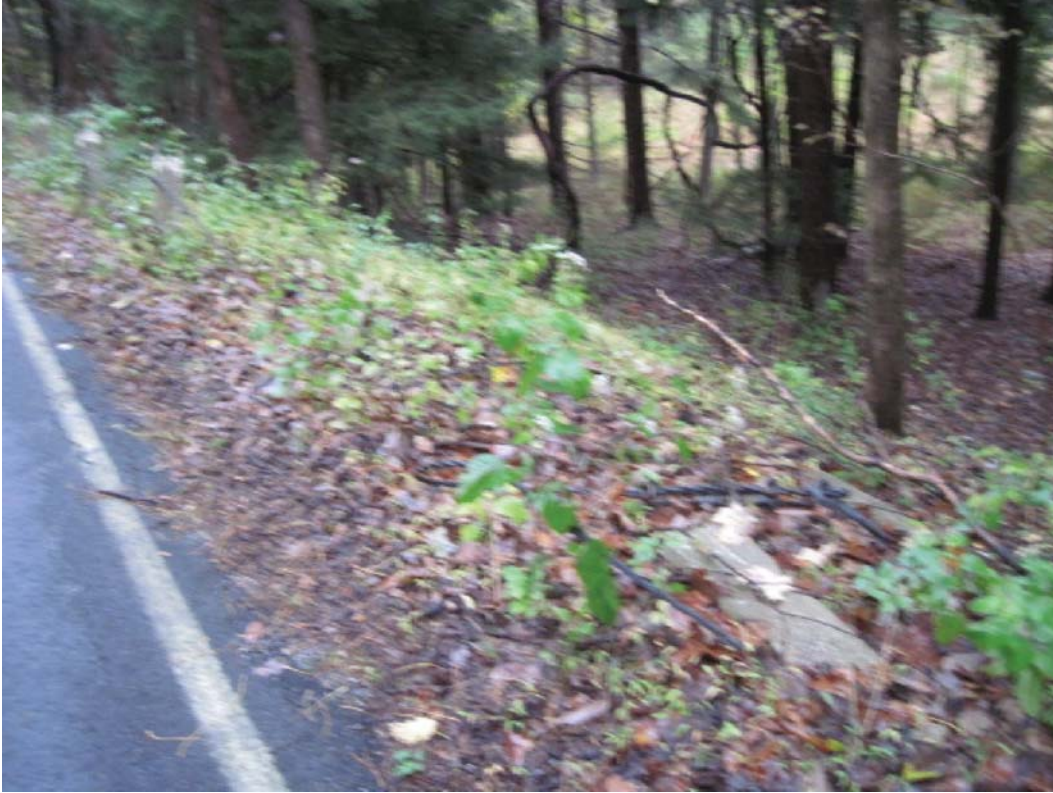
DEWA_0113_2.946_R_1.jpg

Barrier ID:	DEWA-0113-2.946-R				
Route Name:	NPS ROUTE 615				
Inspection Date:	10/05/2010	Barrier Rating:	50.90		
Barrier Description					
Type:	OTHER: 2-STRAND CABLE	Barrier Function:	TRAFFIC		
Barrier Material:	CABLE	Post Material:	OTHER: CONCRETE		
Blockout Type:	N/A	Length (ft.):	689		
Speed Limit (MPH):	35	Placement with Respect to Road:	BOTH INSIDE AND OUTSIDE		
Hazard Behind Barrier:	MEDIUM				
Barrier Crashworthiness					
Appropriate Test Level:	TL-2	Barrier Test Level:	NCW	Is Barrier Crashworthy?:	NO
Beg. End Trtmt Type:	NONE	Is Beg. End Trtmt Crashworthy?:	N/A	Approach Transition Type:	NONE
Ending End Trtmt Type:	NONE	Ending End Trtmt Crashworthy?:	N/A		
Average Measurements					
Design Height (In.):	27	Width (In.):	0.0	Post Spacing (In.):	128.0
Height (In.):	23.5	Lateral Offset (In.):	42.0	Road Grade (%):	5.70
Physical Condition					
Barrier	Alignment and Height:	Alignment deflects 6 in to 12 in for 150 ft and greater than 12 in for 400 ft. Height ranges from 1 in to 7 in below 27 in design height.

Breaking and Cracking:	First 30 ft section of barrier has been impacted and destroyed. Eighteen posts are cracked on top and showing rebar.			
	Missing Elements:	No missing elements observed.			
	Corrosion and Weathering:	No loss of cross section or erosion around posts observed.			
End Treatments	Alignment and Height:				
	Breaking and Cracking:				
	Missing Elements:				
	Corrosion and Weathering:

Repair Action:	REPLACE	FMSS Work Type:	CAPITAL IMPROVEMENT	Repair Cost:	\$66038
Brief Workorder:	Replace cable guardrail with Steel-Backed Timber w/o blockouts and 2 flared end treatments.				
Workorder:	Remove Cable Guardrail at \$5- per -Lin. Ft. for 689 LF = \$3445. Steel-Backed Timber w/o Blockout at \$60- per -Lin. Ft. for 629 LF = \$37740. SBT / Log Flared at \$5000- per -Each for 2 Unit(s) = \$10000. Low Speed Traffic Control at \$1475- per -Day for 6 Day(s) = \$8850. 3 days removal and 3 days installation.

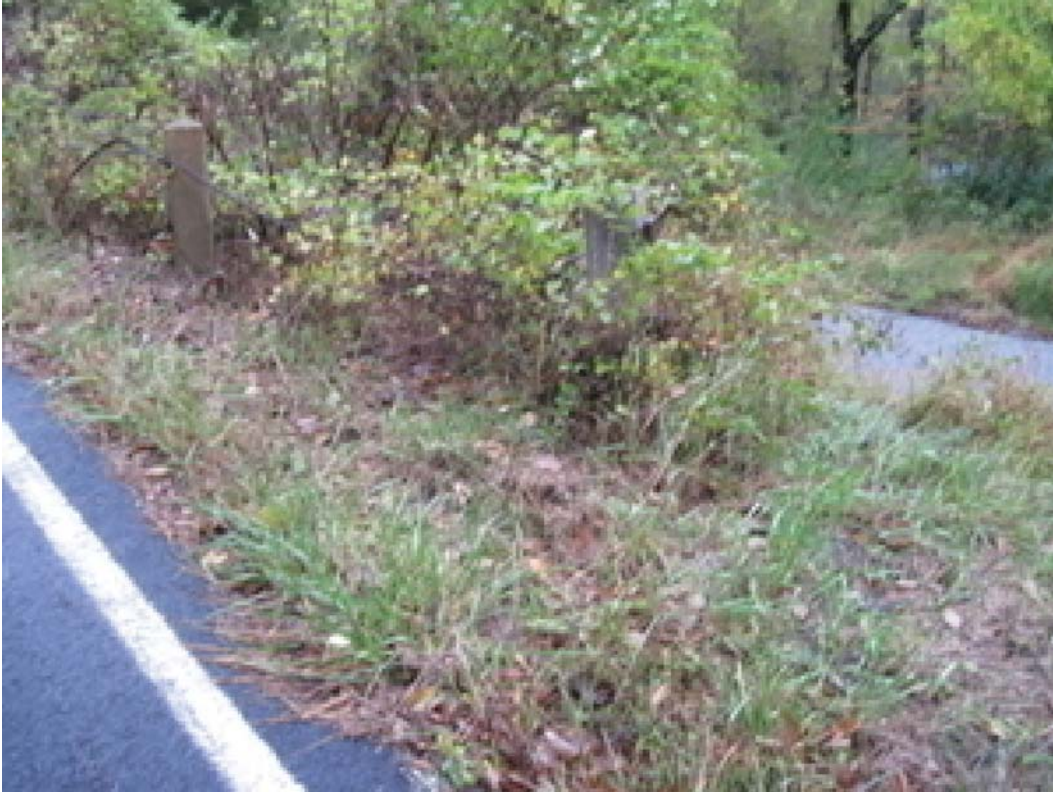
DEWA_0113_3.691_R_1.jpg

Barrier ID:	DEWA-0113-3.691-R				
Route Name:	NPS ROUTE 615				
Inspection Date:	10/05/2010	Barrier Rating:	28.20		
Barrier Description					
Type:	OTHER: 2-STRAND CABLE	Barrier Function:	TRAFFIC		
Barrier Material:	CABLE	Post Material:	OTHER: CONCRETE		
Blockout Type:	N/A	Length (ft.):	217		
Speed Limit (MPH):	35	Placement with Respect to Road:	TANGENT		
Hazard Behind Barrier:	LOW				
Barrier Crashworthiness					
Appropriate Test Level:	TL-2	Barrier Test Level:	NCW	Is Barrier Crashworthy?:	NO
Beg. End Trtmt Type:	NONE	Is Beg. End Trtmt Crashworthy?:	N/A	Approach Transition Type:	NONE
Ending End Trtmt Type:	NONE	Ending End Trtmt Crashworthy?:	N/A		
Average Measurements					
Design Height (In.):	27	Width (In.):	0.0	Post Spacing (In.):	123.6
Height (In.):	22.7	Lateral Offset (In.):	38.2	Road Grade (%):	4.90
Physical Condition					
Barrier	Alignment and Height:	150 ft of barrier is tipping backward out of alignment by more than 12 in. Barrier is 3 - 6 in below 27-in. design height

Breaking and Cracking:	No breaking or cracking was observed in posts. No fraying breaking or severing of cables observed.			
	Missing Elements:	No missing elements were observed.			
	Corrosion and Weathering:	No loss of cable cross section or erosion around posts observed.			
End Treatments	Alignment and Height:				
	Breaking and Cracking:				
	Missing Elements:				
	Corrosion and Weathering:

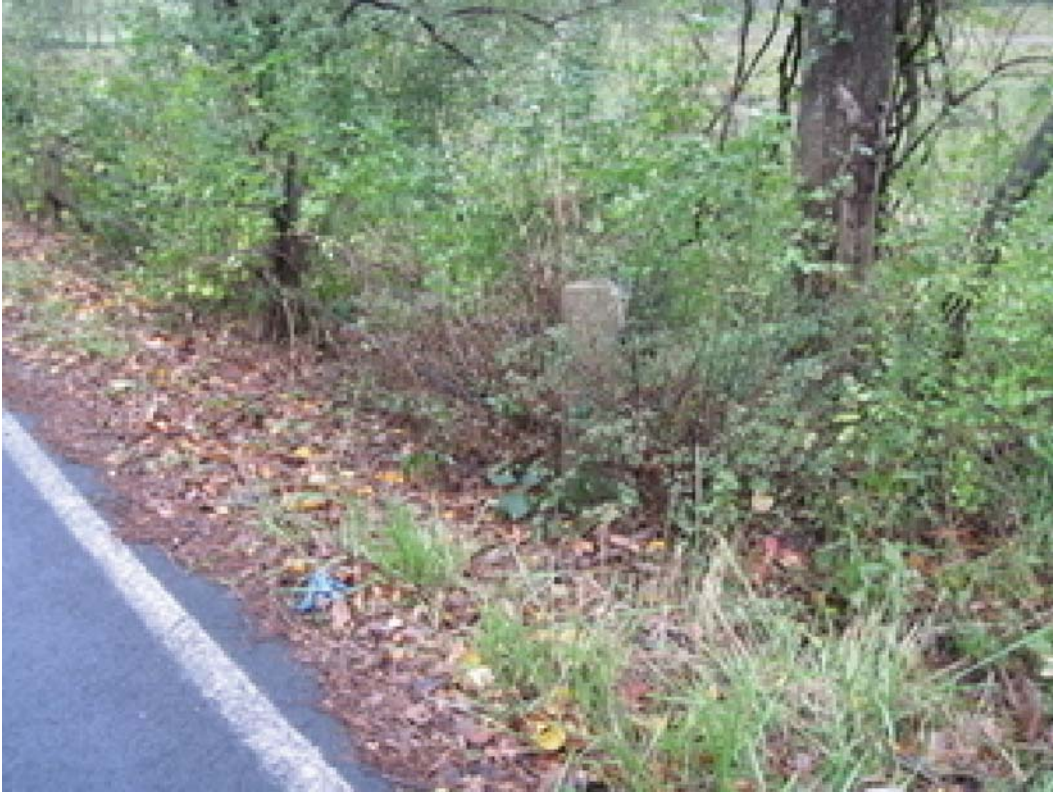
DEWA_0113_3.896_R_1.jpg

Barrier ID:	DEWA-0113-3.896-R				
Route Name:	NPS ROUTE 615				
Inspection Date:	10/05/2010	Barrier Rating:	35.50		
Barrier Description					
Type:	OTHER: 2-STRAND CABLE	Barrier Function:	TRAFFIC		
Barrier Material:	CABLE	Post Material:	OTHER: CONCRETE		
Blockout Type:	N/A	Length (ft.):	478		
Speed Limit (MPH):	35	Placement with Respect to Road:	TANGENT		
Hazard Behind Barrier:	LOW				
Barrier Crashworthiness					
Appropriate Test Level:	TL-2	Barrier Test Level:	NCW	Is Barrier Crashworthy?:	NO
Beg. End Trtmt Type:	NONE	Is Beg. End Trtmt Crashworthy?:	N/A	Approach Transition Type:	NONE
Ending End Trtmt Type:	NONE	Ending End Trtmt Crashworthy?:	N/A		
Average Measurements					
Design Height (In.):	27	Width (In.):	0.0	Post Spacing (In.):	123.3
Height (In.):	14.0	Lateral Offset (In.):	32.0	Road Grade (%):	2.80
Physical Condition					
Barrier	Alignment and Height:	Alignment deflects more than 12 in along 300 ft of barrier. Height ranges from 9 to 17 in below the 27 in design height along entire length.
