NPS Guardwall/Rail Inventory Program Delaware Water Gap National Recreation Area

**Federal Lands Highway
Road Inventory Program**

Federal Highway Administration
Eastern Federal Lands Highway Division
Road Inventory Program (RIP)

Data Collection Date: October 2010
Report Date: December 2015

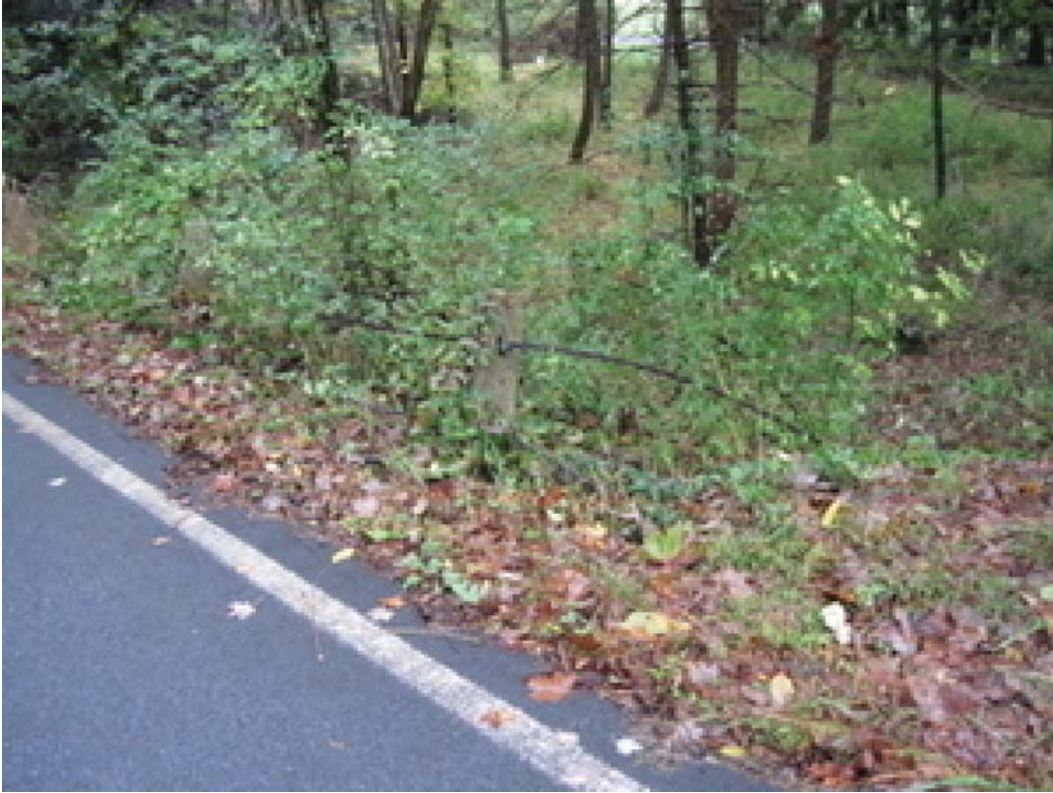
DEWA_0113_3.992_R_1.jpg

Barrier ID:	DEWA-0113-3.992-R				
Route Name:	NPS ROUTE 615				
Inspection Date:	10/05/2010	Barrier Rating:	24.10		
Barrier Description					
Type:	OTHER: 2-STRAND CABLE	Barrier Function:	TRAFFIC		
Barrier Material:	CABLE	Post Material:	OTHER: CONCRETE		
Blockout Type:	N/A	Length (ft.):	57		
Speed Limit (MPH):	35	Placement with Respect to Road:	TANGENT		
Hazard Behind Barrier:	LOW				
Barrier Crashworthiness					
Appropriate Test Level:	TL-2	Barrier Test Level:	NCW	Is Barrier Crashworthy?:	NO
Beg. End Trtmt Type:	NONE	Is Beg. End Trtmt Crashworthy?:	N/A	Approach Transition Type:	NONE
Ending End Trtmt Type:	NONE	Ending End Trtmt Crashworthy?:	N/A		
Average Measurements					
Design Height (In.):	27	Width (In.):	0.0	Post Spacing (In.):	107.3
Height (In.):	19.2	Lateral Offset (In.):	47.7	Road Grade (%):	2.30
Physical Condition					
Barrier	Alignment and Height:	Alignment deflects more than 12 in along 20 ft of barrier. Height ranges from 6 to 11 in below 27 in design height along entire barrier length.

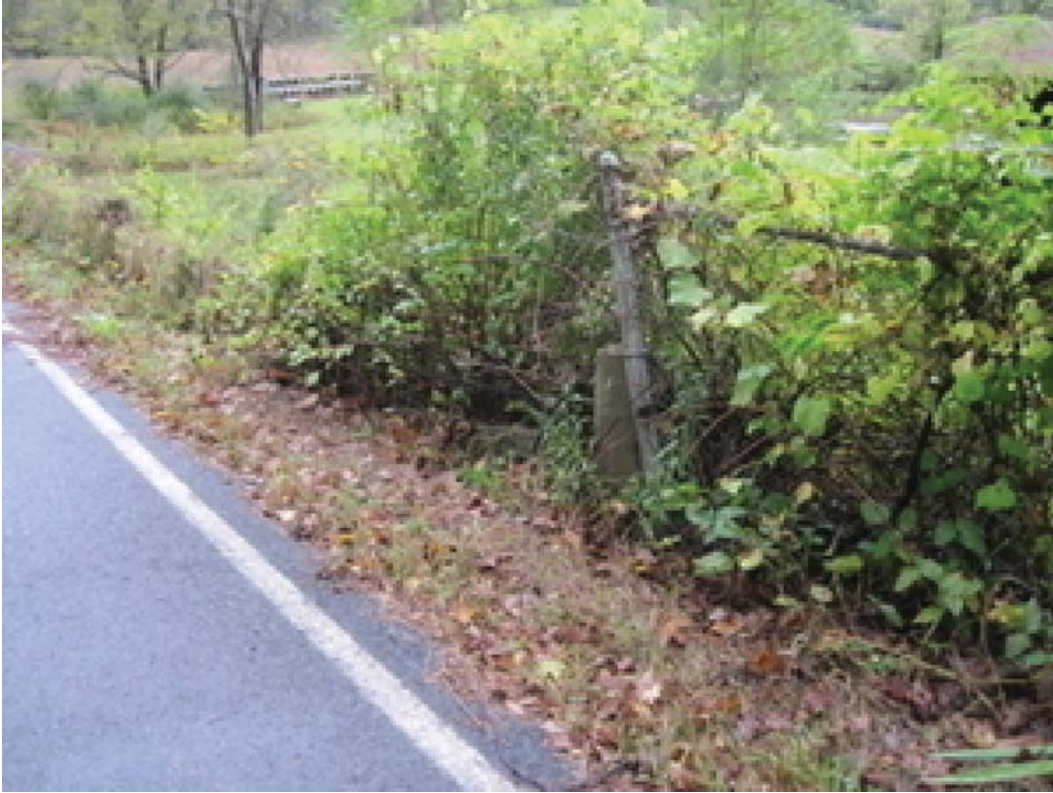
DEWA_0113_4.093_R_1.jpg

Barrier ID:	DEWA-0113-4.093-R				
Route Name:	NPS ROUTE 615				
Inspection Date:	10/06/2010	Barrier Rating:	58.00		
Barrier Description					
Type:	OTHER: 2-STRAND CABLE	Barrier Function:	TRAFFIC		
Barrier Material:	CABLE	Post Material:	OTHER: CONCRETE		
Blockout Type:	N/A	Length (ft.):	3005		
Speed Limit (MPH):	35	Placement with Respect to Road:	OUTSIDE OF CURVE		
Hazard Behind Barrier:	MEDIUM				
Barrier Crashworthiness					
Appropriate Test Level:	TL-2	Barrier Test Level:	NCW	Is Barrier Crashworthy?:	NO
Beg. End Trtmt Type:	NONE	Is Beg. End Trtmt Crashworthy?:	N/A	Approach Transition Type:	NONE
Ending End Trtmt Type:	NONE	Ending End Trtmt Crashworthy?:	N/A		
Average Measurements					
Design Height (In.):	27	Width (In.):	0.0	Post Spacing (In.):	118.5
Height (In.):	16.7	Lateral Offset (In.):	35.0	Road Grade (%):	3.00
Physical Condition					
Barrier	Alignment and Height:	Alignment deflects more than 12 in along 1600 ft of barrier. Alignment deflects 6 to 12 in along 600 of barrier. Height ranges from 2 to 20 in below the 27 in design height.

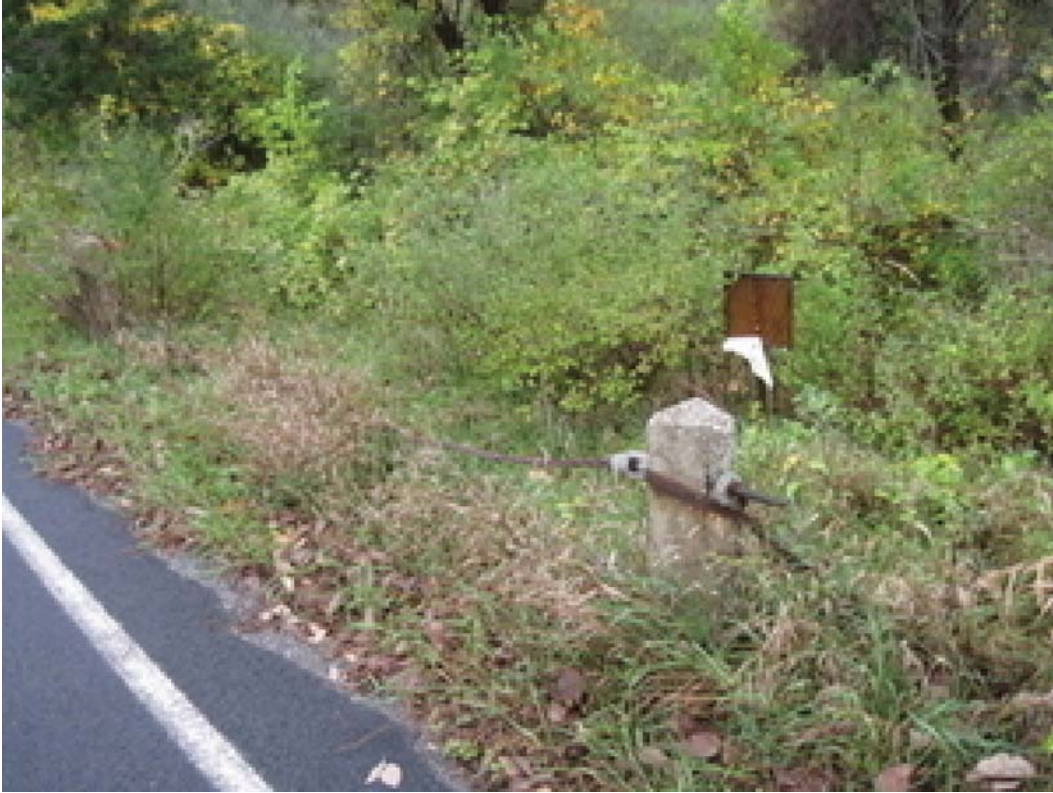
DEWA_0113_5.168_R_1.jpg

Barrier ID:	DEWA-0113-5.168-R				
Route Name:	NPS ROUTE 615				
Inspection Date:	10/06/2010	Barrier Rating:	27.00		
Barrier Description					
Type:	OTHER: 2-STRAND CABLE	Barrier Function:	TRAFFIC		
Barrier Material:	CABLE	Post Material:	OTHER: CONCRETE		
Blockout Type:	N/A	Length (ft.):	99		
Speed Limit (MPH):	35	Placement with Respect to Road:	INSIDE OF CURVE		
Hazard Behind Barrier:	LOW				
Barrier Crashworthiness					
Appropriate Test Level:	TL-2	Barrier Test Level:	NCW	Is Barrier Crashworthy?:	NO
Beg. End Trtmt Type:	NONE	Is Beg. End Trtmt Crashworthy?:	N/A	Approach Transition Type:	NONE
Ending End Trtmt Type:	NONE	Ending End Trtmt Crashworthy?:	N/A		
Average Measurements					
Design Height (In.):	27	Width (In.):	0.0	Post Spacing (In.):	104.3
Height (In.):	20.2	Lateral Offset (In.):	35.7	Road Grade (%):	0.30
Physical Condition					
Barrier	Alignment and Height:	No alignment deflection observed. Height ranges from 5 in to 8 in below 27 in design height.

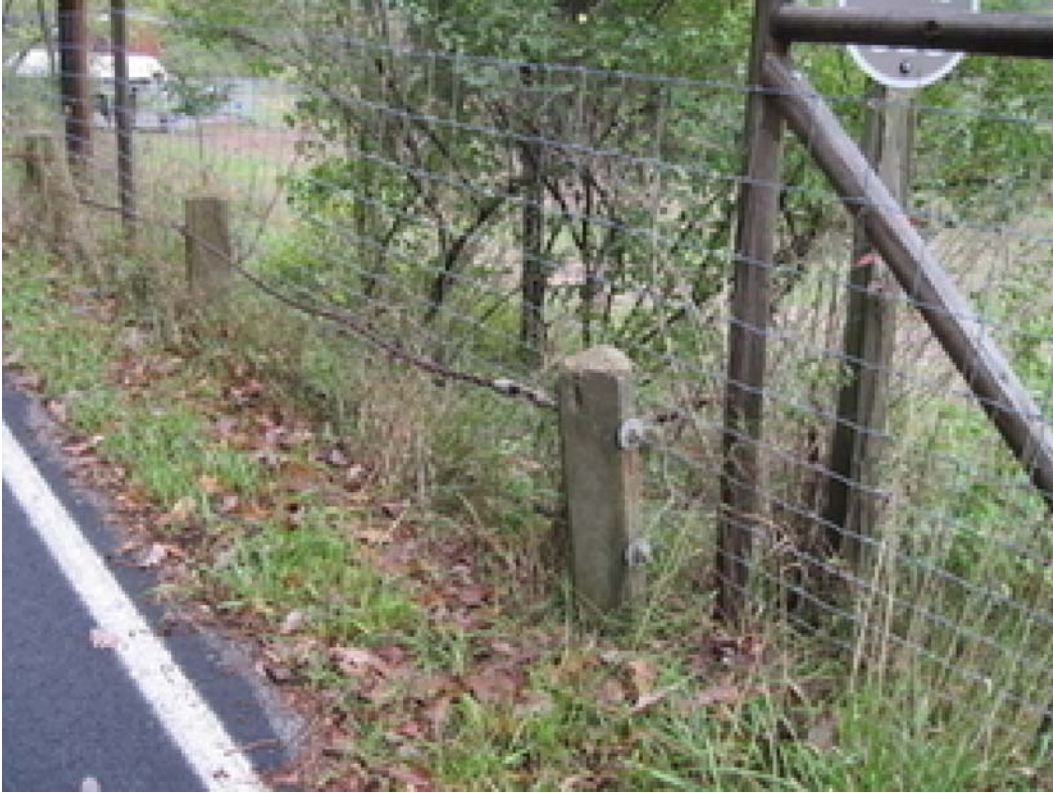
DEWA_0113_5.250_R_1.jpg

Barrier ID:	DEWA-0113-5.250-R				
Route Name:	NPS ROUTE 615				
Inspection Date:	10/06/2010	Barrier Rating:	28.20		
Barrier Description					
Type:	OTHER: 2-STRAND CABLE	Barrier Function:	TRAFFIC		
Barrier Material:	CABLE	Post Material:	OTHER: CONCRETE		
Blockout Type:	N/A	Length (ft.):	256		
Speed Limit (MPH):	35	Placement with Respect to Road:	TANGENT		
Hazard Behind Barrier:	LOW				
Barrier Crashworthiness					
Appropriate Test Level:	TL-2	Barrier Test Level:	NCW	Is Barrier Crashworthy?:	NO
Beg. End Trtmt Type:	NONE	Is Beg. End Trtmt Crashworthy?:	N/A	Approach Transition Type:	NONE
Ending End Trtmt Type:	NONE	Ending End Trtmt Crashworthy?:	N/A		
Average Measurements					
Design Height (In.):	27	Width (In.):	0.0	Post Spacing (In.):	120.3
Height (In.):	21.0	Lateral Offset (In.):	48.2	Road Grade (%):	1.90
Physical Condition					
Barrier	Alignment and Height:	No alignment deflection was observed. Height is 4 - 8 in below 27-in design height throughout length.

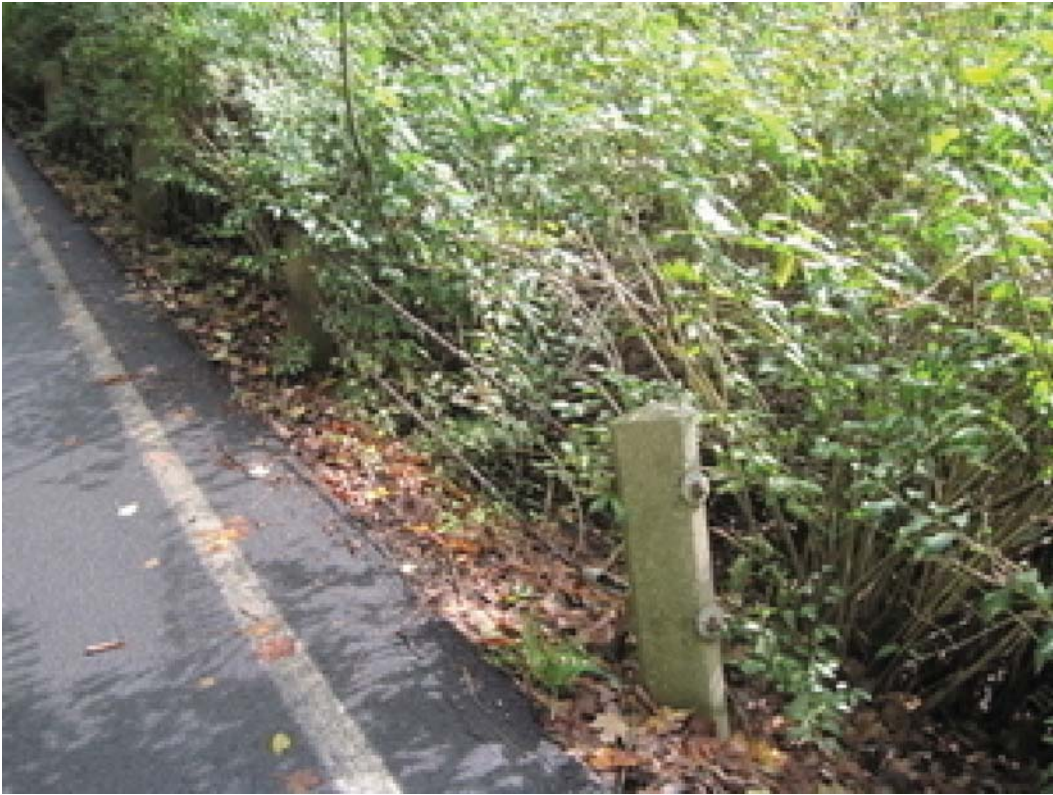
DEWA_0113_5.324_R_1.jpg

Barrier ID:	DEWA-0113-5.324-R				
Route Name:	NPS ROUTE 615				
Inspection Date:	10/06/2010	Barrier Rating:	58.00		
Barrier Description					
Type:	OTHER: 2-STRAND CABLE	Barrier Function:	TRAFFIC		
Barrier Material:	CABLE	Post Material:	OTHER: CONCRETE		
Blockout Type:	N/A	Length (ft.):	2030		
Speed Limit (MPH):	35	Placement with Respect to Road:	BOTH INSIDE AND OUTSIDE		
Hazard Behind Barrier:	MEDIUM				
Barrier Crashworthiness					
Appropriate Test Level:	TL-2	Barrier Test Level:	NCW	Is Barrier Crashworthy?:	NO
Beg. End Trtmt Type:	NONE	Is Beg. End Trtmt Crashworthy?:	N/A	Approach Transition Type:	NONE
Ending End Trtmt Type:	NONE	Ending End Trtmt Crashworthy?:	N/A		
Average Measurements					
Design Height (In.):	27	Width (In.):	0.0	Post Spacing (In.):	118.0
Height (In.):	19.7	Lateral Offset (In.):	34.2	Road Grade (%):	2.30
Physical Condition					
Barrier	Alignment and Height:	Alignment deflects 6 to 12 in along 700 ft of barrier. Alignment deflects more than 12 in along 1000 ft of barrier. Height ranges from 4 to 11 in below the 27 in design height along 1800 ft of barrier.

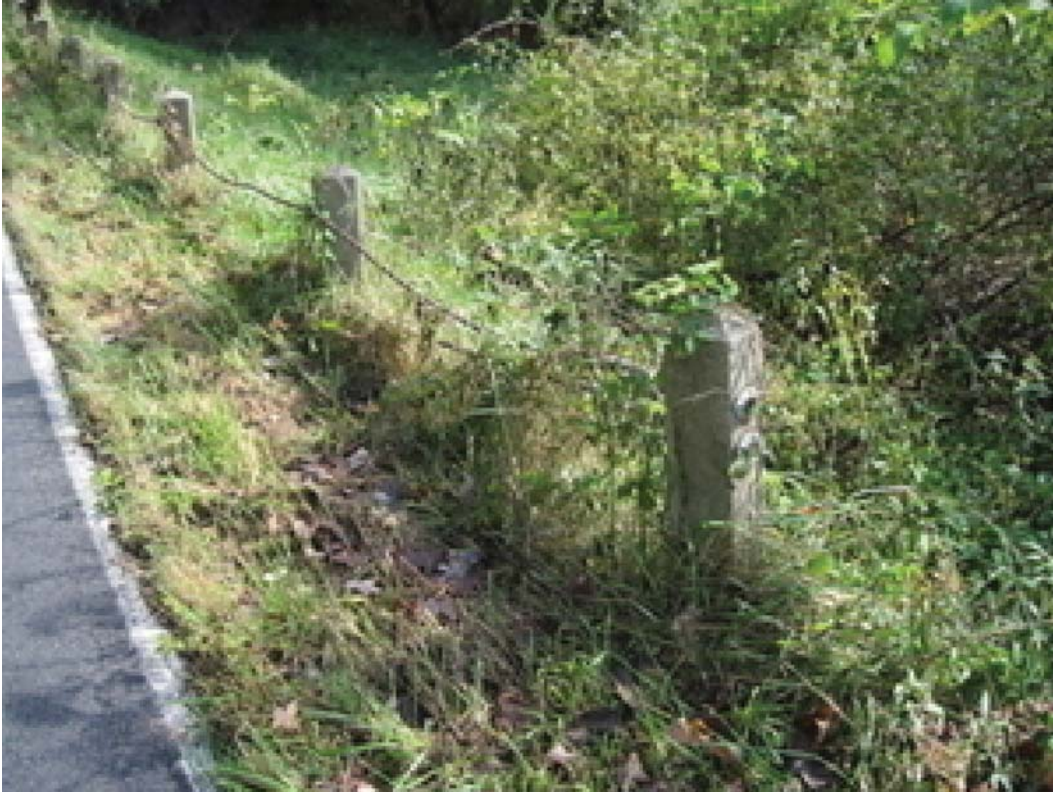
DEWA_0113_6.268_R_1.jpg

Barrier ID:	DEWA-0113-6.268-R				
Route Name:	NPS ROUTE 615				
Inspection Date:	10/06/2010	Barrier Rating:	31.20		
Barrier Description					
Type:	OTHER: 2-STRAND CABLE	Barrier Function:	TRAFFIC		
Barrier Material:	CABLE	Post Material:	OTHER: CONCRETE		
Blockout Type:	N/A	Length (ft.):	244		
Speed Limit (MPH):	35	Placement with Respect to Road:	INSIDE OF CURVE		
Hazard Behind Barrier:	LOW				
Barrier Crashworthiness					
Appropriate Test Level:	TL-2	Barrier Test Level:	NCW	Is Barrier Crashworthy?:	NO
Beg. End Trtmt Type:	NONE	Is Beg. End Trtmt Crashworthy?:	N/A	Approach Transition Type:	NONE
Ending End Trtmt Type:	NONE	Ending End Trtmt Crashworthy?:	N/A		
Average Measurements					
Design Height (In.):	27	Width (In.):	0.0	Post Spacing (In.):	98.3
Height (In.):	19.2	Lateral Offset (In.):	41.0	Road Grade (%):	9.70
Physical Condition					
Barrier	Alignment and Height:	Alignment deflects 6 in to 12 in for 40 ft and greater than 12 in for 150 ft. Height ranges from 3 in to 12 in below 27 in design height.

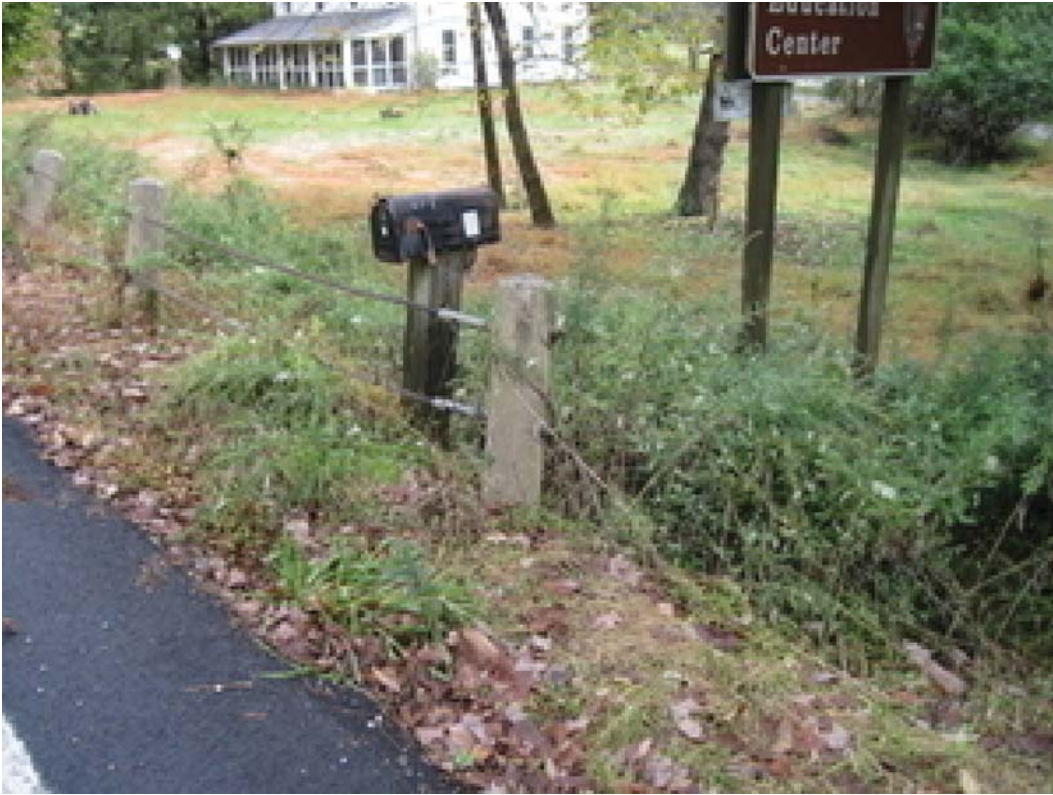
DEWA_0113_6.326_R_1.jpg

Barrier ID:	DEWA-0113-6.326-R				
Route Name:	NPS ROUTE 615				
Inspection Date:	10/06/2010	Barrier Rating:	35.50		
Barrier Description					
Type:	OTHER: 2-STRAND CABLE	Barrier Function:	TRAFFIC		
Barrier Material:	CABLE	Post Material:	OTHER: CONCRETE		
Blockout Type:	N/A	Length (ft.):	408		
Speed Limit (MPH):	35	Placement with Respect to Road:	TANGENT		
Hazard Behind Barrier:	LOW				
Barrier Crashworthiness					
Appropriate Test Level:	TL-2	Barrier Test Level:	NCW	Is Barrier Crashworthy?:	NO
Beg. End Trtmt Type:	NONE	Is Beg. End Trtmt Crashworthy?:	N/A	Approach Transition Type:	NONE
Ending End Trtmt Type:	NONE	Ending End Trtmt Crashworthy?:	N/A		
Average Measurements					
Design Height (In.):	27	Width (In.):	0.0	Post Spacing (In.):	119.3
Height (In.):	19.7	Lateral Offset (In.):	44.0	Road Grade (%):	0.80
Physical Condition					
Barrier	Alignment and Height:	Alignment is off by 6 - 12 in over 80 ft and more than 12 in over 110 ft. Height is 6 - 10 in below 27-in design height along entire length.

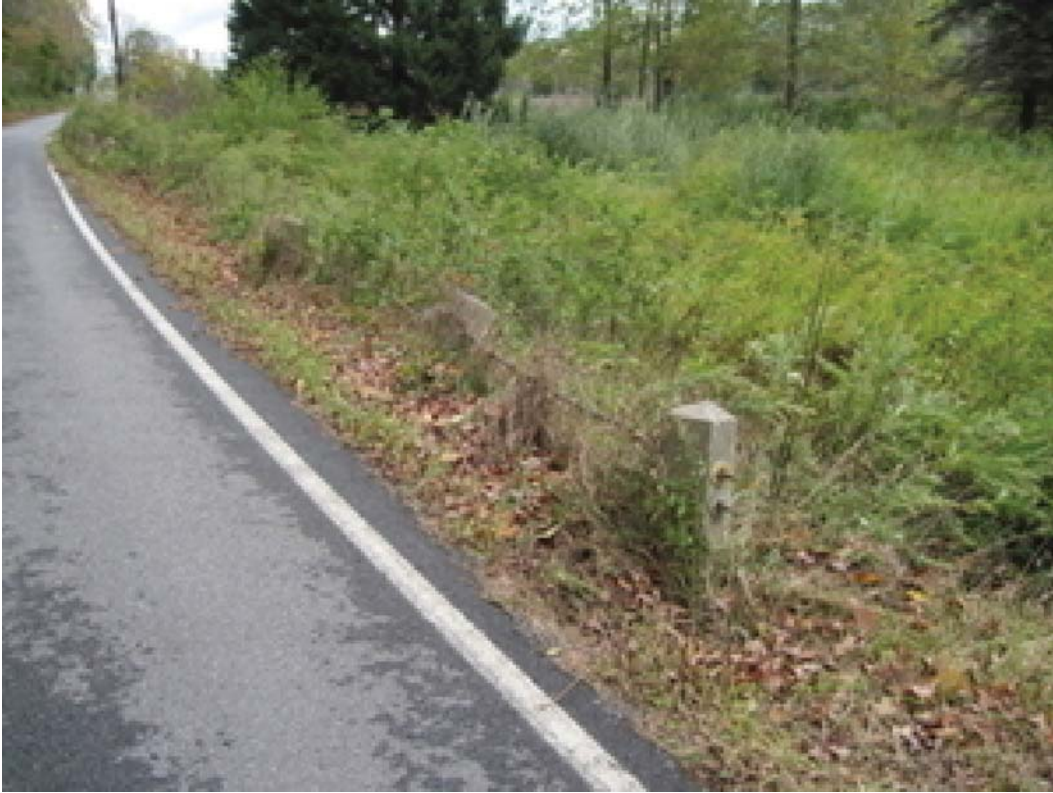
DEWA_0113_6.530_R_1.jpg

Barrier ID:	DEWA-0113-6.530-R				
Route Name:	NPS ROUTE 615				
Inspection Date:	10/06/2010	Barrier Rating:	46.90		
Barrier Description					
Type:	OTHER: 2-STRAND CABLE	Barrier Function:	TRAFFIC		
Barrier Material:	CABLE	Post Material:	OTHER: CONCRETE		
Blockout Type:	N/A	Length (ft.):	1718		
Speed Limit (MPH):	35	Placement with Respect to Road:	TANGENT		
Hazard Behind Barrier:	LOW				
Barrier Crashworthiness					
Appropriate Test Level:	TL-2	Barrier Test Level:	NCW	Is Barrier Crashworthy?:	NO
Beg. End Trtmt Type:	NONE	Is Beg. End Trtmt Crashworthy?:	N/A	Approach Transition Type:	NONE
Ending End Trtmt Type:	NONE	Ending End Trtmt Crashworthy?:	N/A		
Average Measurements					
Design Height (In.):	27	Width (In.):	0.0	Post Spacing (In.):	123.9
Height (In.):	17.7	Lateral Offset (In.):	31.3	Road Grade (%):	2.80
Physical Condition					
Barrier	Alignment and Height:	Alignment deflects more than 12 in along 1400 ft of barrier. Height ranges from 4 to 13 in below 27 in design height along entire length.

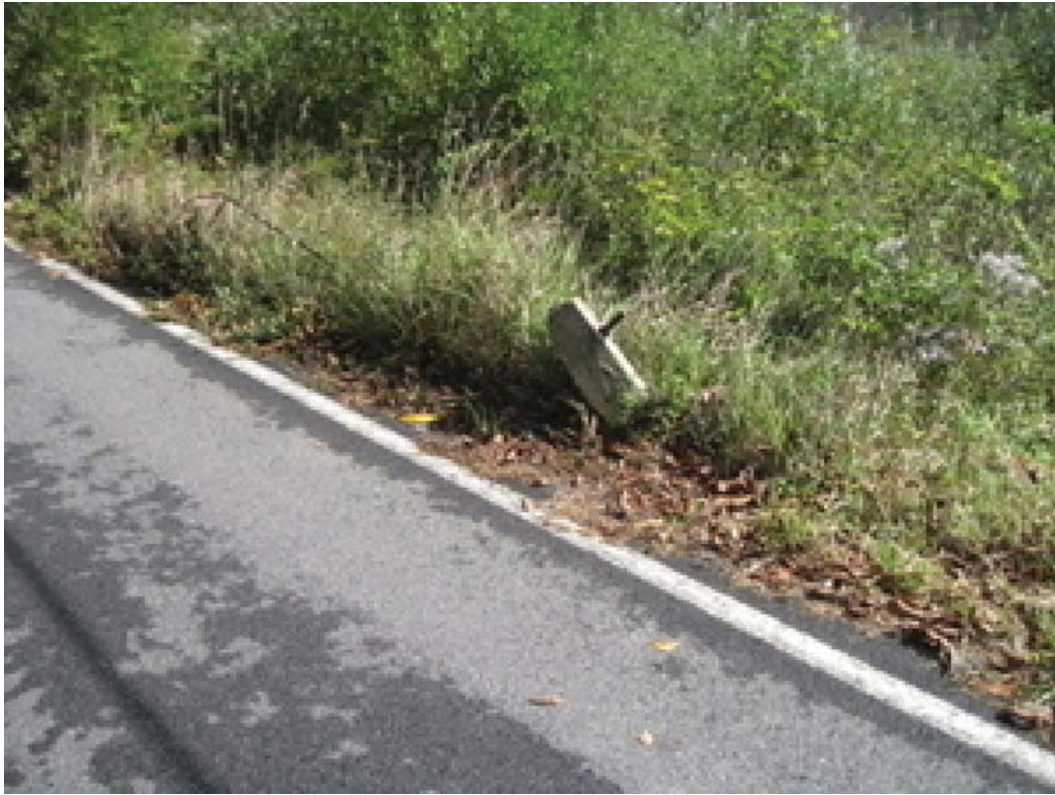
DEWA_0113_6.898_R_1.jpg

Barrier ID:	DEWA-0113-6.898-R				
Route Name:	NPS ROUTE 615				
Inspection Date:	10/06/2010	Barrier Rating:	31.20		
Barrier Description					
Type:	OTHER: 2-STRAND CABLE	Barrier Function:	TRAFFIC		
Barrier Material:	CABLE	Post Material:	OTHER: CONCRETE		
Blockout Type:	N/A	Length (ft.):	352		
Speed Limit (MPH):	35	Placement with Respect to Road:	TANGENT		
Hazard Behind Barrier:	LOW				
Barrier Crashworthiness					
Appropriate Test Level:	TL-2	Barrier Test Level:	NCW	Is Barrier Crashworthy?:	NO
Beg. End Trtmt Type:	NONE	Is Beg. End Trtmt Crashworthy?:	N/A	Approach Transition Type:	NONE
Ending End Trtmt Type:	NONE	Ending End Trtmt Crashworthy?:	N/A		
Average Measurements					
Design Height (In.):	27	Width (In.):	0.0	Post Spacing (In.):	124.6
Height (In.):	20.0	Lateral Offset (In.):	26.0	Road Grade (%):	1.50
Physical Condition					
Barrier	Alignment and Height:	Barrier is out of alignment by 6 - 12 in along 200 ft and more than 12 in along 70 ft. Barrier is collapsed along 30 ft. Height is 5 - 9 in below 27-in design height along entire length.

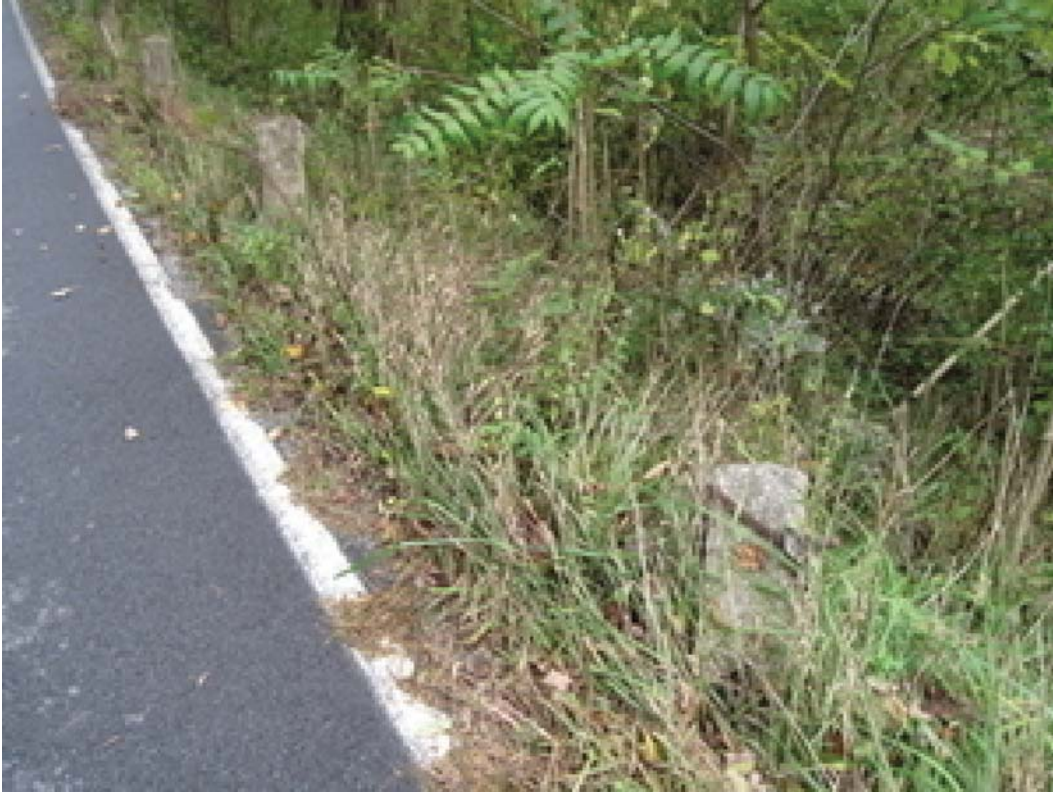
DEWA_0113_7.120_R_1.jpg

Barrier ID:	DEWA-0113-7.120-R				
Route Name:	NPS ROUTE 615				
Inspection Date:	10/06/2010	Barrier Rating:	28.20		
Barrier Description					
Type:	OTHER: 2-STRAND CABLE	Barrier Function:	TRAFFIC		
Barrier Material:	CABLE	Post Material:	OTHER: CONCRETE		
Blockout Type:	N/A	Length (ft.):	232		
Speed Limit (MPH):	35	Placement with Respect to Road:	TANGENT		
Hazard Behind Barrier:	LOW				
Barrier Crashworthiness					
Appropriate Test Level:	TL-2	Barrier Test Level:	NCW	Is Barrier Crashworthy?:	NO
Beg. End Trtmt Type:	NONE	Is Beg. End Trtmt Crashworthy?:	N/A	Approach Transition Type:	NONE
Ending End Trtmt Type:	NONE	Ending End Trtmt Crashworthy?:	N/A		
Average Measurements					
Design Height (In.):	27	Width (In.):	0.0	Post Spacing (In.):	126.3
Height (In.):	16.7	Lateral Offset (In.):	28.7	Road Grade (%):	2.30
Physical Condition					
Barrier	Alignment and Height:	Alignment deflects 6 in to 12 in for 200 ft and greater than 12 in for 30 ft. Height ranges from 9 in to 12 in below 27 in design height.

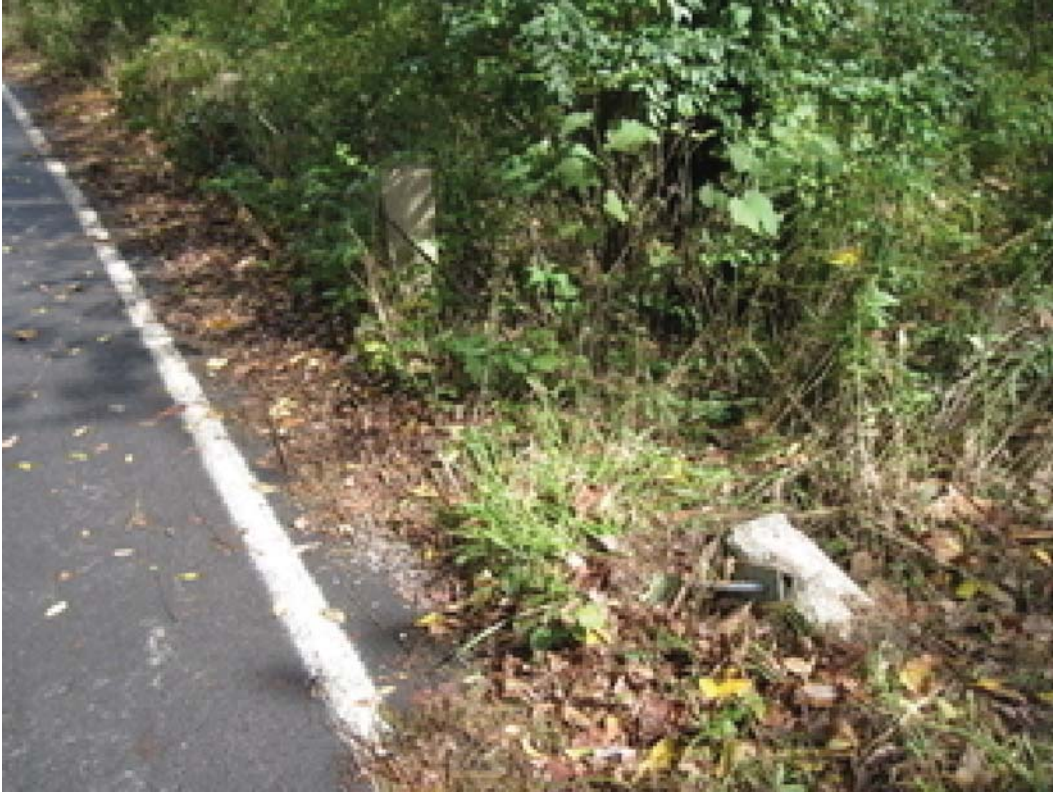
DEWA_0113_7.180_R_1.jpg

Barrier ID:	DEWA-0113-7.180-R				
Route Name:	NPS ROUTE 615				
Inspection Date:	10/06/2010	Barrier Rating:	24.10		
Barrier Description					
Type:	OTHER: 2-STRAND CABLE	Barrier Function:	TRAFFIC		
Barrier Material:	CABLE	Post Material:	OTHER: CONCRETE		
Blockout Type:	N/A	Length (ft.):	150		
Speed Limit (MPH):	35	Placement with Respect to Road:	TANGENT		
Hazard Behind Barrier:	LOW				
Barrier Crashworthiness					
Appropriate Test Level:	TL-2	Barrier Test Level:	NCW	Is Barrier Crashworthy?:	NO
Beg. End Trtmt Type:	NONE	Is Beg. End Trtmt Crashworthy?:	N/A	Approach Transition Type:	NONE
Ending End Trtmt Type:	NONE	Ending End Trtmt Crashworthy?:	N/A		
Average Measurements					
Design Height (In.):	27	Width (In.):	0.0	Post Spacing (In.):	129.0
Height (In.):	18.7	Lateral Offset (In.):	44.0	Road Grade (%):	0.50
Physical Condition					
Barrier	Alignment and Height:	Alignment deflects more than 12 in along 100 ft of barrier. Height ranges between 8 and 9 in below 27 in design height along entire length.

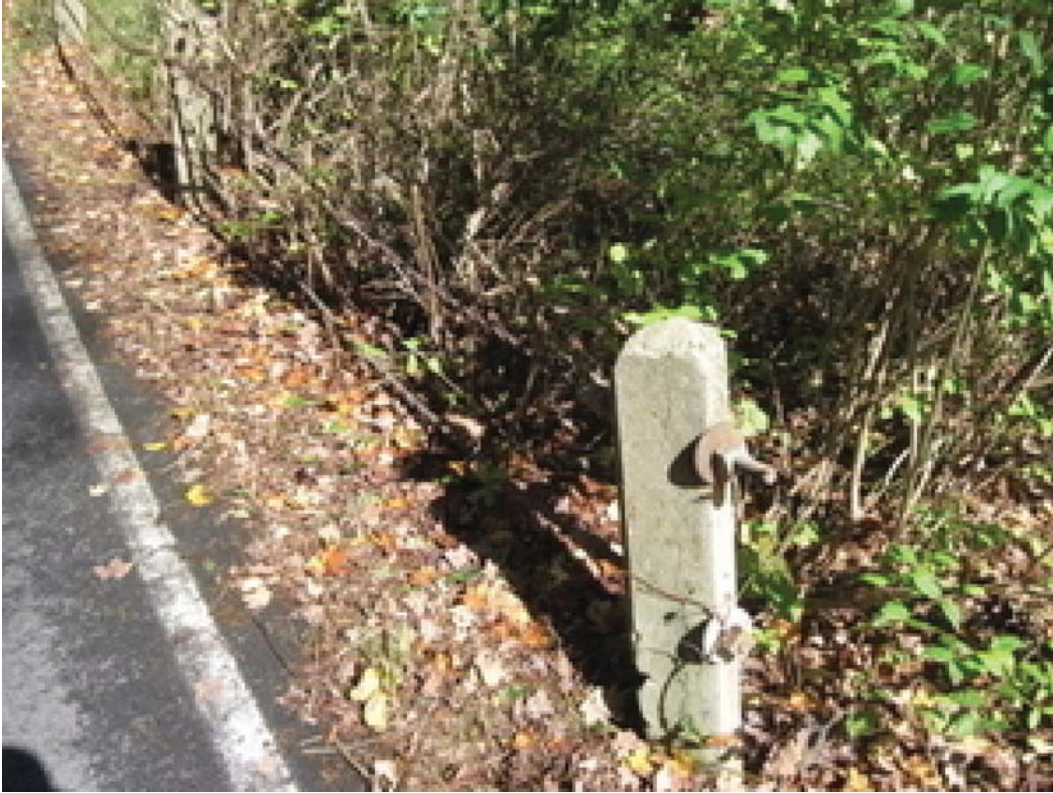
DEWA_0113_7.256_R_1.jpg

Barrier ID:	DEWA-0113-7.256-R				
Route Name:	NPS ROUTE 615				
Inspection Date:	10/06/2010	Barrier Rating:	51.00		
Barrier Description					
Type:	OTHER: 2-STRAND CABLE	Barrier Function:	TRAFFIC		
Barrier Material:	CABLE	Post Material:	OTHER: CONCRETE		
Blockout Type:	N/A	Length (ft.):	772		
Speed Limit (MPH):	35	Placement with Respect to Road:	BOTH INSIDE AND OUTSIDE		
Hazard Behind Barrier:	LOW				
Barrier Crashworthiness					
Appropriate Test Level:	TL-2	Barrier Test Level:	NCW	Is Barrier Crashworthy?:	NO
Beg. End Trtmt Type:	NONE	Is Beg. End Trtmt Crashworthy?:	N/A	Approach Transition Type:	NONE
Ending End Trtmt Type:	NONE	Ending End Trtmt Crashworthy?:	N/A		
Average Measurements					
Design Height (In.):	27	Width (In.):	0.0	Post Spacing (In.):	127.8
Height (In.):	18.5	Lateral Offset (In.):	33.5	Road Grade (%):	3.30
Physical Condition					
Barrier	Alignment and Height:	Height is 4 - 17 in below 27-in. design height along entire length. Alignment is off by 6 - 12 in for 190 ft and more than 12 in for 300 ft of which 130 ft has collapsed.

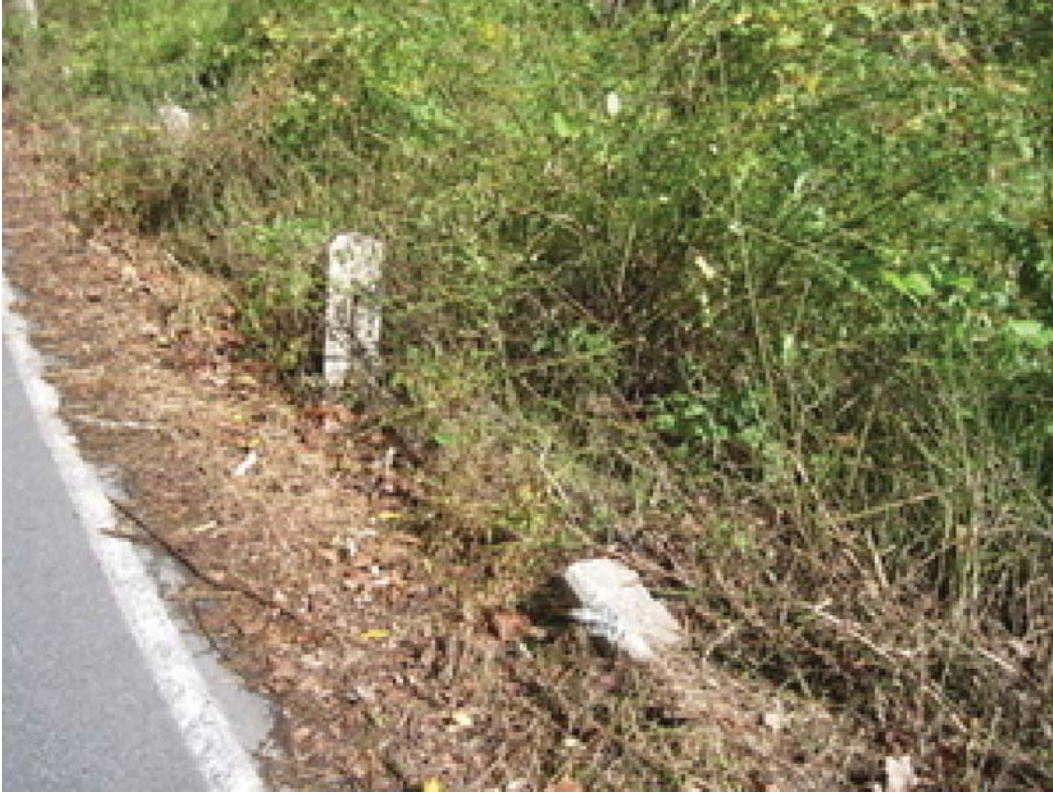
DEWA_0113_7.408_R_1.jpg

Barrier ID:	DEWA-0113-7.408-R				
Route Name:	NPS ROUTE 615				
Inspection Date:	10/06/2010	Barrier Rating:	24.10		
Barrier Description					
Type:	OTHER: 2-STRAND CABLE	Barrier Function:	TRAFFIC		
Barrier Material:	CABLE	Post Material:	OTHER: CONCRETE		
Blockout Type:	N/A	Length (ft.):	171		
Speed Limit (MPH):	35	Placement with Respect to Road:	INSIDE OF CURVE		
Hazard Behind Barrier:	LOW				
Barrier Crashworthiness					
Appropriate Test Level:	TL-2	Barrier Test Level:	NCW	Is Barrier Crashworthy?:	NO
Beg. End Trtmt Type:	NONE	Is Beg. End Trtmt Crashworthy?:	N/A	Approach Transition Type:	NONE
Ending End Trtmt Type:	NONE	Ending End Trtmt Crashworthy?:	N/A		
Average Measurements					
Design Height (In.):	27	Width (In.):	0.0	Post Spacing (In.):	125.0
Height (In.):	19.7	Lateral Offset (In.):	49.0	Road Grade (%):	2.30
Physical Condition					
Barrier	Alignment and Height:	Alignment deflects more than 12 in along 100 ft of barrier. Height ranges between 4 and 11 in below 27 in design height along entire length.

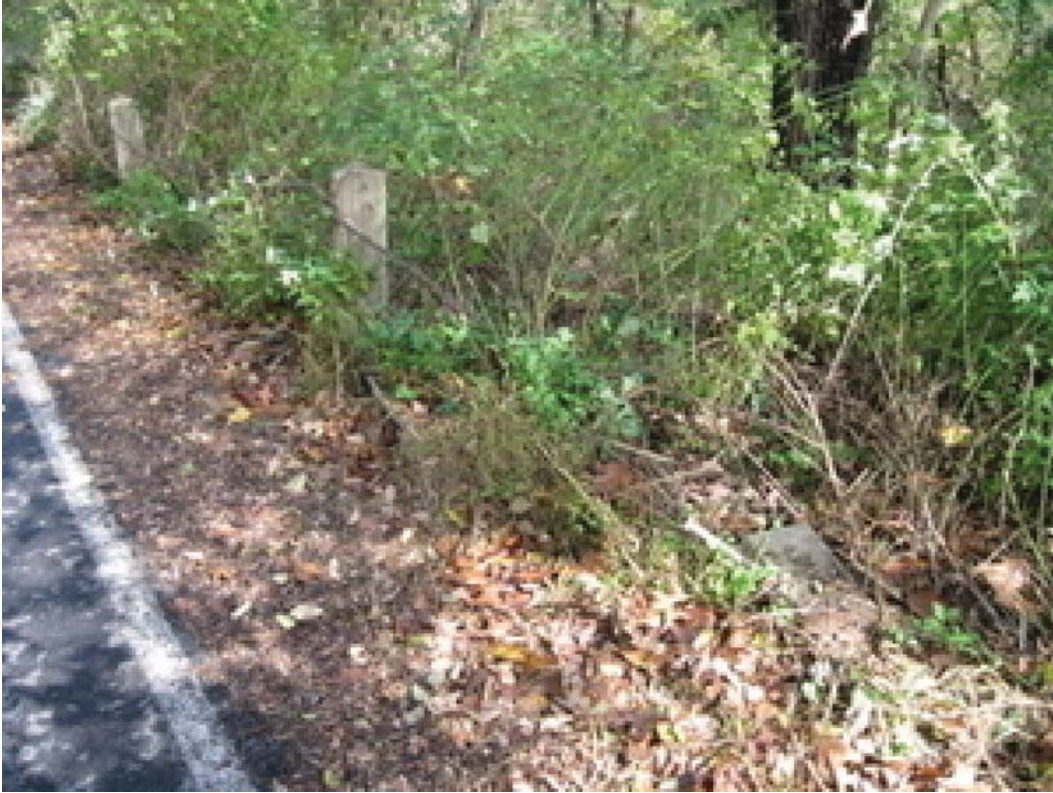
DEWA_0113_7.612_R_1.jpg

Barrier ID:	DEWA-0113-7.612-R				
Route Name:	NPS ROUTE 615				
Inspection Date:	10/06/2010	Barrier Rating:	34.00		
Barrier Description					
Type:	OTHER: 2-STRAND CABLE	Barrier Function:	TRAFFIC		
Barrier Material:	CABLE	Post Material:	OTHER: CONCRETE		
Blockout Type:	N/A	Length (ft.):	264		
Speed Limit (MPH):	35	Placement with Respect to Road:	INSIDE OF CURVE		
Hazard Behind Barrier:	LOW				
Barrier Crashworthiness					
Appropriate Test Level:	TL-2	Barrier Test Level:	NCW	Is Barrier Crashworthy?:	NO
Beg. End Trtmt Type:	NONE	Is Beg. End Trtmt Crashworthy?:	N/A	Approach Transition Type:	NONE
Ending End Trtmt Type:	NONE	Ending End Trtmt Crashworthy?:	N/A		
Average Measurements					
Design Height (In.):	27	Width (In.):	0.0	Post Spacing (In.):	102.0
Height (In.):	13.6	Lateral Offset (In.):	33.7	Road Grade (%):	0.20
Physical Condition					
Barrier	Alignment and Height:	60 ft of barrier is collapsed. Deflection of remaining barrier is less than 6 in. Height ranges between 11 and 15 in below 27-in design height.

Breaking and Cracking:	2 posts are broken and have exposed rebar.			
	Missing Elements:	No missing elements were observed.			
	Corrosion and Weathering:	No loss of cable cross section or erosion around posts observed.			
End Treatments	Alignment and Height:				
	Breaking and Cracking:				
	Missing Elements:				
	Corrosion and Weathering:

Repair Action:	REPLACE	FMSS Work Type:	CAPITAL IMPROVEMENT	Repair Cost:	\$32406
Brief Workorder:	Replace cable guardrail with Steel-Backed Timber w/o blockouts and 2 flared Steel-Backed Timber end treatments.				
Workorder:	Remove Cable Guardrail at \$5- per -Lin. Ft. for 264 LF = \$1320. Steel-Backed Timber w/o Blockout at \$60- per -Lin. Ft. for 204 LF = \$12240. SBT / Log Flared at \$5000- per -Each for 2 Unit(s) = \$10000. Low Speed Traffic Control at \$1475- per -Day for 4 Day(s) = \$5900. 2 days removal and 2 days installation.

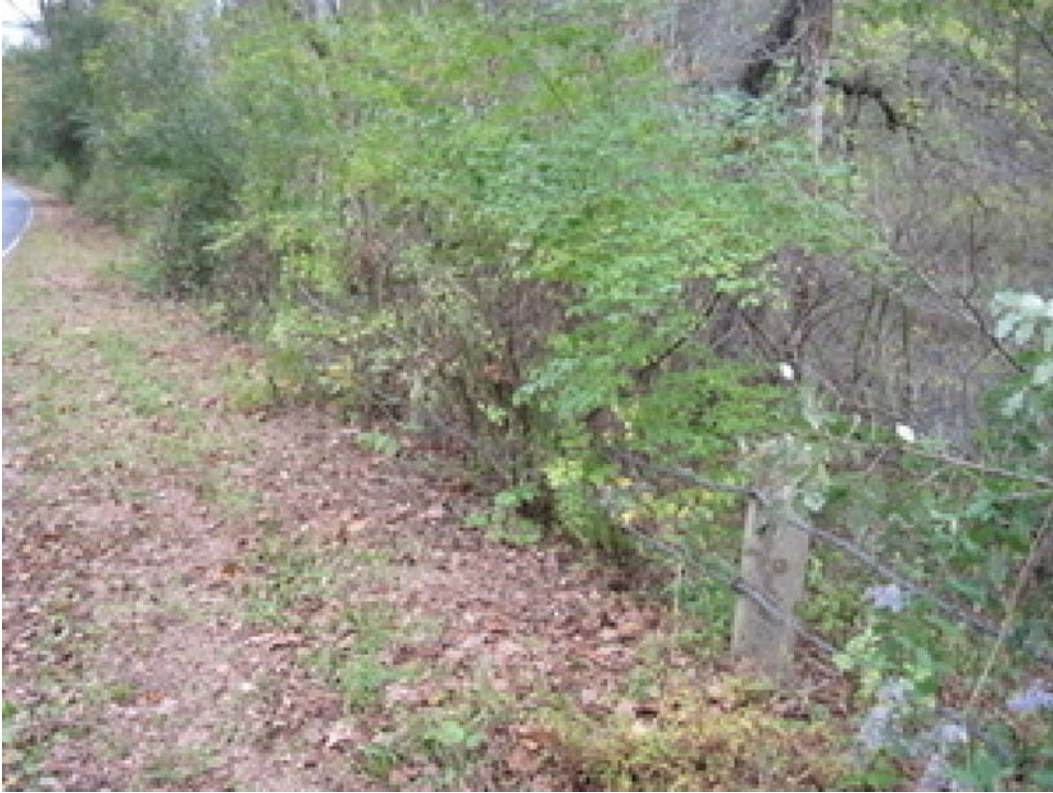
DEWA_0113_8.350_R_1.jpg

Barrier ID:	DEWA-0113-8.350-R				
Route Name:	NPS ROUTE 615				
Inspection Date:	10/06/2010	Barrier Rating:	55.00		
Barrier Description					
Type:	OTHER: 2-STRAND CABLE	Barrier Function:	TRAFFIC		
Barrier Material:	CABLE	Post Material:	OTHER: CONCRETE		
Blockout Type:	N/A	Length (ft.):	1140		
Speed Limit (MPH):	35	Placement with Respect to Road:	BOTH INSIDE AND OUTSIDE		
Hazard Behind Barrier:	MEDIUM				
Barrier Crashworthiness					
Appropriate Test Level:	TL-2	Barrier Test Level:	NCW	Is Barrier Crashworthy?:	NO
Beg. End Trtmt Type:	NONE	Is Beg. End Trtmt Crashworthy?:	N/A	Approach Transition Type:	NONE
Ending End Trtmt Type:	NONE	Ending End Trtmt Crashworthy?:	N/A		
Average Measurements					
Design Height (In.):	27	Width (In.):	0.0	Post Spacing (In.):	123.5
Height (In.):	16.0	Lateral Offset (In.):	79.0	Road Grade (%):	0.30
Physical Condition					
Barrier	Alignment and Height:	Alignment deflects 6 in to 12 in for 700 ft and greater than 12 in for 150 ft. Height ranges from 9 in to 15 in below 27 in design height.

Breaking and Cracking:	No breaking or cracking observed.			
	Missing Elements:	No missing elements observed.			
	Corrosion and Weathering:	No corrosion or weathering observed.			
End Treatments	Alignment and Height:				
	Breaking and Cracking:				
	Missing Elements:				
	Corrosion and Weathering:

Repair Action:	REPLACE	FMSS Work Type:	CAPITAL IMPROVEMENT	Repair Cost:	\$111925
Brief Workorder:	Replace cable guardrail with Steel-Backed Timber w/o blockouts and 2 flared end treatments.				
Workorder:	Remove Cable Guardrail at \$5- per -Lin. Ft. for 1240 LF = \$6200. Steel-Backed Timber w/o Blockout at \$60- per -Lin. Ft. for 1180 LF = \$70800. SBT / Log Flared at \$5000- per -Each for 2 Unit(s) = \$10000. Low Speed Traffic Control at \$1475- per -Day for 10 Day(s) = \$14750. 5 days removal and 5 days installation.

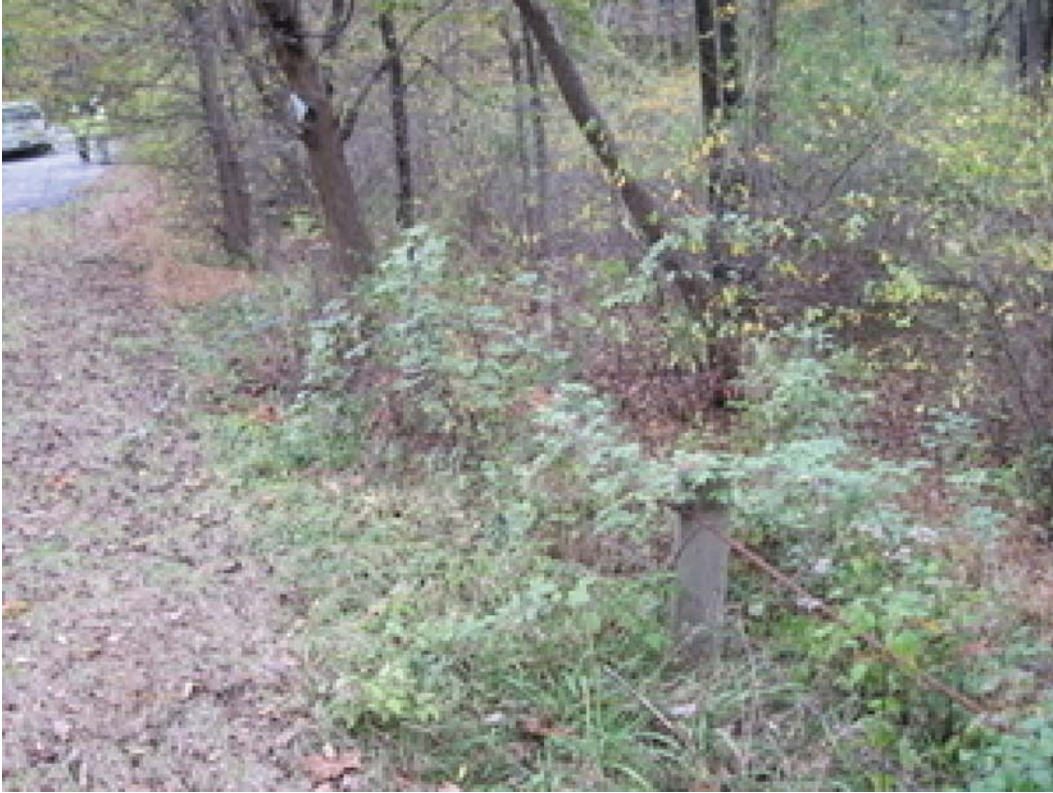
DEWA_0113_8.566_R_1.jpg

Barrier ID:	DEWA-0113-8.566-R				
Route Name:	NPS ROUTE 615				
Inspection Date:	10/06/2010	Barrier Rating:	15.50		
Barrier Description					
Type:	OTHER: 2-STRAND CABLE	Barrier Function:	NON-TRAFFIC		
Barrier Material:	CABLE	Post Material:	OTHER: CONCRETE		
Blockout Type:	N/A	Length (ft.):	125		
Speed Limit (MPH):	35	Placement with Respect to Road:	NON-TRAFFIC BARRIER		
Hazard Behind Barrier:	LOW				
Barrier Crashworthiness					
Appropriate Test Level:	TL-2	Barrier Test Level:	N/A	Is Barrier Crashworthy?:	N/A
Beg. End Trtmt Type:	NONE	Is Beg. End Trtmt Crashworthy?:	N/A	Approach Transition Type:	NONE
Ending End Trtmt Type:	NONE	Ending End Trtmt Crashworthy?:	N/A		
Average Measurements					
Design Height (In.):	27	Width (In.):	0.0	Post Spacing (In.):	119.3
Height (In.):	27.2	Lateral Offset (In.):	0.0	Road Grade (%):	0.00
Physical Condition					
Barrier	Alignment and Height:	No alignment deflection observed. Height ranges from 7 in below 27 in design height to 5 in over.

Breaking and Cracking:	No breaking or cracking observed in posts.			
	Missing Elements:	No missing elements observed.			
	Corrosion and Weathering:	No loss of cross section or erosion around posts observed.			
End Treatments	Alignment and Height:				
	Breaking and Cracking:				
	Missing Elements:				
	Corrosion and Weathering:

Repair Action:	REPLACE	FMSS Work Type:	CAPITAL IMPROVEMENT	Repair Cost:	\$21202
Brief Workorder:	Replace cable guardrail with Steel-Backed Timber w/o blockouts and 2 flared Steel-Backed Timber end treatments.				
Workorder:	Remove Cable Guardrail at \$5- per -Lin. Ft. for 125 LF = \$625. Steel-Backed Timber w/o Blockout at \$60- per -Lin. Ft. for 95 LF = \$5700. SBT / Log Flared at \$5000- per -Each for 2 Unit(s) = \$10000. Low Speed Traffic Control at \$1475- per -Day for 2 Day(s) = \$2950. 1 day removal and 1 day installation.

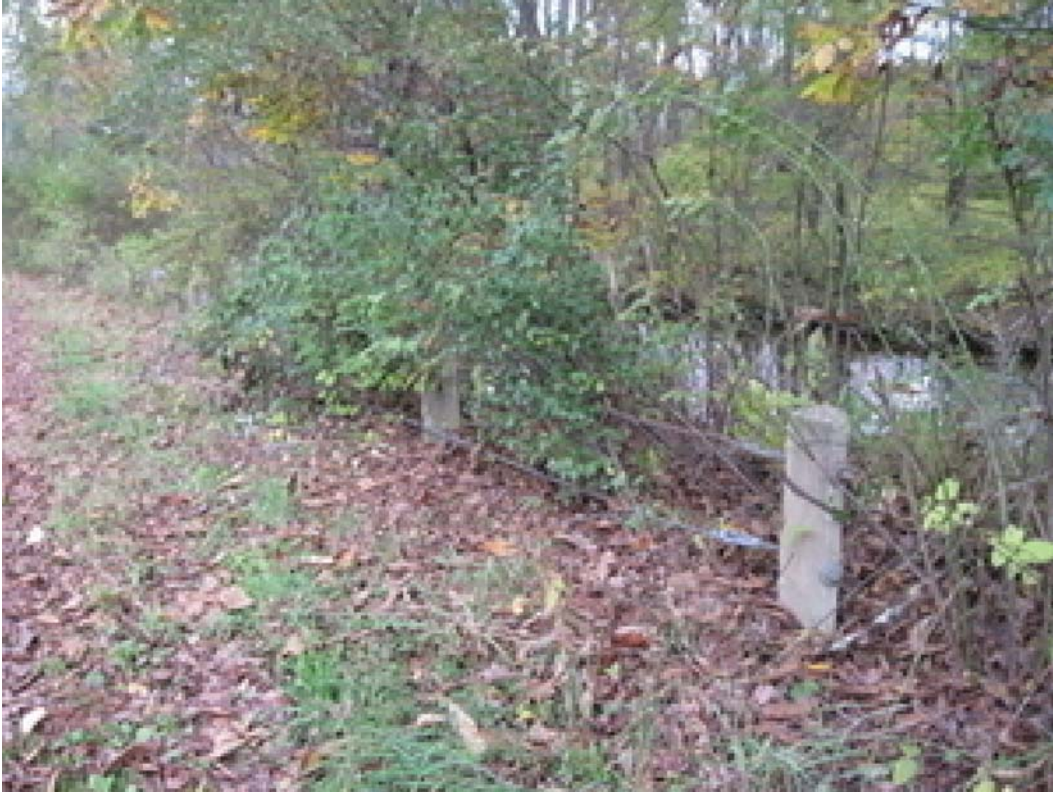
DEWA_0113_8.604_R_1.jpg

Barrier ID:	DEWA-0113-8.604-R				
Route Name:	NPS ROUTE 615				
Inspection Date:	10/06/2010	Barrier Rating:	18.60		
Barrier Description					
Type:	OTHER: 2-STRAND CABLE	Barrier Function:	NON-TRAFFIC		
Barrier Material:	CABLE	Post Material:	OTHER: CONCRETE		
Blockout Type:	N/A	Length (ft.):	173		
Speed Limit (MPH):	35	Placement with Respect to Road:	NON-TRAFFIC BARRIER		
Hazard Behind Barrier:	N/A				
Barrier Crashworthiness					
Appropriate Test Level:	TL-2	Barrier Test Level:	N/A	Is Barrier Crashworthy?:	N/A
Beg. End Trtmt Type:	NONE	Is Beg. End Trtmt Crashworthy?:	N/A	Approach Transition Type:	NONE
Ending End Trtmt Type:	NONE	Ending End Trtmt Crashworthy?:	N/A		
Average Measurements					
Design Height (In.):	27	Width (In.):	0.0	Post Spacing (In.):	117.0
Height (In.):	19.2	Lateral Offset (In.):	0.0	Road Grade (%):	0.00
Physical Condition					
Barrier	Alignment and Height:	Alignment deflects less than 3 in throughout barrier length. Height ranges between 7 and 9 in below 27 in design height along entire length.

Breaking and Cracking:	1 post is broken and has exposed rebar.			
	Missing Elements:	No missing elements observed.			
	Corrosion and Weathering:	No loss of cable cross section or erosion around posts observed.			
End Treatments	Alignment and Height:	NA			
	Breaking and Cracking:	NA			
	Missing Elements:	NA			
	Corrosion and Weathering:	NA

Repair Action:	REPLACE	FMSS Work Type:	CAPITAL IMPROVEMENT	Repair Cost:	\$19134
Brief Workorder:	Replace cable guardrail with Steel-Backed Timber w/o blockouts and one flared end treatment. Tie in to adjacent traffic barrier.				
Workorder:	Remove Cable Guardrail at \$5- per -Lin. Ft. for 173 LF = \$865. Remove cable guardrail Steel-Backed Timber w/o Blockout at \$60- per -Lin. Ft. for 143 LF = \$8580. SBT / Log Flared at \$5000- per -Each for 1 Unit(s) = \$5000. Low Speed Traffic Control at \$1475- per -Day for 2 Day(s) = \$2950. 1 day removal and 1 day installation.

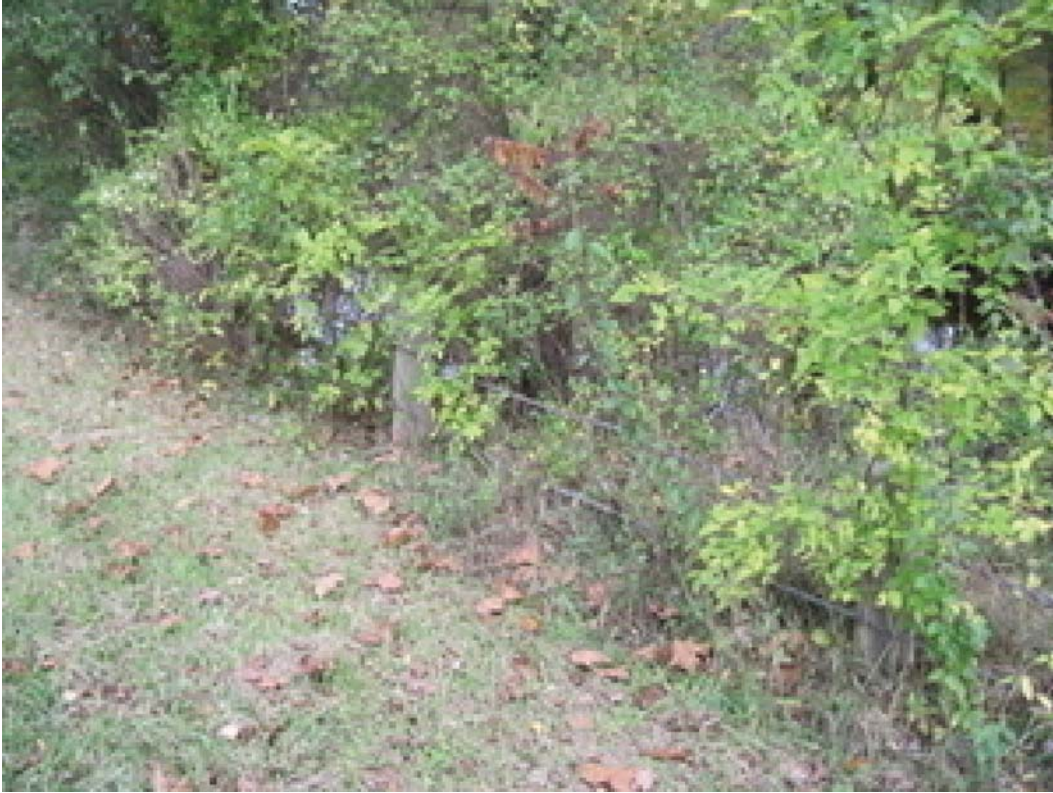
DEWA_0113_8.637_R_1.jpg

Barrier ID:	DEWA-0113-8.637-R				
Route Name:	NPS ROUTE 615				
Inspection Date:	10/06/2010	Barrier Rating:	35.00		
Barrier Description					
Type:	OTHER: 2-STRAND CABLE	Barrier Function:	TRAFFIC		
Barrier Material:	CABLE	Post Material:	OTHER: CONCRETE		
Blockout Type:	N/A	Length (ft.):	501		
Speed Limit (MPH):	35	Placement with Respect to Road:	TANGENT		
Hazard Behind Barrier:	MEDIUM				
Barrier Crashworthiness					
Appropriate Test Level:	TL-2	Barrier Test Level:	NCW	Is Barrier Crashworthy?:	NO
Beg. End Trtmt Type:	NONE	Is Beg. End Trtmt Crashworthy?:	N/A	Approach Transition Type:	NONE
Ending End Trtmt Type:	NONE	Ending End Trtmt Crashworthy?:	N/A		
Average Measurements					
Design Height (In.):	27	Width (In.):	0.0	Post Spacing (In.):	121.6
Height (In.):	20.0	Lateral Offset (In.):	68.6	Road Grade (%):	2.30
Physical Condition					
Barrier	Alignment and Height:	Alignment deflects 6 to 12 in along 200 ft of barrier. Height ranges between 3 and 11 in below 27 in design height along entire length.

Breaking and Cracking:	11 posts are broken and have exposed rebar.			
	Missing Elements:	No missing elements observed.			
	Corrosion and Weathering:	No loss of cross section or erosion around posts observed.			
End Treatments	Alignment and Height:	NA			
	Breaking and Cracking:	NA			
	Missing Elements:	NA			
	Corrosion and Weathering:	NA

Repair Action:	REPLACE	FMSS Work Type:	CAPITAL IMPROVEMENT	Repair Cost:	\$45832
Brief Workorder:	Replace cable guardrail with Steel-Backed Timber w/o blockouts and one flared end treatment. Tie into adjacent non-traffic barrier in the pullout.				
Workorder:	Remove Cable Guardrail at \$5- per -Lin. Ft. for 501 LF = \$2505. Remove cable guardrail Steel-Backed Timber w/o Blockout at \$60- per -Lin. Ft. for 471 LF = \$28260. SBT / Log Flared at \$5000- per -Each for 1 Unit(s) = \$5000. Low Speed Traffic Control at \$1475- per -Day for 4 Day(s) = \$5900. 2 days removal and 2 days installation.
