NPS Guardwall/Rail Inventory Program Delaware Water Gap National Recreation Area

**Federal Lands Highway
Road Inventory Program**

Federal Highway Administration
Eastern Federal Lands Highway Division
Road Inventory Program (RIP)

Data Collection Date: October 2010
Report Date: December 2015

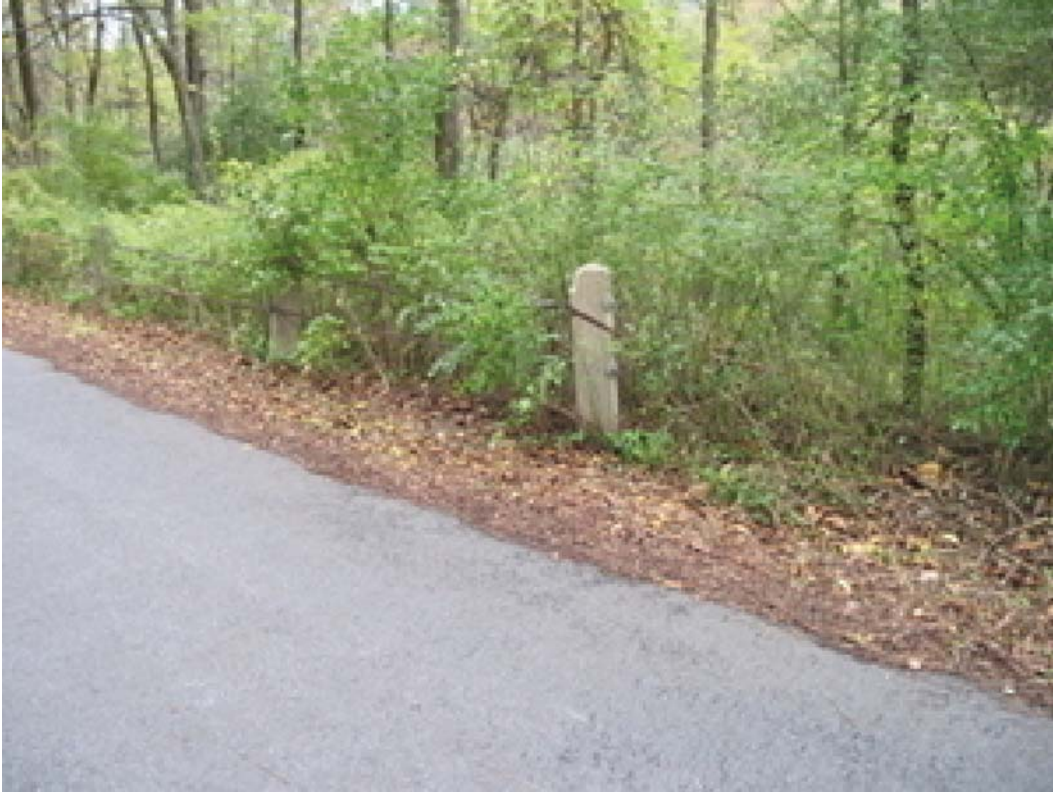
DEWA_0113_8.824_R_1.jpg

Barrier ID:	DEWA-0113-8.824-R				
Route Name:	NPS ROUTE 615				
Inspection Date:	10/06/2010	Barrier Rating:	49.40		
Barrier Description					
Type:	OTHER: 2-STRAND CABLE	Barrier Function:	TRAFFIC		
Barrier Material:	CABLE	Post Material:	OTHER: CONCRETE		
Blockout Type:	N/A	Length (ft.):	877		
Speed Limit (MPH):	35	Placement with Respect to Road:	BOTH INSIDE AND OUTSIDE		
Hazard Behind Barrier:	MEDIUM				
Barrier Crashworthiness					
Appropriate Test Level:	TL-2	Barrier Test Level:	NCW	Is Barrier Crashworthy?:	NO
Beg. End Trtmt Type:	NONE	Is Beg. End Trtmt Crashworthy?:	N/A	Approach Transition Type:	NONE
Ending End Trtmt Type:	NONE	Ending End Trtmt Crashworthy?:	N/A		
Average Measurements					
Design Height (In.):	27	Width (In.):	0.0	Post Spacing (In.):	120.0
Height (In.):	23.2	Lateral Offset (In.):	43.5	Road Grade (%):	0.90
Physical Condition					
Barrier	Alignment and Height:	250 ft of barrier is 3 - 12 in below 27-in design height. Remainder of barrier ranges from 1 in above to 3 in below the design height. 80ft. of barrier is out of alignment by 6 - 12 ines 140ft. is out of alignment by 12 ines or more.

Breaking and Cracking:	5 posts are broken and have exposed rebar.			
	Missing Elements:	No missing elements were observed.			
	Corrosion and Weathering:	No loss of cross section or erosion around posts observed.			
End Treatments	Alignment and Height:				
	Breaking and Cracking:				
	Missing Elements:				
	Corrosion and Weathering:

Repair Action:	REPLACE	FMSS Work Type:	CAPITAL IMPROVEMENT	Repair Cost:	\$82726
Brief Workorder:	Replace cable guardrail with Steel-Backed Timber w/o blockouts and 2 flared end treatments.				
Workorder:	Remove Cable Guardrail at \$5- per -Lin. Ft. for 877 LF = \$4385. Steel-Backed Timber w/o Blockout at \$60- per -Lin. Ft. for 817 LF = \$49020. SBT / Log Flared at \$5000- per -Each for 2 Unit(s) = \$10000. Low Speed Traffic Control at \$1475- per -Day for 8 Day(s) = \$11800. 4 days removal and 4 days installation.

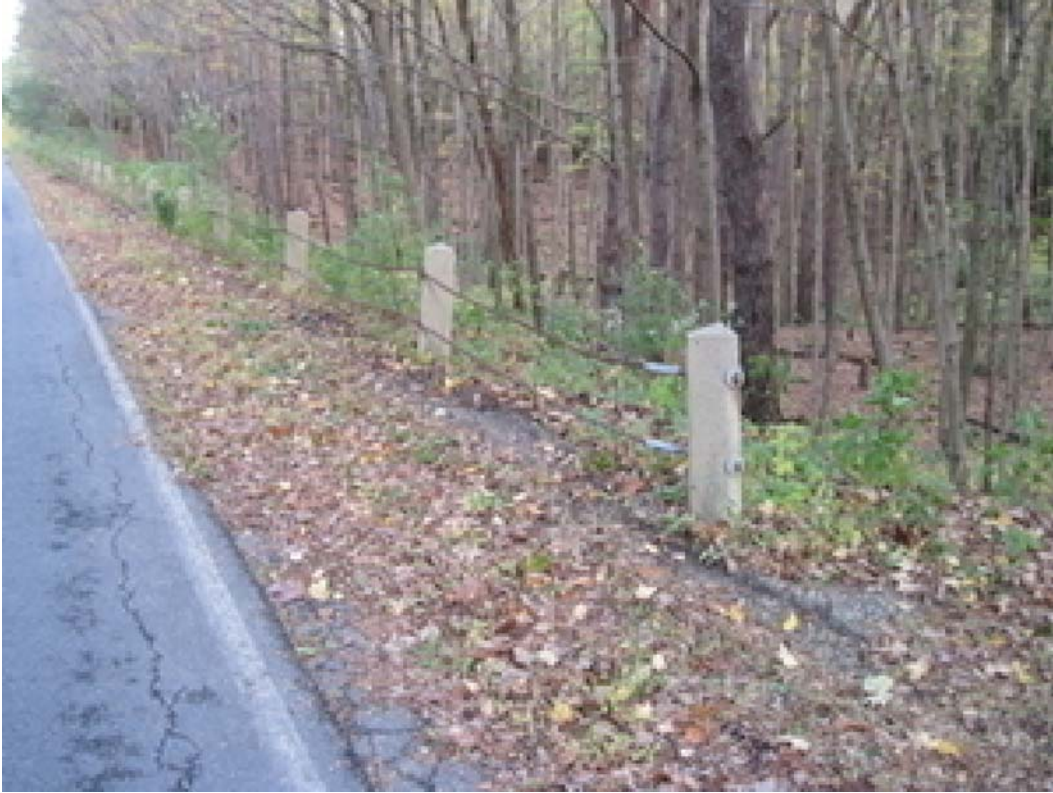
DEWA_0113_9.261_R_1.jpg

Barrier ID:	DEWA-0113-9.261-R				
Route Name:	NPS ROUTE 615				
Inspection Date:	10/06/2010	Barrier Rating:	25.30		
Barrier Description					
Type:	OTHER: 2-STRAND CABLE	Barrier Function:	TRAFFIC		
Barrier Material:	CABLE	Post Material:	OTHER: CONCRETE		
Blockout Type:	N/A	Length (ft.):	236		
Speed Limit (MPH):	35	Placement with Respect to Road:	TANGENT		
Hazard Behind Barrier:	LOW				
Barrier Crashworthiness					
Appropriate Test Level:	TL-2	Barrier Test Level:	NCW	Is Barrier Crashworthy?:	NO
Beg. End Trtmt Type:	NONE	Is Beg. End Trtmt Crashworthy?:	N/A	Approach Transition Type:	NONE
Ending End Trtmt Type:	NONE	Ending End Trtmt Crashworthy?:	N/A		
Average Measurements					
Design Height (In.):	27	Width (In.):	0.0	Post Spacing (In.):	121.3
Height (In.):	20.2	Lateral Offset (In.):	58.0	Road Grade (%):	2.00
Physical Condition					
Barrier	Alignment and Height:	Alignment deflects less than 6 in along entire length. Height ranges between 5 and 9 in below 27 in design height along entire length.

Breaking and Cracking:	No breaking or cracking observed in posts.			
	Missing Elements:	No missing elements observed.			
	Corrosion and Weathering:	No loss of cable cross section or erosion around posts observed.			
End Treatments	Alignment and Height:	NA			
	Breaking and Cracking:	NA			
	Missing Elements:	NA			
	Corrosion and Weathering:	NA

Repair Action:	REPLACE	FMSS Work Type:	CAPITAL IMPROVEMENT	Repair Cost:	\$27159
Brief Workorder:	Replace cable guardrail with Steel-Backed Timber w/o blockouts and 2 flared end treatments.				
Workorder:	Remove Cable Guardrail at \$5- per -Lin. Ft. for 236 LF = \$1180. Remove cable guardrail. Steel-Backed Timber w/o Blockout at \$60- per -Lin. Ft. for 176 LF = \$10560. SBT / Log Flared at \$5000- per -Each for 2 Unit(s) = \$10000. Low Speed Traffic Control at \$1475- per -Day for 2 Day(s) = \$2950. 1 day removal and 1 day installation.

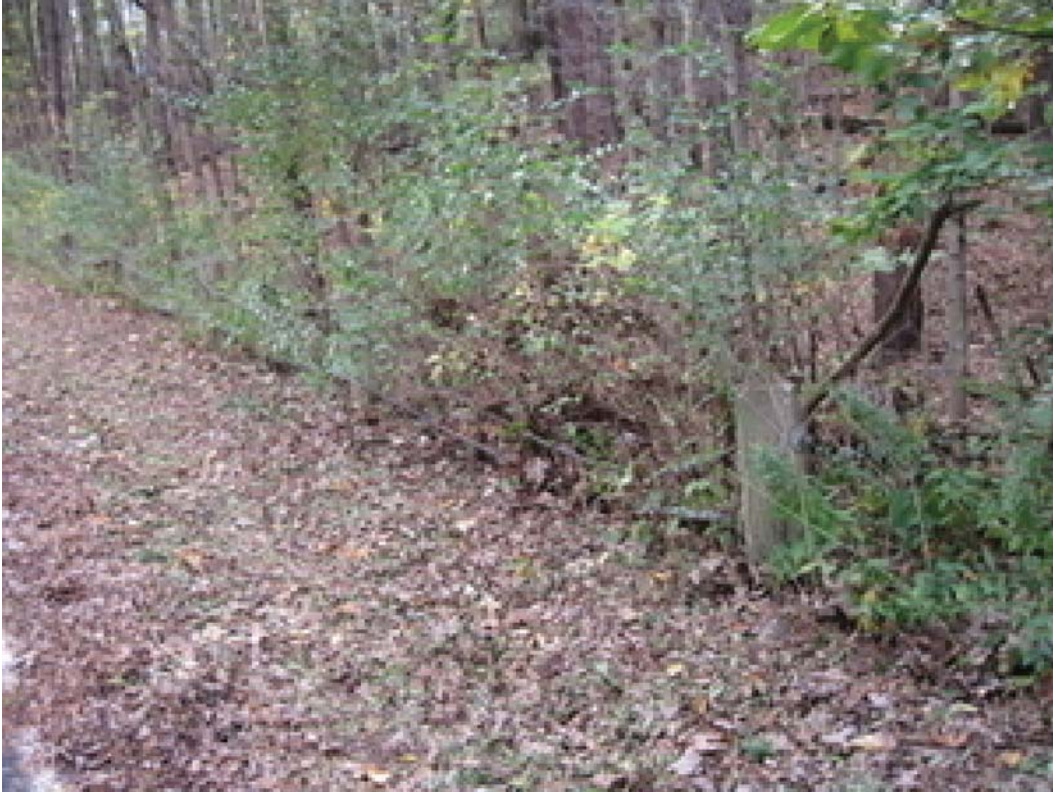
DEWA_0113_9.269_L_1.jpg

Barrier ID:	DEWA-0113-9.269-L				
Route Name:	NPS ROUTE 615				
Inspection Date:	10/06/2010	Barrier Rating:	21.20		
Barrier Description					
Type:	OTHER: 2-STRAND CABLE	Barrier Function:	TRAFFIC		
Barrier Material:	CABLE	Post Material:	OTHER: CONCRETE		
Blockout Type:	N/A	Length (ft.):	162		
Speed Limit (MPH):	35	Placement with Respect to Road:	TANGENT		
Hazard Behind Barrier:	LOW				
Barrier Crashworthiness					
Appropriate Test Level:	TL-2	Barrier Test Level:	NCW	Is Barrier Crashworthy?:	NO
Beg. End Trtmt Type:	NONE	Is Beg. End Trtmt Crashworthy?:	N/A	Approach Transition Type:	NONE
Ending End Trtmt Type:	NONE	Ending End Trtmt Crashworthy?:	N/A		
Average Measurements					
Design Height (In.):	27	Width (In.):	0.0	Post Spacing (In.):	117.6
Height (In.):	21.7	Lateral Offset (In.):	74.3	Road Grade (%):	2.50
Physical Condition					
Barrier	Alignment and Height:	No alignment deflection observed. Height ranges from 2 in to 8 in below 27 in design height.

Breaking and Cracking:	No breaking or cracking observed in posts.			
	Missing Elements:	No missing elements observed.			
	Corrosion and Weathering:	No loss of cable cross section or erosion around posts observed.			
End Treatments	Alignment and Height:				
	Breaking and Cracking:				
	Missing Elements:				
	Corrosion and Weathering:

Repair Action:	REPLACE	FMSS Work Type:	CAPITAL IMPROVEMENT	Repair Cost:	\$21868
Brief Workorder:	Replace cable guardrail with Steel-Backed Timber w/o blockouts and 2 flared end treatments.				
Workorder:	Remove Cable Guardrail at \$5- per -Lin. Ft. for 162 LF = \$810. Steel-Backed Timber w/o Blockout at \$60- per -Lin. Ft. for 102 LF = \$6120. SBT / Log Flared at \$5000- per -Each for 2 Unit(s) = \$10000. Low Speed Traffic Control at \$1475- per -Day for 2 Day(s) = \$2950. 1 day removal and 1 day installation.

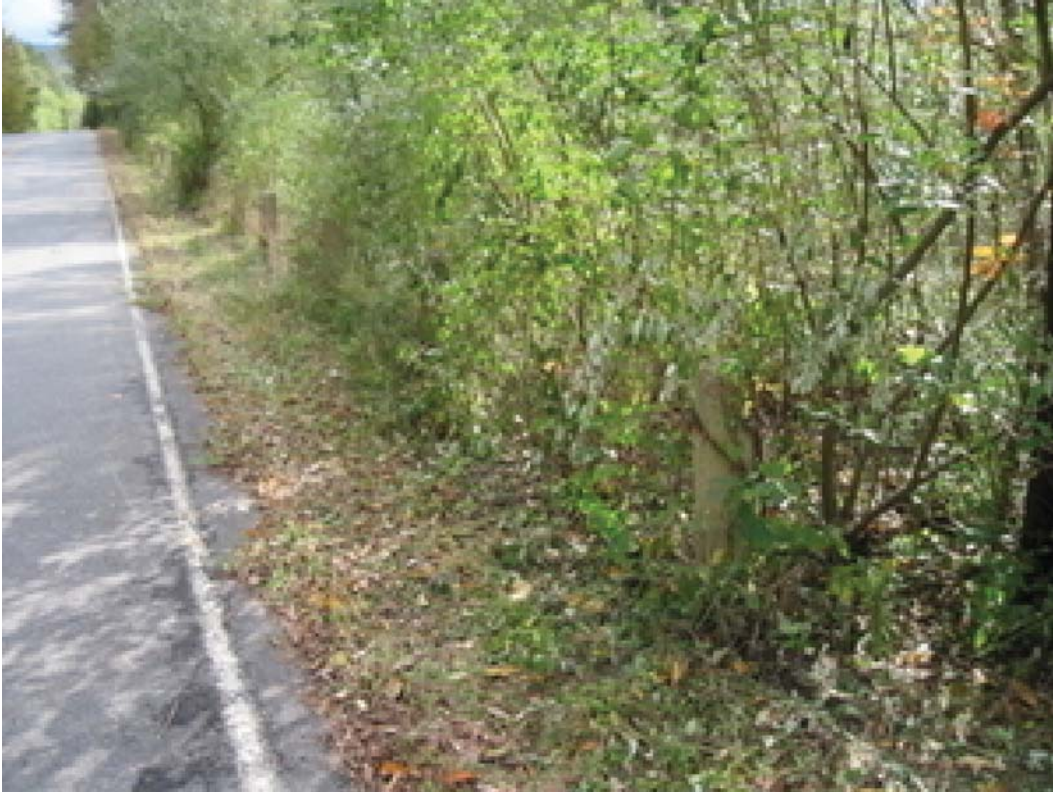
DEWA_0113_9.329_L_1.jpg

Barrier ID:	DEWA-0113-9.329-L				
Route Name:	NPS ROUTE 615				
Inspection Date:	10/06/2010	Barrier Rating:	21.20		
Barrier Description					
Type:	OTHER: 2-STRAND CABLE	Barrier Function:	TRAFFIC		
Barrier Material:	CABLE	Post Material:	OTHER: CONCRETE		
Blockout Type:	N/A	Length (ft.):	190		
Speed Limit (MPH):	35	Placement with Respect to Road:	TANGENT		
Hazard Behind Barrier:	LOW				
Barrier Crashworthiness					
Appropriate Test Level:	TL-2	Barrier Test Level:	NCW	Is Barrier Crashworthy?:	NO
Beg. End Trtmt Type:	NONE	Is Beg. End Trtmt Crashworthy?:	N/A	Approach Transition Type:	NONE
Ending End Trtmt Type:	NONE	Ending End Trtmt Crashworthy?:	N/A		
Average Measurements					
Design Height (In.):	27	Width (In.):	0.0	Post Spacing (In.):	122.3
Height (In.):	21.2	Lateral Offset (In.):	51.7	Road Grade (%):	1.00
Physical Condition					
Barrier	Alignment and Height:	Alignment deflects 6 in to 12 in for 20 ft. Height ranges from 5 in to 6 in below 27 in design height.

Breaking and Cracking:	No breaking or cracking observed in posts.			
	Missing Elements:	No missing elements observed.			
	Corrosion and Weathering:	No loss of cable cross section or erosion around posts observed.			
End Treatments	Alignment and Height:				
	Breaking and Cracking:				
	Missing Elements:				
	Corrosion and Weathering:

Repair Action:	REPLACE	FMSS Work Type:	CAPITAL IMPROVEMENT	Repair Cost:	\$23870
Brief Workorder:	Replace cable guardrail with Steel-Backed Timber w/o blockouts and 2 flared end treatments.				
Workorder:	Remove Cable Guardrail at \$5- per -Lin. Ft. for 190 LF = \$950. Steel-Backed Timber w/o Blockout at \$60- per -Lin. Ft. for 130 LF = \$7800. SBT / Log Flared at \$5000- per -Each for 2 Unit(s) = \$10000. Low Speed Traffic Control at \$1475- per -Day for 2 Day(s) = \$2950. 1 day removal and 1 day installation.

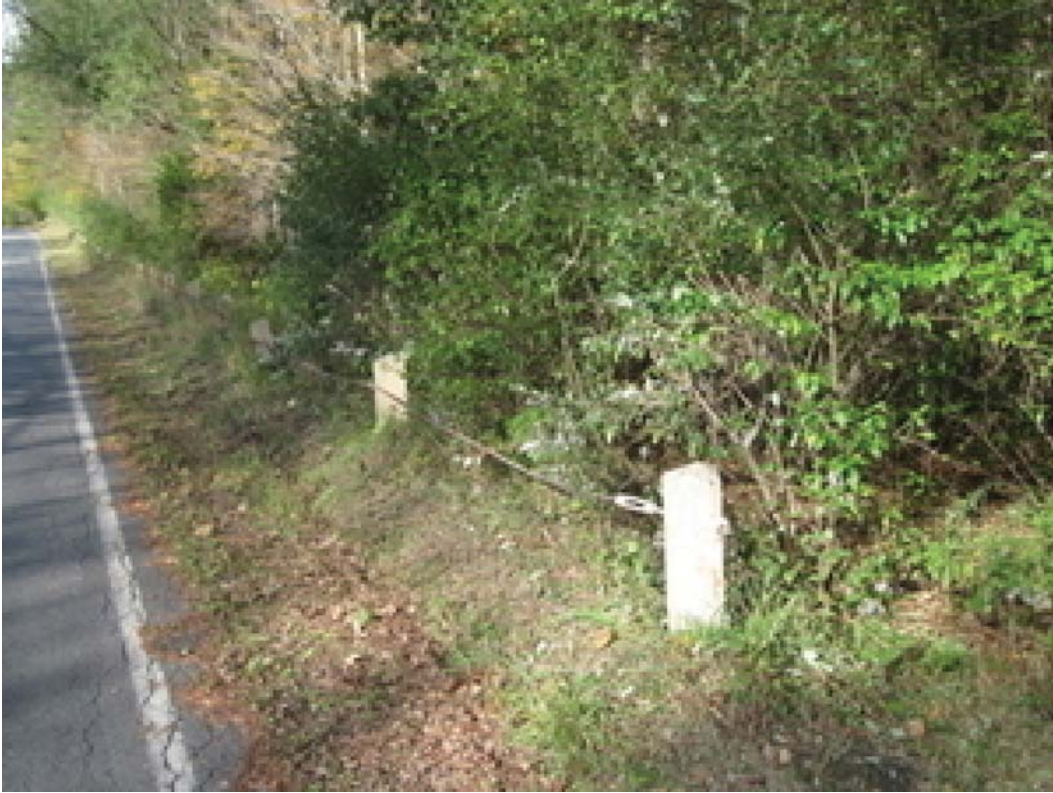
DEWA_0113_9.330_R_1.jpg

Barrier ID:	DEWA-0113-9.330-R				
Route Name:	NPS ROUTE 615				
Inspection Date:	10/06/2010	Barrier Rating:	25.30		
Barrier Description					
Type:	OTHER: 2-STRAND CABLE	Barrier Function:	TRAFFIC		
Barrier Material:	CABLE	Post Material:	OTHER: CONCRETE		
Blockout Type:	N/A	Length (ft.):	232		
Speed Limit (MPH):	35	Placement with Respect to Road:	TANGENT		
Hazard Behind Barrier:	LOW				
Barrier Crashworthiness					
Appropriate Test Level:	TL-2	Barrier Test Level:	NCW	Is Barrier Crashworthy?:	NO
Beg. End Trtmt Type:	NONE	Is Beg. End Trtmt Crashworthy?:	N/A	Approach Transition Type:	NONE
Ending End Trtmt Type:	NONE	Ending End Trtmt Crashworthy?:	N/A		
Average Measurements					
Design Height (In.):	27	Width (In.):	0.0	Post Spacing (In.):	119.3
Height (In.):	19.0	Lateral Offset (In.):	68.3	Road Grade (%):	1.20
Physical Condition					
Barrier	Alignment and Height:	Alignment deflects less than 6 in along entire length. Height ranges between 6 and 11 in below 27 in design height along entire length.

Breaking and Cracking:	2 posts are broken and on the ground.			
	Missing Elements:	No missing elements observed.			
	Corrosion and Weathering:	No loss of cross section or erosion around posts observed.			
End Treatments	Alignment and Height:	NA			
	Breaking and Cracking:	NA			
	Missing Elements:	NA			
	Corrosion and Weathering:	NA

Repair Action:	REPLACE	FMSS Work Type:	CAPITAL IMPROVEMENT	Repair Cost:	\$26873
Brief Workorder:	Replace cable guardrail with Steel-Backed Timber w/o blockouts and 2 flared end treatments.				
Workorder:	Remove Cable Guardrail at \$5- per -Lin. Ft. for 232 LF = \$1160. Remove cable guardrail. Steel-Backed Timber w/o Blockout at \$60- per -Lin. Ft. for 172 LF = \$10320. SBT / Log Flared at \$5000- per -Each for 2 Unit(s) = \$10000. Low Speed Traffic Control at \$1475- per -Day for 2 Day(s) = \$2950. 1 day removal and 1 day installation.

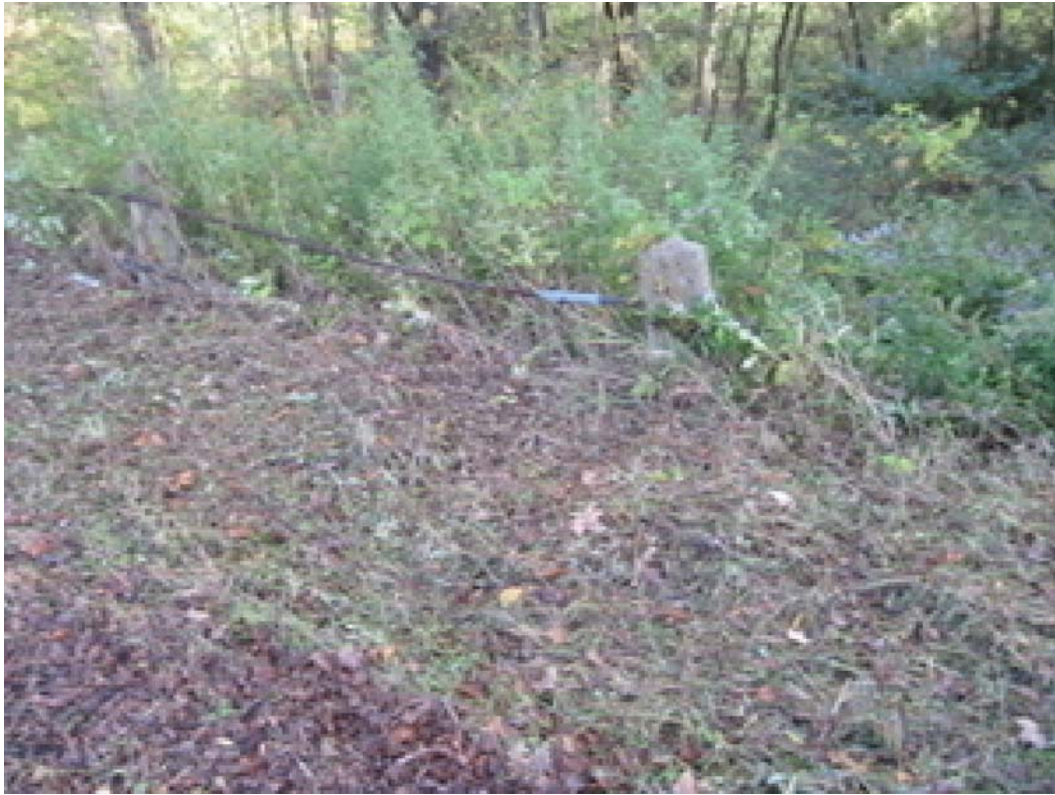
DEWA_0113_9.458_R_1.jpg

Barrier ID:	DEWA-0113-9.458-R				
Route Name:	NPS ROUTE 615				
Inspection Date:	10/07/2010	Barrier Rating:	30.70		
Barrier Description					
Type:	OTHER: 2-STRAND CABLE	Barrier Function:	TRAFFIC		
Barrier Material:	CABLE	Post Material:	OTHER: CONCRETE		
Blockout Type:	N/A	Length (ft.):	291		
Speed Limit (MPH):	35	Placement with Respect to Road:	TANGENT		
Hazard Behind Barrier:	MEDIUM				
Barrier Crashworthiness					
Appropriate Test Level:	TL-2	Barrier Test Level:	NCW	Is Barrier Crashworthy?:	NO
Beg. End Trtmt Type:	NONE	Is Beg. End Trtmt Crashworthy?:	N/A	Approach Transition Type:	NONE
Ending End Trtmt Type:	NONE	Ending End Trtmt Crashworthy?:	N/A		
Average Measurements					
Design Height (In.):	27	Width (In.):	0.0	Post Spacing (In.):	120.6
Height (In.):	21.0	Lateral Offset (In.):	61.2	Road Grade (%):	1.10
Physical Condition					
Barrier	Alignment and Height:	No alignment deflection observed. Height ranges from 5 in to 7 in below 27 in design height.

Breaking and Cracking:	No breaking or cracking observed in posts.			
	Missing Elements:	No missing elements observed.			
	Corrosion and Weathering:	No loss of cable cross section or erosion around posts observed.			
End Treatments	Alignment and Height:				
	Breaking and Cracking:				
	Missing Elements:				
	Corrosion and Weathering:

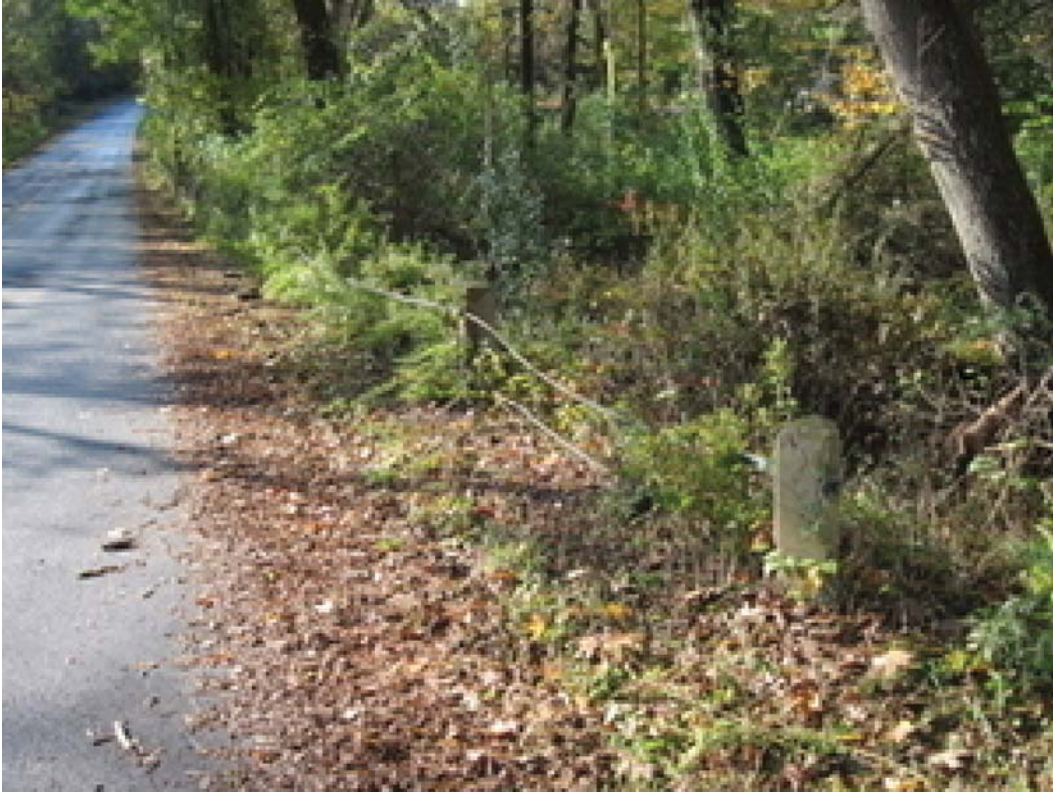
DEWA_0113_9.460_L_1.jpg

Barrier ID:	DEWA-0113-9.460-L				
Route Name:	NPS ROUTE 615				
Inspection Date:	10/07/2010	Barrier Rating:	28.20		
Barrier Description					
Type:	OTHER: 2-STRAND CABLE	Barrier Function:	TRAFFIC		
Barrier Material:	CABLE	Post Material:	OTHER: CONCRETE		
Blockout Type:	N/A	Length (ft.):	436		
Speed Limit (MPH):	35	Placement with Respect to Road:	TANGENT		
Hazard Behind Barrier:	LOW				
Barrier Crashworthiness					
Appropriate Test Level:	TL-2	Barrier Test Level:	NCW	Is Barrier Crashworthy?:	NO
Beg. End Trtmt Type:	NONE	Is Beg. End Trtmt Crashworthy?:	N/A	Approach Transition Type:	NONE
Ending End Trtmt Type:	NONE	Ending End Trtmt Crashworthy?:	N/A		
Average Measurements					
Design Height (In.):	27	Width (In.):	0.0	Post Spacing (In.):	122.3
Height (In.):	23.0	Lateral Offset (In.):	61.2	Road Grade (%):	2.50
Physical Condition					
Barrier	Alignment and Height:	30 ft of barrier is tipping backwards out of alignment by more than 12 in. 220 ft of barrier is 3 - 6 in below 27-in design height. The rest of the barrier has no deflection and is 3 in below design height.

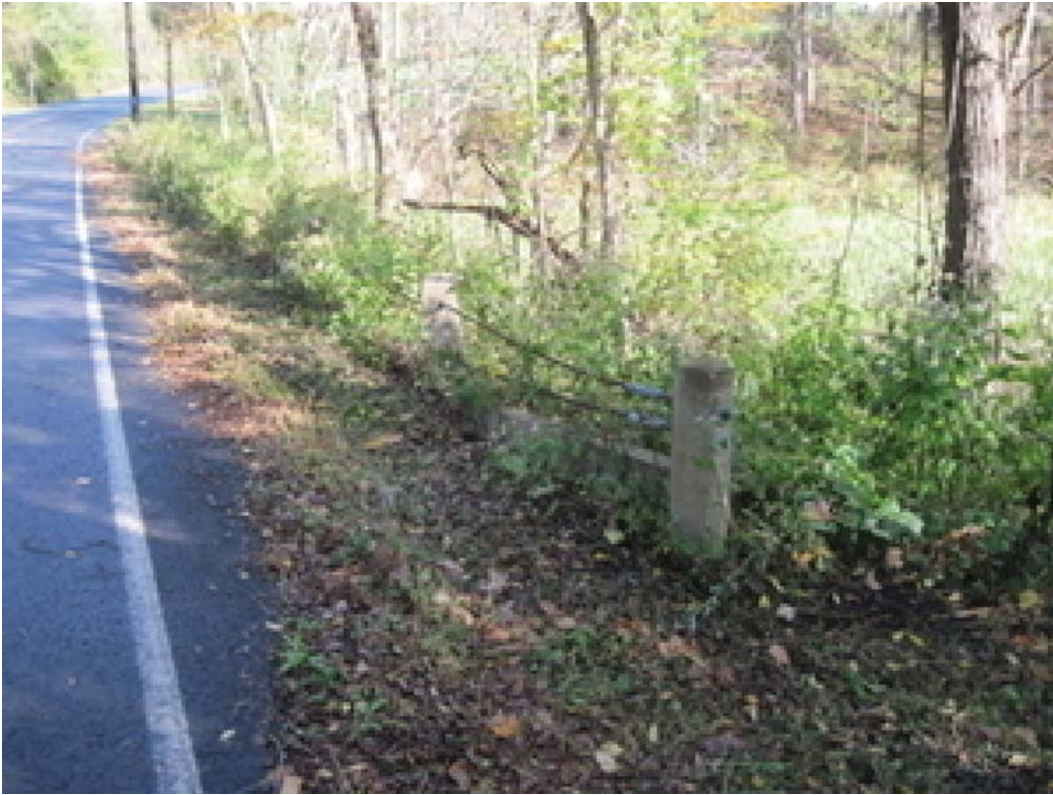
DEWA_0113_9.524_R_1.jpg

Barrier ID:	DEWA-0113-9.524-R				
Route Name:	NPS ROUTE 615				
Inspection Date:	10/07/2010	Barrier Rating:	21.20		
Barrier Description					
Type:	OTHER: 2-STRAND CABLE	Barrier Function:	TRAFFIC		
Barrier Material:	CABLE	Post Material:	OTHER: CONCRETE		
Blockout Type:	N/A	Length (ft.):	101		
Speed Limit (MPH):	35	Placement with Respect to Road:	TANGENT		
Hazard Behind Barrier:	LOW				
Barrier Crashworthiness					
Appropriate Test Level:	TL-2	Barrier Test Level:	NCW	Is Barrier Crashworthy?:	NO
Beg. End Trtmt Type:	NONE	Is Beg. End Trtmt Crashworthy?:	N/A	Approach Transition Type:	NONE
Ending End Trtmt Type:	NONE	Ending End Trtmt Crashworthy?:	N/A		
Average Measurements					
Design Height (In.):	27	Width (In.):	0.0	Post Spacing (In.):	124.6
Height (In.):	21.0	Lateral Offset (In.):	58.2	Road Grade (%):	5.00
Physical Condition					
Barrier	Alignment and Height:	No alignment deflection observed. Height ranges between 4 and 8 in below 27 in design height along entire length.

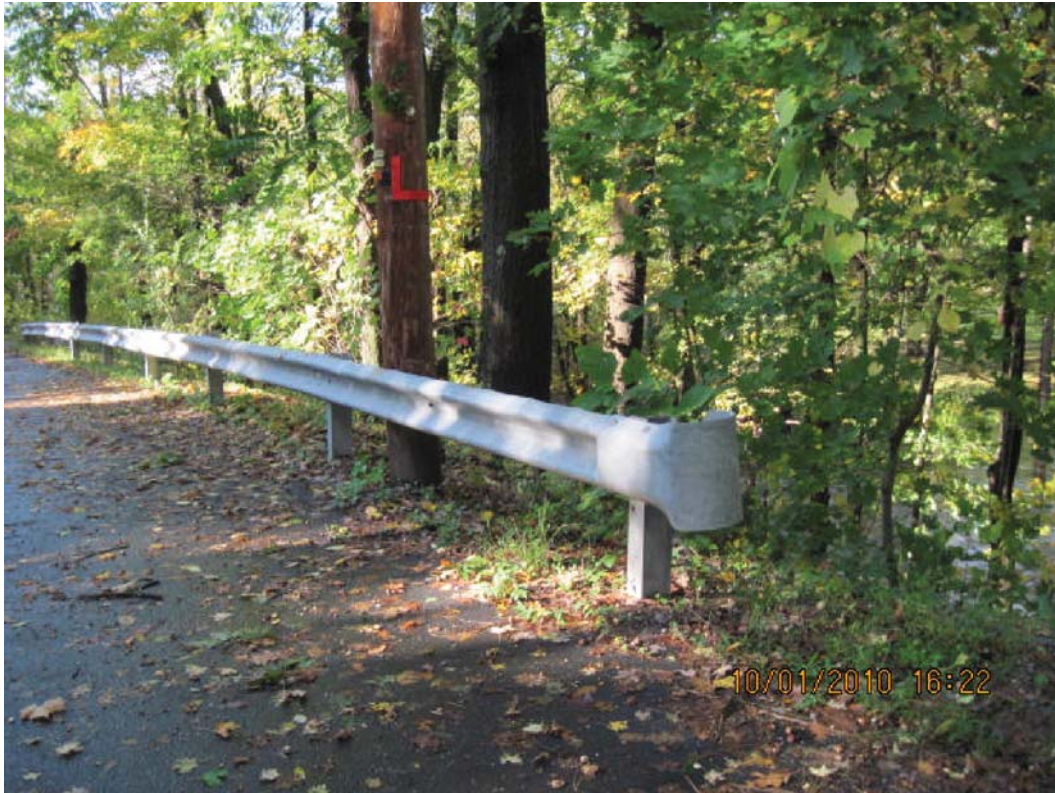
DEWA_0115_0.005_R_1.jpg

Barrier ID:	DEWA-0115-0.005-R				
Route Name:	ICE HOUSE ROAD				
Inspection Date:	10/01/2010	Barrier Rating:	25.50		
Barrier Description					
Type:	W-BEAM WEAK POST	Barrier Function:	TRAFFIC		
Barrier Material:	GALVANIZED STEEL	Post Material:	GALVANIZED STEEL		
Blockout Type:	N/A	Length (ft.):	175		
Speed Limit (MPH):	25	Placement with Respect to Road:	INSIDE OF CURVE		
Hazard Behind Barrier:	HIGH				
Barrier Crashworthiness					
Appropriate Test Level:	TL-1	Barrier Test Level:	TL-2	Is Barrier Crashworthy?:	YES
Beg. End Trtmt Type:	W-BEAM TRAILING END	Is Beg. End Trtmt Crashworthy?:	YES	Approach Transition Type:	RIGID W-BEAM - W-BEAM
Ending End Trtmt Type:	NONE	Ending End Trtmt Crashworthy?:	N/A		
Average Measurements					
Design Height (In.):	27	Width (In.):	0.0	Post Spacing (In.):	124.5
Height (In.):	26.5	Lateral Offset (In.):	30.2	Road Grade (%):	6.70
Physical Condition					
Barrier	Alignment and Height:	No deflections in alignment observed. 150 ft of barrier is 1 in or less below or exceeds 27 in design height by 1 in. 25 ft of barrier is 1 to 3 in below 27 in design height.

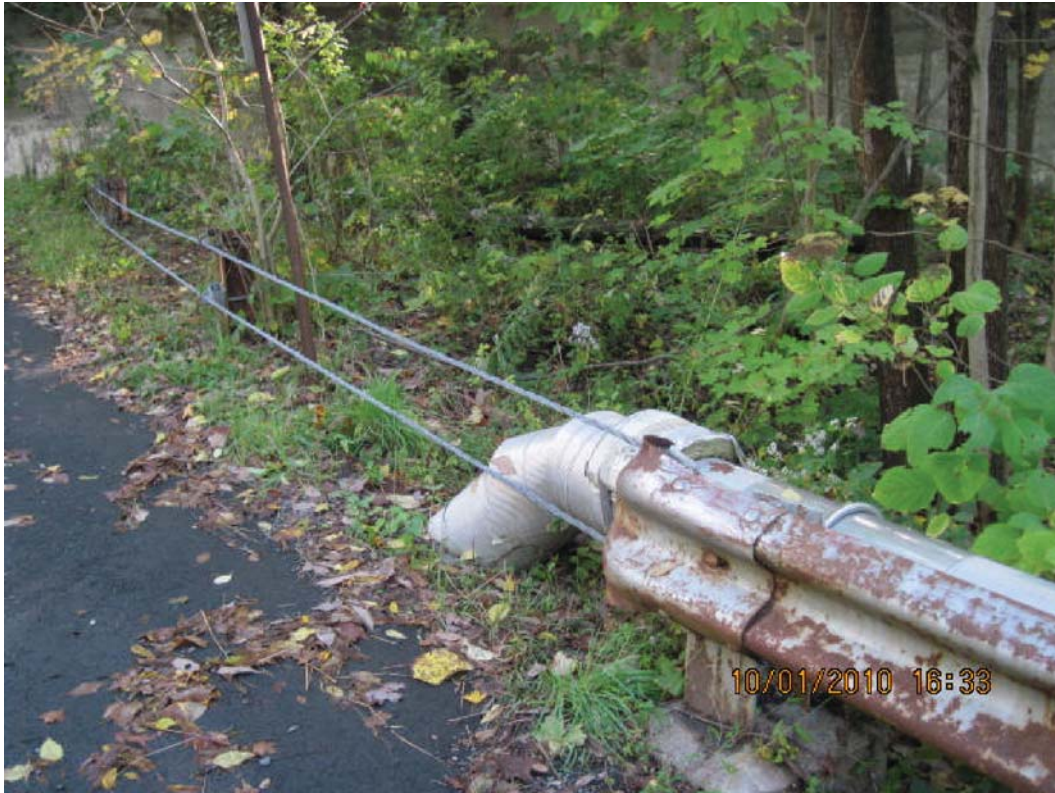
DEWA_0115_0.035_L_1.jpg

Barrier ID:	DEWA-0115-0.035-L				
Route Name:	ICE HOUSE ROAD				
Inspection Date:	10/01/2010	Barrier Rating:	22.20		
Barrier Description					
Type:	OTHER: 2-STRAND CABLE	Barrier Function:	TRAFFIC		
Barrier Material:	CABLE	Post Material:	GALVANIZED STEEL		
Blockout Type:	N/A	Length (ft.):	42		
Speed Limit (MPH):	25	Placement with Respect to Road:	TANGENT		
Hazard Behind Barrier:	MEDIUM				
Barrier Crashworthiness					
Appropriate Test Level:	TL-1	Barrier Test Level:	NCW	Is Barrier Crashworthy?:	NO
Beg. End Trtmt Type:	NONE	Is Beg. End Trtmt Crashworthy?:	N/A	Approach Transition Type:	OTHER: 2-STRAND CABLE/RIGID
Ending End Trtmt Type:	NONE	Ending End Trtmt Crashworthy?:	N/A		
Average Measurements					
Design Height (In.):	27	Width (In.):	0.0	Post Spacing (In.):	162.3
Height (In.):	20.2	Lateral Offset (In.):	28.7	Road Grade (%):	8.60
Physical Condition					
Barrier	Alignment and Height:	No posts were observed to be bent. The cables had sufficient tension. The barrier height was 4.5 to 9 in below the 27 in design height for the entire length.

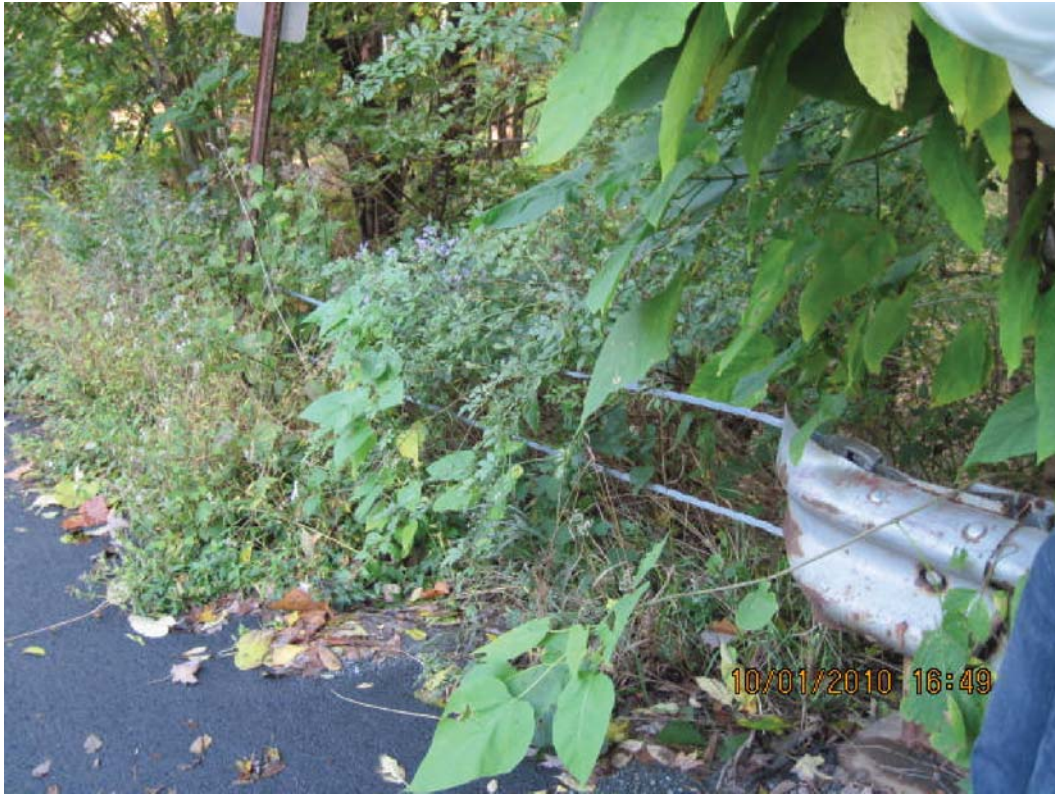
DEWA_0115_0.051_R_1.jpg

Barrier ID:	DEWA-0115-0.051-R				
Route Name:	ICE HOUSE ROAD				
Inspection Date:	10/01/2010	Barrier Rating:	23.70		
Barrier Description					
Type:	OTHER: 2-STRAND CABLE	Barrier Function:	TRAFFIC		
Barrier Material:	CABLE	Post Material:	GALVANIZED STEEL		
Blockout Type:	N/A	Length (ft.):	82		
Speed Limit (MPH):	25	Placement with Respect to Road:	TANGENT		
Hazard Behind Barrier:	MEDIUM				
Barrier Crashworthiness					
Appropriate Test Level:	TL-1	Barrier Test Level:	NCW	Is Barrier Crashworthy?:	NO
Beg. End Trtmt Type:	NONE	Is Beg. End Trtmt Crashworthy?:	N/A	Approach Transition Type:	OTHER: 2-STRAND CABLE/RIGID
Ending End Trtmt Type:	NONE	Ending End Trtmt Crashworthy?:	N/A		
Average Measurements					
Design Height (In.):	27	Width (In.):	0.0	Post Spacing (In.):	185.3
Height (In.):	17.7	Lateral Offset (In.):	53.7	Road Grade (%):	5.10
Physical Condition					
Barrier	Alignment and Height:	No bent posts were observed. Both cables are tensioned sufficiently. Entire barrier is 8 to 11 in below 27 in design height.

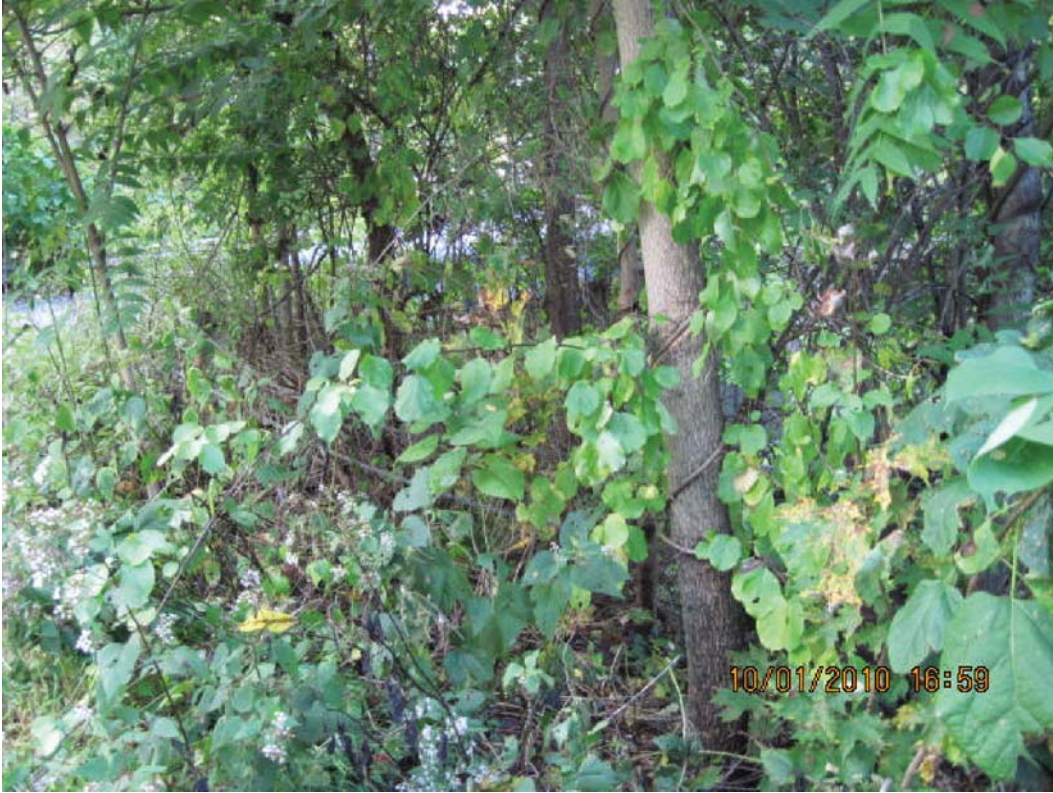
DEWA_0115_0.053_L_1.jpg

Barrier ID:	DEWA-0115-0.053-L				
Route Name:	ICE HOUSE ROAD				
Inspection Date:	10/01/2010	Barrier Rating:	19.30		
Barrier Description					
Type:	OTHER: 2-STRAND CABLE	Barrier Function:	TRAFFIC		
Barrier Material:	CABLE	Post Material:	GALVANIZED STEEL		
Blockout Type:	N/A	Length (ft.):	40		
Speed Limit (MPH):	25	Placement with Respect to Road:	TANGENT		
Hazard Behind Barrier:	MEDIUM				
Barrier Crashworthiness					
Appropriate Test Level:	TL-1	Barrier Test Level:	NCW	Is Barrier Crashworthy?:	NO
Beg. End Trtmt Type:	NONE	Is Beg. End Trtmt Crashworthy?:	N/A	Approach Transition Type:	OTHER: 2-STRAND CABLE/RIGID
Ending End Trtmt Type:	NONE	Ending End Trtmt Crashworthy?:	N/A		
Average Measurements					
Design Height (In.):	27	Width (In.):	0.0	Post Spacing (In.):	187.3
Height (In.):	21.0	Lateral Offset (In.):	105.0	Road Grade (%):	8.00
Physical Condition					
Barrier	Alignment and Height:	No posts were observed to be bent. The cables had no tension. The barrier was 4 to 8 in below the 27 in design height for the entire length.

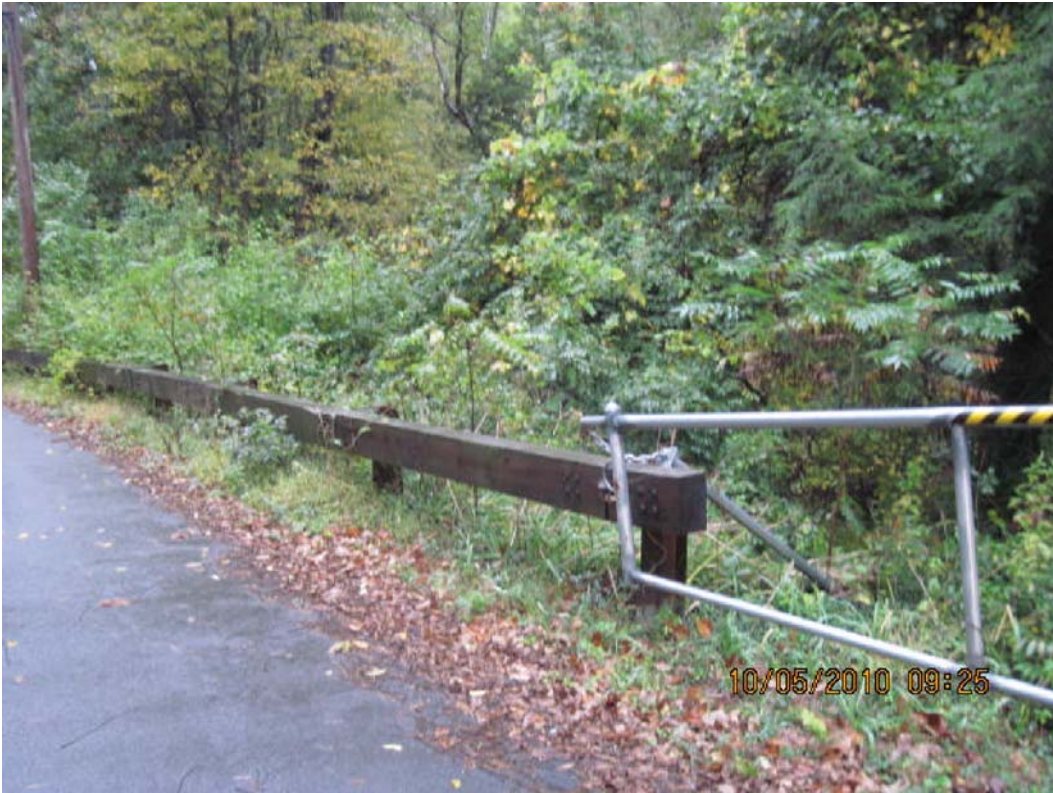
DEWA_0218_0.018_R_1.jpg

Barrier ID:	DEWA-0218-0.018-R				
Route Name:	DINGMANS FALLS ROAD				
Inspection Date:	10/05/2010	Barrier Rating:	46.90		
Barrier Description					
Type:	STEEL-BACKED TIMBER WITH BLOCKOUT	Barrier Function:	TRAFFIC		
Barrier Material:	STEEL-BACKED TIMBER/LOG	Post Material:	CORTEN		
Blockout Type:	WOOD	Length (ft.):	194		
Speed Limit (MPH):	25	Placement with Respect to Road:	OUTSIDE OF CURVE		
Hazard Behind Barrier:	MEDIUM				
Barrier Crashworthiness					
Appropriate Test Level:	TL-1	Barrier Test Level:	TL-3	Is Barrier Crashworthy?:	YES
Beg. End Trtmt Type:	NONE	Is Beg. End Trtmt Crashworthy?:	N/A	Approach Transition Type:	NONE
Ending End Trtmt Type:	NONE	Ending End Trtmt Crashworthy?:	N/A		
Average Measurements					
Design Height (In.):	27	Width (In.):	0.0	Post Spacing (In.):	121.1
Height (In.):	22.7	Lateral Offset (In.):	25.5	Road Grade (%):	4.70
Physical Condition					
Barrier	Alignment and Height:	Alignment deflection was less than 6 in. 20 ft of the barrier was between 1 and 3 in below design height (27 in). 124 ft of the barrier was 3 to 8 in below design height (27 in).

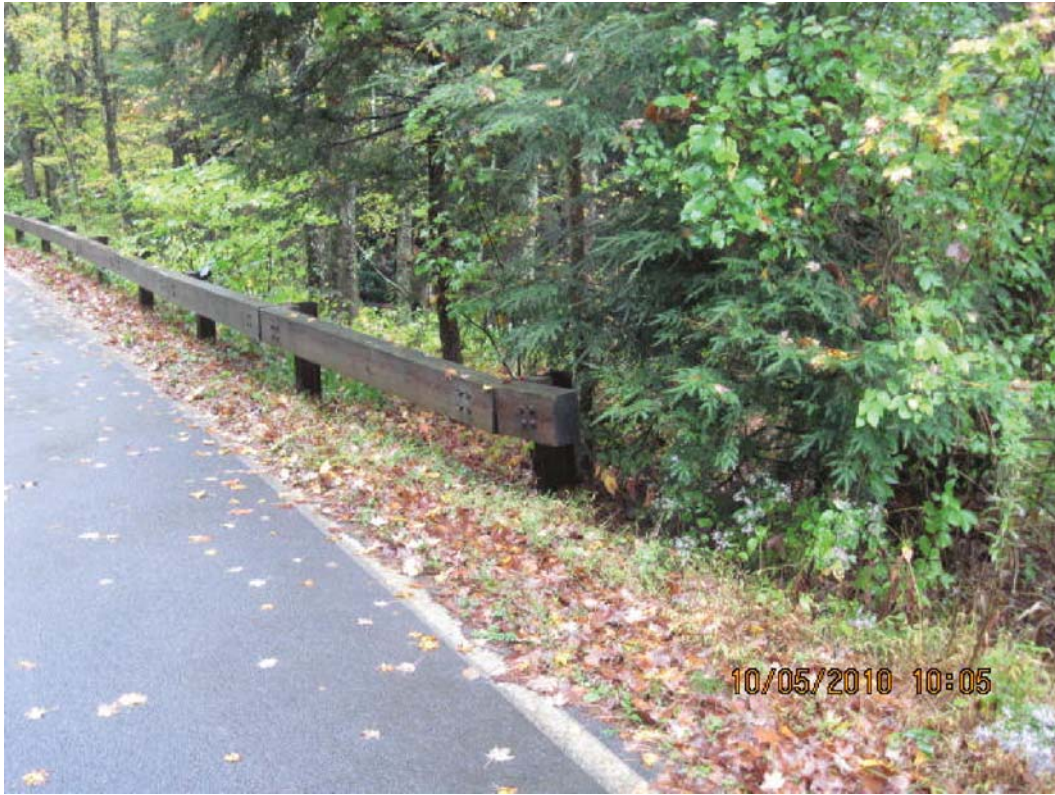
DEWA_0218_0.118_L_1.jpg

Barrier ID:	DEWA-0218-0.118-L				
Route Name:	DINGMANS FALLS ROAD				
Inspection Date:	10/05/2010	Barrier Rating:	29.60		
Barrier Description					
Type:	STEEL-BACKED TIMBER WITH BLOCKOUT	Barrier Function:	TRAFFIC		
Barrier Material:	STEEL-BACKED TIMBER/LOG	Post Material:	CORTEN		
Blockout Type:	WOOD	Length (ft.):	275		
Speed Limit (MPH):	25	Placement with Respect to Road:	INSIDE OF CURVE		
Hazard Behind Barrier:	MEDIUM				
Barrier Crashworthiness					
Appropriate Test Level:	TL-1	Barrier Test Level:	TL-3	Is Barrier Crashworthy?:	YES
Beg. End Trtmt Type:	NONE	Is Beg. End Trtmt Crashworthy?:	N/A	Approach Transition Type:	NONE
Ending End Trtmt Type:	NONE	Ending End Trtmt Crashworthy?:	N/A		
Average Measurements					
Design Height (In.):	27	Width (In.):	0.0	Post Spacing (In.):	120.0
Height (In.):	26.2	Lateral Offset (In.):	23.7	Road Grade (%):	5.60
Physical Condition					
Barrier	Alignment and Height:	No deflections greater than 6 in were observed in the alignment. The barrier height was equal to or within 1 in of the 27 in design height for the entire length.

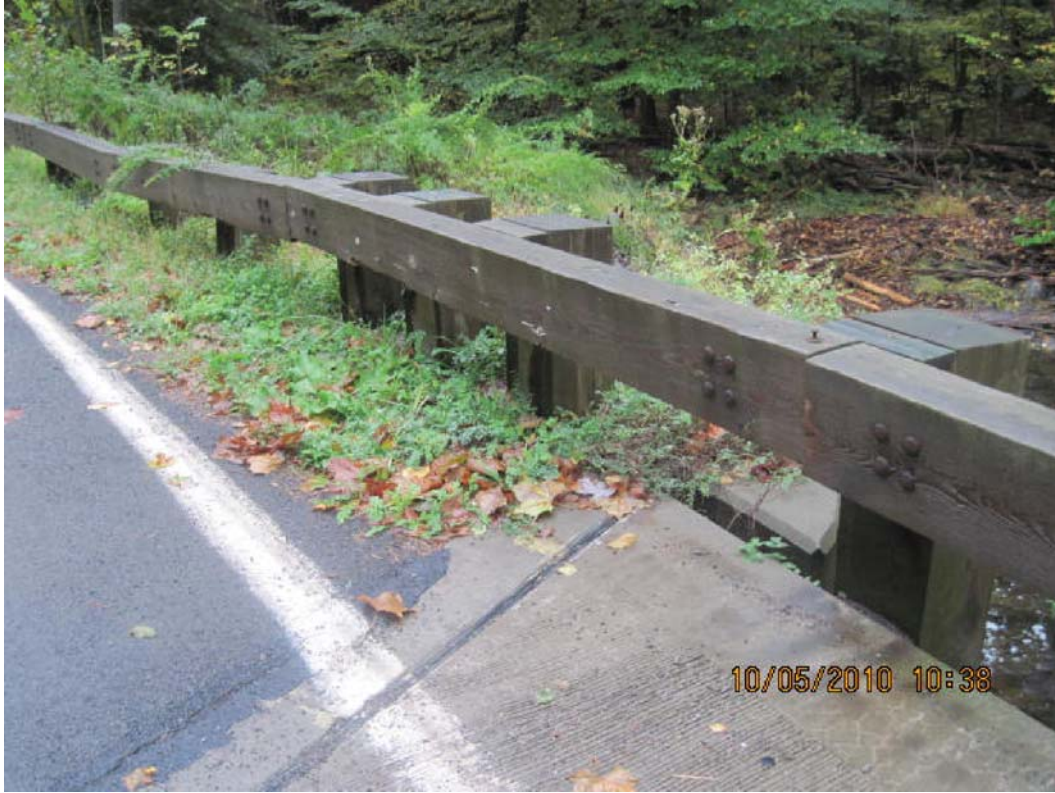
DEWA_0218_0.181_L_1.jpg

Barrier ID:	DEWA-0218-0.181-L				
Route Name:	DINGMANS FALLS ROAD				
Inspection Date:	10/05/2010	Barrier Rating:	41.20		
Barrier Description					
Type:	STEEL-BACKED TIMBER WITH BLOCKOUT	Barrier Function:	TRAFFIC		
Barrier Material:	STEEL-BACKED TIMBER/LOG	Post Material:	CORTEN		
Blockout Type:	WOOD	Length (ft.):	397		
Speed Limit (MPH):	25	Placement with Respect to Road:	OUTSIDE OF CURVE		
Hazard Behind Barrier:	MEDIUM				
Barrier Crashworthiness					
Appropriate Test Level:	TL-1	Barrier Test Level:	TL-3	Is Barrier Crashworthy?:	YES
Beg. End Trtmt Type:	NONE	Is Beg. End Trtmt Crashworthy?:	N/A	Approach Transition Type:	OTHER: SBT-SBT
Ending End Trtmt Type:	NONE	Ending End Trtmt Crashworthy?:	N/A		
Average Measurements					
Design Height (In.):	27	Width (In.):	0.0	Post Spacing (In.):	119.6
Height (In.):	24.0	Lateral Offset (In.):	31.2	Road Grade (%):	1.70
Physical Condition					
Barrier	Alignment and Height:	Alignment deflection was less than 6 in. 120 ft of the barrier was 1 to 3 in below design height (27 ines). 180 ft of the barrier was 3 to 5.5 ines below design height (27 ines).

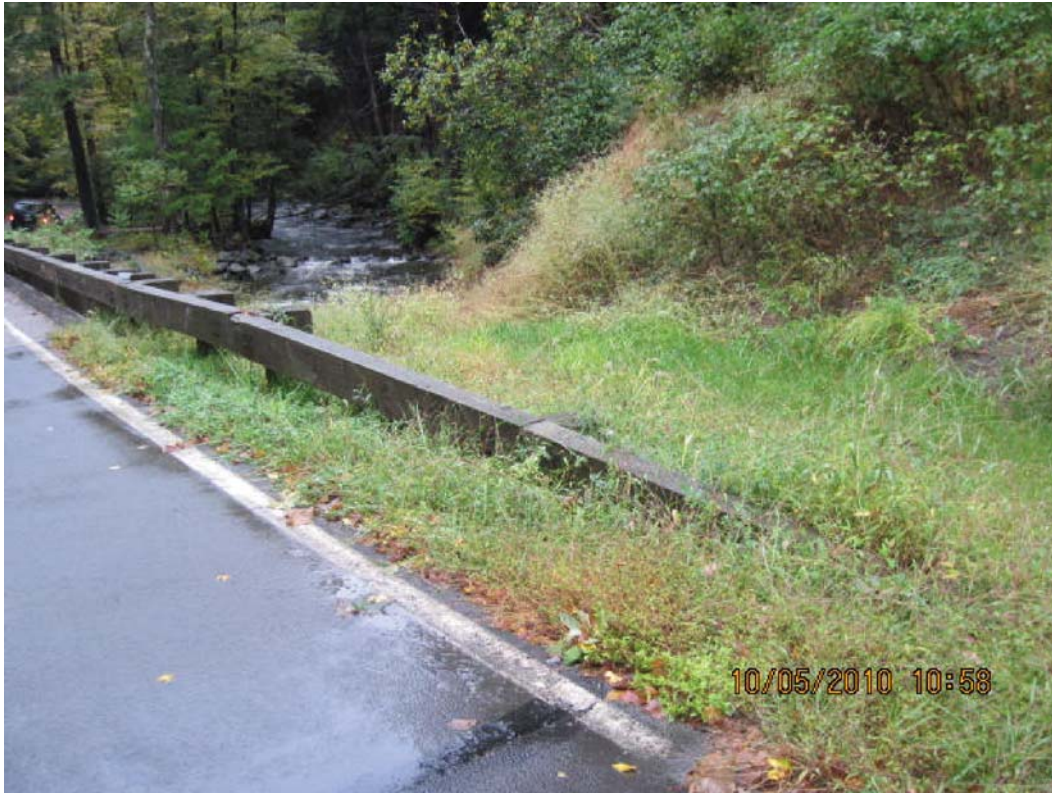
DEWA_0218_0.247_R_1.jpg

Barrier ID:	DEWA-0218-0.247-R				
Route Name:	DINGMANS FALLS ROAD				
Inspection Date:	10/05/2010	Barrier Rating:	26.70		
Barrier Description					
Type:	STEEL-BACKED TIMBER WITH BLOCKOUT	Barrier Function:	TRAFFIC		
Barrier Material:	STEEL-BACKED TIMBER/LOG	Post Material:	WOOD		
Blockout Type:	WOOD	Length (ft.):	35		
Speed Limit (MPH):	25	Placement with Respect to Road:	INSIDE OF CURVE		
Hazard Behind Barrier:	MEDIUM				
Barrier Crashworthiness					
Appropriate Test Level:	TL-1	Barrier Test Level:	TL-3	Is Barrier Crashworthy?:	YES
Beg. End Trtmt Type:	SBT/LOG FLARED	Is Beg. End Trtmt Crashworthy?:	NO	Approach Transition Type:	OTHER: SBT-SBT
Ending End Trtmt Type:	NONE	Ending End Trtmt Crashworthy?:	N/A		
Average Measurements					
Design Height (In.):	27	Width (In.):	0.0	Post Spacing (In.):	51.2
Height (In.):	23.7	Lateral Offset (In.):	23.7	Road Grade (%):	0.40
Physical Condition					
Barrier	Alignment and Height:	No deflections observed in alignment. Barrier is end treatment for bridge approach so height transition is as designed.

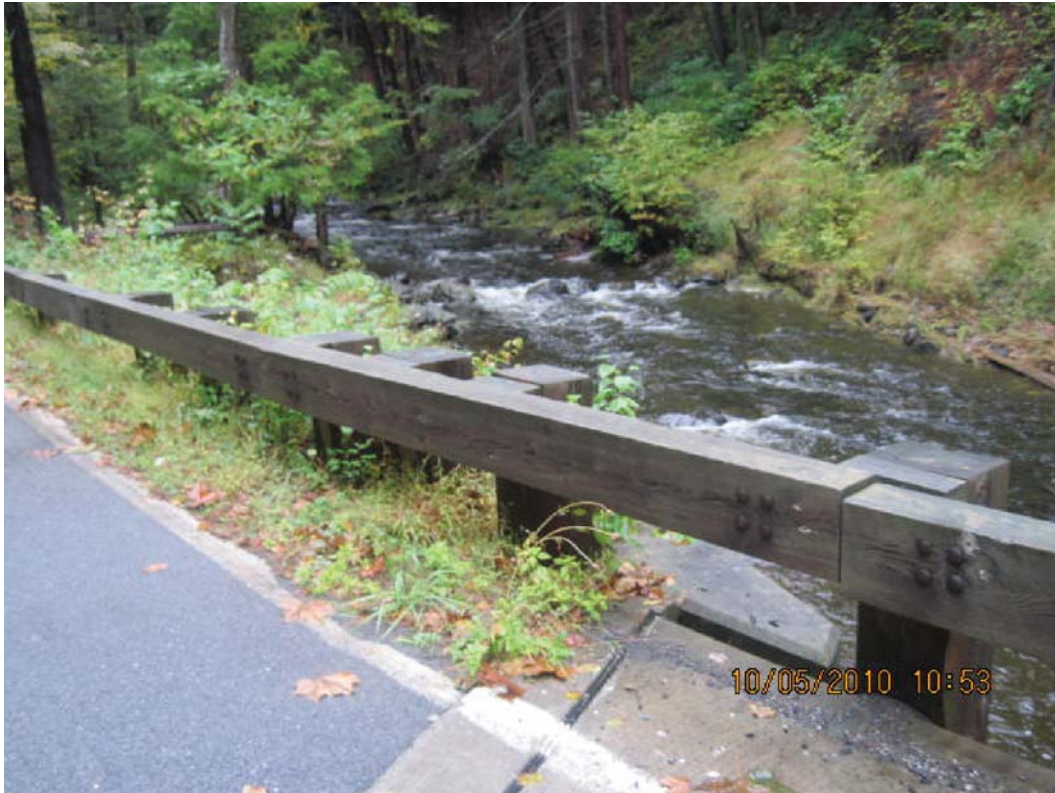
DEWA_0218_0.263_R_1.jpg

Barrier ID:	DEWA-0218-0.263-R				
Route Name:	DINGMANS FALLS ROAD				
Inspection Date:	10/05/2010	Barrier Rating:	31.10		
Barrier Description					
Type:	STEEL-BACKED TIMBER WITHOUT BLOCKOUT	Barrier Function:	TRAFFIC		
Barrier Material:	STEEL-BACKED TIMBER/LOG	Post Material:	WOOD		
Blockout Type:	N/A	Length (ft.):	90		
Speed Limit (MPH):	25	Placement with Respect to Road:	INSIDE OF CURVE		
Hazard Behind Barrier:	MEDIUM				
Barrier Crashworthiness					
Appropriate Test Level:	TL-1	Barrier Test Level:	TL-2	Is Barrier Crashworthy?:	YES
Beg. End Trtmt Type:	NONE	Is Beg. End Trtmt Crashworthy?:	N/A	Approach Transition Type:	OTHER: SBT-SBT
Ending End Trtmt Type:	SBT/LOG FLARED	Ending End Trtmt Crashworthy?:	NO		
Average Measurements					
Design Height (In.):	27	Width (In.):	0.0	Post Spacing (In.):	120.1
Height (In.):	25.5	Lateral Offset (In.):	21.7	Road Grade (%):	3.10
Physical Condition					
Barrier	Alignment and Height:	No deflections greater than 6 in observed in alignment. 60 ft of barrier is 1 to 3 in below 27 in design height. 30 ft of barrier is 1 in or less below 27 in design height.

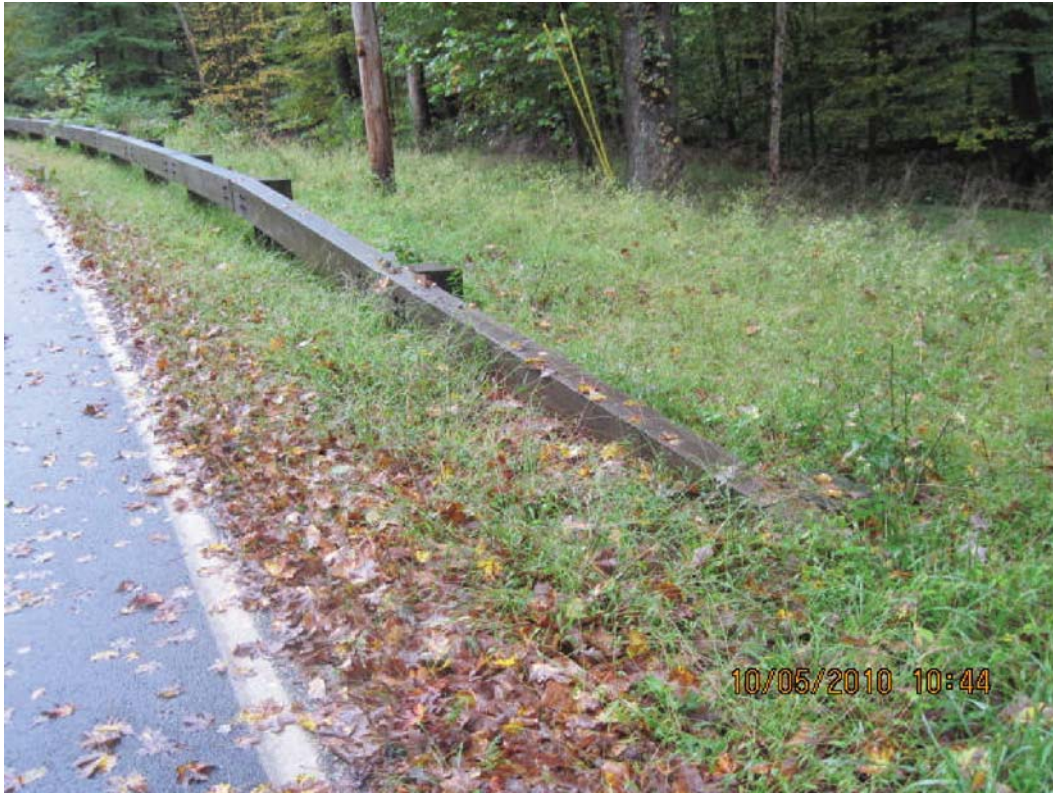
DEWA_0218_0.265_L_1.jpg

Barrier ID:	DEWA-0218-0.265-L				
Route Name:	DINGMANS FALLS ROAD				
Inspection Date:	10/05/2010	Barrier Rating:	22.70		
Barrier Description					
Type:	STEEL-BACKED TIMBER WITH BLOCKOUT	Barrier Function:	TRAFFIC		
Barrier Material:	STEEL-BACKED TIMBER/LOG	Post Material:	WOOD		
Blockout Type:	WOOD	Length (ft.):	108		
Speed Limit (MPH):	25	Placement with Respect to Road:	OUTSIDE OF CURVE		
Hazard Behind Barrier:	LOW				
Barrier Crashworthiness					
Appropriate Test Level:	TL-1	Barrier Test Level:	TL-3	Is Barrier Crashworthy?:	YES
Beg. End Trtmt Type:	NONE	Is Beg. End Trtmt Crashworthy?:	N/A	Approach Transition Type:	OTHER: SBT-SBT
Ending End Trtmt Type:	SBT/LOG FLARED	Ending End Trtmt Crashworthy?:	NO		
Average Measurements					
Design Height (In.):	27	Width (In.):	0.0	Post Spacing (In.):	119.8
Height (In.):	26.7	Lateral Offset (In.):	41.7	Road Grade (%):	2.40
Physical Condition					
Barrier	Alignment and Height:	Alignment deflection was less than 6 in. The entire barrier exceeded by 1 in or was within 1 in below design height (27 in).
