NPS Guardwall/Rail Inventory Program Delaware Water Gap National Recreation Area

**Federal Lands Highway
Road Inventory Program**

Federal Highway Administration
Eastern Federal Lands Highway Division
Road Inventory Program (RIP)

Data Collection Date: October 2010
Report Date: December 2015

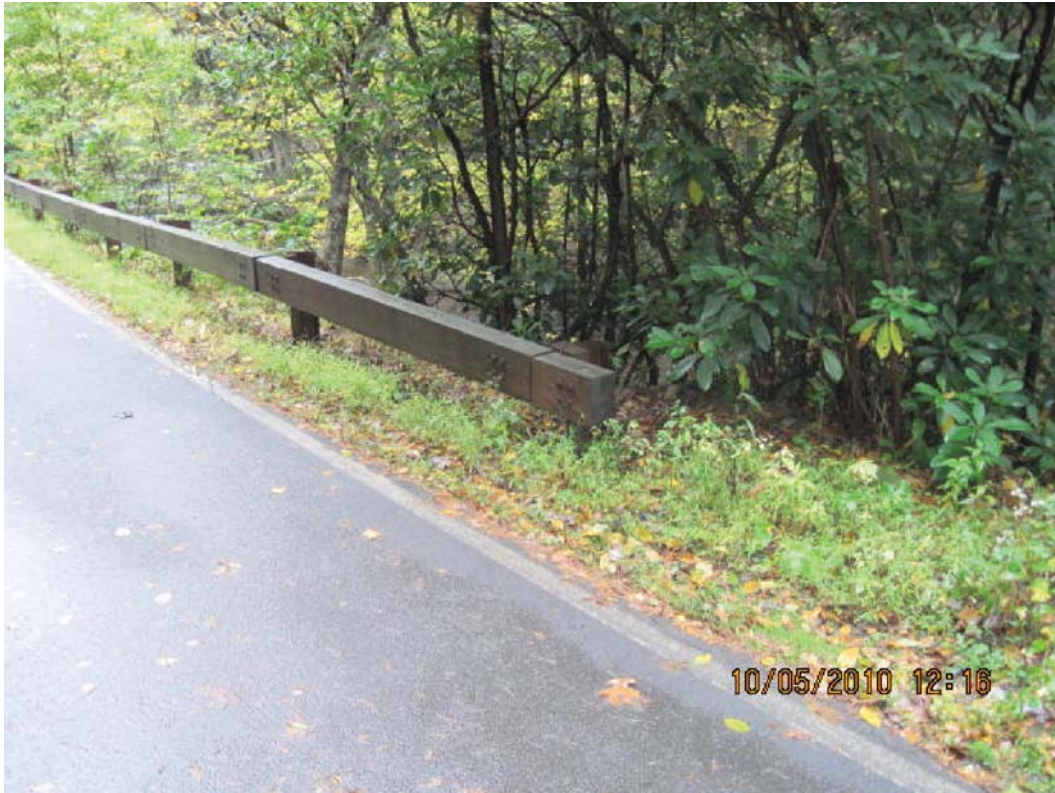
DEWA_0218_0.489_R_1.jpg

Barrier ID:	DEWA-0218-0.489-R				
Route Name:	DINGMANS FALLS ROAD				
Inspection Date:	10/05/2010	Barrier Rating:	35.40		
Barrier Description					
Type:	STEEL-BACKED TIMBER WITH BLOCKOUT	Barrier Function:	TRAFFIC		
Barrier Material:	STEEL-BACKED TIMBER/LOG	Post Material:	CORTEN		
Blockout Type:	WOOD	Length (ft.):	357		
Speed Limit (MPH):	25	Placement with Respect to Road:	BOTH INSIDE AND OUTSIDE		
Hazard Behind Barrier:	MEDIUM				
Barrier Crashworthiness					
Appropriate Test Level:	TL-1	Barrier Test Level:	TL-3	Is Barrier Crashworthy?:	YES
Beg. End Trtmt Type:	NONE	Is Beg. End Trtmt Crashworthy?:	N/A	Approach Transition Type:	NONE
Ending End Trtmt Type:	SBT/LOG FLARED	Ending End Trtmt Crashworthy?:	NO		
Average Measurements					
Design Height (In.):	27	Width (In.):	0.0	Post Spacing (In.):	120.5
Height (In.):	27.7	Lateral Offset (In.):	22.7	Road Grade (%):	1.80
Physical Condition					
Barrier	Alignment and Height:	An approximately 18 in deflection was observed for 40 ft in the horizontal alignment. Otherwise no deflections greater than 6 in observed. The barrier height was 1 in greater than or equal to the 27 in design height for the entire length.

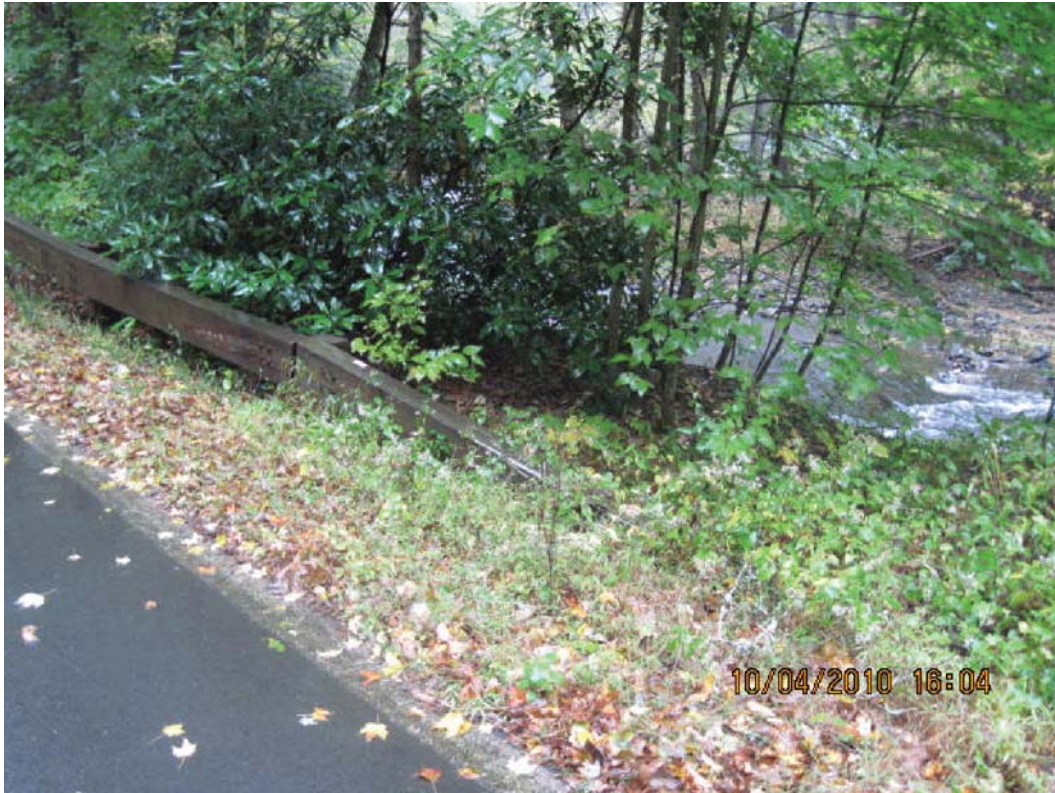
DEWA_0218_0.566_R_1.jpg

Barrier ID:	DEWA-0218-0.566-R				
Route Name:	DINGMANS FALLS ROAD				
Inspection Date:	10/04/2010	Barrier Rating:	28.30		
Barrier Description					
Type:	STEEL-BACKED TIMBER WITH BLOCKOUT	Barrier Function:	TRAFFIC		
Barrier Material:	STEEL-BACKED TIMBER/LOG	Post Material:	GALVANIZED STEEL		
Blockout Type:	WOOD	Length (ft.):	88		
Speed Limit (MPH):	15	Placement with Respect to Road:	INSIDE OF CURVE		
Hazard Behind Barrier:	MEDIUM				
Barrier Crashworthiness					
Appropriate Test Level:	TL-1	Barrier Test Level:	TL-3	Is Barrier Crashworthy?:	YES
Beg. End Trtmt Type:	SBT/LOG FLARED	Is Beg. End Trtmt Crashworthy?:	NO	Approach Transition Type:	NONE
Ending End Trtmt Type:	SBT/LOG FLARED	Ending End Trtmt Crashworthy?:	NO		
Average Measurements					
Design Height (In.):	27	Width (In.):	0.0	Post Spacing (In.):	120.6
Height (In.):	24.5	Lateral Offset (In.):	27.0	Road Grade (%):	5.30
Physical Condition					
Barrier	Alignment and Height:	No deflections greater than 6 in observed in alignment. Barrier is 1 to 3 in below 27 in design height for 40 ft. Barrier is 3 to 6 in below 27 in design height for 20 ft.

Breaking and Cracking:	No impact related breaking or cracking observed.			
	Missing Elements:	No elements were observed to be missing.			
	Corrosion and Weathering:	No loss of cross section or erosion around posts observed.			
End Treatments	Alignment and Height:	Alignment acceptable. Height is within 1-in. of 27-in. design height.			
	Breaking and Cracking:	No breaks or cracks were observed.			
	Missing Elements:	No elements were observed to be missing.			
	Corrosion and Weathering:	No loss of cross section or erosion around posts observed.

Repair Action:	REPAIR	FMSS Work Type:	DEFERRED MAINTENANCE	Repair Cost:	\$2282
Brief Workorder:	Raise 60 feet of barrier to 27 inch design height.				
Workorder:	Adjust Guardrail at \$10- per -Lin. Ft. for 60 LF = \$600. Raise 60 feet of barrier to 27 inch design height. Low Speed Traffic Control at \$1475- per -Day for 1 Day(s) = \$1475.

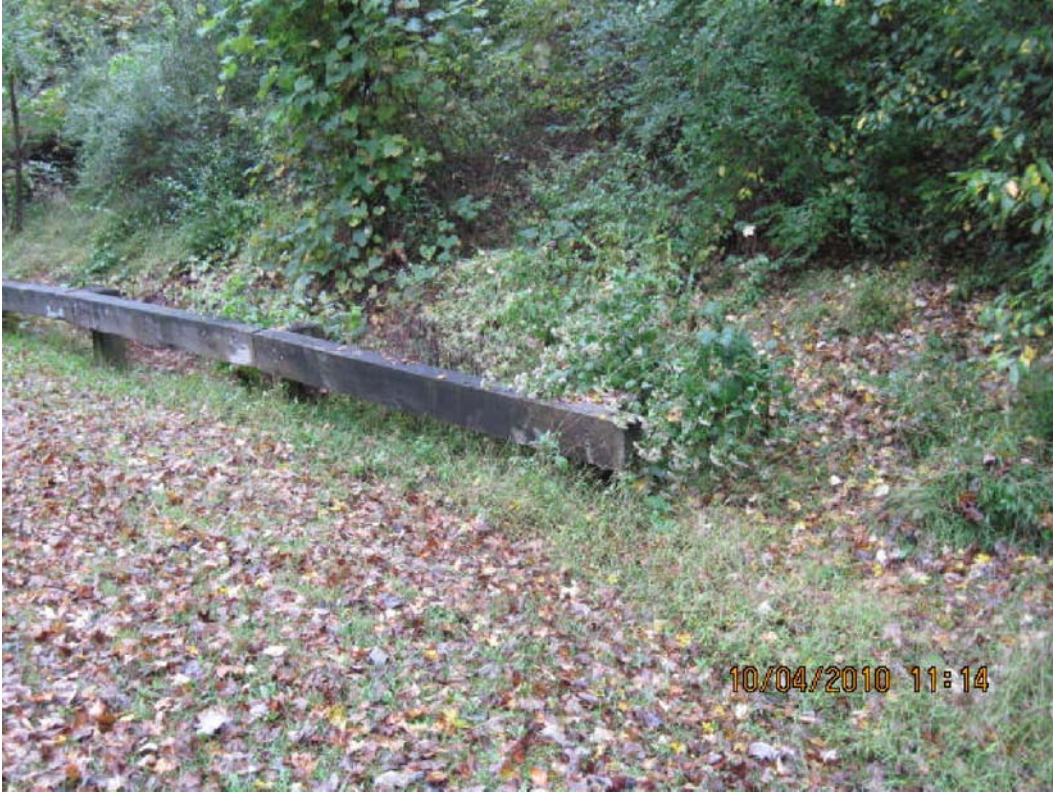
DEWA_0233ZZ_0.076_R_1.jpg

Barrier ID:	DEWA-0233ZZ-0.076-R				
Route Name:	SMITHFIELD BEACH ACCESS ROADS				
Inspection Date:	10/04/2010	Barrier Rating:	39.50		
Barrier Description					
Type:	STEEL-BACKED TIMBER WITH BLOCKOUT	Barrier Function:	TRAFFIC		
Barrier Material:	STEEL-BACKED TIMBER/LOG	Post Material:	WOOD		
Blockout Type:	WOOD	Length (ft.):	346		
Speed Limit (MPH):	15	Placement with Respect to Road:	OUTSIDE OF CURVE		
Hazard Behind Barrier:	MEDIUM				
Barrier Crashworthiness					
Appropriate Test Level:	TL-1	Barrier Test Level:	TL-3	Is Barrier Crashworthy?:	YES
Beg. End Trtmt Type:	SBT/LOG FLARED	Is Beg. End Trtmt Crashworthy?:	NO	Approach Transition Type:	NONE
Ending End Trtmt Type:	SBT/LOG FLARED	Ending End Trtmt Crashworthy?:	NO		
Average Measurements					
Design Height (In.):	27	Width (In.):	0.0	Post Spacing (In.):	122.0
Height (In.):	25.0	Lateral Offset (In.):	12.6	Road Grade (%):	6.00
Physical Condition					
Barrier	Alignment and Height:	No deflections greater than 6 in were observed in the alignment. The barrier height was within 1 in of the 27 in design height for 101 ft and between 1 and 3 in below the design height for 175 ft.

Breaking and Cracking:	No impact related breaking or cracking was observed. 1 rail had very minor damage from a rub impact.			
	Missing Elements:	No elements were observed to be missing.			
	Corrosion and Weathering:	1 post was hollowed out. No erosion around posts observed.			
End Treatments	Alignment and Height:	Alignment acceptable. Height is within 1-in. of 27-in. design height.			
	Breaking and Cracking:	No breaking or cracking was observed.			
	Missing Elements:	No elements were observed to be missing.			
	Corrosion and Weathering:	No loss of cross section or erosion around posts observed.

Repair Action:	REPAIR	FMSS Work Type:	DEFERRED MAINTENANCE	Repair Cost:	\$3658
Brief Workorder:	Raise 175 feet of guardrail up to the 27 inch design height and replace 1 post.				
Workorder:	Adjust Guardrail at \$10- per -Lin. Ft. for 175 LF = \$1750. Raise 175 feet of guardrail to 27 inch design height. Replace Post at \$100- per -Each for 1 Post(s) = \$100. Replace 1 hollowed out post. Low Speed Traffic Control at \$1475- per -Day for 1 Day(s) = \$1475.

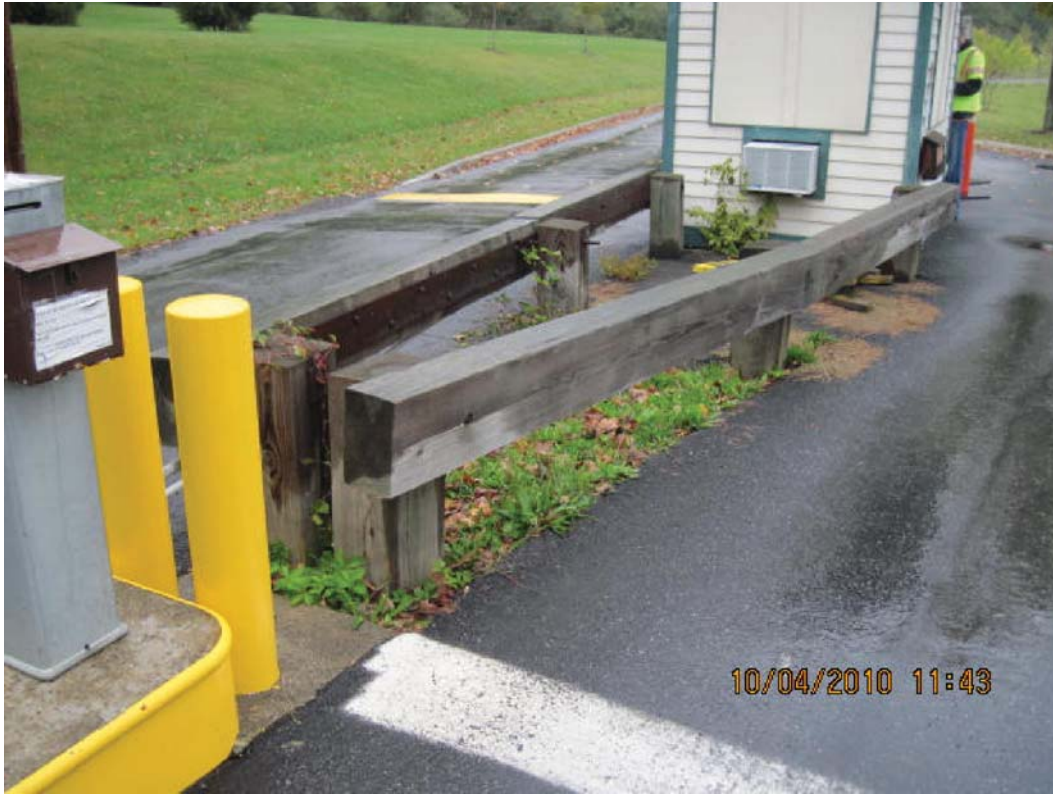
DEWA_0233ZZ_0.150_L_1.jpg

Barrier ID:	DEWA-0233ZZ-0.150-L				
Route Name:	SMITHFIELD BEACH ACCESS ROADS				
Inspection Date:	10/04/2010	Barrier Rating:	16.80		
Barrier Description					
Type:	STEEL-BACKED TIMBER WITHOUT BLOCKOUT	Barrier Function:	TRAFFIC		
Barrier Material:	STEEL-BACKED TIMBER/LOG	Post Material:	WOOD		
Blockout Type:	N/A	Length (ft.):	42		
Speed Limit (MPH):	15	Placement with Respect to Road:	TANGENT		
Hazard Behind Barrier:	LOW				
Barrier Crashworthiness					
Appropriate Test Level:	TL-1	Barrier Test Level:	TL-2	Is Barrier Crashworthy?:	YES
Beg. End Trtmt Type:	NONE	Is Beg. End Trtmt Crashworthy?:	N/A	Approach Transition Type:	NONE
Ending End Trtmt Type:	NONE	Ending End Trtmt Crashworthy?:	N/A		
Average Measurements					
Design Height (In.):	27	Width (In.):	0.0	Post Spacing (In.):	52.7
Height (In.):	26.2	Lateral Offset (In.):	0.0	Road Grade (%):	2.20
Physical Condition					
Barrier	Alignment and Height:	Alignment deflection was less than 6 in. The entire barrier was 1 to 3 in below design height (27 in).

Breaking and Cracking:	No impact related breaking or cracking observed.			
	Missing Elements:	No elements appeared to be missing.			
	Corrosion and Weathering:	No loss of cross section or erosion around posts observed.			
End Treatments	Alignment and Height:				
	Breaking and Cracking:				
	Missing Elements:				
	Corrosion and Weathering:

Repair Action:	REPAIR	FMSS Work Type:	DEFERRED MAINTENANCE	Repair Cost:	\$2084
Brief Workorder:	Raise 42 feet of barrier to 27 inch design height.				
Workorder:	Adjust Guardrail at \$10- per -Lin. Ft. for 42 LF = \$420. Raise 42 feet of barrier to 27 inch design height. Low Speed Traffic Control at \$1475- per -Day for 1 Day(s) = \$1475.

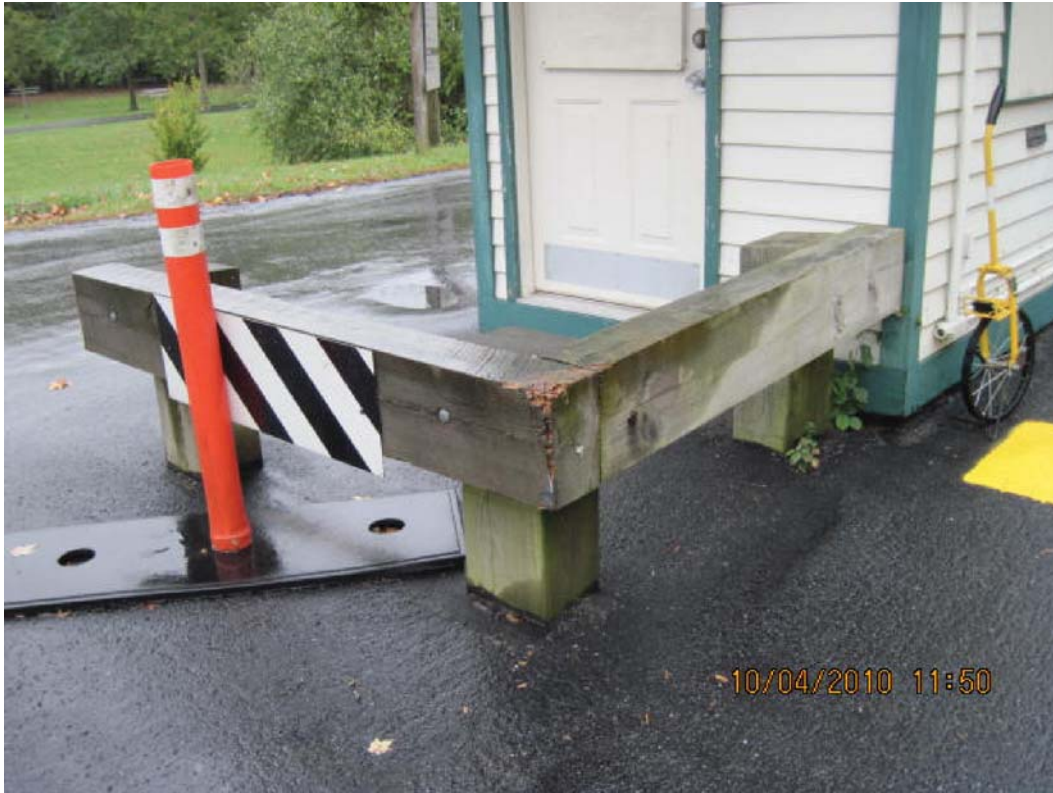
DEWA_0233ZZ_0.155_L_1.jpg

Barrier ID:	DEWA-0233ZZ-0.155-L				
Route Name:	SMITHFIELD BEACH ACCESS ROADS				
Inspection Date:	10/04/2010	Barrier Rating:	12.50		
Barrier Description					
Type:	STEEL-BACKED TIMBER WITHOUT BLOCKOUT	Barrier Function:	TRAFFIC		
Barrier Material:	STEEL-BACKED TIMBER/LOG	Post Material:	WOOD		
Blockout Type:	N/A	Length (ft.):	13		
Speed Limit (MPH):	15	Placement with Respect to Road:	TANGENT		
Hazard Behind Barrier:	LOW				
Barrier Crashworthiness					
Appropriate Test Level:	TL-1	Barrier Test Level:	TL-2	Is Barrier Crashworthy?:	YES
Beg. End Trtmt Type:	NONE	Is Beg. End Trtmt Crashworthy?:	N/A	Approach Transition Type:	NONE
Ending End Trtmt Type:	NONE	Ending End Trtmt Crashworthy?:	N/A		
Average Measurements					
Design Height (In.):	27	Width (In.):	0.0	Post Spacing (In.):	108.0
Height (In.):	24.5	Lateral Offset (In.):	0.0	Road Grade (%):	2.90
Physical Condition					
Barrier	Alignment and Height:	Alignment deflection was less than 6 in. The entire barrier was equal to or was within 1 in below the design height (27 in).

Breaking and Cracking:	No impact related breaking or cracking observed.			
	Missing Elements:	No elements appeared to be missing.			
	Corrosion and Weathering:	No loss of cross section or erosion around posts observed.			
End Treatments	Alignment and Height:				
	Breaking and Cracking:				
	Missing Elements:				
	Corrosion and Weathering:

Repair Action:	NO ACTION	FMSS Work Type:	N/A	Repair Cost:	\$0
Brief Workorder:	N/A				
Workorder:	No action required.

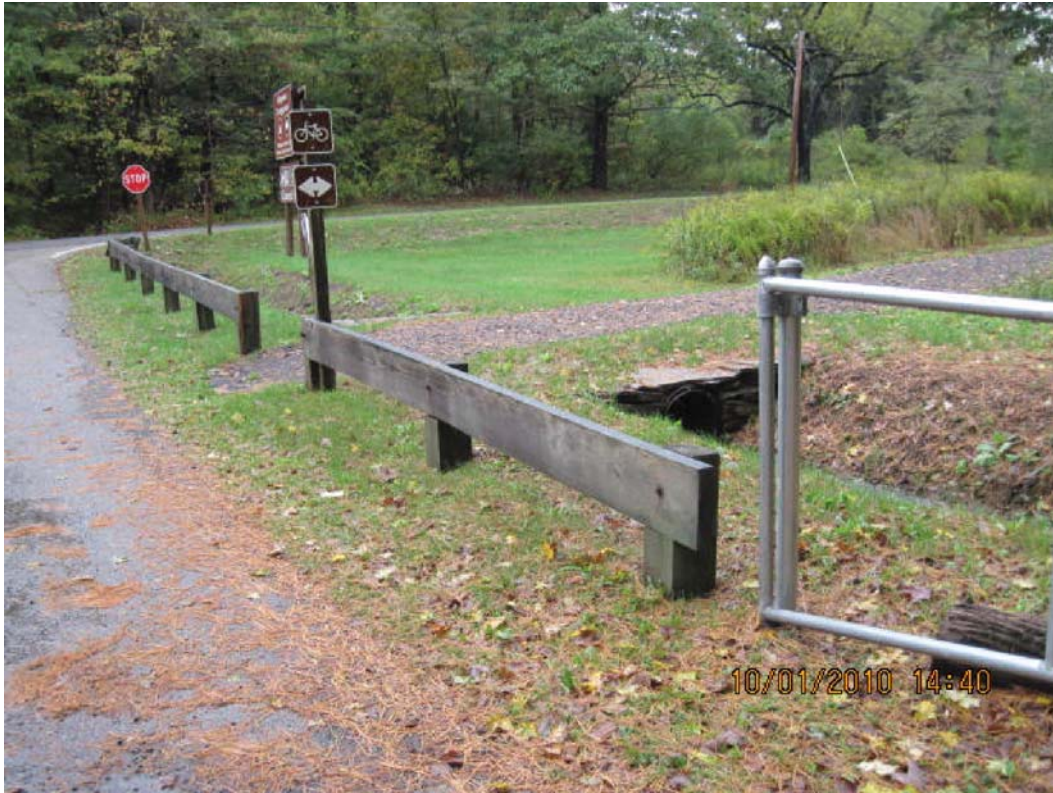
DEWA_0235_0.000_L_1.jpg

Barrier ID:	DEWA-0235-0.000-L				
Route Name:	DINGMAN'S CAMPGROUND ENTRY DRIVE				
Inspection Date:	10/01/2010	Barrier Rating:	11.10		
Barrier Description					
Type:	OTHER: TIMBER RAIL ON TIMBER POSTS	Barrier Function:	TRAFFIC		
Barrier Material:	LOG/TIMBER/WOOD	Post Material:	WOOD		
Blockout Type:	N/A	Length (ft.):	72		
Speed Limit (MPH):	25	Placement with Respect to Road:	TANGENT		
Hazard Behind Barrier:	LOW				
Barrier Crashworthiness					
Appropriate Test Level:	TL-1	Barrier Test Level:	NCW	Is Barrier Crashworthy?:	NO
Beg. End Trtmt Type:	NONE	Is Beg. End Trtmt Crashworthy?:	N/A	Approach Transition Type:	NONE
Ending End Trtmt Type:	NONE	Ending End Trtmt Crashworthy?:	N/A		
Average Measurements					
Design Height (In.):	27	Width (In.):	0.0	Post Spacing (In.):	94.6
Height (In.):	25.0	Lateral Offset (In.):	47.2	Road Grade (%):	4.10
Physical Condition					
Barrier	Alignment and Height:	No deflections greater than 6 in were observed in the alignment. The barrier height was within 1 in of the 27 in design height for 27 ft and between 1 in and 3 in below the design height for 45 ft.

Breaking and Cracking:	8 ft of rail was severely cracked due to impact. 1 post had impact damage.			
	Missing Elements:	No elements were observed to be missing.			
	Corrosion and Weathering:	Less than 5% loss of cross section observed. No erosion around posts observed.			
End Treatments	Alignment and Height:				
	Breaking and Cracking:				
	Missing Elements:				
	Corrosion and Weathering:

Repair Action:	REPAIR	FMSS Work Type:	DEFERRED MAINTENANCE	Repair Cost:	\$2448
Brief Workorder:	Raise 45 feet of guardrail to 27 inch design height replace 8 feet of rail and 1 post.				
Workorder:	Replace Rail at \$25- per -Lin. Ft. for 8 LF = \$200. Replace cracked rail. Replace Post at \$100- per -Each for 1 Post(s) = \$100. Replace 1 post. Adjust Guardrail at \$10- per -Lin. Ft. for 45 LF = \$450. Raise 45 feet of guardrail to 27 inch design height. Low Speed Traffic Control at \$1475- per -Day for 1 Day(s) = \$1475.

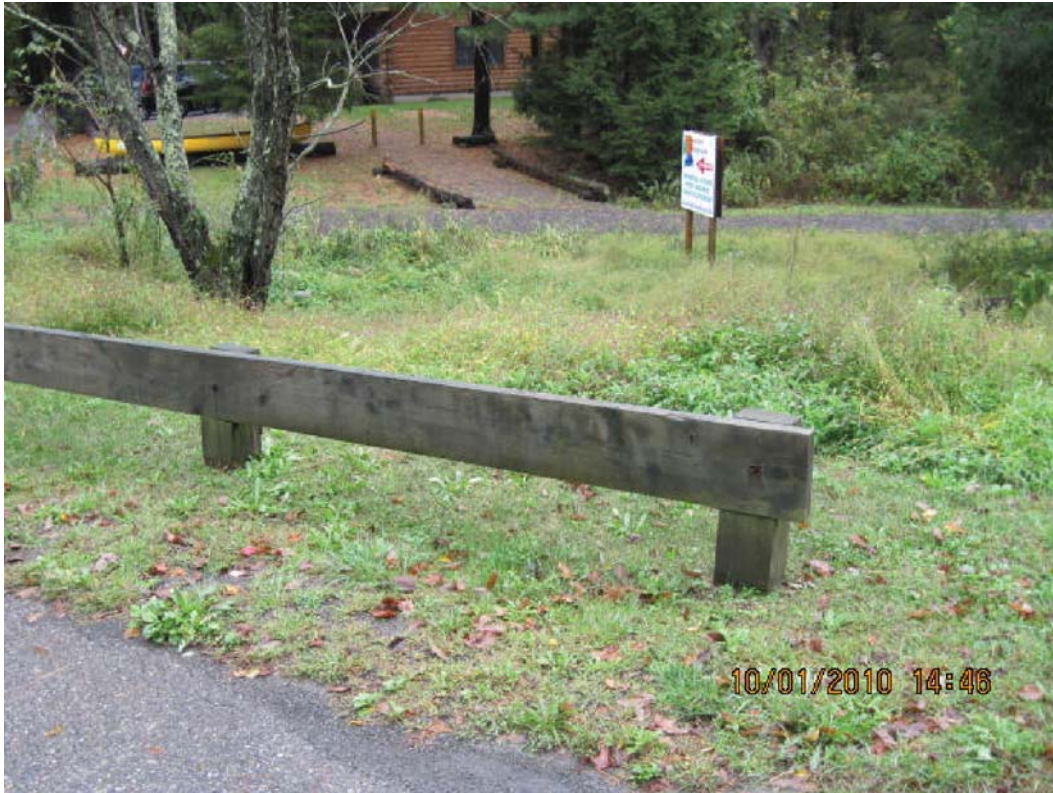
DEWA_0235_0.000_R_1.jpg

Barrier ID:	DEWA-0235-0.000-R				
Route Name:	DINGMAN'S CAMPGROUND ENTRY DRIVE				
Inspection Date:	10/01/2010	Barrier Rating:	12.60		
Barrier Description					
Type:	OTHER: TIMBER RAIL ON TIMBER POSTS	Barrier Function:	TRAFFIC		
Barrier Material:	LOG/TIMBER/WOOD	Post Material:	WOOD		
Blockout Type:	N/A	Length (ft.):	84		
Speed Limit (MPH):	25	Placement with Respect to Road:	TANGENT		
Hazard Behind Barrier:	LOW				
Barrier Crashworthiness					
Appropriate Test Level:	TL-1	Barrier Test Level:	NCW	Is Barrier Crashworthy?:	NO
Beg. End Trtmt Type:	NONE	Is Beg. End Trtmt Crashworthy?:	N/A	Approach Transition Type:	NONE
Ending End Trtmt Type:	NONE	Ending End Trtmt Crashworthy?:	N/A		
Average Measurements					
Design Height (In.):	27	Width (In.):	0.0	Post Spacing (In.):	98.6
Height (In.):	25.5	Lateral Offset (In.):	74.3	Road Grade (%):	4.20
Physical Condition					
Barrier	Alignment and Height:	No deflections greater than 6 in observed in alignment. Entire barrier is 1 to 3 in below 27 in design height.

Breaking and Cracking:	No breaking or cracking was observed.			
	Missing Elements:	No elements were observed to be missing.			
	Corrosion and Weathering:	No loss of cross section or erosion around posts observed.			
End Treatments	Alignment and Height:				
	Breaking and Cracking:				
	Missing Elements:				
	Corrosion and Weathering:

Repair Action:	REPAIR	FMSS Work Type:	DEFERRED MAINTENANCE	Repair Cost:	\$2546
Brief Workorder:	Raise 84 feet of barrier to 27 inch design height.				
Workorder:	Adjust Guardrail at \$10- per -Lin. Ft. for 84 LF = \$840. Raise 84 feet of barrier to 27 inch design height. Low Speed Traffic Control at \$1475- per -Day for 1 Day(s) = \$1475.

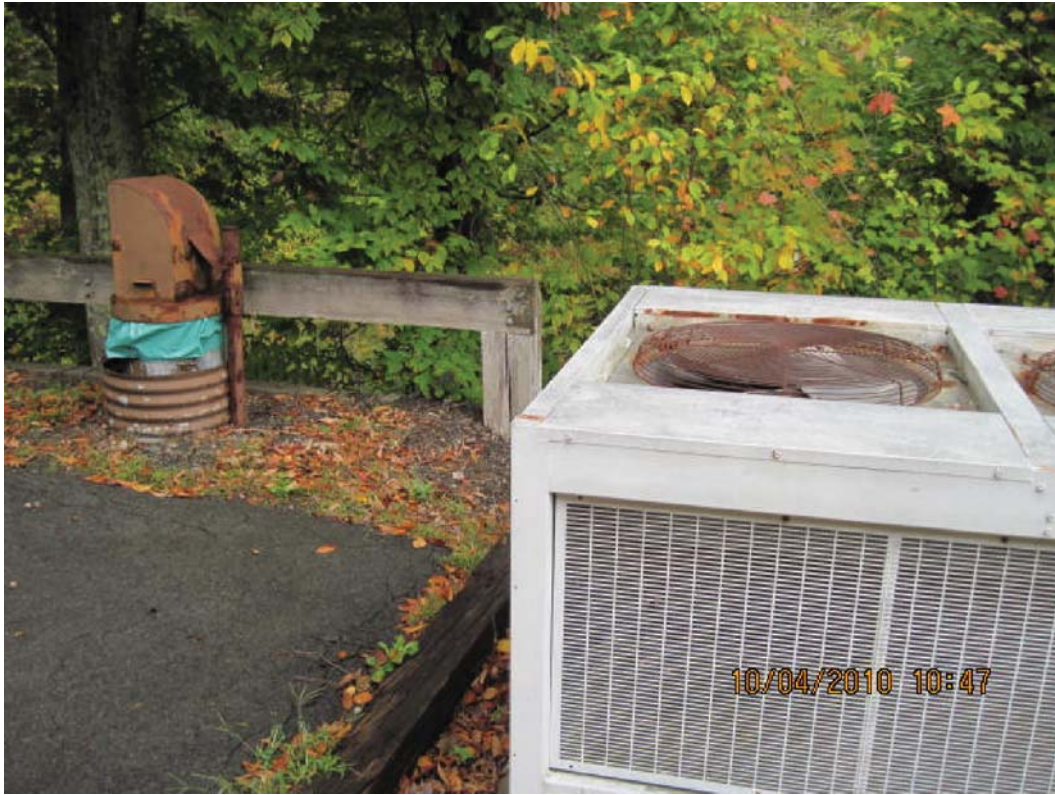
DEWA_0423_0.000_L_1.jpg

Barrier ID:	DEWA-0423-0.000-L				
Route Name:	HEADQUARTER SERVICE ROAD				
Inspection Date:	10/04/2010	Barrier Rating:	20.80		
Barrier Description					
Type:	OTHER: TIMBER RAIL ON TIMBER POSTS	Barrier Function:	TRAFFIC		
Barrier Material:	LOG/TIMBER/WOOD	Post Material:	WOOD		
Blockout Type:	N/A	Length (ft.):	193		
Speed Limit (MPH):	15	Placement with Respect to Road:	INSIDE OF CURVE		
Hazard Behind Barrier:	MEDIUM				
Barrier Crashworthiness					
Appropriate Test Level:	TL-1	Barrier Test Level:	NCW	Is Barrier Crashworthy?:	NO
Beg. End Trtmt Type:	NONE	Is Beg. End Trtmt Crashworthy?:	N/A	Approach Transition Type:	NONE
Ending End Trtmt Type:	NONE	Ending End Trtmt Crashworthy?:	N/A		
Average Measurements					
Design Height (In.):	27	Width (In.):	0.0	Post Spacing (In.):	94.5
Height (In.):	31.2	Lateral Offset (In.):	40.7	Road Grade (%):	5.00
Physical Condition					
Barrier	Alignment and Height:	No deflections in alignment observed. Entire barrier exceeds 27 in design height by 3 to 5 in.

Breaking and Cracking:	Cracking in several posts with cracks up to 1/4 in width observed. 3 posts have severe cracking/rotting up to 2 in width.			
	Missing Elements:	There was 1 post observed to be missing.			
	Corrosion and Weathering:	Weathering of posts has caused minor cracking in several posts and severe cracking in 3 posts. Barrier hardware is in like new condition.			
End Treatments	Alignment and Height:				
	Breaking and Cracking:				
	Missing Elements:				
	Corrosion and Weathering:

Repair Action:	REPAIR	FMSS Work Type:	DEFERRED MAINTENANCE	Repair Cost:	\$2062
Brief Workorder:	Replace 3 cracked posts and 1 missing post.				
Workorder:	Replace Post at \$100- per -Each for 4 Post(s) = \$400. Replace 3 cracked posts and 1 missing post. Low Speed Traffic Control at \$1475- per -Day for 1 Day(s) = \$1475.

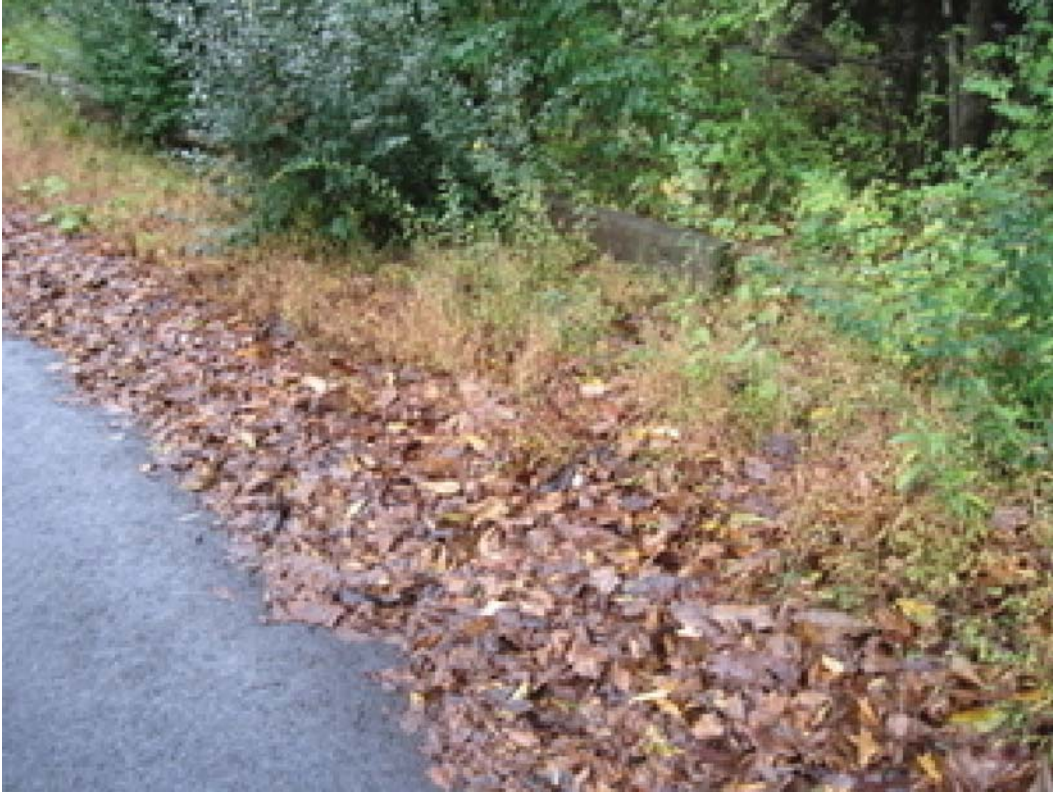
DEWA_0600_0.200_R_1.jpg

Barrier ID:	DEWA-0600-0.200-R				
Route Name:	MAIN STREET (WALPACK)				
Inspection Date:	10/04/2010	Barrier Rating:	34.00		
Barrier Description					
Type:	STEEL-BACKED TIMBER WITH BLOCKOUT	Barrier Function:	TRAFFIC		
Barrier Material:	STEEL-BACKED TIMBER/LOG	Post Material:	CORTEN		
Blockout Type:	WOOD	Length (ft.):	164		
Speed Limit (MPH):	15	Placement with Respect to Road:	OUTSIDE OF CURVE		
Hazard Behind Barrier:	MEDIUM				
Barrier Crashworthiness					
Appropriate Test Level:	TL-1	Barrier Test Level:	TL-3	Is Barrier Crashworthy?:	YES
Beg. End Trtmt Type:	NONE	Is Beg. End Trtmt Crashworthy?:	N/A	Approach Transition Type:	NONE
Ending End Trtmt Type:	NONE	Ending End Trtmt Crashworthy?:	N/A		
Average Measurements					
Design Height (In.):	27	Width (In.):	0.0	Post Spacing (In.):	122.0
Height (In.):	23.7	Lateral Offset (In.):	27.7	Road Grade (%):	7.00
Physical Condition					
Barrier	Alignment and Height:	No alignment deflection observed. Height ranges from 3 to 4 in below 27 in design height.

Breaking and Cracking:	No breaking or cracking observed.			
	Missing Elements:	No missing elements observed.			
	Corrosion and Weathering:	No loss of cross section or erosion around posts observed.			
End Treatments	Alignment and Height:				
	Breaking and Cracking:				
	Missing Elements:				
	Corrosion and Weathering:

Repair Action:	REPAIR	FMSS Work Type:	DEFERRED MAINTENANCE	Repair Cost:	\$3426
Brief Workorder:	Raise 164 ft of guardrail up to the 27 inch design height.				
Workorder:	Adjust Guardrail at \$10- per -Lin. Ft. for 164 LF = \$1640. Raise 164ft of barrier to 27 inch design height. Low Speed Traffic Control at \$1475- per -Day for 1 Day(s) = \$1475.

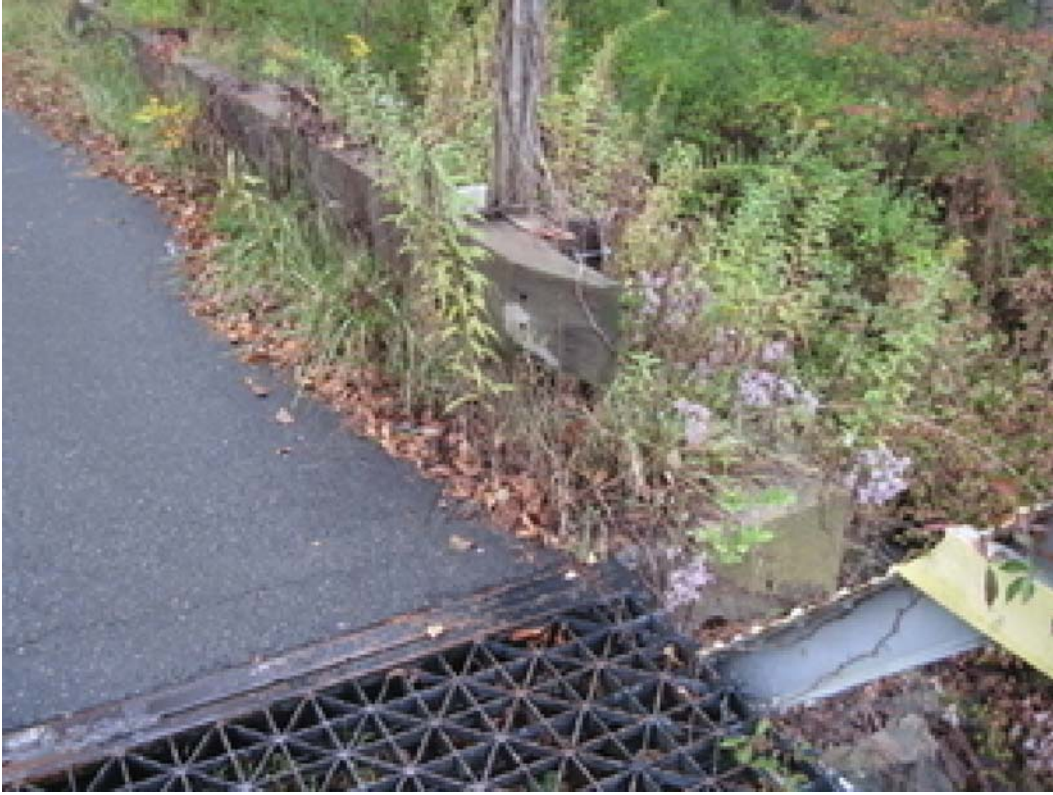
DEWA_0600_0.223_L_1.jpg

Barrier ID:	DEWA-0600-0.223-L				
Route Name:	MAIN STREET (WALPACK)				
Inspection Date:	10/04/2010	Barrier Rating:	34.20		
Barrier Description					
Type:	STEEL-BACKED TIMBER WITH BLOCKOUT	Barrier Function:	TRAFFIC		
Barrier Material:	STEEL-BACKED TIMBER/LOG	Post Material:	CORTEN		
Blockout Type:	WOOD	Length (ft.):	40		
Speed Limit (MPH):	15	Placement with Respect to Road:	OUTSIDE OF CURVE		
Hazard Behind Barrier:	LOW				
Barrier Crashworthiness					
Appropriate Test Level:	TL-1	Barrier Test Level:	TL-3	Is Barrier Crashworthy?:	YES
Beg. End Trtmt Type:	SBT/LOG FLARED	Is Beg. End Trtmt Crashworthy?:	NO	Approach Transition Type:	NONE
Ending End Trtmt Type:	NONE	Ending End Trtmt Crashworthy?:	N/A		
Average Measurements					
Design Height (In.):	27	Width (In.):	0.0	Post Spacing (In.):	113.3
Height (In.):	22.0	Lateral Offset (In.):	16.7	Road Grade (%):	1.00
Physical Condition					
Barrier	Alignment and Height:	No alignment deflection was observed. Height is 5 in below 27 in design height.

Breaking and Cracking:	No breaking or cracking observed.			
	Missing Elements:	No missing elements were observed.			
	Corrosion and Weathering:	No loss of cross section or erosion around posts observed.			
End Treatments	Alignment and Height:	Alignment acceptable. Height is within 1-in. of 27-in. design height.			
	Breaking and Cracking:	No breaking or cracking was observed.			
	Missing Elements:	No missing elements were observed.			
	Corrosion and Weathering:	No loss of cross section or erosion around posts observed.

Repair Action:	REPAIR	FMSS Work Type:	DEFERRED MAINTENANCE	Repair Cost:	\$2063
Brief Workorder:	Raise 40 feet of guardrail up to the 27 inch design height.				
Workorder:	Adjust Guardrail at \$10- per -Lin. Ft. for 40 LF = \$400. Raise 40ft of guardrail to 27 inch design height. Low Speed Traffic Control at \$1475- per -Day for 1 Day(s) = \$1475.

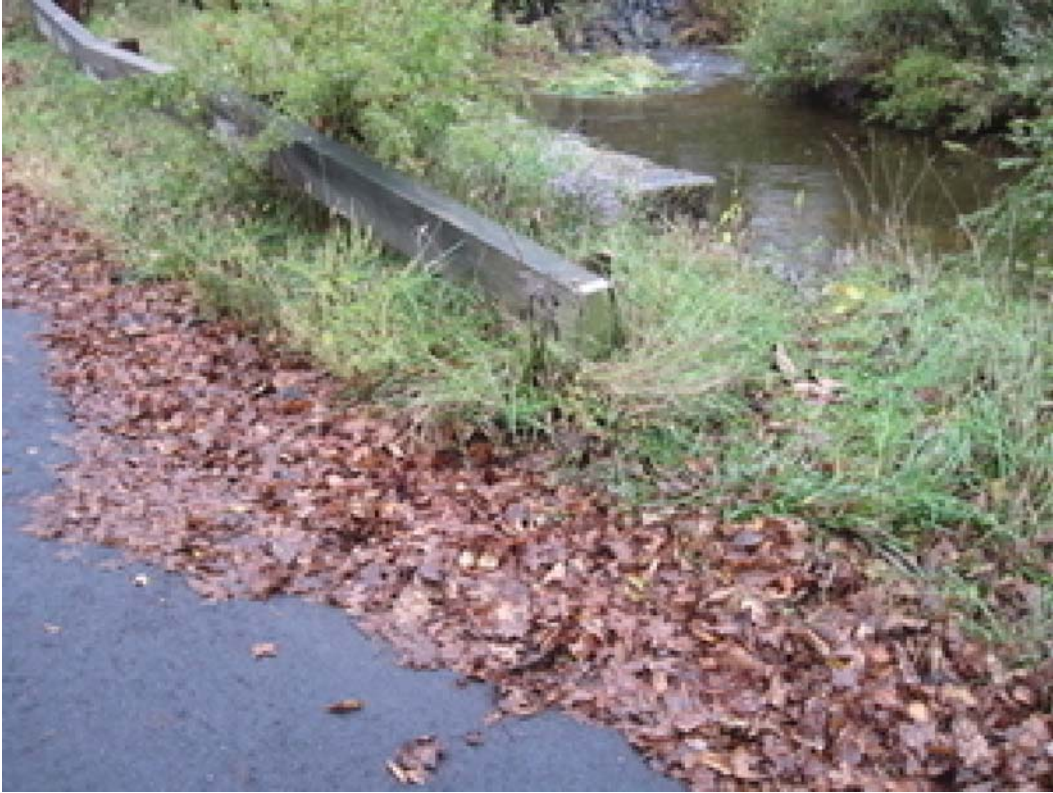
DEWA_0600_0.244_L_1.jpg

Barrier ID:	DEWA-0600-0.244-L				
Route Name:	MAIN STREET (WALPACK)				
Inspection Date:	10/04/2010	Barrier Rating:	12.80		
Barrier Description					
Type:	STEEL-BACKED TIMBER WITH BLOCKOUT	Barrier Function:	TRAFFIC		
Barrier Material:	STEEL-BACKED TIMBER/LOG	Post Material:	CORTEN		
Blockout Type:	WOOD	Length (ft.):	55		
Speed Limit (MPH):	15	Placement with Respect to Road:	INSIDE OF CURVE		
Hazard Behind Barrier:	LOW				
Barrier Crashworthiness					
Appropriate Test Level:	TL-1	Barrier Test Level:	TL-3	Is Barrier Crashworthy?:	YES
Beg. End Trtmt Type:	NONE	Is Beg. End Trtmt Crashworthy?:	N/A	Approach Transition Type:	NONE
Ending End Trtmt Type:	NONE	Ending End Trtmt Crashworthy?:	N/A		
Average Measurements					
Design Height (In.):	27	Width (In.):	0.0	Post Spacing (In.):	109.0
Height (In.):	25.7	Lateral Offset (In.):	29.2	Road Grade (%):	7.90
Physical Condition					
Barrier	Alignment and Height:	No alignment deflection was observed. Barrier is 1 to 2 in below 27 in design height for 30 ft.

Breaking and Cracking:	No breaking or cracking was observed.			
	Missing Elements:	No missing elements were observed.			
	Corrosion and Weathering:	No loss of cross section or erosion around posts observed.			
End Treatments	Alignment and Height:				
	Breaking and Cracking:				
	Missing Elements:				
	Corrosion and Weathering:

Repair Action:	REPAIR	FMSS Work Type:	DEFERRED MAINTENANCE	Repair Cost:	\$1952
Brief Workorder:	Raise 30 feet of guardrail up to the 27 inch design height.				
Workorder:	Adjust Guardrail at \$10- per -Lin. Ft. for 30 LF = \$300. Raise 30ft of barrier to 27 inch design height. Low Speed Traffic Control at \$1475- per -Day for 1 Day(s) = \$1475.

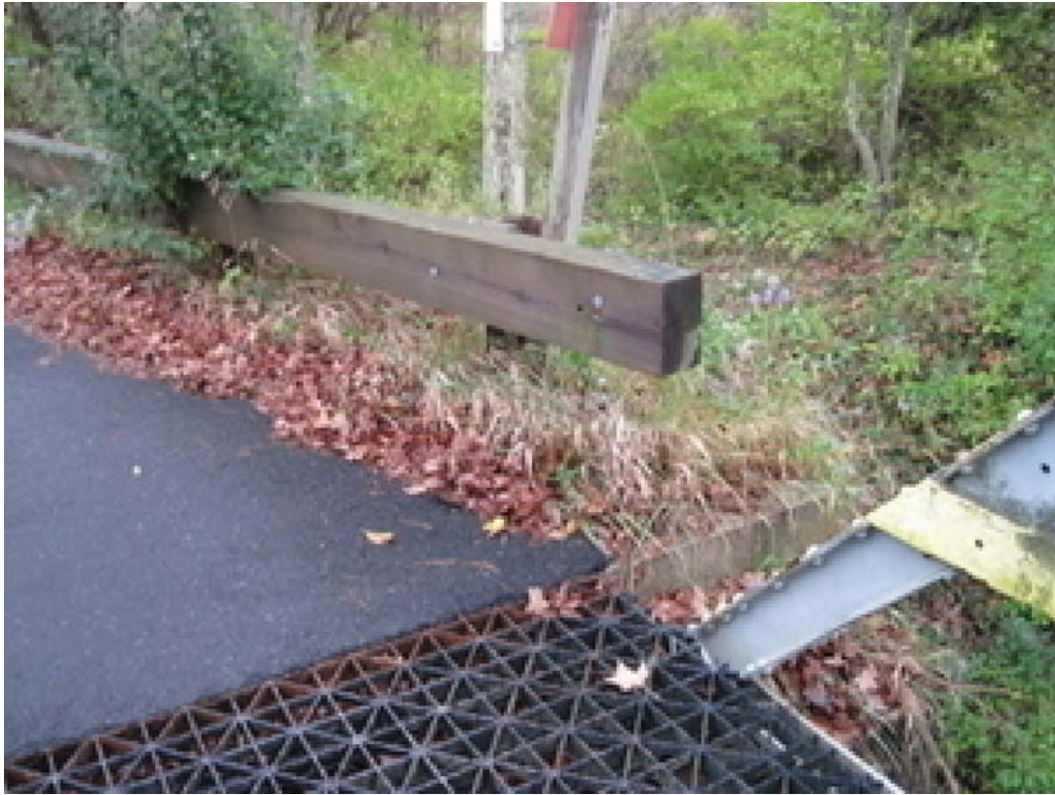
DEWA_0600_0.244_R_1.jpg

Barrier ID:	DEWA-0600-0.244-R				
Route Name:	MAIN STREET (WALPACK)				
Inspection Date:	10/04/2010	Barrier Rating:	25.60		
Barrier Description					
Type:	STEEL-BACKED TIMBER WITH BLOCKOUT	Barrier Function:	TRAFFIC		
Barrier Material:	STEEL-BACKED TIMBER/LOG	Post Material:	CORTEN		
Blockout Type:	WOOD	Length (ft.):	50		
Speed Limit (MPH):	15	Placement with Respect to Road:	OUTSIDE OF CURVE		
Hazard Behind Barrier:	LOW				
Barrier Crashworthiness					
Appropriate Test Level:	TL-1	Barrier Test Level:	TL-3	Is Barrier Crashworthy?:	YES
Beg. End Trtmt Type:	NONE	Is Beg. End Trtmt Crashworthy?:	N/A	Approach Transition Type:	NONE
Ending End Trtmt Type:	NONE	Ending End Trtmt Crashworthy?:	N/A		
Average Measurements					
Design Height (In.):	27	Width (In.):	0.0	Post Spacing (In.):	119.6
Height (In.):	25.0	Lateral Offset (In.):	15.6	Road Grade (%):	4.30
Physical Condition					
Barrier	Alignment and Height:	No alignment deflection observed. 25-ft. was within 1-in. of the 27-in. design height 10-ft. was between 1 and 3-in. below and 15-ft. was more than 3-in. below the design height.

Breaking and Cracking:	No breaking or cracking observed.			
	Missing Elements:	No missing elements observed.			
	Corrosion and Weathering:	No loss of cross section or erosion around posts observed.			
End Treatments	Alignment and Height:				
	Breaking and Cracking:				
	Missing Elements:				
	Corrosion and Weathering:

Repair Action:	REPAIR	FMSS Work Type:	DEFERRED MAINTENANCE	Repair Cost:	\$1898
Brief Workorder:	Raise 25 feet of guardrail up to the 27 inch design height.				
Workorder:	Adjust Guardrail at \$10- per -Lin. Ft. for 25 LF = \$250. Raise 25 feet of guardrail to 27 inch design height. Low Speed Traffic Control at \$1475- per -Day for 1 Day(s) = \$1475.

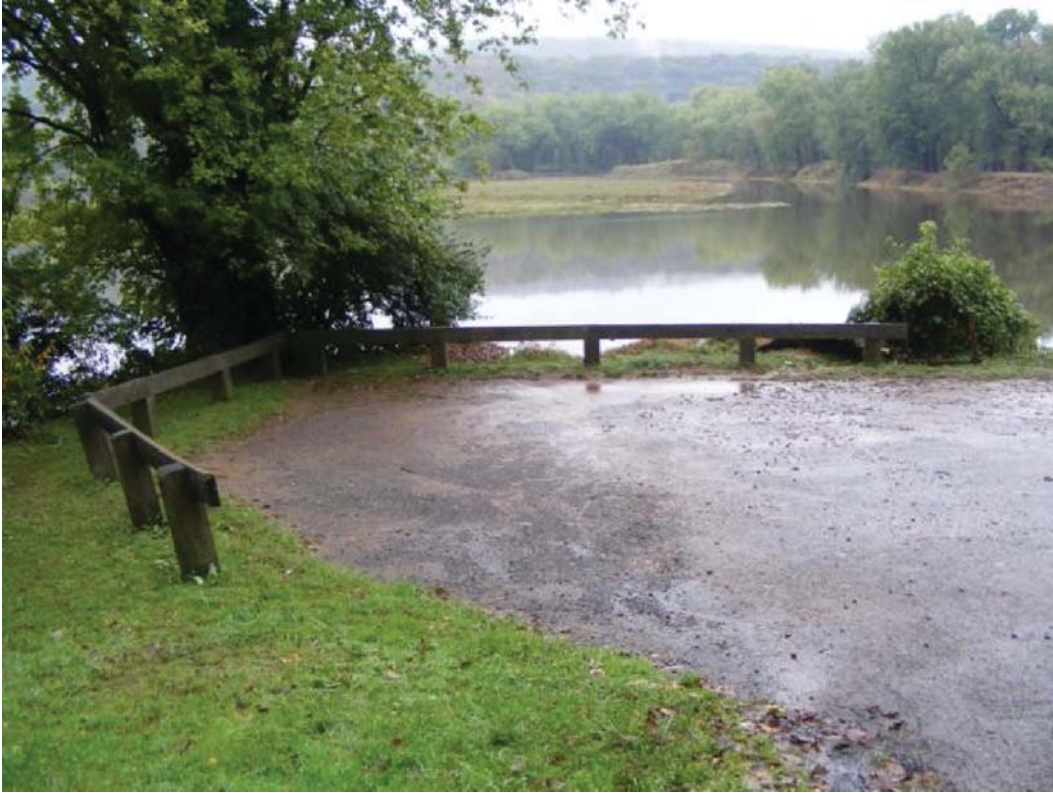
DEWA_0900ZZ_0.000_P1_1.JPG

Barrier ID:	DEWA-0900ZZ-0.000-P1				
Route Name:	POXONO BOAT LAUNCH PARKING AREAS				
Inspection Date:	10/05/2010	Barrier Rating:	0.00		
Barrier Description					
Type:	OTHER: TIMBER RAIL ON TIMBER POSTS	Barrier Function:	NON-TRAFFIC		
Barrier Material:	LOG/TIMBER/WOOD	Post Material:	WOOD		
Blockout Type:	N/A	Length (ft.):	73		
Speed Limit (MPH):	15	Placement with Respect to Road:	NON-TRAFFIC BARRIER		
Hazard Behind Barrier:	N/A				
Barrier Crashworthiness					
Appropriate Test Level:	TL-1	Barrier Test Level:	N/A	Is Barrier Crashworthy?:	N/A
Beg. End Trtmt Type:	NONE	Is Beg. End Trtmt Crashworthy?:	N/A	Approach Transition Type:	NONE
Ending End Trtmt Type:	NONE	Ending End Trtmt Crashworthy?:	N/A		
Average Measurements					
Design Height (In.):	27	Width (In.):	0.0	Post Spacing (In.):	0.0
Height (In.):	31.0	Lateral Offset (In.):	0.0	Road Grade (%):	0.00
Physical Condition					
Barrier	Alignment and Height:	No deflections observed in alignment. The height is at or above the design of 27 in up to 9 in above.

Breaking and Cracking:	No breaking or cracking observed.			
	Missing Elements:	No missing elements observed.			
	Corrosion and Weathering:	No loss of cross section or erosion around posts observed.			
End Treatments	Alignment and Height:				
	Breaking and Cracking:				
	Missing Elements:				
	Corrosion and Weathering:

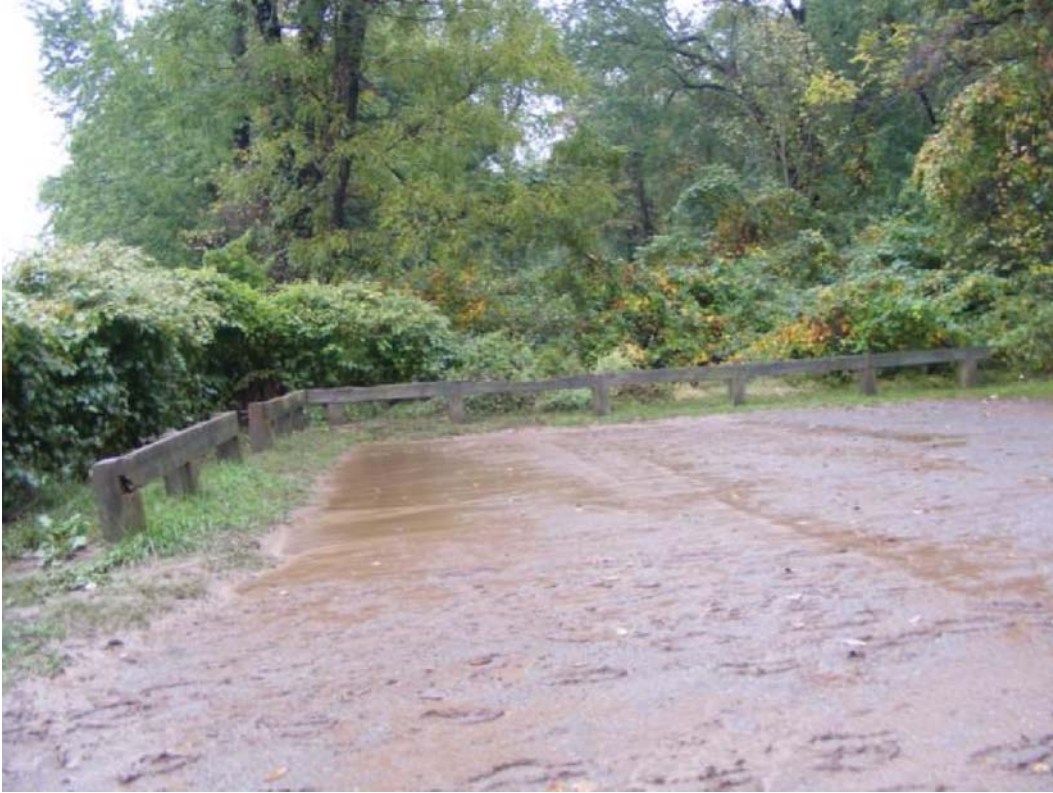
DEWA_0900ZZ_0.000_P2_1.JPG

Barrier ID:	DEWA-0900ZZ-0.000-P2				
Route Name:	POXONO BOAT LAUNCH PARKING AREAS				
Inspection Date:	10/05/2010	Barrier Rating:	0.00		
Barrier Description					
Type:	OTHER: TIMBER RAIL ON TIMBER POSTS	Barrier Function:	NON-TRAFFIC		
Barrier Material:	LOG/TIMBER/WOOD	Post Material:	WOOD		
Blockout Type:	N/A	Length (ft.):	88		
Speed Limit (MPH):	15	Placement with Respect to Road:	NON-TRAFFIC BARRIER		
Hazard Behind Barrier:	N/A				
Barrier Crashworthiness					
Appropriate Test Level:	TL-1	Barrier Test Level:	N/A	Is Barrier Crashworthy?:	N/A
Beg. End Trtmt Type:	NONE	Is Beg. End Trtmt Crashworthy?:	N/A	Approach Transition Type:	NONE
Ending End Trtmt Type:	NONE	Ending End Trtmt Crashworthy?:	N/A		
Average Measurements					
Design Height (In.):	27	Width (In.):	0.0	Post Spacing (In.):	0.0
Height (In.):	28.2	Lateral Offset (In.):	0.0	Road Grade (%):	0.00
Physical Condition					
Barrier	Alignment and Height:	No deflections observed in alignment. The height is at or above the design of 27 in by up to 3 in.

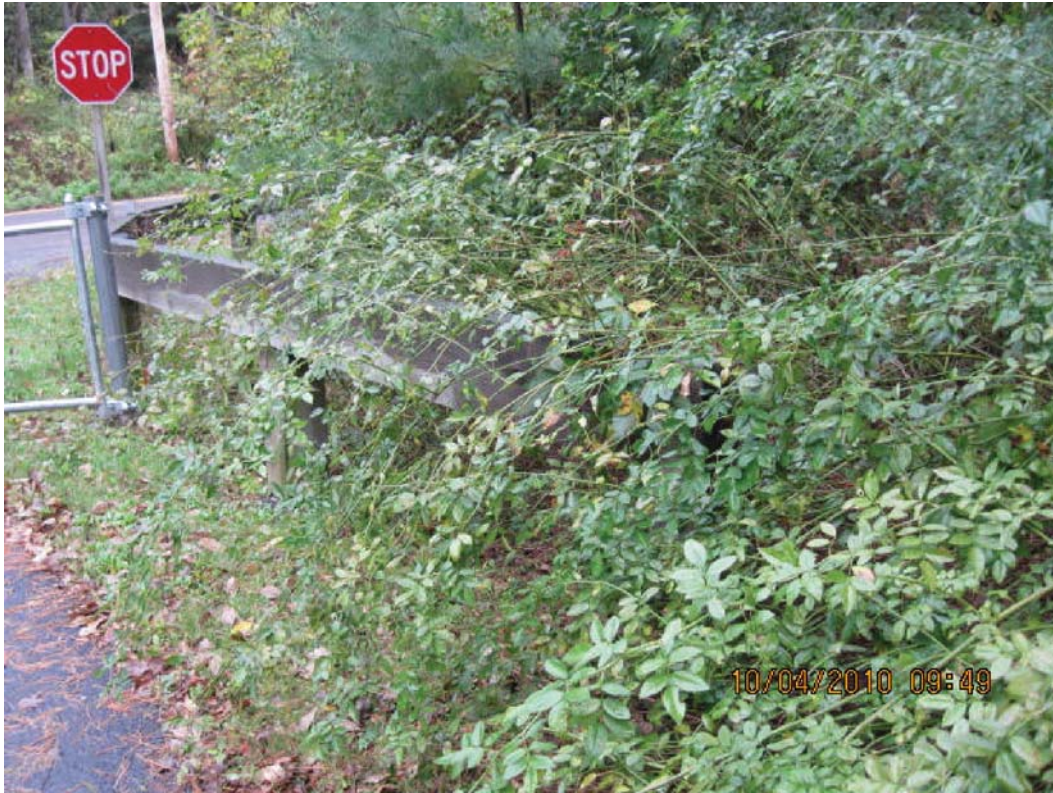
DEWA_0908_0.000_P1_1.jpg

Barrier ID:	DEWA-0908-0.000-P1				
Route Name:	DINGMAN'S FERRY ACCESS PARKING AREA				
Inspection Date:	10/04/2010	Barrier Rating:	8.30		
Barrier Description					
Type:	OTHER: TIMBER RAIL ON TIMBER POSTS	Barrier Function:	NON-TRAFFIC		
Barrier Material:	LOG/TIMBER/WOOD	Post Material:	WOOD		
Blockout Type:	N/A	Length (ft.):	46		
Speed Limit (MPH):	15	Placement with Respect to Road:	NON-TRAFFIC BARRIER		
Hazard Behind Barrier:	N/A				
Barrier Crashworthiness					
Appropriate Test Level:	TL-1	Barrier Test Level:	N/A	Is Barrier Crashworthy?:	N/A
Beg. End Trtmt Type:	NONE	Is Beg. End Trtmt Crashworthy?:	N/A	Approach Transition Type:	NONE
Ending End Trtmt Type:	NONE	Ending End Trtmt Crashworthy?:	N/A		
Average Measurements					
Design Height (In.):	27	Width (In.):	0.0	Post Spacing (In.):	0.0
Height (In.):	34.2	Lateral Offset (In.):	0.0	Road Grade (%):	0.00
Physical Condition					
Barrier	Alignment and Height:	Alignment deflection was less than 6 in. The entire barrier exceeded design height (27 in) by 6.5 to 8 in.

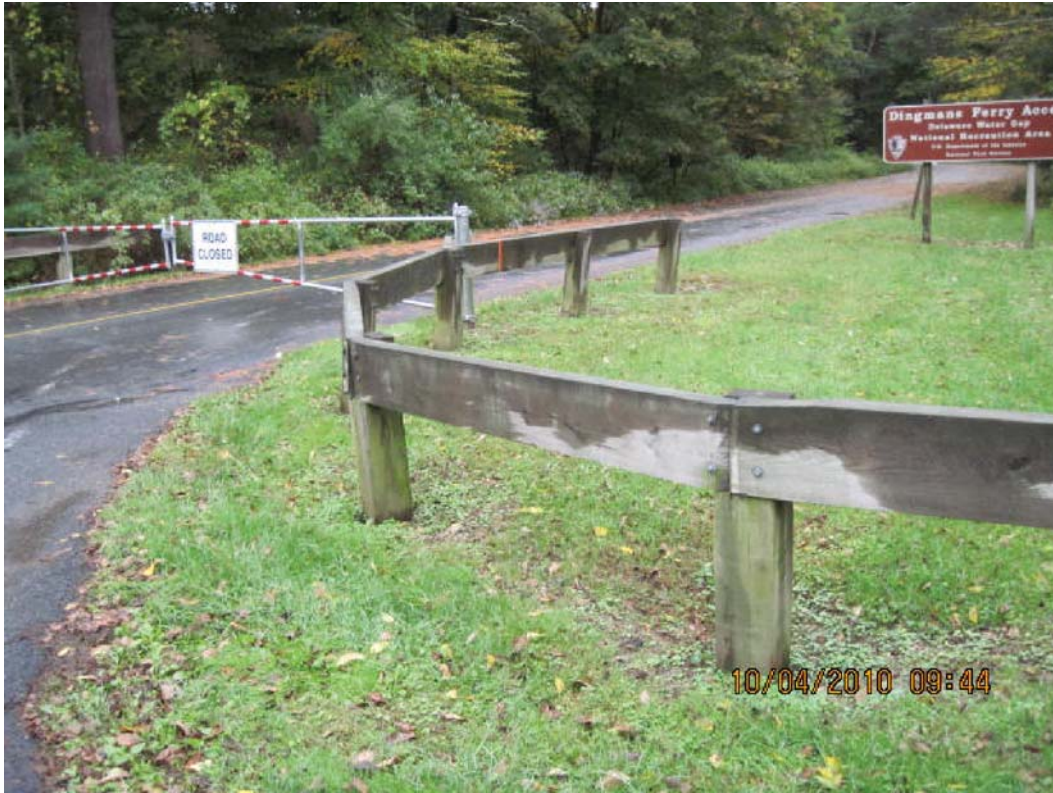
DEWA_0908_0.000_P2_1.jpg

Barrier ID:	DEWA-0908-0.000-P2				
Route Name:	DINGMAN'S FERRY ACCESS PARKING AREA				
Inspection Date:	10/04/2010	Barrier Rating:	11.10		
Barrier Description					
Type:	OTHER: TIMBER RAIL ON TIMBER POSTS	Barrier Function:	TRAFFIC		
Barrier Material:	LOG/TIMBER/WOOD	Post Material:	WOOD		
Blockout Type:	N/A	Length (ft.):	43		
Speed Limit (MPH):	15	Placement with Respect to Road:	TANGENT		
Hazard Behind Barrier:	LOW				
Barrier Crashworthiness					
Appropriate Test Level:	TL-1	Barrier Test Level:	NCW	Is Barrier Crashworthy?:	NO
Beg. End Trtmt Type:	NONE	Is Beg. End Trtmt Crashworthy?:	N/A	Approach Transition Type:	NONE
Ending End Trtmt Type:	NONE	Ending End Trtmt Crashworthy?:	N/A		
Average Measurements					
Design Height (In.):	27	Width (In.):	0.0	Post Spacing (In.):	93.6
Height (In.):	34.0	Lateral Offset (In.):	45.5	Road Grade (%):	0.80
Physical Condition					
Barrier	Alignment and Height:	Alignment deflection was less than 6 in. The entire barrier exceeded design height (27 in) by 6 to 9 in.

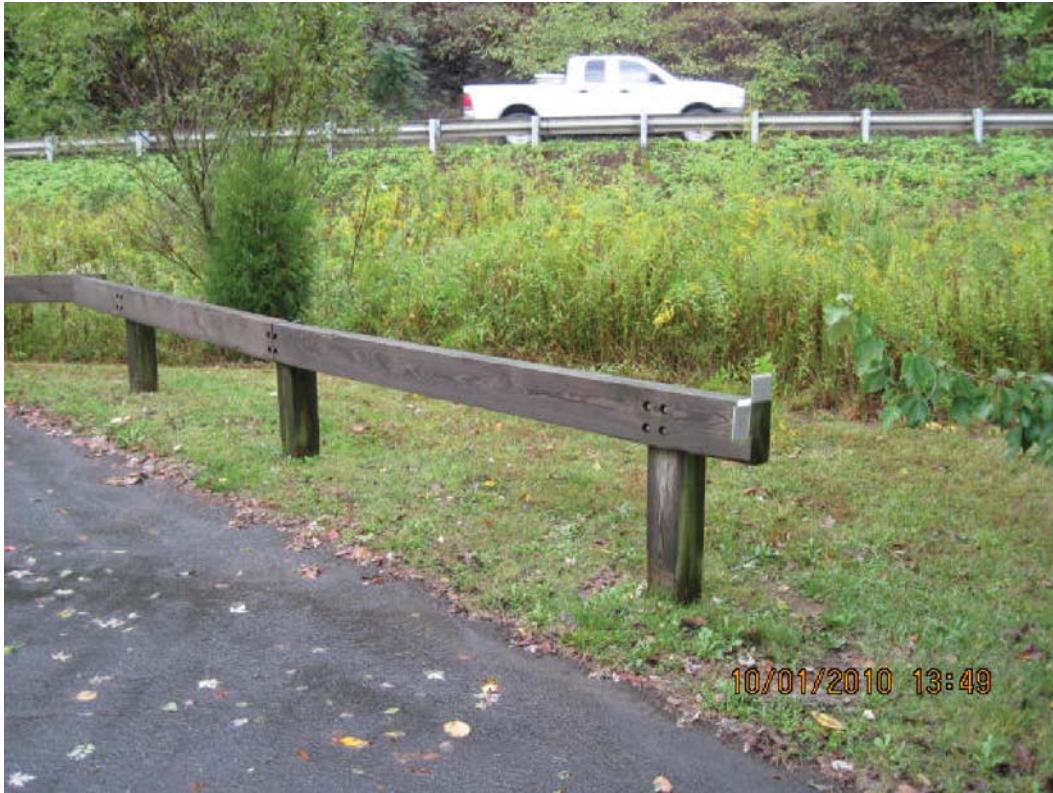
DEWA_0910_0.000_P1_1.jpg

Barrier ID:	DEWA-0910-0.000-P1				
Route Name:	BUSHKILL ACCESS PARKING AREA				
Inspection Date:	10/01/2010	Barrier Rating:	0.00		
Barrier Description					
Type:	OTHER: TIMBER RAIL ON TIMBER POSTS	Barrier Function:	NON-TRAFFIC		
Barrier Material:	LOG/TIMBER/WOOD	Post Material:	WOOD		
Blockout Type:	N/A	Length (ft.):	136		
Speed Limit (MPH):	15	Placement with Respect to Road:	NON-TRAFFIC BARRIER		
Hazard Behind Barrier:	N/A				
Barrier Crashworthiness					
Appropriate Test Level:	TL-1	Barrier Test Level:	N/A	Is Barrier Crashworthy?:	N/A
Beg. End Trtmt Type:	NONE	Is Beg. End Trtmt Crashworthy?:	N/A	Approach Transition Type:	NONE
Ending End Trtmt Type:	NONE	Ending End Trtmt Crashworthy?:	N/A		
Average Measurements					
Design Height (In.):	27	Width (In.):	0.0	Post Spacing (In.):	117.0
Height (In.):	28.7	Lateral Offset (In.):	0.0	Road Grade (%):	0.00
Physical Condition					
Barrier	Alignment and Height:	No deflections greater than 6 in were observed in the alignment. Entire barrier is 1 in below to 4in. above the 27 in design height.
