NPS Guardwall/Rail Inventory Program Delaware Water Gap National Recreation Area

**Federal Lands Highway
Road Inventory Program**

Federal Highway Administration
Eastern Federal Lands Highway Division
Road Inventory Program (RIP)

Data Collection Date: October 2010
Report Date: December 2015

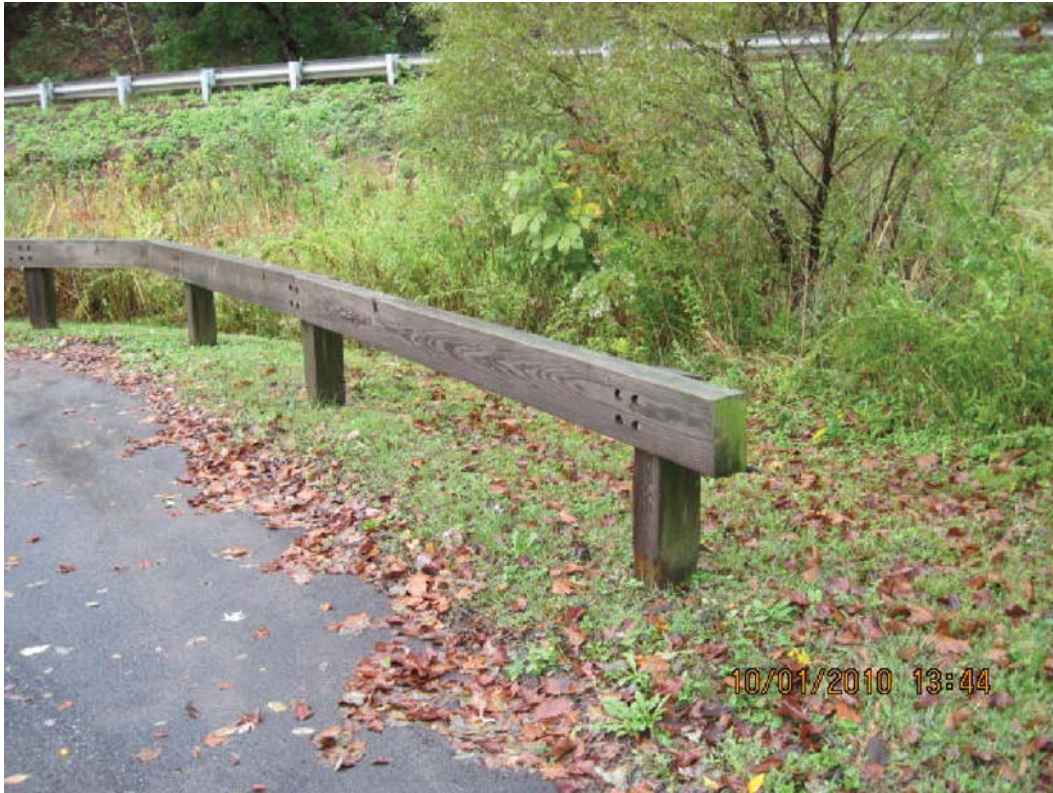
DEWA_0910_0.000_P2_1.jpg

Barrier ID:	DEWA-0910-0.000-P2				
Route Name:	BUSHKILL ACCESS PARKING AREA				
Inspection Date:	10/01/2010	Barrier Rating:	0.00		
Barrier Description					
Type:	OTHER: TIMBER RAIL ON TIMBER POSTS	Barrier Function:	NON-TRAFFIC		
Barrier Material:	LOG/TIMBER/WOOD	Post Material:	WOOD		
Blockout Type:	N/A	Length (ft.):	180		
Speed Limit (MPH):	15	Placement with Respect to Road:	NON-TRAFFIC BARRIER		
Hazard Behind Barrier:	N/A				
Barrier Crashworthiness					
Appropriate Test Level:	TL-1	Barrier Test Level:	N/A	Is Barrier Crashworthy?:	N/A
Beg. End Trtmt Type:	NONE	Is Beg. End Trtmt Crashworthy?:	N/A	Approach Transition Type:	NONE
Ending End Trtmt Type:	NONE	Ending End Trtmt Crashworthy?:	N/A		
Average Measurements					
Design Height (In.):	27	Width (In.):	0.0	Post Spacing (In.):	110.0
Height (In.):	30.2	Lateral Offset (In.):	0.0	Road Grade (%):	0.00
Physical Condition					
Barrier	Alignment and Height:	No deflections greater than 6 in were observed in the alignment. Barrier height was 1-5in. greater than the 27 in design height for the entire length.

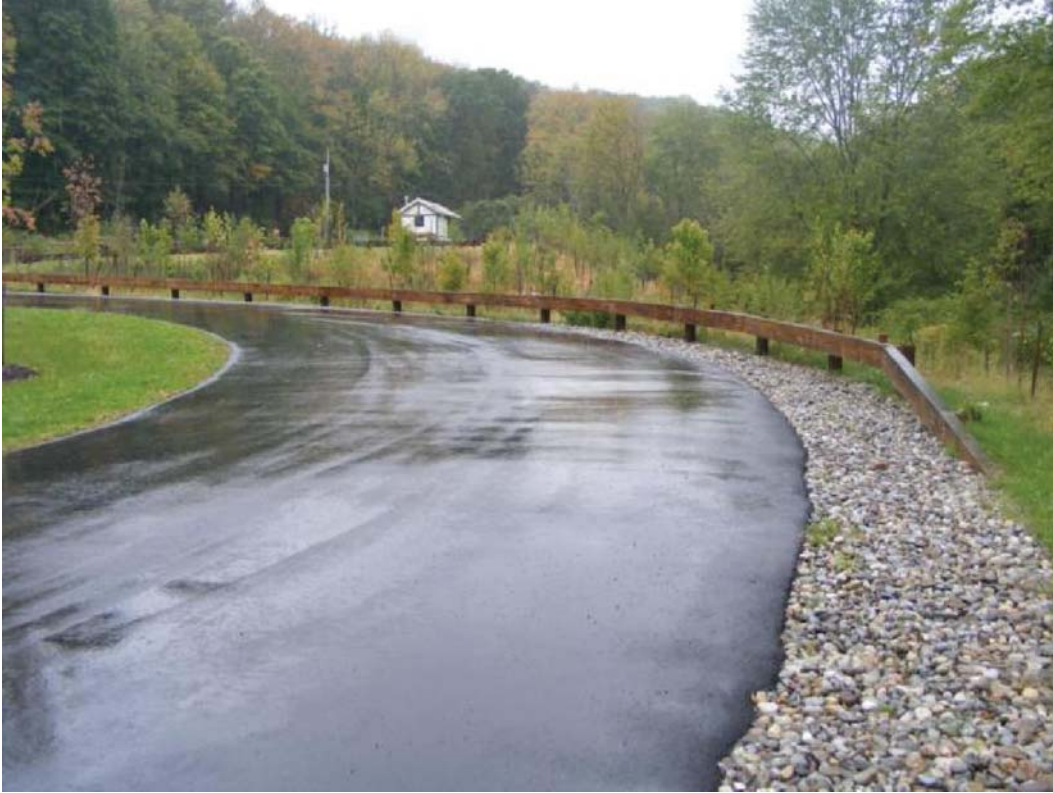
DEWA_0980_0.000_P1_1.JPG

Barrier ID:	DEWA-0980-0.000-P1				
Route Name:	TURTLE BEACH PARKING				
Inspection Date:	10/04/2010	Barrier Rating:	2.90		
Barrier Description					
Type:	STEEL-BACKED TIMBER WITH BLOCKOUT	Barrier Function:	NON-TRAFFIC		
Barrier Material:	STEEL-BACKED TIMBER/LOG	Post Material:	CORTEN		
Blockout Type:	WOOD	Length (ft.):	486		
Speed Limit (MPH):	15	Placement with Respect to Road:	NON-TRAFFIC BARRIER		
Hazard Behind Barrier:	N/A				
Barrier Crashworthiness					
Appropriate Test Level:	TL-1	Barrier Test Level:	TL-3	Is Barrier Crashworthy?:	N/A
Beg. End Trtmt Type:	SBT/LOG FLARED	Is Beg. End Trtmt Crashworthy?:	NO	Approach Transition Type:	NONE
Ending End Trtmt Type:	SBT/LOG FLARED	Ending End Trtmt Crashworthy?:	NO		
Average Measurements					
Design Height (In.):	27	Width (In.):	0.0	Post Spacing (In.):	0.0
Height (In.):	28.2	Lateral Offset (In.):	0.0	Road Grade (%):	0.00
Physical Condition					
Barrier	Alignment and Height:	No deflections observed in alignment. The height is at or above the design of 27 in by up to 3 in.
