NPS Guardwall/Rail Inventory Program
Great Smoky Mountains National Park

Federal Highway Administration
Eastern Federal Lands Highway Division
Road Inventory Program (RIP)

Data Collection Date: September 2010
Report Date: December 2015

Great Smoky Mountains National Park in North Carolina and Tennessee

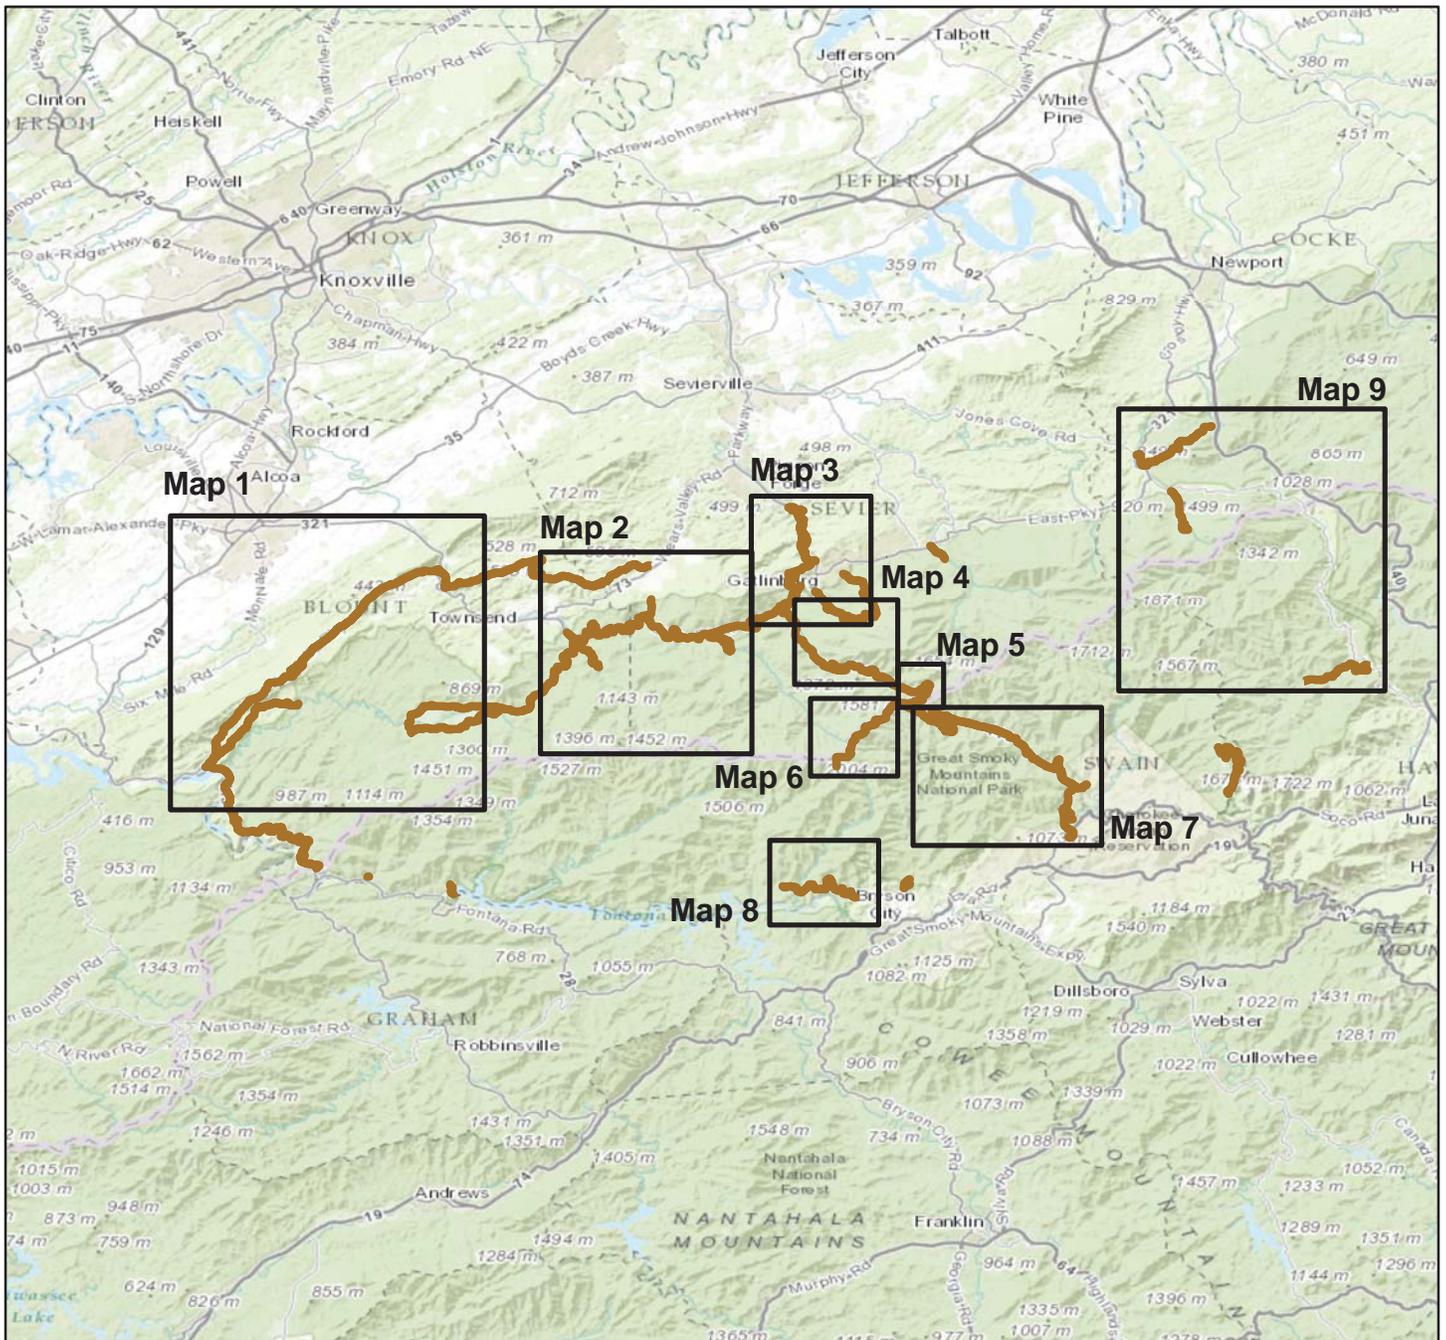
Key Map

BARRIER LOCATION MAP

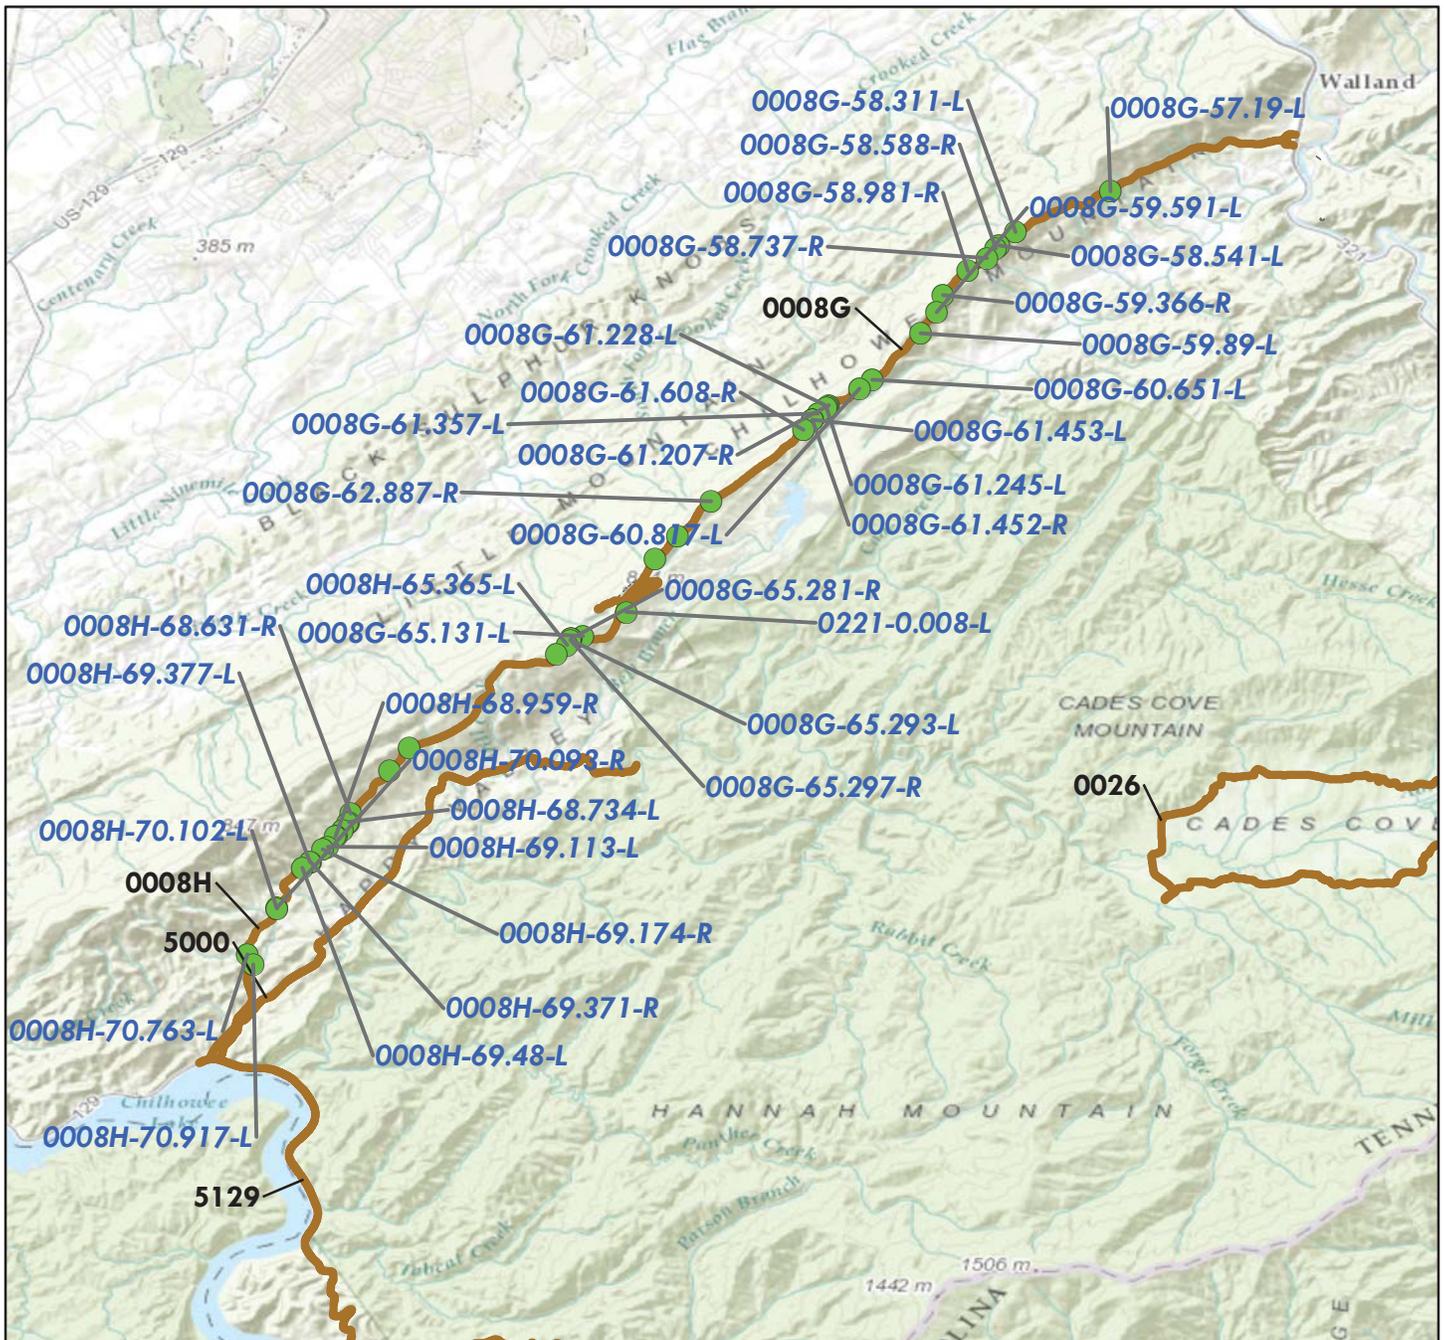
Map 1

BARRIER LOCATION MAP

● Barrier Locations (Not all labeled)

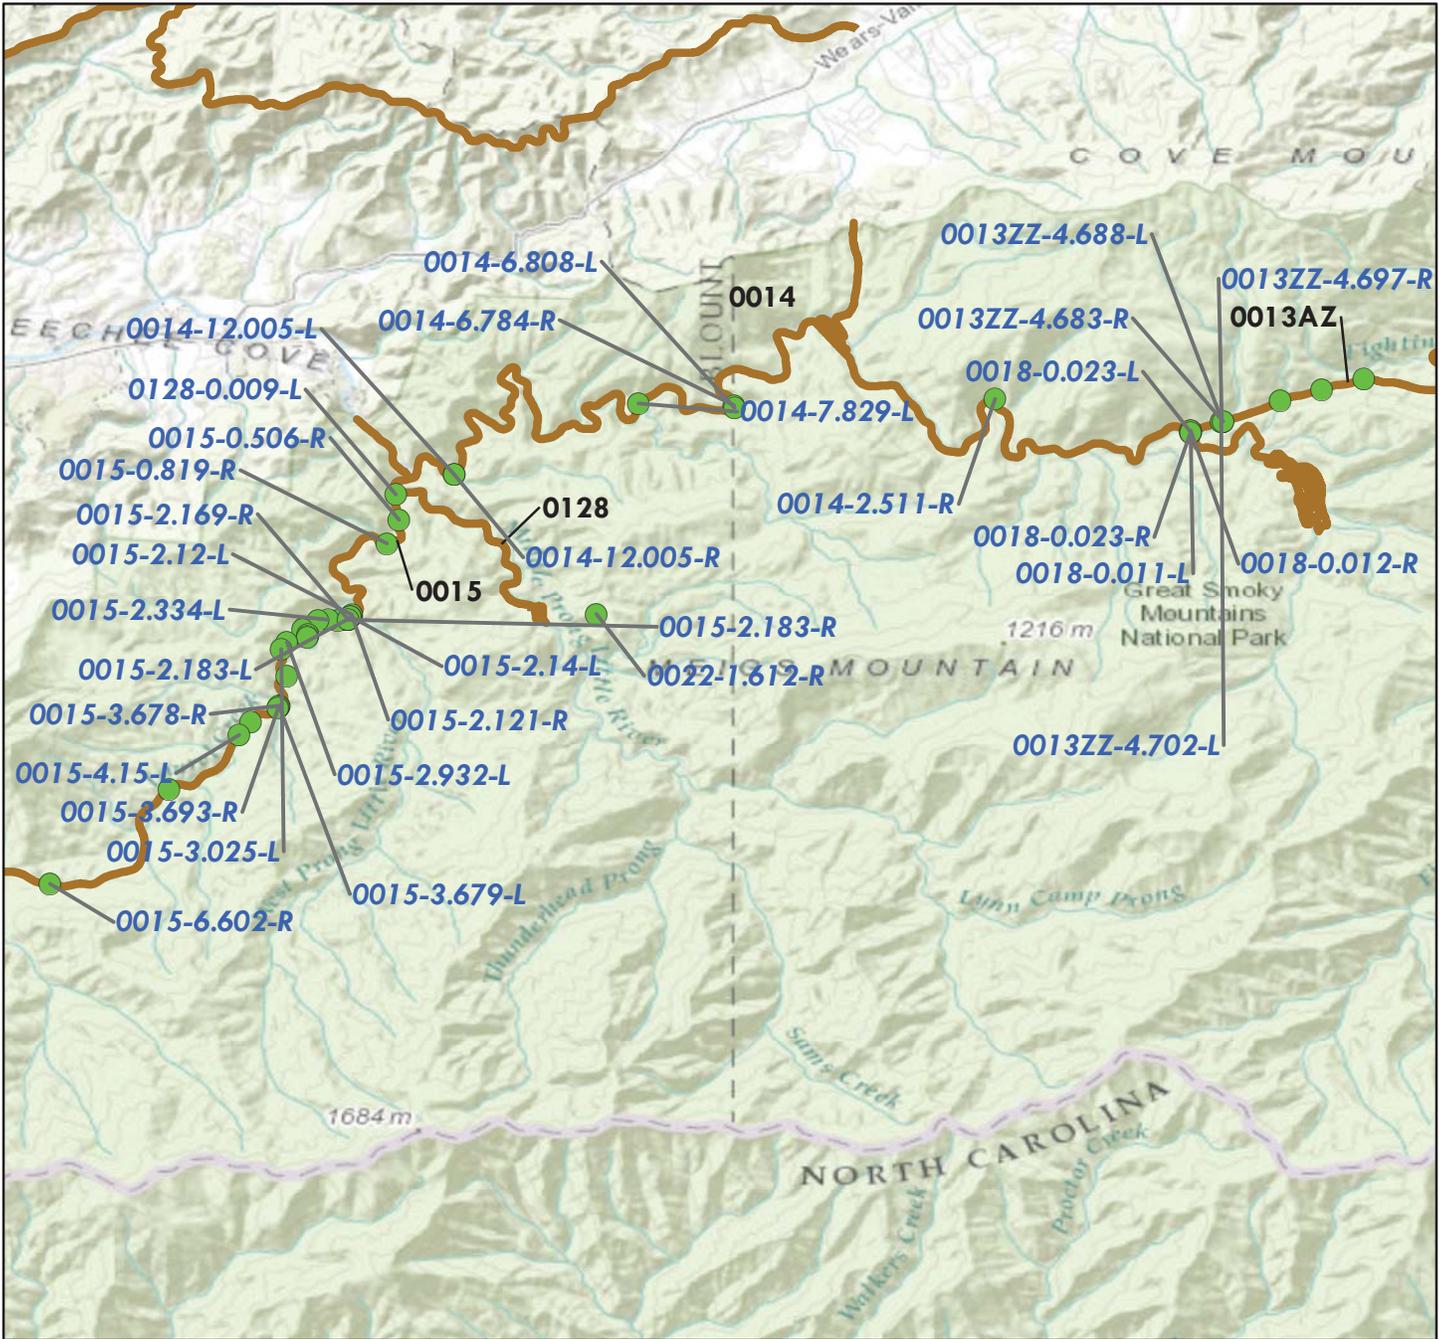
Map 2

BARRIER LOCATION MAP

● Barrier Locations (Not all labeled)

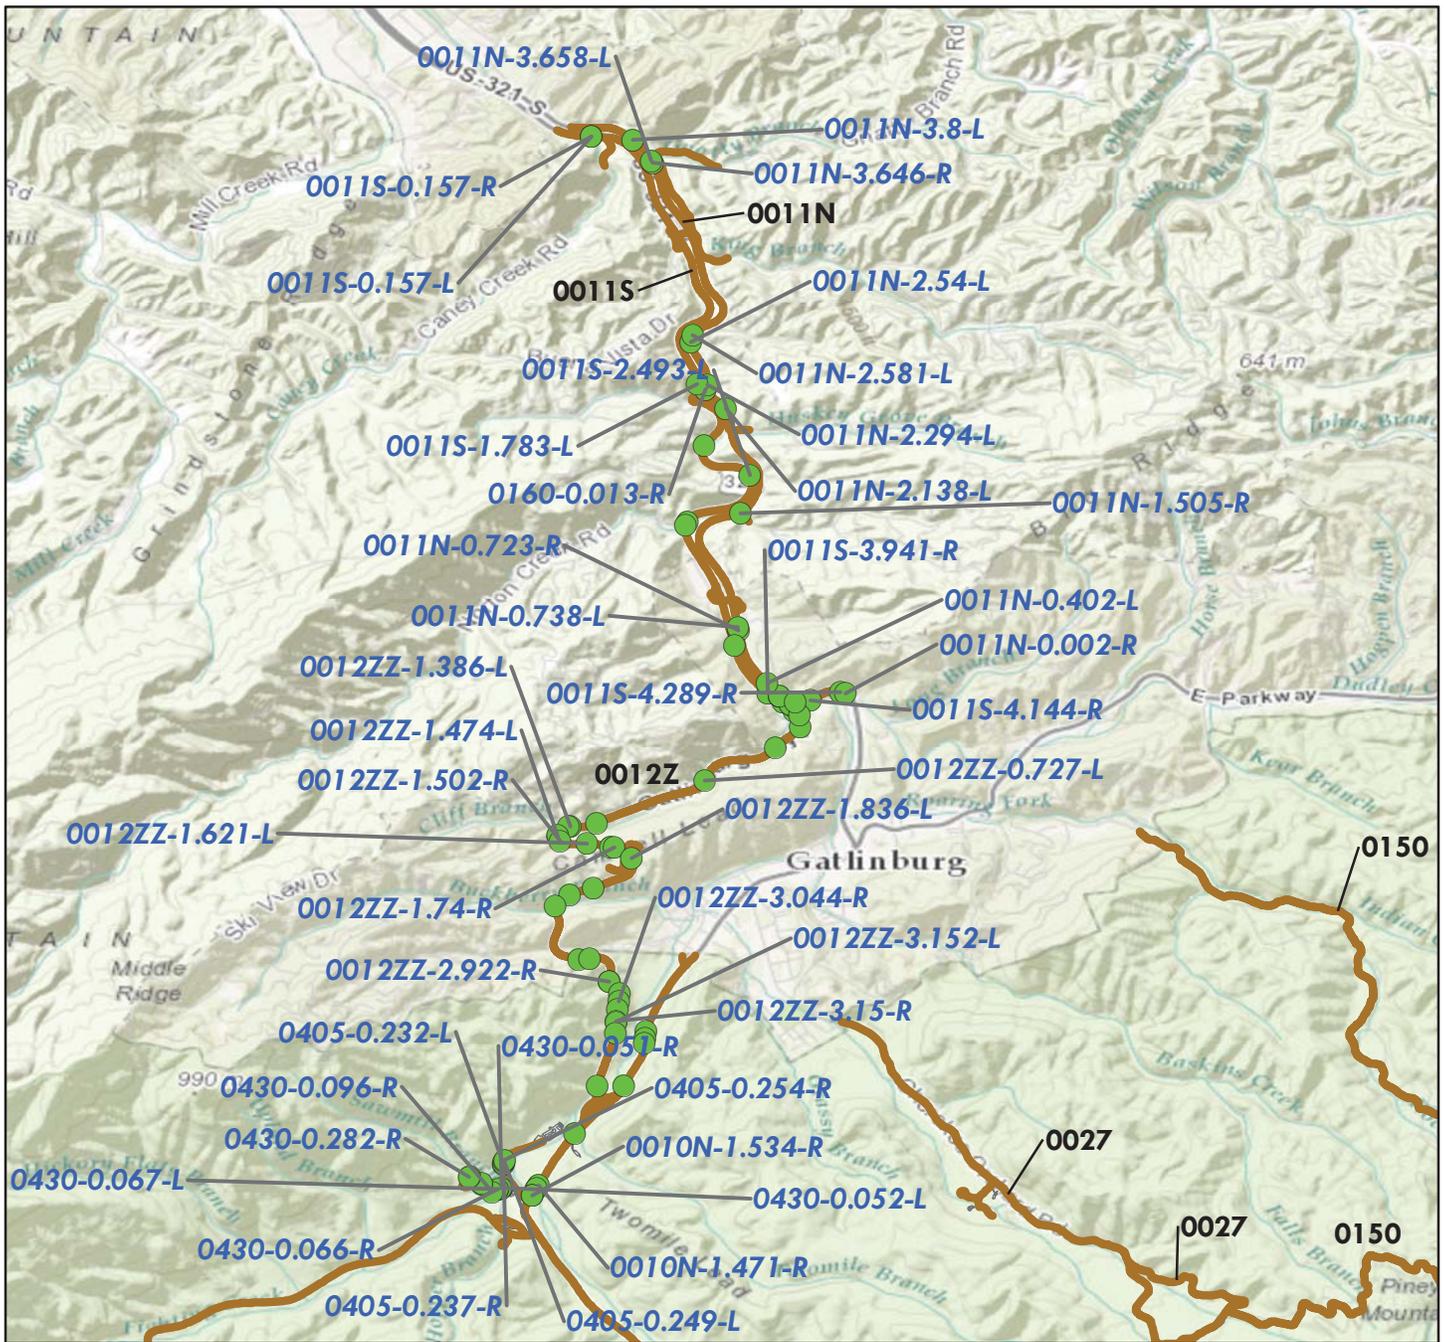
Map 3

BARRIER LOCATION MAP

● Barrier Locations (Not all labeled)

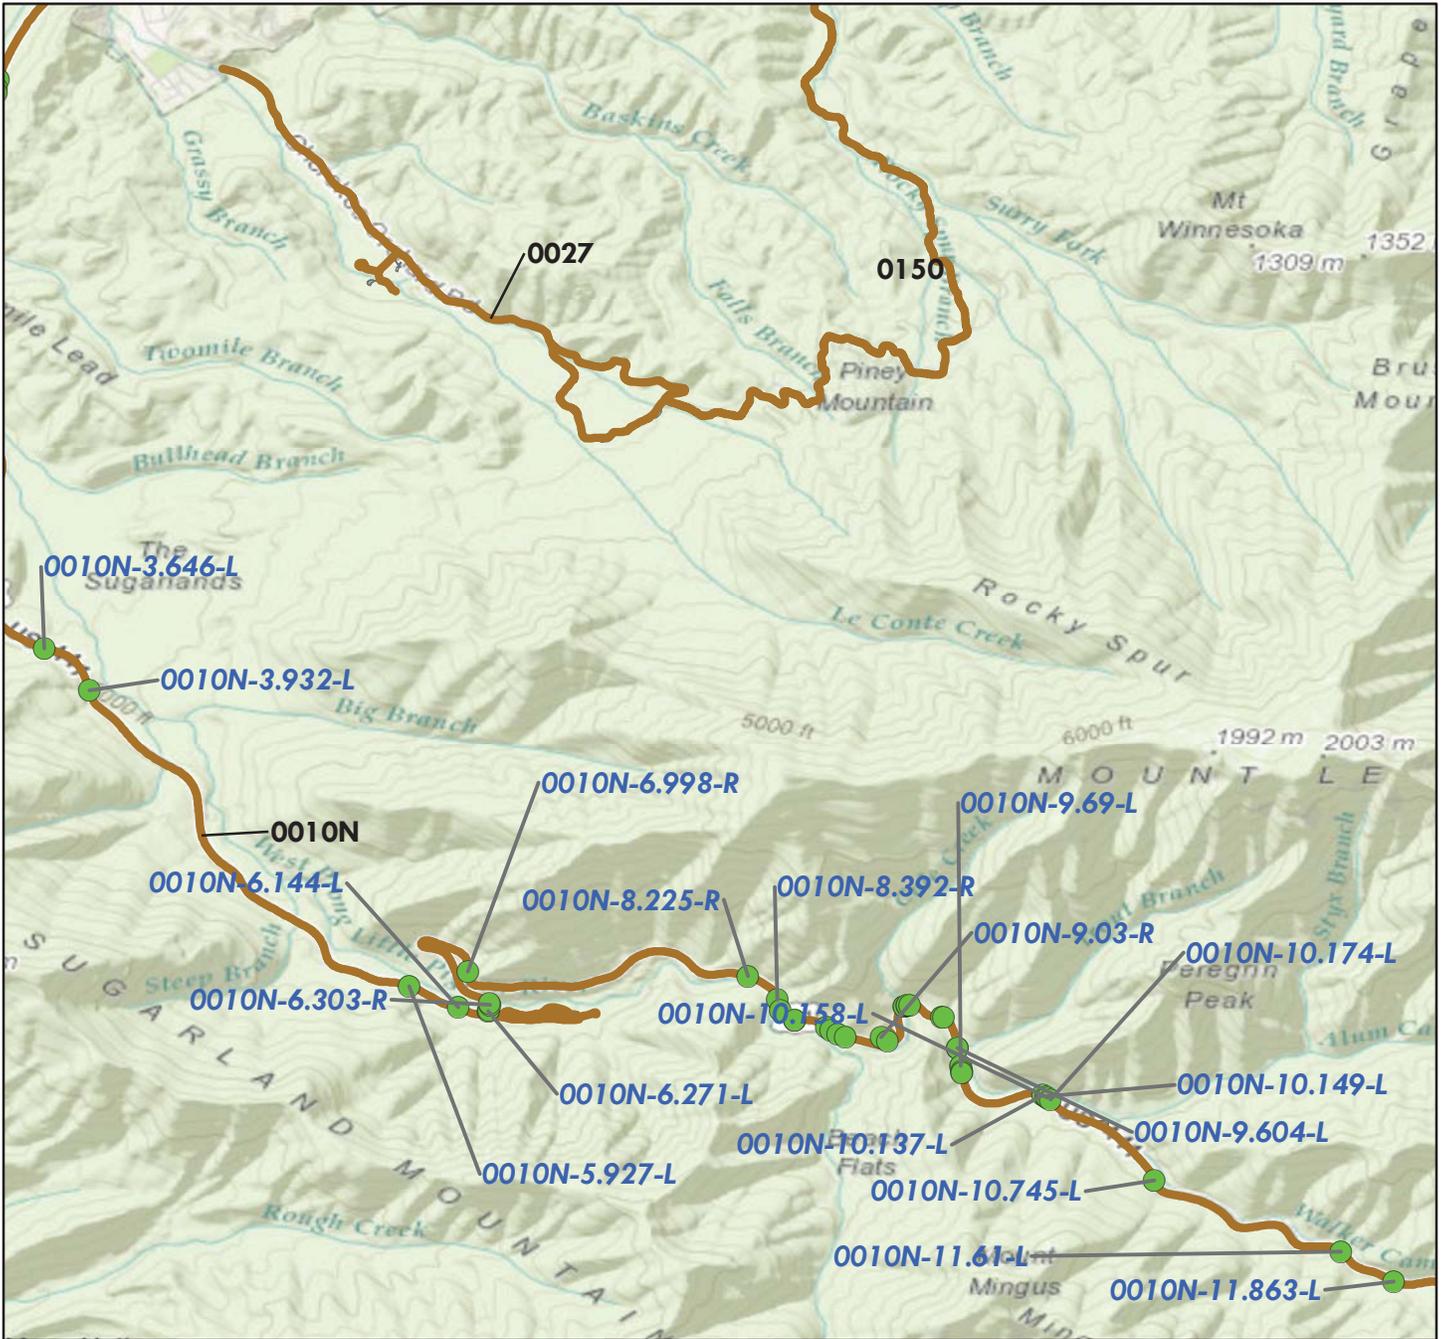
Map 4

BARRIER LOCATION MAP

● Barrier Locations (Not all labeled)

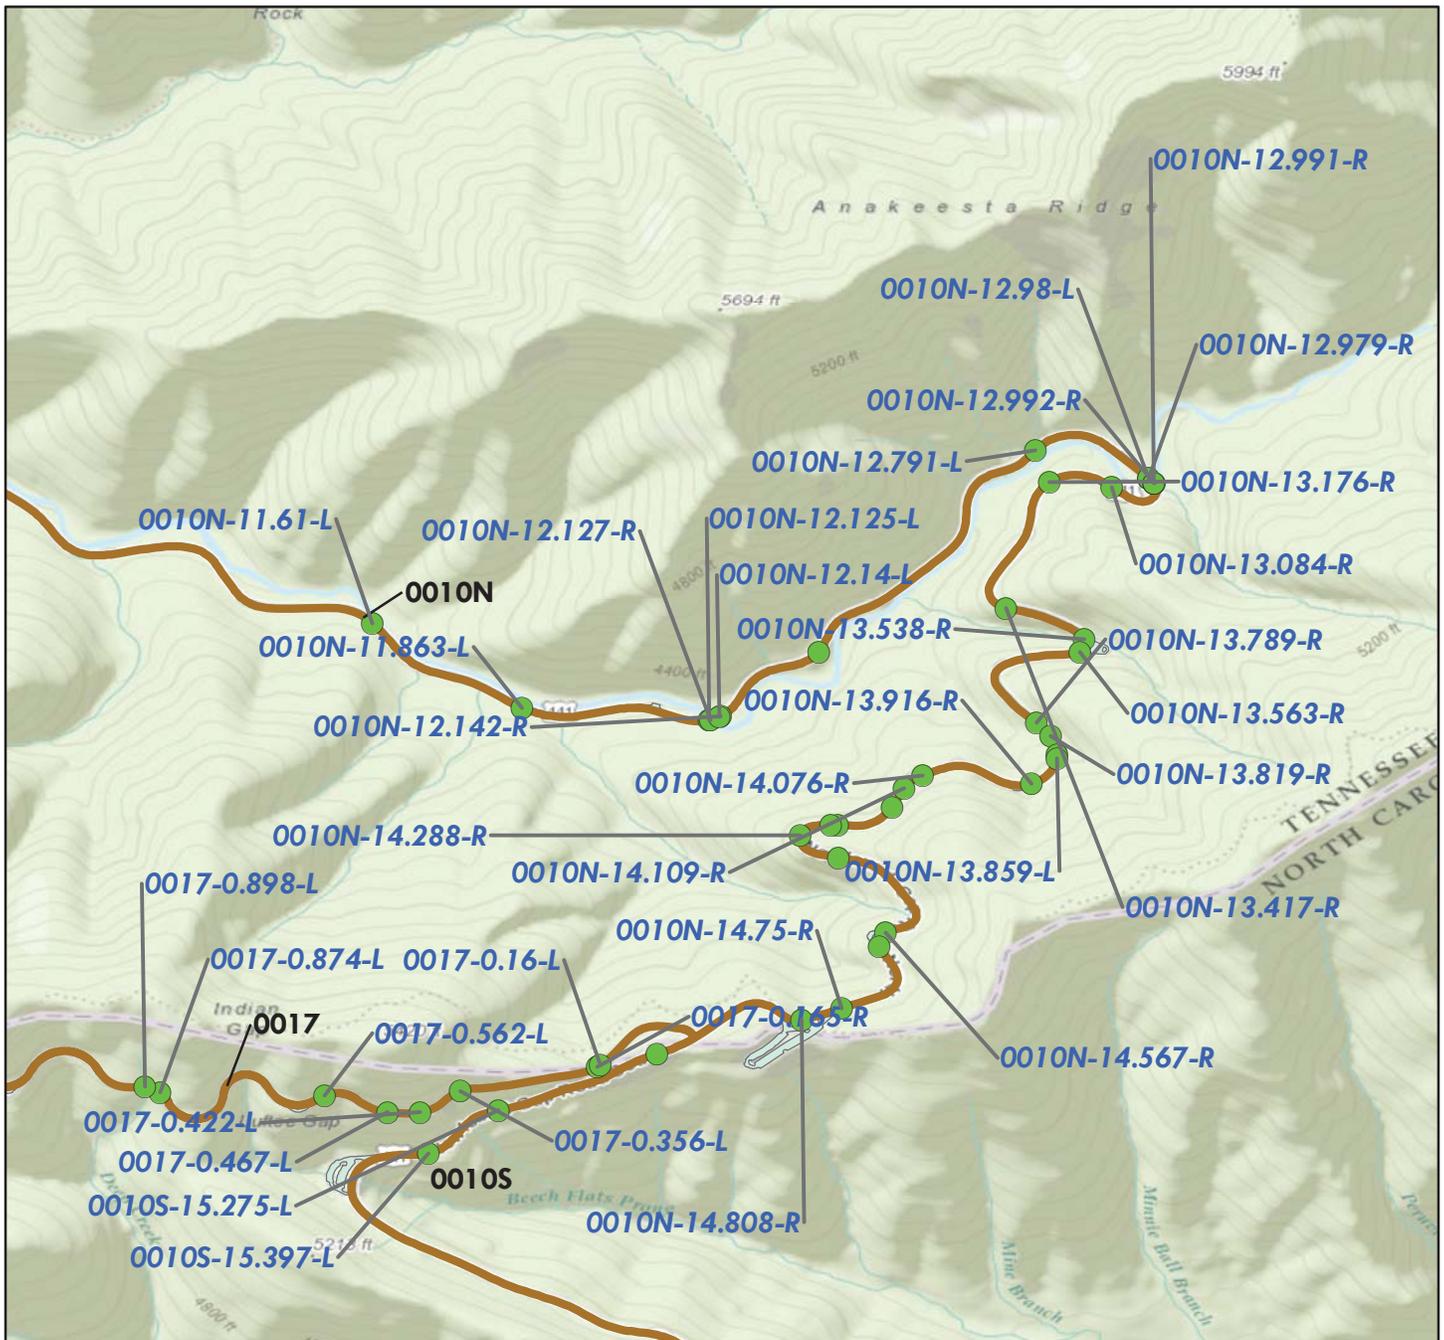
Map 5

BARRIER LOCATION MAP

● Barrier Locations (Not all labeled)

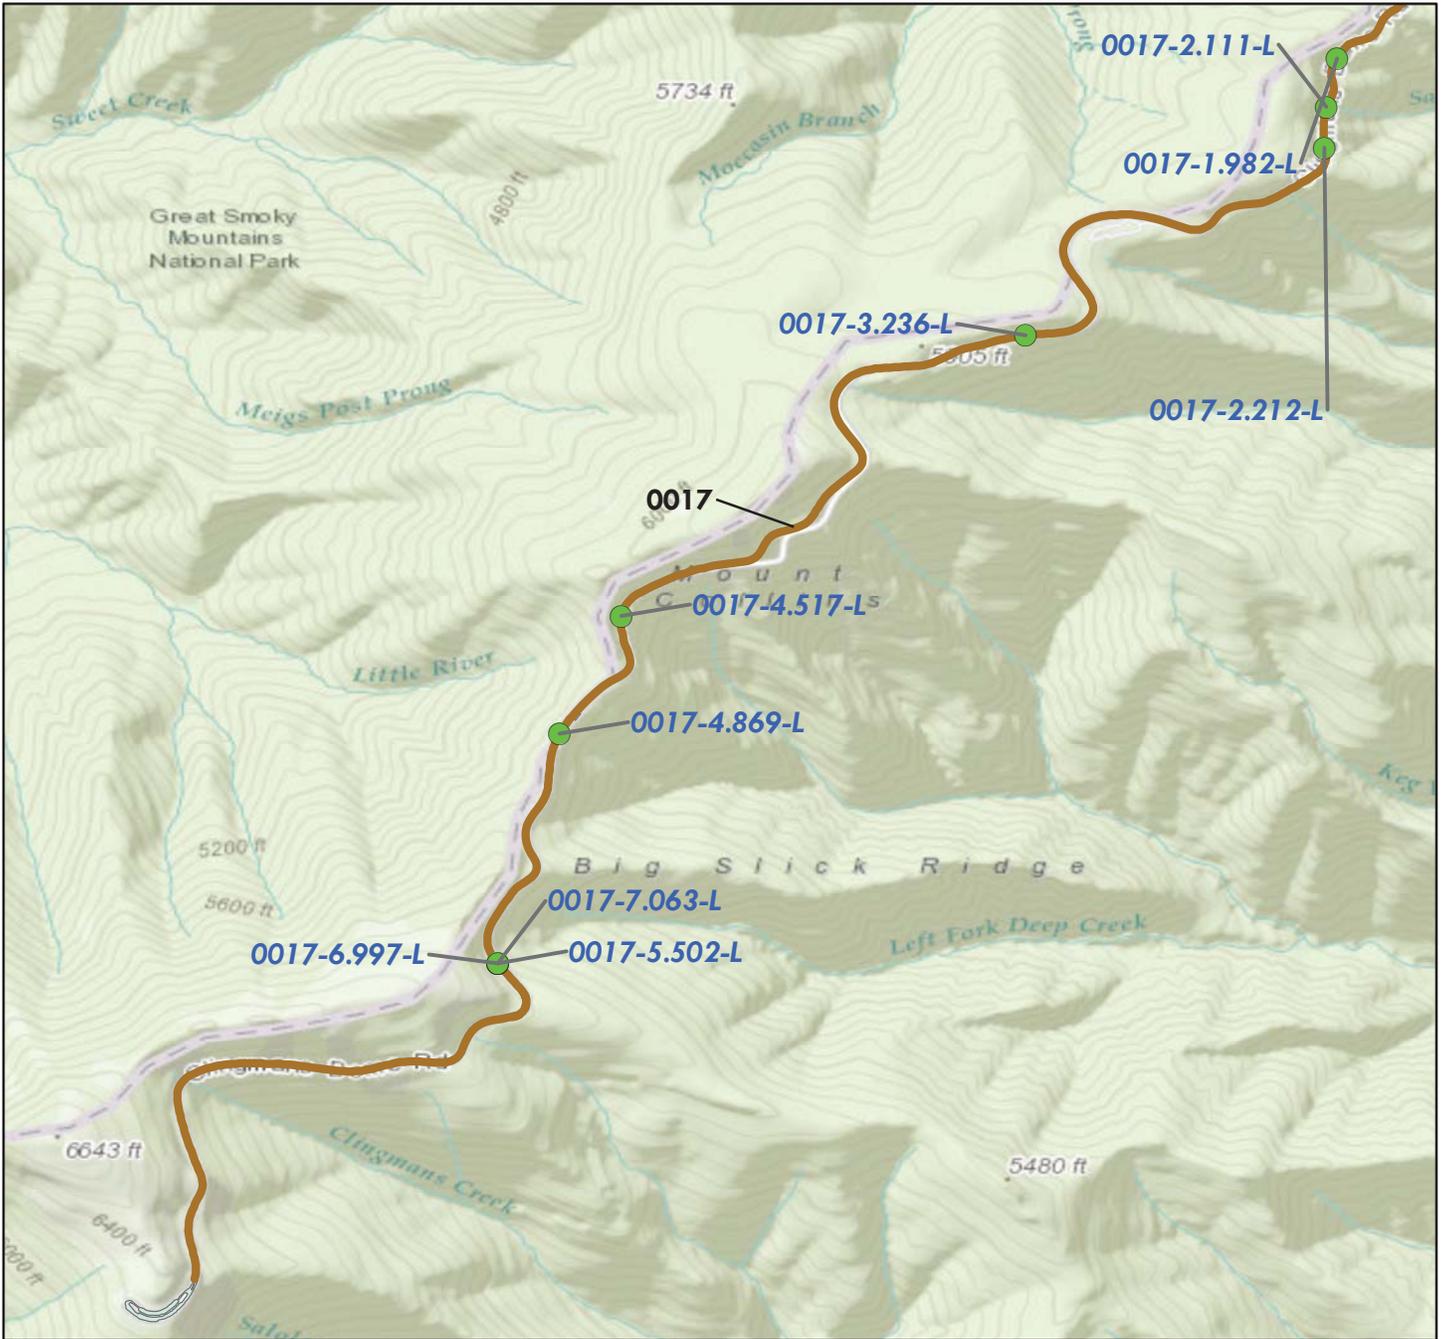
Map 6

BARRIER LOCATION MAP

● **Barrier Locations**

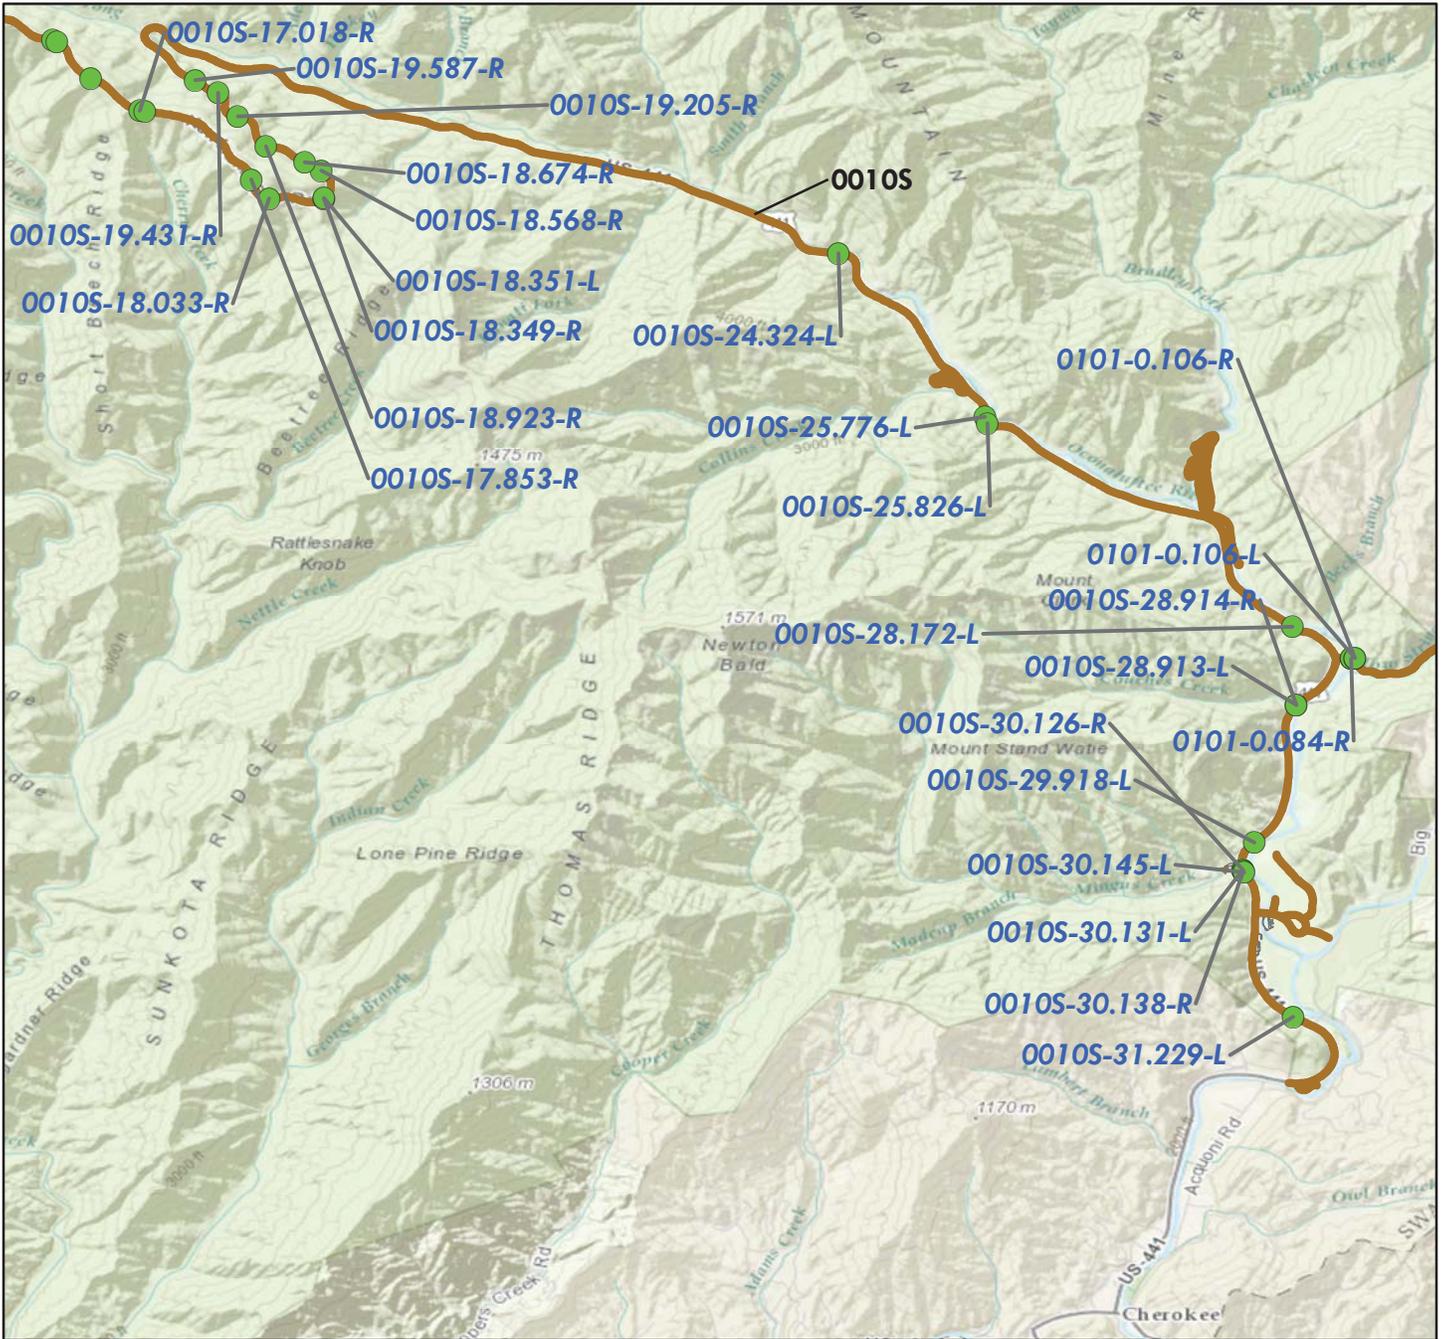
Map 7

BARRIER LOCATION MAP

● Barrier Locations (Not all labeled)

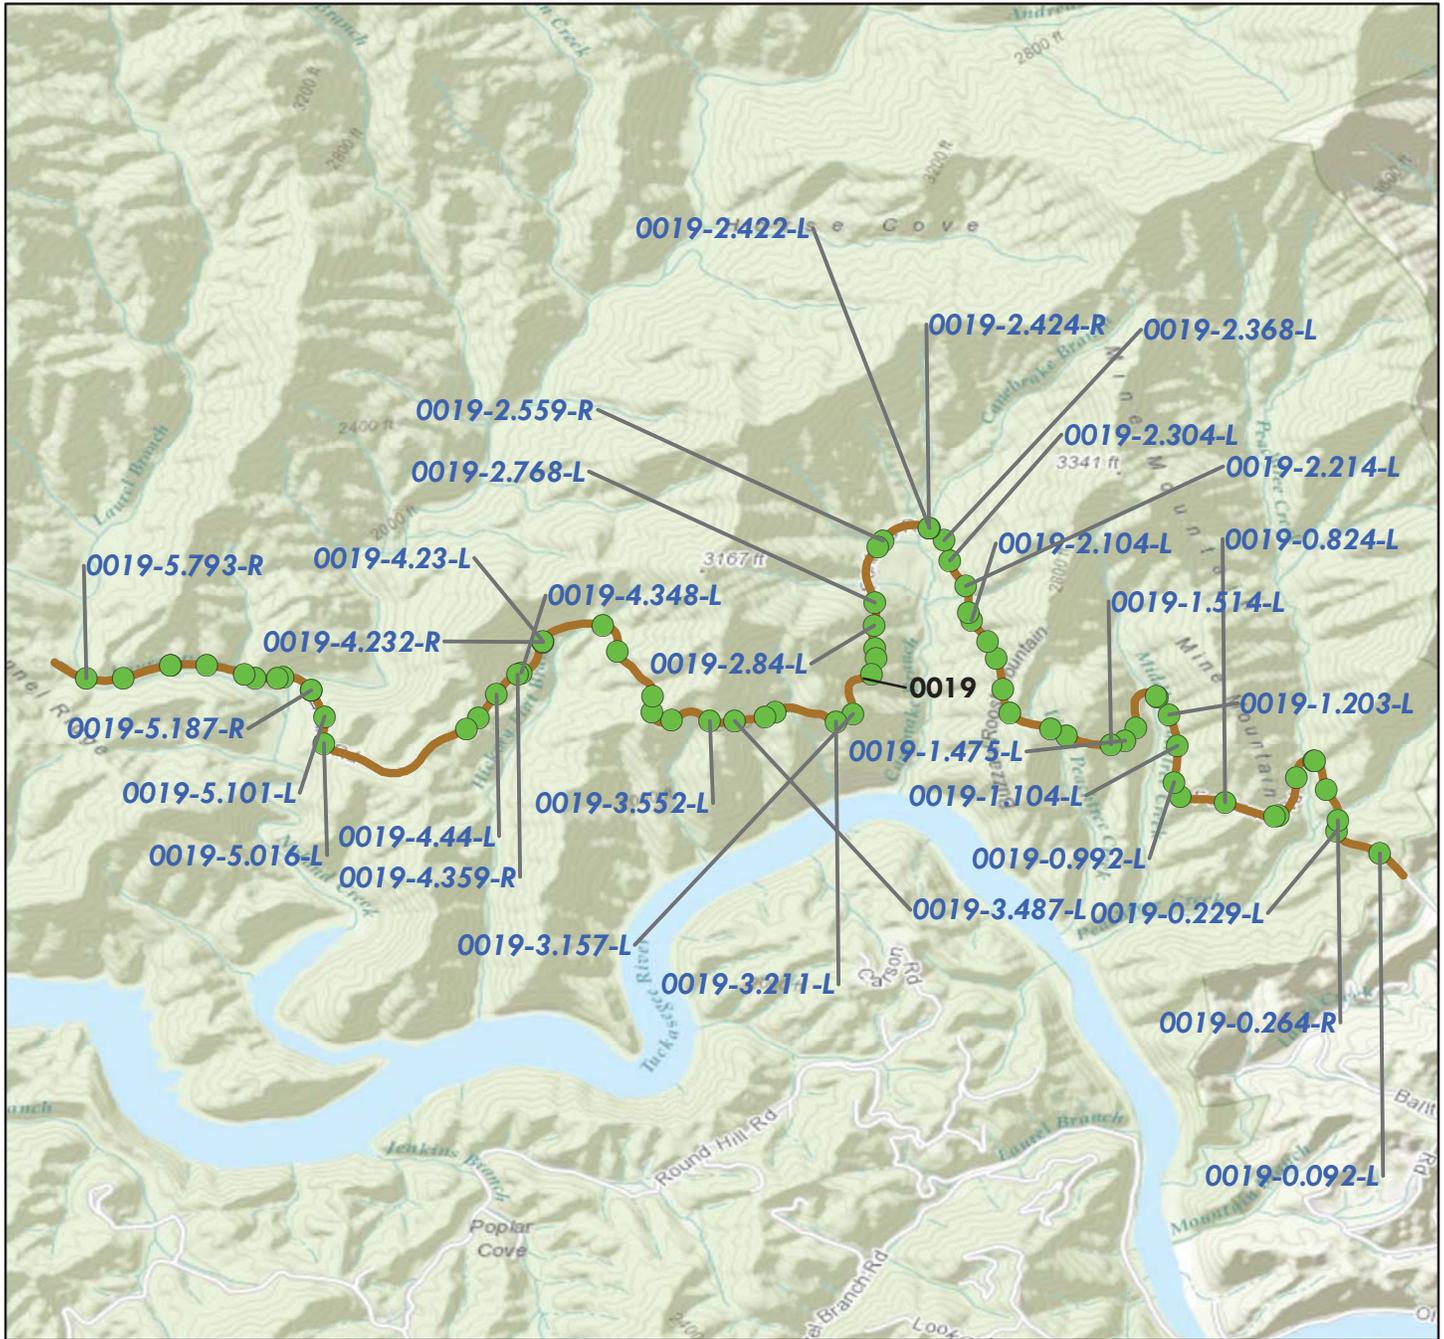
Map 8

BARRIER LOCATION MAP

● Barrier Locations (Not all labeled)

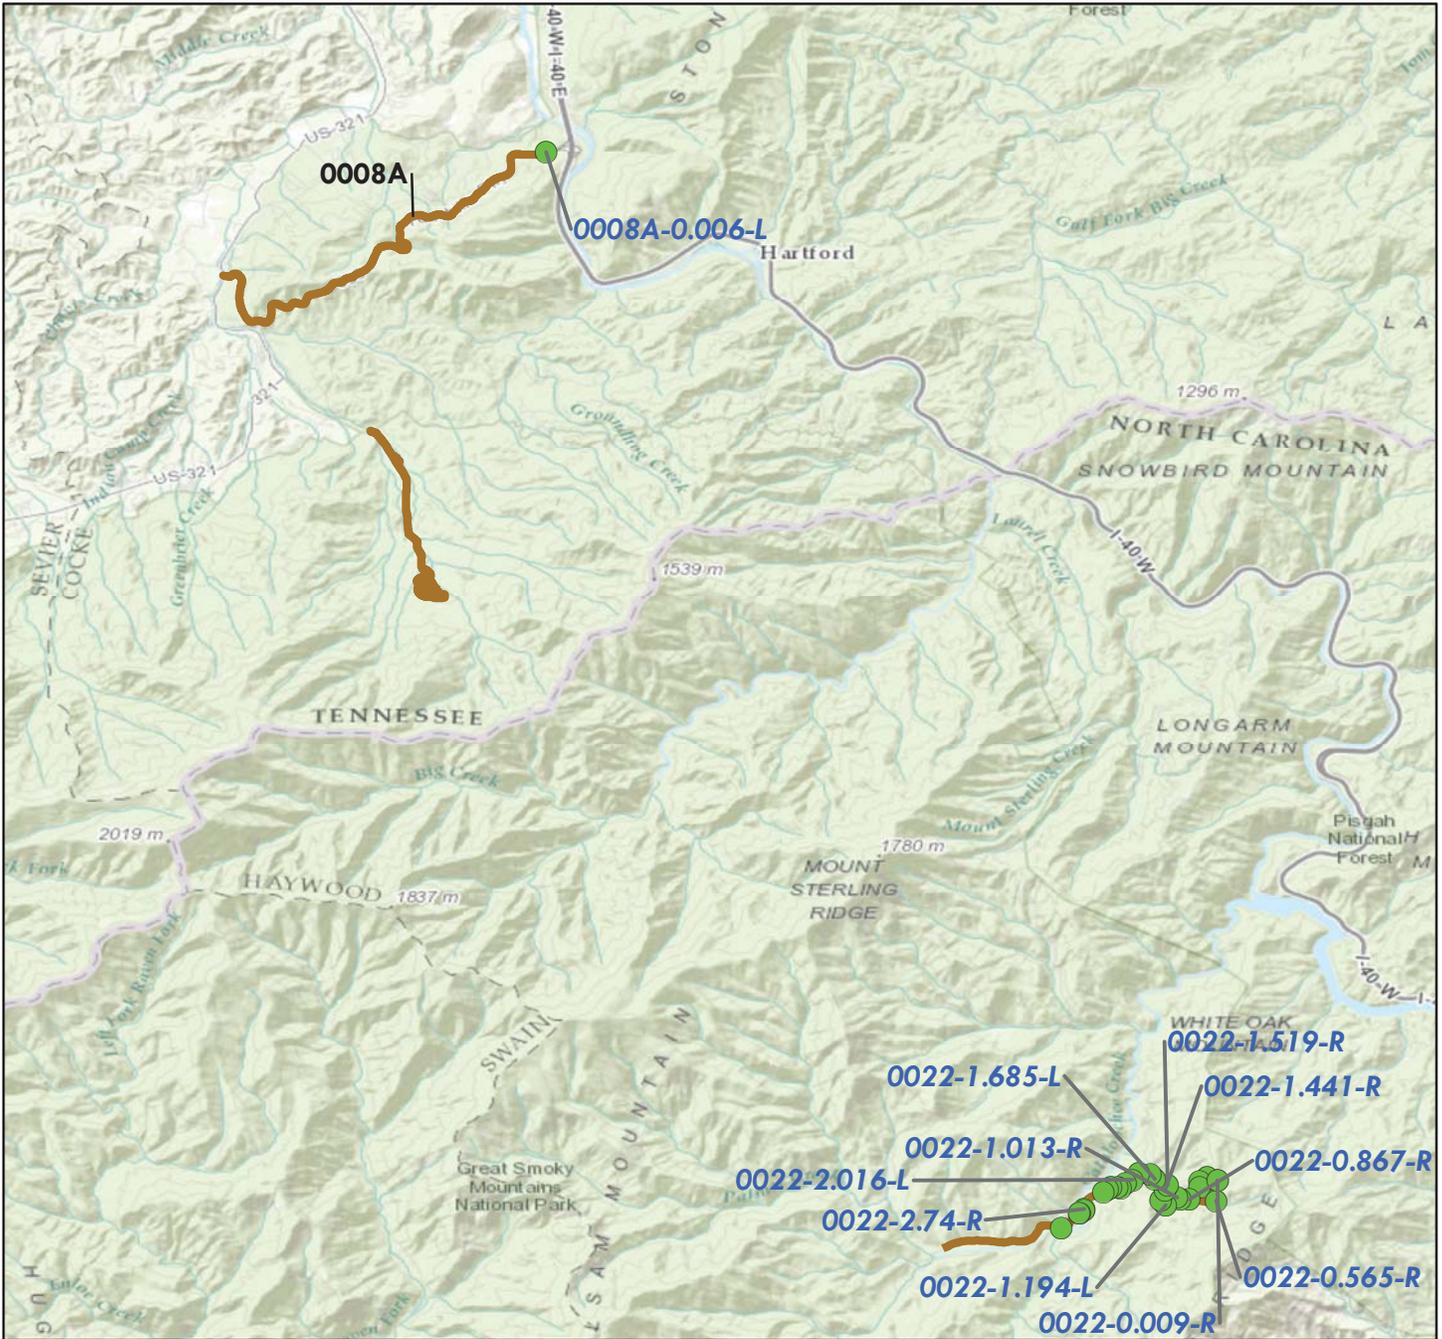
Map 9

BARRIER LOCATION MAP

● Barrier Locations (Not all labeled)

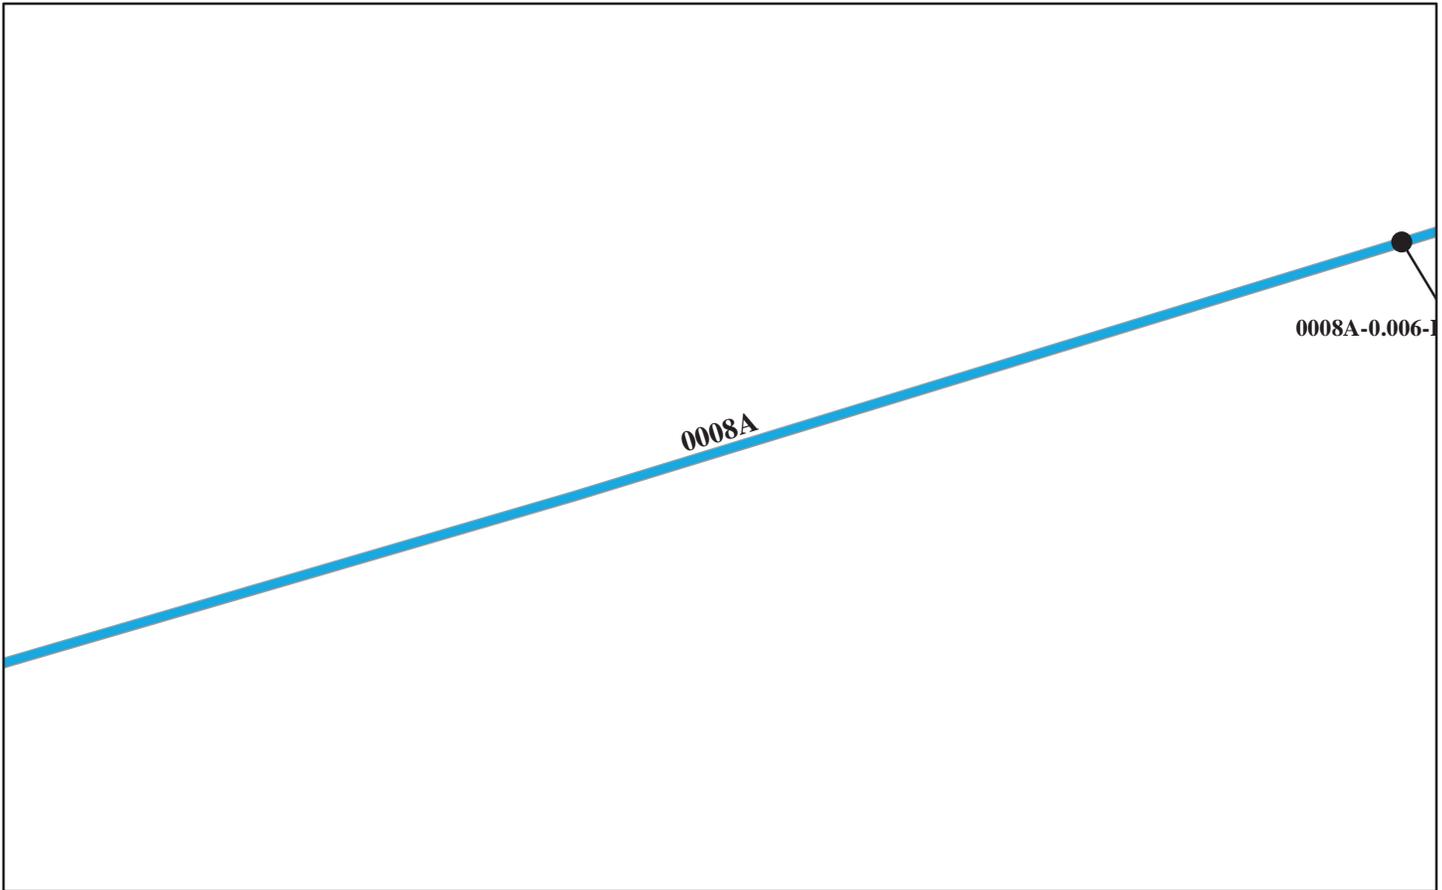
ROUTE 0008A: FOOTHILLS PARKWAY SECTION 8A

Barrier ID Inspection Date	Barrier Length (Ft.)	Barrier Type	Barrier End Treatment		*Repair Cost
			Begin	End	
GRSM-0008A-0.006-L 9/10/2010	160	W-BEAM STRONG POST	NONE	W-BEAM FLARED 350 COMPLIANT	\$0.00

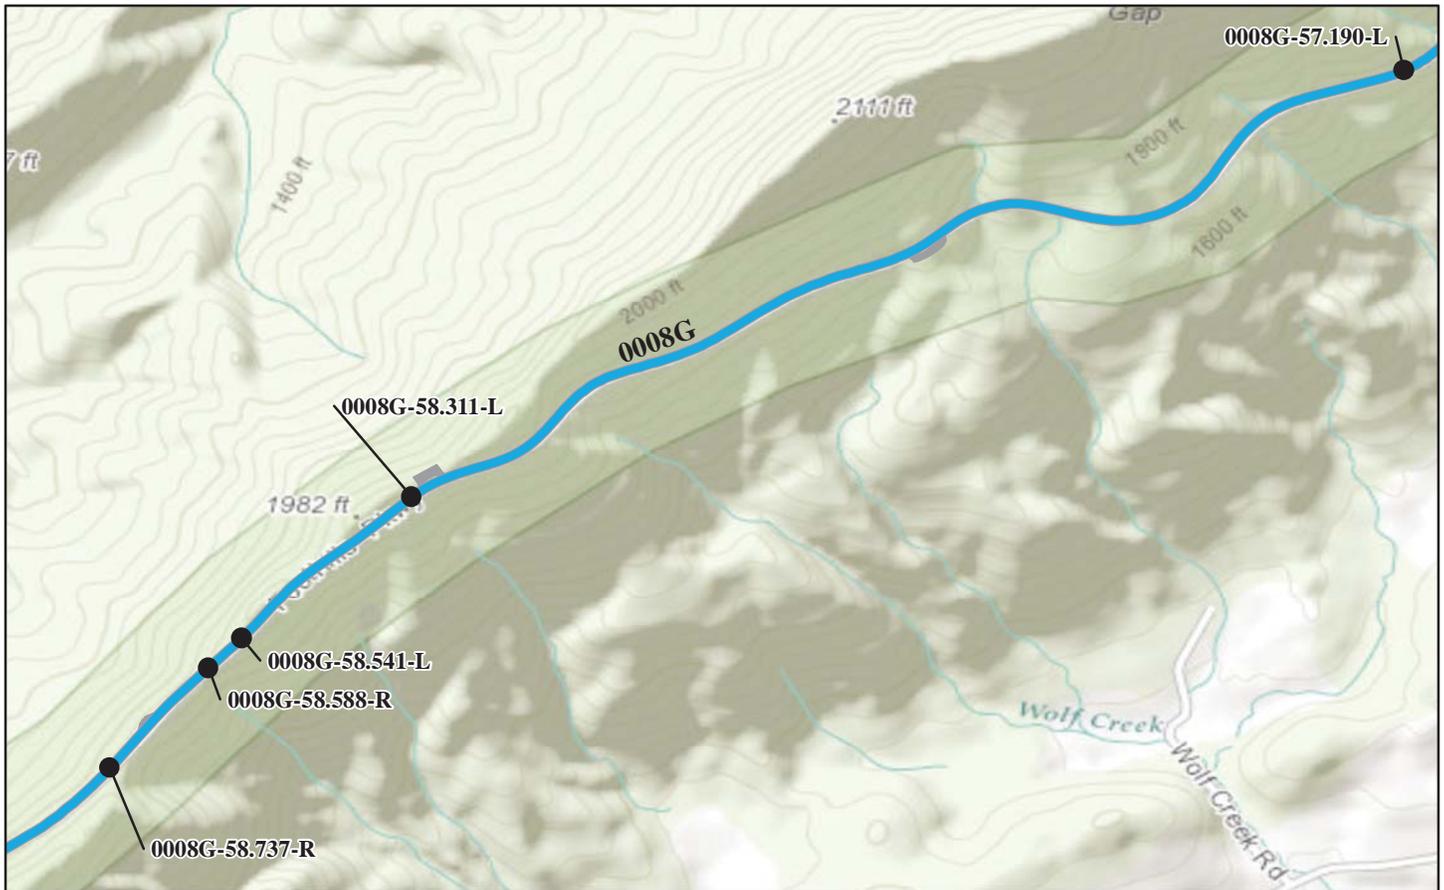
ROUTE 0008G: FOOTHILLS PARKWAY SECTION 8G

Barrier ID Inspection Date	Barrier Length (Ft.)	Barrier Type	Barrier End Treatment		*Repair Cost
			Begin	End	
GRSM-0008G-57.190-L 9/24/2010	595	STEEL-BACKED TIMBER WITHOUT BLOCKOUT	SBT/LOG FLARED	SBT/LOG FLARED	\$11,413.00
GRSM-0008G-58.311-L 9/24/2010	581	STEEL-BACKED TIMBER WITHOUT BLOCKOUT	SBT/LOG FLARED	SBT/LOG FLARED	\$2,503.00
GRSM-0008G-58.541-L 9/24/2010	310	STEEL-BACKED TIMBER WITHOUT BLOCKOUT	SBT/LOG FLARED	SBT/LOG FLARED	\$6,655.00
GRSM-0008G-58.588-R 9/24/2010	344	STEEL-BACKED TIMBER WITHOUT BLOCKOUT	SBT/LOG FLARED	SBT/LOG FLARED	\$7,029.00
GRSM-0008G-58.737-R 9/24/2010	523	STEEL-BACKED TIMBER WITHOUT BLOCKOUT	SBT/LOG FLARED	SBT/LOG FLARED	\$10,620.00
