NPS Guardwall/Rail Inventory Program
Great Smoky Mountains National Park

Federal Highway Administration
Eastern Federal Lands Highway Division
Road Inventory Program (RIP)

Data Collection Date: September 2010
Report Date: December 2015

Great Smoky Mountains National Park in North Carolina and Tennessee

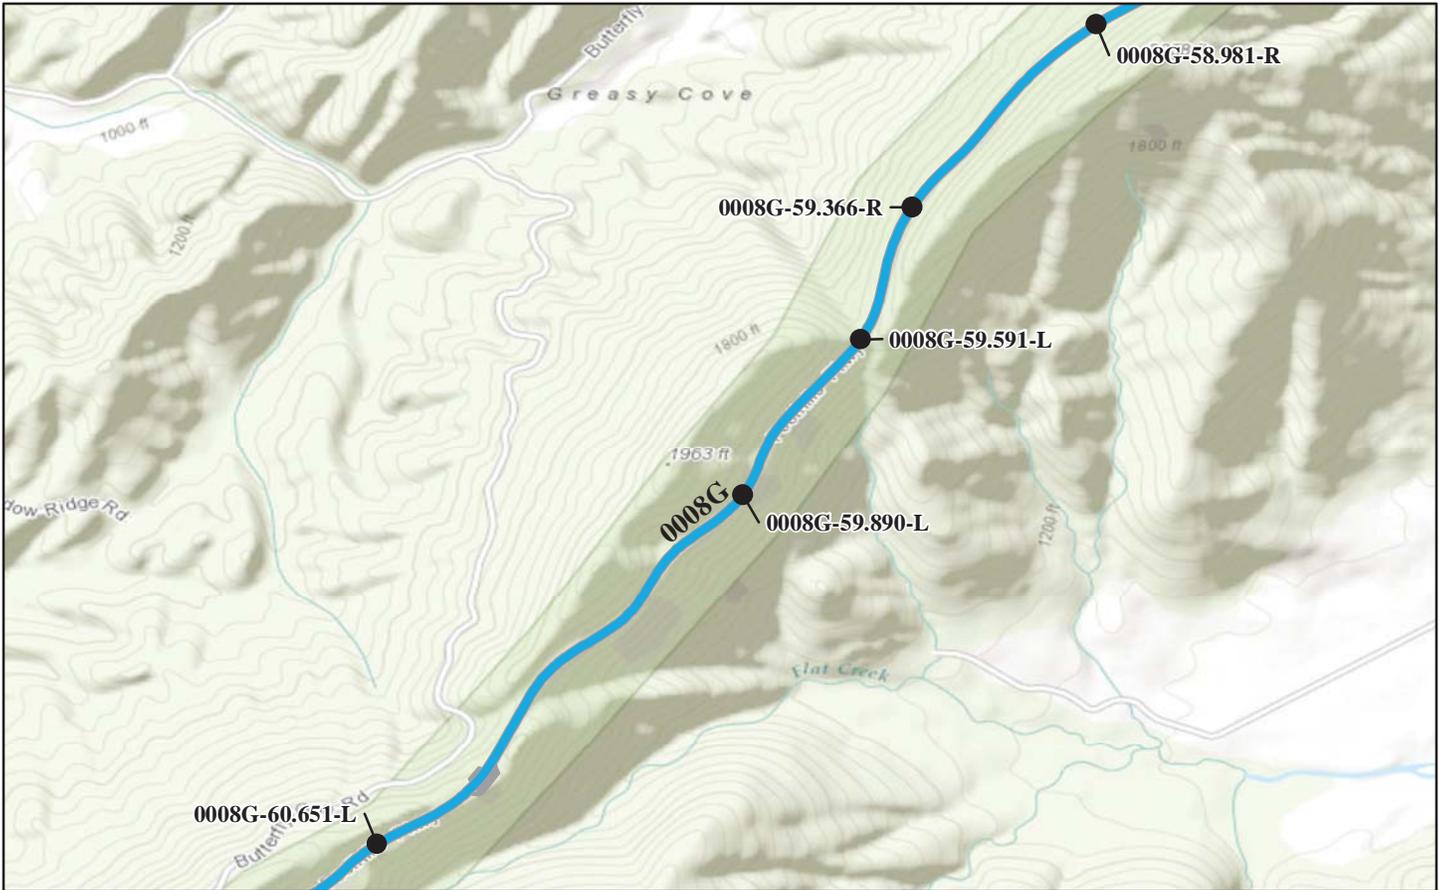
ROUTE 0008G: FOOTHILLS PARKWAY SECTION 8G

Barrier ID Inspection Date	Barrier Length (Ft.)	Barrier Type	Barrier End Treatment		*Repair Cost
			Begin	End	
GRSM-0008G-58.981-R 9/24/2010	1,223	STEEL-BACKED TIMBER WITHOUT BLOCKOUT	SBT/LOG FLARED	SBT/LOG FLARED	\$21,566.00
GRSM-0008G-59.366-R 9/24/2010	548	STEEL-BACKED TIMBER WITHOUT BLOCKOUT	SBT/LOG FLARED	SBT/LOG FLARED	\$9,273.00
GRSM-0008G-59.591-L 9/24/2010	422	STEEL-BACKED TIMBER WITHOUT BLOCKOUT	SBT/LOG FLARED	SBT/LOG FLARED	\$6,501.00
GRSM-0008G-59.890-L 9/24/2010	278	STEEL-BACKED TIMBER WITHOUT BLOCKOUT	SBT/LOG FLARED	SBT/LOG FLARED	\$0.00
GRSM-0008G-60.651-L 9/24/2010	321	STEEL-BACKED TIMBER WITHOUT BLOCKOUT	SBT/LOG FLARED	SBT/LOG FLARED	\$0.00

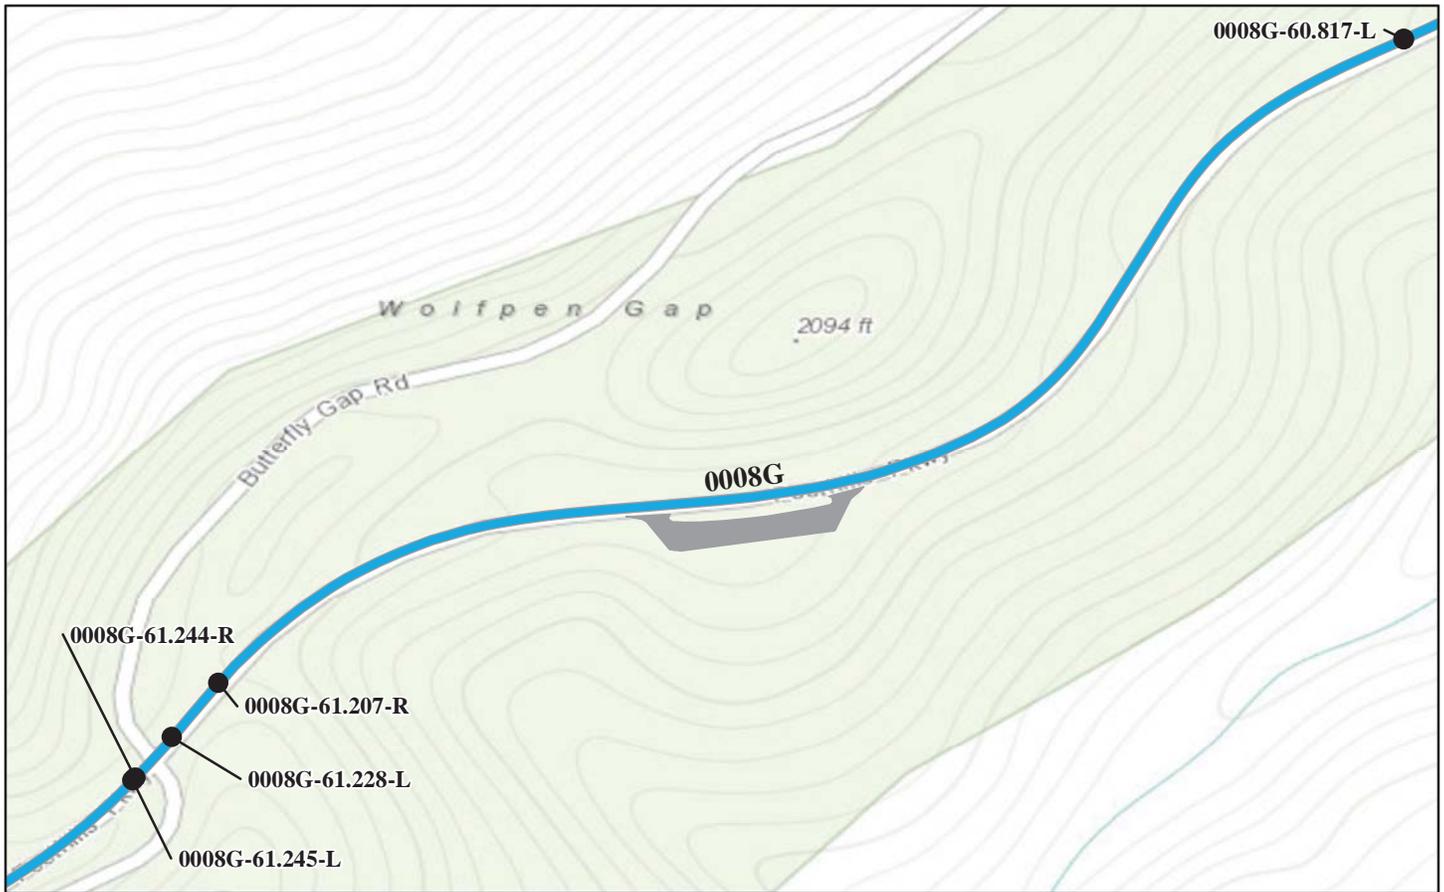
ROUTE 0008G: FOOTHILLS PARKWAY SECTION 8G

Barrier ID Inspection Date	Barrier Length (Ft.)	Barrier Type	Barrier End Treatment		*Repair Cost
			Begin	End	
GRSM-0008G-60.817-L 9/24/2010	582	STEEL-BACKED TIMBER WITHOUT BLOCKOUT	SBT/LOG FLARED	SBT/LOG FLARED	\$0.00
GRSM-0008G-61.207-R 9/24/2010	166	STEEL-BACKED TIMBER WITHOUT BLOCKOUT	SBT/LOG FLARED	NONE	\$3,449.00
GRSM-0008G-61.228-L 9/24/2010	63	STEEL-BACKED TIMBER WITHOUT BLOCKOUT	SBT/LOG BURIED	NONE	\$2,206.00
GRSM-0008G-61.244-R 9/24/2010	273	STEEL-BACKED TIMBER WITHOUT BLOCKOUT	NONE	SBT/LOG FLARED	\$6,248.00
GRSM-0008G-61.245-L 9/24/2010	177	STEEL-BACKED TIMBER WITHOUT BLOCKOUT	SBT/LOG FLARED	NONE	\$3,570.00

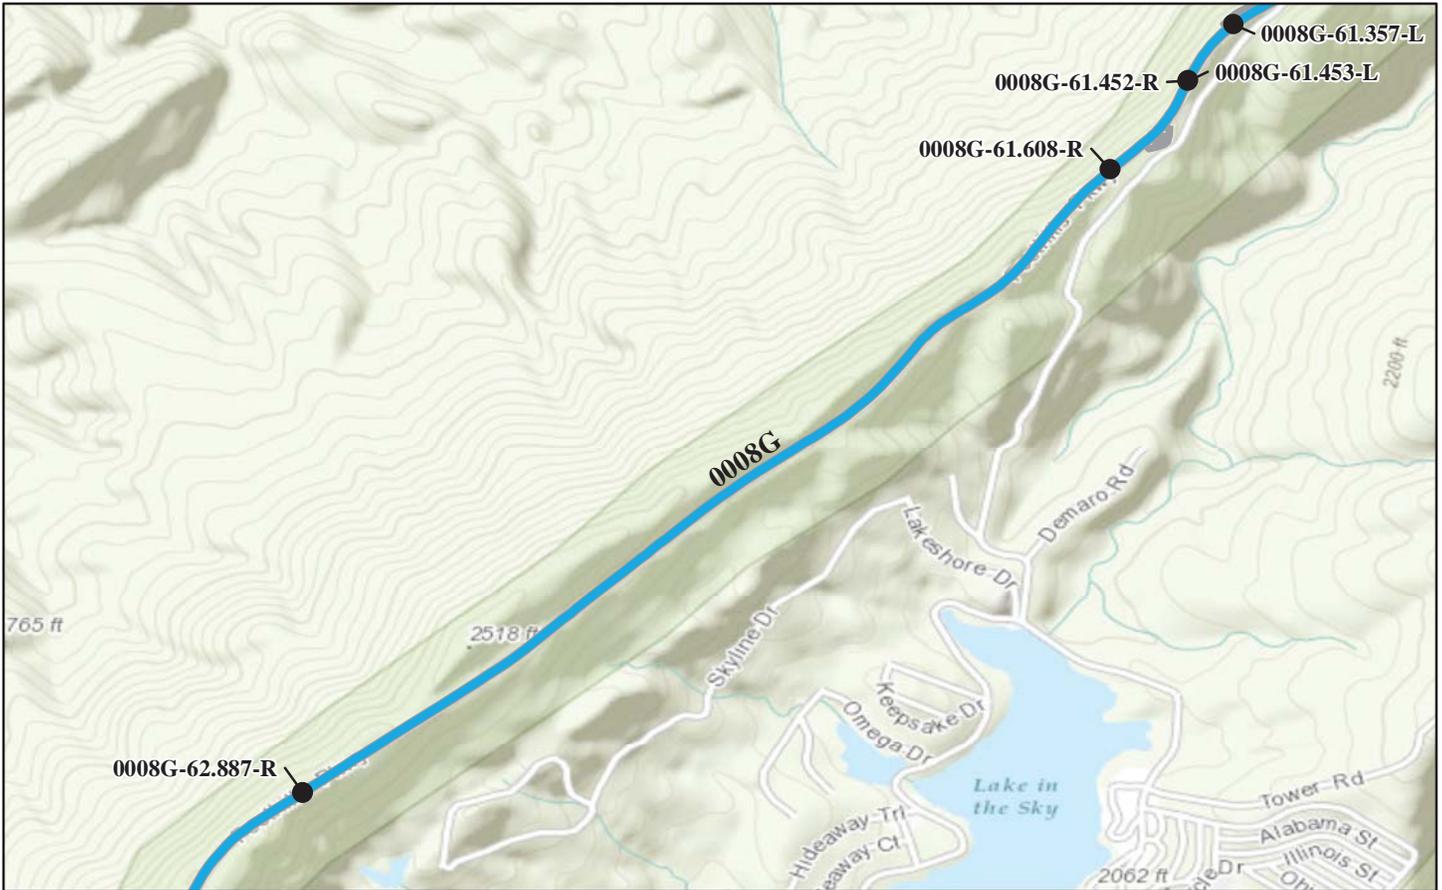
ROUTE 0008G: FOOTHILLS PARKWAY SECTION 8G

Barrier ID Inspection Date	Barrier Length (Ft.)	Barrier Type	Barrier End Treatment		*Repair Cost
			Begin	End	
GRSM-0008G-61.357-L 9/24/2010	330	STEEL-BACKED TIMBER WITHOUT BLOCKOUT	SBT/LOG FLARED	SBT/LOG FLARED	\$3,273.00
GRSM-0008G-61.452-R 9/24/2010	468	STEEL-BACKED TIMBER WITHOUT BLOCKOUT	SBT/LOG FLARED	SBT/LOG FLARED	\$0.00
GRSM-0008G-61.453-L 9/24/2010	270	STEEL-BACKED TIMBER WITHOUT BLOCKOUT	SBT/LOG FLARED	SBT/LOG FLARED	\$2,833.00
GRSM-0008G-61.608-R 9/24/2010	215	STEEL-BACKED TIMBER WITHOUT BLOCKOUT	SBT/LOG FLARED	SBT/LOG FLARED	\$0.00
GRSM-0008G-62.887-R 9/24/2010	826	STEEL-BACKED TIMBER WITHOUT BLOCKOUT	SBT/LOG FLARED	SBT/LOG BURIED	\$15,576.00
*2008 cost estimate (ASTM Class D), preliminary for comparison to other repair costs only.

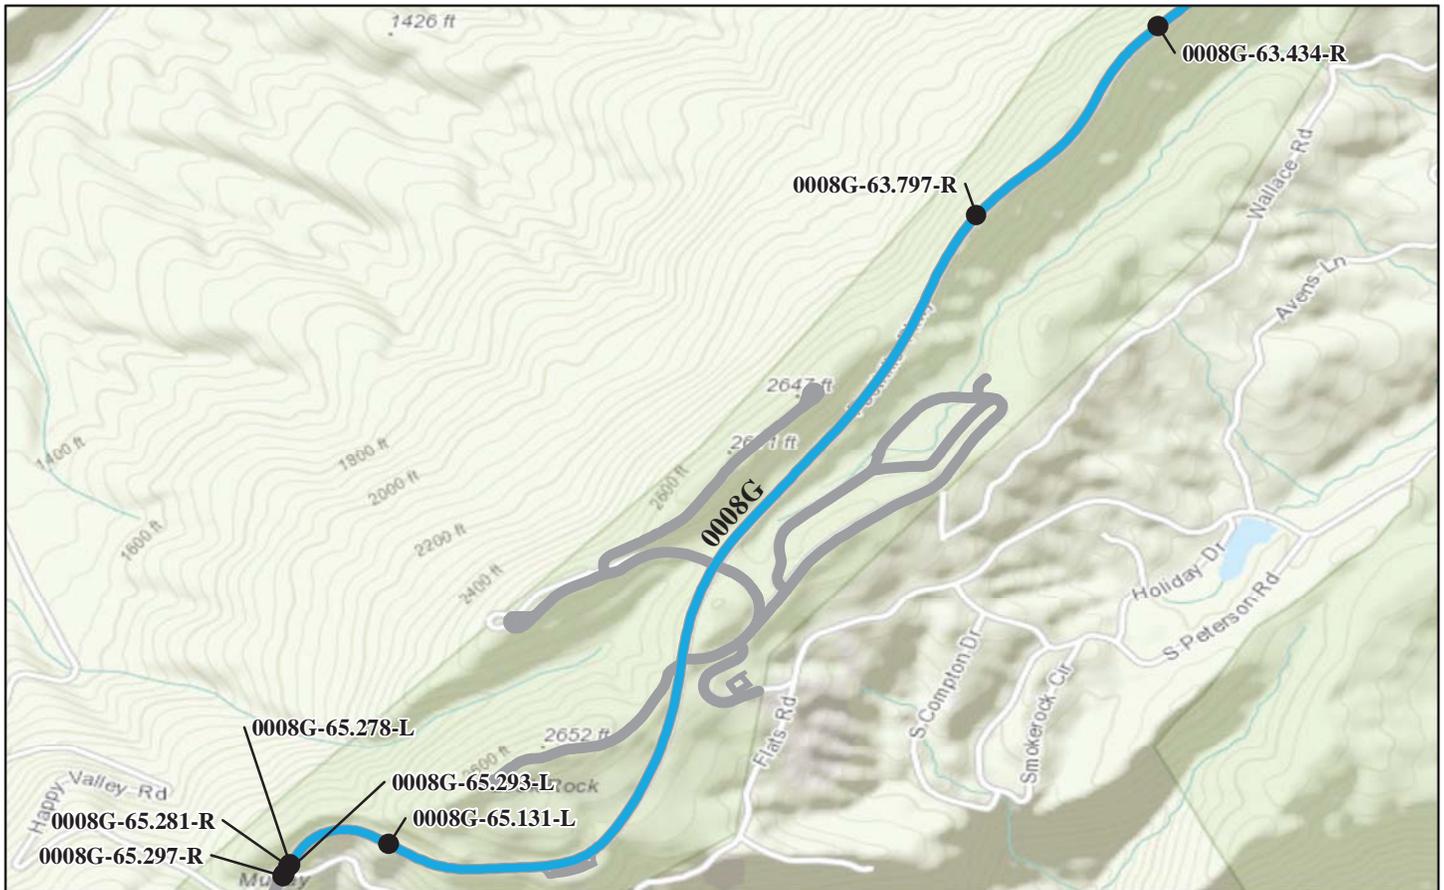
ROUTE 0008G: FOOTHILLS PARKWAY SECTION 8G

Barrier ID Inspection Date	Barrier Length (Ft.)	Barrier Type	Barrier End Treatment		*Repair Cost
			Begin	End	
GRSM-0008G-63.434-R 9/24/2010	310	STEEL-BACKED TIMBER WITHOUT BLOCKOUT	SBT/LOG FLARED	SBT/LOG FLARED	\$0.00
GRSM-0008G-63.797-R 9/24/2010	373	STEEL-BACKED TIMBER WITHOUT BLOCKOUT	SBT/LOG FLARED	SBT/LOG FLARED	\$7,348.00
GRSM-0008G-65.131-L 9/22/2010	294	STEEL-BACKED TIMBER WITHOUT BLOCKOUT	SBT/LOG BURIED	SBT/LOG FLARED	\$3,163.00
GRSM-0008G-65.278-L 9/22/2010	50	STEEL-BACKED TIMBER WITHOUT BLOCKOUT	SBT/LOG FLARED	NONE	\$0.00
GRSM-0008G-65.281-R 9/22/2010	43	STEEL-BACKED TIMBER WITHOUT BLOCKOUT	SBT/LOG BURIED	NONE	\$0.00

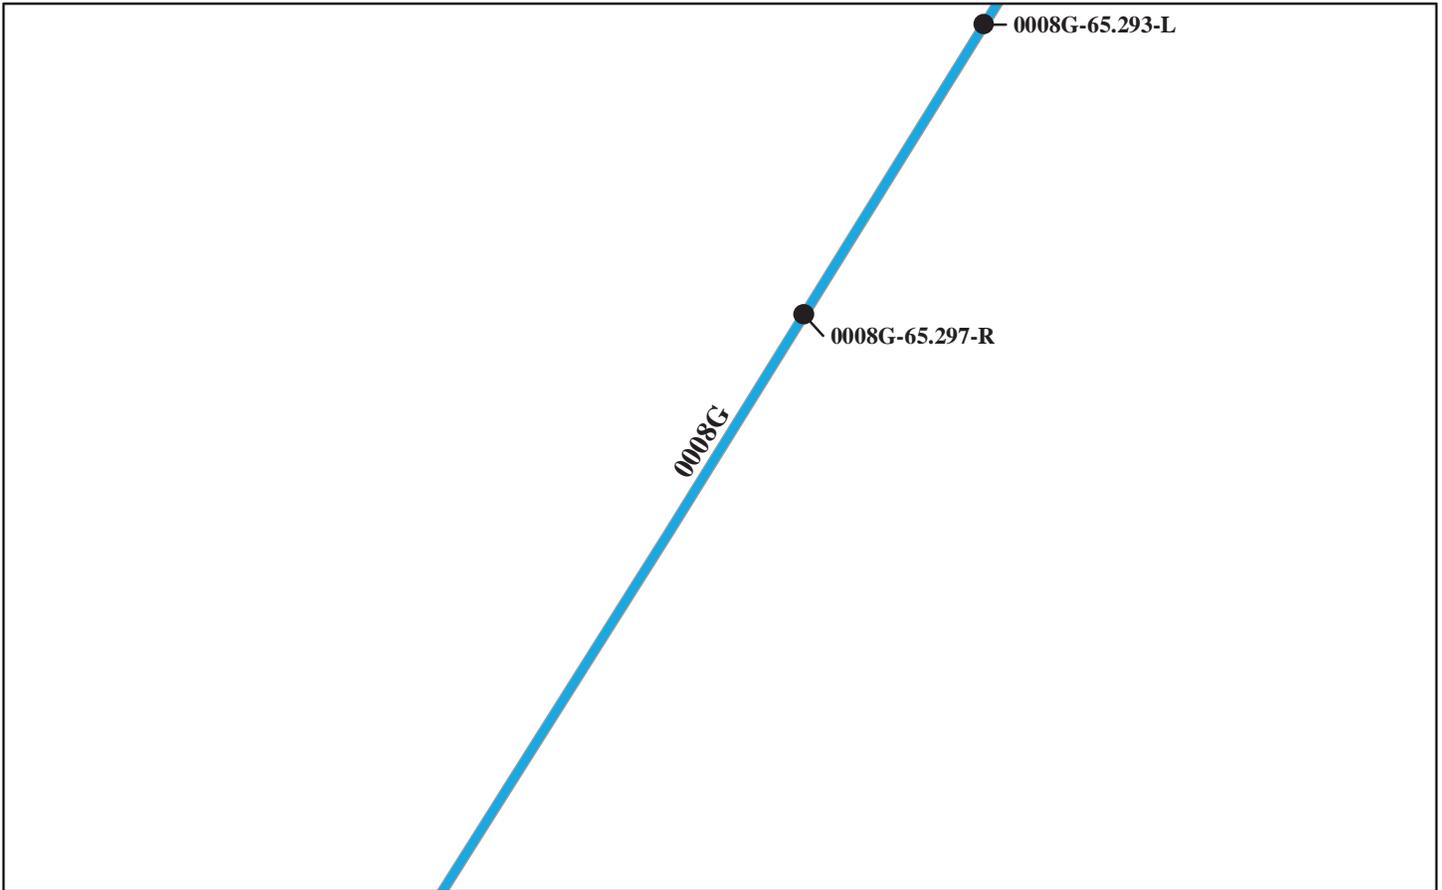
ROUTE 0008G: FOOTHILLS PARKWAY SECTION 8G

Barrier ID Inspection Date	Barrier Length (Ft.)	Barrier Type	Barrier End Treatment		*Repair Cost
			Begin	End	
GRSM-0008G-65.293-L 9/22/2010	100	STEEL-BACKED TIMBER WITHOUT BLOCKOUT	NONE	SBT/LOG FLARED	\$0.00
GRSM-0008G-65.297-R 9/22/2010	45	STEEL-BACKED TIMBER WITHOUT BLOCKOUT	NONE	SBT/LOG FLARED	\$0.00

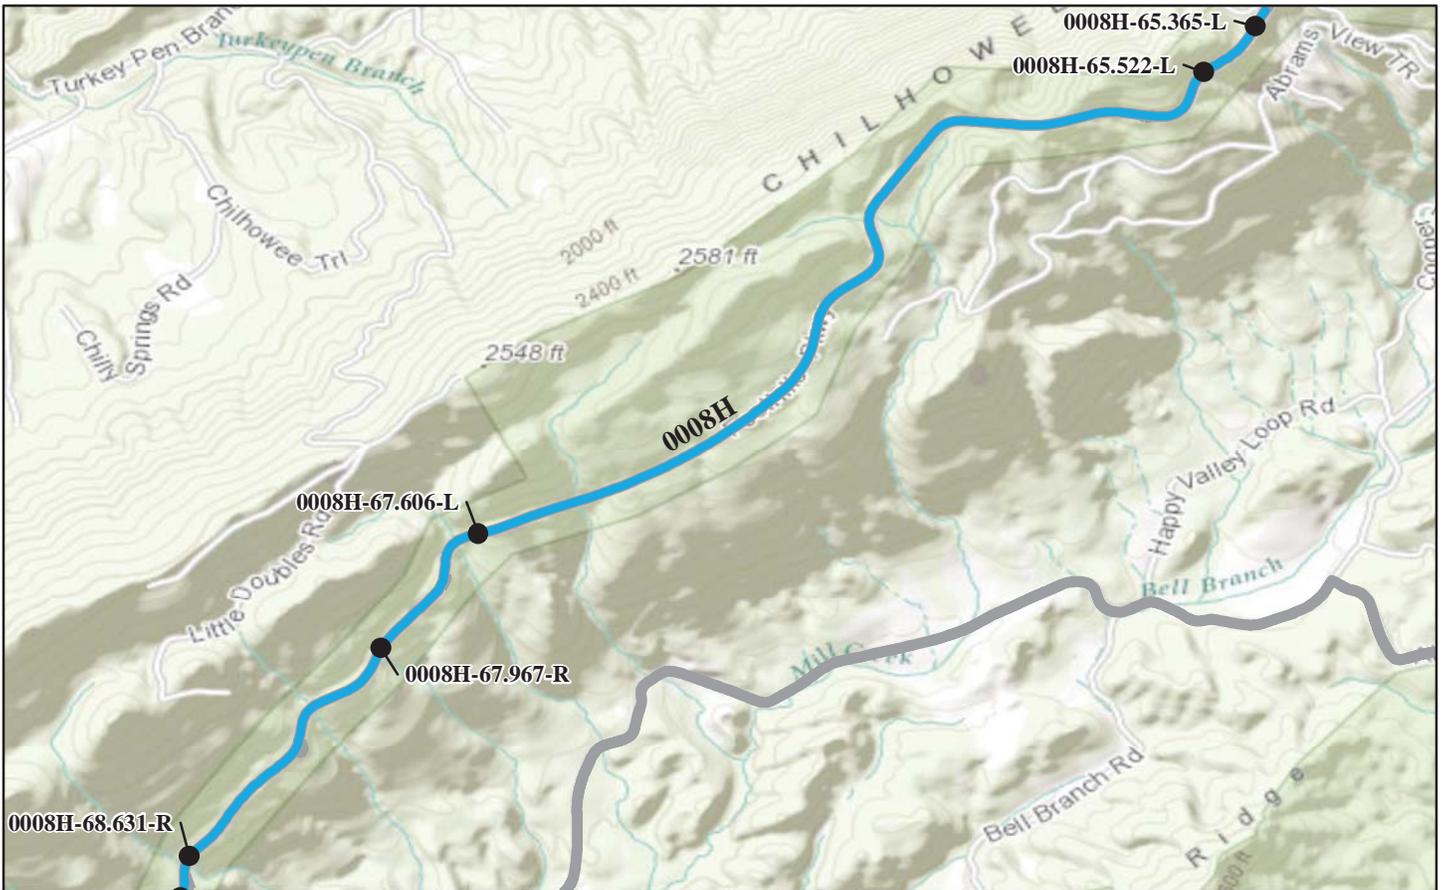
ROUTE 0008H: FOOTHILLS PARKWAY SECTION 8H

Barrier ID Inspection Date	Barrier Length (Ft.)	Barrier Type	Barrier End Treatment		*Repair Cost
			Begin	End	
GRSM-0008H-65.365-L 9/22/2010	380	STEEL-BACKED TIMBER WITHOUT BLOCKOUT	SBT/LOG FLARED	SBT/LOG BURIED	\$7,425.00
GRSM-0008H-65.522-L 9/22/2010	230	STEEL-BACKED TIMBER WITHOUT BLOCKOUT	SBT/LOG FLARED	SBT/LOG FLARED	\$3,603.00
GRSM-0008H-67.606-L 9/22/2010	608	STEEL-BACKED TIMBER WITHOUT BLOCKOUT	SBT/LOG FLARED	SBT/LOG FLARED	\$0.00
GRSM-0008H-67.967-R 9/22/2010	115	STEEL-BACKED TIMBER WITHOUT BLOCKOUT	SBT/LOG BURIED	SBT/LOG FLARED	\$0.00
GRSM-0008H-68.631-R 9/22/2010	210	STEEL-BACKED TIMBER WITHOUT BLOCKOUT	SBT/LOG BURIED	SBT/LOG FLARED	\$0.00

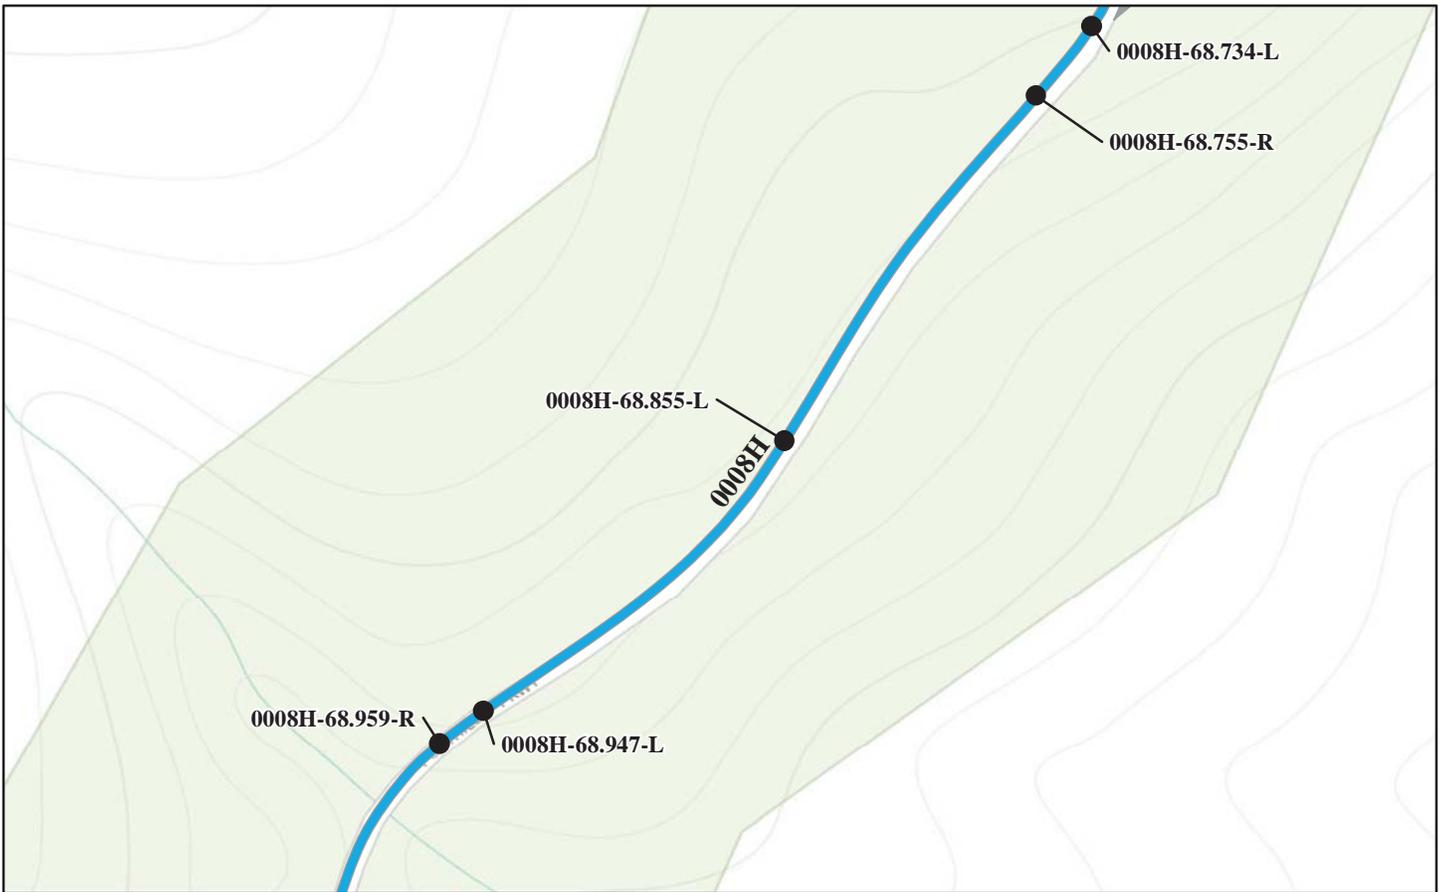
ROUTE 0008H: FOOTHILLS PARKWAY SECTION 8H

Barrier ID Inspection Date	Barrier Length (Ft.)	Barrier Type	Barrier End Treatment		*Repair Cost
			Begin	End	
GRSM-0008H-68.734-L 9/22/2010	472	STEEL-BACKED TIMBER WITHOUT BLOCKOUT	SBT/LOG FLARED	SBT/LOG FLARED	\$0.00
GRSM-0008H-68.755-R 9/22/2010	132	STEEL-BACKED TIMBER WITHOUT BLOCKOUT	SBT/LOG BURIED	SBT/LOG FLARED	\$0.00
GRSM-0008H-68.855-L 9/22/2010	379	STEEL-BACKED TIMBER WITHOUT BLOCKOUT	SBT/LOG BURIED	SBT/LOG FLARED	\$0.00
GRSM-0008H-68.947-L 9/22/2010	566	STEEL-BACKED TIMBER WITHOUT BLOCKOUT	SBT/LOG FLARED	SBT/LOG FLARED	\$0.00
GRSM-0008H-68.959-R 9/22/2010	202	STEEL-BACKED TIMBER WITHOUT BLOCKOUT	SBT/LOG BURIED	SBT/LOG FLARED	\$0.00

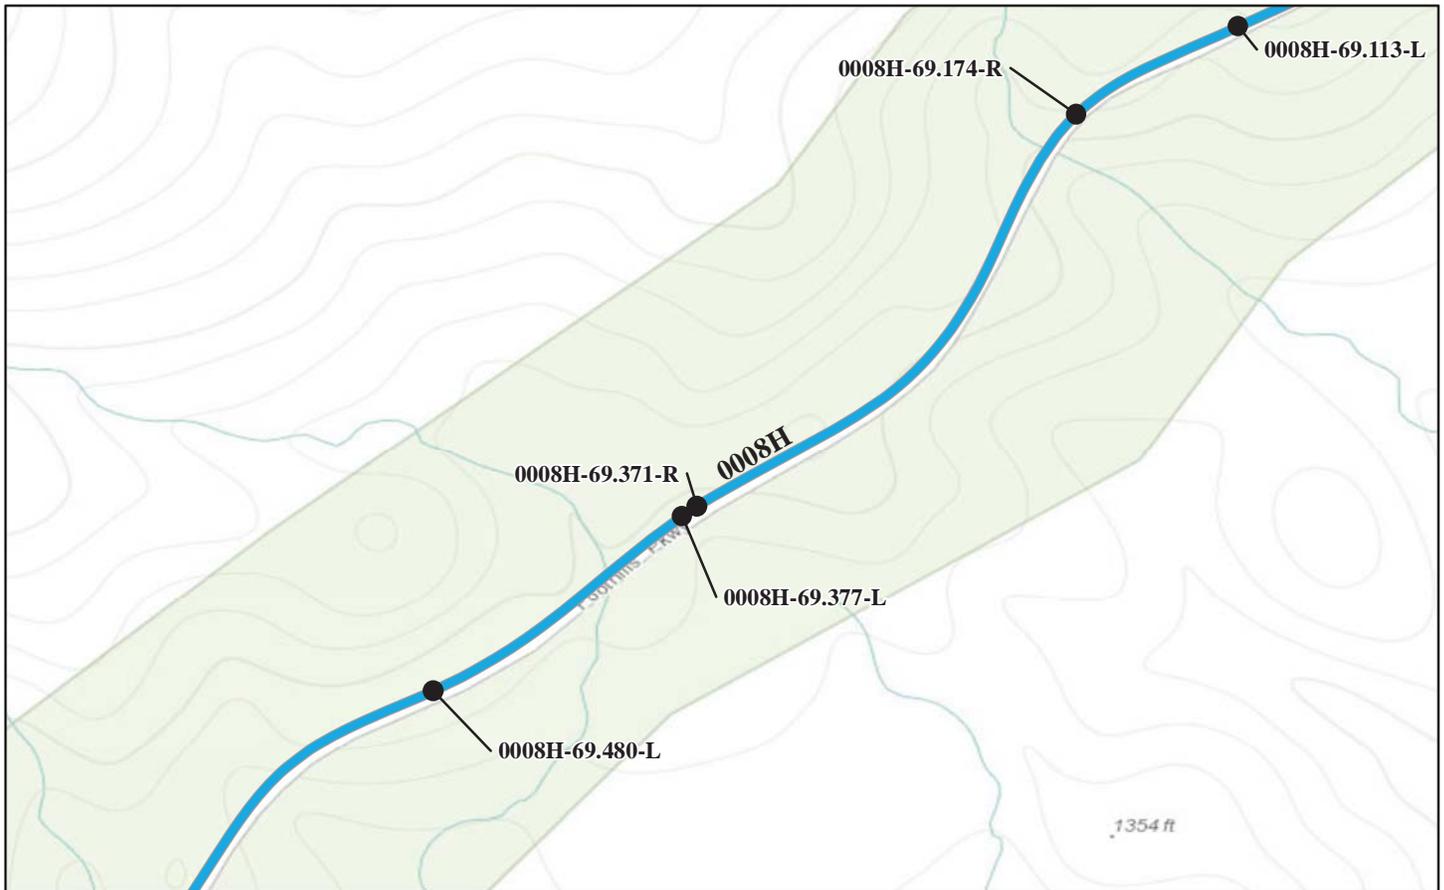
ROUTE 0008H: FOOTHILLS PARKWAY SECTION 8H

Barrier ID Inspection Date	Barrier Length (Ft.)	Barrier Type	Barrier End Treatment		*Repair Cost
			Begin	End	
GRSM-0008H-69.113-L 9/22/2010	546	STEEL-BACKED TIMBER WITHOUT BLOCKOUT	SBT/LOG FLARED	SBT/LOG FLARED	\$0.00
GRSM-0008H-69.174-R 9/22/2010	147	STEEL-BACKED TIMBER WITHOUT BLOCKOUT	SBT/LOG FLARED	SBT/LOG FLARED	\$2,503.00
GRSM-0008H-69.371-R 9/22/2010	92	STEEL-BACKED TIMBER WITHOUT BLOCKOUT	SBT/LOG FLARED	SBT/LOG FLARED	\$0.00
GRSM-0008H-69.377-L 9/22/2010	94	STEEL-BACKED TIMBER WITHOUT BLOCKOUT	SBT/LOG FLARED	SBT/LOG FLARED	\$0.00
GRSM-0008H-69.480-L 9/22/2010	539	STEEL-BACKED TIMBER WITHOUT BLOCKOUT	SBT/LOG FLARED	SBT/LOG BURIED	\$0.00

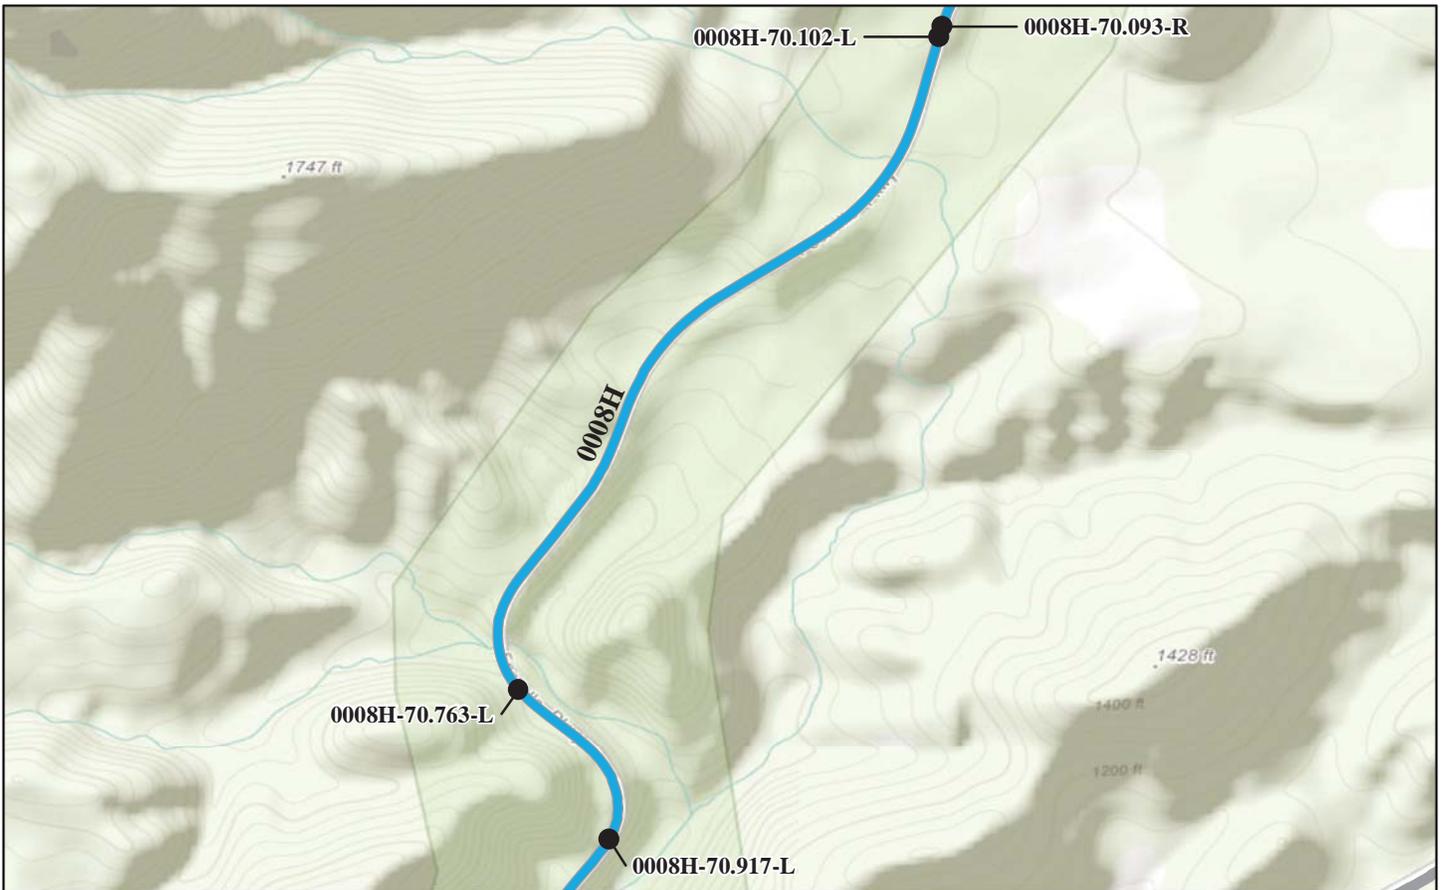
ROUTE 0008H: FOOTHILLS PARKWAY SECTION 8H

Barrier ID Inspection Date	Barrier Length (Ft.)	Barrier Type	Barrier End Treatment		*Repair Cost
			Begin	End	
GRSM-0008H-70.093-R 9/22/2010	145	STEEL-BACKED TIMBER WITHOUT BLOCKOUT	SBT/LOG FLARED	SBT/LOG FLARED	\$0.00
GRSM-0008H-70.102-L 9/22/2010	145	STEEL-BACKED TIMBER WITHOUT BLOCKOUT	SBT/LOG FLARED	SBT/LOG FLARED	\$0.00
GRSM-0008H-70.763-L 9/22/2010	682	STEEL-BACKED TIMBER WITHOUT BLOCKOUT	SBT/LOG FLARED	SBT/LOG FLARED	\$0.00
GRSM-0008H-70.917-L 9/22/2010	188	STEEL-BACKED TIMBER WITHOUT BLOCKOUT	SBT/LOG FLARED	SBT/LOG FLARED	\$0.00

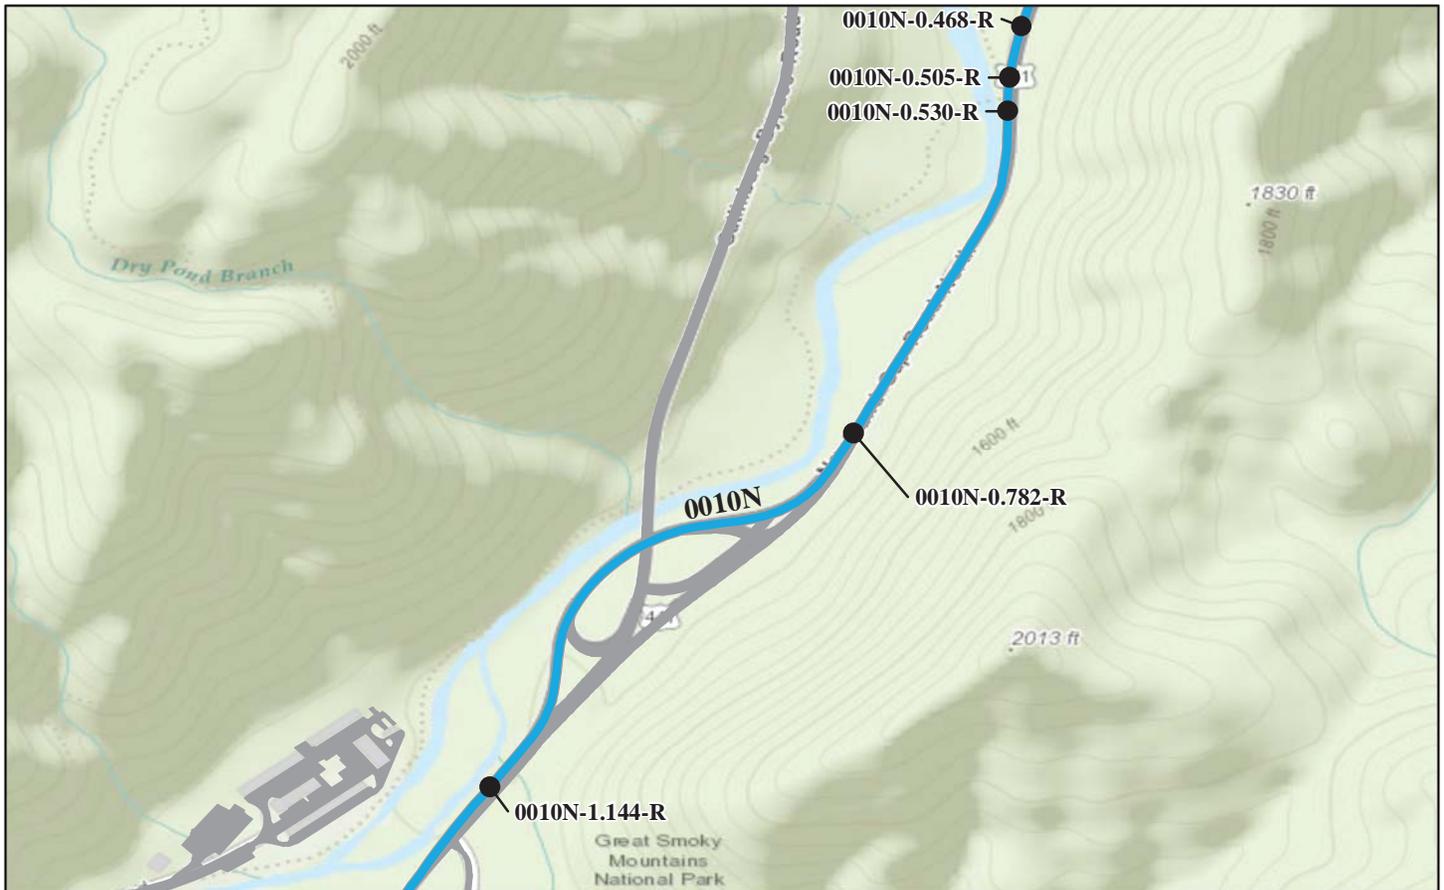
ROUTE 0010N: NEWFOUND GAP ROAD NORTH

Barrier ID Inspection Date	Barrier Length (Ft.)	Barrier Type	Barrier End Treatment		*Repair Cost
			Begin	End	
GRSM-0010N-0.468-R 9/15/2010	194	STEEL-BACKED TIMBER WITHOUT BLOCKOUT	SBT/LOG FLARED	NONE	\$0.00
GRSM-0010N-0.505-R 9/15/2010	129	STEEL-BACKED TIMBER WITHOUT BLOCKOUT	NONE	NONE	\$0.00
GRSM-0010N-0.530-R 9/14/2010	304	STONE MASONRY WITHOUT CONCRETE CORE WALL	NONE	NONE	\$2,393.00
GRSM-0010N-0.782-R 9/15/2010	498	STEEL-BACKED TIMBER WITHOUT BLOCKOUT	SBT/LOG FLARED	SBT/LOG FLARED	\$0.00
GRSM-0010N-1.144-R 9/15/2010	392	STEEL-BACKED TIMBER WITHOUT BLOCKOUT	SBT/LOG FLARED	SBT/LOG FLARED	\$0.00

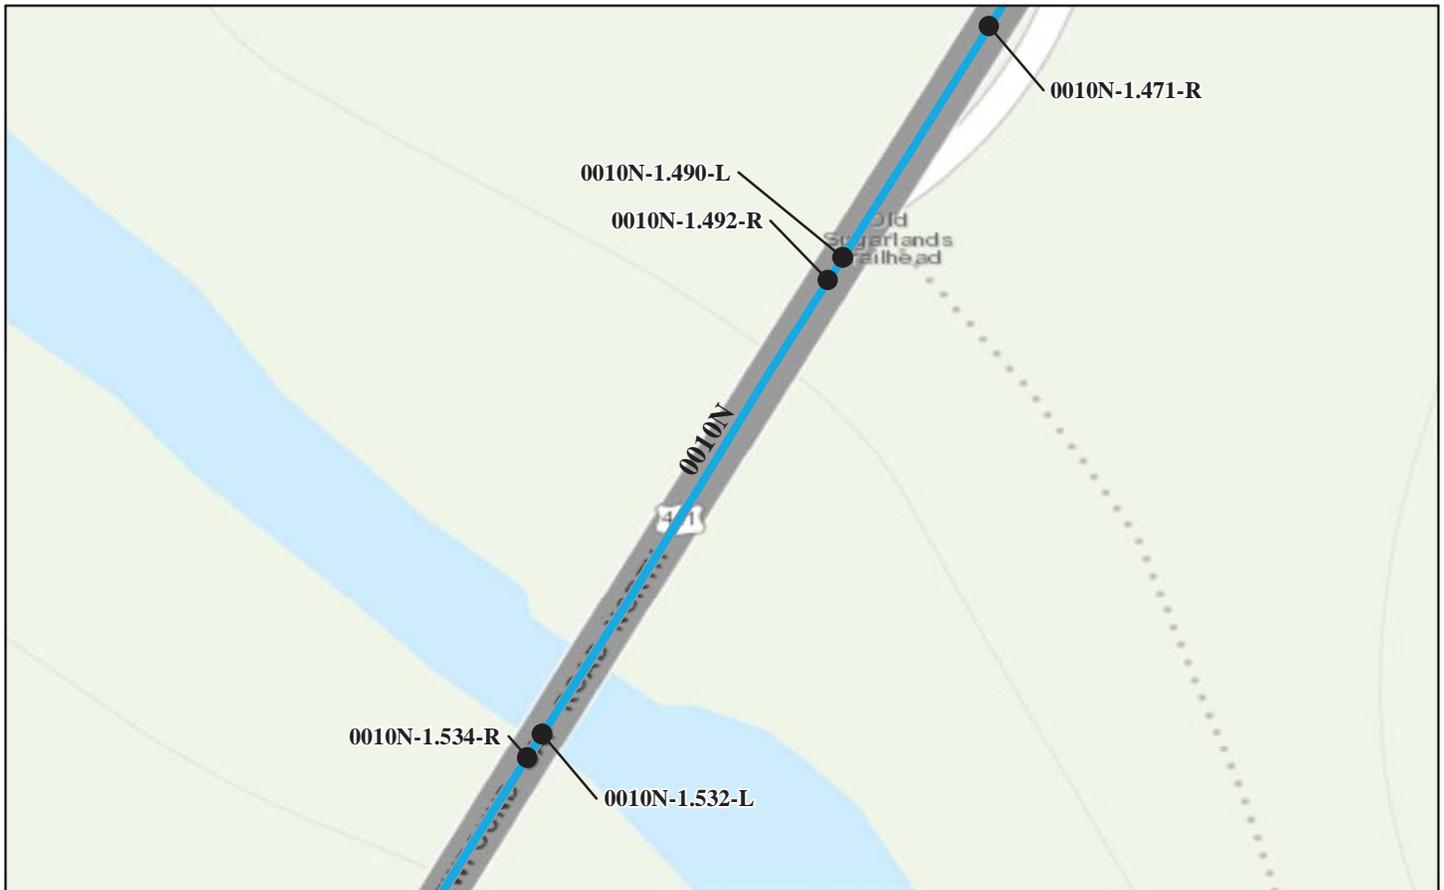
ROUTE 0010N: NEWFOUND GAP ROAD NORTH

Barrier ID Inspection Date	Barrier Length (Ft.)	Barrier Type	Barrier End Treatment		*Repair Cost
			Begin	End	
GRSM-0010N-1.471-R 9/15/2010	104	STEEL-BACKED TIMBER WITHOUT BLOCKOUT	SBT/LOG FLARED	SBT/LOG FLARED	\$0.00
GRSM-0010N-1.490-L 9/15/2010	52	STONE MASONRY WITHOUT CONCRETE CORE WALL	NONE	NONE	\$0.00
GRSM-0010N-1.492-R 9/15/2010	52	STONE MASONRY WITHOUT CONCRETE CORE WALL	NONE	NONE	\$0.00
GRSM-0010N-1.532-L 9/15/2010	52	STONE MASONRY WITHOUT CONCRETE CORE WALL	NONE	NONE	\$0.00
GRSM-0010N-1.534-R 9/15/2010	51	STONE MASONRY WITHOUT CONCRETE CORE WALL	NONE	NONE	\$0.00

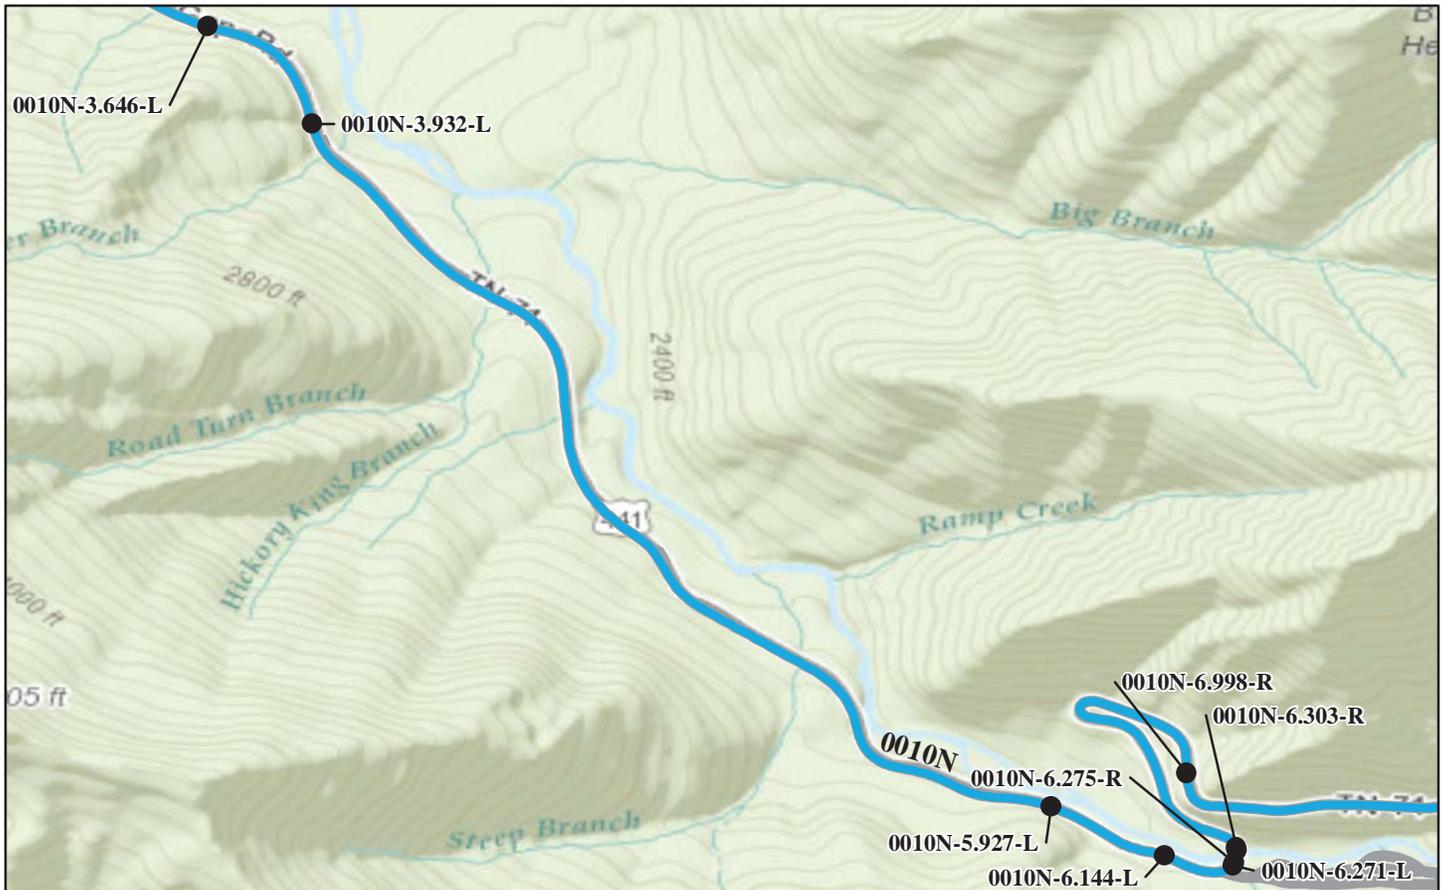
ROUTE 0010N: NEWFOUND GAP ROAD NORTH

Barrier ID Inspection Date	Barrier Length (Ft.)	Barrier Type	Barrier End Treatment		*Repair Cost
			Begin	End	
GRSM-0010N-3.646-L 9/15/2010	860	STEEL-BACKED TIMBER WITHOUT BLOCKOUT	SBT/LOG FLARED	SBT/LOG FLARED	\$2,448.00
GRSM-0010N-3.932-L 9/15/2010	118	STEEL-BACKED TIMBER WITHOUT BLOCKOUT	NONE	SBT/LOG FLARED	\$0.00
GRSM-0010N-5.927-L 9/15/2010	167	STONE MASONRY WITHOUT CONCRETE CORE WALL	NONE	NONE	\$77,990.00
GRSM-0010N-6.144-L 9/15/2010	640	STEEL-BACKED TIMBER WITHOUT BLOCKOUT	NONE	NONE	\$12,458.00
GRSM-0010N-6.271-L 9/15/2010	33	STONE MASONRY WITHOUT CONCRETE CORE WALL	NONE	NONE	\$0.00

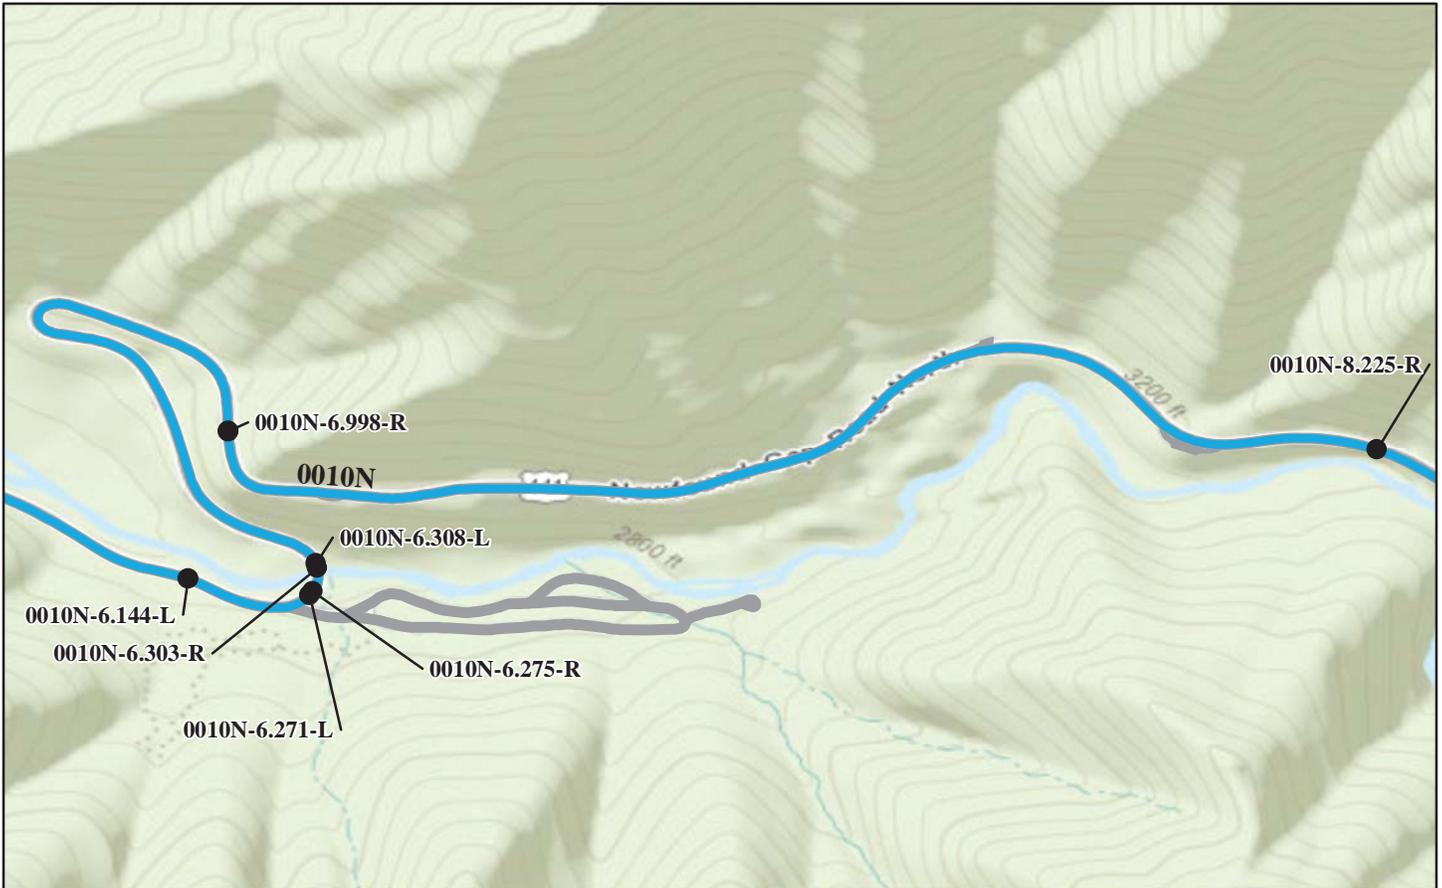
ROUTE 0010N: NEWFOUND GAP ROAD NORTH

Barrier ID Inspection Date	Barrier Length (Ft.)	Barrier Type	Barrier End Treatment		*Repair Cost
			Begin	End	
GRSM-0010N-6.275-R 9/15/2010	52	STONE MASONRY WITHOUT CONCRETE CORE WALL	NONE	NONE	\$0.00
GRSM-0010N-6.303-R 9/14/2010	54	STONE MASONRY WITHOUT CONCRETE CORE WALL	NONE	NONE	\$0.00
GRSM-0010N-6.308-L 9/15/2010	32	STONE MASONRY WITHOUT CONCRETE CORE WALL	NONE	NONE	\$0.00
GRSM-0010N-6.998-R 9/15/2010	483	STONE MASONRY WITHOUT CONCRETE CORE WALL	NONE	NONE	\$2,855.00
GRSM-0010N-8.225-R 9/15/2010	136	STEEL-BACKED TIMBER WITHOUT BLOCKOUT	SBT/LOG FLARED	SBT/LOG FLARED	\$0.00

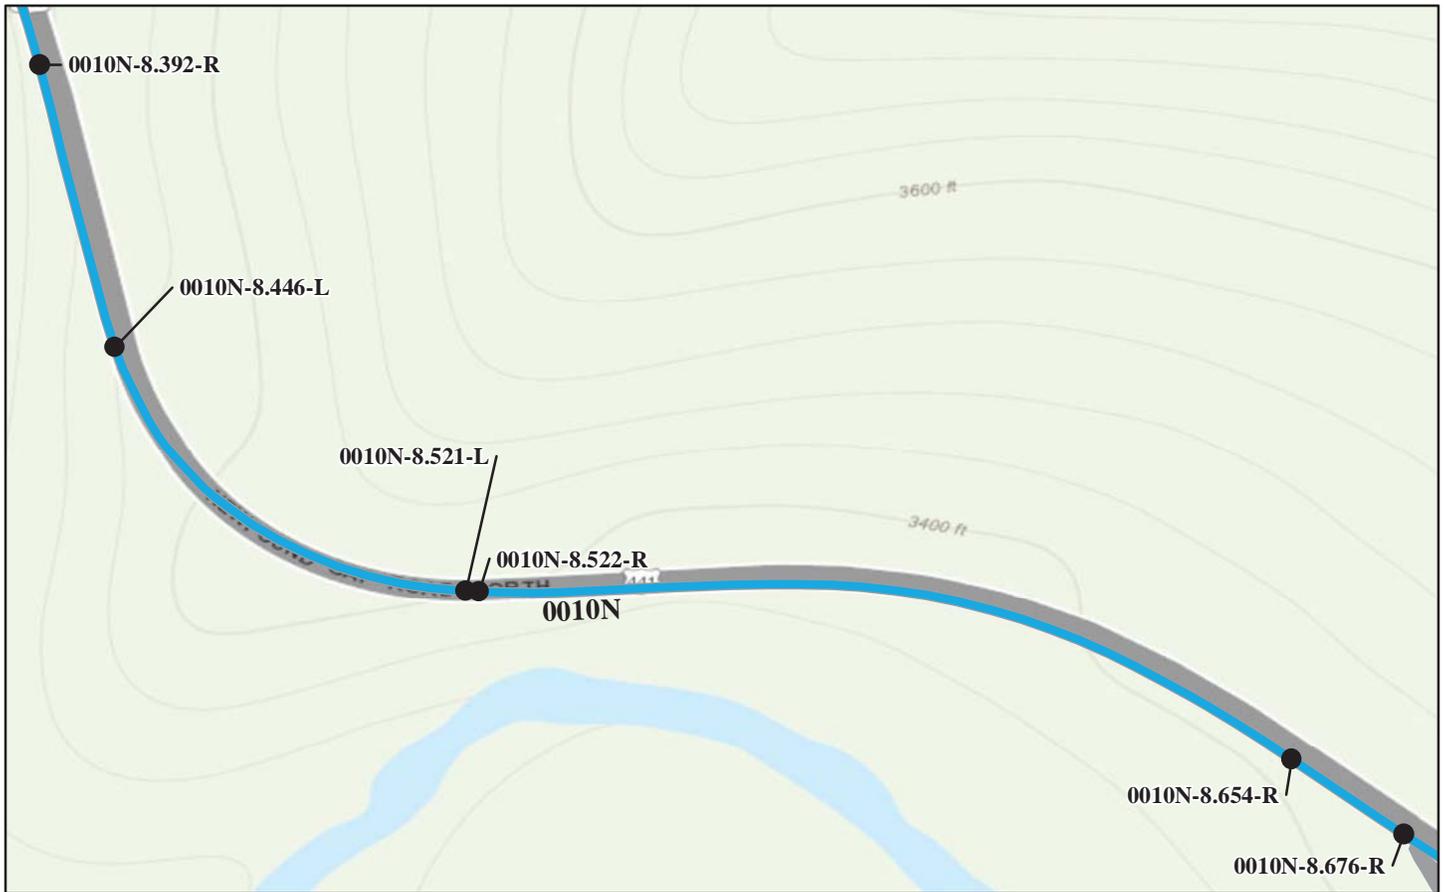
ROUTE 0010N: NEWFOUND GAP ROAD NORTH

Barrier ID Inspection Date	Barrier Length (Ft.)	Barrier Type	Barrier End Treatment		*Repair Cost
			Begin	End	
GRSM-0010N-8.392-R 9/15/2010	436	STONE MASONRY CRENELLATED WITHOUT CORE WALL	NONE	NONE	\$0.00
GRSM-0010N-8.446-L 9/15/2010	152	STONE MASONRY CRENELLATED WITHOUT CORE WALL	NONE	NONE	\$0.00
GRSM-0010N-8.521-L 9/15/2010	111	STONE MASONRY CRENELLATED WITHOUT CORE WALL	NONE	NONE	\$0.00
GRSM-0010N-8.522-R 9/15/2010	110	STONE MASONRY CRENELLATED WITHOUT CORE WALL	NONE	NONE	\$0.00
GRSM-0010N-8.654-R 9/15/2010	134	STONE MASONRY CRENELLATED WITHOUT CORE WALL	NONE	NONE	\$0.00

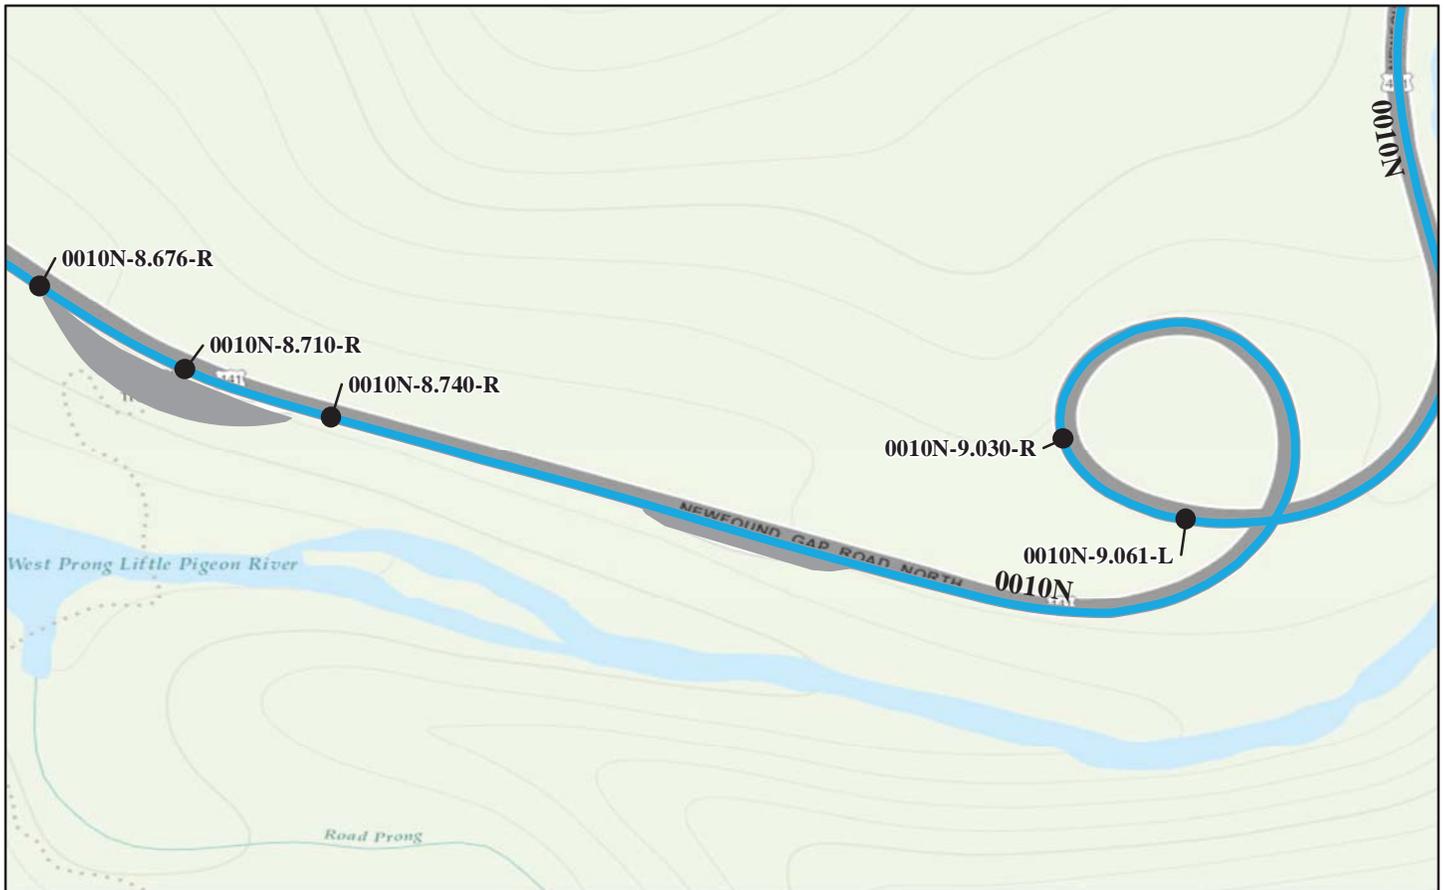
ROUTE 0010N: NEWFOUND GAP ROAD NORTH

Barrier ID Inspection Date	Barrier Length (Ft.)	Barrier Type	Barrier End Treatment		*Repair Cost
			Begin	End	
GRSM-0010N-8.676-R 9/16/2010	158	STONE MASONRY CRENELLATED WITHOUT CORE WALL	NONE	NONE	\$0.00
GRSM-0010N-8.710-R 9/16/2010	154	STONE MASONRY CRENELLATED WITHOUT CORE WALL	NONE	NONE	\$0.00
GRSM-0010N-8.740-R 9/15/2010	85	STONE MASONRY CRENELLATED WITHOUT CORE WALL	NONE	NONE	\$0.00
GRSM-0010N-9.030-R 9/16/2010	392	STEEL-BACKED TIMBER WITHOUT BLOCKOUT	NONE	SBT/LOG FLARED	\$0.00
GRSM-0010N-9.061-L 9/16/2010	232	STEEL-BACKED TIMBER WITHOUT BLOCKOUT	SBT/LOG FLARED	SBT/LOG FLARED	\$0.00
