NPS Guardwall/Rail Inventory Program
Great Smoky Mountains National Park

Federal Highway Administration
Eastern Federal Lands Highway Division
Road Inventory Program (RIP)

Data Collection Date: September 2010
Report Date: December 2015

Great Smoky Mountains National Park in North Carolina and Tennessee

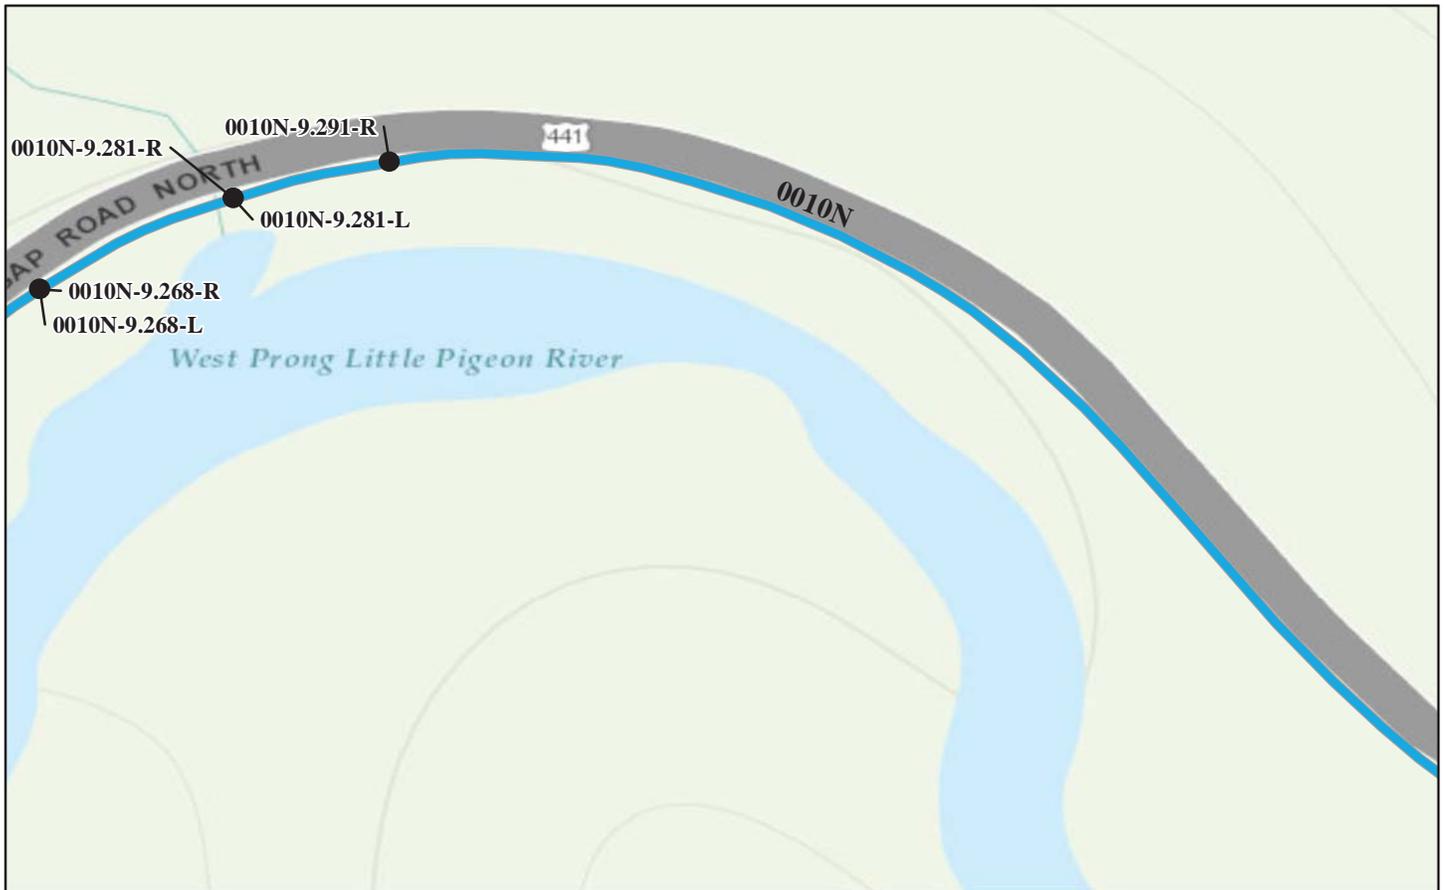
ROUTE 0010N: NEWFOUND GAP ROAD NORTH

Barrier ID Inspection Date	Barrier Length (Ft.)	Barrier Type	Barrier End Treatment		*Repair Cost
			Begin	End	
GRSM-0010N-9.268-L 9/16/2010	40	STONE MASONRY WITHOUT CONCRETE CORE WALL	NONE	NONE	\$0.00
GRSM-0010N-9.268-R 9/16/2010	44	STONE MASONRY WITHOUT CONCRETE CORE WALL	NONE	NONE	\$0.00
GRSM-0010N-9.281-L 9/16/2010	43	STONE MASONRY WITHOUT CONCRETE CORE WALL	NONE	NONE	\$0.00
GRSM-0010N-9.281-R 9/16/2010	42	STONE MASONRY WITHOUT CONCRETE CORE WALL	NONE	NONE	\$0.00
GRSM-0010N-9.291-R 9/16/2010	412	STEEL-BACKED TIMBER WITHOUT BLOCKOUT	NONE	NONE	\$7,777.00

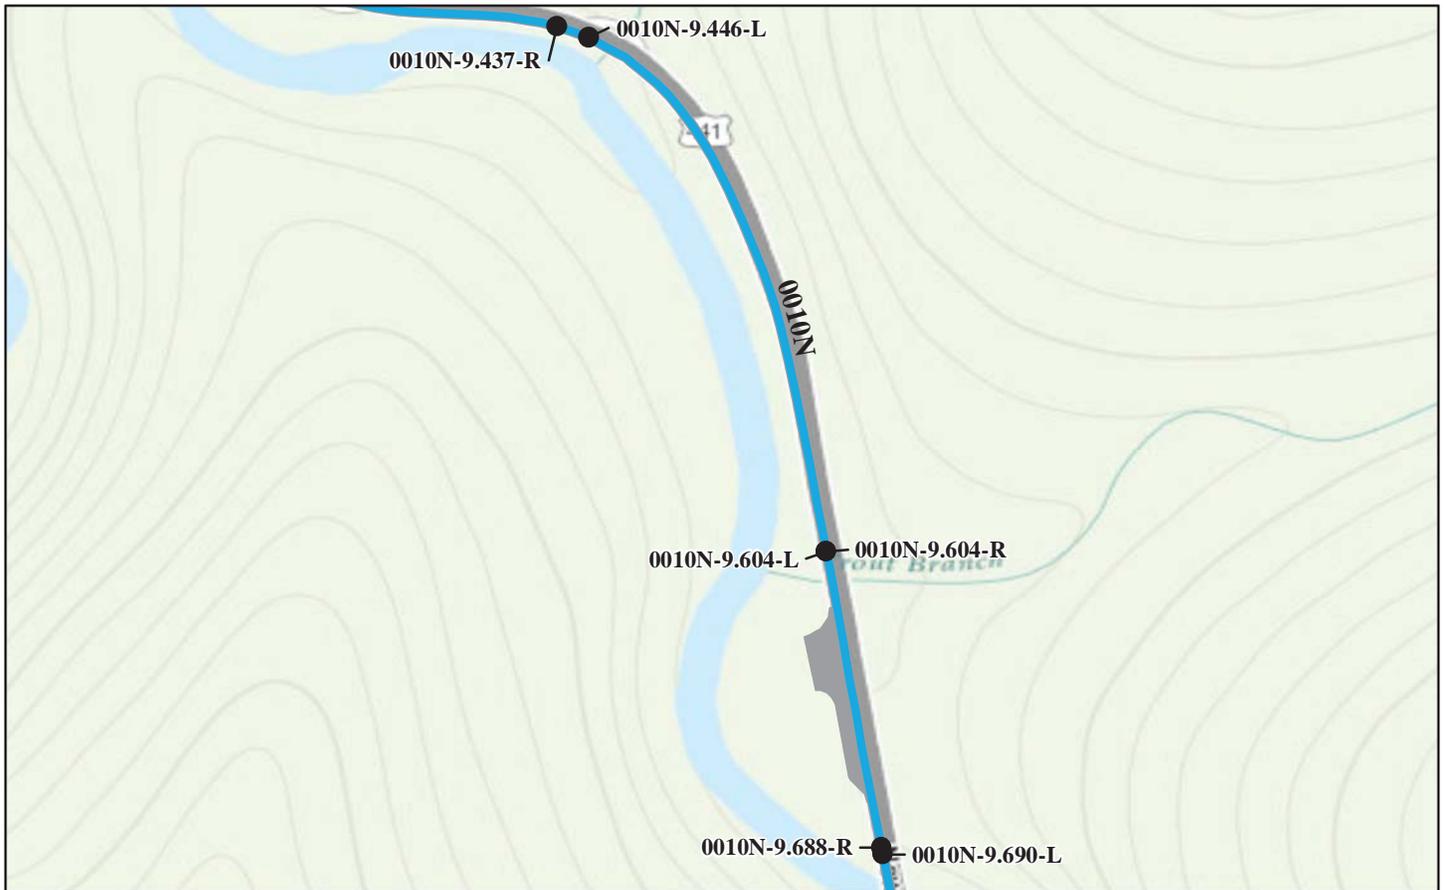
ROUTE 0010N: NEWFOUND GAP ROAD NORTH

Barrier ID Inspection Date	Barrier Length (Ft.)	Barrier Type	Barrier End Treatment		*Repair Cost
			Begin	End	
GRSM-0010N-9.437-R 9/16/2010	82	STONE MASONRY CRENELLATED WITHOUT CORE WALL	NONE	NONE	\$21,368.00
GRSM-0010N-9.446-L 9/16/2010	40	STONE MASONRY CRENELLATED WITHOUT CORE WALL	NONE	NONE	\$42,268.00
GRSM-0010N-9.604-L 9/16/2010	76	STONE MASONRY WITHOUT CONCRETE CORE WALL	NONE	NONE	\$0.00
GRSM-0010N-9.604-R 9/16/2010	75	STONE MASONRY WITHOUT CONCRETE CORE WALL	NONE	NONE	\$1,777.00
GRSM-0010N-9.688-R 9/16/2010	40	STONE MASONRY WITHOUT CONCRETE CORE WALL	NONE	NONE	\$0.00

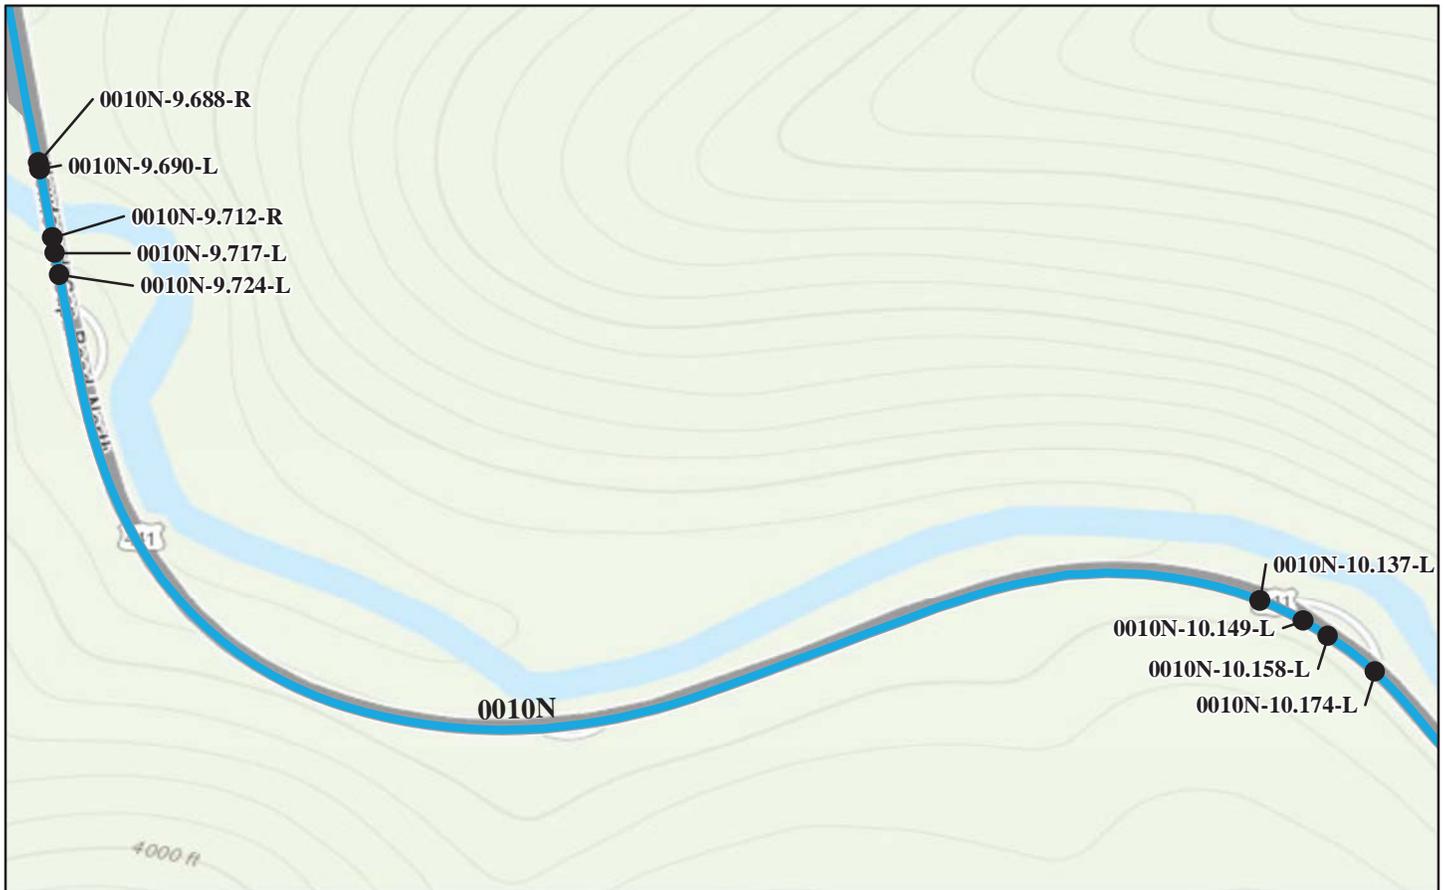
ROUTE 0010N: NEWFOUND GAP ROAD NORTH

Barrier ID Inspection Date	Barrier Length (Ft.)	Barrier Type	Barrier End Treatment		*Repair Cost
			Begin	End	
GRSM-0010N-9.690-L 9/16/2010	53	STONE MASONRY WITHOUT CONCRETE CORE WALL	NONE	NONE	\$1,898.00
GRSM-0010N-9.712-R 9/16/2010	52	STONE MASONRY WITHOUT CONCRETE CORE WALL	NONE	NONE	\$2,085.00
GRSM-0010N-9.717-L 9/16/2010	35	STONE MASONRY WITHOUT CONCRETE CORE WALL	NONE	NONE	\$0.00
GRSM-0010N-9.724-L 9/16/2010	111	STONE MASONRY CRENELLATED WITHOUT CORE WALL	NONE	NONE	\$57,090.00
GRSM-0010N-10.137-L 9/16/2010	63	STONE MASONRY CRENELLATED WITHOUT CORE WALL	NONE	NONE	\$0.00

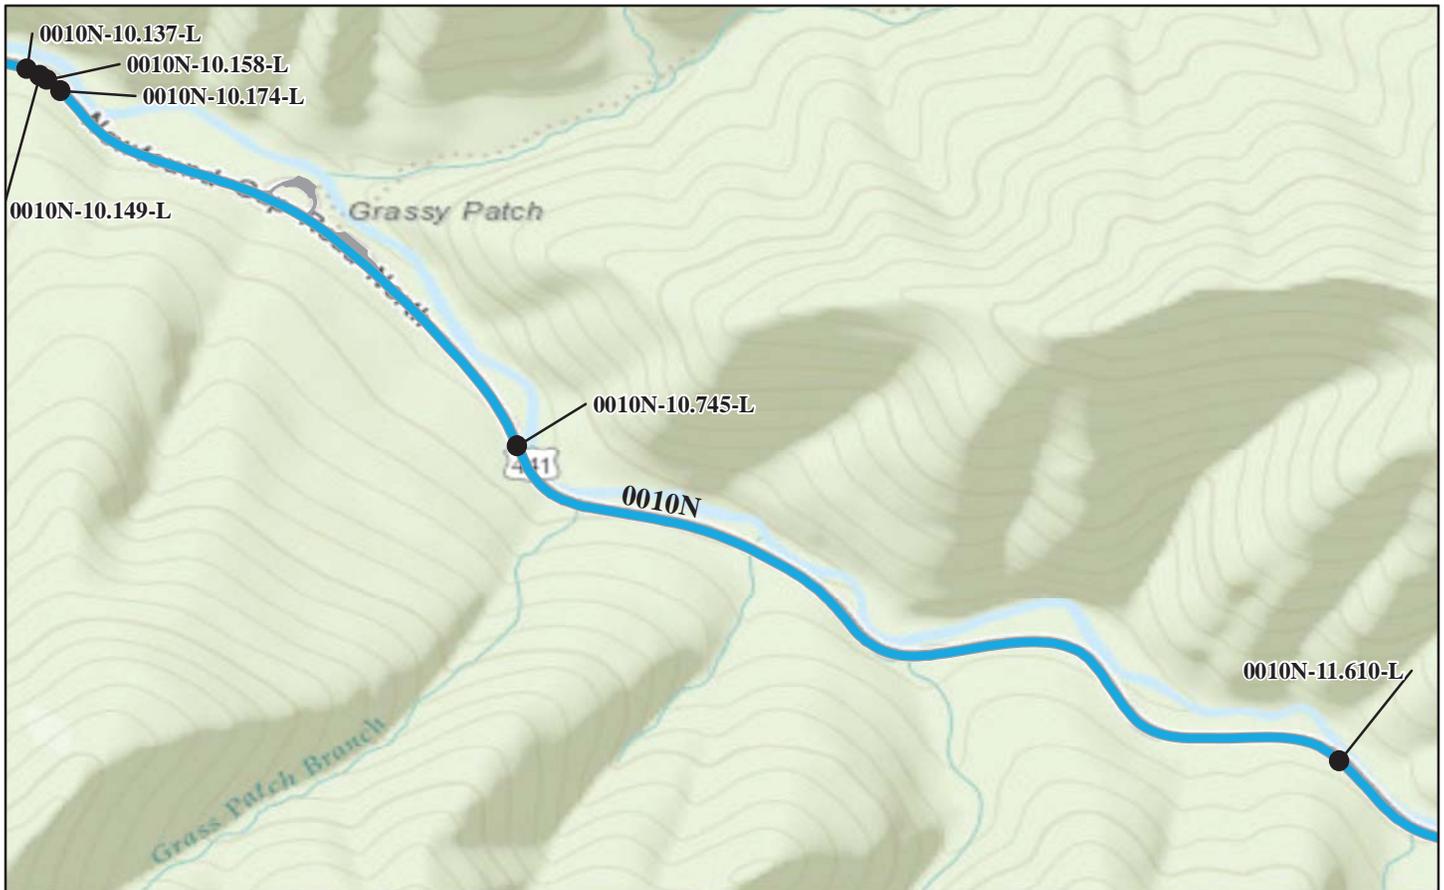
ROUTE 0010N: NEWFOUND GAP ROAD NORTH

Barrier ID Inspection Date	Barrier Length (Ft.)	Barrier Type	Barrier End Treatment		*Repair Cost
			Begin	End	
GRSM-0010N-10.149-L 9/16/2010	65	STONE MASONRY CRENELLATED WITHOUT CORE WALL	NONE	NONE	\$0.00
GRSM-0010N-10.158-L 9/16/2010	86	STONE MASONRY CRENELLATED WITHOUT CORE WALL	NONE	NONE	\$0.00
GRSM-0010N-10.174-L 9/16/2010	68	STONE MASONRY CRENELLATED WITHOUT CORE WALL	NONE	NONE	\$0.00
GRSM-0010N-10.745-L 9/16/2010	101	STONE MASONRY WITHOUT CONCRETE CORE WALL	NONE	NONE	\$0.00
GRSM-0010N-11.610-L 9/16/2010	460	STONE MASONRY CRENELLATED WITHOUT CORE WALL	NONE	NONE	\$103,318.00

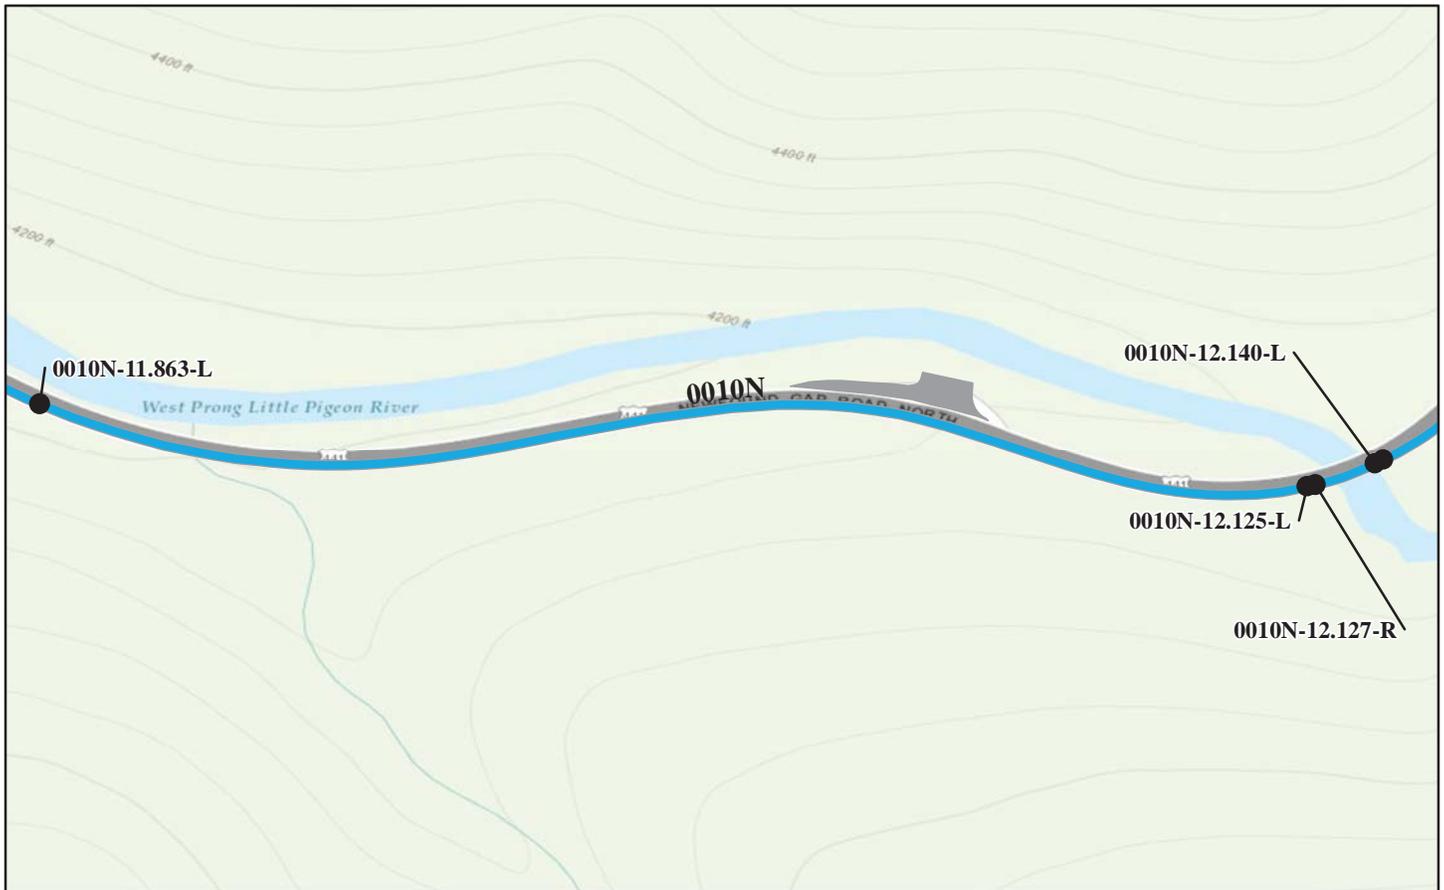
ROUTE 0010N: NEWFOUND GAP ROAD NORTH

Barrier ID Inspection Date	Barrier Length (Ft.)	Barrier Type	Barrier End Treatment		*Repair Cost
			Begin	End	
GRSM-0010N-11.863-L 9/16/2010	139	STONE MASONRY WITHOUT CONCRETE CORE WALL	NONE	NONE	\$1,898.00
GRSM-0010N-12.125-L 9/16/2010	28	STONE MASONRY WITHOUT CONCRETE CORE WALL	NONE	NONE	\$0.00
GRSM-0010N-12.127-R 9/16/2010	32	STONE MASONRY WITHOUT CONCRETE CORE WALL	NONE	NONE	\$0.00
GRSM-0010N-12.140-L 9/16/2010	30	STONE MASONRY WITHOUT CONCRETE CORE WALL	NONE	NONE	\$0.00
GRSM-0010N-12.142-R 9/16/2010	26	STONE MASONRY WITHOUT CONCRETE CORE WALL	NONE	NONE	\$0.00

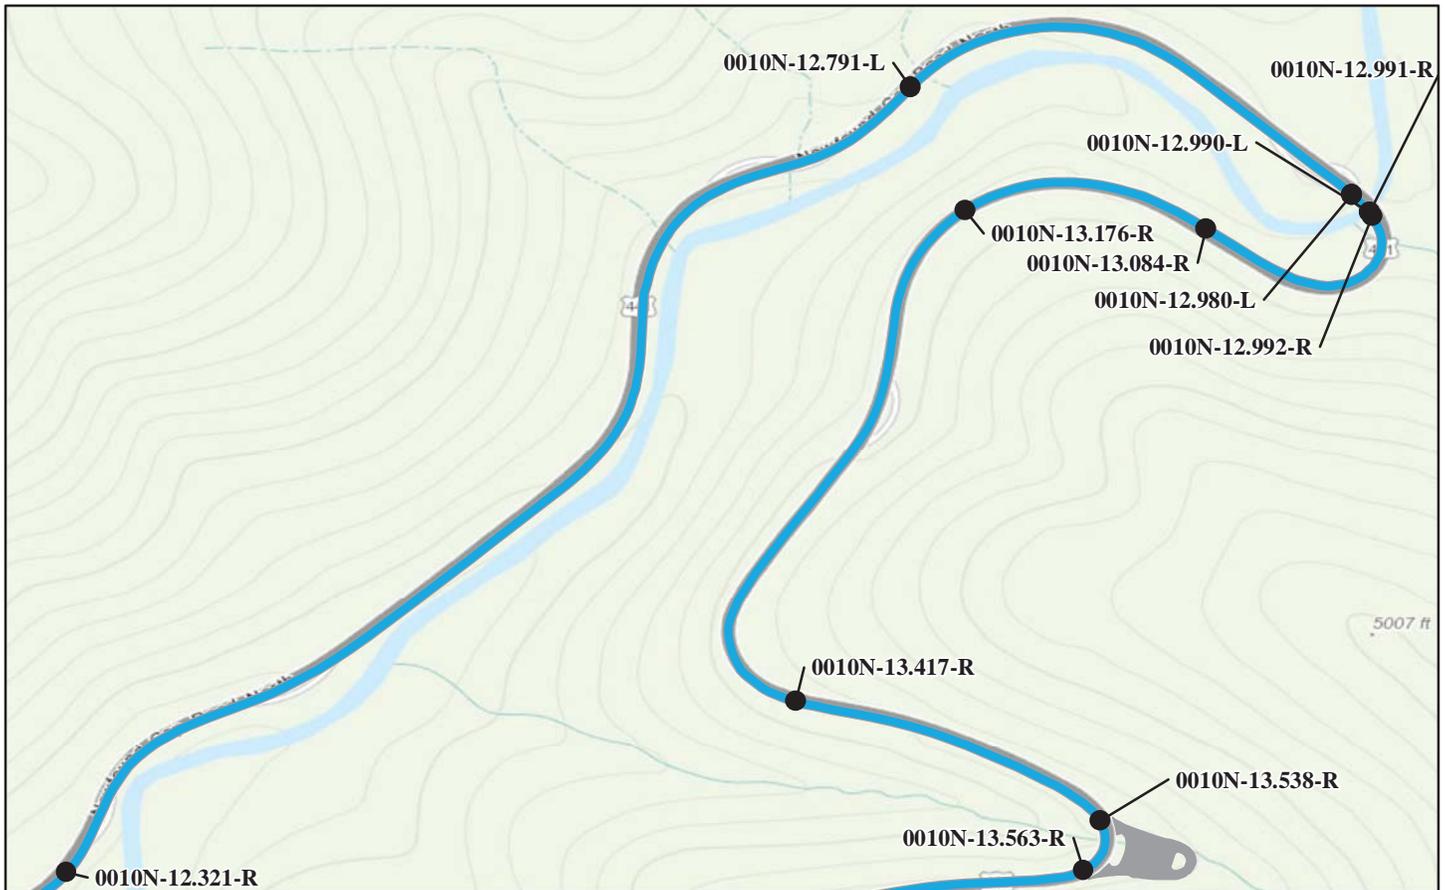
ROUTE 0010N: NEWFOUND GAP ROAD NORTH

Barrier ID Inspection Date	Barrier Length (Ft.)	Barrier Type	Barrier End Treatment		*Repair Cost
			Begin	End	
GRSM-0010N-12.321-R 9/16/2010	260	STONE MASONRY CRENELLATED WITHOUT CORE WALL	NONE	NONE	\$79,371.00
GRSM-0010N-12.791-L 9/16/2010	107	STONE MASONRY WITHOUT CONCRETE CORE WALL	NONE	NONE	\$1,777.00
GRSM-0010N-12.979-R 9/16/2010	22	STONE MASONRY WITHOUT CONCRETE CORE WALL	NONE	NONE	\$0.00
GRSM-0010N-12.980-L 9/16/2010	29	STONE MASONRY WITHOUT CONCRETE CORE WALL	NONE	NONE	\$0.00
GRSM-0010N-12.990-L 9/16/2010	30	STONE MASONRY WITHOUT CONCRETE CORE WALL	NONE	NONE	\$0.00

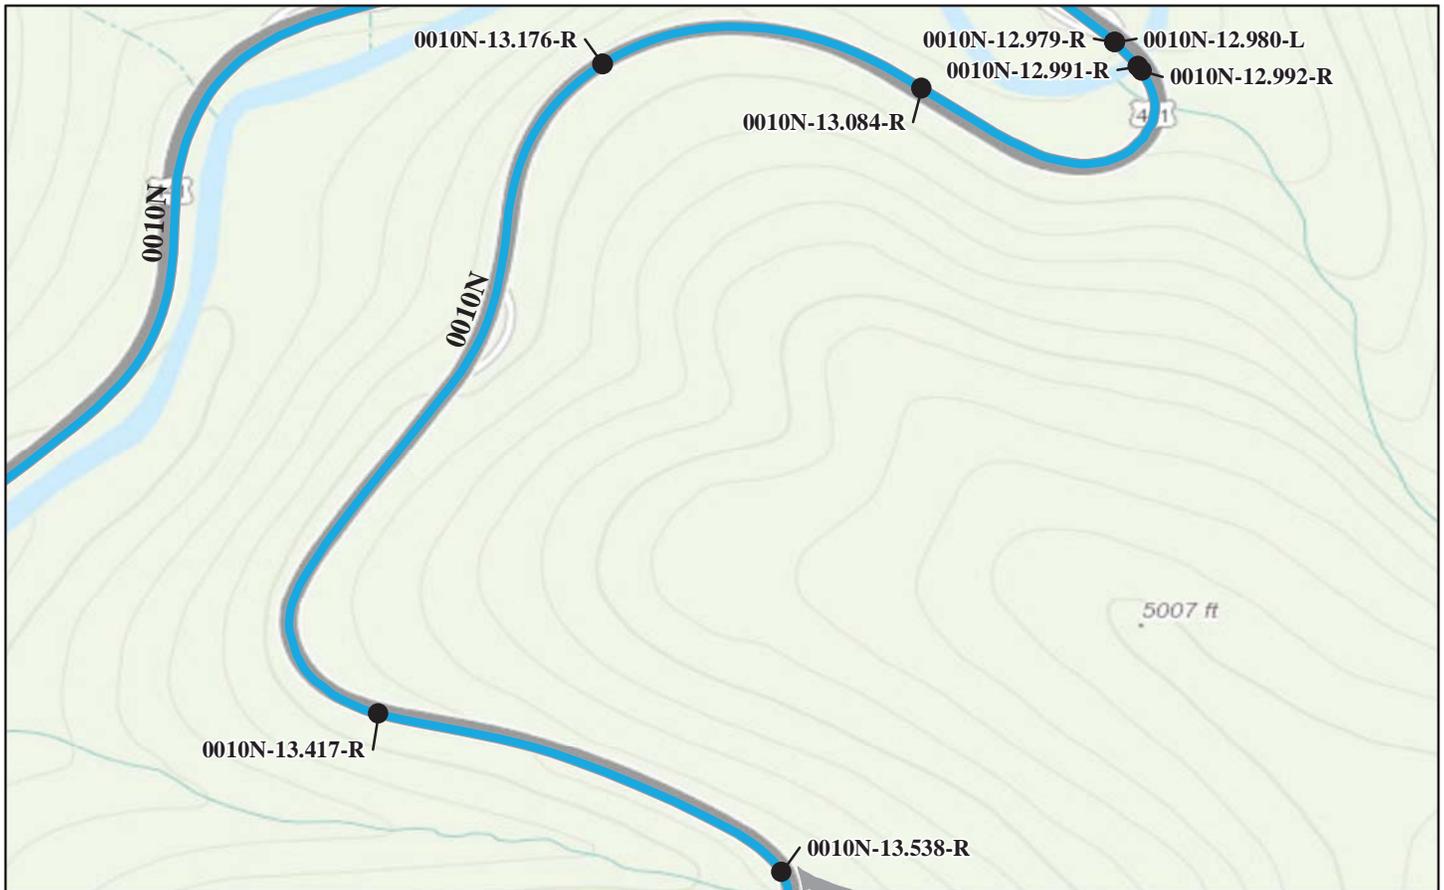
ROUTE 0010N: NEWFOUND GAP ROAD NORTH

Barrier ID Inspection Date	Barrier Length (Ft.)	Barrier Type	Barrier End Treatment		*Repair Cost
			Begin	End	
GRSM-0010N-12.991-R 9/16/2010	30	STONE MASONRY WITHOUT CONCRETE CORE WALL	NONE	NONE	\$0.00
GRSM-0010N-12.992-R 9/16/2010	464	STEEL-BACKED TIMBER WITHOUT BLOCKOUT	NONE	NONE	\$8,349.00
GRSM-0010N-13.084-R 9/16/2010	500	STONE MASONRY WITHOUT CONCRETE CORE WALL	NONE	NONE	\$263,065.00
GRSM-0010N-13.176-R 9/16/2010	1275	STONE MASONRY CRENELLATED WITHOUT CORE WALL	NONE	NONE	\$37,263.00
GRSM-0010N-13.417-R 9/16/2010	640	STONE MASONRY WITHOUT CONCRETE CORE WALL	NONE	NONE	\$686,043.00

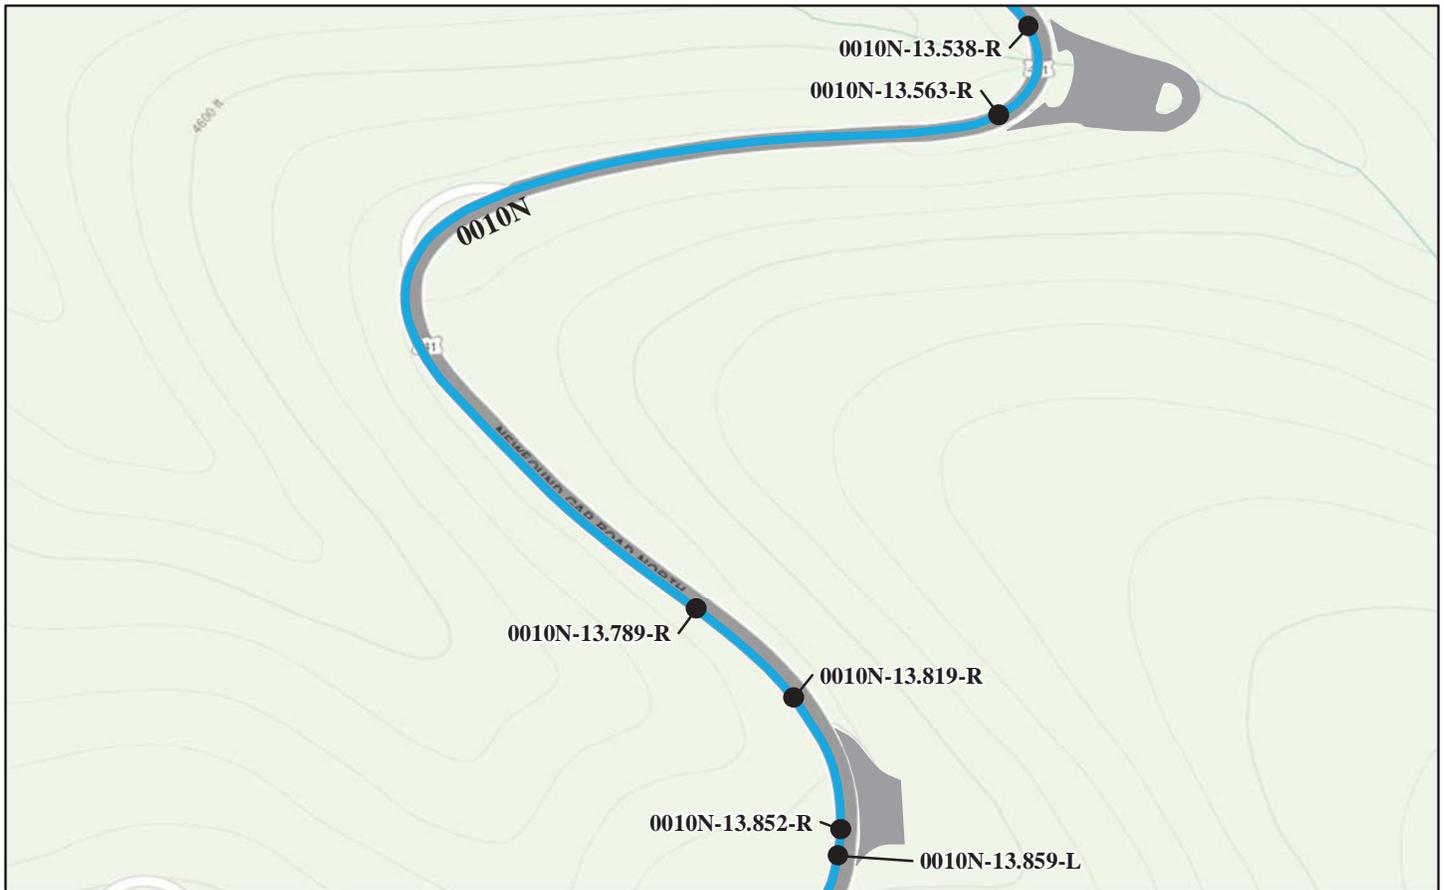
ROUTE 0010N: NEWFOUND GAP ROAD NORTH

Barrier ID Inspection Date	Barrier Length (Ft.)	Barrier Type	Barrier End Treatment		*Repair Cost
			Begin	End	
GRSM-0010N-13.538-R 9/16/2010	121	W-BEAM STRONG POST	NONE	NONE	\$3,295.00
GRSM-0010N-13.563-R 9/16/2010	522	STONE MASONRY WITHOUT CONCRETE CORE WALL	NONE	NONE	\$577,033.00
GRSM-0010N-13.789-R 9/16/2010	156	STONE MASONRY WITHOUT CONCRETE CORE WALL	NONE	NONE	\$0.00
GRSM-0010N-13.819-R 9/16/2010	172	STONE MASONRY WITHOUT CONCRETE CORE WALL	NONE	NONE	\$0.00
GRSM-0010N-13.852-R 9/16/2010	765	STONE MASONRY CRENELLATED WITHOUT CORE WALL	NONE	NONE	\$0.00

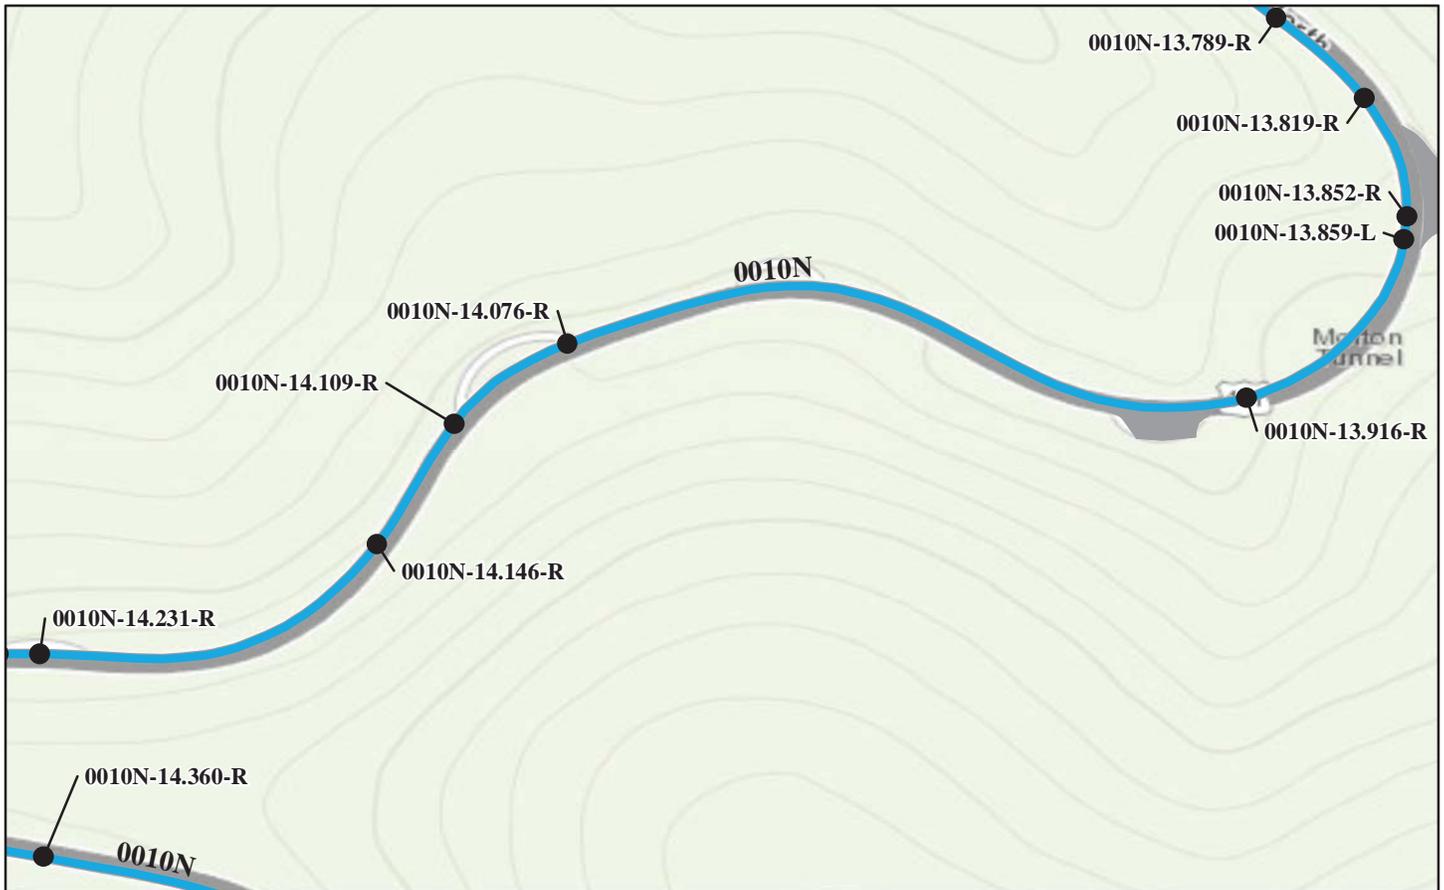
ROUTE 0010N: NEWFOUND GAP ROAD NORTH

Barrier ID Inspection Date	Barrier Length (Ft.)	Barrier Type	Barrier End Treatment		*Repair Cost
			Begin	End	
GRSM-0010N-13.859-L 9/16/2010	21	STONE MASONRY CRENELLATED WITHOUT CORE WALL	NONE	NONE	\$0.00
GRSM-0010N-13.916-R 9/20/2010	530	STONE MASONRY CRENELLATED WITHOUT CORE WALL	NONE	NONE	\$21,423.00
GRSM-0010N-14.076-R 9/20/2010	173	STONE MASONRY WITHOUT CONCRETE CORE WALL	NONE	NONE	\$0.00
GRSM-0010N-14.109-R 9/20/2010	193	STONE MASONRY CRENELLATED WITHOUT CORE WALL	NONE	NONE	\$0.00
GRSM-0010N-14.146-R 9/20/2010	450	STONE MASONRY WITHOUT CONCRETE CORE WALL	NONE	NONE	\$335,528.00

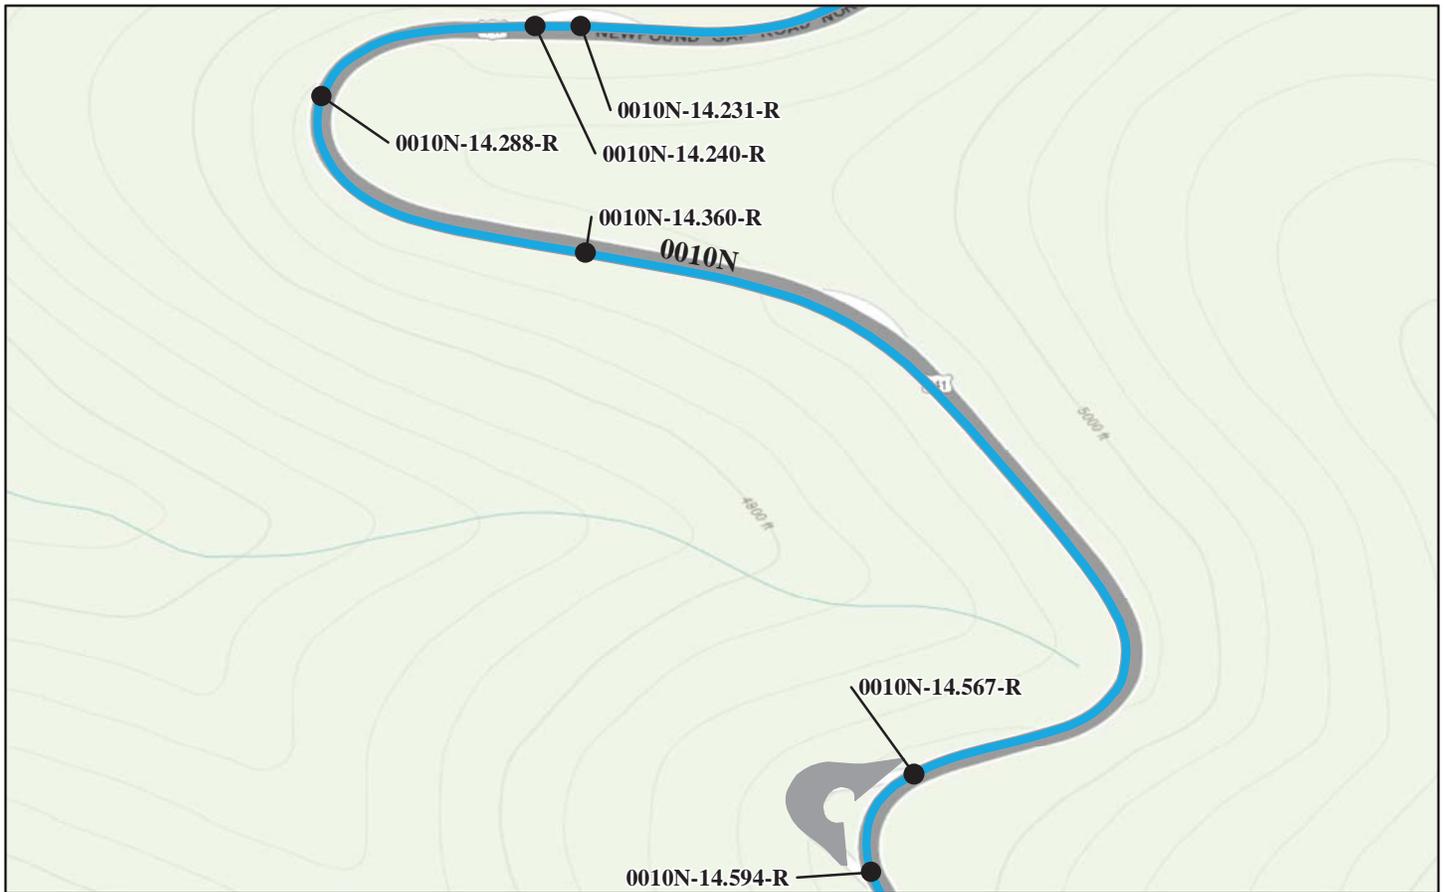
ROUTE 0010N: NEWFOUND GAP ROAD NORTH

Barrier ID Inspection Date	Barrier Length (Ft.)	Barrier Type	Barrier End Treatment		*Repair Cost
			Begin	End	
GRSM-0010N-14.231-R 9/20/2010	50	STONE MASONRY WITHOUT CONCRETE CORE WALL	NONE	NONE	\$0.00
GRSM-0010N-14.240-R 9/20/2010	253	STONE MASONRY WITHOUT CONCRETE CORE WALL	NONE	NONE	\$240,818.00
GRSM-0010N-14.288-R 9/20/2010	433	STONE MASONRY CRENELLATED WITHOUT CORE WALL	NONE	NONE	\$0.00
GRSM-0010N-14.360-R 9/20/2010	1048	STEEL-BACKED TIMBER WITH BLOCKOUT	NONE	NONE	\$0.00
GRSM-0010N-14.567-R 9/20/2010	254	STONE MASONRY WITHOUT CONCRETE CORE WALL	NONE	NONE	\$9,873.00

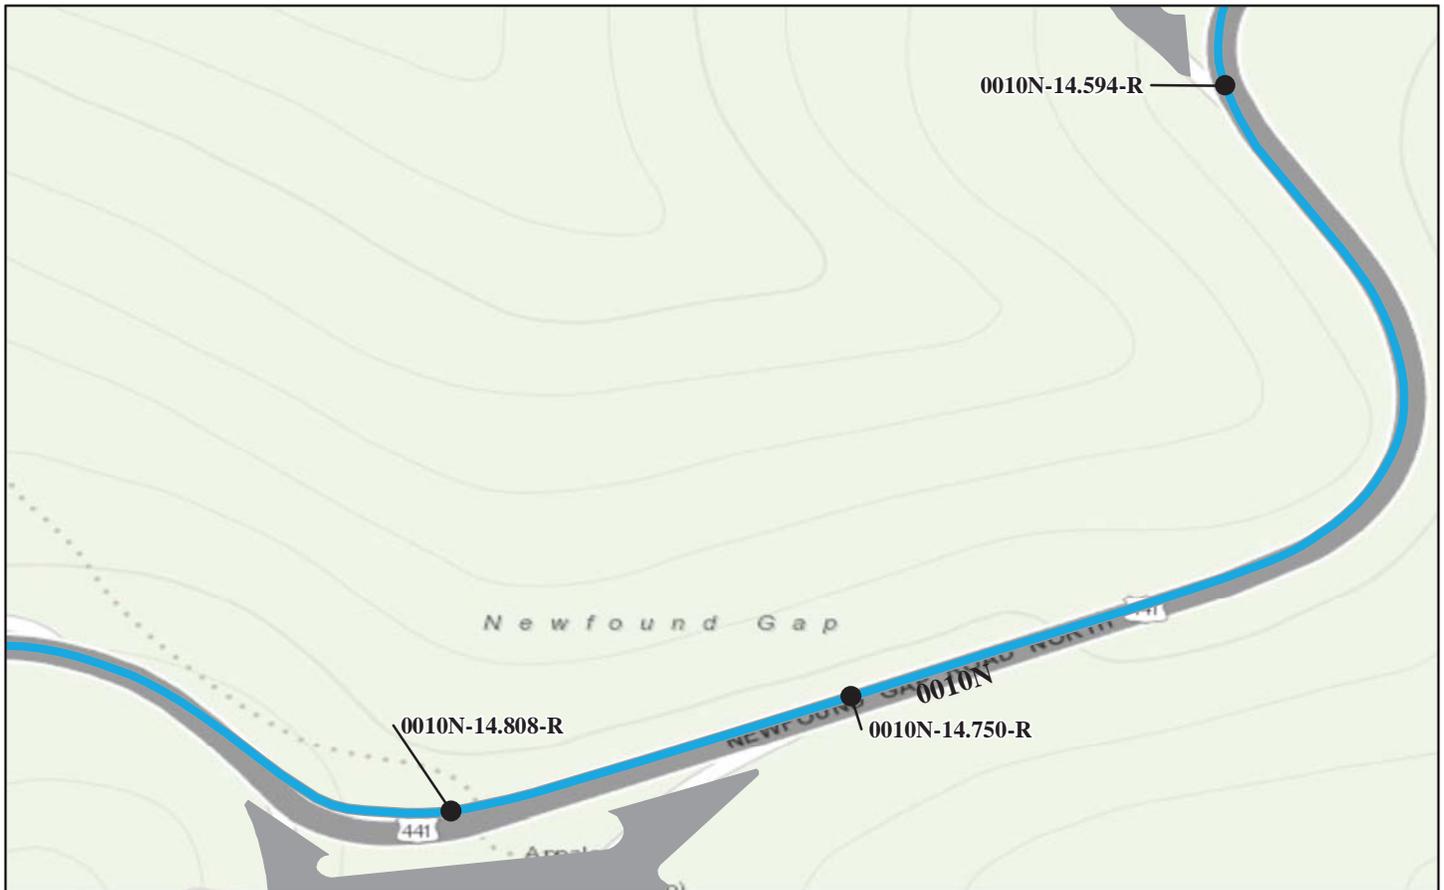
ROUTE 0010N: NEWFOUND GAP ROAD NORTH

Barrier ID Inspection Date	Barrier Length (Ft.)	Barrier Type	Barrier End Treatment		*Repair Cost
			Begin	End	
GRSM-0010N-14.594-R 9/20/2010	792	STEEL-BACKED TIMBER WITHOUT BLOCKOUT	NONE	NONE	\$7,865.00
GRSM-0010N-14.750-R 9/20/2010	271	STONE MASONRY CRENELLATED WITHOUT CORE WALL	NONE	NONE	\$115,583.00
GRSM-0010N-14.808-R 9/20/2010	340	STONE MASONRY CRENELLATED WITHOUT CORE WALL	NONE	NONE	\$222,420.00

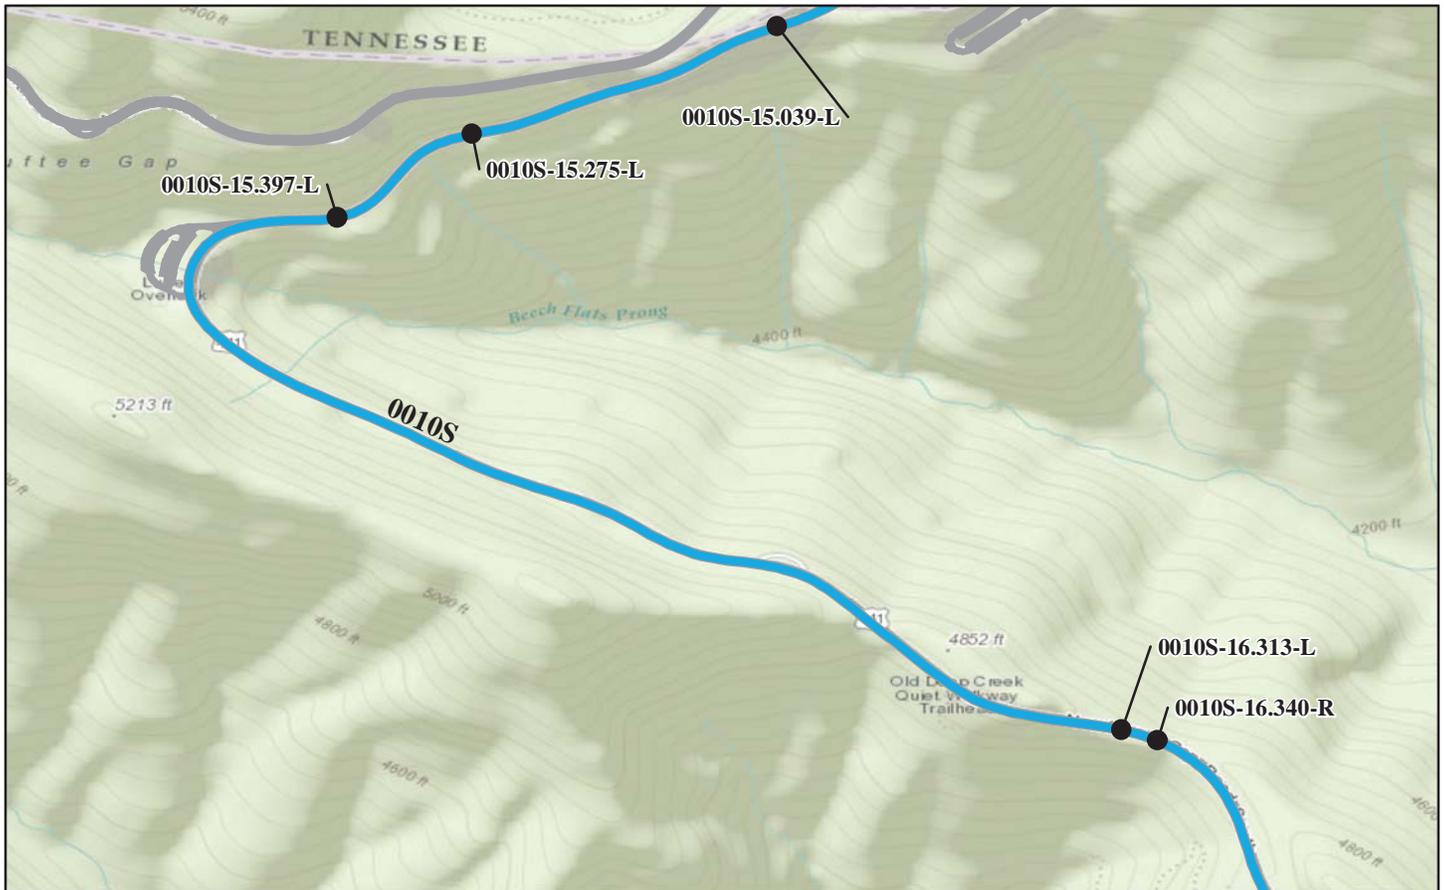
ROUTE 0010S: NEWFOUND GAP ROAD SOUTH

Barrier ID Inspection Date	Barrier Length (Ft.)	Barrier Type	Barrier End Treatment		*Repair Cost
			Begin	End	
GRSM-0010S-15.039-L 9/20/2010	896	STONE MASONRY WITHOUT CONCRETE CORE WALL	NONE	NONE	\$1,113,613.00
GRSM-0010S-15.275-L 9/20/2010	334	STEEL-BACKED TIMBER WITHOUT BLOCKOUT	SBT/LOG FLARED	SBT/LOG BURIED	\$0.00
GRSM-0010S-15.397-L 9/20/2010	919	STEEL-BACKED TIMBER WITHOUT BLOCKOUT	SBT/LOG BURIED	SBT/LOG FLARED	\$0.00
GRSM-0010S-16.313-L 9/20/2010	398	STEEL-BACKED TIMBER WITHOUT BLOCKOUT	SBT/LOG BURIED	SBT/LOG BURIED	\$0.00
GRSM-0010S-16.340-R 9/20/2010	725	STEEL-BACKED TIMBER WITHOUT BLOCKOUT	SBT/LOG FLARED	SBT/LOG BURIED	\$0.00

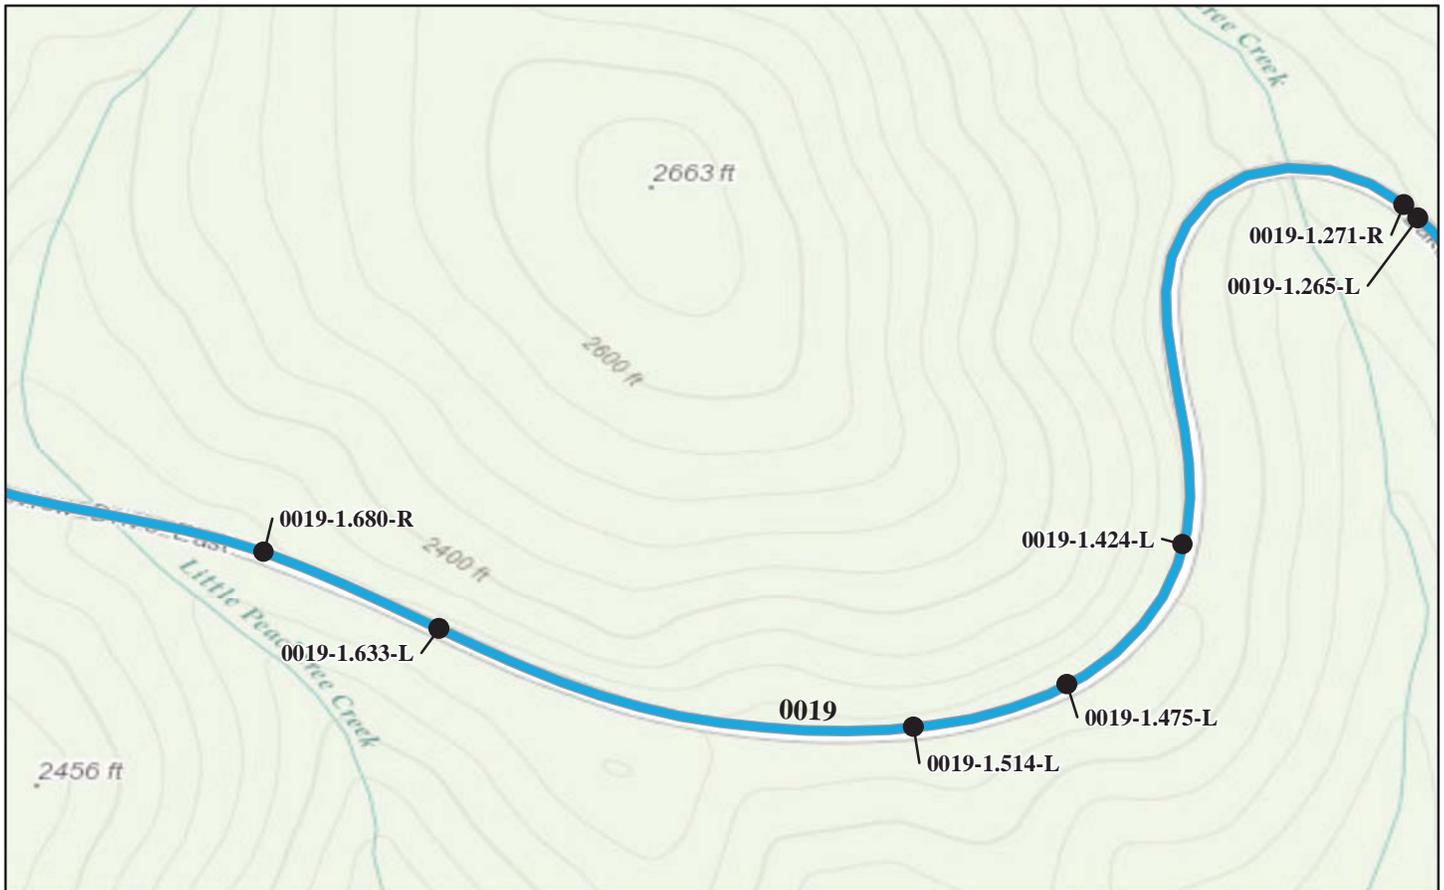
ROUTE 0019: LAKEVIEW DRIVE EAST

Barrier ID Inspection Date	Barrier Length (Ft.)	Barrier Type	Barrier End Treatment		*Repair Cost
			Begin	End	
GRSM-0019-1.271-R 9/21/2010	267	STEEL-BACKED TIMBER WITHOUT BLOCKOUT	SBT/LOG BURIED	SBT/LOG FLARED	\$0.00
GRSM-0019-1.424-L 9/21/2010	89	OTHER: TIMBER RAIL ON TIMBER POSTS	NONE	NONE	\$1,089.00
GRSM-0019-1.475-L 9/21/2010	89	OTHER: TIMBER RAIL ON TIMBER POSTS	NONE	NONE	\$2,602.00
GRSM-0019-1.514-L 9/21/2010	240	OTHER: TIMBER RAIL ON TIMBER POSTS	NONE	NONE	\$5,528.00
GRSM-0019-1.633-L 9/21/2010	530	OTHER: TIMBER RAIL ON TIMBER POSTS	NONE	NONE	\$10,093.00

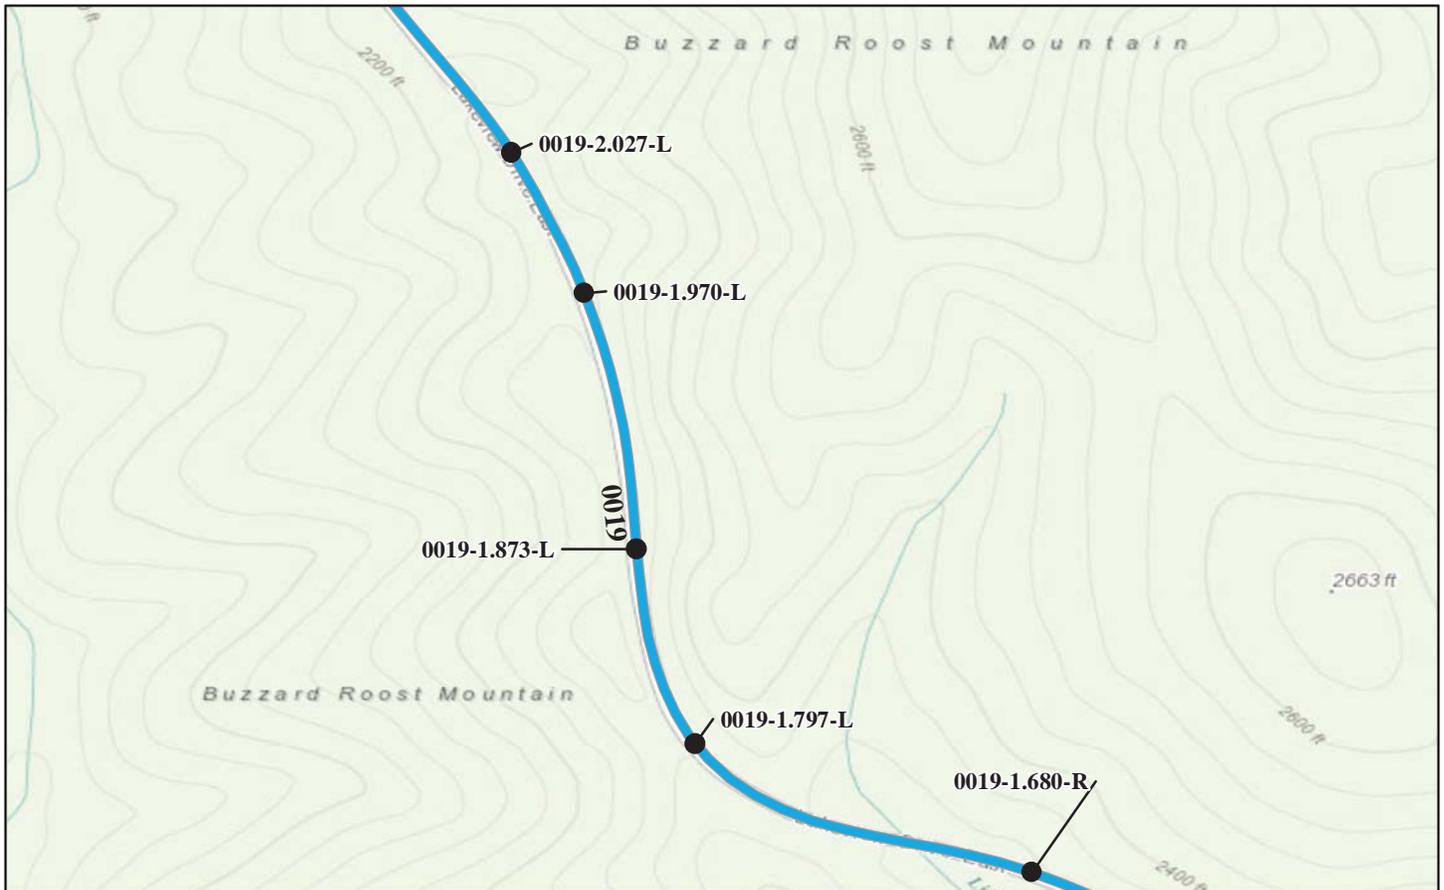
ROUTE 0019: LAKEVIEW DRIVE EAST

Barrier ID Inspection Date	Barrier Length (Ft.)	Barrier Type	Barrier End Treatment		*Repair Cost
			Begin	End	
GRSM-0019-1.680-R 9/21/2010	288	OTHER: TIMBER RAIL ON TIMBER POSTS	NONE	NONE	\$2,723.00
GRSM-0019-1.797-L 9/21/2010	81	OTHER: TIMBER RAIL ON TIMBER POSTS	NONE	NONE	\$3,174.00
GRSM-0019-1.873-L 9/21/2010	200	OTHER: TIMBER RAIL ON TIMBER POSTS	NONE	NONE	\$4,813.00
GRSM-0019-1.970-L 9/21/2010	210	OTHER: TIMBER RAIL ON TIMBER POSTS	NONE	NONE	\$3,410.00
GRSM-0019-2.027-L 9/21/2010	290	OTHER: TIMBER RAIL ON TIMBER POSTS	NONE	NONE	\$5,088.00

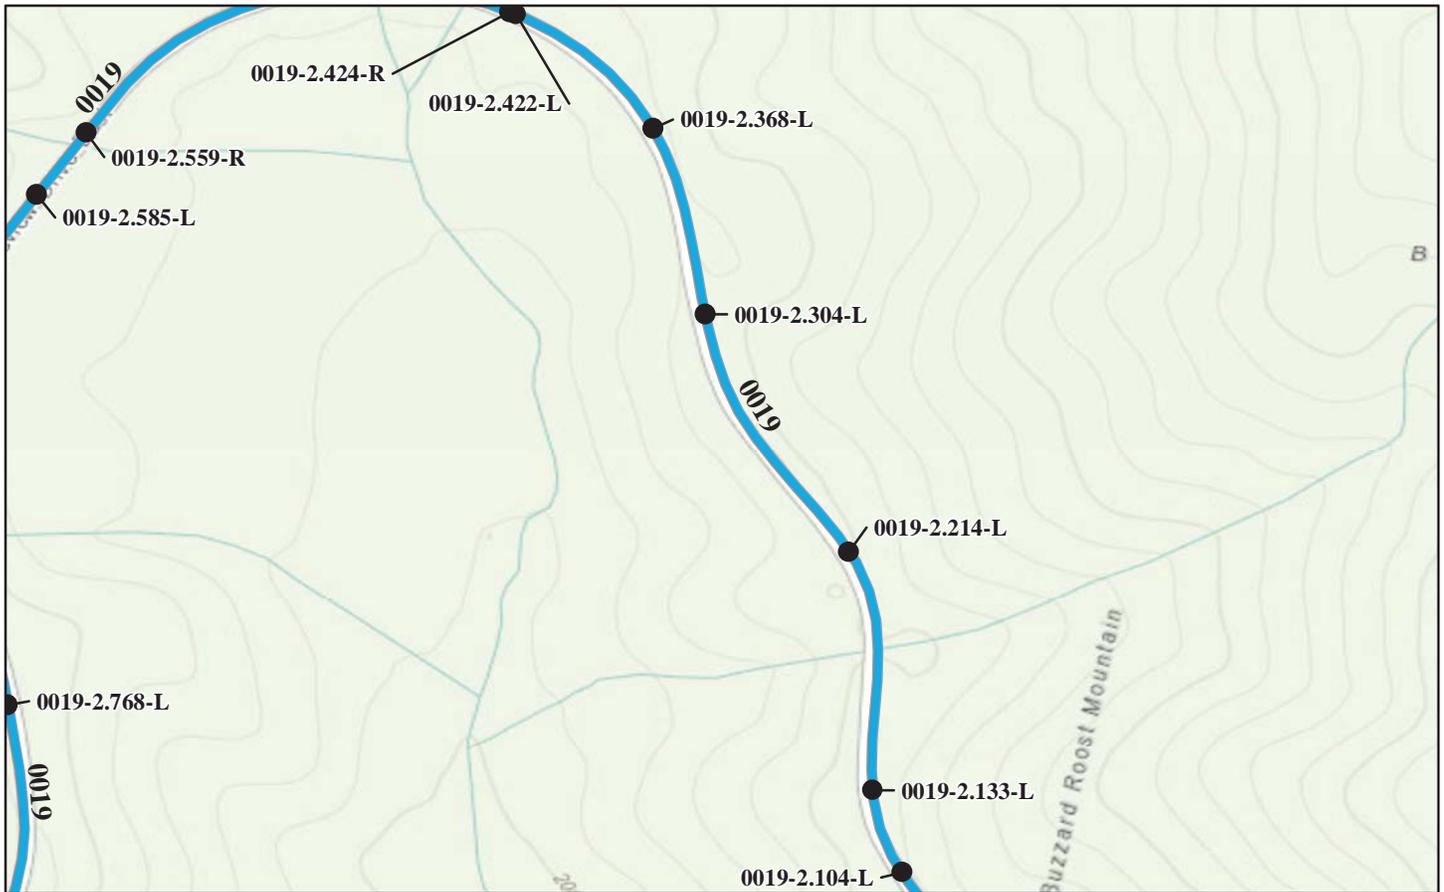
ROUTE 0019: LAKEVIEW DRIVE EAST

Barrier ID Inspection Date	Barrier Length (Ft.)	Barrier Type	Barrier End Treatment		*Repair Cost
			Begin	End	
GRSM-0019-2.104-L 9/17/2010	121	OTHER: TIMBER RAIL ON TIMBER POSTS	NONE	NONE	\$2,833.00
GRSM-0019-2.133-L 9/17/2010	342	OTHER: TIMBER RAIL ON TIMBER POSTS	NONE	NONE	\$6,815.00
GRSM-0019-2.214-L 9/17/2010	281	OTHER: TIMBER RAIL ON TIMBER POSTS	NONE	NONE	\$2,942.00
GRSM-0019-2.304-L 9/17/2010	230	OTHER: TIMBER RAIL ON TIMBER POSTS	NONE	NONE	\$27,995.00
GRSM-0019-2.368-L 9/17/2010	234	OTHER: TIMBER RAIL ON TIMBER POSTS	NONE	NONE	\$3,014.00
