NPS Guardwall/Rail Inventory Program
Great Smoky Mountains National Park

Federal Highway Administration
Eastern Federal Lands Highway Division
Road Inventory Program (RIP)

Data Collection Date: September 2010
Report Date: December 2015

Great Smoky Mountains National Park in North Carolina and Tennessee

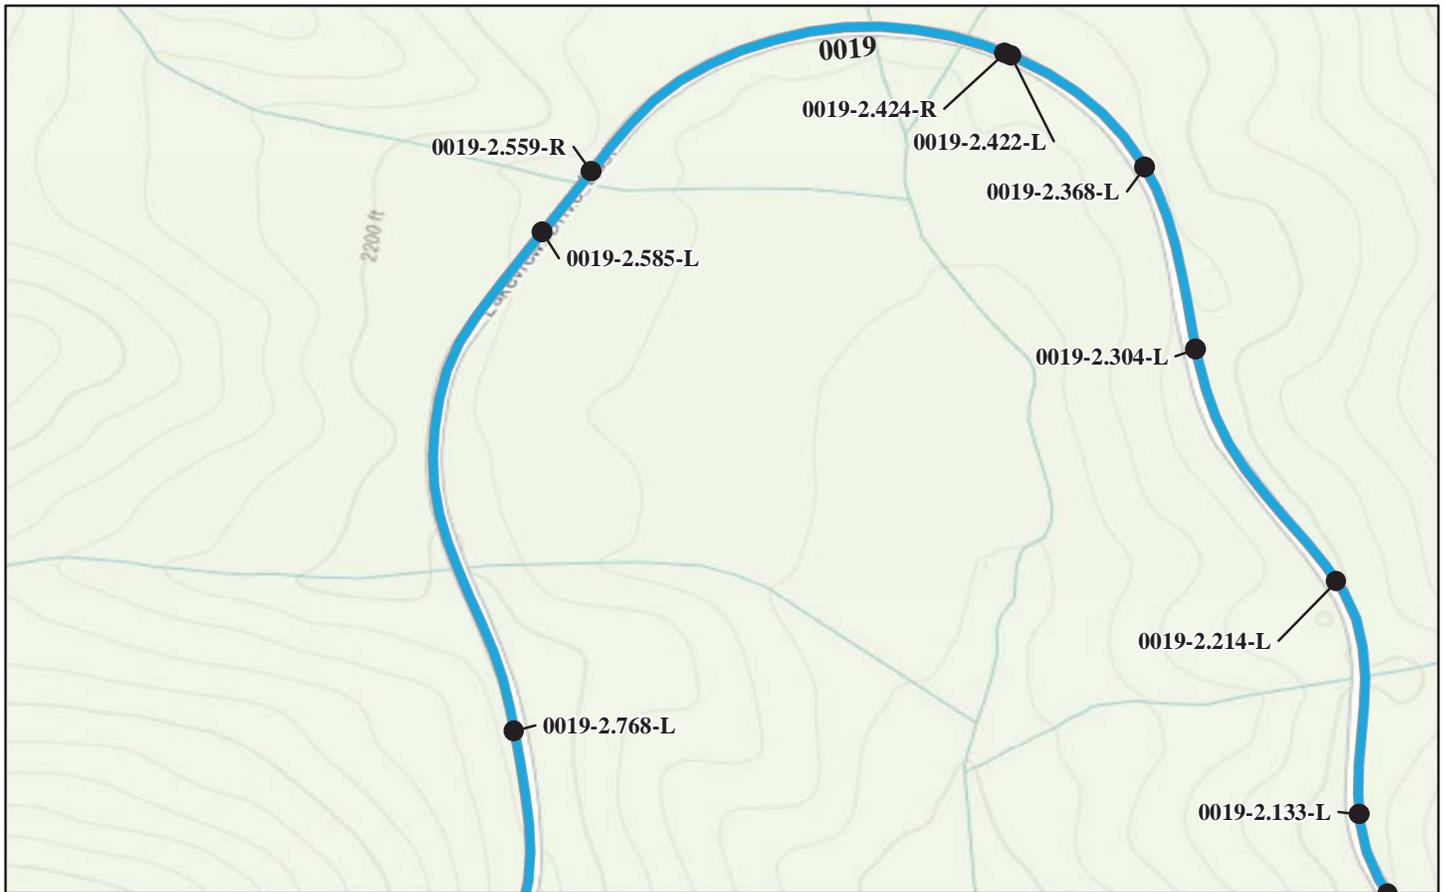
ROUTE 0019: LAKEVIEW DRIVE EAST

Barrier ID Inspection Date	Barrier Length (Ft.)	Barrier Type	Barrier End Treatment		*Repair Cost
			Begin	End	
GRSM-0019-2.422-L 9/17/2010	655	OTHER: TIMBER RAIL ON TIMBER POSTS	NONE	NONE	\$9,378.00
GRSM-0019-2.424-R 9/17/2010	278	STEEL-BACKED TIMBER WITHOUT BLOCKOUT	SBT/LOG BURIED	SBT/LOG FLARED	\$2,524.00
GRSM-0019-2.559-R 9/17/2010	40	OTHER: TIMBER RAIL ON TIMBER POSTS	NONE	NONE	\$2,063.00
GRSM-0019-2.585-L 9/17/2010	821	OTHER: TIMBER RAIL ON TIMBER POSTS	NONE	NONE	\$15,521.00
GRSM-0019-2.768-L 9/17/2010	258	OTHER: TIMBER RAIL ON TIMBER POSTS	NONE	NONE	\$4,901.00

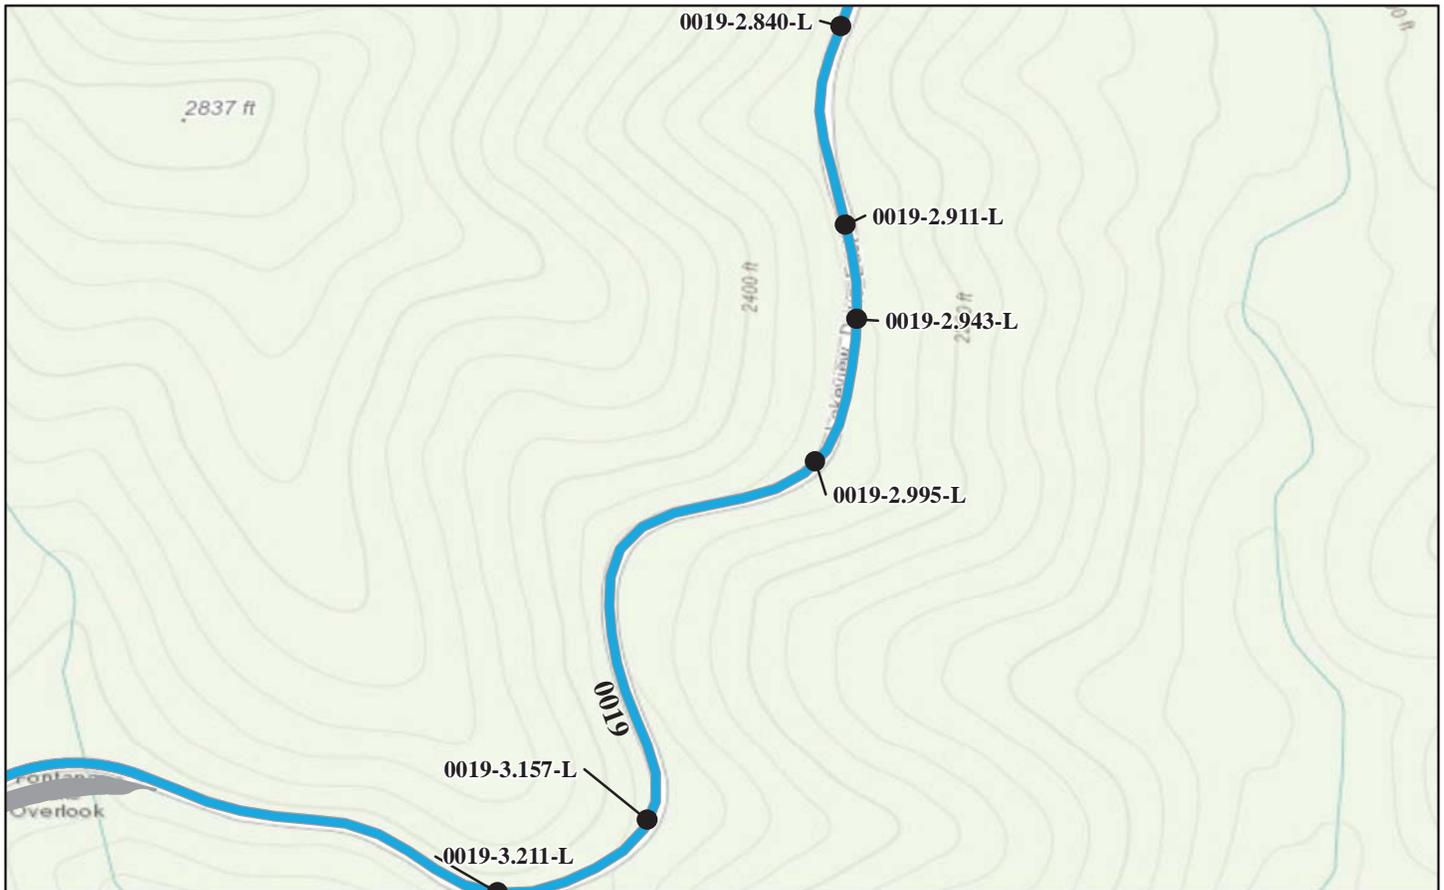
ROUTE 0019: LAKEVIEW DRIVE EAST

Barrier ID Inspection Date	Barrier Length (Ft.)	Barrier Type	Barrier End Treatment		*Repair Cost
			Begin	End	
GRSM-0019-2.840-L 9/17/2010	242	OTHER: TIMBER RAIL ON TIMBER POSTS	NONE	NONE	\$4,285.00
GRSM-0019-2.911-L 9/17/2010	144	OTHER: TIMBER RAIL ON TIMBER POSTS	NONE	NONE	\$0.00
GRSM-0019-2.943-L 9/17/2010	231	OTHER: TIMBER RAIL ON TIMBER POSTS	NONE	NONE	\$3,548.00
GRSM-0019-2.995-L 9/17/2010	748	STEEL-BACKED TIMBER WITHOUT BLOCKOUT	SBT/LOG BURIED	SBT/LOG FLARED	\$0.00
GRSM-0019-3.157-L 9/17/2010	148	OTHER: TIMBER RAIL ON TIMBER POSTS	NONE	NONE	\$2,448.00

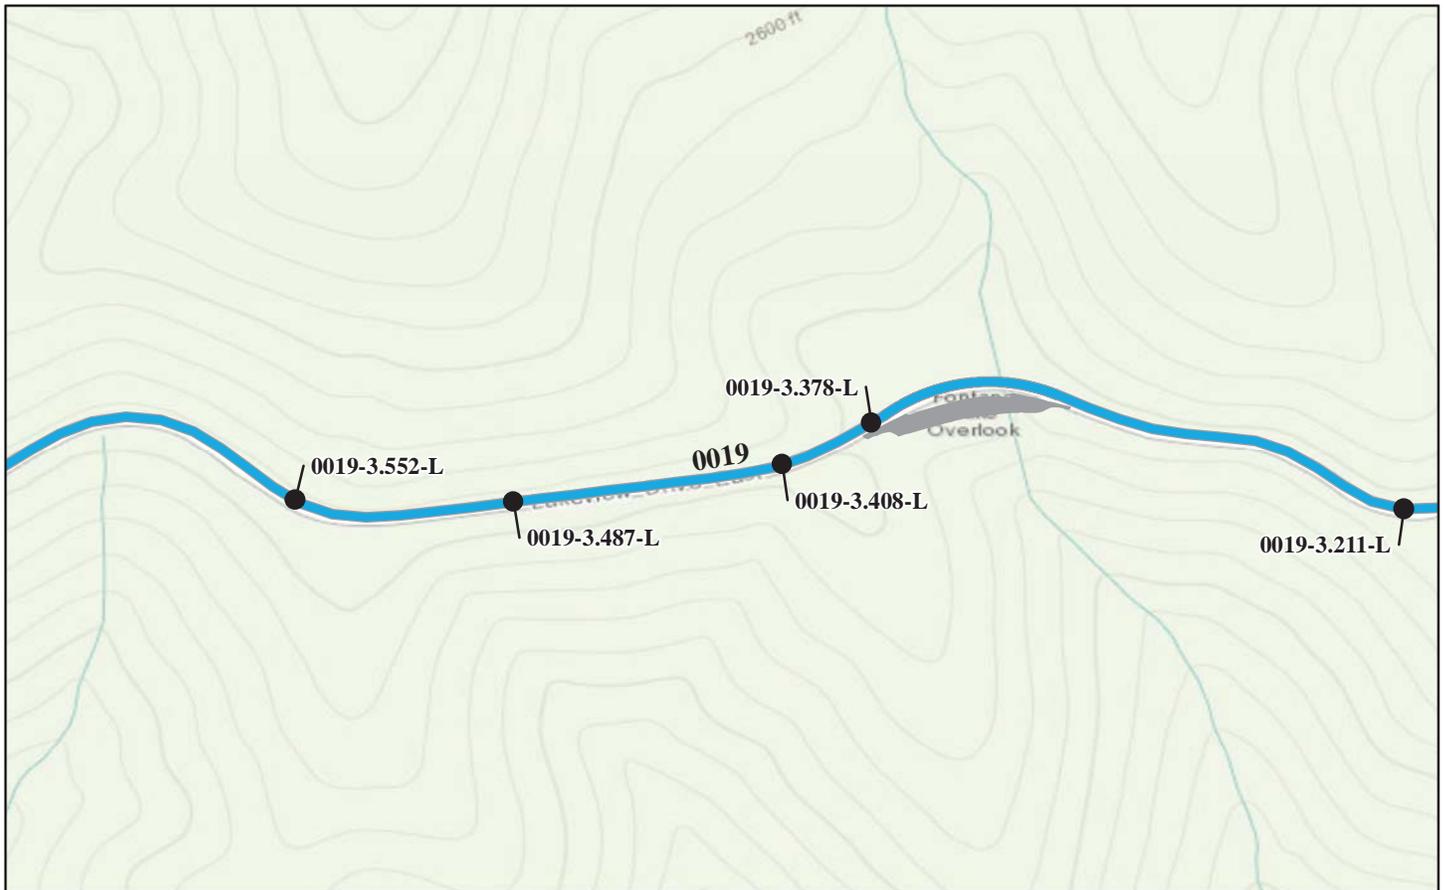
ROUTE 0019: LAKEVIEW DRIVE EAST

Barrier ID Inspection Date	Barrier Length (Ft.)	Barrier Type	Barrier End Treatment		*Repair Cost
			Begin	End	
GRSM-0019-3.211-L 9/16/2010	529	OTHER: TIMBER RAIL ON TIMBER POSTS	NONE	NONE	\$10,687.00
GRSM-0019-3.378-L 9/17/2010	33	OTHER: TIMBER RAIL ON TIMBER POSTS	NONE	NONE	\$1,843.00
GRSM-0019-3.408-L 9/17/2010	283	OTHER: TIMBER RAIL ON TIMBER POSTS	NONE	NONE	\$3,823.00
GRSM-0019-3.487-L 9/17/2010	160	OTHER: TIMBER RAIL ON TIMBER POSTS	NONE	NONE	\$3,383.00
GRSM-0019-3.552-L 9/17/2010	433	OTHER: TIMBER RAIL ON TIMBER POSTS	NONE	NONE	\$0.00

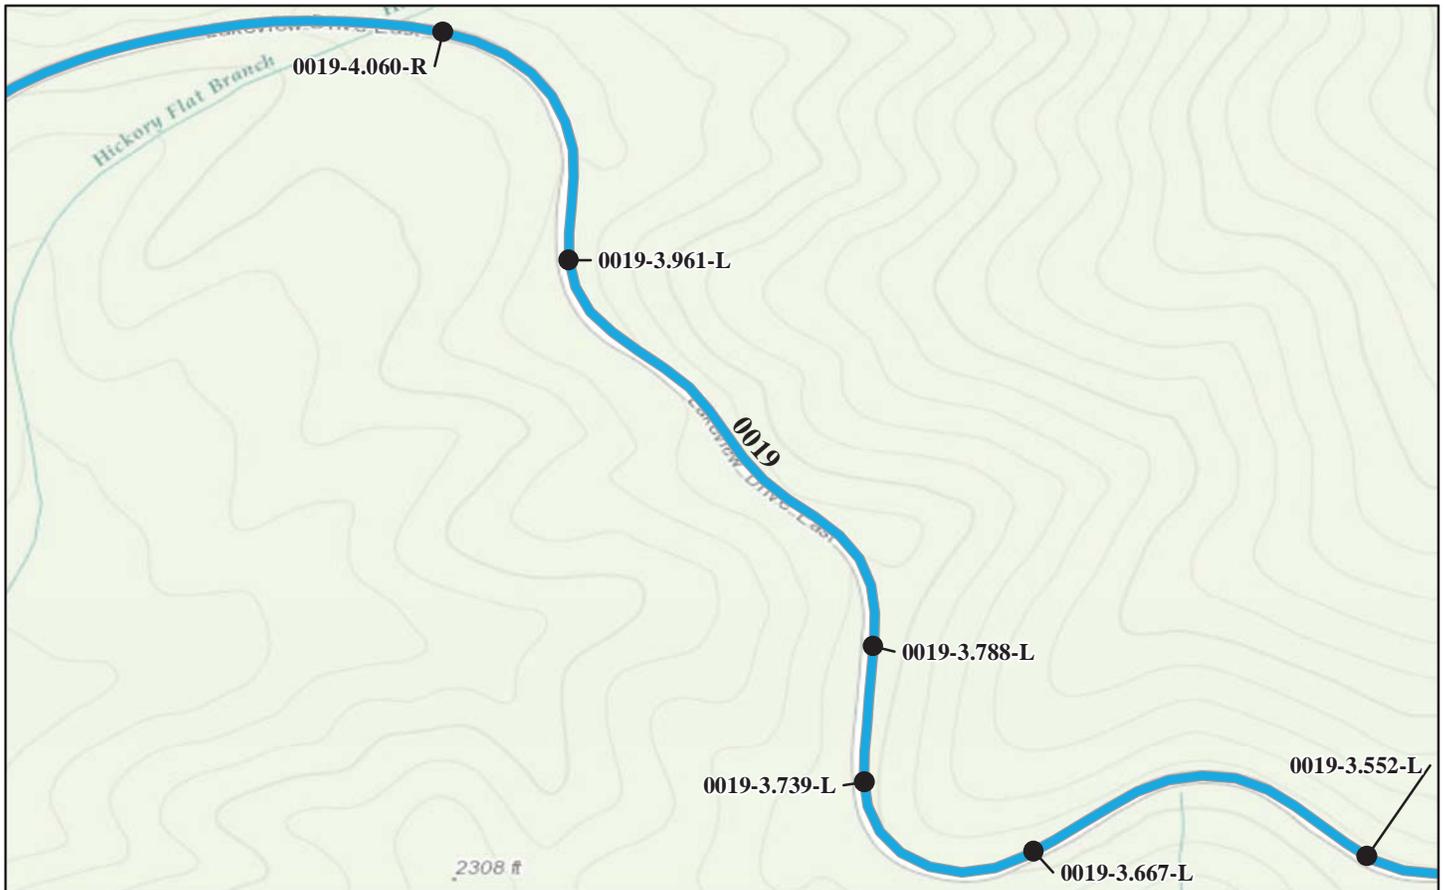
ROUTE 0019: LAKEVIEW DRIVE EAST

Barrier ID Inspection Date	Barrier Length (Ft.)	Barrier Type	Barrier End Treatment		*Repair Cost
			Begin	End	
GRSM-0019-3.667-L 9/17/2010	265	OTHER: TIMBER RAIL ON TIMBER POSTS	NONE	NONE	\$33,935.00
GRSM-0019-3.739-L 9/17/2010	110	OTHER: TIMBER RAIL ON TIMBER POSTS	NONE	NONE	\$18,755.00
GRSM-0019-3.788-L 9/17/2010	382	OTHER: TIMBER RAIL ON TIMBER POSTS	NONE	NONE	\$6,408.00
GRSM-0019-3.961-L 9/17/2010	1309	OTHER: TIMBER RAIL ON TIMBER POSTS	NONE	NONE	\$127,303.00
GRSM-0019-4.060-R 9/17/2010	62	OTHER: TIMBER RAIL ON TIMBER POSTS	NONE	NONE	\$2,118.00

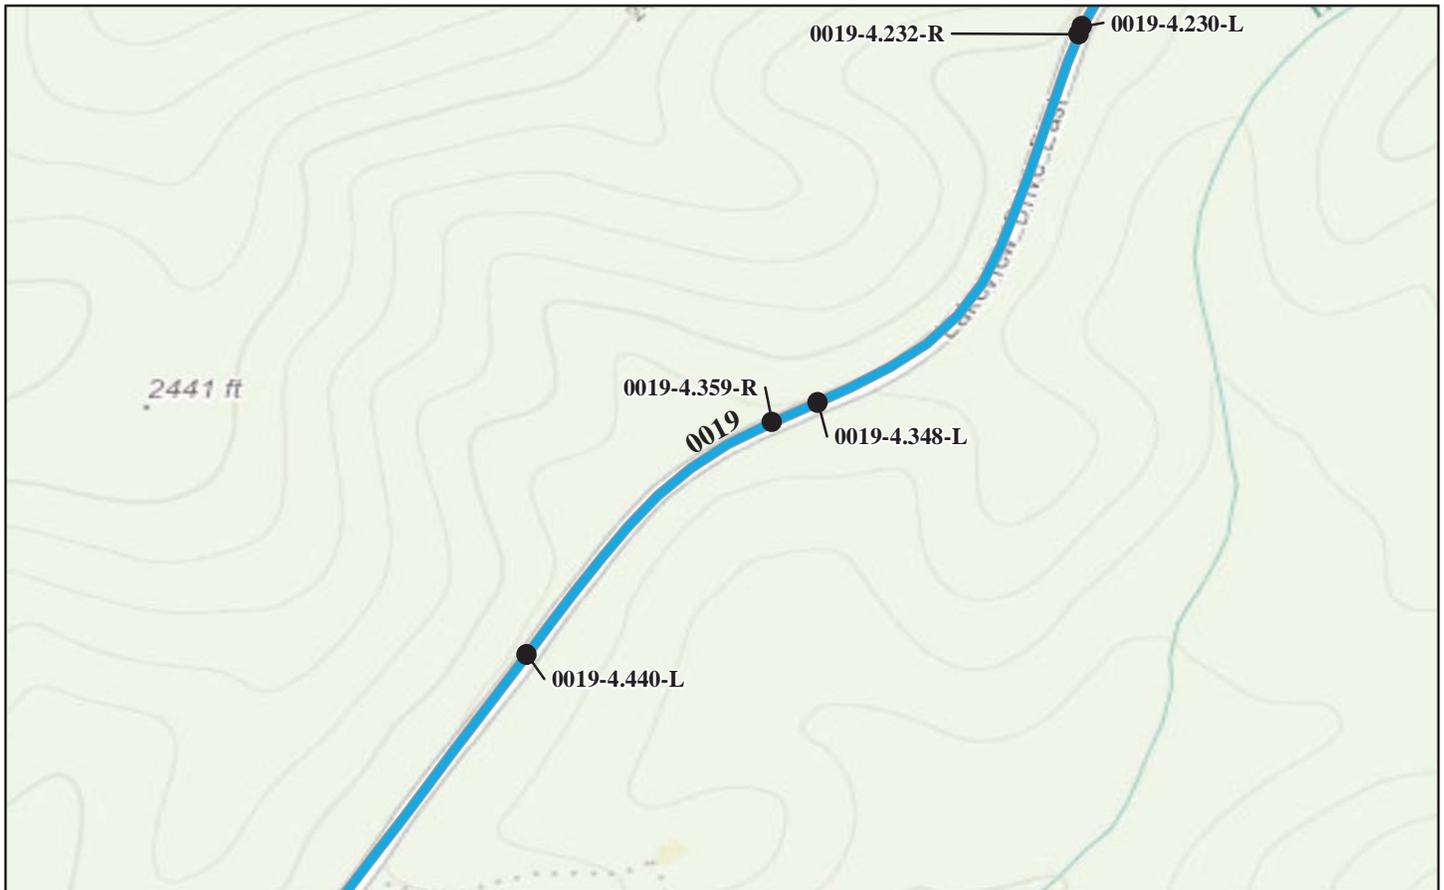
ROUTE 0019: LAKEVIEW DRIVE EAST

Barrier ID Inspection Date	Barrier Length (Ft.)	Barrier Type	Barrier End Treatment		*Repair Cost
			Begin	End	
GRSM-0019-4.230-L 9/17/2010	453	OTHER: TIMBER RAIL ON TIMBER POSTS	NONE	NONE	\$48,411.00
GRSM-0019-4.232-R 9/17/2010	190	OTHER: TIMBER RAIL ON TIMBER POSTS	NONE	NONE	\$4,373.00
GRSM-0019-4.348-L 9/17/2010	422	OTHER: TIMBER RAIL ON TIMBER POSTS	NONE	NONE	\$46,024.00
GRSM-0019-4.359-R 9/17/2010	299	OTHER: TIMBER RAIL ON TIMBER POSTS	NONE	NONE	\$36,553.00
GRSM-0019-4.440-L 9/17/2010	355	OTHER: TIMBER RAIL ON TIMBER POSTS	NONE	NONE	\$8,250.00

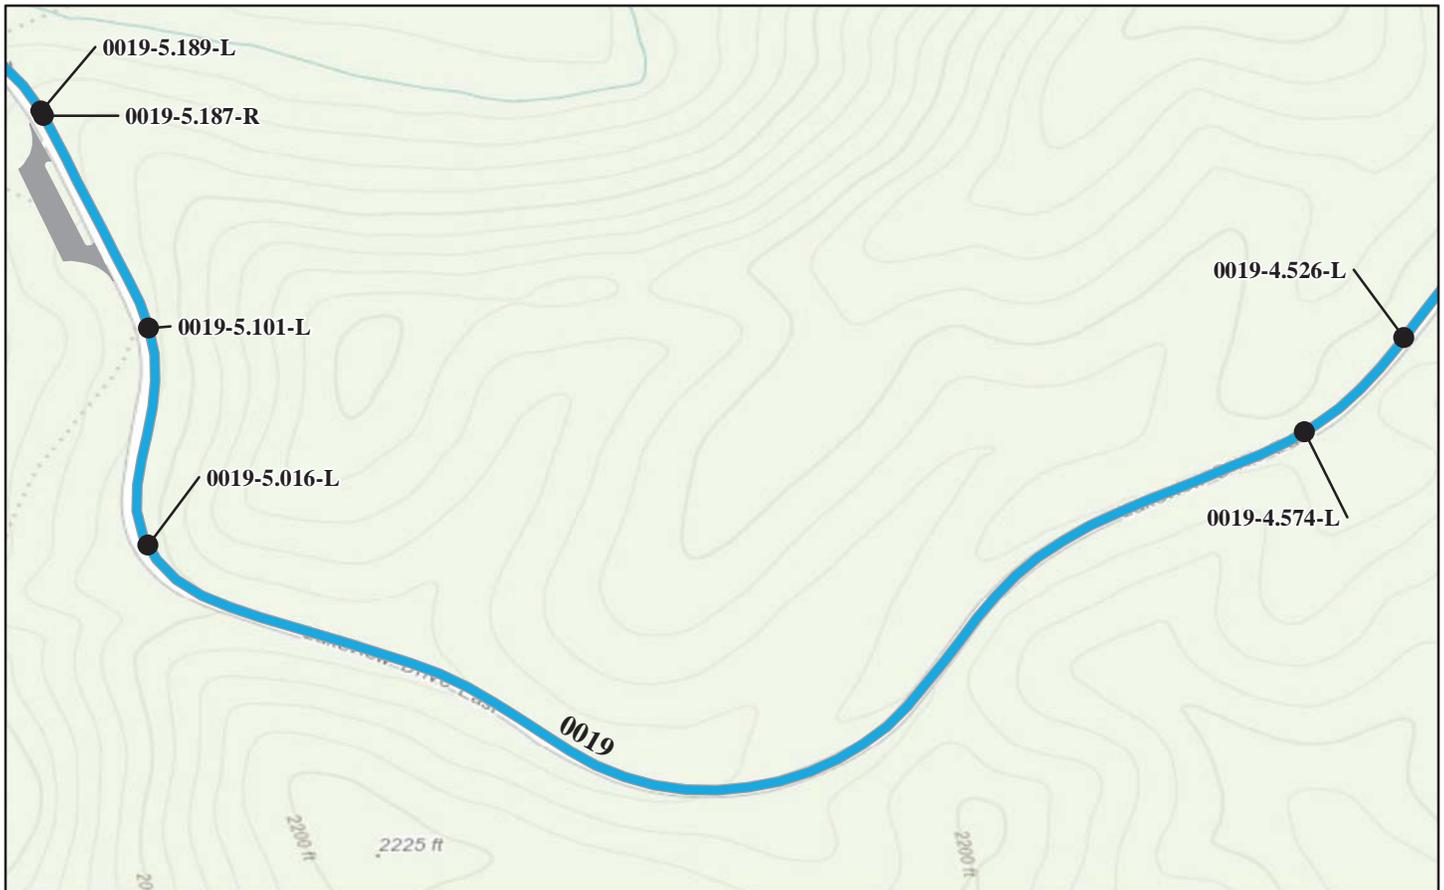
ROUTE 0019: LAKEVIEW DRIVE EAST

Barrier ID Inspection Date	Barrier Length (Ft.)	Barrier Type	Barrier End Treatment		*Repair Cost
			Begin	End	
GRSM-0019-4.526-L 9/17/2010	183	OTHER: TIMBER RAIL ON TIMBER POSTS	NONE	NONE	\$4,296.00
GRSM-0019-4.574-L 9/15/2010	745	OTHER: TIMBER RAIL ON TIMBER POSTS	NONE	NONE	\$74,140.00
GRSM-0019-5.016-L 9/15/2010	401	OTHER: TIMBER RAIL ON TIMBER POSTS	NONE	NONE	\$8,140.00
GRSM-0019-5.101-L 9/15/2010	125	OTHER: TIMBER RAIL ON TIMBER POSTS	NONE	NONE	\$3,658.00
GRSM-0019-5.187-R 9/15/2010	26	OTHER: TIMBER RAIL ON TIMBER POSTS	NONE	NONE	\$1,821.00

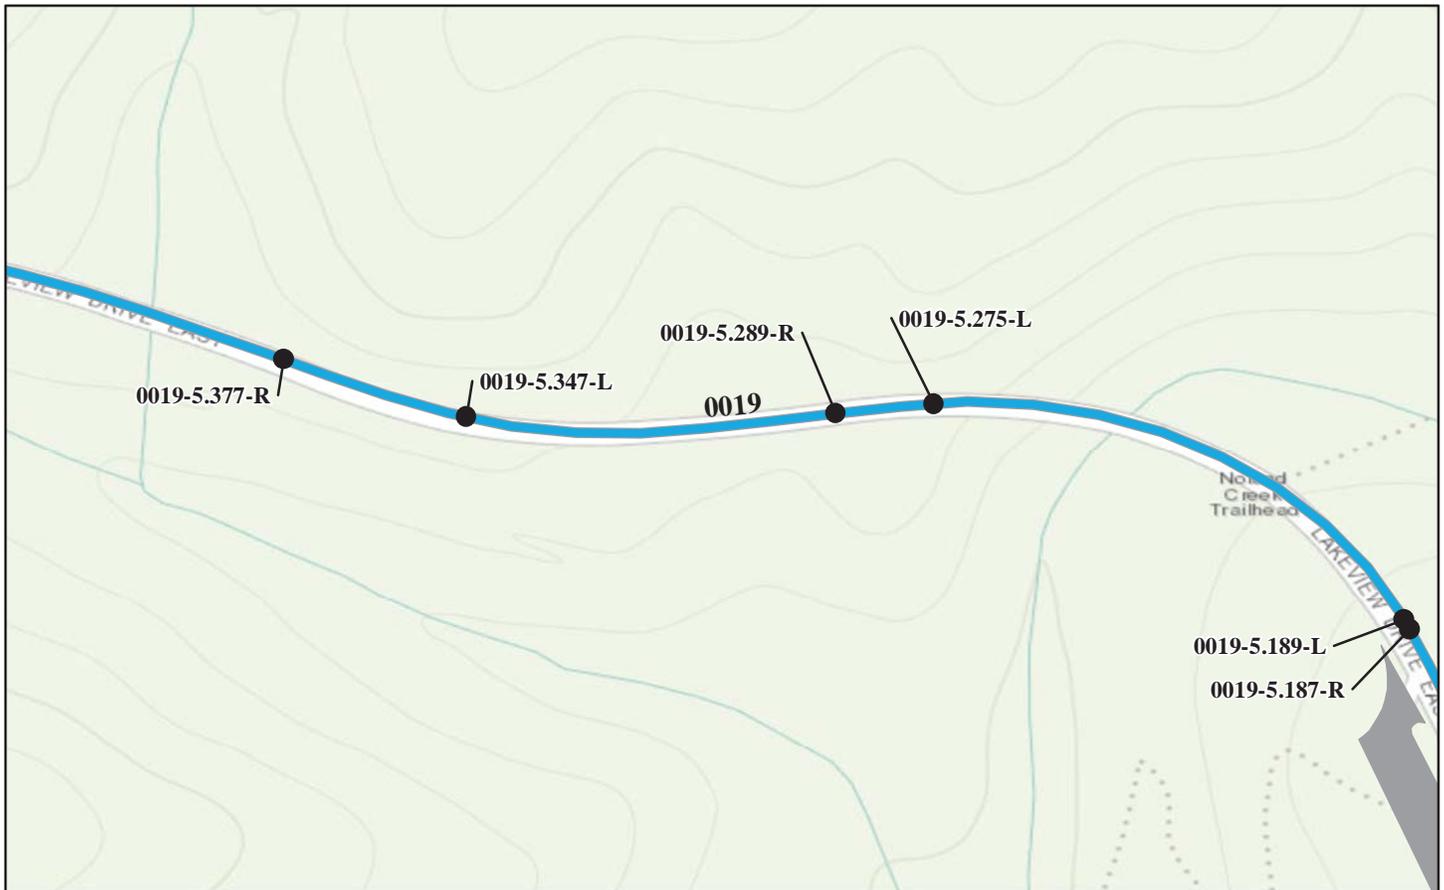
ROUTE 0019: LAKEVIEW DRIVE EAST

Barrier ID Inspection Date	Barrier Length (Ft.)	Barrier Type	Barrier End Treatment		*Repair Cost
			Begin	End	
GRSM-0019-5.189-L 9/15/2010	11	OTHER: TIMBER RAIL ON TIMBER POSTS	NONE	NONE	\$2,046.00
GRSM-0019-5.275-L 9/15/2010	273	OTHER: TIMBER RAIL ON TIMBER POSTS	NONE	NONE	\$34,551.00
GRSM-0019-5.289-R 9/15/2010	153	OTHER: TIMBER RAIL ON TIMBER POSTS	NONE	NONE	\$22,066.00
GRSM-0019-5.347-L 9/15/2010	965	OTHER: TIMBER RAIL ON TIMBER POSTS	NONE	NONE	\$13,778.00
GRSM-0019-5.377-R 9/15/2010	214	OTHER: TIMBER RAIL ON TIMBER POSTS	NONE	NONE	\$2,612.00

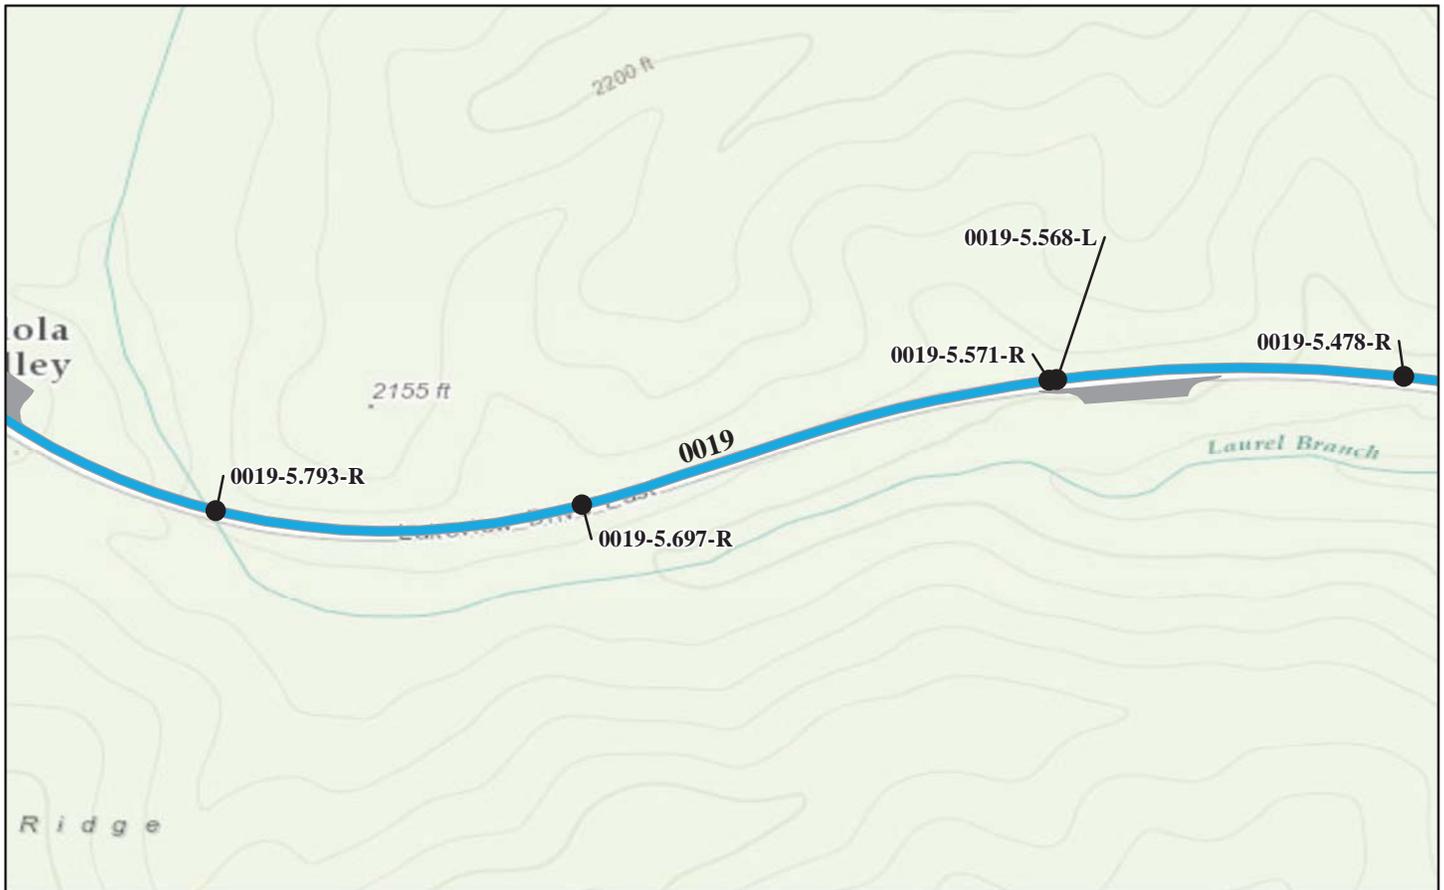
ROUTE 0019: LAKEVIEW DRIVE EAST

Barrier ID Inspection Date	Barrier Length (Ft.)	Barrier Type	Barrier End Treatment		*Repair Cost
			Begin	End	
GRSM-0019-5.478-R 9/15/2010	150	OTHER: TIMBER RAIL ON TIMBER POSTS	NONE	NONE	\$2,062.00
GRSM-0019-5.568-L 9/15/2010	1447	OTHER: TIMBER RAIL ON TIMBER POSTS	NONE	NONE	\$22,935.00
GRSM-0019-5.571-R 9/15/2010	190	OTHER: TIMBER RAIL ON TIMBER POSTS	NONE	OTHER: TIMBER BURIED	\$1,952.00
GRSM-0019-5.697-R 9/15/2010	134	OTHER: TIMBER RAIL ON TIMBER POSTS	NONE	NONE	\$2,833.00
GRSM-0019-5.793-R 9/15/2010	266	OTHER: TIMBER RAIL ON TIMBER POSTS	NONE	NONE	\$1,732.00

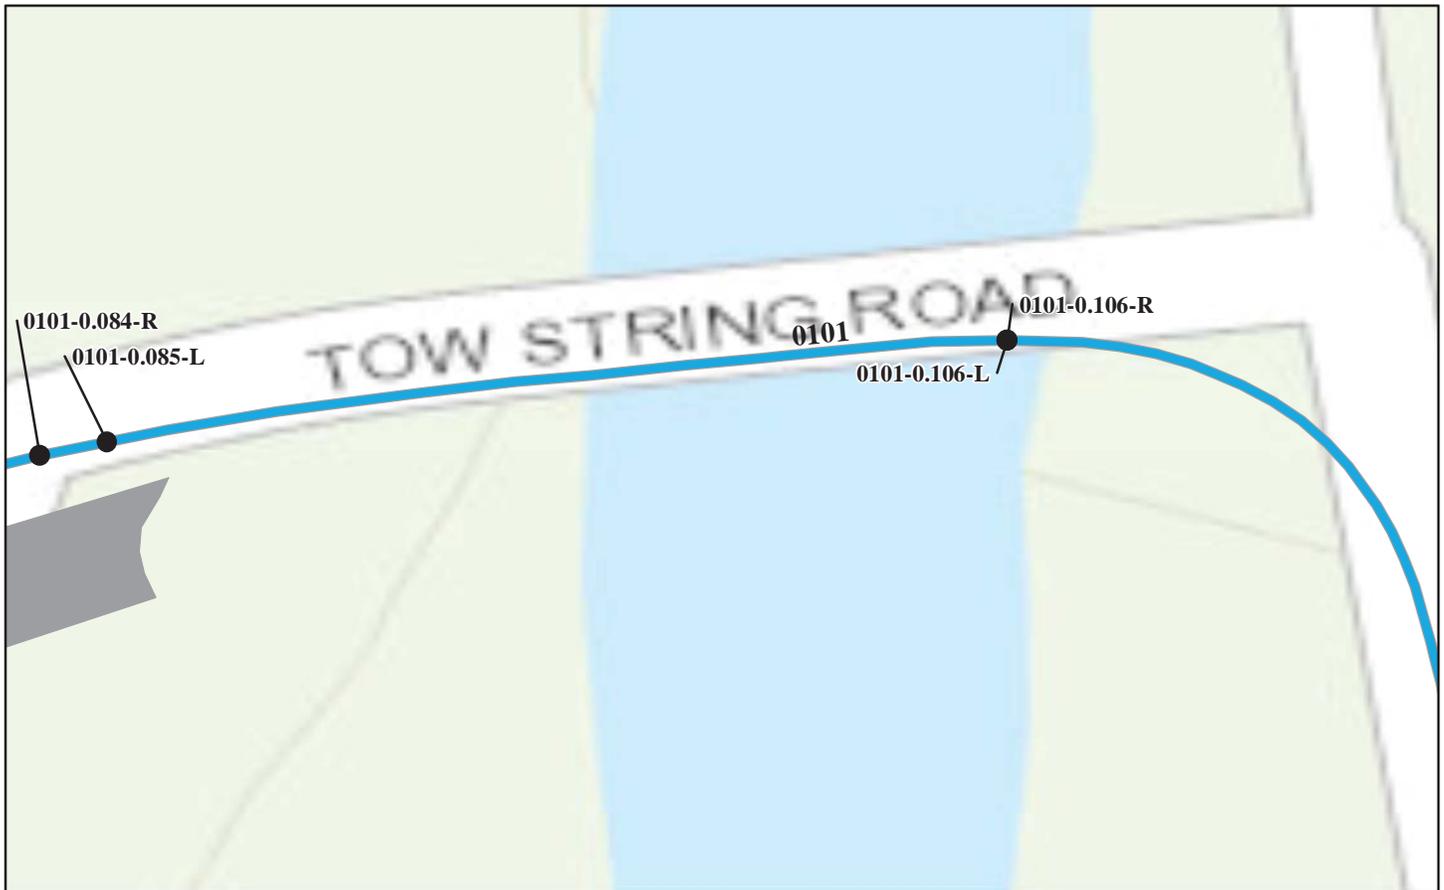
ROUTE 0101: TOW STRING ROAD

Barrier ID Inspection Date	Barrier Length (Ft.)	Barrier Type	Barrier End Treatment		*Repair Cost
			Begin	End	
GRSM-0101-0.084-R 9/23/2010	40	STEEL-BACKED TIMBER WITHOUT BLOCKOUT	SBT/LOG FLARED	NONE	\$3,724.00
GRSM-0101-0.085-L 9/23/2010	40	STEEL-BACKED TIMBER WITHOUT BLOCKOUT	SBT/LOG FLARED	NONE	\$1,397.00
GRSM-0101-0.106-L 9/23/2010	42	STEEL-BACKED TIMBER WITHOUT BLOCKOUT	NONE	SBT/LOG FLARED	\$0.00
GRSM-0101-0.106-R 9/23/2010	54	STEEL-BACKED TIMBER WITHOUT BLOCKOUT	NONE	SBT/LOG FLARED	\$0.00

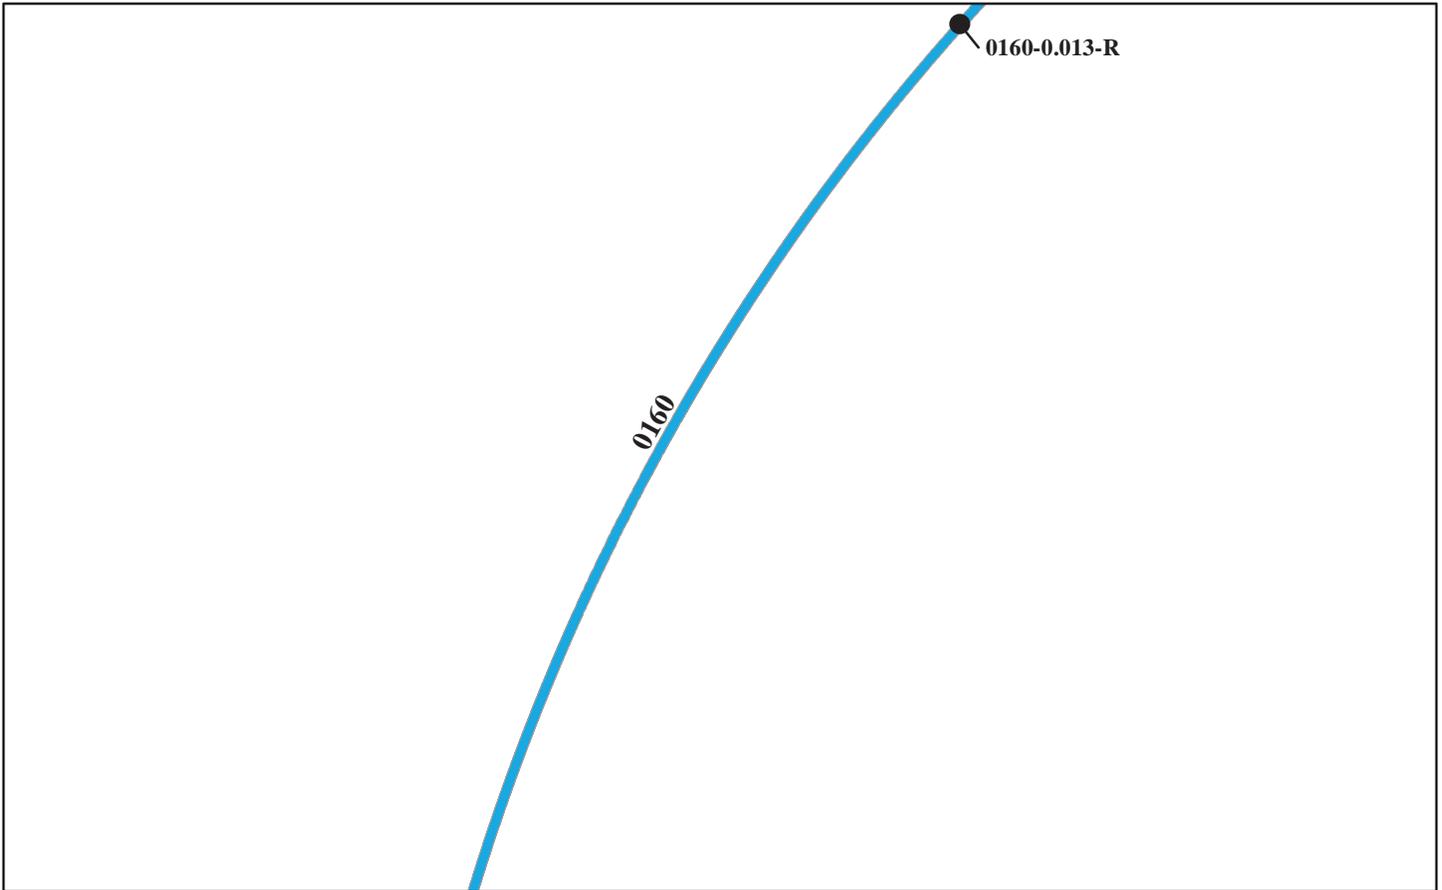
ROUTE 0160: HUSKEY GROVE ROAD

Barrier ID Inspection Date	Barrier Length (Ft.)	Barrier Type	Barrier End Treatment		*Repair Cost
			Begin	End	
GRSM-0160-0.013-R 9/10/2010	102	STEEL-BACKED TIMBER WITH BLOCKOUT	NONE	SBT/LOG FLARED	\$2,392.00

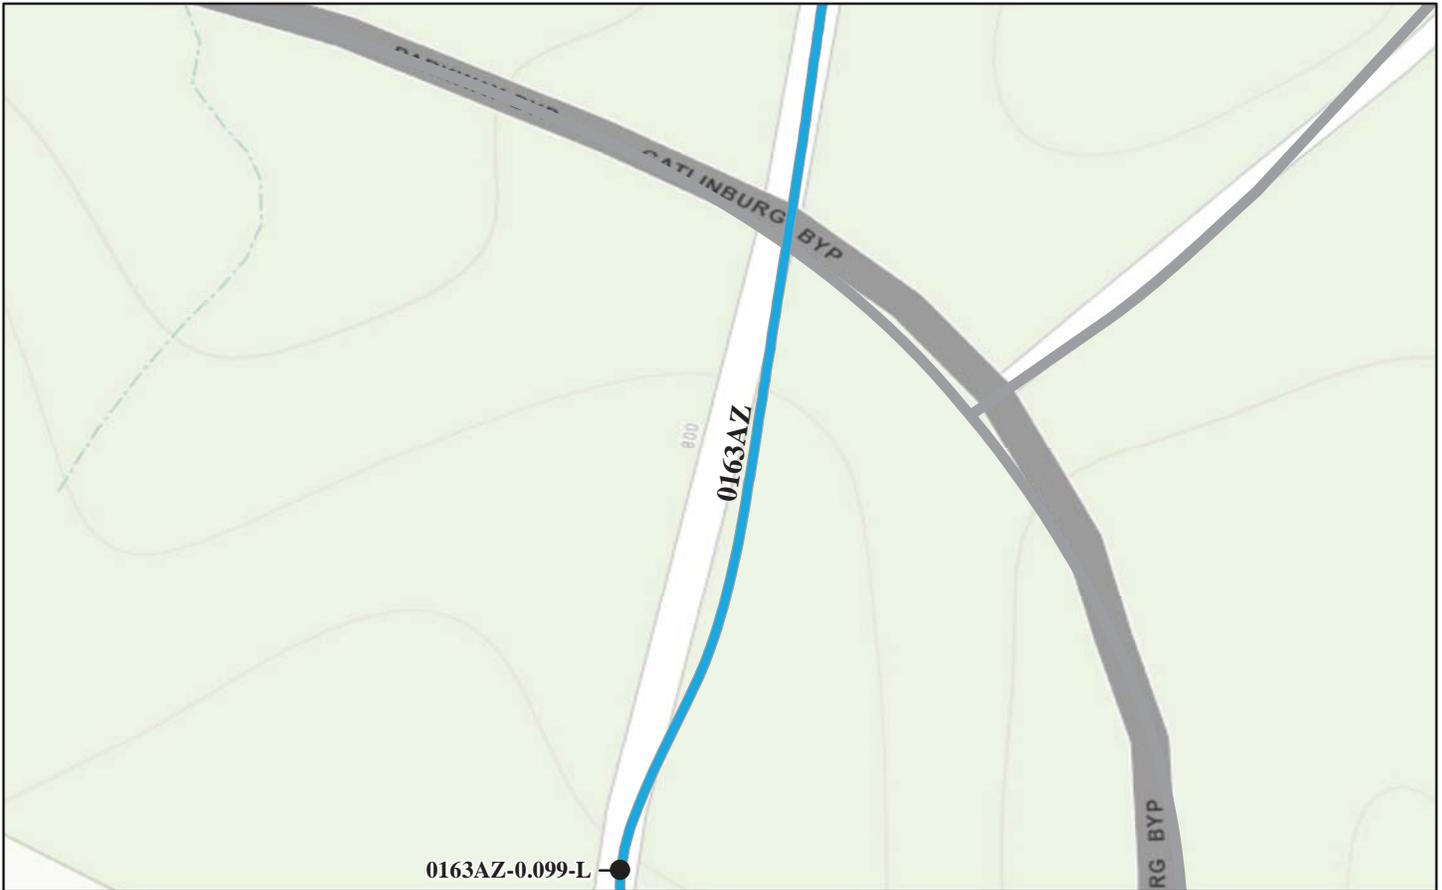
ROUTE 0163AZ: CAMPBELL LEAD ROAD

Barrier ID Inspection Date	Barrier Length (Ft.)	Barrier Type	Barrier End Treatment		*Repair Cost
			Begin	End	
GRSM-0163AZ-0.099-L 9/11/2010	430	W-BEAM STRONG POST	NONE	NONE	\$0.00

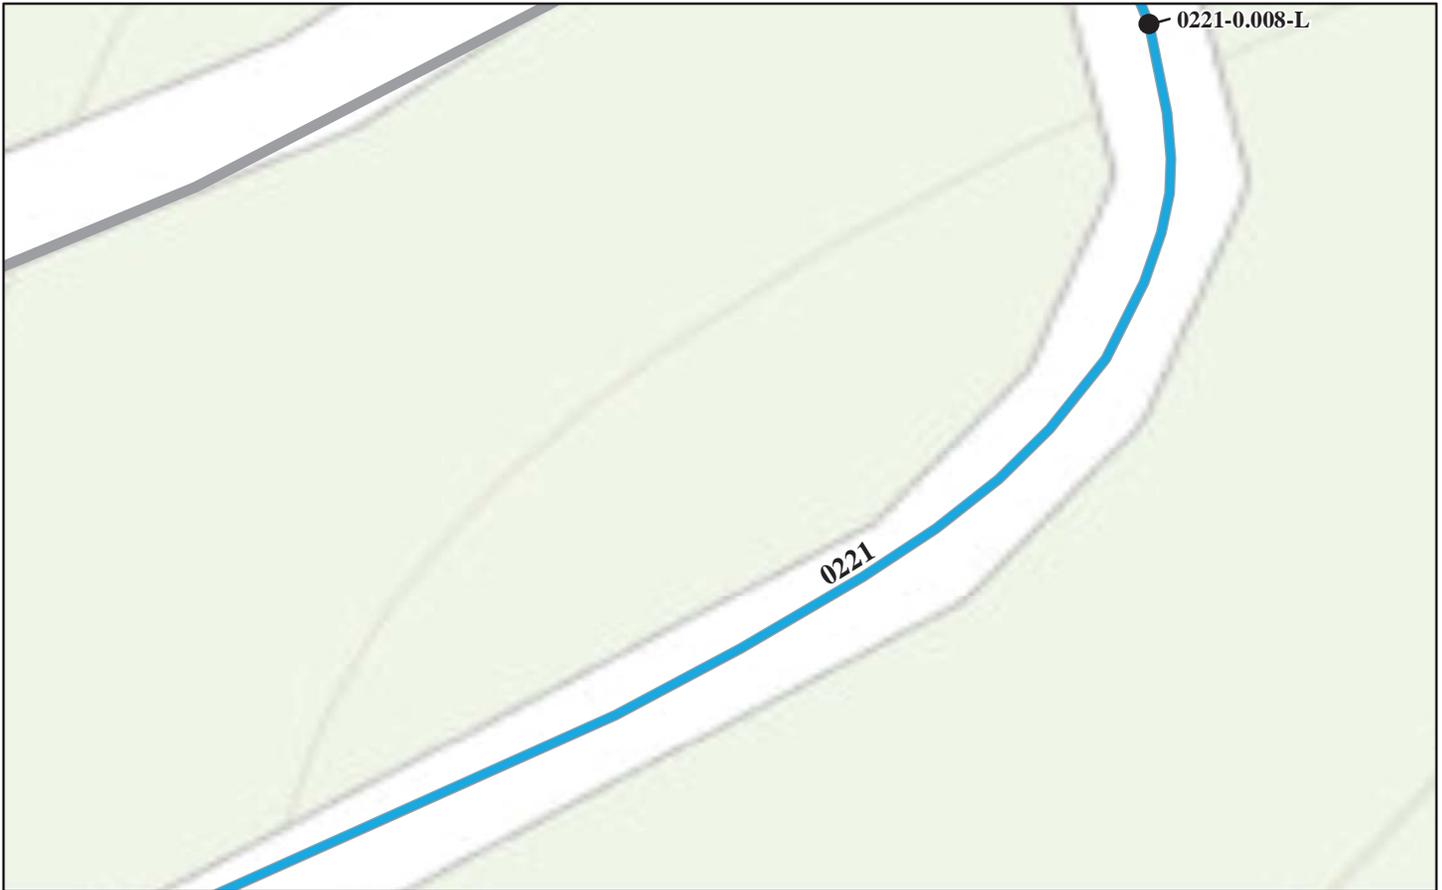
ROUTE 0221: LOOK ROCK MAINTENANCE ACCESS

Barrier ID Inspection Date	Barrier Length (Ft.)	Barrier Type	Barrier End Treatment		*Repair Cost
			Begin	End	
GRSM-0221-0.008-L 9/24/2010	185	STEEL-BACKED TIMBER WITHOUT BLOCKOUT	SBT/LOG FLARED	SBT/LOG FLARED	\$0.00

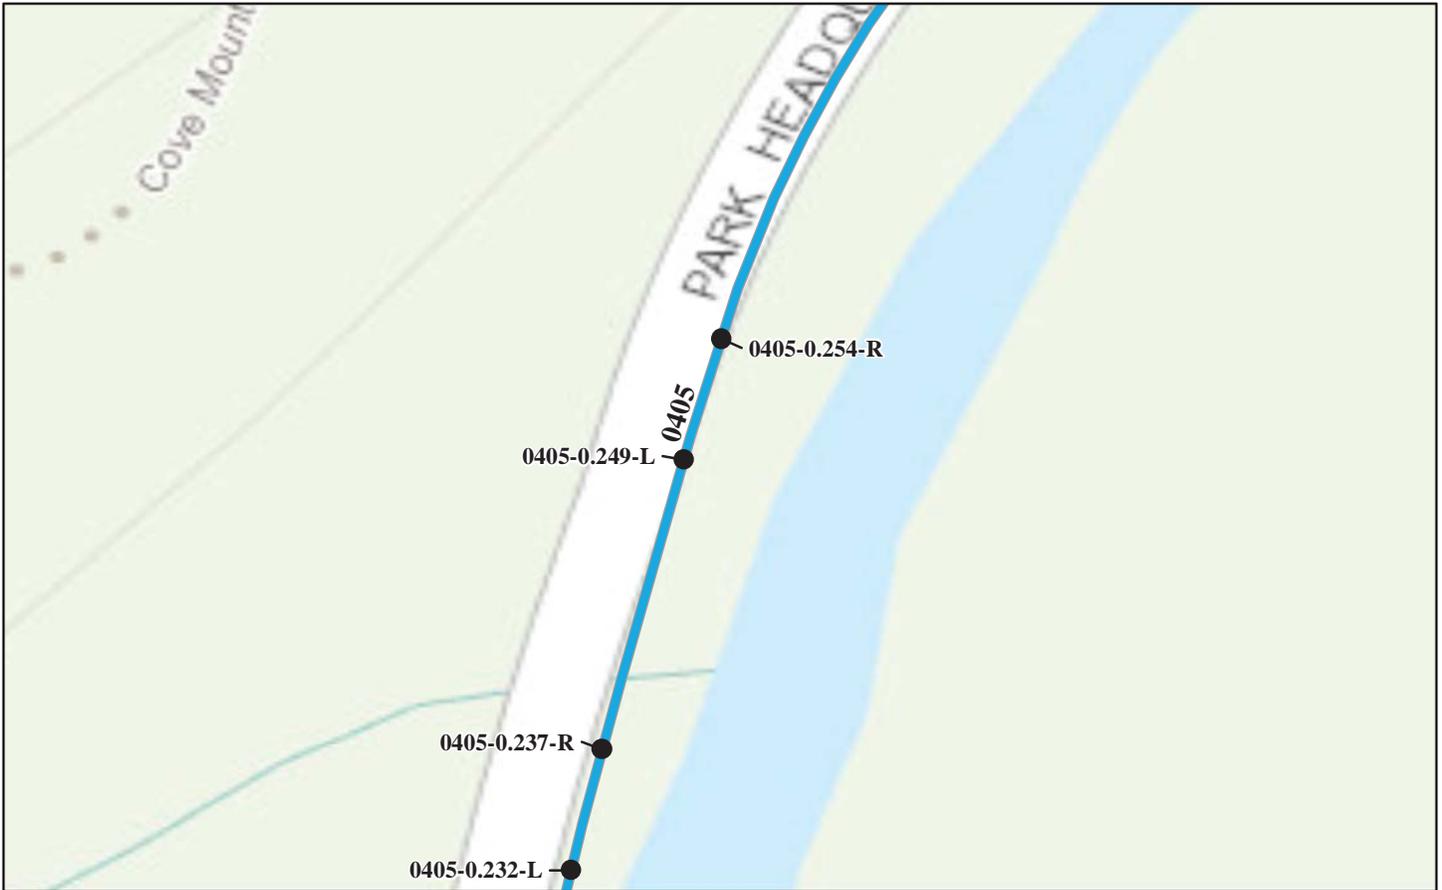
ROUTE 0405: SUGARLANDS HEADQUARTERS ROAD

Barrier ID Inspection Date	Barrier Length (Ft.)	Barrier Type	Barrier End Treatment		*Repair Cost
			Begin	End	
GRSM-0405-0.232-L 9/11/2010	28	STONE MASONRY WITHOUT CONCRETE CORE WALL	NONE	NONE	\$0.00
GRSM-0405-0.237-R 9/11/2010	26	STONE MASONRY WITHOUT CONCRETE CORE WALL	NONE	NONE	\$0.00
GRSM-0405-0.249-L 9/11/2010	32	STONE MASONRY WITHOUT CONCRETE CORE WALL	NONE	NONE	\$0.00
GRSM-0405-0.254-R 9/11/2010	72	STONE MASONRY WITHOUT CONCRETE CORE WALL	NONE	NONE	\$0.00

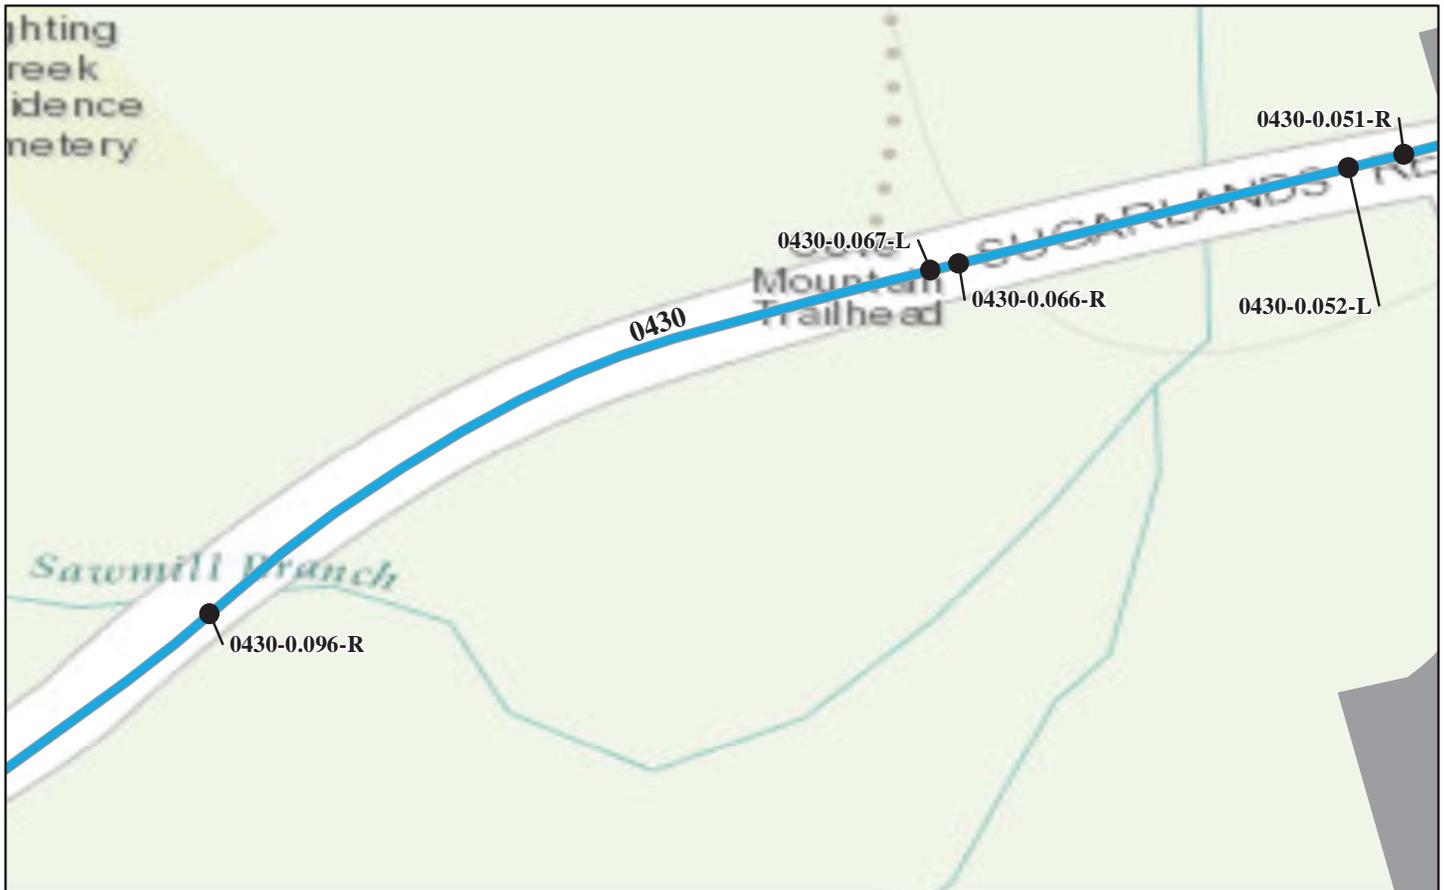
ROUTE 0430: SUGARLANDS RESIDENCE ROAD

Barrier ID Inspection Date	Barrier Length (Ft.)	Barrier Type	Barrier End Treatment		*Repair Cost
			Begin	End	
GRSM-0430-0.051-R 9/11/2010	27	STONE MASONRY WITHOUT CONCRETE CORE WALL	NONE	NONE	\$4,394.00
GRSM-0430-0.052-L 9/11/2010	27	STONE MASONRY WITHOUT CONCRETE CORE WALL	NONE	NONE	\$4,394.00
GRSM-0430-0.066-R 9/11/2010	40	STONE MASONRY WITHOUT CONCRETE CORE WALL	NONE	NONE	\$5,627.00
GRSM-0430-0.067-L 9/11/2010	160	STONE MASONRY WITHOUT CONCRETE CORE WALL	NONE	NONE	\$18,645.00
GRSM-0430-0.096-R 9/11/2010	46	STONE MASONRY WITHOUT CONCRETE CORE WALL	NONE	NONE	\$7,865.00

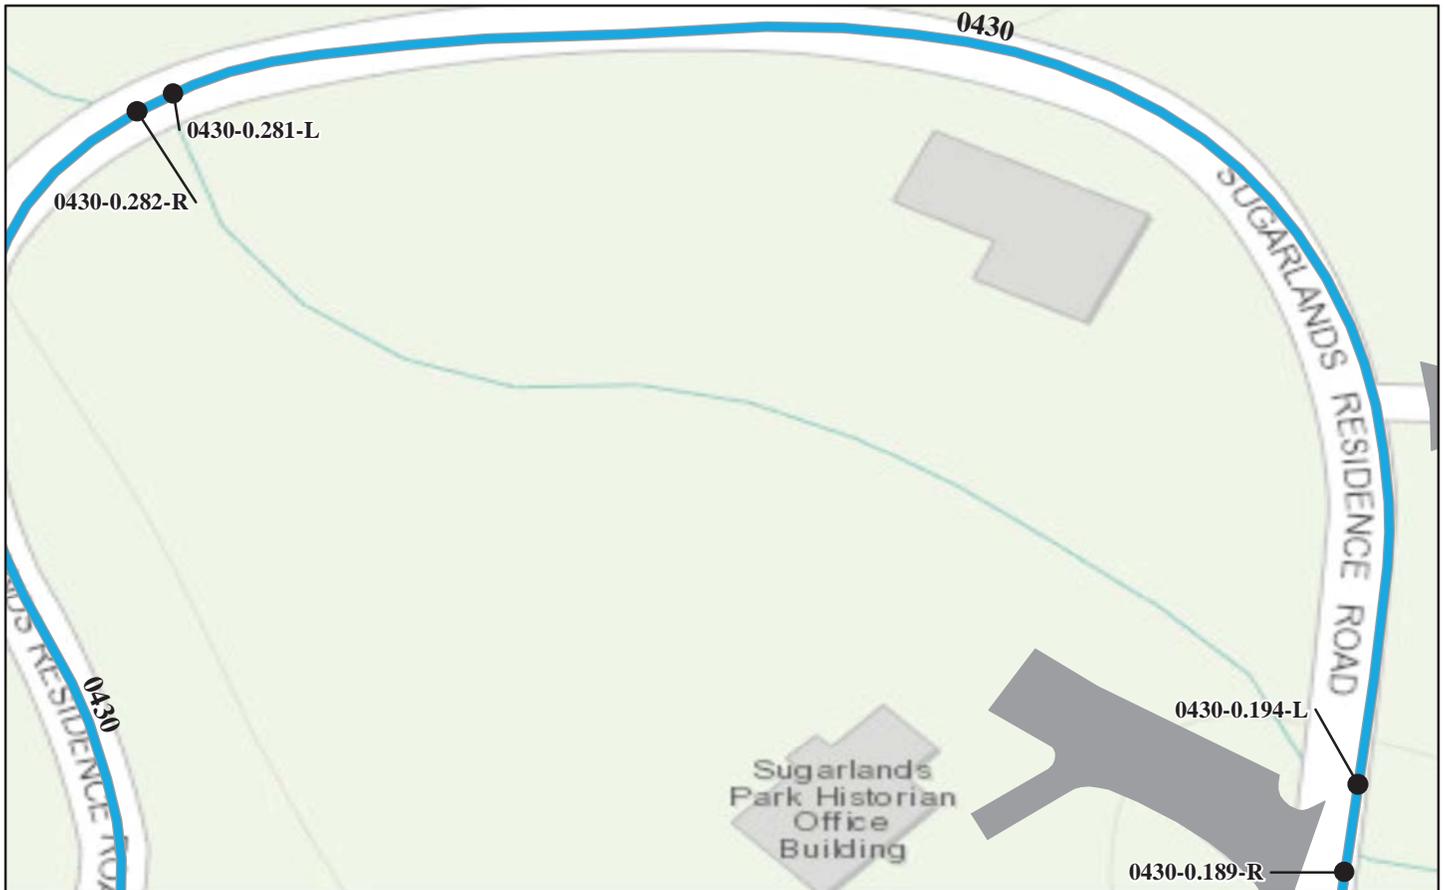
ROUTE 0430: SUGARLANDS RESIDENCE ROAD

Barrier ID Inspection Date	Barrier Length (Ft.)	Barrier Type	Barrier End Treatment		*Repair Cost
			Begin	End	
GRSM-0430-0.189-R 9/11/2010	60	STONE MASONRY WITHOUT CONCRETE CORE WALL	NONE	NONE	\$10,412.00
GRSM-0430-0.194-L 9/11/2010	52	STONE MASONRY WITHOUT CONCRETE CORE WALL	NONE	NONE	\$8,019.00
GRSM-0430-0.281-L 9/11/2010	30	STONE MASONRY WITHOUT CONCRETE CORE WALL	NONE	NONE	\$5,165.00
GRSM-0430-0.282-R 9/11/2010	35	STONE MASONRY WITHOUT CONCRETE CORE WALL	NONE	NONE	\$5,473.00

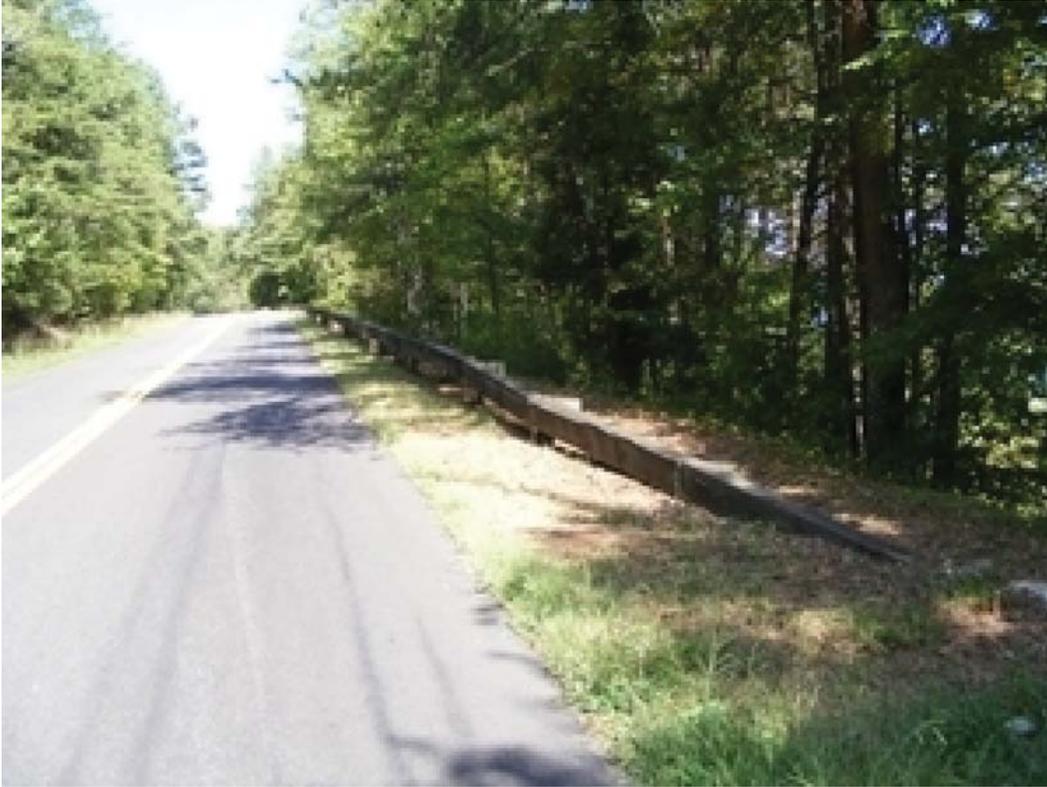
GRSM_0008G_58.311_L_1.JPG

Barrier ID:	GRSM-0008G-58.311-L				
Route Name:	FOOTHILLS PARKWAY SECTION 8G				
Inspection Date:	09/24/2010	Barrier Rating:	35.50		
Barrier Description					
Type:	STEEL-BACKED TIMBER WITHOUT BLOCKOUT	Barrier Function:	TRAFFIC		
Barrier Material:	STEEL-BACKED TIMBER/LOG	Post Material:	WOOD		
Blockout Type:	N/A	Length (ft.):	581		
Speed Limit (MPH):	45	Placement with Respect to Road:	OUTSIDE OF CURVE		
Hazard Behind Barrier:	HIGH				
Barrier Crashworthiness					
Appropriate Test Level:	TL-2	Barrier Test Level:	TL-2	Is Barrier Crashworthy?:	YES
Beg. End Trtmt Type:	SBT/LOG FLARED	Is Beg. End Trtmt Crashworthy?:	NO	Approach Transition Type:	NONE
Ending End Trtmt Type:	SBT/LOG FLARED	Ending End Trtmt Crashworthy?:	NO		
Average Measurements					
Design Height (In.):	27	Width (In.):	0.0	Post Spacing (In.):	120.0
Height (In.):	26.2	Lateral Offset (In.):	49.2	Road Grade (%):	3.50
Physical Condition					
Barrier	Alignment and Height:	The alignment has no deviation and the height is 1 to 2 in below the design height of 27 in for 80 ft.

Breaking and Cracking:	No breaking or cracking observed.			
	Missing Elements:	No missing elements observed.			
	Corrosion and Weathering:	No corrosion or weathering observed.			
End Treatments	Alignment and Height:	Alignment acceptable. Height is within 1 in of the 27-in design height.			
	Breaking and Cracking:	No breaking or cracking observed.			
	Missing Elements:	No missing elements observed.			
	Corrosion and Weathering:	No corrosion or weathering observed.

Repair Action:	REPAIR	FMSS Work Type:	DEFERRED MAINTENANCE	Repair Cost:	\$2503
Brief Workorder:	Raise 80-ft of barrier up to 27-in design height.				
Workorder:	Adjust Guardrail at \$10- per -Lin. Ft. for 80 LF = \$800. Raise 80-ft of barrier up to 27-in design height. Low Speed Traffic Control at \$1475- per -Day for 1 Day(s) = \$1475.
