NPS Guardwall/Rail Inventory Program
Great Smoky Mountains National Park

Federal Highway Administration
Eastern Federal Lands Highway Division
Road Inventory Program (RIP)

Data Collection Date: September 2010
Report Date: December 2015

Great Smoky Mountains National Park in North Carolina and Tennessee

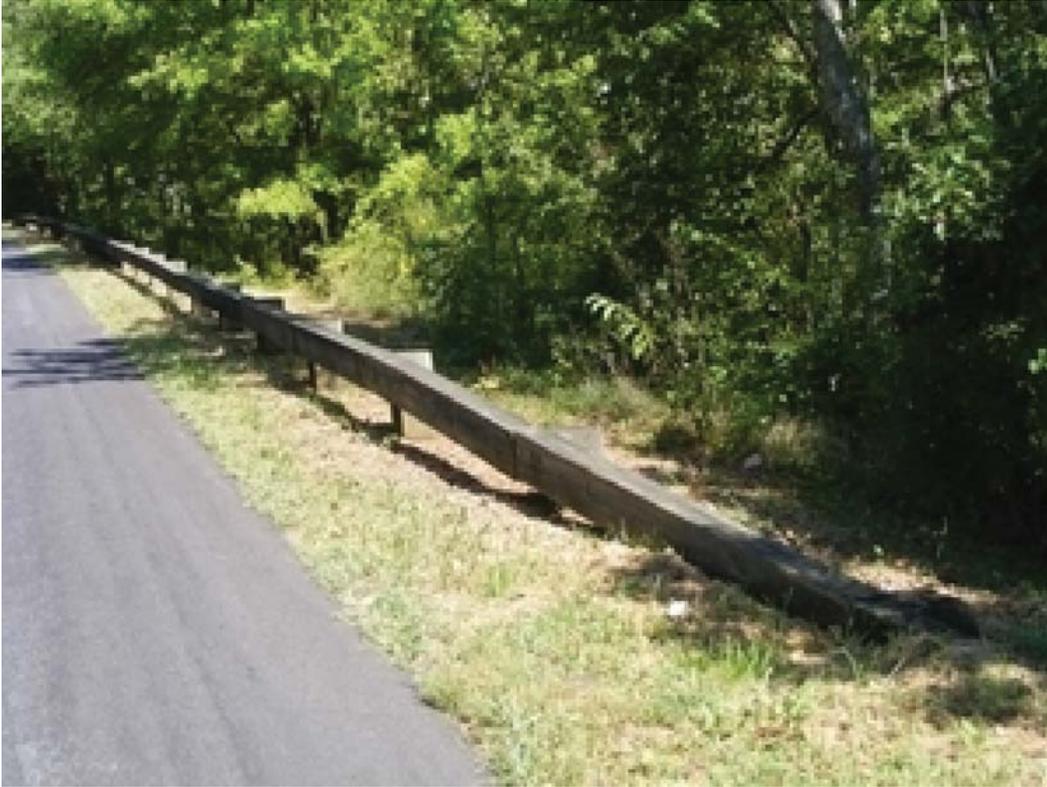
GRSM_0008G_58.541_L_1.JPG

Barrier ID:	GRSM-0008G-58.541-L				
Route Name:	FOOTHILLS PARKWAY SECTION 8G				
Inspection Date:	09/24/2010		Barrier Rating:	41.00	
Barrier Description					
Type:	STEEL-BACKED TIMBER WITHOUT BLOCKOUT		Barrier Function:	TRAFFIC	
Barrier Material:	STEEL-BACKED TIMBER/LOG		Post Material:	WOOD	
Blockout Type:	N/A		Length (ft.):	310	
Speed Limit (MPH):	45		Placement with Respect to Road:	OUTSIDE OF CURVE	
Hazard Behind Barrier:	MEDIUM				
Barrier Crashworthiness					
Appropriate Test Level:	TL-2	Barrier Test Level:	TL-2	Is Barrier Crashworthy?:	YES
Beg. End Trtmt Type:	SBT/LOG FLARED	Is Beg. End Trtmt Crashworthy?:	NO	Approach Transition Type:	NONE
Ending End Trtmt Type:	SBT/LOG FLARED	Ending End Trtmt Crashworthy?:	NO		
Average Measurements					
Design Height (In.):	27	Width (In.):	0.0	Post Spacing (In.):	120.0
Height (In.):	24.2	Lateral Offset (In.):	47.5	Road Grade (%):	5.30
Physical Condition					
Barrier	Alignment and Height:	The alignment has no deviation and the height is 1 to 3 in below the design height of 27 in for 310 ft.

Breaking and Cracking:	No breaking or cracking observed.			
	Missing Elements:	No missing elements observed.			
	Corrosion and Weathering:	No corrosion or weathering observed.			
End Treatments	Alignment and Height:	Alignment acceptable. Height is within 1 in of the 27-in design height.			
	Breaking and Cracking:	No breaking or cracking observed.			
	Missing Elements:	No missing elements observed.			
	Corrosion and Weathering:	No corrosion or weathering observed.

Repair Action:	REPAIR	FMSS Work Type:	DEFERRED MAINTENANCE	Repair Cost:	\$6655
Brief Workorder:	Raise 310-ft of barrier up to 27-in design height.				
Workorder:	Adjust Guardrail at \$10- per -Lin. Ft. for 310 LF = \$3100. Raise 310-ft of barrier up to 27-in design height. Low Speed Traffic Control at \$1475- per -Day for 2 Day(s) = \$2950.

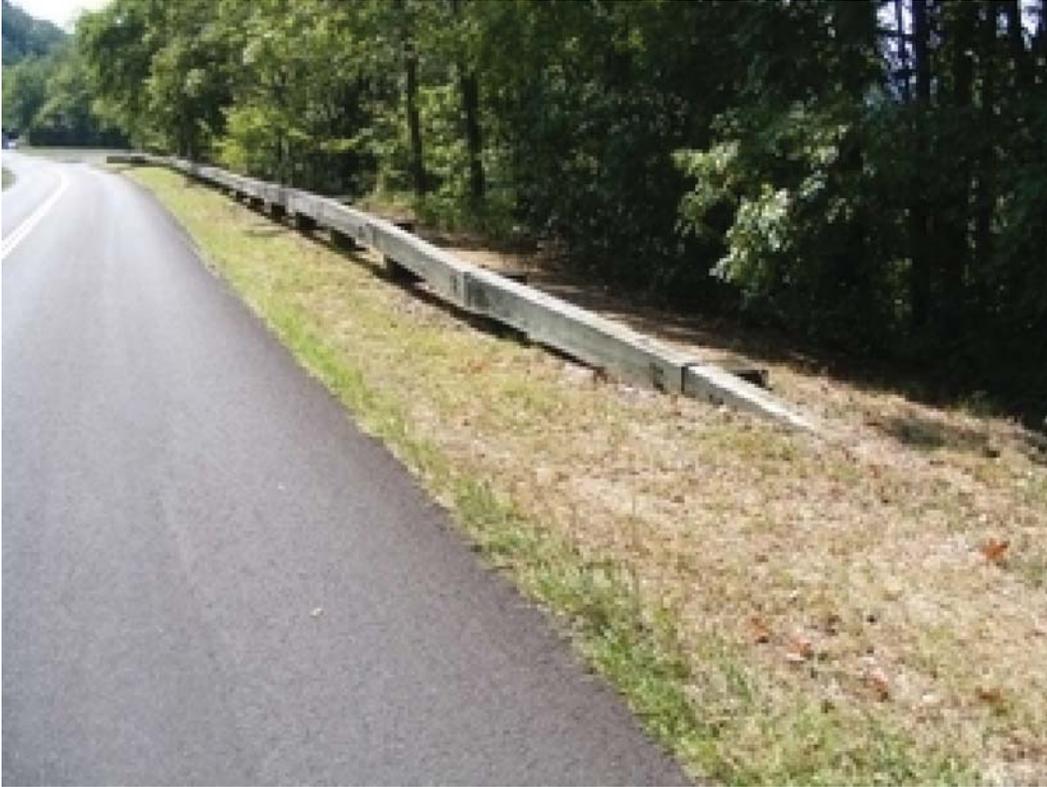
GRSM_0008G_58.588_R_1.JPG

Barrier ID:	GRSM-0008G-58.588-R				
Route Name:	FOOTHILLS PARKWAY SECTION 8G				
Inspection Date:	09/24/2010	Barrier Rating:	42.50		
Barrier Description					
Type:	STEEL-BACKED TIMBER WITHOUT BLOCKOUT	Barrier Function:	TRAFFIC		
Barrier Material:	STEEL-BACKED TIMBER/LOG	Post Material:	WOOD		
Blockout Type:	N/A	Length (ft.):	344		
Speed Limit (MPH):	45	Placement with Respect to Road:	OUTSIDE OF CURVE		
Hazard Behind Barrier:	MEDIUM				
Barrier Crashworthiness					
Appropriate Test Level:	TL-2	Barrier Test Level:	TL-2	Is Barrier Crashworthy?:	YES
Beg. End Trtmt Type:	SBT/LOG FLARED	Is Beg. End Trtmt Crashworthy?:	NO	Approach Transition Type:	NONE
Ending End Trtmt Type:	SBT/LOG FLARED	Ending End Trtmt Crashworthy?:	NO		
Average Measurements					
Design Height (In.):	27	Width (In.):	0.0	Post Spacing (In.):	120.0
Height (In.):	24.0	Lateral Offset (In.):	55.2	Road Grade (%):	5.10
Physical Condition					
Barrier	Alignment and Height:	The alignment has no deviation and the height is 1 to 3 in below the design height of 27 in for 344 ft.

Breaking and Cracking:	No breaking or cracking observed.			
	Missing Elements:	No missing elements observed.			
	Corrosion and Weathering:	No corrosion or weathering observed.			
End Treatments	Alignment and Height:	Alignment acceptable. Height is within 1 in of the 27-in design height.			
	Breaking and Cracking:	No breaking or cracking observed.			
	Missing Elements:	No missing elements observed.			
	Corrosion and Weathering:	No corrosion or weathering observed.

Repair Action:	REPAIR	FMSS Work Type:	DEFERRED MAINTENANCE	Repair Cost:	\$7029
Brief Workorder:	Raise 344 feet of barrier up to 27-in design height.				
Workorder:	Adjust Guardrail at \$10- per -Lin. Ft. for 344 LF = \$3440. Raise 344-ft of barrier up to 27-in design height. Low Speed Traffic Control at \$1475- per -Day for 2 Day(s) = \$2950.

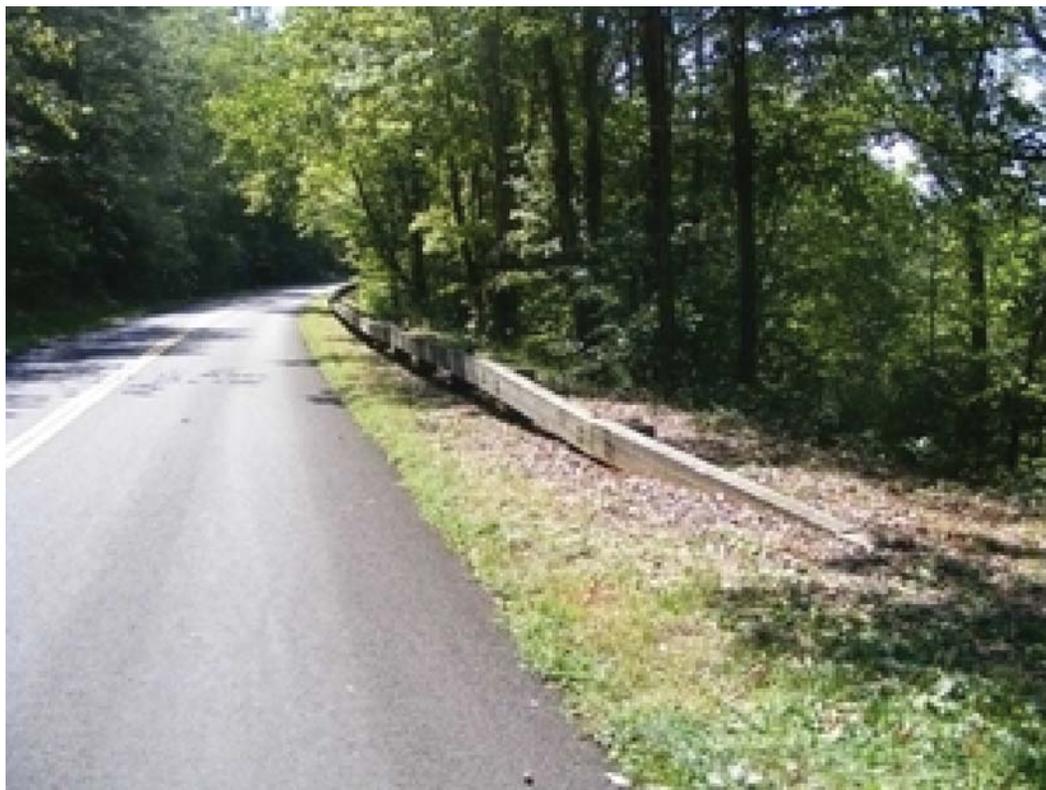
GRSM_0008G_58.737_R_1.JPG

Barrier ID:	GRSM-0008G-58.737-R				
Route Name:	FOOTHILLS PARKWAY SECTION 8G				
Inspection Date:	09/24/2010	Barrier Rating:	41.00		
Barrier Description					
Type:	STEEL-BACKED TIMBER WITHOUT BLOCKOUT	Barrier Function:	TRAFFIC		
Barrier Material:	STEEL-BACKED TIMBER/LOG	Post Material:	WOOD		
Blockout Type:	N/A	Length (ft.):	523		
Speed Limit (MPH):	45	Placement with Respect to Road:	INSIDE OF CURVE		
Hazard Behind Barrier:	MEDIUM				
Barrier Crashworthiness					
Appropriate Test Level:	TL-2	Barrier Test Level:	TL-2	Is Barrier Crashworthy?:	YES
Beg. End Trtmt Type:	SBT/LOG FLARED	Is Beg. End Trtmt Crashworthy?:	NO	Approach Transition Type:	NONE
Ending End Trtmt Type:	SBT/LOG FLARED	Ending End Trtmt Crashworthy?:	NO		
Average Measurements					
Design Height (In.):	27	Width (In.):	0.0	Post Spacing (In.):	120.0
Height (In.):	23.2	Lateral Offset (In.):	51.2	Road Grade (%):	3.30
Physical Condition					
Barrier	Alignment and Height:	The alignment has no deviation and the height is 1 to 3 in below the 27-in design height for 187 ft and 3 to 6 in below for 336 ft.

Breaking and Cracking:	No breaking or cracking observed.			
	Missing Elements:	No missing elements observed.			
	Corrosion and Weathering:	No corrosion or weathering observed.			
End Treatments	Alignment and Height:	Alignment acceptable. Height is within 1 in of the 27-in design height.			
	Breaking and Cracking:	No breaking or cracking observed.			
	Missing Elements:	No missing elements observed.			
	Corrosion and Weathering:	No corrosion or weathering observed.

Repair Action:	REPAIR	FMSS Work Type:	DEFERRED MAINTENANCE	Repair Cost:	\$10620
Brief Workorder:	Raise 523 feet of guardrail up to the 27 inch design height.				
Workorder:	Adjust Guardrail at \$10- per -Lin. Ft. for 523 LF = \$5230. Raise 523-ft of barrier up to 27-in design height. Low Speed Traffic Control at \$1475- per -Day for 3 Day(s) = \$4425.

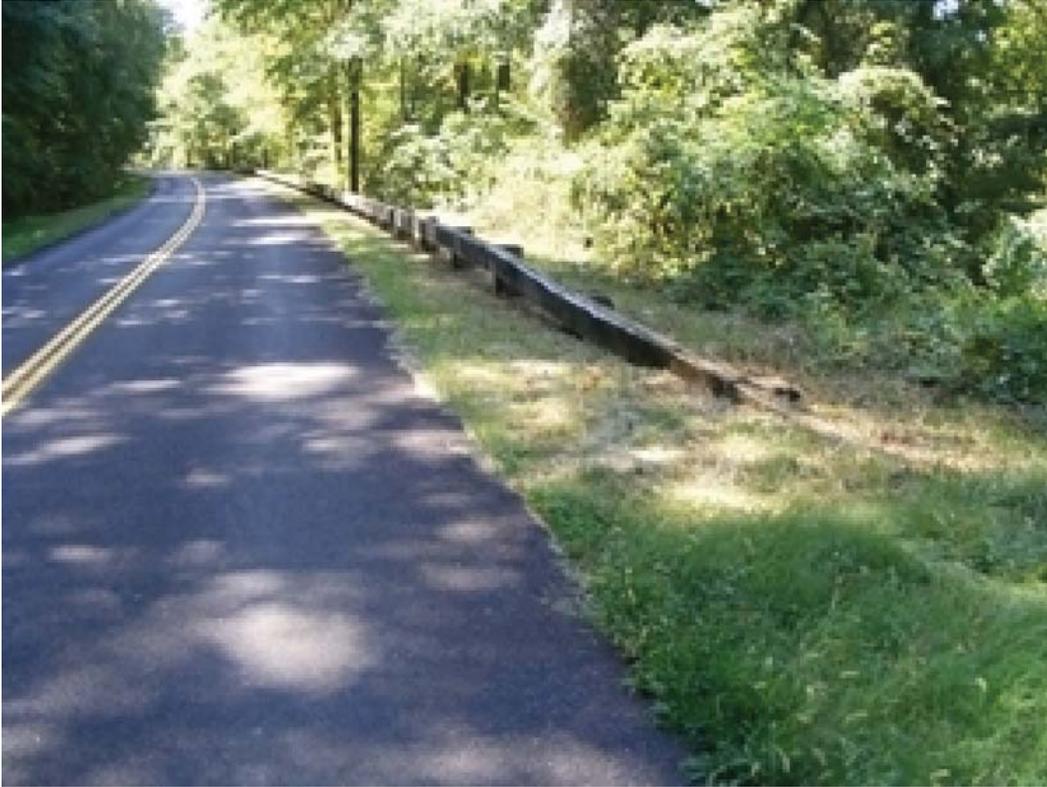
GRSM_0008G_58.981_R_1.JPG

Barrier ID:	GRSM-0008G-58.981-R				
Route Name:	FOOTHILLS PARKWAY SECTION 8G				
Inspection Date:	09/24/2010	Barrier Rating:	49.50		
Barrier Description					
Type:	STEEL-BACKED TIMBER WITHOUT BLOCKOUT	Barrier Function:	TRAFFIC		
Barrier Material:	STEEL-BACKED TIMBER/LOG	Post Material:	WOOD		
Blockout Type:	N/A	Length (ft.):	1223		
Speed Limit (MPH):	45	Placement with Respect to Road:	OUTSIDE OF CURVE		
Hazard Behind Barrier:	MEDIUM				
Barrier Crashworthiness					
Appropriate Test Level:	TL-2	Barrier Test Level:	TL-2	Is Barrier Crashworthy?:	YES
Beg. End Trtmt Type:	SBT/LOG FLARED	Is Beg. End Trtmt Crashworthy?:	NO	Approach Transition Type:	NONE
Ending End Trtmt Type:	SBT/LOG FLARED	Ending End Trtmt Crashworthy?:	NO		
Average Measurements					
Design Height (In.):	27	Width (In.):	0.0	Post Spacing (In.):	120.0
Height (In.):	24.0	Lateral Offset (In.):	49.0	Road Grade (%):	3.10
Physical Condition					
Barrier	Alignment and Height:	The alignment has no deviation and the height is 1 to 3 in below the 27-in design height for 1098 ft and 3 to 5 in below for 125 ft.

Breaking and Cracking:	No breaking or cracking observed.			
	Missing Elements:	No missing elements observed.			
	Corrosion and Weathering:	No corrosion or weathering observed.			
End Treatments	Alignment and Height:	Alignment acceptable. Height is within 1 in of the 27-in design height.			
	Breaking and Cracking:	No breaking or cracking observed.			
	Missing Elements:	No missing elements observed.			
	Corrosion and Weathering:	No corrosion or weathering observed.

Repair Action:	REPAIR	FMSS Work Type:	DEFERRED MAINTENANCE	Repair Cost:	\$21566
Brief Workorder:	Raise 1223 feet of guardrail up to the 27 inch design height.				
Workorder:	Adjust Guardrail at \$10- per -Lin. Ft. for 1223 LF = \$12230. Raise 1223 feet of guardrail up to the 27 inch design height. Low Speed Traffic Control at \$1475- per -Day for 5 Day(s) = \$7375.

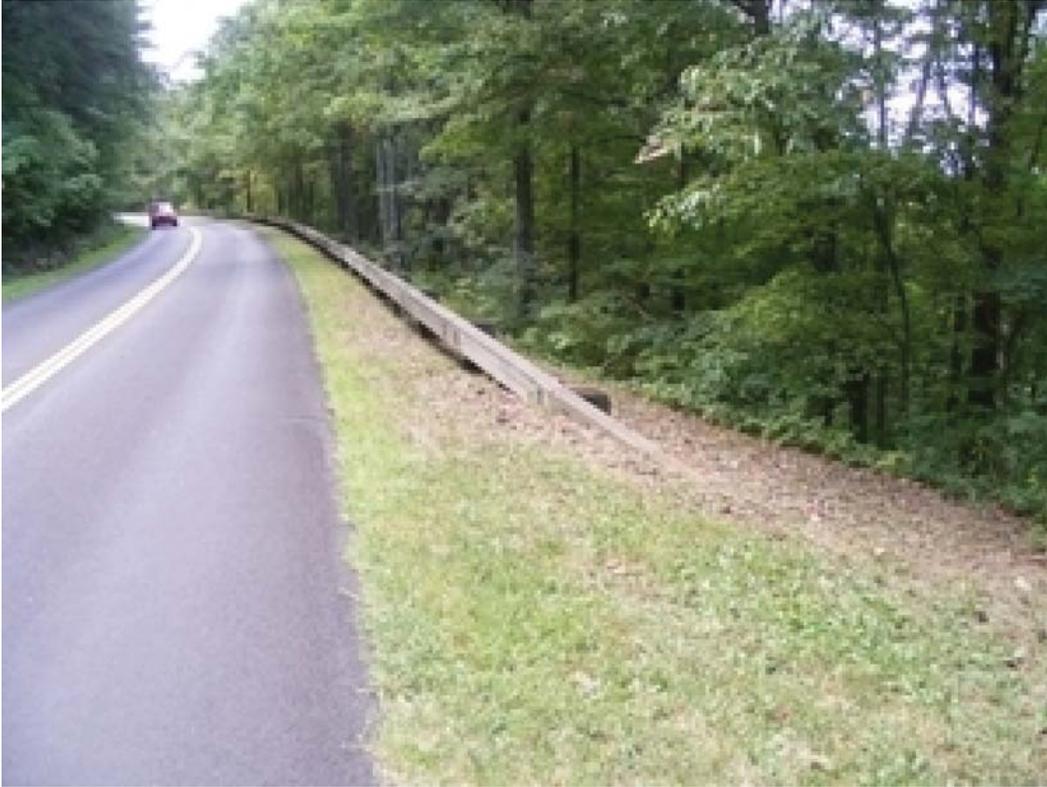
GRSM_0008G_59.366_R_1.JPG

Barrier ID:	GRSM-0008G-59.366-R				
Route Name:	FOOTHILLS PARKWAY SECTION 8G				
Inspection Date:	09/24/2010	Barrier Rating:	42.50		
Barrier Description					
Type:	STEEL-BACKED TIMBER WITHOUT BLOCKOUT	Barrier Function:	TRAFFIC		
Barrier Material:	STEEL-BACKED TIMBER/LOG	Post Material:	WOOD		
Blockout Type:	N/A	Length (ft.):	548		
Speed Limit (MPH):	45	Placement with Respect to Road:	OUTSIDE OF CURVE		
Hazard Behind Barrier:	MEDIUM				
Barrier Crashworthiness					
Appropriate Test Level:	TL-2	Barrier Test Level:	TL-2	Is Barrier Crashworthy?:	YES
Beg. End Trtmt Type:	SBT/LOG FLARED	Is Beg. End Trtmt Crashworthy?:	NO	Approach Transition Type:	NONE
Ending End Trtmt Type:	SBT/LOG FLARED	Ending End Trtmt Crashworthy?:	NO		
Average Measurements					
Design Height (In.):	27	Width (In.):	0.0	Post Spacing (In.):	120.0
Height (In.):	24.6	Lateral Offset (In.):	49.5	Road Grade (%):	3.20
Physical Condition					
Barrier	Alignment and Height:	The alignment has no deviation and the height is 1 to 3 in below the 27-in design height for 468 ft and 3 to 5 in below for 80 ft.

Breaking and Cracking:	No breaking or cracking observed.			
	Missing Elements:	No missing elements observed.			
	Corrosion and Weathering:	No corrosion or weathering observed.			
End Treatments	Alignment and Height:	Alignment acceptable. Height is within 1 in of the 27-in design height.			
	Breaking and Cracking:	No breaking or cracking observed.			
	Missing Elements:	No missing elements observed.			
	Corrosion and Weathering:	No corrosion or weathering observed.

Repair Action:	REPAIR	FMSS Work Type:	DEFERRED MAINTENANCE	Repair Cost:	\$9273
Brief Workorder:	Raise 548 feet of guardrail up to the 27 inch design height.				
Workorder:	Adjust Guardrail at \$10- per -Lin. Ft. for 548 LF = \$5480. Raise 548 feet of guardrail up to the 27 inch design height. Low Speed Traffic Control at \$1475- per -Day for 3 Day(s) = \$2950.

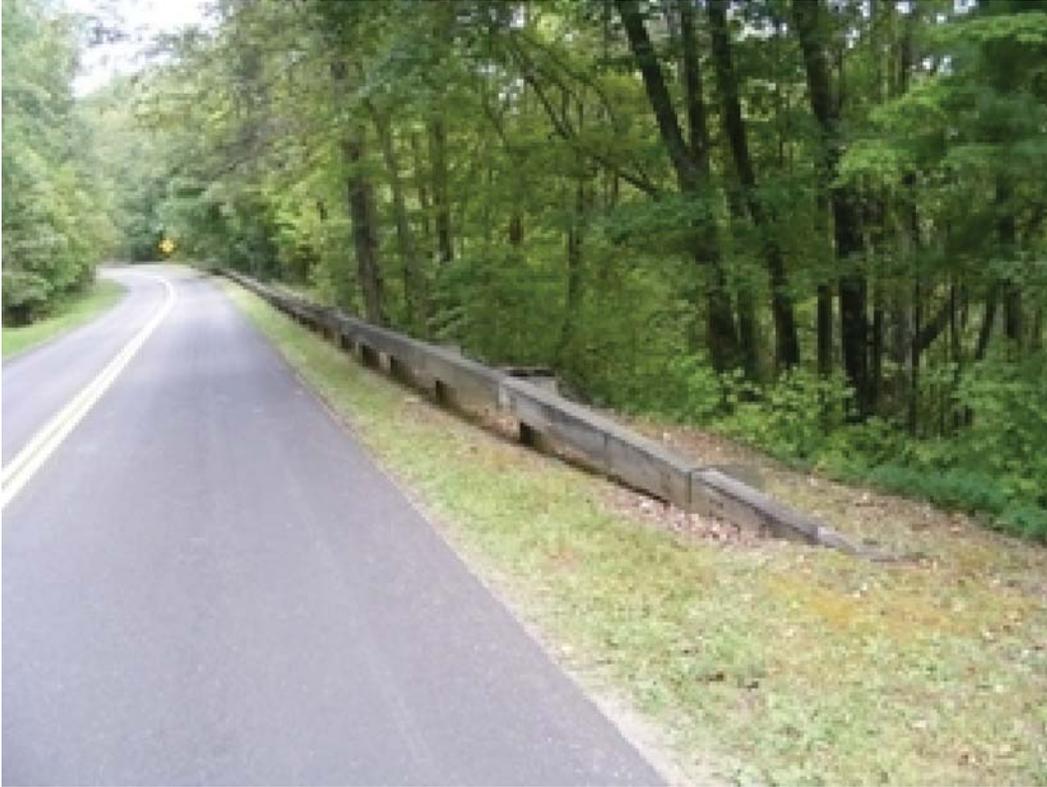
GRSM_0008G_59.591_L_1.JPG

Barrier ID:	GRSM-0008G-59.591-L				
Route Name:	FOOTHILLS PARKWAY SECTION 8G				
Inspection Date:	09/24/2010	Barrier Rating:	41.00		
Barrier Description					
Type:	STEEL-BACKED TIMBER WITHOUT BLOCKOUT	Barrier Function:	TRAFFIC		
Barrier Material:	STEEL-BACKED TIMBER/LOG	Post Material:	WOOD		
Blockout Type:	N/A	Length (ft.):	422		
Speed Limit (MPH):	45	Placement with Respect to Road:	OUTSIDE OF CURVE		
Hazard Behind Barrier:	MEDIUM				
Barrier Crashworthiness					
Appropriate Test Level:	TL-2	Barrier Test Level:	TL-2	Is Barrier Crashworthy?:	YES
Beg. End Trtmt Type:	SBT/LOG FLARED	Is Beg. End Trtmt Crashworthy?:	NO	Approach Transition Type:	NONE
Ending End Trtmt Type:	SBT/LOG FLARED	Ending End Trtmt Crashworthy?:	NO		
Average Measurements					
Design Height (In.):	27	Width (In.):	0.0	Post Spacing (In.):	119.5
Height (In.):	25.6	Lateral Offset (In.):	45.0	Road Grade (%):	1.00
Physical Condition					
Barrier	Alignment and Height:	The alignment has no deviation and the height is 1 to 3 in below the design height of 27 in for 272 ft.

Breaking and Cracking:	No breaking or cracking observed. One section had a bent mounting bracket.			
	Missing Elements:	No missing elements observed.			
	Corrosion and Weathering:	No corrosion or weathering observed.			
End Treatments	Alignment and Height:	Alignment acceptable. Height is within 1 in of the 27-in design height.			
	Breaking and Cracking:	No breaking or cracking observed.			
	Missing Elements:	No missing elements observed.			
	Corrosion and Weathering:	No corrosion or weathering observed.

Repair Action:	REPAIR	FMSS Work Type:	DEFERRED MAINTENANCE	Repair Cost:	\$6501
Brief Workorder:	Raise 272 feet of guardrail up to the 27 inch design height and straighten a bent mounting bracket.				
Workorder:	Labor at \$60- per -Hour for 1 Hrs = \$60. Straighten mounting bracket. Adjust Guardrail at \$10- per -Lin. Ft. for 272 LF = \$2720. Adjust 272 feet of low barrier to design height of 27 inches. Low Speed Traffic Control at \$1475- per -Day for 2 Day(s) = \$2950.

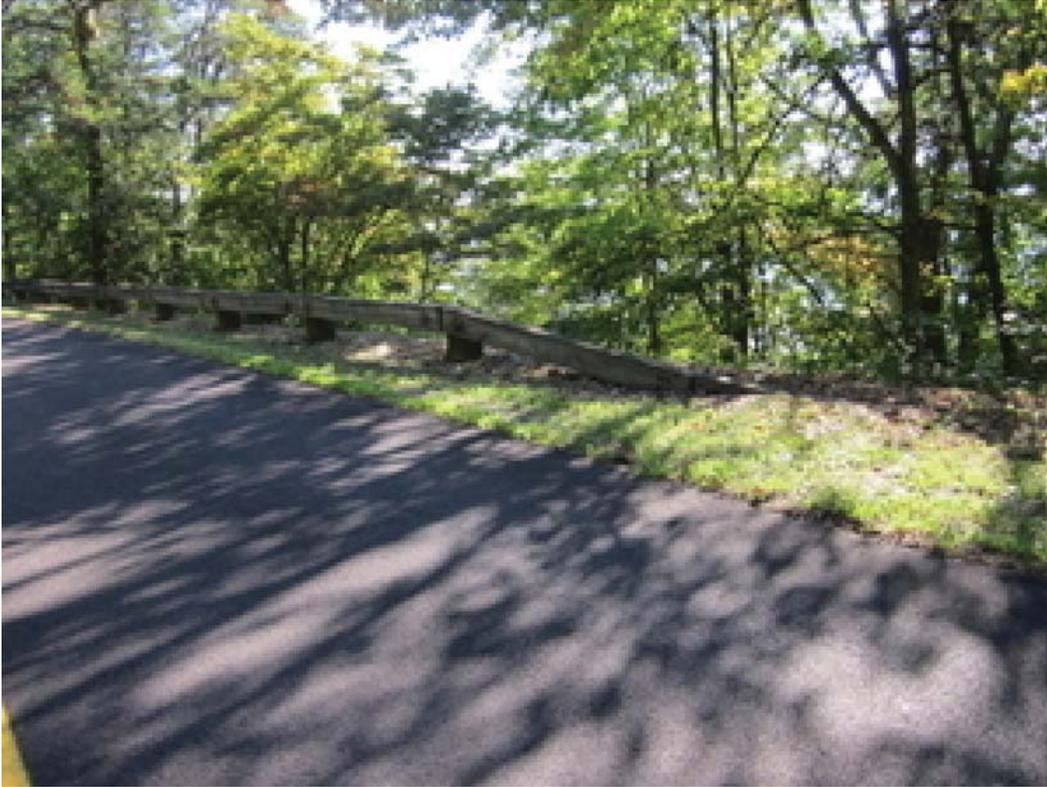
GRSM_0008G_59.890_L_1.JPG

Barrier ID:	GRSM-0008G-59.890-L				
Route Name:	FOOTHILLS PARKWAY SECTION 8G				
Inspection Date:	09/24/2010	Barrier Rating:	29.30		
Barrier Description					
Type:	STEEL-BACKED TIMBER WITHOUT BLOCKOUT	Barrier Function:	TRAFFIC		
Barrier Material:	STEEL-BACKED TIMBER/LOG	Post Material:	WOOD		
Blockout Type:	N/A	Length (ft.):	278		
Speed Limit (MPH):	45	Placement with Respect to Road:	OUTSIDE OF CURVE		
Hazard Behind Barrier:	MEDIUM				
Barrier Crashworthiness					
Appropriate Test Level:	TL-2	Barrier Test Level:	TL-2	Is Barrier Crashworthy?:	YES
Beg. End Trtmt Type:	SBT/LOG FLARED	Is Beg. End Trtmt Crashworthy?:	NO	Approach Transition Type:	NONE
Ending End Trtmt Type:	SBT/LOG FLARED	Ending End Trtmt Crashworthy?:	NO		
Average Measurements					
Design Height (In.):	27	Width (In.):	0.0	Post Spacing (In.):	120.0
Height (In.):	26.0	Lateral Offset (In.):	50.2	Road Grade (%):	1.60
Physical Condition					
Barrier	Alignment and Height:	Alignment has no deviation and the height is within 1 in of the 27 in design height.

Breaking and Cracking:	No breaking or cracking observed.			
	Missing Elements:	No missing elements observed.			
	Corrosion and Weathering:	Moderate corrosion and weathering observed. Weathering of Moderate of the rails observed.			
End Treatments	Alignment and Height:	Alignment acceptable. Height is within 1 in of the 27-in design height.			
	Breaking and Cracking:	No breaking or cracking observed.			
	Missing Elements:	No missing elements observed.			
	Corrosion and Weathering:	No corrosion or weathering observed.

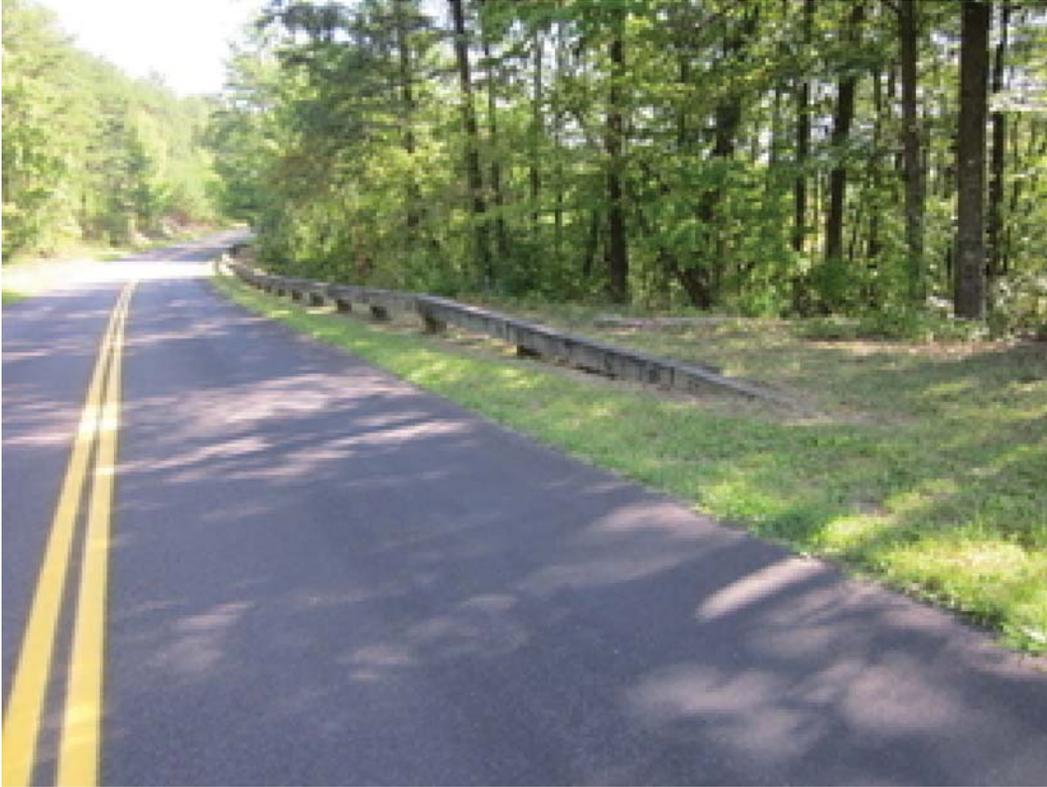
GRSM_0008G_60.651_L_1.JPG

Barrier ID:	GRSM-0008G-60.651-L				
Route Name:	FOOTHILLS PARKWAY SECTION 8G				
Inspection Date:	09/24/2010	Barrier Rating:	30.80		
Barrier Description					
Type:	STEEL-BACKED TIMBER WITHOUT BLOCKOUT	Barrier Function:	TRAFFIC		
Barrier Material:	STEEL-BACKED TIMBER/LOG	Post Material:	WOOD		
Blockout Type:	N/A	Length (ft.):	321		
Speed Limit (MPH):	45	Placement with Respect to Road:	INSIDE OF CURVE		
Hazard Behind Barrier:	MEDIUM				
Barrier Crashworthiness					
Appropriate Test Level:	TL-2	Barrier Test Level:	TL-2	Is Barrier Crashworthy?:	YES
Beg. End Trtmt Type:	SBT/LOG FLARED	Is Beg. End Trtmt Crashworthy?:	NO	Approach Transition Type:	NONE
Ending End Trtmt Type:	SBT/LOG FLARED	Ending End Trtmt Crashworthy?:	NO		
Average Measurements					
Design Height (In.):	27	Width (In.):	0.0	Post Spacing (In.):	120.0
Height (In.):	26.2	Lateral Offset (In.):	43.0	Road Grade (%):	5.20
Physical Condition					
Barrier	Alignment and Height:	Alignment has no deviation and the height is at or within 1 in of the 27 in design height.

Breaking and Cracking:	No breaking or cracking observed.			
	Missing Elements:	No missing elements observed.			
	Corrosion and Weathering:	No corrosion or weathering observed.			
End Treatments	Alignment and Height:	Alignment acceptable. Height is within 1 in of the 27-in design height.			
	Breaking and Cracking:	No breaking or cracking observed.			
	Missing Elements:	No missing elements observed.			
	Corrosion and Weathering:	No corrosion or weathering observed.

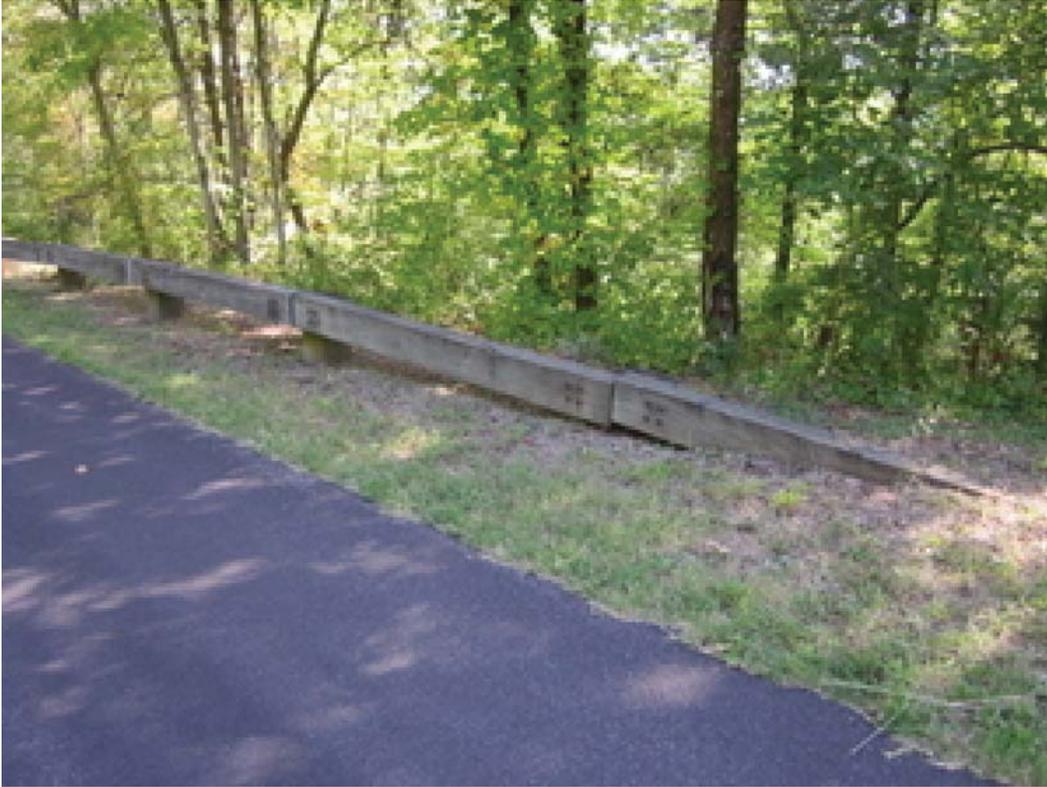
GRSM_0008G_60.817_L_1.JPG

Barrier ID:	GRSM-0008G-60.817-L				
Route Name:	FOOTHILLS PARKWAY SECTION 8G				
Inspection Date:	09/24/2010	Barrier Rating:	34.00		
Barrier Description					
Type:	STEEL-BACKED TIMBER WITHOUT BLOCKOUT	Barrier Function:	TRAFFIC		
Barrier Material:	STEEL-BACKED TIMBER/LOG	Post Material:	WOOD		
Blockout Type:	N/A	Length (ft.):	582		
Speed Limit (MPH):	45	Placement with Respect to Road:	INSIDE OF CURVE		
Hazard Behind Barrier:	HIGH				
Barrier Crashworthiness					
Appropriate Test Level:	TL-2	Barrier Test Level:	TL-2	Is Barrier Crashworthy?:	YES
Beg. End Trtmt Type:	SBT/LOG FLARED	Is Beg. End Trtmt Crashworthy?:	NO	Approach Transition Type:	NONE
Ending End Trtmt Type:	SBT/LOG FLARED	Ending End Trtmt Crashworthy?:	NO		
Average Measurements					
Design Height (In.):	27	Width (In.):	0.0	Post Spacing (In.):	120.0
Height (In.):	26.2	Lateral Offset (In.):	52.7	Road Grade (%):	6.90
Physical Condition					
Barrier	Alignment and Height:	Alignment has no deviation and the height is within 1 in of the 27 in design height.

Breaking and Cracking:	No breaking or cracking observed.			
	Missing Elements:	No missing elements observed.			
	Corrosion and Weathering:	No corrosion or weathering observed.			
End Treatments	Alignment and Height:	Alignment acceptable. Height is within 1 in of the 27-in design height.			
	Breaking and Cracking:	No breaking or cracking observed.			
	Missing Elements:	No missing elements observed.			
	Corrosion and Weathering:	No corrosion or weathering observed.

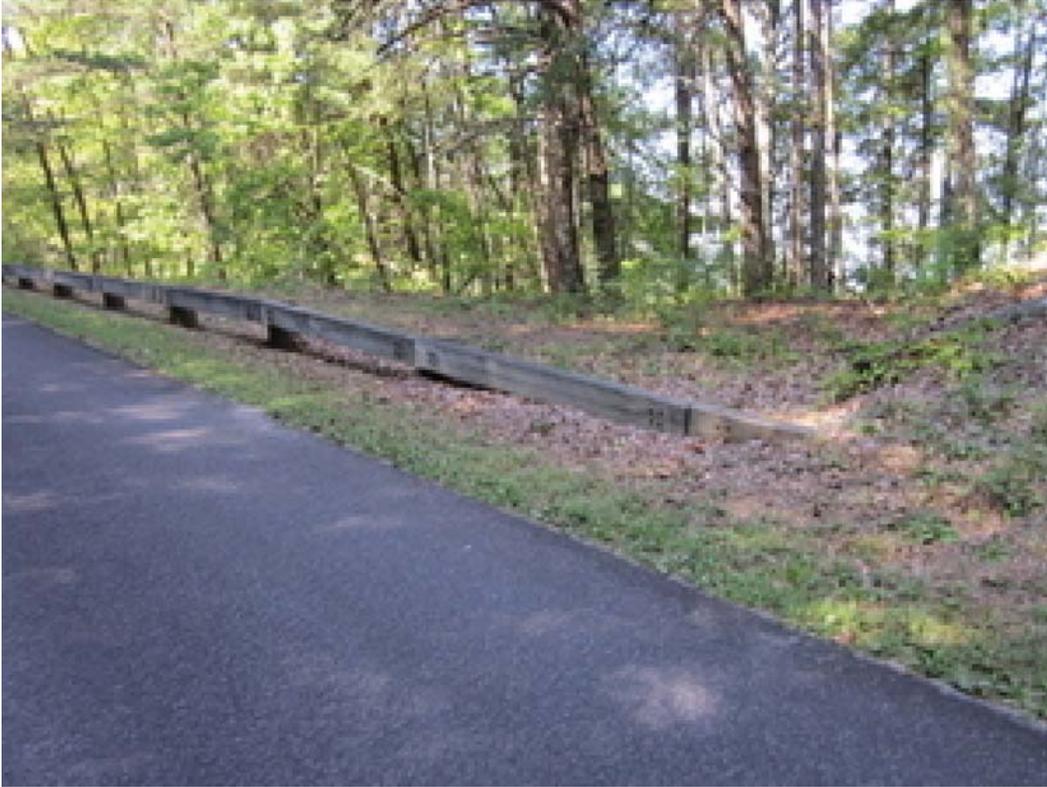
GRSM_0008G_61.207_R_1.JPG

Barrier ID:	GRSM-0008G-61.207-R				
Route Name:	FOOTHILLS PARKWAY SECTION 8G				
Inspection Date:	09/24/2010	Barrier Rating:	38.20		
Barrier Description					
Type:	STEEL-BACKED TIMBER WITHOUT BLOCKOUT	Barrier Function:	TRAFFIC		
Barrier Material:	STEEL-BACKED TIMBER/LOG	Post Material:	WOOD		
Blockout Type:	N/A	Length (ft.):	166		
Speed Limit (MPH):	45	Placement with Respect to Road:	OUTSIDE OF CURVE		
Hazard Behind Barrier:	MEDIUM				
Barrier Crashworthiness					
Appropriate Test Level:	TL-2	Barrier Test Level:	TL-2	Is Barrier Crashworthy?:	YES
Beg. End Trtmt Type:	SBT/LOG FLARED	Is Beg. End Trtmt Crashworthy?:	NO	Approach Transition Type:	NONE
Ending End Trtmt Type:	NONE	Ending End Trtmt Crashworthy?:	N/A		
Average Measurements					
Design Height (In.):	27	Width (In.):	0.0	Post Spacing (In.):	120.0
Height (In.):	23.0	Lateral Offset (In.):	48.0	Road Grade (%):	5.90
Physical Condition					
Barrier	Alignment and Height:	Alignment has no deviation and the height is 2 to 3 in low for 66 ft and 4 to 6 in low for 100 ft from the 27 in design height.

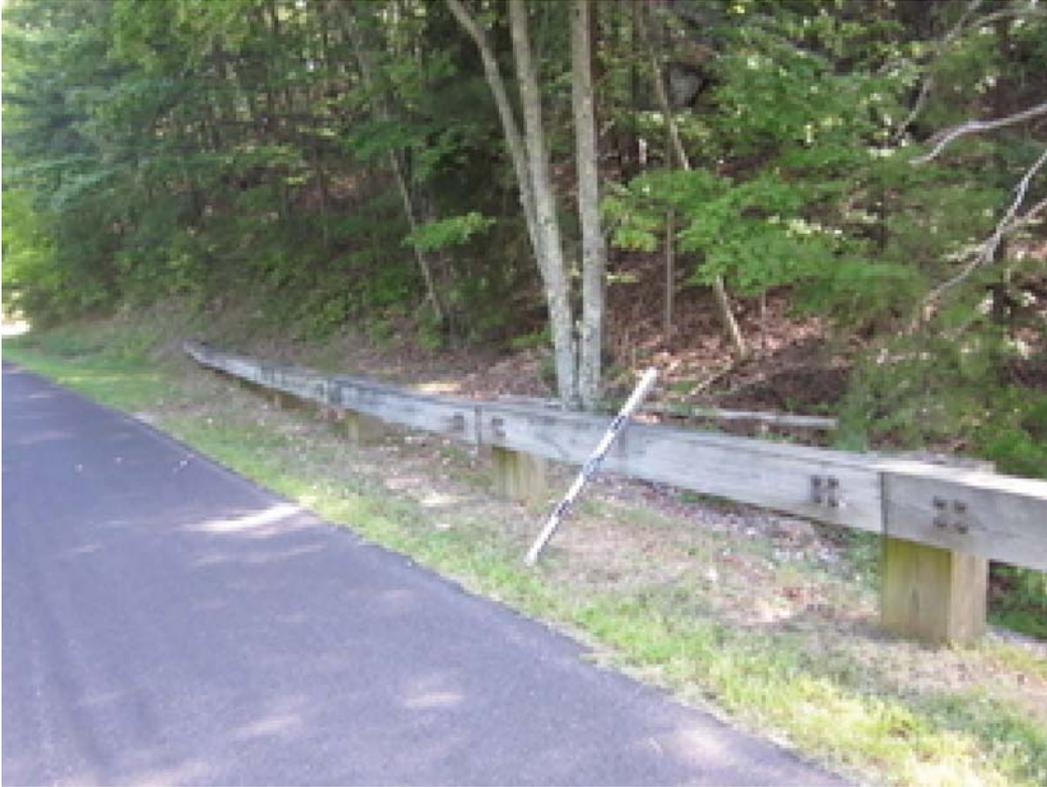
GRSM_0008G_61.228_L_1.JPG

Barrier ID:	GRSM-0008G-61.228-L				
Route Name:	FOOTHILLS PARKWAY SECTION 8G				
Inspection Date:	09/24/2010	Barrier Rating:	33.70		
Barrier Description					
Type:	STEEL-BACKED TIMBER WITHOUT BLOCKOUT	Barrier Function:	TRAFFIC		
Barrier Material:	STEEL-BACKED TIMBER/LOG	Post Material:	WOOD		
Blockout Type:	N/A	Length (ft.):	63		
Speed Limit (MPH):	45	Placement with Respect to Road:	INSIDE OF CURVE		
Hazard Behind Barrier:	MEDIUM				
Barrier Crashworthiness					
Appropriate Test Level:	TL-2	Barrier Test Level:	TL-2	Is Barrier Crashworthy?:	YES
Beg. End Trtmt Type:	SBT/LOG BURIED	Is Beg. End Trtmt Crashworthy?:	YES	Approach Transition Type:	NONE
Ending End Trtmt Type:	NONE	Ending End Trtmt Crashworthy?:	N/A		
Average Measurements					
Design Height (In.):	27	Width (In.):	0.0	Post Spacing (In.):	120.0
Height (In.):	24.6	Lateral Offset (In.):	53.2	Road Grade (%):	6.30
Physical Condition					
Barrier	Alignment and Height:	Alignment has no deviation and the height is 2-3 in below for 53 ft from the 27 in design height.

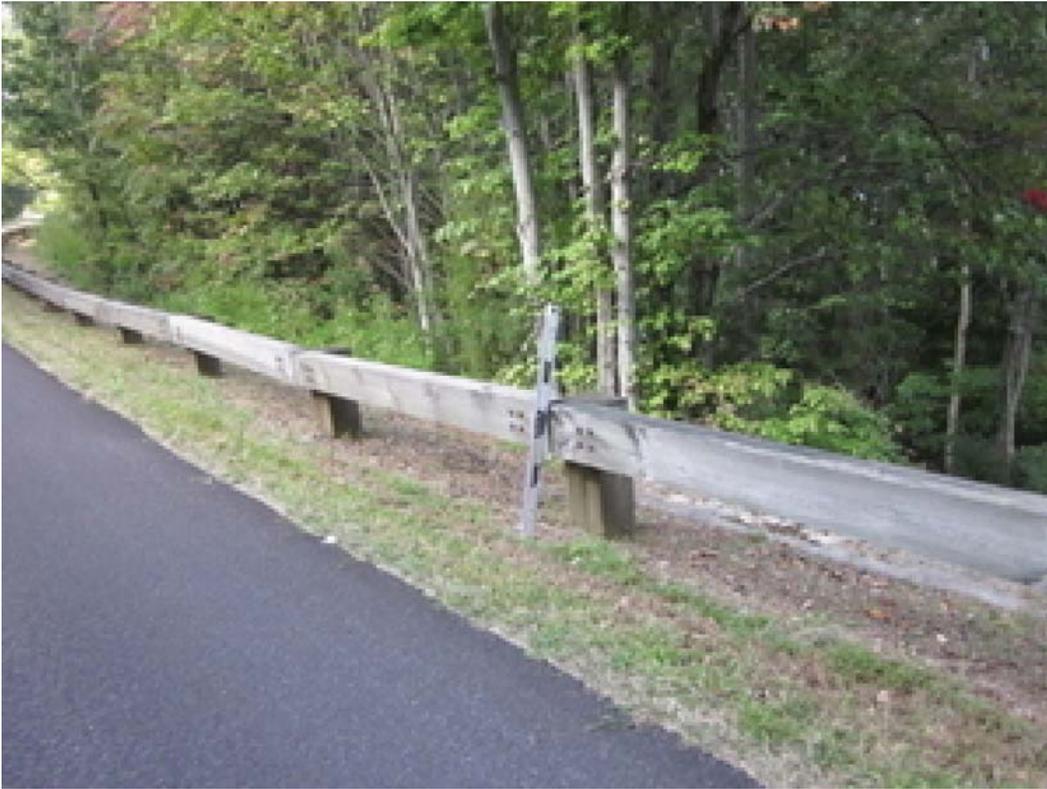
GRSM_0008G_61.244_R_1.JPG

Barrier ID:	GRSM-0008G-61.244-R				
Route Name:	FOOTHILLS PARKWAY SECTION 8G				
Inspection Date:	09/24/2010	Barrier Rating:	38.20		
Barrier Description					
Type:	STEEL-BACKED TIMBER WITHOUT BLOCKOUT	Barrier Function:	TRAFFIC		
Barrier Material:	STEEL-BACKED TIMBER/LOG	Post Material:	WOOD		
Blockout Type:	N/A	Length (ft.):	273		
Speed Limit (MPH):	45	Placement with Respect to Road:	BOTH INSIDE AND OUTSIDE		
Hazard Behind Barrier:	MEDIUM				
Barrier Crashworthiness					
Appropriate Test Level:	TL-2	Barrier Test Level:	TL-2	Is Barrier Crashworthy?:	YES
Beg. End Trtmt Type:	NONE	Is Beg. End Trtmt Crashworthy?:	N/A	Approach Transition Type:	NONE
Ending End Trtmt Type:	SBT/LOG FLARED	Ending End Trtmt Crashworthy?:	NO		
Average Measurements					
Design Height (In.):	27	Width (In.):	0.0	Post Spacing (In.):	120.0
Height (In.):	23.2	Lateral Offset (In.):	56.7	Road Grade (%):	6.10
Physical Condition					
Barrier	Alignment and Height:	Alignment has no deviation and the height and the height is 2 to 3 in low for 223 ft and 4 to 5 in low for 50 ft from the 27 in design height.

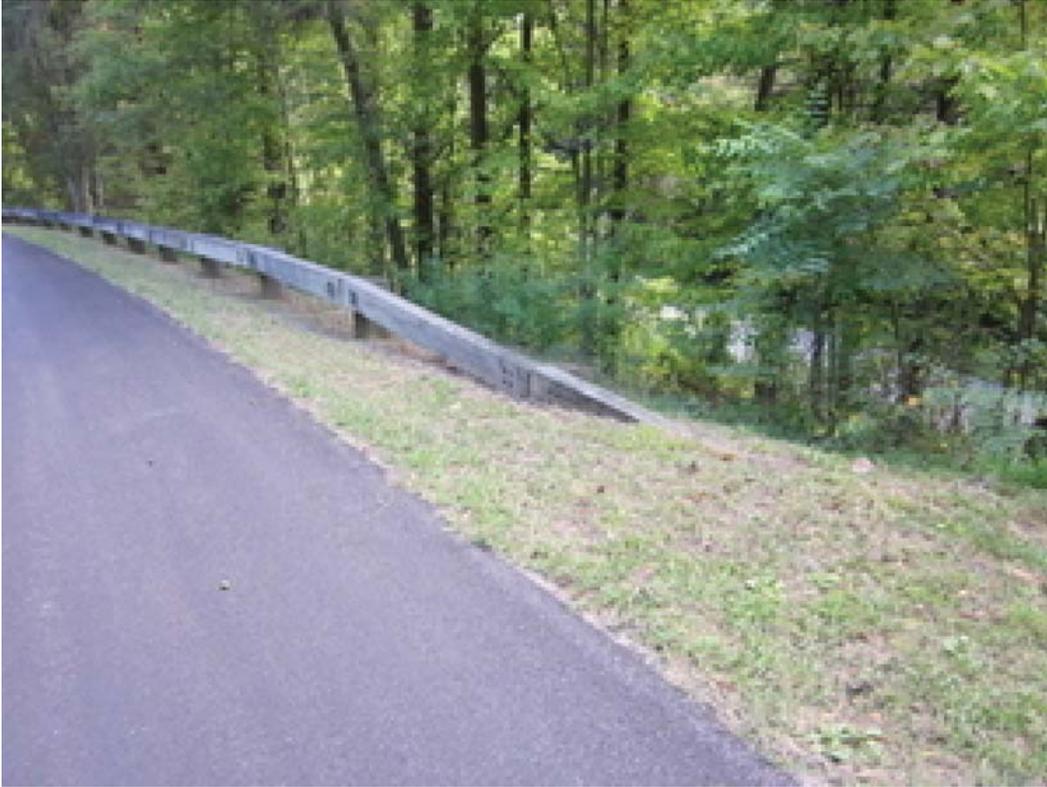
GRSM_0008G_61.245_L_1.JPG

Barrier ID:	GRSM-0008G-61.245-L				
Route Name:	FOOTHILLS PARKWAY SECTION 8G				
Inspection Date:	09/24/2010	Barrier Rating:	33.90		
Barrier Description					
Type:	STEEL-BACKED TIMBER WITHOUT BLOCKOUT	Barrier Function:	TRAFFIC		
Barrier Material:	STEEL-BACKED TIMBER/LOG	Post Material:	WOOD		
Blockout Type:	N/A	Length (ft.):	177		
Speed Limit (MPH):	45	Placement with Respect to Road:	INSIDE OF CURVE		
Hazard Behind Barrier:	MEDIUM				
Barrier Crashworthiness					
Appropriate Test Level:	TL-2	Barrier Test Level:	TL-2	Is Barrier Crashworthy?:	YES
Beg. End Trtmt Type:	SBT/LOG FLARED	Is Beg. End Trtmt Crashworthy?:	NO	Approach Transition Type:	NONE
Ending End Trtmt Type:	NONE	Ending End Trtmt Crashworthy?:	N/A		
Average Measurements					
Design Height (In.):	27	Width (In.):	0.0	Post Spacing (In.):	119.3
Height (In.):	25.0	Lateral Offset (In.):	48.2	Road Grade (%):	5.90
Physical Condition					
Barrier	Alignment and Height:	Alignment has no deviation and the height is 2 in below the 27 in design height for 177 ft.

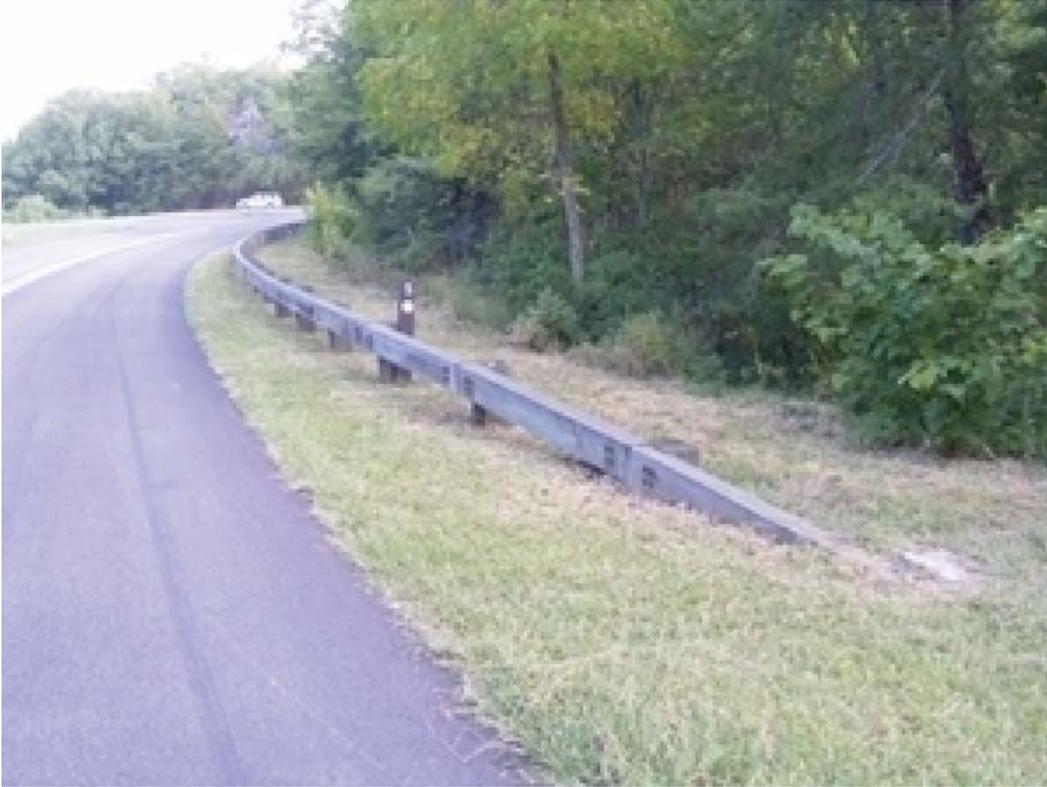
GRSM_0008G_61.357_L_1.JPG

Barrier ID:	GRSM-0008G-61.357-L				
Route Name:	FOOTHILLS PARKWAY SECTION 8G				
Inspection Date:	09/24/2010	Barrier Rating:	36.70		
Barrier Description					
Type:	STEEL-BACKED TIMBER WITHOUT BLOCKOUT	Barrier Function:	TRAFFIC		
Barrier Material:	STEEL-BACKED TIMBER/LOG	Post Material:	WOOD		
Blockout Type:	N/A	Length (ft.):	330		
Speed Limit (MPH):	45	Placement with Respect to Road:	INSIDE OF CURVE		
Hazard Behind Barrier:	MEDIUM				
Barrier Crashworthiness					
Appropriate Test Level:	TL-2	Barrier Test Level:	TL-2	Is Barrier Crashworthy?:	YES
Beg. End Trtmt Type:	SBT/LOG FLARED	Is Beg. End Trtmt Crashworthy?:	NO	Approach Transition Type:	NONE
Ending End Trtmt Type:	SBT/LOG FLARED	Ending End Trtmt Crashworthy?:	NO		
Average Measurements					
Design Height (In.):	27	Width (In.):	0.0	Post Spacing (In.):	120.0
Height (In.):	26.0	Lateral Offset (In.):	49.0	Road Grade (%):	6.90
Physical Condition					
Barrier	Alignment and Height:	The alignment has no deviation and the height is 1 to 3 in below the design height of 27 in for 150 ft.

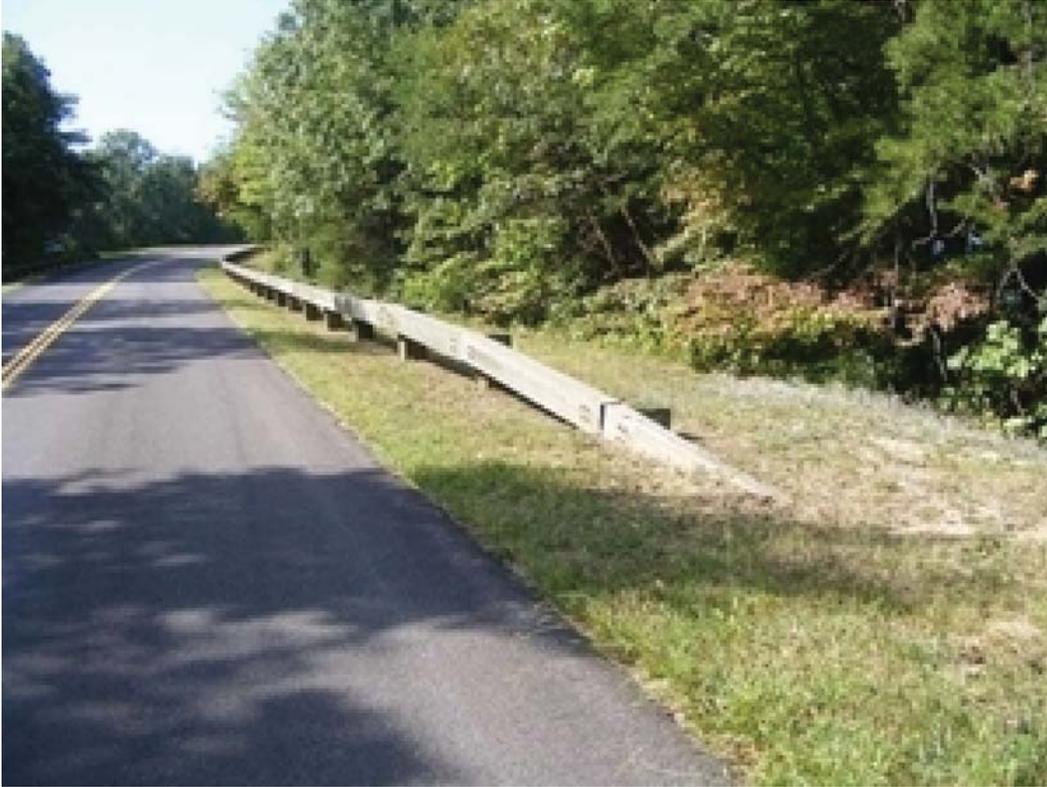
GRSM_0008G_61.452_R_1.JPG

Barrier ID:	GRSM-0008G-61.452-R				
Route Name:	FOOTHILLS PARKWAY SECTION 8G				
Inspection Date:	09/24/2010	Barrier Rating:	23.70		
Barrier Description					
Type:	STEEL-BACKED TIMBER WITHOUT BLOCKOUT	Barrier Function:	TRAFFIC		
Barrier Material:	STEEL-BACKED TIMBER/LOG	Post Material:	WOOD		
Blockout Type:	N/A	Length (ft.):	468		
Speed Limit (MPH):	45	Placement with Respect to Road:	INSIDE OF CURVE		
Hazard Behind Barrier:	MEDIUM				
Barrier Crashworthiness					
Appropriate Test Level:	TL-2	Barrier Test Level:	TL-2	Is Barrier Crashworthy?:	YES
Beg. End Trtmt Type:	SBT/LOG FLARED	Is Beg. End Trtmt Crashworthy?:	NO	Approach Transition Type:	NONE
Ending End Trtmt Type:	SBT/LOG FLARED	Ending End Trtmt Crashworthy?:	NO		
Average Measurements					
Design Height (In.):	27	Width (In.):	0.0	Post Spacing (In.):	120.0
Height (In.):	27.6	Lateral Offset (In.):	49.0	Road Grade (%):	4.90
Physical Condition					
Barrier	Alignment and Height:	The alignment has no deviation and the height is at or up to 2 in above the design height of 27 in.

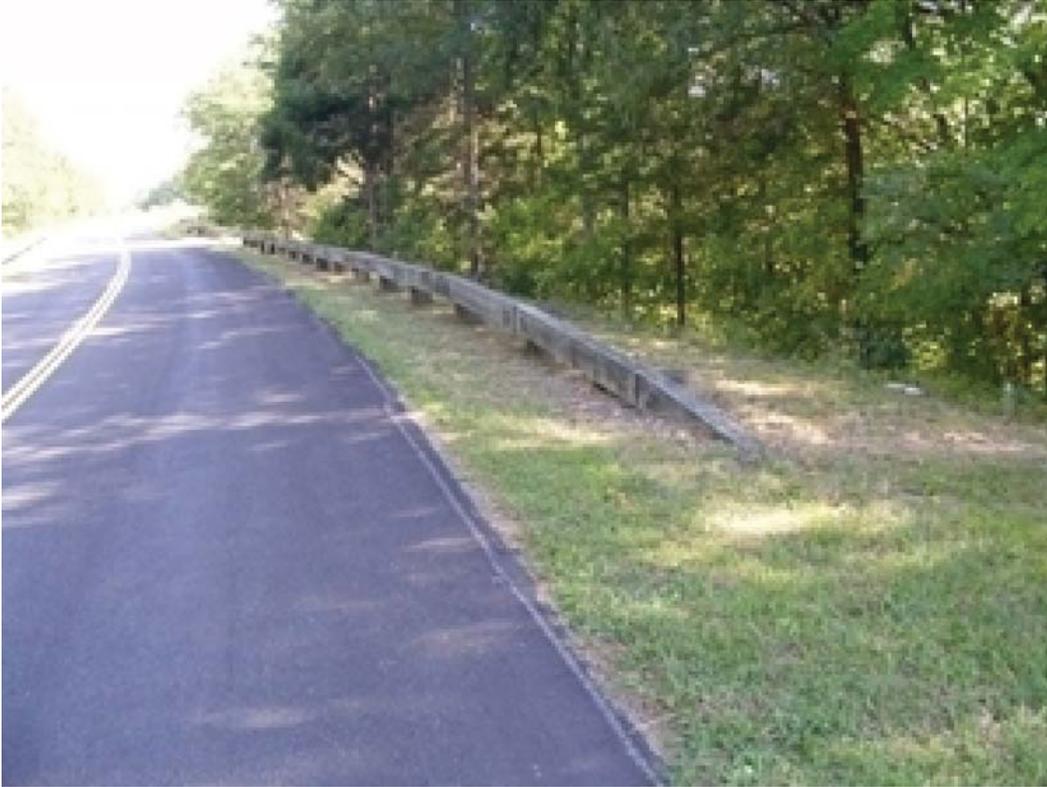
GRSM_0008G_61.453_L_1.JPG

Barrier ID:	GRSM-0008G-61.453-L				
Route Name:	FOOTHILLS PARKWAY SECTION 8G				
Inspection Date:	09/24/2010	Barrier Rating:	38.00		
Barrier Description					
Type:	STEEL-BACKED TIMBER WITHOUT BLOCKOUT	Barrier Function:	TRAFFIC		
Barrier Material:	STEEL-BACKED TIMBER/LOG	Post Material:	WOOD		
Blockout Type:	N/A	Length (ft.):	270		
Speed Limit (MPH):	45	Placement with Respect to Road:	OUTSIDE OF CURVE		
Hazard Behind Barrier:	MEDIUM				
Barrier Crashworthiness					
Appropriate Test Level:	TL-2	Barrier Test Level:	TL-2	Is Barrier Crashworthy?:	YES
Beg. End Trtmt Type:	SBT/LOG FLARED	Is Beg. End Trtmt Crashworthy?:	NO	Approach Transition Type:	NONE
Ending End Trtmt Type:	SBT/LOG FLARED	Ending End Trtmt Crashworthy?:	NO		
Average Measurements					
Design Height (In.):	27	Width (In.):	0.0	Post Spacing (In.):	120.0
Height (In.):	25.2	Lateral Offset (In.):	54.0	Road Grade (%):	6.00
Physical Condition					
Barrier	Alignment and Height:	The alignment has no deviation and the height is 1 to 3 in below the design height of 27 in for 110 ft.

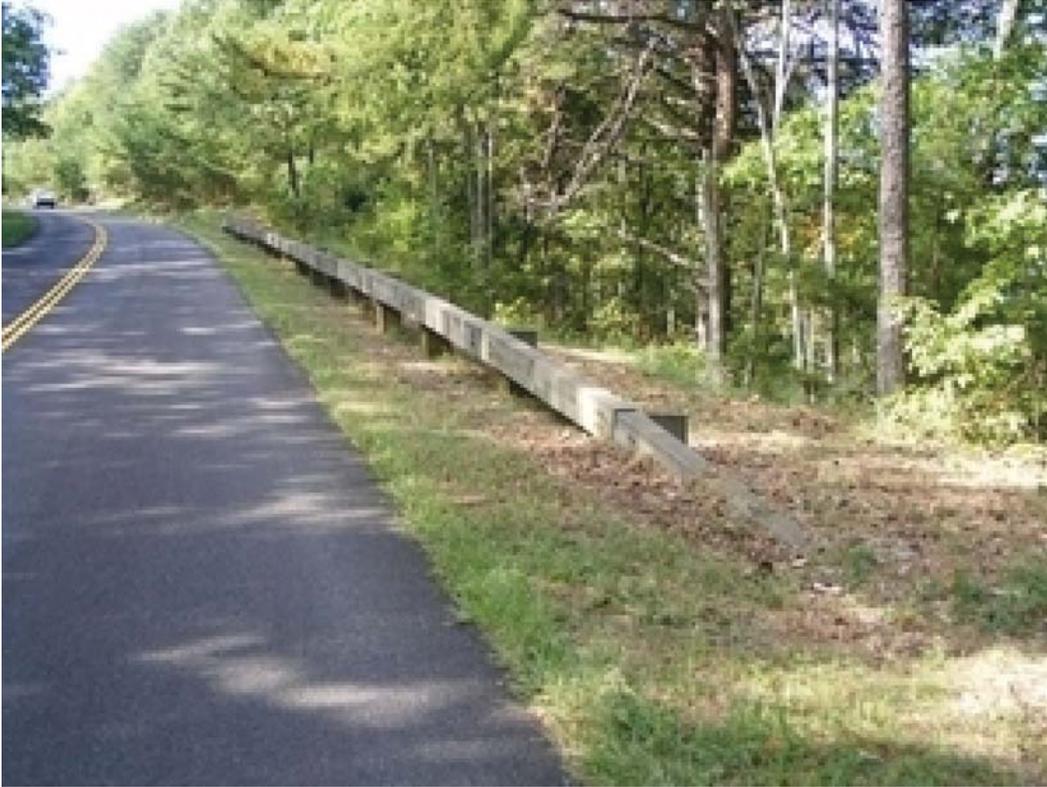
GRSM_0008G_61.608_R_1.JPG

Barrier ID:	GRSM-0008G-61.608-R				
Route Name:	FOOTHILLS PARKWAY SECTION 8G				
Inspection Date:	09/24/2010	Barrier Rating:	33.70		
Barrier Description					
Type:	STEEL-BACKED TIMBER WITHOUT BLOCKOUT	Barrier Function:	TRAFFIC		
Barrier Material:	STEEL-BACKED TIMBER/LOG	Post Material:	WOOD		
Blockout Type:	N/A	Length (ft.):	215		
Speed Limit (MPH):	45	Placement with Respect to Road:	OUTSIDE OF CURVE		
Hazard Behind Barrier:	MEDIUM				
Barrier Crashworthiness					
Appropriate Test Level:	TL-2	Barrier Test Level:	TL-2	Is Barrier Crashworthy?:	YES
Beg. End Trtmt Type:	SBT/LOG FLARED	Is Beg. End Trtmt Crashworthy?:	NO	Approach Transition Type:	NONE
Ending End Trtmt Type:	SBT/LOG FLARED	Ending End Trtmt Crashworthy?:	NO		
Average Measurements					
Design Height (In.):	27	Width (In.):	0.0	Post Spacing (In.):	120.0
Height (In.):	26.6	Lateral Offset (In.):	46.5	Road Grade (%):	5.20
Physical Condition					
Barrier	Alignment and Height:	The alignment has no deviation and the height is at or 1 in below the design height of 27 in.

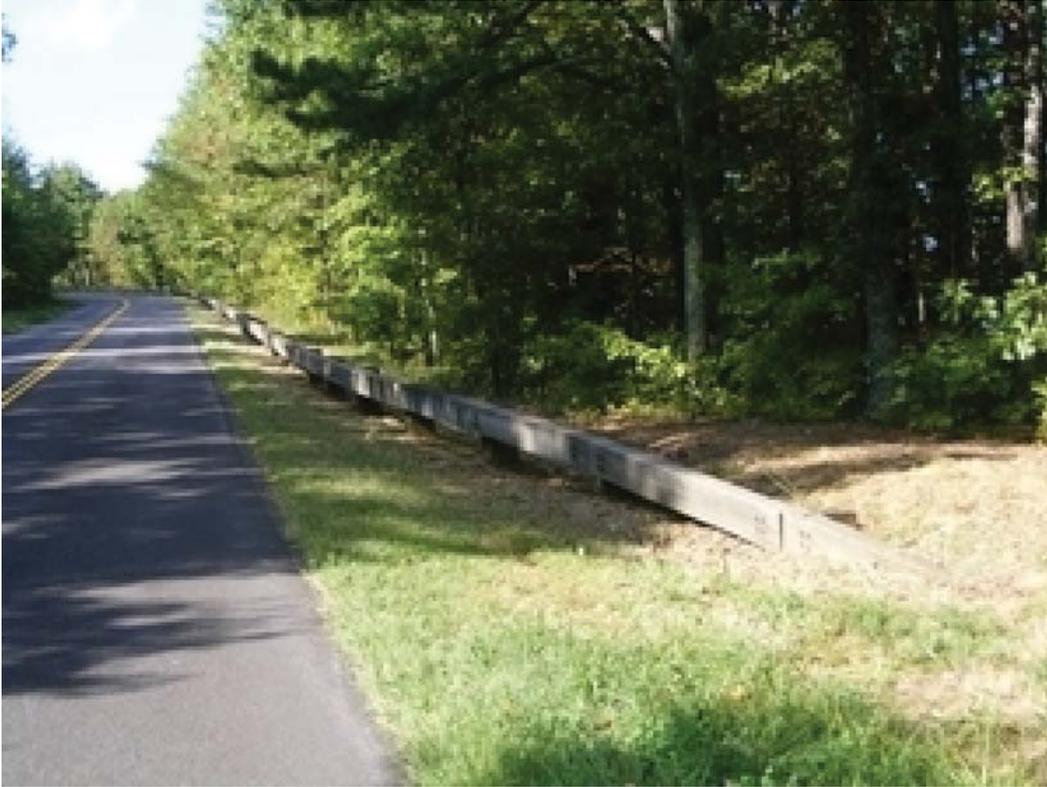
GRSM_0008G_62.887_R_1.JPG

Barrier ID:	GRSM-0008G-62.887-R				
Route Name:	FOOTHILLS PARKWAY SECTION 8G				
Inspection Date:	09/24/2010	Barrier Rating:	45.20		
Barrier Description					
Type:	STEEL-BACKED TIMBER WITHOUT BLOCKOUT	Barrier Function:	TRAFFIC		
Barrier Material:	STEEL-BACKED TIMBER/LOG	Post Material:	WOOD		
Blockout Type:	N/A	Length (ft.):	826		
Speed Limit (MPH):	45	Placement with Respect to Road:	OUTSIDE OF CURVE		
Hazard Behind Barrier:	MEDIUM				
Barrier Crashworthiness					
Appropriate Test Level:	TL-2	Barrier Test Level:	TL-2	Is Barrier Crashworthy?:	YES
Beg. End Trtmt Type:	SBT/LOG FLARED	Is Beg. End Trtmt Crashworthy?:	NO	Approach Transition Type:	NONE
Ending End Trtmt Type:	SBT/LOG BURIED	Ending End Trtmt Crashworthy?:	YES		
Average Measurements					
Design Height (In.):	27	Width (In.):	0.0	Post Spacing (In.):	120.0
Height (In.):	23.7	Lateral Offset (In.):	51.5	Road Grade (%):	0.10
Physical Condition					
Barrier	Alignment and Height:	The alignment has no deviation and the height is 1 to 3 in below the 27-in design height for 726 ft and 3 to 5 in below for 100 ft.
