NPS Guardwall/Rail Inventory Program
Great Smoky Mountains National Park

Federal Highway Administration
Eastern Federal Lands Highway Division
Road Inventory Program (RIP)

Data Collection Date: September 2010
Report Date: December 2015

Great Smoky Mountains National Park in North Carolina and Tennessee

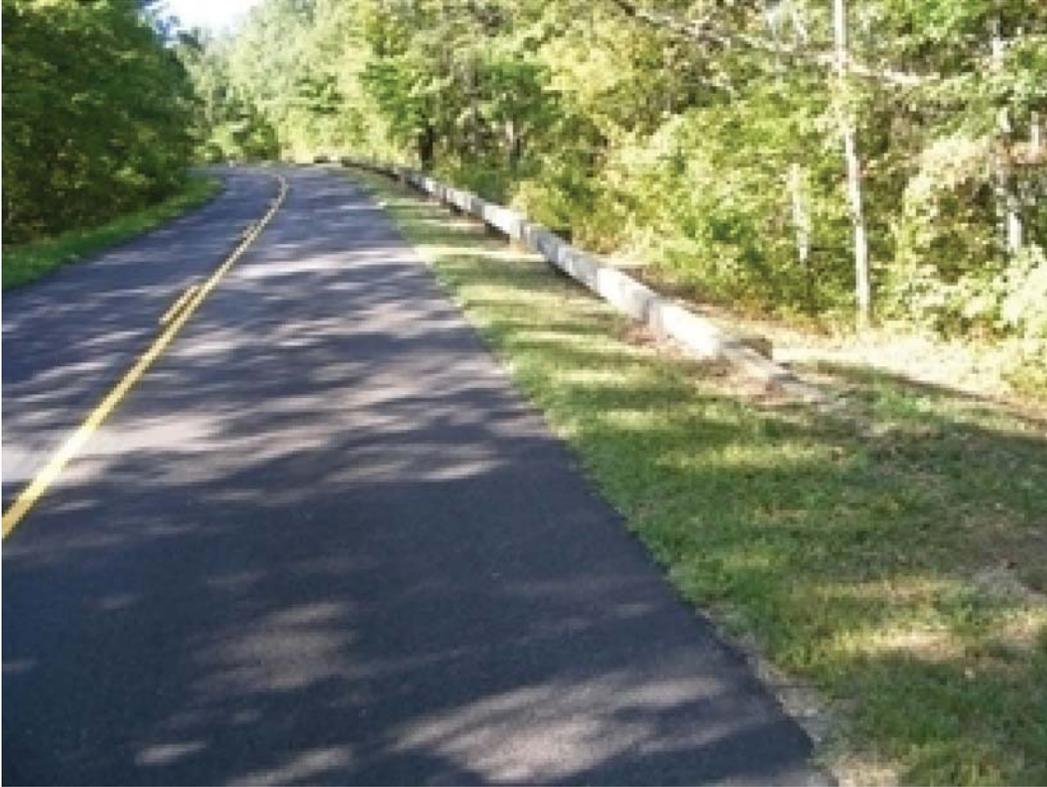
GRSM_0008G_63.434_R_1.JPG

Barrier ID:	GRSM-0008G-63.434-R				
Route Name:	FOOTHILLS PARKWAY SECTION 8G				
Inspection Date:	09/24/2010	Barrier Rating:	29.30		
Barrier Description					
Type:	STEEL-BACKED TIMBER WITHOUT BLOCKOUT	Barrier Function:	TRAFFIC		
Barrier Material:	STEEL-BACKED TIMBER/LOG	Post Material:	WOOD		
Blockout Type:	N/A	Length (ft.):	310		
Speed Limit (MPH):	45	Placement with Respect to Road:	OUTSIDE OF CURVE		
Hazard Behind Barrier:	MEDIUM				
Barrier Crashworthiness					
Appropriate Test Level:	TL-2	Barrier Test Level:	TL-2	Is Barrier Crashworthy?:	YES
Beg. End Trtmt Type:	SBT/LOG FLARED	Is Beg. End Trtmt Crashworthy?:	NO	Approach Transition Type:	NONE
Ending End Trtmt Type:	SBT/LOG FLARED	Ending End Trtmt Crashworthy?:	NO		
Average Measurements					
Design Height (In.):	27	Width (In.):	0.0	Post Spacing (In.):	120.0
Height (In.):	26.7	Lateral Offset (In.):	53.2	Road Grade (%):	5.80
Physical Condition					
Barrier	Alignment and Height:	The alignment has no deviation and the height is at or 1 in below the design height of 27 in.

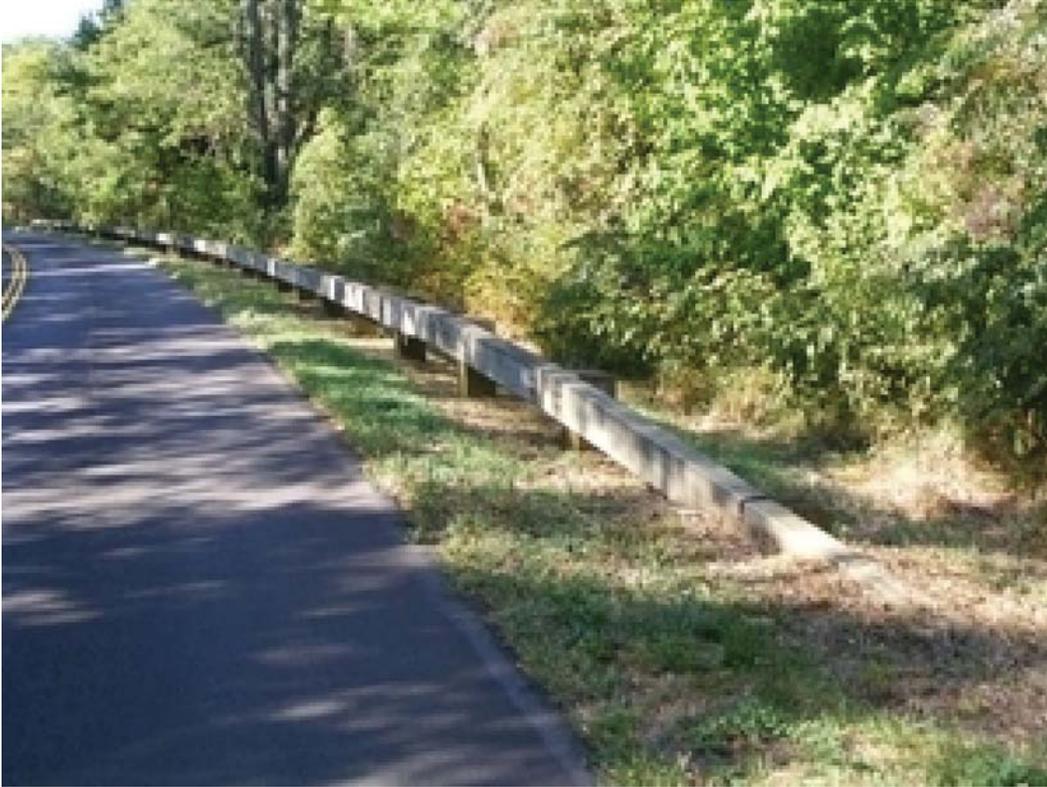
GRSM_0008G_63.797_R_1.JPG

Barrier ID:	GRSM-0008G-63.797-R				
Route Name:	FOOTHILLS PARKWAY SECTION 8G				
Inspection Date:	09/24/2010		Barrier Rating:	45.20	
Barrier Description					
Type:	STEEL-BACKED TIMBER WITHOUT BLOCKOUT		Barrier Function:	TRAFFIC	
Barrier Material:	STEEL-BACKED TIMBER/LOG		Post Material:	WOOD	
Blockout Type:	N/A		Length (ft.):	373	
Speed Limit (MPH):	45		Placement with Respect to Road:	OUTSIDE OF CURVE	
Hazard Behind Barrier:	MEDIUM				
Barrier Crashworthiness					
Appropriate Test Level:	TL-2	Barrier Test Level:	TL-2	Is Barrier Crashworthy?:	YES
Beg. End Trtmt Type:	SBT/LOG FLARED	Is Beg. End Trtmt Crashworthy?:	NO	Approach Transition Type:	NONE
Ending End Trtmt Type:	SBT/LOG FLARED	Ending End Trtmt Crashworthy?:	NO		
Average Measurements					
Design Height (In.):	27	Width (In.):	0.0	Post Spacing (In.):	120.0
Height (In.):	23.6	Lateral Offset (In.):	47.2	Road Grade (%):	1.90
Physical Condition					
Barrier	Alignment and Height:	The alignment has no deviation and the height is 1 to 3 in below the 27-in design height for 93 ft and 3 to 4 in below for 280 ft.

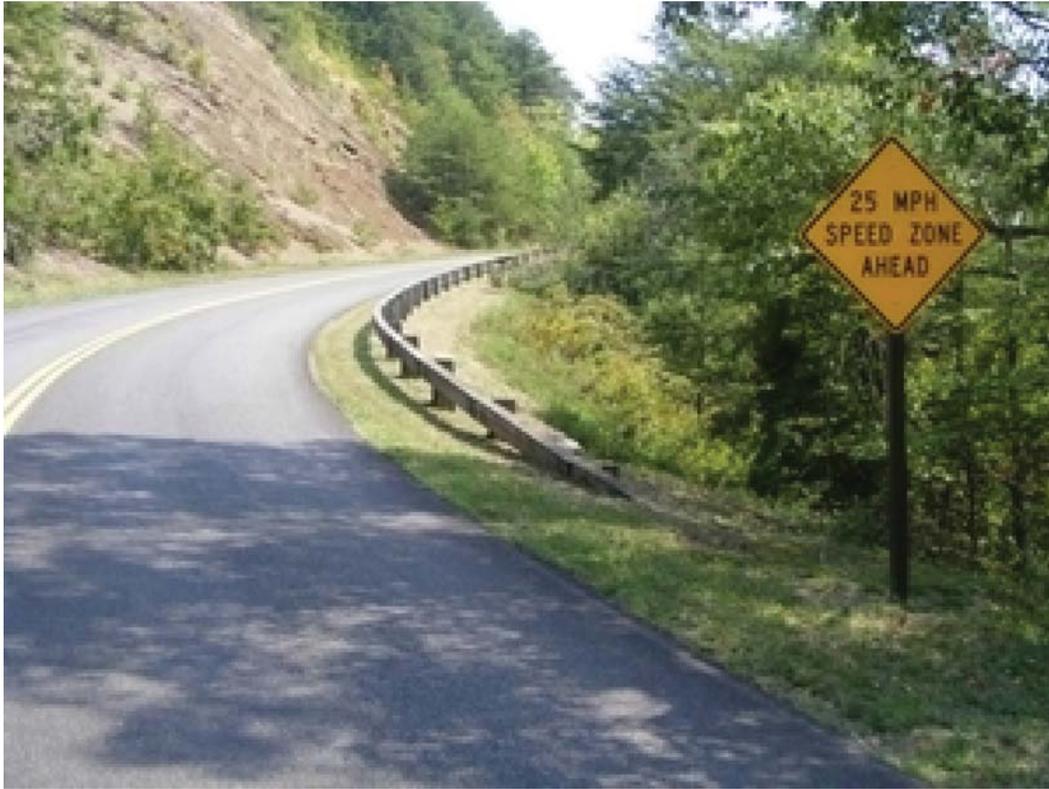
GRSM_0008G_65.131_L_1.JPG

Barrier ID:	GRSM-0008G-65.131-L				
Route Name:	FOOTHILLS PARKWAY SECTION 8G				
Inspection Date:	09/22/2010	Barrier Rating:	28.10		
Barrier Description					
Type:	STEEL-BACKED TIMBER WITHOUT BLOCKOUT	Barrier Function:	TRAFFIC		
Barrier Material:	STEEL-BACKED TIMBER/LOG	Post Material:	WOOD		
Blockout Type:	N/A	Length (ft.):	294		
Speed Limit (MPH):	45	Placement with Respect to Road:	INSIDE OF CURVE		
Hazard Behind Barrier:	MEDIUM				
Barrier Crashworthiness					
Appropriate Test Level:	TL-2	Barrier Test Level:	TL-2	Is Barrier Crashworthy?:	YES
Beg. End Trtmt Type:	SBT/LOG BURIED	Is Beg. End Trtmt Crashworthy?:	YES	Approach Transition Type:	NONE
Ending End Trtmt Type:	SBT/LOG FLARED	Ending End Trtmt Crashworthy?:	NO		
Average Measurements					
Design Height (In.):	27	Width (In.):	0.0	Post Spacing (In.):	120.0
Height (In.):	26.2	Lateral Offset (In.):	52.0	Road Grade (%):	6.80
Physical Condition					
Barrier	Alignment and Height:	The alignment has no deviation and the height is 1 to 3 in below the design height of 27 in for 140 ft.

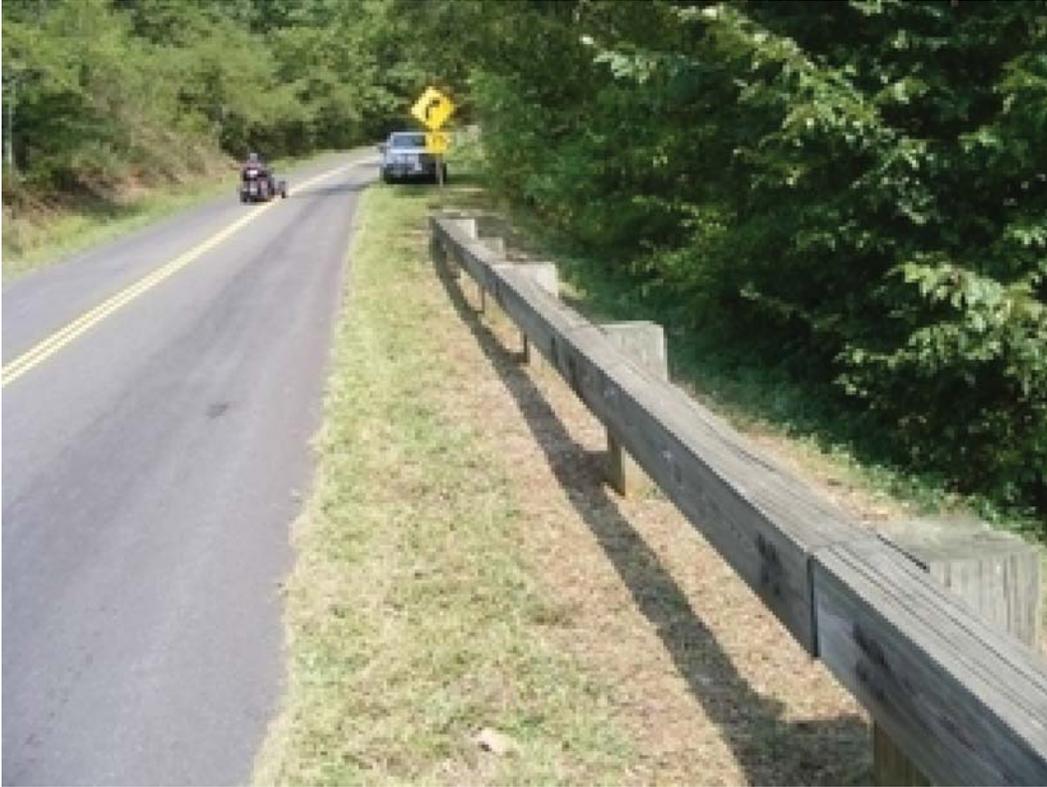
GRSM_0008G_65.278_L_1.JPG

Barrier ID:	GRSM-0008G-65.278-L				
Route Name:	FOOTHILLS PARKWAY SECTION 8G				
Inspection Date:	09/22/2010	Barrier Rating:	19.70		
Barrier Description					
Type:	STEEL-BACKED TIMBER WITHOUT BLOCKOUT	Barrier Function:	TRAFFIC		
Barrier Material:	STEEL-BACKED TIMBER/LOG	Post Material:	WOOD		
Blockout Type:	N/A	Length (ft.):	50		
Speed Limit (MPH):	45	Placement with Respect to Road:	TANGENT		
Hazard Behind Barrier:	HIGH				
Barrier Crashworthiness					
Appropriate Test Level:	TL-2	Barrier Test Level:	TL-2	Is Barrier Crashworthy?:	YES
Beg. End Trtmt Type:	SBT/LOG FLARED	Is Beg. End Trtmt Crashworthy?:	NO	Approach Transition Type:	NONE
Ending End Trtmt Type:	NONE	Ending End Trtmt Crashworthy?:	N/A		
Average Measurements					
Design Height (In.):	27	Width (In.):	0.0	Post Spacing (In.):	120.0
Height (In.):	28.2	Lateral Offset (In.):	52.0	Road Grade (%):	2.10
Physical Condition					
Barrier	Alignment and Height:	The alignment has no deviation and the height is at or above the design height of 27 in by up to 2 in.

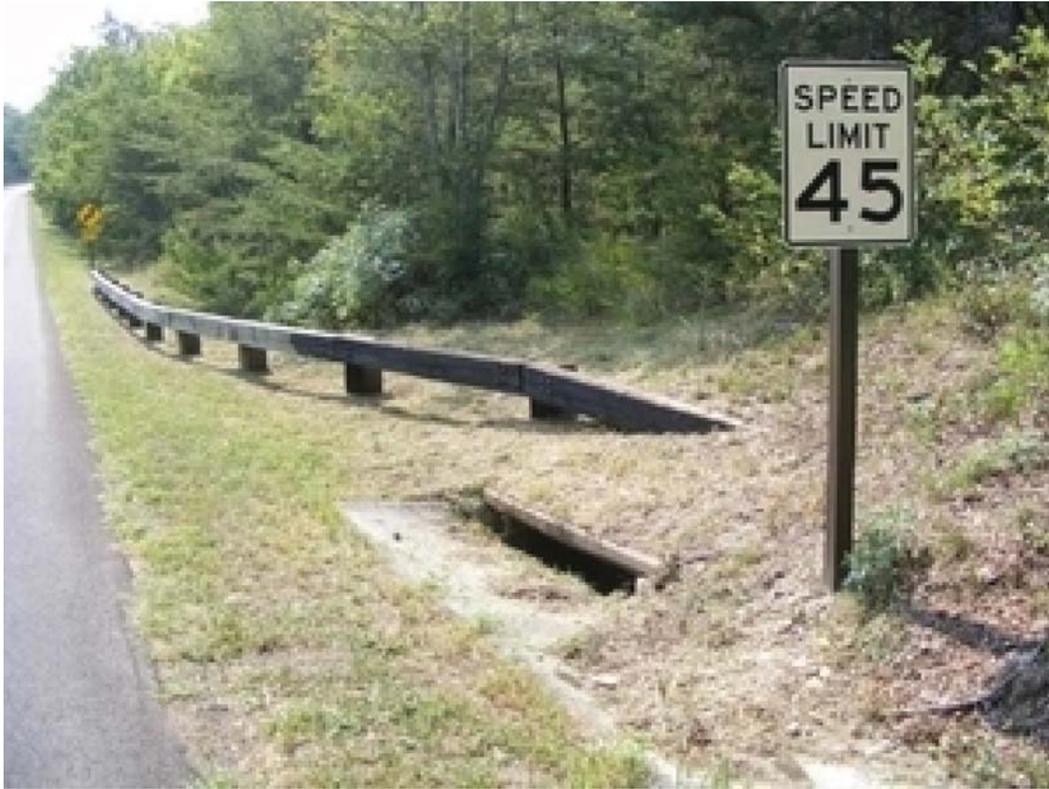
GRSM_0008G_65.281_R_1.JPG

Barrier ID:	GRSM-0008G-65.281-R				
Route Name:	FOOTHILLS PARKWAY SECTION 8G				
Inspection Date:	09/22/2010	Barrier Rating:	24.00		
Barrier Description					
Type:	STEEL-BACKED TIMBER WITHOUT BLOCKOUT	Barrier Function:	TRAFFIC		
Barrier Material:	STEEL-BACKED TIMBER/LOG	Post Material:	WOOD		
Blockout Type:	N/A	Length (ft.):	43		
Speed Limit (MPH):	45	Placement with Respect to Road:	TANGENT		
Hazard Behind Barrier:	HIGH				
Barrier Crashworthiness					
Appropriate Test Level:	TL-2	Barrier Test Level:	TL-2	Is Barrier Crashworthy?:	YES
Beg. End Trtmt Type:	SBT/LOG BURIED	Is Beg. End Trtmt Crashworthy?:	YES	Approach Transition Type:	NONE
Ending End Trtmt Type:	NONE	Ending End Trtmt Crashworthy?:	N/A		
Average Measurements					
Design Height (In.):	27	Width (In.):	0.0	Post Spacing (In.):	119.5
Height (In.):	27.0	Lateral Offset (In.):	61.5	Road Grade (%):	3.60
Physical Condition					
Barrier	Alignment and Height:	The alignment has no deviation and the height is at the design height of 27 in.

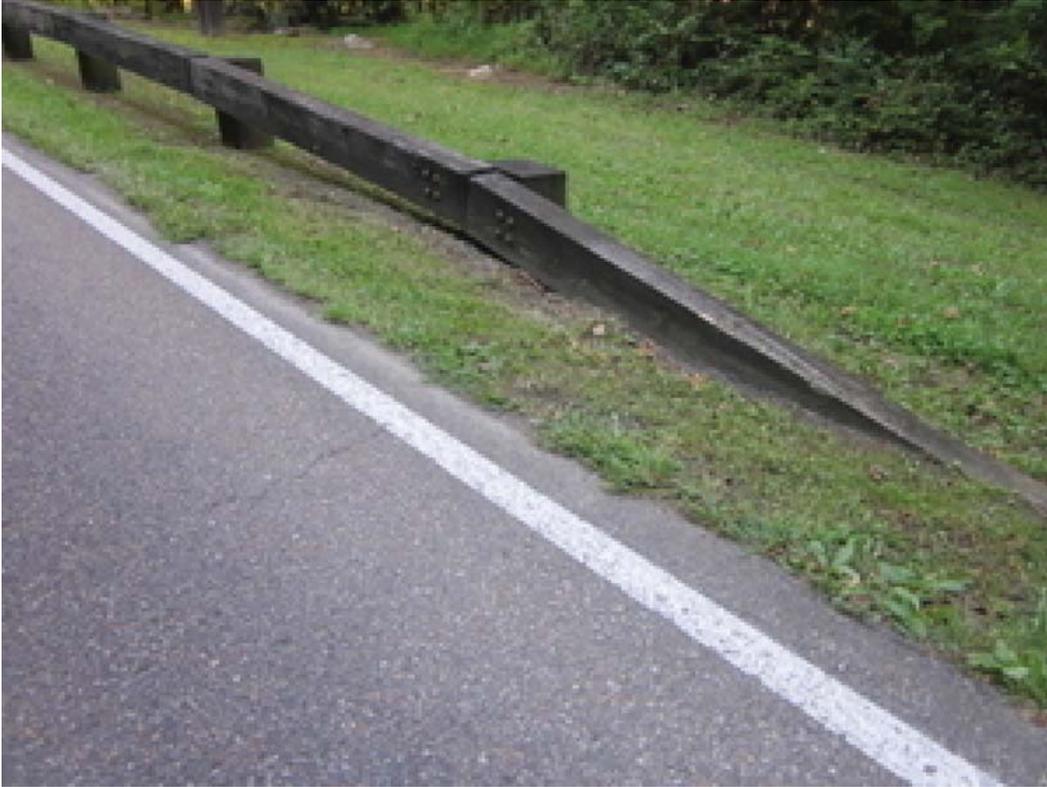
GRSM_0010N_1.471_R_1.JPG

Barrier ID:	GRSM-0010N-1.471-R				
Route Name:	NEWFOUND GAP ROAD NORTH				
Inspection Date:	09/15/2010	Barrier Rating:	18.30		
Barrier Description					
Type:	STEEL-BACKED TIMBER WITHOUT BLOCKOUT	Barrier Function:	TRAFFIC		
Barrier Material:	STEEL-BACKED TIMBER/LOG	Post Material:	WOOD		
Blockout Type:	N/A	Length (ft.):	104		
Speed Limit (MPH):	25	Placement with Respect to Road:	TANGENT		
Hazard Behind Barrier:	LOW				
Barrier Crashworthiness					
Appropriate Test Level:	TL-1	Barrier Test Level:	TL-2	Is Barrier Crashworthy?:	YES
Beg. End Trtmt Type:	SBT/LOG FLARED	Is Beg. End Trtmt Crashworthy?:	NO	Approach Transition Type:	NONE
Ending End Trtmt Type:	SBT/LOG FLARED	Ending End Trtmt Crashworthy?:	NO		
Average Measurements					
Design Height (In.):	27	Width (In.):	0.0	Post Spacing (In.):	120.0
Height (In.):	26.7	Lateral Offset (In.):	49.0	Road Grade (%):	0.60
Physical Condition					
Barrier	Alignment and Height:	Alignment has no deviation and the height is within 1 in of the design height of 27 in.

Breaking and Cracking:	No breaking or cracking observed.			
	Missing Elements:	No missing elements observed.			
	Corrosion and Weathering:	No corrosion or weathering observed.			
End Treatments	Alignment and Height:	Alignment acceptable. Height is within 1 in of the 27-in design height.			
	Breaking and Cracking:	No breaking or cracking observed.			
	Missing Elements:	No missing elements observed.			
	Corrosion and Weathering:	No corrosion or weathering observed.

Barrier ID:	GRSM-0010N-1.471-R				
Route Name:	NEWFOUND GAP ROAD NORTH				
Inspection Date:	09/15/2010	Barrier Rating:		18.30	
Repair Recommendations					
Repair Action:	NO ACTION	FMSS Work Type:	N/A	Repair Cost:	\$0
Brief Workorder:	N/A				
Workorder:

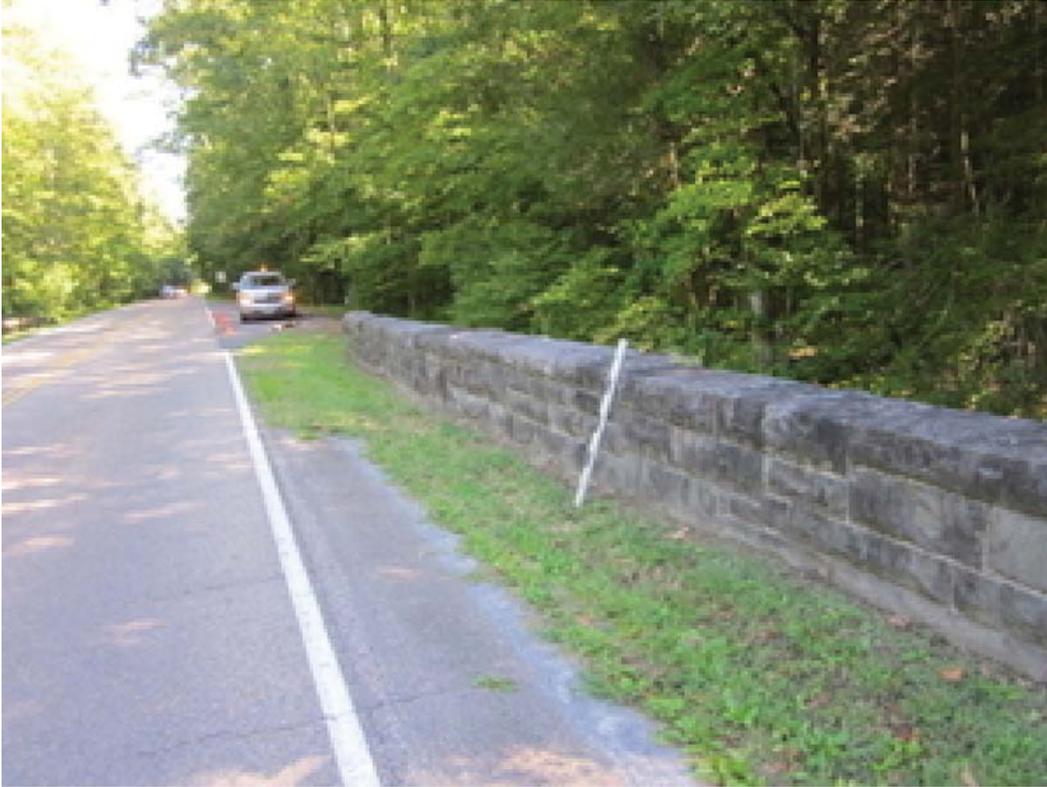
GRSM_0010N_1.490_L_1.JPG

Barrier ID:	GRSM-0010N-1.490-L				
Route Name:	NEWFOUND GAP ROAD NORTH				
Inspection Date:	09/15/2010	Barrier Rating:	26.60		
Barrier Description					
Type:	STONE MASONRY WITHOUT CONCRETE CORE WALL	Barrier Function:	TRAFFIC		
Barrier Material:	STONE	Post Material:	N/A		
Blockout Type:	N/A	Length (ft.):	52		
Speed Limit (MPH):	25	Placement with Respect to Road:	TANGENT		
Hazard Behind Barrier:	MEDIUM				
Barrier Crashworthiness					
Appropriate Test Level:	TL-1	Barrier Test Level:	NCW	Is Barrier Crashworthy?:	NO
Beg. End Trtmt Type:	NONE	Is Beg. End Trtmt Crashworthy?:	N/A	Approach Transition Type:	NONE
Ending End Trtmt Type:	NONE	Ending End Trtmt Crashworthy?:	N/A		
Average Measurements					
Design Height (In.):	24	Width (In.):	27.6	Post Spacing (In.):	0.0
Height (In.):	35.0	Lateral Offset (In.):	87.3	Road Grade (%):	0.30
Physical Condition					
Barrier	Alignment and Height:	Alignment has no deviation and the height is 11 in above the 24 in design height.

Breaking and Cracking:	No breaking or cracking observed.			
	Missing Elements:	No missing elements observed.			
	Corrosion and Weathering:	No corrosion or weathering observed.			
End Treatments	Alignment and Height:				
	Breaking and Cracking:				
	Missing Elements:				
	Corrosion and Weathering:

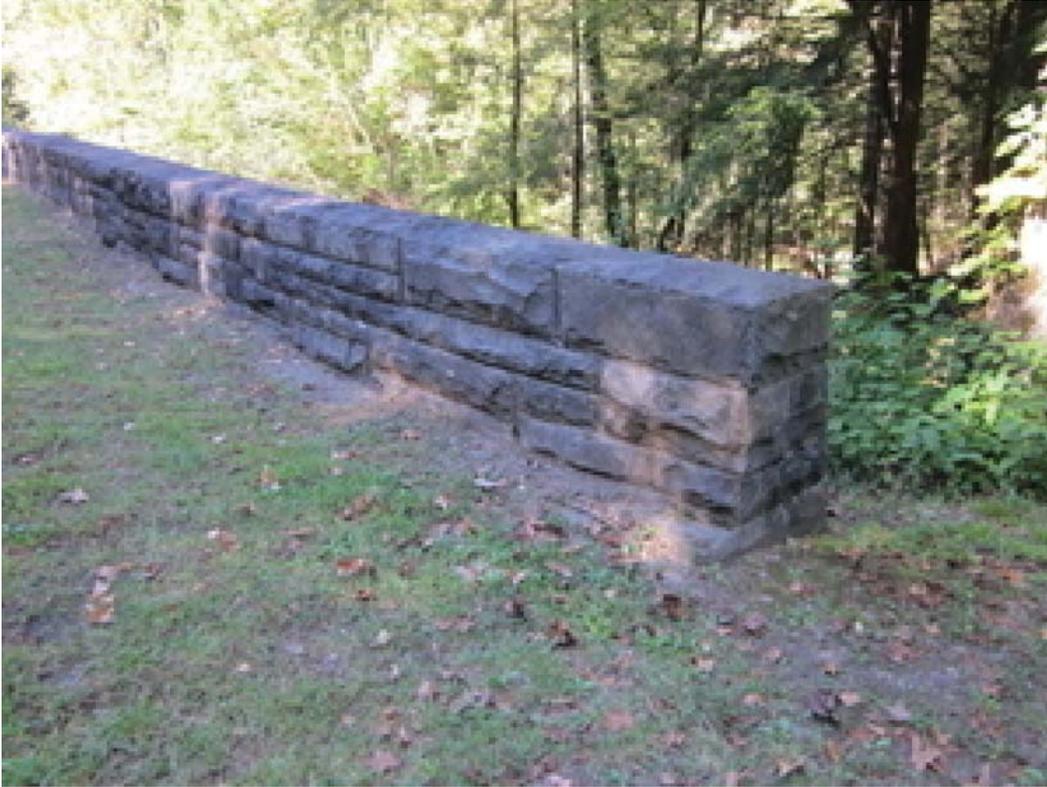
GRSM_0010N_1.492_R_1.JPG

Barrier ID:	GRSM-0010N-1.492-R				
Route Name:	NEWFOUND GAP ROAD NORTH				
Inspection Date:	09/15/2010	Barrier Rating:	28.30		
Barrier Description					
Type:	STONE MASONRY WITHOUT CONCRETE CORE WALL	Barrier Function:	TRAFFIC		
Barrier Material:	STONE	Post Material:	N/A		
Blockout Type:	N/A	Length (ft.):	52		
Speed Limit (MPH):	25	Placement with Respect to Road:	TANGENT		
Hazard Behind Barrier:	HIGH				
Barrier Crashworthiness					
Appropriate Test Level:	TL-1	Barrier Test Level:	NCW	Is Barrier Crashworthy?:	NO
Beg. End Trtmt Type:	NONE	Is Beg. End Trtmt Crashworthy?:	N/A	Approach Transition Type:	NONE
Ending End Trtmt Type:	NONE	Ending End Trtmt Crashworthy?:	N/A		
Average Measurements					
Design Height (In.):	24	Width (In.):	25.2	Post Spacing (In.):	0.0
Height (In.):	35.7	Lateral Offset (In.):	106.6	Road Grade (%):	0.90
Physical Condition					
Barrier	Alignment and Height:	Alignment has no deviation and the height is 11 to 12 in above the 24 in design height.

Breaking and Cracking:	No breaking or cracking observed.			
	Missing Elements:	No missing elements observed.			
	Corrosion and Weathering:	No corrosion or weathering observed.			
End Treatments	Alignment and Height:				
	Breaking and Cracking:				
	Missing Elements:				
	Corrosion and Weathering:

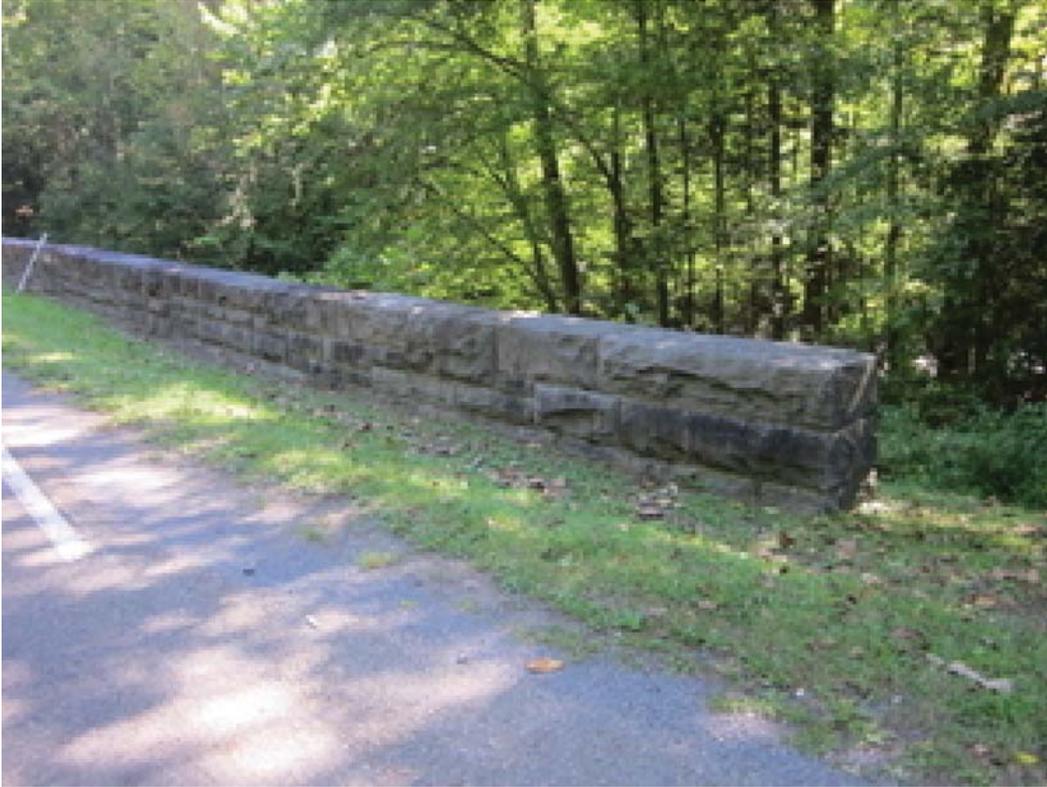
GRSM_0010N_1.532_L_1.JPG

Barrier ID:	GRSM-0010N-1.532-L				
Route Name:	NEWFOUND GAP ROAD NORTH				
Inspection Date:	09/15/2010	Barrier Rating:	19.50		
Barrier Description					
Type:	STONE MASONRY WITHOUT CONCRETE CORE WALL	Barrier Function:	TRAFFIC		
Barrier Material:	STONE	Post Material:	N/A		
Blockout Type:	N/A	Length (ft.):	52		
Speed Limit (MPH):	25	Placement with Respect to Road:	TANGENT		
Hazard Behind Barrier:	MEDIUM				
Barrier Crashworthiness					
Appropriate Test Level:	TL-1	Barrier Test Level:	NCW	Is Barrier Crashworthy?:	NO
Beg. End Trtmt Type:	NONE	Is Beg. End Trtmt Crashworthy?:	N/A	Approach Transition Type:	NONE
Ending End Trtmt Type:	NONE	Ending End Trtmt Crashworthy?:	N/A		
Average Measurements					
Design Height (In.):	24	Width (In.):	27.6	Post Spacing (In.):	0.0
Height (In.):	31.6	Lateral Offset (In.):	95.3	Road Grade (%):	0.50
Physical Condition					
Barrier	Alignment and Height:	Alignment has no deviation and the height is 7 to 8 in above the 24 in design height.

Breaking and Cracking:	No breaking or cracking observed.			
	Missing Elements:	No missing elements observed.			
	Corrosion and Weathering:	No corrosion or weathering observed.			
End Treatments	Alignment and Height:				
	Breaking and Cracking:				
	Missing Elements:				
	Corrosion and Weathering:

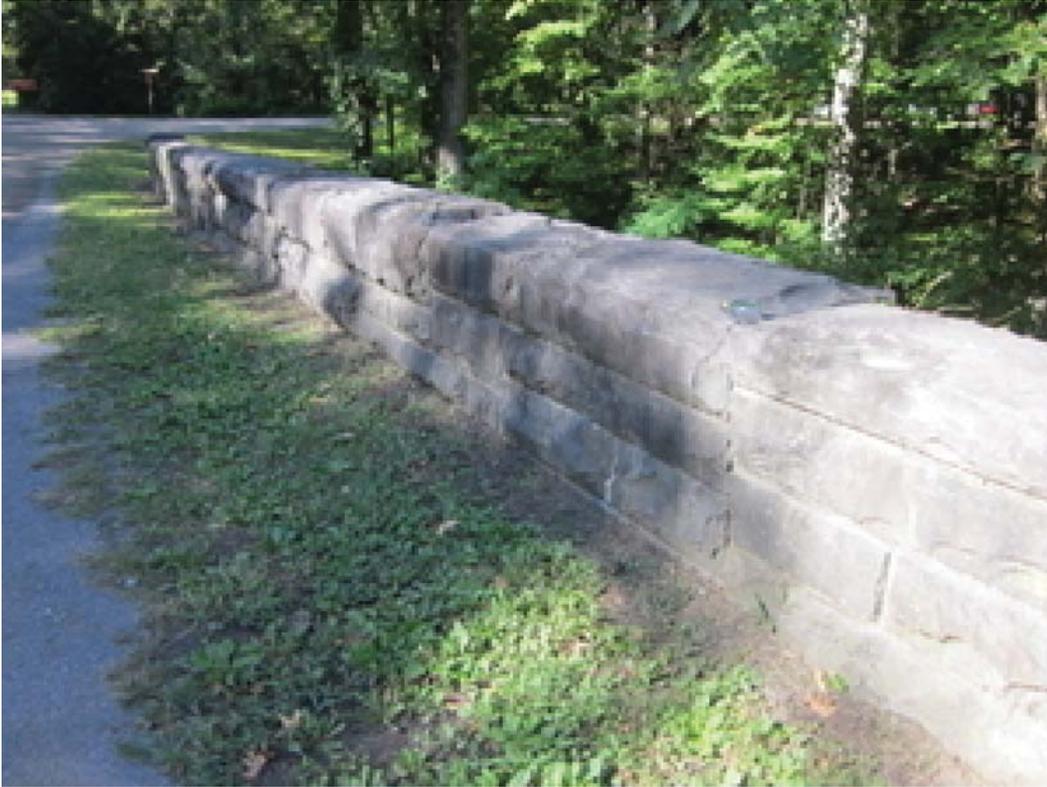
GRSM_0010N_1.534_R_1.JPG

Barrier ID:	GRSM-0010N-1.534-R				
Route Name:	NEWFOUND GAP ROAD NORTH				
Inspection Date:	09/15/2010	Barrier Rating:	21.20		
Barrier Description					
Type:	STONE MASONRY WITHOUT CONCRETE CORE WALL	Barrier Function:	TRAFFIC		
Barrier Material:	STONE	Post Material:	N/A		
Blockout Type:	N/A	Length (ft.):	51		
Speed Limit (MPH):	25	Placement with Respect to Road:	TANGENT		
Hazard Behind Barrier:	HIGH				
Barrier Crashworthiness					
Appropriate Test Level:	TL-1	Barrier Test Level:	NCW	Is Barrier Crashworthy?:	NO
Beg. End Trtmt Type:	NONE	Is Beg. End Trtmt Crashworthy?:	N/A	Approach Transition Type:	NONE
Ending End Trtmt Type:	NONE	Ending End Trtmt Crashworthy?:	N/A		
Average Measurements					
Design Height (In.):	24	Width (In.):	27.2	Post Spacing (In.):	0.0
Height (In.):	31.7	Lateral Offset (In.):	92.0	Road Grade (%):	1.20
Physical Condition					
Barrier	Alignment and Height:	Alignment has no deviation and the height is 7 to 9 in above the 24 in design height.

Breaking and Cracking:	No breaking or cracking observed.			
	Missing Elements:	No missing elements observed.			
	Corrosion and Weathering:	No corrosion or weathering observed.			
End Treatments	Alignment and Height:				
	Breaking and Cracking:				
	Missing Elements:				
	Corrosion and Weathering:

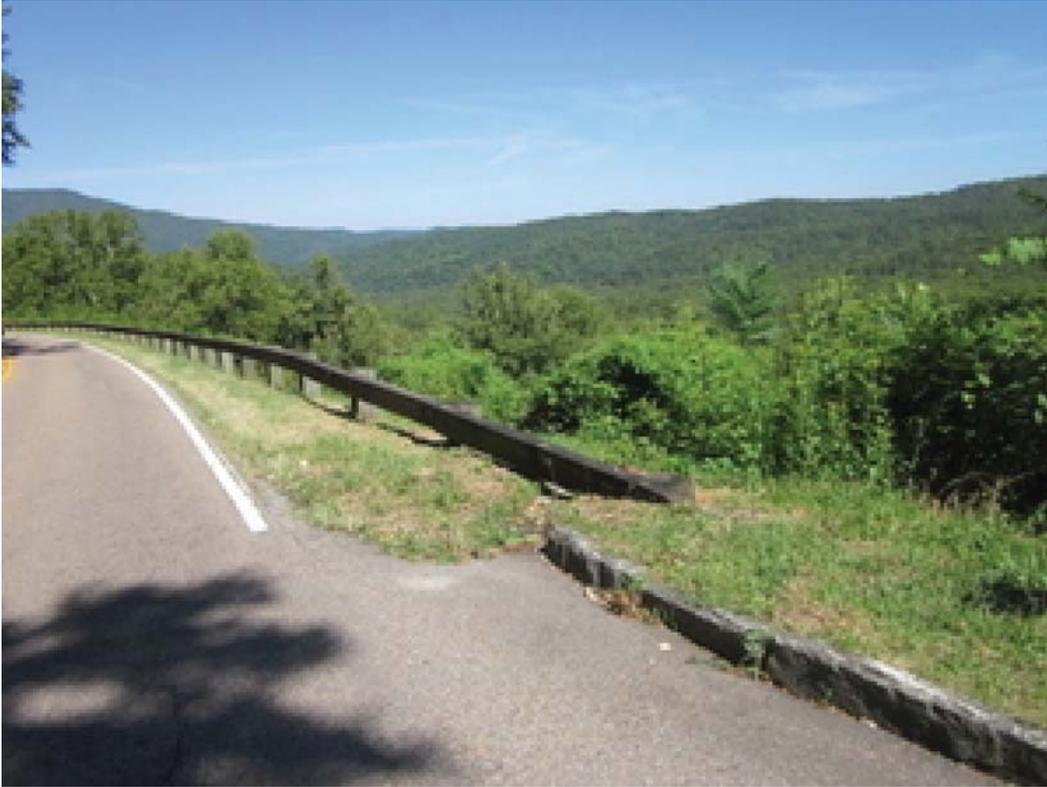
GRSM_0010N_3.646_L_1.JPG

Barrier ID:	GRSM-0010N-3.646-L				
Route Name:	NEWFOUND GAP ROAD NORTH				
Inspection Date:	09/15/2010	Barrier Rating:	47.20		
Barrier Description					
Type:	STEEL-BACKED TIMBER WITHOUT BLOCKOUT	Barrier Function:	TRAFFIC		
Barrier Material:	STEEL-BACKED TIMBER/LOG	Post Material:	WOOD		
Blockout Type:	N/A	Length (ft.):	860		
Speed Limit (MPH):	35	Placement with Respect to Road:	OUTSIDE OF CURVE		
Hazard Behind Barrier:	EXTREME				
Barrier Crashworthiness					
Appropriate Test Level:	TL-2	Barrier Test Level:	TL-2	Is Barrier Crashworthy?:	YES
Beg. End Trtmt Type:	SBT/LOG FLARED	Is Beg. End Trtmt Crashworthy?:	NO	Approach Transition Type:	NONE
Ending End Trtmt Type:	SBT/LOG FLARED	Ending End Trtmt Crashworthy?:	NO		
Average Measurements					
Design Height (In.):	27	Width (In.):	0.0	Post Spacing (In.):	119.5
Height (In.):	28.7	Lateral Offset (In.):	67.3	Road Grade (%):	5.60
Physical Condition					
Barrier	Alignment and Height:	Alignment has no deviation and the height is 1 to 6 in above the 27 in design height with 75 ft being 6 in above.

Breaking and Cracking:	No breaking or cracking observed.			
	Missing Elements:	No missing elements observed.			
	Corrosion and Weathering:	No corrosion or weathering observed.			
End Treatments	Alignment and Height:	Alignment acceptable. Height is within 1 in of the 27-in design height.			
	Breaking and Cracking:	No breaking or cracking observed.			
	Missing Elements:	No missing elements observed.			
	Corrosion and Weathering:	No corrosion or weathering observed.

Repair Action:	REPAIR	FMSS Work Type:	DEFERRED MAINTENANCE	Repair Cost:	\$2448
Brief Workorder:	Lower 75 feet of barrier down to the 27 inch design height.				
Workorder:	Adjust Guardrail at \$10- per -Lin. Ft. for 75 LF = \$750. Lower 75 feet of barrier down to 27 inch design height. Low Speed Traffic Control at \$1475- per -Day for 1 Day(s) = \$1475.

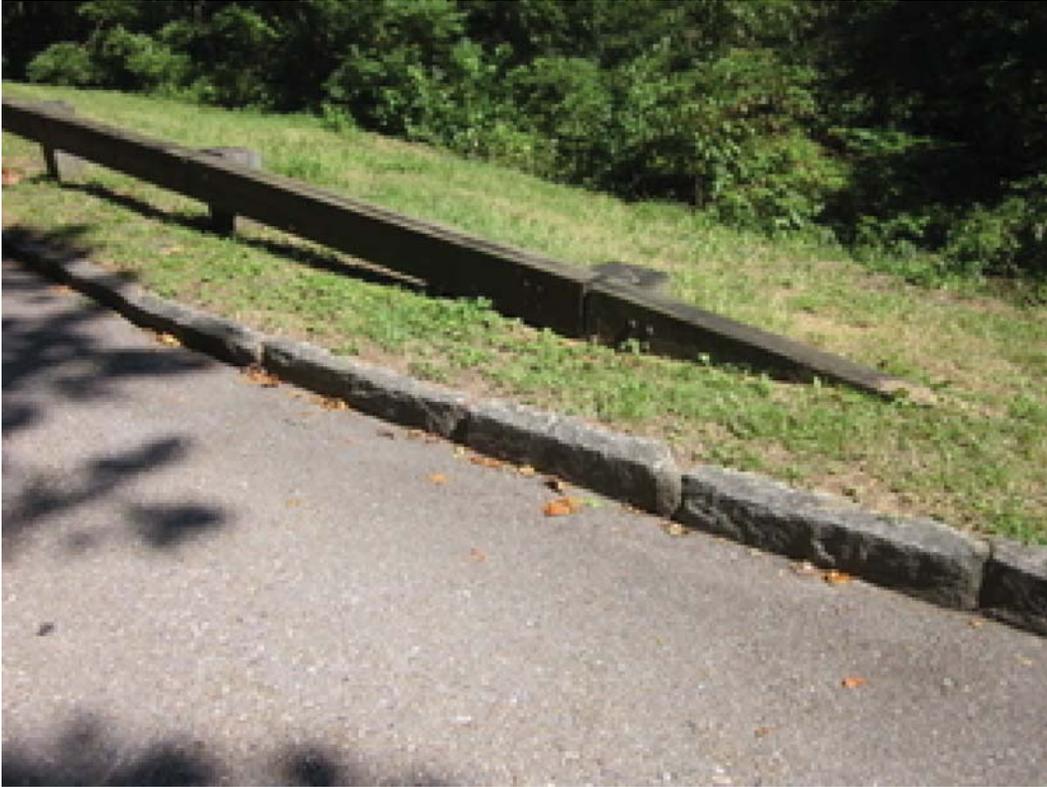
GRSM_0010N_3.932_L_1.JPG

Barrier ID:	GRSM-0010N-3.932-L				
Route Name:	NEWFOUND GAP ROAD NORTH				
Inspection Date:	09/15/2010	Barrier Rating:	32.40		
Barrier Description					
Type:	STEEL-BACKED TIMBER WITHOUT BLOCKOUT	Barrier Function:	TRAFFIC		
Barrier Material:	STEEL-BACKED TIMBER/LOG	Post Material:	WOOD		
Blockout Type:	N/A	Length (ft.):	118		
Speed Limit (MPH):	35	Placement with Respect to Road:	TANGENT		
Hazard Behind Barrier:	MEDIUM				
Barrier Crashworthiness					
Appropriate Test Level:	TL-2	Barrier Test Level:	TL-2	Is Barrier Crashworthy?:	YES
Beg. End Trtmt Type:	NONE	Is Beg. End Trtmt Crashworthy?:	N/A	Approach Transition Type:	NONE
Ending End Trtmt Type:	SBT/LOG FLARED	Ending End Trtmt Crashworthy?:	NO		
Average Measurements					
Design Height (In.):	27	Width (In.):	0.0	Post Spacing (In.):	120.0
Height (In.):	28.0	Lateral Offset (In.):	36.5	Road Grade (%):	4.10
Physical Condition					
Barrier	Alignment and Height:	Alignment has no deviation and the height is above by 1 in from the 27 in design height.

Breaking and Cracking:	No breaking or cracking observed.			
	Missing Elements:	No missing elements observed.			
	Corrosion and Weathering:	No corrosion or weathering observed.			
End Treatments	Alignment and Height:	Alignment acceptable. Height is within 1 in of the 27-in design height.			
	Breaking and Cracking:	No breaking or cracking observed.			
	Missing Elements:	No missing elements observed.			
	Corrosion and Weathering:	No corrosion or weathering observed.

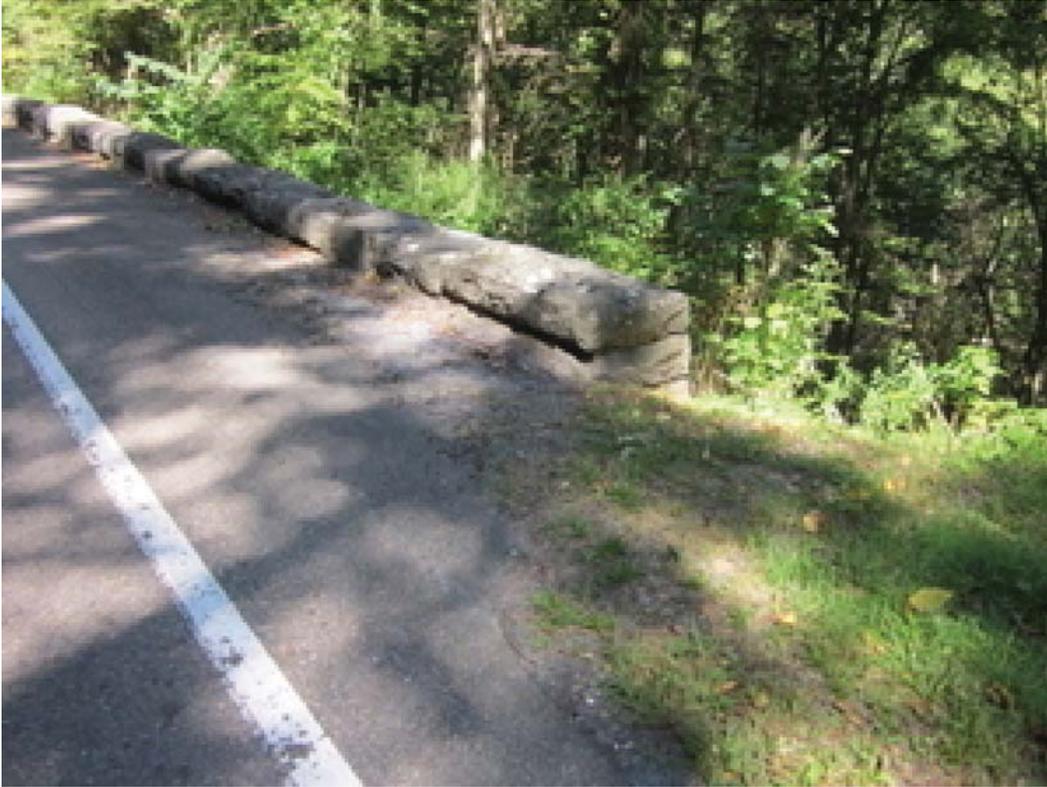
GRSM_0010N_5.927_L_1.JPG

Barrier ID:	GRSM-0010N-5.927-L				
Route Name:	NEWFOUND GAP ROAD NORTH				
Inspection Date:	09/15/2010	Barrier Rating:	62.90		
Barrier Description					
Type:	STONE MASONRY WITHOUT CONCRETE CORE WALL	Barrier Function:	TRAFFIC		
Barrier Material:	STONE	Post Material:	N/A		
Blockout Type:	N/A	Length (ft.):	167		
Speed Limit (MPH):	35	Placement with Respect to Road:	OUTSIDE OF CURVE		
Hazard Behind Barrier:	HIGH				
Barrier Crashworthiness					
Appropriate Test Level:	TL-2	Barrier Test Level:	NCW	Is Barrier Crashworthy?:	NO
Beg. End Trtmt Type:	NONE	Is Beg. End Trtmt Crashworthy?:	N/A	Approach Transition Type:	NONE
Ending End Trtmt Type:	NONE	Ending End Trtmt Crashworthy?:	N/A		
Average Measurements					
Design Height (In.):	24	Width (In.):	25.2	Post Spacing (In.):	0.0
Height (In.):	18.7	Lateral Offset (In.):	87.3	Road Grade (%):	5.40
Physical Condition					
Barrier	Alignment and Height:	Alignment has no deviation and the height is 3 to 6 in below the 24-in design height for 92 ft and 6 to 14 in below for 58 ft.

Breaking and Cracking:	No breaking or cracking observed.			
	Missing Elements:	No missing elements observed.			
	Corrosion and Weathering:	No corrosion or weathering observed.			
End Treatments	Alignment and Height:				
	Breaking and Cracking:				
	Missing Elements:				
	Corrosion and Weathering:

Repair Action:	REPAIR	FMSS Work Type:	DEFERRED MAINTENANCE	Repair Cost:	\$77990
Brief Workorder:	Raise guardwall 10-in. Remove and reset 58-ft of stone masonry guardwall on concrete footer to adjacent 18-in height.				
Workorder:	Remove & Reset Stone Masonry Guardwall at \$250- per -Cu. Ft. for 244 CF = \$61000. [(58ft)(2ft)(2.1ft)] = 243.6 CF. Structural Concrete at \$1000- per -Cu. Yd. for 4 CY = \$4000. [(2.1ft)(0.8ft)(58ft)] /27 = 3.6 CY. Low Speed Traffic Control at \$1475- per -Day for 4 Day(s) = \$5900. 1 day removal 3 days installation.

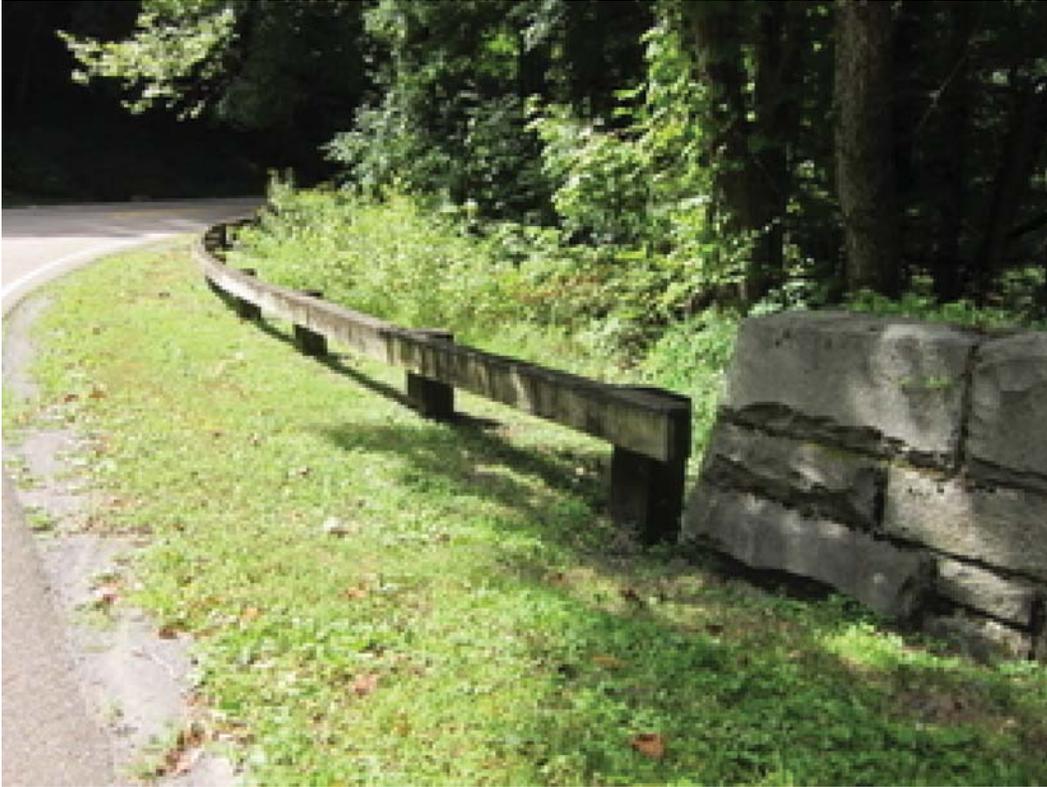
GRSM_0010N_6.144_L_1.JPG

Barrier ID:	GRSM-0010N-6.144-L				
Route Name:	NEWFOUND GAP ROAD NORTH				
Inspection Date:	09/15/2010	Barrier Rating:	64.30		
Barrier Description					
Type:	STEEL-BACKED TIMBER WITHOUT BLOCKOUT	Barrier Function:	TRAFFIC		
Barrier Material:	STEEL-BACKED TIMBER/LOG	Post Material:	WOOD		
Blockout Type:	N/A	Length (ft.):	640		
Speed Limit (MPH):	35	Placement with Respect to Road:	BOTH INSIDE AND OUTSIDE		
Hazard Behind Barrier:	HIGH				
Barrier Crashworthiness					
Appropriate Test Level:	TL-2	Barrier Test Level:	TL-2	Is Barrier Crashworthy?:	YES
Beg. End Trtmt Type:	NONE	Is Beg. End Trtmt Crashworthy?:	N/A	Approach Transition Type:	NONE
Ending End Trtmt Type:	NONE	Ending End Trtmt Crashworthy?:	N/A		
Average Measurements					
Design Height (In.):	27	Width (In.):	0.0	Post Spacing (In.):	120.0
Height (In.):	22.7	Lateral Offset (In.):	70.3	Road Grade (%):	2.00
Physical Condition					
Barrier	Alignment and Height:	Alignment has no deviation and the height is 2 to 3 in below the 27-in design height for 200 ft and 4 to 7 in below for 440 ft.

Breaking and Cracking:	20 ft of rail is severely broken and cracked.			
	Missing Elements:	No missing elements observed. No missing elements observed.			
	Corrosion and Weathering:	No corrosion or weathering observed.			
End Treatments	Alignment and Height:				
	Breaking and Cracking:				
	Missing Elements:				
	Corrosion and Weathering:

Repair Action:	REPAIR	FMSS Work Type:	DEFERRED MAINTENANCE	Repair Cost:	\$12458
Brief Workorder:	Raise 640 feet of guardrail up to the 27 inch design height and replace 20-ft of rail.				
Workorder:	Adjust Guardrail at \$10- per -Lin. Ft. for 640 LF = \$6400. Raise 640 feet of barrier up to 27-in design height. Replace Rail at \$25- per -Lin. Ft. for 20 LF = \$500. Low Speed Traffic Control at \$1475- per -Day for 3 Day(s) = \$4425.

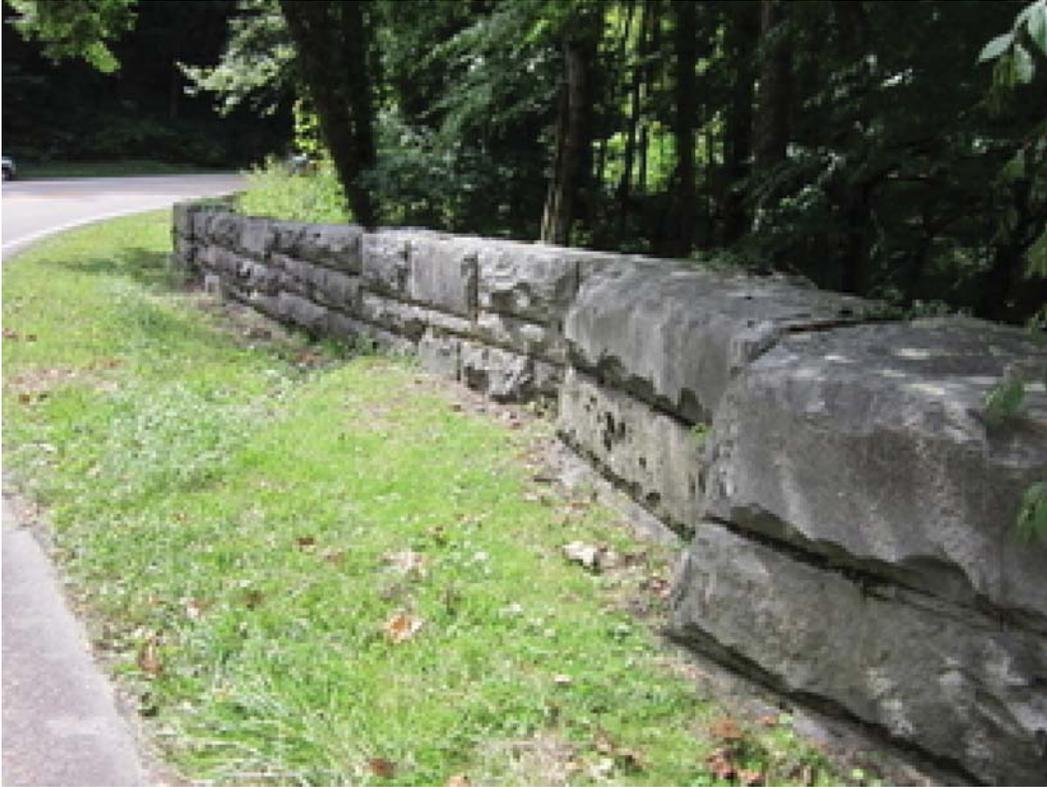
GRSM_0010N_6.271_L_1.JPG

Barrier ID:	GRSM-0010N-6.271-L				
Route Name:	NEWFOUND GAP ROAD NORTH				
Inspection Date:	09/15/2010	Barrier Rating:	33.70		
Barrier Description					
Type:	STONE MASONRY WITHOUT CONCRETE CORE WALL	Barrier Function:	TRAFFIC		
Barrier Material:	STONE	Post Material:	N/A		
Blockout Type:	N/A	Length (ft.):	33		
Speed Limit (MPH):	35	Placement with Respect to Road:	INSIDE OF CURVE		
Hazard Behind Barrier:	MEDIUM				
Barrier Crashworthiness					
Appropriate Test Level:	TL-2	Barrier Test Level:	NCW	Is Barrier Crashworthy?:	NO
Beg. End Trtmt Type:	NONE	Is Beg. End Trtmt Crashworthy?:	N/A	Approach Transition Type:	NONE
Ending End Trtmt Type:	NONE	Ending End Trtmt Crashworthy?:	N/A		
Average Measurements					
Design Height (In.):	24	Width (In.):	19.3	Post Spacing (In.):	0.0
Height (In.):	39.2	Lateral Offset (In.):	123.0	Road Grade (%):	1.40
Physical Condition					
Barrier	Alignment and Height:	Alignment has no deviation and the height is above the 24 in design height by 13 to 19 in.

Breaking and Cracking:	No breaking or cracking observed.			
	Missing Elements:	No missing elements observed.			
	Corrosion and Weathering:	No corrosion or weathering observed.			
End Treatments	Alignment and Height:				
	Breaking and Cracking:				
	Missing Elements:				
	Corrosion and Weathering:

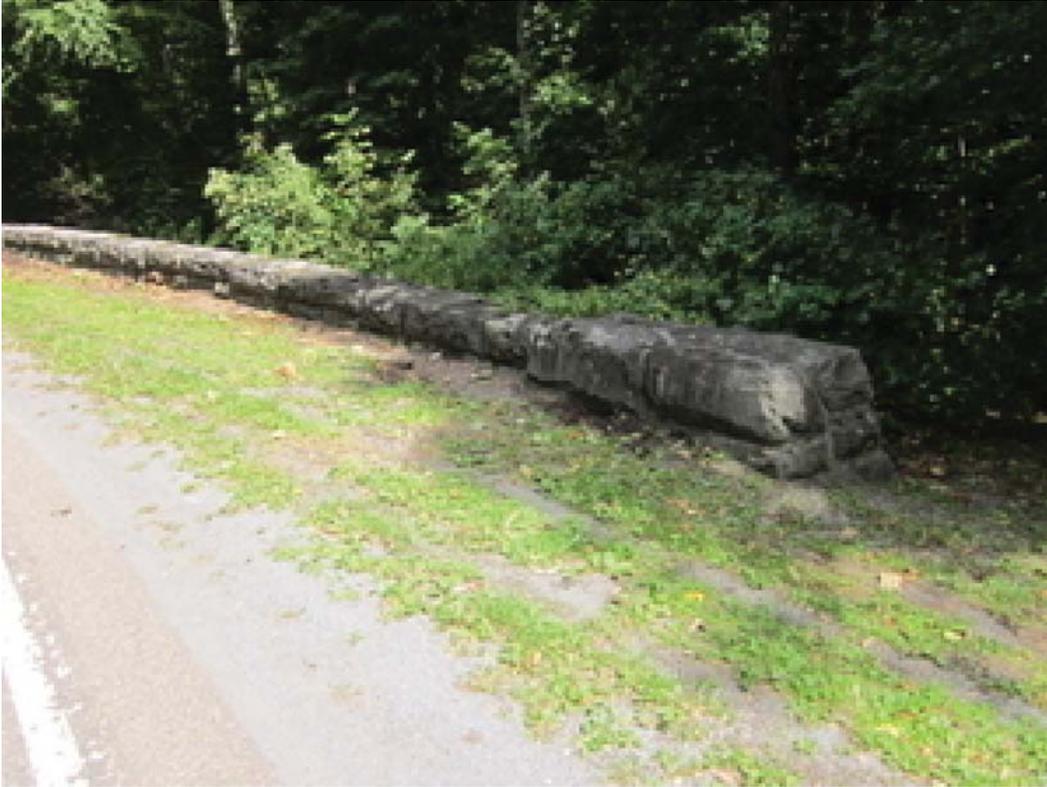
GRSM_0010N_6.275_R_1.JPG

Barrier ID:	GRSM-0010N-6.275-R				
Route Name:	NEWFOUND GAP ROAD NORTH				
Inspection Date:	09/15/2010	Barrier Rating:	41.20		
Barrier Description					
Type:	STONE MASONRY WITHOUT CONCRETE CORE WALL	Barrier Function:	TRAFFIC		
Barrier Material:	STONE	Post Material:	N/A		
Blockout Type:	N/A	Length (ft.):	52		
Speed Limit (MPH):	35	Placement with Respect to Road:	OUTSIDE OF CURVE		
Hazard Behind Barrier:	HIGH				
Barrier Crashworthiness					
Appropriate Test Level:	TL-2	Barrier Test Level:	NCW	Is Barrier Crashworthy?:	NO
Beg. End Trtmt Type:	NONE	Is Beg. End Trtmt Crashworthy?:	N/A	Approach Transition Type:	NONE
Ending End Trtmt Type:	NONE	Ending End Trtmt Crashworthy?:	N/A		
Average Measurements					
Design Height (In.):	24	Width (In.):	28.0	Post Spacing (In.):	0.0
Height (In.):	25.0	Lateral Offset (In.):	129.3	Road Grade (%):	1.00
Physical Condition					
Barrier	Alignment and Height:	Alignment has no deviation and the height is 0-3 in above the 24 in design height.

Breaking and Cracking:	No breaking or cracking observed.			
	Missing Elements:	No missing elements observed.			
	Corrosion and Weathering:	No corrosion or weathering observed.			
End Treatments	Alignment and Height:				
	Breaking and Cracking:				
	Missing Elements:				
	Corrosion and Weathering:

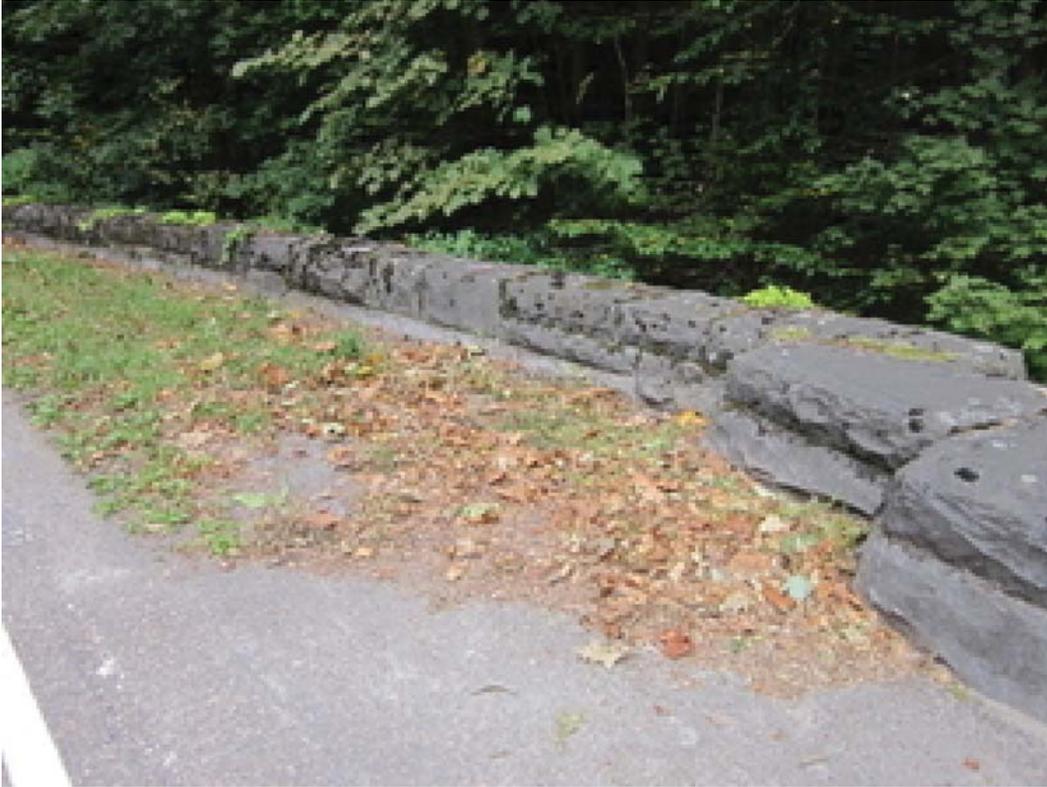
GRSM_0010N_6.303_R_1.JPG

Barrier ID:	GRSM-0010N-6.303-R				
Route Name:	NEWFOUND GAP ROAD NORTH				
Inspection Date:	09/14/2010	Barrier Rating:	34.20		
Barrier Description					
Type:	STONE MASONRY WITHOUT CONCRETE CORE WALL	Barrier Function:	TRAFFIC		
Barrier Material:	STONE	Post Material:	N/A		
Blockout Type:	N/A	Length (ft.):	54		
Speed Limit (MPH):	35	Placement with Respect to Road:	BOTH INSIDE AND OUTSIDE		
Hazard Behind Barrier:	HIGH				
Barrier Crashworthiness					
Appropriate Test Level:	TL-2	Barrier Test Level:	NCW	Is Barrier Crashworthy?:	NO
Beg. End Trtmt Type:	NONE	Is Beg. End Trtmt Crashworthy?:	N/A	Approach Transition Type:	NONE
Ending End Trtmt Type:	NONE	Ending End Trtmt Crashworthy?:	N/A		
Average Measurements					
Design Height (In.):	24	Width (In.):	26.2	Post Spacing (In.):	0.0
Height (In.):	24.0	Lateral Offset (In.):	124.6	Road Grade (%):	0.90
Physical Condition					
Barrier	Alignment and Height:	Alignment has no deviation and the height is at the 24 in design height.

Breaking and Cracking:	No breaking or cracking observed.			
	Missing Elements:	No missing elements observed.			
	Corrosion and Weathering:	No corrosion or weathering observed.			
End Treatments	Alignment and Height:				
	Breaking and Cracking:				
	Missing Elements:				
	Corrosion and Weathering:

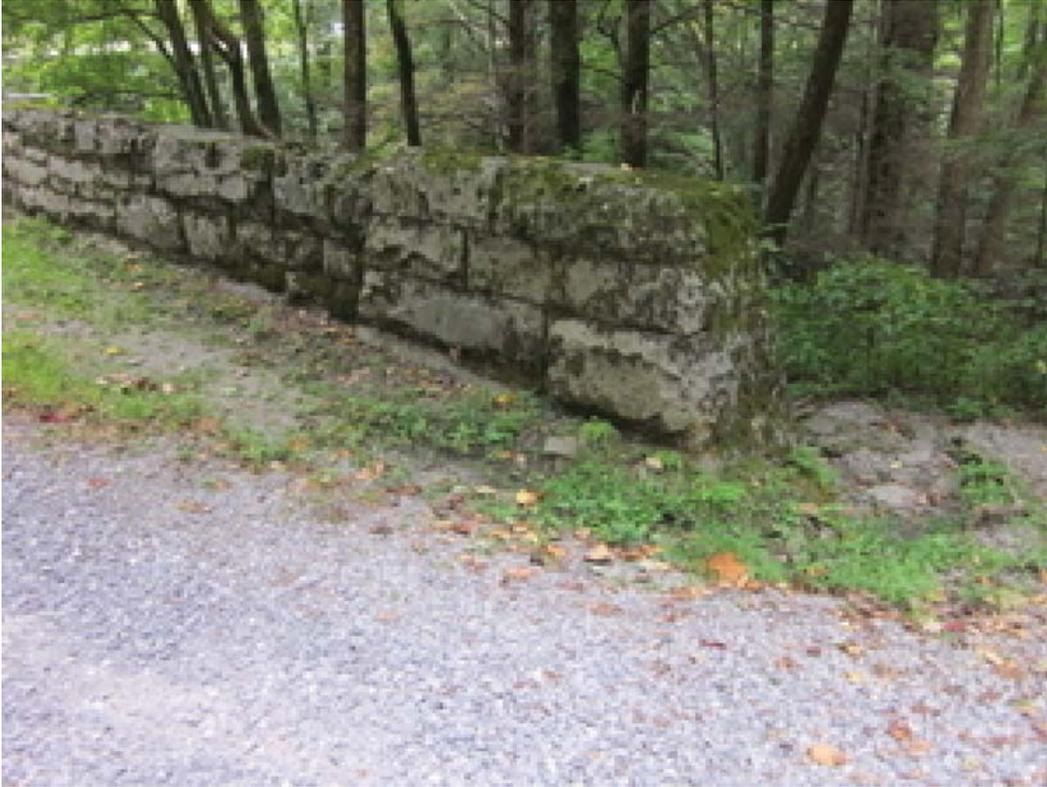
GRSM_0010N_6.308_L_1.JPG

Barrier ID:	GRSM-0010N-6.308-L				
Route Name:	NEWFOUND GAP ROAD NORTH				
Inspection Date:	09/15/2010	Barrier Rating:	26.70		
Barrier Description					
Type:	STONE MASONRY WITHOUT CONCRETE CORE WALL	Barrier Function:	TRAFFIC		
Barrier Material:	STONE	Post Material:	N/A		
Blockout Type:	N/A	Length (ft.):	32		
Speed Limit (MPH):	35	Placement with Respect to Road:	INSIDE OF CURVE		
Hazard Behind Barrier:	MEDIUM				
Barrier Crashworthiness					
Appropriate Test Level:	TL-2	Barrier Test Level:	NCW	Is Barrier Crashworthy?:	NO
Beg. End Trtmt Type:	NONE	Is Beg. End Trtmt Crashworthy?:	N/A	Approach Transition Type:	NONE
Ending End Trtmt Type:	NONE	Ending End Trtmt Crashworthy?:	N/A		
Average Measurements					
Design Height (In.):	24	Width (In.):	21.6	Post Spacing (In.):	0.0
Height (In.):	42.0	Lateral Offset (In.):	131.0	Road Grade (%):	0.30
Physical Condition					
Barrier	Alignment and Height:	Alignment has no deviation and the height is 16 to 21 in above the 24 in design height.

Breaking and Cracking:	No breaking or cracking observed.			
	Missing Elements:	No missing elements observed.			
	Corrosion and Weathering:	No corrosion and weathering observed.			
End Treatments	Alignment and Height:				
	Breaking and Cracking:				
	Missing Elements:				
	Corrosion and Weathering:
