NPS Guardwall/Rail Inventory Program
Great Smoky Mountains National Park

Federal Highway Administration
Eastern Federal Lands Highway Division
Road Inventory Program (RIP)

Data Collection Date: September 2010
Report Date: December 2015

Great Smoky Mountains National Park in North Carolina and Tennessee

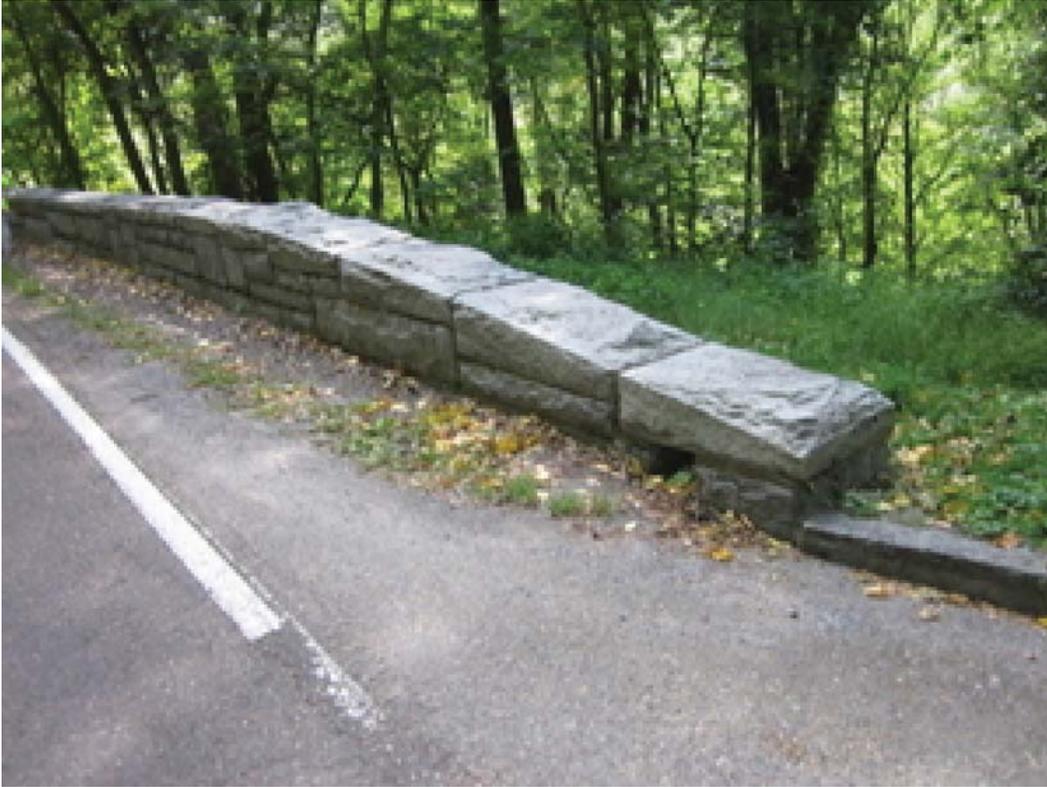
GRSM_0010N_6.998_R_1.JPG

Barrier ID:	GRSM-0010N-6.998-R				
Route Name:	NEWFOUND GAP ROAD NORTH				
Inspection Date:	09/15/2010	Barrier Rating:	45.90		
Barrier Description					
Type:	STONE MASONRY WITHOUT CONCRETE CORE WALL	Barrier Function:	TRAFFIC		
Barrier Material:	STONE	Post Material:	N/A		
Blockout Type:	N/A	Length (ft.):	483		
Speed Limit (MPH):	35	Placement with Respect to Road:	OUTSIDE OF CURVE		
Hazard Behind Barrier:	EXTREME				
Barrier Crashworthiness					
Appropriate Test Level:	TL-2	Barrier Test Level:	NCW	Is Barrier Crashworthy?:	NO
Beg. End Trtmt Type:	NONE	Is Beg. End Trtmt Crashworthy?:	N/A	Approach Transition Type:	NONE
Ending End Trtmt Type:	NONE	Ending End Trtmt Crashworthy?:	N/A		
Average Measurements					
Design Height (In.):	24	Width (In.):	26.0	Post Spacing (In.):	0.0
Height (In.):	36.0	Lateral Offset (In.):	72.3	Road Grade (%):	4.70
Physical Condition					
Barrier	Alignment and Height:	Alignment has no deviation and the height is 10 to 14 in above the 24 in design height.

Breaking and Cracking:	18 ft of major breaking and cracking due to land shifting.			
	Missing Elements:	No missing elements observed.			
	Corrosion and Weathering:	No corrosion or weathering observed.			
End Treatments	Alignment and Height:				
	Breaking and Cracking:				
	Missing Elements:				
	Corrosion and Weathering:

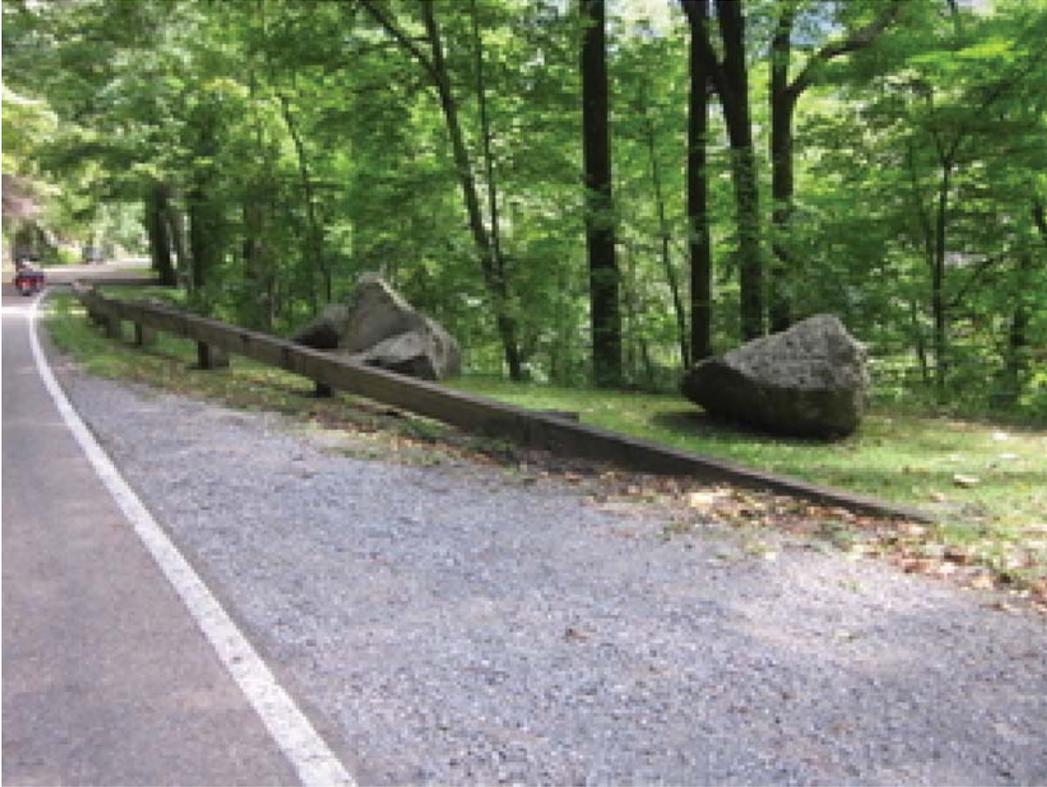
GRSM_0010N_8.225_R_1.JPG

Barrier ID:	GRSM-0010N-8.225-R				
Route Name:	NEWFOUND GAP ROAD NORTH				
Inspection Date:	09/15/2010	Barrier Rating:	32.70		
Barrier Description					
Type:	STEEL-BACKED TIMBER WITHOUT BLOCKOUT	Barrier Function:	TRAFFIC		
Barrier Material:	STEEL-BACKED TIMBER/LOG	Post Material:	WOOD		
Blockout Type:	N/A	Length (ft.):	136		
Speed Limit (MPH):	35	Placement with Respect to Road:	INSIDE OF CURVE		
Hazard Behind Barrier:	HIGH				
Barrier Crashworthiness					
Appropriate Test Level:	TL-2	Barrier Test Level:	TL-2	Is Barrier Crashworthy?:	YES
Beg. End Trtmt Type:	SBT/LOG FLARED	Is Beg. End Trtmt Crashworthy?:	NO	Approach Transition Type:	NONE
Ending End Trtmt Type:	SBT/LOG FLARED	Ending End Trtmt Crashworthy?:	NO		
Average Measurements					
Design Height (In.):	27	Width (In.):	0.0	Post Spacing (In.):	120.0
Height (In.):	27.0	Lateral Offset (In.):	38.0	Road Grade (%):	6.60
Physical Condition					
Barrier	Alignment and Height:	Alignment has no deviation and the height is at the 27 in design height.

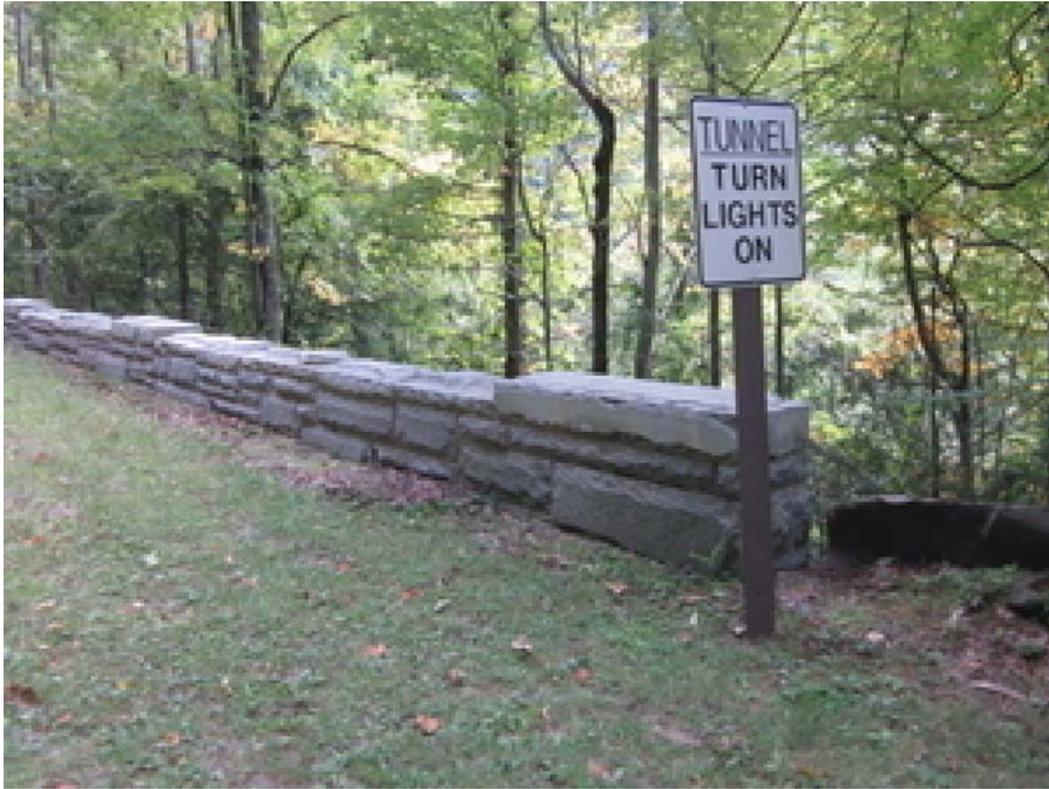
GRSM_0010N_8.392_R_1.JPG

Barrier ID:	GRSM-0010N-8.392-R				
Route Name:	NEWFOUND GAP ROAD NORTH				
Inspection Date:	09/15/2010	Barrier Rating:	44.20		
Barrier Description					
Type:	STONE MASONRY CRENELLATED WITHOUT	Barrier Function:	TRAFFIC		
Barrier Material:	STONE	Post Material:	N/A		
Blockout Type:	N/A	Length (ft.):	436		
Speed Limit (MPH):	35	Placement with Respect to Road:	OUTSIDE OF CURVE		
Hazard Behind Barrier:	HIGH				
Barrier Crashworthiness					
Appropriate Test Level:	TL-2	Barrier Test Level:	NCW	Is Barrier Crashworthy?:	NO
Beg. End Trtmt Type:	NONE	Is Beg. End Trtmt Crashworthy?:	N/A	Approach Transition Type:	NONE
Ending End Trtmt Type:	NONE	Ending End Trtmt Crashworthy?:	N/A		
Average Measurements					
Design Height (In.):	21	Width (In.):	26.0	Post Spacing (In.):	0.0
Height (In.):	27.0	Lateral Offset (In.):	115.0	Road Grade (%):	5.80
Physical Condition					
Barrier	Alignment and Height:	Alignment has no deviation and the height is 6 in above the 21/24 in crenellated design height.

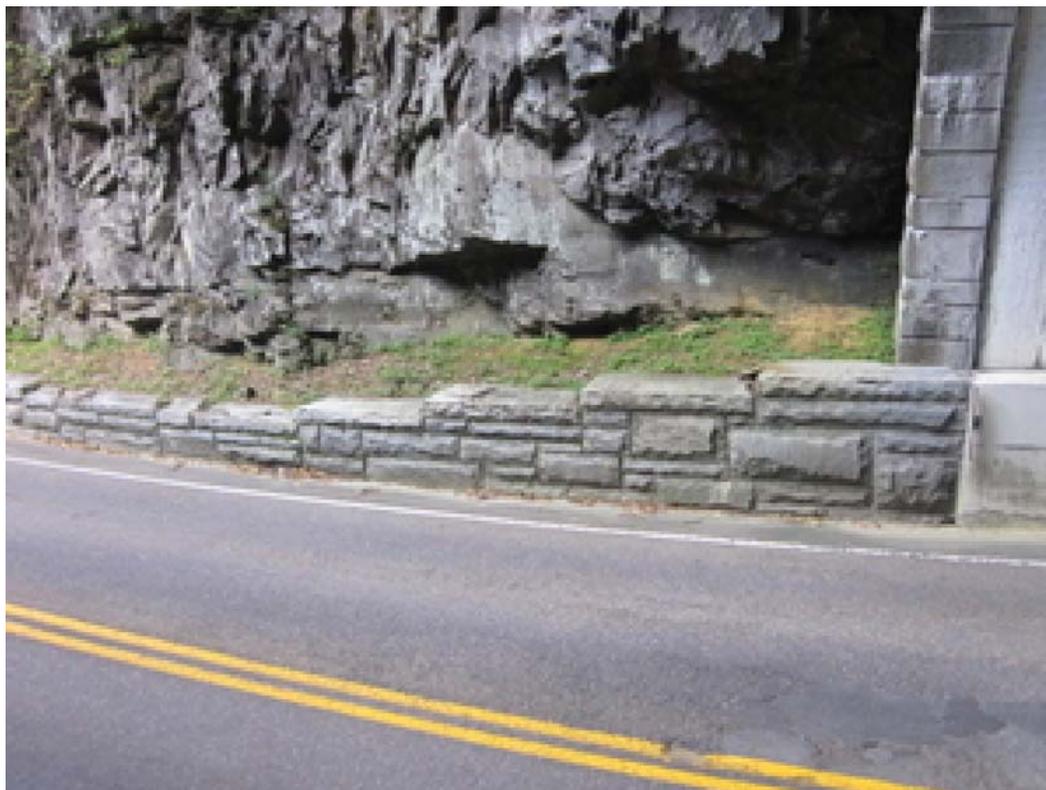
GRSM_0010N_8.446_L_1.JPG

Barrier ID:	GRSM-0010N-8.446-L				
Route Name:	NEWFOUND GAP ROAD NORTH				
Inspection Date:	09/15/2010	Barrier Rating:	42.70		
Barrier Description					
Type:	STONE MASONRY CRENELLATED WITHOUT	Barrier Function:	TRAFFIC		
Barrier Material:	STONE	Post Material:	N/A		
Blockout Type:	N/A	Length (ft.):	152		
Speed Limit (MPH):	35	Placement with Respect to Road:	INSIDE OF CURVE		
Hazard Behind Barrier:	LOW				
Barrier Crashworthiness					
Appropriate Test Level:	TL-2	Barrier Test Level:	NCW	Is Barrier Crashworthy?:	NO
Beg. End Trtmt Type:	NONE	Is Beg. End Trtmt Crashworthy?:	N/A	Approach Transition Type:	NONE
Ending End Trtmt Type:	NONE	Ending End Trtmt Crashworthy?:	N/A		
Average Measurements					
Design Height (In.):	21	Width (In.):	24.0	Post Spacing (In.):	0.0
Height (In.):	26.0	Lateral Offset (In.):	26.7	Road Grade (%):	6.30
Physical Condition					
Barrier	Alignment and Height:	Alignment has no deviation and the height is 5 in above the 21/24 in crenellated design height.

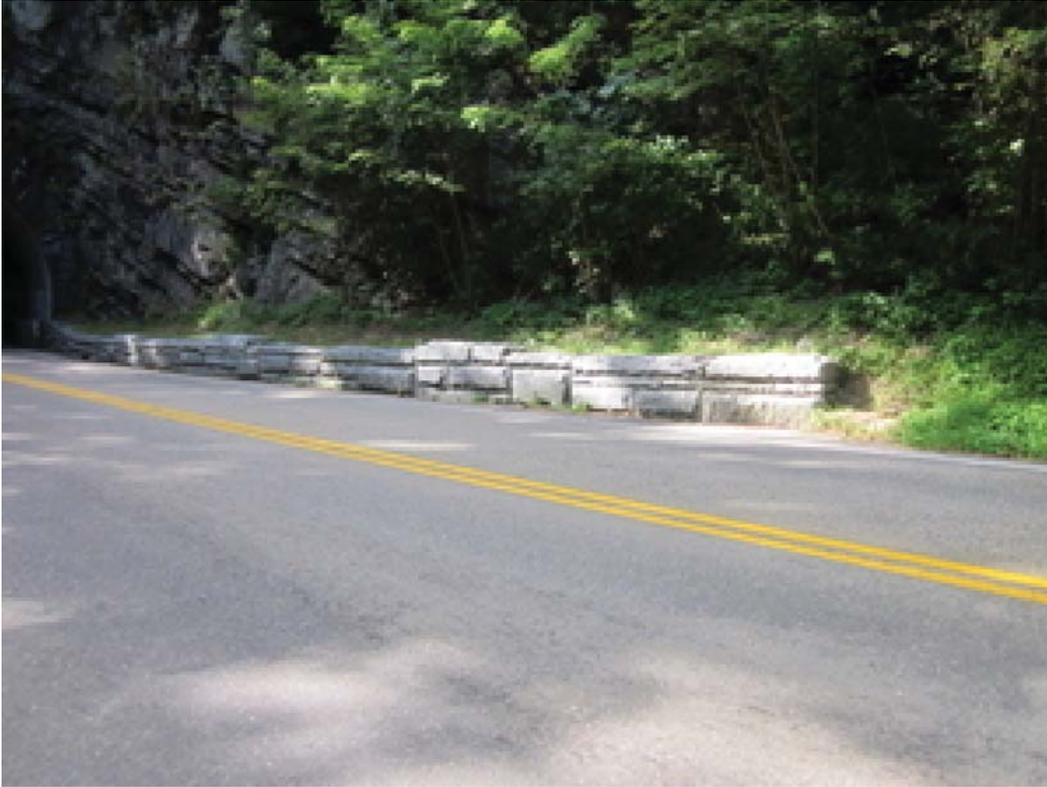
GRSM_0010N_8.521_L_1.JPG

Barrier ID:	GRSM-0010N-8.521-L				
Route Name:	NEWFOUND GAP ROAD NORTH				
Inspection Date:	09/15/2010	Barrier Rating:	42.70		
Barrier Description					
Type:	STONE MASONRY CRENELLATED WITHOUT	Barrier Function:	TRAFFIC		
Barrier Material:	STONE	Post Material:	N/A		
Blockout Type:	N/A	Length (ft.):	111		
Speed Limit (MPH):	35	Placement with Respect to Road:	INSIDE OF CURVE		
Hazard Behind Barrier:	LOW				
Barrier Crashworthiness					
Appropriate Test Level:	TL-2	Barrier Test Level:	NCW	Is Barrier Crashworthy?:	NO
Beg. End Trtmt Type:	NONE	Is Beg. End Trtmt Crashworthy?:	N/A	Approach Transition Type:	NONE
Ending End Trtmt Type:	NONE	Ending End Trtmt Crashworthy?:	N/A		
Average Measurements					
Design Height (In.):	21	Width (In.):	26.2	Post Spacing (In.):	0.0
Height (In.):	30.0	Lateral Offset (In.):	27.7	Road Grade (%):	6.80
Physical Condition					
Barrier	Alignment and Height:	Alignment has no deviation and the height is 9 in above the 21/24 in crenellated design height.

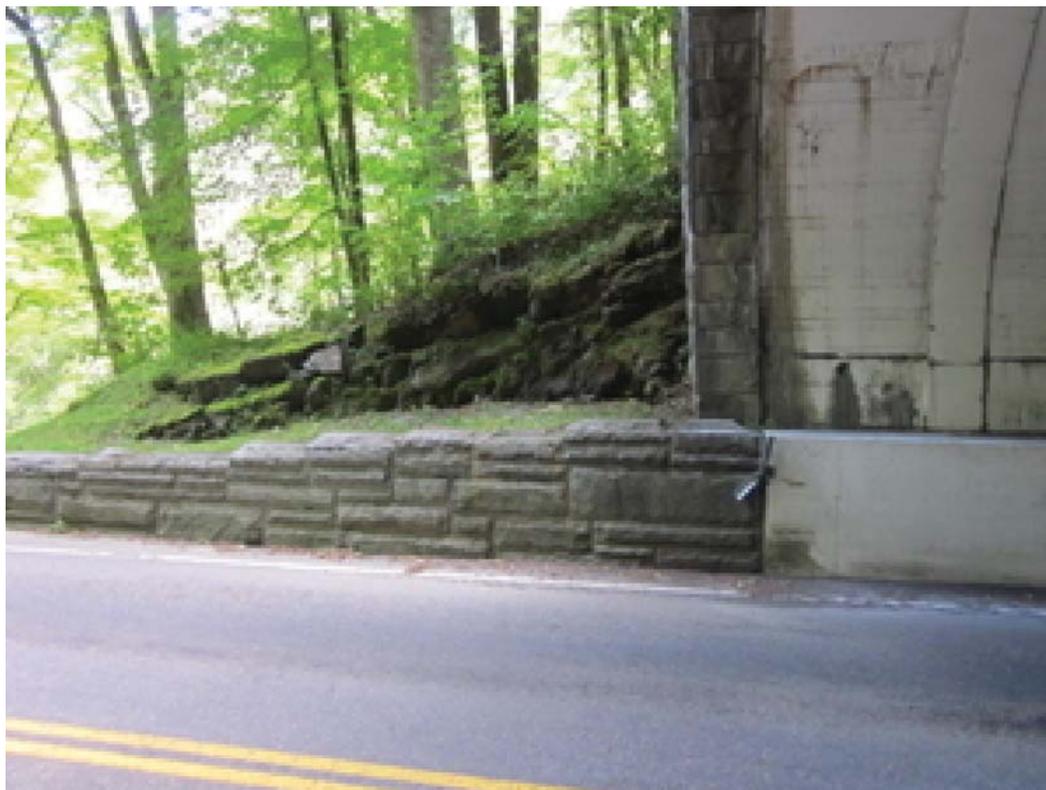
GRSM_0010N_8.522_R_1.JPG

Barrier ID:	GRSM-0010N-8.522-R				
Route Name:	NEWFOUND GAP ROAD NORTH				
Inspection Date:	09/15/2010	Barrier Rating:	37.00		
Barrier Description					
Type:	STONE MASONRY CRENELLATED WITHOUT	Barrier Function:	TRAFFIC		
Barrier Material:	STONE	Post Material:	N/A		
Blockout Type:	N/A	Length (ft.):	110		
Speed Limit (MPH):	35	Placement with Respect to Road:	OUTSIDE OF CURVE		
Hazard Behind Barrier:	LOW				
Barrier Crashworthiness					
Appropriate Test Level:	TL-2	Barrier Test Level:	NCW	Is Barrier Crashworthy?:	NO
Beg. End Trtmt Type:	NONE	Is Beg. End Trtmt Crashworthy?:	N/A	Approach Transition Type:	NONE
Ending End Trtmt Type:	NONE	Ending End Trtmt Crashworthy?:	N/A		
Average Measurements					
Design Height (In.):	21	Width (In.):	28.0	Post Spacing (In.):	0.0
Height (In.):	32.0	Lateral Offset (In.):	82.0	Road Grade (%):	3.70
Physical Condition					
Barrier	Alignment and Height:	Alignment has no deviation and the height is 11 in above the 21/24 in crenellated design height.

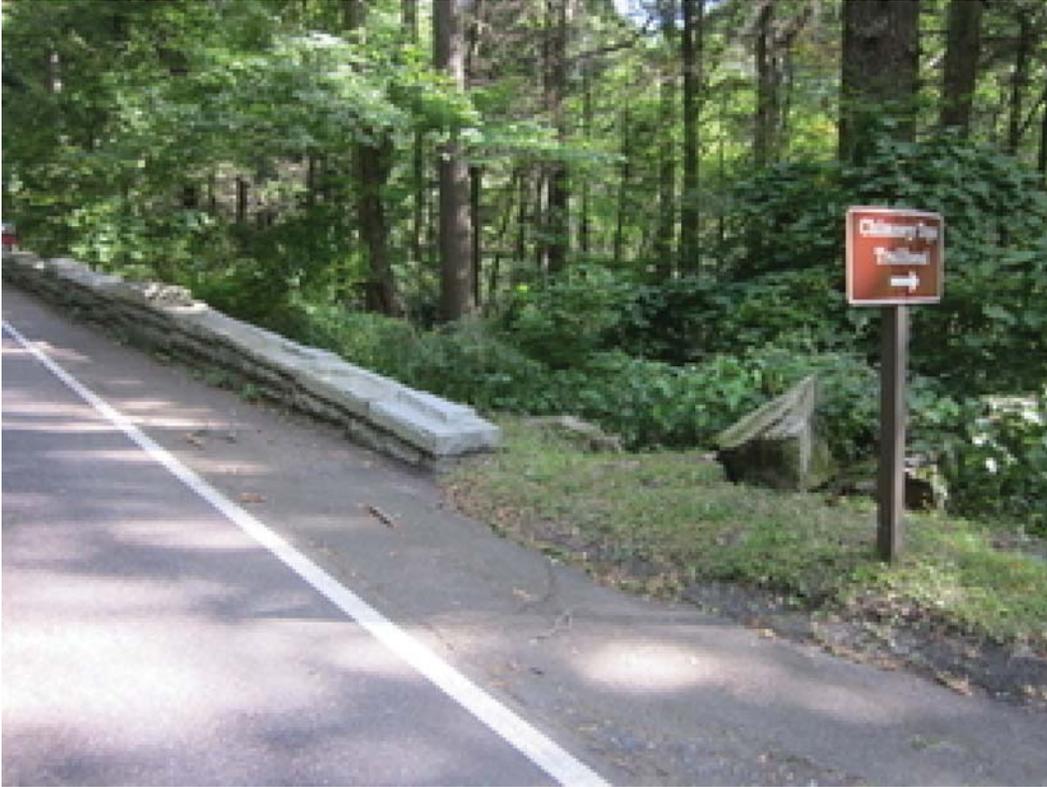
GRSM_0010N_8.654_R_1.JPG

Barrier ID:	GRSM-0010N-8.654-R				
Route Name:	NEWFOUND GAP ROAD NORTH				
Inspection Date:	09/15/2010	Barrier Rating:	30.80		
Barrier Description					
Type:	STONE MASONRY CRENELLATED WITHOUT	Barrier Function:	TRAFFIC		
Barrier Material:	STONE	Post Material:	N/A		
Blockout Type:	N/A	Length (ft.):	134		
Speed Limit (MPH):	35	Placement with Respect to Road:	TANGENT		
Hazard Behind Barrier:	MEDIUM				
Barrier Crashworthiness					
Appropriate Test Level:	TL-2	Barrier Test Level:	NCW	Is Barrier Crashworthy?:	NO
Beg. End Trtmt Type:	NONE	Is Beg. End Trtmt Crashworthy?:	N/A	Approach Transition Type:	NONE
Ending End Trtmt Type:	NONE	Ending End Trtmt Crashworthy?:	N/A		
Average Measurements					
Design Height (In.):	21	Width (In.):	25.0	Post Spacing (In.):	0.0
Height (In.):	30.0	Lateral Offset (In.):	51.0	Road Grade (%):	7.70
Physical Condition					
Barrier	Alignment and Height:	Alignment has no deviation and the height is 9 in above the 21-in/24-in crenellated design height.

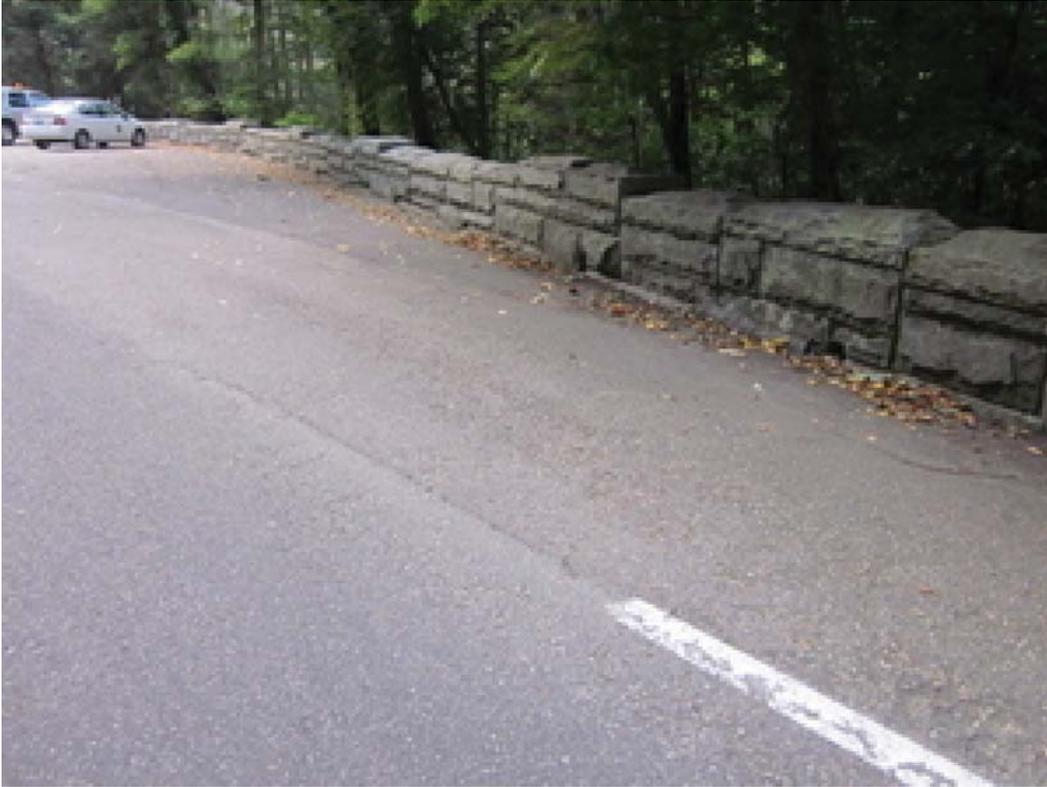
GRSM_0010N_8.676_R_1.JPG

Barrier ID:	GRSM-0010N-8.676-R				
Route Name:	NEWFOUND GAP ROAD NORTH				
Inspection Date:	09/16/2010	Barrier Rating:	8.60		
Barrier Description					
Type:	STONE MASONRY CRENELLATED WITHOUT	Barrier Function:	NON-TRAFFIC		
Barrier Material:	STONE	Post Material:	N/A		
Blockout Type:	N/A	Length (ft.):	158		
Speed Limit (MPH):	15	Placement with Respect to Road:	NON-TRAFFIC BARRIER		
Hazard Behind Barrier:	N/A				
Barrier Crashworthiness					
Appropriate Test Level:	TL-1	Barrier Test Level:	N/A	Is Barrier Crashworthy?:	N/A
Beg. End Trtmt Type:	NONE	Is Beg. End Trtmt Crashworthy?:	N/A	Approach Transition Type:	NONE
Ending End Trtmt Type:	NONE	Ending End Trtmt Crashworthy?:	N/A		
Average Measurements					
Design Height (In.):	21	Width (In.):	25.7	Post Spacing (In.):	0.0
Height (In.):	26.7	Lateral Offset (In.):	0.0	Road Grade (%):	0.00
Physical Condition					
Barrier	Alignment and Height:	Alignment has no deviation and the height is 5 to 7 in above the 21-in/24-in crenellated design height.

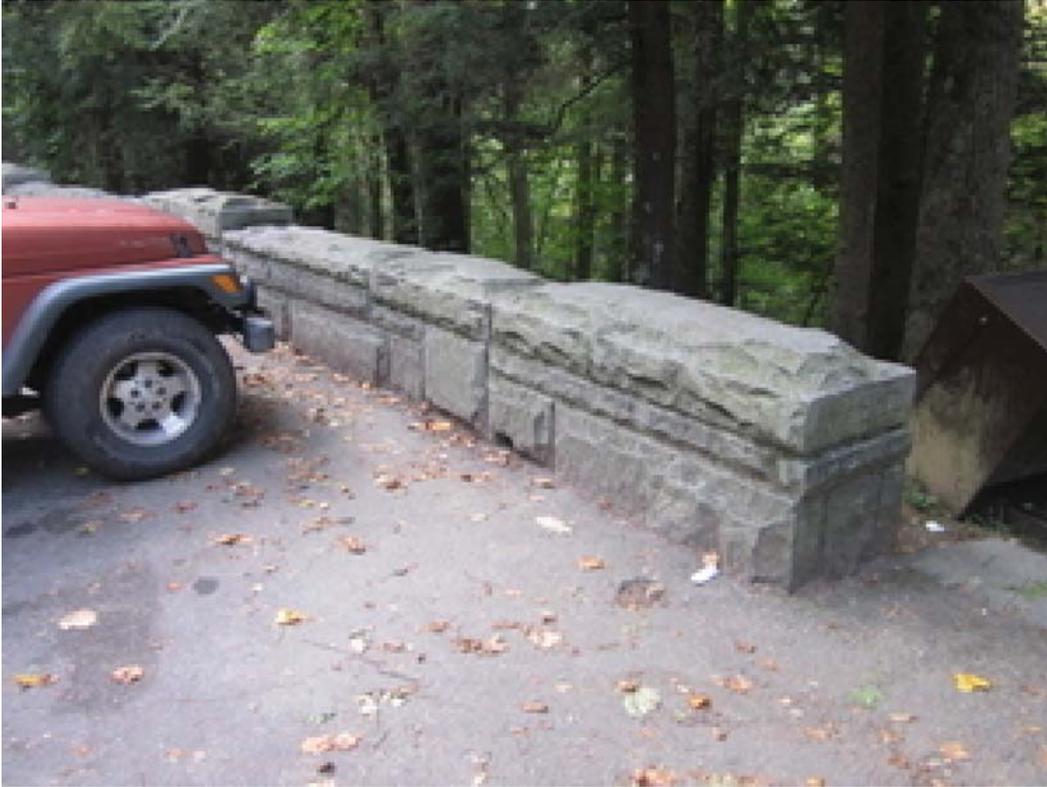
GRSM_0010N_8.710_R_1.JPG

Barrier ID:	GRSM-0010N-8.710-R				
Route Name:	NEWFOUND GAP ROAD NORTH				
Inspection Date:	09/16/2010	Barrier Rating:	8.60		
Barrier Description					
Type:	STONE MASONRY CRENELLATED WITHOUT	Barrier Function:	NON-TRAFFIC		
Barrier Material:	STONE	Post Material:	N/A		
Blockout Type:	N/A	Length (ft.):	154		
Speed Limit (MPH):	15	Placement with Respect to Road:	NON-TRAFFIC BARRIER		
Hazard Behind Barrier:	N/A				
Barrier Crashworthiness					
Appropriate Test Level:	TL-1	Barrier Test Level:	N/A	Is Barrier Crashworthy?:	N/A
Beg. End Trtmt Type:	NONE	Is Beg. End Trtmt Crashworthy?:	N/A	Approach Transition Type:	NONE
Ending End Trtmt Type:	NONE	Ending End Trtmt Crashworthy?:	N/A		
Average Measurements					
Design Height (In.):	21	Width (In.):	24.0	Post Spacing (In.):	0.0
Height (In.):	26.6	Lateral Offset (In.):	0.0	Road Grade (%):	0.00
Physical Condition					
Barrier	Alignment and Height:	Alignment has no deviation and the height is 5 to 6 in above the 21-in/24-in crenellated design height.

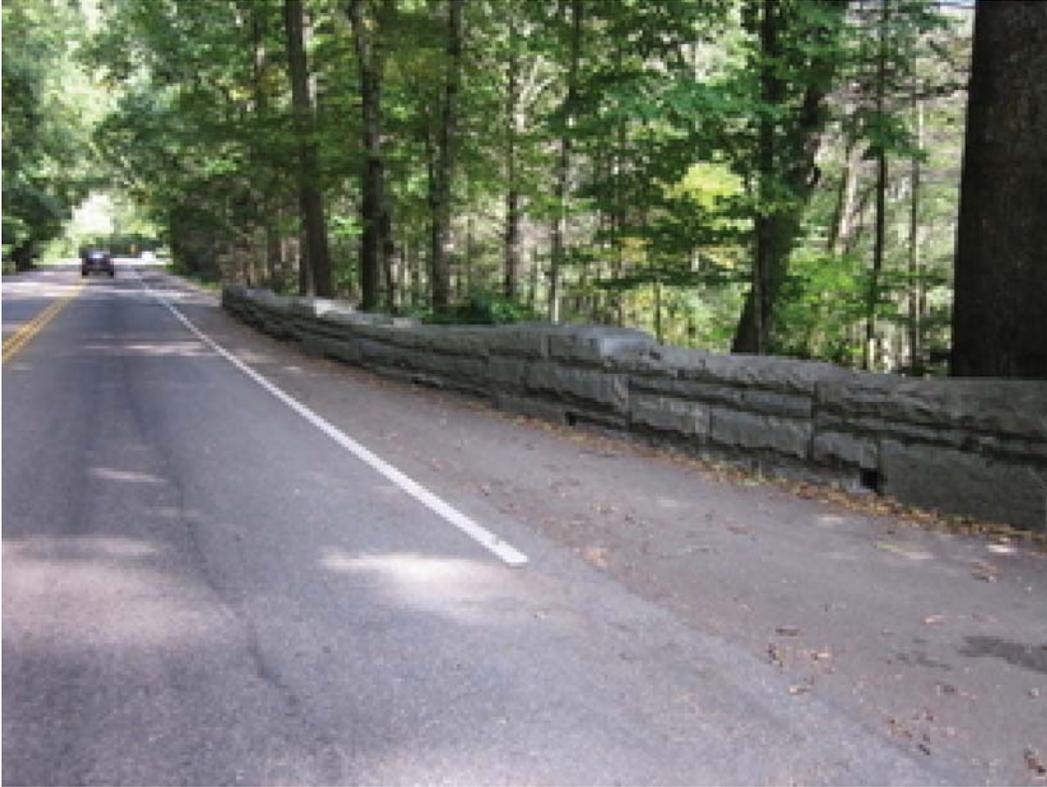
GRSM_0010N_8.740_R_1.JPG

Barrier ID:	GRSM-0010N-8.740-R				
Route Name:	NEWFOUND GAP ROAD NORTH				
Inspection Date:	09/15/2010		Barrier Rating:	44.20	
Barrier Description					
Type:	STONE MASONRY CRENELLATED WITHOUT		Barrier Function:	TRAFFIC	
Barrier Material:	STONE		Post Material:	N/A	
Blockout Type:	N/A		Length (ft.):	85	
Speed Limit (MPH):	35		Placement with Respect to Road:	OUTSIDE OF CURVE	
Hazard Behind Barrier:	HIGH				
Barrier Crashworthiness					
Appropriate Test Level:	TL-2	Barrier Test Level:	NCW	Is Barrier Crashworthy?:	NO
Beg. End Trtmt Type:	NONE	Is Beg. End Trtmt Crashworthy?:	N/A	Approach Transition Type:	NONE
Ending End Trtmt Type:	NONE	Ending End Trtmt Crashworthy?:	N/A		
Average Measurements					
Design Height (In.):	21	Width (In.):	25.0	Post Spacing (In.):	0.0
Height (In.):	28.0	Lateral Offset (In.):	48.0	Road Grade (%):	7.50
Physical Condition					
Barrier	Alignment and Height:	Alignment has no deviation and the height is 7 in above the 21-in/24-in crenellated design height.

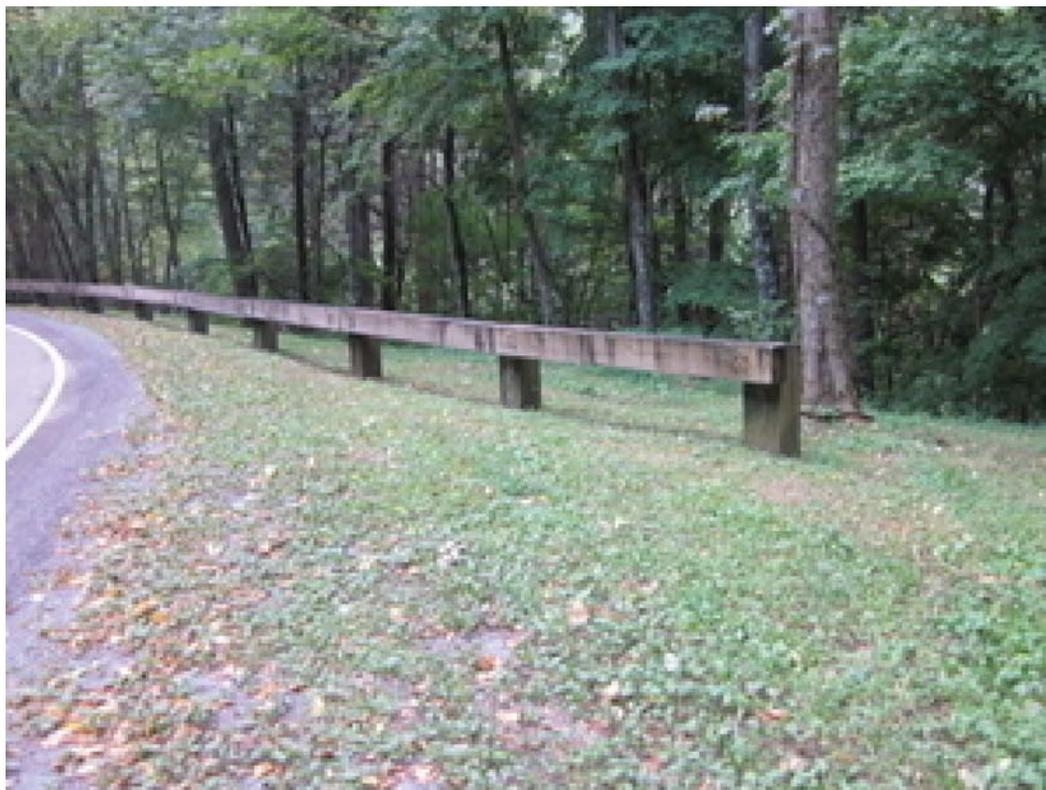
GRSM_0010N_9.030_R_1.JPG

Barrier ID:	GRSM-0010N-9.030-R				
Route Name:	NEWFOUND GAP ROAD NORTH				
Inspection Date:	09/16/2010	Barrier Rating:	38.50		
Barrier Description					
Type:	STEEL-BACKED TIMBER WITHOUT BLOCKOUT	Barrier Function:	TRAFFIC		
Barrier Material:	STEEL-BACKED TIMBER/LOG	Post Material:	WOOD		
Blockout Type:	N/A	Length (ft.):	392		
Speed Limit (MPH):	35	Placement with Respect to Road:	OUTSIDE OF CURVE		
Hazard Behind Barrier:	HIGH				
Barrier Crashworthiness					
Appropriate Test Level:	TL-2	Barrier Test Level:	TL-2	Is Barrier Crashworthy?:	YES
Beg. End Trtmt Type:	NONE	Is Beg. End Trtmt Crashworthy?:	N/A	Approach Transition Type:	NONE
Ending End Trtmt Type:	SBT/LOG FLARED	Ending End Trtmt Crashworthy?:	NO		
Average Measurements					
Design Height (In.):	27	Width (In.):	0.0	Post Spacing (In.):	120.0
Height (In.):	27.2	Lateral Offset (In.):	72.0	Road Grade (%):	5.30
Physical Condition					
Barrier	Alignment and Height:	Alignment has no deviation and the height is within 1 in of the 27 in design height.

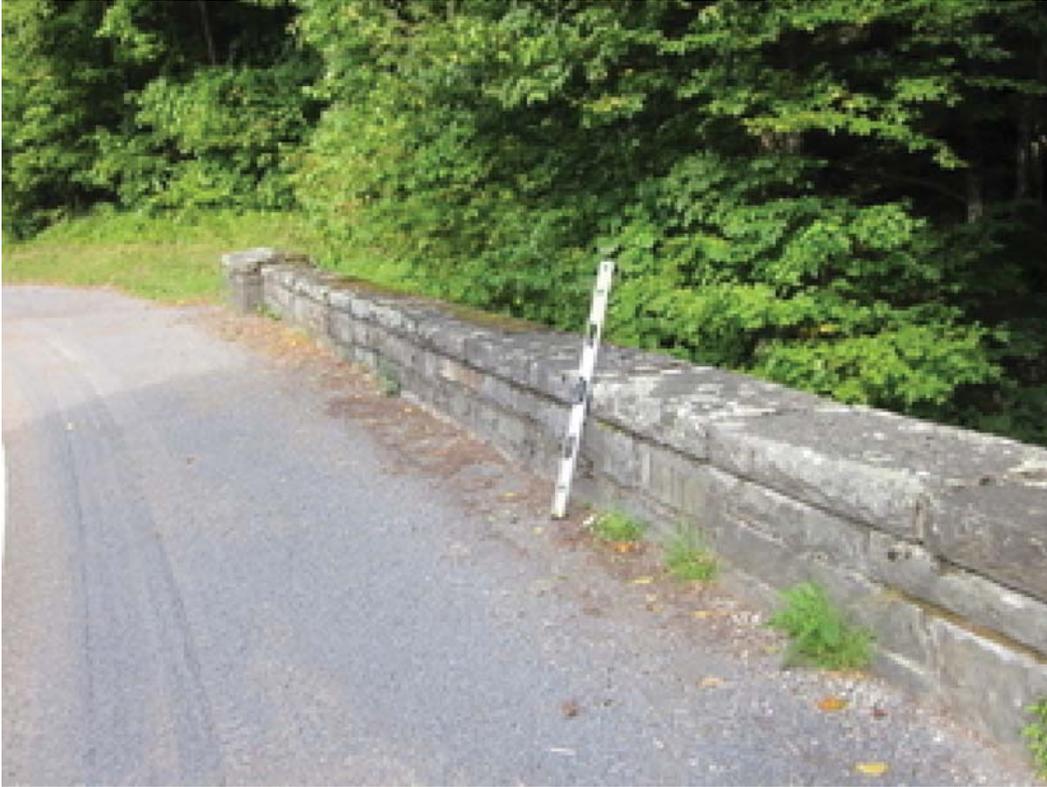
GRSM_0010N_9.268_L_1.JPG

Barrier ID:	GRSM-0010N-9.268-L				
Route Name:	NEWFOUND GAP ROAD NORTH				
Inspection Date:	09/16/2010	Barrier Rating:	41.20		
Barrier Description					
Type:	STONE MASONRY WITHOUT CONCRETE CORE WALL	Barrier Function:	TRAFFIC		
Barrier Material:	STONE	Post Material:	N/A		
Blockout Type:	N/A	Length (ft.):	40		
Speed Limit (MPH):	35	Placement with Respect to Road:	OUTSIDE OF CURVE		
Hazard Behind Barrier:	LOW				
Barrier Crashworthiness					
Appropriate Test Level:	TL-2	Barrier Test Level:	NCW	Is Barrier Crashworthy?:	NO
Beg. End Trtmt Type:	NONE	Is Beg. End Trtmt Crashworthy?:	N/A	Approach Transition Type:	NONE
Ending End Trtmt Type:	NONE	Ending End Trtmt Crashworthy?:	N/A		
Average Measurements					
Design Height (In.):	24	Width (In.):	24.7	Post Spacing (In.):	0.0
Height (In.):	26.2	Lateral Offset (In.):	121.6	Road Grade (%):	3.10
Physical Condition					
Barrier	Alignment and Height:	Alignment has no deviation and the height is 1 to 4 in above the 24-in design height.

Breaking and Cracking:	No breaking or cracking observed.			
	Missing Elements:	No missing elements observed.			
	Corrosion and Weathering:	No corrosion or weathering observed.			
End Treatments	Alignment and Height:				
	Breaking and Cracking:				
	Missing Elements:				
	Corrosion and Weathering:

Repair Action:	NO ACTION	FMSS Work Type:	N/A	Repair Cost:	\$0
Brief Workorder:	N/A				
Workorder:

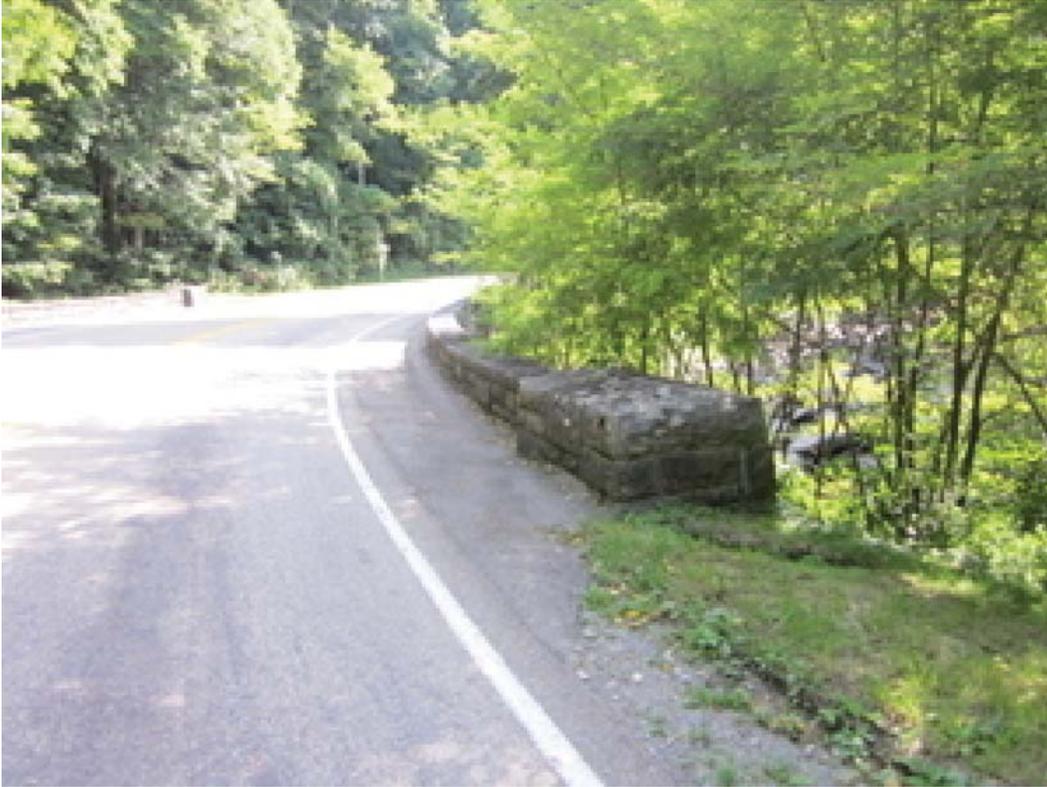
GRSM_0010N_9.268_R_1.JPG

Barrier ID:	GRSM-0010N-9.268-R				
Route Name:	NEWFOUND GAP ROAD NORTH				
Inspection Date:	09/16/2010	Barrier Rating:	31.20		
Barrier Description					
Type:	STONE MASONRY WITHOUT CONCRETE CORE WALL	Barrier Function:	TRAFFIC		
Barrier Material:	STONE	Post Material:	N/A		
Blockout Type:	N/A	Length (ft.):	44		
Speed Limit (MPH):	35	Placement with Respect to Road:	INSIDE OF CURVE		
Hazard Behind Barrier:	LOW				
Barrier Crashworthiness					
Appropriate Test Level:	TL-2	Barrier Test Level:	NCW	Is Barrier Crashworthy?:	NO
Beg. End Trtmt Type:	NONE	Is Beg. End Trtmt Crashworthy?:	N/A	Approach Transition Type:	NONE
Ending End Trtmt Type:	NONE	Ending End Trtmt Crashworthy?:	N/A		
Average Measurements					
Design Height (In.):	24	Width (In.):	24.0	Post Spacing (In.):	0.0
Height (In.):	23.6	Lateral Offset (In.):	70.0	Road Grade (%):	6.70
Physical Condition					
Barrier	Alignment and Height:	Alignment has no deviation and the height is at or within 1 in of the 24 in design height.

Breaking and Cracking:	No breaking or cracking observed.			
	Missing Elements:	No missing elements observed.			
	Corrosion and Weathering:	No corrosion or weathering observed.			
End Treatments	Alignment and Height:				
	Breaking and Cracking:				
	Missing Elements:				
	Corrosion and Weathering:

Repair Action:	NO ACTION	FMSS Work Type:	N/A	Repair Cost:	\$0
Brief Workorder:	N/A				
Workorder:

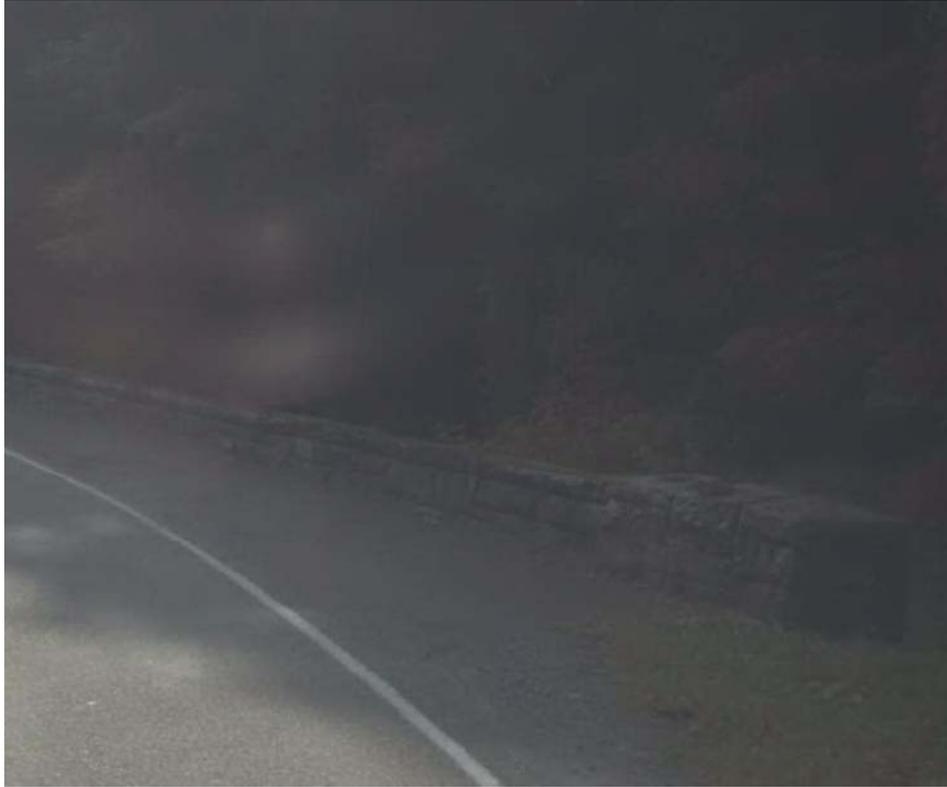
GRSM_0010N_9.281_L_1.JPG

Barrier ID:	GRSM-0010N-9.281-L				
Route Name:	NEWFOUND GAP ROAD NORTH				
Inspection Date:	09/16/2010	Barrier Rating:	36.70		
Barrier Description					
Type:	STONE MASONRY WITHOUT CONCRETE CORE WALL	Barrier Function:	TRAFFIC		
Barrier Material:	STONE	Post Material:	N/A		
Blockout Type:	N/A	Length (ft.):	43		
Speed Limit (MPH):	35	Placement with Respect to Road:	OUTSIDE OF CURVE		
Hazard Behind Barrier:	MEDIUM				
Barrier Crashworthiness					
Appropriate Test Level:	TL-2	Barrier Test Level:	NCW	Is Barrier Crashworthy?:	NO
Beg. End Trtmt Type:	NONE	Is Beg. End Trtmt Crashworthy?:	N/A	Approach Transition Type:	NONE
Ending End Trtmt Type:	NONE	Ending End Trtmt Crashworthy?:	N/A		
Average Measurements					
Design Height (In.):	24	Width (In.):	25.6	Post Spacing (In.):	0.0
Height (In.):	25.2	Lateral Offset (In.):	117.3	Road Grade (%):	5.10
Physical Condition					
Barrier	Alignment and Height:	Alignment has no deviation and the height is 1 to 3 in above the 24 in design height.

Breaking and Cracking:	No breaking or cracking observed. No breaking or cracking observed.			
	Missing Elements:	No missing elements observed.			
	Corrosion and Weathering:	No corrosion or weathering observed.			
End Treatments	Alignment and Height:				
	Breaking and Cracking:				
	Missing Elements:				
	Corrosion and Weathering:

Barrier ID:	GRSM-0010N-9.281-L				
Route Name:	NEWFOUND GAP ROAD NORTH				
Inspection Date:	09/16/2010		Barrier Rating:	36.70	
Repair Recommendations					
Repair Action:	NO ACTION	FMSS Work Type:	N/A	Repair Cost:	\$0
Brief Workorder:	N/A				
Workorder:

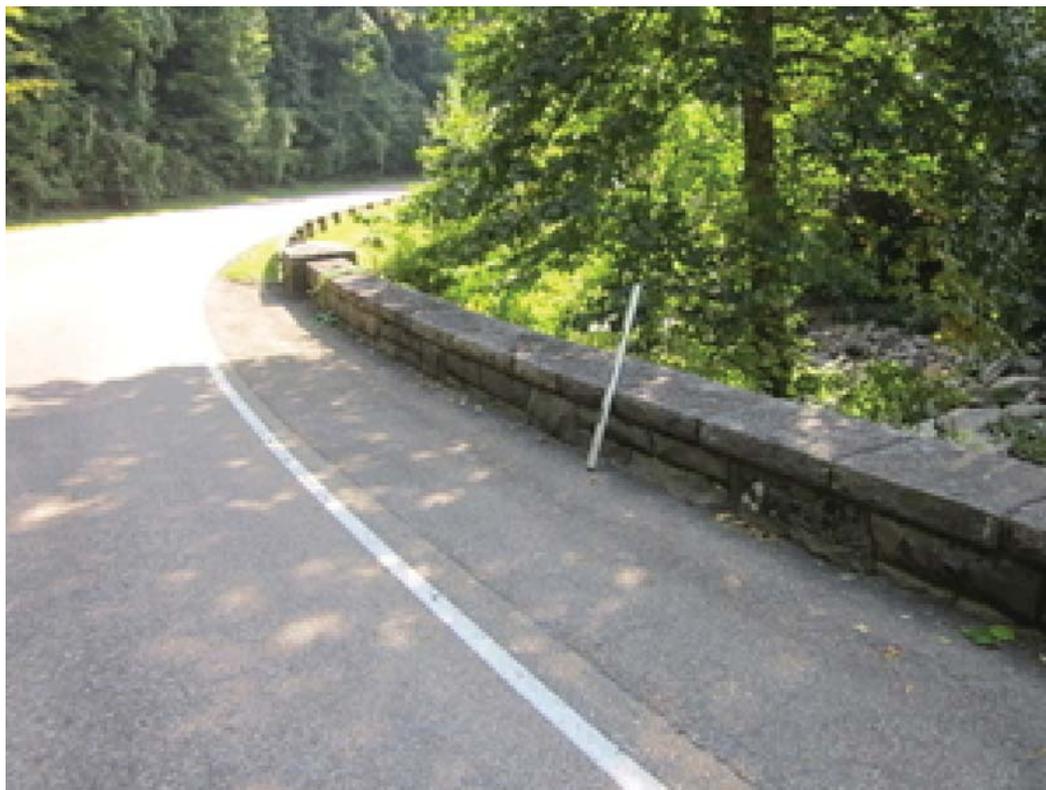
GRSM_0010N_9.281_R_1.JPG

Barrier ID:	GRSM-0010N-9.281-R				
Route Name:	NEWFOUND GAP ROAD NORTH				
Inspection Date:	09/16/2010	Barrier Rating:	26.70		
Barrier Description					
Type:	STONE MASONRY WITHOUT CONCRETE CORE WALL	Barrier Function:	TRAFFIC		
Barrier Material:	STONE	Post Material:	N/A		
Blockout Type:	N/A	Length (ft.):	42		
Speed Limit (MPH):	35	Placement with Respect to Road:	INSIDE OF CURVE		
Hazard Behind Barrier:	MEDIUM				
Barrier Crashworthiness					
Appropriate Test Level:	TL-2	Barrier Test Level:	NCW	Is Barrier Crashworthy?:	NO
Beg. End Trtmt Type:	NONE	Is Beg. End Trtmt Crashworthy?:	N/A	Approach Transition Type:	NONE
Ending End Trtmt Type:	NONE	Ending End Trtmt Crashworthy?:	N/A		
Average Measurements					
Design Height (In.):	24	Width (In.):	24.0	Post Spacing (In.):	0.0
Height (In.):	24.0	Lateral Offset (In.):	70.0	Road Grade (%):	4.20
Physical Condition					
Barrier	Alignment and Height:	Alignment has no deviation and the height is at the 24 in design height.

Breaking and Cracking:	No breaking or cracking observed.			
	Missing Elements:	No missing elements observed.			
	Corrosion and Weathering:	No corrosion or weathering observed.			
End Treatments	Alignment and Height:				
	Breaking and Cracking:				
	Missing Elements:				
	Corrosion and Weathering:

Repair Action:	NO ACTION	FMSS Work Type:	N/A	Repair Cost:	\$0
Brief Workorder:	N/A				
Workorder:

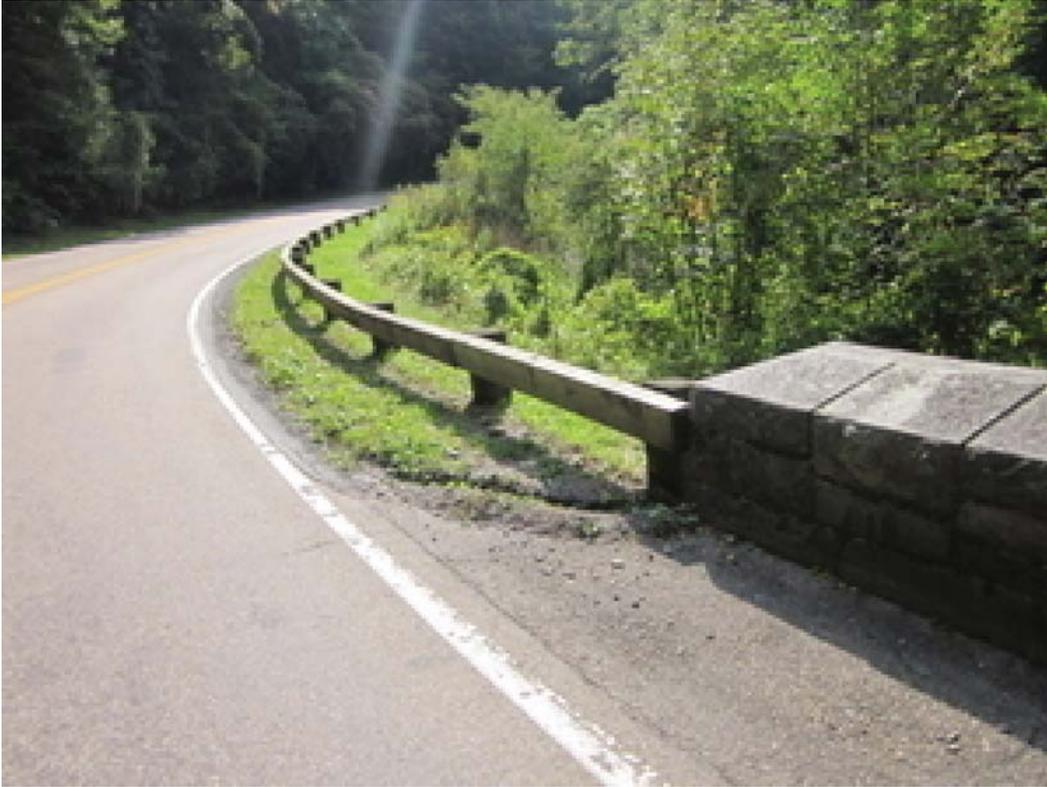
GRSM_0010N_9.291_R_1.JPG

Barrier ID:	GRSM-0010N-9.291-R				
Route Name:	NEWFOUND GAP ROAD NORTH				
Inspection Date:	09/16/2010	Barrier Rating:	44.00		
Barrier Description					
Type:	STEEL-BACKED TIMBER WITHOUT BLOCKOUT	Barrier Function:	TRAFFIC		
Barrier Material:	STEEL-BACKED TIMBER/LOG	Post Material:	WOOD		
Blockout Type:	N/A	Length (ft.):	412		
Speed Limit (MPH):	35	Placement with Respect to Road:	INSIDE OF CURVE		
Hazard Behind Barrier:	MEDIUM				
Barrier Crashworthiness					
Appropriate Test Level:	TL-2	Barrier Test Level:	TL-2	Is Barrier Crashworthy?:	YES
Beg. End Trtmt Type:	NONE	Is Beg. End Trtmt Crashworthy?:	N/A	Approach Transition Type:	NONE
Ending End Trtmt Type:	NONE	Ending End Trtmt Crashworthy?:	N/A		
Average Measurements					
Design Height (In.):	27	Width (In.):	0.0	Post Spacing (In.):	120.0
Height (In.):	24.0	Lateral Offset (In.):	66.3	Road Grade (%):	6.50
Physical Condition					
Barrier	Alignment and Height:	Alignment has no deviation and the height is 2 to 3 in below the 27-in design height for 202 ft and 4 in below for 210 ft.

Breaking and Cracking:	No breaking or cracking observed.			
	Missing Elements:	No missing elements observed.			
	Corrosion and Weathering:	No corrosion or weathering observed.			
End Treatments	Alignment and Height:				
	Breaking and Cracking:				
	Missing Elements:				
	Corrosion and Weathering:

Repair Action:	REPAIR	FMSS Work Type:	DEFERRED MAINTENANCE	Repair Cost:	\$7777
Brief Workorder:	Raise 412 feet of guardrail to 27 inch design height.				
Workorder:	Adjust Guardrail at \$10- per -Lin. Ft. for 412 LF = \$4120. Raise 412-ft of barrier up to 27-in design height. Low Speed Traffic Control at \$1475- per -Day for 2 Day(s) = \$2950.

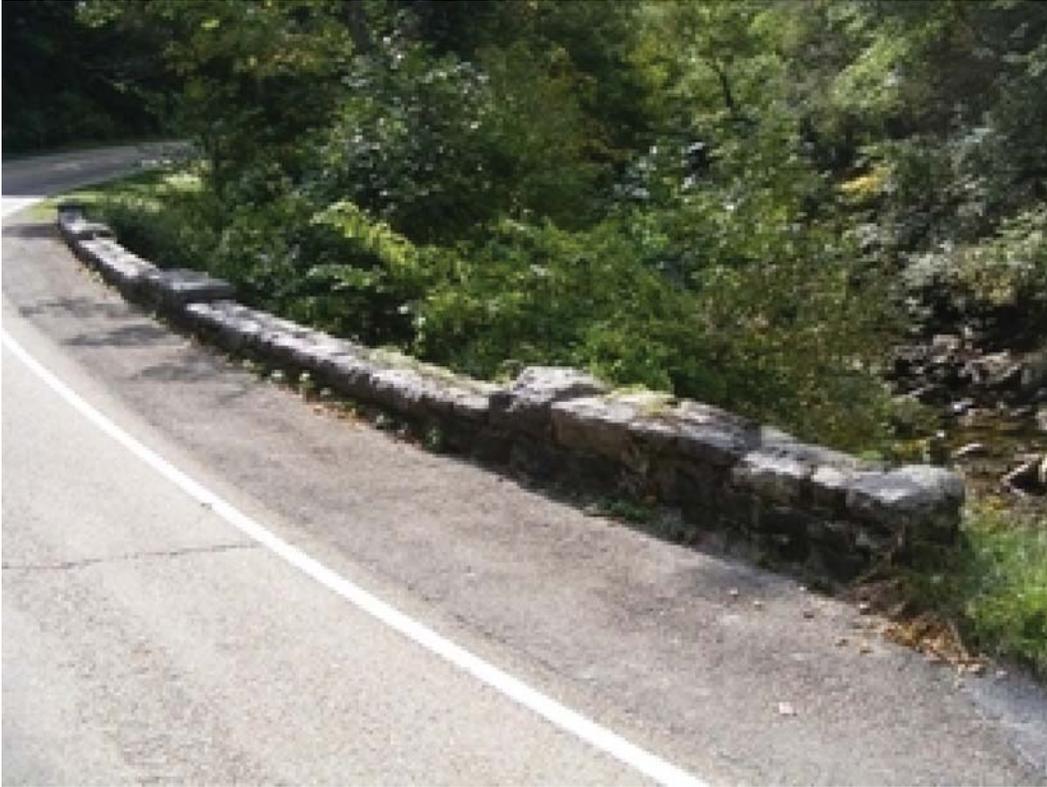
GRSM_0010N_9.437_R_1.JPG

Barrier ID:	GRSM-0010N-9.437-R				
Route Name:	NEWFOUND GAP ROAD NORTH				
Inspection Date:	09/16/2010	Barrier Rating:	61.50		
Barrier Description					
Type:	STONE MASONRY CRENELLATED WITHOUT	Barrier Function:	TRAFFIC		
Barrier Material:	STONE	Post Material:	N/A		
Blockout Type:	N/A	Length (ft.):	82		
Speed Limit (MPH):	35	Placement with Respect to Road:	INSIDE OF CURVE		
Hazard Behind Barrier:	HIGH				
Barrier Crashworthiness					
Appropriate Test Level:	TL-2	Barrier Test Level:	NCW	Is Barrier Crashworthy?:	NO
Beg. End Trtmt Type:	NONE	Is Beg. End Trtmt Crashworthy?:	N/A	Approach Transition Type:	NONE
Ending End Trtmt Type:	NONE	Ending End Trtmt Crashworthy?:	N/A		
Average Measurements					
Design Height (In.):	18	Width (In.):	18.0	Post Spacing (In.):	0.0
Height (In.):	11.3	Lateral Offset (In.):	64.5	Road Grade (%):	6.10
Physical Condition					
Barrier	Alignment and Height:	The alignment has no deviation and the height is 5 to 6 in below the 18-in/24-in crenellated design height for 34 ft and 6 to 9 in below for 48 ft.

Breaking and Cracking:	No broken stones minor cracking of the grout observed. 1/4 in or less wide.			
	Missing Elements:	No missing elements observed.			
	Corrosion and Weathering:	Moderate weathering of the barrier observed.			
End Treatments	Alignment and Height:				
	Breaking and Cracking:				
	Missing Elements:				
	Corrosion and Weathering:

Repair Action:	REPAIR	FMSS Work Type:	DEFERRED MAINTENANCE	Repair Cost:	\$21368
Brief Workorder:	Raise guardwall 3 inches. Remove and reset 48 feet of stone masonry guardwall on 1 row of new stones to raise barrier to the adjacent 12 inch height.				
Workorder:	Remove & Reset Stone Masonry Guardwall at \$250- per -Cu. Ft. for 36 CF = \$9000. [(0.5ft)(1.5ft)(48ft)] = 36 CF. Remove top layer of stones in barrier for 48 feet. Replace Stones at \$250- per -Each for 24 Unit(s) = \$6000. [(48ft) / (2ft/stone)] x 1 row = 24 stones. Insert new stone on retaining wall to increase barrier height then reset top layer of barrier. Low Speed Traffic Control at \$1475- per -Day for 3 Day(s) = \$4425. 1 day removal 2 days installation.

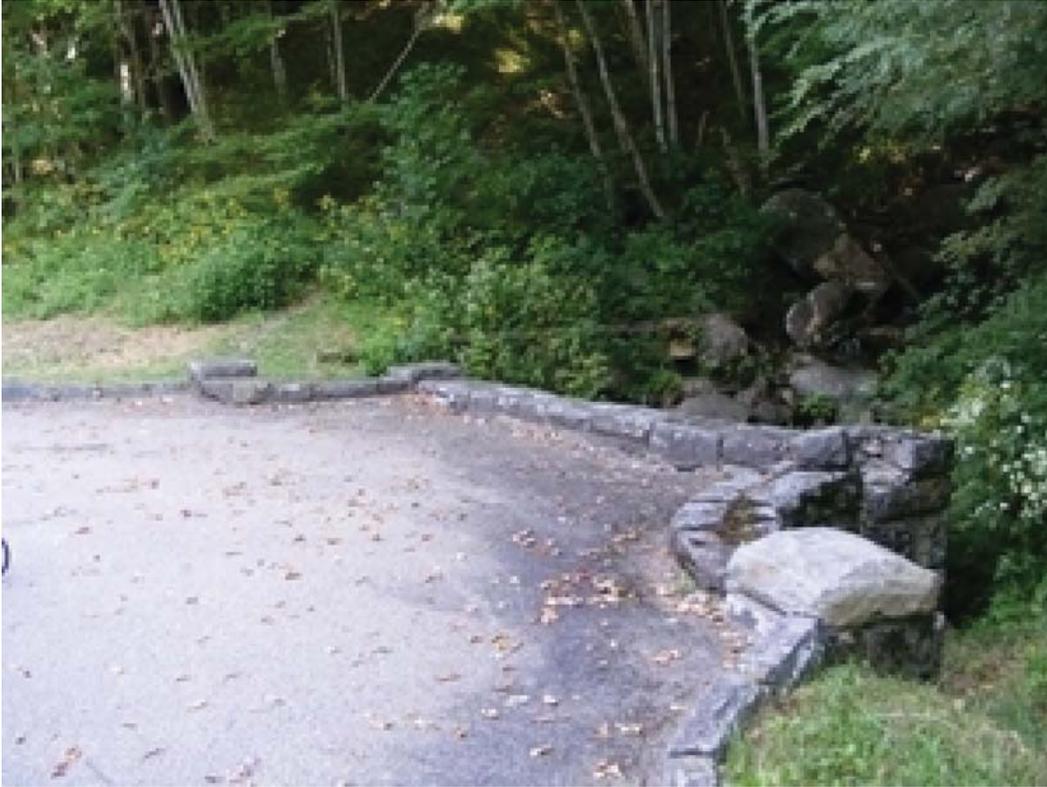
GRSM_0010N_9.446_L_1.JPG

Barrier ID:	GRSM-0010N-9.446-L				
Route Name:	NEWFOUND GAP ROAD NORTH				
Inspection Date:	09/16/2010	Barrier Rating:	38.90		
Barrier Description					
Type:	STONE MASONRY CRENELLATED WITHOUT	Barrier Function:	NON-TRAFFIC		
Barrier Material:	STONE	Post Material:	N/A		
Blockout Type:	N/A	Length (ft.):	40		
Speed Limit (MPH):	35	Placement with Respect to Road:	NON-TRAFFIC BARRIER		
Hazard Behind Barrier:	N/A				
Barrier Crashworthiness					
Appropriate Test Level:	TL-2	Barrier Test Level:	N/A	Is Barrier Crashworthy?:	N/A
Beg. End Trtmt Type:	NONE	Is Beg. End Trtmt Crashworthy?:	N/A	Approach Transition Type:	NONE
Ending End Trtmt Type:	NONE	Ending End Trtmt Crashworthy?:	N/A		
Average Measurements					
Design Height (In.):	18	Width (In.):	18.7	Post Spacing (In.):	0.0
Height (In.):	9.3	Lateral Offset (In.):	0.0	Road Grade (%):	0.00
Physical Condition					
Barrier	Alignment and Height:	The alignment has no deviation and the height is 8 to 10 in below the 18-in/24-in crenellated design height for 40 ft.

Breaking and Cracking:	Mortar broken on one stone stone separated from guardwall.			
	Missing Elements:	No missing elements observed.			
	Corrosion and Weathering:	No corrosion or weathering observed.			
End Treatments	Alignment and Height:				
	Breaking and Cracking:				
	Missing Elements:				
	Corrosion and Weathering:

Repair Action:	REPAIR	FMSS Work Type:	DEFERRED MAINTENANCE	Repair Cost:	\$42268
Brief Workorder:	Raise guardwall 9-in. Remove and reset 40-ft of stone masonry guardwall on concrete footer to crenellated design height of 18in/24in.				
Workorder:	Remove & Reset Stone Masonry Guardwall at \$250- per -Cu. Ft. for 128 CF = \$32000. [(2ft)(1.6ft)(40ft)] = 128 CF. Structural Concrete at \$1000- per -Cu. Yd. for 2 CY = \$2000. [(1.6ft)(0.75ft)(40ft)] /27 = 1.8 CY. Low Speed Traffic Control at \$1475- per -Day for 3 Day(s) = \$4425. 1 day removal 2 days installation.

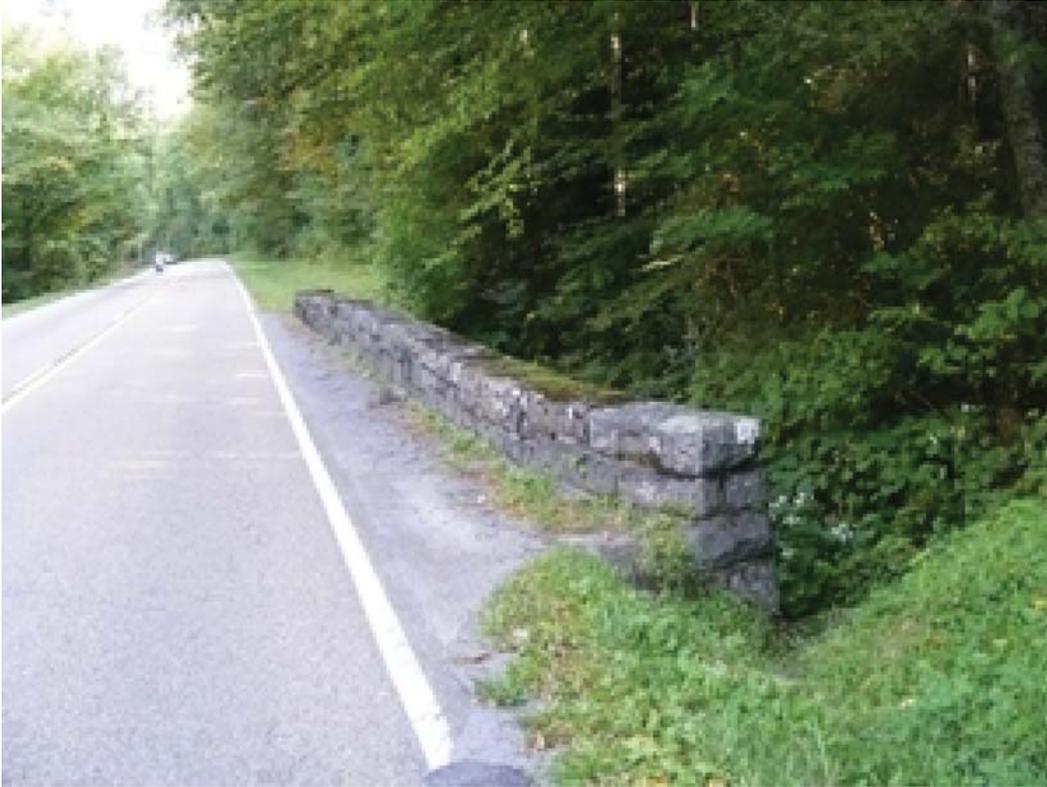
GRSM_0010N_9.604_L_1.JPG

Barrier ID:	GRSM-0010N-9.604-L				
Route Name:	NEWFOUND GAP ROAD NORTH				
Inspection Date:	09/16/2010	Barrier Rating:	33.70		
Barrier Description					
Type:	STONE MASONRY WITHOUT CONCRETE CORE WALL	Barrier Function:	TRAFFIC		
Barrier Material:	STONE	Post Material:	N/A		
Blockout Type:	N/A	Length (ft.):	76		
Speed Limit (MPH):	35	Placement with Respect to Road:	TANGENT		
Hazard Behind Barrier:	MEDIUM				
Barrier Crashworthiness					
Appropriate Test Level:	TL-2	Barrier Test Level:	NCW	Is Barrier Crashworthy?:	NO
Beg. End Trtmt Type:	NONE	Is Beg. End Trtmt Crashworthy?:	N/A	Approach Transition Type:	NONE
Ending End Trtmt Type:	NONE	Ending End Trtmt Crashworthy?:	N/A		
Average Measurements					
Design Height (In.):	24	Width (In.):	18.2	Post Spacing (In.):	0.0
Height (In.):	25.2	Lateral Offset (In.):	33.2	Road Grade (%):	1.80
Physical Condition					
Barrier	Alignment and Height:	The alignment has no deviation and the height is at or up to 2 in above the design height of 24 in.

Breaking and Cracking:	No breaking or cracking observed.			
	Missing Elements:	No missing elements observed.			
	Corrosion and Weathering:	Moderate minor corrosion and weathering of the barrier observed.			
End Treatments	Alignment and Height:				
	Breaking and Cracking:				
	Missing Elements:				
	Corrosion and Weathering:

Barrier ID:	GRSM-0010N-9.604-L				
Route Name:	NEWFOUND GAP ROAD NORTH				
Inspection Date:	09/16/2010		Barrier Rating:	33.70	
Repair Recommendations					
Repair Action:	NO ACTION	FMSS Work Type:	N/A	Repair Cost:	\$0
Brief Workorder:	N/A				
Workorder:
