NPS Guardwall/Rail Inventory Program
Great Smoky Mountains National Park

Federal Highway Administration
Eastern Federal Lands Highway Division
Road Inventory Program (RIP)

Data Collection Date: September 2010
Report Date: December 2015

Great Smoky Mountains National Park in North Carolina and Tennessee

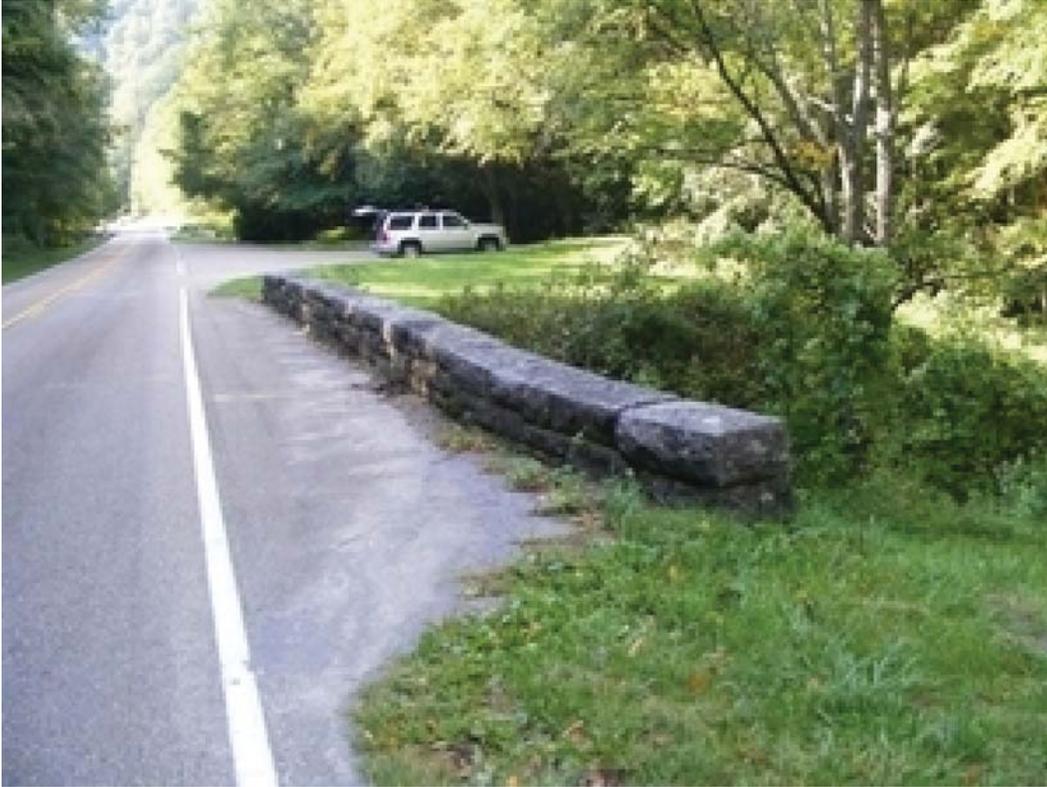
GRSM_0010N_9.604_R_1.JPG

Barrier ID:	GRSM-0010N-9.604-R				
Route Name:	NEWFOUND GAP ROAD NORTH				
Inspection Date:	09/16/2010	Barrier Rating:	30.80		
Barrier Description					
Type:	STONE MASONRY WITHOUT CONCRETE CORE WALL	Barrier Function:	TRAFFIC		
Barrier Material:	STONE	Post Material:	N/A		
Blockout Type:	N/A	Length (ft.):	75		
Speed Limit (MPH):	35	Placement with Respect to Road:	TANGENT		
Hazard Behind Barrier:	MEDIUM				
Barrier Crashworthiness					
Appropriate Test Level:	TL-2	Barrier Test Level:	NCW	Is Barrier Crashworthy?:	NO
Beg. End Trtmt Type:	NONE	Is Beg. End Trtmt Crashworthy?:	N/A	Approach Transition Type:	NONE
Ending End Trtmt Type:	NONE	Ending End Trtmt Crashworthy?:	N/A		
Average Measurements					
Design Height (In.):	24	Width (In.):	18.0	Post Spacing (In.):	0.0
Height (In.):	25.0	Lateral Offset (In.):	66.0	Road Grade (%):	2.00
Physical Condition					
Barrier	Alignment and Height:	The alignment has no deviation and the height is at or up to 2 in above the design height of 24 in.

Breaking and Cracking:	1 loose rock.			
	Missing Elements:	No missing elements observed.			
	Corrosion and Weathering:	Moderate minor corrosion and weathering of the barrier observed.			
End Treatments	Alignment and Height:				
	Breaking and Cracking:				
	Missing Elements:				
	Corrosion and Weathering:

Repair Action:	REPAIR	FMSS Work Type:	DEFERRED MAINTENANCE	Repair Cost:	\$1777
Brief Workorder:	Repoint 1 loose rock on terminating end of barrier.				
Workorder:	Re-Point Stone Masonry Barrier at \$140- per -Sq. Yd. for 1 SY = \$140. Top (1.5 x 3) + front and back (1 x 3 x 2) = 10.5ft / 9 = 1 SY. Low Speed Traffic Control at \$1475- per -Day for 1 Day(s) = \$1475.

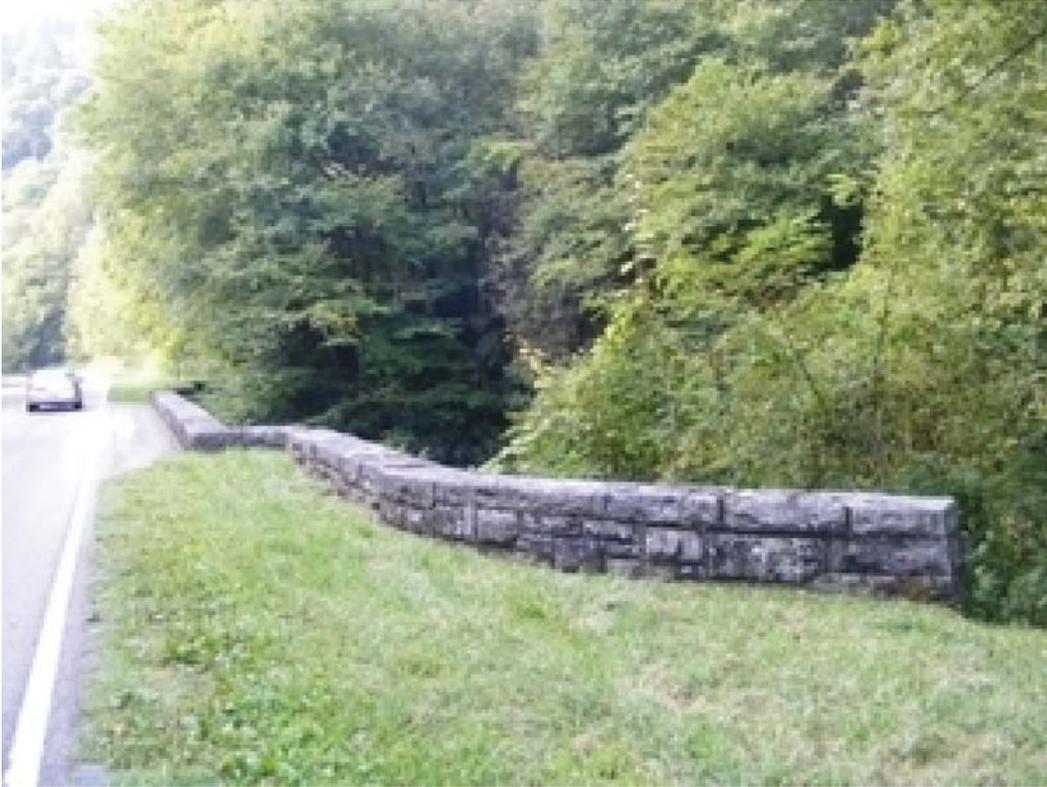
GRSM_0010N_9.688_R_1.JPG

Barrier ID:	GRSM-0010N-9.688-R				
Route Name:	NEWFOUND GAP ROAD NORTH				
Inspection Date:	09/16/2010	Barrier Rating:	30.80		
Barrier Description					
Type:	STONE MASONRY WITHOUT CONCRETE CORE WALL	Barrier Function:	TRAFFIC		
Barrier Material:	STONE	Post Material:	N/A		
Blockout Type:	N/A	Length (ft.):	40		
Speed Limit (MPH):	35	Placement with Respect to Road:	TANGENT		
Hazard Behind Barrier:	MEDIUM				
Barrier Crashworthiness					
Appropriate Test Level:	TL-2	Barrier Test Level:	NCW	Is Barrier Crashworthy?:	NO
Beg. End Trtmt Type:	NONE	Is Beg. End Trtmt Crashworthy?:	N/A	Approach Transition Type:	NONE
Ending End Trtmt Type:	NONE	Ending End Trtmt Crashworthy?:	N/A		
Average Measurements					
Design Height (In.):	24	Width (In.):	25.0	Post Spacing (In.):	0.0
Height (In.):	23.6	Lateral Offset (In.):	110.5	Road Grade (%):	3.30
Physical Condition					
Barrier	Alignment and Height:	The alignment has no deviation and the height is 0-1 in below the design height of 24 in.

Breaking and Cracking:	Minor breaking and cracking of mortar observed 1/4 to 1/2 in.			
	Missing Elements:	No missing elements observed.			
	Corrosion and Weathering:	No corrosion or weathering observed.			
End Treatments	Alignment and Height:				
	Breaking and Cracking:				
	Missing Elements:				
	Corrosion and Weathering:

Barrier ID:	GRSM-0010N-9.688-R				
Route Name:	NEWFOUND GAP ROAD NORTH				
Inspection Date:	09/16/2010	Barrier Rating:		30.80	
Repair Recommendations					
Repair Action:	NO ACTION	FMSS Work Type:	N/A	Repair Cost:	\$0
Brief Workorder:	N/A				
Workorder:

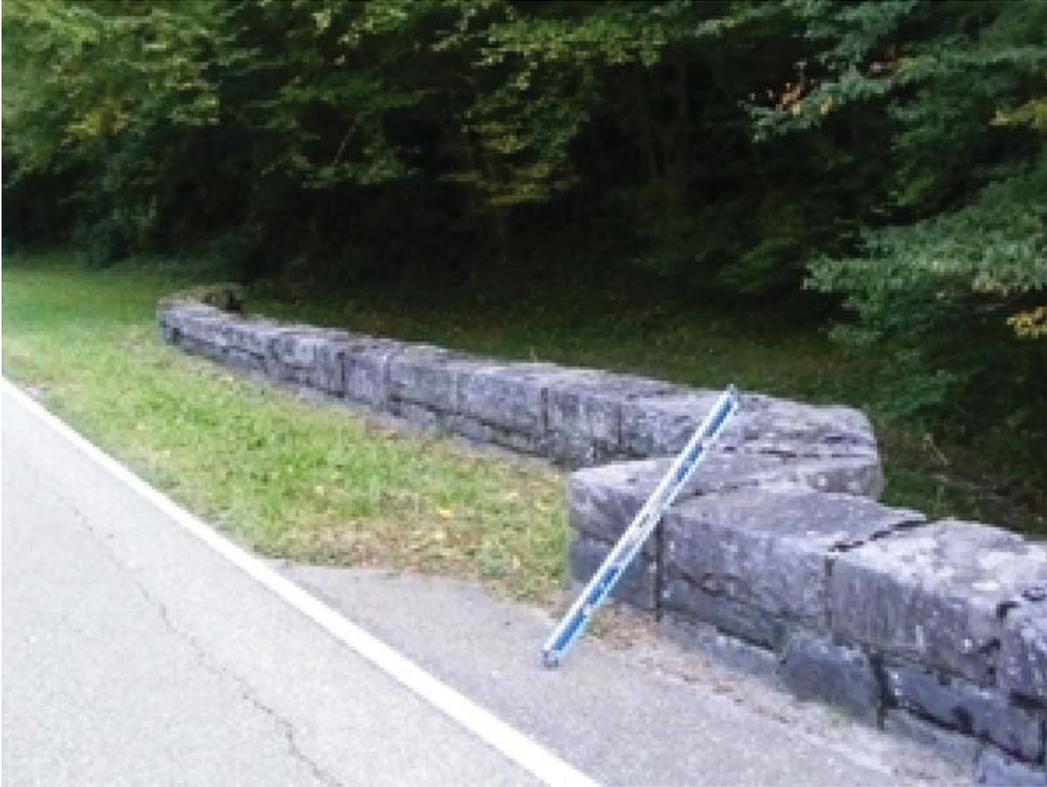
GRSM_0010N_9.690_L_1.JPG

Barrier ID:	GRSM-0010N-9.690-L				
Route Name:	NEWFOUND GAP ROAD NORTH				
Inspection Date:	09/16/2010	Barrier Rating:	35.20		
Barrier Description					
Type:	STONE MASONRY WITHOUT CONCRETE CORE WALL	Barrier Function:	TRAFFIC		
Barrier Material:	STONE	Post Material:	N/A		
Blockout Type:	N/A	Length (ft.):	53		
Speed Limit (MPH):	35	Placement with Respect to Road:	TANGENT		
Hazard Behind Barrier:	MEDIUM				
Barrier Crashworthiness					
Appropriate Test Level:	TL-2	Barrier Test Level:	NCW	Is Barrier Crashworthy?:	NO
Beg. End Trtmt Type:	NONE	Is Beg. End Trtmt Crashworthy?:	N/A	Approach Transition Type:	NONE
Ending End Trtmt Type:	NONE	Ending End Trtmt Crashworthy?:	N/A		
Average Measurements					
Design Height (In.):	24	Width (In.):	25.2	Post Spacing (In.):	0.0
Height (In.):	23.0	Lateral Offset (In.):	84.3	Road Grade (%):	4.40
Physical Condition					
Barrier	Alignment and Height:	The alignment has no deviation and the height is 1 in below the design height of 24 in.

Breaking and Cracking:	Some cracked mortar between 1/4 and 1/2 in wide.			
	Missing Elements:	A large 4 ft missing stone was missing.			
	Corrosion and Weathering:	No corrosion or weathering observed.			
End Treatments	Alignment and Height:				
	Breaking and Cracking:				
	Missing Elements:				
	Corrosion and Weathering:

Repair Action:	REPAIR	FMSS Work Type:	DEFERRED MAINTENANCE	Repair Cost:	\$1898
Brief Workorder:	Replace one missing stone.				
Workorder:	Replace Stone at \$250- per -Each for 1 Unit(s) = \$250. Replace one missing stone. Low Speed Traffic Control at \$1475- per -Day for 1 Day(s) = \$1475.

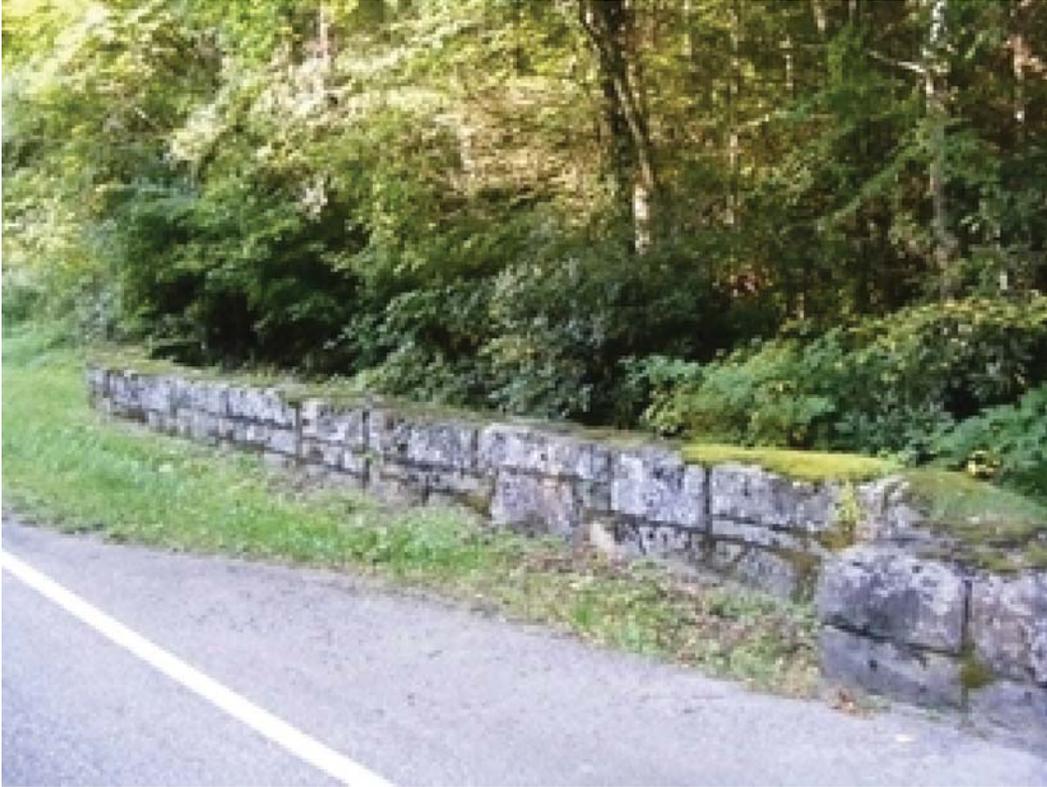
GRSM_0010N_9.712_R_1.JPG

Barrier ID:	GRSM-0010N-9.712-R				
Route Name:	NEWFOUND GAP ROAD NORTH				
Inspection Date:	09/16/2010	Barrier Rating:	23.70		
Barrier Description					
Type:	STONE MASONRY WITHOUT CONCRETE CORE WALL	Barrier Function:	TRAFFIC		
Barrier Material:	STONE	Post Material:	N/A		
Blockout Type:	N/A	Length (ft.):	52		
Speed Limit (MPH):	35	Placement with Respect to Road:	TANGENT		
Hazard Behind Barrier:	MEDIUM				
Barrier Crashworthiness					
Appropriate Test Level:	TL-2	Barrier Test Level:	NCW	Is Barrier Crashworthy?:	NO
Beg. End Trtmt Type:	NONE	Is Beg. End Trtmt Crashworthy?:	N/A	Approach Transition Type:	NONE
Ending End Trtmt Type:	NONE	Ending End Trtmt Crashworthy?:	N/A		
Average Measurements					
Design Height (In.):	24	Width (In.):	25.2	Post Spacing (In.):	0.0
Height (In.):	25.0	Lateral Offset (In.):	114.0	Road Grade (%):	4.80
Physical Condition					
Barrier	Alignment and Height:	The alignment has no deviation and the height is 0-2 in above the design height of 24 in.

Breaking and Cracking:	No breaking or cracking observed.			
	Missing Elements:	Missing mortar in two 2-ft sections of barrier.			
	Corrosion and Weathering:	No corrosion or weathering observed.			
End Treatments	Alignment and Height:				
	Breaking and Cracking:				
	Missing Elements:				
	Corrosion and Weathering:

Repair Action:	REPAIR	FMSS Work Type:	DEFERRED MAINTENANCE	Repair Cost:	\$2085
Brief Workorder:	Repoint two 2 foot sections of guardwall.				
Workorder:	Re-Point Masonry Barrier at \$140- per -Sq. Yd. for 3 = \$420. front (2 x 2) + top (2 x 2) + back (2 x 2) x 2 sections = 24 sf/9 = 2.6 sy Low Speed Traffic Control at \$1475- per -Day for 1 Day(s) = \$1475.

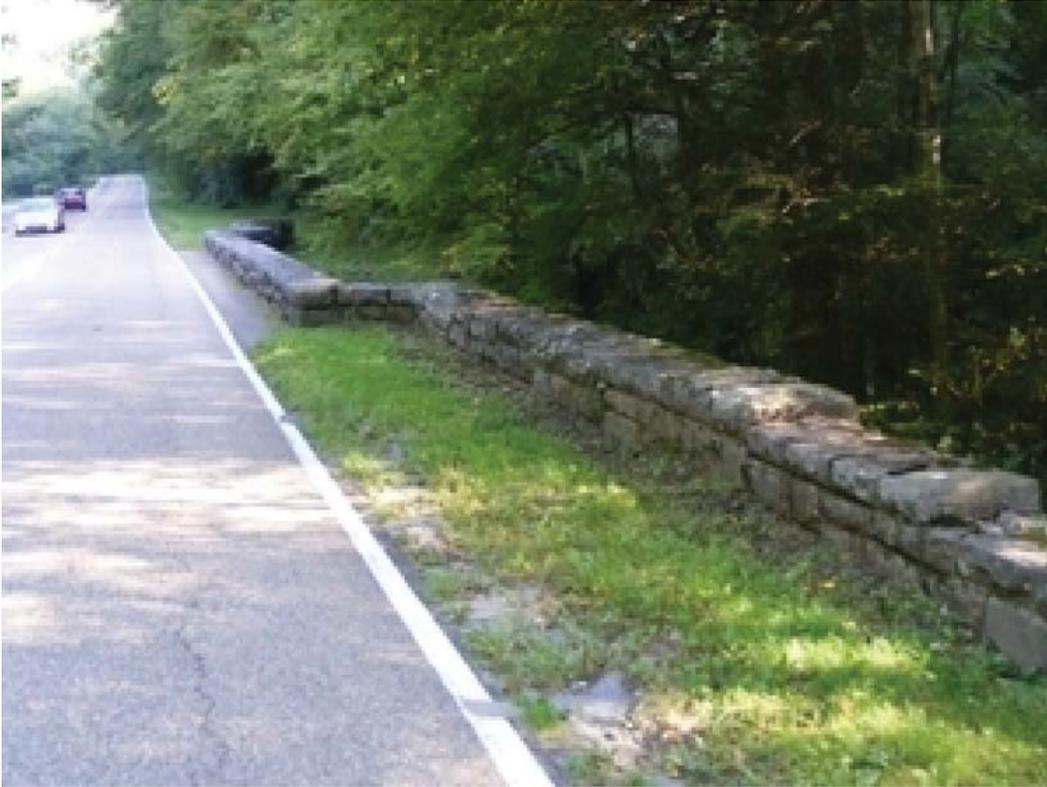
GRSM_0010N_9.717_L_1.JPG

Barrier ID:	GRSM-0010N-9.717-L				
Route Name:	NEWFOUND GAP ROAD NORTH				
Inspection Date:	09/16/2010	Barrier Rating:	32.50		
Barrier Description					
Type:	STONE MASONRY WITHOUT CONCRETE CORE WALL	Barrier Function:	TRAFFIC		
Barrier Material:	STONE	Post Material:	N/A		
Blockout Type:	N/A	Length (ft.):	35		
Speed Limit (MPH):	35	Placement with Respect to Road:	TANGENT		
Hazard Behind Barrier:	MEDIUM				
Barrier Crashworthiness					
Appropriate Test Level:	TL-2	Barrier Test Level:	NCW	Is Barrier Crashworthy?:	NO
Beg. End Trtmt Type:	NONE	Is Beg. End Trtmt Crashworthy?:	N/A	Approach Transition Type:	NONE
Ending End Trtmt Type:	NONE	Ending End Trtmt Crashworthy?:	N/A		
Average Measurements					
Design Height (In.):	24	Width (In.):	25.6	Post Spacing (In.):	0.0
Height (In.):	22.2	Lateral Offset (In.):	73.0	Road Grade (%):	4.50
Physical Condition					
Barrier	Alignment and Height:	The alignment has no deviation and the height is 1 to 2 in below the design height of 24 in.

Breaking and Cracking:	No broken stones minor cracking of the grout observed. 1/4 to 1/2 in wide.			
	Missing Elements:	No missing elements observed.			
	Corrosion and Weathering:	Moderate weathering of the barrier observed.			
End Treatments	Alignment and Height:				
	Breaking and Cracking:				
	Missing Elements:				
	Corrosion and Weathering:

Barrier ID:	GRSM-0010N-9.717-L				
Route Name:	NEWFOUND GAP ROAD NORTH				
Inspection Date:	09/16/2010	Barrier Rating:		32.50	
Repair Recommendations					
Repair Action:	NO ACTION	FMSS Work Type:	N/A	Repair Cost:	\$0
Brief Workorder:	N/A				
Workorder:

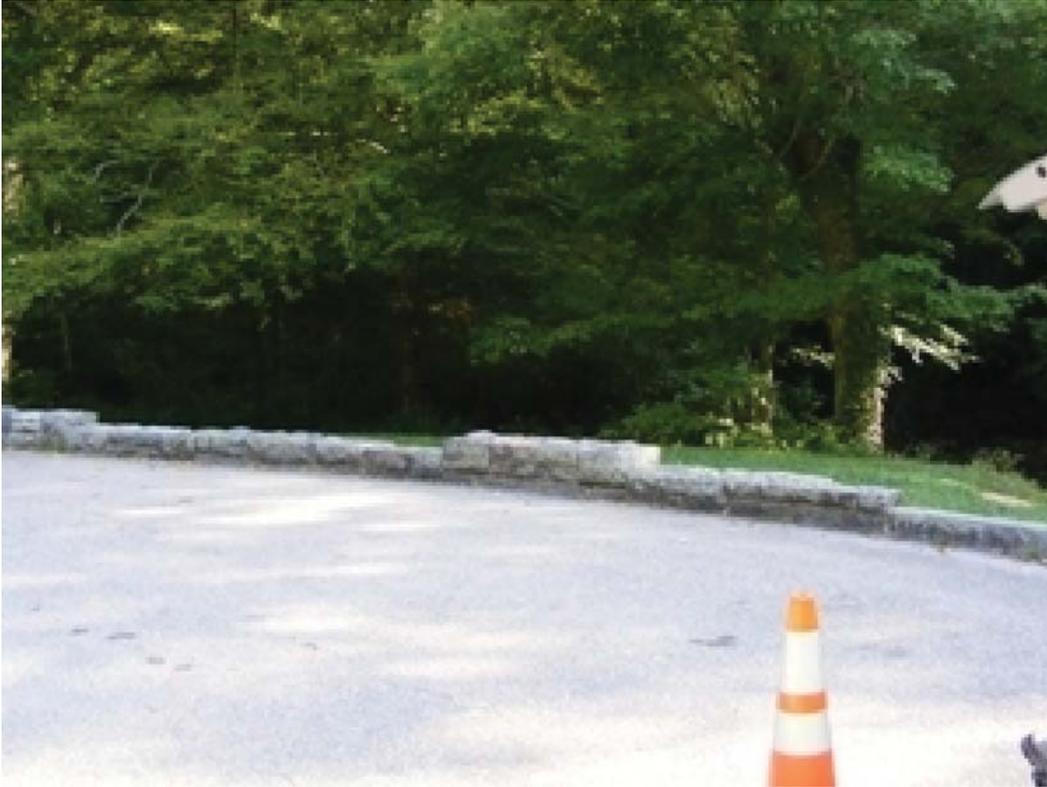
GRSM_0010N_9.724_L_1.JPG

Barrier ID:	GRSM-0010N-9.724-L				
Route Name:	NEWFOUND GAP ROAD NORTH				
Inspection Date:	09/16/2010		Barrier Rating:	36.70	
Barrier Description					
Type:	STONE MASONRY CRENELLATED WITHOUT		Barrier Function:	NON-TRAFFIC	
Barrier Material:	STONE		Post Material:	N/A	
Blockout Type:	N/A		Length (ft.):	111	
Speed Limit (MPH):	35		Placement with Respect to Road:	NON-TRAFFIC BARRIER	
Hazard Behind Barrier:	N/A				
Barrier Crashworthiness					
Appropriate Test Level:	TL-2	Barrier Test Level:	N/A	Is Barrier Crashworthy?:	N/A
Beg. End Trtmt Type:	NONE	Is Beg. End Trtmt Crashworthy?:	N/A	Approach Transition Type:	NONE
Ending End Trtmt Type:	NONE	Ending End Trtmt Crashworthy?:	N/A		
Average Measurements					
Design Height (In.):	18	Width (In.):	19.6	Post Spacing (In.):	0.0
Height (In.):	14.0	Lateral Offset (In.):	0.0	Road Grade (%):	0.00
Physical Condition					
Barrier	Alignment and Height:	The alignment has no deviation and the height is 3 to 6 in below the 18-in/24-in crenellated design height for 56 ft and 6 to 9 in below for 55 ft.

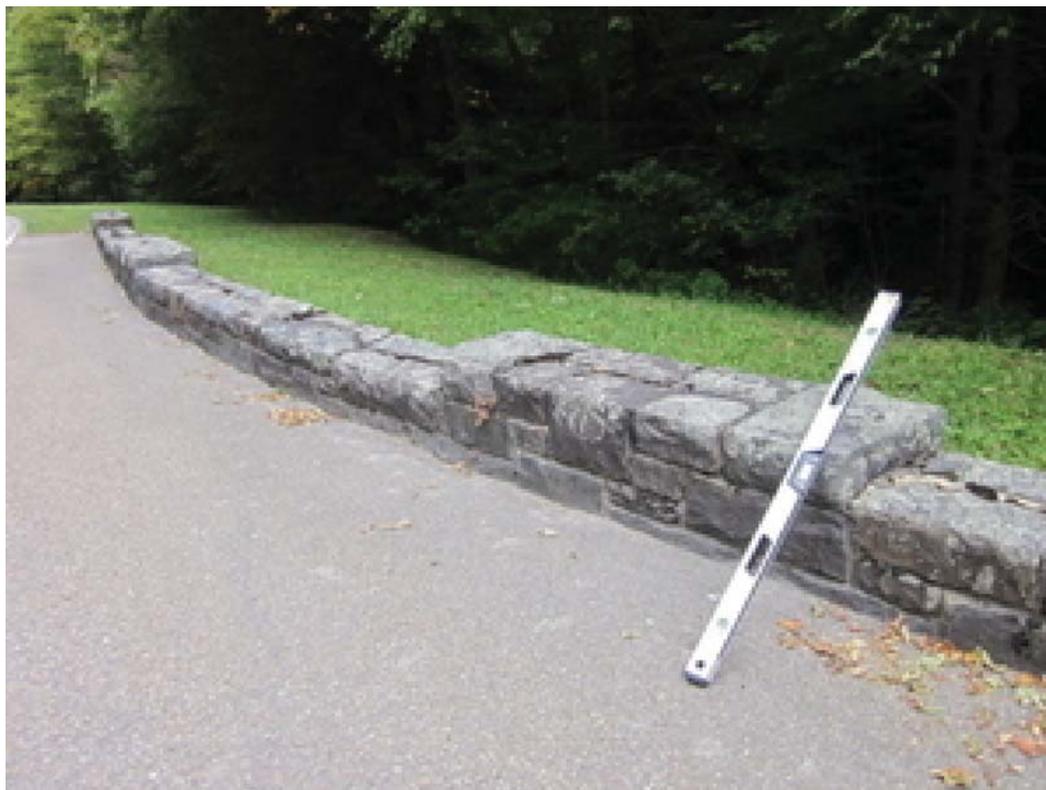
GRSM_0010N_10.137_L_1.JPG

Barrier ID:	GRSM-0010N-10.137-L				
Route Name:	NEWFOUND GAP ROAD NORTH				
Inspection Date:	09/16/2010	Barrier Rating:	45.70		
Barrier Description					
Type:	STONE MASONRY CRENELLATED WITHOUT	Barrier Function:	TRAFFIC		
Barrier Material:	STONE	Post Material:	N/A		
Blockout Type:	N/A	Length (ft.):	63		
Speed Limit (MPH):	35	Placement with Respect to Road:	OUTSIDE OF CURVE		
Hazard Behind Barrier:	LOW				
Barrier Crashworthiness					
Appropriate Test Level:	TL-2	Barrier Test Level:	NCW	Is Barrier Crashworthy?:	NO
Beg. End Trtmt Type:	NONE	Is Beg. End Trtmt Crashworthy?:	N/A	Approach Transition Type:	NONE
Ending End Trtmt Type:	NONE	Ending End Trtmt Crashworthy?:	N/A		
Average Measurements					
Design Height (In.):	18	Width (In.):	20.0	Post Spacing (In.):	0.0
Height (In.):	14.6	Lateral Offset (In.):	100.0	Road Grade (%):	3.30
Physical Condition					
Barrier	Alignment and Height:	Alignment has no deviation and the height is 3 to 6 in below the 18-in/24-in crenellated design height for 13 ft.

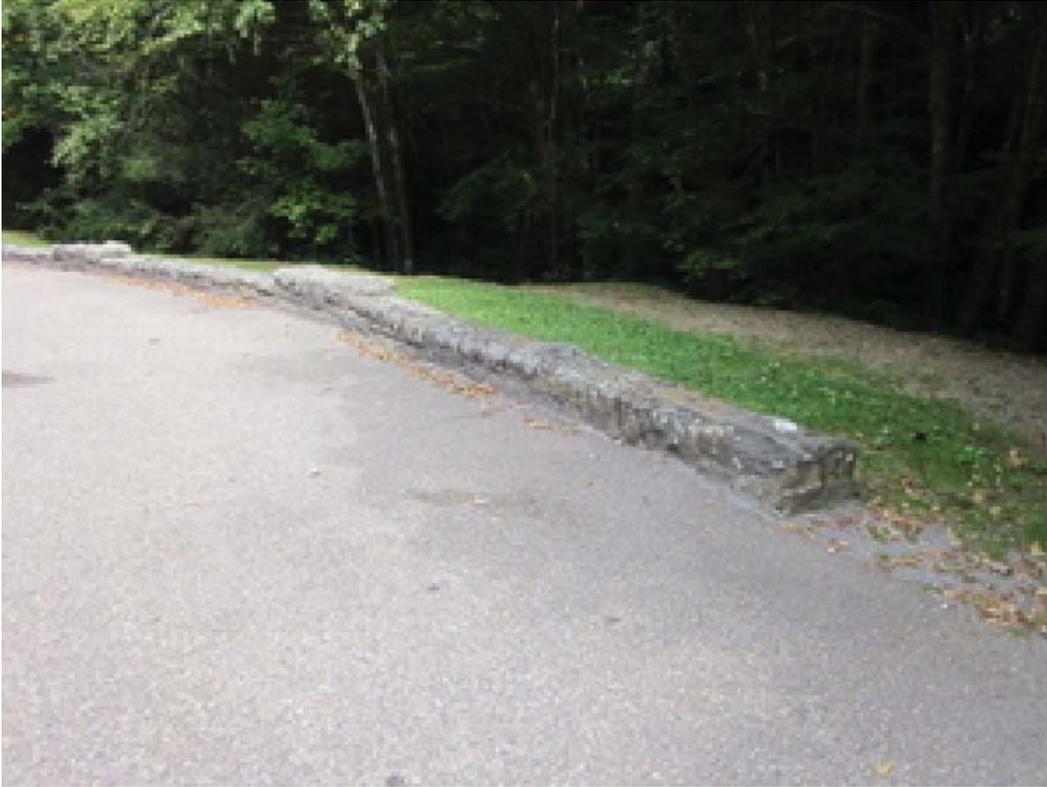
GRSM_0010N_10.149_L_1.JPG

Barrier ID:	GRSM-0010N-10.149-L				
Route Name:	NEWFOUND GAP ROAD NORTH				
Inspection Date:	09/16/2010	Barrier Rating:	32.40		
Barrier Description					
Type:	STONE MASONRY CRENELLATED WITHOUT	Barrier Function:	NON-TRAFFIC		
Barrier Material:	STONE	Post Material:	N/A		
Blockout Type:	N/A	Length (ft.):	65		
Speed Limit (MPH):	35	Placement with Respect to Road:	NON-TRAFFIC BARRIER		
Hazard Behind Barrier:	N/A				
Barrier Crashworthiness					
Appropriate Test Level:	TL-2	Barrier Test Level:	N/A	Is Barrier Crashworthy?:	N/A
Beg. End Trtmt Type:	NONE	Is Beg. End Trtmt Crashworthy?:	N/A	Approach Transition Type:	NONE
Ending End Trtmt Type:	NONE	Ending End Trtmt Crashworthy?:	N/A		
Average Measurements					
Design Height (In.):	18	Width (In.):	18.7	Post Spacing (In.):	0.0
Height (In.):	12.0	Lateral Offset (In.):	0.0	Road Grade (%):	0.00
Physical Condition					
Barrier	Alignment and Height:	Alignment has no deviation and the height is 3 to 6 in below the 18-in/24-in crenellated design height for 65 ft.

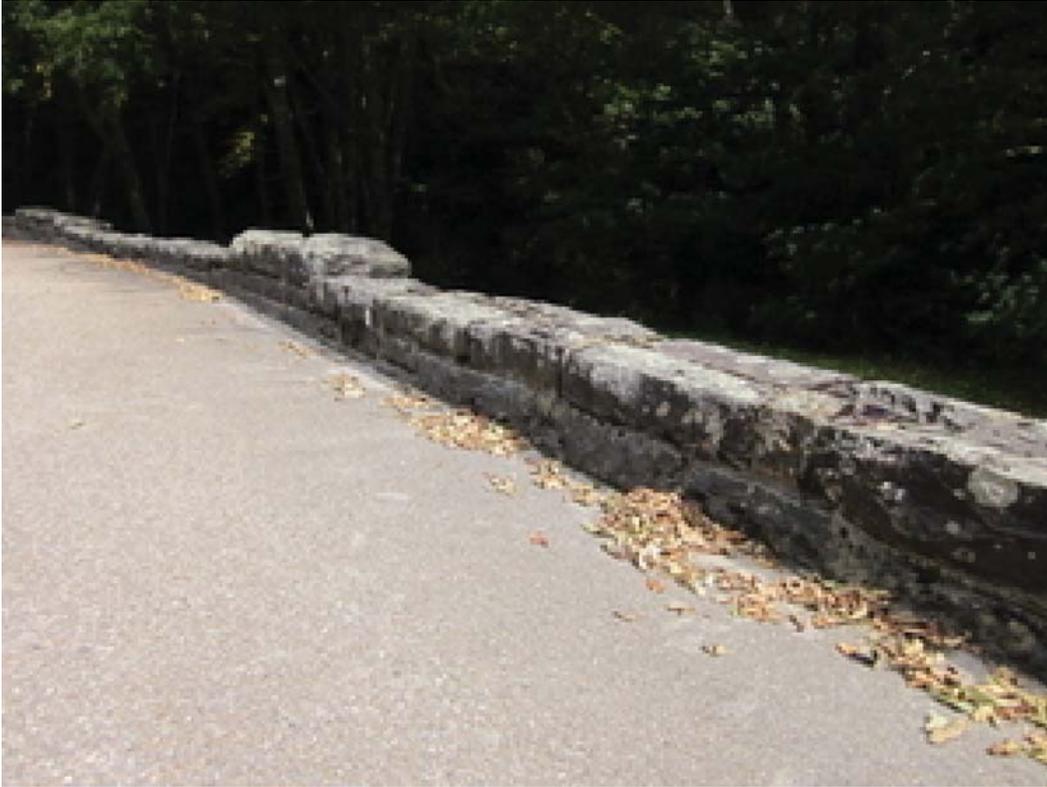
GRSM_0010N_10.158_L_1.JPG

Barrier ID:	GRSM-0010N-10.158-L				
Route Name:	NEWFOUND GAP ROAD NORTH				
Inspection Date:	09/16/2010	Barrier Rating:	28.10		
Barrier Description					
Type:	STONE MASONRY CRENELLATED WITHOUT	Barrier Function:	NON-TRAFFIC		
Barrier Material:	STONE	Post Material:	N/A		
Blockout Type:	N/A	Length (ft.):	86		
Speed Limit (MPH):	15	Placement with Respect to Road:	NON-TRAFFIC BARRIER		
Hazard Behind Barrier:	N/A				
Barrier Crashworthiness					
Appropriate Test Level:	TL-1	Barrier Test Level:	N/A	Is Barrier Crashworthy?:	N/A
Beg. End Trtmt Type:	NONE	Is Beg. End Trtmt Crashworthy?:	N/A	Approach Transition Type:	NONE
Ending End Trtmt Type:	NONE	Ending End Trtmt Crashworthy?:	N/A		
Average Measurements					
Design Height (In.):	18	Width (In.):	19.2	Post Spacing (In.):	0.0
Height (In.):	12.0	Lateral Offset (In.):	0.0	Road Grade (%):	0.00
Physical Condition					
Barrier	Alignment and Height:	Alignment has no deviation and the height is 6 in below the 18-in/24-in crenellated design height for 86 ft.

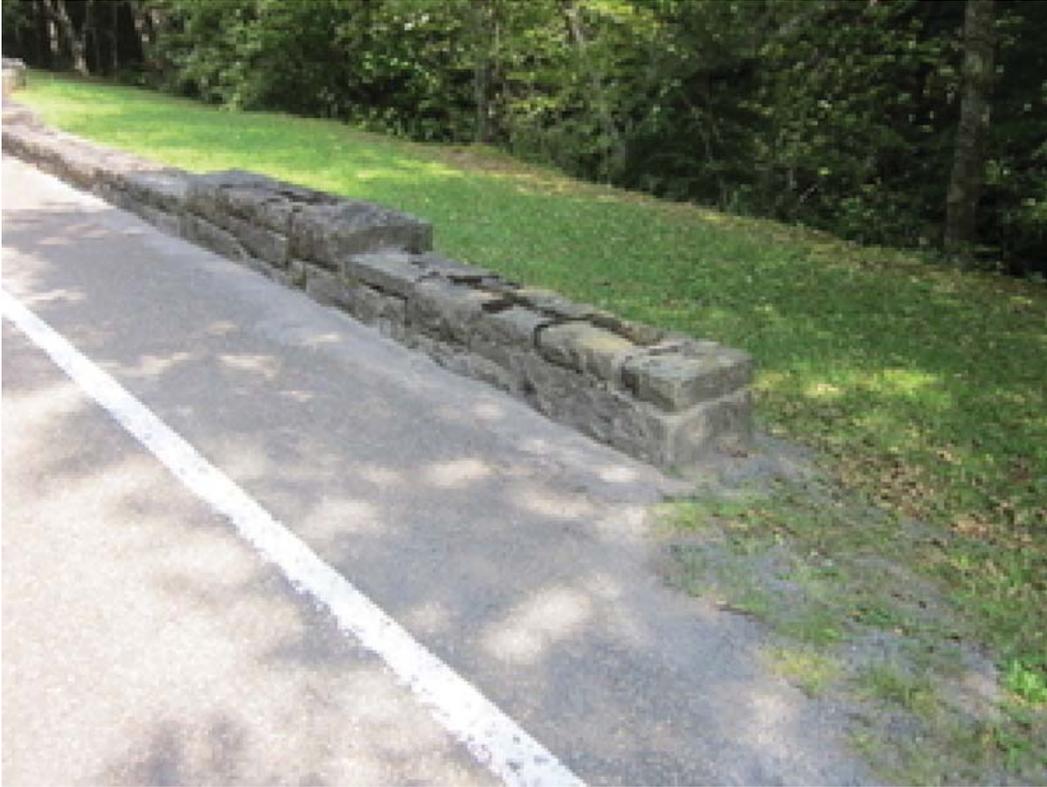
GRSM_0010N_10.174_L_1.JPG

Barrier ID:	GRSM-0010N-10.174-L				
Route Name:	NEWFOUND GAP ROAD NORTH				
Inspection Date:	09/16/2010	Barrier Rating:	42.70		
Barrier Description					
Type:	STONE MASONRY CRENELLATED WITHOUT	Barrier Function:	TRAFFIC		
Barrier Material:	STONE	Post Material:	N/A		
Blockout Type:	N/A	Length (ft.):	68		
Speed Limit (MPH):	35	Placement with Respect to Road:	OUTSIDE OF CURVE		
Hazard Behind Barrier:	LOW				
Barrier Crashworthiness					
Appropriate Test Level:	TL-2	Barrier Test Level:	NCW	Is Barrier Crashworthy?:	NO
Beg. End Trtmt Type:	NONE	Is Beg. End Trtmt Crashworthy?:	N/A	Approach Transition Type:	NONE
Ending End Trtmt Type:	NONE	Ending End Trtmt Crashworthy?:	N/A		
Average Measurements					
Design Height (In.):	18	Width (In.):	18.7	Post Spacing (In.):	0.0
Height (In.):	12.3	Lateral Offset (In.):	70.3	Road Grade (%):	2.00
Physical Condition					
Barrier	Alignment and Height:	Alignment has no deviation and the height is 5 to 6 in below the 18-in/24-in crenellated design height for 68 ft.

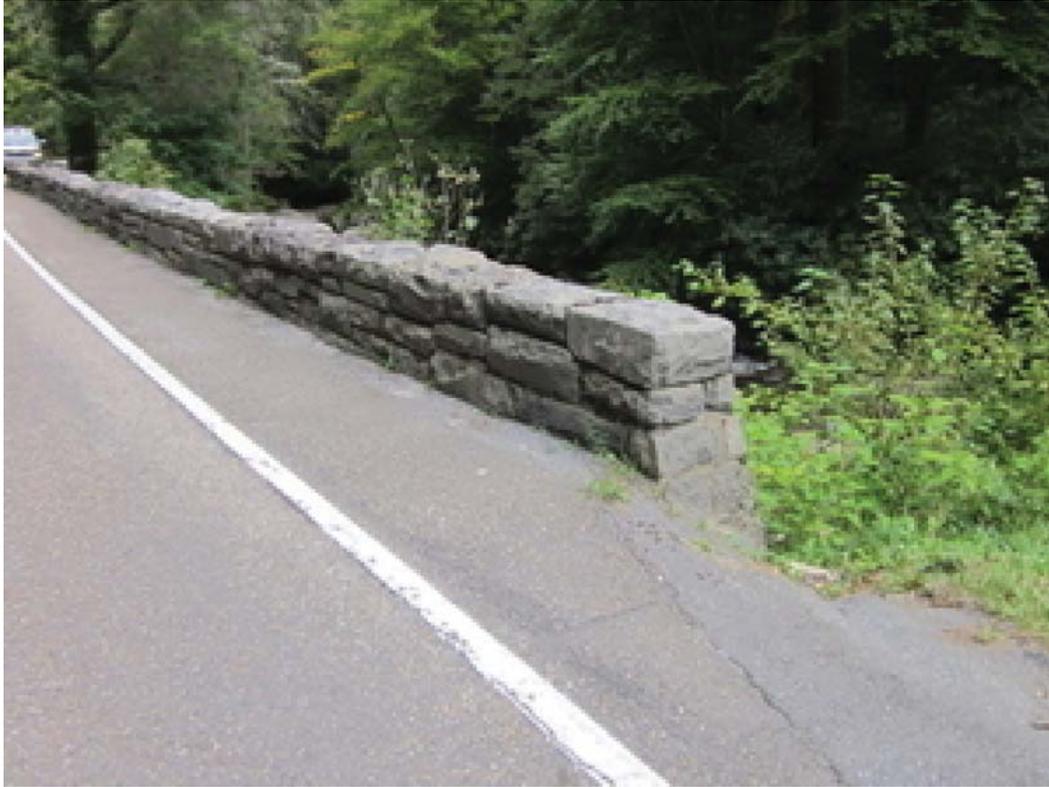
GRSM_0010N_10.745_L_1.JPG

Barrier ID:	GRSM-0010N-10.745-L				
Route Name:	NEWFOUND GAP ROAD NORTH				
Inspection Date:	09/16/2010	Barrier Rating:	38.00		
Barrier Description					
Type:	STONE MASONRY WITHOUT CONCRETE CORE WALL	Barrier Function:	TRAFFIC		
Barrier Material:	STONE	Post Material:	N/A		
Blockout Type:	N/A	Length (ft.):	101		
Speed Limit (MPH):	35	Placement with Respect to Road:	INSIDE OF CURVE		
Hazard Behind Barrier:	MEDIUM				
Barrier Crashworthiness					
Appropriate Test Level:	TL-2	Barrier Test Level:	NCW	Is Barrier Crashworthy?:	NO
Beg. End Trtmt Type:	NONE	Is Beg. End Trtmt Crashworthy?:	N/A	Approach Transition Type:	NONE
Ending End Trtmt Type:	NONE	Ending End Trtmt Crashworthy?:	N/A		
Average Measurements					
Design Height (In.):	24	Width (In.):	22.0	Post Spacing (In.):	0.0
Height (In.):	26.2	Lateral Offset (In.):	50.2	Road Grade (%):	4.30
Physical Condition					
Barrier	Alignment and Height:	Alignment has no deviation and the height is 2 to 3 in above the 24 in design height.

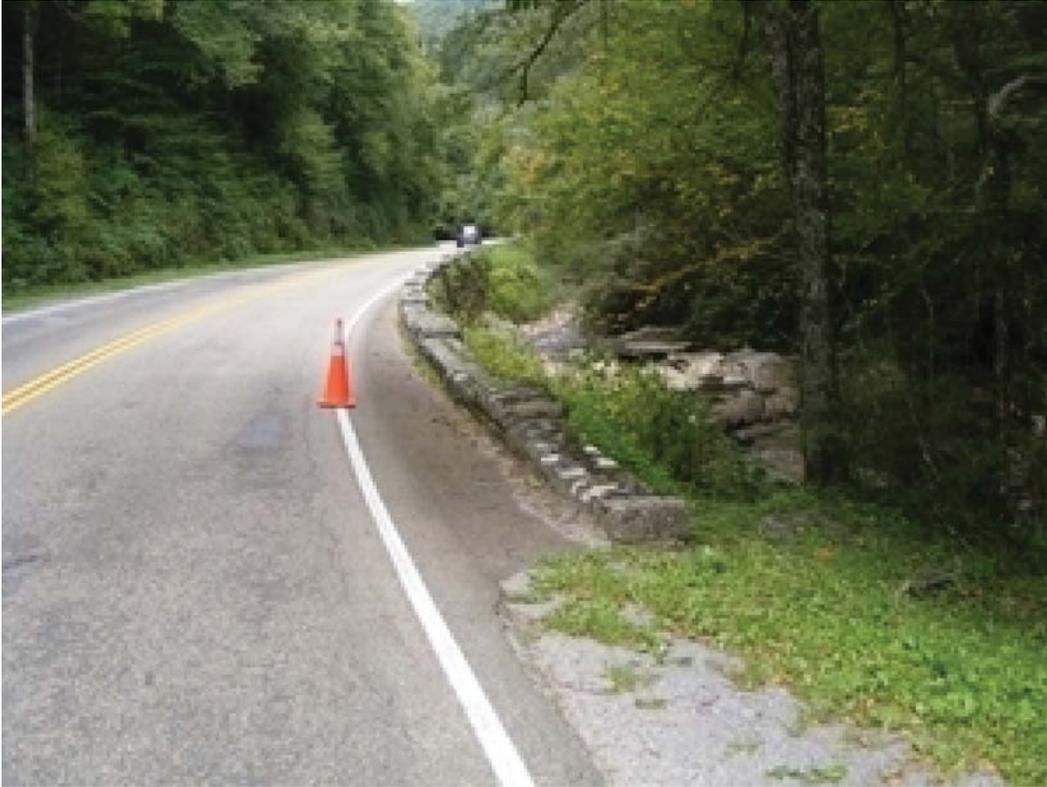
GRSM_0010N_11.610_L_1.JPG

Barrier ID:	GRSM-0010N-11.610-L				
Route Name:	NEWFOUND GAP ROAD NORTH				
Inspection Date:	09/16/2010	Barrier Rating:	72.90		
Barrier Description					
Type:	STONE MASONRY CRENELLATED WITHOUT	Barrier Function:	TRAFFIC		
Barrier Material:	STONE	Post Material:	N/A		
Blockout Type:	N/A	Length (ft.):	460		
Speed Limit (MPH):	35	Placement with Respect to Road:	BOTH INSIDE AND OUTSIDE		
Hazard Behind Barrier:	HIGH				
Barrier Crashworthiness					
Appropriate Test Level:	TL-2	Barrier Test Level:	NCW	Is Barrier Crashworthy?:	NO
Beg. End Trtmt Type:	NONE	Is Beg. End Trtmt Crashworthy?:	N/A	Approach Transition Type:	NONE
Ending End Trtmt Type:	NONE	Ending End Trtmt Crashworthy?:	N/A		
Average Measurements					
Design Height (In.):	18	Width (In.):	18.6	Post Spacing (In.):	0.0
Height (In.):	14.0	Lateral Offset (In.):	38.2	Road Grade (%):	4.40
Physical Condition					
Barrier	Alignment and Height:	The alignment has no deviation and the height is 3 to 6 in below the 18-in/24-in crenellated design height for 92 ft and 6 to 9 in below for 229 ft.

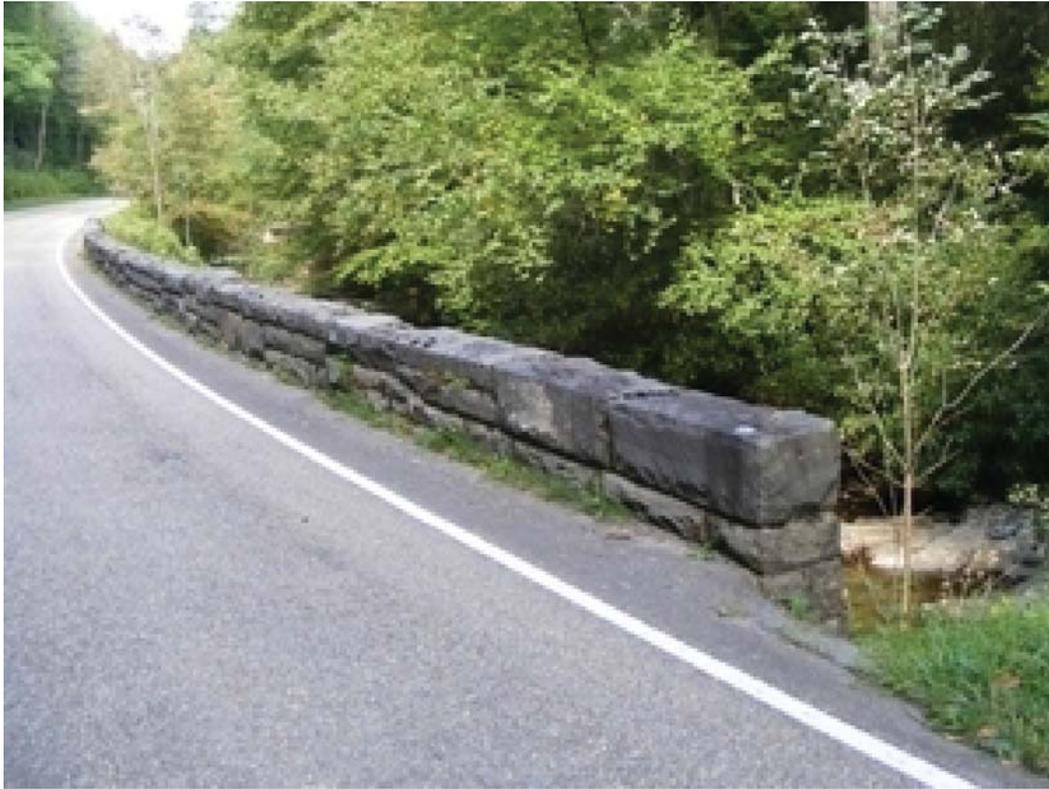
GRSM_0010N_11.863_L_1.JPG

Barrier ID:	GRSM-0010N-11.863-L				
Route Name:	NEWFOUND GAP ROAD NORTH				
Inspection Date:	09/16/2010	Barrier Rating:	42.70		
Barrier Description					
Type:	STONE MASONRY WITHOUT CONCRETE CORE WALL	Barrier Function:	TRAFFIC		
Barrier Material:	STONE	Post Material:	N/A		
Blockout Type:	N/A	Length (ft.):	139		
Speed Limit (MPH):	35	Placement with Respect to Road:	INSIDE OF CURVE		
Hazard Behind Barrier:	HIGH				
Barrier Crashworthiness					
Appropriate Test Level:	TL-2	Barrier Test Level:	NCW	Is Barrier Crashworthy?:	NO
Beg. End Trtmt Type:	NONE	Is Beg. End Trtmt Crashworthy?:	N/A	Approach Transition Type:	NONE
Ending End Trtmt Type:	NONE	Ending End Trtmt Crashworthy?:	N/A		
Average Measurements					
Design Height (In.):	24	Width (In.):	19.2	Post Spacing (In.):	0.0
Height (In.):	24.2	Lateral Offset (In.):	26.2	Road Grade (%):	4.80
Physical Condition					
Barrier	Alignment and Height:	The alignment has no deviation and the height is at or 1 in above the design height of 24 in.

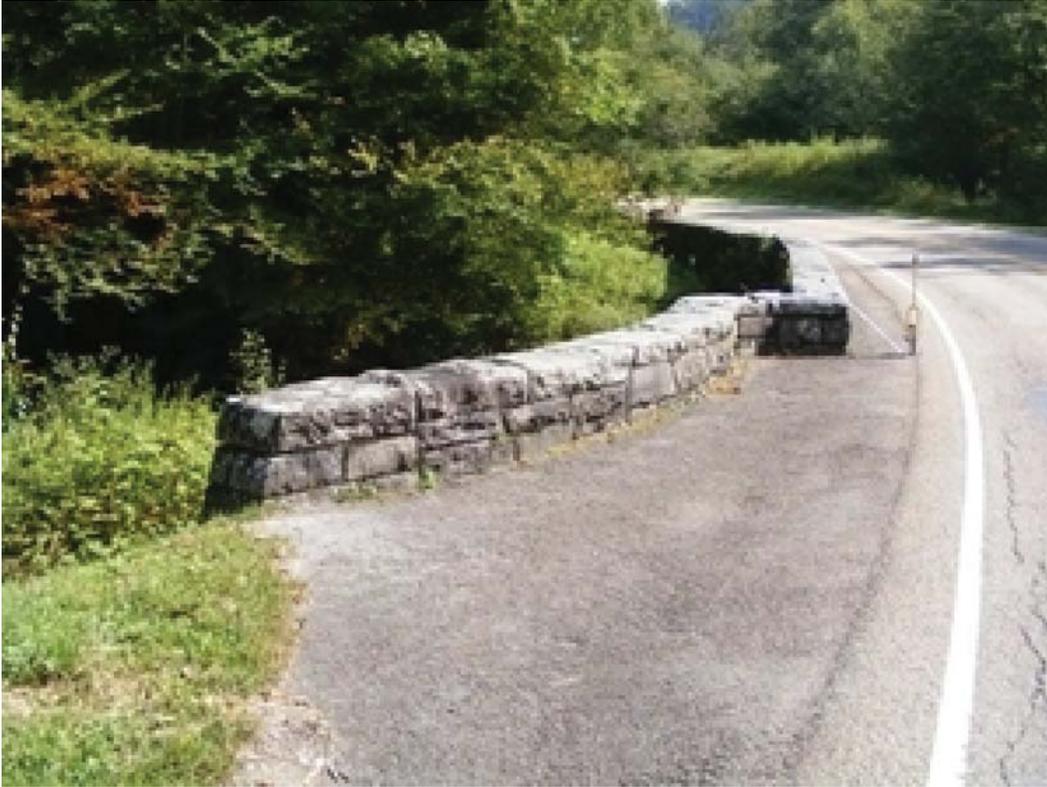
GRSM_0010N_12.125_L_1.JPG

Barrier ID:	GRSM-0010N-12.125-L				
Route Name:	NEWFOUND GAP ROAD NORTH				
Inspection Date:	09/16/2010	Barrier Rating:	42.40		
Barrier Description					
Type:	STONE MASONRY WITHOUT CONCRETE CORE WALL	Barrier Function:	TRAFFIC		
Barrier Material:	STONE	Post Material:	N/A		
Blockout Type:	N/A	Length (ft.):	28		
Speed Limit (MPH):	35	Placement with Respect to Road:	INSIDE OF CURVE		
Hazard Behind Barrier:	MEDIUM				
Barrier Crashworthiness					
Appropriate Test Level:	TL-2	Barrier Test Level:	NCW	Is Barrier Crashworthy?:	NO
Beg. End Trtmt Type:	NONE	Is Beg. End Trtmt Crashworthy?:	N/A	Approach Transition Type:	NONE
Ending End Trtmt Type:	NONE	Ending End Trtmt Crashworthy?:	N/A		
Average Measurements					
Design Height (In.):	24	Width (In.):	25.6	Post Spacing (In.):	0.0
Height (In.):	25.0	Lateral Offset (In.):	93.3	Road Grade (%):	6.50
Physical Condition					
Barrier	Alignment and Height:	The alignment has no deviation and the height is 1 in above the design height of 24 in.

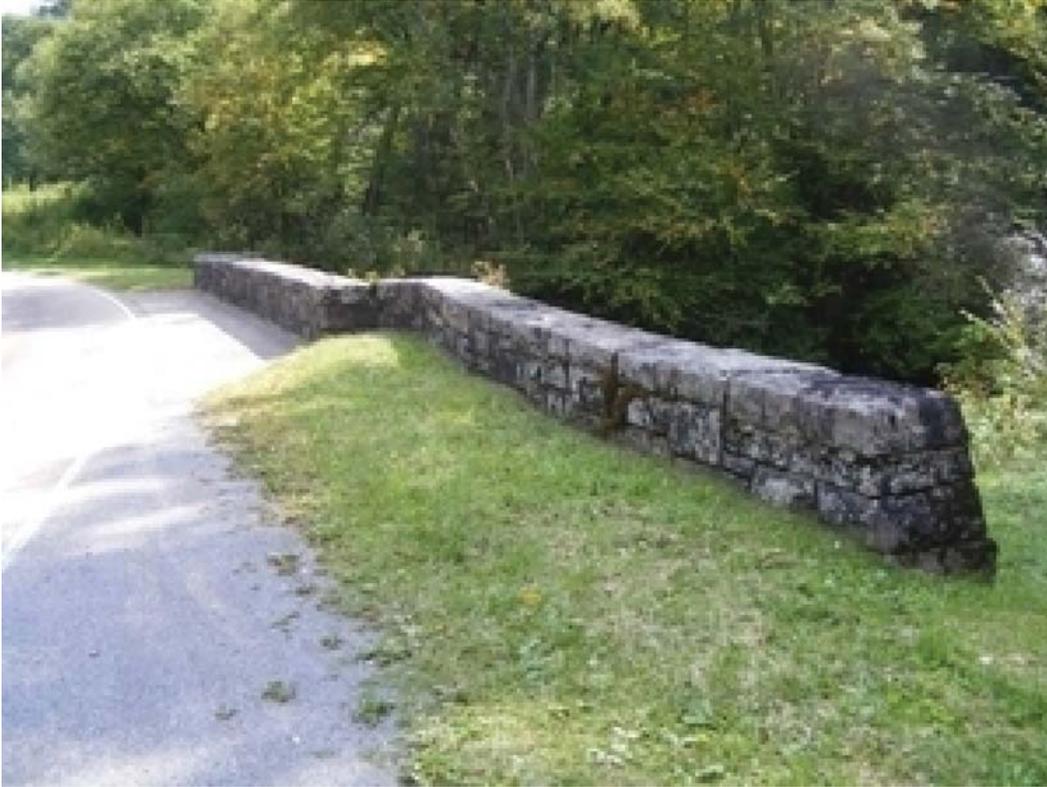
GRSM_0010N_12.127_R_1.JPG

Barrier ID:	GRSM-0010N-12.127-R				
Route Name:	NEWFOUND GAP ROAD NORTH				
Inspection Date:	09/16/2010	Barrier Rating:	39.50		
Barrier Description					
Type:	STONE MASONRY WITHOUT CONCRETE CORE WALL	Barrier Function:	TRAFFIC		
Barrier Material:	STONE	Post Material:	N/A		
Blockout Type:	N/A	Length (ft.):	32		
Speed Limit (MPH):	35	Placement with Respect to Road:	OUTSIDE OF CURVE		
Hazard Behind Barrier:	MEDIUM				
Barrier Crashworthiness					
Appropriate Test Level:	TL-2	Barrier Test Level:	NCW	Is Barrier Crashworthy?:	NO
Beg. End Trtmt Type:	NONE	Is Beg. End Trtmt Crashworthy?:	N/A	Approach Transition Type:	NONE
Ending End Trtmt Type:	NONE	Ending End Trtmt Crashworthy?:	N/A		
Average Measurements					
Design Height (In.):	24	Width (In.):	25.0	Post Spacing (In.):	0.0
Height (In.):	26.6	Lateral Offset (In.):	128.3	Road Grade (%):	5.50
Physical Condition					
Barrier	Alignment and Height:	The alignment has no deviation and the height is 1 in below to 3 in above the design height of 24 in.

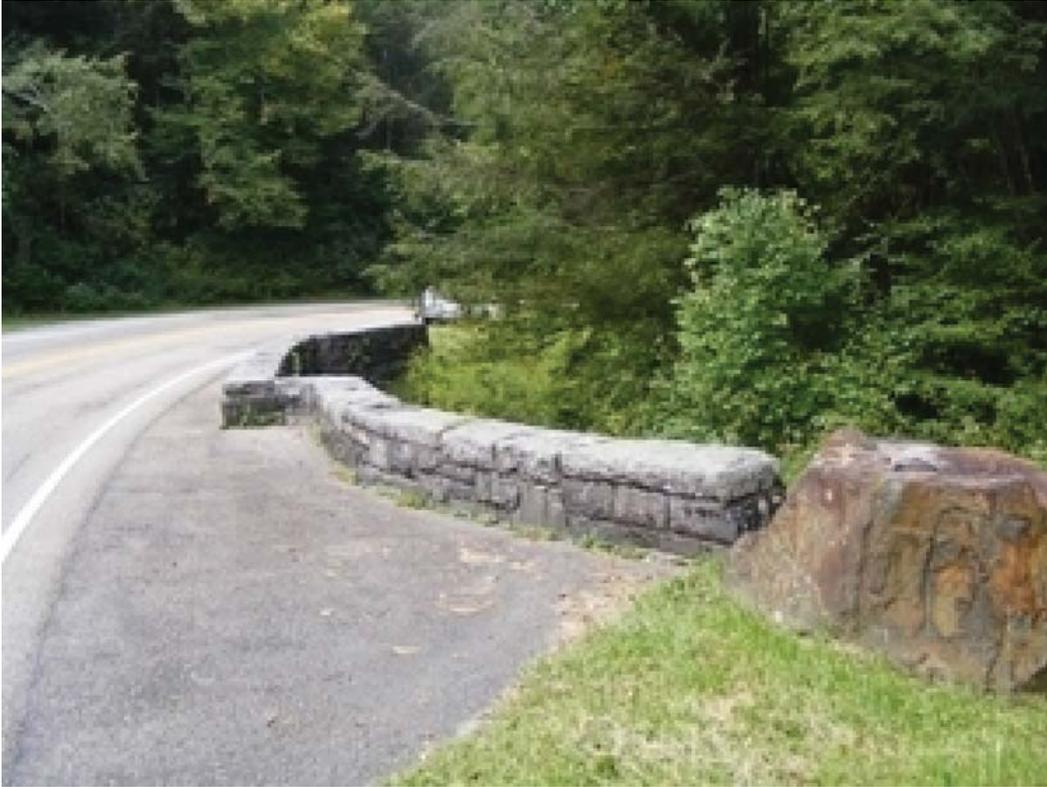
GRSM_0010N_12.140_L_1.JPG

Barrier ID:	GRSM-0010N-12.140-L				
Route Name:	NEWFOUND GAP ROAD NORTH				
Inspection Date:	09/16/2010	Barrier Rating:	35.20		
Barrier Description					
Type:	STONE MASONRY WITHOUT CONCRETE CORE WALL	Barrier Function:	TRAFFIC		
Barrier Material:	STONE	Post Material:	N/A		
Blockout Type:	N/A	Length (ft.):	30		
Speed Limit (MPH):	35	Placement with Respect to Road:	INSIDE OF CURVE		
Hazard Behind Barrier:	MEDIUM				
Barrier Crashworthiness					
Appropriate Test Level:	TL-2	Barrier Test Level:	NCW	Is Barrier Crashworthy?:	NO
Beg. End Trtmt Type:	NONE	Is Beg. End Trtmt Crashworthy?:	N/A	Approach Transition Type:	NONE
Ending End Trtmt Type:	NONE	Ending End Trtmt Crashworthy?:	N/A		
Average Measurements					
Design Height (In.):	24	Width (In.):	25.6	Post Spacing (In.):	0.0
Height (In.):	26.2	Lateral Offset (In.):	111.0	Road Grade (%):	6.70
Physical Condition					
Barrier	Alignment and Height:	The alignment has no deviation and the height is 1 in below to 3 in above the design height of 24 in.

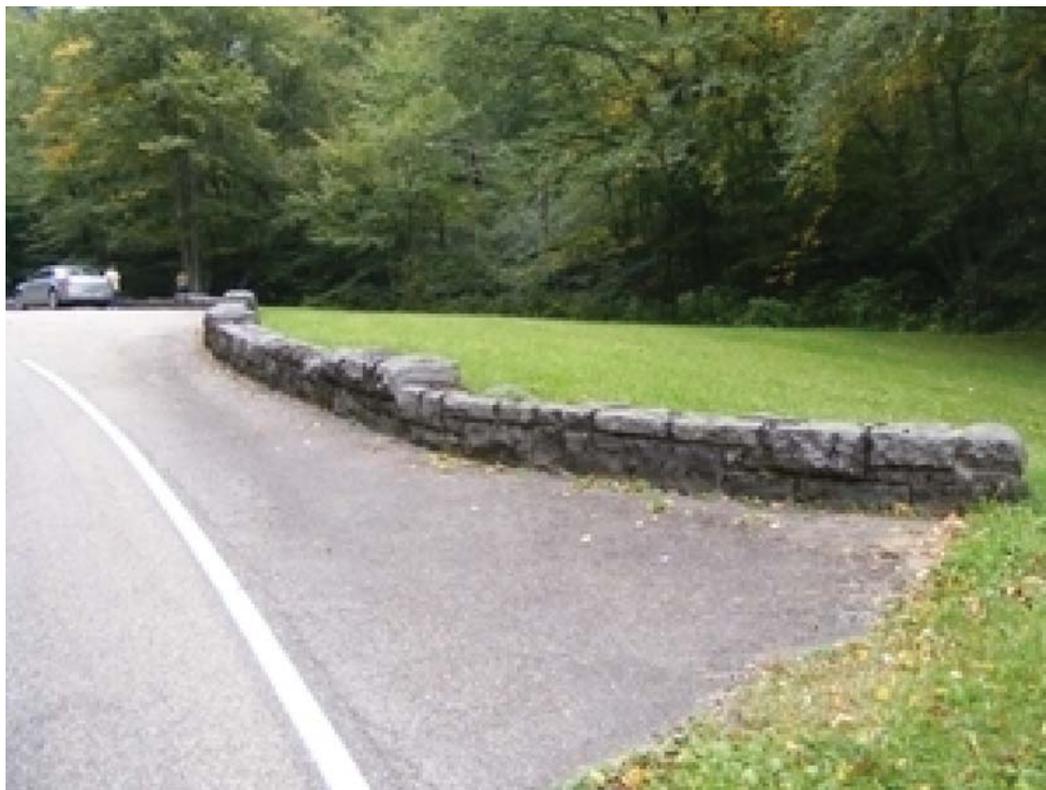
GRSM_0010N_12.321_R_1.JPG

Barrier ID:	GRSM-0010N-12.321-R				
Route Name:	NEWFOUND GAP ROAD NORTH				
Inspection Date:	09/16/2010	Barrier Rating:	46.70		
Barrier Description					
Type:	STONE MASONRY CRENELLATED WITHOUT	Barrier Function:	NON-TRAFFIC		
Barrier Material:	STONE	Post Material:	N/A		
Blockout Type:	N/A	Length (ft.):	260		
Speed Limit (MPH):	35	Placement with Respect to Road:	NON-TRAFFIC BARRIER		
Hazard Behind Barrier:	N/A				
Barrier Crashworthiness					
Appropriate Test Level:	TL-2	Barrier Test Level:	N/A	Is Barrier Crashworthy?:	N/A
Beg. End Trtmt Type:	NONE	Is Beg. End Trtmt Crashworthy?:	N/A	Approach Transition Type:	NONE
Ending End Trtmt Type:	NONE	Ending End Trtmt Crashworthy?:	N/A		
Average Measurements					
Design Height (In.):	18	Width (In.):	18.2	Post Spacing (In.):	0.0
Height (In.):	13.3	Lateral Offset (In.):	0.0	Road Grade (%):	0.00
Physical Condition					
Barrier	Alignment and Height:	The alignment has no deviation and the height is 3 to 6 in below the 18-in/24-in crenellated design height for 78 ft and 6 to 8 in below for 82 ft.

Breaking and Cracking:	No breaking but cracking was observed up to 1 in wide along 3 L.F.			
	Missing Elements:	No missing elements observed.			
	Corrosion and Weathering:	Moderate corrosion and weathering observed.			
End Treatments	Alignment and Height:				
	Breaking and Cracking:				
	Missing Elements:				
	Corrosion and Weathering:

Repair Action:	REPAIR	FMSS Work Type:	DEFERRED MAINTENANCE	Repair Cost:	\$79371
Brief Workorder:	Raise guardwall 2-in. Remove and reset 82-ft of stone masonry guardwall on concrete footer to adjacent 12-in height.				
Workorder:	Re-Point Stone Masonry Barrier at \$140- per -Sq. Yd. for 2 SY = \$280. $[(1.4ft + 1.5ft + 1.4ft)(3ft)] / 9 = 1.4 SY$. Remove & Reset Stone Masonry Guardwall at \$250- per -Cu. Ft. for 246 CF = \$61500. $[(2ft)(1.5ft)(82ft)] = 246 CF$. Structural Concrete at \$1000- per -Cu. Yd. for 3 CY = \$3000. $[(1.5ft)(0.5ft)(82ft)] / 27 = 2.3 CY$. Low Speed Traffic Control at \$1475- per -Day for 5 Day(s) = \$7375. 1 day removal 4 days installation

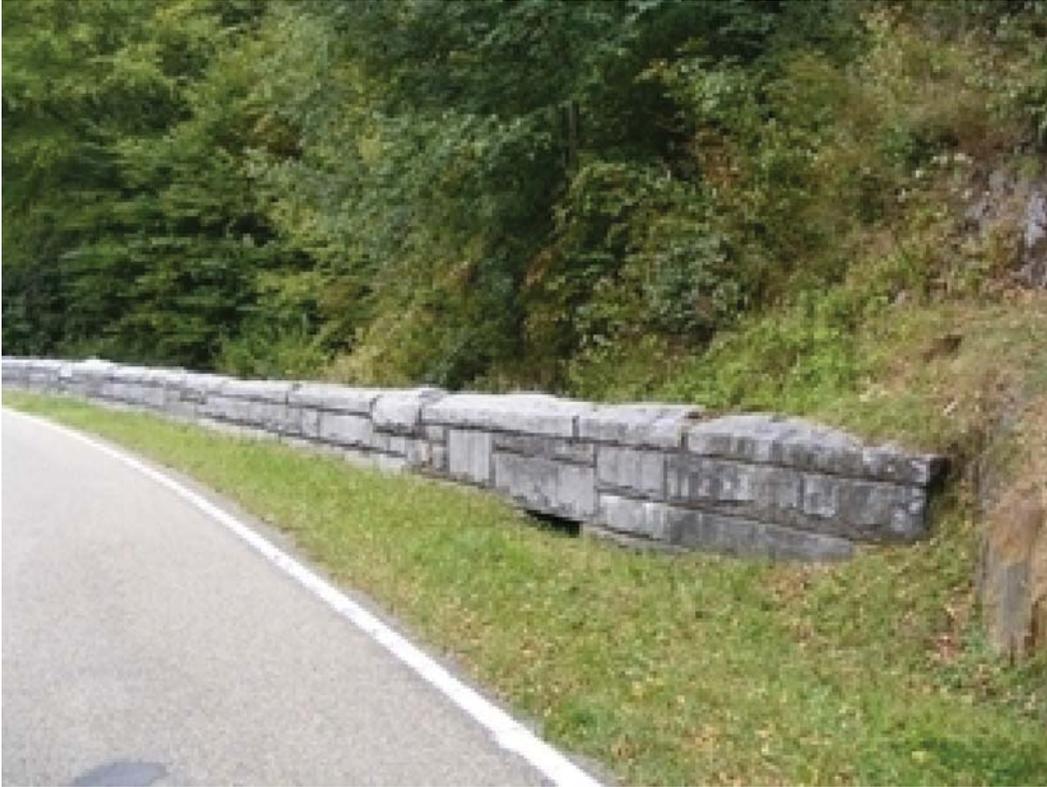
GRSM_0010N_12.791_L_1.JPG

Barrier ID:	GRSM-0010N-12.791-L				
Route Name:	NEWFOUND GAP ROAD NORTH				
Inspection Date:	09/16/2010	Barrier Rating:	48.00		
Barrier Description					
Type:	STONE MASONRY WITHOUT CONCRETE CORE WALL	Barrier Function:	TRAFFIC		
Barrier Material:	STONE	Post Material:	N/A		
Blockout Type:	N/A	Length (ft.):	107		
Speed Limit (MPH):	35	Placement with Respect to Road:	OUTSIDE OF CURVE		
Hazard Behind Barrier:	MEDIUM				
Barrier Crashworthiness					
Appropriate Test Level:	TL-2	Barrier Test Level:	NCW	Is Barrier Crashworthy?:	NO
Beg. End Trtmt Type:	NONE	Is Beg. End Trtmt Crashworthy?:	N/A	Approach Transition Type:	NONE
Ending End Trtmt Type:	NONE	Ending End Trtmt Crashworthy?:	N/A		
Average Measurements					
Design Height (In.):	24	Width (In.):	24.0	Post Spacing (In.):	0.0
Height (In.):	28.0	Lateral Offset (In.):	60.0	Road Grade (%):	6.40
Physical Condition					
Barrier	Alignment and Height:	The alignment has no deviation and the height is at or up to 4 in above the design height of 24 in.

Breaking and Cracking:	Last stone in barrier is separated along the mortar line. Opening is greater than 1/2 in.			
	Missing Elements:	No missing elements observed.			
	Corrosion and Weathering:	No weathering observed.			
End Treatments	Alignment and Height:				
	Breaking and Cracking:				
	Missing Elements:				
	Corrosion and Weathering:

Repair Action:	REPAIR	FMSS Work Type:	DEFERRED MAINTENANCE	Repair Cost:	\$1777
Brief Workorder:	Repoint one displaced stone at end of guardwall.				
Workorder:	Re-Point Stone Masonry Barrier at \$140- per -Sq. Yd. for 1 SY = \$140. [(1.5ft)(2ft)] /9 = 0.3 SY. Low Speed Traffic Control at \$1475- per -Day for 1 Day(s) = \$1475.

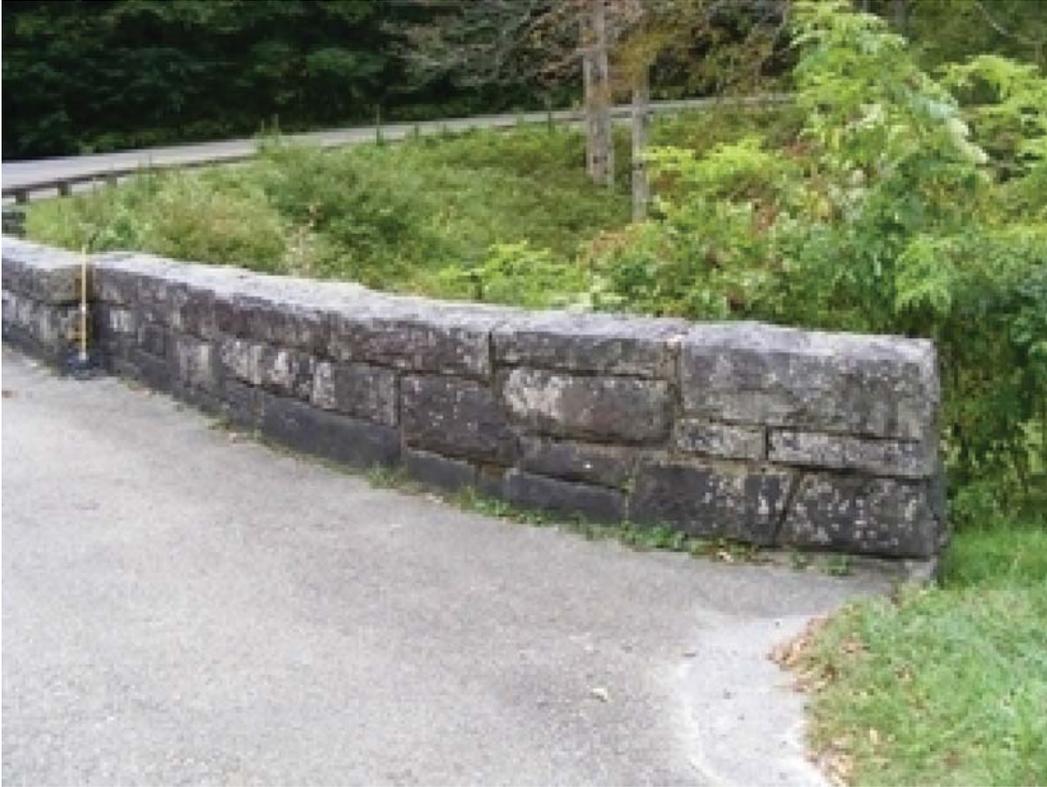
GRSM_0010N_12.979_R_1.JPG

Barrier ID:	GRSM-0010N-12.979-R				
Route Name:	NEWFOUND GAP ROAD NORTH				
Inspection Date:	09/16/2010	Barrier Rating:	33.70		
Barrier Description					
Type:	STONE MASONRY WITHOUT CONCRETE CORE WALL	Barrier Function:	TRAFFIC		
Barrier Material:	STONE	Post Material:	N/A		
Blockout Type:	N/A	Length (ft.):	22		
Speed Limit (MPH):	35	Placement with Respect to Road:	INSIDE OF CURVE		
Hazard Behind Barrier:	MEDIUM				
Barrier Crashworthiness					
Appropriate Test Level:	TL-2	Barrier Test Level:	NCW	Is Barrier Crashworthy?:	NO
Beg. End Trtmt Type:	NONE	Is Beg. End Trtmt Crashworthy?:	N/A	Approach Transition Type:	NONE
Ending End Trtmt Type:	NONE	Ending End Trtmt Crashworthy?:	N/A		
Average Measurements					
Design Height (In.):	24	Width (In.):	20.2	Post Spacing (In.):	0.0
Height (In.):	33.0	Lateral Offset (In.):	103.3	Road Grade (%):	3.10
Physical Condition					
Barrier	Alignment and Height:	The alignment has no deviation and the height is 8-10 in above the design height of 24 in.

Breaking and Cracking:	No breaking or cracking observed.			
	Missing Elements:	No missing elements observed.			
	Corrosion and Weathering:	No corrosion or weathering observed.			
End Treatments	Alignment and Height:				
	Breaking and Cracking:				
	Missing Elements:				
	Corrosion and Weathering:
