NPS Guardwall/Rail Inventory Program
Great Smoky Mountains National Park

Federal Highway Administration
Eastern Federal Lands Highway Division
Road Inventory Program (RIP)

Data Collection Date: September 2010
Report Date: December 2015

Great Smoky Mountains National Park in North Carolina and Tennessee

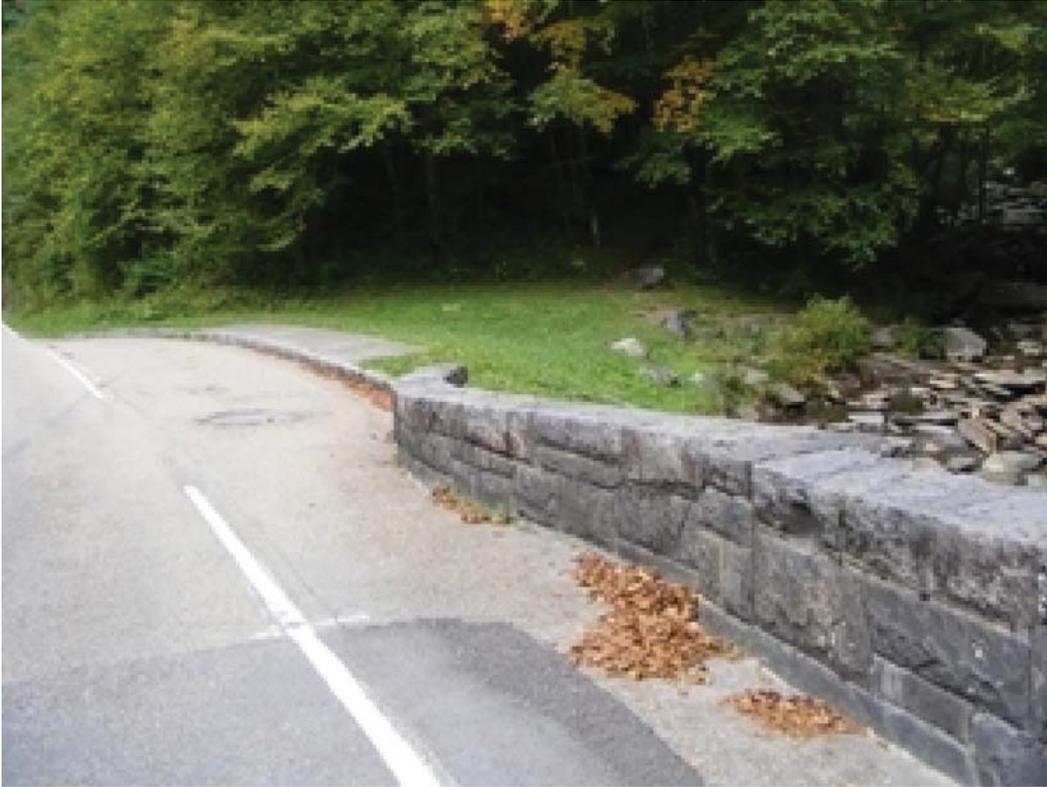
GRSM_0010N_12.980_L_1.JPG

Barrier ID:	GRSM-0010N-12.980-L				
Route Name:	NEWFOUND GAP ROAD NORTH				
Inspection Date:	09/16/2010	Barrier Rating:	43.70		
Barrier Description					
Type:	STONE MASONRY WITHOUT CONCRETE CORE WALL	Barrier Function:	TRAFFIC		
Barrier Material:	STONE	Post Material:	N/A		
Blockout Type:	N/A	Length (ft.):	29		
Speed Limit (MPH):	35	Placement with Respect to Road:	OUTSIDE OF CURVE		
Hazard Behind Barrier:	MEDIUM				
Barrier Crashworthiness					
Appropriate Test Level:	TL-2	Barrier Test Level:	NCW	Is Barrier Crashworthy?:	NO
Beg. End Trtmt Type:	NONE	Is Beg. End Trtmt Crashworthy?:	N/A	Approach Transition Type:	NONE
Ending End Trtmt Type:	NONE	Ending End Trtmt Crashworthy?:	N/A		
Average Measurements					
Design Height (In.):	24	Width (In.):	18.0	Post Spacing (In.):	0.0
Height (In.):	27.6	Lateral Offset (In.):	65.3	Road Grade (%):	5.70
Physical Condition					
Barrier	Alignment and Height:	The alignment has no deviation and the height is between 1 in below to 6 in above the design height of 24 in.

Breaking and Cracking:	No breaking or cracking observed.			
	Missing Elements:	No missing elements observed.			
	Corrosion and Weathering:	No corrosion or weathering observed.			
End Treatments	Alignment and Height:				
	Breaking and Cracking:				
	Missing Elements:				
	Corrosion and Weathering:

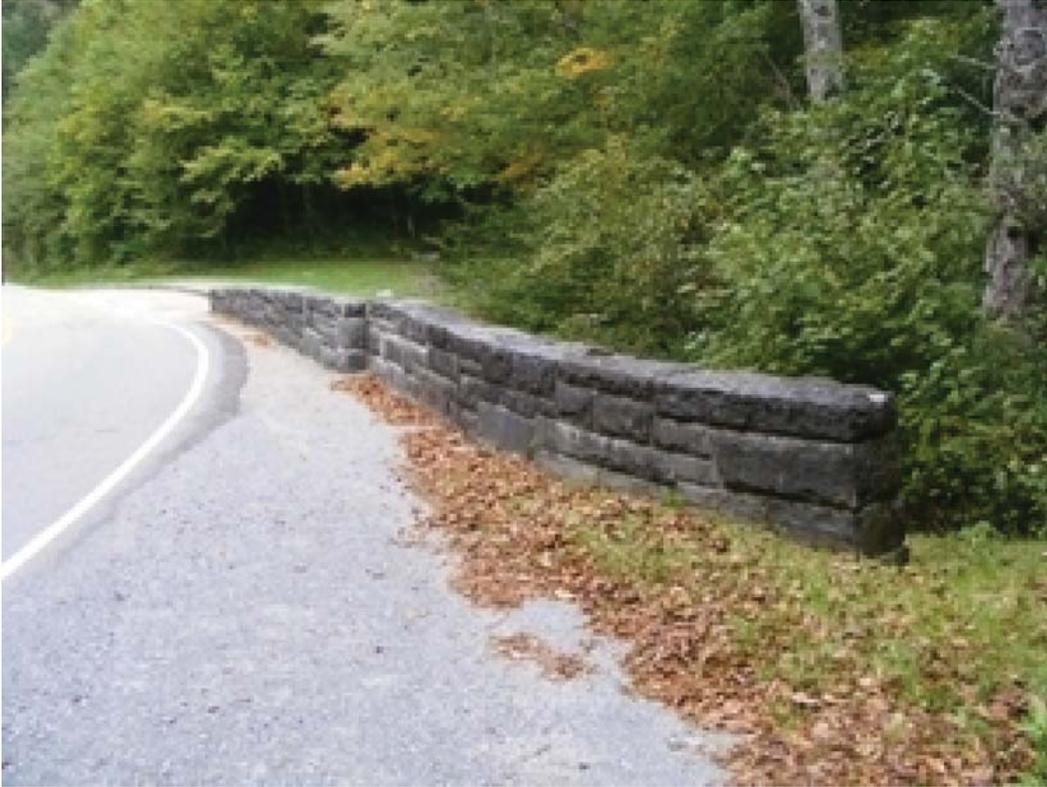
GRSM_0010N_12.990_L_1.JPG

Barrier ID:	GRSM-0010N-12.990-L				
Route Name:	NEWFOUND GAP ROAD NORTH				
Inspection Date:	09/16/2010	Barrier Rating:	36.70		
Barrier Description					
Type:	STONE MASONRY WITHOUT CONCRETE CORE WALL	Barrier Function:	TRAFFIC		
Barrier Material:	STONE	Post Material:	N/A		
Blockout Type:	N/A	Length (ft.):	30		
Speed Limit (MPH):	35	Placement with Respect to Road:	OUTSIDE OF CURVE		
Hazard Behind Barrier:	MEDIUM				
Barrier Crashworthiness					
Appropriate Test Level:	TL-2	Barrier Test Level:	NCW	Is Barrier Crashworthy?:	NO
Beg. End Trtmt Type:	NONE	Is Beg. End Trtmt Crashworthy?:	N/A	Approach Transition Type:	NONE
Ending End Trtmt Type:	NONE	Ending End Trtmt Crashworthy?:	N/A		
Average Measurements					
Design Height (In.):	24	Width (In.):	18.0	Post Spacing (In.):	0.0
Height (In.):	31.2	Lateral Offset (In.):	89.3	Road Grade (%):	3.60
Physical Condition					
Barrier	Alignment and Height:	The alignment has no deviation and the height is 6-9 in above the design height of 24 in.

Breaking and Cracking:	No breaking or cracking observed.			
	Missing Elements:	No missing elements observed.			
	Corrosion and Weathering:	No corrosion or weathering observed.			
End Treatments	Alignment and Height:				
	Breaking and Cracking:				
	Missing Elements:				
	Corrosion and Weathering:

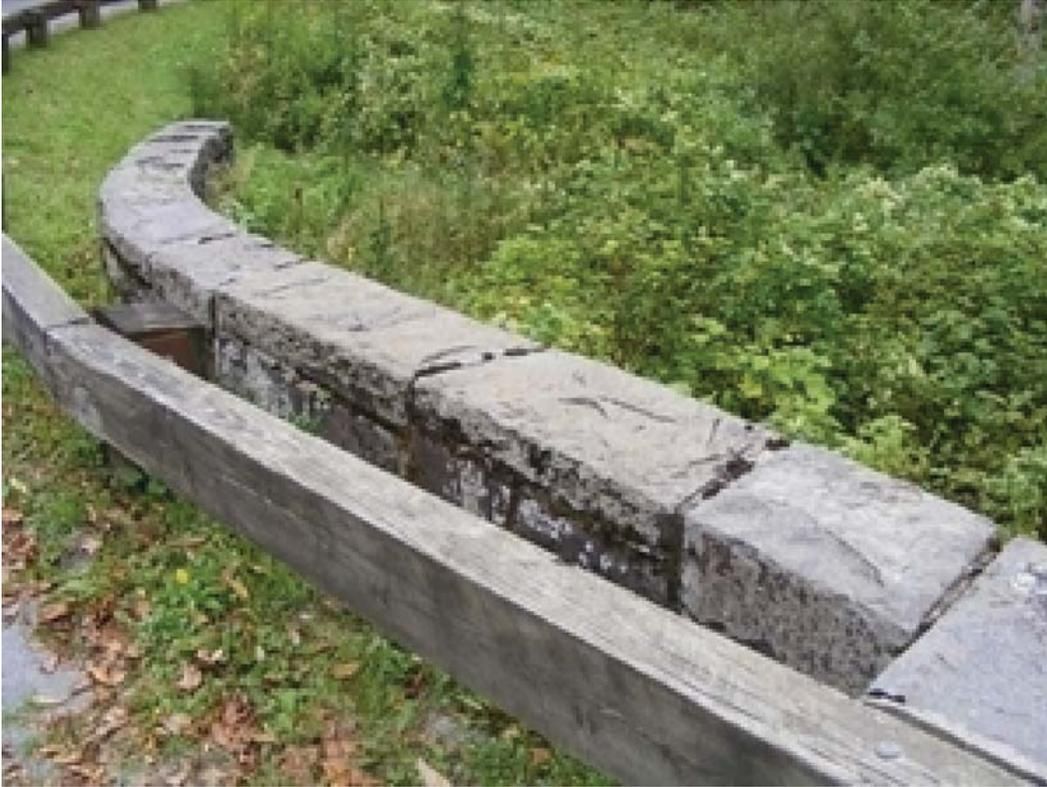
GRSM_0010N_12.991_R_1.JPG

Barrier ID:	GRSM-0010N-12.991-R				
Route Name:	NEWFOUND GAP ROAD NORTH				
Inspection Date:	09/16/2010	Barrier Rating:	31.10		
Barrier Description					
Type:	STONE MASONRY WITHOUT CONCRETE CORE WALL	Barrier Function:	TRAFFIC		
Barrier Material:	STONE	Post Material:	N/A		
Blockout Type:	N/A	Length (ft.):	30		
Speed Limit (MPH):	35	Placement with Respect to Road:	INSIDE OF CURVE		
Hazard Behind Barrier:	MEDIUM				
Barrier Crashworthiness					
Appropriate Test Level:	TL-2	Barrier Test Level:	NCW	Is Barrier Crashworthy?:	NO
Beg. End Trtmt Type:	NONE	Is Beg. End Trtmt Crashworthy?:	N/A	Approach Transition Type:	NONE
Ending End Trtmt Type:	NONE	Ending End Trtmt Crashworthy?:	N/A		
Average Measurements					
Design Height (In.):	24	Width (In.):	18.2	Post Spacing (In.):	0.0
Height (In.):	22.2	Lateral Offset (In.):	91.0	Road Grade (%):	2.40
Physical Condition					
Barrier	Alignment and Height:	The alignment has no deviation and the height is 1-3 in below the 24-in design height.

Breaking and Cracking:	No breaking or cracking observed.			
	Missing Elements:	No missing elements observed.			
	Corrosion and Weathering:	No corrosion or weathering observed.			
End Treatments	Alignment and Height:				
	Breaking and Cracking:				
	Missing Elements:				
	Corrosion and Weathering:

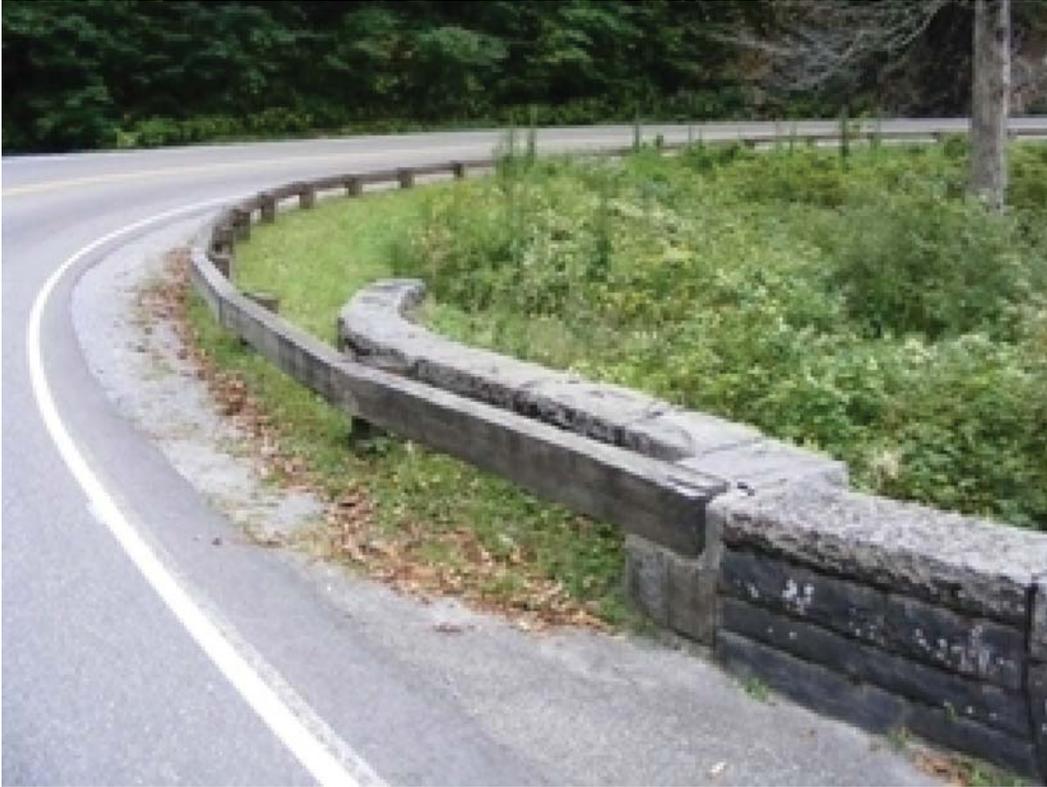
GRSM_0010N_12.992_R_1.JPG

Barrier ID:	GRSM-0010N-12.992-R				
Route Name:	NEWFOUND GAP ROAD NORTH				
Inspection Date:	09/16/2010	Barrier Rating:	45.70		
Barrier Description					
Type:	STEEL-BACKED TIMBER WITHOUT BLOCKOUT	Barrier Function:	TRAFFIC		
Barrier Material:	STEEL-BACKED TIMBER/LOG	Post Material:	WOOD		
Blockout Type:	N/A	Length (ft.):	464		
Speed Limit (MPH):	35	Placement with Respect to Road:	INSIDE OF CURVE		
Hazard Behind Barrier:	HIGH				
Barrier Crashworthiness					
Appropriate Test Level:	TL-2	Barrier Test Level:	TL-2	Is Barrier Crashworthy?:	YES
Beg. End Trtmt Type:	NONE	Is Beg. End Trtmt Crashworthy?:	N/A	Approach Transition Type:	NONE
Ending End Trtmt Type:	NONE	Ending End Trtmt Crashworthy?:	N/A		
Average Measurements					
Design Height (In.):	27	Width (In.):	0.0	Post Spacing (In.):	120.0
Height (In.):	24.6	Lateral Offset (In.):	66.5	Road Grade (%):	4.10
Physical Condition					
Barrier	Alignment and Height:	The alignment is off by 6 to 12 in for 180 ft. The height is 1-3 in below the 27-in design height for 180 ft and 3-4 in below for 284 ft.

Breaking and Cracking:	No breaking or cracking observed.			
	Missing Elements:	No missing elements observed.			
	Corrosion and Weathering:	Minor erosion at beginning end of stone barrier/ending end of the SBT.			
End Treatments	Alignment and Height:				
	Breaking and Cracking:				
	Missing Elements:				
	Corrosion and Weathering:

Repair Action:	REPAIR	FMSS Work Type:	DEFERRED MAINTENANCE	Repair Cost:	\$8349
Brief Workorder:	Adjust 180 ft of deflected guardrail back into alignment and raise 284 ft of guardrail up to the 27 inch design height.				
Workorder:	Adjust Guardrail at \$10- per -Lin. Ft. for 464 LF = \$4640. Raise and adjust 464 of low and unaligned guardrail up to the 27 inch design height. Low Speed Traffic Control at \$1475- per -Day for 2 Day(s) = \$2950.

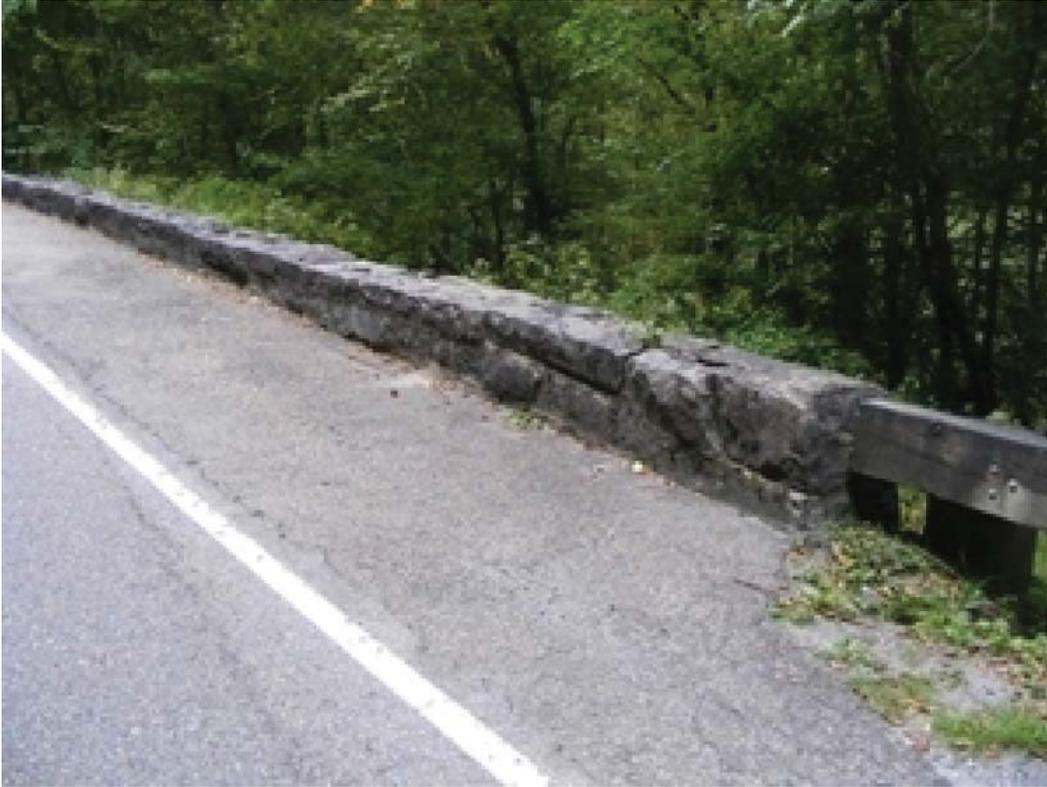
GRSM_0010N_13.084_R_1.JPG

Barrier ID:	GRSM-0010N-13.084-R				
Route Name:	NEWFOUND GAP ROAD NORTH				
Inspection Date:	09/16/2010	Barrier Rating:	72.10		
Barrier Description					
Type:	STONE MASONRY WITHOUT CONCRETE CORE WALL	Barrier Function:	TRAFFIC		
Barrier Material:	STONE	Post Material:	N/A		
Blockout Type:	N/A	Length (ft.):	500		
Speed Limit (MPH):	35	Placement with Respect to Road:	OUTSIDE OF CURVE		
Hazard Behind Barrier:	HIGH				
Barrier Crashworthiness					
Appropriate Test Level:	TL-2	Barrier Test Level:	NCW	Is Barrier Crashworthy?:	NO
Beg. End Trtmt Type:	NONE	Is Beg. End Trtmt Crashworthy?:	N/A	Approach Transition Type:	NONE
Ending End Trtmt Type:	NONE	Ending End Trtmt Crashworthy?:	N/A		
Average Measurements					
Design Height (In.):	24	Width (In.):	19.0	Post Spacing (In.):	0.0
Height (In.):	16.2	Lateral Offset (In.):	86.6	Road Grade (%):	5.30
Physical Condition					
Barrier	Alignment and Height:	The alignment has no deviation and the height is 3 to 6 in below the 24-in design height for 237 ft and 6 to 12 in below for 263 ft.

Breaking and Cracking:	No breaking or cracking observed.			
	Missing Elements:	No missing elements observed.			
	Corrosion and Weathering:	No corrosion or weathering observed.			
End Treatments	Alignment and Height:				
	Breaking and Cracking:				
	Missing Elements:				
	Corrosion and Weathering:

Repair Action:	REPAIR	FMSS Work Type:	DEFERRED MAINTENANCE	Repair Cost:	\$263065
Brief Workorder:	Raise guardwall 4-in. Remove and reset 263-ft of stone masonry guardwall on concrete footer to adjacent 18-in height.				
Workorder:	Remove & Reset Stone Masonry Guardwall at \$250- per -Cu. Ft. for 842 CF = \$210500. [(2ft)(1.6ft)(263ft)] = 841.6 CF. Structural Concrete at \$1000- per -Cu. Yd. for 8 CY = \$8000. [(1.6ft)(0.5ft)(263ft)] /27 = 7.8 CY. Low Speed Traffic Control at \$1475- per -Day for 14 Day(s) = \$20650. 3 days removal 11 days installation.

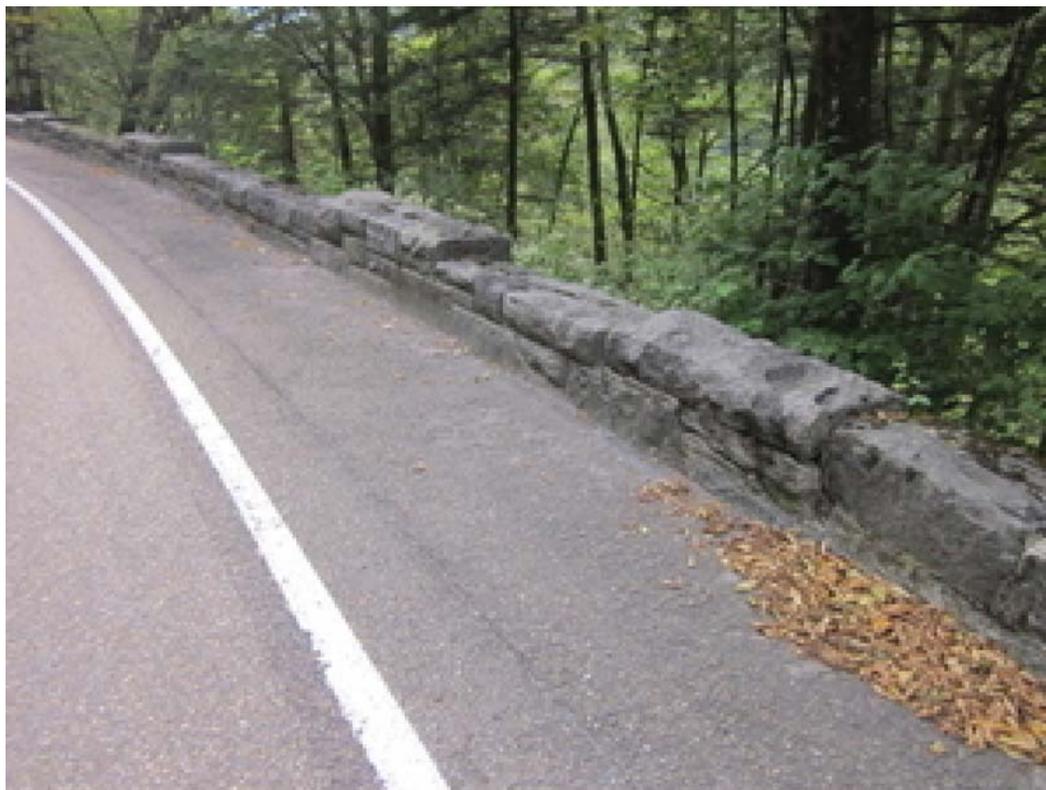
GRSM_0010N_13.176_R_1.JPG

Barrier ID:	GRSM-0010N-13.176-R				
Route Name:	NEWFOUND GAP ROAD NORTH				
Inspection Date:	09/16/2010	Barrier Rating:	44.40		
Barrier Description					
Type:	STONE MASONRY CRENELLATED WITHOUT	Barrier Function:	TRAFFIC		
Barrier Material:	STONE	Post Material:	N/A		
Blockout Type:	N/A	Length (ft.):	1275		
Speed Limit (MPH):	25	Placement with Respect to Road:	BOTH INSIDE AND OUTSIDE		
Hazard Behind Barrier:	HIGH				
Barrier Crashworthiness					
Appropriate Test Level:	TL-1	Barrier Test Level:	NCW	Is Barrier Crashworthy?:	NO
Beg. End Trtmt Type:	NONE	Is Beg. End Trtmt Crashworthy?:	N/A	Approach Transition Type:	NONE
Ending End Trtmt Type:	NONE	Ending End Trtmt Crashworthy?:	N/A		
Average Measurements					
Design Height (In.):	18	Width (In.):	19.7	Post Spacing (In.):	0.0
Height (In.):	16.1	Lateral Offset (In.):	52.0	Road Grade (%):	5.10
Physical Condition					
Barrier	Alignment and Height:	Alignment has no deviation and the height is 3 to 6 in below the 18-in/24-in crenellated design height for 411 ft and 6 to 9 in below for 81.

Breaking and Cracking:	81 linear ft with breaking of mortar and no cracking observed.			
	Missing Elements:	No missing elements observed.			
	Corrosion and Weathering:	No corrosion or weathering observed.			
End Treatments	Alignment and Height:				
	Breaking and Cracking:				
	Missing Elements:				
	Corrosion and Weathering:

Repair Action:	REPAIR	FMSS Work Type:	DEFERRED MAINTENANCE	Repair Cost:	\$37263
Brief Workorder:	Raise guardwall 2-in. Remove and reset 81-ft of stone masonry guardwall on 1 row of new stone to raise barrier to the adjacent 12-in height.				
Workorder:	Remove & Reset Stone Masonry Guardwall at \$250- per -Cu. Ft. for 65 CF = \$16250. [(0.5ft)(1.6ft)(81ft)] = 64.8 CF. Remove top layer of stones in barrier for 81 feet. New Stone at \$250- per -Each for 41 Unit(s) = \$10250. [(81ft) / (2ft/stone)] x 1 row = 41 stones. Insert new stone on retaining wall to increase barrier height then reset top layer of barrier. Low Speed Traffic Control at \$1475- per -Day for 5 Day(s) = \$7375. 1 day removal 4 days installation.

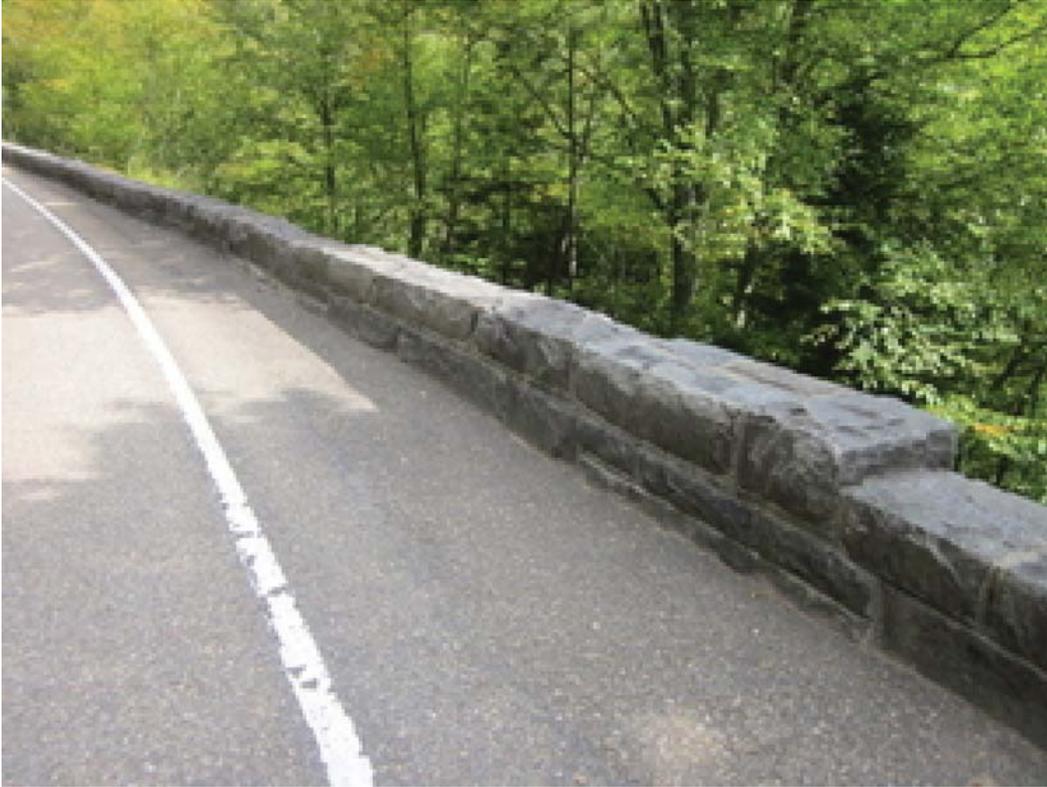
GRSM_0010N_13.417_R_1.JPG

Barrier ID:	GRSM-0010N-13.417-R				
Route Name:	NEWFOUND GAP ROAD NORTH				
Inspection Date:	09/16/2010	Barrier Rating:	72.10		
Barrier Description					
Type:	STONE MASONRY WITHOUT CONCRETE CORE WALL	Barrier Function:	TRAFFIC		
Barrier Material:	STONE	Post Material:	N/A		
Blockout Type:	N/A	Length (ft.):	640		
Speed Limit (MPH):	25	Placement with Respect to Road:	OUTSIDE OF CURVE		
Hazard Behind Barrier:	HIGH				
Barrier Crashworthiness					
Appropriate Test Level:	TL-1	Barrier Test Level:	NCW	Is Barrier Crashworthy?:	NO
Beg. End Trtmt Type:	NONE	Is Beg. End Trtmt Crashworthy?:	N/A	Approach Transition Type:	NONE
Ending End Trtmt Type:	NONE	Ending End Trtmt Crashworthy?:	N/A		
Average Measurements					
Design Height (In.):	24	Width (In.):	20.7	Post Spacing (In.):	0.0
Height (In.):	14.8	Lateral Offset (In.):	30.2	Road Grade (%):	5.80
Physical Condition					
Barrier	Alignment and Height:	Alignment has no deviation and the height is 6 to 11 in below the 24 in design height for 640 ft.

Breaking and Cracking:	20 linear ft of severe breaking and cracking.			
	Missing Elements:	6 linear feet of missing stone off next to wall.			
	Corrosion and Weathering:	No corrosion or weathering observed.			
End Treatments	Alignment and Height:				
	Breaking and Cracking:				
	Missing Elements:				
	Corrosion and Weathering:

Repair Action:	REPAIR	FMSS Work Type:	DEFERRED MAINTENANCE	Repair Cost:	\$686043
Brief Workorder:	Raise guardwall 9-in. Remove and reset 640-ft of stone masonry guardwall on concrete footer to design height of 24-in.				
Workorder:	Remove & Reset Stone Masonry Guardwall at \$250- per -Cu. Ft. for 2176 CF = \$544000. [(2ft)(1.7ft)(640ft)] = 2176 CF. Structural Concrete at \$1000- per -Cu. Yd. for 31 CY = \$31000. [(1.7ft)(0.75ft)(640ft)] /27 = 30.2 CY. Low Speed Traffic Control at \$1475- per -Day for 33 Day(s) = \$48675. 7 days removal 26 days installation.

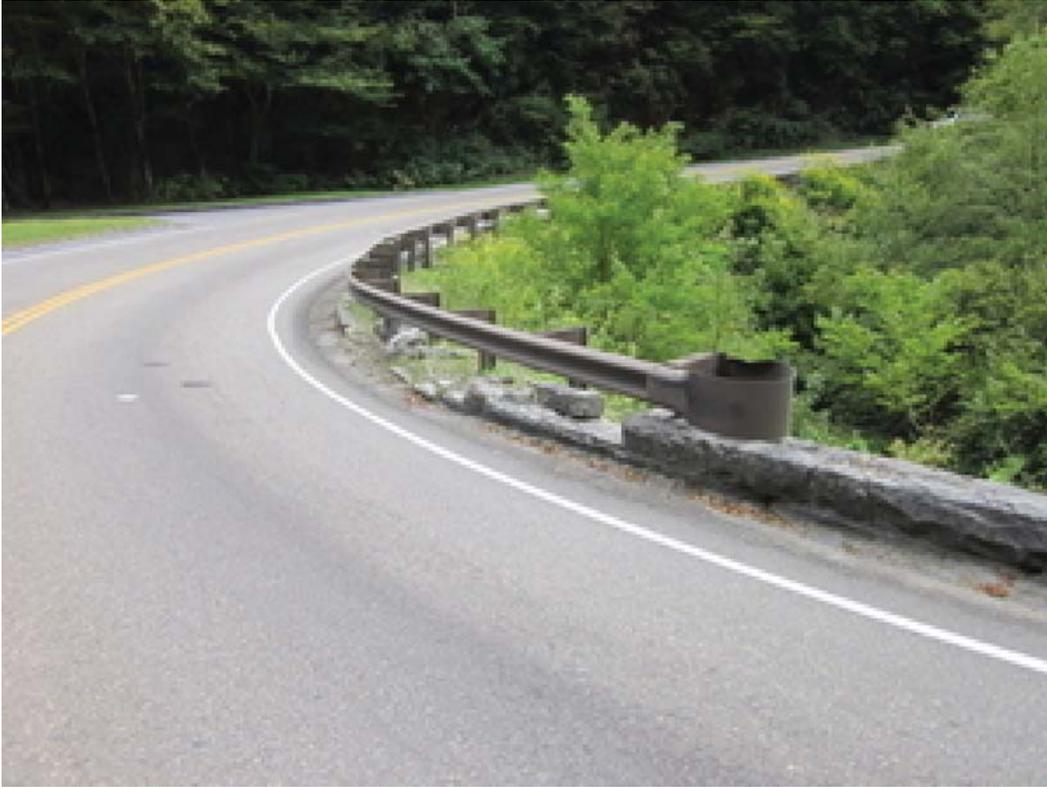
GRSM_0010N_13.538_R_1.JPG

Barrier ID:	GRSM-0010N-13.538-R				
Route Name:	NEWFOUND GAP ROAD NORTH				
Inspection Date:	09/16/2010	Barrier Rating:	30.00		
Barrier Description					
Type:	W-BEAM STRONG POST	Barrier Function:	TRAFFIC		
Barrier Material:	GALVANIZED STEEL	Post Material:	GALVANIZED STEEL		
Blockout Type:	WOOD	Length (ft.):	121		
Speed Limit (MPH):	25	Placement with Respect to Road:	INSIDE OF CURVE		
Hazard Behind Barrier:	HIGH				
Barrier Crashworthiness					
Appropriate Test Level:	TL-1	Barrier Test Level:	TL-3	Is Barrier Crashworthy?:	YES
Beg. End Trtmt Type:	NONE	Is Beg. End Trtmt Crashworthy?:	N/A	Approach Transition Type:	NONE
Ending End Trtmt Type:	NONE	Ending End Trtmt Crashworthy?:	N/A		
Average Measurements					
Design Height (In.):	27	Width (In.):	0.0	Post Spacing (In.):	74.3
Height (In.):	31.7	Lateral Offset (In.):	58.2	Road Grade (%):	4.50
Physical Condition					
Barrier	Alignment and Height:	Alignment has no deviation and the height is 2 to 7 in above the 27 in design height with 35 ft being more than 5 in above.

Breaking and Cracking:	26 ft of barrier is damaged from impact.			
	Missing Elements:	No missing elements observed.			
	Corrosion and Weathering:	No corrosion or weathering observed.			
End Treatments	Alignment and Height:				
	Breaking and Cracking:				
	Missing Elements:				
	Corrosion and Weathering:

Repair Action:	REPAIR	FMSS Work Type:	DEFERRED MAINTENANCE	Repair Cost:	\$3295
Brief Workorder:	Replace 26 linear feet of guardrail and lower 35 feet of barrier down to the 27-in design height.				
Workorder:	Remove Guardrail at \$10- per -Lin. Ft. for 26 LF = \$260. W-Beam Strong Post at \$35- per -Lin. Ft. for 26 LF = \$910. Adjust Guardrail at \$10- per -Lin. Ft. for 35 LF = \$350. Lower 35 feet of barrier down to the 27-in design height. Low Speed Traffic Control at \$1475- per -Day for 1 Day(s) = \$1475.

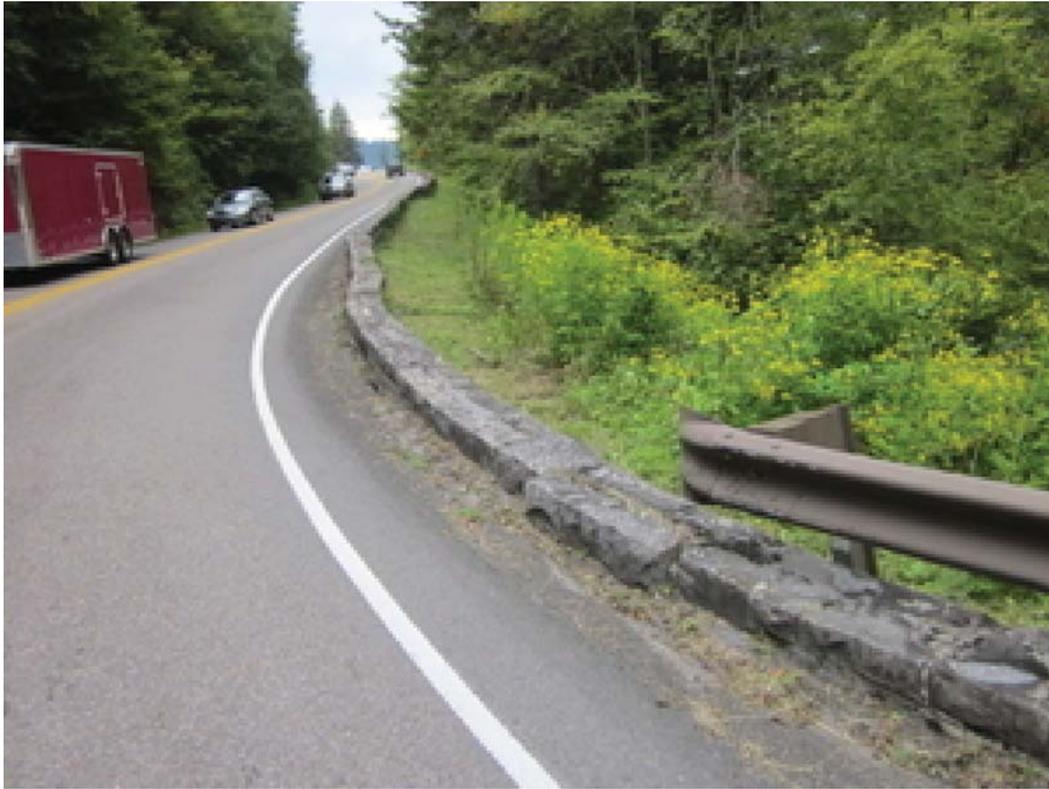
GRSM_0010N_13.563_R_1.JPG

Barrier ID:	GRSM-0010N-13.563-R				
Route Name:	NEWFOUND GAP ROAD NORTH				
Inspection Date:	09/16/2010	Barrier Rating:	73.30		
Barrier Description					
Type:	STONE MASONRY WITHOUT CONCRETE CORE WALL	Barrier Function:	TRAFFIC		
Barrier Material:	STONE	Post Material:	N/A		
Blockout Type:	N/A	Length (ft.):	522		
Speed Limit (MPH):	25	Placement with Respect to Road:	BOTH INSIDE AND OUTSIDE		
Hazard Behind Barrier:	MEDIUM				
Barrier Crashworthiness					
Appropriate Test Level:	TL-1	Barrier Test Level:	NCW	Is Barrier Crashworthy?:	NO
Beg. End Trtmt Type:	NONE	Is Beg. End Trtmt Crashworthy?:	N/A	Approach Transition Type:	NONE
Ending End Trtmt Type:	NONE	Ending End Trtmt Crashworthy?:	N/A		
Average Measurements					
Design Height (In.):	24	Width (In.):	21.0	Post Spacing (In.):	0.0
Height (In.):	14.0	Lateral Offset (In.):	37.0	Road Grade (%):	6.20
Physical Condition					
Barrier	Alignment and Height:	Alignment has no deviation and the height is 10 in below the 24 in design height for 522 ft.

Breaking and Cracking:	Severe breaking and cracking observed.			
	Missing Elements:	No missing elements observed.			
	Corrosion and Weathering:	Severe corrosion and weathering observed.			
End Treatments	Alignment and Height:				
	Breaking and Cracking:				
	Missing Elements:				
	Corrosion and Weathering:

Repair Action:	REPAIR	FMSS Work Type:	DEFERRED MAINTENANCE	Repair Cost:	\$577033
Brief Workorder:	Raise guardwall 10-in. Remove and reset 522-ft of stone masonry guardwall on concrete footer to design height of 24-in.				
Workorder:	Remove & Reset Stone Masonry Guardwall at \$250- per -Cu. Ft. for 1827 CF = \$456750. [(2ft)(1.75ft)(522ft)] = 1827 CF. Structural Concrete at \$1000- per -Cu. Yd. for 28 CY = \$28000. [(1.75ft)(0.8ft)(522ft)] /27 = 27.1 CY. Low Speed Traffic Control at \$1475- per -Day for 27 Day(s) = \$39825. 6 days removal 21 days installation

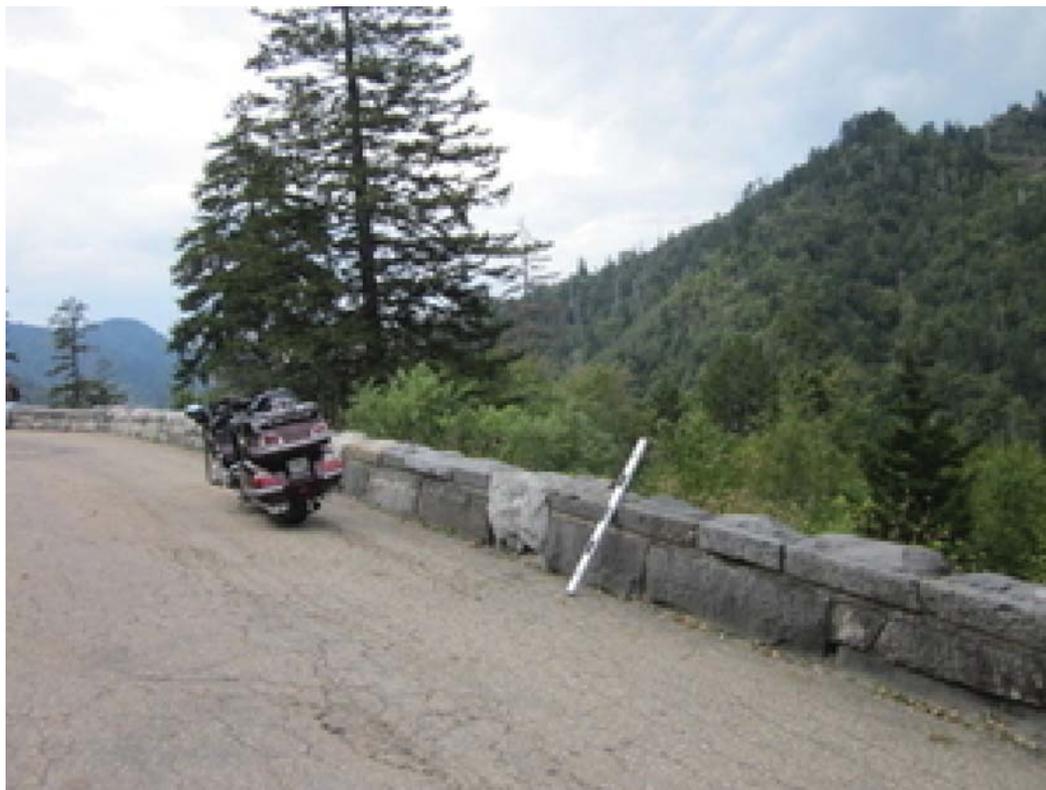
GRSM_0010N_13.789_R_1.JPG

Barrier ID:	GRSM-0010N-13.789-R				
Route Name:	NEWFOUND GAP ROAD NORTH				
Inspection Date:	09/16/2010	Barrier Rating:	8.60		
Barrier Description					
Type:	STONE MASONRY WITHOUT CONCRETE CORE WALL	Barrier Function:	NON-TRAFFIC		
Barrier Material:	STONE	Post Material:	N/A		
Blockout Type:	N/A	Length (ft.):	156		
Speed Limit (MPH):	15	Placement with Respect to Road:	NON-TRAFFIC BARRIER		
Hazard Behind Barrier:	N/A				
Barrier Crashworthiness					
Appropriate Test Level:	TL-1	Barrier Test Level:	N/A	Is Barrier Crashworthy?:	N/A
Beg. End Trtmt Type:	NONE	Is Beg. End Trtmt Crashworthy?:	N/A	Approach Transition Type:	NONE
Ending End Trtmt Type:	NONE	Ending End Trtmt Crashworthy?:	N/A		
Average Measurements					
Design Height (In.):	24	Width (In.):	20.2	Post Spacing (In.):	0.0
Height (In.):	24.0	Lateral Offset (In.):	0.0	Road Grade (%):	0.00
Physical Condition					
Barrier	Alignment and Height:	Alignment has no deviation and the height is 0-2 in above the 24 in design height.

Breaking and Cracking:	No breaking or cracking observed.			
	Missing Elements:	No missing elements observed.			
	Corrosion and Weathering:	No corrosion or weathering observed.			
End Treatments	Alignment and Height:				
	Breaking and Cracking:				
	Missing Elements:				
	Corrosion and Weathering:

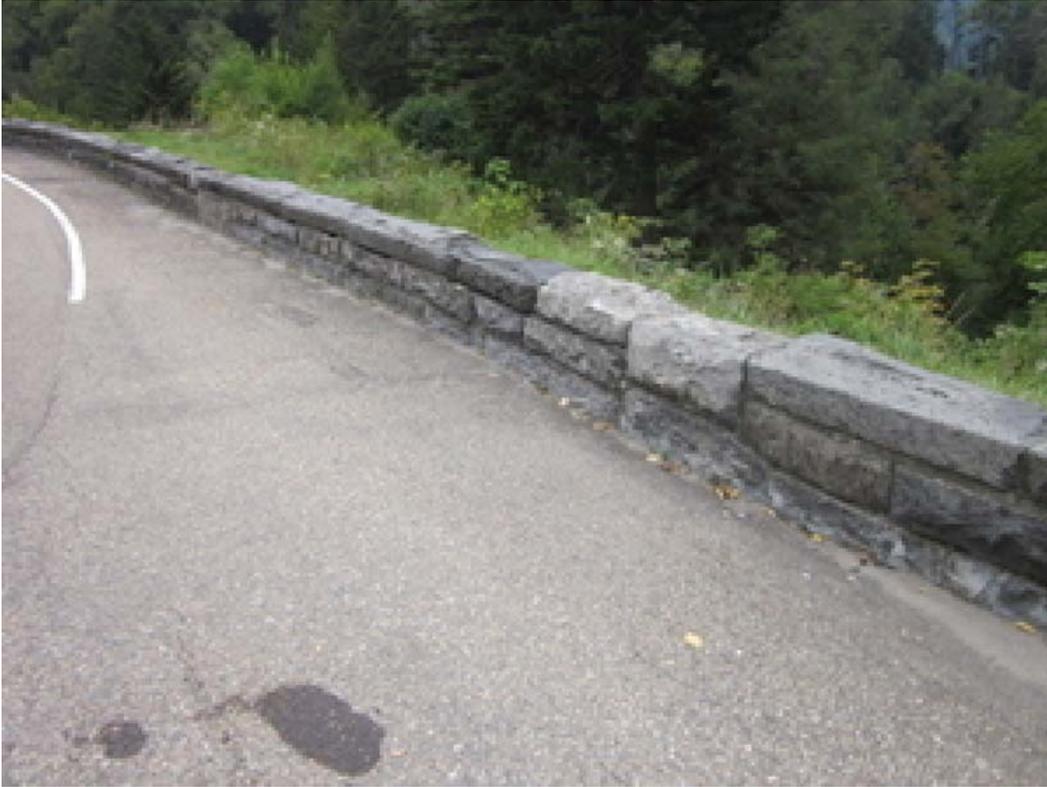
GRSM_0010N_13.819_R_1.JPG

Barrier ID:	GRSM-0010N-13.819-R				
Route Name:	NEWFOUND GAP ROAD NORTH				
Inspection Date:	09/16/2010	Barrier Rating:	32.50		
Barrier Description					
Type:	STONE MASONRY WITHOUT CONCRETE CORE WALL	Barrier Function:	TRAFFIC		
Barrier Material:	STONE	Post Material:	N/A		
Blockout Type:	N/A	Length (ft.):	172		
Speed Limit (MPH):	25	Placement with Respect to Road:	OUTSIDE OF CURVE		
Hazard Behind Barrier:	MEDIUM				
Barrier Crashworthiness					
Appropriate Test Level:	TL-1	Barrier Test Level:	NCW	Is Barrier Crashworthy?:	NO
Beg. End Trtmt Type:	NONE	Is Beg. End Trtmt Crashworthy?:	N/A	Approach Transition Type:	NONE
Ending End Trtmt Type:	NONE	Ending End Trtmt Crashworthy?:	N/A		
Average Measurements					
Design Height (In.):	24	Width (In.):	19.7	Post Spacing (In.):	0.0
Height (In.):	22.2	Lateral Offset (In.):	56.2	Road Grade (%):	4.40
Physical Condition					
Barrier	Alignment and Height:	Alignment has no deviation and the height ranges from 3 in below to 2 in above the 24 in design height for 117 ft and 3-4 ins below for 55 ft.

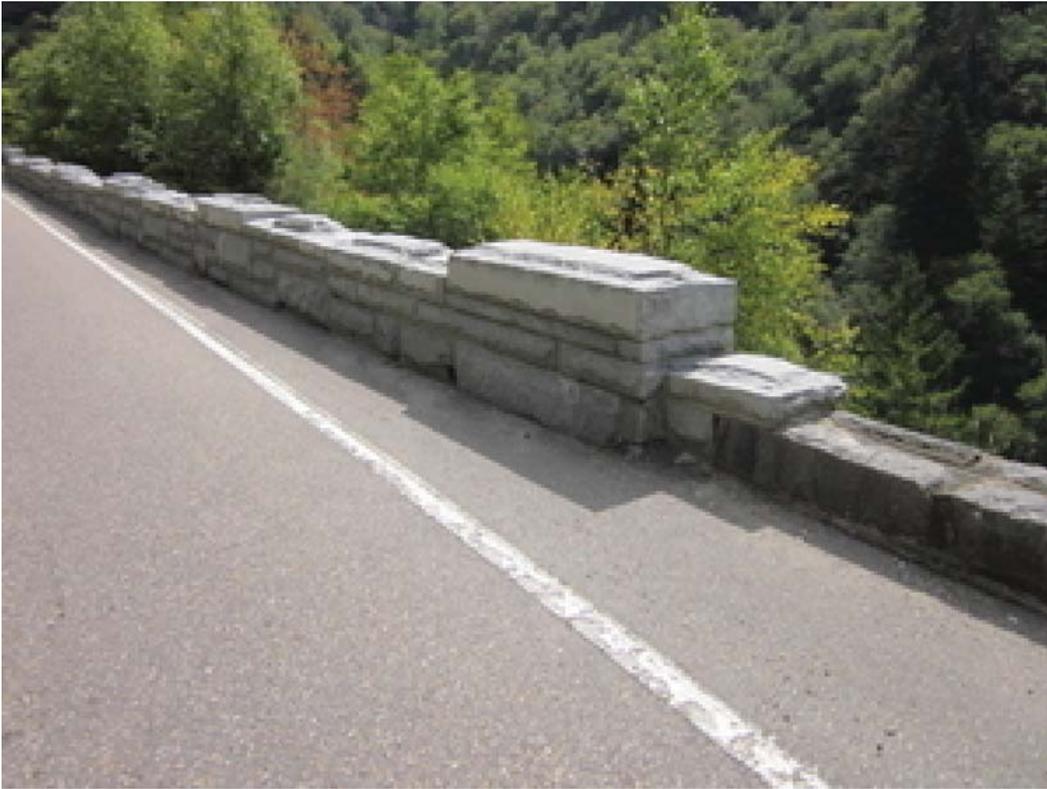
GRSM_0010N_13.852_R_1.JPG

Barrier ID:	GRSM-0010N-13.852-R				
Route Name:	NEWFOUND GAP ROAD NORTH				
Inspection Date:	09/16/2010	Barrier Rating:	38.50		
Barrier Description					
Type:	STONE MASONRY CRENELLATED WITHOUT	Barrier Function:	TRAFFIC		
Barrier Material:	STONE	Post Material:	N/A		
Blockout Type:	N/A	Length (ft.):	765		
Speed Limit (MPH):	25	Placement with Respect to Road:	BOTH INSIDE AND OUTSIDE		
Hazard Behind Barrier:	HIGH				
Barrier Crashworthiness					
Appropriate Test Level:	TL-1	Barrier Test Level:	NCW	Is Barrier Crashworthy?:	NO
Beg. End Trtmt Type:	NONE	Is Beg. End Trtmt Crashworthy?:	N/A	Approach Transition Type:	NONE
Ending End Trtmt Type:	NONE	Ending End Trtmt Crashworthy?:	N/A		
Average Measurements					
Design Height (In.):	21	Width (In.):	26.0	Post Spacing (In.):	0.0
Height (In.):	29.5	Lateral Offset (In.):	45.7	Road Grade (%):	6.30
Physical Condition					
Barrier	Alignment and Height:	Alignment has no deviation and the height is 10 to 13 in above the 21-in/24-in crenellated design height.

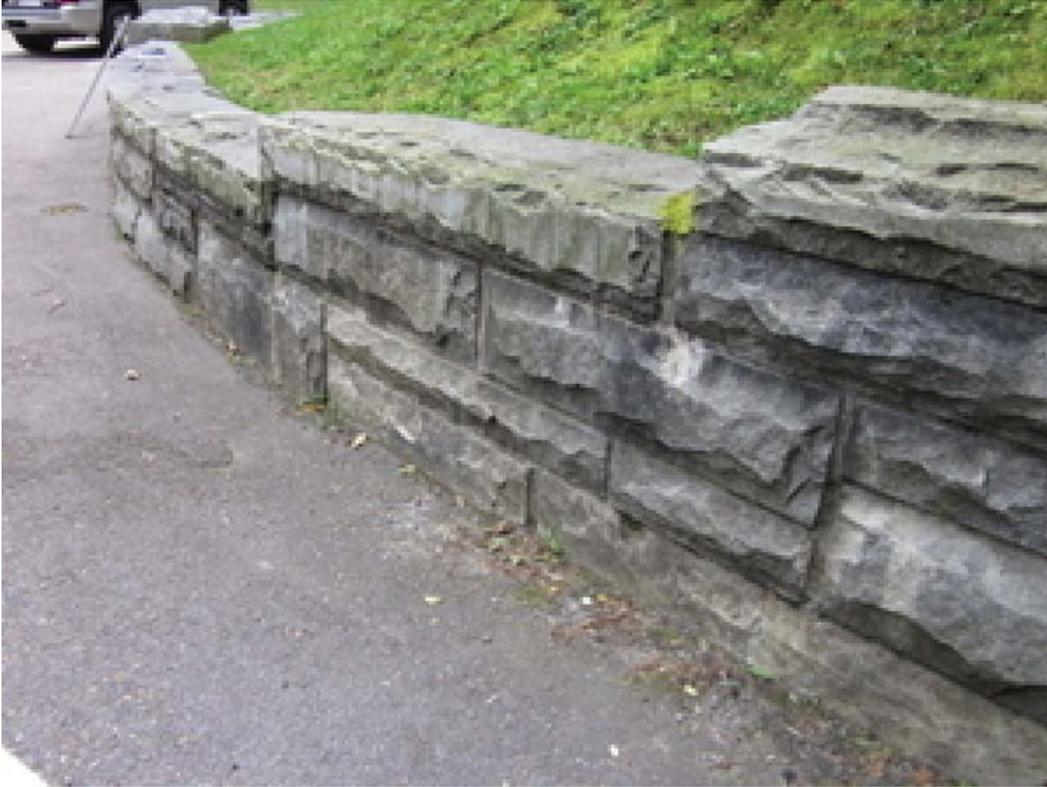
GRSM_0010N_13.859_L_1.JPG

Barrier ID:	GRSM-0010N-13.859-L				
Route Name:	NEWFOUND GAP ROAD NORTH				
Inspection Date:	09/16/2010	Barrier Rating:	39.50		
Barrier Description					
Type:	STONE MASONRY CRENELLATED WITHOUT	Barrier Function:	TRAFFIC		
Barrier Material:	STONE	Post Material:	N/A		
Blockout Type:	N/A	Length (ft.):	21		
Speed Limit (MPH):	25	Placement with Respect to Road:	OUTSIDE OF CURVE		
Hazard Behind Barrier:	MEDIUM				
Barrier Crashworthiness					
Appropriate Test Level:	TL-1	Barrier Test Level:	NCW	Is Barrier Crashworthy?:	NO
Beg. End Trtmt Type:	NONE	Is Beg. End Trtmt Crashworthy?:	N/A	Approach Transition Type:	NONE
Ending End Trtmt Type:	NONE	Ending End Trtmt Crashworthy?:	N/A		
Average Measurements					
Design Height (In.):	21	Width (In.):	24.7	Post Spacing (In.):	0.0
Height (In.):	31.2	Lateral Offset (In.):	100.6	Road Grade (%):	5.60
Physical Condition					
Barrier	Alignment and Height:	Alignment has no deviation and the height is 13 to 14 in above the 21-in/24-in crenellated design height.

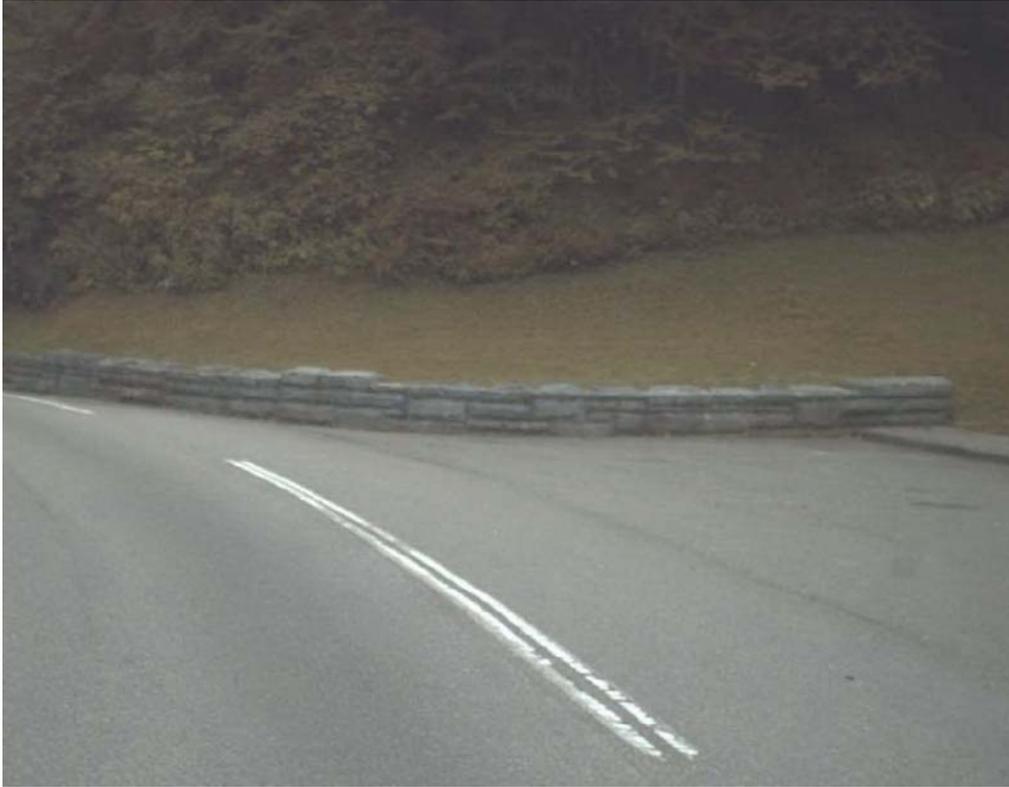
GRSM_0010N_13.916_R_1.JPG

Barrier ID:	GRSM-0010N-13.916-R				
Route Name:	NEWFOUND GAP ROAD NORTH				
Inspection Date:	09/20/2010	Barrier Rating:	44.20		
Barrier Description					
Type:	STONE MASONRY CRENELLATED WITHOUT	Barrier Function:	TRAFFIC		
Barrier Material:	STONE	Post Material:	N/A		
Blockout Type:	N/A	Length (ft.):	530		
Speed Limit (MPH):	35	Placement with Respect to Road:	BOTH INSIDE AND OUTSIDE		
Hazard Behind Barrier:	HIGH				
Barrier Crashworthiness					
Appropriate Test Level:	TL-2	Barrier Test Level:	NCW	Is Barrier Crashworthy?:	NO
Beg. End Trtmt Type:	NONE	Is Beg. End Trtmt Crashworthy?:	N/A	Approach Transition Type:	NONE
Ending End Trtmt Type:	NONE	Ending End Trtmt Crashworthy?:	N/A		
Average Measurements					
Design Height (In.):	21	Width (In.):	24.2	Post Spacing (In.):	0.0
Height (In.):	28.7	Lateral Offset (In.):	61.2	Road Grade (%):	7.40
Physical Condition					
Barrier	Alignment and Height:	Alignment has no deviation and the height is 10 to 12 in above the 21-in/24-in crenellated design height.

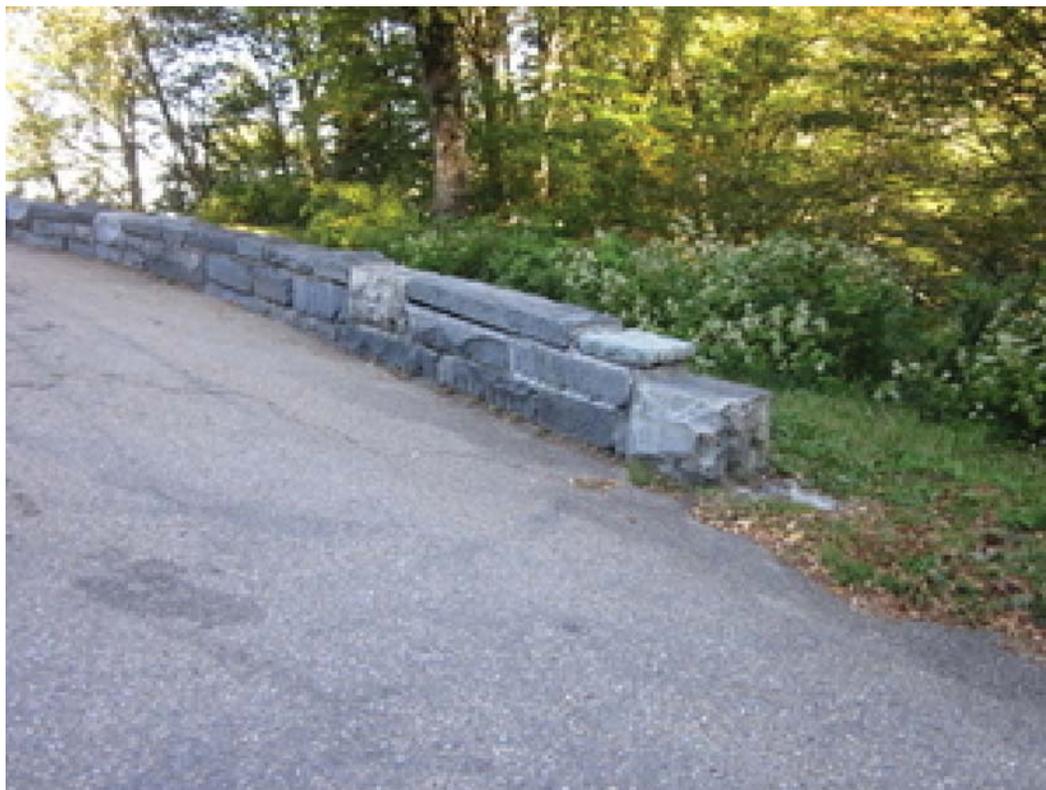
GRSM_0010N_14.076_R_1.JPG

Barrier ID:	GRSM-0010N-14.076-R				
Route Name:	NEWFOUND GAP ROAD NORTH				
Inspection Date:	09/20/2010	Barrier Rating:	20.10		
Barrier Description					
Type:	STONE MASONRY WITHOUT CONCRETE CORE WALL	Barrier Function:	NON-TRAFFIC		
Barrier Material:	STONE	Post Material:	N/A		
Blockout Type:	N/A	Length (ft.):	173		
Speed Limit (MPH):	35	Placement with Respect to Road:	NON-TRAFFIC BARRIER		
Hazard Behind Barrier:	N/A				
Barrier Crashworthiness					
Appropriate Test Level:	TL-2	Barrier Test Level:	N/A	Is Barrier Crashworthy?:	N/A
Beg. End Trtmt Type:	NONE	Is Beg. End Trtmt Crashworthy?:	N/A	Approach Transition Type:	NONE
Ending End Trtmt Type:	NONE	Ending End Trtmt Crashworthy?:	N/A		
Average Measurements					
Design Height (In.):	24	Width (In.):	23.0	Post Spacing (In.):	0.0
Height (In.):	25.0	Lateral Offset (In.):	0.0	Road Grade (%):	0.00
Physical Condition					
Barrier	Alignment and Height:	Alignment has no deviation and the height is 1 in above the 24 in design height.

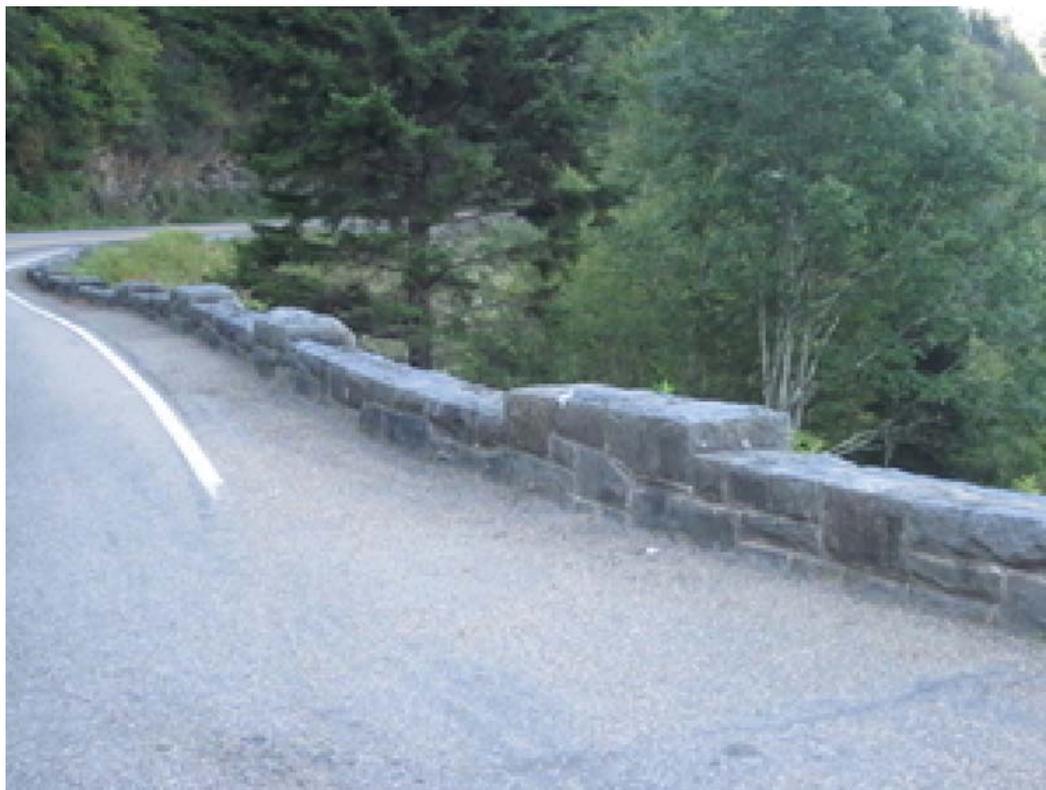
GRSM_0010N_14.109_R_1.JPG

Barrier ID:	GRSM-0010N-14.109-R				
Route Name:	NEWFOUND GAP ROAD NORTH				
Inspection Date:	09/20/2010	Barrier Rating:	50.00		
Barrier Description					
Type:	STONE MASONRY CRENELLATED WITHOUT	Barrier Function:	TRAFFIC		
Barrier Material:	STONE	Post Material:	N/A		
Blockout Type:	N/A	Length (ft.):	193		
Speed Limit (MPH):	35	Placement with Respect to Road:	OUTSIDE OF CURVE		
Hazard Behind Barrier:	HIGH				
Barrier Crashworthiness					
Appropriate Test Level:	TL-2	Barrier Test Level:	NCW	Is Barrier Crashworthy?:	NO
Beg. End Trtmt Type:	NONE	Is Beg. End Trtmt Crashworthy?:	N/A	Approach Transition Type:	NONE
Ending End Trtmt Type:	NONE	Ending End Trtmt Crashworthy?:	N/A		
Average Measurements					
Design Height (In.):	18	Width (In.):	19.2	Post Spacing (In.):	0.0
Height (In.):	14.0	Lateral Offset (In.):	38.7	Road Grade (%):	4.20
Physical Condition					
Barrier	Alignment and Height:	Alignment has no deviation and the height is 3 to 6 in below the 18-in/24-in crenellated design height for 93 ft.

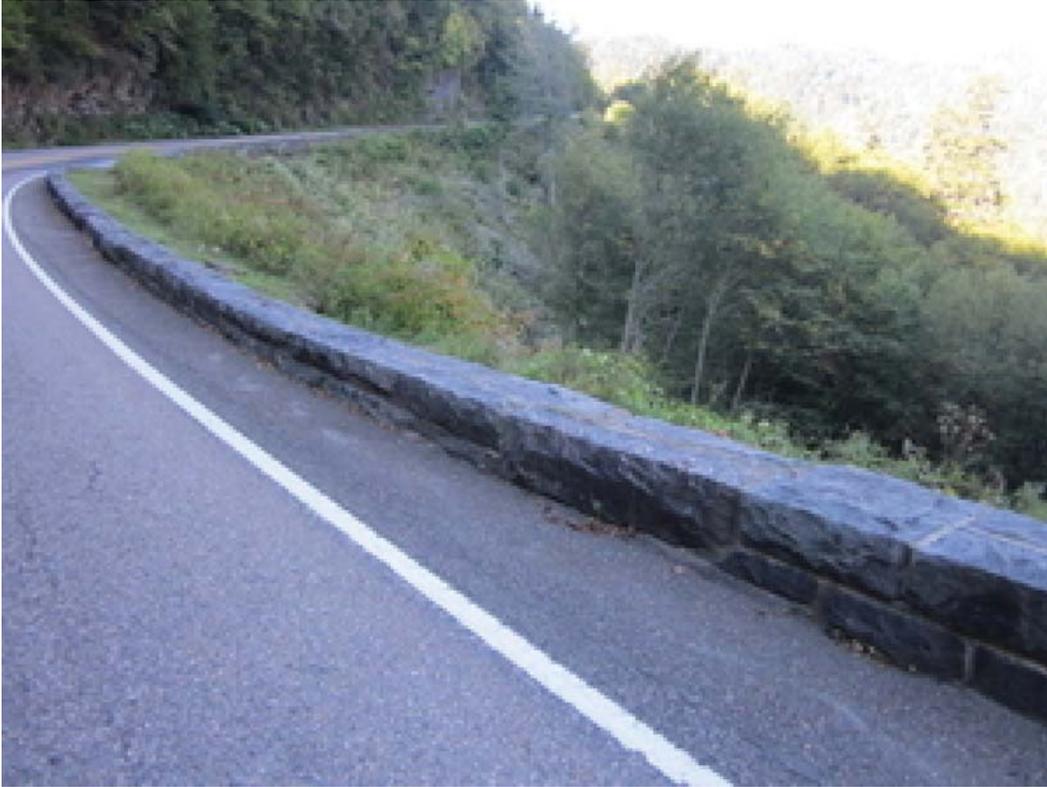
GRSM_0010N_14.146_R_1.JPG

Barrier ID:	GRSM-0010N-14.146-R				
Route Name:	NEWFOUND GAP ROAD NORTH				
Inspection Date:	09/20/2010	Barrier Rating:	59.40		
Barrier Description					
Type:	STONE MASONRY WITHOUT CONCRETE CORE WALL	Barrier Function:	TRAFFIC		
Barrier Material:	STONE	Post Material:	N/A		
Blockout Type:	N/A	Length (ft.):	450		
Speed Limit (MPH):	35	Placement with Respect to Road:	INSIDE OF CURVE		
Hazard Behind Barrier:	HIGH				
Barrier Crashworthiness					
Appropriate Test Level:	TL-2	Barrier Test Level:	NCW	Is Barrier Crashworthy?:	NO
Beg. End Trtmt Type:	NONE	Is Beg. End Trtmt Crashworthy?:	N/A	Approach Transition Type:	NONE
Ending End Trtmt Type:	NONE	Ending End Trtmt Crashworthy?:	N/A		
Average Measurements					
Design Height (In.):	24	Width (In.):	18.2	Post Spacing (In.):	0.0
Height (In.):	14.3	Lateral Offset (In.):	49.7	Road Grade (%):	5.40
Physical Condition					
Barrier	Alignment and Height:	Alignment has no deviation and the height is 6 in below the 24 in design height for 94 ft and 6 to 13 in below for 356 ft.

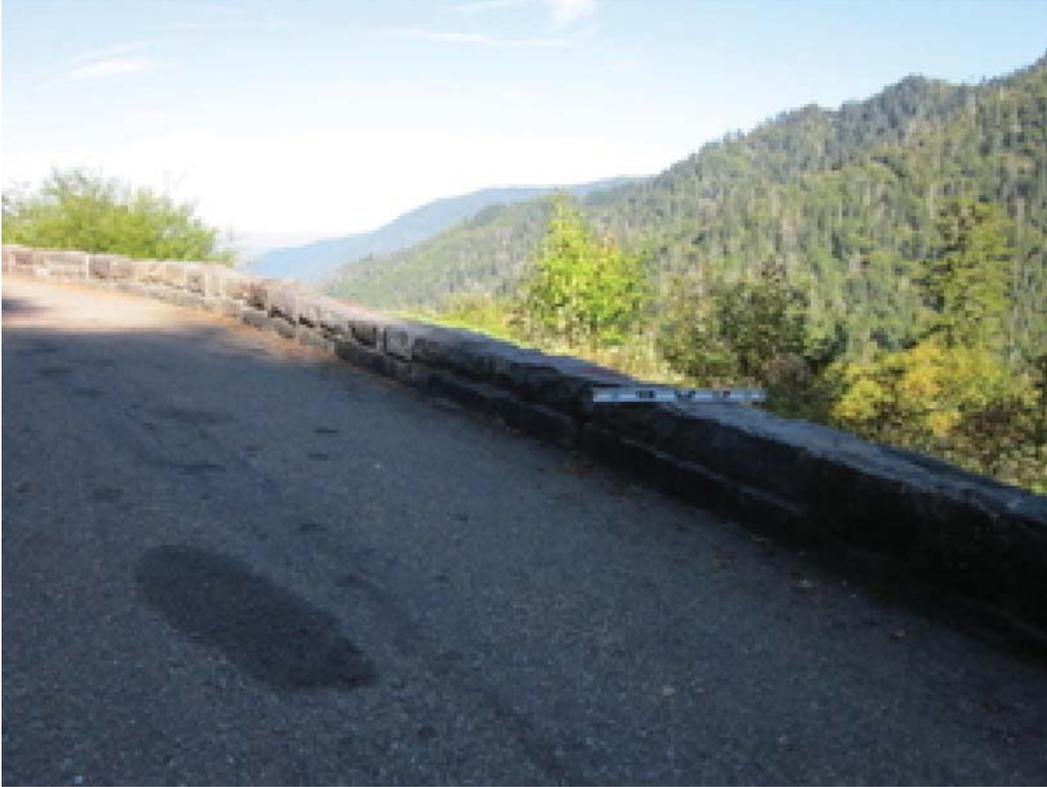
GRSM_0010N_14.231_R_1.JPG

Barrier ID:	GRSM-0010N-14.231-R				
Route Name:	NEWFOUND GAP ROAD NORTH				
Inspection Date:	09/20/2010	Barrier Rating:	17.30		
Barrier Description					
Type:	STONE MASONRY WITHOUT CONCRETE CORE WALL	Barrier Function:	NON-TRAFFIC		
Barrier Material:	STONE	Post Material:	N/A		
Blockout Type:	N/A	Length (ft.):	50		
Speed Limit (MPH):	35	Placement with Respect to Road:	NON-TRAFFIC BARRIER		
Hazard Behind Barrier:	N/A				
Barrier Crashworthiness					
Appropriate Test Level:	TL-2	Barrier Test Level:	N/A	Is Barrier Crashworthy?:	N/A
Beg. End Trtmt Type:	NONE	Is Beg. End Trtmt Crashworthy?:	N/A	Approach Transition Type:	NONE
Ending End Trtmt Type:	NONE	Ending End Trtmt Crashworthy?:	N/A		
Average Measurements					
Design Height (In.):	24	Width (In.):	19.0	Post Spacing (In.):	0.0
Height (In.):	20.2	Lateral Offset (In.):	0.0	Road Grade (%):	0.00
Physical Condition					
Barrier	Alignment and Height:	Alignment has no deviation and the height is 2 to 5 in below the 24 in design height for 50 ft.
