NPS Guardwall/Rail Inventory Program
Great Smoky Mountains National Park

Federal Highway Administration
Eastern Federal Lands Highway Division
Road Inventory Program (RIP)

Data Collection Date: September 2010
Report Date: December 2015

Great Smoky Mountains National Park in North Carolina and Tennessee

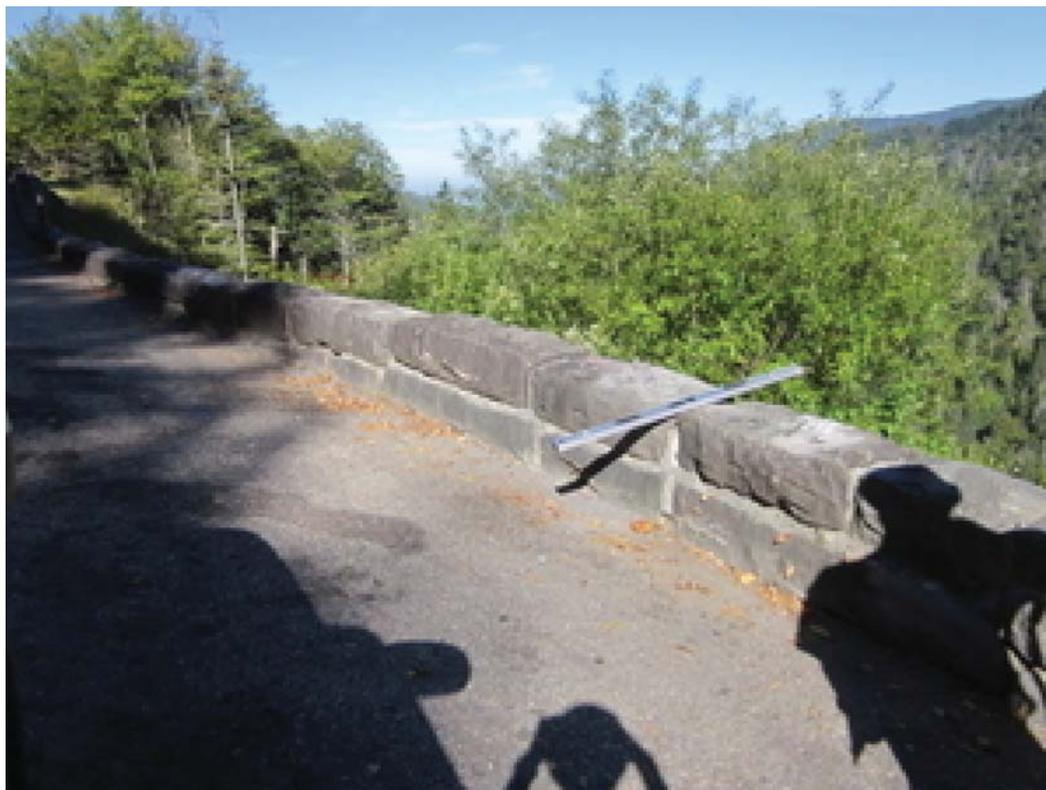
GRSM_0010N_14.240_R_1.JPG

Barrier ID:	GRSM-0010N-14.240-R				
Route Name:	NEWFOUND GAP ROAD NORTH				
Inspection Date:	09/20/2010	Barrier Rating:	67.10		
Barrier Description					
Type:	STONE MASONRY WITHOUT CONCRETE CORE WALL	Barrier Function:	TRAFFIC		
Barrier Material:	STONE	Post Material:	N/A		
Blockout Type:	N/A	Length (ft.):	253		
Speed Limit (MPH):	35	Placement with Respect to Road:	OUTSIDE OF CURVE		
Hazard Behind Barrier:	HIGH				
Barrier Crashworthiness					
Appropriate Test Level:	TL-2	Barrier Test Level:	NCW	Is Barrier Crashworthy?:	NO
Beg. End Trtmt Type:	NONE	Is Beg. End Trtmt Crashworthy?:	N/A	Approach Transition Type:	NONE
Ending End Trtmt Type:	NONE	Ending End Trtmt Crashworthy?:	N/A		
Average Measurements					
Design Height (In.):	24	Width (In.):	19.2	Post Spacing (In.):	0.0
Height (In.):	9.7	Lateral Offset (In.):	69.3	Road Grade (%):	3.40
Physical Condition					
Barrier	Alignment and Height:	Alignment has no deviation and the height is 3 to 6 in below the 24 in design height for 12 ft and 6 to 17 in below for 232.

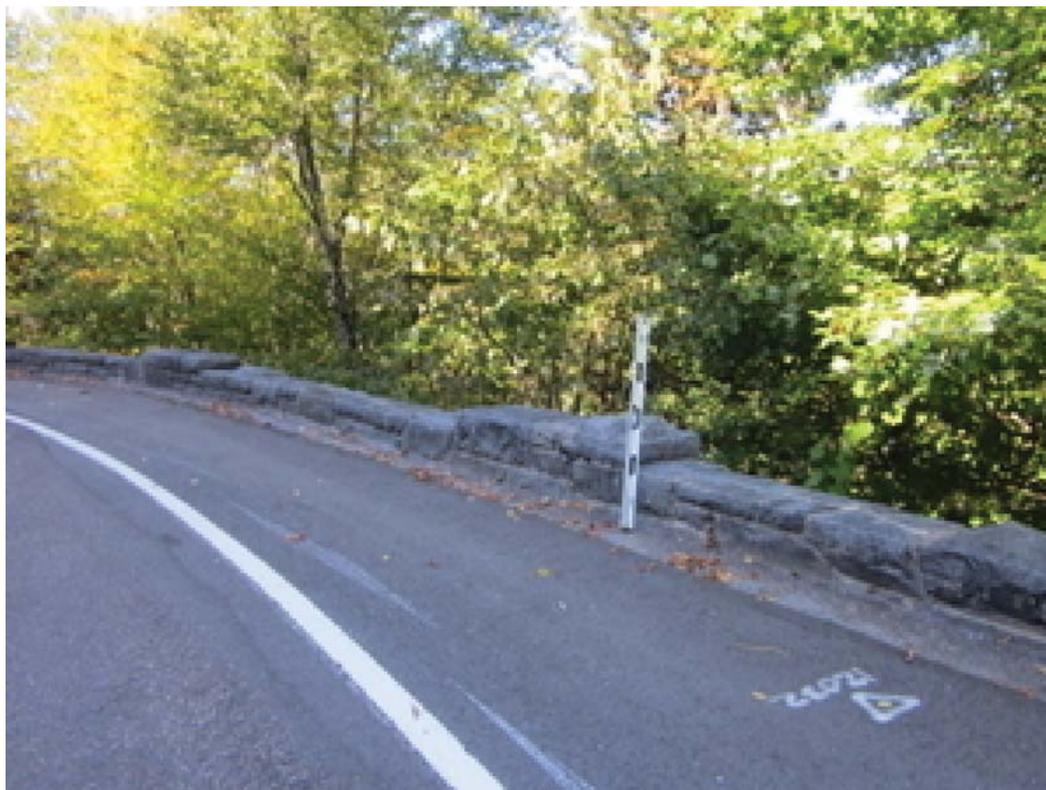
GRSM_0010N_14.288_R_1.JPG

Barrier ID:	GRSM-0010N-14.288-R				
Route Name:	NEWFOUND GAP ROAD NORTH				
Inspection Date:	09/20/2010	Barrier Rating:	45.90		
Barrier Description					
Type:	STONE MASONRY CRENELLATED WITHOUT	Barrier Function:	TRAFFIC		
Barrier Material:	STONE	Post Material:	N/A		
Blockout Type:	N/A	Length (ft.):	433		
Speed Limit (MPH):	35	Placement with Respect to Road:	OUTSIDE OF CURVE		
Hazard Behind Barrier:	HIGH				
Barrier Crashworthiness					
Appropriate Test Level:	TL-2	Barrier Test Level:	NCW	Is Barrier Crashworthy?:	NO
Beg. End Trtmt Type:	NONE	Is Beg. End Trtmt Crashworthy?:	N/A	Approach Transition Type:	NONE
Ending End Trtmt Type:	NONE	Ending End Trtmt Crashworthy?:	N/A		
Average Measurements					
Design Height (In.):	18	Width (In.):	20.0	Post Spacing (In.):	0.0
Height (In.):	16.0	Lateral Offset (In.):	57.7	Road Grade (%):	5.50
Physical Condition					
Barrier	Alignment and Height:	Alignment has no deviation and the height is 3 to 6 in below the 18-in/24-in crenellated design height for 162 ft.

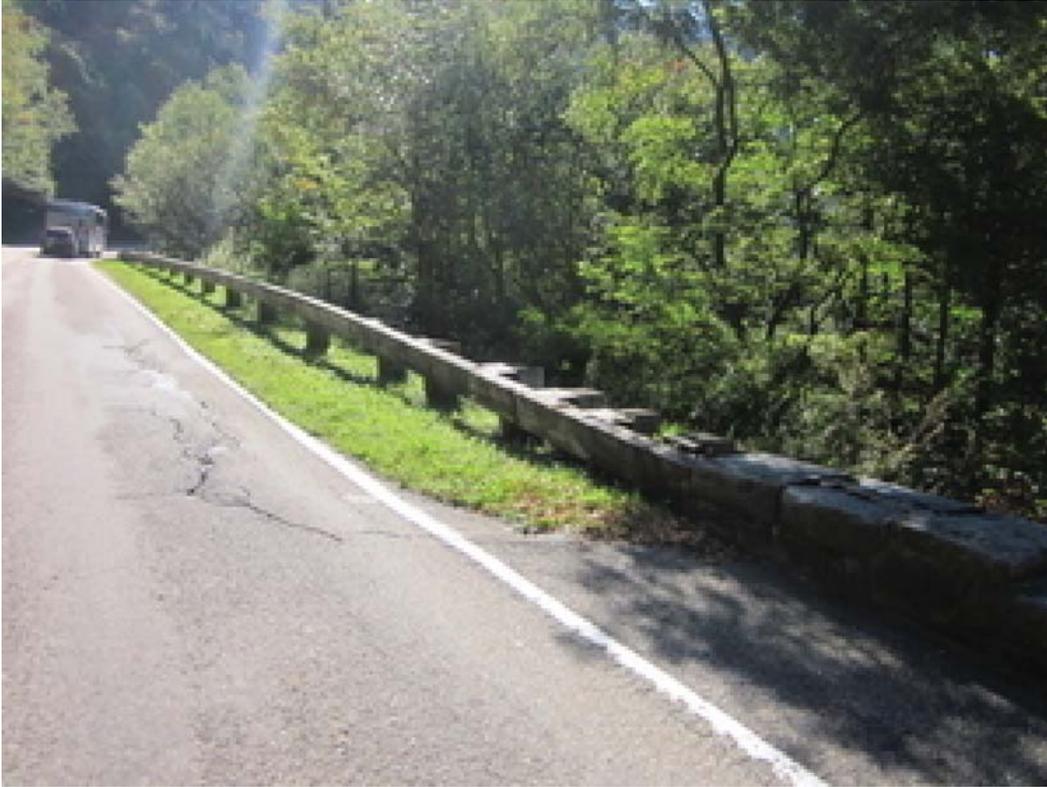
GRSM_0010N_14.360_R_1.JPG

Barrier ID:	GRSM-0010N-14.360-R				
Route Name:	NEWFOUND GAP ROAD NORTH				
Inspection Date:	09/20/2010	Barrier Rating:	47.20		
Barrier Description					
Type:	STEEL-BACKED TIMBER WITH BLOCKOUT	Barrier Function:	TRAFFIC		
Barrier Material:	STEEL-BACKED TIMBER/LOG	Post Material:	WOOD		
Blockout Type:	WOOD	Length (ft.):	1048		
Speed Limit (MPH):	35	Placement with Respect to Road:	BOTH INSIDE AND OUTSIDE		
Hazard Behind Barrier:	EXTREME				
Barrier Crashworthiness					
Appropriate Test Level:	TL-2	Barrier Test Level:	TL-3	Is Barrier Crashworthy?:	YES
Beg. End Trtmt Type:	NONE	Is Beg. End Trtmt Crashworthy?:	N/A	Approach Transition Type:	CONC/MASON SBT
Ending End Trtmt Type:	NONE	Ending End Trtmt Crashworthy?:	N/A		
Average Measurements					
Design Height (In.):	27	Width (In.):	0.0	Post Spacing (In.):	120.5
Height (In.):	28.7	Lateral Offset (In.):	61.0	Road Grade (%):	6.40
Physical Condition					
Barrier	Alignment and Height:	Alignment has no deviation and the height is 1 in below to 4 in above the 27 in design height.

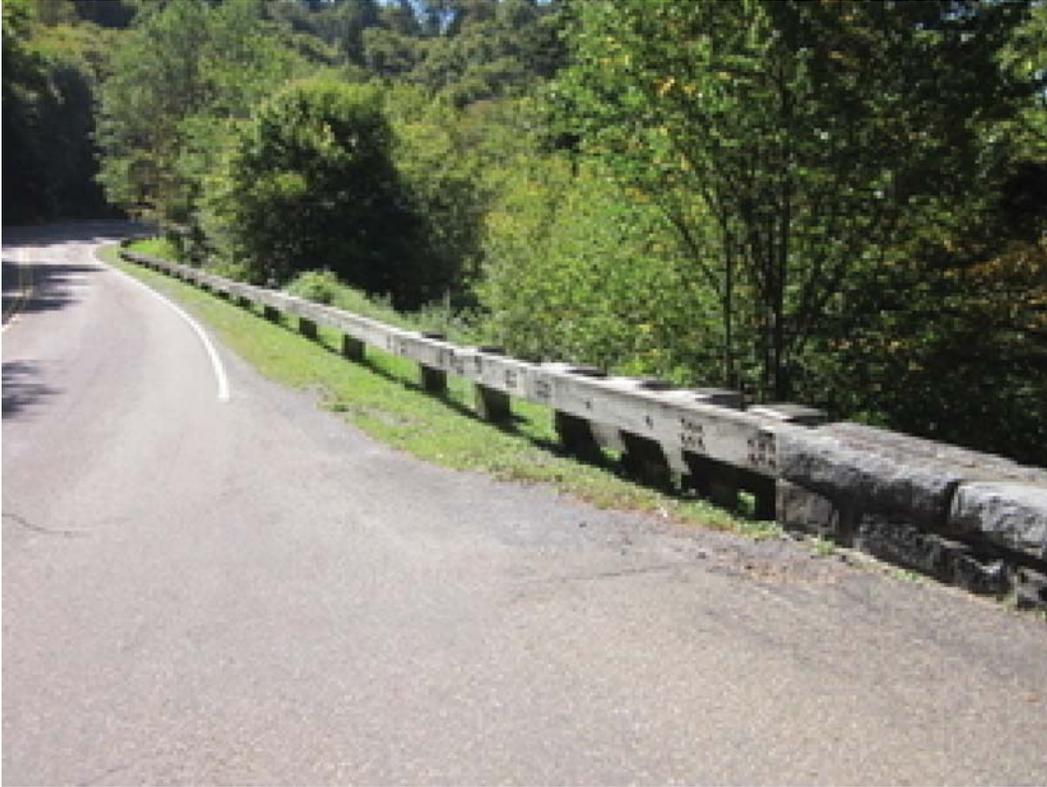
GRSM_0010N_14.594_R_1.JPG

Barrier ID:	GRSM-0010N-14.594-R				
Route Name:	NEWFOUND GAP ROAD NORTH				
Inspection Date:	09/20/2010	Barrier Rating:	50.00		
Barrier Description					
Type:	STEEL-BACKED TIMBER WITHOUT BLOCKOUT	Barrier Function:	TRAFFIC		
Barrier Material:	STEEL-BACKED TIMBER/LOG	Post Material:	WOOD		
Blockout Type:	N/A	Length (ft.):	792		
Speed Limit (MPH):	35	Placement with Respect to Road:	BOTH INSIDE AND OUTSIDE		
Hazard Behind Barrier:	HIGH				
Barrier Crashworthiness					
Appropriate Test Level:	TL-2	Barrier Test Level:	TL-2	Is Barrier Crashworthy?:	YES
Beg. End Trtmt Type:	NONE	Is Beg. End Trtmt Crashworthy?:	N/A	Approach Transition Type:	CONC/MASON SBT
Ending End Trtmt Type:	NONE	Ending End Trtmt Crashworthy?:	N/A		
Average Measurements					
Design Height (In.):	27	Width (In.):	0.0	Post Spacing (In.):	120.5
Height (In.):	25.5	Lateral Offset (In.):	62.0	Road Grade (%):	5.70
Physical Condition					
Barrier	Alignment and Height:	Alignment has no deviation and the height is 1 to 3 in below the 27 in design height for 380 ft and 3 to 5 in below for 40 ft.

Breaking and Cracking:	No breaking or cracking observed.			
	Missing Elements:	No missing elements observed.			
	Corrosion and Weathering:	No corrosion or weathering observed.			
End Treatments	Alignment and Height:				
	Breaking and Cracking:				
	Missing Elements:				
	Corrosion and Weathering:

Repair Action:	REPAIR	FMSS Work Type:	DEFERRED MAINTENANCE	Repair Cost:	\$7865
Brief Workorder:	Raise 420 feet of guardrail up to the 27 inch design height.				
Workorder:	Adjust Guardrail at \$10- per -Lin. Ft. for 420 LF = \$4200. Raise 420 feet of guardrail up to the 27 inch design height. Low Speed Traffic Control at \$1475- per -Day for 2 Day(s) = \$2950.

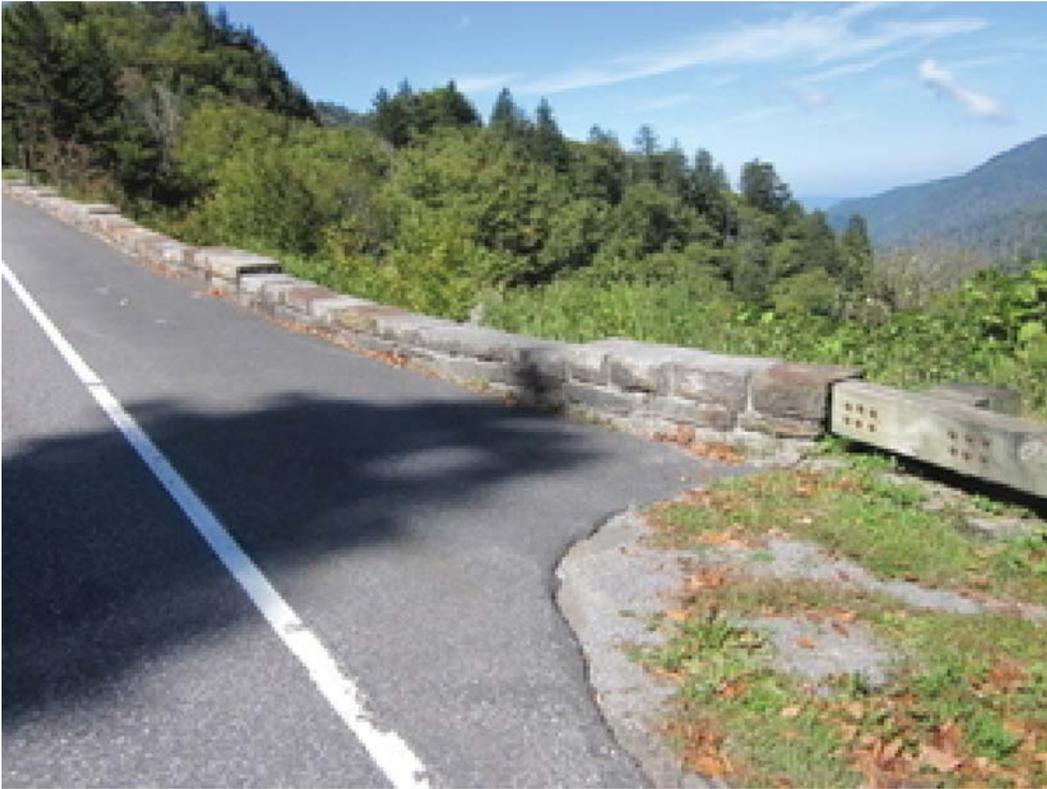
GRSM_0010N_14.750_R_1.JPG

Barrier ID:	GRSM-0010N-14.750-R				
Route Name:	NEWFOUND GAP ROAD NORTH				
Inspection Date:	09/20/2010	Barrier Rating:	63.20		
Barrier Description					
Type:	STONE MASONRY CRENELLATED WITHOUT	Barrier Function:	TRAFFIC		
Barrier Material:	STONE	Post Material:	N/A		
Blockout Type:	N/A	Length (ft.):	271		
Speed Limit (MPH):	35	Placement with Respect to Road:	TANGENT		
Hazard Behind Barrier:	EXTREME				
Barrier Crashworthiness					
Appropriate Test Level:	TL-2	Barrier Test Level:	NCW	Is Barrier Crashworthy?:	NO
Beg. End Trtmt Type:	NONE	Is Beg. End Trtmt Crashworthy?:	N/A	Approach Transition Type:	NONE
Ending End Trtmt Type:	NONE	Ending End Trtmt Crashworthy?:	N/A		
Average Measurements					
Design Height (In.):	18	Width (In.):	18.0	Post Spacing (In.):	0.0
Height (In.):	9.3	Lateral Offset (In.):	56.2	Road Grade (%):	6.40
Physical Condition					
Barrier	Alignment and Height:	Alignment has no deviation and he height is 5 in below the 18-in/24-in crenellated design height for 150 ft and 6 to 13 in below for 121 ft.

Breaking and Cracking:	No breaking or cracking observed.			
	Missing Elements:	No missing elements observed.			
	Corrosion and Weathering:	No corrosion or weathering observed.			
End Treatments	Alignment and Height:				
	Breaking and Cracking:				
	Missing Elements:				
	Corrosion and Weathering:

Repair Action:	REPAIR	FMSS Work Type:	DEFERRED MAINTENANCE	Repair Cost:	\$115583
Brief Workorder:	Raise guardwall 6-in. Remove and reset 121-ft of stone masonry guardwall on concrete footer to adjacent 18-in height.				
Workorder:	Remove & Reset Stone Masonry Guardwall at \$250- per -Cu. Ft. for 363 CF = \$90750. [(2ft)(1.5ft)(121ft)] = 363 CF. Structural Concrete at \$1000- per -Cu. Yd. for 4 CY = \$4000. [(1.5ft)(0.5ft)(121ft)] /27 = 3.4 CY. Low Speed Traffic Control at \$1475- per -Day for 7 Day(s) = \$10325. 2 days removal 5 days installation.

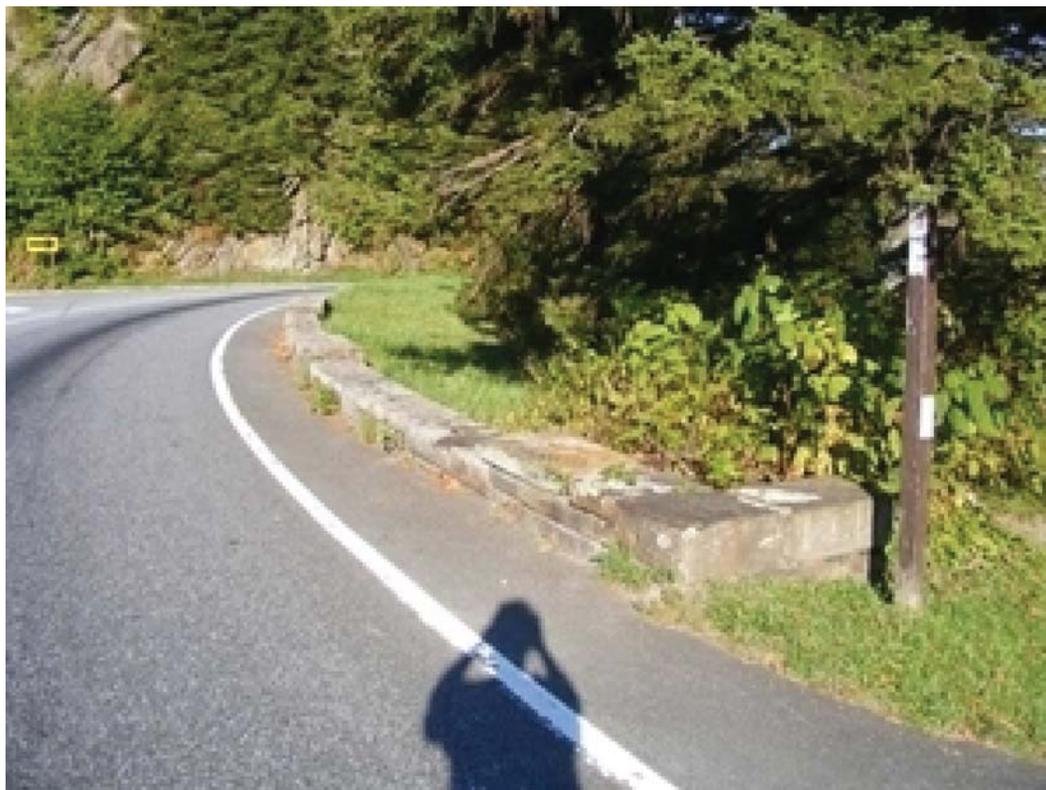
GRSM_0010N_14.808_R_1.JPG

Barrier ID:	GRSM-0010N-14.808-R				
Route Name:	NEWFOUND GAP ROAD NORTH				
Inspection Date:	09/20/2010	Barrier Rating:	69.50		
Barrier Description					
Type:	STONE MASONRY CRENELLATED WITHOUT	Barrier Function:	TRAFFIC		
Barrier Material:	STONE	Post Material:	N/A		
Blockout Type:	N/A	Length (ft.):	340		
Speed Limit (MPH):	25	Placement with Respect to Road:	BOTH INSIDE AND OUTSIDE		
Hazard Behind Barrier:	EXTREME				
Barrier Crashworthiness					
Appropriate Test Level:	TL-1	Barrier Test Level:	NCW	Is Barrier Crashworthy?:	NO
Beg. End Trtmt Type:	NONE	Is Beg. End Trtmt Crashworthy?:	N/A	Approach Transition Type:	NONE
Ending End Trtmt Type:	NONE	Ending End Trtmt Crashworthy?:	N/A		
Average Measurements					
Design Height (In.):	21	Width (In.):	19.2	Post Spacing (In.):	0.0
Height (In.):	14.0	Lateral Offset (In.):	50.2	Road Grade (%):	0.40
Physical Condition					
Barrier	Alignment and Height:	The alignment has no deviation and the height is 3 to 6 in below the 21-in/24-in crenellated design height for 48 ft and 6 to 13 in below for 196 ft.

Breaking and Cracking:	7 broken loose stones on 4 crenellations minor cracking of grout 1/4 to 1/2 in wide observed.			
	Missing Elements:	2 missing stones(found behind barrier) observed.			
	Corrosion and Weathering:	Moderate weathering of the grout and stones observed.			
End Treatments	Alignment and Height:				
	Breaking and Cracking:				
	Missing Elements:				
	Corrosion and Weathering:

Repair Action:	REPAIR	FMSS Work Type:	DEFERRED MAINTENANCE	Repair Cost:	\$222420
Brief Workorder:	Raise guardwall 4-in. Remove and reset 196-ft of stone masonry guardwall on concrete footer to adjacent 12-in height. Remove and reset 27 additional feet of loose and missing stones.				
Workorder:	Remove & Reset Stone Masonry Guardwall at \$250- per -Cu. Ft. for 714 CF = \$178500. [(2ft)(1.6ft)(223ft)] = 713.6 CF. Structural Concrete at \$1000- per -Cu. Yd. for 6 CY = \$6000. [(1.6ft)(0.5ft)(196ft)] /27 = 5.8 CY. Low Speed Traffic Control at \$1475- per -Day for 12 Day(s) = \$17700. 3 days removal 9 days installation.

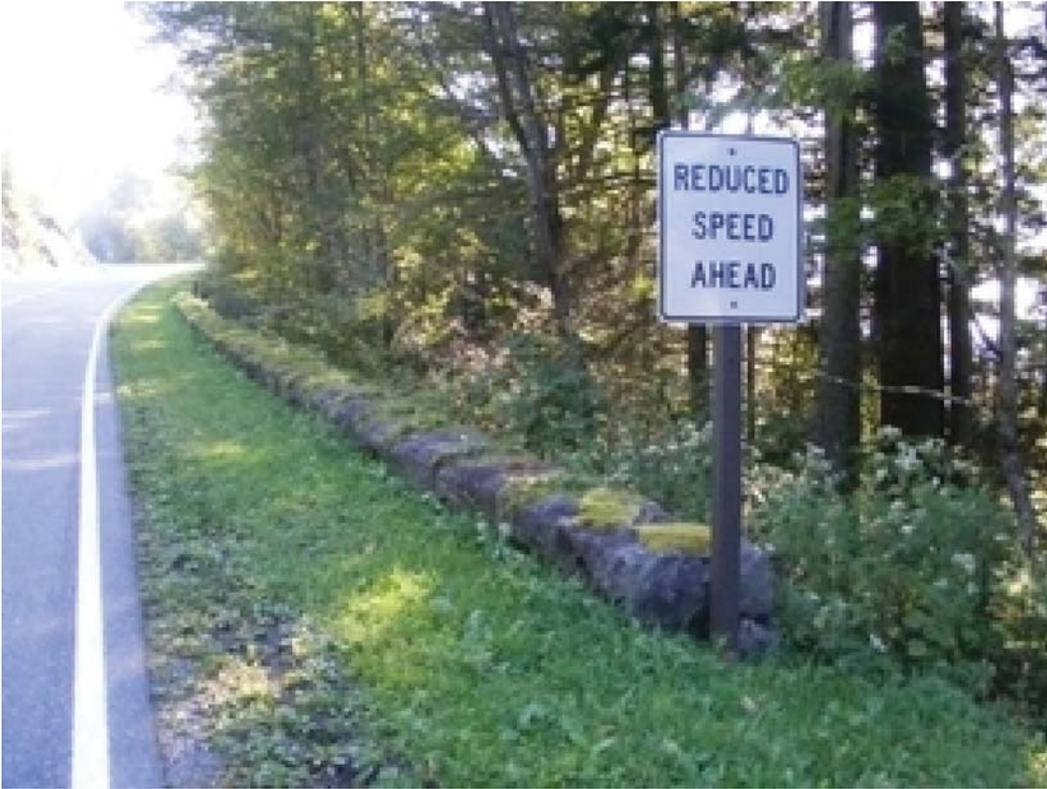
GRSM_0010S_15.039_L_1.JPG

Barrier ID:	GRSM-0010S-15.039-L				
Route Name:	NEWFOUND GAP ROAD SOUTH				
Inspection Date:	09/20/2010	Barrier Rating:	86.00		
Barrier Description					
Type:	STONE MASONRY WITHOUT CONCRETE CORE WALL	Barrier Function:	TRAFFIC		
Barrier Material:	STONE	Post Material:	N/A		
Blockout Type:	N/A	Length (ft.):	896		
Speed Limit (MPH):	35	Placement with Respect to Road:	BOTH INSIDE AND OUTSIDE		
Hazard Behind Barrier:	MEDIUM				
Barrier Crashworthiness					
Appropriate Test Level:	TL-2	Barrier Test Level:	NCW	Is Barrier Crashworthy?:	NO
Beg. End Trtmt Type:	NONE	Is Beg. End Trtmt Crashworthy?:	N/A	Approach Transition Type:	NONE
Ending End Trtmt Type:	NONE	Ending End Trtmt Crashworthy?:	N/A		
Average Measurements					
Design Height (In.):	24	Width (In.):	24.0	Post Spacing (In.):	0.0
Height (In.):	15.0	Lateral Offset (In.):	77.5	Road Grade (%):	6.40
Physical Condition					
Barrier	Alignment and Height:	The alignment has no deviation and the height is 8 to 12 in below the 24 in design height for 896 ft.

Breaking and Cracking:	Some breaking and cracking of a quarter in to half inch.			
	Missing Elements:	No missing elements observed.			
	Corrosion and Weathering:	Major corrosion and weathering. Large amounts of moss and grass growing on barrier.			
End Treatments	Alignment and Height:				
	Breaking and Cracking:				
	Missing Elements:				
	Corrosion and Weathering:

Repair Action:	REPAIR	FMSS Work Type:	DEFERRED MAINTENANCE	Repair Cost:	\$1113613
Brief Workorder:	Raise guardwall 9-in. Remove and reset 896-ft of stone masonry guardwall on concrete footer to design height of 24-in.				
Workorder:	Remove & Reset Stone Masonry Guardwall at \$250- per -Cu. Ft. for 3584 CF = \$896000. [(2ft)(2ft)(896ft)] = 3584 CF. Structural Concrete at \$1000- per -Cu. Yd. for 50 CY = \$50000. [(2ft)(0.75ft)(896ft)] /27 = 49.8 CY. Low Speed Traffic Control at \$1475- per -Day for 45 Day(s) = \$66375. 9 days removal 36 days installation.

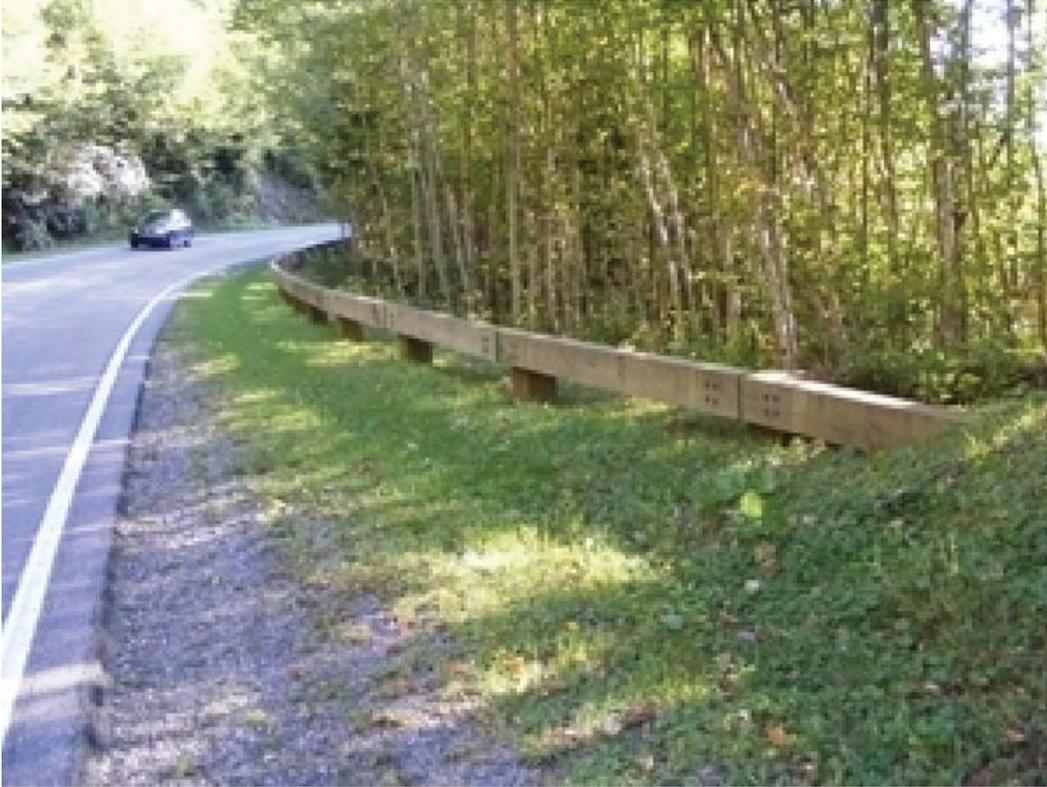
GRSM_0010S_15.275_L_1.JPG

Barrier ID:	GRSM-0010S-15.275-L				
Route Name:	NEWFOUND GAP ROAD SOUTH				
Inspection Date:	09/20/2010	Barrier Rating:	35.20		
Barrier Description					
Type:	STEEL-BACKED TIMBER WITHOUT BLOCKOUT	Barrier Function:	TRAFFIC		
Barrier Material:	STEEL-BACKED TIMBER/LOG	Post Material:	WOOD		
Blockout Type:	N/A	Length (ft.):	334		
Speed Limit (MPH):	35	Placement with Respect to Road:	INSIDE OF CURVE		
Hazard Behind Barrier:	MEDIUM				
Barrier Crashworthiness					
Appropriate Test Level:	TL-2	Barrier Test Level:	TL-2	Is Barrier Crashworthy?:	YES
Beg. End Trtmt Type:	SBT/LOG FLARED	Is Beg. End Trtmt Crashworthy?:	NO	Approach Transition Type:	NONE
Ending End Trtmt Type:	SBT/LOG BURIED	Ending End Trtmt Crashworthy?:	YES		
Average Measurements					
Design Height (In.):	27	Width (In.):	0.0	Post Spacing (In.):	120.0
Height (In.):	27.0	Lateral Offset (In.):	86.5	Road Grade (%):	5.30
Physical Condition					
Barrier	Alignment and Height:	The alignment has no deviation and the height is 1 in below to 1 in above the design height of 27 in.

Breaking and Cracking:	No breaking or cracking observed.			
	Missing Elements:	No missing elements observed.			
	Corrosion and Weathering:	No corrosion or weathering observed.			
End Treatments	Alignment and Height:	Alignment acceptable. Height is within 1 in of the 27-in design height.			
	Breaking and Cracking:	No breaking or cracking observed.			
	Missing Elements:	No missing elements observed.			
	Corrosion and Weathering:	No corrosion or weathering observed.

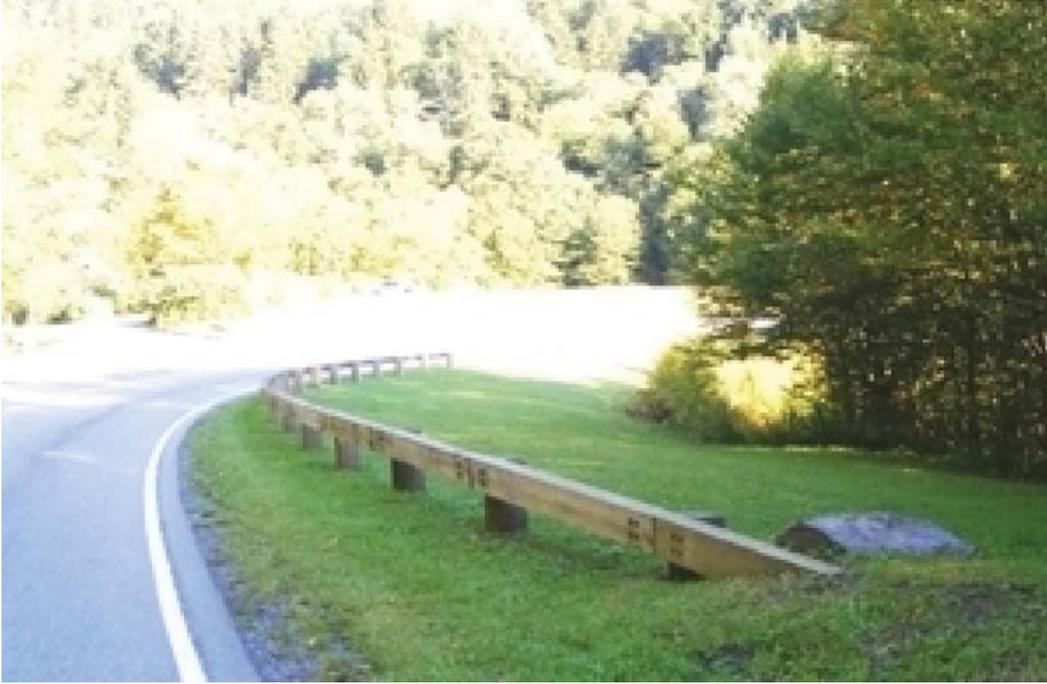
GRSM_0010S_15.397_L_1.JPG

Barrier ID:	GRSM-0010S-15.397-L				
Route Name:	NEWFOUND GAP ROAD SOUTH				
Inspection Date:	09/20/2010	Barrier Rating:	38.00		
Barrier Description					
Type:	STEEL-BACKED TIMBER WITHOUT BLOCKOUT	Barrier Function:	TRAFFIC		
Barrier Material:	STEEL-BACKED TIMBER/LOG	Post Material:	WOOD		
Blockout Type:	N/A	Length (ft.):	919		
Speed Limit (MPH):	35	Placement with Respect to Road:	INSIDE OF CURVE		
Hazard Behind Barrier:	MEDIUM				
Barrier Crashworthiness					
Appropriate Test Level:	TL-2	Barrier Test Level:	TL-2	Is Barrier Crashworthy?:	YES
Beg. End Trtmt Type:	SBT/LOG BURIED	Is Beg. End Trtmt Crashworthy?:	YES	Approach Transition Type:	NONE
Ending End Trtmt Type:	SBT/LOG FLARED	Ending End Trtmt Crashworthy?:	NO		
Average Measurements					
Design Height (In.):	27	Width (In.):	0.0	Post Spacing (In.):	119.8
Height (In.):	28.0	Lateral Offset (In.):	80.5	Road Grade (%):	3.80
Physical Condition					
Barrier	Alignment and Height:	The alignment has no deviation and the height is 1 in below to 4 in above the design height of 27 in.

Breaking and Cracking:	No breaking or cracking observed.			
	Missing Elements:	No missing elements observed.			
	Corrosion and Weathering:	No corrosion or weathering observed.			
End Treatments	Alignment and Height:	Alignment acceptable. Height is within 1 in of the 27-in design height.			
	Breaking and Cracking:	No breaking or cracking observed.			
	Missing Elements:	No missing elements observed.			
	Corrosion and Weathering:	No corrosion or weathering observed.

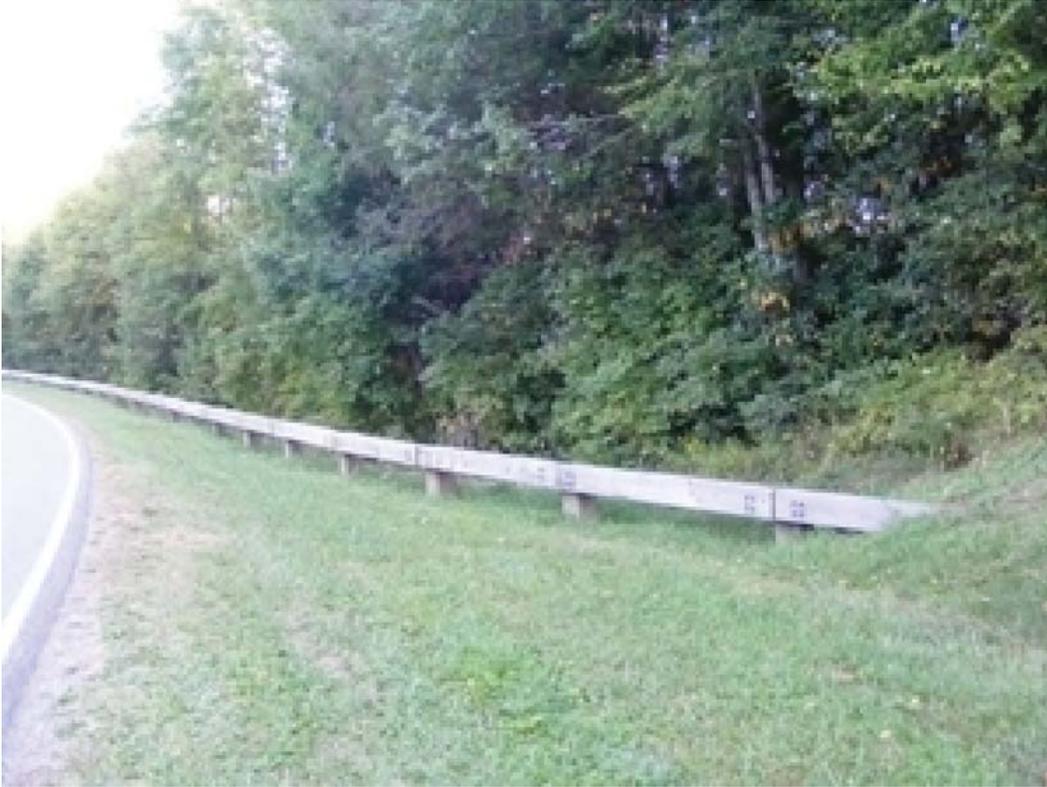
GRSM_0010S_16.313_L_1.JPG

Barrier ID:	GRSM-0010S-16.313-L				
Route Name:	NEWFOUND GAP ROAD SOUTH				
Inspection Date:	09/20/2010	Barrier Rating:	36.70		
Barrier Description					
Type:	STEEL-BACKED TIMBER WITHOUT BLOCKOUT	Barrier Function:	TRAFFIC		
Barrier Material:	STEEL-BACKED TIMBER/LOG	Post Material:	WOOD		
Blockout Type:	N/A	Length (ft.):	398		
Speed Limit (MPH):	35	Placement with Respect to Road:	OUTSIDE OF CURVE		
Hazard Behind Barrier:	MEDIUM				
Barrier Crashworthiness					
Appropriate Test Level:	TL-2	Barrier Test Level:	TL-2	Is Barrier Crashworthy?:	YES
Beg. End Trtmt Type:	SBT/LOG BURIED	Is Beg. End Trtmt Crashworthy?:	YES	Approach Transition Type:	NONE
Ending End Trtmt Type:	SBT/LOG BURIED	Ending End Trtmt Crashworthy?:	YES		
Average Measurements					
Design Height (In.):	27	Width (In.):	0.0	Post Spacing (In.):	120.0
Height (In.):	27.6	Lateral Offset (In.):	98.5	Road Grade (%):	4.80
Physical Condition					
Barrier	Alignment and Height:	The alignment has no deviation and the height is 1 in below to 2 in above the design height of 27 in.

Breaking and Cracking:	No breaking or cracking observed.			
	Missing Elements:	No missing elements observed.			
	Corrosion and Weathering:	No corrosion or weathering observed.			
End Treatments	Alignment and Height:	Alignment acceptable. Height is within 1 in of the 27-in design height.			
	Breaking and Cracking:	No breaking or cracking observed.			
	Missing Elements:	No missing elements observed.			
	Corrosion and Weathering:	No corrosion or weathering observed.

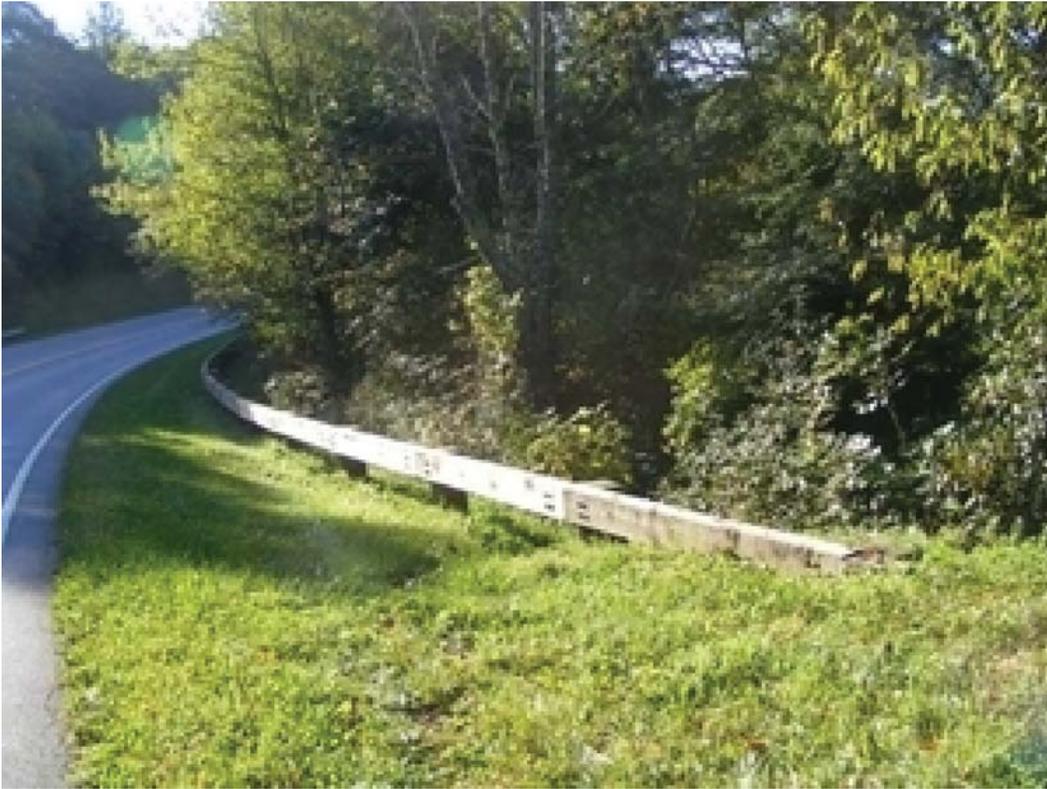
GRSM_0010S_16.340_R_1.JPG

Barrier ID:	GRSM-0010S-16.340-R				
Route Name:	NEWFOUND GAP ROAD SOUTH				
Inspection Date:	09/20/2010	Barrier Rating:	31.00		
Barrier Description					
Type:	STEEL-BACKED TIMBER WITHOUT BLOCKOUT	Barrier Function:	TRAFFIC		
Barrier Material:	STEEL-BACKED TIMBER/LOG	Post Material:	WOOD		
Blockout Type:	N/A	Length (ft.):	725		
Speed Limit (MPH):	35	Placement with Respect to Road:	INSIDE OF CURVE		
Hazard Behind Barrier:	MEDIUM				
Barrier Crashworthiness					
Appropriate Test Level:	TL-2	Barrier Test Level:	TL-2	Is Barrier Crashworthy?:	YES
Beg. End Trtmt Type:	SBT/LOG FLARED	Is Beg. End Trtmt Crashworthy?:	NO	Approach Transition Type:	NONE
Ending End Trtmt Type:	SBT/LOG BURIED	Ending End Trtmt Crashworthy?:	YES		
Average Measurements					
Design Height (In.):	27	Width (In.):	0.0	Post Spacing (In.):	119.5
Height (In.):	28.0	Lateral Offset (In.):	117.0	Road Grade (%):	0.70
Physical Condition					
Barrier	Alignment and Height:	The alignment has no deviation and the height is 0 to 2 in above the design height of 27 in.

Breaking and Cracking:	No breaking or cracking observed.			
	Missing Elements:	No missing elements observed.			
	Corrosion and Weathering:	No corrosion or weathering observed.			
End Treatments	Alignment and Height:	Alignment acceptable. Height is within 1 in of the 27-in design height.			
	Breaking and Cracking:	No breaking or cracking observed.			
	Missing Elements:	No missing elements observed.			
	Corrosion and Weathering:	No corrosion or weathering observed.

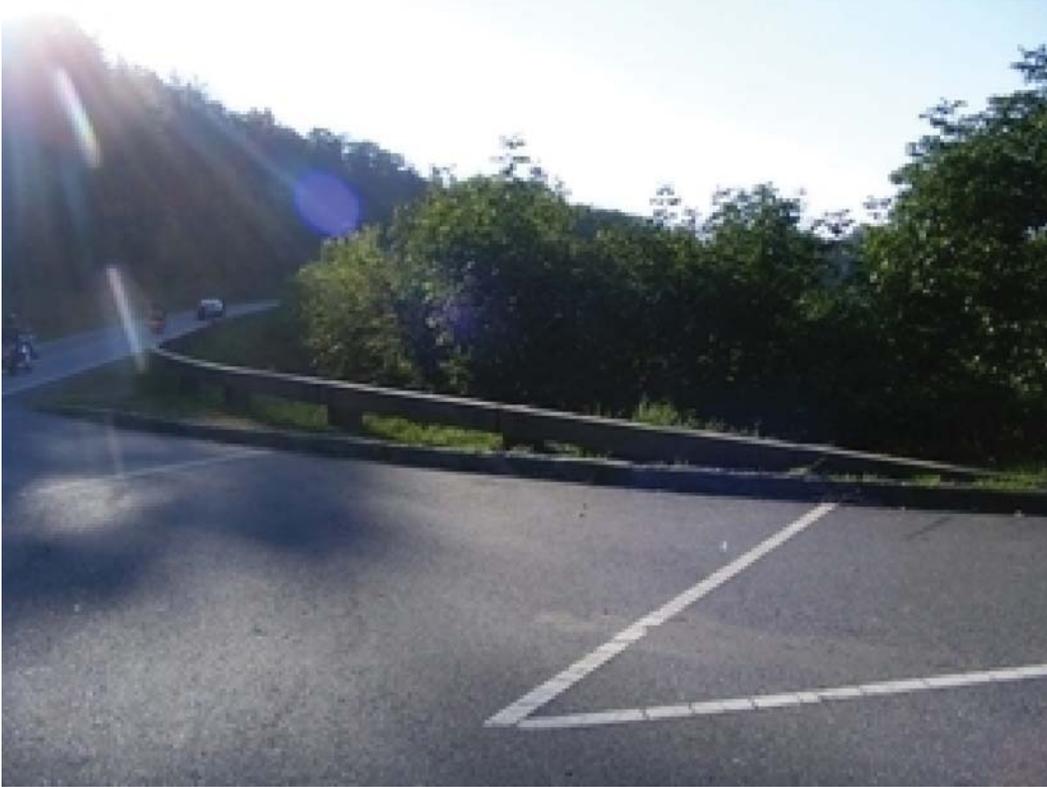
GRSM_0010S_16.660_R_1.JPG

Barrier ID:	GRSM-0010S-16.660-R				
Route Name:	NEWFOUND GAP ROAD SOUTH				
Inspection Date:	09/20/2010	Barrier Rating:	37.00		
Barrier Description					
Type:	STEEL-BACKED TIMBER WITHOUT BLOCKOUT	Barrier Function:	TRAFFIC		
Barrier Material:	STEEL-BACKED TIMBER/LOG	Post Material:	WOOD		
Blockout Type:	N/A	Length (ft.):	640		
Speed Limit (MPH):	35	Placement with Respect to Road:	INSIDE OF CURVE		
Hazard Behind Barrier:	HIGH				
Barrier Crashworthiness					
Appropriate Test Level:	TL-2	Barrier Test Level:	TL-2	Is Barrier Crashworthy?:	YES
Beg. End Trtmt Type:	SBT/LOG FLARED	Is Beg. End Trtmt Crashworthy?:	NO	Approach Transition Type:	NONE
Ending End Trtmt Type:	SBT/LOG FLARED	Ending End Trtmt Crashworthy?:	NO		
Average Measurements					
Design Height (In.):	27	Width (In.):	0.0	Post Spacing (In.):	120.0
Height (In.):	27.6	Lateral Offset (In.):	86.0	Road Grade (%):	4.80
Physical Condition					
Barrier	Alignment and Height:	The alignment has no deviation and the height is at or 1 in above the design height of 27 in.

Breaking and Cracking:	No breaking or cracking observed.			
	Missing Elements:	No missing elements observed.			
	Corrosion and Weathering:	No corrosion or weathering observed.			
End Treatments	Alignment and Height:	Alignment acceptable. Height is within 1 in of the 27-in design height.			
	Breaking and Cracking:	No breaking or cracking observed.			
	Missing Elements:	No missing elements observed.			
	Corrosion and Weathering:	No corrosion or weathering observed.

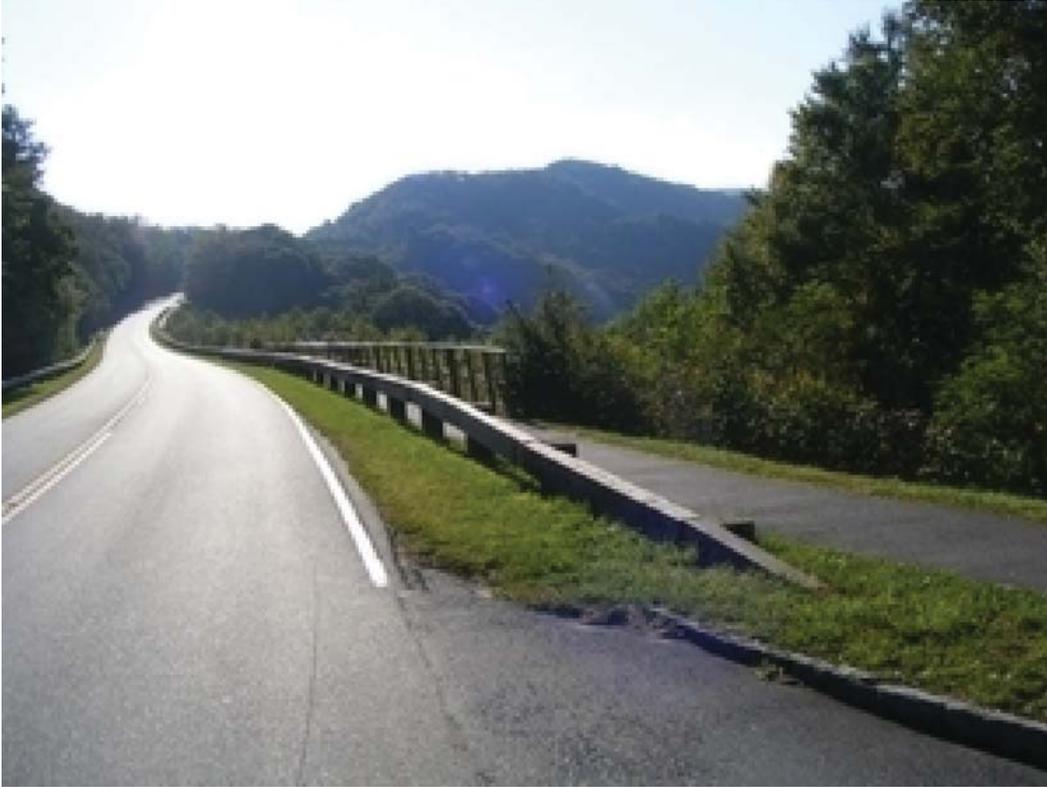
GRSM_0010S_17.018_R_1.JPG

Barrier ID:	GRSM-0010S-17.018-R				
Route Name:	NEWFOUND GAP ROAD SOUTH				
Inspection Date:	09/20/2010	Barrier Rating:	48.50		
Barrier Description					
Type:	STEEL-BACKED TIMBER WITHOUT BLOCKOUT	Barrier Function:	TRAFFIC		
Barrier Material:	STEEL-BACKED TIMBER/LOG	Post Material:	WOOD		
Blockout Type:	N/A	Length (ft.):	1062		
Speed Limit (MPH):	35	Placement with Respect to Road:	BOTH INSIDE AND OUTSIDE		
Hazard Behind Barrier:	HIGH				
Barrier Crashworthiness					
Appropriate Test Level:	TL-2	Barrier Test Level:	TL-2	Is Barrier Crashworthy?:	YES
Beg. End Trtmt Type:	SBT/LOG FLARED	Is Beg. End Trtmt Crashworthy?:	NO	Approach Transition Type:	NONE
Ending End Trtmt Type:	SBT/LOG FLARED	Ending End Trtmt Crashworthy?:	NO		
Average Measurements					
Design Height (In.):	27	Width (In.):	0.0	Post Spacing (In.):	120.0
Height (In.):	27.2	Lateral Offset (In.):	46.7	Road Grade (%):	4.00
Physical Condition					
Barrier	Alignment and Height:	The alignment has no deviation and the height is 1 in below to 2 in above the design height of 27 in.

Breaking and Cracking:	No breaking or cracking observed.			
	Missing Elements:	No missing elements observed.			
	Corrosion and Weathering:	No corrosion or weathering observed.			
End Treatments	Alignment and Height:	Alignment acceptable. Height is within 1 in of the 27-in design height.			
	Breaking and Cracking:	No breaking or cracking observed.			
	Missing Elements:	No missing elements observed.			
	Corrosion and Weathering:	No corrosion or weathering observed.

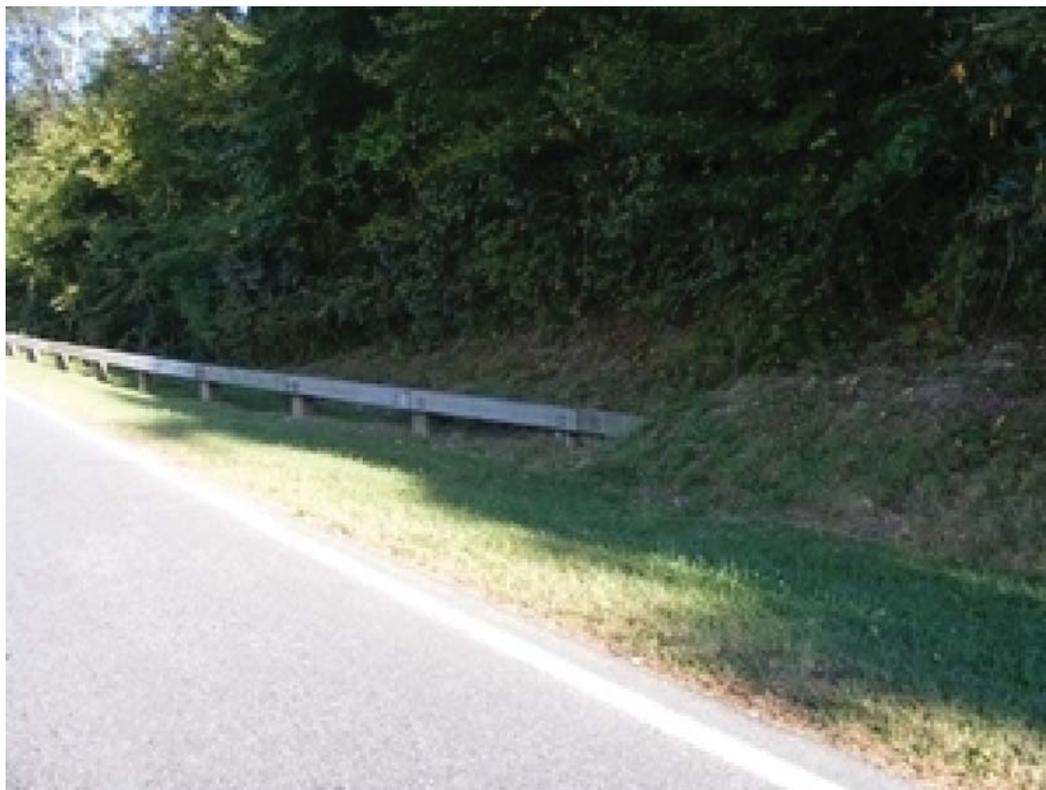
GRSM_0010S_17.049_L_1.JPG

Barrier ID:	GRSM-0010S-17.049-L				
Route Name:	NEWFOUND GAP ROAD SOUTH				
Inspection Date:	09/20/2010	Barrier Rating:	36.70		
Barrier Description					
Type:	STEEL-BACKED TIMBER WITHOUT BLOCKOUT	Barrier Function:	TRAFFIC		
Barrier Material:	STEEL-BACKED TIMBER/LOG	Post Material:	WOOD		
Blockout Type:	N/A	Length (ft.):	665		
Speed Limit (MPH):	35	Placement with Respect to Road:	OUTSIDE OF CURVE		
Hazard Behind Barrier:	MEDIUM				
Barrier Crashworthiness					
Appropriate Test Level:	TL-2	Barrier Test Level:	TL-2	Is Barrier Crashworthy?:	YES
Beg. End Trtmt Type:	SBT/LOG BURIED	Is Beg. End Trtmt Crashworthy?:	YES	Approach Transition Type:	NONE
Ending End Trtmt Type:	SBT/LOG BURIED	Ending End Trtmt Crashworthy?:	YES		
Average Measurements					
Design Height (In.):	27	Width (In.):	0.0	Post Spacing (In.):	120.0
Height (In.):	28.0	Lateral Offset (In.):	70.5	Road Grade (%):	4.90
Physical Condition					
Barrier	Alignment and Height:	The alignment has no deviation and the height ranges from 3 in below to 2 in above the 27 in design height with 70 ft being 1 to 3 ins below.

Breaking and Cracking:	No breaking or cracking observed.			
	Missing Elements:	No missing elements observed.			
	Corrosion and Weathering:	No corrosion or weathering observed.			
End Treatments	Alignment and Height:	Alignment acceptable. Height is within 1 in of the 27-in design height.			
	Breaking and Cracking:	No breaking or cracking observed.			
	Missing Elements:	No missing elements observed.			
	Corrosion and Weathering:	No corrosion or weathering observed.

Repair Action:	REPAIR	FMSS Work Type:	DEFERRED MAINTENANCE	Repair Cost:	\$2393
Brief Workorder:	Raise 70 feet of barrier up to the 27 inch design height.				
Workorder:	Adjust Guardrail at \$10- per -Lin. Ft. for 70 LF = \$700. Raise 70 feet of barrier to the 27-in design height. Low Speed Traffic Control at \$1475- per -Day for 1 Day(s) = \$1475.

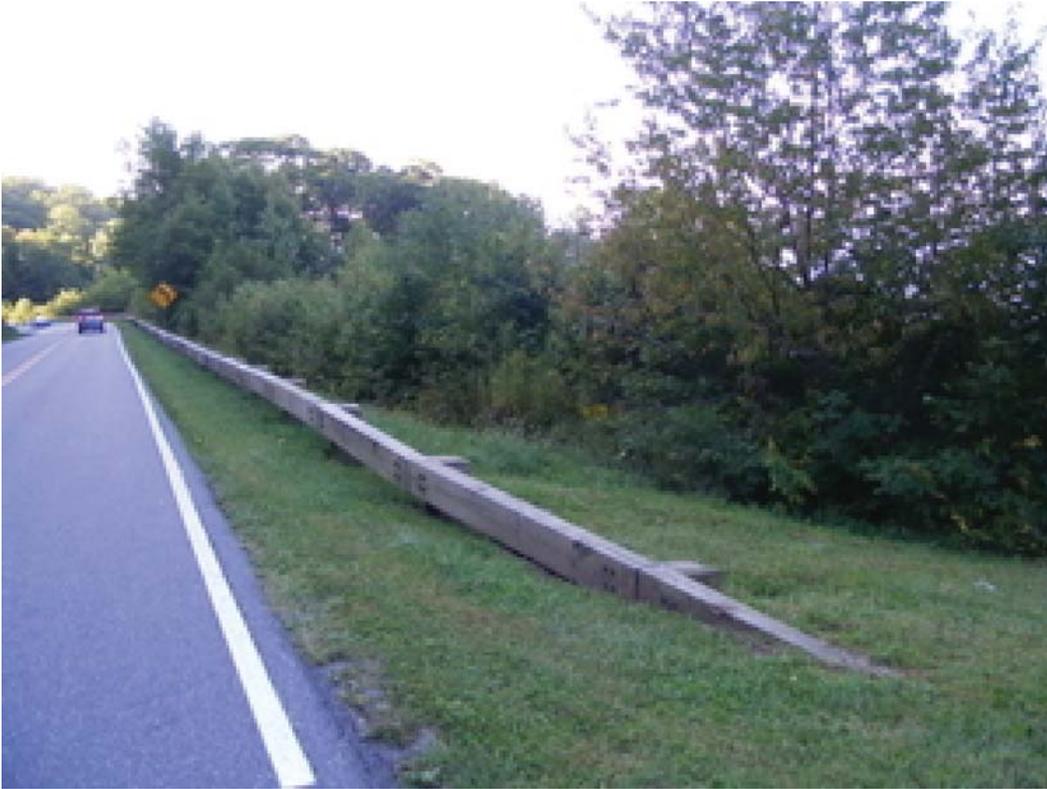
GRSM_0010S_17.853_R_1.JPG

Barrier ID:	GRSM-0010S-17.853-R				
Route Name:	NEWFOUND GAP ROAD SOUTH				
Inspection Date:	09/20/2010	Barrier Rating:	42.70		
Barrier Description					
Type:	STEEL-BACKED TIMBER WITHOUT BLOCKOUT	Barrier Function:	TRAFFIC		
Barrier Material:	STEEL-BACKED TIMBER/LOG	Post Material:	WOOD		
Blockout Type:	N/A	Length (ft.):	718		
Speed Limit (MPH):	35	Placement with Respect to Road:	OUTSIDE OF CURVE		
Hazard Behind Barrier:	HIGH				
Barrier Crashworthiness					
Appropriate Test Level:	TL-2	Barrier Test Level:	TL-2	Is Barrier Crashworthy?:	YES
Beg. End Trtmt Type:	SBT/LOG FLARED	Is Beg. End Trtmt Crashworthy?:	NO	Approach Transition Type:	NONE
Ending End Trtmt Type:	SBT/LOG BURIED	Ending End Trtmt Crashworthy?:	YES		
Average Measurements					
Design Height (In.):	27	Width (In.):	0.0	Post Spacing (In.):	120.0
Height (In.):	28.2	Lateral Offset (In.):	61.2	Road Grade (%):	4.60
Physical Condition					
Barrier	Alignment and Height:	The alignment has no deviation and the height is at or up to 2 in above the design height of 27 in.

Breaking and Cracking:	No breaking or cracking observed.			
	Missing Elements:	No missing elements observed.			
	Corrosion and Weathering:	No corrosion or weathering observed.			
End Treatments	Alignment and Height:	Alignment acceptable. Height is within 1 in of the 27-in design height.			
	Breaking and Cracking:	No breaking or cracking observed.			
	Missing Elements:	No missing elements observed.			
	Corrosion and Weathering:	No corrosion or weathering observed.

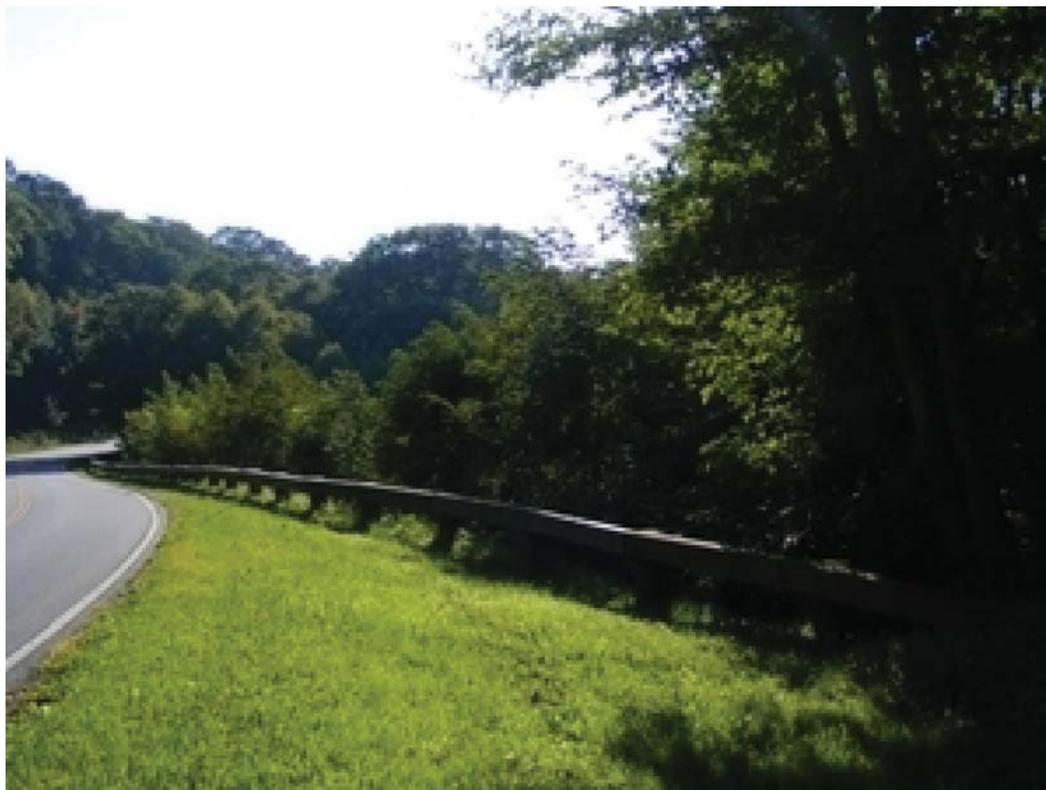
GRSM_0010S_18.033_R_1.JPG

Barrier ID:	GRSM-0010S-18.033-R				
Route Name:	NEWFOUND GAP ROAD SOUTH				
Inspection Date:	09/20/2010	Barrier Rating:	47.20		
Barrier Description					
Type:	STEEL-BACKED TIMBER WITHOUT BLOCKOUT	Barrier Function:	TRAFFIC		
Barrier Material:	STEEL-BACKED TIMBER/LOG	Post Material:	WOOD		
Blockout Type:	N/A	Length (ft.):	584		
Speed Limit (MPH):	35	Placement with Respect to Road:	OUTSIDE OF CURVE		
Hazard Behind Barrier:	HIGH				
Barrier Crashworthiness					
Appropriate Test Level:	TL-2	Barrier Test Level:	TL-2	Is Barrier Crashworthy?:	YES
Beg. End Trtmt Type:	SBT/LOG BURIED	Is Beg. End Trtmt Crashworthy?:	YES	Approach Transition Type:	NONE
Ending End Trtmt Type:	SBT/LOG FLARED	Ending End Trtmt Crashworthy?:	NO		
Average Measurements					
Design Height (In.):	27	Width (In.):	0.0	Post Spacing (In.):	120.0
Height (In.):	28.0	Lateral Offset (In.):	67.6	Road Grade (%):	4.70
Physical Condition					
Barrier	Alignment and Height:	The barrier alignment is deflected more than 12 in off alignment for 30 ft due to impact. The height is at or above the design height of 27 in by up to 3 ins.

Breaking and Cracking:	No breaking or cracking observed.			
	Missing Elements:	No missing elements observed.			
	Corrosion and Weathering:	No corrosion or weathering observed.			
End Treatments	Alignment and Height:	Alignment acceptable. Height is within 1 in of the 27-in design height.			
	Breaking and Cracking:	No breaking or cracking observed.			
	Missing Elements:	No missing elements observed.			
	Corrosion and Weathering:	No corrosion or weathering observed.

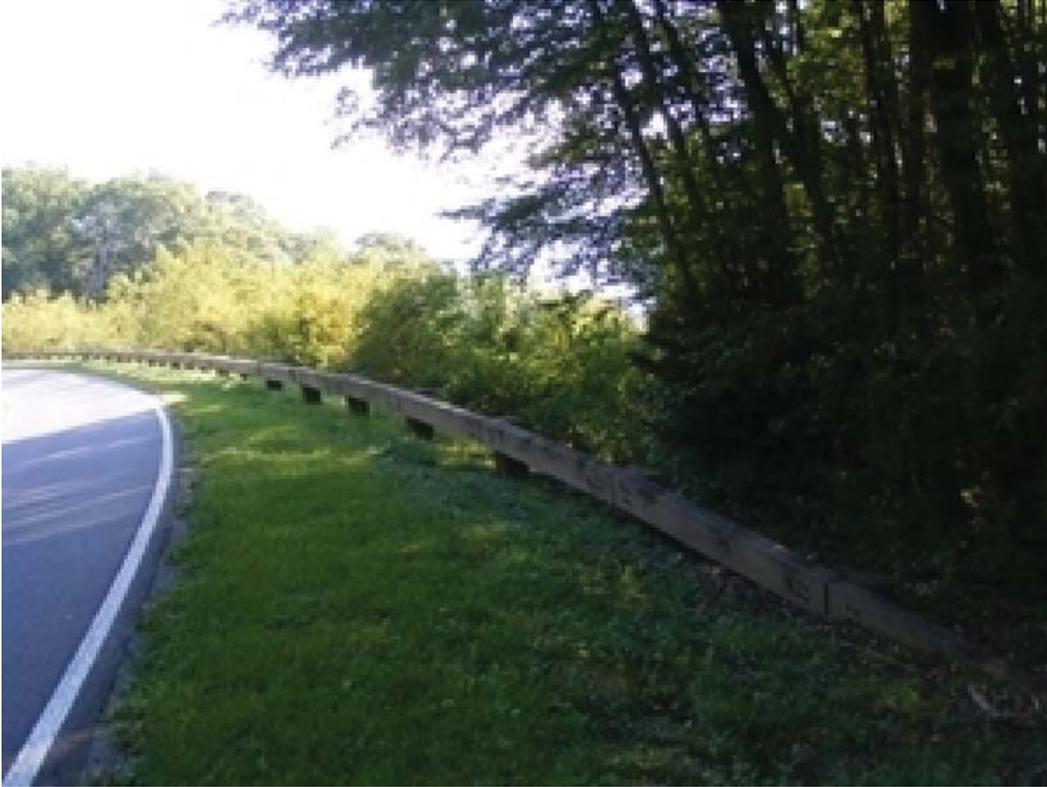
GRSM_0010S_18.349_R_1.JPG

Barrier ID:	GRSM-0010S-18.349-R				
Route Name:	NEWFOUND GAP ROAD SOUTH				
Inspection Date:	09/20/2010	Barrier Rating:	45.20		
Barrier Description					
Type:	STEEL-BACKED TIMBER WITHOUT BLOCKOUT	Barrier Function:	TRAFFIC		
Barrier Material:	STEEL-BACKED TIMBER/LOG	Post Material:	WOOD		
Blockout Type:	N/A	Length (ft.):	472		
Speed Limit (MPH):	35	Placement with Respect to Road:	OUTSIDE OF CURVE		
Hazard Behind Barrier:	MEDIUM				
Barrier Crashworthiness					
Appropriate Test Level:	TL-2	Barrier Test Level:	TL-2	Is Barrier Crashworthy?:	YES
Beg. End Trtmt Type:	SBT/LOG FLARED	Is Beg. End Trtmt Crashworthy?:	NO	Approach Transition Type:	NONE
Ending End Trtmt Type:	SBT/LOG FLARED	Ending End Trtmt Crashworthy?:	NO		
Average Measurements					
Design Height (In.):	27	Width (In.):	0.0	Post Spacing (In.):	120.0
Height (In.):	27.0	Lateral Offset (In.):	73.5	Road Grade (%):	7.10
Physical Condition					
Barrier	Alignment and Height:	The alignment has no deviation and the height is at the 27 in design height.

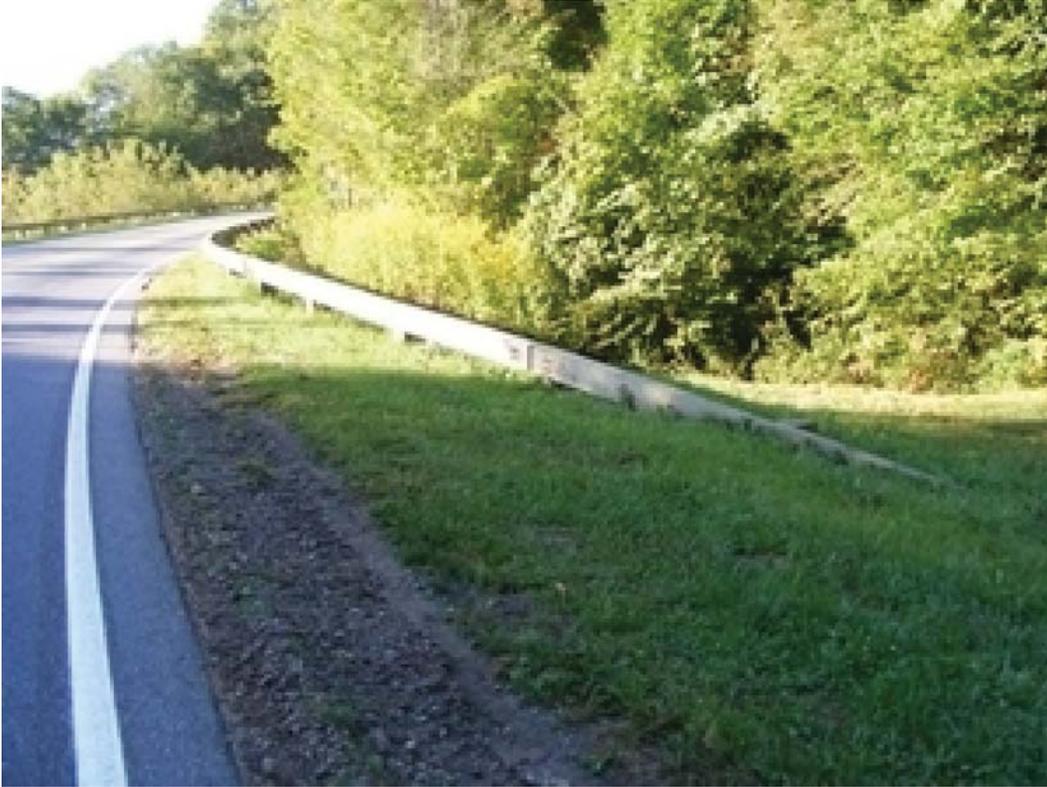
GRSM_0010S_18.351_L_1.JPG

Barrier ID:	GRSM-0010S-18.351-L				
Route Name:	NEWFOUND GAP ROAD SOUTH				
Inspection Date:	09/20/2010	Barrier Rating:	31.00		
Barrier Description					
Type:	STEEL-BACKED TIMBER WITHOUT BLOCKOUT	Barrier Function:	TRAFFIC		
Barrier Material:	STEEL-BACKED TIMBER/LOG	Post Material:	WOOD		
Blockout Type:	N/A	Length (ft.):	414		
Speed Limit (MPH):	35	Placement with Respect to Road:	INSIDE OF CURVE		
Hazard Behind Barrier:	MEDIUM				
Barrier Crashworthiness					
Appropriate Test Level:	TL-2	Barrier Test Level:	TL-2	Is Barrier Crashworthy?:	YES
Beg. End Trtmt Type:	SBT/LOG FLARED	Is Beg. End Trtmt Crashworthy?:	NO	Approach Transition Type:	NONE
Ending End Trtmt Type:	SBT/LOG FLARED	Ending End Trtmt Crashworthy?:	NO		
Average Measurements					
Design Height (In.):	27	Width (In.):	0.0	Post Spacing (In.):	120.0
Height (In.):	27.2	Lateral Offset (In.):	59.5	Road Grade (%):	6.40
Physical Condition					
Barrier	Alignment and Height:	The alignment has no deviation and the height is at or up to 1 in above the design height of 27 in.
