NPS Guardwall/Rail Inventory Program
Great Smoky Mountains National Park

Federal Highway Administration
Eastern Federal Lands Highway Division
Road Inventory Program (RIP)

Data Collection Date: September 2010
Report Date: December 2015

Great Smoky Mountains National Park in North Carolina and Tennessee

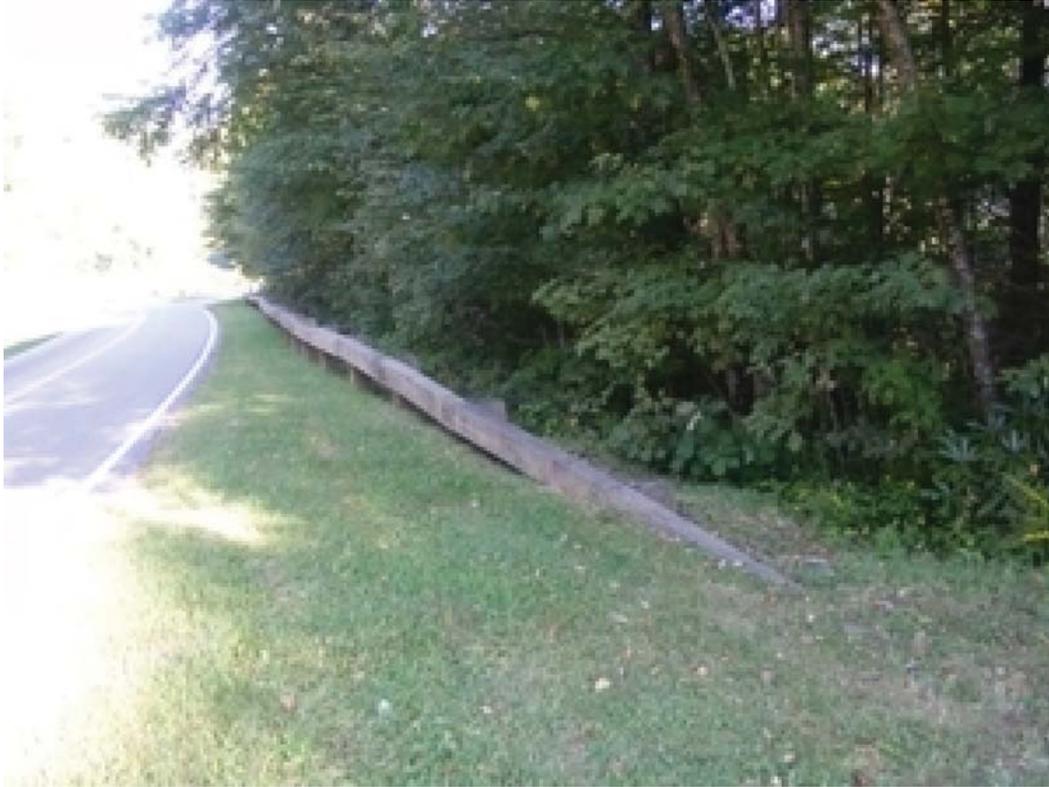
GRSM_0010S_18.568_R_1.JPG

Barrier ID:	GRSM-0010S-18.568-R				
Route Name:	NEWFOUND GAP ROAD SOUTH				
Inspection Date:	09/20/2010	Barrier Rating:	49.70		
Barrier Description					
Type:	STEEL-BACKED TIMBER WITHOUT BLOCKOUT	Barrier Function:	TRAFFIC		
Barrier Material:	STEEL-BACKED TIMBER/LOG	Post Material:	WOOD		
Blockout Type:	N/A	Length (ft.):	315		
Speed Limit (MPH):	35	Placement with Respect to Road:	OUTSIDE OF CURVE		
Hazard Behind Barrier:	MEDIUM				
Barrier Crashworthiness					
Appropriate Test Level:	TL-2	Barrier Test Level:	TL-2	Is Barrier Crashworthy?:	YES
Beg. End Trtmt Type:	SBT/LOG FLARED	Is Beg. End Trtmt Crashworthy?:	NO	Approach Transition Type:	NONE
Ending End Trtmt Type:	SBT/LOG FLARED	Ending End Trtmt Crashworthy?:	NO		
Average Measurements					
Design Height (In.):	27	Width (In.):	0.0	Post Spacing (In.):	120.0
Height (In.):	28.6	Lateral Offset (In.):	73.0	Road Grade (%):	7.30
Physical Condition					
Barrier	Alignment and Height:	The alignment is deflected more than 12 in off alignment for 30 ft due to impact. The height is 1 in below to 3 in above the design height of 27 in.

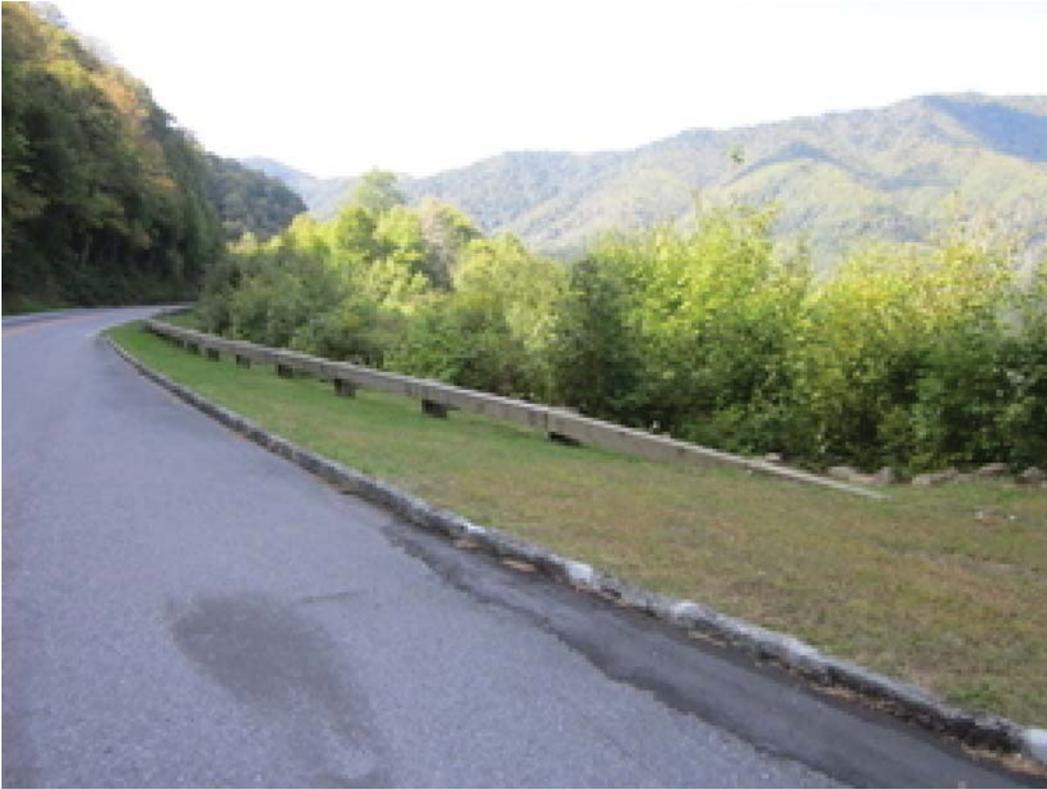
GRSM_0010S_18.674_R_1.JPG

Barrier ID:	GRSM-0010S-18.674-R				
Route Name:	NEWFOUND GAP ROAD SOUTH				
Inspection Date:	09/20/2010	Barrier Rating:	51.50		
Barrier Description					
Type:	STEEL-BACKED TIMBER WITHOUT BLOCKOUT	Barrier Function:	TRAFFIC		
Barrier Material:	STEEL-BACKED TIMBER/LOG	Post Material:	WOOD		
Blockout Type:	N/A	Length (ft.):	1147		
Speed Limit (MPH):	35	Placement with Respect to Road:	BOTH INSIDE AND OUTSIDE		
Hazard Behind Barrier:	EXTREME				
Barrier Crashworthiness					
Appropriate Test Level:	TL-2	Barrier Test Level:	TL-2	Is Barrier Crashworthy?:	YES
Beg. End Trtmt Type:	SBT/LOG FLARED	Is Beg. End Trtmt Crashworthy?:	NO	Approach Transition Type:	NONE
Ending End Trtmt Type:	SBT/LOG FLARED	Ending End Trtmt Crashworthy?:	NO		
Average Measurements					
Design Height (In.):	27	Width (In.):	0.0	Post Spacing (In.):	120.5
Height (In.):	28.2	Lateral Offset (In.):	74.8	Road Grade (%):	6.60
Physical Condition					
Barrier	Alignment and Height:	Alignment has no deviation and the height and the height ranges from 3 in below to 6 in above the 27 in design height with 30 ft being 2-3 in below and 50 ft being more than 5 in above.

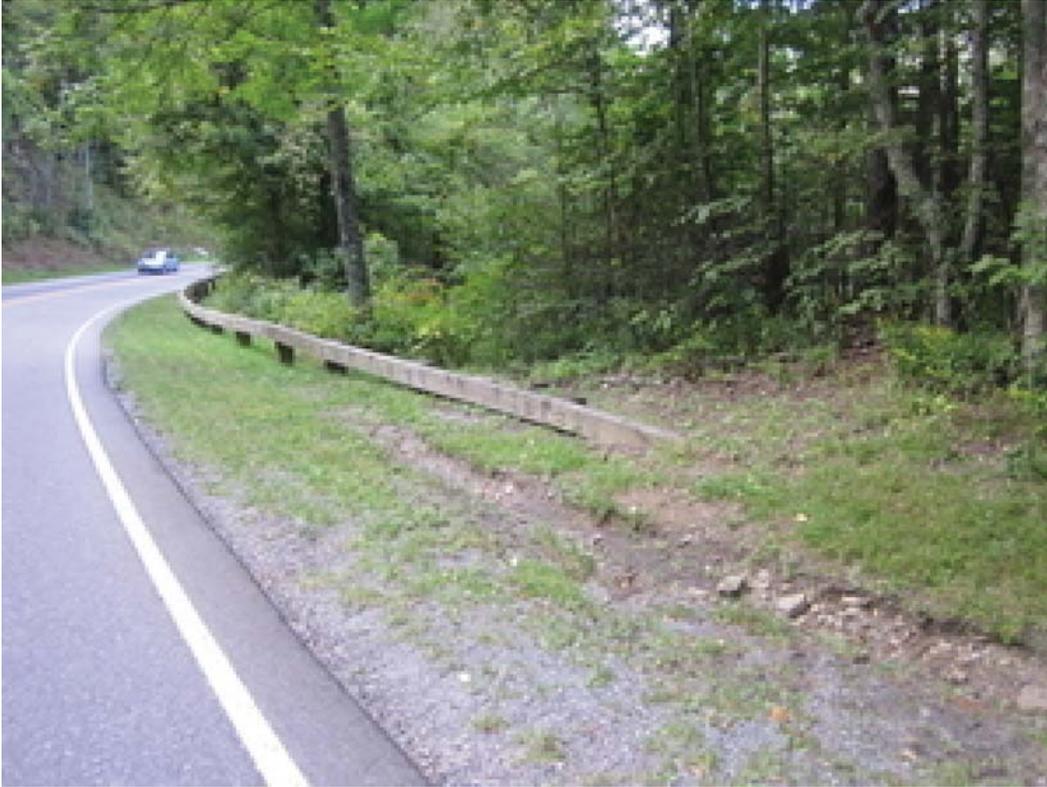
GRSM_0010S_18.923_R_1.JPG

Barrier ID:	GRSM-0010S-18.923-R				
Route Name:	NEWFOUND GAP ROAD SOUTH				
Inspection Date:	09/20/2010	Barrier Rating:	37.00		
Barrier Description					
Type:	STEEL-BACKED TIMBER WITHOUT BLOCKOUT	Barrier Function:	TRAFFIC		
Barrier Material:	STEEL-BACKED TIMBER/LOG	Post Material:	WOOD		
Blockout Type:	N/A	Length (ft.):	634		
Speed Limit (MPH):	35	Placement with Respect to Road:	INSIDE OF CURVE		
Hazard Behind Barrier:	HIGH				
Barrier Crashworthiness					
Appropriate Test Level:	TL-2	Barrier Test Level:	TL-2	Is Barrier Crashworthy?:	YES
Beg. End Trtmt Type:	SBT/LOG FLARED	Is Beg. End Trtmt Crashworthy?:	NO	Approach Transition Type:	NONE
Ending End Trtmt Type:	SBT/LOG FLARED	Ending End Trtmt Crashworthy?:	NO		
Average Measurements					
Design Height (In.):	27	Width (In.):	0.0	Post Spacing (In.):	120.0
Height (In.):	29.2	Lateral Offset (In.):	65.6	Road Grade (%):	5.90
Physical Condition					
Barrier	Alignment and Height:	Alignment has no deviation and the height is 2 to 3 in above the 27 in design height.

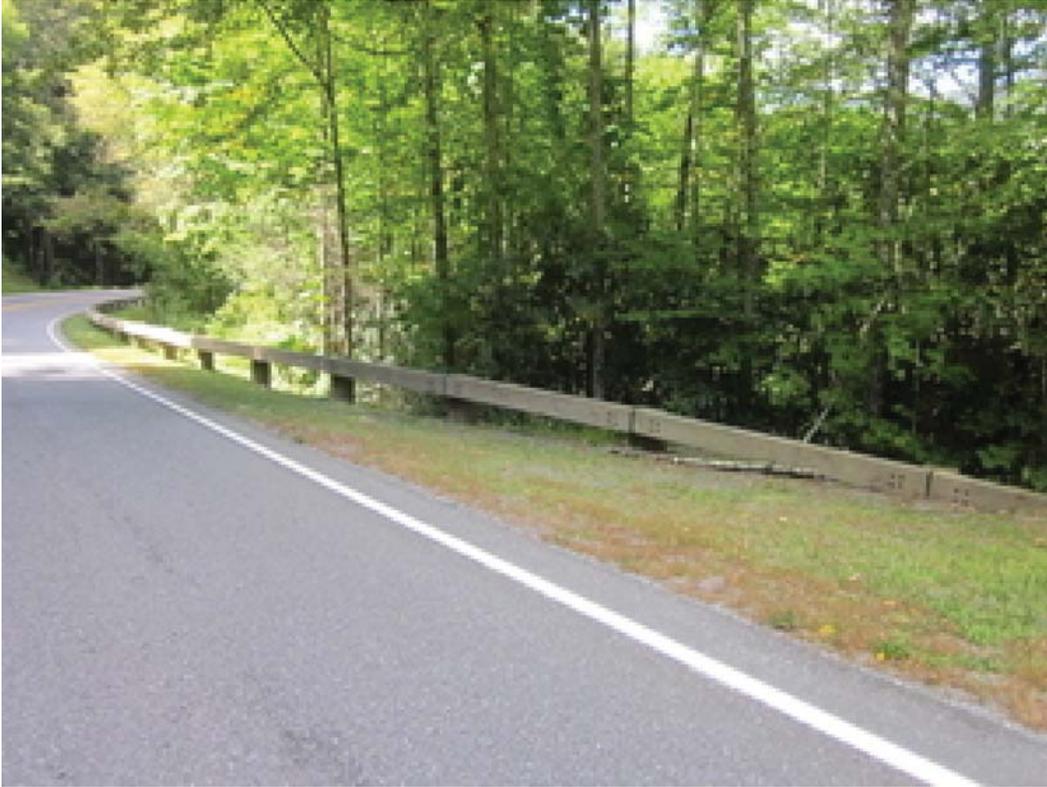
GRSM_0010S_19.205_R_1.JPG

Barrier ID:	GRSM-0010S-19.205-R				
Route Name:	NEWFOUND GAP ROAD SOUTH				
Inspection Date:	09/20/2010	Barrier Rating:	39.90		
Barrier Description					
Type:	STEEL-BACKED TIMBER WITHOUT BLOCKOUT	Barrier Function:	TRAFFIC		
Barrier Material:	STEEL-BACKED TIMBER/LOG	Post Material:	WOOD		
Blockout Type:	N/A	Length (ft.):	792		
Speed Limit (MPH):	35	Placement with Respect to Road:	INSIDE OF CURVE		
Hazard Behind Barrier:	HIGH				
Barrier Crashworthiness					
Appropriate Test Level:	TL-2	Barrier Test Level:	TL-2	Is Barrier Crashworthy?:	YES
Beg. End Trtmt Type:	SBT/LOG FLARED	Is Beg. End Trtmt Crashworthy?:	NO	Approach Transition Type:	NONE
Ending End Trtmt Type:	SBT/LOG FLARED	Ending End Trtmt Crashworthy?:	NO		
Average Measurements					
Design Height (In.):	27	Width (In.):	0.0	Post Spacing (In.):	119.8
Height (In.):	29.7	Lateral Offset (In.):	52.2	Road Grade (%):	5.80
Physical Condition					
Barrier	Alignment and Height:	Alignment has no deviation and the height is 0 to 5 in above the 27 in design height.

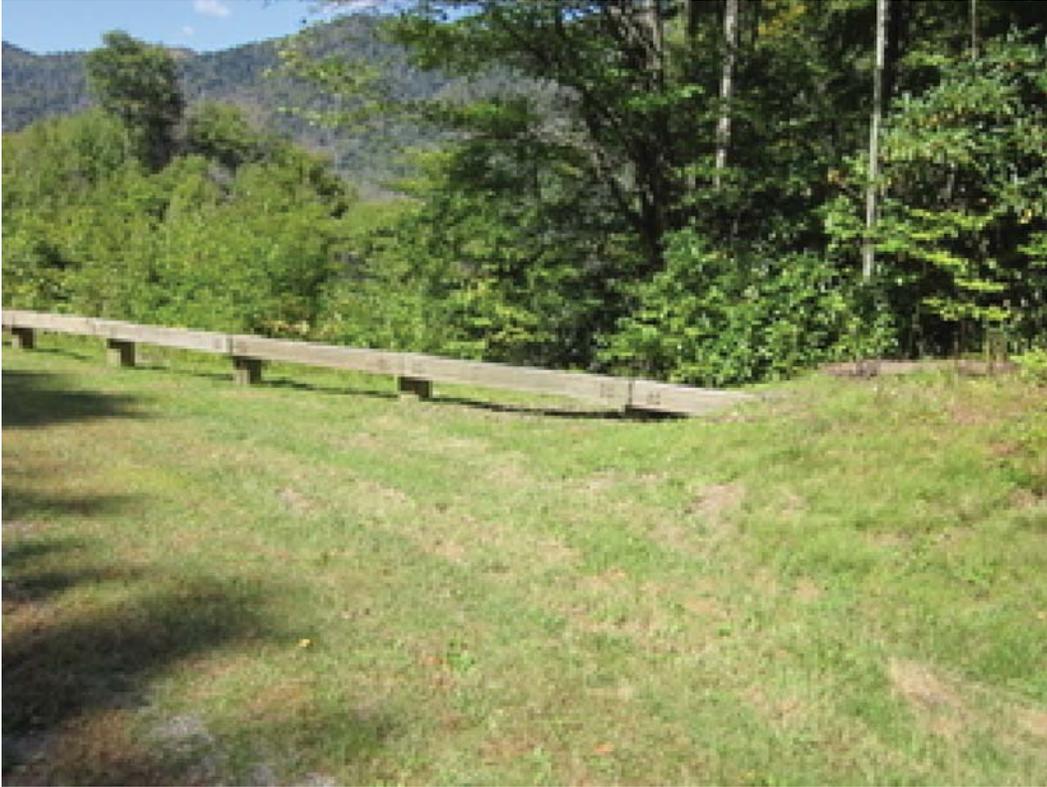
GRSM_0010S_19.431_R_1.JPG

Barrier ID:	GRSM-0010S-19.431-R				
Route Name:	NEWFOUND GAP ROAD SOUTH				
Inspection Date:	09/20/2010	Barrier Rating:	53.20		
Barrier Description					
Type:	STEEL-BACKED TIMBER WITHOUT BLOCKOUT	Barrier Function:	TRAFFIC		
Barrier Material:	STEEL-BACKED TIMBER/LOG	Post Material:	WOOD		
Blockout Type:	N/A	Length (ft.):	438		
Speed Limit (MPH):	35	Placement with Respect to Road:	OUTSIDE OF CURVE		
Hazard Behind Barrier:	EXTREME				
Barrier Crashworthiness					
Appropriate Test Level:	TL-2	Barrier Test Level:	TL-2	Is Barrier Crashworthy?:	YES
Beg. End Trtmt Type:	SBT/LOG BURIED	Is Beg. End Trtmt Crashworthy?:	YES	Approach Transition Type:	NONE
Ending End Trtmt Type:	NONE	Ending End Trtmt Crashworthy?:	N/A		
Average Measurements					
Design Height (In.):	27	Width (In.):	0.0	Post Spacing (In.):	120.0
Height (In.):	25.6	Lateral Offset (In.):	68.0	Road Grade (%):	6.70
Physical Condition					
Barrier	Alignment and Height:	Alignment has no deviation and the height ranges from 0-3 in below the 27 in design height with 50 ft being 1-3 in below.

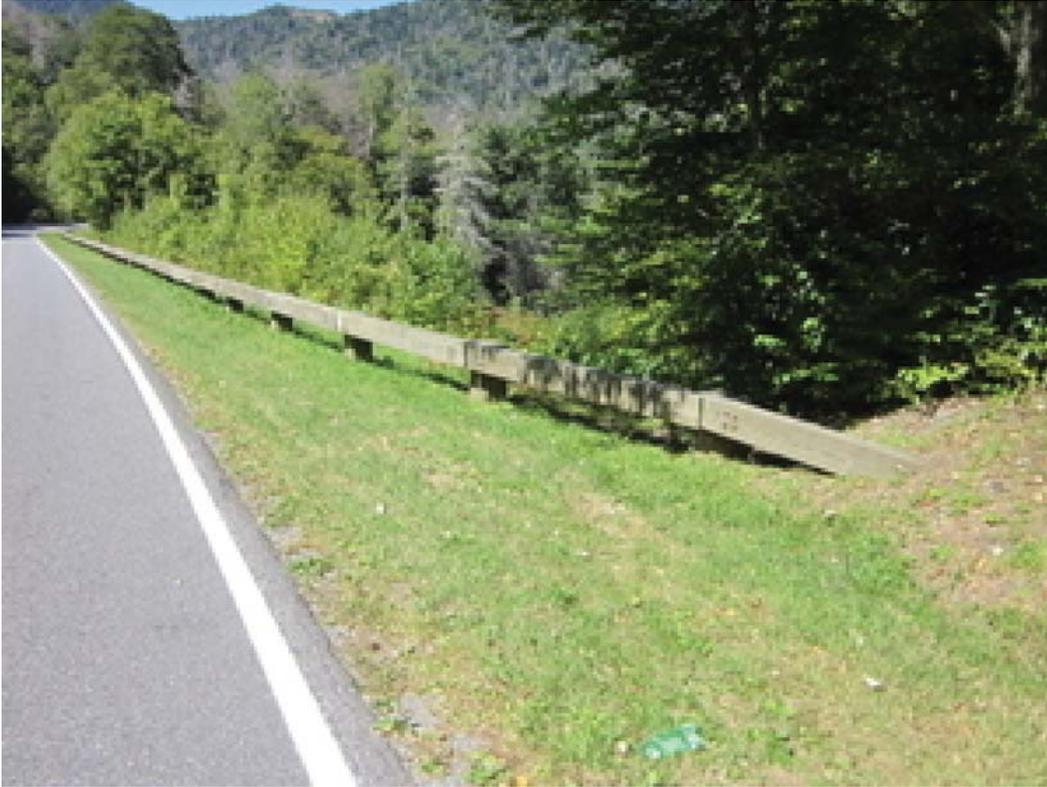
GRSM_0010S_19.587_R_1.JPG

Barrier ID:	GRSM-0010S-19.587-R				
Route Name:	NEWFOUND GAP ROAD SOUTH				
Inspection Date:	09/20/2010	Barrier Rating:	47.00		
Barrier Description					
Type:	STEEL-BACKED TIMBER WITHOUT BLOCKOUT	Barrier Function:	TRAFFIC		
Barrier Material:	STEEL-BACKED TIMBER/LOG	Post Material:	WOOD		
Blockout Type:	N/A	Length (ft.):	400		
Speed Limit (MPH):	35	Placement with Respect to Road:	BOTH INSIDE AND OUTSIDE		
Hazard Behind Barrier:	HIGH				
Barrier Crashworthiness					
Appropriate Test Level:	TL-2	Barrier Test Level:	TL-2	Is Barrier Crashworthy?:	YES
Beg. End Trtmt Type:	SBT/LOG BURIED	Is Beg. End Trtmt Crashworthy?:	YES	Approach Transition Type:	NONE
Ending End Trtmt Type:	SBT/LOG FLARED	Ending End Trtmt Crashworthy?:	NO		
Average Measurements					
Design Height (In.):	27	Width (In.):	0.0	Post Spacing (In.):	120.3
Height (In.):	27.7	Lateral Offset (In.):	83.3	Road Grade (%):	6.90
Physical Condition					
Barrier	Alignment and Height:	Alignment has no deviation and the height is between 1 in below to 2 in above the 27 in design height.

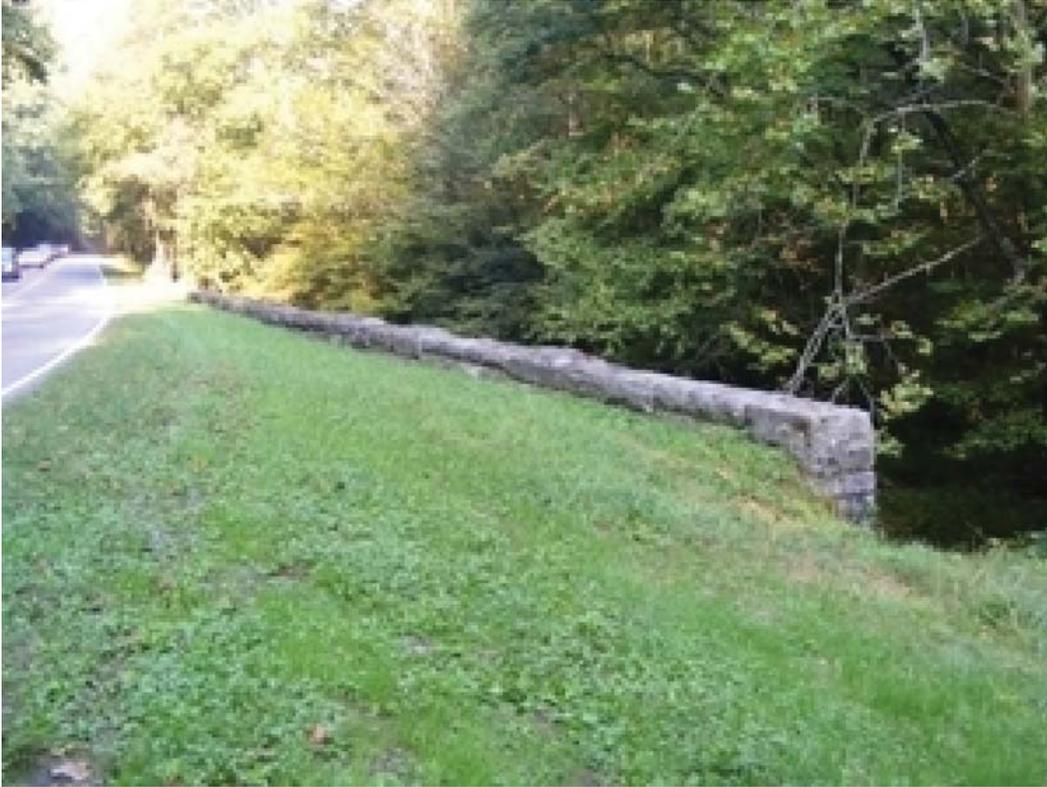
GRSM_0010S_24.324_L_1.JPG

Barrier ID:	GRSM-0010S-24.324-L				
Route Name:	NEWFOUND GAP ROAD SOUTH				
Inspection Date:	09/23/2010	Barrier Rating:	48.20		
Barrier Description					
Type:	STONE MASONRY WITHOUT CONCRETE CORE WALL	Barrier Function:	TRAFFIC		
Barrier Material:	STONE	Post Material:	N/A		
Blockout Type:	N/A	Length (ft.):	205		
Speed Limit (MPH):	45	Placement with Respect to Road:	OUTSIDE OF CURVE		
Hazard Behind Barrier:	MEDIUM				
Barrier Crashworthiness					
Appropriate Test Level:	TL-2	Barrier Test Level:	NCW	Is Barrier Crashworthy?:	NO
Beg. End Trtmt Type:	NONE	Is Beg. End Trtmt Crashworthy?:	N/A	Approach Transition Type:	NONE
Ending End Trtmt Type:	NONE	Ending End Trtmt Crashworthy?:	N/A		
Average Measurements					
Design Height (In.):	24	Width (In.):	24.6	Post Spacing (In.):	0.0
Height (In.):	22.2	Lateral Offset (In.):	122.0	Road Grade (%):	4.10
Physical Condition					
Barrier	Alignment and Height:	The alignment has no deviation and the height is 1 to 3 in below the design height of 24 in.

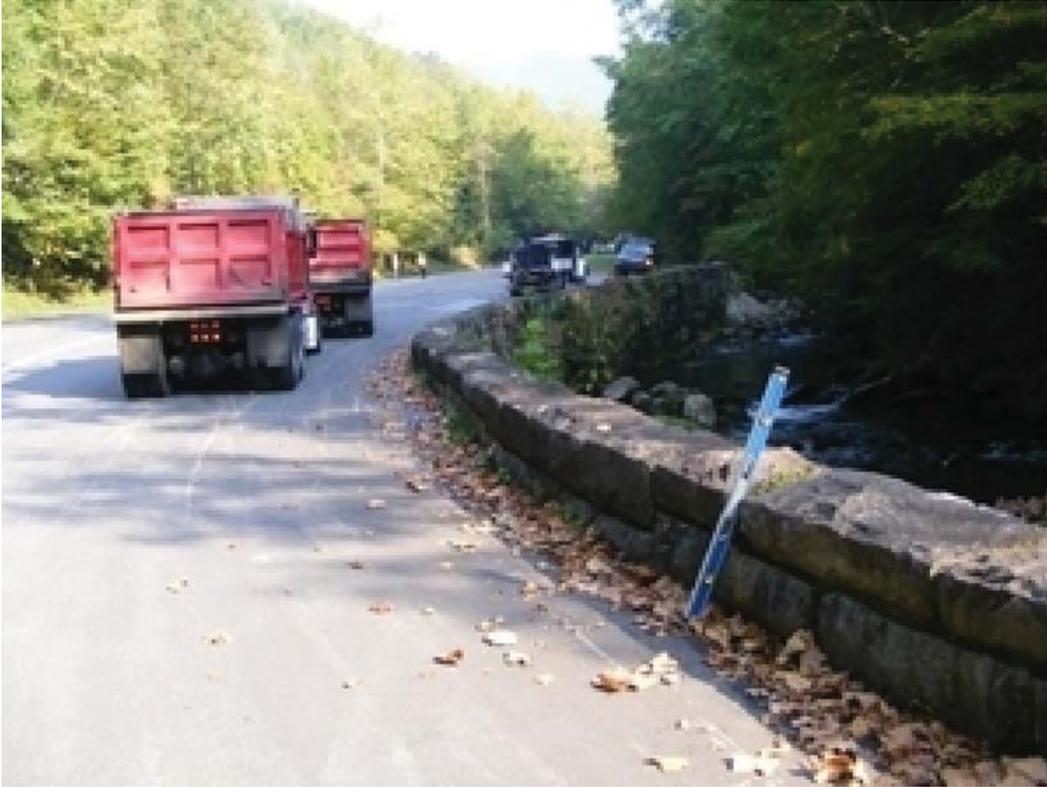
GRSM_0010S_25.776_L_1.JPG

Barrier ID:	GRSM-0010S-25.776-L				
Route Name:	NEWFOUND GAP ROAD SOUTH				
Inspection Date:	09/23/2010	Barrier Rating:	20.10		
Barrier Description					
Type:	STONE MASONRY WITHOUT CONCRETE CORE WALL	Barrier Function:	NON-TRAFFIC		
Barrier Material:	STONE	Post Material:	N/A		
Blockout Type:	N/A	Length (ft.):	220		
Speed Limit (MPH):	35	Placement with Respect to Road:	NON-TRAFFIC BARRIER		
Hazard Behind Barrier:	N/A				
Barrier Crashworthiness					
Appropriate Test Level:	TL-2	Barrier Test Level:	N/A	Is Barrier Crashworthy?:	N/A
Beg. End Trtmt Type:	NONE	Is Beg. End Trtmt Crashworthy?:	N/A	Approach Transition Type:	NONE
Ending End Trtmt Type:	NONE	Ending End Trtmt Crashworthy?:	N/A		
Average Measurements					
Design Height (In.):	24	Width (In.):	25.6	Post Spacing (In.):	0.0
Height (In.):	23.0	Lateral Offset (In.):	0.0	Road Grade (%):	0.00
Physical Condition					
Barrier	Alignment and Height:	The alignment has no deviation and the height is 0-3 in below the design height of 24 in.

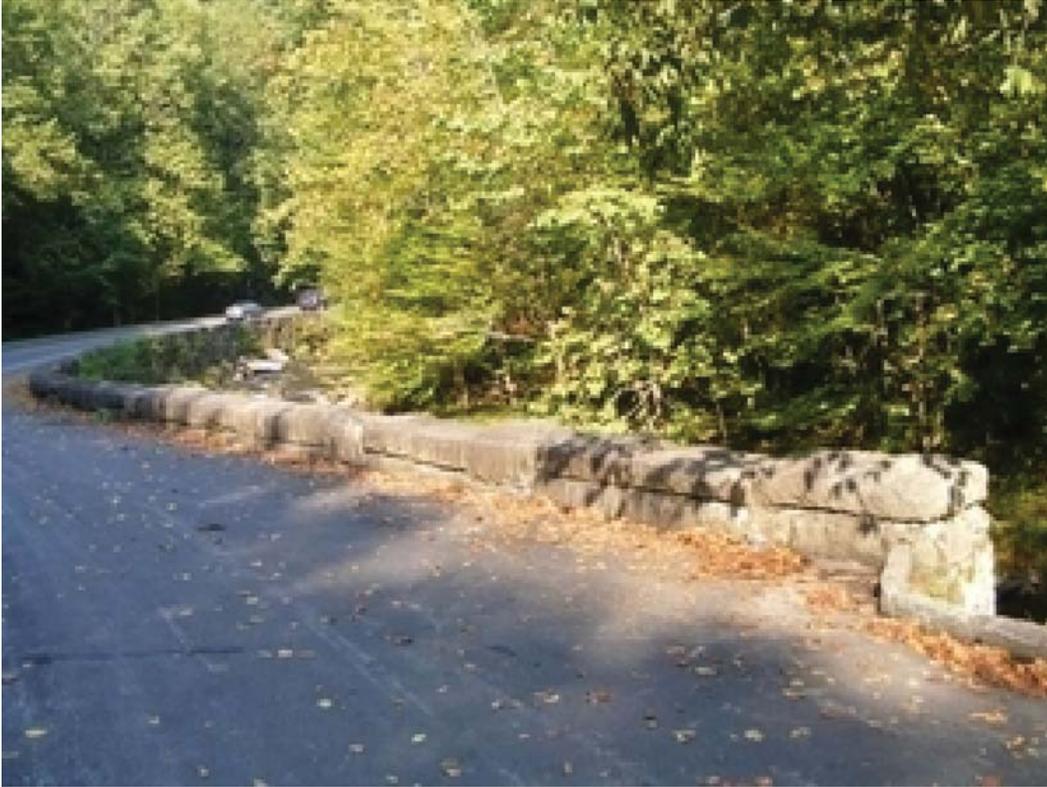
GRSM_0010S_25.826_L_1.JPG

Barrier ID:	GRSM-0010S-25.826-L				
Route Name:	NEWFOUND GAP ROAD SOUTH				
Inspection Date:	09/23/2010	Barrier Rating:	38.20		
Barrier Description					
Type:	STONE MASONRY WITHOUT CONCRETE CORE WALL	Barrier Function:	TRAFFIC		
Barrier Material:	STONE	Post Material:	N/A		
Blockout Type:	N/A	Length (ft.):	372		
Speed Limit (MPH):	45	Placement with Respect to Road:	INSIDE OF CURVE		
Hazard Behind Barrier:	MEDIUM				
Barrier Crashworthiness					
Appropriate Test Level:	TL-2	Barrier Test Level:	NCW	Is Barrier Crashworthy?:	NO
Beg. End Trtmt Type:	NONE	Is Beg. End Trtmt Crashworthy?:	N/A	Approach Transition Type:	NONE
Ending End Trtmt Type:	NONE	Ending End Trtmt Crashworthy?:	N/A		
Average Measurements					
Design Height (In.):	24	Width (In.):	27.0	Post Spacing (In.):	0.0
Height (In.):	22.0	Lateral Offset (In.):	132.3	Road Grade (%):	2.60
Physical Condition					
Barrier	Alignment and Height:	The alignment has no deviation and the height is 0-3 in below the design height of 24 in.

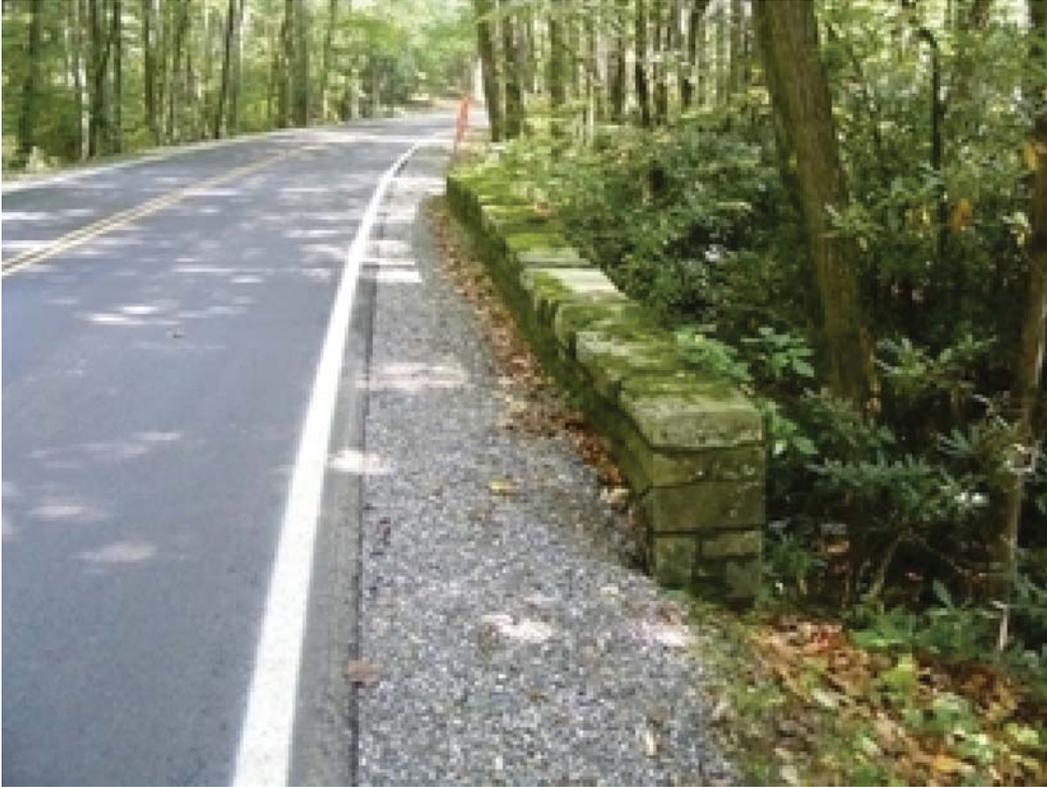
GRSM_0010S_28.913_L_1.JPG

Barrier ID:	GRSM-0010S-28.913-L				
Route Name:	NEWFOUND GAP ROAD SOUTH				
Inspection Date:	09/23/2010	Barrier Rating:	41.00		
Barrier Description					
Type:	STONE MASONRY WITHOUT CONCRETE CORE WALL	Barrier Function:	TRAFFIC		
Barrier Material:	STONE	Post Material:	N/A		
Blockout Type:	N/A	Length (ft.):	53		
Speed Limit (MPH):	45	Placement with Respect to Road:	INSIDE OF CURVE		
Hazard Behind Barrier:	MEDIUM				
Barrier Crashworthiness					
Appropriate Test Level:	TL-2	Barrier Test Level:	NCW	Is Barrier Crashworthy?:	NO
Beg. End Trtmt Type:	NONE	Is Beg. End Trtmt Crashworthy?:	N/A	Approach Transition Type:	NONE
Ending End Trtmt Type:	NONE	Ending End Trtmt Crashworthy?:	N/A		
Average Measurements					
Design Height (In.):	24	Width (In.):	18.2	Post Spacing (In.):	0.0
Height (In.):	23.2	Lateral Offset (In.):	45.2	Road Grade (%):	0.80
Physical Condition					
Barrier	Alignment and Height:	The alignment has no deviation and the height is low by 2 in or less from the design height of 24 in.

Breaking and Cracking:	No breaking or cracking observed.			
	Missing Elements:	No missing elements observed.			
	Corrosion and Weathering:	Moderate corrosion or weathering observed.			
End Treatments	Alignment and Height:				
	Breaking and Cracking:				
	Missing Elements:				
	Corrosion and Weathering:

Barrier ID:	GRSM-0010S-28.913-L				
Route Name:	NEWFOUND GAP ROAD SOUTH				
Inspection Date:	09/23/2010		Barrier Rating:	41.00	
Repair Recommendations					
Repair Action:	NO ACTION	FMSS Work Type:	N/A	Repair Cost:	\$0
Brief Workorder:	N/A				
Workorder:

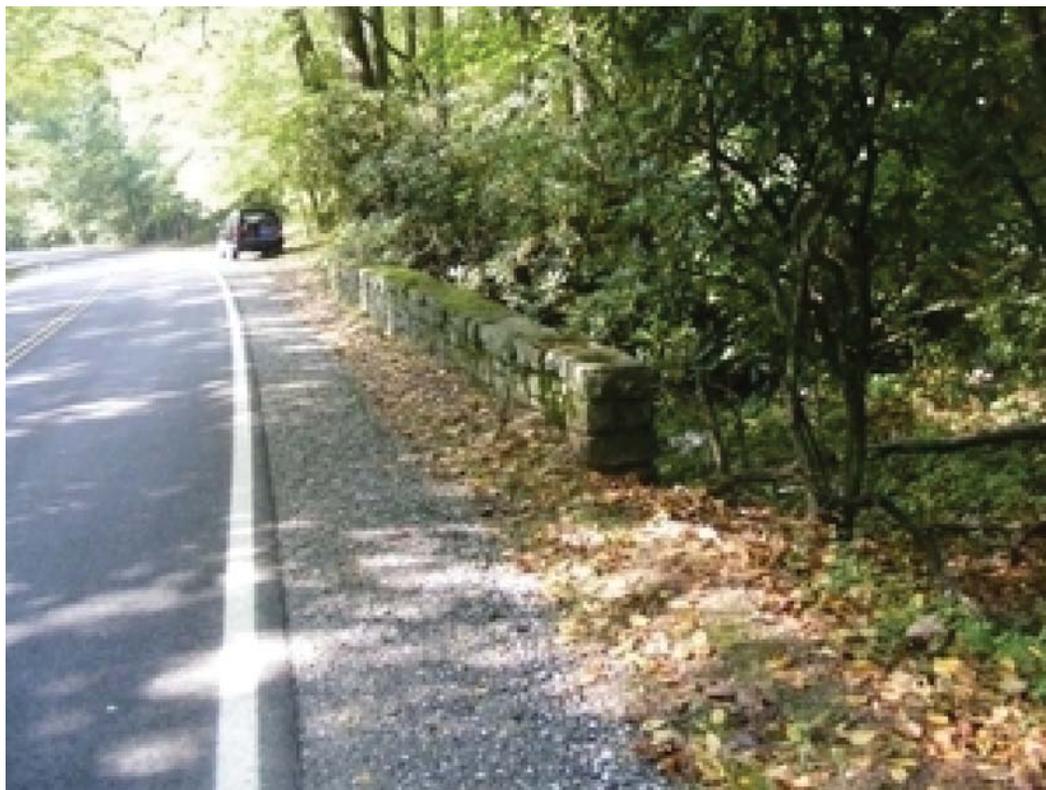
GRSM_0010S_28.914_R_1.JPG

Barrier ID:	GRSM-0010S-28.914-R				
Route Name:	NEWFOUND GAP ROAD SOUTH				
Inspection Date:	09/23/2010	Barrier Rating:	43.70		
Barrier Description					
Type:	STONE MASONRY WITHOUT CONCRETE CORE WALL	Barrier Function:	TRAFFIC		
Barrier Material:	STONE	Post Material:	N/A		
Blockout Type:	N/A	Length (ft.):	53		
Speed Limit (MPH):	45	Placement with Respect to Road:	OUTSIDE OF CURVE		
Hazard Behind Barrier:	MEDIUM				
Barrier Crashworthiness					
Appropriate Test Level:	TL-2	Barrier Test Level:	NCW	Is Barrier Crashworthy?:	NO
Beg. End Trtmt Type:	NONE	Is Beg. End Trtmt Crashworthy?:	N/A	Approach Transition Type:	NONE
Ending End Trtmt Type:	NONE	Ending End Trtmt Crashworthy?:	N/A		
Average Measurements					
Design Height (In.):	24	Width (In.):	20.2	Post Spacing (In.):	0.0
Height (In.):	27.2	Lateral Offset (In.):	70.0	Road Grade (%):	0.90
Physical Condition					
Barrier	Alignment and Height:	The alignment has no deviation and the height is at or up to 6 in above the design height of 24 in.

Breaking and Cracking:	No breaking or cracking observed.			
	Missing Elements:	No missing elements observed.			
	Corrosion and Weathering:	Moderate weathering of the barrier observed.			
End Treatments	Alignment and Height:				
	Breaking and Cracking:				
	Missing Elements:				
	Corrosion and Weathering:

Repair Action:	NO ACTION	FMSS Work Type:	N/A	Repair Cost:	\$0
Brief Workorder:	N/A				
Workorder:

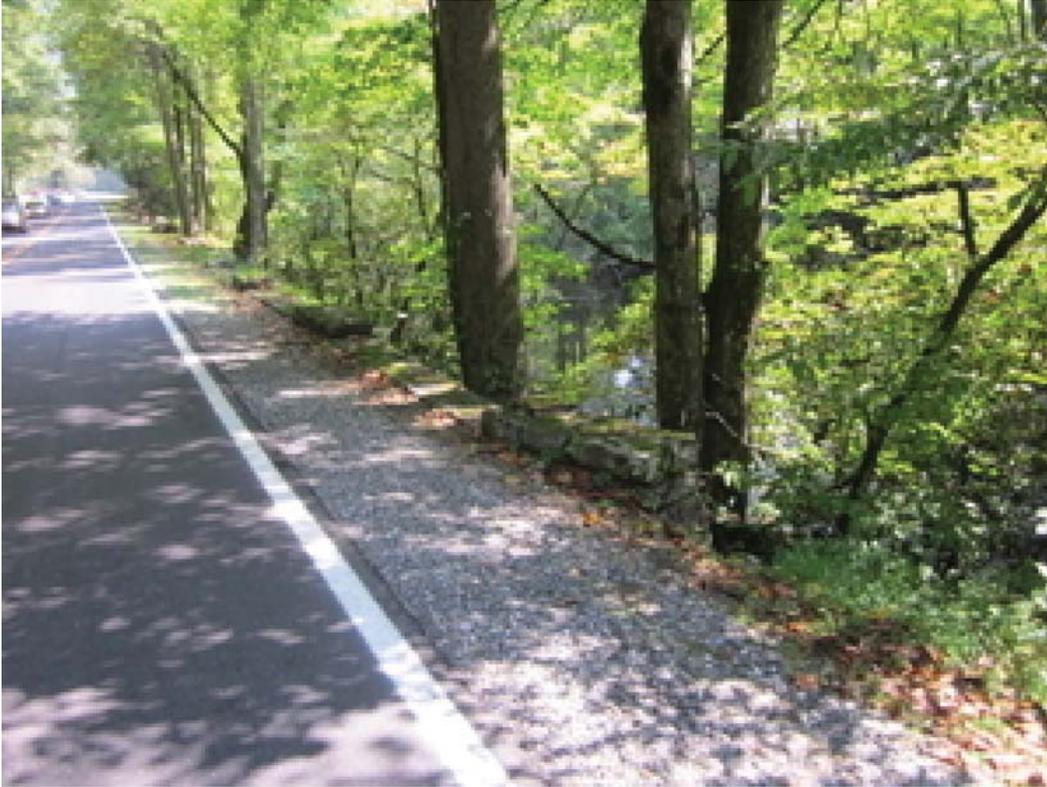
GRSM_0010S_29.918_L_1.JPG

Barrier ID:	GRSM-0010S-29.918-L				
Route Name:	NEWFOUND GAP ROAD SOUTH				
Inspection Date:	09/23/2010	Barrier Rating:	56.70		
Barrier Description					
Type:	STONE MASONRY CRENELLATED WITHOUT	Barrier Function:	TRAFFIC		
Barrier Material:	STONE	Post Material:	N/A		
Blockout Type:	N/A	Length (ft.):	61		
Speed Limit (MPH):	35	Placement with Respect to Road:	TANGENT		
Hazard Behind Barrier:	MEDIUM				
Barrier Crashworthiness					
Appropriate Test Level:	TL-2	Barrier Test Level:	NCW	Is Barrier Crashworthy?:	NO
Beg. End Trtmt Type:	NONE	Is Beg. End Trtmt Crashworthy?:	N/A	Approach Transition Type:	NONE
Ending End Trtmt Type:	NONE	Ending End Trtmt Crashworthy?:	N/A		
Average Measurements					
Design Height (In.):	18	Width (In.):	16.0	Post Spacing (In.):	0.0
Height (In.):	3.0	Lateral Offset (In.):	54.2	Road Grade (%):	0.33
Physical Condition					
Barrier	Alignment and Height:	Alignment has no deviation and the height is 15 in below the 18-in/24-in crenellated design height for 61 ft.

Breaking and Cracking:	All crenellated severely broken and cracked.			
	Missing Elements:	No missing elements observed.			
	Corrosion and Weathering:	No corrosion or weathering observed.			
End Treatments	Alignment and Height:				
	Breaking and Cracking:				
	Missing Elements:				
	Corrosion and Weathering:

Repair Action:	REPAIR	FMSS Work Type:	DEFERRED MAINTENANCE	Repair Cost:	\$54615
Brief Workorder:	Raise guardwall 15-in. Remove and reset 61-ft of stone masonry guardwall on concrete footer to crenellated design height of 18-in/24-in.				
Workorder:	Remove & Reset Stone Masonry Guardwall at \$250- per -Cu. Ft. for 159 CF = \$39750. $[(2\text{ft})(1.3\text{ft})(61\text{ft})] = 158.6 \text{ CF}$. Structural Concrete at \$1000- per -Cu. Yd. for 4 CY = \$4000. $[(1.3\text{ft})(1.25\text{ft})(61\text{ft})] / 27 = 3.7 \text{ CY}$. Low Speed Traffic Control at \$1475- per -Day for 4 Day(s) = \$5900. 1 day removal 3 days installation.

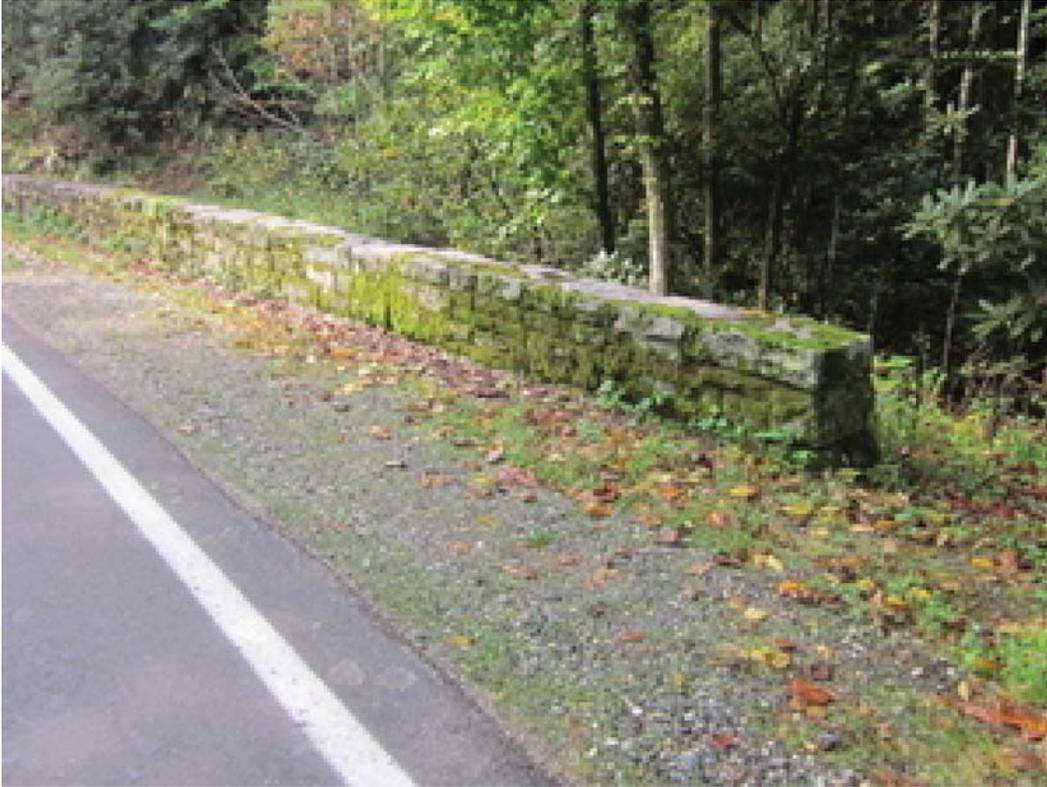
GRSM_0010S_30.126_R_1.JPG

Barrier ID:	GRSM-0010S-30.126-R				
Route Name:	NEWFOUND GAP ROAD SOUTH				
Inspection Date:	09/23/2010	Barrier Rating:	37.00		
Barrier Description					
Type:	STONE MASONRY WITHOUT CONCRETE CORE WALL	Barrier Function:	TRAFFIC		
Barrier Material:	STONE	Post Material:	N/A		
Blockout Type:	N/A	Length (ft.):	27		
Speed Limit (MPH):	35	Placement with Respect to Road:	OUTSIDE OF CURVE		
Hazard Behind Barrier:	LOW				
Barrier Crashworthiness					
Appropriate Test Level:	TL-2	Barrier Test Level:	NCW	Is Barrier Crashworthy?:	NO
Beg. End Trtmt Type:	NONE	Is Beg. End Trtmt Crashworthy?:	N/A	Approach Transition Type:	NONE
Ending End Trtmt Type:	NONE	Ending End Trtmt Crashworthy?:	N/A		
Average Measurements					
Design Height (In.):	24	Width (In.):	22.0	Post Spacing (In.):	0.0
Height (In.):	28.6	Lateral Offset (In.):	92.3	Road Grade (%):	1.70
Physical Condition					
Barrier	Alignment and Height:	Alignment has no deviation and the height is 4 to 5 in above the 24 in design height.

Breaking and Cracking:	No breaking or cracking observed.			
	Missing Elements:	No missing elements observed.			
	Corrosion and Weathering:	Moderate corrosion and weathering observed. Heavy moss build-up observed.			
End Treatments	Alignment and Height:				
	Breaking and Cracking:				
	Missing Elements:				
	Corrosion and Weathering:

Barrier ID:	GRSM-0010S-30.126-R				
Route Name:	NEWFOUND GAP ROAD SOUTH				
Inspection Date:	09/23/2010	Barrier Rating:		37.00	
Repair Recommendations					
Repair Action:	NO ACTION	FMSS Work Type:	N/A	Repair Cost:	\$0
Brief Workorder:	N/A				
Workorder:

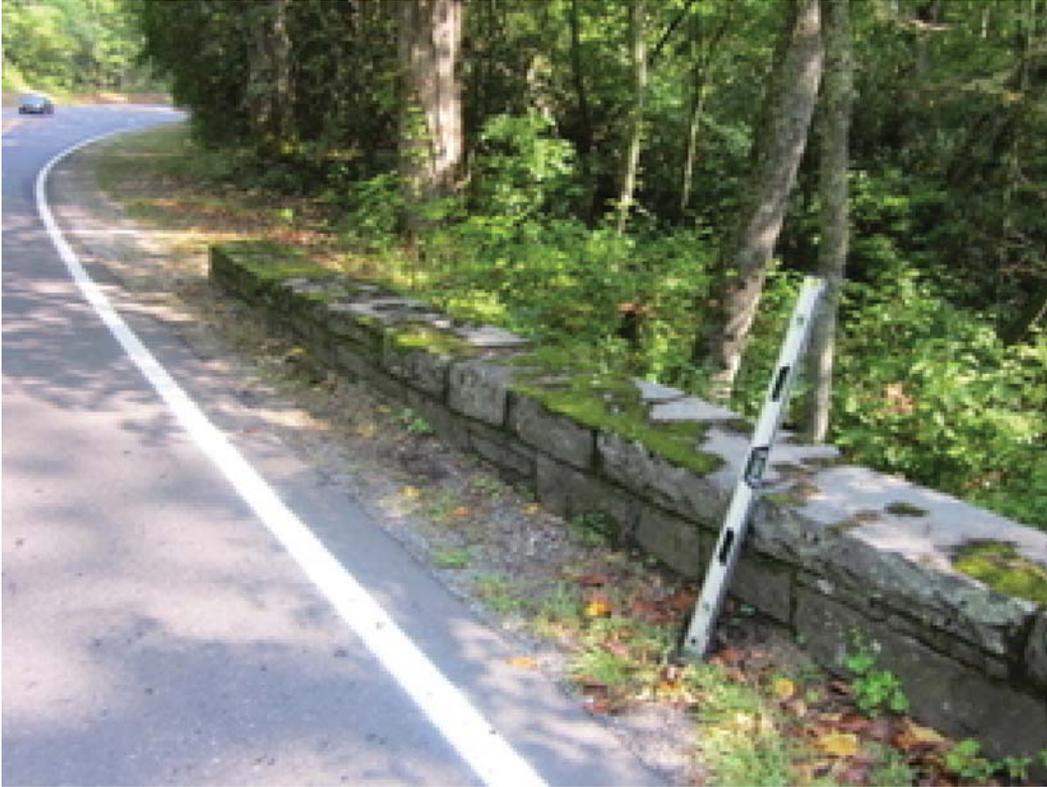
GRSM_0010S_30.131_L_1.JPG

Barrier ID:	GRSM-0010S-30.131-L				
Route Name:	NEWFOUND GAP ROAD SOUTH				
Inspection Date:	09/23/2010	Barrier Rating:	49.50		
Barrier Description					
Type:	STONE MASONRY WITHOUT CONCRETE CORE WALL	Barrier Function:	TRAFFIC		
Barrier Material:	STONE	Post Material:	N/A		
Blockout Type:	N/A	Length (ft.):	22		
Speed Limit (MPH):	35	Placement with Respect to Road:	INSIDE OF CURVE		
Hazard Behind Barrier:	MEDIUM				
Barrier Crashworthiness					
Appropriate Test Level:	TL-2	Barrier Test Level:	NCW	Is Barrier Crashworthy?:	NO
Beg. End Trtmt Type:	NONE	Is Beg. End Trtmt Crashworthy?:	N/A	Approach Transition Type:	NONE
Ending End Trtmt Type:	NONE	Ending End Trtmt Crashworthy?:	N/A		
Average Measurements					
Design Height (In.):	24	Width (In.):	22.0	Post Spacing (In.):	0.0
Height (In.):	19.2	Lateral Offset (In.):	36.2	Road Grade (%):	1.60
Physical Condition					
Barrier	Alignment and Height:	Alignment has no deviation and the height ranges from 3-8 in below the 24 in design height with 10 ft being 6-8 in below.

Breaking and Cracking:	No breaking or cracking observed.			
	Missing Elements:	No missing elements observed.			
	Corrosion and Weathering:	No corrosion or weathering observed.			
End Treatments	Alignment and Height:				
	Breaking and Cracking:				
	Missing Elements:				
	Corrosion and Weathering:

Repair Action:	REPAIR	FMSS Work Type:	DEFERRED MAINTENANCE	Repair Cost:	\$14245
Brief Workorder:	Raise guardwall 2-in. Remove and reset 10-ft of stone masonry guardwall on concrete footer to adjacent 18-in height.				
Workorder:	Remove & Reset Stone Masonry Guardwall at \$250- per -Cu. Ft. for 36 CF = \$9000. [(2ft)(1.8ft)(10ft)] = 36 CF. Structural Concrete at \$1000- per -Cu. Yd. for 1 CY = \$1000. [(1.8ft)(0.5ft)(10ft)] /27 = 1 CY. Low Speed Traffic Control at \$1475- per -Day for 2 Day(s) = \$2950. 1 day removal 1 day installation.

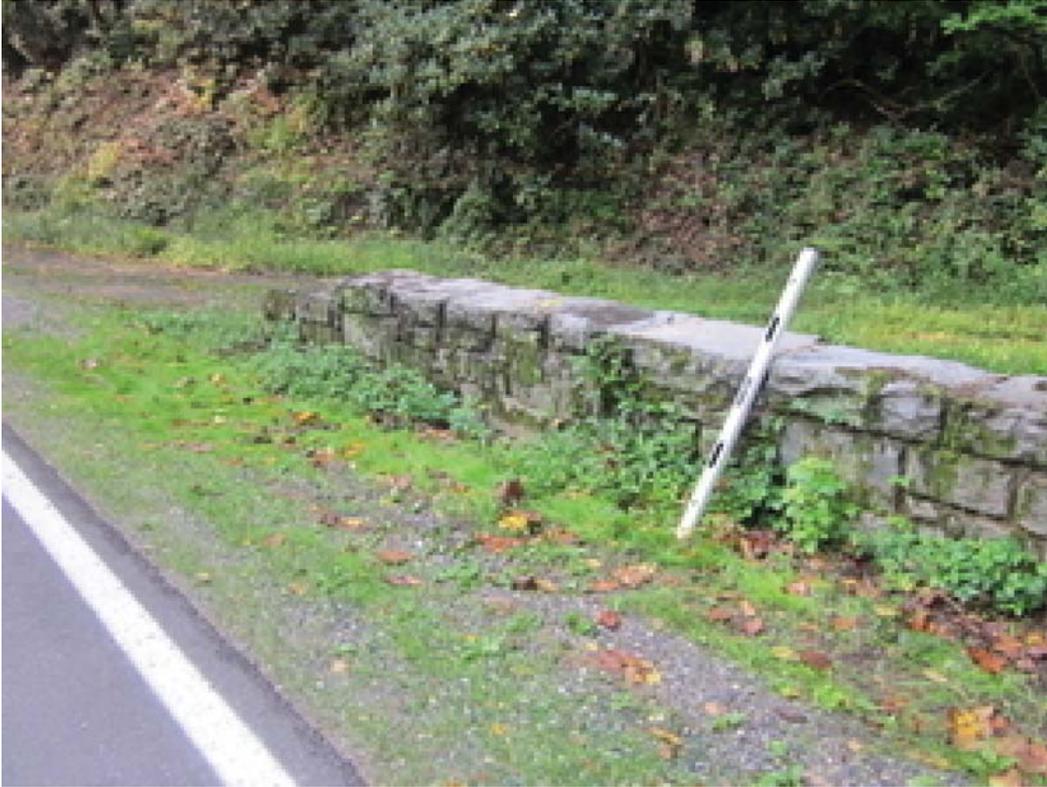
GRSM_0010S_30.138_R_1.JPG

Barrier ID:	GRSM-0010S-30.138-R				
Route Name:	NEWFOUND GAP ROAD SOUTH				
Inspection Date:	09/23/2010	Barrier Rating:	29.80		
Barrier Description					
Type:	STONE MASONRY WITHOUT CONCRETE CORE WALL	Barrier Function:	TRAFFIC		
Barrier Material:	STONE	Post Material:	N/A		
Blockout Type:	N/A	Length (ft.):	16		
Speed Limit (MPH):	35	Placement with Respect to Road:	OUTSIDE OF CURVE		
Hazard Behind Barrier:	LOW				
Barrier Crashworthiness					
Appropriate Test Level:	TL-2	Barrier Test Level:	NCW	Is Barrier Crashworthy?:	NO
Beg. End Trtmt Type:	NONE	Is Beg. End Trtmt Crashworthy?:	N/A	Approach Transition Type:	NONE
Ending End Trtmt Type:	NONE	Ending End Trtmt Crashworthy?:	N/A		
Average Measurements					
Design Height (In.):	24	Width (In.):	22.2	Post Spacing (In.):	0.0
Height (In.):	26.2	Lateral Offset (In.):	83.0	Road Grade (%):	1.70
Physical Condition					
Barrier	Alignment and Height:	Alignment has no deviation and the height is 0-4 in above the 24 in design height.

Breaking and Cracking:	No breaking observed. Some cracking of less than a quarter of an in observed.			
	Missing Elements:	1 missing stone at the end observed. Missing stone is 48 in long.			
	Corrosion and Weathering:	Moderate corrosion and weathering observed. Heavy moss build-up observed.			
End Treatments	Alignment and Height:				
	Breaking and Cracking:				
	Missing Elements:				
	Corrosion and Weathering:

Repair Action:	REPAIR	FMSS Work Type:	DEFERRED MAINTENANCE	Repair Cost:	\$1898
Brief Workorder:	Replace a 48 inch stone at the beginning end of bridge.				
Workorder:	New Stone at \$250- per -Each for 1 Unit(s) = \$250. Replace a 48 inch stone at the beginning end of the bridge. Low Speed Traffic Control at \$1475- per -Day for 1 Day(s) = \$1475.

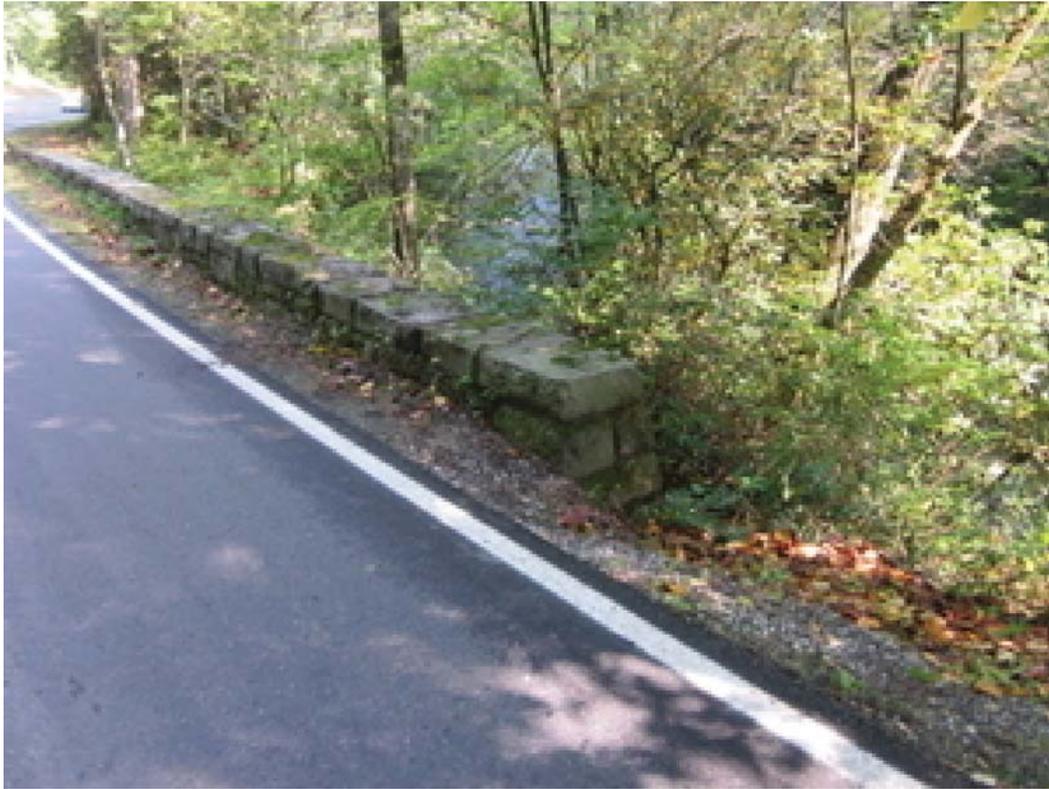
GRSM_0010S_30.145_L_1.JPG

Barrier ID:	GRSM-0010S-30.145-L				
Route Name:	NEWFOUND GAP ROAD SOUTH				
Inspection Date:	09/23/2010	Barrier Rating:	42.50		
Barrier Description					
Type:	STONE MASONRY WITHOUT CONCRETE CORE WALL	Barrier Function:	TRAFFIC		
Barrier Material:	STONE	Post Material:	N/A		
Blockout Type:	N/A	Length (ft.):	21		
Speed Limit (MPH):	35	Placement with Respect to Road:	INSIDE OF CURVE		
Hazard Behind Barrier:	MEDIUM				
Barrier Crashworthiness					
Appropriate Test Level:	TL-2	Barrier Test Level:	NCW	Is Barrier Crashworthy?:	NO
Beg. End Trtmt Type:	NONE	Is Beg. End Trtmt Crashworthy?:	N/A	Approach Transition Type:	NONE
Ending End Trtmt Type:	NONE	Ending End Trtmt Crashworthy?:	N/A		
Average Measurements					
Design Height (In.):	24	Width (In.):	22.0	Post Spacing (In.):	0.0
Height (In.):	19.2	Lateral Offset (In.):	25.7	Road Grade (%):	2.00
Physical Condition					
Barrier	Alignment and Height:	Alignment has no deviation and the height is 3 to 6 in below the 24 in design height for 5 ft and 6 to 8 in below for 8 ft.

Breaking and Cracking:	No breaking or cracking observed.			
	Missing Elements:	No missing elements observed.			
	Corrosion and Weathering:	No corrosion or weathering observed.			
End Treatments	Alignment and Height:				
	Breaking and Cracking:				
	Missing Elements:				
	Corrosion and Weathering:

Repair Action:	REPAIR	FMSS Work Type:	DEFERRED MAINTENANCE	Repair Cost:	\$6545
Brief Workorder:	Raise guardwall 2-in. Remove and reset 8-ft of stone masonry guardwall on 1 row of new stone to raise barrier to the adjacent 18-in height.				
Workorder:	Remove & Reset Stone Masonry Guardwall at \$250- per -Cu. Ft. for 8 CF = \$2000. $[(0.5ft)(1.8ft)(8ft)] = 7.2 CF$. Remove top layer of stones in barrier for 8 feet. New Stone at \$250- per -Each for 4 Unit(s) = \$1000. $[(8ft) / (2ft/stone)] \times 1 \text{ row} = 4 \text{ stones}$. Insert new stone on retaining wall to increase barrier height then reset top layer of barrier. Low Speed Traffic Control at \$1475- per -Day for 2 Day(s) = \$2950. 1 day removal 1 day installation.

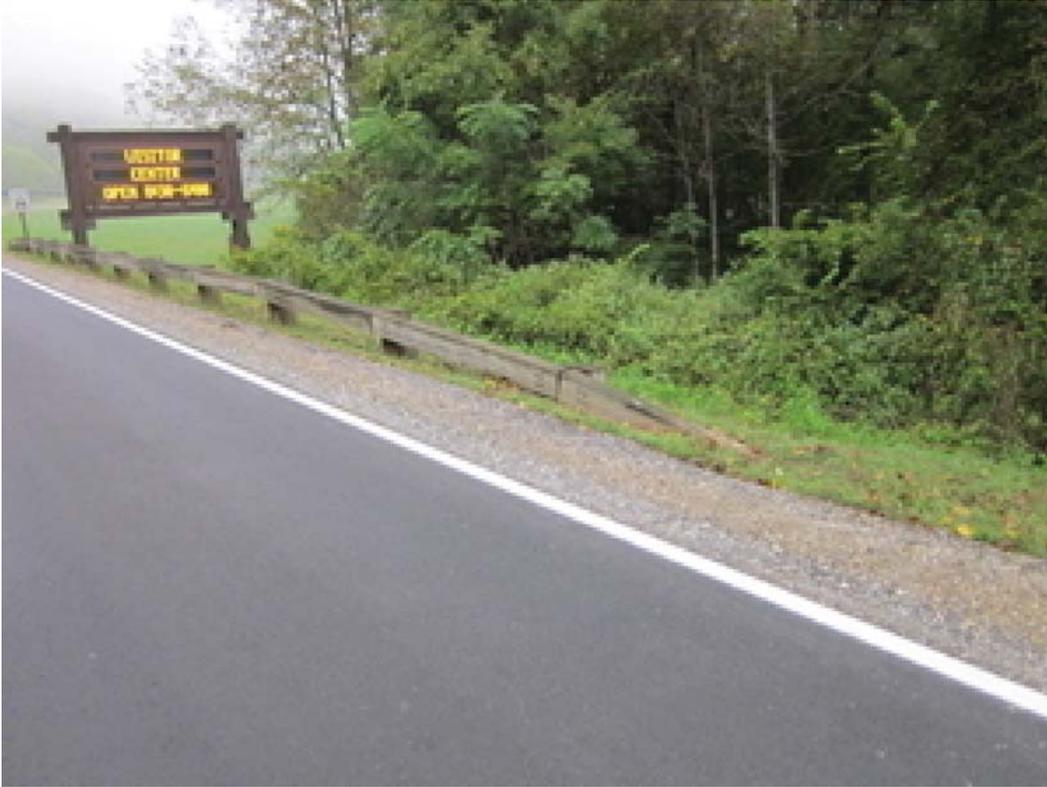
GRSM_0010S_31.229_L_1.JPG

Barrier ID:	GRSM-0010S-31.229-L				
Route Name:	NEWFOUND GAP ROAD SOUTH				
Inspection Date:	09/23/2010	Barrier Rating:	27.10		
Barrier Description					
Type:	STEEL-BACKED TIMBER WITHOUT BLOCKOUT	Barrier Function:	TRAFFIC		
Barrier Material:	STEEL-BACKED TIMBER/LOG	Post Material:	WOOD		
Blockout Type:	N/A	Length (ft.):	132		
Speed Limit (MPH):	35	Placement with Respect to Road:	TANGENT		
Hazard Behind Barrier:	LOW				
Barrier Crashworthiness					
Appropriate Test Level:	TL-2	Barrier Test Level:	TL-2	Is Barrier Crashworthy?:	YES
Beg. End Trtmt Type:	SBT/LOG FLARED	Is Beg. End Trtmt Crashworthy?:	NO	Approach Transition Type:	NONE
Ending End Trtmt Type:	SBT/LOG FLARED	Ending End Trtmt Crashworthy?:	NO		
Average Measurements					
Design Height (In.):	27	Width (In.):	0.0	Post Spacing (In.):	120.0
Height (In.):	24.7	Lateral Offset (In.):	56.2	Road Grade (%):	0.90
Physical Condition					
Barrier	Alignment and Height:	Alignment has no deviation and the height is 2 to 3 in below the 27 in design height for 50 ft.

Breaking and Cracking:	No breaking or cracking observed.			
	Missing Elements:	No missing elements observed.			
	Corrosion and Weathering:	No corrosion or weathering observed.			
End Treatments	Alignment and Height:	Alignment acceptable. Height is within 1 in of the 27-in design height.			
	Breaking and Cracking:	No breaking or cracking observed.			
	Missing Elements:	No missing elements observed.			
	Corrosion and Weathering:	No corrosion or weathering observed.

Repair Action:	REPAIR	FMSS Work Type:	DEFERRED MAINTENANCE	Repair Cost:	\$2173
Brief Workorder:	Raise 50 feet of guardrail up to the 27 inch design height.				
Workorder:	Adjust Guardrail at \$10- per -Lin. Ft. for 50 LF = \$500. Raise 50-ft of barrier up to 27-in design height. Low Speed Traffic Control at \$1475- per -Day for 1 Day(s) = \$1475.

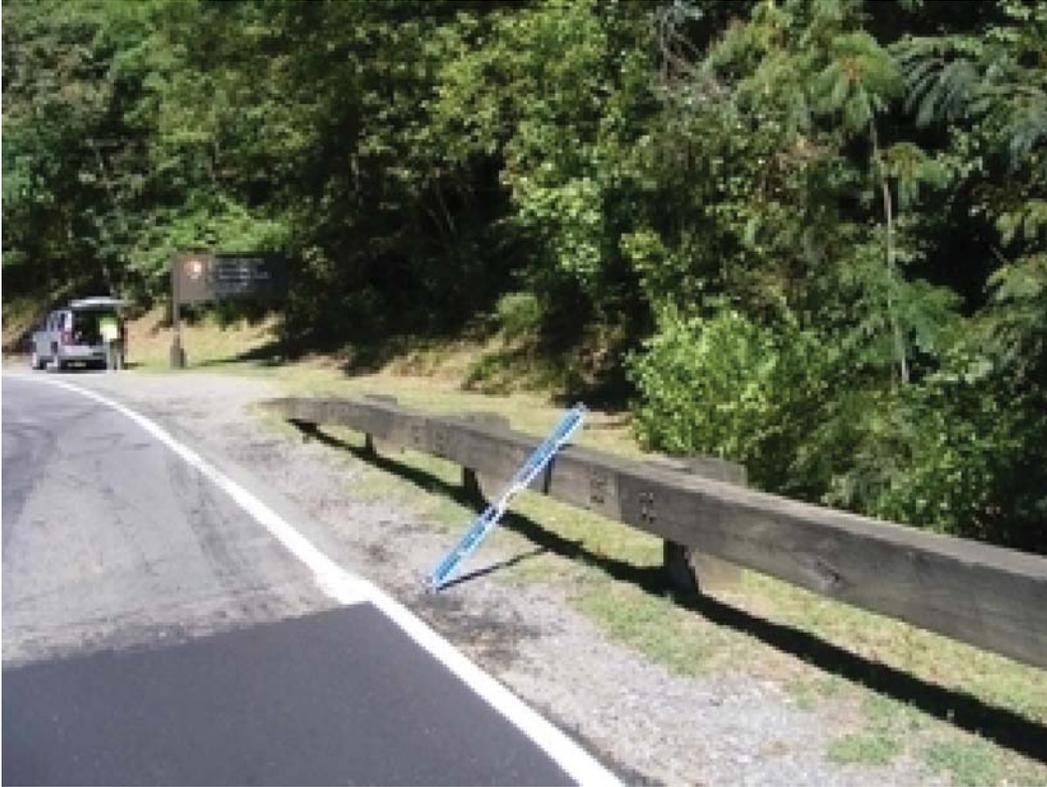
GRSM_0011N_0.002_R_1.JPG

Barrier ID:	GRSM-0011N-0.002-R				
Route Name:	GATLINBURG SPUR ROAD (NORTHBOUND)				
Inspection Date:	09/13/2010	Barrier Rating:	45.00		
Barrier Description					
Type:	STEEL-BACKED TIMBER WITH BLOCKOUT	Barrier Function:	TRAFFIC		
Barrier Material:	STEEL-BACKED TIMBER/LOG	Post Material:	WOOD		
Blockout Type:	WOOD	Length (ft.):	43		
Speed Limit (MPH):	25	Placement with Respect to Road:	OUTSIDE OF CURVE		
Hazard Behind Barrier:	MEDIUM				
Barrier Crashworthiness					
Appropriate Test Level:	TL-1	Barrier Test Level:	TL-3	Is Barrier Crashworthy?:	YES
Beg. End Trtmt Type:	NONE	Is Beg. End Trtmt Crashworthy?:	N/A	Approach Transition Type:	NONE
Ending End Trtmt Type:	SBT/LOG FLARED	Ending End Trtmt Crashworthy?:	NO		
Average Measurements					
Design Height (In.):	27	Width (In.):	0.0	Post Spacing (In.):	120.3
Height (In.):	27.0	Lateral Offset (In.):	41.5	Road Grade (%):	4.20
Physical Condition					
Barrier	Alignment and Height:	The alignment has no deviation and the height is at the 27 in design height.

Breaking and Cracking:	No breaking observed.			
	Missing Elements:	No missing elements observed.			
	Corrosion and Weathering:	No corrosion or weathering observed.			
End Treatments	Alignment and Height:	Alignment acceptable. Height is within 1 in of the 27-in design height.			
	Breaking and Cracking:	No breaking or cracking observed.			
	Missing Elements:	No missing elements observed.			
	Corrosion and Weathering:	No corrosion or weathering observed.

Barrier ID:	GRSM-0011N-0.002-R				
Route Name:	GATLINBURG SPUR ROAD (NORTHBOUND)				
Inspection Date:	09/13/2010	Barrier Rating:		45.00	
Repair Recommendations					
Repair Action:	NO ACTION	FMSS Work Type:	N/A	Repair Cost:	\$0
Brief Workorder:	N/A				
Workorder:
