NPS Guardwall/Rail Inventory Program
Great Smoky Mountains National Park

Federal Highway Administration
Eastern Federal Lands Highway Division
Road Inventory Program (RIP)

Data Collection Date: September 2010
Report Date: December 2015

Great Smoky Mountains National Park in North Carolina and Tennessee

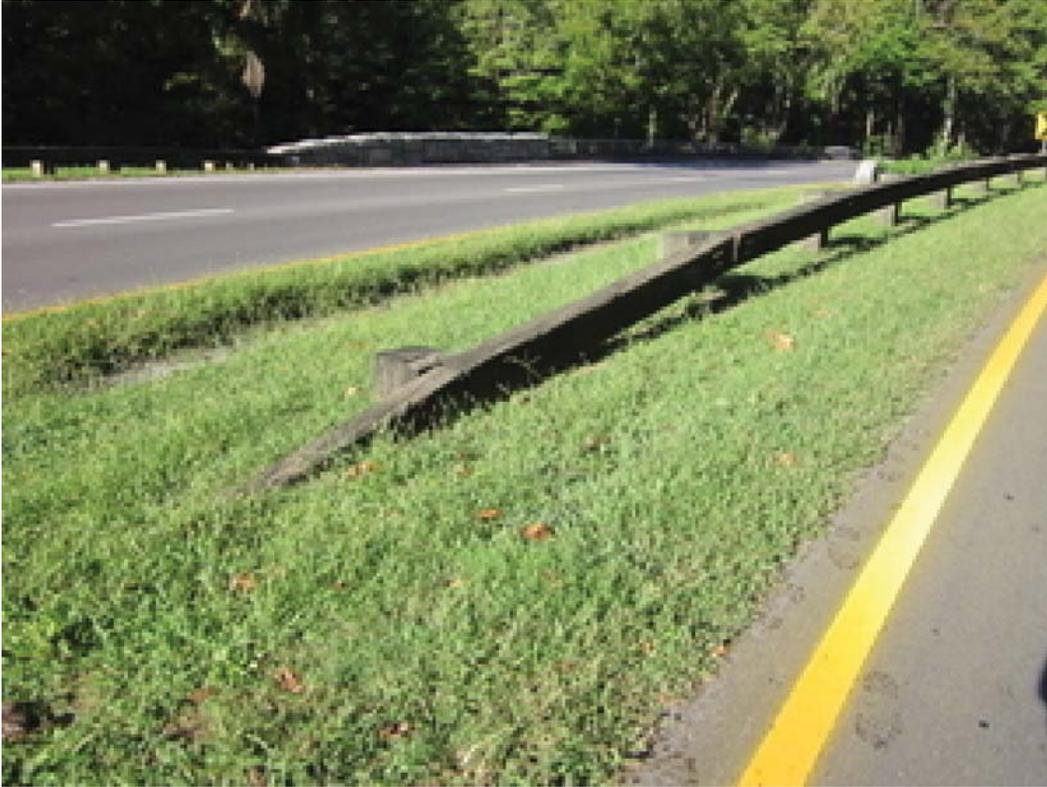
GRSM_0011N_0.240_L_1.JPG

Barrier ID:	GRSM-0011N-0.240-L				
Route Name:	GATLINBURG SPUR ROAD (NORTHBOUND)				
Inspection Date:	09/13/2010	Barrier Rating:	42.50		
Barrier Description					
Type:	STEEL-BACKED TIMBER WITH BLOCKOUT	Barrier Function:	TRAFFIC		
Barrier Material:	STEEL-BACKED TIMBER/LOG	Post Material:	WOOD		
Blockout Type:	WOOD	Length (ft.):	524		
Speed Limit (MPH):	35	Placement with Respect to Road:	OUTSIDE OF CURVE		
Hazard Behind Barrier:	LOW				
Barrier Crashworthiness					
Appropriate Test Level:	TL-2	Barrier Test Level:	TL-3	Is Barrier Crashworthy?:	YES
Beg. End Trtmt Type:	SBT/LOG FLARED	Is Beg. End Trtmt Crashworthy?:	NO	Approach Transition Type:	NONE
Ending End Trtmt Type:	SBT/LOG FLARED	Ending End Trtmt Crashworthy?:	NO		
Average Measurements					
Design Height (In.):	27	Width (In.):	0.0	Post Spacing (In.):	120.0
Height (In.):	26.2	Lateral Offset (In.):	53.2	Road Grade (%):	1.20
Physical Condition					
Barrier	Alignment and Height:	The alignment has no deviation and the height is 1-3 in below the design height of 27 in for 80 ft.

Breaking and Cracking:	No breaking or cracking observed.			
	Missing Elements:	No missing elements observed.			
	Corrosion and Weathering:	No corrosion or weathering observed			
End Treatments	Alignment and Height:	Alignment acceptable. Height is within 1 in of the 27-in design height.			
	Breaking and Cracking:	No breaking or cracking observed.			
	Missing Elements:	No missing elements observed.			
	Corrosion and Weathering:	No corrosion or weathering observed

Repair Action:	REPAIR	FMSS Work Type:	DEFERRED MAINTENANCE	Repair Cost:	\$2503
Brief Workorder:	Raise 80 feet of guardrail up to the 27 inch design height.				
Workorder:	Adjust Guardrail at \$10- per -Lin. Ft. for 80 LF = \$800. Raise 80-ft of barrier up to 27-in design height. Low Speed Traffic Control at \$1475- per -Day for 1 Day(s) = \$1475.

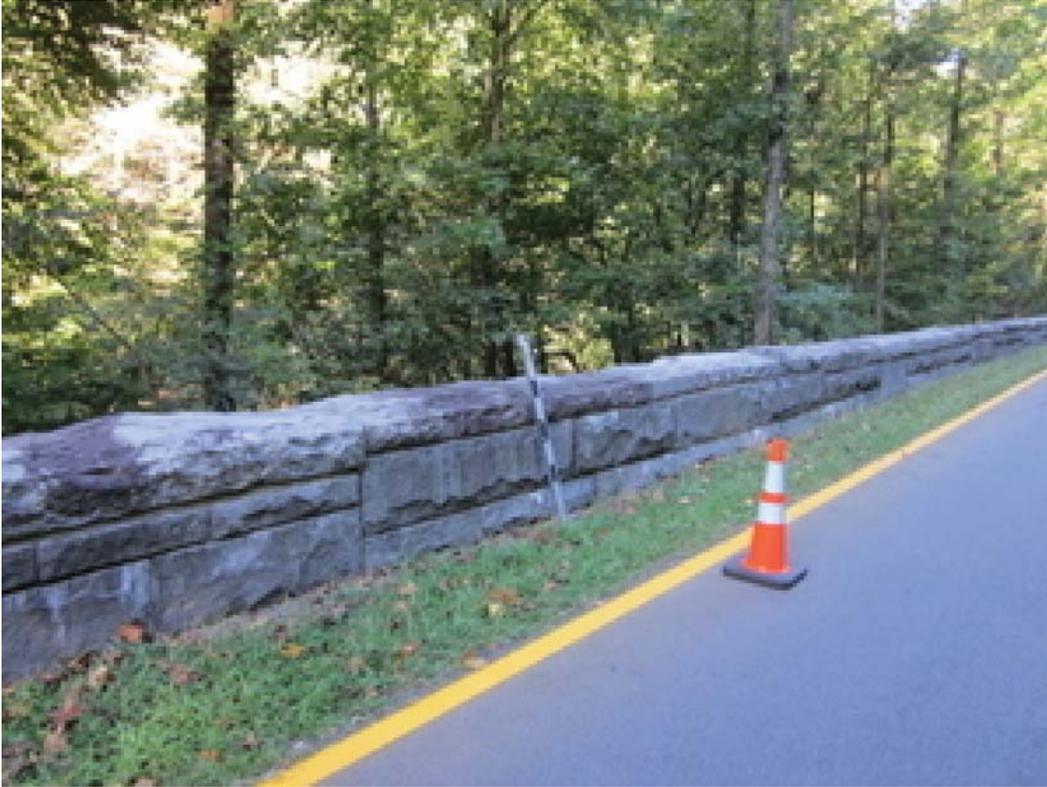
GRSM_0011N_0.402_L_1.JPG

Barrier ID:	GRSM-0011N-0.402-L				
Route Name:	GATLINBURG SPUR ROAD (NORTHBOUND)				
Inspection Date:	09/13/2010	Barrier Rating:	52.20		
Barrier Description					
Type:	STONE MASONRY WITH CONCRETE CORE WALL	Barrier Function:	TRAFFIC		
Barrier Material:	CONCRETE	Post Material:	N/A		
Blockout Type:	N/A	Length (ft.):	651		
Speed Limit (MPH):	35	Placement with Respect to Road:	OUTSIDE OF CURVE		
Hazard Behind Barrier:	MEDIUM				
Barrier Crashworthiness					
Appropriate Test Level:	TL-2	Barrier Test Level:	TL-3	Is Barrier Crashworthy?:	YES
Beg. End Trtmt Type:	NONE	Is Beg. End Trtmt Crashworthy?:	N/A	Approach Transition Type:	NONE
Ending End Trtmt Type:	NONE	Ending End Trtmt Crashworthy?:	N/A		
Average Measurements					
Design Height (In.):	27	Width (In.):	24.2	Post Spacing (In.):	0.0
Height (In.):	29.7	Lateral Offset (In.):	38.2	Road Grade (%):	3.00
Physical Condition					
Barrier	Alignment and Height:	The alignment has no deviation and the height is 0-4 in from the 27 in design height.

Breaking and Cracking:	No breaking or cracking observed.			
	Missing Elements:	No missing elements observed.			
	Corrosion and Weathering:	No corrosion or weathering observed.			
End Treatments	Alignment and Height:				
	Breaking and Cracking:				
	Missing Elements:				
	Corrosion and Weathering:

Repair Action:	NO ACTION	FMSS Work Type:	N/A	Repair Cost:	\$0
Brief Workorder:	N/A				
Workorder:

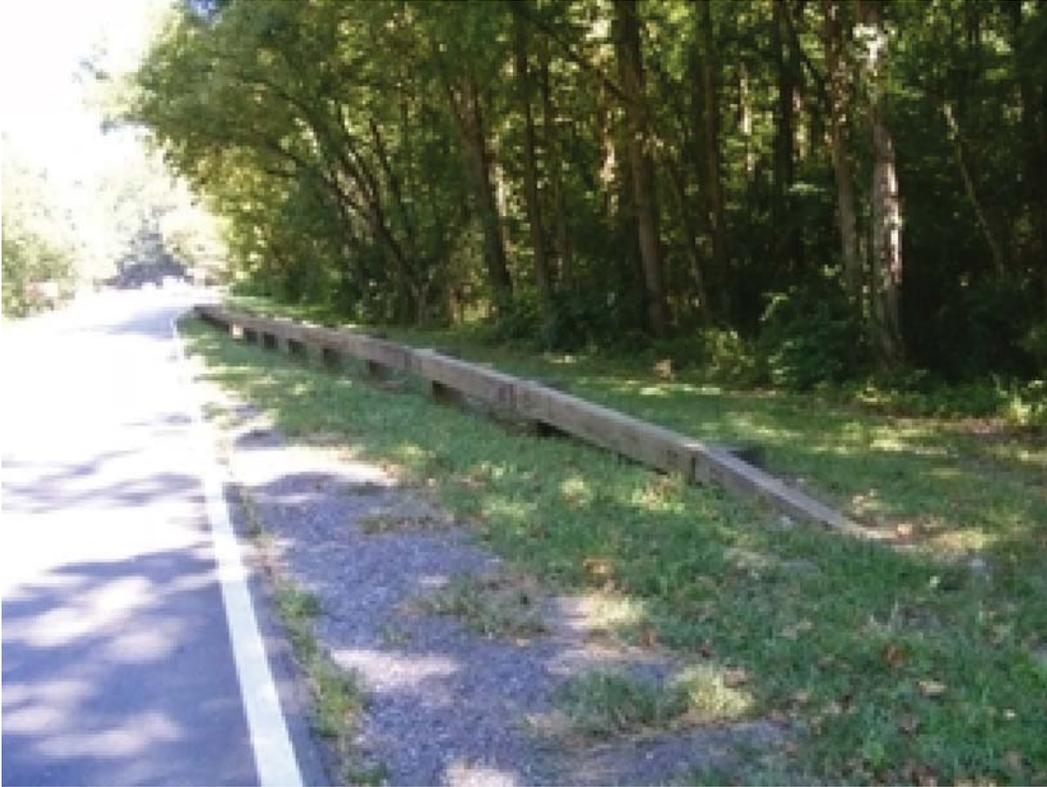
GRSM_0011N_0.723_R_1.JPG

Barrier ID:	GRSM-0011N-0.723-R				
Route Name:	GATLINBURG SPUR ROAD (NORTHBOUND)				
Inspection Date:	09/13/2010	Barrier Rating:	40.70		
Barrier Description					
Type:	STEEL-BACKED TIMBER WITH BLOCKOUT	Barrier Function:	TRAFFIC		
Barrier Material:	STEEL-BACKED TIMBER/LOG	Post Material:	WOOD		
Blockout Type:	WOOD	Length (ft.):	175		
Speed Limit (MPH):	45	Placement with Respect to Road:	TANGENT		
Hazard Behind Barrier:	MEDIUM				
Barrier Crashworthiness					
Appropriate Test Level:	TL-2	Barrier Test Level:	TL-3	Is Barrier Crashworthy?:	YES
Beg. End Trtmt Type:	SBT/LOG FLARED	Is Beg. End Trtmt Crashworthy?:	NO	Approach Transition Type:	NONE
Ending End Trtmt Type:	SBT/LOG FLARED	Ending End Trtmt Crashworthy?:	NO		
Average Measurements					
Design Height (In.):	27	Width (In.):	0.0	Post Spacing (In.):	120.0
Height (In.):	28.2	Lateral Offset (In.):	43.0	Road Grade (%):	1.10
Physical Condition					
Barrier	Alignment and Height:	The barrier alignment has no deviation and the height is at or above the design height of 27 in by up to 3 in.

Breaking and Cracking:	No breaking or cracking observed.			
	Missing Elements:	No missing elements observed.			
	Corrosion and Weathering:	No corrosion or weathering observed.			
End Treatments	Alignment and Height:	Alignment acceptable. Height is within 1 in of the 27-in design height.			
	Breaking and Cracking:	No breaking or cracking observed.			
	Missing Elements:	No missing elements observed.			
	Corrosion and Weathering:	No corrosion or weathering observed.

Repair Action:	NO ACTION	FMSS Work Type:	N/A	Repair Cost:	\$0
Brief Workorder:	N/A				
Workorder:

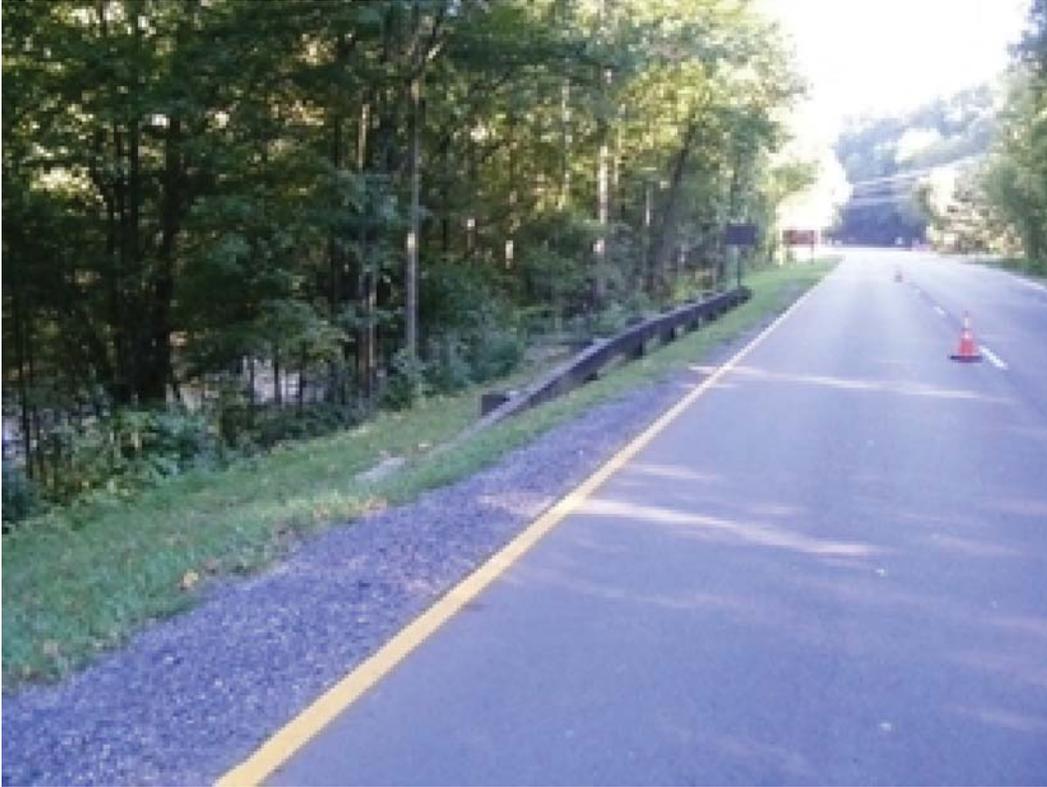
GRSM_0011N_0.738_L_1.JPG

Barrier ID:	GRSM-0011N-0.738-L				
Route Name:	GATLINBURG SPUR ROAD (NORTHBOUND)				
Inspection Date:	09/13/2010	Barrier Rating:	55.20		
Barrier Description					
Type:	STEEL-BACKED TIMBER WITH BLOCKOUT	Barrier Function:	TRAFFIC		
Barrier Material:	STEEL-BACKED TIMBER/LOG	Post Material:	WOOD		
Blockout Type:	WOOD	Length (ft.):	98		
Speed Limit (MPH):	45	Placement with Respect to Road:	TANGENT		
Hazard Behind Barrier:	MEDIUM				
Barrier Crashworthiness					
Appropriate Test Level:	TL-2	Barrier Test Level:	TL-3	Is Barrier Crashworthy?:	YES
Beg. End Trtmt Type:	SBT/LOG FLARED	Is Beg. End Trtmt Crashworthy?:	NO	Approach Transition Type:	NONE
Ending End Trtmt Type:	SBT/LOG FLARED	Ending End Trtmt Crashworthy?:	NO		
Average Measurements					
Design Height (In.):	27	Width (In.):	0.0	Post Spacing (In.):	120.0
Height (In.):	21.0	Lateral Offset (In.):	53.2	Road Grade (%):	0.70
Physical Condition					
Barrier	Alignment and Height:	The alignment has no deviation and the height is 3 to 6 in below the 27 in design height for 98 ft.

Breaking and Cracking:	No breaking or cracking observed.			
	Missing Elements:	No missing elements observed.			
	Corrosion and Weathering:	No corrosion or weathering observed.			
End Treatments	Alignment and Height:	Alignment acceptable. Height is within 1 in of the 27-in design height.			
	Breaking and Cracking:	No breaking or cracking observed.			
	Missing Elements:	No missing elements observed.			
	Corrosion and Weathering:	No corrosion or weathering observed.

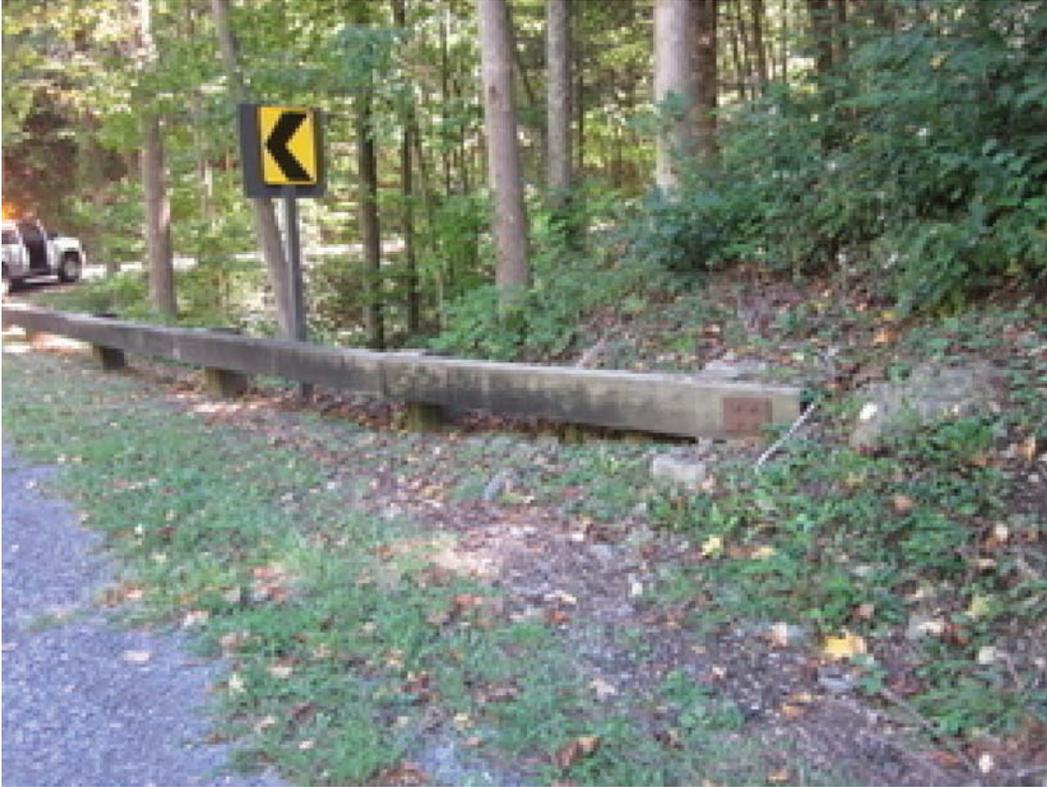
GRSM_0011N_1.505_R_1.JPG

Barrier ID:	GRSM-0011N-1.505-R				
Route Name:	GATLINBURG SPUR ROAD (NORTHBOUND)				
Inspection Date:	09/13/2010	Barrier Rating:	39.70		
Barrier Description					
Type:	STEEL-BACKED TIMBER WITHOUT BLOCKOUT	Barrier Function:	TRAFFIC		
Barrier Material:	STEEL-BACKED TIMBER/LOG	Post Material:	WOOD		
Blockout Type:	N/A	Length (ft.):	68		
Speed Limit (MPH):	35	Placement with Respect to Road:	OUTSIDE OF CURVE		
Hazard Behind Barrier:	LOW				
Barrier Crashworthiness					
Appropriate Test Level:	TL-2	Barrier Test Level:	TL-2	Is Barrier Crashworthy?:	YES
Beg. End Trtmt Type:	SBT/LOG BURIED	Is Beg. End Trtmt Crashworthy?:	YES	Approach Transition Type:	NONE
Ending End Trtmt Type:	SBT/LOG FLARED	Ending End Trtmt Crashworthy?:	NO		
Average Measurements					
Design Height (In.):	27	Width (In.):	0.0	Post Spacing (In.):	120.0
Height (In.):	26.0	Lateral Offset (In.):	115.0	Road Grade (%):	0.80
Physical Condition					
Barrier	Alignment and Height:	The alignment has no deviation and the height is 1 in below the 27 in design height.

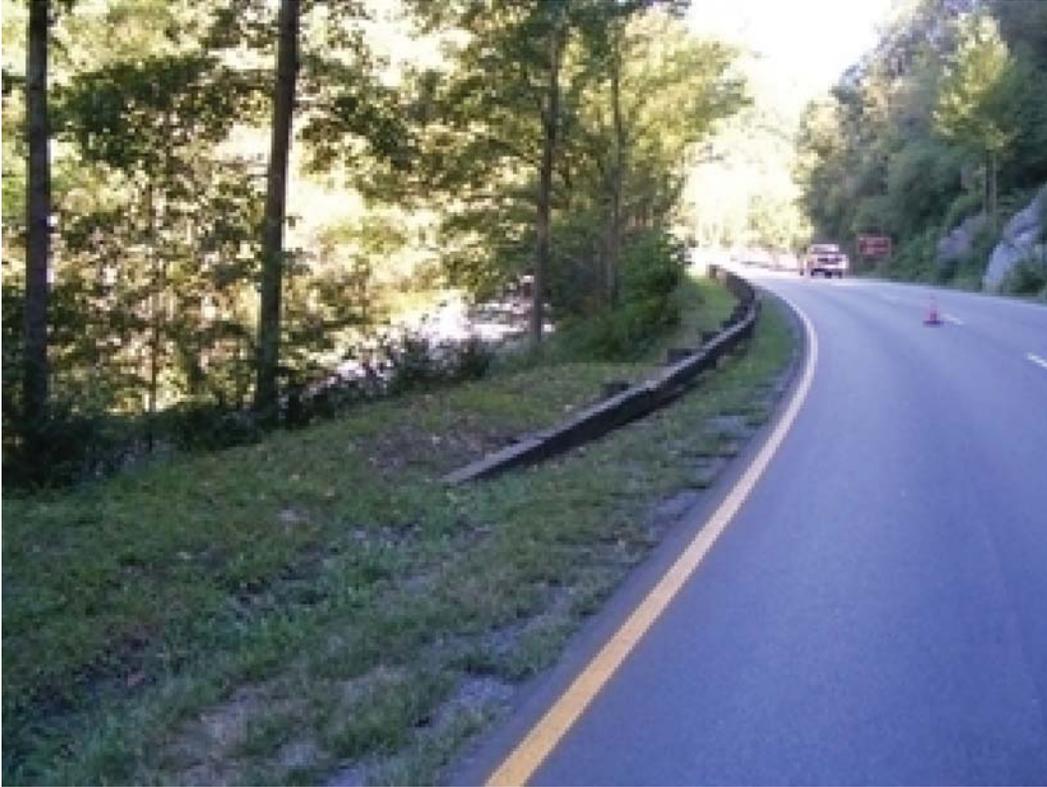
GRSM_0011N_2.138_L_1.JPG

Barrier ID:	GRSM-0011N-2.138-L				
Route Name:	GATLINBURG SPUR ROAD (NORTHBOUND)				
Inspection Date:	09/13/2010	Barrier Rating:	64.10		
Barrier Description					
Type:	STEEL-BACKED TIMBER WITH BLOCKOUT	Barrier Function:	TRAFFIC		
Barrier Material:	STEEL-BACKED TIMBER/LOG	Post Material:	WOOD		
Blockout Type:	WOOD	Length (ft.):	692		
Speed Limit (MPH):	45	Placement with Respect to Road:	BOTH INSIDE AND OUTSIDE		
Hazard Behind Barrier:	HIGH				
Barrier Crashworthiness					
Appropriate Test Level:	TL-2	Barrier Test Level:	TL-3	Is Barrier Crashworthy?:	YES
Beg. End Trtmt Type:	SBT/LOG FLARED	Is Beg. End Trtmt Crashworthy?:	NO	Approach Transition Type:	NONE
Ending End Trtmt Type:	SBT/LOG FLARED	Ending End Trtmt Crashworthy?:	NO		
Average Measurements					
Design Height (In.):	27	Width (In.):	0.0	Post Spacing (In.):	120.3
Height (In.):	24.2	Lateral Offset (In.):	52.0	Road Grade (%):	0.00
Physical Condition

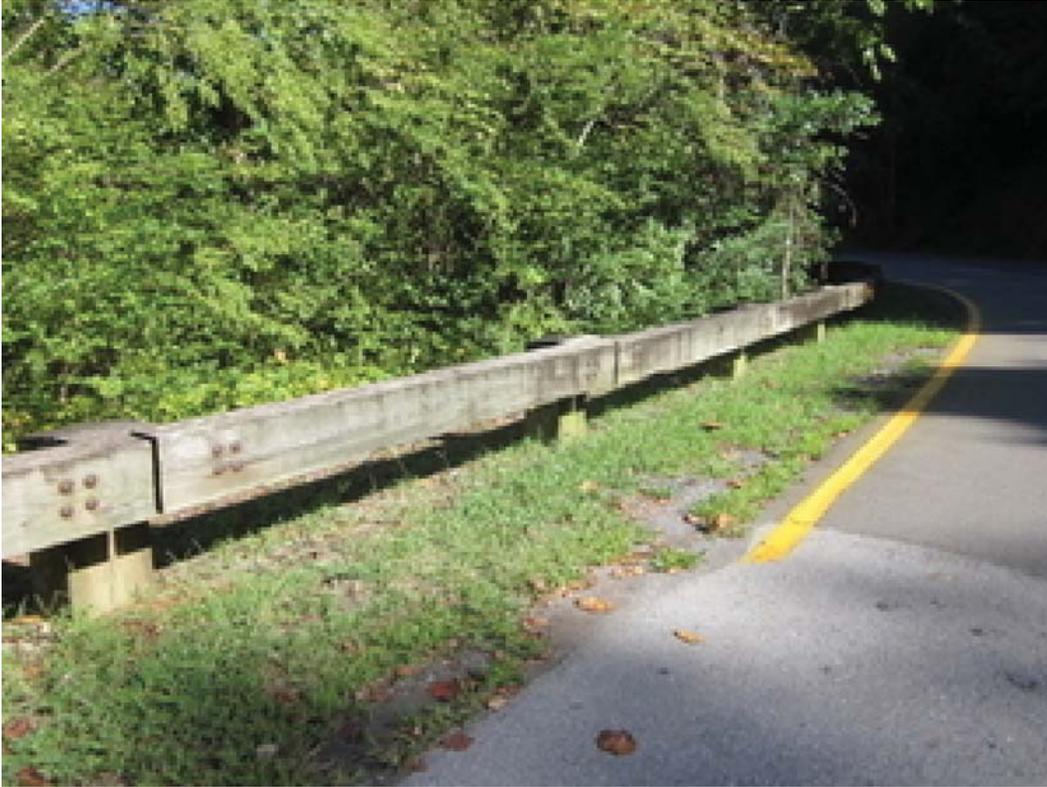
GRSM_0011N_2.294_L_1.JPG

Barrier ID:	GRSM-0011N-2.294-L				
Route Name:	GATLINBURG SPUR ROAD (NORTHBOUND)				
Inspection Date:	09/13/2010	Barrier Rating:	46.90		
Barrier Description					
Type:	STEEL-BACKED TIMBER WITH BLOCKOUT	Barrier Function:	TRAFFIC		
Barrier Material:	STEEL-BACKED TIMBER/LOG	Post Material:	WOOD		
Blockout Type:	WOOD	Length (ft.):	284		
Speed Limit (MPH):	45	Placement with Respect to Road:	OUTSIDE OF CURVE		
Hazard Behind Barrier:	LOW				
Barrier Crashworthiness					
Appropriate Test Level:	TL-2	Barrier Test Level:	TL-3	Is Barrier Crashworthy?:	YES
Beg. End Trtmt Type:	NONE	Is Beg. End Trtmt Crashworthy?:	N/A	Approach Transition Type:	NONE
Ending End Trtmt Type:	NONE	Ending End Trtmt Crashworthy?:	N/A		
Average Measurements					
Design Height (In.):	27	Width (In.):	0.0	Post Spacing (In.):	120.6
Height (In.):	28.2	Lateral Offset (In.):	51.5	Road Grade (%):	1.00
Physical Condition					
Barrier	Alignment and Height:	The alignment has no deviation and the height is 1-3 in below the 27 in design height for 30 ft and 0-3 in above for 254 ft.

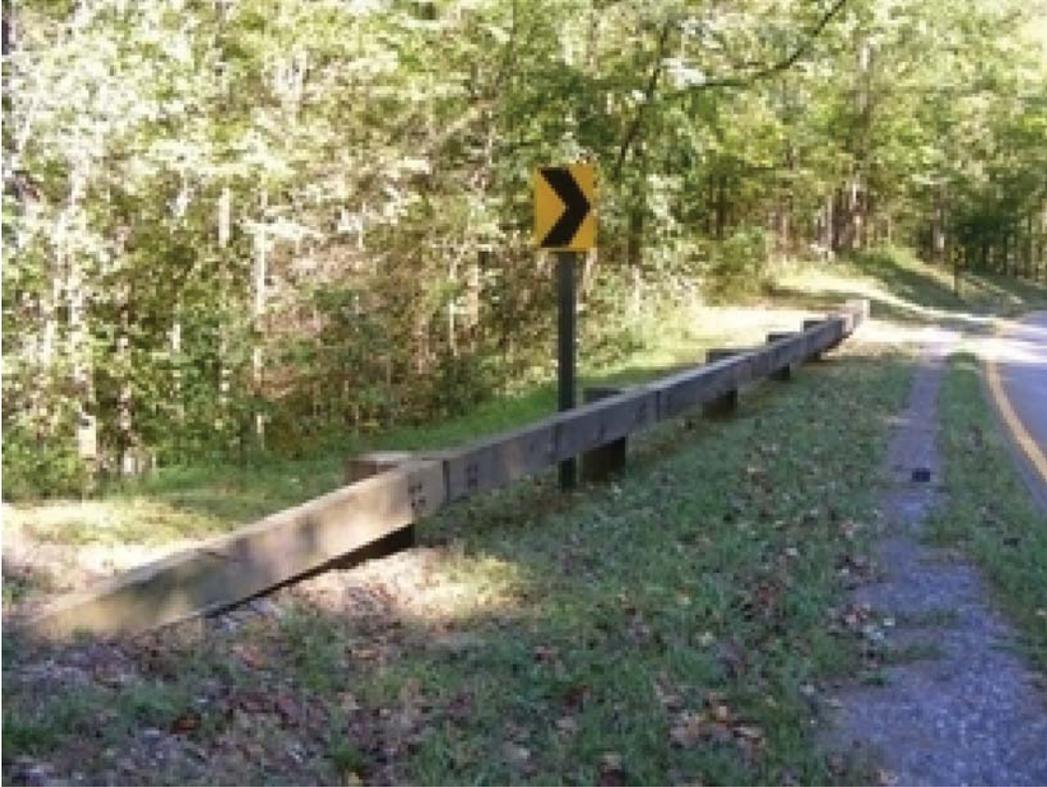
GRSM_0011N_2.540_L_1.JPG

Barrier ID:	GRSM-0011N-2.540-L				
Route Name:	GATLINBURG SPUR ROAD (NORTHBOUND)				
Inspection Date:	09/13/2010	Barrier Rating:	46.50		
Barrier Description					
Type:	STEEL-BACKED TIMBER WITH BLOCKOUT	Barrier Function:	TRAFFIC		
Barrier Material:	STEEL-BACKED TIMBER/LOG	Post Material:	WOOD		
Blockout Type:	WOOD	Length (ft.):	98		
Speed Limit (MPH):	45	Placement with Respect to Road:	OUTSIDE OF CURVE		
Hazard Behind Barrier:	MEDIUM				
Barrier Crashworthiness					
Appropriate Test Level:	TL-2	Barrier Test Level:	TL-3	Is Barrier Crashworthy?:	YES
Beg. End Trtmt Type:	SBT/LOG FLARED	Is Beg. End Trtmt Crashworthy?:	NO	Approach Transition Type:	NONE
Ending End Trtmt Type:	SBT/LOG BURIED	Ending End Trtmt Crashworthy?:	YES		
Average Measurements					
Design Height (In.):	27	Width (In.):	0.0	Post Spacing (In.):	119.0
Height (In.):	26.2	Lateral Offset (In.):	89.3	Road Grade (%):	0.40
Physical Condition					
Barrier	Alignment and Height:	The alignment has no deviation and the height is low by 1 in or less from the design height of 27 in for 58 LF.

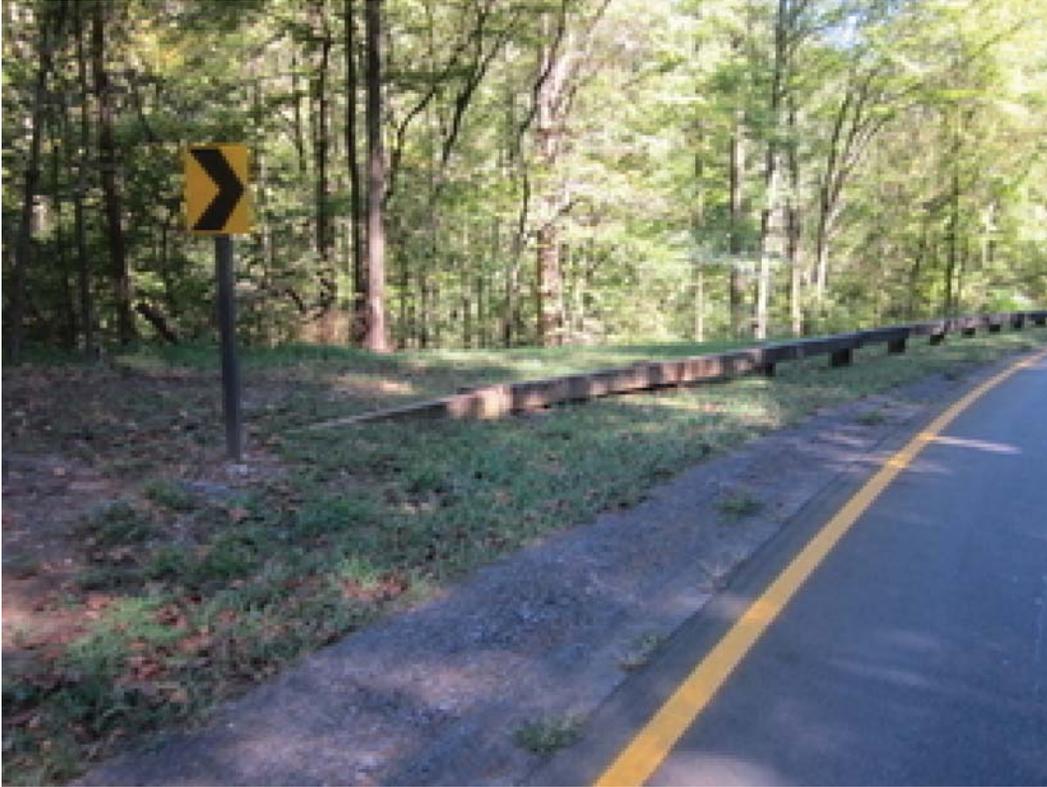
GRSM_0011N_2.581_L_1.JPG

Barrier ID:	GRSM-0011N-2.581-L				
Route Name:	GATLINBURG SPUR ROAD (NORTHBOUND)				
Inspection Date:	09/13/2010	Barrier Rating:	58.20		
Barrier Description					
Type:	STEEL-BACKED TIMBER WITH BLOCKOUT	Barrier Function:	TRAFFIC		
Barrier Material:	STEEL-BACKED TIMBER/LOG	Post Material:	WOOD		
Blockout Type:	WOOD	Length (ft.):	434		
Speed Limit (MPH):	45	Placement with Respect to Road:	OUTSIDE OF CURVE		
Hazard Behind Barrier:	MEDIUM				
Barrier Crashworthiness					
Appropriate Test Level:	TL-2	Barrier Test Level:	TL-3	Is Barrier Crashworthy?:	YES
Beg. End Trtmt Type:	SBT/LOG FLARED	Is Beg. End Trtmt Crashworthy?:	NO	Approach Transition Type:	NONE
Ending End Trtmt Type:	SBT/LOG FLARED	Ending End Trtmt Crashworthy?:	NO		
Average Measurements					
Design Height (In.):	27	Width (In.):	0.0	Post Spacing (In.):	120.0
Height (In.):	25.2	Lateral Offset (In.):	71.3	Road Grade (%):	2.10
Physical Condition					
Barrier	Alignment and Height:	The alignment has no deviation and the height is 1-3 in below the 27 in design height for 90 ft.

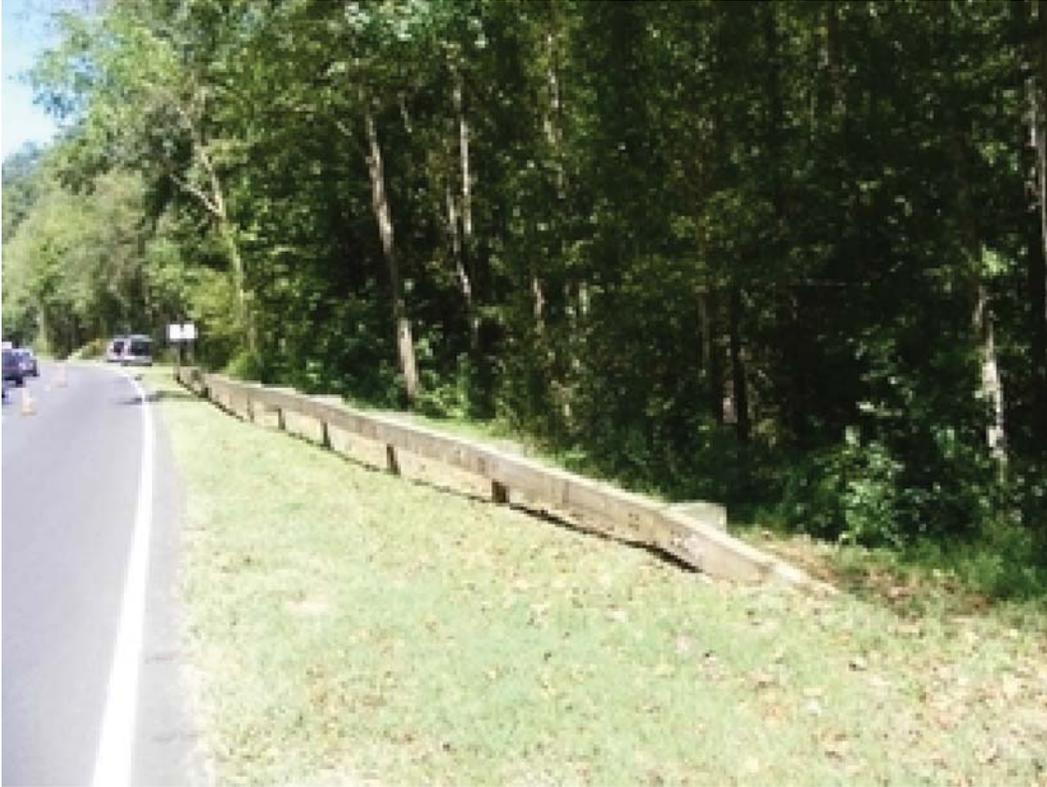
GRSM_0011N_3.646_R_1.JPG

Barrier ID:	GRSM-0011N-3.646-R				
Route Name:	GATLINBURG SPUR ROAD (NORTHBOUND)				
Inspection Date:	09/13/2010	Barrier Rating:	46.50		
Barrier Description					
Type:	STEEL-BACKED TIMBER WITH BLOCKOUT	Barrier Function:	TRAFFIC		
Barrier Material:	STEEL-BACKED TIMBER/LOG	Post Material:	WOOD		
Blockout Type:	WOOD	Length (ft.):	154		
Speed Limit (MPH):	45	Placement with Respect to Road:	OUTSIDE OF CURVE		
Hazard Behind Barrier:	MEDIUM				
Barrier Crashworthiness					
Appropriate Test Level:	TL-2	Barrier Test Level:	TL-3	Is Barrier Crashworthy?:	YES
Beg. End Trtmt Type:	SBT/LOG FLARED	Is Beg. End Trtmt Crashworthy?:	NO	Approach Transition Type:	NONE
Ending End Trtmt Type:	SBT/LOG FLARED	Ending End Trtmt Crashworthy?:	NO		
Average Measurements					
Design Height (In.):	27	Width (In.):	0.0	Post Spacing (In.):	119.3
Height (In.):	27.6	Lateral Offset (In.):	53.5	Road Grade (%):	0.60
Physical Condition					
Barrier	Alignment and Height:	The alignment has no deviation and the height is 0-2 in above the 27 in design height.

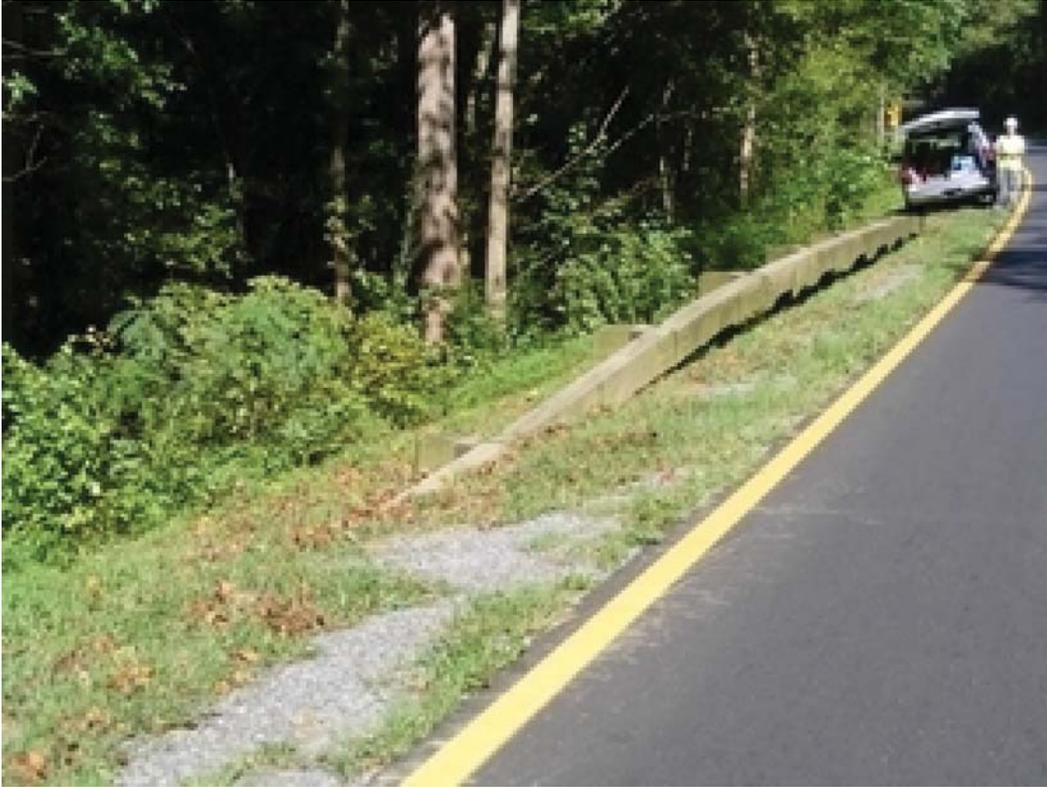
GRSM_0011N_3.658_L_1.JPG

Barrier ID:	GRSM-0011N-3.658-L				
Route Name:	GATLINBURG SPUR ROAD (NORTHBOUND)				
Inspection Date:	09/13/2010	Barrier Rating:	59.90		
Barrier Description					
Type:	STEEL-BACKED TIMBER WITH BLOCKOUT	Barrier Function:	TRAFFIC		
Barrier Material:	STEEL-BACKED TIMBER/LOG	Post Material:	WOOD		
Blockout Type:	WOOD	Length (ft.):	95		
Speed Limit (MPH):	45	Placement with Respect to Road:	INSIDE OF CURVE		
Hazard Behind Barrier:	HIGH				
Barrier Crashworthiness					
Appropriate Test Level:	TL-2	Barrier Test Level:	TL-3	Is Barrier Crashworthy?:	YES
Beg. End Trtmt Type:	SBT/LOG FLARED	Is Beg. End Trtmt Crashworthy?:	NO	Approach Transition Type:	NONE
Ending End Trtmt Type:	SBT/LOG FLARED	Ending End Trtmt Crashworthy?:	NO		
Average Measurements					
Design Height (In.):	27	Width (In.):	0.0	Post Spacing (In.):	120.0
Height (In.):	21.2	Lateral Offset (In.):	49.0	Road Grade (%):	0.50
Physical Condition					
Barrier	Alignment and Height:	The alignment has no deviation and the height is 3 to 7 in below the 27 in design height for 95 ft.

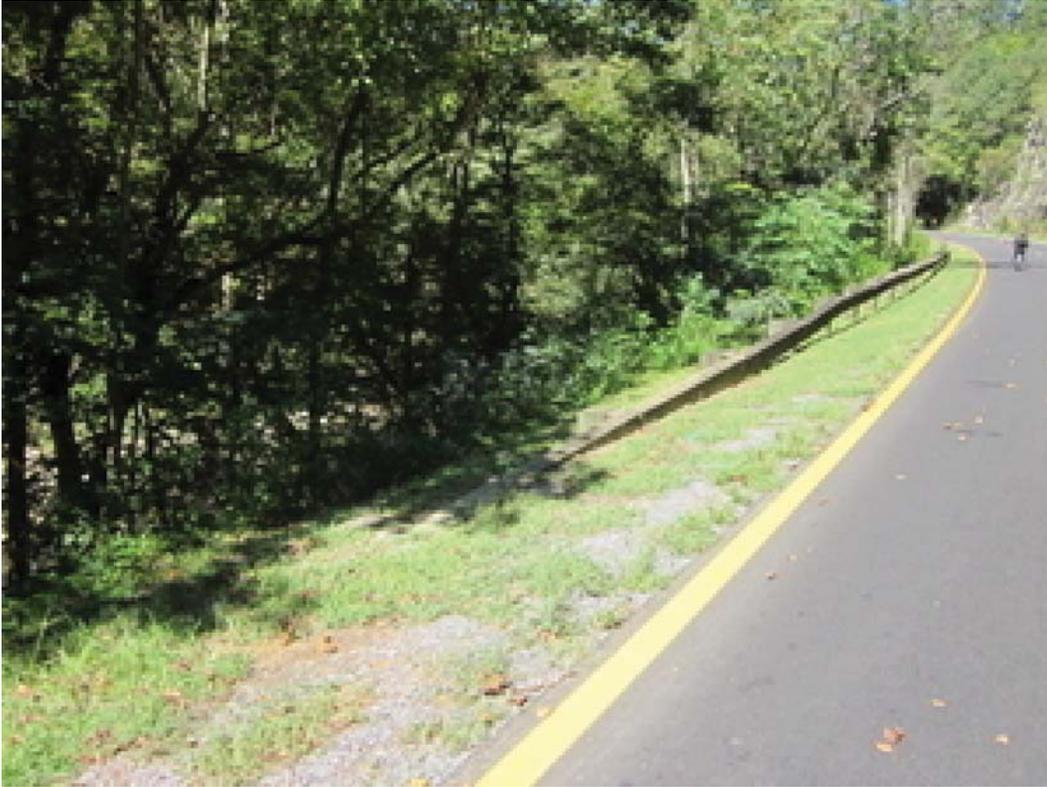
GRSM_0011N_3.800_L_1.JPG

Barrier ID:	GRSM-0011N-3.800-L				
Route Name:	GATLINBURG SPUR ROAD (NORTHBOUND)				
Inspection Date:	09/13/2010	Barrier Rating:	65.50		
Barrier Description					
Type:	STEEL-BACKED TIMBER WITH BLOCKOUT	Barrier Function:	TRAFFIC		
Barrier Material:	STEEL-BACKED TIMBER/LOG	Post Material:	WOOD		
Blockout Type:	WOOD	Length (ft.):	1059		
Speed Limit (MPH):	45	Placement with Respect to Road:	INSIDE OF CURVE		
Hazard Behind Barrier:	HIGH				
Barrier Crashworthiness					
Appropriate Test Level:	TL-2	Barrier Test Level:	TL-3	Is Barrier Crashworthy?:	YES
Beg. End Trtmt Type:	SBT/LOG FLARED	Is Beg. End Trtmt Crashworthy?:	NO	Approach Transition Type:	NONE
Ending End Trtmt Type:	SBT/LOG FLARED	Ending End Trtmt Crashworthy?:	NO		
Average Measurements					
Design Height (In.):	27	Width (In.):	0.0	Post Spacing (In.):	120.0
Height (In.):	23.0	Lateral Offset (In.):	61.4	Road Grade (%):	1.20
Physical Condition					
Barrier	Alignment and Height:	No deviation in alignment and height is 1-3 in below the 27 in design height for 230 ft and 550 ft and 3 to 7 in below for 550 ft.

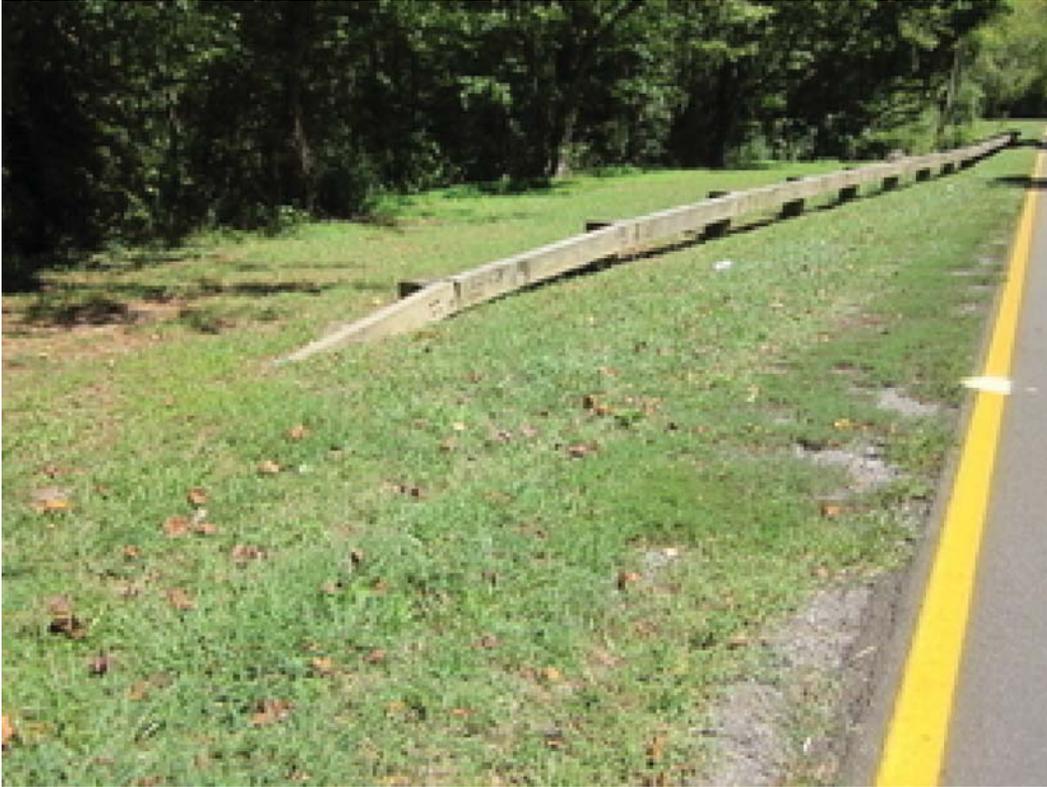
GRSM_0011S_0.157_L_1.JPG

Barrier ID:	GRSM-0011S-0.157-L				
Route Name:	GATLINBURG SPUR ROAD (SOUTHBOUND)				
Inspection Date:	09/13/2010	Barrier Rating:	29.50		
Barrier Description					
Type:	STEEL-BACKED TIMBER WITH BLOCKOUT	Barrier Function:	TRAFFIC		
Barrier Material:	STEEL-BACKED TIMBER/LOG	Post Material:	WOOD		
Blockout Type:	WOOD	Length (ft.):	216		
Speed Limit (MPH):	45	Placement with Respect to Road:	TANGENT		
Hazard Behind Barrier:	MEDIUM				
Barrier Crashworthiness					
Appropriate Test Level:	TL-2	Barrier Test Level:	TL-3	Is Barrier Crashworthy?:	YES
Beg. End Trtmt Type:	SBT/LOG FLARED	Is Beg. End Trtmt Crashworthy?:	NO	Approach Transition Type:	NONE
Ending End Trtmt Type:	SBT/LOG FLARED	Ending End Trtmt Crashworthy?:	NO		
Average Measurements					
Design Height (In.):	27	Width (In.):	0.0	Post Spacing (In.):	120.0
Height (In.):	26.2	Lateral Offset (In.):	61.0	Road Grade (%):	0.30
Physical Condition					
Barrier	Alignment and Height:	The alignment has no deviation and the height is within 1 in of the 27 in design height.

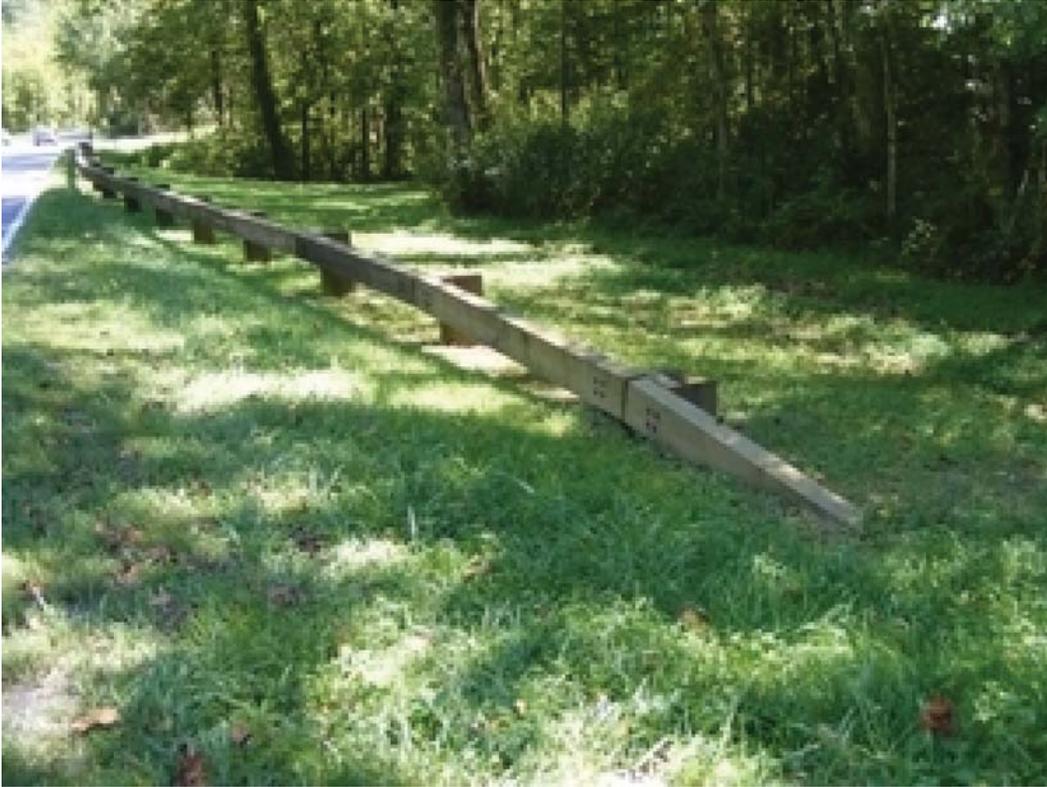
GRSM_0011S_0.157_R_1.JPG

Barrier ID:	GRSM-0011S-0.157-R				
Route Name:	GATLINBURG SPUR ROAD (SOUTHBOUND)				
Inspection Date:	09/13/2010	Barrier Rating:	29.50		
Barrier Description					
Type:	STEEL-BACKED TIMBER WITH BLOCKOUT	Barrier Function:	TRAFFIC		
Barrier Material:	STEEL-BACKED TIMBER/LOG	Post Material:	WOOD		
Blockout Type:	WOOD	Length (ft.):	220		
Speed Limit (MPH):	45	Placement with Respect to Road:	TANGENT		
Hazard Behind Barrier:	MEDIUM				
Barrier Crashworthiness					
Appropriate Test Level:	TL-2	Barrier Test Level:	TL-3	Is Barrier Crashworthy?:	YES
Beg. End Trtmt Type:	SBT/LOG FLARED	Is Beg. End Trtmt Crashworthy?:	NO	Approach Transition Type:	NONE
Ending End Trtmt Type:	SBT/LOG FLARED	Ending End Trtmt Crashworthy?:	NO		
Average Measurements					
Design Height (In.):	27	Width (In.):	0.0	Post Spacing (In.):	120.3
Height (In.):	26.0	Lateral Offset (In.):	49.7	Road Grade (%):	0.30
Physical Condition					
Barrier	Alignment and Height:	The alignment has no deviation and the height is 1 to 3 in below for 60 ft of the 27 in design height.

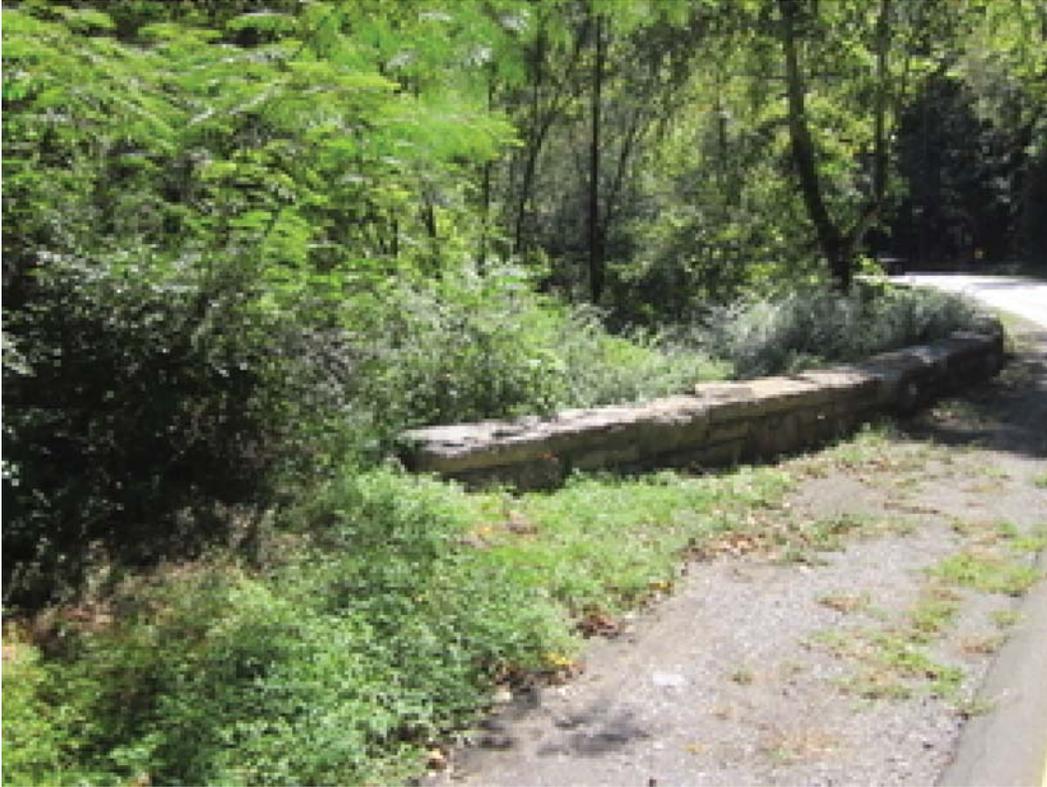
GRSM_0011S_2.180_L_1.JPG

Barrier ID:	GRSM-0011S-2.180-L				
Route Name:	GATLINBURG SPUR ROAD (SOUTHBOUND)				
Inspection Date:	09/13/2010	Barrier Rating:	42.70		
Barrier Description					
Type:	STONE MASONRY WITHOUT CONCRETE CORE WALL	Barrier Function:	TRAFFIC		
Barrier Material:	STONE	Post Material:	N/A		
Blockout Type:	N/A	Length (ft.):	267		
Speed Limit (MPH):	45	Placement with Respect to Road:	INSIDE OF CURVE		
Hazard Behind Barrier:	HIGH				
Barrier Crashworthiness					
Appropriate Test Level:	TL-2	Barrier Test Level:	NCW	Is Barrier Crashworthy?:	NO
Beg. End Trtmt Type:	NONE	Is Beg. End Trtmt Crashworthy?:	N/A	Approach Transition Type:	NONE
Ending End Trtmt Type:	NONE	Ending End Trtmt Crashworthy?:	N/A		
Average Measurements					
Design Height (In.):	24	Width (In.):	25.2	Post Spacing (In.):	0.0
Height (In.):	28.0	Lateral Offset (In.):	65.0	Road Grade (%):	0.40
Physical Condition					
Barrier	Alignment and Height:	No deviation in alignment and height is 4 in above the 24 in design height.

Breaking and Cracking:	No breaking or cracking observed.			
	Missing Elements:	No missing elements observed.			
	Corrosion and Weathering:	No corrosion or weathering observed			
End Treatments	Alignment and Height:				
	Breaking and Cracking:				
	Missing Elements:				
	Corrosion and Weathering:

Repair Action:	NO ACTION	FMSS Work Type:	N/A	Repair Cost:	\$0
Brief Workorder:	N/A				
Workorder:

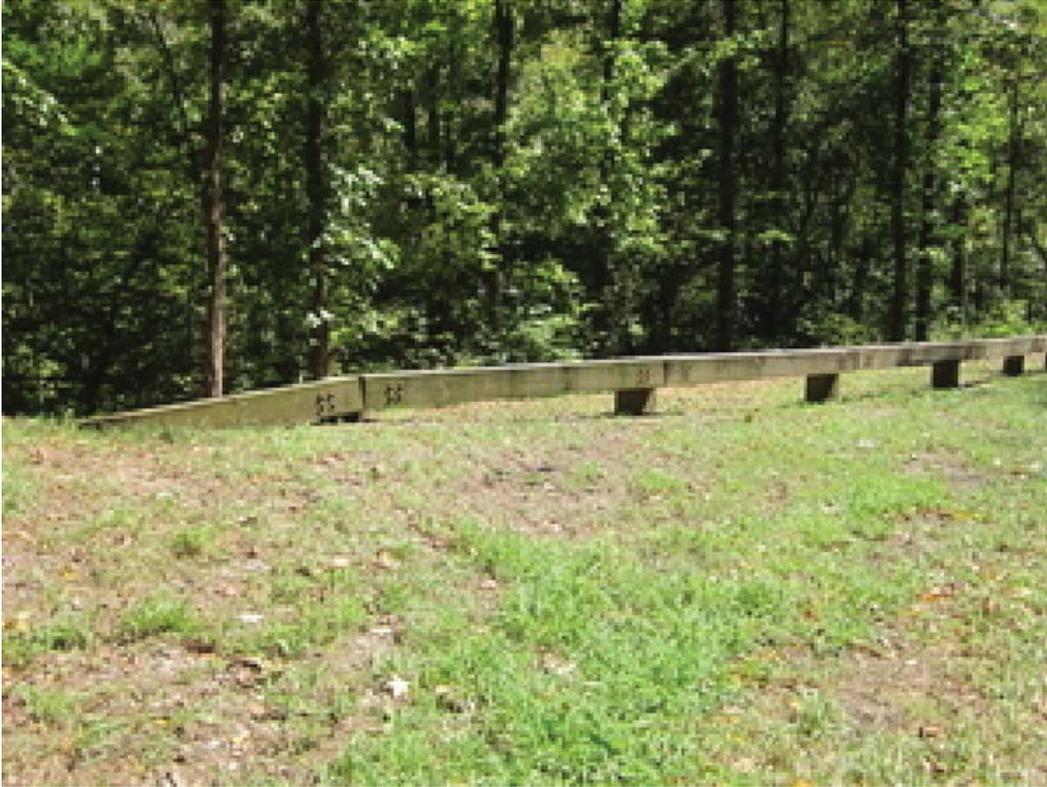
GRSM_0011S_2.493_L_1.JPG

Barrier ID:	GRSM-0011S-2.493-L				
Route Name:	GATLINBURG SPUR ROAD (SOUTHBOUND)				
Inspection Date:	09/13/2010	Barrier Rating:	32.40		
Barrier Description					
Type:	STEEL-BACKED TIMBER WITH BLOCKOUT	Barrier Function:	TRAFFIC		
Barrier Material:	STEEL-BACKED TIMBER/LOG	Post Material:	WOOD		
Blockout Type:	WOOD	Length (ft.):	206		
Speed Limit (MPH):	45	Placement with Respect to Road:	INSIDE OF CURVE		
Hazard Behind Barrier:	MEDIUM				
Barrier Crashworthiness					
Appropriate Test Level:	TL-2	Barrier Test Level:	TL-3	Is Barrier Crashworthy?:	YES
Beg. End Trtmt Type:	SBT/LOG FLARED	Is Beg. End Trtmt Crashworthy?:	NO	Approach Transition Type:	NONE
Ending End Trtmt Type:	SBT/LOG FLARED	Ending End Trtmt Crashworthy?:	NO		
Average Measurements					
Design Height (In.):	27	Width (In.):	0.0	Post Spacing (In.):	119.5
Height (In.):	26.2	Lateral Offset (In.):	55.0	Road Grade (%):	1.50
Physical Condition					
Barrier	Alignment and Height:	The alignment has no deviation and the height is within 1 in of the 27 in design height.

Breaking and Cracking:	No breaking or cracking observed.			
	Missing Elements:	No missing elements observed.			
	Corrosion and Weathering:	No corrosion or weathering observed			
End Treatments	Alignment and Height:	Alignment acceptable. Height is within 1 in of the 27-in design height.			
	Breaking and Cracking:	No breaking or cracking observed.			
	Missing Elements:	No missing elements observed.			
	Corrosion and Weathering:	No corrosion or weathering observed

Repair Action:	NO ACTION	FMSS Work Type:	N/A	Repair Cost:	\$0
Brief Workorder:	N/A				
Workorder:

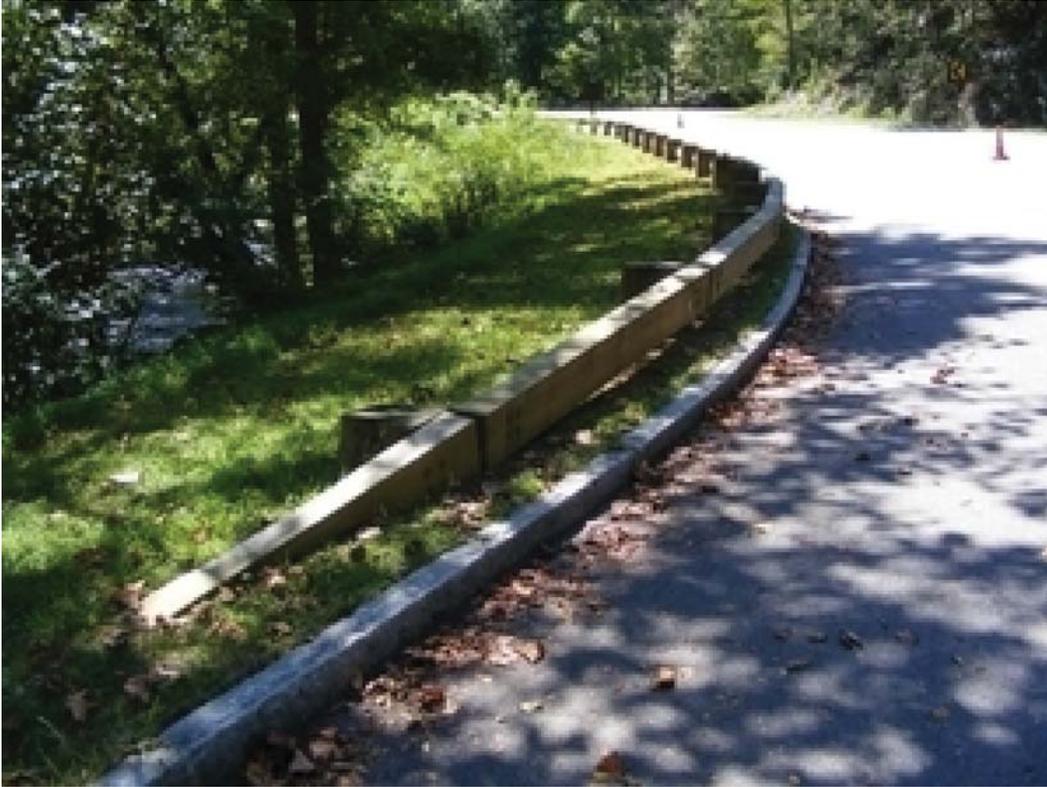
GRSM_0011S_2.925_L_1.JPG

Barrier ID:	GRSM-0011S-2.925-L				
Route Name:	GATLINBURG SPUR ROAD (SOUTHBOUND)				
Inspection Date:	09/13/2010	Barrier Rating:	39.70		
Barrier Description					
Type:	STEEL-BACKED TIMBER WITH BLOCKOUT	Barrier Function:	TRAFFIC		
Barrier Material:	STEEL-BACKED TIMBER/LOG	Post Material:	WOOD		
Blockout Type:	WOOD	Length (ft.):	380		
Speed Limit (MPH):	45	Placement with Respect to Road:	INSIDE OF CURVE		
Hazard Behind Barrier:	MEDIUM				
Barrier Crashworthiness					
Appropriate Test Level:	TL-2	Barrier Test Level:	TL-3	Is Barrier Crashworthy?:	YES
Beg. End Trtmt Type:	SBT/LOG FLARED	Is Beg. End Trtmt Crashworthy?:	NO	Approach Transition Type:	NONE
Ending End Trtmt Type:	SBT/LOG FLARED	Ending End Trtmt Crashworthy?:	NO		
Average Measurements					
Design Height (In.):	27	Width (In.):	0.0	Post Spacing (In.):	119.5
Height (In.):	26.2	Lateral Offset (In.):	72.0	Road Grade (%):	1.30
Physical Condition					
Barrier	Alignment and Height:	The alignment has no deviation and the height is 3 to 4 in below the 27 in design height for 145 ft.

Breaking and Cracking:	Minor cracking observed.			
	Missing Elements:	One broken barrier reflector observed.			
	Corrosion and Weathering:	Minor weathering 1/4 in to 1/2 in observed on 3 consecutive rails.			
End Treatments	Alignment and Height:	Alignment acceptable. Height is within 1 in of the 27-in design height.			
	Breaking and Cracking:	No breaking or cracking observed.			
	Missing Elements:	No missing elements observed.			
	Corrosion and Weathering:	No corrosion or weathering observed.

Repair Action:	REPAIR	FMSS Work Type:	DEFERRED MAINTENANCE	Repair Cost:	\$3328
Brief Workorder:	Raise 145 feet of barrier to the 27 inch design height and replace one reflector.				
Workorder:	Barrier Reflectors at \$100- per -Each for 1 Unit(s) = \$100. Replace 1 broken reflector. Adjust Guardrail at \$10- per -Lin. Ft. for 145 LF = \$1450. Raise 145-ft of barrier up to 27-in design height. Low Speed Traffic Control at \$1475- per -Day for 1 Day(s) = \$1475.

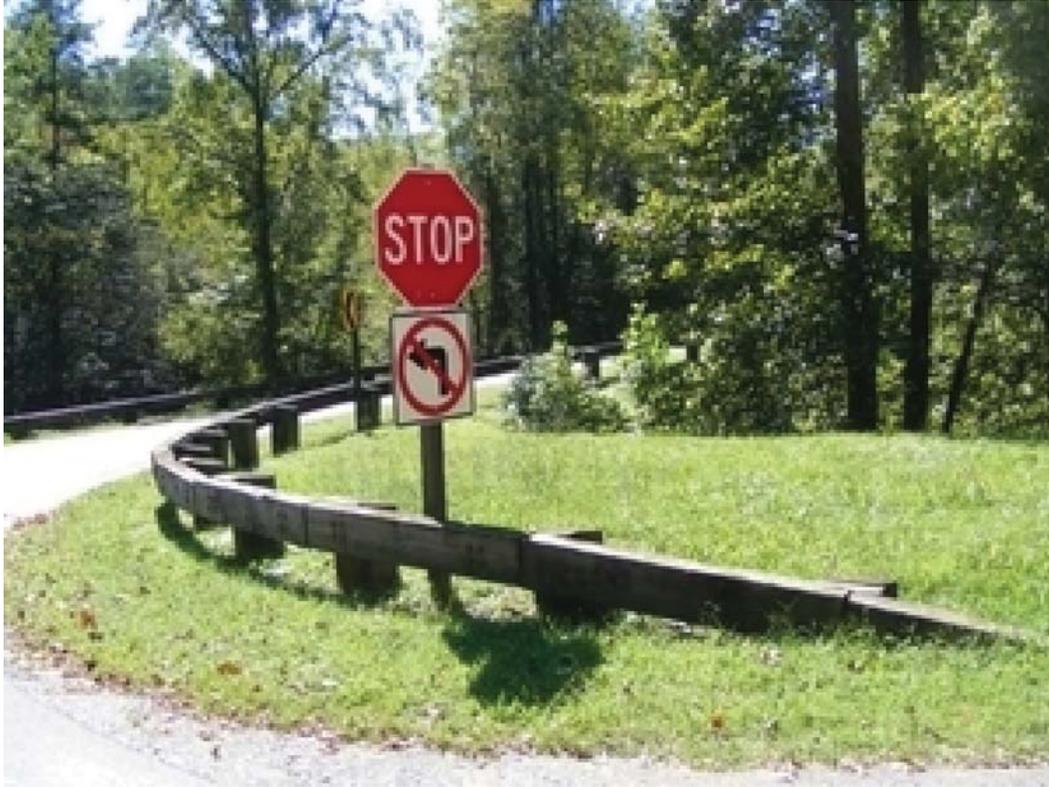
GRSM_0011S_2.948_R_1.JPG

Barrier ID:	GRSM-0011S-2.948-R				
Route Name:	GATLINBURG SPUR ROAD (SOUTHBOUND)				
Inspection Date:	09/14/2010	Barrier Rating:	51.50		
Barrier Description					
Type:	STEEL-BACKED TIMBER WITH BLOCKOUT	Barrier Function:	TRAFFIC		
Barrier Material:	STEEL-BACKED TIMBER/LOG	Post Material:	WOOD		
Blockout Type:	WOOD	Length (ft.):	214		
Speed Limit (MPH):	45	Placement with Respect to Road:	OUTSIDE OF CURVE		
Hazard Behind Barrier:	HIGH				
Barrier Crashworthiness					
Appropriate Test Level:	TL-2	Barrier Test Level:	TL-3	Is Barrier Crashworthy?:	YES
Beg. End Trtmt Type:	SBT/LOG FLARED	Is Beg. End Trtmt Crashworthy?:	NO	Approach Transition Type:	NONE
Ending End Trtmt Type:	SBT/LOG BURIED	Ending End Trtmt Crashworthy?:	YES		
Average Measurements					
Design Height (In.):	27	Width (In.):	0.0	Post Spacing (In.):	119.0
Height (In.):	25.2	Lateral Offset (In.):	38.2	Road Grade (%):	0.50
Physical Condition					
Barrier	Alignment and Height:	The alignment has no deviation and the height is 1 to 3 in below the 27 in design height for 20 ft and 3 to 4 in below for 94 ft.

Breaking and Cracking:	1 broken blockout with 1/2 in or greater crack 2 broken barrier reflectors and 1 possible impact zone on barrier.			
	Missing Elements:	No missing elements observed.			
	Corrosion and Weathering:	Minor corrosion and weathering observed.			
End Treatments	Alignment and Height:	Alignment acceptable. Height is within 1 in of the 27-in design height.			
	Breaking and Cracking:	No breaking or cracking observed.			
	Missing Elements:	No missing elements observed.			
	Corrosion and Weathering:	Minor corrosion or weathering observed.

Repair Action:	REPAIR	FMSS Work Type:	DEFERRED MAINTENANCE	Repair Cost:	\$3130
Brief Workorder:	Raise 114 feet of guardrail up to the 27 inch design height replace one block and 2 reflectors.				
Workorder:	Replace Block at \$30- per -Each for 1 Block(s) = \$30. Replace 1 blockout. Adjust Guardrail at \$10- per -Lin. Ft. for 114 LF = \$1140. Raise 114 feet of guardrail up to the 27 inch design height. Barrier Reflectors at \$100- per -Each for 2 Unit(s) = \$200. Replace 2 broken reflectors. Low Speed Traffic Control at \$1475- per -Day for 1 Day(s) = \$1475.
