NPS Guardwall/Rail Inventory Program
Great Smoky Mountains National Park

Federal Highway Administration
Eastern Federal Lands Highway Division
Road Inventory Program (RIP)

Data Collection Date: September 2010
Report Date: December 2015

Great Smoky Mountains National Park in North Carolina and Tennessee

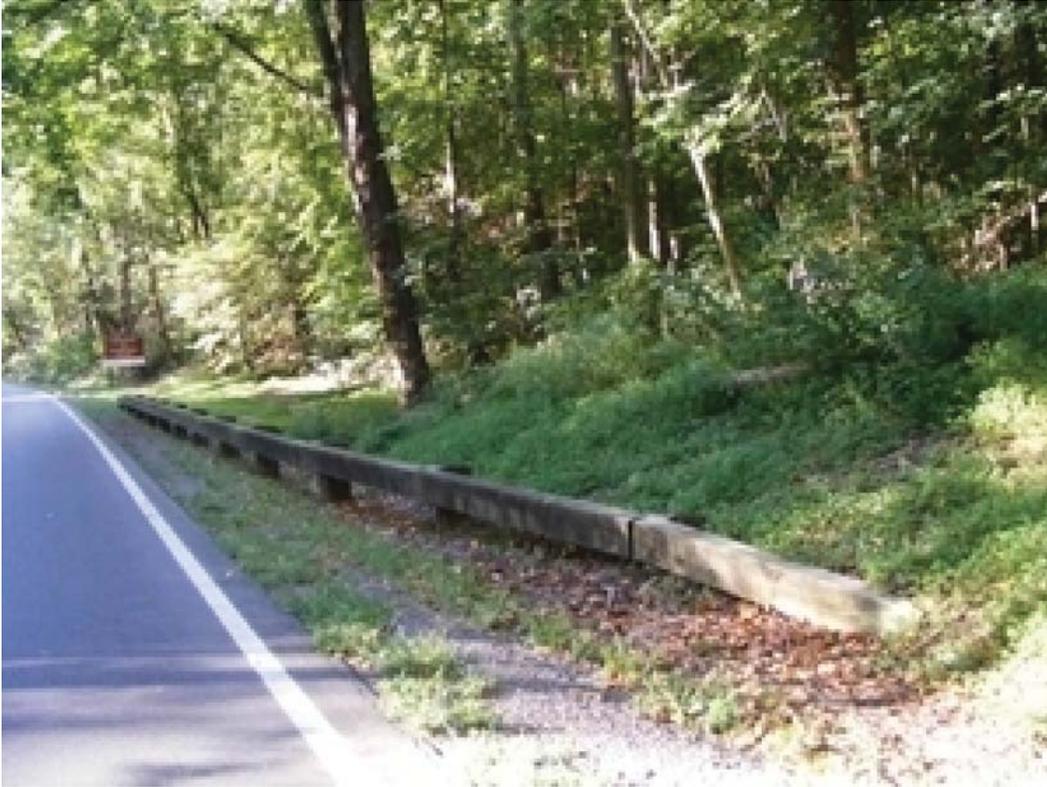
GRSM_0011S_3.641_R_1.JPG

Barrier ID:	GRSM-0011S-3.641-R				
Route Name:	GATLINBURG SPUR ROAD (SOUTHBOUND)				
Inspection Date:	09/14/2010	Barrier Rating:	55.40		
Barrier Description					
Type:	STEEL-BACKED TIMBER WITH BLOCKOUT	Barrier Function:	TRAFFIC		
Barrier Material:	STEEL-BACKED TIMBER/LOG	Post Material:	WOOD		
Blockout Type:	WOOD	Length (ft.):	122		
Speed Limit (MPH):	45	Placement with Respect to Road:	OUTSIDE OF CURVE		
Hazard Behind Barrier:	MEDIUM				
Barrier Crashworthiness					
Appropriate Test Level:	TL-2	Barrier Test Level:	TL-3	Is Barrier Crashworthy?:	YES
Beg. End Trtmt Type:	SBT/LOG FLARED	Is Beg. End Trtmt Crashworthy?:	NO	Approach Transition Type:	NONE
Ending End Trtmt Type:	SBT/LOG FLARED	Ending End Trtmt Crashworthy?:	NO		
Average Measurements					
Design Height (In.):	27	Width (In.):	0.0	Post Spacing (In.):	120.0
Height (In.):	22.2	Lateral Offset (In.):	55.2	Road Grade (%):	0.80
Physical Condition					
Barrier	Alignment and Height:	The alignment has no deviation and the height is 3 to 5 in below the 27 in design height for 122 ft.

Breaking and Cracking:	No breaking or cracking observed.			
	Missing Elements:	No missing elements observed.			
	Corrosion and Weathering:	No corrosion or weathering observed.			
End Treatments	Alignment and Height:	Alignment acceptable. Height is within 1 in of the 27-in design height.			
	Breaking and Cracking:	No breaking or cracking observed.			
	Missing Elements:	No missing elements observed.			
	Corrosion and Weathering:	No corrosion or weathering observed.

Repair Action:	REPAIR	FMSS Work Type:	DEFERRED MAINTENANCE	Repair Cost:	\$2965
Brief Workorder:	Raise 122 feet of barrier up to the 27 inch design height.				
Workorder:	Adjust Guardrail at \$10- per -Lin. Ft. for 122 LF = \$1220. Raise 122-ft of barrier up to 27-in design height. Low Speed Traffic Control at \$1475- per -Day for 1 Day(s) = \$1475.

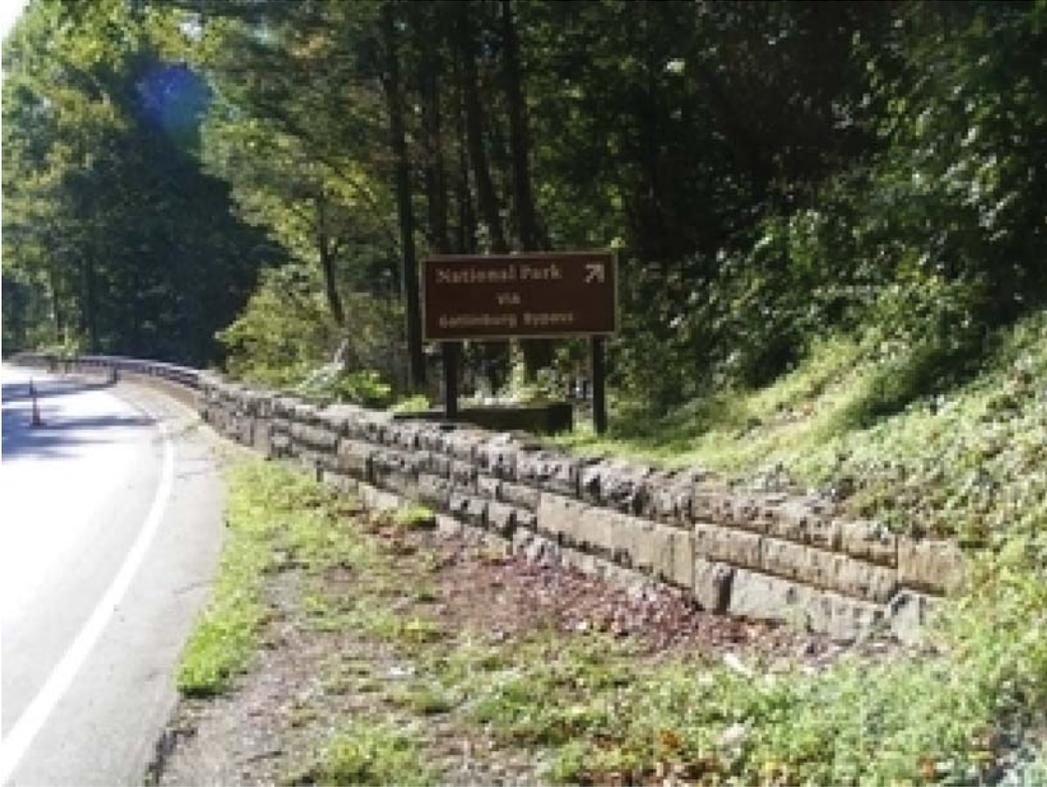
GRSM_0011S_3.941_R_1.JPG

Barrier ID:	GRSM-0011S-3.941-R				
Route Name:	GATLINBURG SPUR ROAD (SOUTHBOUND)				
Inspection Date:	09/14/2010	Barrier Rating:	38.00		
Barrier Description					
Type:	STONE MASONRY WITH CONCRETE CORE WALL	Barrier Function:	TRAFFIC		
Barrier Material:	CONCRETE	Post Material:	N/A		
Blockout Type:	N/A	Length (ft.):	49		
Speed Limit (MPH):	45	Placement with Respect to Road:	OUTSIDE OF CURVE		
Hazard Behind Barrier:	MEDIUM				
Barrier Crashworthiness					
Appropriate Test Level:	TL-2	Barrier Test Level:	TL-3	Is Barrier Crashworthy?:	YES
Beg. End Trtmt Type:	NONE	Is Beg. End Trtmt Crashworthy?:	N/A	Approach Transition Type:	NONE
Ending End Trtmt Type:	NONE	Ending End Trtmt Crashworthy?:	N/A		
Average Measurements					
Design Height (In.):	27	Width (In.):	20.0	Post Spacing (In.):	0.0
Height (In.):	35.0	Lateral Offset (In.):	71.3	Road Grade (%):	2.20
Physical Condition					
Barrier	Alignment and Height:	The alignment has no deviation and the height is 6 to 10 in above the design height of 27 in.

Breaking and Cracking:	No breaking or cracking observed.			
	Missing Elements:	No missing elements observed.			
	Corrosion and Weathering:	No corrosion or weathering observed.			
End Treatments	Alignment and Height:				
	Breaking and Cracking:				
	Missing Elements:				
	Corrosion and Weathering:

Repair Action:	NO ACTION	FMSS Work Type:	N/A	Repair Cost:	\$0
Brief Workorder:	N/A				
Workorder:

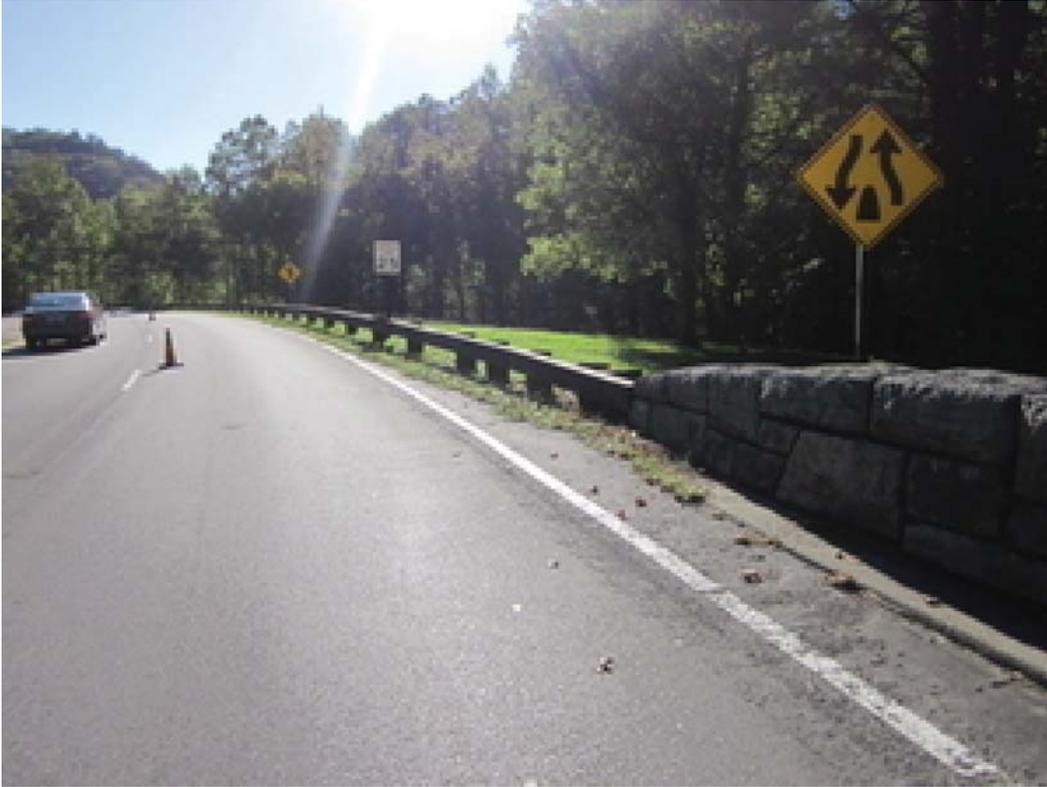
GRSM_0011S_4.067_R_1.JPG

Barrier ID:	GRSM-0011S-4.067-R				
Route Name:	GATLINBURG SPUR ROAD (SOUTHBOUND)				
Inspection Date:	09/14/2010	Barrier Rating:	44.00		
Barrier Description					
Type:	STEEL-BACKED TIMBER WITH BLOCKOUT	Barrier Function:	TRAFFIC		
Barrier Material:	STEEL-BACKED TIMBER/LOG	Post Material:	WOOD		
Blockout Type:	WOOD	Length (ft.):	321		
Speed Limit (MPH):	25	Placement with Respect to Road:	OUTSIDE OF CURVE		
Hazard Behind Barrier:	MEDIUM				
Barrier Crashworthiness					
Appropriate Test Level:	TL-1	Barrier Test Level:	TL-3	Is Barrier Crashworthy?:	YES
Beg. End Trtmt Type:	NONE	Is Beg. End Trtmt Crashworthy?:	N/A	Approach Transition Type:	RIGID SBT WALL - SBT
Ending End Trtmt Type:	SBT/LOG FLARED	Ending End Trtmt Crashworthy?:	NO		
Average Measurements					
Design Height (In.):	27	Width (In.):	0.0	Post Spacing (In.):	120.0
Height (In.):	23.0	Lateral Offset (In.):	44.0	Road Grade (%):	0.60
Physical Condition

Barrier	Alignment and Height:	Alignment has no deviation and the height is 1-3 in below the 27 in design height for 206 ft and 4-6 in below for 115 ft.			
	Breaking and Cracking:	No breaking or cracking observed.			
	Missing Elements:	No missing elements observed.			
	Corrosion and Weathering:	No corrosion or weathering observed.			
End Treatments	Alignment and Height:	Alignment acceptable. Height is within 1 in of the 27-in design height.			
	Breaking and Cracking:	No breaking or cracking observed.			
	Missing Elements:	No missing elements observed.			
	Corrosion and Weathering:	No corrosion or weathering observed.

Repair Action:	REPAIR	FMSS Work Type:	DEFERRED MAINTENANCE	Repair Cost:	\$6776
Brief Workorder:	Raise 321 feet of barrier up to the 27 inch design height.				
Workorder:	Adjust Guardrail at \$10- per -Lin. Ft. for 321 LF = \$3210. Raise 321 feet of barrier up to the 27 inch design height. Low Speed Traffic Control at \$1475- per -Day for 2 Day(s) = \$2950.

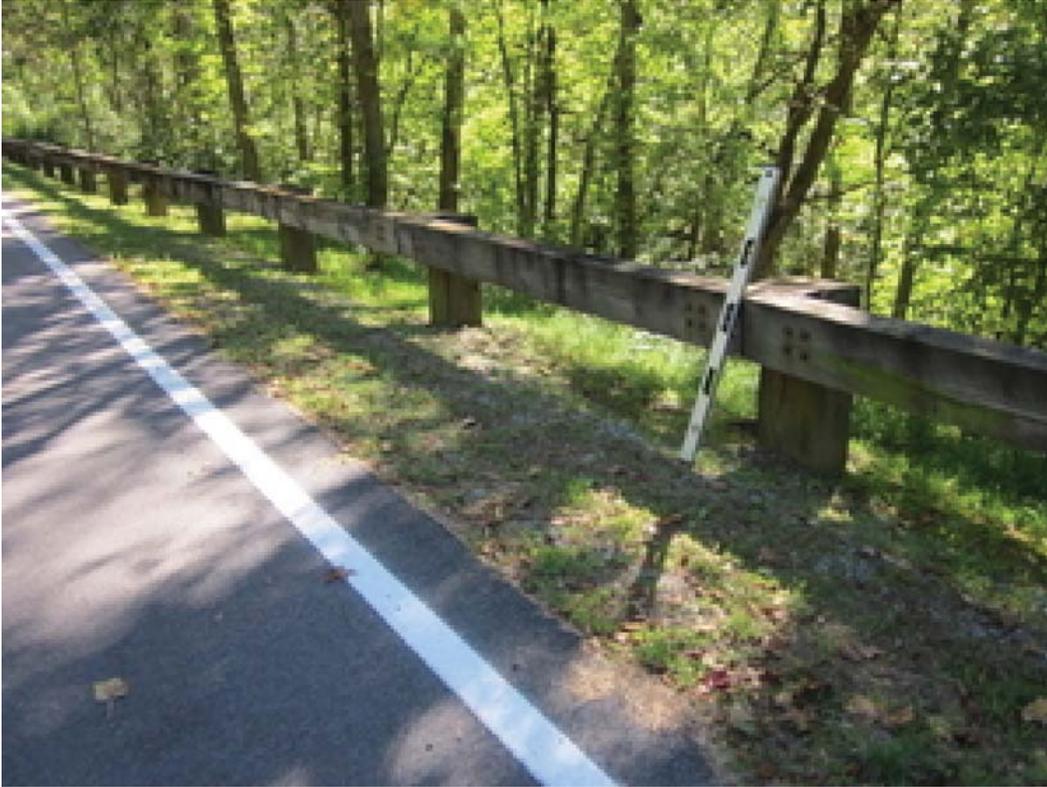
GRSM_0011S_4.144_R_1.JPG

Barrier ID:	GRSM-0011S-4.144-R				
Route Name:	GATLINBURG SPUR ROAD (SOUTHBOUND)				
Inspection Date:	09/14/2010	Barrier Rating:	41.50		
Barrier Description					
Type:	STEEL-BACKED TIMBER WITH BLOCKOUT	Barrier Function:	TRAFFIC		
Barrier Material:	STEEL-BACKED TIMBER/LOG	Post Material:	WOOD		
Blockout Type:	WOOD	Length (ft.):	334		
Speed Limit (MPH):	25	Placement with Respect to Road:	OUTSIDE OF CURVE		
Hazard Behind Barrier:	HIGH				
Barrier Crashworthiness					
Appropriate Test Level:	TL-1	Barrier Test Level:	TL-3	Is Barrier Crashworthy?:	YES
Beg. End Trtmt Type:	NONE	Is Beg. End Trtmt Crashworthy?:	N/A	Approach Transition Type:	NONE
Ending End Trtmt Type:	SBT/LOG FLARED	Ending End Trtmt Crashworthy?:	NO		
Average Measurements					
Design Height (In.):	27	Width (In.):	0.0	Post Spacing (In.):	120.0
Height (In.):	26.7	Lateral Offset (In.):	42.2	Road Grade (%):	0.80
Physical Condition					
Barrier	Alignment and Height:	The alignment has no deviation and the height is ranges from 1-3 in below the 27 in design height for 160 ft. Rest of barrier was between 1 in below to 5 in above.

Breaking and Cracking:	No breaking or cracking observed.			
	Missing Elements:	No missing elements observed.			
	Corrosion and Weathering:	No corrosion or weathering observed.			
End Treatments	Alignment and Height:	Alignment acceptable. Height is within 1 in of the 27-in design height.			
	Breaking and Cracking:	No breaking or cracking observed.			
	Missing Elements:	No missing elements observed.			
	Corrosion and Weathering:	No corrosion or weathering observed.

Repair Action:	REPAIR	FMSS Work Type:	DEFERRED MAINTENANCE	Repair Cost:	\$3383
Brief Workorder:	Raise 160 feet of guardrail up to the 27 inch design height.				
Workorder:	Adjust Guardrail at \$10- per -Lin. Ft. for 160 LF = \$1600. Raise 160 feet of barrier up to the 27 inch design height. Low Speed Traffic Control at \$1475- per -Day for 1 Day(s) = \$1475.

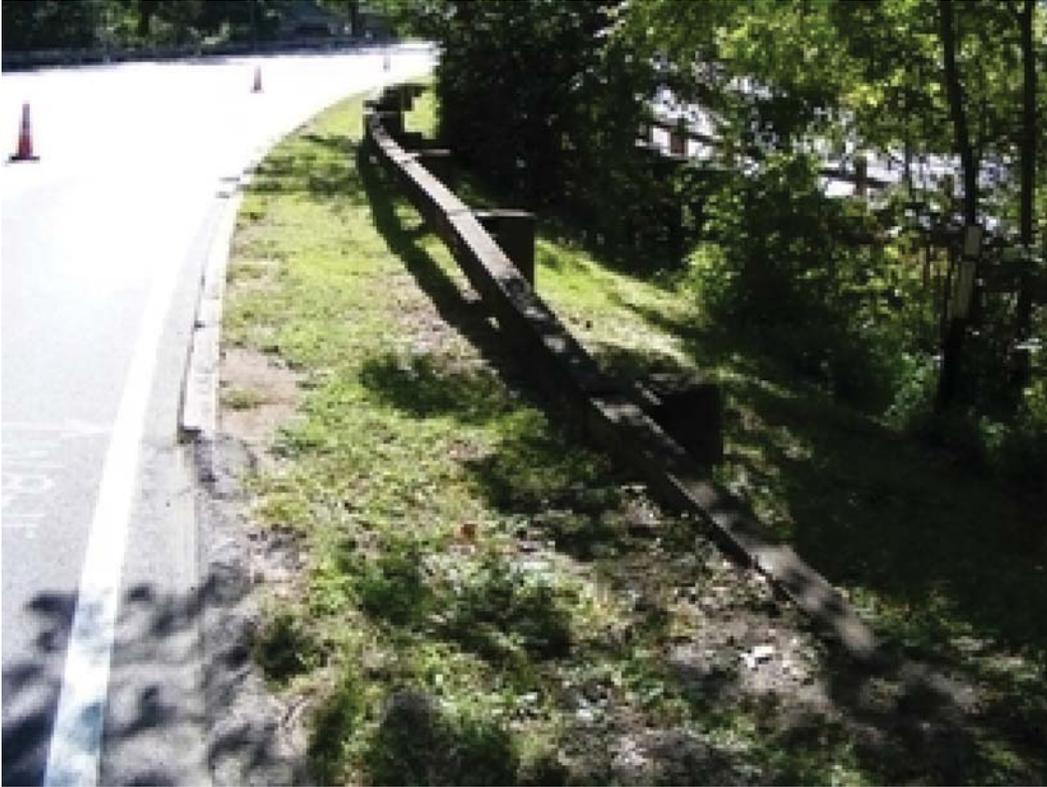
GRSM_0011S_4.289_R_1.JPG

Barrier ID:	GRSM-0011S-4.289-R				
Route Name:	GATLINBURG SPUR ROAD (SOUTHBOUND)				
Inspection Date:	09/14/2010	Barrier Rating:	25.60		
Barrier Description					
Type:	STEEL-BACKED TIMBER WITH BLOCKOUT	Barrier Function:	TRAFFIC		
Barrier Material:	STEEL-BACKED TIMBER/LOG	Post Material:	WOOD		
Blockout Type:	WOOD	Length (ft.):	120		
Speed Limit (MPH):	25	Placement with Respect to Road:	INSIDE OF CURVE		
Hazard Behind Barrier:	HIGH				
Barrier Crashworthiness					
Appropriate Test Level:	TL-1	Barrier Test Level:	TL-3	Is Barrier Crashworthy?:	YES
Beg. End Trtmt Type:	SBT/LOG FLARED	Is Beg. End Trtmt Crashworthy?:	NO	Approach Transition Type:	NONE
Ending End Trtmt Type:	SBT/LOG FLARED	Ending End Trtmt Crashworthy?:	NO		
Average Measurements					
Design Height (In.):	27	Width (In.):	0.0	Post Spacing (In.):	120.0
Height (In.):	27.0	Lateral Offset (In.):	67.0	Road Grade (%):	3.40
Physical Condition					
Barrier	Alignment and Height:	The alignment has no deviation and the height is within 1 in of the design height of 27 in.

Breaking and Cracking:	No breaking or cracking observed.			
	Missing Elements:	No missing elements observed.			
	Corrosion and Weathering:	No corrosion or weathering observed.			
End Treatments	Alignment and Height:	Alignment acceptable. Height is within 1 in of the 27-in design height.			
	Breaking and Cracking:	No breaking observed.			
	Missing Elements:	No missing elements observed.			
	Corrosion and Weathering:	No weathering observed.

Repair Action:	NO ACTION	FMSS Work Type:	N/A	Repair Cost:	\$0
Brief Workorder:	N/A				
Workorder:

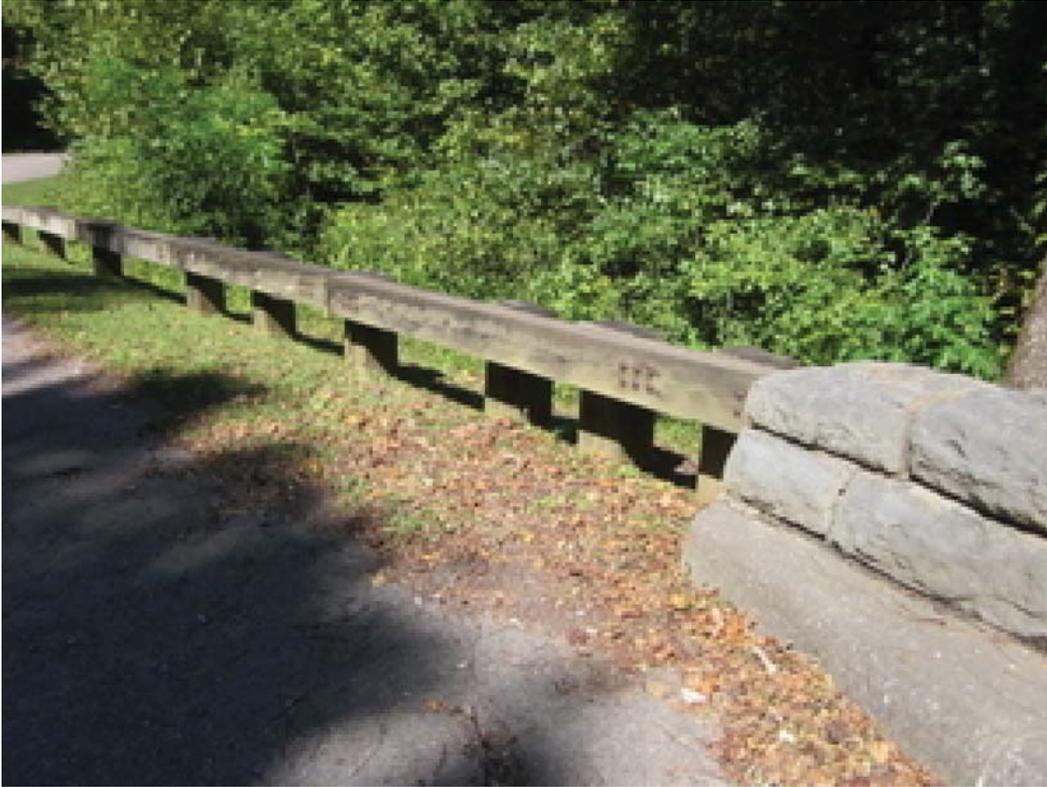
GRSM_0012ZZ_0.016_R_1.JPG

Barrier ID:	GRSM-0012ZZ-0.016-R				
Route Name:	GATLINBURG BYPASS ROAD AND RAMPS				
Inspection Date:	09/14/2010	Barrier Rating:	22.70		
Barrier Description					
Type:	STEEL-BACKED TIMBER WITH BLOCKOUT	Barrier Function:	TRAFFIC		
Barrier Material:	STEEL-BACKED TIMBER/LOG	Post Material:	WOOD		
Blockout Type:	WOOD	Length (ft.):	266		
Speed Limit (MPH):	35	Placement with Respect to Road:	BOTH INSIDE AND OUTSIDE		
Hazard Behind Barrier:	HIGH				
Barrier Crashworthiness					
Appropriate Test Level:	TL-2	Barrier Test Level:	TL-3	Is Barrier Crashworthy?:	YES
Beg. End Trtmt Type:	SBT/LOG FLARED	Is Beg. End Trtmt Crashworthy?:	NO	Approach Transition Type:	NONE
Ending End Trtmt Type:	NONE	Ending End Trtmt Crashworthy?:	N/A		
Average Measurements					
Design Height (In.):	27	Width (In.):	0.0	Post Spacing (In.):	120.0
Height (In.):	27.2	Lateral Offset (In.):	54.7	Road Grade (%):	7.10
Physical Condition					
Barrier	Alignment and Height:	No deviation in alignment and height is within 1 in of the 27 in design height.

Breaking and Cracking:	No breaking or cracking observed.			
	Missing Elements:	No missing elements observed.			
	Corrosion and Weathering:	No corrosion or weathering observed.			
End Treatments	Alignment and Height:	Alignment acceptable. Height is within 1 in of the 27-in design height.			
	Breaking and Cracking:	No breaking or cracking observed.			
	Missing Elements:	No missing elements observed.			
	Corrosion and Weathering:	No corrosion or weathering observed.

Repair Action:	NO ACTION	FMSS Work Type:	N/A	Repair Cost:	\$0
Brief Workorder:	N/A				
Workorder:

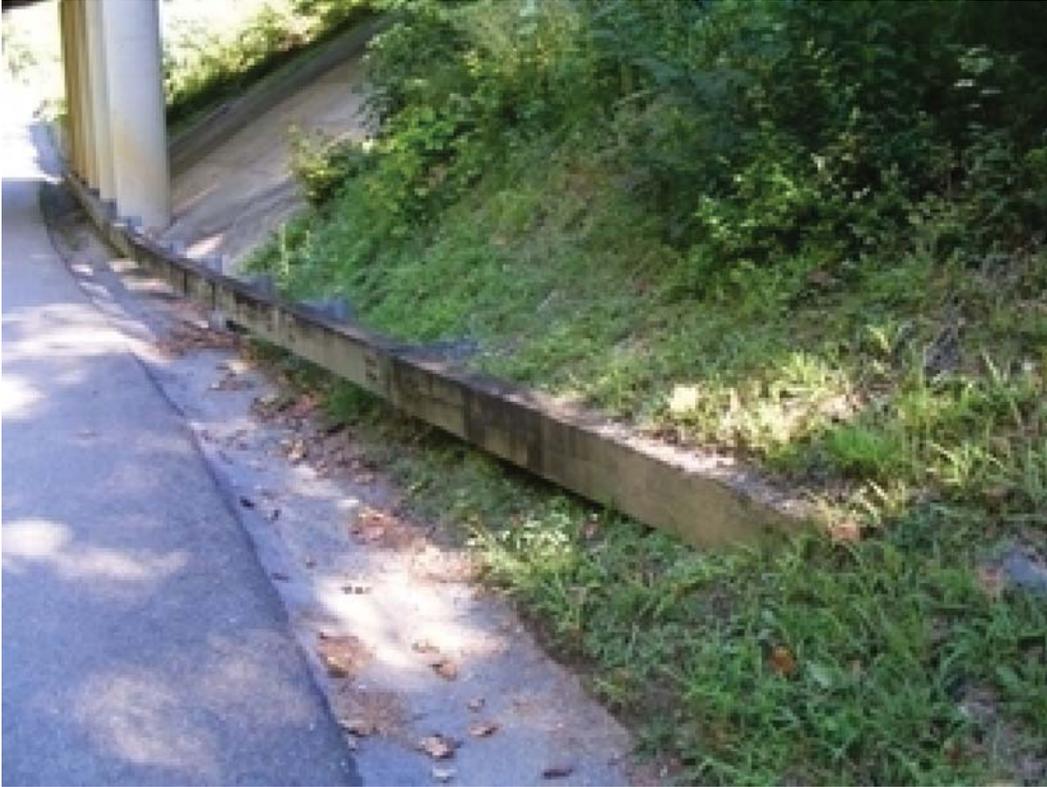
GRSM_0012ZZ_0.082_R_1.JPG

Barrier ID:	GRSM-0012ZZ-0.082-R				
Route Name:	GATLINBURG BYPASS ROAD AND RAMPS				
Inspection Date:	09/14/2010	Barrier Rating:	14.10		
Barrier Description					
Type:	STEEL-BACKED TIMBER WITH BLOCKOUT	Barrier Function:	TRAFFIC		
Barrier Material:	STEEL-BACKED TIMBER/LOG	Post Material:	GALVANIZED STEEL		
Blockout Type:	STEEL	Length (ft.):	113		
Speed Limit (MPH):	35	Placement with Respect to Road:	TANGENT		
Hazard Behind Barrier:	HIGH				
Barrier Crashworthiness					
Appropriate Test Level:	TL-2	Barrier Test Level:	TL-3	Is Barrier Crashworthy?:	YES
Beg. End Trtmt Type:	SBT/LOG BURIED	Is Beg. End Trtmt Crashworthy?:	YES	Approach Transition Type:	NONE
Ending End Trtmt Type:	NONE	Ending End Trtmt Crashworthy?:	N/A		
Average Measurements					
Design Height (In.):	27	Width (In.):	0.0	Post Spacing (In.):	74.5
Height (In.):	26.6	Lateral Offset (In.):	36.0	Road Grade (%):	1.10
Physical Condition					
Barrier	Alignment and Height:	The alignment has no deviation and the height is 0-1 in below the design height of 27 in.

Breaking and Cracking:	No breaking or cracking observed.			
	Missing Elements:	No missing elements observed.			
	Corrosion and Weathering:	No corrosion or weathering observed.			
End Treatments	Alignment and Height:	Alignment acceptable. Height is within 1 in of the 27-in design height.			
	Breaking and Cracking:	No breaking or cracking observed.			
	Missing Elements:	No missing elements observed.			
	Corrosion and Weathering:	No corrosion or weathering observed.

Repair Action:	NO ACTION	FMSS Work Type:	N/A	Repair Cost:	\$0
Brief Workorder:	N/A				
Workorder:

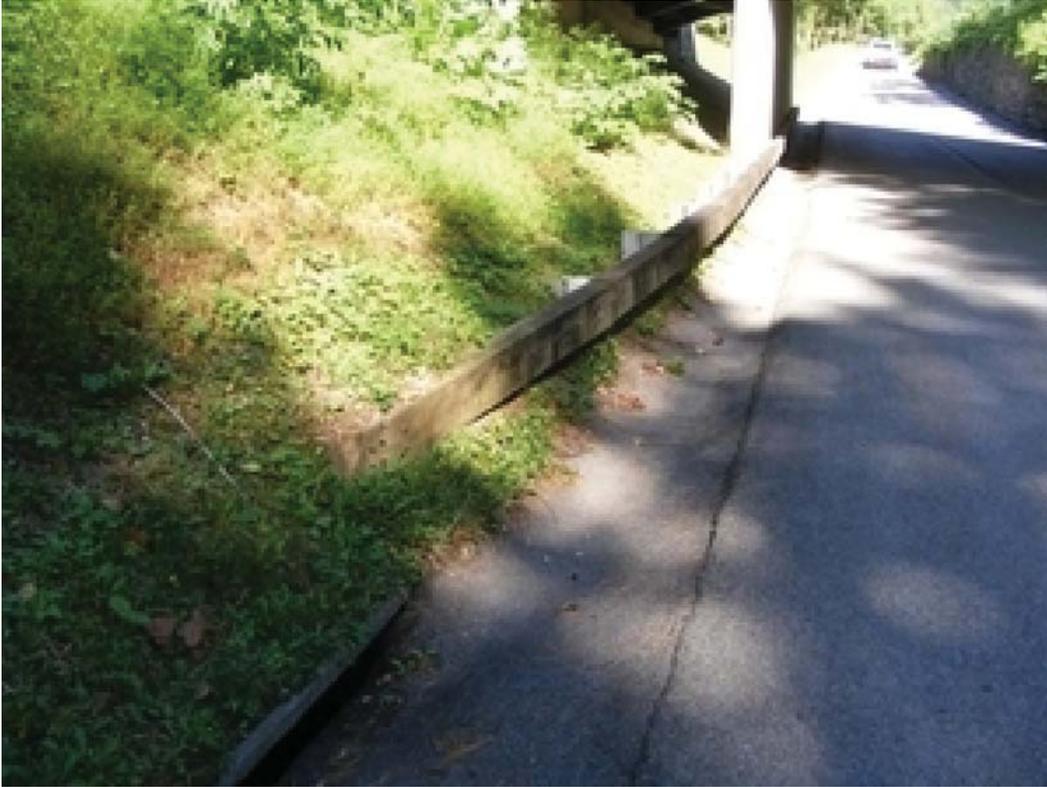
GRSM_0012ZZ_0.088_L_1.JPG

Barrier ID:	GRSM-0012ZZ-0.088-L				
Route Name:	GATLINBURG BYPASS ROAD AND RAMPS				
Inspection Date:	09/14/2010	Barrier Rating:	14.10		
Barrier Description					
Type:	STEEL-BACKED TIMBER WITH BLOCKOUT	Barrier Function:	TRAFFIC		
Barrier Material:	STEEL-BACKED TIMBER/LOG	Post Material:	GALVANIZED STEEL		
Blockout Type:	STEEL	Length (ft.):	124		
Speed Limit (MPH):	35	Placement with Respect to Road:	TANGENT		
Hazard Behind Barrier:	HIGH				
Barrier Crashworthiness					
Appropriate Test Level:	TL-2	Barrier Test Level:	TL-3	Is Barrier Crashworthy?:	YES
Beg. End Trtmt Type:	SBT/LOG BURIED	Is Beg. End Trtmt Crashworthy?:	YES	Approach Transition Type:	NONE
Ending End Trtmt Type:	NONE	Ending End Trtmt Crashworthy?:	N/A		
Average Measurements					
Design Height (In.):	27	Width (In.):	0.0	Post Spacing (In.):	72.3
Height (In.):	26.2	Lateral Offset (In.):	36.0	Road Grade (%):	0.90
Physical Condition					
Barrier	Alignment and Height:	The alignment has no deviation and the height is within 1 in of the design height of 27 in.

Breaking and Cracking:	No breaking or cracking observed.			
	Missing Elements:	No missing elements observed.			
	Corrosion and Weathering:	No corrosion or weathering observed.			
End Treatments	Alignment and Height:	Alignment acceptable. Height is within 1 in of the 27-in design height.			
	Breaking and Cracking:	No breaking or cracking observed.			
	Missing Elements:	No missing elements observed.			
	Corrosion and Weathering:	No corrosion or weathering observed.

Repair Action:	NO ACTION	FMSS Work Type:	N/A	Repair Cost:	\$0
Brief Workorder:	N/A				
Workorder:

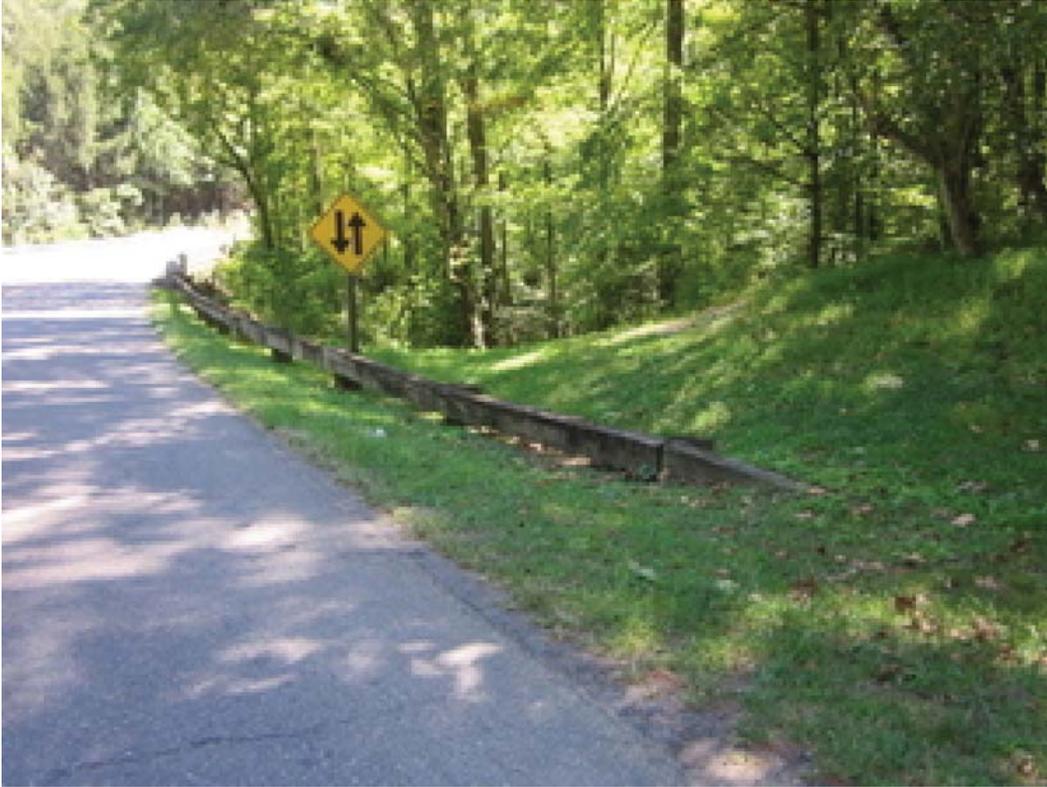
GRSM_0012ZZ_0.080_R_1.JPG

Barrier ID:	GRSM-0012ZZ-0.080-R				
Route Name:	GATLINBURG BYPASS ROAD AND RAMPS				
Inspection Date:	09/13/2010	Barrier Rating:	22.20		
Barrier Description					
Type:	STEEL-BACKED TIMBER WITHOUT BLOCKOUT	Barrier Function:	TRAFFIC		
Barrier Material:	STEEL-BACKED TIMBER/LOG	Post Material:	WOOD		
Blockout Type:	N/A	Length (ft.):	137		
Speed Limit (MPH):	35	Placement with Respect to Road:	TANGENT		
Hazard Behind Barrier:	MEDIUM				
Barrier Crashworthiness					
Appropriate Test Level:	TL-2	Barrier Test Level:	TL-2	Is Barrier Crashworthy?:	YES
Beg. End Trtmt Type:	SBT/LOG BURIED	Is Beg. End Trtmt Crashworthy?:	YES	Approach Transition Type:	RIGID SBT WALL - SBT
Ending End Trtmt Type:	NONE	Ending End Trtmt Crashworthy?:	N/A		
Average Measurements					
Design Height (In.):	27	Width (In.):	0.0	Post Spacing (In.):	120.0
Height (In.):	27.0	Lateral Offset (In.):	43.7	Road Grade (%):	1.80
Physical Condition					
Barrier	Alignment and Height:	The alignment has no deviation and the height is within 1 in of the design height of 27 in.

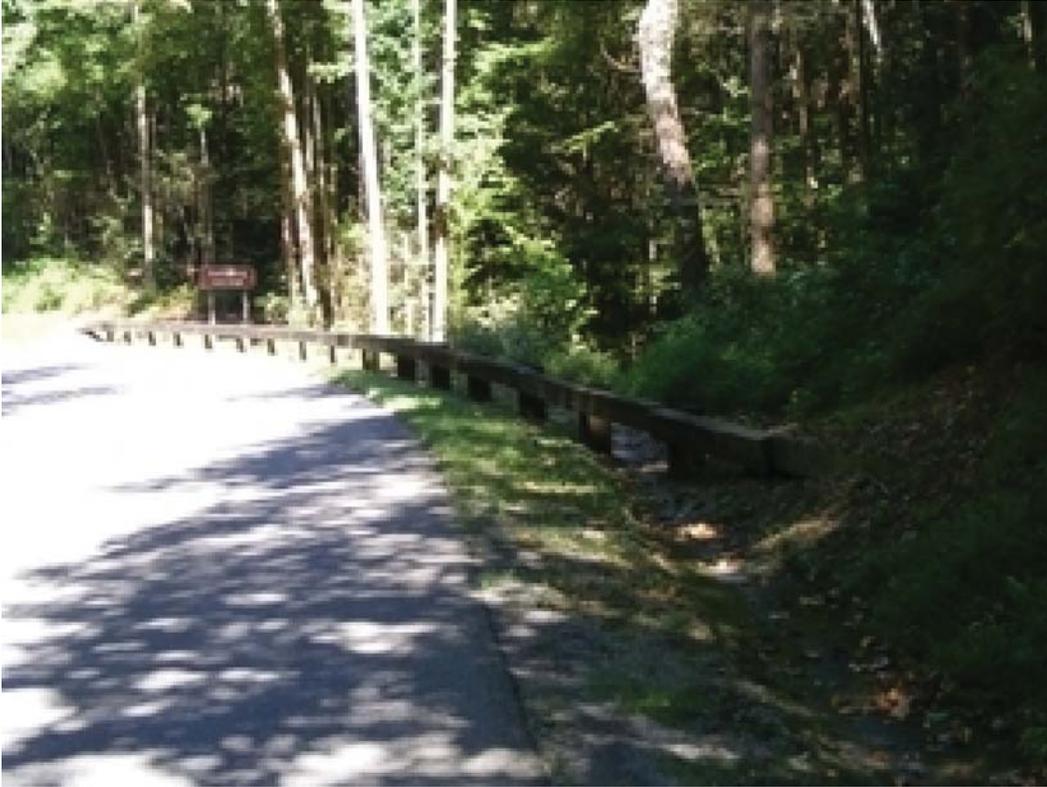
GRSM_0012ZZ_0.181_L_1.JPG

Barrier ID:	GRSM-0012ZZ-0.181-L				
Route Name:	GATLINBURG BYPASS ROAD AND RAMPS				
Inspection Date:	09/13/2010	Barrier Rating:	40.70		
Barrier Description					
Type:	STEEL-BACKED TIMBER WITHOUT BLOCKOUT	Barrier Function:	TRAFFIC		
Barrier Material:	STEEL-BACKED TIMBER/LOG	Post Material:	WOOD		
Blockout Type:	N/A	Length (ft.):	188		
Speed Limit (MPH):	45	Placement with Respect to Road:	OUTSIDE OF CURVE		
Hazard Behind Barrier:	MEDIUM				
Barrier Crashworthiness					
Appropriate Test Level:	TL-2	Barrier Test Level:	TL-2	Is Barrier Crashworthy?:	YES
Beg. End Trtmt Type:	SBT/LOG BURIED	Is Beg. End Trtmt Crashworthy?:	YES	Approach Transition Type:	NONE
Ending End Trtmt Type:	SBT/LOG BURIED	Ending End Trtmt Crashworthy?:	YES		
Average Measurements					
Design Height (In.):	27	Width (In.):	0.0	Post Spacing (In.):	120.0
Height (In.):	28.0	Lateral Offset (In.):	49.5	Road Grade (%):	7.20
Physical Condition					
Barrier	Alignment and Height:	The alignment has no deviation and the height is 0-2 in above the 27 in design height.

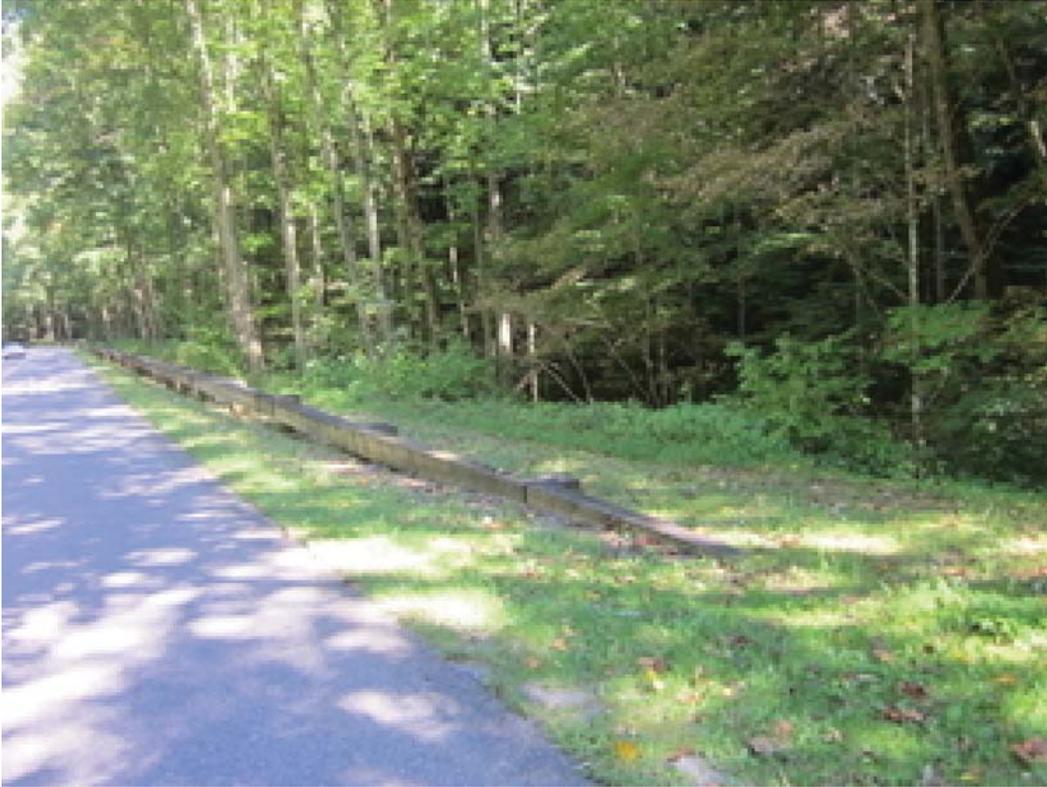
GRSM_0012ZZ_0.338_L_1.JPG

Barrier ID:	GRSM-0012ZZ-0.338-L				
Route Name:	GATLINBURG BYPASS ROAD AND RAMPS				
Inspection Date:	09/13/2010	Barrier Rating:	53.90		
Barrier Description					
Type:	STEEL-BACKED TIMBER WITHOUT BLOCKOUT	Barrier Function:	TRAFFIC		
Barrier Material:	STEEL-BACKED TIMBER/LOG	Post Material:	WOOD		
Blockout Type:	N/A	Length (ft.):	1030		
Speed Limit (MPH):	35	Placement with Respect to Road:	BOTH INSIDE AND OUTSIDE		
Hazard Behind Barrier:	MEDIUM				
Barrier Crashworthiness					
Appropriate Test Level:	TL-2	Barrier Test Level:	TL-2	Is Barrier Crashworthy?:	YES
Beg. End Trtmt Type:	SBT/LOG FLARED	Is Beg. End Trtmt Crashworthy?:	NO	Approach Transition Type:	NONE
Ending End Trtmt Type:	SBT/LOG FLARED	Ending End Trtmt Crashworthy?:	NO		
Average Measurements					
Design Height (In.):	27	Width (In.):	0.0	Post Spacing (In.):	120.8
Height (In.):	25.3	Lateral Offset (In.):	45.0	Road Grade (%):	7.20
Physical Condition

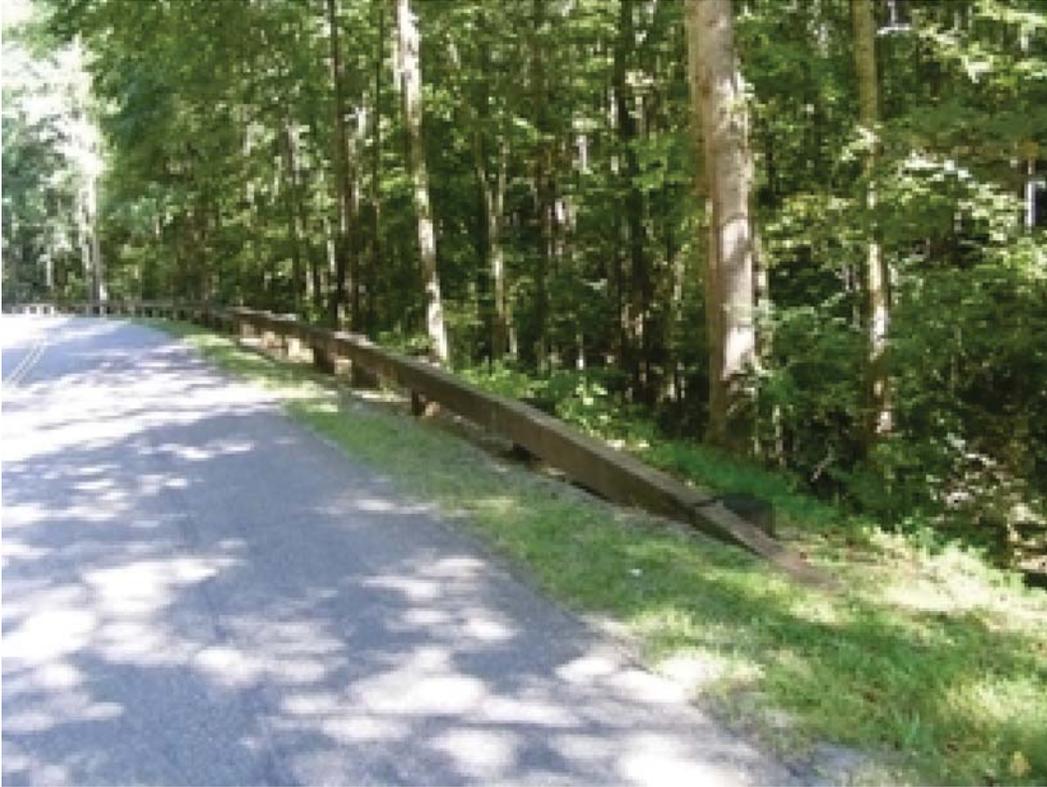
GRSM_0012ZZ_0.727_L_1.JPG

Barrier ID:	GRSM-0012ZZ-0.727-L				
Route Name:	GATLINBURG BYPASS ROAD AND RAMPS				
Inspection Date:	09/13/2010	Barrier Rating:	41.20		
Barrier Description					
Type:	STEEL-BACKED TIMBER WITHOUT BLOCKOUT	Barrier Function:	TRAFFIC		
Barrier Material:	STEEL-BACKED TIMBER/LOG	Post Material:	WOOD		
Blockout Type:	N/A	Length (ft.):	530		
Speed Limit (MPH):	35	Placement with Respect to Road:	OUTSIDE OF CURVE		
Hazard Behind Barrier:	HIGH				
Barrier Crashworthiness					
Appropriate Test Level:	TL-2	Barrier Test Level:	TL-2	Is Barrier Crashworthy?:	YES
Beg. End Trtmt Type:	SBT/LOG FLARED	Is Beg. End Trtmt Crashworthy?:	NO	Approach Transition Type:	NONE
Ending End Trtmt Type:	SBT/LOG FLARED	Ending End Trtmt Crashworthy?:	NO		
Average Measurements					
Design Height (In.):	27	Width (In.):	0.0	Post Spacing (In.):	119.5
Height (In.):	28.2	Lateral Offset (In.):	50.0	Road Grade (%):	7.10
Physical Condition					
Barrier	Alignment and Height:	The alignment has no deviation and the height is 0-3 in above the 27 in design height.

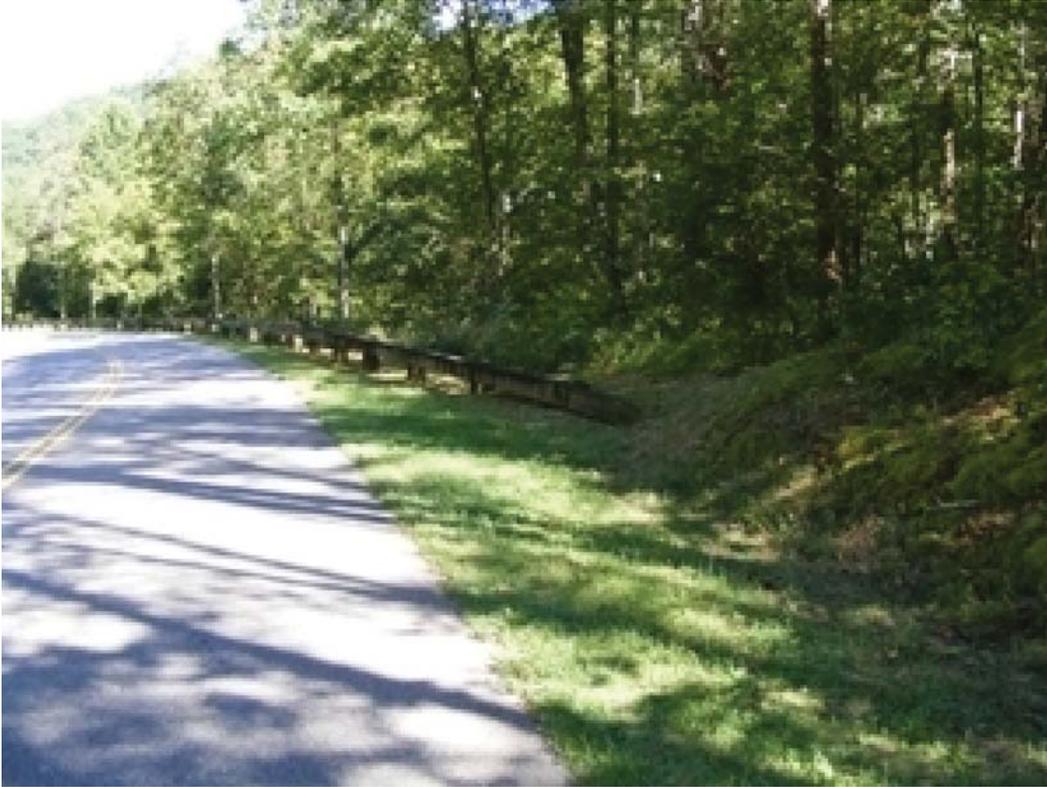
GRSM_0012ZZ_1.268_L_1.JPG

Barrier ID:	GRSM-0012ZZ-1.268-L				
Route Name:	GATLINBURG BYPASS ROAD AND RAMPS				
Inspection Date:	09/13/2010	Barrier Rating:	41.20		
Barrier Description					
Type:	STEEL-BACKED TIMBER WITHOUT BLOCKOUT	Barrier Function:	TRAFFIC		
Barrier Material:	STEEL-BACKED TIMBER/LOG	Post Material:	WOOD		
Blockout Type:	N/A	Length (ft.):	416		
Speed Limit (MPH):	35	Placement with Respect to Road:	OUTSIDE OF CURVE		
Hazard Behind Barrier:	HIGH				
Barrier Crashworthiness					
Appropriate Test Level:	TL-2	Barrier Test Level:	TL-2	Is Barrier Crashworthy?:	YES
Beg. End Trtmt Type:	SBT/LOG FLARED	Is Beg. End Trtmt Crashworthy?:	NO	Approach Transition Type:	NONE
Ending End Trtmt Type:	SBT/LOG FLARED	Ending End Trtmt Crashworthy?:	NO		
Average Measurements					
Design Height (In.):	27	Width (In.):	0.0	Post Spacing (In.):	120.0
Height (In.):	28.0	Lateral Offset (In.):	53.2	Road Grade (%):	8.10
Physical Condition					
Barrier	Alignment and Height:	The alignment has no deviation and the height is 0-1 in above the 27 in design height.

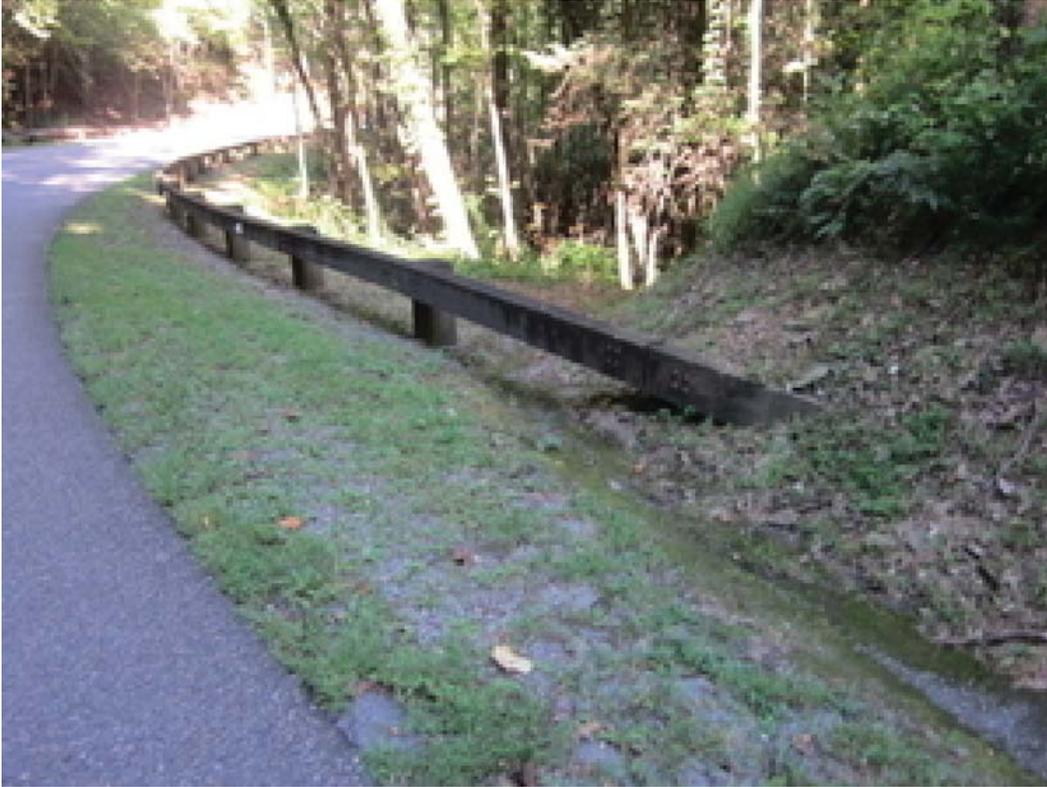
GRSM_0012ZZ_1.386_L_1.JPG

Barrier ID:	GRSM-0012ZZ-1.386-L				
Route Name:	GATLINBURG BYPASS ROAD AND RAMPS				
Inspection Date:	09/13/2010	Barrier Rating:	28.20		
Barrier Description					
Type:	STEEL-BACKED TIMBER WITHOUT BLOCKOUT	Barrier Function:	TRAFFIC		
Barrier Material:	STEEL-BACKED TIMBER/LOG	Post Material:	WOOD		
Blockout Type:	N/A	Length (ft.):	230		
Speed Limit (MPH):	35	Placement with Respect to Road:	INSIDE OF CURVE		
Hazard Behind Barrier:	HIGH				
Barrier Crashworthiness					
Appropriate Test Level:	TL-2	Barrier Test Level:	TL-2	Is Barrier Crashworthy?:	YES
Beg. End Trtmt Type:	SBT/LOG FLARED	Is Beg. End Trtmt Crashworthy?:	NO	Approach Transition Type:	NONE
Ending End Trtmt Type:	SBT/LOG BURIED	Ending End Trtmt Crashworthy?:	YES		
Average Measurements					
Design Height (In.):	27	Width (In.):	0.0	Post Spacing (In.):	120.0
Height (In.):	27.0	Lateral Offset (In.):	62.7	Road Grade (%):	5.40
Physical Condition					
Barrier	Alignment and Height:	No deviation in alignment and height is within 1 in of the design height of 27 in.

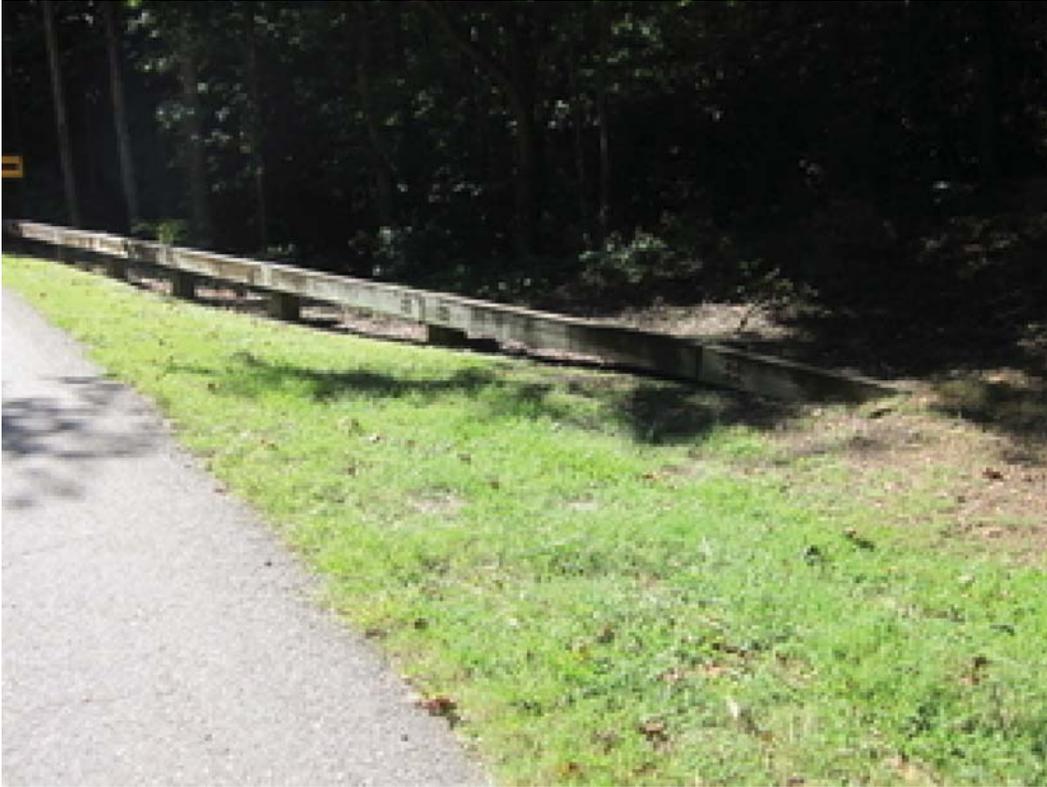
GRSM_0012ZZ_1.394_R_1.JPG

Barrier ID:	GRSM-0012ZZ-1.394-R				
Route Name:	GATLINBURG BYPASS ROAD AND RAMPS				
Inspection Date:	09/13/2010	Barrier Rating:	27.80		
Barrier Description					
Type:	STEEL-BACKED TIMBER WITHOUT BLOCKOUT	Barrier Function:	TRAFFIC		
Barrier Material:	STEEL-BACKED TIMBER/LOG	Post Material:	WOOD		
Blockout Type:	N/A	Length (ft.):	221		
Speed Limit (MPH):	35	Placement with Respect to Road:	OUTSIDE OF CURVE		
Hazard Behind Barrier:	MEDIUM				
Barrier Crashworthiness					
Appropriate Test Level:	TL-2	Barrier Test Level:	TL-2	Is Barrier Crashworthy?:	YES
Beg. End Trtmt Type:	SBT/LOG FLARED	Is Beg. End Trtmt Crashworthy?:	NO	Approach Transition Type:	NONE
Ending End Trtmt Type:	SBT/LOG FLARED	Ending End Trtmt Crashworthy?:	NO		
Average Measurements					
Design Height (In.):	27	Width (In.):	0.0	Post Spacing (In.):	119.3
Height (In.):	28.2	Lateral Offset (In.):	56.2	Road Grade (%):	7.00
Physical Condition					
Barrier	Alignment and Height:	The alignment has no deviation and the height is 0-3 in above the 27 in design height.

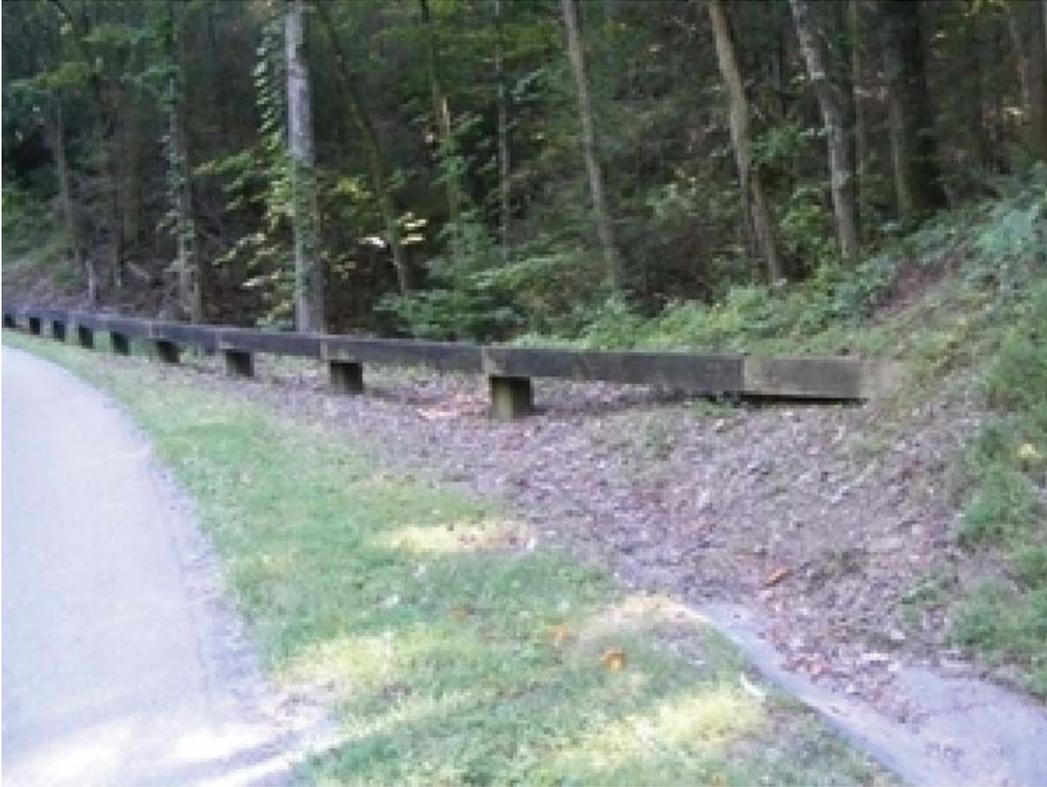
GRSM_0012ZZ_1.471_R_1.JPG

Barrier ID:	GRSM-0012ZZ-1.471-R				
Route Name:	GATLINBURG BYPASS ROAD AND RAMPS				
Inspection Date:	09/13/2010	Barrier Rating:	27.80		
Barrier Description					
Type:	STEEL-BACKED TIMBER WITHOUT BLOCKOUT	Barrier Function:	TRAFFIC		
Barrier Material:	STEEL-BACKED TIMBER/LOG	Post Material:	WOOD		
Blockout Type:	N/A	Length (ft.):	115		
Speed Limit (MPH):	35	Placement with Respect to Road:	OUTSIDE OF CURVE		
Hazard Behind Barrier:	MEDIUM				
Barrier Crashworthiness					
Appropriate Test Level:	TL-2	Barrier Test Level:	TL-2	Is Barrier Crashworthy?:	YES
Beg. End Trtmt Type:	SBT/LOG BURIED	Is Beg. End Trtmt Crashworthy?:	YES	Approach Transition Type:	NONE
Ending End Trtmt Type:	SBT/LOG BURIED	Ending End Trtmt Crashworthy?:	YES		
Average Measurements					
Design Height (In.):	27	Width (In.):	0.0	Post Spacing (In.):	120.5
Height (In.):	27.6	Lateral Offset (In.):	56.5	Road Grade (%):	5.70
Physical Condition					
Barrier	Alignment and Height:	The alignment has no deviation and the height is 0-1 in above the 27 in design height.

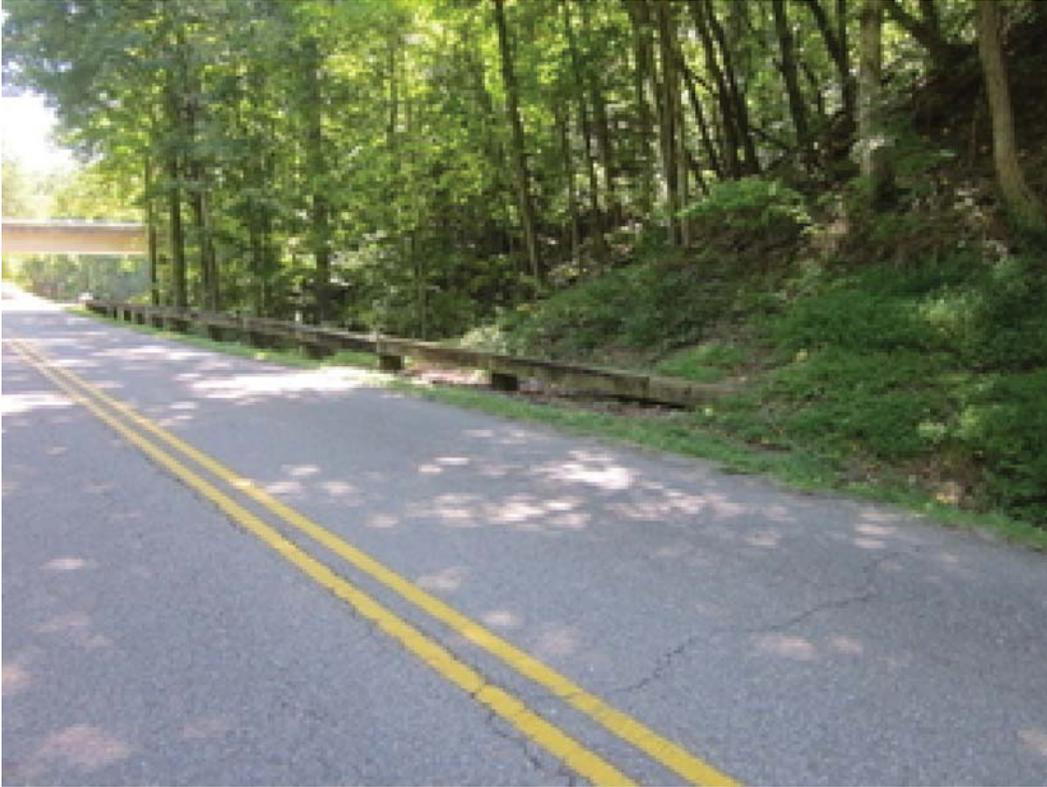
GRSM_0012ZZ_1.740_R_1.JPG

Barrier ID:	GRSM-0012ZZ-1.740-R				
Route Name:	GATLINBURG BYPASS ROAD AND RAMPS				
Inspection Date:	09/14/2010	Barrier Rating:	22.20		
Barrier Description					
Type:	STEEL-BACKED TIMBER WITHOUT BLOCKOUT	Barrier Function:	TRAFFIC		
Barrier Material:	STEEL-BACKED TIMBER/LOG	Post Material:	WOOD		
Blockout Type:	N/A	Length (ft.):	175		
Speed Limit (MPH):	35	Placement with Respect to Road:	INSIDE OF CURVE		
Hazard Behind Barrier:	MEDIUM				
Barrier Crashworthiness					
Appropriate Test Level:	TL-2	Barrier Test Level:	TL-2	Is Barrier Crashworthy?:	YES
Beg. End Trtmt Type:	SBT/LOG FLARED	Is Beg. End Trtmt Crashworthy?:	NO	Approach Transition Type:	NONE
Ending End Trtmt Type:	SBT/LOG FLARED	Ending End Trtmt Crashworthy?:	NO		
Average Measurements					
Design Height (In.):	27	Width (In.):	0.0	Post Spacing (In.):	120.6
Height (In.):	27.2	Lateral Offset (In.):	50.0	Road Grade (%):	2.30
Physical Condition					
Barrier	Alignment and Height:	The alignment has no deviation and the height is within 1 in of the 27 in design height.

Breaking and Cracking:	No breaking or cracking observed.			
	Missing Elements:	No missing elements observed.			
	Corrosion and Weathering:	No corrosion or weathering observed.			
End Treatments	Alignment and Height:	Alignment acceptable. Height is within 1 in of the 27-in design height.			
	Breaking and Cracking:	No breaking or cracking observed.			
	Missing Elements:	No missing elements observed.			
	Corrosion and Weathering:	No corrosion or weathering observed.

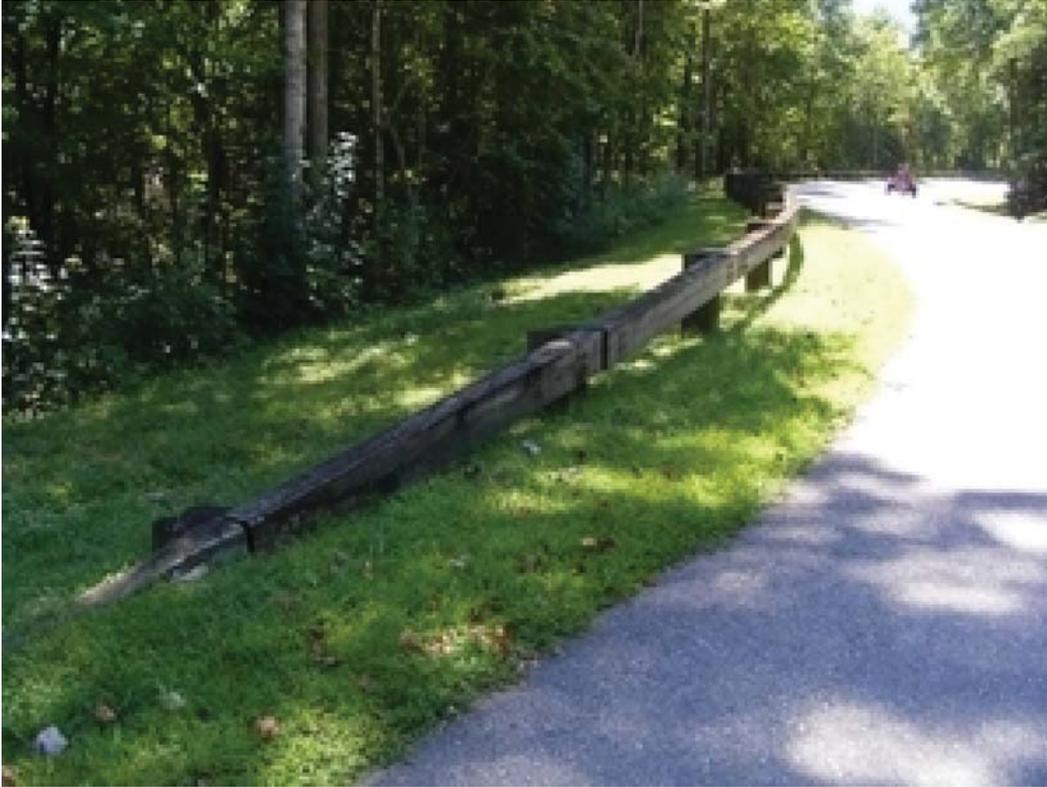
GRSM_0012ZZ_1.836_L_1.JPG

Barrier ID:	GRSM-0012ZZ-1.836-L				
Route Name:	GATLINBURG BYPASS ROAD AND RAMPS				
Inspection Date:	09/14/2010	Barrier Rating:	35.40		
Barrier Description					
Type:	STEEL-BACKED TIMBER WITHOUT BLOCKOUT	Barrier Function:	TRAFFIC		
Barrier Material:	STEEL-BACKED TIMBER/LOG	Post Material:	WOOD		
Blockout Type:	N/A	Length (ft.):	838		
Speed Limit (MPH):	35	Placement with Respect to Road:	OUTSIDE OF CURVE		
Hazard Behind Barrier:	HIGH				
Barrier Crashworthiness					
Appropriate Test Level:	TL-2	Barrier Test Level:	TL-2	Is Barrier Crashworthy?:	YES
Beg. End Trtmt Type:	SBT/LOG FLARED	Is Beg. End Trtmt Crashworthy?:	NO	Approach Transition Type:	NONE
Ending End Trtmt Type:	SBT/LOG FLARED	Ending End Trtmt Crashworthy?:	NO		
Average Measurements					
Design Height (In.):	27	Width (In.):	0.0	Post Spacing (In.):	119.8
Height (In.):	29.0	Lateral Offset (In.):	53.2	Road Grade (%):	3.20
Physical Condition					
Barrier	Alignment and Height:	The alignment has no deviation and the height is 0-3 in above the design height of 27 in.

Breaking and Cracking:	No breaking observed.			
	Missing Elements:	No missing elements observed.			
	Corrosion and Weathering:	No corrosion or weathering observed.			
End Treatments	Alignment and Height:	Alignment acceptable. Height is within 1 in of the 27-in design height.			
	Breaking and Cracking:	No breaking or cracking observed.			
	Missing Elements:	No missing elements observed.			
	Corrosion and Weathering:	No corrosion observed.
