NPS Guardwall/Rail Inventory Program
Great Smoky Mountains National Park

Federal Highway Administration
Eastern Federal Lands Highway Division
Road Inventory Program (RIP)

Data Collection Date: September 2010
Report Date: December 2015

Great Smoky Mountains National Park in North Carolina and Tennessee

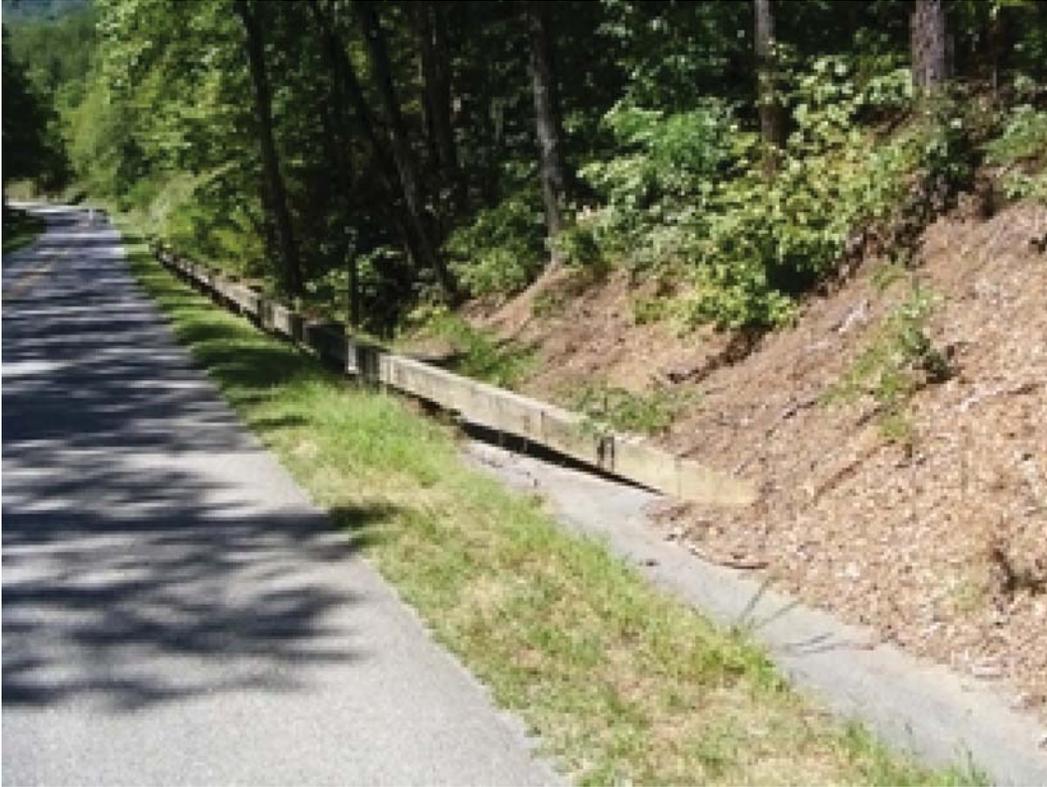
GRSM_0012ZZ_2.106_R_1.JPG

Barrier ID:	GRSM-0012ZZ-2.106-R				
Route Name:	GATLINBURG BYPASS ROAD AND RAMPS				
Inspection Date:	09/14/2010	Barrier Rating:	29.30		
Barrier Description					
Type:	STEEL-BACKED TIMBER WITHOUT BLOCKOUT	Barrier Function:	TRAFFIC		
Barrier Material:	STEEL-BACKED TIMBER/LOG	Post Material:	WOOD		
Blockout Type:	N/A	Length (ft.):	257		
Speed Limit (MPH):	35	Placement with Respect to Road:	TANGENT		
Hazard Behind Barrier:	MEDIUM				
Barrier Crashworthiness					
Appropriate Test Level:	TL-2	Barrier Test Level:	TL-2	Is Barrier Crashworthy?:	YES
Beg. End Trtmt Type:	SBT/LOG BURIED	Is Beg. End Trtmt Crashworthy?:	YES	Approach Transition Type:	NONE
Ending End Trtmt Type:	SBT/LOG FLARED	Ending End Trtmt Crashworthy?:	NO		
Average Measurements					
Design Height (In.):	27	Width (In.):	0.0	Post Spacing (In.):	120.3
Height (In.):	28.0	Lateral Offset (In.):	44.5	Road Grade (%):	4.80
Physical Condition					
Barrier	Alignment and Height:	The alignment has no deviation and the height is 0-3 in above the design height of 27 in.

Breaking and Cracking:	No breaking or cracking observed.			
	Missing Elements:	No missing elements observed.			
	Corrosion and Weathering:	No corrosion or weathering observed.			
End Treatments	Alignment and Height:	Alignment acceptable. Height is within 1 in of the 27-in design height.			
	Breaking and Cracking:	No breaking or cracking observed.			
	Missing Elements:	No missing elements observed.			
	Corrosion and Weathering:	No corrosion or weathering observed.

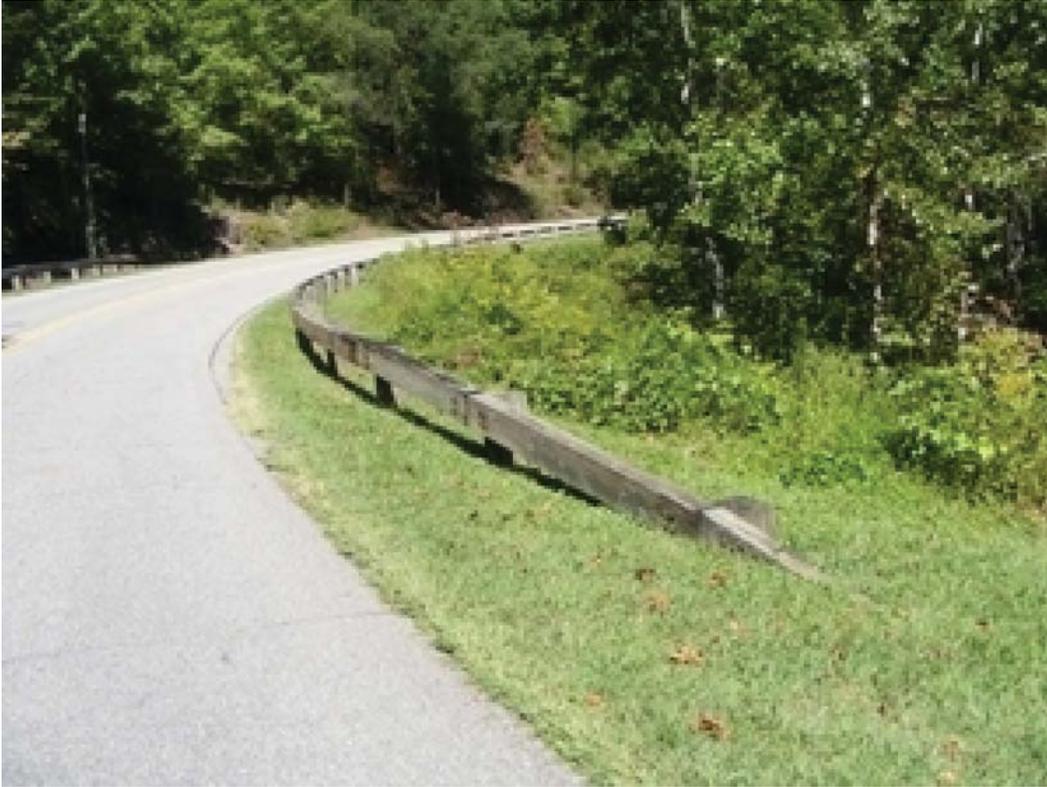
GRSM_0012ZZ_2.212_L_1.JPG

Barrier ID:	GRSM-0012ZZ-2.212-L				
Route Name:	GATLINBURG BYPASS ROAD AND RAMPS				
Inspection Date:	09/14/2010	Barrier Rating:	28.60		
Barrier Description					
Type:	STEEL-BACKED TIMBER WITHOUT BLOCKOUT	Barrier Function:	TRAFFIC		
Barrier Material:	STEEL-BACKED TIMBER/LOG	Post Material:	WOOD		
Blockout Type:	N/A	Length (ft.):	658		
Speed Limit (MPH):	35	Placement with Respect to Road:	INSIDE OF CURVE		
Hazard Behind Barrier:	EXTREME				
Barrier Crashworthiness					
Appropriate Test Level:	TL-2	Barrier Test Level:	TL-2	Is Barrier Crashworthy?:	YES
Beg. End Trtmt Type:	SBT/LOG FLARED	Is Beg. End Trtmt Crashworthy?:	NO	Approach Transition Type:	NONE
Ending End Trtmt Type:	SBT/LOG FLARED	Ending End Trtmt Crashworthy?:	NO		
Average Measurements					
Design Height (In.):	27	Width (In.):	0.0	Post Spacing (In.):	120.0
Height (In.):	26.7	Lateral Offset (In.):	51.0	Road Grade (%):	0.50
Physical Condition					
Barrier	Alignment and Height:	The alignment has no deviation and the height is within 1 in of the design height of 27 in.

Breaking and Cracking:	No breaking or cracking observed.			
	Missing Elements:	No missing elements observed.			
	Corrosion and Weathering:	No corrosion or weathering observed.			
End Treatments	Alignment and Height:	Alignment acceptable. Height is within 1 in of the 27-in design height.			
	Breaking and Cracking:	No breaking or cracking observed.			
	Missing Elements:	No missing elements observed.			
	Corrosion and Weathering:	No corrosion or weathering observed.

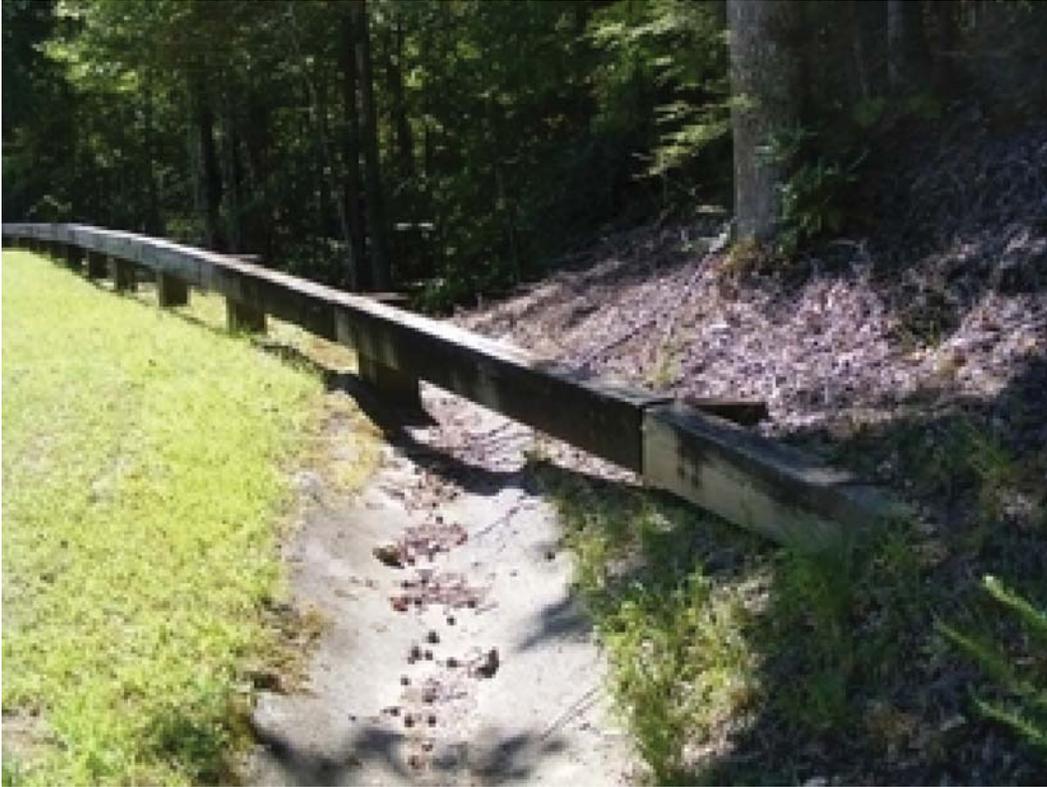
GRSM_0012ZZ_2.306_R_1.JPG

Barrier ID:	GRSM-0012ZZ-2.306-R				
Route Name:	GATLINBURG BYPASS ROAD AND RAMPS				
Inspection Date:	09/14/2010	Barrier Rating:	29.70		
Barrier Description					
Type:	STEEL-BACKED TIMBER WITHOUT BLOCKOUT	Barrier Function:	TRAFFIC		
Barrier Material:	STEEL-BACKED TIMBER/LOG	Post Material:	WOOD		
Blockout Type:	N/A	Length (ft.):	215		
Speed Limit (MPH):	35	Placement with Respect to Road:	OUTSIDE OF CURVE		
Hazard Behind Barrier:	HIGH				
Barrier Crashworthiness					
Appropriate Test Level:	TL-2	Barrier Test Level:	TL-2	Is Barrier Crashworthy?:	YES
Beg. End Trtmt Type:	SBT/LOG FLARED	Is Beg. End Trtmt Crashworthy?:	NO	Approach Transition Type:	NONE
Ending End Trtmt Type:	SBT/LOG FLARED	Ending End Trtmt Crashworthy?:	NO		
Average Measurements					
Design Height (In.):	27	Width (In.):	0.0	Post Spacing (In.):	120.3
Height (In.):	28.7	Lateral Offset (In.):	52.2	Road Grade (%):	1.30
Physical Condition					
Barrier	Alignment and Height:	The alignment has no deviation and the height is 0-3 in above the design height of 27 in.

Breaking and Cracking:	No breaking or cracking observed.			
	Missing Elements:	No missing elements observed.			
	Corrosion and Weathering:	No corrosion or weathering observed.			
End Treatments	Alignment and Height:	Alignment acceptable. Height is within 1 in of the 27-in design height.			
	Breaking and Cracking:	No breaking or cracking observed.			
	Missing Elements:	No missing elements observed.			
	Corrosion and Weathering:	No corrosion observed.

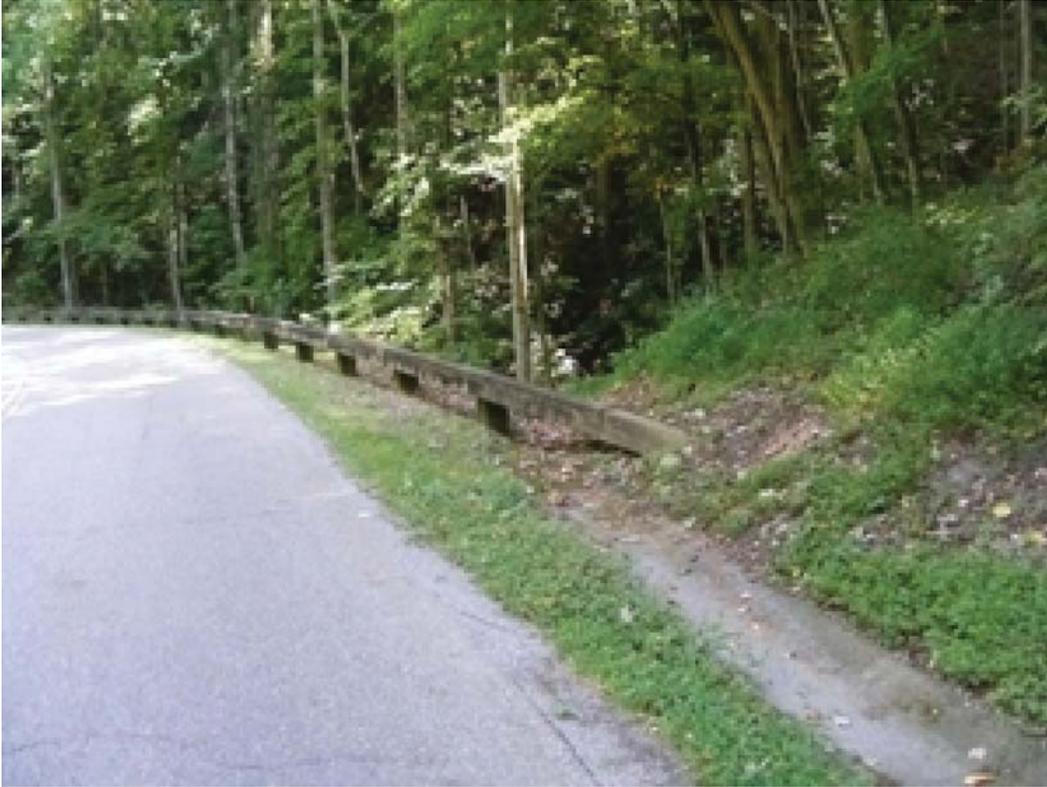
GRSM_0012ZZ_2.673_R_1.JPG

Barrier ID:	GRSM-0012ZZ-2.673-R				
Route Name:	GATLINBURG BYPASS ROAD AND RAMPS				
Inspection Date:	09/14/2010	Barrier Rating:	58.40		
Barrier Description					
Type:	STEEL-BACKED TIMBER WITHOUT BLOCKOUT	Barrier Function:	TRAFFIC		
Barrier Material:	STEEL-BACKED TIMBER/LOG	Post Material:	WOOD		
Blockout Type:	N/A	Length (ft.):	224		
Speed Limit (MPH):	35	Placement with Respect to Road:	OUTSIDE OF CURVE		
Hazard Behind Barrier:	HIGH				
Barrier Crashworthiness					
Appropriate Test Level:	TL-2	Barrier Test Level:	TL-2	Is Barrier Crashworthy?:	YES
Beg. End Trtmt Type:	SBT/LOG FLARED	Is Beg. End Trtmt Crashworthy?:	NO	Approach Transition Type:	NONE
Ending End Trtmt Type:	SBT/LOG FLARED	Ending End Trtmt Crashworthy?:	NO		
Average Measurements					
Design Height (In.):	27	Width (In.):	0.0	Post Spacing (In.):	120.0
Height (In.):	22.2	Lateral Offset (In.):	41.5	Road Grade (%):	4.80
Physical Condition					
Barrier	Alignment and Height:	The alignment has no deviation and the height is 4 to 6 in below the 27 in design height for 224 ft.

Breaking and Cracking:	No breaking or cracking observed.			
	Missing Elements:	No missing elements observed.			
	Corrosion and Weathering:	No corrosion or weathering observed.			
End Treatments	Alignment and Height:	Alignment acceptable. Height is within 1 in of the 27-in design height.			
	Breaking and Cracking:	No breaking or cracking observed.			
	Missing Elements:	No missing elements observed.			
	Corrosion and Weathering:	No corrosion or weathering observed.

Repair Action:	REPAIR	FMSS Work Type:	DEFERRED MAINTENANCE	Repair Cost:	\$4086
Brief Workorder:	Raise 224 feet of barrier to the 27 inch design height.				
Workorder:	Adjust Guardrail at \$10- per -Lin. Ft. for 224 LF = \$2240. Raise 224 feet of barrier to the 27 inch design height. Low Speed Traffic Control at \$1475- per -Day for 1 Day(s) = \$1475.

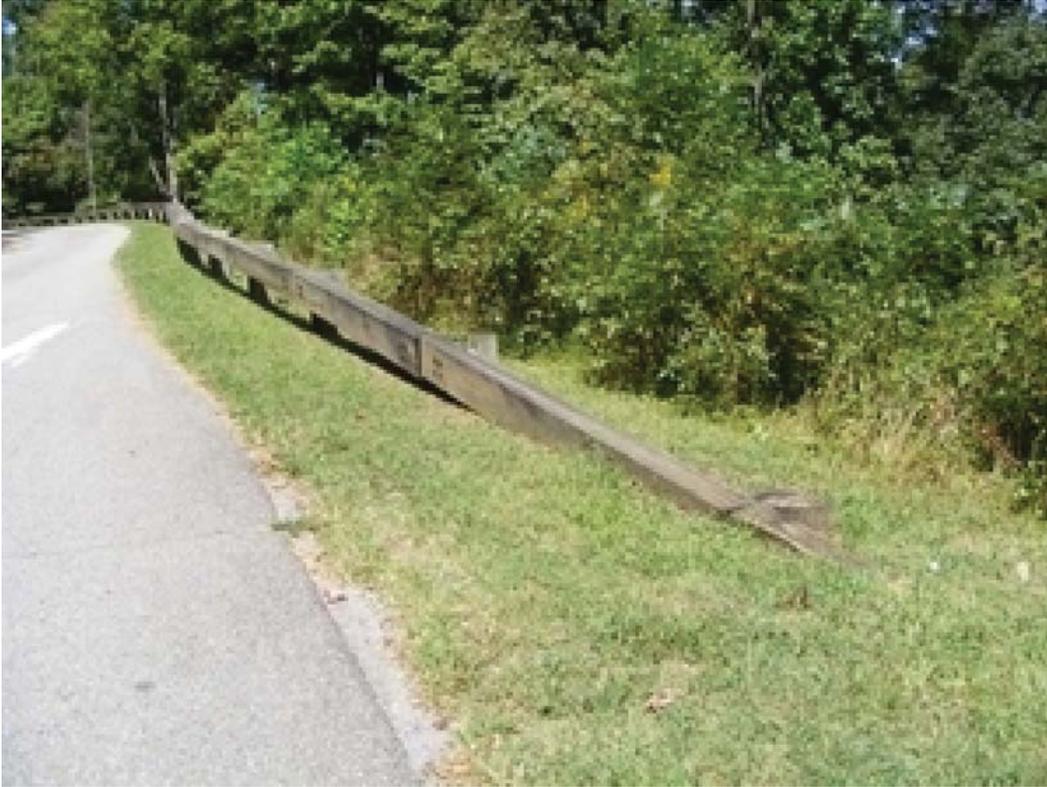
GRSM_0012ZZ_2.719_L_1.JPG

Barrier ID:	GRSM-0012ZZ-2.719-L				
Route Name:	GATLINBURG BYPASS ROAD AND RAMPS				
Inspection Date:	09/14/2010	Barrier Rating:	40.00		
Barrier Description					
Type:	STEEL-BACKED TIMBER WITHOUT BLOCKOUT	Barrier Function:	TRAFFIC		
Barrier Material:	STEEL-BACKED TIMBER/LOG	Post Material:	WOOD		
Blockout Type:	N/A	Length (ft.):	803		
Speed Limit (MPH):	35	Placement with Respect to Road:	OUTSIDE OF CURVE		
Hazard Behind Barrier:	EXTREME				
Barrier Crashworthiness					
Appropriate Test Level:	TL-2	Barrier Test Level:	TL-2	Is Barrier Crashworthy?:	YES
Beg. End Trtmt Type:	SBT/LOG FLARED	Is Beg. End Trtmt Crashworthy?:	NO	Approach Transition Type:	NONE
Ending End Trtmt Type:	SBT/LOG FLARED	Ending End Trtmt Crashworthy?:	NO		
Average Measurements					
Design Height (In.):	27	Width (In.):	0.0	Post Spacing (In.):	119.6
Height (In.):	27.0	Lateral Offset (In.):	43.7	Road Grade (%):	3.20
Physical Condition					
Barrier	Alignment and Height:	The alignment has no deviation and the height within 1 in of the design height of 27 in.

Breaking and Cracking:	No breaking or cracking observed.			
	Missing Elements:	No missing elements observed.			
	Corrosion and Weathering:	No corrosion or weathering observed.			
End Treatments	Alignment and Height:	Alignment acceptable. Height is within 1 in of the 27-in design height.			
	Breaking and Cracking:	No breaking or cracking observed.			
	Missing Elements:	No missing elements observed.			
	Corrosion and Weathering:	No corrosion or weathering observed.

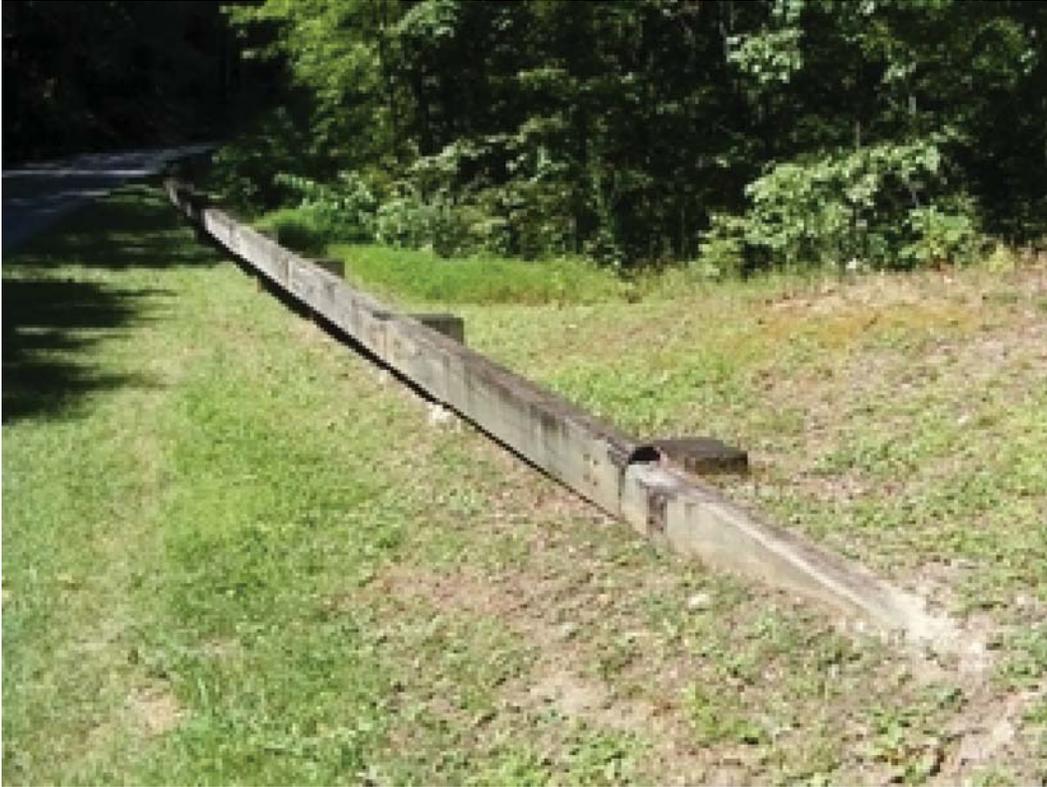
GRSM_0012ZZ_2.922_L_1.JPG

Barrier ID:	GRSM-0012ZZ-2.922-L				
Route Name:	GATLINBURG BYPASS ROAD AND RAMPS				
Inspection Date:	09/14/2010	Barrier Rating:	26.80		
Barrier Description					
Type:	STEEL-BACKED TIMBER WITHOUT BLOCKOUT	Barrier Function:	TRAFFIC		
Barrier Material:	STEEL-BACKED TIMBER/LOG	Post Material:	WOOD		
Blockout Type:	N/A	Length (ft.):	260		
Speed Limit (MPH):	35	Placement with Respect to Road:	INSIDE OF CURVE		
Hazard Behind Barrier:	HIGH				
Barrier Crashworthiness					
Appropriate Test Level:	TL-2	Barrier Test Level:	TL-2	Is Barrier Crashworthy?:	YES
Beg. End Trtmt Type:	SBT/LOG BURIED	Is Beg. End Trtmt Crashworthy?:	YES	Approach Transition Type:	NONE
Ending End Trtmt Type:	SBT/LOG FLARED	Ending End Trtmt Crashworthy?:	NO		
Average Measurements					
Design Height (In.):	27	Width (In.):	0.0	Post Spacing (In.):	119.0
Height (In.):	28.2	Lateral Offset (In.):	63.2	Road Grade (%):	6.30
Physical Condition					
Barrier	Alignment and Height:	The alignment has no deviation and the height is 0-2 in above the design height of 27 in.

Breaking and Cracking:	No breaking observed.			
	Missing Elements:	No missing elements observed.			
	Corrosion and Weathering:	No corrosion or weathering observed.			
End Treatments	Alignment and Height:	Alignment acceptable. Height is within 1 in of the 27-in design height.			
	Breaking and Cracking:	No breaking observed.			
	Missing Elements:	No missing elements observed.			
	Corrosion and Weathering:	No corrosion observed.

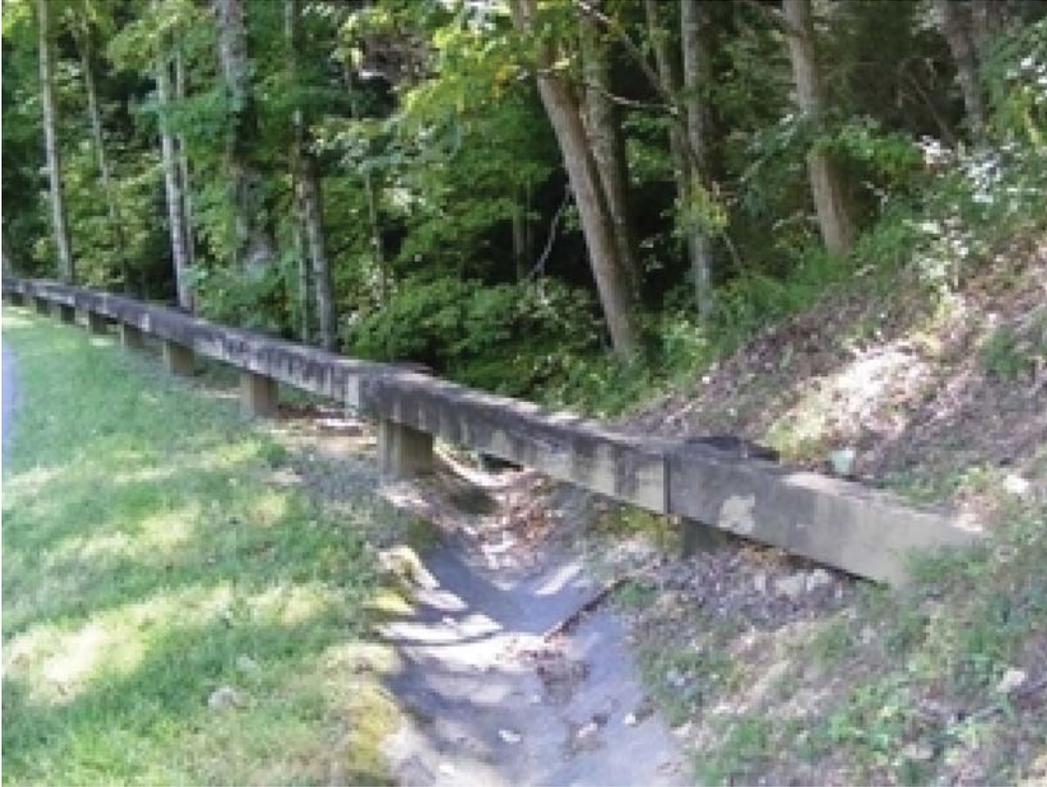
GRSM_0012ZZ_2.922_R_1.JPG

Barrier ID:	GRSM-0012ZZ-2.922-R				
Route Name:	GATLINBURG BYPASS ROAD AND RAMPS				
Inspection Date:	09/14/2010	Barrier Rating:	38.20		
Barrier Description					
Type:	STEEL-BACKED TIMBER WITHOUT BLOCKOUT	Barrier Function:	TRAFFIC		
Barrier Material:	STEEL-BACKED TIMBER/LOG	Post Material:	WOOD		
Blockout Type:	N/A	Length (ft.):	214		
Speed Limit (MPH):	35	Placement with Respect to Road:	OUTSIDE OF CURVE		
Hazard Behind Barrier:	HIGH				
Barrier Crashworthiness					
Appropriate Test Level:	TL-2	Barrier Test Level:	TL-2	Is Barrier Crashworthy?:	YES
Beg. End Trtmt Type:	SBT/LOG BURIED	Is Beg. End Trtmt Crashworthy?:	YES	Approach Transition Type:	NONE
Ending End Trtmt Type:	SBT/LOG FLARED	Ending End Trtmt Crashworthy?:	NO		
Average Measurements					
Design Height (In.):	27	Width (In.):	0.0	Post Spacing (In.):	120.3
Height (In.):	29.0	Lateral Offset (In.):	51.2	Road Grade (%):	7.30
Physical Condition					
Barrier	Alignment and Height:	The alignment has no deviation and the height is 0-5 in above the design height of 27 in.

Breaking and Cracking:	No breaking or cracking observed.			
	Missing Elements:	No missing elements observed.			
	Corrosion and Weathering:	No corrosion or weathering observed.			
End Treatments	Alignment and Height:	Alignment acceptable. Height is within 1 in of the 27-in design height.			
	Breaking and Cracking:	No breaking observed.			
	Missing Elements:	No missing elements observed.			
	Corrosion and Weathering:	No weathering observed.

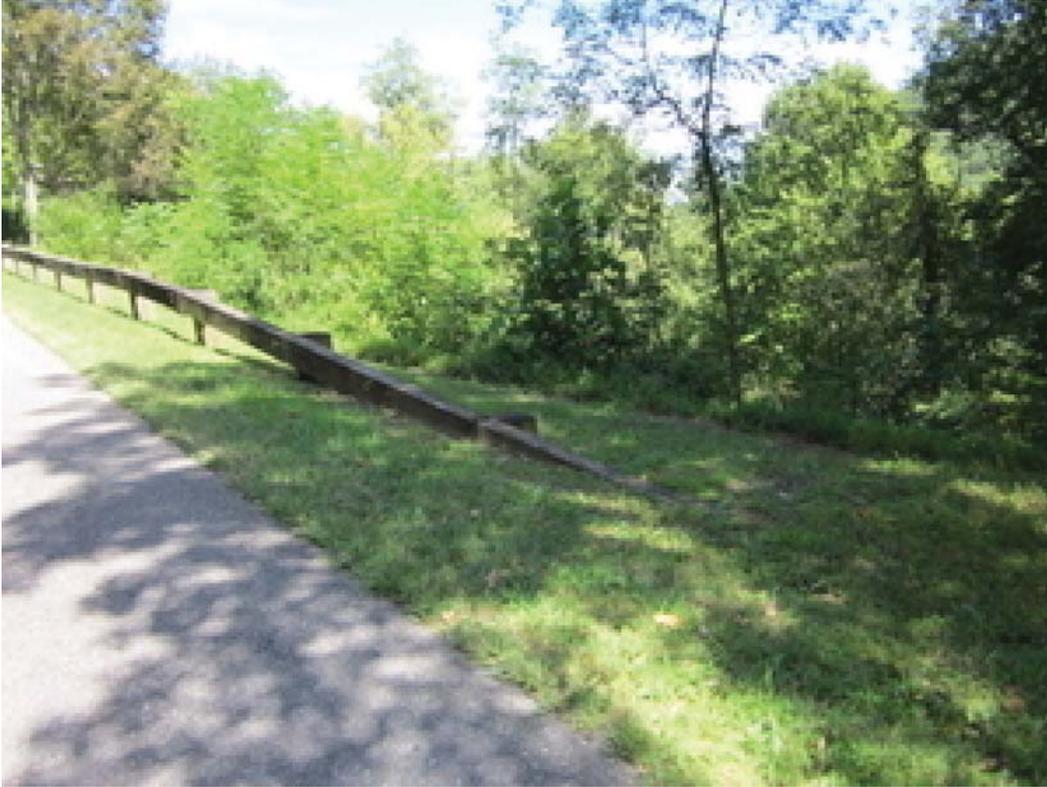
GRSM_0012ZZ_2.994_L_1.JPG

Barrier ID:	GRSM-0012ZZ-2.994-L				
Route Name:	GATLINBURG BYPASS ROAD AND RAMPS				
Inspection Date:	09/14/2010	Barrier Rating:	32.50		
Barrier Description					
Type:	STEEL-BACKED TIMBER WITHOUT BLOCKOUT	Barrier Function:	TRAFFIC		
Barrier Material:	STEEL-BACKED TIMBER/LOG	Post Material:	WOOD		
Blockout Type:	N/A	Length (ft.):	325		
Speed Limit (MPH):	35	Placement with Respect to Road:	OUTSIDE OF CURVE		
Hazard Behind Barrier:	HIGH				
Barrier Crashworthiness					
Appropriate Test Level:	TL-2	Barrier Test Level:	TL-2	Is Barrier Crashworthy?:	YES
Beg. End Trtmt Type:	SBT/LOG FLARED	Is Beg. End Trtmt Crashworthy?:	NO	Approach Transition Type:	NONE
Ending End Trtmt Type:	SBT/LOG FLARED	Ending End Trtmt Crashworthy?:	NO		
Average Measurements					
Design Height (In.):	27	Width (In.):	0.0	Post Spacing (In.):	120.3
Height (In.):	29.6	Lateral Offset (In.):	50.0	Road Grade (%):	7.50
Physical Condition					
Barrier	Alignment and Height:	The alignment has no deviation and the height is 2 to 3 in above the 27 in design height.

Breaking and Cracking:	No breaking or cracking observed.			
	Missing Elements:	No missing elements observed.			
	Corrosion and Weathering:	No corrosion or weathering observed.			
End Treatments	Alignment and Height:	Alignment acceptable. Height is within 1 in of the 27-in design height.			
	Breaking and Cracking:	No breaking or cracking observed.			
	Missing Elements:	No missing elements observed.			
	Corrosion and Weathering:	No corrosion or weathering observed.

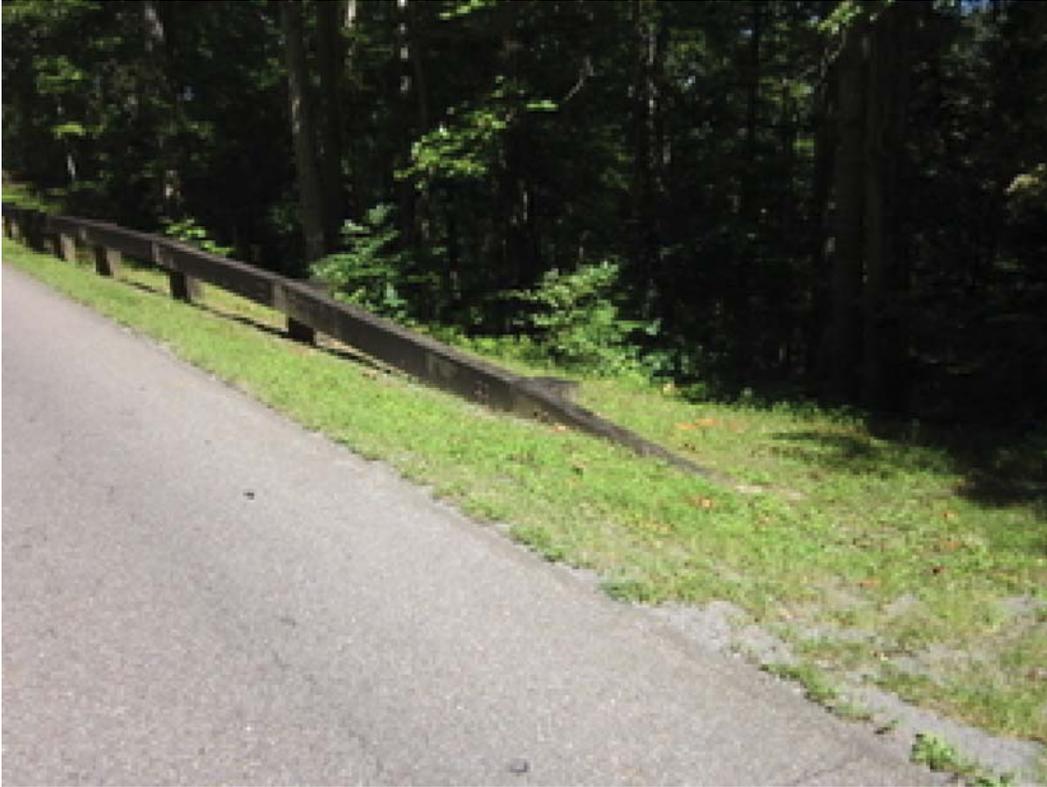
GRSM_0012ZZ_3.087_L_1.JPG

Barrier ID:	GRSM-0012ZZ-3.087-L				
Route Name:	GATLINBURG BYPASS ROAD AND RAMPS				
Inspection Date:	09/14/2010	Barrier Rating:	29.30		
Barrier Description					
Type:	STEEL-BACKED TIMBER WITHOUT BLOCKOUT	Barrier Function:	TRAFFIC		
Barrier Material:	STEEL-BACKED TIMBER/LOG	Post Material:	WOOD		
Blockout Type:	N/A	Length (ft.):	161		
Speed Limit (MPH):	35	Placement with Respect to Road:	INSIDE OF CURVE		
Hazard Behind Barrier:	MEDIUM				
Barrier Crashworthiness					
Appropriate Test Level:	TL-2	Barrier Test Level:	TL-2	Is Barrier Crashworthy?:	YES
Beg. End Trtmt Type:	SBT/LOG FLARED	Is Beg. End Trtmt Crashworthy?:	NO	Approach Transition Type:	NONE
Ending End Trtmt Type:	SBT/LOG FLARED	Ending End Trtmt Crashworthy?:	NO		
Average Measurements					
Design Height (In.):	27	Width (In.):	0.0	Post Spacing (In.):	119.6
Height (In.):	26.0	Lateral Offset (In.):	30.2	Road Grade (%):	5.60
Physical Condition					
Barrier	Alignment and Height:	The alignment has no deviation and the height is within 1 in of the design height of 27 in.

Breaking and Cracking:	No breaking or cracking observed.			
	Missing Elements:	No missing elements observed.			
	Corrosion and Weathering:	No corrosion or weathering observed.			
End Treatments	Alignment and Height:	Alignment acceptable. Height is within 1 in of the 27-in design height.			
	Breaking and Cracking:	No breaking or cracking observed.			
	Missing Elements:	No missing elements observed.			
	Corrosion and Weathering:	No corrosion or weathering observed.

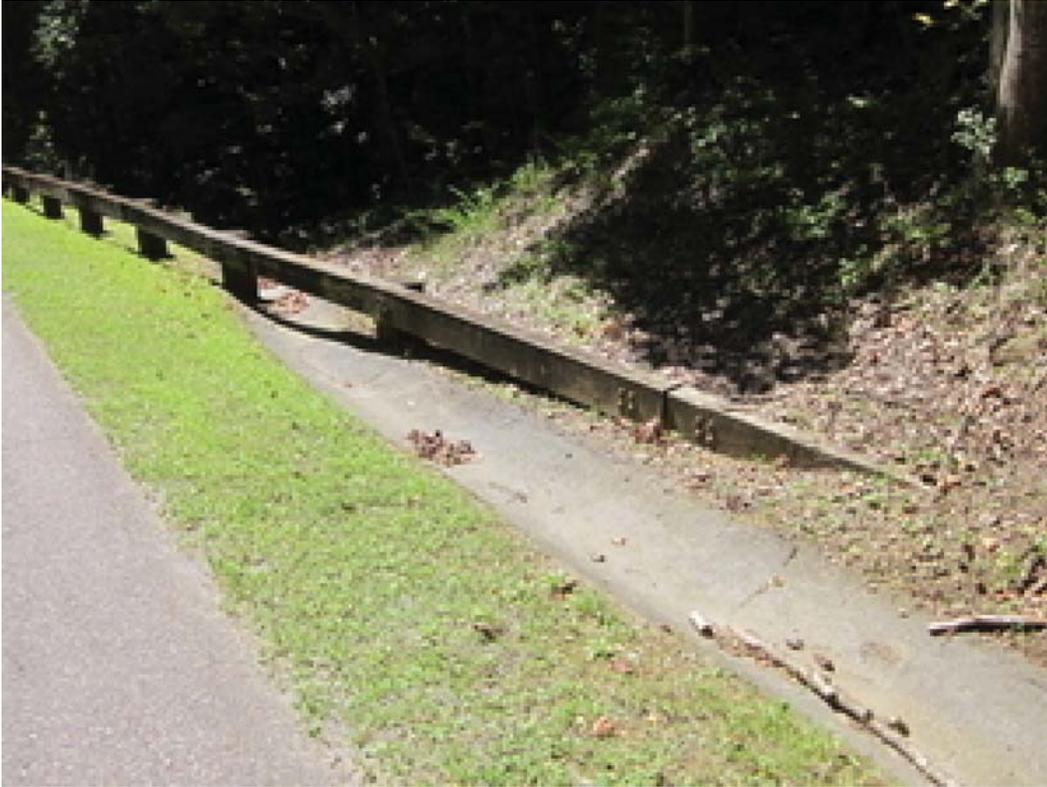
GRSM_0012ZZ_3.150_R_1.JPG

Barrier ID:	GRSM-0012ZZ-3.150-R				
Route Name:	GATLINBURG BYPASS ROAD AND RAMPS				
Inspection Date:	09/14/2010	Barrier Rating:	30.70		
Barrier Description					
Type:	STEEL-BACKED TIMBER WITHOUT BLOCKOUT	Barrier Function:	TRAFFIC		
Barrier Material:	STEEL-BACKED TIMBER/LOG	Post Material:	WOOD		
Blockout Type:	N/A	Length (ft.):	179		
Speed Limit (MPH):	35	Placement with Respect to Road:	TANGENT		
Hazard Behind Barrier:	MEDIUM				
Barrier Crashworthiness					
Appropriate Test Level:	TL-2	Barrier Test Level:	TL-2	Is Barrier Crashworthy?:	YES
Beg. End Trtmt Type:	SBT/LOG FLARED	Is Beg. End Trtmt Crashworthy?:	NO	Approach Transition Type:	NONE
Ending End Trtmt Type:	SBT/LOG FLARED	Ending End Trtmt Crashworthy?:	NO		
Average Measurements					
Design Height (In.):	27	Width (In.):	0.0	Post Spacing (In.):	120.6
Height (In.):	26.7	Lateral Offset (In.):	34.2	Road Grade (%):	6.40
Physical Condition					
Barrier	Alignment and Height:	The alignment has no deviation and the height is within 1 in of the design height of 27 in.

Breaking and Cracking:	No breaking or cracking observed.			
	Missing Elements:	No missing elements observed.			
	Corrosion and Weathering:	No corrosion or weathering observed.			
End Treatments	Alignment and Height:	Alignment acceptable. Height is within 1 in of the 27-in design height.			
	Breaking and Cracking:	No breaking or cracking observed.			
	Missing Elements:	No missing elements observed.			
	Corrosion and Weathering:	No corrosion or weathering observed.

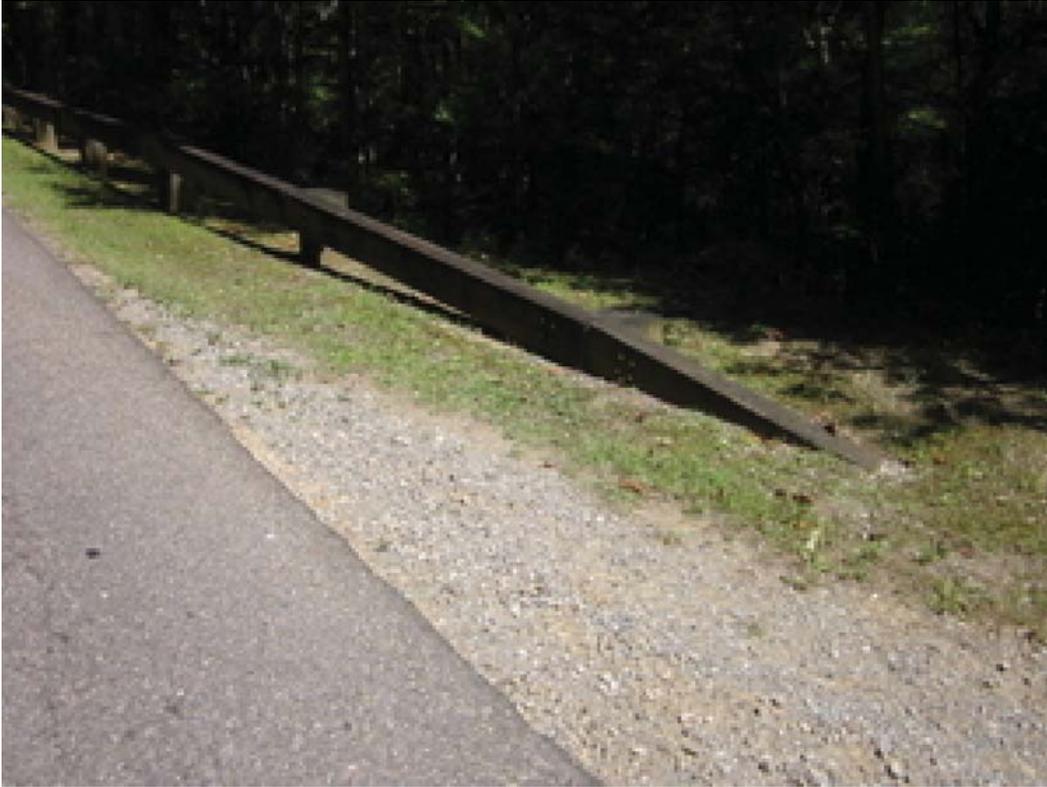
GRSM_0012ZZ_3.152_L_1.JPG

Barrier ID:	GRSM-0012ZZ-3.152-L				
Route Name:	GATLINBURG BYPASS ROAD AND RAMPS				
Inspection Date:	09/14/2010	Barrier Rating:	22.20		
Barrier Description					
Type:	STEEL-BACKED TIMBER WITHOUT BLOCKOUT	Barrier Function:	TRAFFIC		
Barrier Material:	STEEL-BACKED TIMBER/LOG	Post Material:	WOOD		
Blockout Type:	N/A	Length (ft.):	179		
Speed Limit (MPH):	35	Placement with Respect to Road:	TANGENT		
Hazard Behind Barrier:	MEDIUM				
Barrier Crashworthiness					
Appropriate Test Level:	TL-2	Barrier Test Level:	TL-2	Is Barrier Crashworthy?:	YES
Beg. End Trtmt Type:	SBT/LOG FLARED	Is Beg. End Trtmt Crashworthy?:	NO	Approach Transition Type:	NONE
Ending End Trtmt Type:	SBT/LOG FLARED	Ending End Trtmt Crashworthy?:	NO		
Average Measurements					
Design Height (In.):	27	Width (In.):	0.0	Post Spacing (In.):	121.0
Height (In.):	26.2	Lateral Offset (In.):	41.7	Road Grade (%):	6.90
Physical Condition					
Barrier	Alignment and Height:	The alignment has no deviation and the height is within 1 in of the 27 in design height.

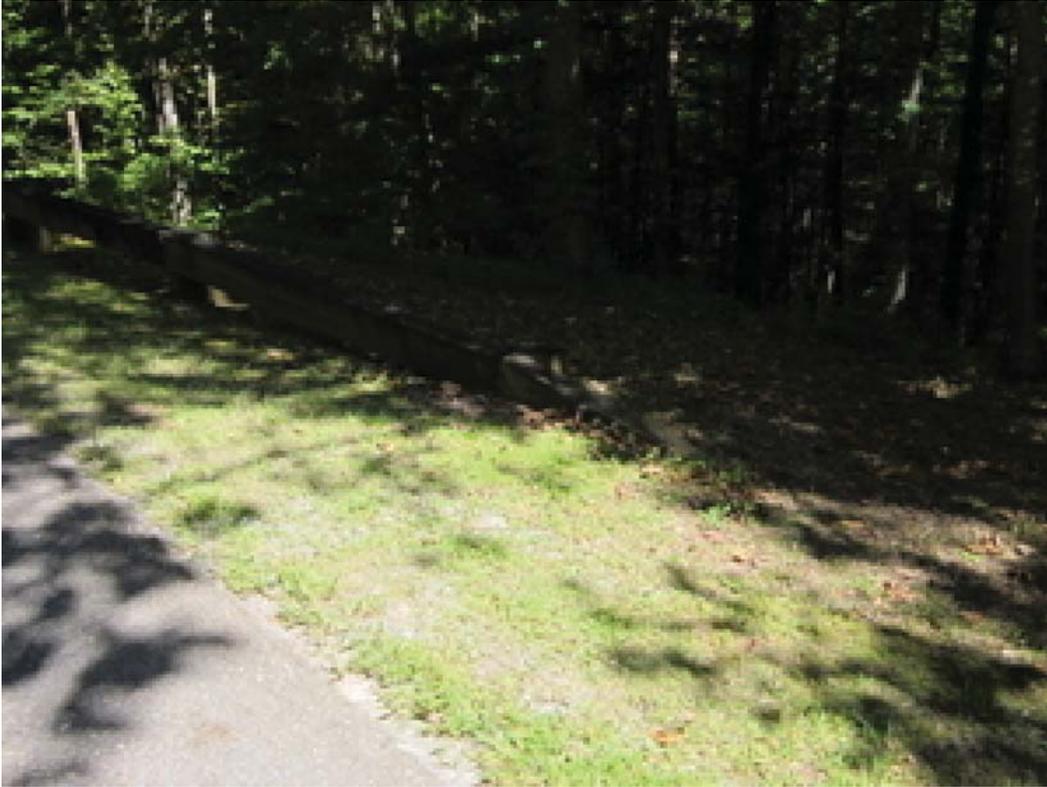
GRSM_0012ZZ_3.211_L_1.JPG

Barrier ID:	GRSM-0012ZZ-3.211-L				
Route Name:	GATLINBURG BYPASS ROAD AND RAMPS				
Inspection Date:	09/14/2010	Barrier Rating:	27.80		
Barrier Description					
Type:	STEEL-BACKED TIMBER WITHOUT BLOCKOUT	Barrier Function:	TRAFFIC		
Barrier Material:	STEEL-BACKED TIMBER/LOG	Post Material:	WOOD		
Blockout Type:	N/A	Length (ft.):	149		
Speed Limit (MPH):	35	Placement with Respect to Road:	OUTSIDE OF CURVE		
Hazard Behind Barrier:	MEDIUM				
Barrier Crashworthiness					
Appropriate Test Level:	TL-2	Barrier Test Level:	TL-2	Is Barrier Crashworthy?:	YES
Beg. End Trtmt Type:	SBT/LOG FLARED	Is Beg. End Trtmt Crashworthy?:	NO	Approach Transition Type:	NONE
Ending End Trtmt Type:	SBT/LOG FLARED	Ending End Trtmt Crashworthy?:	NO		
Average Measurements					
Design Height (In.):	27	Width (In.):	0.0	Post Spacing (In.):	120.3
Height (In.):	29.0	Lateral Offset (In.):	51.2	Road Grade (%):	6.70
Physical Condition					
Barrier	Alignment and Height:	The alignment has no deviation and the height is 0-3 in above the 27 in design height.

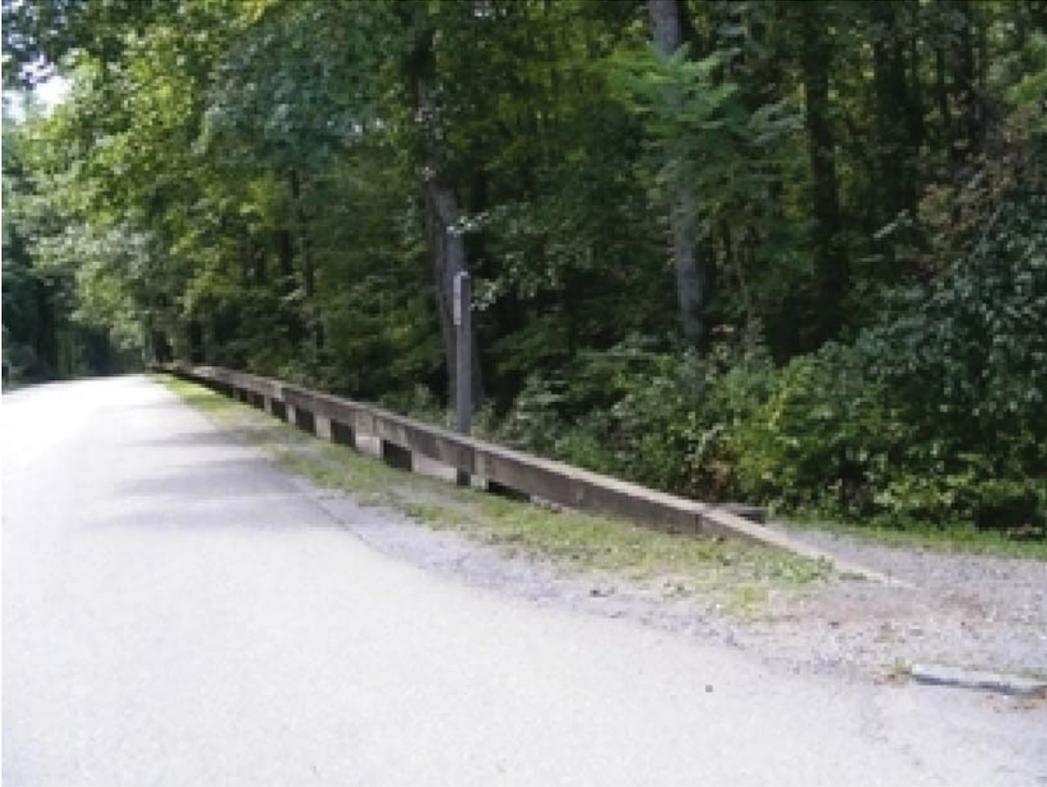
GRSM_0013ZZ_3.837_R_1.JPG

Barrier ID:	GRSM-0013ZZ-3.837-R				
Route Name:	FIGHTING CREEK GAP ROAD AND SPUR				
Inspection Date:	09/09/2010	Barrier Rating:	35.20		
Barrier Description					
Type:	STEEL-BACKED TIMBER WITHOUT BLOCKOUT	Barrier Function:	TRAFFIC		
Barrier Material:	STEEL-BACKED TIMBER/LOG	Post Material:	WOOD		
Blockout Type:	N/A	Length (ft.):	901		
Speed Limit (MPH):	25	Placement with Respect to Road:	INSIDE OF CURVE		
Hazard Behind Barrier:	MEDIUM				
Barrier Crashworthiness					
Appropriate Test Level:	TL-1	Barrier Test Level:	TL-2	Is Barrier Crashworthy?:	YES
Beg. End Trtmt Type:	SBT/LOG FLARED	Is Beg. End Trtmt Crashworthy?:	NO	Approach Transition Type:	NONE
Ending End Trtmt Type:	SBT/LOG FLARED	Ending End Trtmt Crashworthy?:	NO		
Average Measurements					
Design Height (In.):	27	Width (In.):	0.0	Post Spacing (In.):	120.0
Height (In.):	26.3	Lateral Offset (In.):	39.7	Road Grade (%):	4.20
Physical Condition					
Barrier	Alignment and Height:	Two sections slightly twisted possible impact zones deflections less than 6 in. The height is 0-1 in below the design height of 27 in.

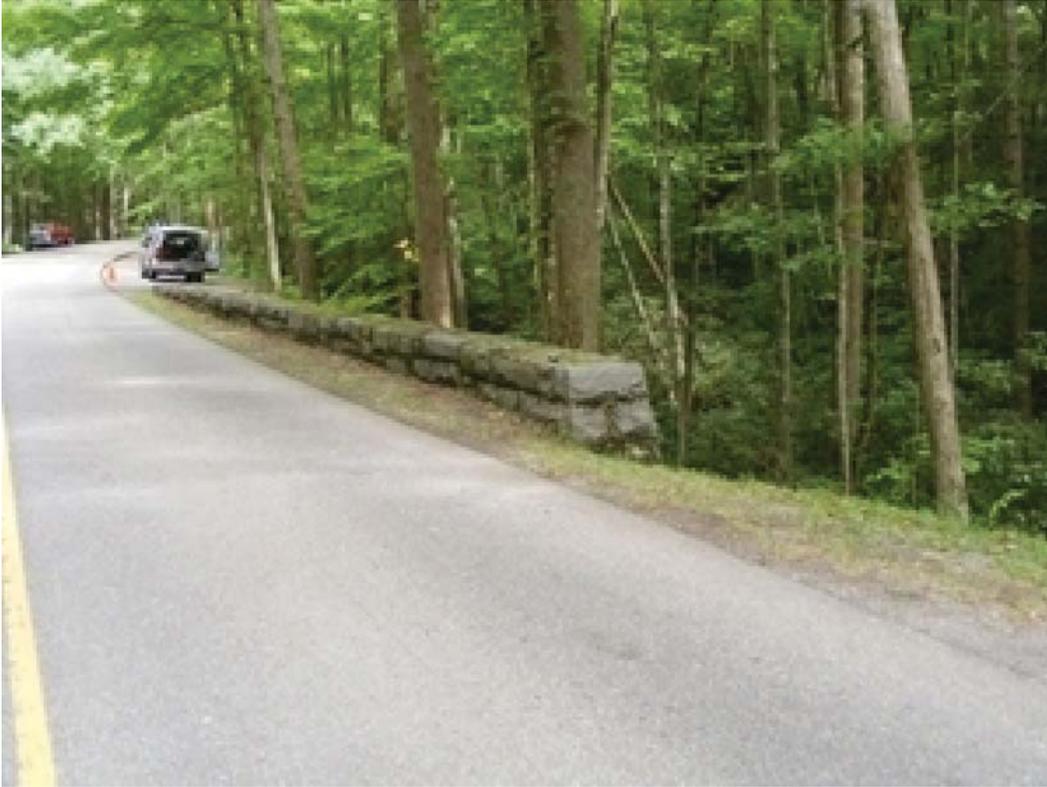
GRSM_0013ZZ_4.184_L_1.JPG

Barrier ID:	GRSM-0013ZZ-4.184-L				
Route Name:	FIGHTING CREEK GAP ROAD AND SPUR				
Inspection Date:	09/09/2010	Barrier Rating:	45.70		
Barrier Description					
Type:	STONE MASONRY WITHOUT CONCRETE CORE WALL	Barrier Function:	TRAFFIC		
Barrier Material:	STONE	Post Material:	N/A		
Blockout Type:	N/A	Length (ft.):	90		
Speed Limit (MPH):	35	Placement with Respect to Road:	TANGENT		
Hazard Behind Barrier:	HIGH				
Barrier Crashworthiness					
Appropriate Test Level:	TL-2	Barrier Test Level:	NCW	Is Barrier Crashworthy?:	NO
Beg. End Trtmt Type:	NONE	Is Beg. End Trtmt Crashworthy?:	N/A	Approach Transition Type:	NONE
Ending End Trtmt Type:	NONE	Ending End Trtmt Crashworthy?:	N/A		
Average Measurements					
Design Height (In.):	24	Width (In.):	24.0	Post Spacing (In.):	0.0
Height (In.):	18.6	Lateral Offset (In.):	30.0	Road Grade (%):	3.40
Physical Condition					
Barrier	Alignment and Height:	The alignment has no deviation and the height is 3 to 6 in below the 24 in design height for 48 ft and 6 to 8 in below for 32 ft.

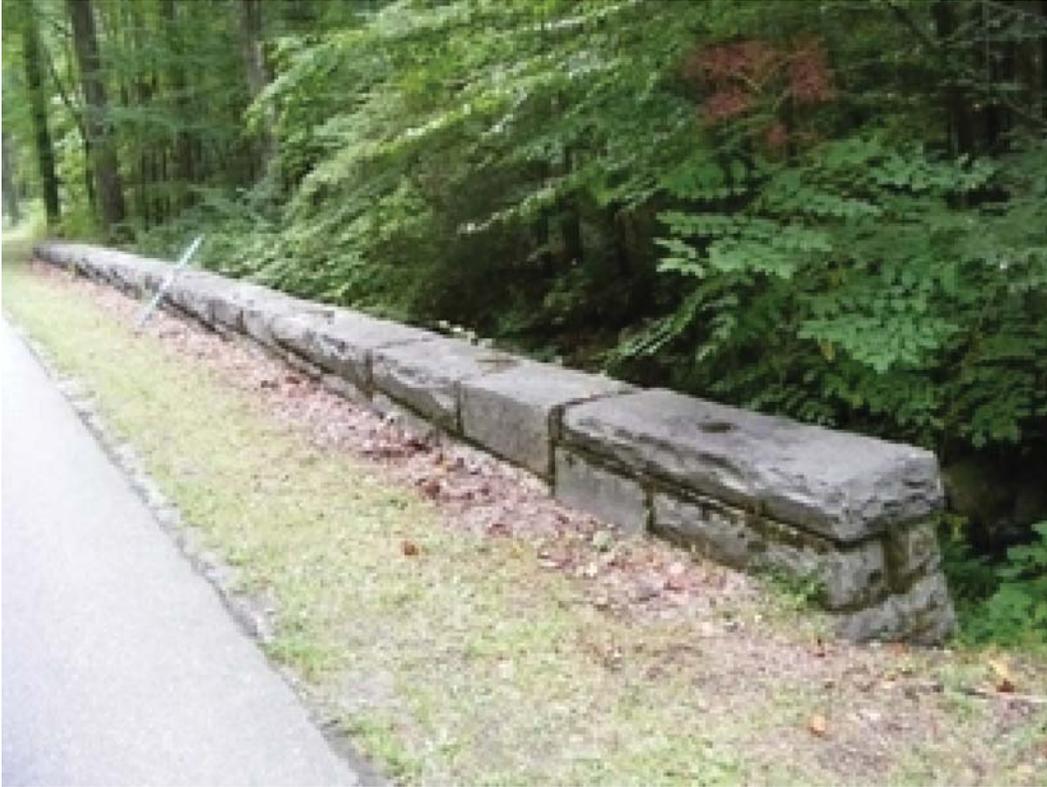
GRSM_0013ZZ_4.683_R_1.JPG

Barrier ID:	GRSM-0013ZZ-4.683-R				
Route Name:	FIGHTING CREEK GAP ROAD AND SPUR				
Inspection Date:	09/09/2010	Barrier Rating:	46.70		
Barrier Description					
Type:	STONE MASONRY WITHOUT CONCRETE CORE WALL	Barrier Function:	TRAFFIC		
Barrier Material:	STONE	Post Material:	N/A		
Blockout Type:	N/A	Length (ft.):	35		
Speed Limit (MPH):	35	Placement with Respect to Road:	TANGENT		
Hazard Behind Barrier:	MEDIUM				
Barrier Crashworthiness					
Appropriate Test Level:	TL-2	Barrier Test Level:	NCW	Is Barrier Crashworthy?:	NO
Beg. End Trtmt Type:	NONE	Is Beg. End Trtmt Crashworthy?:	N/A	Approach Transition Type:	NONE
Ending End Trtmt Type:	NONE	Ending End Trtmt Crashworthy?:	N/A		
Average Measurements					
Design Height (In.):	24	Width (In.):	23.7	Post Spacing (In.):	0.0
Height (In.):	19.2	Lateral Offset (In.):	71.3	Road Grade (%):	5.60
Physical Condition					
Barrier	Alignment and Height:	The alignment has no deviation and the height is 4 to 5 in below the design height of 24 in.

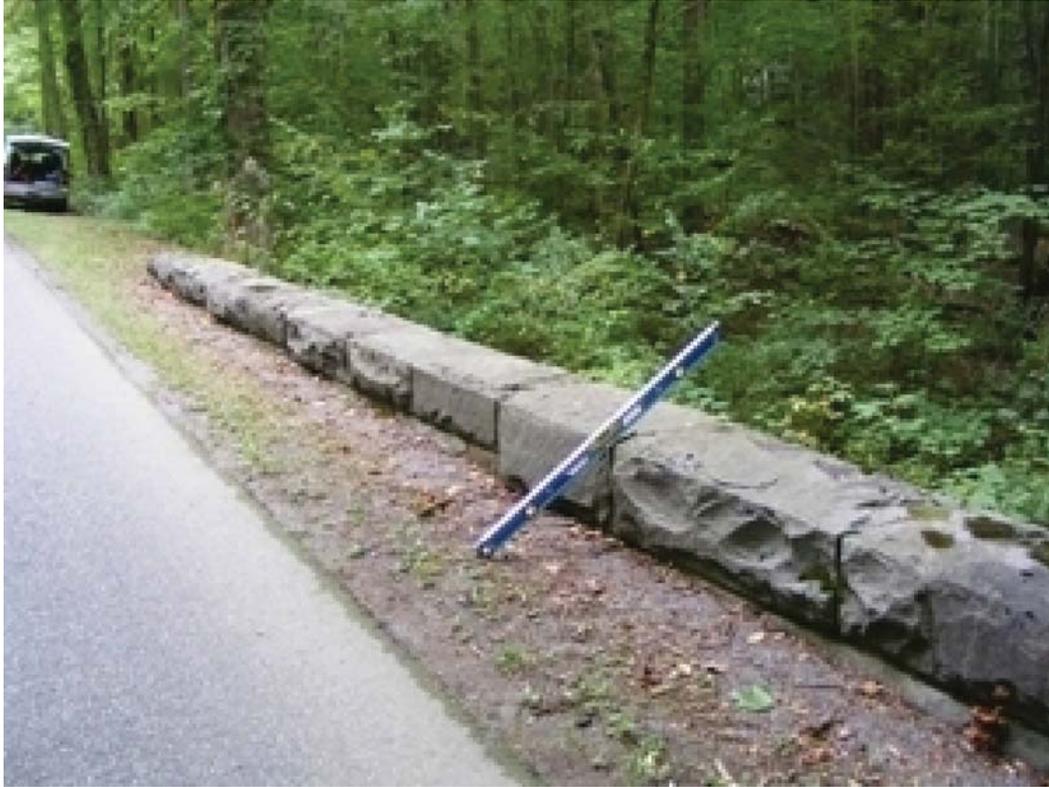
GRSM_0013ZZ_4.688_L_1.JPG

Barrier ID:	GRSM-0013ZZ-4.688-L				
Route Name:	FIGHTING CREEK GAP ROAD AND SPUR				
Inspection Date:	09/09/2010	Barrier Rating:	50.50		
Barrier Description					
Type:	STONE MASONRY WITHOUT CONCRETE CORE WALL	Barrier Function:	TRAFFIC		
Barrier Material:	STONE	Post Material:	N/A		
Blockout Type:	N/A	Length (ft.):	35		
Speed Limit (MPH):	35	Placement with Respect to Road:	TANGENT		
Hazard Behind Barrier:	MEDIUM				
Barrier Crashworthiness					
Appropriate Test Level:	TL-2	Barrier Test Level:	NCW	Is Barrier Crashworthy?:	NO
Beg. End Trtmt Type:	NONE	Is Beg. End Trtmt Crashworthy?:	N/A	Approach Transition Type:	NONE
Ending End Trtmt Type:	NONE	Ending End Trtmt Crashworthy?:	N/A		
Average Measurements					
Design Height (In.):	24	Width (In.):	23.2	Post Spacing (In.):	0.0
Height (In.):	15.6	Lateral Offset (In.):	46.0	Road Grade (%):	5.40
Physical Condition					
Barrier	Alignment and Height:	The alignment has no deviation and the height is 8 to 9 in below the design height of 24 in.

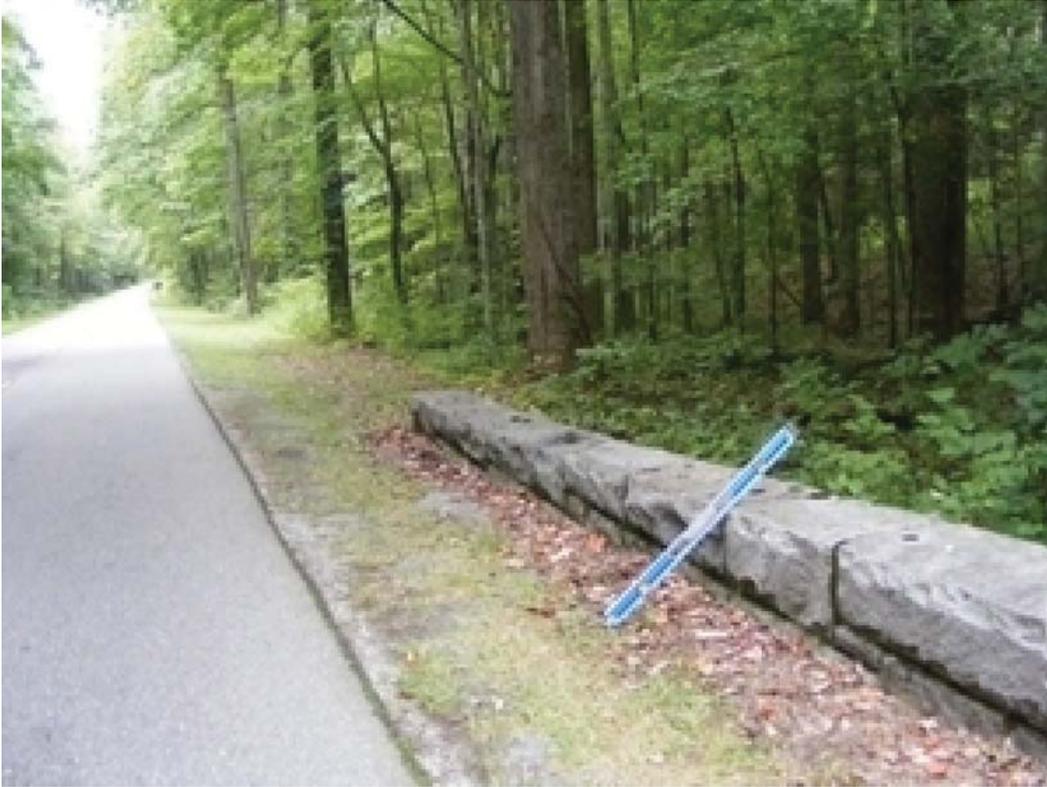
GRSM_0013ZZ_4.697_R_1.JPG

Barrier ID:	GRSM-0013ZZ-4.697-R				
Route Name:	FIGHTING CREEK GAP ROAD AND SPUR				
Inspection Date:	09/09/2010	Barrier Rating:	45.20		
Barrier Description					
Type:	STONE MASONRY WITHOUT CONCRETE CORE WALL	Barrier Function:	TRAFFIC		
Barrier Material:	STONE	Post Material:	N/A		
Blockout Type:	N/A	Length (ft.):	24		
Speed Limit (MPH):	35	Placement with Respect to Road:	TANGENT		
Hazard Behind Barrier:	MEDIUM				
Barrier Crashworthiness					
Appropriate Test Level:	TL-2	Barrier Test Level:	NCW	Is Barrier Crashworthy?:	NO
Beg. End Trtmt Type:	NONE	Is Beg. End Trtmt Crashworthy?:	N/A	Approach Transition Type:	NONE
Ending End Trtmt Type:	NONE	Ending End Trtmt Crashworthy?:	N/A		
Average Measurements					
Design Height (In.):	24	Width (In.):	23.7	Post Spacing (In.):	0.0
Height (In.):	18.7	Lateral Offset (In.):	72.3	Road Grade (%):	6.70
Physical Condition					
Barrier	Alignment and Height:	The alignment has no deviation and the height is 5 to 6 in below the design height of 24 in.

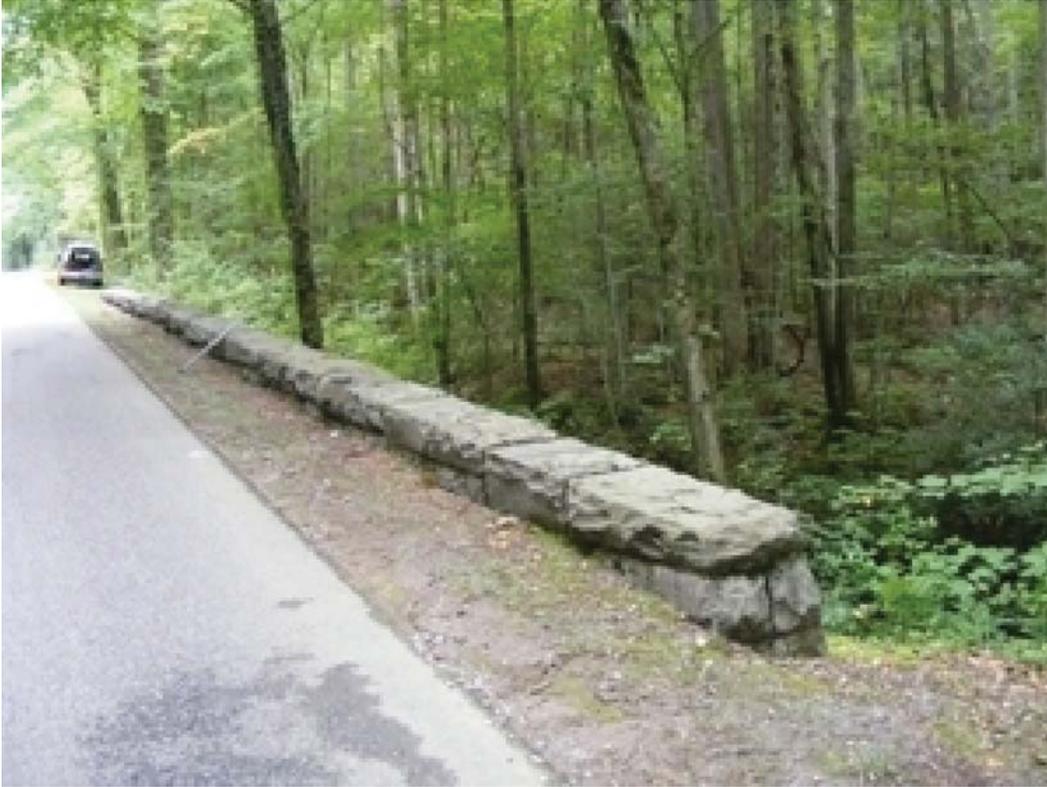
GRSM_0013ZZ_4.702_L_1.JPG

Barrier ID:	GRSM-0013ZZ-4.702-L				
Route Name:	FIGHTING CREEK GAP ROAD AND SPUR				
Inspection Date:	09/09/2010	Barrier Rating:	50.50		
Barrier Description					
Type:	STONE MASONRY WITHOUT CONCRETE CORE WALL	Barrier Function:	TRAFFIC		
Barrier Material:	STONE	Post Material:	N/A		
Blockout Type:	N/A	Length (ft.):	35		
Speed Limit (MPH):	35	Placement with Respect to Road:	TANGENT		
Hazard Behind Barrier:	MEDIUM				
Barrier Crashworthiness					
Appropriate Test Level:	TL-2	Barrier Test Level:	NCW	Is Barrier Crashworthy?:	NO
Beg. End Trtmt Type:	NONE	Is Beg. End Trtmt Crashworthy?:	N/A	Approach Transition Type:	NONE
Ending End Trtmt Type:	NONE	Ending End Trtmt Crashworthy?:	N/A		
Average Measurements					
Design Height (In.):	24	Width (In.):	23.2	Post Spacing (In.):	0.0
Height (In.):	16.0	Lateral Offset (In.):	44.7	Road Grade (%):	6.00
Physical Condition					
Barrier	Alignment and Height:	The alignment has no deviation and the height is 8 in below the design height of 24 in.
