NPS Guardwall/Rail Inventory Program
Great Smoky Mountains National Park

Federal Highway Administration
Eastern Federal Lands Highway Division
Road Inventory Program (RIP)

Data Collection Date: September 2010
Report Date: December 2015

Great Smoky Mountains National Park in North Carolina and Tennessee

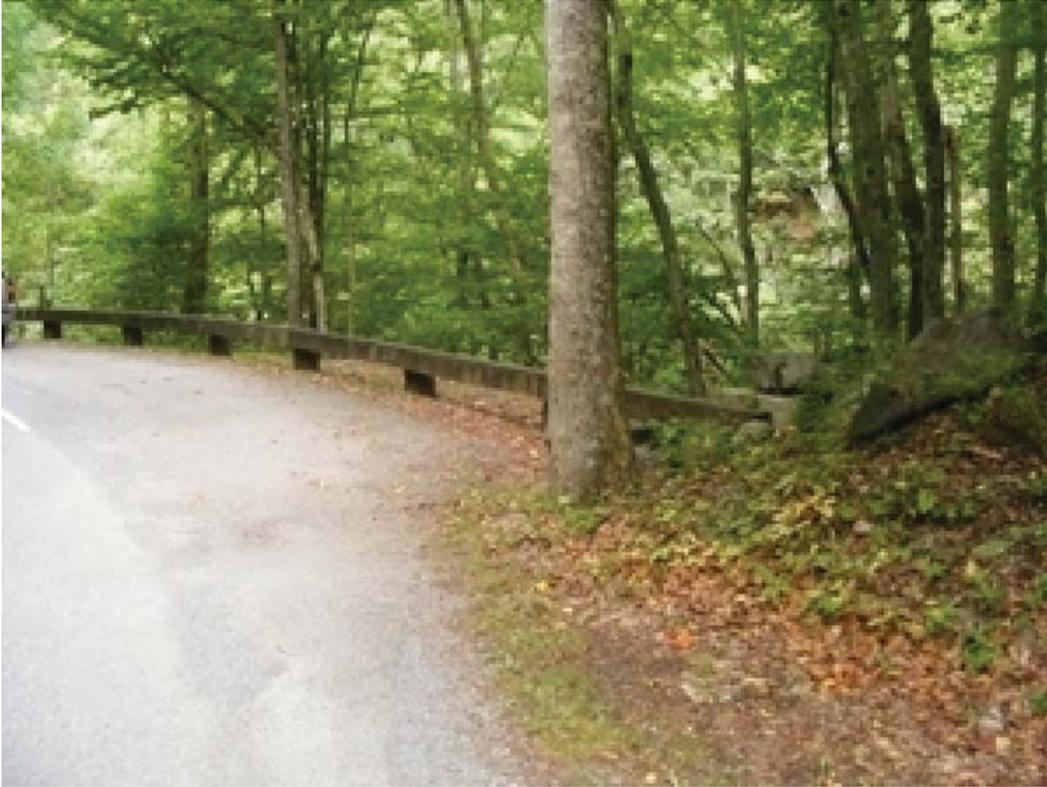
GRSM_0014_2.511_R_1.JPG

Barrier ID:	GRSM-0014-2.511-R				
Route Name:	LITTLE RIVER GORGE ROAD				
Inspection Date:	09/09/2010	Barrier Rating:	31.20		
Barrier Description					
Type:	STEEL-BACKED TIMBER WITHOUT BLOCKOUT	Barrier Function:	TRAFFIC		
Barrier Material:	STEEL-BACKED TIMBER/LOG	Post Material:	WOOD		
Blockout Type:	N/A	Length (ft.):	364		
Speed Limit (MPH):	30	Placement with Respect to Road:	OUTSIDE OF CURVE		
Hazard Behind Barrier:	HIGH				
Barrier Crashworthiness					
Appropriate Test Level:	TL-1	Barrier Test Level:	TL-2	Is Barrier Crashworthy?:	YES
Beg. End Trtmt Type:	SBT/LOG BURIED	Is Beg. End Trtmt Crashworthy?:	YES	Approach Transition Type:	NONE
Ending End Trtmt Type:	SBT/LOG FLARED	Ending End Trtmt Crashworthy?:	NO		
Average Measurements					
Design Height (In.):	27	Width (In.):	0.0	Post Spacing (In.):	120.0
Height (In.):	26.6	Lateral Offset (In.):	62.5	Road Grade (%):	3.50
Physical Condition					
Barrier	Alignment and Height:	The alignment has no deviation and the height is 0-1 in below the design height of 27 in.

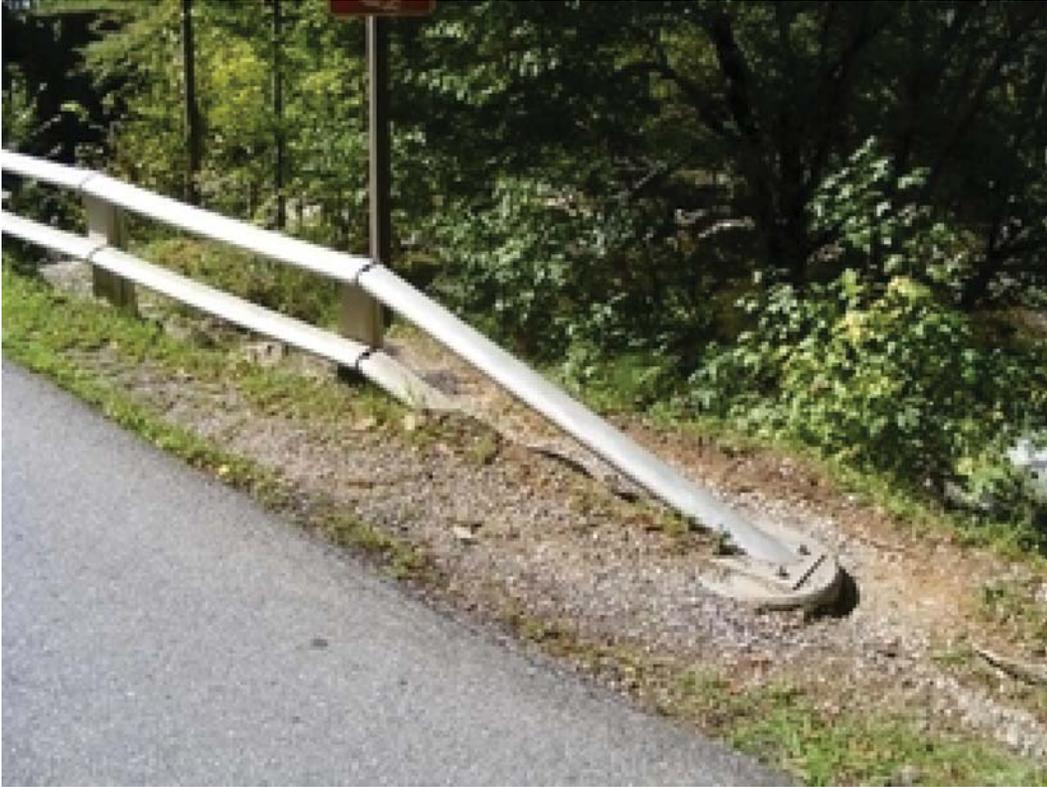
GRSM_0014_6.784_R_1.JPG

Barrier ID:	GRSM-0014-6.784-R				
Route Name:	LITTLE RIVER GORGE ROAD				
Inspection Date:	09/09/2010	Barrier Rating:	29.70		
Barrier Description					
Type:	OTHER: RIGID ALUMINUM TWO BEAMS	Barrier Function:	TRAFFIC		
Barrier Material:	OTHER: ALUMINUM	Post Material:	OTHER: ALUMINUM		
Blockout Type:	N/A	Length (ft.):	47		
Speed Limit (MPH):	30	Placement with Respect to Road:	INSIDE OF CURVE		
Hazard Behind Barrier:	HIGH				
Barrier Crashworthiness					
Appropriate Test Level:	TL-1	Barrier Test Level:	NCW	Is Barrier Crashworthy?:	NO
Beg. End Trtmt Type:	OTHER: ALUMINUM	Is Beg. End Trtmt Crashworthy?:	NO	Approach Transition Type:	OTHER: BRIDGE RAIL ALUMINUM
Ending End Trtmt Type:	NONE	Ending End Trtmt Crashworthy?:	N/A		
Average Measurements					
Design Height (In.):	27	Width (In.):	0.0	Post Spacing (In.):	72.0
Height (In.):	28.0	Lateral Offset (In.):	14.0	Road Grade (%):	2.20
Physical Condition					
Barrier	Alignment and Height:	The alignment has no deviation and the height is 0-2 in above the design height of 27 in.

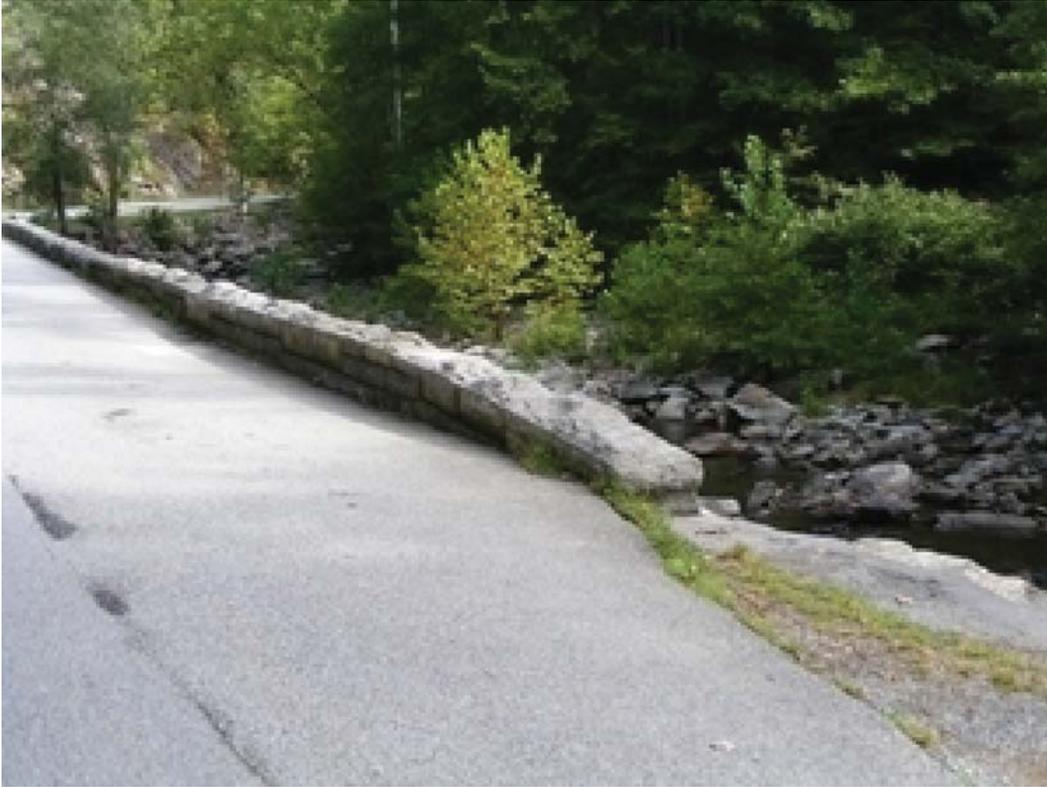
GRSM_0014_7.829_L_1.JPG

Barrier ID:	GRSM-0014-7.829-L				
Route Name:	LITTLE RIVER GORGE ROAD				
Inspection Date:	09/09/2010	Barrier Rating:	15.80		
Barrier Description					
Type:	STONE MASONRY WITHOUT CONCRETE CORE WALL	Barrier Function:	NON-TRAFFIC		
Barrier Material:	STONE	Post Material:	N/A		
Blockout Type:	N/A	Length (ft.):	282		
Speed Limit (MPH):	30	Placement with Respect to Road:	NON-TRAFFIC BARRIER		
Hazard Behind Barrier:	N/A				
Barrier Crashworthiness					
Appropriate Test Level:	TL-1	Barrier Test Level:	N/A	Is Barrier Crashworthy?:	N/A
Beg. End Trtmt Type:	NONE	Is Beg. End Trtmt Crashworthy?:	N/A	Approach Transition Type:	NONE
Ending End Trtmt Type:	NONE	Ending End Trtmt Crashworthy?:	N/A		
Average Measurements					
Design Height (In.):	24	Width (In.):	20.0	Post Spacing (In.):	0.0
Height (In.):	21.0	Lateral Offset (In.):	0.0	Road Grade (%):	0.00
Physical Condition					
Barrier	Alignment and Height:	The alignment has no deviation and the height is 1 to 4 in below the design height of 24 in.

Breaking and Cracking:	No breaking or cracking observed.			
	Missing Elements:	No missing elements observed.			
	Corrosion and Weathering:	No corrosion or weathering observed.			
End Treatments	Alignment and Height:				
	Breaking and Cracking:				
	Missing Elements:				
	Corrosion and Weathering:

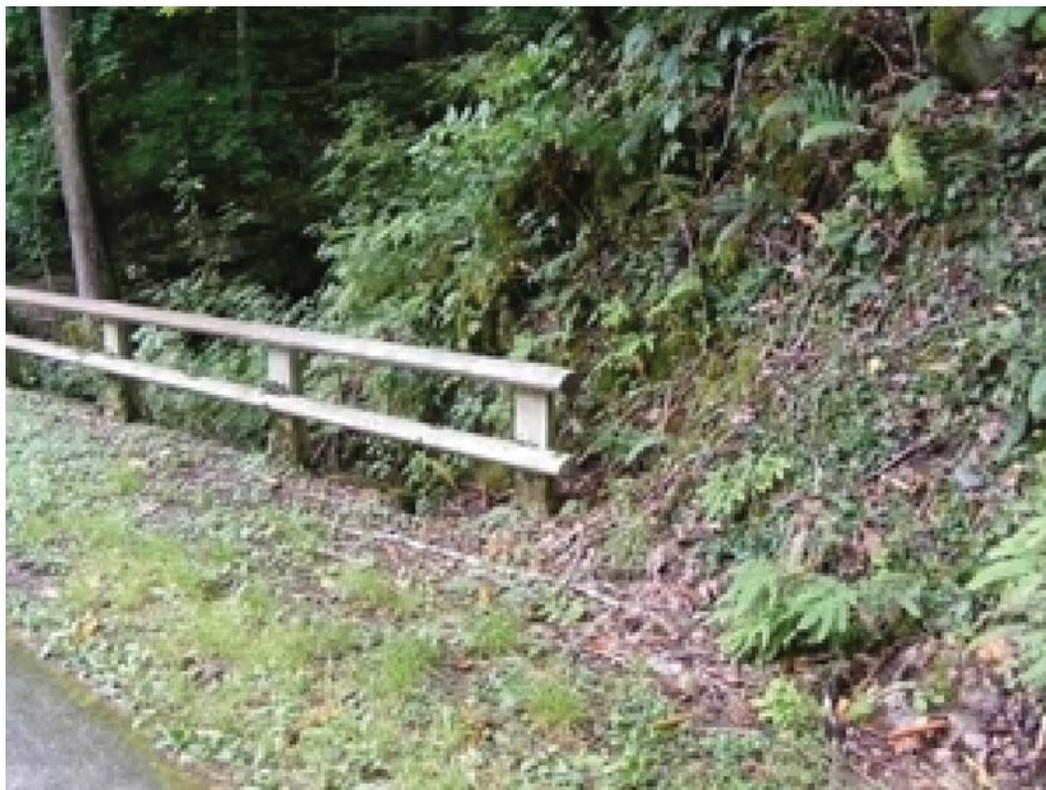
GRSM_0014_12.005_L_1.JPG

Barrier ID:	GRSM-0014-12.005-L				
Route Name:	LITTLE RIVER GORGE ROAD				
Inspection Date:	09/09/2010	Barrier Rating:	27.80		
Barrier Description					
Type:	OTHER: ALUMINUM BRIDGE RAIL	Barrier Function:	TRAFFIC		
Barrier Material:	OTHER: ALUMINUM	Post Material:	OTHER: ALUMINUM		
Blockout Type:	N/A	Length (ft.):	67		
Speed Limit (MPH):	30	Placement with Respect to Road:	OUTSIDE OF CURVE		
Hazard Behind Barrier:	MEDIUM				
Barrier Crashworthiness					
Appropriate Test Level:	TL-1	Barrier Test Level:	NCW	Is Barrier Crashworthy?:	NO
Beg. End Trtmt Type:	OTHER: ALUMINUM	Is Beg. End Trtmt Crashworthy?:	NO	Approach Transition Type:	NONE
Ending End Trtmt Type:	NONE	Ending End Trtmt Crashworthy?:	N/A		
Average Measurements					
Design Height (In.):	27	Width (In.):	0.0	Post Spacing (In.):	72.0
Height (In.):	31.0	Lateral Offset (In.):	77.3	Road Grade (%):	0.30
Physical Condition					
Barrier	Alignment and Height:	The alignment has no deviation and the height is 4 in above the design height of 27 in.

Breaking and Cracking:	No breaking or cracking observed.			
	Missing Elements:	No missing elements observed.			
	Corrosion and Weathering:	No corrosion or weathering observed.			
End Treatments	Alignment and Height:	Alignment acceptable. Height is within 1 in of the 27-in design height.			
	Breaking and Cracking:	No breaking or cracking observed.			
	Missing Elements:	No missing elements observed.			
	Corrosion and Weathering:	No corrosion or weathering observed.

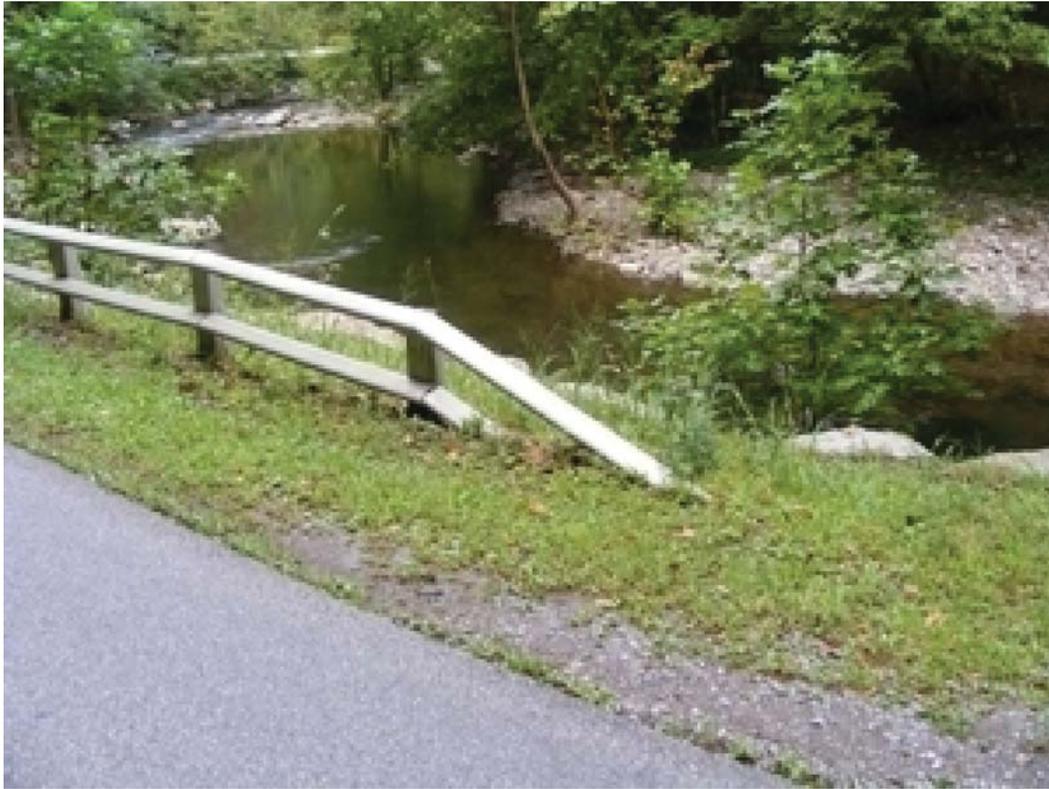
GRSM_0014_12.005_R_1.JPG

Barrier ID:	GRSM-0014-12.005-R				
Route Name:	LITTLE RIVER GORGE ROAD				
Inspection Date:	09/09/2010	Barrier Rating:	25.10		
Barrier Description					
Type:	OTHER: ALUMINUM BRIDGE RAIL	Barrier Function:	TRAFFIC		
Barrier Material:	OTHER: ALUMINUM	Post Material:	OTHER: ALUMINUM		
Blockout Type:	N/A	Length (ft.):	88		
Speed Limit (MPH):	30	Placement with Respect to Road:	INSIDE OF CURVE		
Hazard Behind Barrier:	MEDIUM				
Barrier Crashworthiness					
Appropriate Test Level:	TL-1	Barrier Test Level:	NCW	Is Barrier Crashworthy?:	NO
Beg. End Trtmt Type:	OTHER: ALUMINUM	Is Beg. End Trtmt Crashworthy?:	NO	Approach Transition Type:	NONE
Ending End Trtmt Type:	OTHER: ALUMINUM	Ending End Trtmt Crashworthy?:	NO		
Average Measurements					
Design Height (In.):	27	Width (In.):	0.0	Post Spacing (In.):	72.0
Height (In.):	26.2	Lateral Offset (In.):	47.0	Road Grade (%):	1.50
Physical Condition					
Barrier	Alignment and Height:	The alignment has no deviation and the height is 0-1 in below the design height of 27 in.

Breaking and Cracking:	No breaking or cracking observed.			
	Missing Elements:	No missing elements observed.			
	Corrosion and Weathering:	No corrosion or weathering observed.			
End Treatments	Alignment and Height:	Alignment acceptable. Height is within 1 in of the 27-in design height.			
	Breaking and Cracking:	No breaking or cracking observed.			
	Missing Elements:	No missing elements observed.			
	Corrosion and Weathering:	No corrosion or weathering observed.

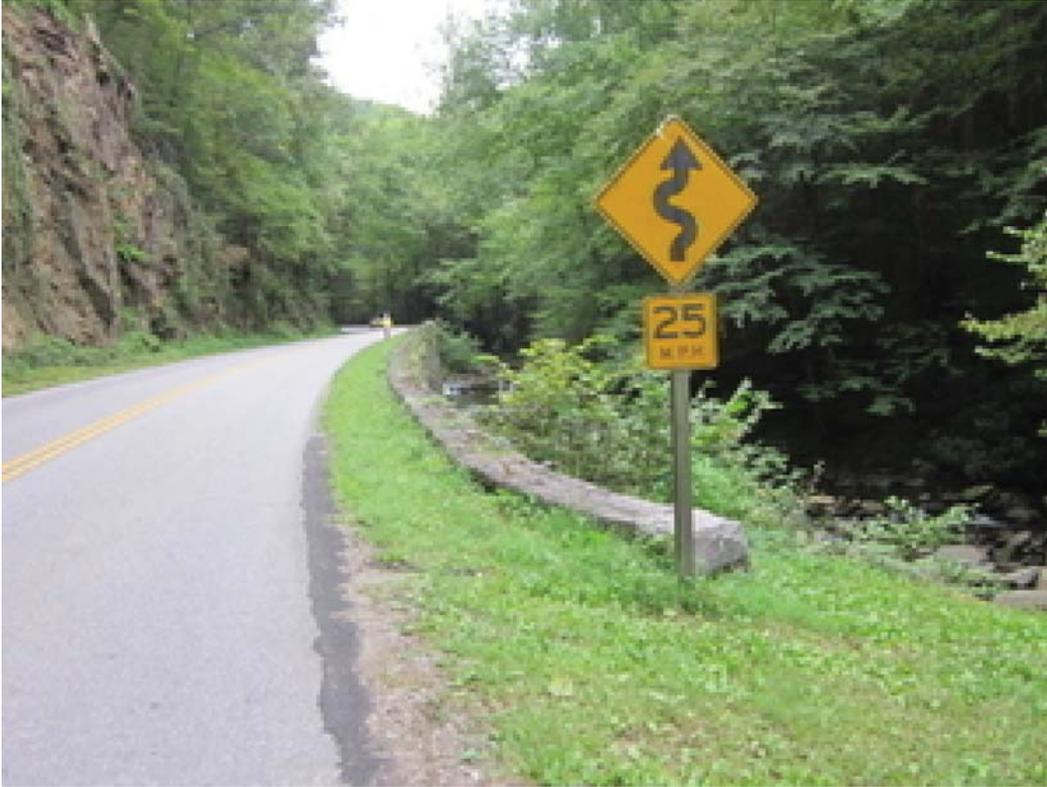
GRSM_0015_0.506_R_1.JPG

Barrier ID:	GRSM-0015-0.506-R				
Route Name:	LAUREL CREEK ROAD				
Inspection Date:	09/10/2010	Barrier Rating:	42.50		
Barrier Description					
Type:	STONE MASONRY WITHOUT CONCRETE CORE WALL	Barrier Function:	TRAFFIC		
Barrier Material:	STONE	Post Material:	N/A		
Blockout Type:	N/A	Length (ft.):	344		
Speed Limit (MPH):	35	Placement with Respect to Road:	OUTSIDE OF CURVE		
Hazard Behind Barrier:	MEDIUM				
Barrier Crashworthiness					
Appropriate Test Level:	TL-2	Barrier Test Level:	NCW	Is Barrier Crashworthy?:	NO
Beg. End Trtmt Type:	NONE	Is Beg. End Trtmt Crashworthy?:	N/A	Approach Transition Type:	NONE
Ending End Trtmt Type:	NONE	Ending End Trtmt Crashworthy?:	N/A		
Average Measurements					
Design Height (In.):	24	Width (In.):	25.0	Post Spacing (In.):	0.0
Height (In.):	22.6	Lateral Offset (In.):	78.5	Road Grade (%):	4.10
Physical Condition					
Barrier	Alignment and Height:	The alignment has no deviation and the height is 6 in below the 24 in design height for 150 ft.

Breaking and Cracking:	Less than 1/4 in cracking in grout. No breaking observed.			
	Missing Elements:	No missing elements observed.			
	Corrosion and Weathering:	No corrosion or weathering observed.			
End Treatments	Alignment and Height:				
	Breaking and Cracking:				
	Missing Elements:				
	Corrosion and Weathering:

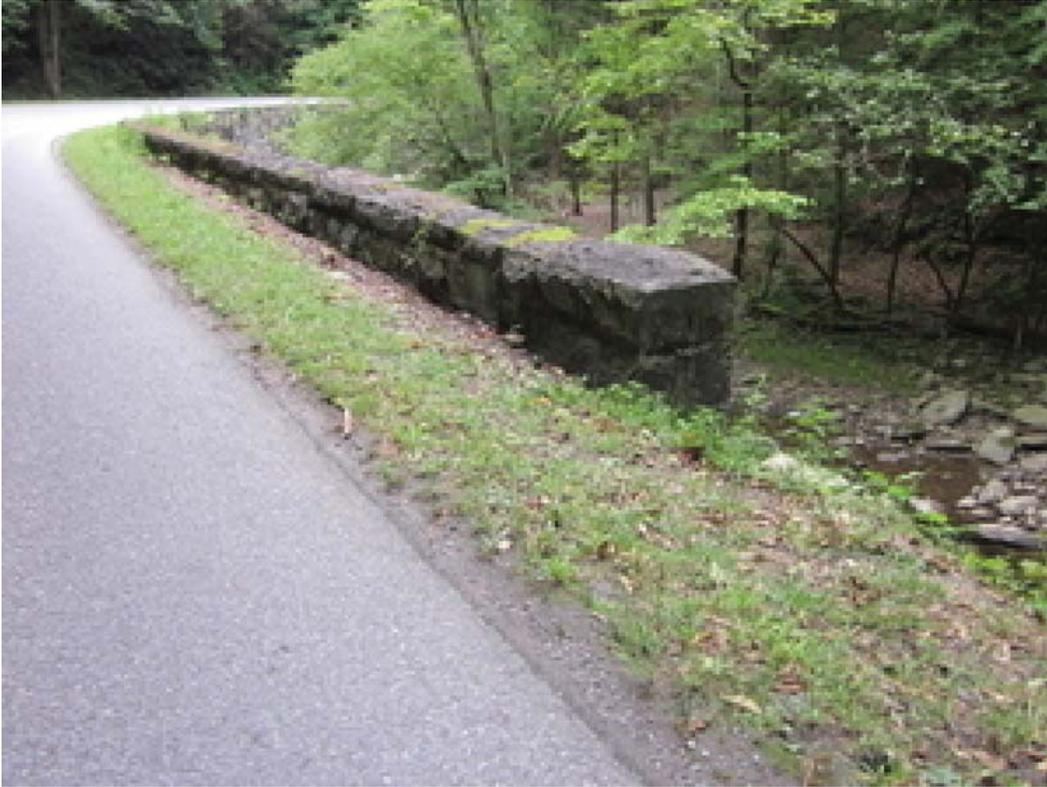
GRSM_0015_0.819_R_1.JPG

Barrier ID:	GRSM-0015-0.819-R				
Route Name:	LAUREL CREEK ROAD				
Inspection Date:	09/09/2010	Barrier Rating:	43.70		
Barrier Description					
Type:	STONE MASONRY WITHOUT CONCRETE CORE WALL	Barrier Function:	TRAFFIC		
Barrier Material:	STONE	Post Material:	N/A		
Blockout Type:	N/A	Length (ft.):	246		
Speed Limit (MPH):	35	Placement with Respect to Road:	OUTSIDE OF CURVE		
Hazard Behind Barrier:	MEDIUM				
Barrier Crashworthiness					
Appropriate Test Level:	TL-2	Barrier Test Level:	NCW	Is Barrier Crashworthy?:	NO
Beg. End Trtmt Type:	NONE	Is Beg. End Trtmt Crashworthy?:	N/A	Approach Transition Type:	NONE
Ending End Trtmt Type:	NONE	Ending End Trtmt Crashworthy?:	N/A		
Average Measurements					
Design Height (In.):	24	Width (In.):	24.6	Post Spacing (In.):	0.0
Height (In.):	19.6	Lateral Offset (In.):	63.2	Road Grade (%):	2.10
Physical Condition					
Barrier	Alignment and Height:	Alignment has no deviation and the height is 4 to 6 in below the 24 in design height for 91 ft.

Breaking and Cracking:	No breaking or cracking observed.			
	Missing Elements:	No missing elements observed.			
	Corrosion and Weathering:	No corrosion or weathering observed.			
End Treatments	Alignment and Height:				
	Breaking and Cracking:				
	Missing Elements:				
	Corrosion and Weathering:

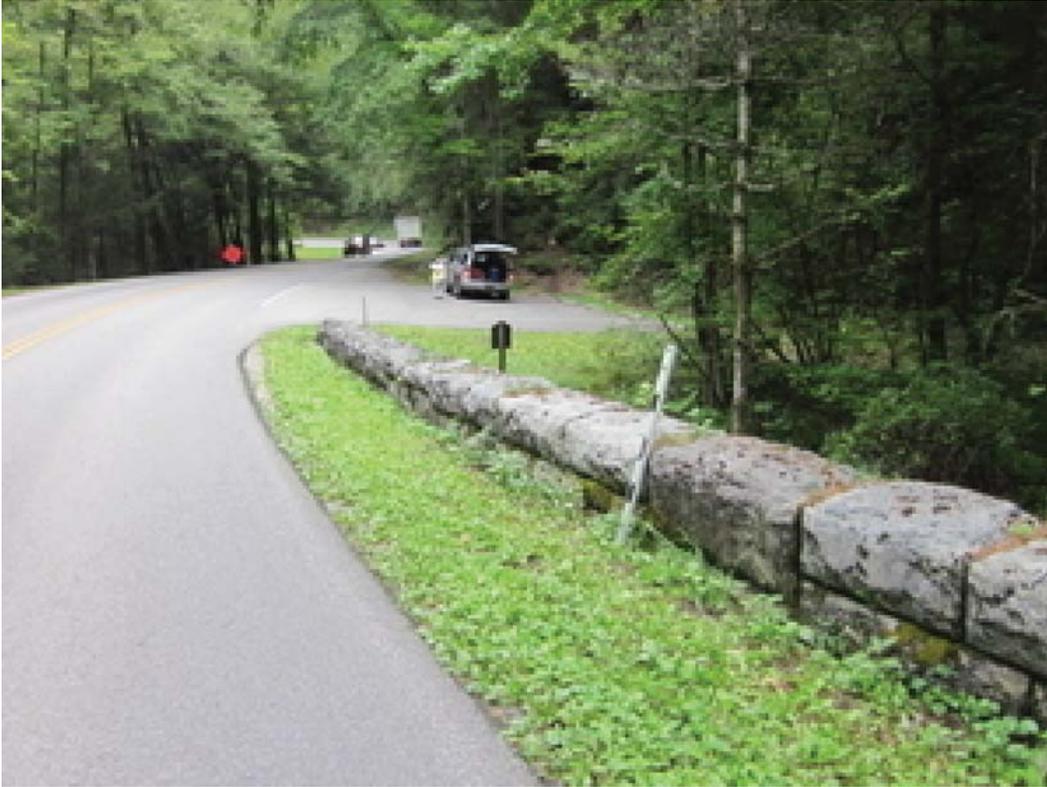
GRSM_0015_2.120_L_1.JPG

Barrier ID:	GRSM-0015-2.120-L				
Route Name:	LAUREL CREEK ROAD				
Inspection Date:	09/10/2010	Barrier Rating:	39.90		
Barrier Description					
Type:	STONE MASONRY WITHOUT CONCRETE CORE WALL	Barrier Function:	TRAFFIC		
Barrier Material:	STONE	Post Material:	N/A		
Blockout Type:	N/A	Length (ft.):	42		
Speed Limit (MPH):	30	Placement with Respect to Road:	INSIDE OF CURVE		
Hazard Behind Barrier:	HIGH				
Barrier Crashworthiness					
Appropriate Test Level:	TL-1	Barrier Test Level:	NCW	Is Barrier Crashworthy?:	NO
Beg. End Trtmt Type:	NONE	Is Beg. End Trtmt Crashworthy?:	N/A	Approach Transition Type:	NONE
Ending End Trtmt Type:	NONE	Ending End Trtmt Crashworthy?:	N/A		
Average Measurements					
Design Height (In.):	24	Width (In.):	24.7	Post Spacing (In.):	0.0
Height (In.):	21.2	Lateral Offset (In.):	59.2	Road Grade (%):	6.60
Physical Condition					
Barrier	Alignment and Height:	No deviation in alignment and height is 1-5 in below the 24 in design height for 19 ft.

Breaking and Cracking:	No breaking or cracking observed.			
	Missing Elements:	No missing elements observed.			
	Corrosion and Weathering:	No corrosion or weathering observed.			
End Treatments	Alignment and Height:				
	Breaking and Cracking:				
	Missing Elements:				
	Corrosion and Weathering:

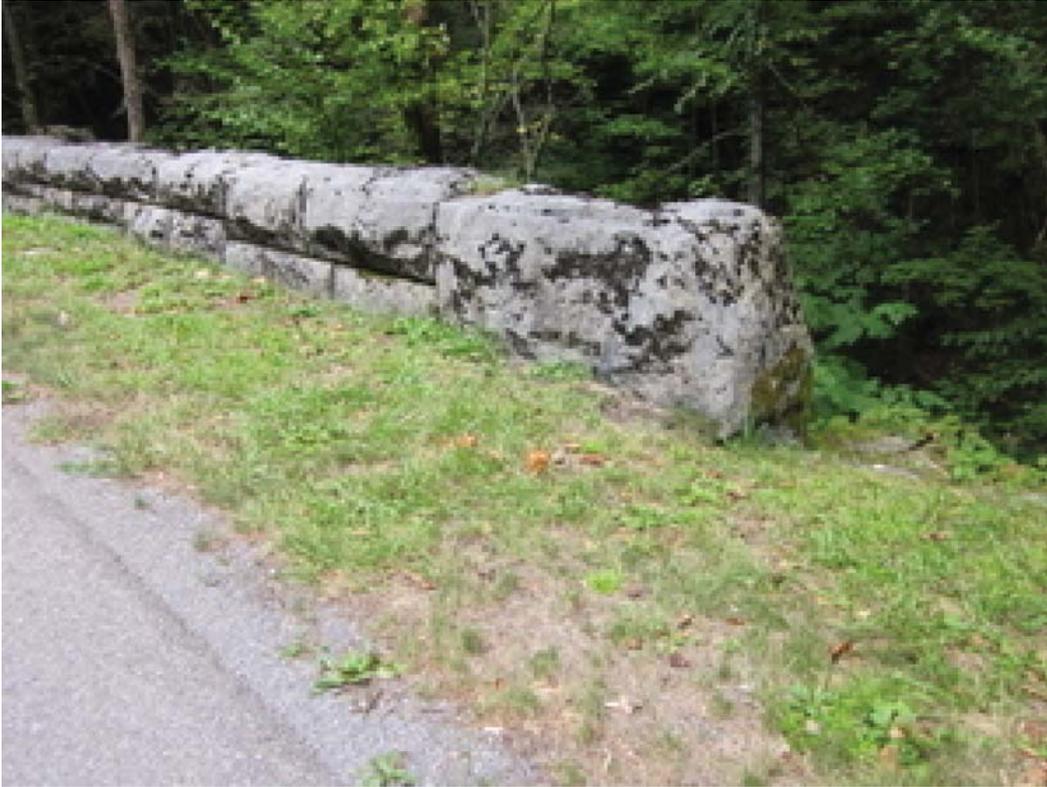
GRSM_0015_2.121_R_1.JPG

Barrier ID:	GRSM-0015-2.121-R				
Route Name:	LAUREL CREEK ROAD				
Inspection Date:	09/10/2010	Barrier Rating:	32.50		
Barrier Description					
Type:	STONE MASONRY WITHOUT CONCRETE CORE WALL	Barrier Function:	TRAFFIC		
Barrier Material:	STONE	Post Material:	N/A		
Blockout Type:	N/A	Length (ft.):	35		
Speed Limit (MPH):	30	Placement with Respect to Road:	OUTSIDE OF CURVE		
Hazard Behind Barrier:	HIGH				
Barrier Crashworthiness					
Appropriate Test Level:	TL-1	Barrier Test Level:	NCW	Is Barrier Crashworthy?:	NO
Beg. End Trtmt Type:	NONE	Is Beg. End Trtmt Crashworthy?:	N/A	Approach Transition Type:	NONE
Ending End Trtmt Type:	NONE	Ending End Trtmt Crashworthy?:	N/A		
Average Measurements					
Design Height (In.):	24	Width (In.):	27.2	Post Spacing (In.):	0.0
Height (In.):	26.7	Lateral Offset (In.):	81.0	Road Grade (%):	6.20
Physical Condition					
Barrier	Alignment and Height:	No deviation in alignment and height is 2 to 4 in above the design height of 24 in.

Breaking and Cracking:	No breaking or cracking observed.			
	Missing Elements:	No missing elements observed.			
	Corrosion and Weathering:	No corrosion or weathering observed.			
End Treatments	Alignment and Height:				
	Breaking and Cracking:				
	Missing Elements:				
	Corrosion and Weathering:

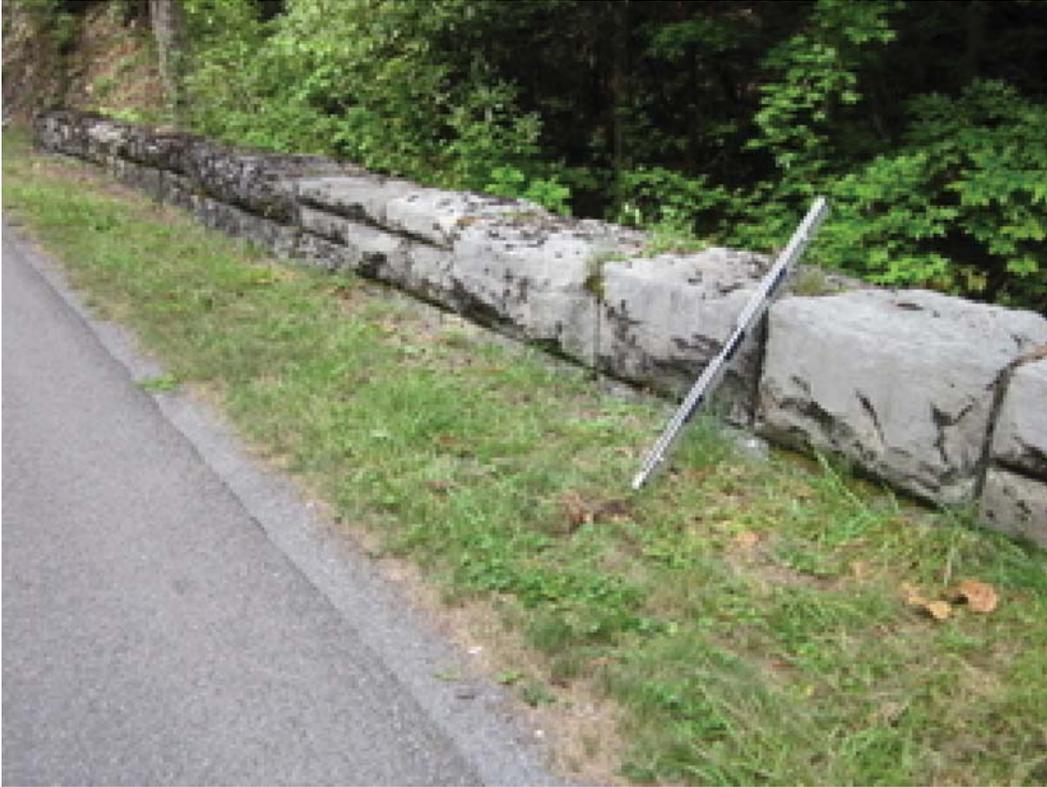
GRSM_0015_2.136_R_1.JPG

Barrier ID:	GRSM-0015-2.136-R				
Route Name:	LAUREL CREEK ROAD				
Inspection Date:	09/10/2010	Barrier Rating:	29.70		
Barrier Description					
Type:	STONE MASONRY WITHOUT CONCRETE CORE WALL	Barrier Function:	TRAFFIC		
Barrier Material:	STONE	Post Material:	N/A		
Blockout Type:	N/A	Length (ft.):	45		
Speed Limit (MPH):	30	Placement with Respect to Road:	OUTSIDE OF CURVE		
Hazard Behind Barrier:	HIGH				
Barrier Crashworthiness					
Appropriate Test Level:	TL-1	Barrier Test Level:	NCW	Is Barrier Crashworthy?:	NO
Beg. End Trtmt Type:	NONE	Is Beg. End Trtmt Crashworthy?:	N/A	Approach Transition Type:	NONE
Ending End Trtmt Type:	NONE	Ending End Trtmt Crashworthy?:	N/A		
Average Measurements					
Design Height (In.):	24	Width (In.):	27.0	Post Spacing (In.):	0.0
Height (In.):	26.7	Lateral Offset (In.):	67.0	Road Grade (%):	5.10
Physical Condition					
Barrier	Alignment and Height:	The alignment has no deviation and the height is 2 to 3 in above the 24 in design height.

Breaking and Cracking:	No breaking or cracking observed.			
	Missing Elements:	No missing elements observed.			
	Corrosion and Weathering:	No corrosion or weathering observed.			
End Treatments	Alignment and Height:				
	Breaking and Cracking:				
	Missing Elements:				
	Corrosion and Weathering:

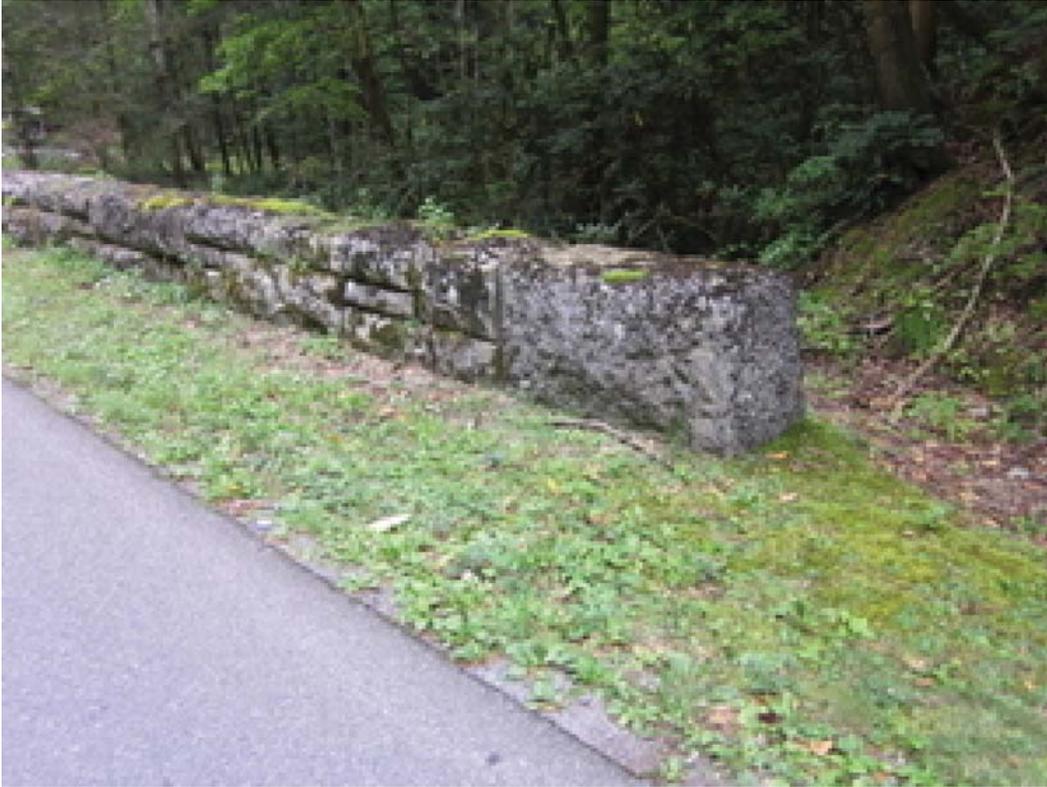
GRSM_0015_2.140_L_1.JPG

Barrier ID:	GRSM-0015-2.140-L				
Route Name:	LAUREL CREEK ROAD				
Inspection Date:	09/10/2010	Barrier Rating:	28.20		
Barrier Description					
Type:	STONE MASONRY WITHOUT CONCRETE CORE WALL	Barrier Function:	TRAFFIC		
Barrier Material:	STONE	Post Material:	N/A		
Blockout Type:	N/A	Length (ft.):	49		
Speed Limit (MPH):	30	Placement with Respect to Road:	INSIDE OF CURVE		
Hazard Behind Barrier:	HIGH				
Barrier Crashworthiness					
Appropriate Test Level:	TL-1	Barrier Test Level:	NCW	Is Barrier Crashworthy?:	NO
Beg. End Trtmt Type:	NONE	Is Beg. End Trtmt Crashworthy?:	N/A	Approach Transition Type:	NONE
Ending End Trtmt Type:	NONE	Ending End Trtmt Crashworthy?:	N/A		
Average Measurements					
Design Height (In.):	24	Width (In.):	25.0	Post Spacing (In.):	0.0
Height (In.):	29.2	Lateral Offset (In.):	67.5	Road Grade (%):	5.70
Physical Condition					
Barrier	Alignment and Height:	The alignment has no deviation and the height is 4 to 7 in above the 24 in design height.

Breaking and Cracking:	No breaking or cracking observed.			
	Missing Elements:	No missing elements observed.			
	Corrosion and Weathering:	No corrosion or weathering observed.			
End Treatments	Alignment and Height:				
	Breaking and Cracking:				
	Missing Elements:				
	Corrosion and Weathering:

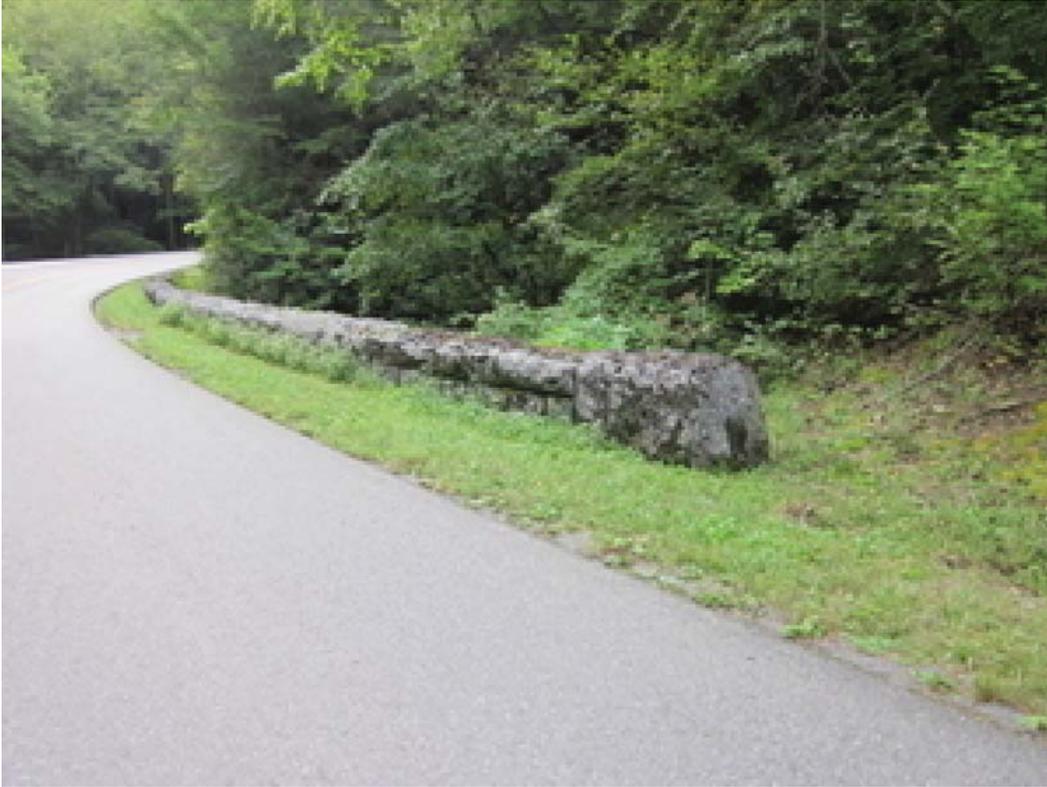
GRSM_0015_2.169_R_1.JPG

Barrier ID:	GRSM-0015-2.169-R				
Route Name:	LAUREL CREEK ROAD				
Inspection Date:	09/09/2010	Barrier Rating:	30.70		
Barrier Description					
Type:	STONE MASONRY WITHOUT CONCRETE CORE WALL	Barrier Function:	TRAFFIC		
Barrier Material:	STONE	Post Material:	N/A		
Blockout Type:	N/A	Length (ft.):	29		
Speed Limit (MPH):	30	Placement with Respect to Road:	OUTSIDE OF CURVE		
Hazard Behind Barrier:	MEDIUM				
Barrier Crashworthiness					
Appropriate Test Level:	TL-1	Barrier Test Level:	NCW	Is Barrier Crashworthy?:	NO
Beg. End Trtmt Type:	NONE	Is Beg. End Trtmt Crashworthy?:	N/A	Approach Transition Type:	NONE
Ending End Trtmt Type:	NONE	Ending End Trtmt Crashworthy?:	N/A		
Average Measurements					
Design Height (In.):	24	Width (In.):	24.2	Post Spacing (In.):	0.0
Height (In.):	25.0	Lateral Offset (In.):	63.2	Road Grade (%):	4.30
Physical Condition					
Barrier	Alignment and Height:	No deviation in alignment and height is 1 in above the 24 in design height.

Breaking and Cracking:	No breaking or cracking observed.			
	Missing Elements:	No missing elements observed.			
	Corrosion and Weathering:	No corrosion or weathering observed.			
End Treatments	Alignment and Height:				
	Breaking and Cracking:				
	Missing Elements:				
	Corrosion and Weathering:

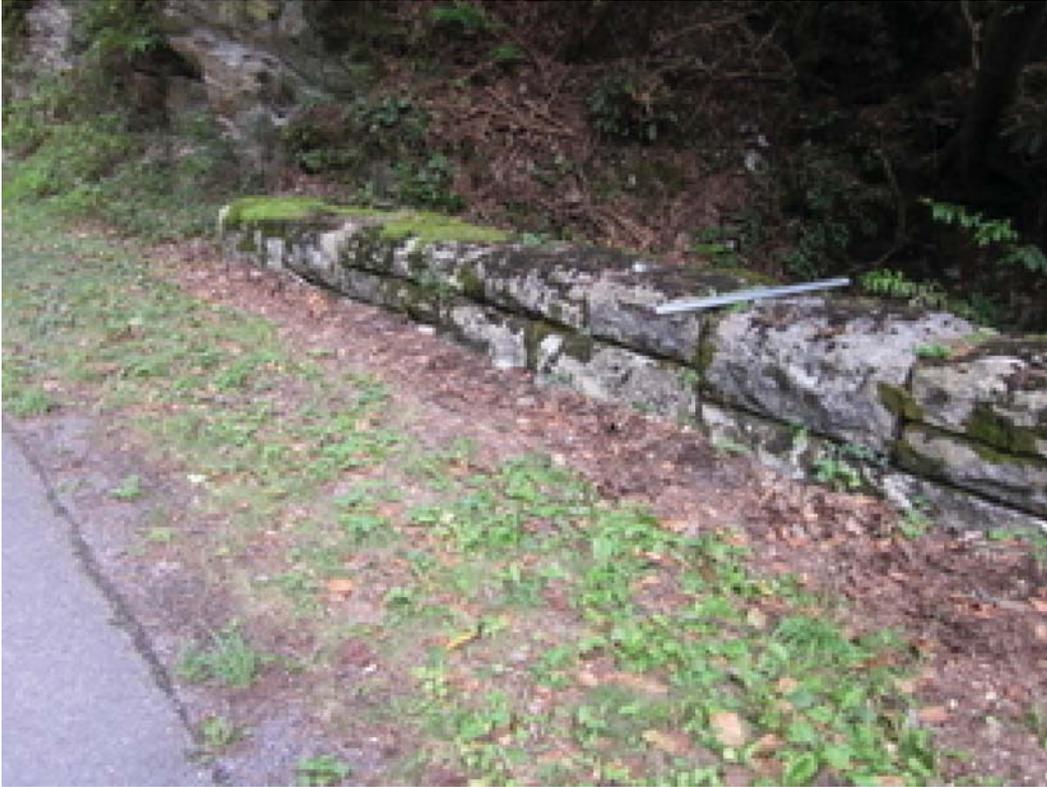
GRSM_0015_2.172_L_1.JPG

Barrier ID:	GRSM-0015-2.172-L				
Route Name:	LAUREL CREEK ROAD				
Inspection Date:	09/09/2010	Barrier Rating:	41.20		
Barrier Description					
Type:	STONE MASONRY WITHOUT CONCRETE CORE WALL	Barrier Function:	TRAFFIC		
Barrier Material:	STONE	Post Material:	N/A		
Blockout Type:	N/A	Length (ft.):	15		
Speed Limit (MPH):	30	Placement with Respect to Road:	OUTSIDE OF CURVE		
Hazard Behind Barrier:	HIGH				
Barrier Crashworthiness					
Appropriate Test Level:	TL-1	Barrier Test Level:	NCW	Is Barrier Crashworthy?:	NO
Beg. End Trtmt Type:	NONE	Is Beg. End Trtmt Crashworthy?:	N/A	Approach Transition Type:	NONE
Ending End Trtmt Type:	NONE	Ending End Trtmt Crashworthy?:	N/A		
Average Measurements					
Design Height (In.):	24	Width (In.):	27.0	Post Spacing (In.):	0.0
Height (In.):	22.2	Lateral Offset (In.):	86.0	Road Grade (%):	5.40
Physical Condition					
Barrier	Alignment and Height:	No deviation in alignment and height is 1 to 3 in below the 24 in design height for 15 ft.

Breaking and Cracking:	No breaking or cracking observed.			
	Missing Elements:	No missing elements observed.			
	Corrosion and Weathering:	No corrosion or weathering observed.			
End Treatments	Alignment and Height:				
	Breaking and Cracking:				
	Missing Elements:				
	Corrosion and Weathering:

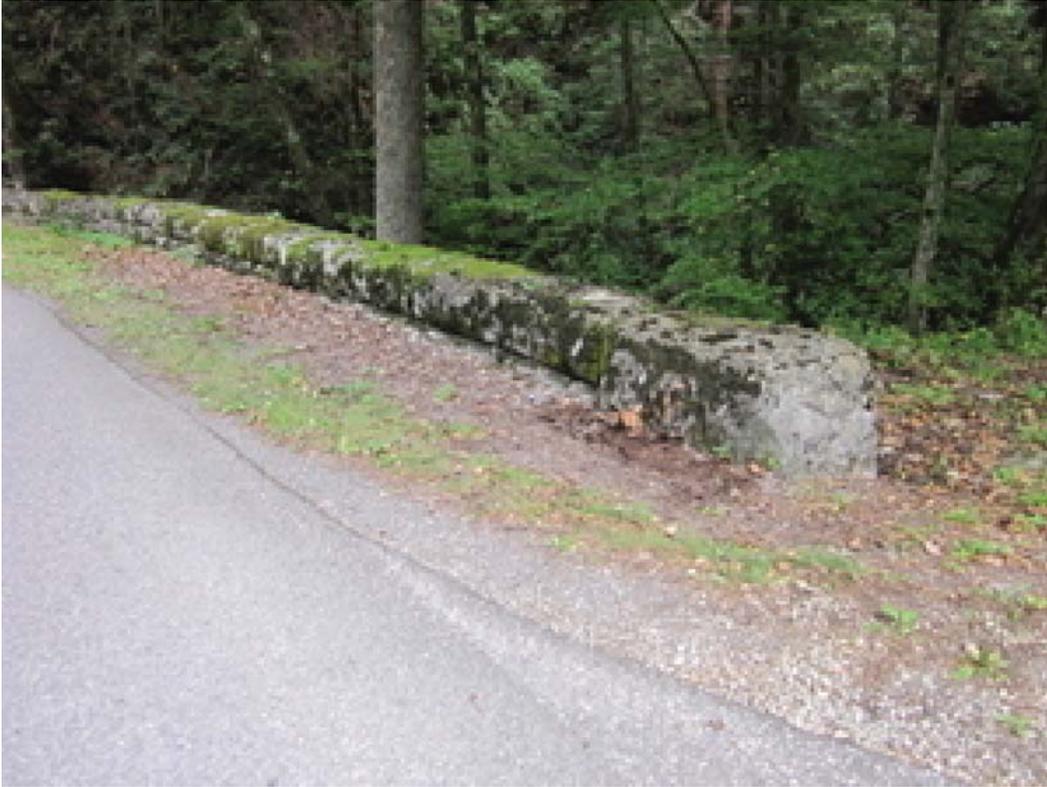
GRSM_0015_2.183_L_1.JPG

Barrier ID:	GRSM-0015-2.183-L				
Route Name:	LAUREL CREEK ROAD				
Inspection Date:	09/09/2010	Barrier Rating:	27.80		
Barrier Description					
Type:	STONE MASONRY WITHOUT CONCRETE CORE WALL	Barrier Function:	TRAFFIC		
Barrier Material:	STONE	Post Material:	N/A		
Blockout Type:	N/A	Length (ft.):	37		
Speed Limit (MPH):	30	Placement with Respect to Road:	OUTSIDE OF CURVE		
Hazard Behind Barrier:	MEDIUM				
Barrier Crashworthiness					
Appropriate Test Level:	TL-1	Barrier Test Level:	NCW	Is Barrier Crashworthy?:	NO
Beg. End Trtmt Type:	NONE	Is Beg. End Trtmt Crashworthy?:	N/A	Approach Transition Type:	NONE
Ending End Trtmt Type:	NONE	Ending End Trtmt Crashworthy?:	N/A		
Average Measurements					
Design Height (In.):	24	Width (In.):	28.7	Post Spacing (In.):	0.0
Height (In.):	26.2	Lateral Offset (In.):	81.0	Road Grade (%):	5.30
Physical Condition					
Barrier	Alignment and Height:	No deviation in alignment and height is 0 to 5 in above the 24 in design height.

Breaking and Cracking:	No breaking or cracking observed.			
	Missing Elements:	No missing elements observed.			
	Corrosion and Weathering:	No corrosion or weathering observed.			
End Treatments	Alignment and Height:				
	Breaking and Cracking:				
	Missing Elements:				
	Corrosion and Weathering:

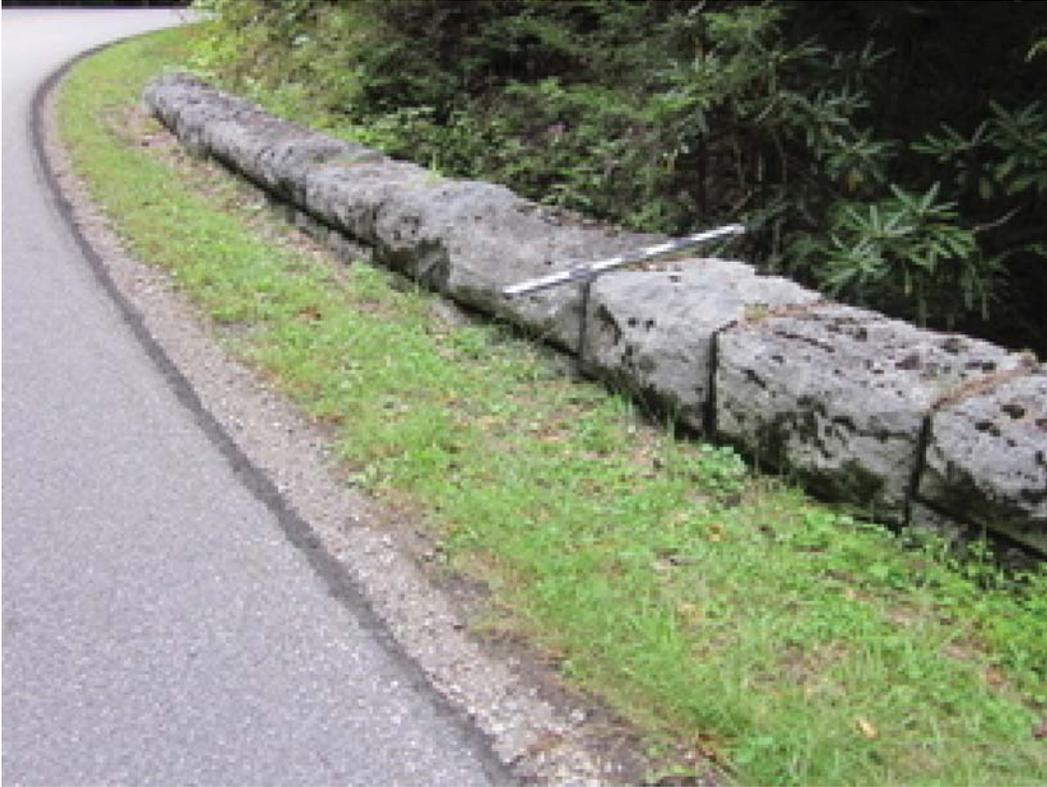
GRSM_0015_2.183_R_1.JPG

Barrier ID:	GRSM-0015-2.183-R				
Route Name:	LAUREL CREEK ROAD				
Inspection Date:	09/09/2010	Barrier Rating:	40.70		
Barrier Description					
Type:	STONE MASONRY WITHOUT CONCRETE CORE WALL	Barrier Function:	TRAFFIC		
Barrier Material:	STONE	Post Material:	N/A		
Blockout Type:	N/A	Length (ft.):	34		
Speed Limit (MPH):	30	Placement with Respect to Road:	OUTSIDE OF CURVE		
Hazard Behind Barrier:	MEDIUM				
Barrier Crashworthiness					
Appropriate Test Level:	TL-1	Barrier Test Level:	NCW	Is Barrier Crashworthy?:	NO
Beg. End Trtmt Type:	NONE	Is Beg. End Trtmt Crashworthy?:	N/A	Approach Transition Type:	NONE
Ending End Trtmt Type:	NONE	Ending End Trtmt Crashworthy?:	N/A		
Average Measurements					
Design Height (In.):	24	Width (In.):	24.0	Post Spacing (In.):	0.0
Height (In.):	19.0	Lateral Offset (In.):	53.0	Road Grade (%):	3.70
Physical Condition					
Barrier	Alignment and Height:	No deviation in alignment and height is 3 to 6 in below the 24 in design height for 34 ft.

Breaking and Cracking:	No breaking or cracking observed.			
	Missing Elements:	No missing elements observed.			
	Corrosion and Weathering:	No corrosion or weathering observed.			
End Treatments	Alignment and Height:				
	Breaking and Cracking:				
	Missing Elements:				
	Corrosion and Weathering:

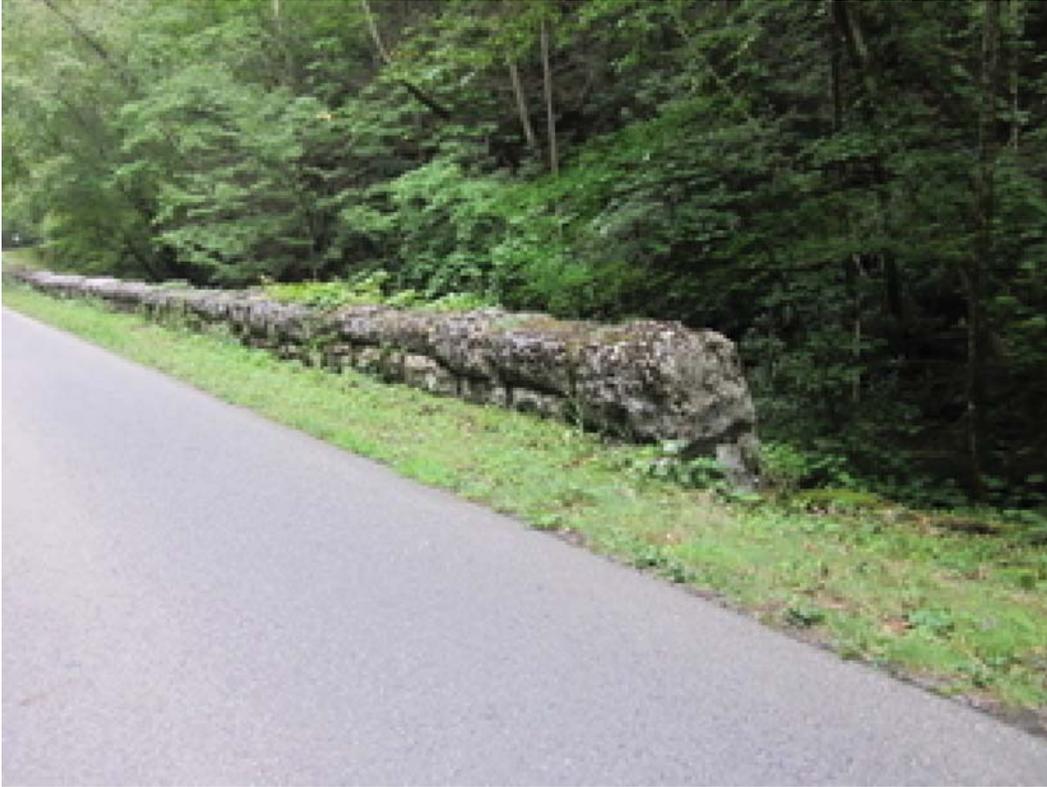
GRSM_0015_2.258_L_1.JPG

Barrier ID:	GRSM-0015-2.258-L				
Route Name:	LAUREL CREEK ROAD				
Inspection Date:	09/09/2010	Barrier Rating:	28.00		
Barrier Description					
Type:	STONE MASONRY WITHOUT CONCRETE CORE WALL	Barrier Function:	TRAFFIC		
Barrier Material:	STONE	Post Material:	N/A		
Blockout Type:	N/A	Length (ft.):	251		
Speed Limit (MPH):	35	Placement with Respect to Road:	INSIDE OF CURVE		
Hazard Behind Barrier:	MEDIUM				
Barrier Crashworthiness					
Appropriate Test Level:	TL-2	Barrier Test Level:	NCW	Is Barrier Crashworthy?:	NO
Beg. End Trtmt Type:	NONE	Is Beg. End Trtmt Crashworthy?:	N/A	Approach Transition Type:	NONE
Ending End Trtmt Type:	NONE	Ending End Trtmt Crashworthy?:	N/A		
Average Measurements					
Design Height (In.):	24	Width (In.):	26.0	Post Spacing (In.):	0.0
Height (In.):	24.0	Lateral Offset (In.):	54.0	Road Grade (%):	2.40
Physical Condition					
Barrier	Alignment and Height:	The alignment has no deviation and the height is at the 24 in design height.

Breaking and Cracking:	No breaking or cracking observed.			
	Missing Elements:	No missing elements observed.			
	Corrosion and Weathering:	No corrosion or weathering observed.			
End Treatments	Alignment and Height:				
	Breaking and Cracking:				
	Missing Elements:				
	Corrosion and Weathering:

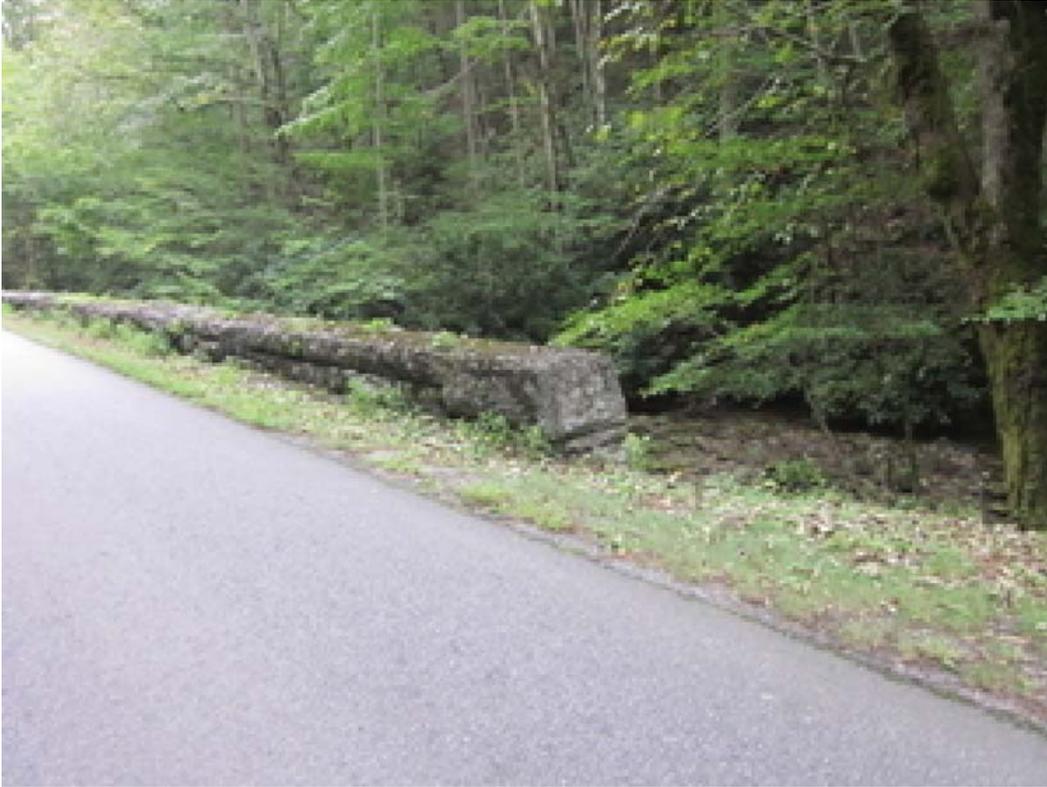
GRSM_0015_2.334_L_1.JPG

Barrier ID:	GRSM-0015-2.334-L				
Route Name:	LAUREL CREEK ROAD				
Inspection Date:	09/09/2010	Barrier Rating:	22.20		
Barrier Description					
Type:	STONE MASONRY WITHOUT CONCRETE CORE WALL	Barrier Function:	TRAFFIC		
Barrier Material:	STONE	Post Material:	N/A		
Blockout Type:	N/A	Length (ft.):	183		
Speed Limit (MPH):	35	Placement with Respect to Road:	TANGENT		
Hazard Behind Barrier:	MEDIUM				
Barrier Crashworthiness					
Appropriate Test Level:	TL-2	Barrier Test Level:	NCW	Is Barrier Crashworthy?:	NO
Beg. End Trtmt Type:	NONE	Is Beg. End Trtmt Crashworthy?:	N/A	Approach Transition Type:	NONE
Ending End Trtmt Type:	NONE	Ending End Trtmt Crashworthy?:	N/A		
Average Measurements					
Design Height (In.):	24	Width (In.):	26.2	Post Spacing (In.):	0.0
Height (In.):	24.2	Lateral Offset (In.):	51.0	Road Grade (%):	1.30
Physical Condition					
Barrier	Alignment and Height:	The alignment has no deviation and the height is 1 in below to 2 in above the 24 in design height.

Breaking and Cracking:	No breaking or cracking observed.			
	Missing Elements:	No missing elements observed.			
	Corrosion and Weathering:	No corrosion or weathering observed.			
End Treatments	Alignment and Height:				
	Breaking and Cracking:				
	Missing Elements:				
	Corrosion and Weathering:

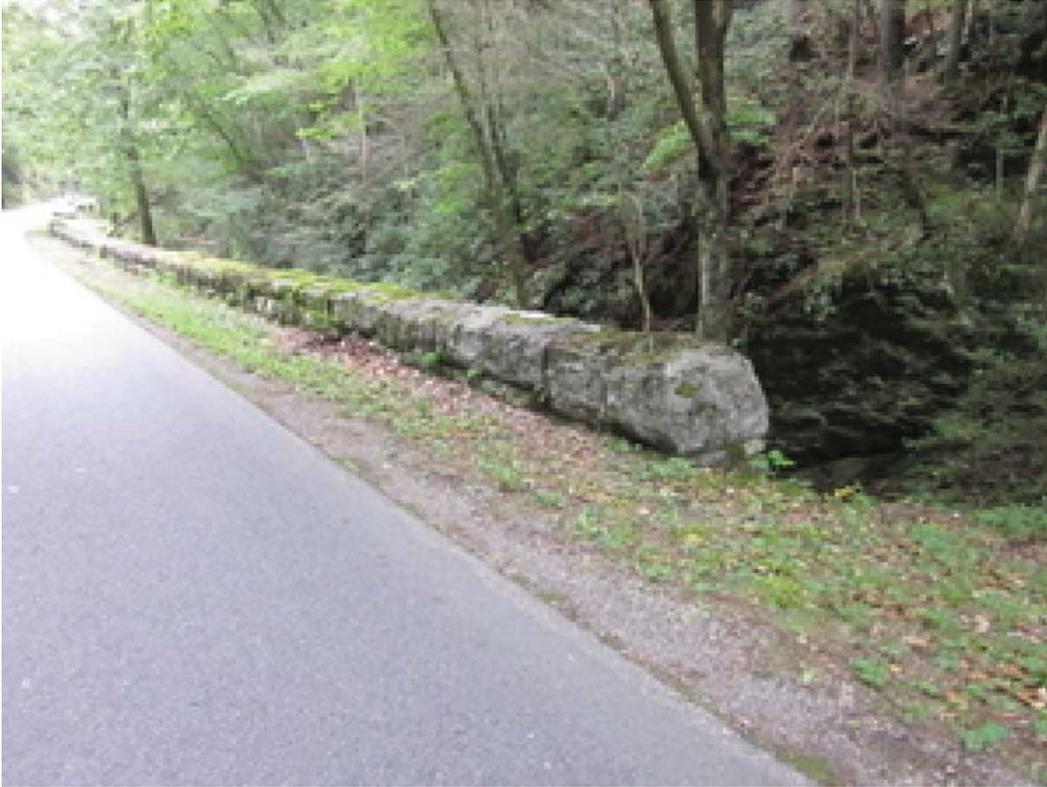
GRSM_0015_2.417_L_1.JPG

Barrier ID:	GRSM-0015-2.417-L				
Route Name:	LAUREL CREEK ROAD				
Inspection Date:	09/09/2010	Barrier Rating:	32.20		
Barrier Description					
Type:	STONE MASONRY WITHOUT CONCRETE CORE WALL	Barrier Function:	TRAFFIC		
Barrier Material:	STONE	Post Material:	N/A		
Blockout Type:	N/A	Length (ft.):	204		
Speed Limit (MPH):	35	Placement with Respect to Road:	TANGENT		
Hazard Behind Barrier:	MEDIUM				
Barrier Crashworthiness					
Appropriate Test Level:	TL-2	Barrier Test Level:	NCW	Is Barrier Crashworthy?:	NO
Beg. End Trtmt Type:	NONE	Is Beg. End Trtmt Crashworthy?:	N/A	Approach Transition Type:	NONE
Ending End Trtmt Type:	NONE	Ending End Trtmt Crashworthy?:	N/A		
Average Measurements					
Design Height (In.):	24	Width (In.):	26.0	Post Spacing (In.):	0.0
Height (In.):	23.6	Lateral Offset (In.):	1.2	Road Grade (%):	3.30
Physical Condition					
Barrier	Alignment and Height:	The alignment has no deviation and the height is within 1 in of the 24 in design height.

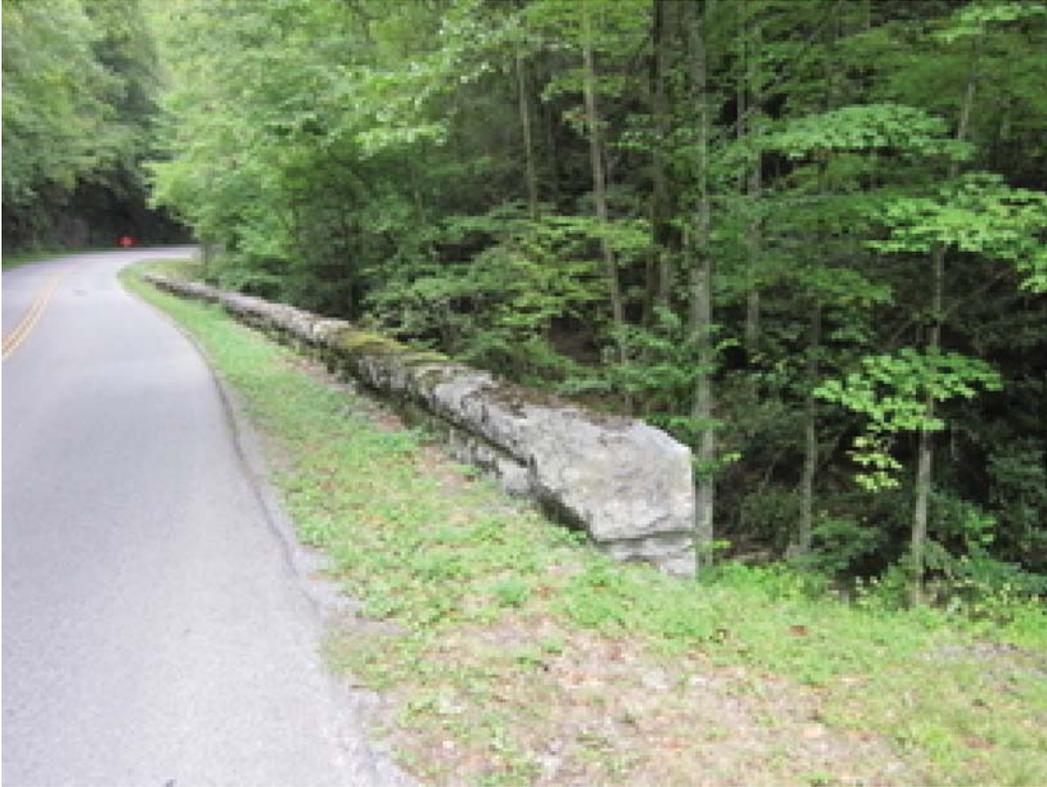
GRSM_0015_2.650_L_1.JPG

Barrier ID:	GRSM-0015-2.650-L				
Route Name:	LAUREL CREEK ROAD				
Inspection Date:	09/09/2010	Barrier Rating:	45.70		
Barrier Description					
Type:	STONE MASONRY WITHOUT CONCRETE CORE WALL	Barrier Function:	TRAFFIC		
Barrier Material:	STONE	Post Material:	N/A		
Blockout Type:	N/A	Length (ft.):	230		
Speed Limit (MPH):	35	Placement with Respect to Road:	BOTH INSIDE AND OUTSIDE		
Hazard Behind Barrier:	HIGH				
Barrier Crashworthiness					
Appropriate Test Level:	TL-2	Barrier Test Level:	NCW	Is Barrier Crashworthy?:	NO
Beg. End Trtmt Type:	NONE	Is Beg. End Trtmt Crashworthy?:	N/A	Approach Transition Type:	NONE
Ending End Trtmt Type:	NONE	Ending End Trtmt Crashworthy?:	N/A		
Average Measurements					
Design Height (In.):	24	Width (In.):	24.0	Post Spacing (In.):	0.0
Height (In.):	22.6	Lateral Offset (In.):	56.2	Road Grade (%):	3.30
Physical Condition					
Barrier	Alignment and Height:	The alignment has no deviation and the height is 4 to 6 in below the 24 in design height for 16 ft and more than 6 in below for 61 ft.
