NPS Guardwall/Rail Inventory Program
Great Smoky Mountains National Park

Federal Highway Administration
Eastern Federal Lands Highway Division
Road Inventory Program (RIP)

Data Collection Date: September 2010
Report Date: December 2015

Great Smoky Mountains National Park in North Carolina and Tennessee

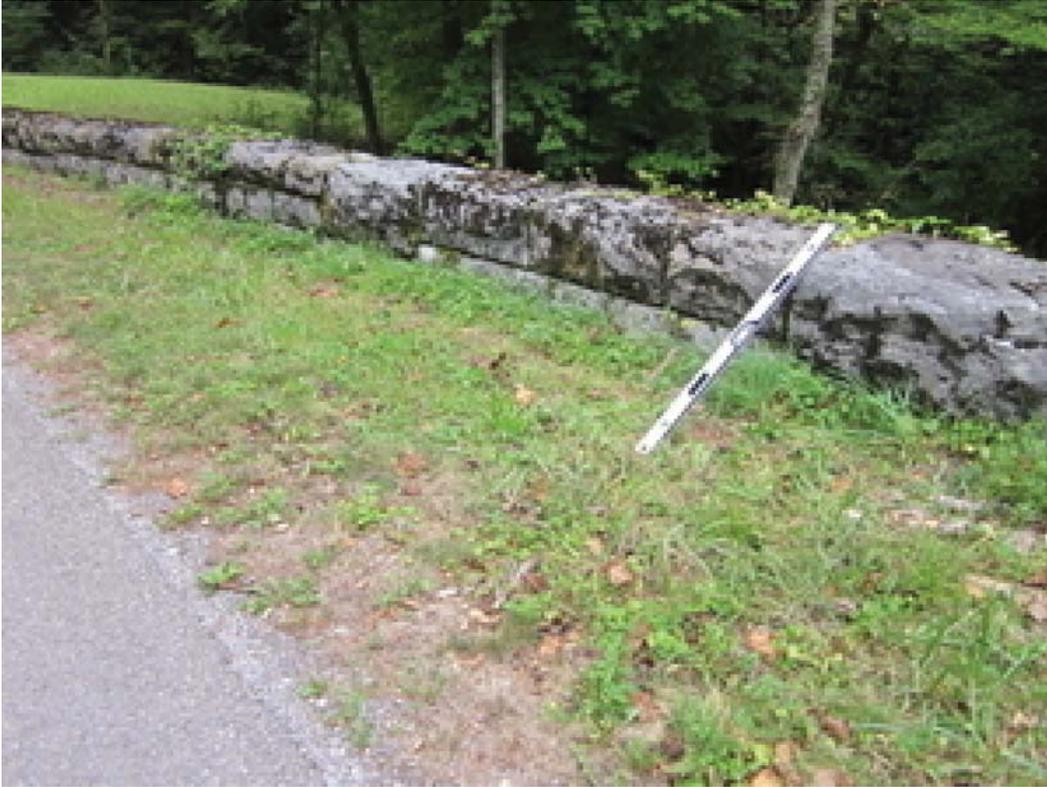
GRSM_0015_2.718_L_1.JPG

Barrier ID:	GRSM-0015-2.718-L				
Route Name:	LAUREL CREEK ROAD				
Inspection Date:	09/09/2010	Barrier Rating:	36.90		
Barrier Description					
Type:	STONE MASONRY WITHOUT CONCRETE CORE WALL	Barrier Function:	TRAFFIC		
Barrier Material:	STONE	Post Material:	N/A		
Blockout Type:	N/A	Length (ft.):	44		
Speed Limit (MPH):	35	Placement with Respect to Road:	OUTSIDE OF CURVE		
Hazard Behind Barrier:	HIGH				
Barrier Crashworthiness					
Appropriate Test Level:	TL-2	Barrier Test Level:	NCW	Is Barrier Crashworthy?:	NO
Beg. End Trtmt Type:	NONE	Is Beg. End Trtmt Crashworthy?:	N/A	Approach Transition Type:	NONE
Ending End Trtmt Type:	NONE	Ending End Trtmt Crashworthy?:	N/A		
Average Measurements					
Design Height (In.):	24	Width (In.):	26.7	Post Spacing (In.):	0.0
Height (In.):	26.0	Lateral Offset (In.):	91.6	Road Grade (%):	4.40
Physical Condition					
Barrier	Alignment and Height:	No deviation in alignment and height is 0-3 in above the 24 in design height.

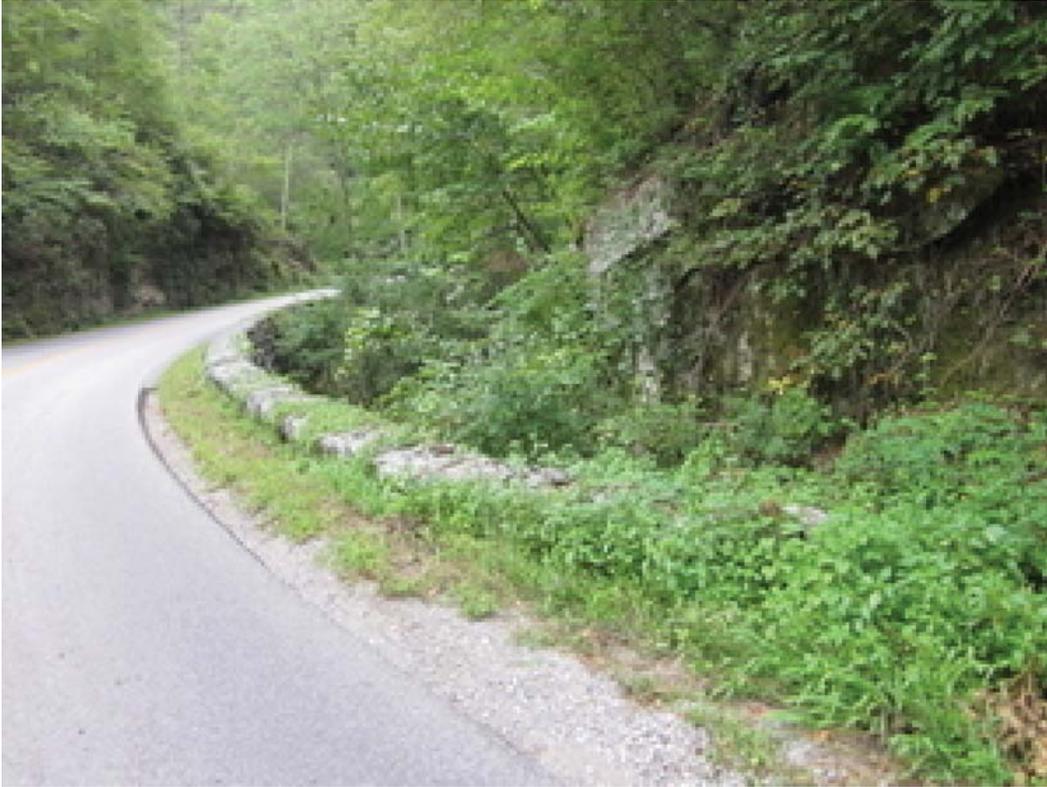
GRSM_0015_2.721_R_1.JPG

Barrier ID:	GRSM-0015-2.721-R				
Route Name:	LAUREL CREEK ROAD				
Inspection Date:	09/09/2010	Barrier Rating:	38.00		
Barrier Description					
Type:	STONE MASONRY WITHOUT CONCRETE CORE WALL	Barrier Function:	TRAFFIC		
Barrier Material:	STONE	Post Material:	N/A		
Blockout Type:	N/A	Length (ft.):	45		
Speed Limit (MPH):	35	Placement with Respect to Road:	INSIDE OF CURVE		
Hazard Behind Barrier:	MEDIUM				
Barrier Crashworthiness					
Appropriate Test Level:	TL-2	Barrier Test Level:	NCW	Is Barrier Crashworthy?:	NO
Beg. End Trtmt Type:	NONE	Is Beg. End Trtmt Crashworthy?:	N/A	Approach Transition Type:	NONE
Ending End Trtmt Type:	NONE	Ending End Trtmt Crashworthy?:	N/A		
Average Measurements					
Design Height (In.):	24	Width (In.):	28.0	Post Spacing (In.):	0.0
Height (In.):	17.2	Lateral Offset (In.):	52.2	Road Grade (%):	4.20
Physical Condition					
Barrier	Alignment and Height:	The alignment has no deviation and the height is 3-6 in below the 24 in design height for 30 ft and 6 to 9 in below for 15 ft.

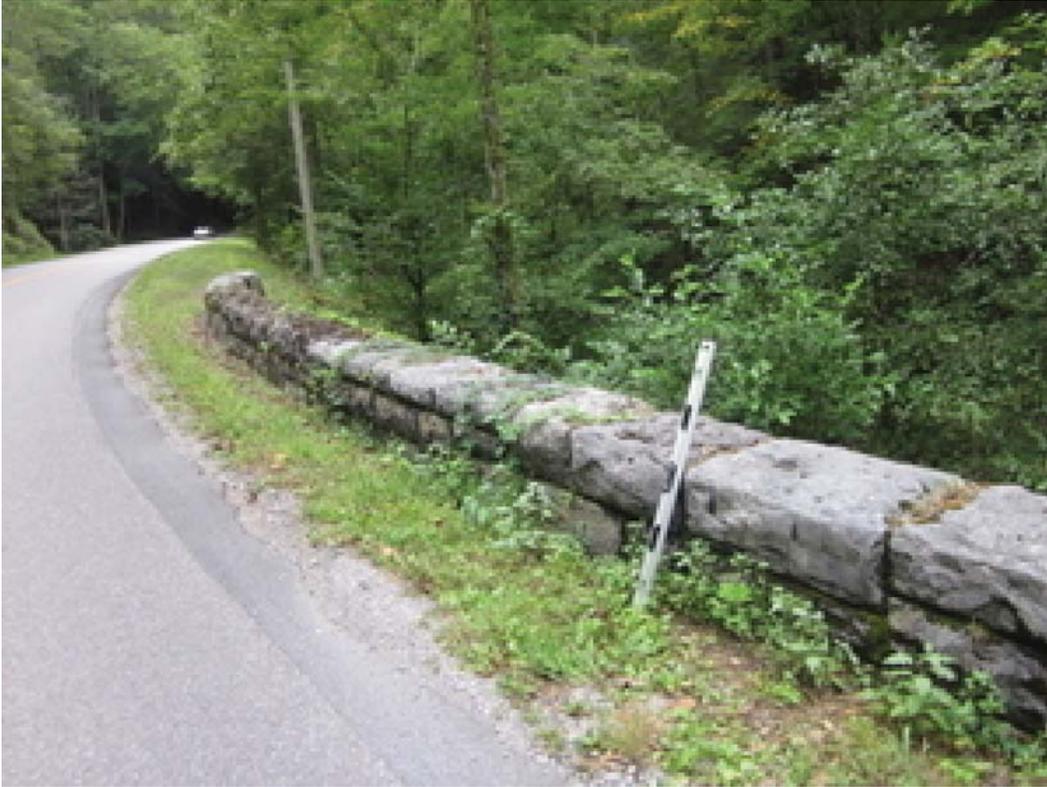
GRSM_0015_2.739_R_1.JPG

Barrier ID:	GRSM-0015-2.739-R				
Route Name:	LAUREL CREEK ROAD				
Inspection Date:	09/09/2010	Barrier Rating:	22.20		
Barrier Description					
Type:	STONE MASONRY WITHOUT CONCRETE CORE WALL	Barrier Function:	TRAFFIC		
Barrier Material:	STONE	Post Material:	N/A		
Blockout Type:	N/A	Length (ft.):	59		
Speed Limit (MPH):	35	Placement with Respect to Road:	INSIDE OF CURVE		
Hazard Behind Barrier:	MEDIUM				
Barrier Crashworthiness					
Appropriate Test Level:	TL-2	Barrier Test Level:	NCW	Is Barrier Crashworthy?:	NO
Beg. End Trtmt Type:	NONE	Is Beg. End Trtmt Crashworthy?:	N/A	Approach Transition Type:	NONE
Ending End Trtmt Type:	NONE	Ending End Trtmt Crashworthy?:	N/A		
Average Measurements					
Design Height (In.):	24	Width (In.):	26.2	Post Spacing (In.):	0.0
Height (In.):	25.6	Lateral Offset (In.):	79.0	Road Grade (%):	5.10
Physical Condition					
Barrier	Alignment and Height:	The alignment has no deviation and the height is 0-3 in above the 24 in design height.

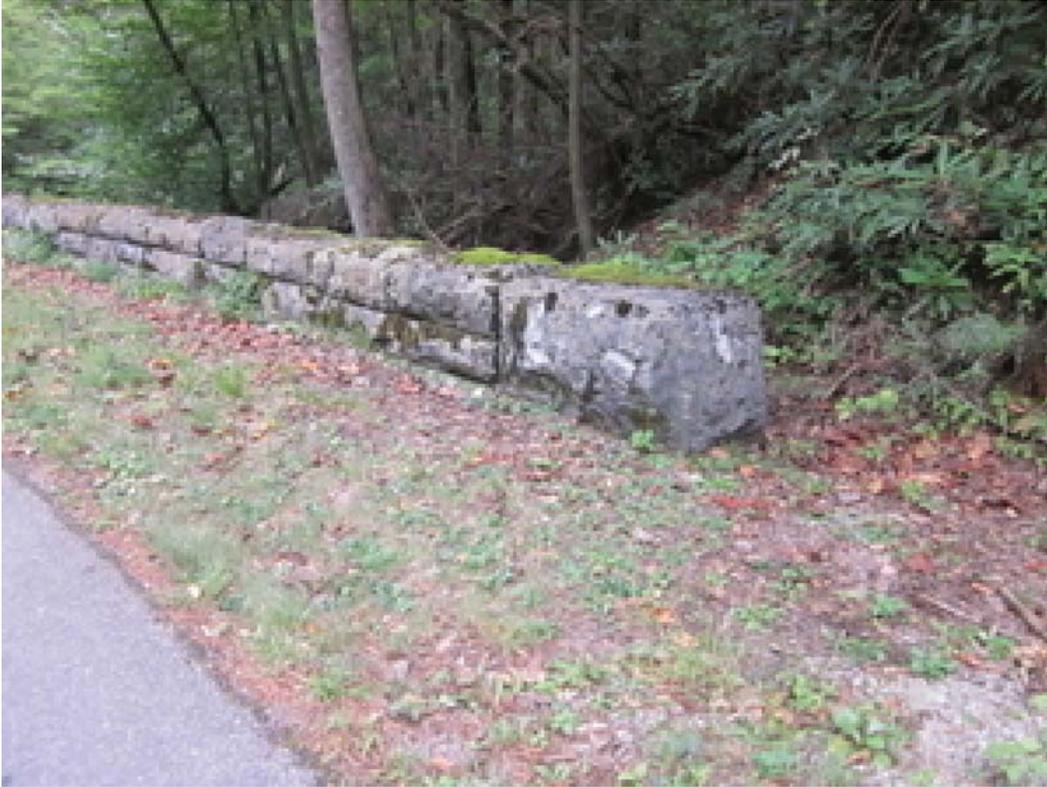
GRSM_0015_2.742_L_1.JPG

Barrier ID:	GRSM-0015-2.742-L				
Route Name:	LAUREL CREEK ROAD				
Inspection Date:	09/09/2010	Barrier Rating:	34.00		
Barrier Description					
Type:	STONE MASONRY WITHOUT CONCRETE CORE WALL	Barrier Function:	TRAFFIC		
Barrier Material:	STONE	Post Material:	N/A		
Blockout Type:	N/A	Length (ft.):	49		
Speed Limit (MPH):	35	Placement with Respect to Road:	OUTSIDE OF CURVE		
Hazard Behind Barrier:	HIGH				
Barrier Crashworthiness					
Appropriate Test Level:	TL-2	Barrier Test Level:	NCW	Is Barrier Crashworthy?:	NO
Beg. End Trtmt Type:	NONE	Is Beg. End Trtmt Crashworthy?:	N/A	Approach Transition Type:	NONE
Ending End Trtmt Type:	NONE	Ending End Trtmt Crashworthy?:	N/A		
Average Measurements					
Design Height (In.):	24	Width (In.):	27.2	Post Spacing (In.):	0.0
Height (In.):	30.0	Lateral Offset (In.):	98.6	Road Grade (%):	3.40
Physical Condition					
Barrier	Alignment and Height:	No deviation in alignment and height is 5 to 7 in above the 24 in design height.

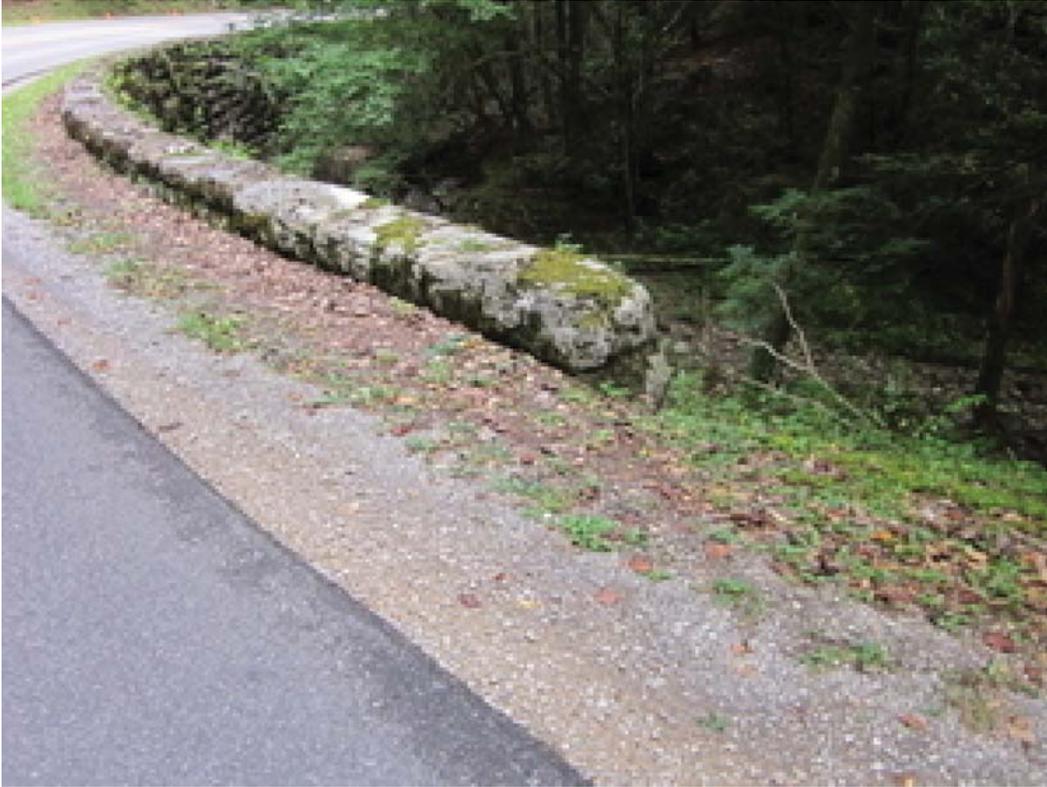
GRSM_0015_2.932_L_1.JPG

Barrier ID:	GRSM-0015-2.932-L				
Route Name:	LAUREL CREEK ROAD				
Inspection Date:	09/09/2010	Barrier Rating:	48.90		
Barrier Description					
Type:	STONE MASONRY WITHOUT CONCRETE CORE WALL	Barrier Function:	TRAFFIC		
Barrier Material:	STONE	Post Material:	N/A		
Blockout Type:	N/A	Length (ft.):	200		
Speed Limit (MPH):	35	Placement with Respect to Road:	INSIDE OF CURVE		
Hazard Behind Barrier:	MEDIUM				
Barrier Crashworthiness					
Appropriate Test Level:	TL-2	Barrier Test Level:	NCW	Is Barrier Crashworthy?:	NO
Beg. End Trtmt Type:	NONE	Is Beg. End Trtmt Crashworthy?:	N/A	Approach Transition Type:	NONE
Ending End Trtmt Type:	NONE	Ending End Trtmt Crashworthy?:	N/A		
Average Measurements					
Design Height (In.):	24	Width (In.):	24.0	Post Spacing (In.):	0.0
Height (In.):	16.2	Lateral Offset (In.):	65.3	Road Grade (%):	0.90
Physical Condition					
Barrier	Alignment and Height:	No deviation in alignment and height is 3 to 6 in below the 24 in design height for 92 ft and 6 to 12 in below for 108 ft.

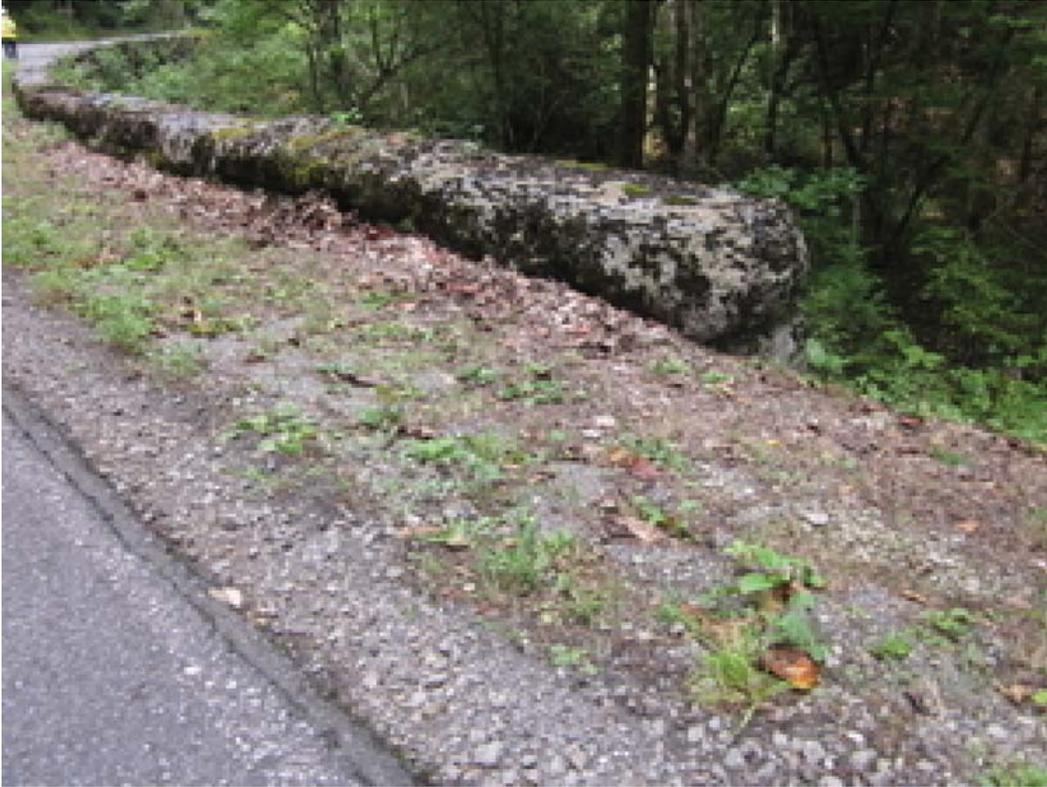
GRSM_0015_3.025_L_1.JPG

Barrier ID:	GRSM-0015-3.025-L				
Route Name:	LAUREL CREEK ROAD				
Inspection Date:	09/09/2010	Barrier Rating:	29.70		
Barrier Description					
Type:	STONE MASONRY WITHOUT CONCRETE CORE WALL	Barrier Function:	TRAFFIC		
Barrier Material:	STONE	Post Material:	N/A		
Blockout Type:	N/A	Length (ft.):	311		
Speed Limit (MPH):	35	Placement with Respect to Road:	INSIDE OF CURVE		
Hazard Behind Barrier:	HIGH				
Barrier Crashworthiness					
Appropriate Test Level:	TL-2	Barrier Test Level:	NCW	Is Barrier Crashworthy?:	NO
Beg. End Trtmt Type:	NONE	Is Beg. End Trtmt Crashworthy?:	N/A	Approach Transition Type:	NONE
Ending End Trtmt Type:	NONE	Ending End Trtmt Crashworthy?:	N/A		
Average Measurements					
Design Height (In.):	24	Width (In.):	26.7	Post Spacing (In.):	0.0
Height (In.):	23.0	Lateral Offset (In.):	67.6	Road Grade (%):	1.50
Physical Condition					
Barrier	Alignment and Height:	No deviation in alignment and height is 0-3 in below the 24 in design height.

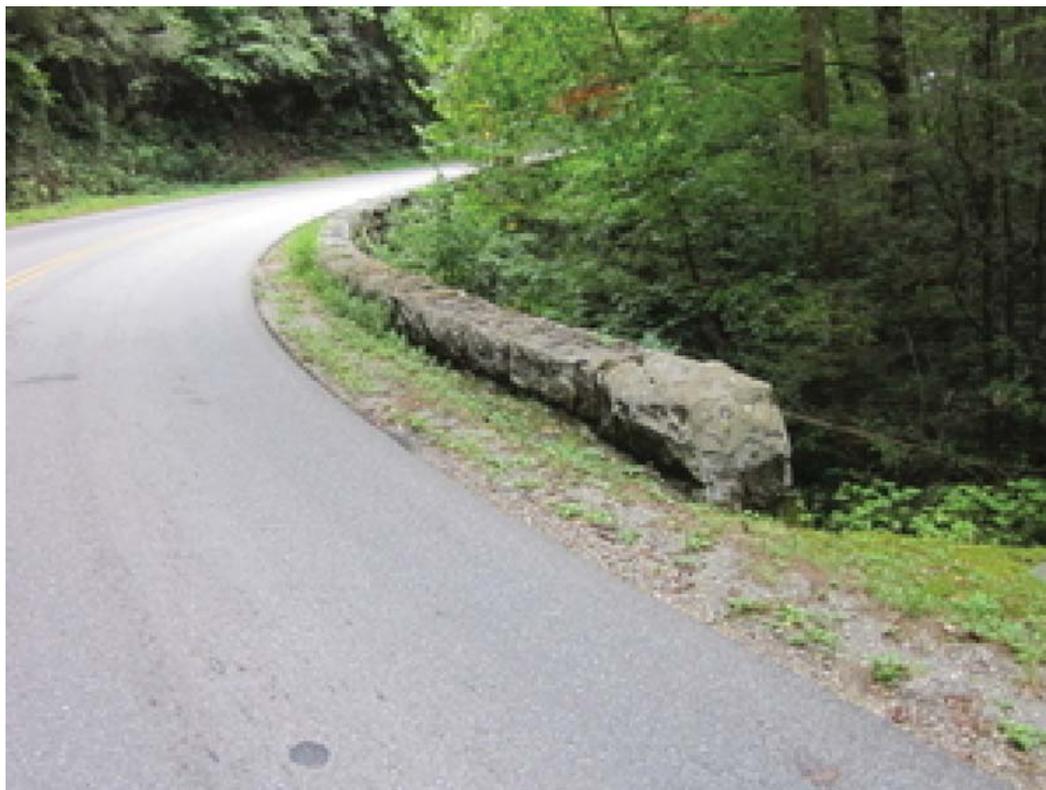
GRSM_0015_3.326_R_1.JPG

Barrier ID:	GRSM-0015-3.326-R				
Route Name:	LAUREL CREEK ROAD				
Inspection Date:	09/09/2010	Barrier Rating:	38.00		
Barrier Description					
Type:	STONE MASONRY WITHOUT CONCRETE CORE WALL	Barrier Function:	TRAFFIC		
Barrier Material:	STONE	Post Material:	N/A		
Blockout Type:	N/A	Length (ft.):	532		
Speed Limit (MPH):	35	Placement with Respect to Road:	BOTH INSIDE AND OUTSIDE		
Hazard Behind Barrier:	MEDIUM				
Barrier Crashworthiness					
Appropriate Test Level:	TL-2	Barrier Test Level:	NCW	Is Barrier Crashworthy?:	NO
Beg. End Trtmt Type:	NONE	Is Beg. End Trtmt Crashworthy?:	N/A	Approach Transition Type:	NONE
Ending End Trtmt Type:	NONE	Ending End Trtmt Crashworthy?:	N/A		
Average Measurements					
Design Height (In.):	24	Width (In.):	26.6	Post Spacing (In.):	0.0
Height (In.):	22.2	Lateral Offset (In.):	63.5	Road Grade (%):	3.90
Physical Condition					
Barrier	Alignment and Height:	The alignment has no deviation and the height is 2 to 5 in below the 24 in design height for 75 ft.

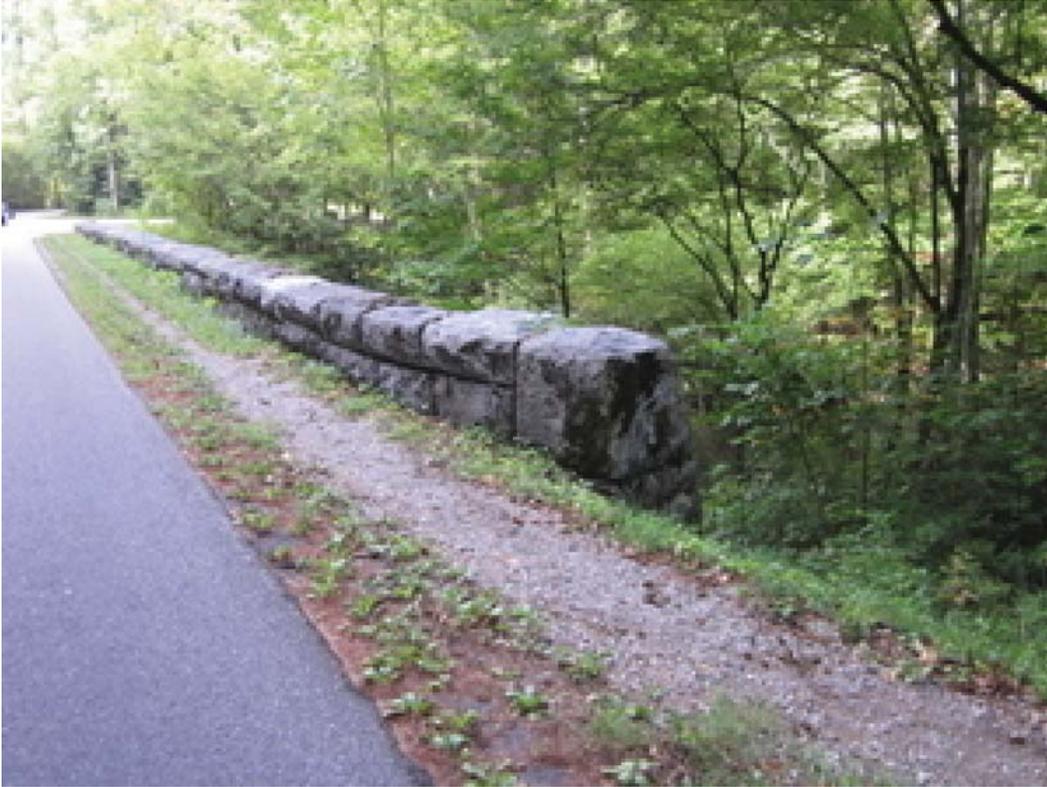
GRSM_0015_3.678_R_1.JPG

Barrier ID:	GRSM-0015-3.678-R				
Route Name:	LAUREL CREEK ROAD				
Inspection Date:	09/09/2010	Barrier Rating:	19.20		
Barrier Description					
Type:	STONE MASONRY WITHOUT CONCRETE CORE WALL	Barrier Function:	TRAFFIC		
Barrier Material:	STONE	Post Material:	N/A		
Blockout Type:	N/A	Length (ft.):	47		
Speed Limit (MPH):	30	Placement with Respect to Road:	TANGENT		
Hazard Behind Barrier:	MEDIUM				
Barrier Crashworthiness					
Appropriate Test Level:	TL-1	Barrier Test Level:	NCW	Is Barrier Crashworthy?:	NO
Beg. End Trtmt Type:	NONE	Is Beg. End Trtmt Crashworthy?:	N/A	Approach Transition Type:	NONE
Ending End Trtmt Type:	NONE	Ending End Trtmt Crashworthy?:	N/A		
Average Measurements					
Design Height (In.):	24	Width (In.):	27.2	Post Spacing (In.):	0.0
Height (In.):	26.2	Lateral Offset (In.):	69.5	Road Grade (%):	0.70
Physical Condition					
Barrier	Alignment and Height:	The alignment has no deviation and the height is 0-4 in above the 24 in design height.

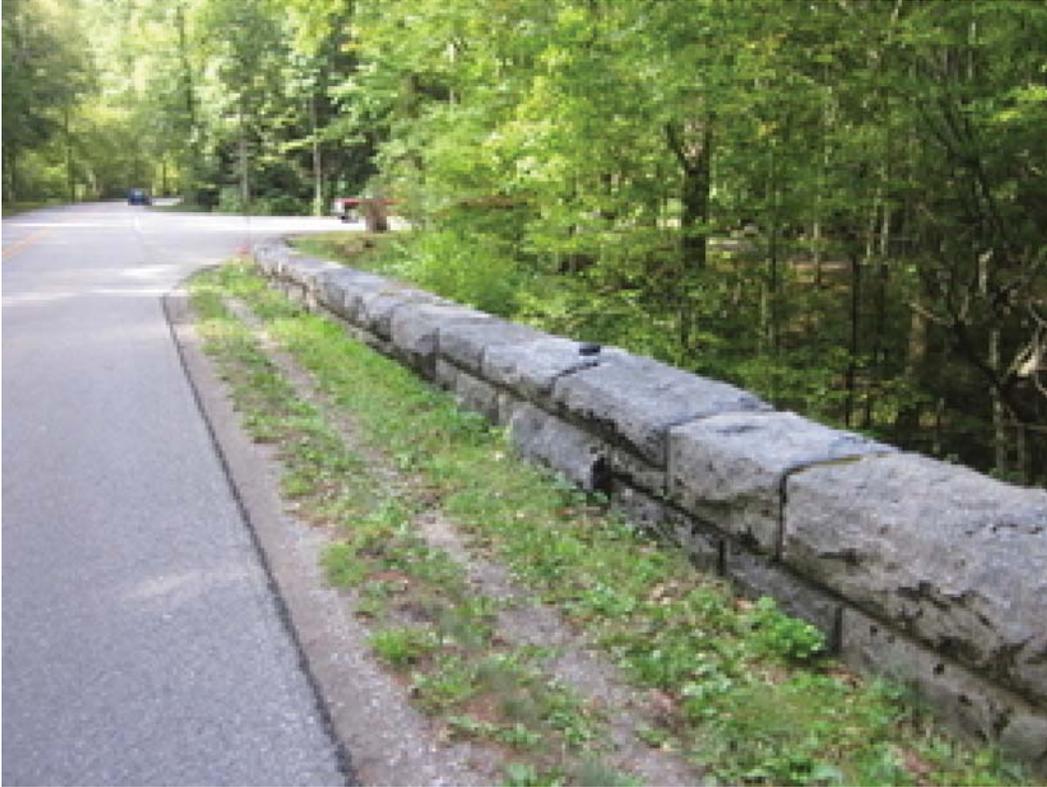
GRSM_0015_3.693_R_1.JPG

Barrier ID:	GRSM-0015-3.693-R				
Route Name:	LAUREL CREEK ROAD				
Inspection Date:	09/09/2010	Barrier Rating:	19.20		
Barrier Description					
Type:	STONE MASONRY WITHOUT CONCRETE CORE WALL	Barrier Function:	TRAFFIC		
Barrier Material:	STONE	Post Material:	N/A		
Blockout Type:	N/A	Length (ft.):	50		
Speed Limit (MPH):	30	Placement with Respect to Road:	TANGENT		
Hazard Behind Barrier:	MEDIUM				
Barrier Crashworthiness					
Appropriate Test Level:	TL-1	Barrier Test Level:	NCW	Is Barrier Crashworthy?:	NO
Beg. End Trtmt Type:	NONE	Is Beg. End Trtmt Crashworthy?:	N/A	Approach Transition Type:	NONE
Ending End Trtmt Type:	NONE	Ending End Trtmt Crashworthy?:	N/A		
Average Measurements					
Design Height (In.):	24	Width (In.):	27.0	Post Spacing (In.):	0.0
Height (In.):	24.0	Lateral Offset (In.):	71.3	Road Grade (%):	0.40
Physical Condition					
Barrier	Alignment and Height:	The alignment has no deviation and the height is at the 24 in design height.

Breaking and Cracking:	No breaking or cracking observed.			
	Missing Elements:	No missing elements observed.			
	Corrosion and Weathering:	No corrosion or weathering observed.			
End Treatments	Alignment and Height:				
	Breaking and Cracking:				
	Missing Elements:				
	Corrosion and Weathering:

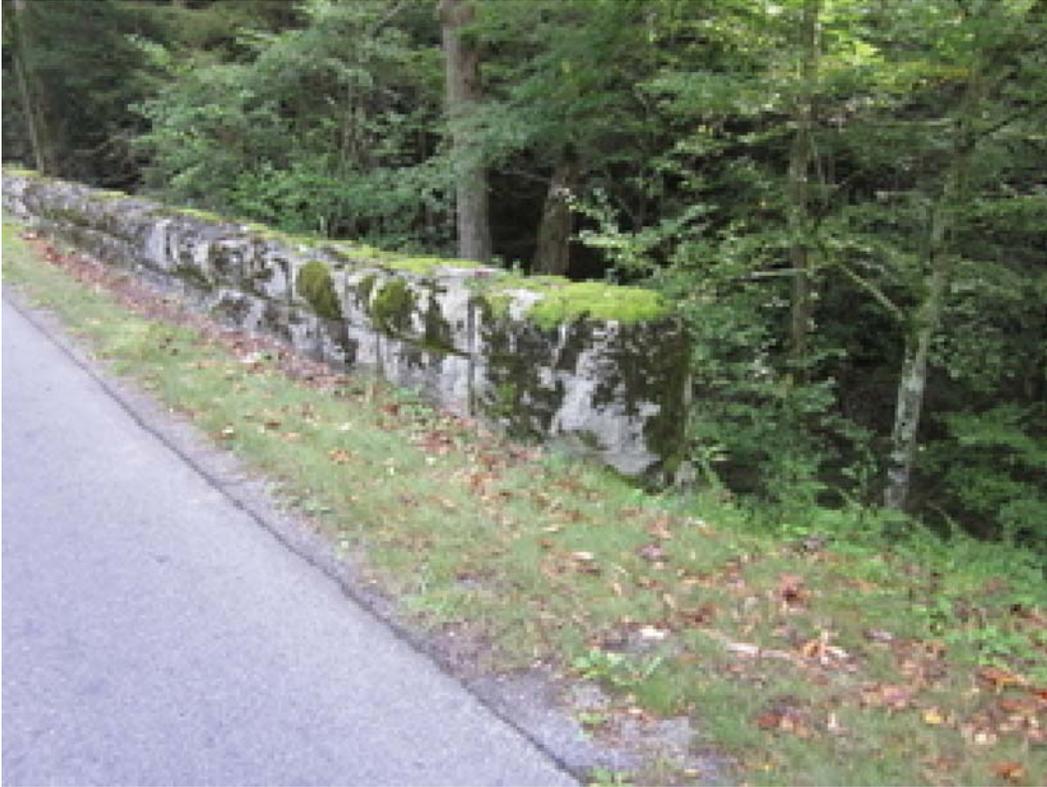
GRSM_0015_3.697_L_1.JPG

Barrier ID:	GRSM-0015-3.697-L				
Route Name:	LAUREL CREEK ROAD				
Inspection Date:	09/09/2010	Barrier Rating:	19.20		
Barrier Description					
Type:	STONE MASONRY WITHOUT CONCRETE CORE WALL	Barrier Function:	TRAFFIC		
Barrier Material:	STONE	Post Material:	N/A		
Blockout Type:	N/A	Length (ft.):	47		
Speed Limit (MPH):	30	Placement with Respect to Road:	TANGENT		
Hazard Behind Barrier:	MEDIUM				
Barrier Crashworthiness					
Appropriate Test Level:	TL-1	Barrier Test Level:	NCW	Is Barrier Crashworthy?:	NO
Beg. End Trtmt Type:	NONE	Is Beg. End Trtmt Crashworthy?:	N/A	Approach Transition Type:	NONE
Ending End Trtmt Type:	NONE	Ending End Trtmt Crashworthy?:	N/A		
Average Measurements					
Design Height (In.):	24	Width (In.):	27.0	Post Spacing (In.):	0.0
Height (In.):	28.0	Lateral Offset (In.):	59.2	Road Grade (%):	0.40
Physical Condition					
Barrier	Alignment and Height:	No deviation in alignment. Height is 3 to 5 in above the 24 in design height.

Breaking and Cracking:	No breaking or cracking observed.			
	Missing Elements:	No missing elements observed.			
	Corrosion and Weathering:	No corrosion or weathering observed.			
End Treatments	Alignment and Height:				
	Breaking and Cracking:				
	Missing Elements:				
	Corrosion and Weathering:

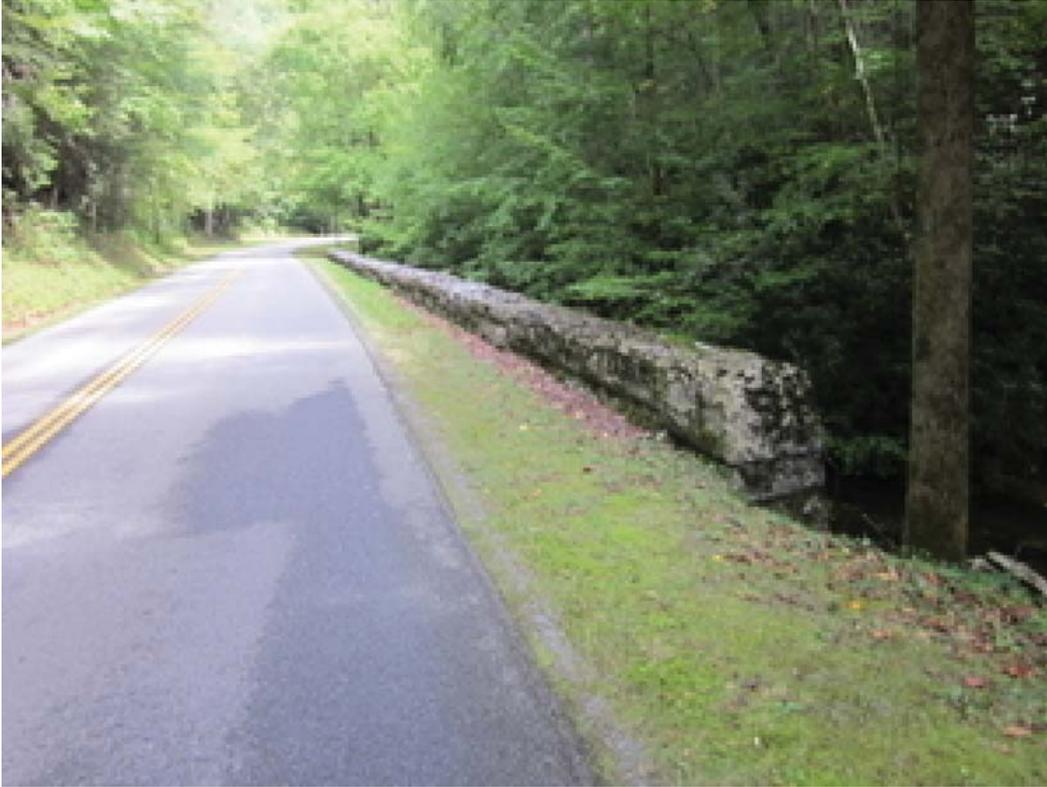
GRSM_0015_3.989_L_1.JPG

Barrier ID:	GRSM-0015-3.989-L				
Route Name:	LAUREL CREEK ROAD				
Inspection Date:	09/09/2010	Barrier Rating:	22.20		
Barrier Description					
Type:	STONE MASONRY WITHOUT CONCRETE CORE WALL	Barrier Function:	TRAFFIC		
Barrier Material:	STONE	Post Material:	N/A		
Blockout Type:	N/A	Length (ft.):	145		
Speed Limit (MPH):	35	Placement with Respect to Road:	TANGENT		
Hazard Behind Barrier:	MEDIUM				
Barrier Crashworthiness					
Appropriate Test Level:	TL-2	Barrier Test Level:	NCW	Is Barrier Crashworthy?:	NO
Beg. End Trtmt Type:	NONE	Is Beg. End Trtmt Crashworthy?:	N/A	Approach Transition Type:	NONE
Ending End Trtmt Type:	NONE	Ending End Trtmt Crashworthy?:	N/A		
Average Measurements					
Design Height (In.):	24	Width (In.):	24.7	Post Spacing (In.):	0.0
Height (In.):	24.7	Lateral Offset (In.):	55.7	Road Grade (%):	1.30
Physical Condition					
Barrier	Alignment and Height:	No deviation in alignment and height is within 1 in of the 24 in design height.

Breaking and Cracking:	No breaking or cracking observed.			
	Missing Elements:	No missing elements observed.			
	Corrosion and Weathering:	No corrosion or weathering observed.			
End Treatments	Alignment and Height:				
	Breaking and Cracking:				
	Missing Elements:				
	Corrosion and Weathering:

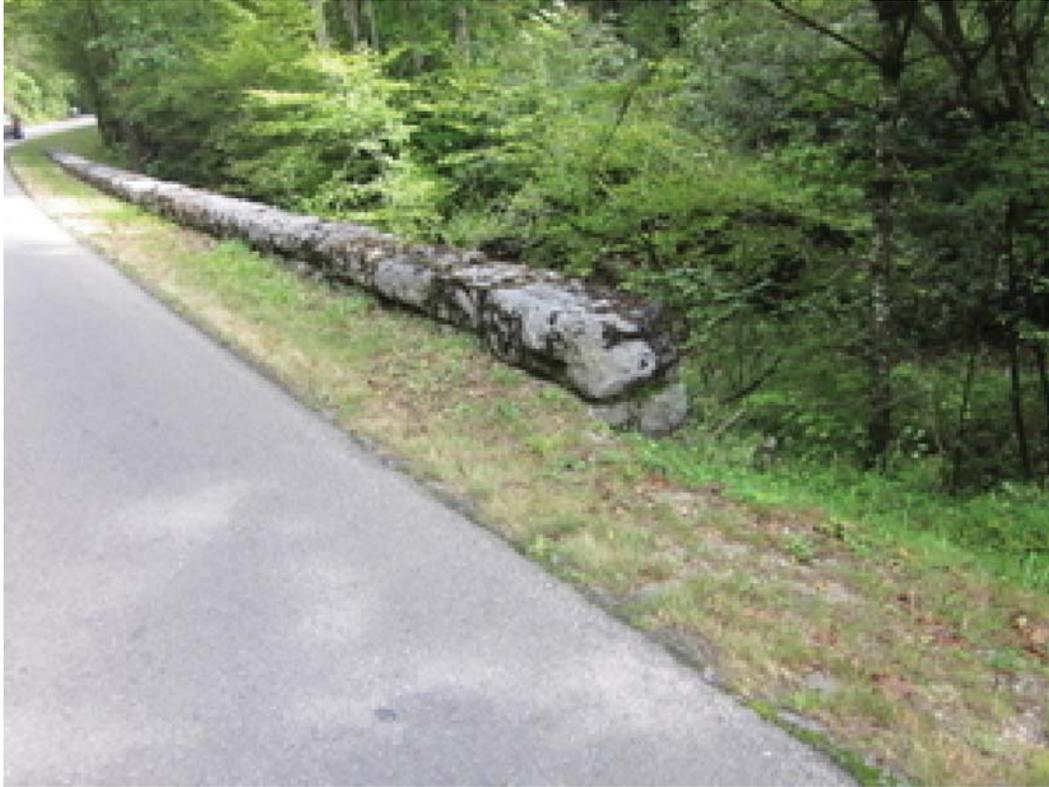
GRSM_0015_4.150_L_1.JPG

Barrier ID:	GRSM-0015-4.150-L				
Route Name:	LAUREL CREEK ROAD				
Inspection Date:	09/09/2010	Barrier Rating:	48.90		
Barrier Description					
Type:	STONE MASONRY WITHOUT CONCRETE CORE WALL	Barrier Function:	TRAFFIC		
Barrier Material:	STONE	Post Material:	N/A		
Blockout Type:	N/A	Length (ft.):	124		
Speed Limit (MPH):	35	Placement with Respect to Road:	INSIDE OF CURVE		
Hazard Behind Barrier:	MEDIUM				
Barrier Crashworthiness					
Appropriate Test Level:	TL-2	Barrier Test Level:	NCW	Is Barrier Crashworthy?:	NO
Beg. End Trtmt Type:	NONE	Is Beg. End Trtmt Crashworthy?:	N/A	Approach Transition Type:	NONE
Ending End Trtmt Type:	NONE	Ending End Trtmt Crashworthy?:	N/A		
Average Measurements					
Design Height (In.):	24	Width (In.):	27.0	Post Spacing (In.):	0.0
Height (In.):	12.6	Lateral Offset (In.):	59.7	Road Grade (%):	0.70
Physical Condition					
Barrier	Alignment and Height:	No deviation in alignment and height is 8 to 14 in below design height of 24 in for 124 ft.

Breaking and Cracking:	No breaking or cracking observed.			
	Missing Elements:	No missing elements observed.			
	Corrosion and Weathering:	No corrosion or weathering observed.			
End Treatments	Alignment and Height:				
	Breaking and Cracking:				
	Missing Elements:				
	Corrosion and Weathering:

Repair Action:	REPAIR	FMSS Work Type:	DEFERRED MAINTENANCE	Repair Cost:	\$179383
Brief Workorder:	Raise guardwall 11-in. Remove and reset 124-ft of stone masonry guardwall on concrete footer to design height of 24-in.				
Workorder:	Remove & Reset Stone Masonry Guardwall at \$250- per -Cu. Ft. for 571 CF = \$142750. [(2ft)(2.3ft)(124ft)] = 570.4 CF. Structural Concrete at \$1000- per -Cu. Yd. for 10 CY = \$10000. [(2.3ft)(0.9ft)(124ft)] /27 = 9.5 CY. Low Speed Traffic Control at \$1475- per -Day for 7 Day(s) = \$10325. 2 days removal 5 days installation.

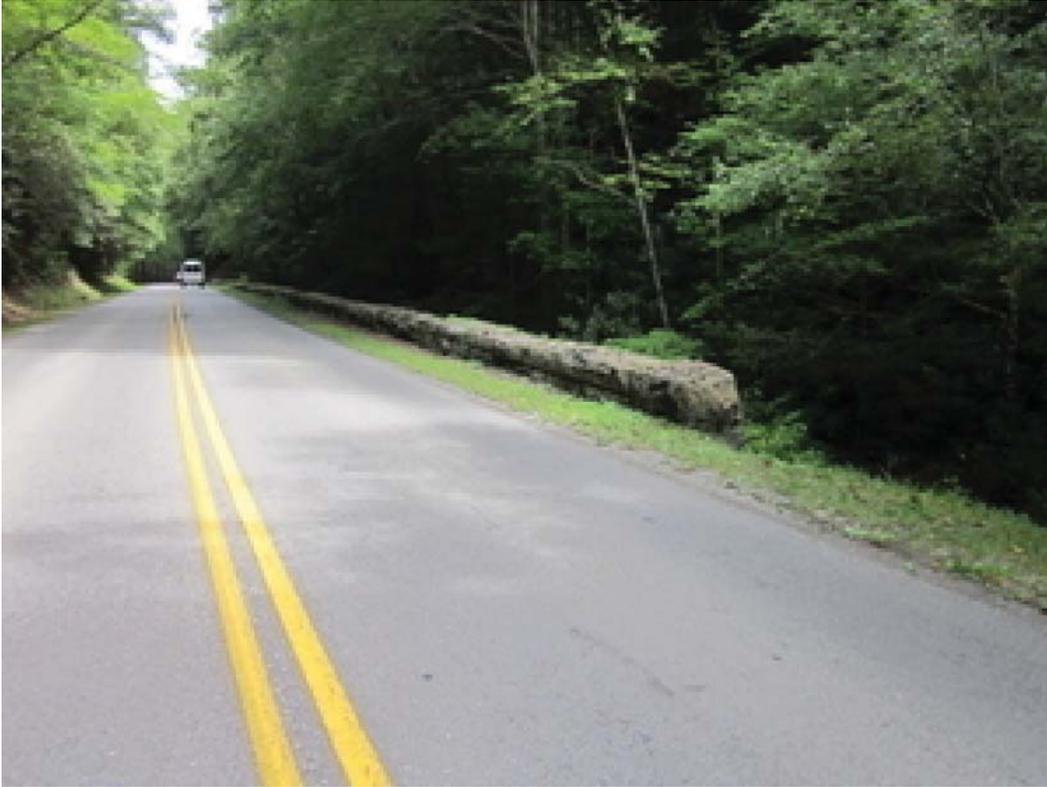
GRSM_0015_4.993_L_1.JPG

Barrier ID:	GRSM-0015-4.993-L				
Route Name:	LAUREL CREEK ROAD				
Inspection Date:	09/09/2010	Barrier Rating:	25.10		
Barrier Description					
Type:	STONE MASONRY WITHOUT CONCRETE CORE WALL	Barrier Function:	TRAFFIC		
Barrier Material:	STONE	Post Material:	N/A		
Blockout Type:	N/A	Length (ft.):	428		
Speed Limit (MPH):	35	Placement with Respect to Road:	TANGENT		
Hazard Behind Barrier:	MEDIUM				
Barrier Crashworthiness					
Appropriate Test Level:	TL-2	Barrier Test Level:	NCW	Is Barrier Crashworthy?:	NO
Beg. End Trtmt Type:	NONE	Is Beg. End Trtmt Crashworthy?:	N/A	Approach Transition Type:	NONE
Ending End Trtmt Type:	NONE	Ending End Trtmt Crashworthy?:	N/A		
Average Measurements					
Design Height (In.):	24	Width (In.):	27.6	Post Spacing (In.):	0.0
Height (In.):	25.0	Lateral Offset (In.):	69.3	Road Grade (%):	0.70
Physical Condition					
Barrier	Alignment and Height:	The alignment has no deviation and the height is 0-3 in above the 24 in design height.

Breaking and Cracking:	No breaking or cracking observed.			
	Missing Elements:	No missing elements observed.			
	Corrosion and Weathering:	No corrosion or weathering observed.			
End Treatments	Alignment and Height:				
	Breaking and Cracking:				
	Missing Elements:				
	Corrosion and Weathering:

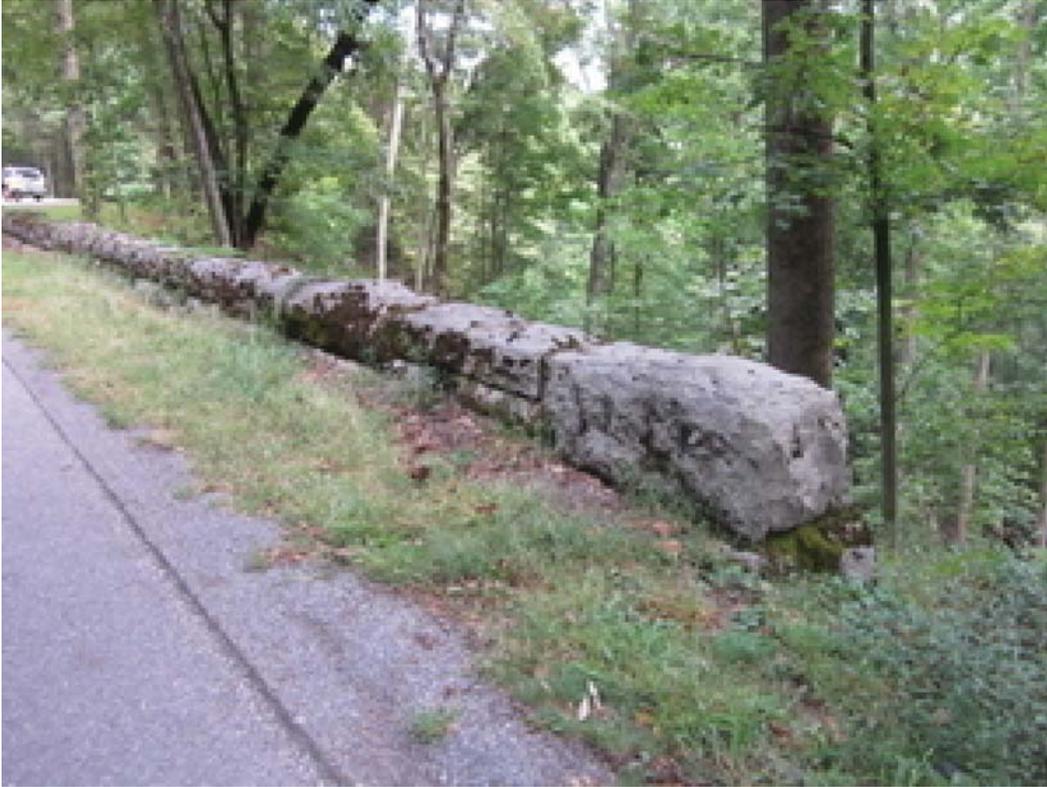
GRSM_0015_6.602_R_1.JPG

Barrier ID:	GRSM-0015-6.602-R				
Route Name:	LAUREL CREEK ROAD				
Inspection Date:	09/09/2010	Barrier Rating:	24.00		
Barrier Description					
Type:	STONE MASONRY WITHOUT CONCRETE CORE WALL	Barrier Function:	TRAFFIC		
Barrier Material:	STONE	Post Material:	N/A		
Blockout Type:	N/A	Length (ft.):	75		
Speed Limit (MPH):	35	Placement with Respect to Road:	TANGENT		
Hazard Behind Barrier:	HIGH				
Barrier Crashworthiness					
Appropriate Test Level:	TL-2	Barrier Test Level:	NCW	Is Barrier Crashworthy?:	NO
Beg. End Trtmt Type:	NONE	Is Beg. End Trtmt Crashworthy?:	N/A	Approach Transition Type:	NONE
Ending End Trtmt Type:	NONE	Ending End Trtmt Crashworthy?:	N/A		
Average Measurements					
Design Height (In.):	24	Width (In.):	25.2	Post Spacing (In.):	0.0
Height (In.):	24.0	Lateral Offset (In.):	79.3	Road Grade (%):	3.80
Physical Condition					
Barrier	Alignment and Height:	Alignment has no deviation and the height ranges from 2 in above to 2 in below the 24 in design height.

Breaking and Cracking:	No breaking or cracking observed.			
	Missing Elements:	No missing elements observed.			
	Corrosion and Weathering:	No corrosion or weathering observed			
End Treatments	Alignment and Height:				
	Breaking and Cracking:				
	Missing Elements:				
	Corrosion and Weathering:

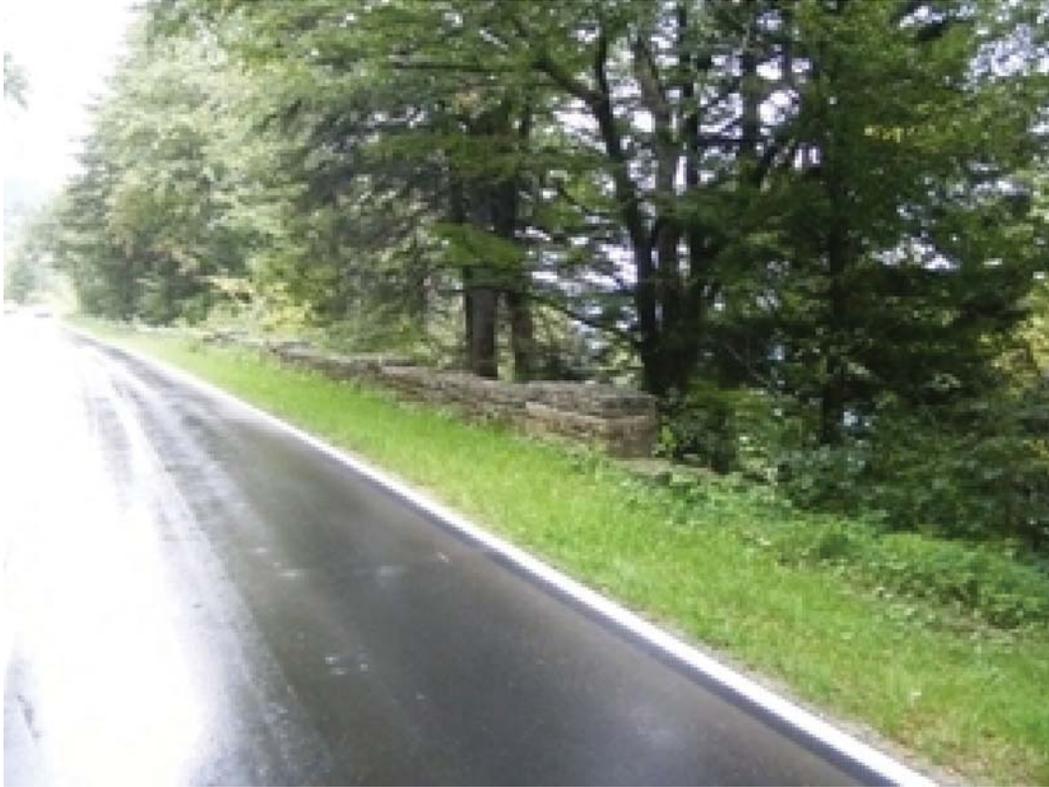
GRSM_0017_0.160_L_1.JPG

Barrier ID:	GRSM-0017-0.160-L				
Route Name:	CLINGMANS DOME ACCESS ROAD				
Inspection Date:	09/10/2010	Barrier Rating:	49.90		
Barrier Description					
Type:	STONE MASONRY CRENELLATED WITHOUT	Barrier Function:	TRAFFIC		
Barrier Material:	STONE	Post Material:	N/A		
Blockout Type:	N/A	Length (ft.):	728		
Speed Limit (MPH):	30	Placement with Respect to Road:	BOTH INSIDE AND OUTSIDE		
Hazard Behind Barrier:	HIGH				
Barrier Crashworthiness					
Appropriate Test Level:	TL-1	Barrier Test Level:	NCW	Is Barrier Crashworthy?:	NO
Beg. End Trtmt Type:	NONE	Is Beg. End Trtmt Crashworthy?:	N/A	Approach Transition Type:	NONE
Ending End Trtmt Type:	NONE	Ending End Trtmt Crashworthy?:	N/A		
Average Measurements					
Design Height (In.):	18	Width (In.):	18.0	Post Spacing (In.):	0.0
Height (In.):	18.2	Lateral Offset (In.):	59.2	Road Grade (%):	2.80
Physical Condition					
Barrier	Alignment and Height:	The alignment has no deviation and the height is 3 to 5 in below the 18-in/24-in crenellated design height for 535 ft.

Breaking and Cracking:	No breaking or cracking observed.			
	Missing Elements:	No missing elements observed.			
	Corrosion and Weathering:	No corrosion or weathering observed.			
End Treatments	Alignment and Height:				
	Breaking and Cracking:				
	Missing Elements:				
	Corrosion and Weathering:

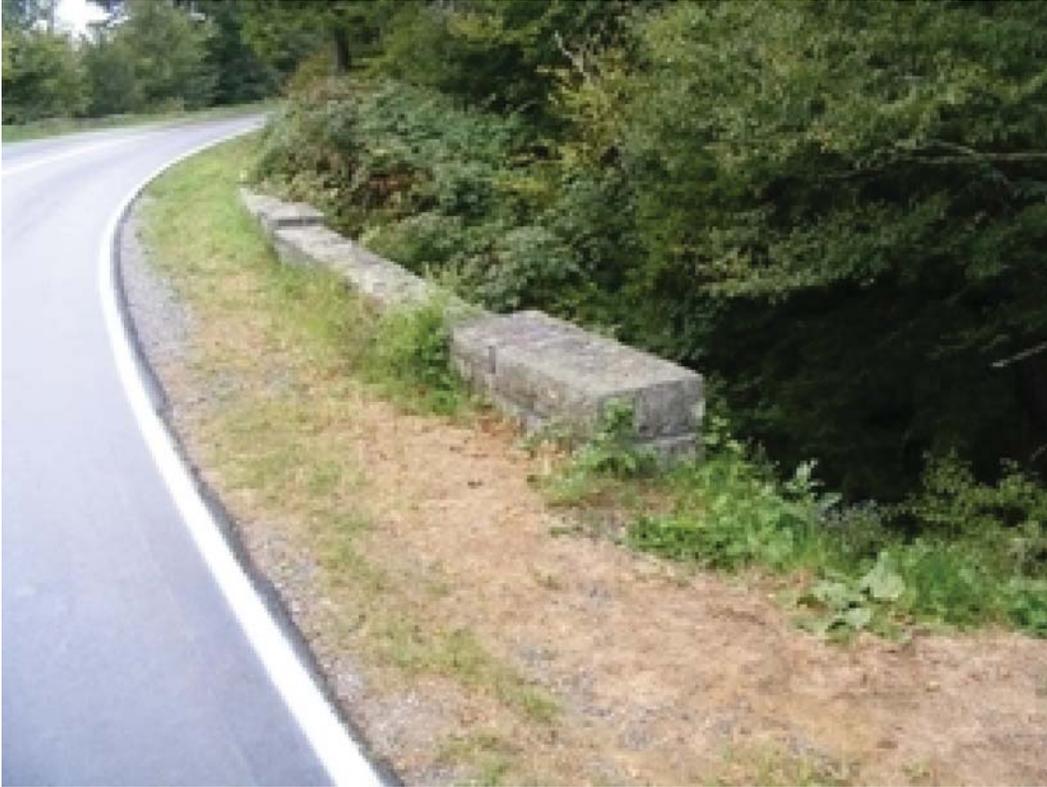
GRSM_0017_0.165_R_1.JPG

Barrier ID:	GRSM-0017-0.165-R				
Route Name:	CLINGMANS DOME ACCESS ROAD				
Inspection Date:	09/10/2010	Barrier Rating:	28.30		
Barrier Description					
Type:	STONE MASONRY CRENELLATED WITHOUT	Barrier Function:	TRAFFIC		
Barrier Material:	STONE	Post Material:	N/A		
Blockout Type:	N/A	Length (ft.):	54		
Speed Limit (MPH):	30	Placement with Respect to Road:	INSIDE OF CURVE		
Hazard Behind Barrier:	HIGH				
Barrier Crashworthiness					
Appropriate Test Level:	TL-1	Barrier Test Level:	NCW	Is Barrier Crashworthy?:	NO
Beg. End Trtmt Type:	NONE	Is Beg. End Trtmt Crashworthy?:	N/A	Approach Transition Type:	NONE
Ending End Trtmt Type:	NONE	Ending End Trtmt Crashworthy?:	N/A		
Average Measurements					
Design Height (In.):	18	Width (In.):	18.7	Post Spacing (In.):	0.0
Height (In.):	14.6	Lateral Offset (In.):	66.0	Road Grade (%):	2.90
Physical Condition					
Barrier	Alignment and Height:	The alignment has no deviation and the height is 2 to 5 in below the 18-in/24-in crenellated design height.

Breaking and Cracking:	No breaking or cracking observed.			
	Missing Elements:	No missing elements observed.			
	Corrosion and Weathering:	No corrosion or weathering observed.			
End Treatments	Alignment and Height:				
	Breaking and Cracking:				
	Missing Elements:				
	Corrosion and Weathering:

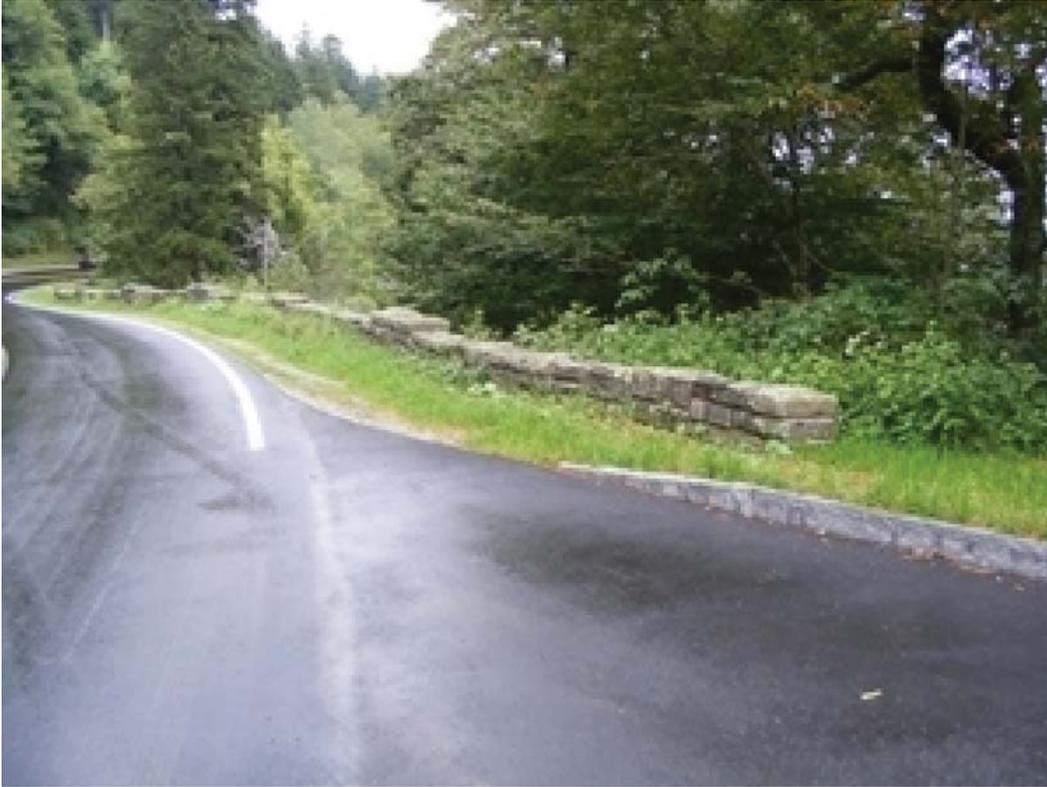
GRSM_0017_0.356_L_1.JPG

Barrier ID:	GRSM-0017-0.356-L				
Route Name:	CLINGMANS DOME ACCESS ROAD				
Inspection Date:	09/10/2010	Barrier Rating:	39.70		
Barrier Description					
Type:	STONE MASONRY CRENELLATED WITHOUT	Barrier Function:	TRAFFIC		
Barrier Material:	STONE	Post Material:	N/A		
Blockout Type:	N/A	Length (ft.):	252		
Speed Limit (MPH):	30	Placement with Respect to Road:	OUTSIDE OF CURVE		
Hazard Behind Barrier:	HIGH				
Barrier Crashworthiness					
Appropriate Test Level:	TL-1	Barrier Test Level:	NCW	Is Barrier Crashworthy?:	NO
Beg. End Trtmt Type:	NONE	Is Beg. End Trtmt Crashworthy?:	N/A	Approach Transition Type:	NONE
Ending End Trtmt Type:	NONE	Ending End Trtmt Crashworthy?:	N/A		
Average Measurements					
Design Height (In.):	18	Width (In.):	19.2	Post Spacing (In.):	0.0
Height (In.):	20.6	Lateral Offset (In.):	62.5	Road Grade (%):	5.60
Physical Condition					
Barrier	Alignment and Height:	The alignment has no deviation and the height is 2-5 in below the 18-in/24-in crenellated design height.

Breaking and Cracking:	No breaking or cracking observed.			
	Missing Elements:	No missing elements observed.			
	Corrosion and Weathering:	No corrosion or weathering observed.			
End Treatments	Alignment and Height:				
	Breaking and Cracking:				
	Missing Elements:				
	Corrosion and Weathering:

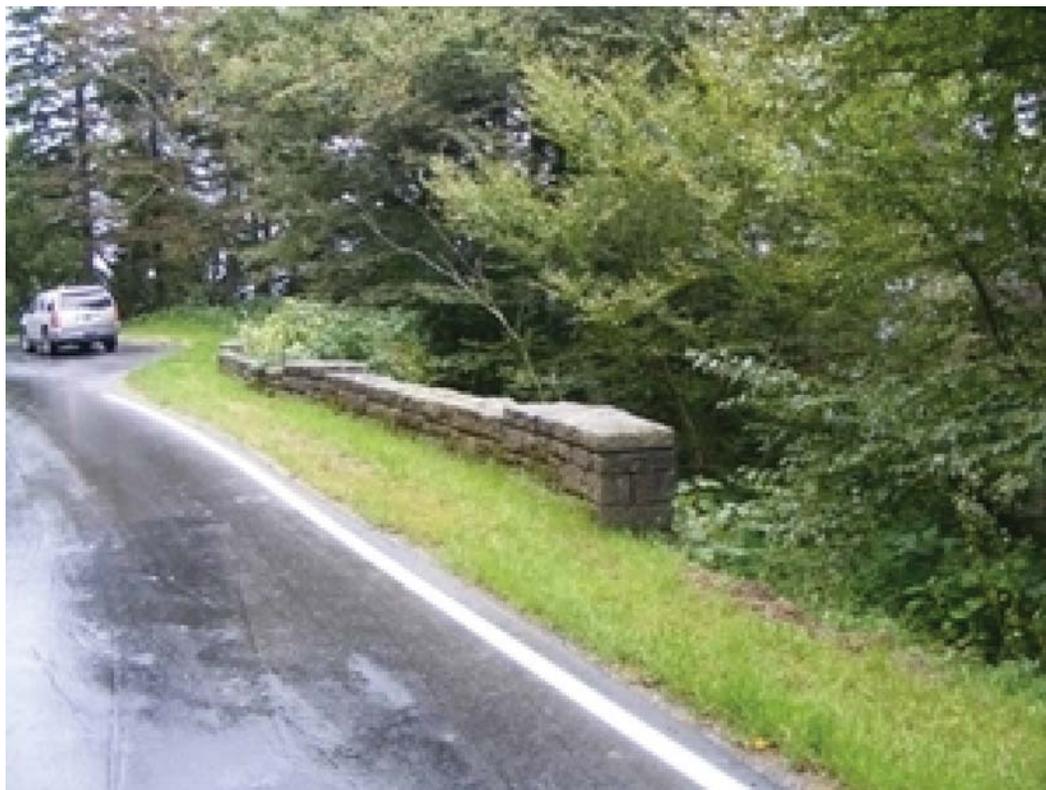
GRSM_0017_0.422_L_1.JPG

Barrier ID:	GRSM-0017-0.422-L				
Route Name:	CLINGMANS DOME ACCESS ROAD				
Inspection Date:	09/10/2010	Barrier Rating:	36.90		
Barrier Description					
Type:	STONE MASONRY CRENELLATED WITHOUT	Barrier Function:	TRAFFIC		
Barrier Material:	STONE	Post Material:	N/A		
Blockout Type:	N/A	Length (ft.):	57		
Speed Limit (MPH):	30	Placement with Respect to Road:	OUTSIDE OF CURVE		
Hazard Behind Barrier:	HIGH				
Barrier Crashworthiness					
Appropriate Test Level:	TL-1	Barrier Test Level:	NCW	Is Barrier Crashworthy?:	NO
Beg. End Trtmt Type:	NONE	Is Beg. End Trtmt Crashworthy?:	N/A	Approach Transition Type:	NONE
Ending End Trtmt Type:	NONE	Ending End Trtmt Crashworthy?:	N/A		
Average Measurements					
Design Height (In.):	21	Width (In.):	18.0	Post Spacing (In.):	0.0
Height (In.):	20.6	Lateral Offset (In.):	62.5	Road Grade (%):	3.80
Physical Condition					
Barrier	Alignment and Height:	The alignment has no deviation and the height is 0-1 in below the 21-in/24-in crenellated design height.

Breaking and Cracking:	No breaking or cracking observed.			
	Missing Elements:	No missing elements observed.			
	Corrosion and Weathering:	No corrosion or weathering observed.			
End Treatments	Alignment and Height:				
	Breaking and Cracking:				
	Missing Elements:				
	Corrosion and Weathering:

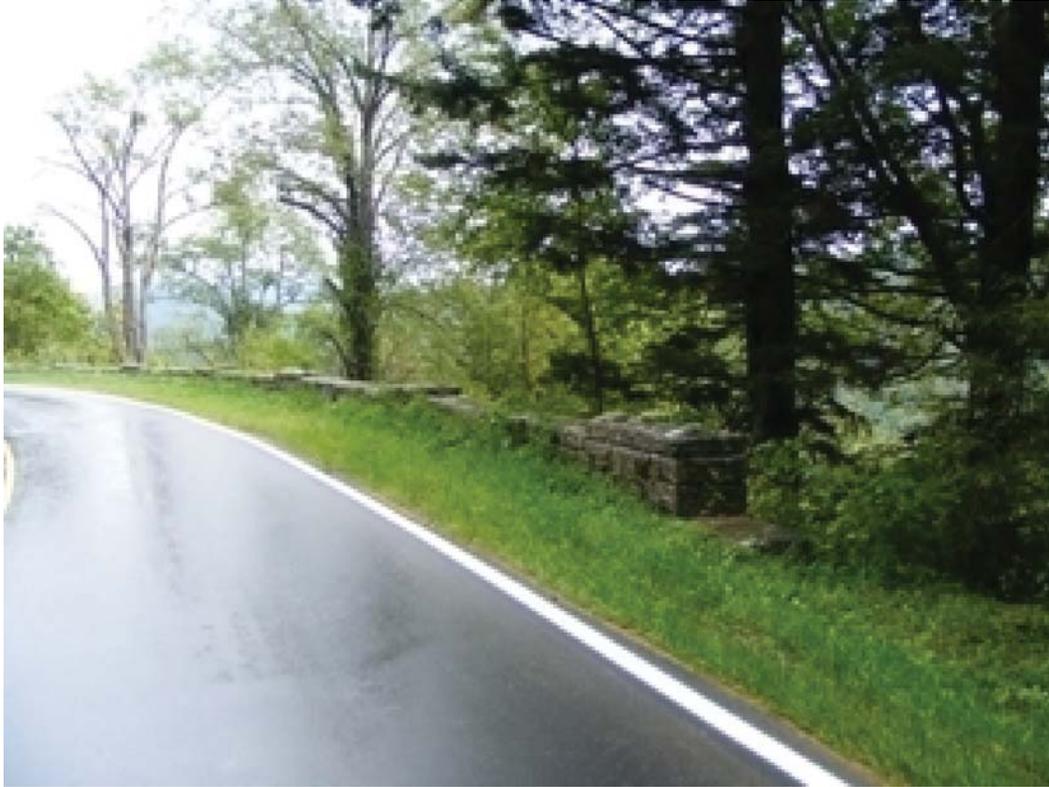
GRSM_0017_0.467_L_1.JPG

Barrier ID:	GRSM-0017-0.467-L				
Route Name:	CLINGMANS DOME ACCESS ROAD				
Inspection Date:	09/10/2010	Barrier Rating:	49.70		
Barrier Description					
Type:	STONE MASONRY CRENELLATED WITHOUT	Barrier Function:	TRAFFIC		
Barrier Material:	STONE	Post Material:	N/A		
Blockout Type:	N/A	Length (ft.):	195		
Speed Limit (MPH):	30	Placement with Respect to Road:	OUTSIDE OF CURVE		
Hazard Behind Barrier:	HIGH				
Barrier Crashworthiness					
Appropriate Test Level:	TL-1	Barrier Test Level:	NCW	Is Barrier Crashworthy?:	NO
Beg. End Trtmt Type:	NONE	Is Beg. End Trtmt Crashworthy?:	N/A	Approach Transition Type:	NONE
Ending End Trtmt Type:	NONE	Ending End Trtmt Crashworthy?:	N/A		
Average Measurements					
Design Height (In.):	18	Width (In.):	18.0	Post Spacing (In.):	0.0
Height (In.):	18.2	Lateral Offset (In.):	66.3	Road Grade (%):	5.40
Physical Condition					
Barrier	Alignment and Height:	The alignment has no deviation and the height ranges from 1 in below to 2 in above the 18-in/24-in crenellated design height.

Breaking and Cracking:	No breaking or cracking observed.			
	Missing Elements:	No missing elements observed.			
	Corrosion and Weathering:	No corrosion or weathering observed.			
End Treatments	Alignment and Height:				
	Breaking and Cracking:				
	Missing Elements:				
	Corrosion and Weathering:
