NPS Guardwall/Rail Inventory Program
Great Smoky Mountains National Park

Federal Highway Administration
Eastern Federal Lands Highway Division
Road Inventory Program (RIP)

Data Collection Date: September 2010
Report Date: December 2015

Great Smoky Mountains National Park in North Carolina and Tennessee

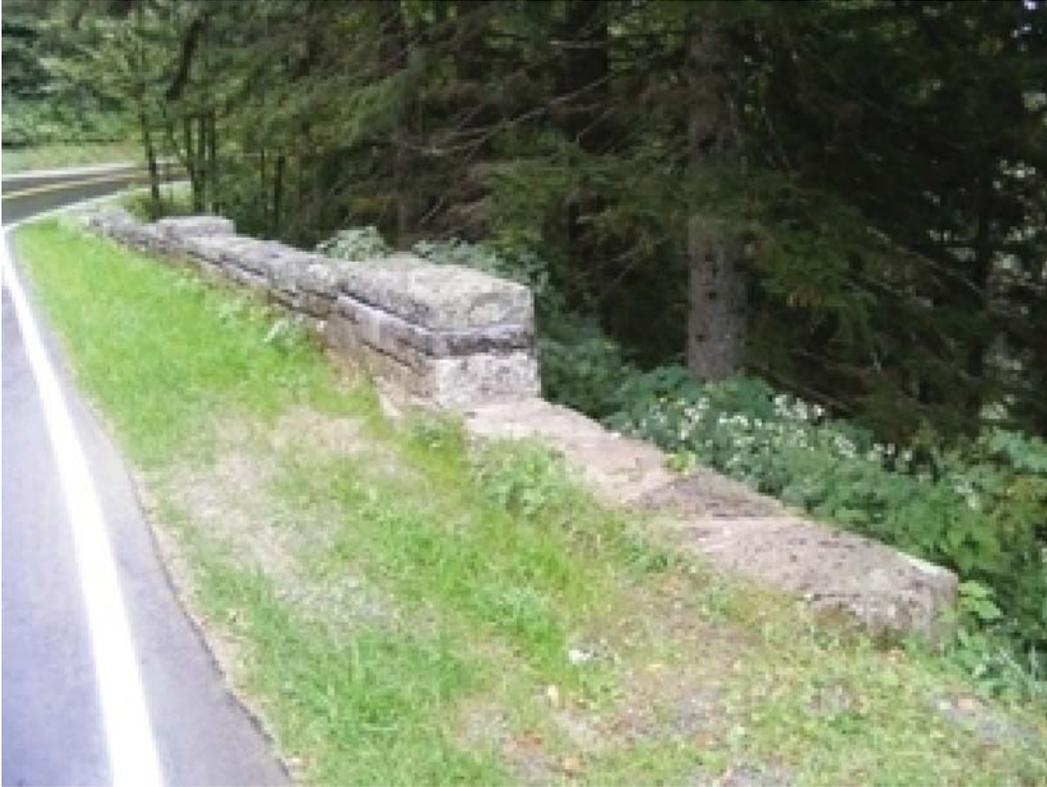
GRSM_0017_0.562_L_1.JPG

Barrier ID:	GRSM-0017-0.562-L				
Route Name:	CLINGMANS DOME ACCESS ROAD				
Inspection Date:	09/10/2010	Barrier Rating:	31.20		
Barrier Description					
Type:	STONE MASONRY CRENELLATED WITHOUT	Barrier Function:	TRAFFIC		
Barrier Material:	STONE	Post Material:	N/A		
Blockout Type:	N/A	Length (ft.):	96		
Speed Limit (MPH):	30	Placement with Respect to Road:	INSIDE OF CURVE		
Hazard Behind Barrier:	HIGH				
Barrier Crashworthiness					
Appropriate Test Level:	TL-1	Barrier Test Level:	NCW	Is Barrier Crashworthy?:	NO
Beg. End Trtmt Type:	NONE	Is Beg. End Trtmt Crashworthy?:	N/A	Approach Transition Type:	NONE
Ending End Trtmt Type:	NONE	Ending End Trtmt Crashworthy?:	N/A		
Average Measurements					
Design Height (In.):	18	Width (In.):	18.0	Post Spacing (In.):	0.0
Height (In.):	20.7	Lateral Offset (In.):	58.7	Road Grade (%):	5.60
Physical Condition					
Barrier	Alignment and Height:	The alignment has no deviation and the height is 0-5 in above the 18-in/24-in crenellated design height.

Breaking and Cracking:	No breaking or cracking observed.			
	Missing Elements:	No missing elements observed.			
	Corrosion and Weathering:	No corrosion or weathering observed.			
End Treatments	Alignment and Height:				
	Breaking and Cracking:				
	Missing Elements:				
	Corrosion and Weathering:

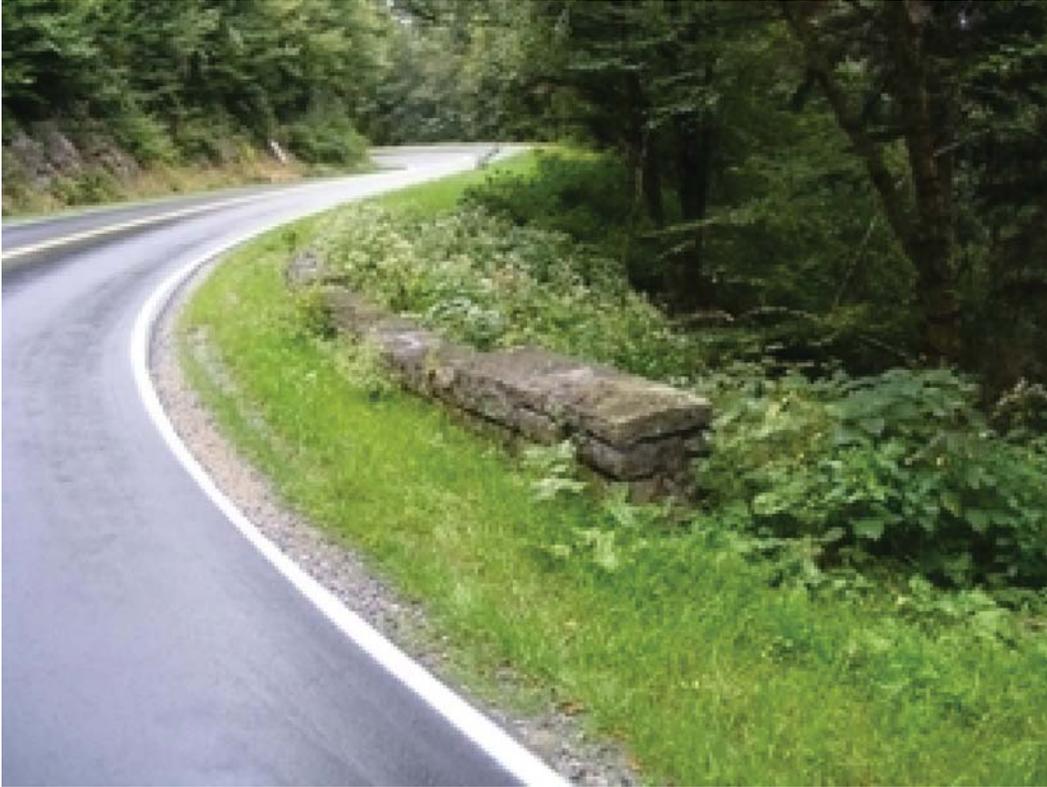
GRSM_0017_0.874_L_1.JPG

Barrier ID:	GRSM-0017-0.874-L				
Route Name:	CLINGMANS DOME ACCESS ROAD				
Inspection Date:	09/10/2010	Barrier Rating:	44.00		
Barrier Description					
Type:	STONE MASONRY CRENELLATED WITHOUT	Barrier Function:	TRAFFIC		
Barrier Material:	STONE	Post Material:	N/A		
Blockout Type:	N/A	Length (ft.):	58		
Speed Limit (MPH):	30	Placement with Respect to Road:	INSIDE OF CURVE		
Hazard Behind Barrier:	HIGH				
Barrier Crashworthiness					
Appropriate Test Level:	TL-1	Barrier Test Level:	NCW	Is Barrier Crashworthy?:	NO
Beg. End Trtmt Type:	NONE	Is Beg. End Trtmt Crashworthy?:	N/A	Approach Transition Type:	NONE
Ending End Trtmt Type:	NONE	Ending End Trtmt Crashworthy?:	N/A		
Average Measurements					
Design Height (In.):	18	Width (In.):	18.0	Post Spacing (In.):	0.0
Height (In.):	13.6	Lateral Offset (In.):	62.2	Road Grade (%):	3.30
Physical Condition					
Barrier	Alignment and Height:	The alignment has no deviation and the height is 2-6 in below the 18-in/24-in crenellated design height.

Breaking and Cracking:	No breaking or cracking observed.			
	Missing Elements:	No missing elements observed.			
	Corrosion and Weathering:	No corrosion or weathering observed.			
End Treatments	Alignment and Height:				
	Breaking and Cracking:				
	Missing Elements:				
	Corrosion and Weathering:

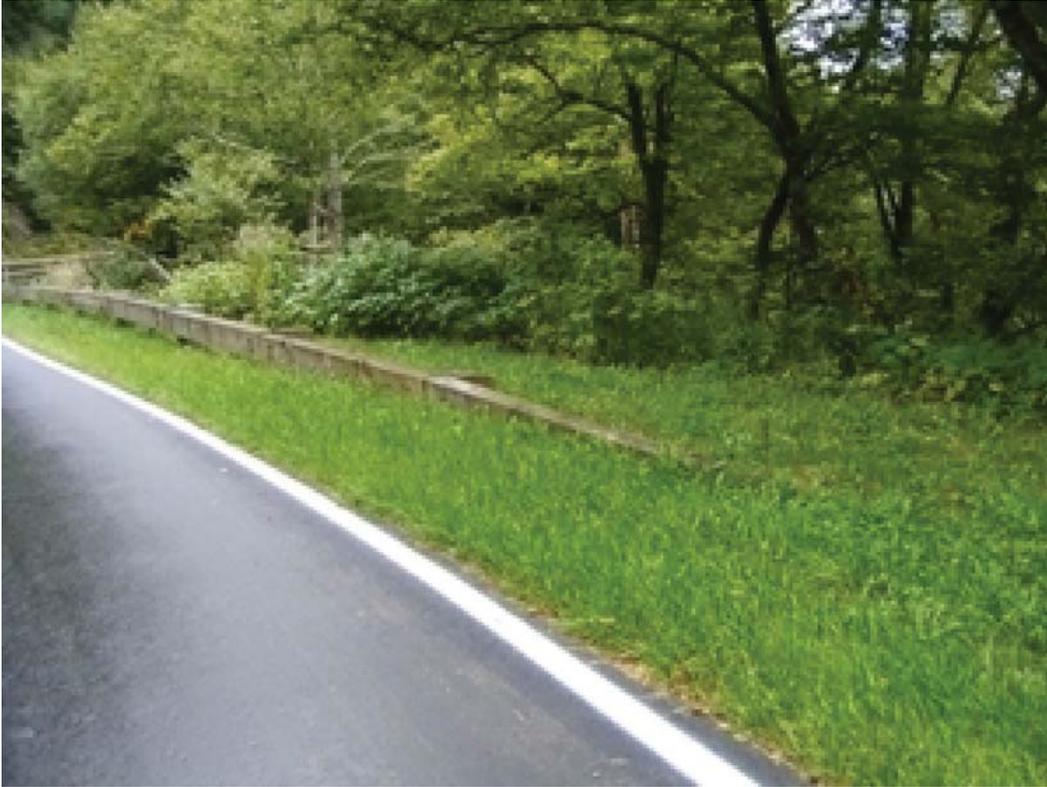
GRSM_0017_0.898_L_1.JPG

Barrier ID:	GRSM-0017-0.898-L				
Route Name:	CLINGMANS DOME ACCESS ROAD				
Inspection Date:	09/10/2010	Barrier Rating:	40.00		
Barrier Description					
Type:	STEEL-BACKED TIMBER WITHOUT BLOCKOUT	Barrier Function:	TRAFFIC		
Barrier Material:	STEEL-BACKED TIMBER/LOG	Post Material:	WOOD		
Blockout Type:	N/A	Length (ft.):	130		
Speed Limit (MPH):	30	Placement with Respect to Road:	BOTH INSIDE AND OUTSIDE		
Hazard Behind Barrier:	HIGH				
Barrier Crashworthiness					
Appropriate Test Level:	TL-1	Barrier Test Level:	TL-2	Is Barrier Crashworthy?:	YES
Beg. End Trtmt Type:	SBT/LOG FLARED	Is Beg. End Trtmt Crashworthy?:	NO	Approach Transition Type:	NONE
Ending End Trtmt Type:	SBT/LOG FLARED	Ending End Trtmt Crashworthy?:	NO		
Average Measurements					
Design Height (In.):	27	Width (In.):	0.0	Post Spacing (In.):	120.0
Height (In.):	24.6	Lateral Offset (In.):	48.2	Road Grade (%):	5.20
Physical Condition					
Barrier	Alignment and Height:	The alignment has no deviation and the height is 2-3 in below the design height of 27 in for 130 LF.

Breaking and Cracking:	No breaking or cracking observed.			
	Missing Elements:	No missing elements observed.			
	Corrosion and Weathering:	No corrosion or weathering observed.			
End Treatments	Alignment and Height:	Alignment acceptable. Height is within 1 in of the 27-in design height.			
	Breaking and Cracking:	No breaking or cracking observed.			
	Missing Elements:	No missing elements observed.			
	Corrosion and Weathering:	No corrosion or weathering observed.

Repair Action:	REPAIR	FMSS Work Type:	DEFERRED MAINTENANCE	Repair Cost:	\$3052
Brief Workorder:	Raise 130 feet of barrier up to the 27 inch design height.				
Workorder:	Adjust Guardrail at \$10- per -Lin. Ft. for 130 LF = \$1300. Raise 130 feet of barrier up to the 27 inch design height. Low Speed Traffic Control at \$1475- per -Day for 1 Day(s) = \$1475.

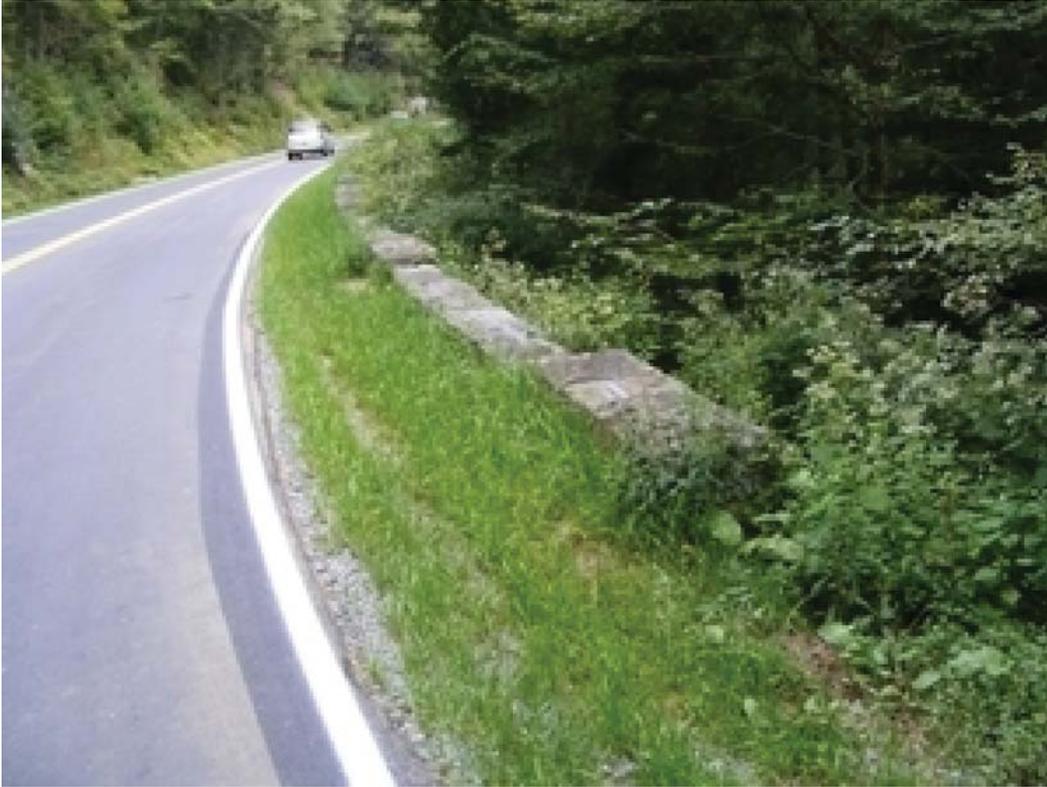
GRSM_0017_1.982_L_1.JPG

Barrier ID:	GRSM-0017-1.982-L				
Route Name:	CLINGMANS DOME ACCESS ROAD				
Inspection Date:	09/10/2010	Barrier Rating:	57.00		
Barrier Description					
Type:	STONE MASONRY CRENELLATED WITHOUT	Barrier Function:	TRAFFIC		
Barrier Material:	STONE	Post Material:	N/A		
Blockout Type:	N/A	Length (ft.):	153		
Speed Limit (MPH):	30	Placement with Respect to Road:	INSIDE OF CURVE		
Hazard Behind Barrier:	HIGH				
Barrier Crashworthiness					
Appropriate Test Level:	TL-1	Barrier Test Level:	NCW	Is Barrier Crashworthy?:	NO
Beg. End Trtmt Type:	NONE	Is Beg. End Trtmt Crashworthy?:	N/A	Approach Transition Type:	NONE
Ending End Trtmt Type:	NONE	Ending End Trtmt Crashworthy?:	N/A		
Average Measurements					
Design Height (In.):	18	Width (In.):	19.2	Post Spacing (In.):	0.0
Height (In.):	11.0	Lateral Offset (In.):	49.0	Road Grade (%):	5.40
Physical Condition					
Barrier	Alignment and Height:	The alignment has no deviation and the height is 6-8 in below the 18-in/24-in crenellated design height.

Breaking and Cracking:	No breaking or cracking observed.			
	Missing Elements:	No missing elements observed.			
	Corrosion and Weathering:	No corrosion or weathering observed.			
End Treatments	Alignment and Height:				
	Breaking and Cracking:				
	Missing Elements:				
	Corrosion and Weathering:

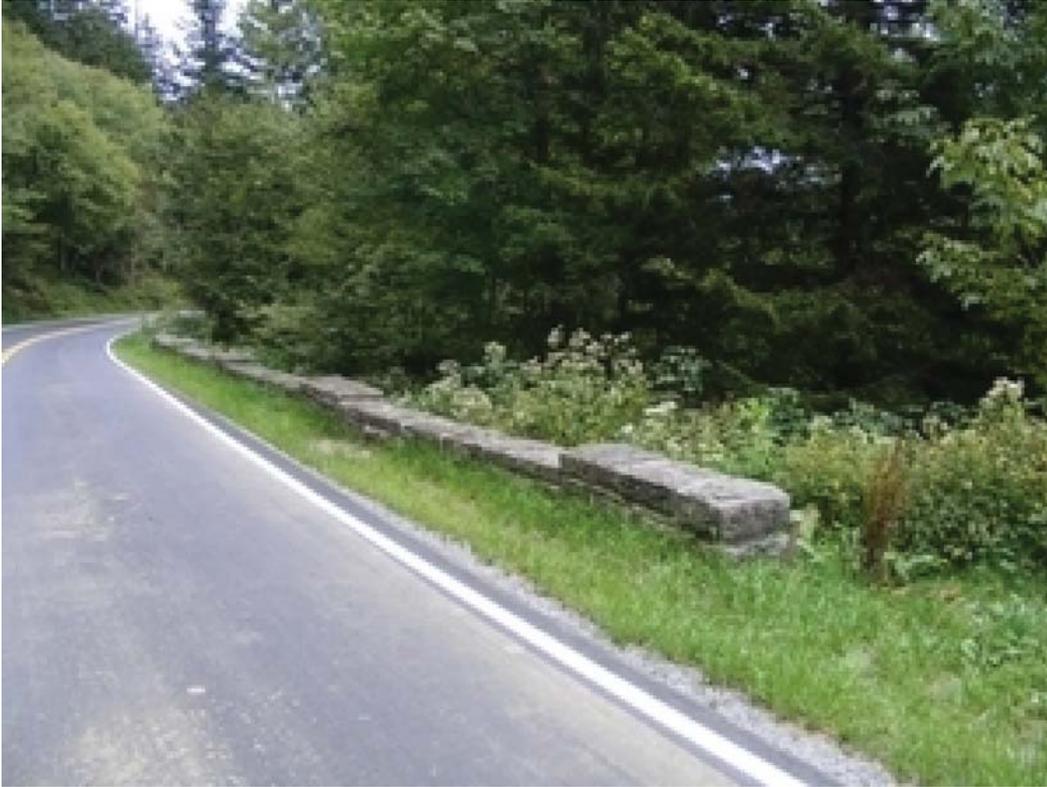
GRSM_0017_2.111_L_1.JPG

Barrier ID:	GRSM-0017-2.111-L				
Route Name:	CLINGMANS DOME ACCESS ROAD				
Inspection Date:	09/10/2010	Barrier Rating:	40.00		
Barrier Description					
Type:	STONE MASONRY CRENELLATED WITHOUT	Barrier Function:	TRAFFIC		
Barrier Material:	STONE	Post Material:	N/A		
Blockout Type:	N/A	Length (ft.):	204		
Speed Limit (MPH):	30	Placement with Respect to Road:	INSIDE OF CURVE		
Hazard Behind Barrier:	HIGH				
Barrier Crashworthiness					
Appropriate Test Level:	TL-1	Barrier Test Level:	NCW	Is Barrier Crashworthy?:	NO
Beg. End Trtmt Type:	NONE	Is Beg. End Trtmt Crashworthy?:	N/A	Approach Transition Type:	NONE
Ending End Trtmt Type:	NONE	Ending End Trtmt Crashworthy?:	N/A		
Average Measurements					
Design Height (In.):	18	Width (In.):	18.6	Post Spacing (In.):	0.0
Height (In.):	15.6	Lateral Offset (In.):	49.5	Road Grade (%):	5.80
Physical Condition					
Barrier	Alignment and Height:	The alignment has no deviation. 84-ft was within 3-in of the 18-in/24-in crenellated design height 40-ft was 3 to 6-in below and 80-ft was 6 to 7-in below.

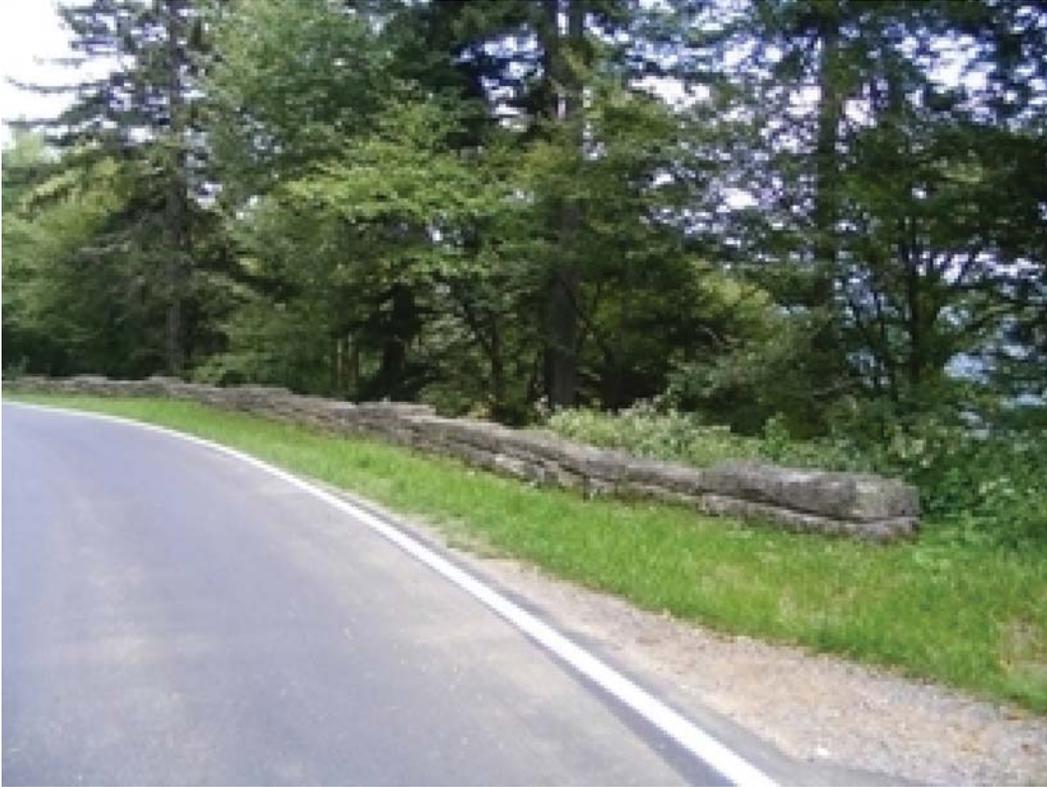
GRSM_0017_2.212_L_1.JPG

Barrier ID:	GRSM-0017-2.212-L				
Route Name:	CLINGMANS DOME ACCESS ROAD				
Inspection Date:	09/10/2010	Barrier Rating:	36.90		
Barrier Description					
Type:	STONE MASONRY CRENELLATED WITHOUT	Barrier Function:	TRAFFIC		
Barrier Material:	STONE	Post Material:	N/A		
Blockout Type:	N/A	Length (ft.):	178		
Speed Limit (MPH):	30	Placement with Respect to Road:	OUTSIDE OF CURVE		
Hazard Behind Barrier:	HIGH				
Barrier Crashworthiness					
Appropriate Test Level:	TL-1	Barrier Test Level:	NCW	Is Barrier Crashworthy?:	NO
Beg. End Trtmt Type:	NONE	Is Beg. End Trtmt Crashworthy?:	N/A	Approach Transition Type:	NONE
Ending End Trtmt Type:	NONE	Ending End Trtmt Crashworthy?:	N/A		
Average Measurements					
Design Height (In.):	18	Width (In.):	18.6	Post Spacing (In.):	0.0
Height (In.):	20.0	Lateral Offset (In.):	64.3	Road Grade (%):	6.00
Physical Condition					
Barrier	Alignment and Height:	The alignment has no deviation and the height is 0-3 in above the 18-in/24-in crenellated design height.

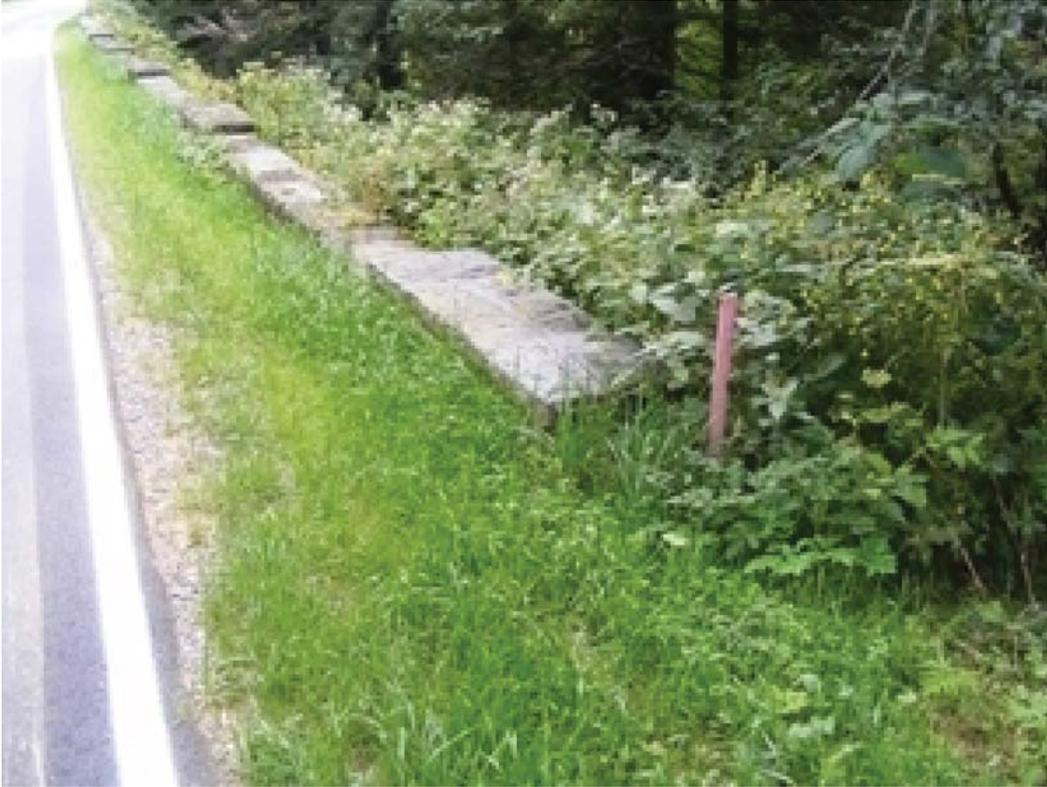
GRSM_0017_3.236_L_1.JPG

Barrier ID:	GRSM-0017-3.236-L				
Route Name:	CLINGMANS DOME ACCESS ROAD				
Inspection Date:	09/10/2010	Barrier Rating:	58.50		
Barrier Description					
Type:	STONE MASONRY CRENELLATED WITHOUT	Barrier Function:	TRAFFIC		
Barrier Material:	STONE	Post Material:	N/A		
Blockout Type:	N/A	Length (ft.):	396		
Speed Limit (MPH):	30	Placement with Respect to Road:	INSIDE OF CURVE		
Hazard Behind Barrier:	HIGH				
Barrier Crashworthiness					
Appropriate Test Level:	TL-1	Barrier Test Level:	NCW	Is Barrier Crashworthy?:	NO
Beg. End Trtmt Type:	NONE	Is Beg. End Trtmt Crashworthy?:	N/A	Approach Transition Type:	NONE
Ending End Trtmt Type:	NONE	Ending End Trtmt Crashworthy?:	N/A		
Average Measurements					
Design Height (In.):	18	Width (In.):	18.6	Post Spacing (In.):	0.0
Height (In.):	12.0	Lateral Offset (In.):	43.0	Road Grade (%):	5.90
Physical Condition					
Barrier	Alignment and Height:	The alignment has no deviation and the height is 4-6 in below the 18-in/24-in crenellated design height for 120 ft and 7 in below for 276.

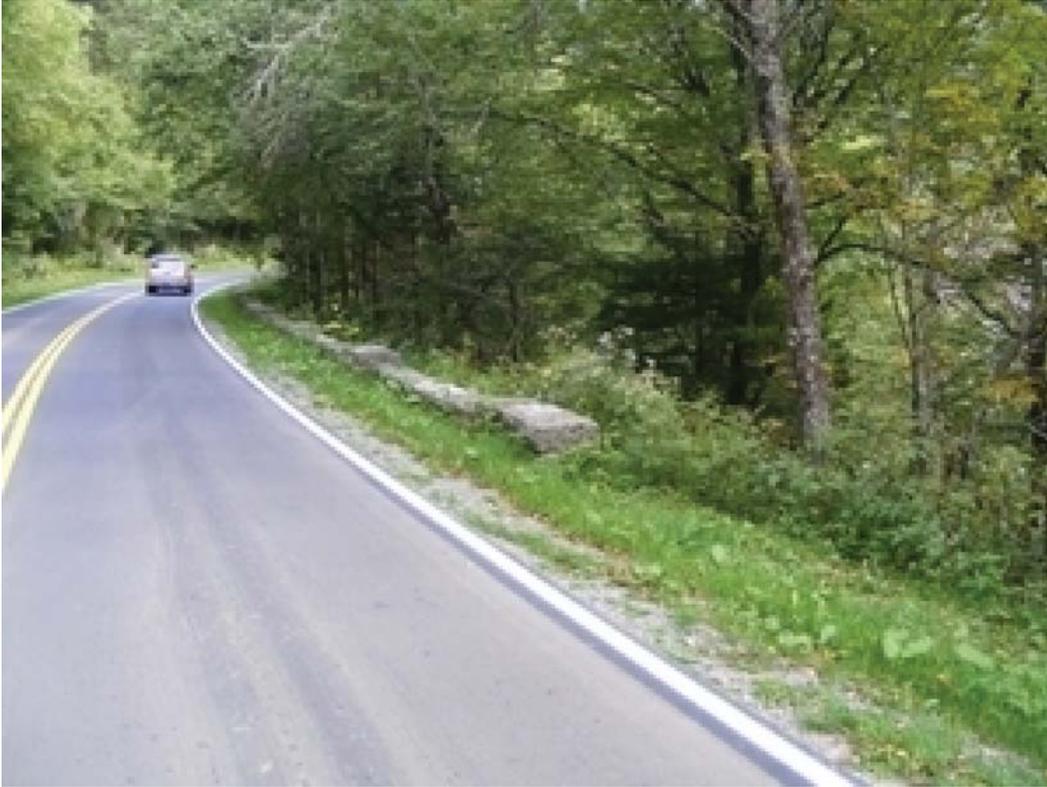
GRSM_0017_4.517_L_1.JPG

Barrier ID:	GRSM-0017-4.517-L				
Route Name:	CLINGMANS DOME ACCESS ROAD				
Inspection Date:	09/10/2010	Barrier Rating:	31.20		
Barrier Description					
Type:	STONE MASONRY CRENELLATED WITHOUT	Barrier Function:	TRAFFIC		
Barrier Material:	STONE	Post Material:	N/A		
Blockout Type:	N/A	Length (ft.):	228		
Speed Limit (MPH):	30	Placement with Respect to Road:	INSIDE OF CURVE		
Hazard Behind Barrier:	HIGH				
Barrier Crashworthiness					
Appropriate Test Level:	TL-1	Barrier Test Level:	NCW	Is Barrier Crashworthy?:	NO
Beg. End Trtmt Type:	NONE	Is Beg. End Trtmt Crashworthy?:	N/A	Approach Transition Type:	NONE
Ending End Trtmt Type:	NONE	Ending End Trtmt Crashworthy?:	N/A		
Average Measurements					
Design Height (In.):	18	Width (In.):	18.2	Post Spacing (In.):	0.0
Height (In.):	15.3	Lateral Offset (In.):	61.0	Road Grade (%):	4.80
Physical Condition					
Barrier	Alignment and Height:	The alignment has no deviation and the height is 2 to 4 in below the 18-in/24-in crenellated design height.

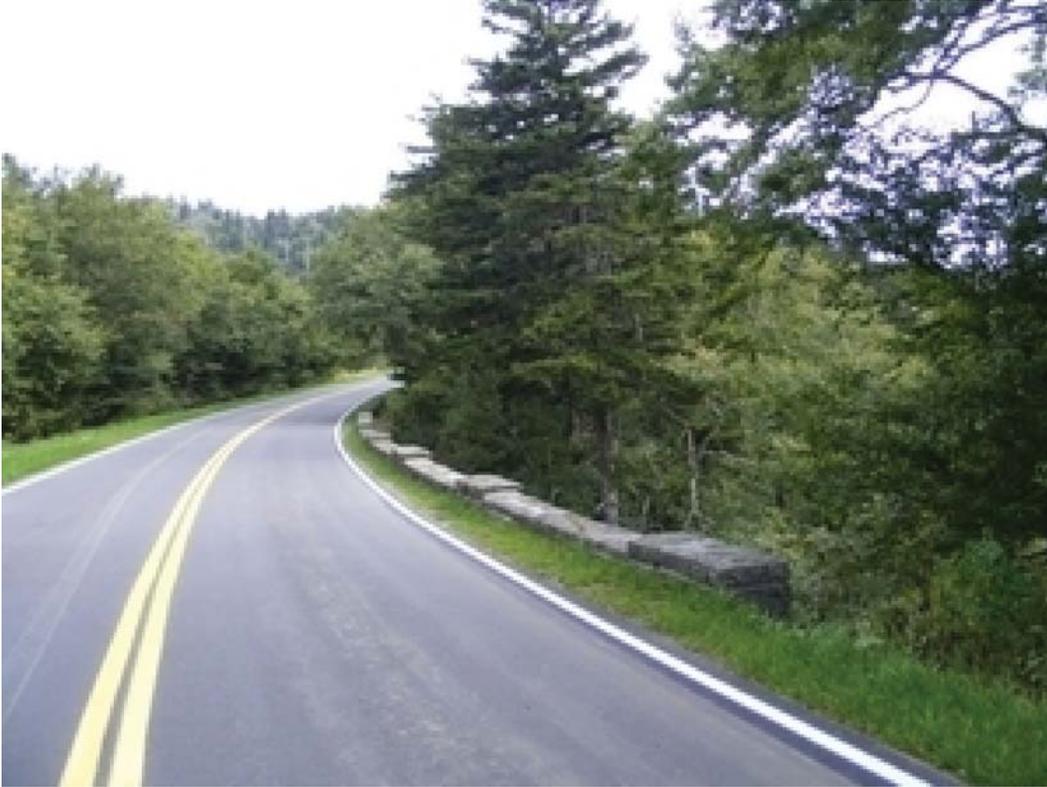
GRSM_0017_4.869_L_1.JPG

Barrier ID:	GRSM-0017-4.869-L				
Route Name:	CLINGMANS DOME ACCESS ROAD				
Inspection Date:	09/10/2010	Barrier Rating:	47.00		
Barrier Description					
Type:	STONE MASONRY CRENELLATED WITHOUT	Barrier Function:	TRAFFIC		
Barrier Material:	STONE	Post Material:	N/A		
Blockout Type:	N/A	Length (ft.):	200		
Speed Limit (MPH):	30	Placement with Respect to Road:	INSIDE OF CURVE		
Hazard Behind Barrier:	HIGH				
Barrier Crashworthiness					
Appropriate Test Level:	TL-1	Barrier Test Level:	NCW	Is Barrier Crashworthy?:	NO
Beg. End Trtmt Type:	NONE	Is Beg. End Trtmt Crashworthy?:	N/A	Approach Transition Type:	NONE
Ending End Trtmt Type:	NONE	Ending End Trtmt Crashworthy?:	N/A		
Average Measurements					
Design Height (In.):	18	Width (In.):	18.6	Post Spacing (In.):	0.0
Height (In.):	12.3	Lateral Offset (In.):	29.0	Road Grade (%):	1.70
Physical Condition					
Barrier	Alignment and Height:	The barrier alignment shows no delineation the height is 5-6 in below the 18-in/24-in crenellated design height.

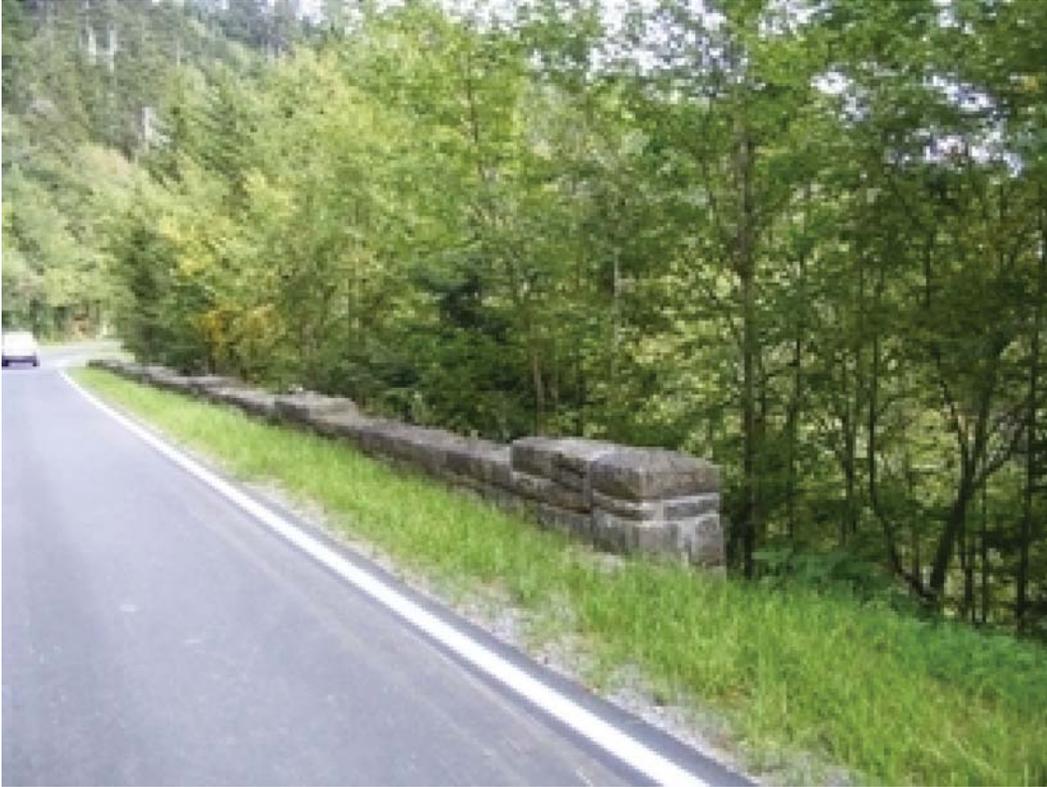
GRSM_0017_5.502_L_1.JPG

Barrier ID:	GRSM-0017-5.502-L				
Route Name:	CLINGMANS DOME ACCESS ROAD				
Inspection Date:	09/10/2010	Barrier Rating:	39.90		
Barrier Description					
Type:	STONE MASONRY CRENELLATED WITHOUT	Barrier Function:	TRAFFIC		
Barrier Material:	STONE	Post Material:	N/A		
Blockout Type:	N/A	Length (ft.):	175		
Speed Limit (MPH):	30	Placement with Respect to Road:	INSIDE OF CURVE		
Hazard Behind Barrier:	HIGH				
Barrier Crashworthiness					
Appropriate Test Level:	TL-1	Barrier Test Level:	NCW	Is Barrier Crashworthy?:	NO
Beg. End Trtmt Type:	NONE	Is Beg. End Trtmt Crashworthy?:	N/A	Approach Transition Type:	NONE
Ending End Trtmt Type:	NONE	Ending End Trtmt Crashworthy?:	N/A		
Average Measurements					
Design Height (In.):	18	Width (In.):	18.0	Post Spacing (In.):	0.0
Height (In.):	15.6	Lateral Offset (In.):	52.0	Road Grade (%):	6.80
Physical Condition					
Barrier	Alignment and Height:	The alignment has no deviation and the height is 2 to 3 in below the 18-in/24-in crenellated design height.

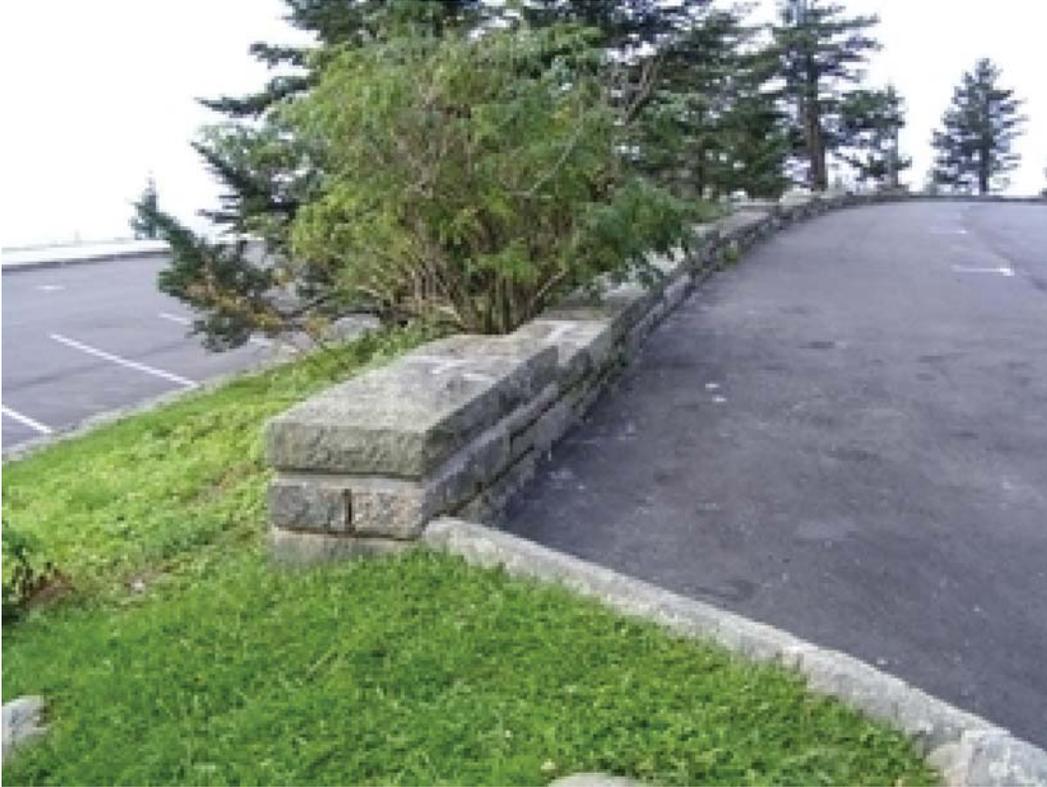
GRSM_0017_6.997_L_1.JPG

Barrier ID:	GRSM-0017-6.997-L				
Route Name:	CLINGMANS DOME ACCESS ROAD				
Inspection Date:	09/10/2010	Barrier Rating:	35.20		
Barrier Description					
Type:	STONE MASONRY CRENELLATED WITHOUT	Barrier Function:	NON-TRAFFIC		
Barrier Material:	STONE	Post Material:	N/A		
Blockout Type:	N/A	Length (ft.):	342		
Speed Limit (MPH):	30	Placement with Respect to Road:	NON-TRAFFIC BARRIER		
Hazard Behind Barrier:	N/A				
Barrier Crashworthiness					
Appropriate Test Level:	TL-1	Barrier Test Level:	N/A	Is Barrier Crashworthy?:	N/A
Beg. End Trtmt Type:	NONE	Is Beg. End Trtmt Crashworthy?:	N/A	Approach Transition Type:	NONE
Ending End Trtmt Type:	NONE	Ending End Trtmt Crashworthy?:	N/A		
Average Measurements					
Design Height (In.):	18	Width (In.):	18.2	Post Spacing (In.):	0.0
Height (In.):	13.6	Lateral Offset (In.):	0.0	Road Grade (%):	0.00
Physical Condition					
Barrier	Alignment and Height:	Alignment has no deviation and height is between 3 to 5 in the 18-in/24-in crenellated design height.

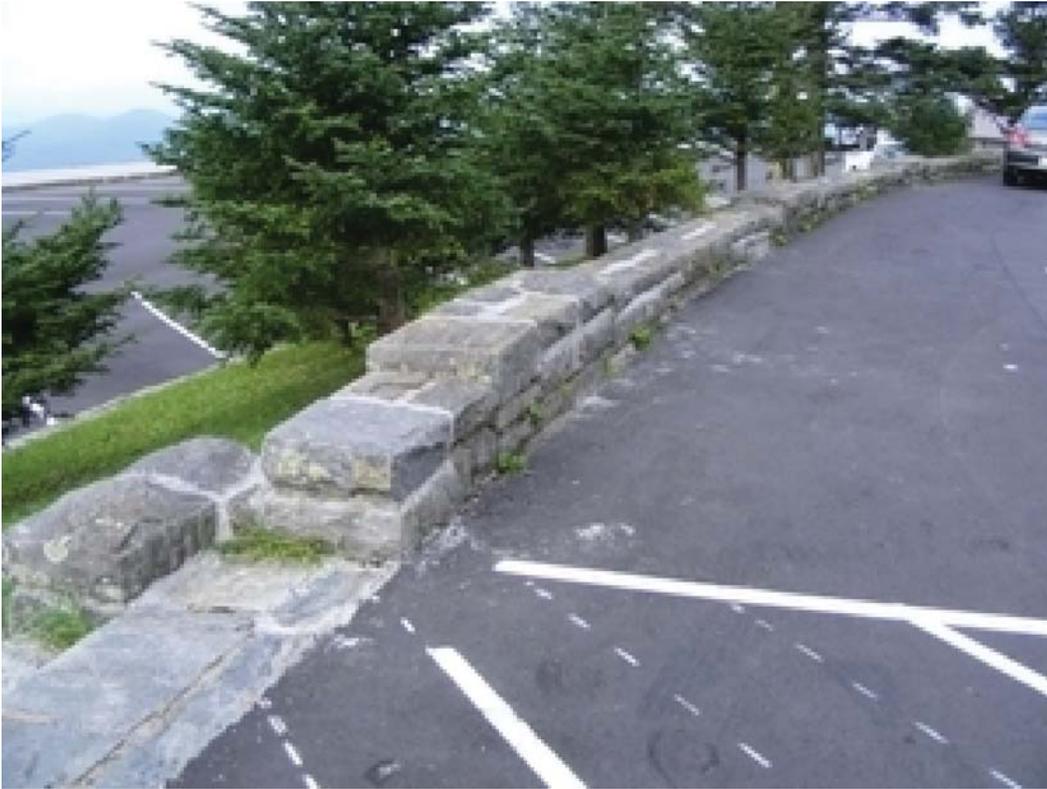
GRSM_0017_7.063_L_1.JPG

Barrier ID:	GRSM-0017-7.063-L				
Route Name:	CLINGMANS DOME ACCESS ROAD				
Inspection Date:	09/10/2010	Barrier Rating:	32.20		
Barrier Description					
Type:	STONE MASONRY CRENELLATED WITHOUT	Barrier Function:	NON-TRAFFIC		
Barrier Material:	STONE	Post Material:	N/A		
Blockout Type:	N/A	Length (ft.):	165		
Speed Limit (MPH):	30	Placement with Respect to Road:	NON-TRAFFIC BARRIER		
Hazard Behind Barrier:	N/A				
Barrier Crashworthiness					
Appropriate Test Level:	TL-1	Barrier Test Level:	N/A	Is Barrier Crashworthy?:	N/A
Beg. End Trtmt Type:	NONE	Is Beg. End Trtmt Crashworthy?:	N/A	Approach Transition Type:	NONE
Ending End Trtmt Type:	NONE	Ending End Trtmt Crashworthy?:	N/A		
Average Measurements					
Design Height (In.):	18	Width (In.):	18.2	Post Spacing (In.):	0.0
Height (In.):	12.6	Lateral Offset (In.):	0.0	Road Grade (%):	0.00
Physical Condition					
Barrier	Alignment and Height:	The alignment has no deviation and the height is 4 to 6 in below the 18-in/24-in crenellated design height.

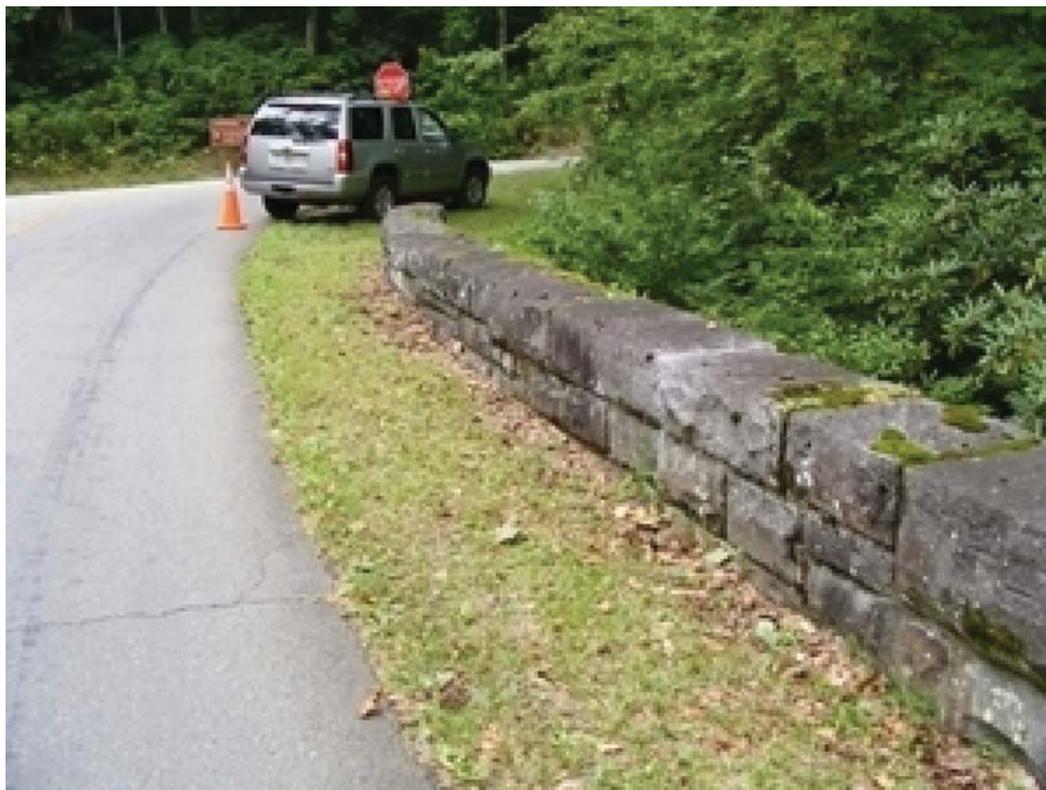
GRSM_0018_0.011_L_1.JPG

Barrier ID:	GRSM-0018-0.011-L				
Route Name:	ELKMONT ROAD				
Inspection Date:	09/09/2010	Barrier Rating:	17.80		
Barrier Description					
Type:	STONE MASONRY WITHOUT CONCRETE CORE WALL	Barrier Function:	TRAFFIC		
Barrier Material:	STONE	Post Material:	N/A		
Blockout Type:	N/A	Length (ft.):	33		
Speed Limit (MPH):	25	Placement with Respect to Road:	INSIDE OF CURVE		
Hazard Behind Barrier:	MEDIUM				
Barrier Crashworthiness					
Appropriate Test Level:	TL-1	Barrier Test Level:	NCW	Is Barrier Crashworthy?:	NO
Beg. End Trtmt Type:	NONE	Is Beg. End Trtmt Crashworthy?:	N/A	Approach Transition Type:	NONE
Ending End Trtmt Type:	NONE	Ending End Trtmt Crashworthy?:	N/A		
Average Measurements					
Design Height (In.):	24	Width (In.):	23.6	Post Spacing (In.):	0.0
Height (In.):	24.0	Lateral Offset (In.):	51.5	Road Grade (%):	5.30
Physical Condition					
Barrier	Alignment and Height:	The alignment has no deviation and the height is at the design height of 24 in.

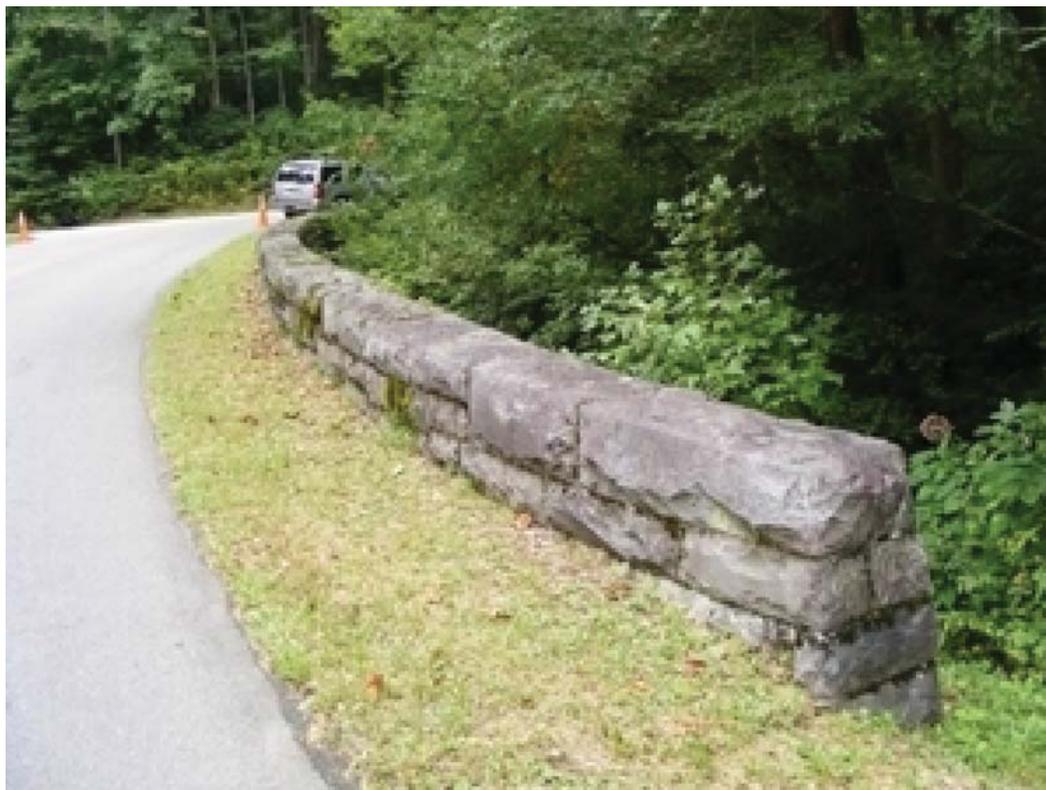
GRSM_0018_0.023_L_1.JPG

Barrier ID:	GRSM-0018-0.023-L				
Route Name:	ELKMONT ROAD				
Inspection Date:	09/09/2010	Barrier Rating:	17.80		
Barrier Description					
Type:	STONE MASONRY WITHOUT CONCRETE CORE WALL	Barrier Function:	TRAFFIC		
Barrier Material:	STONE	Post Material:	N/A		
Blockout Type:	N/A	Length (ft.):	29		
Speed Limit (MPH):	25	Placement with Respect to Road:	INSIDE OF CURVE		
Hazard Behind Barrier:	MEDIUM				
Barrier Crashworthiness					
Appropriate Test Level:	TL-1	Barrier Test Level:	NCW	Is Barrier Crashworthy?:	NO
Beg. End Trtmt Type:	NONE	Is Beg. End Trtmt Crashworthy?:	N/A	Approach Transition Type:	NONE
Ending End Trtmt Type:	NONE	Ending End Trtmt Crashworthy?:	N/A		
Average Measurements					
Design Height (In.):	24	Width (In.):	23.6	Post Spacing (In.):	0.0
Height (In.):	27.2	Lateral Offset (In.):	53.5	Road Grade (%):	4.70
Physical Condition					
Barrier	Alignment and Height:	The alignment has no deviation and the height is 0-1 in above the design height of 24 in.

Breaking and Cracking:	No breaking or cracking observed.			
	Missing Elements:	No missing elements observed.			
	Corrosion and Weathering:	No corrosion or weathering observed.			
End Treatments	Alignment and Height:				
	Breaking and Cracking:				
	Missing Elements:				
	Corrosion and Weathering:

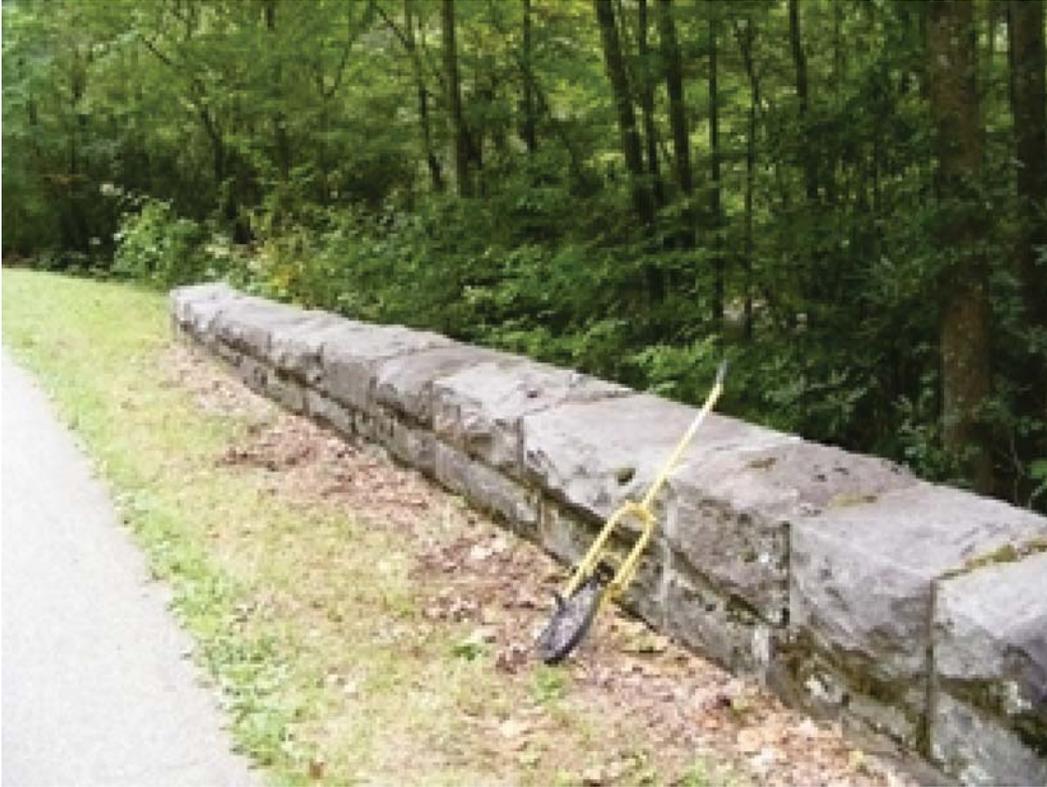
GRSM_0018_0.023_R_1.JPG

Barrier ID:	GRSM-0018-0.023-R				
Route Name:	ELKMONT ROAD				
Inspection Date:	09/09/2010	Barrier Rating:	32.20		
Barrier Description					
Type:	STONE MASONRY WITHOUT CONCRETE CORE WALL	Barrier Function:	TRAFFIC		
Barrier Material:	STONE	Post Material:	N/A		
Blockout Type:	N/A	Length (ft.):	28		
Speed Limit (MPH):	25	Placement with Respect to Road:	OUTSIDE OF CURVE		
Hazard Behind Barrier:	MEDIUM				
Barrier Crashworthiness					
Appropriate Test Level:	TL-1	Barrier Test Level:	NCW	Is Barrier Crashworthy?:	NO
Beg. End Trtmt Type:	NONE	Is Beg. End Trtmt Crashworthy?:	N/A	Approach Transition Type:	NONE
Ending End Trtmt Type:	NONE	Ending End Trtmt Crashworthy?:	N/A		
Average Measurements					
Design Height (In.):	24	Width (In.):	24.2	Post Spacing (In.):	0.0
Height (In.):	21.6	Lateral Offset (In.):	51.5	Road Grade (%):	4.60
Physical Condition					
Barrier	Alignment and Height:	The alignment has no deviation and the height is 1 to 3 in below the design height of 24 in.

Breaking and Cracking:	No breaking or cracking observed.			
	Missing Elements:	No missing elements observed.			
	Corrosion and Weathering:	No corrosion or weathering observed.			
End Treatments	Alignment and Height:				
	Breaking and Cracking:				
	Missing Elements:				
	Corrosion and Weathering:

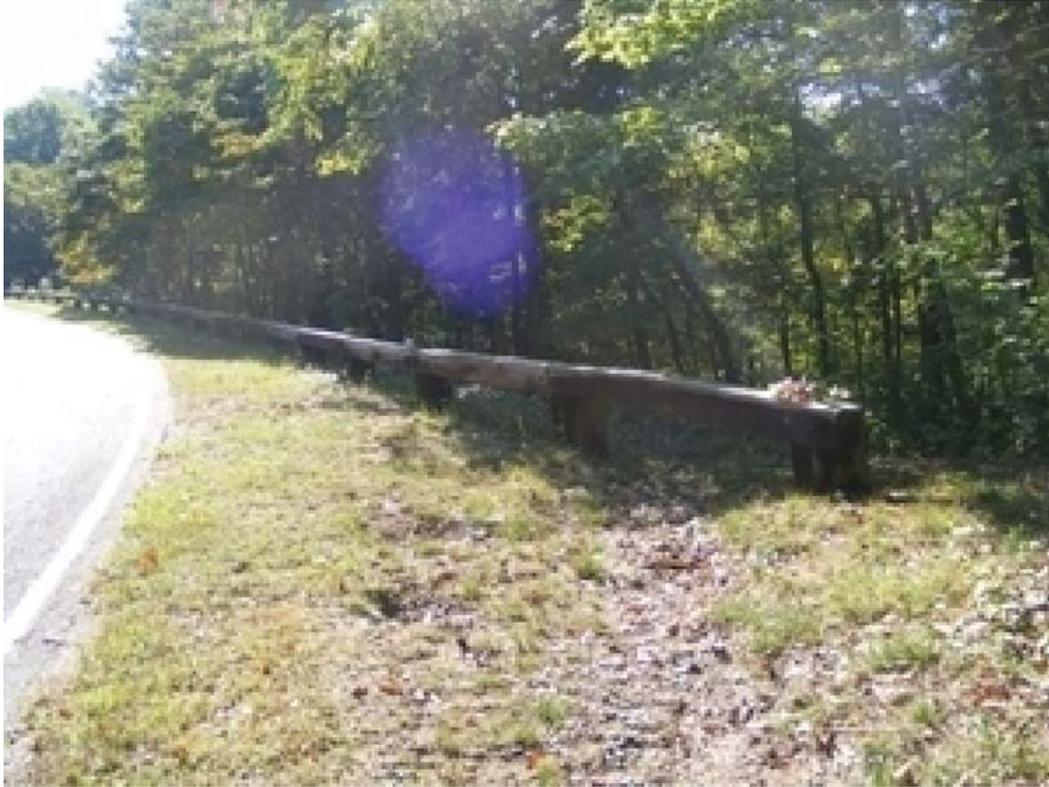
GRSM_0019_0.092_L_1.JPG

Barrier ID:	GRSM-0019-0.092-L				
Route Name:	LAKEVIEW DRIVE EAST				
Inspection Date:	09/21/2010	Barrier Rating:	33.70		
Barrier Description					
Type:	OTHER: TIMBER RAIL ON TIMBER POSTS	Barrier Function:	TRAFFIC		
Barrier Material:	LOG/TIMBER/WOOD	Post Material:	WOOD		
Blockout Type:	N/A	Length (ft.):	544		
Speed Limit (MPH):	35	Placement with Respect to Road:	INSIDE OF CURVE		
Hazard Behind Barrier:	MEDIUM				
Barrier Crashworthiness					
Appropriate Test Level:	TL-2	Barrier Test Level:	NCW	Is Barrier Crashworthy?:	NO
Beg. End Trtmt Type:	NONE	Is Beg. End Trtmt Crashworthy?:	N/A	Approach Transition Type:	NONE
Ending End Trtmt Type:	NONE	Ending End Trtmt Crashworthy?:	N/A		
Average Measurements					
Design Height (In.):	24	Width (In.):	0.0	Post Spacing (In.):	120.3
Height (In.):	22.0	Lateral Offset (In.):	83.0	Road Grade (%):	2.60
Physical Condition					
Barrier	Alignment and Height:	The alignment has no deviation. 125 ft was 0-1 in below the 24 in design height and 419 ft was 1-3 in below.

Breaking and Cracking:	No breaking or cracking observed.			
	Missing Elements:	No missing elements observed.			
	Corrosion and Weathering:	15 posts observed as rotted and hollow.			
End Treatments	Alignment and Height:				
	Breaking and Cracking:				
	Missing Elements:				
	Corrosion and Weathering:

Repair Action:	REPAIR	FMSS Work Type:	DEFERRED MAINTENANCE	Repair Cost:	\$11127
Brief Workorder:	Raise 419-ft of barrier up to 24-in design height.				
Workorder:	Replace Post at \$100- per -Each for 15 Post(s) = \$1500. Replace 15 posts rotted and hollow. Adjust Guardrail at \$10- per -Lin. Ft. for 419 LF = \$4190. Raise 419-ft of barrier up to 24-in design height. Low Speed Traffic Control at \$1475- per -Day for 3 Day(s) = \$4425.

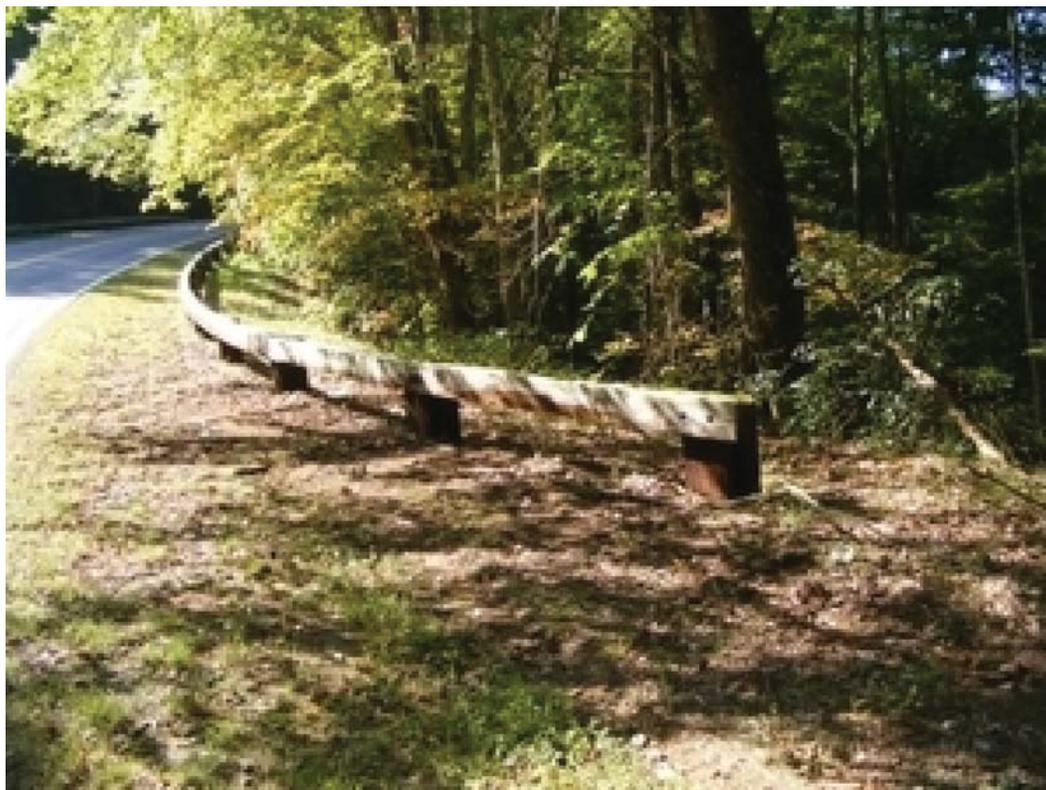
GRSM_0019_0.229_L_1.JPG

Barrier ID:	GRSM-0019-0.229-L				
Route Name:	LAKEVIEW DRIVE EAST				
Inspection Date:	09/21/2010	Barrier Rating:	35.20		
Barrier Description					
Type:	OTHER: TIMBER RAIL ON TIMBER POSTS	Barrier Function:	TRAFFIC		
Barrier Material:	LOG/TIMBER/WOOD	Post Material:	WOOD		
Blockout Type:	N/A	Length (ft.):	430		
Speed Limit (MPH):	35	Placement with Respect to Road:	BOTH INSIDE AND OUTSIDE		
Hazard Behind Barrier:	MEDIUM				
Barrier Crashworthiness					
Appropriate Test Level:	TL-2	Barrier Test Level:	NCW	Is Barrier Crashworthy?:	NO
Beg. End Trtmt Type:	NONE	Is Beg. End Trtmt Crashworthy?:	N/A	Approach Transition Type:	NONE
Ending End Trtmt Type:	NONE	Ending End Trtmt Crashworthy?:	N/A		
Average Measurements					
Design Height (In.):	24	Width (In.):	0.0	Post Spacing (In.):	119.3
Height (In.):	21.2	Lateral Offset (In.):	92.0	Road Grade (%):	4.50
Physical Condition					
Barrier	Alignment and Height:	The alignment has no deviation and the height is 2-3 in below the 24 in design height

Breaking and Cracking:	Minor cracking of rails observed.			
	Missing Elements:	No missing elements observed.			
	Corrosion and Weathering:	13 posts observed as rotted and hollow.			
End Treatments	Alignment and Height:				
	Breaking and Cracking:				
	Missing Elements:				
	Corrosion and Weathering:

Repair Action:	REPAIR	FMSS Work Type:	DEFERRED MAINTENANCE	Repair Cost:	\$11028
Brief Workorder:	Raise 430-ft of barrier up to 24-in design height.				
Workorder:	Replace Post at \$100- per -Each for 13 Post(s) = \$1300. Replace 13 posts rotted and hollow. Adjust Guardrail at \$10- per -Lin. Ft. for 430 LF = \$4300. Raise 430-ft of barrier up to 24-in design height. Low Speed Traffic Control at \$1475- per -Day for 3 Day(s) = \$4425.

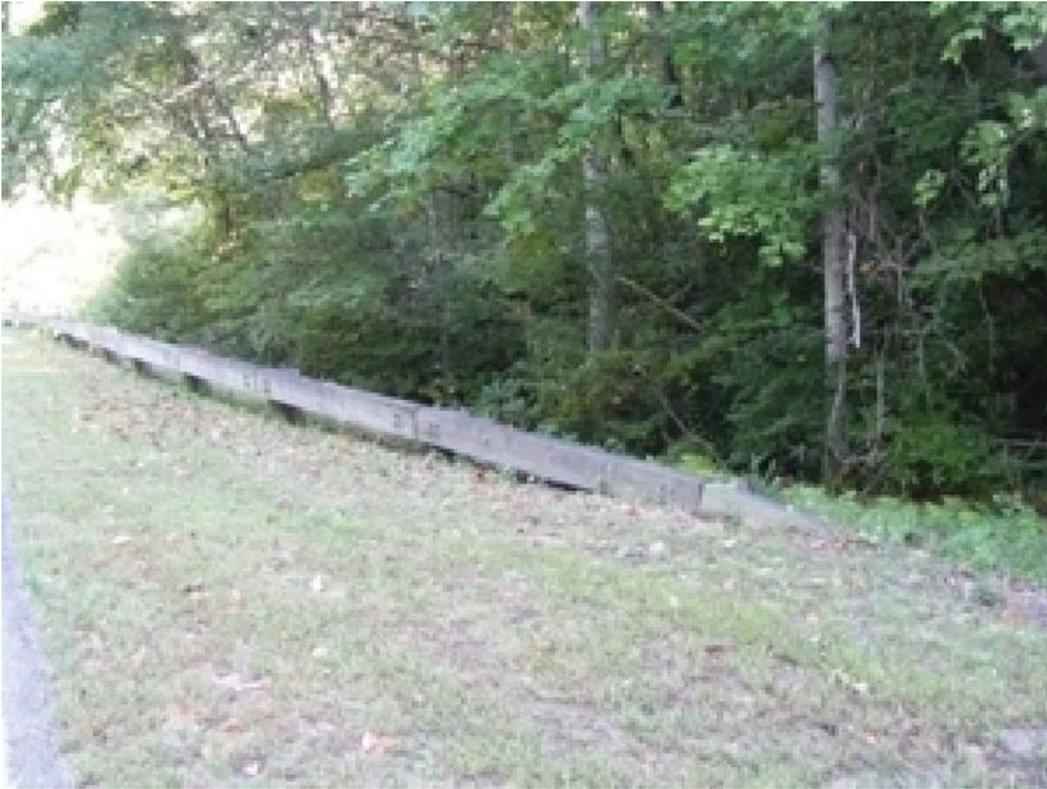
GRSM_0019_0.264_R_1.JPG

Barrier ID:	GRSM-0019-0.264-R				
Route Name:	LAKEVIEW DRIVE EAST				
Inspection Date:	09/21/2010	Barrier Rating:	29.30		
Barrier Description					
Type:	STEEL-BACKED TIMBER WITHOUT BLOCKOUT	Barrier Function:	TRAFFIC		
Barrier Material:	STEEL-BACKED TIMBER/LOG	Post Material:	WOOD		
Blockout Type:	N/A	Length (ft.):	320		
Speed Limit (MPH):	35	Placement with Respect to Road:	OUTSIDE OF CURVE		
Hazard Behind Barrier:	MEDIUM				
Barrier Crashworthiness					
Appropriate Test Level:	TL-2	Barrier Test Level:	TL-2	Is Barrier Crashworthy?:	YES
Beg. End Trtmt Type:	SBT/LOG FLARED	Is Beg. End Trtmt Crashworthy?:	NO	Approach Transition Type:	NONE
Ending End Trtmt Type:	SBT/LOG FLARED	Ending End Trtmt Crashworthy?:	NO		
Average Measurements					
Design Height (In.):	27	Width (In.):	0.0	Post Spacing (In.):	119.0
Height (In.):	27.6	Lateral Offset (In.):	94.3	Road Grade (%):	4.20
Physical Condition					
Barrier	Alignment and Height:	The alignment has no deviation and the height is 0-1 in above the 27 in design height.

Breaking and Cracking:	No breaking or cracking observed.			
	Missing Elements:	No missing elements observed.			
	Corrosion and Weathering:	No corrosion or weathering observed.			
End Treatments	Alignment and Height:	Alignment acceptable. Height is within 1 in of the 27-in design height.			
	Breaking and Cracking:	No breaking or cracking observed.			
	Missing Elements:	No missing elements observed.			
	Corrosion and Weathering:	No corrosion or weathering observed.

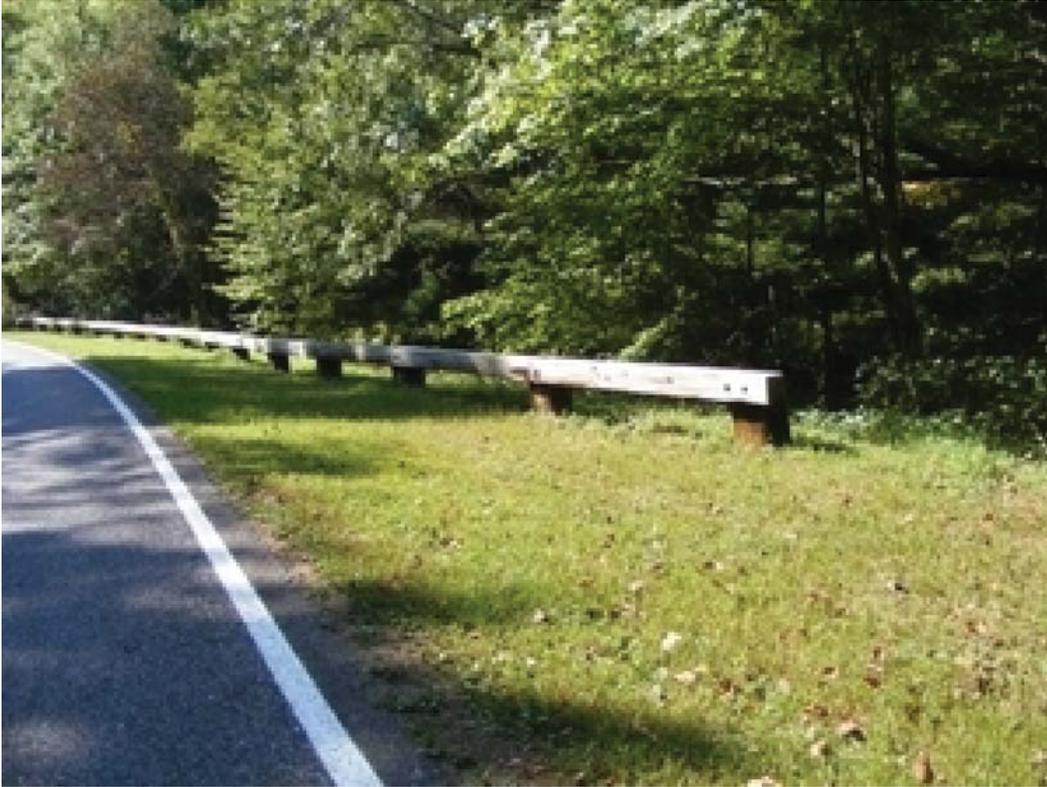
GRSM_0019_0.364_L_1.JPG

Barrier ID:	GRSM-0019-0.364-L				
Route Name:	LAKEVIEW DRIVE EAST				
Inspection Date:	09/21/2010	Barrier Rating:	32.20		
Barrier Description					
Type:	OTHER: TIMBER RAIL ON TIMBER POSTS	Barrier Function:	TRAFFIC		
Barrier Material:	LOG/TIMBER/WOOD	Post Material:	WOOD		
Blockout Type:	N/A	Length (ft.):	170		
Speed Limit (MPH):	35	Placement with Respect to Road:	OUTSIDE OF CURVE		
Hazard Behind Barrier:	MEDIUM				
Barrier Crashworthiness					
Appropriate Test Level:	TL-2	Barrier Test Level:	NCW	Is Barrier Crashworthy?:	NO
Beg. End Trtmt Type:	NONE	Is Beg. End Trtmt Crashworthy?:	N/A	Approach Transition Type:	NONE
Ending End Trtmt Type:	NONE	Ending End Trtmt Crashworthy?:	N/A		
Average Measurements					
Design Height (In.):	24	Width (In.):	0.0	Post Spacing (In.):	119.0
Height (In.):	22.0	Lateral Offset (In.):	101.3	Road Grade (%):	4.30
Physical Condition					
Barrier	Alignment and Height:	The alignment has no deviation and the height is 2 in below the 24 in design height.

Breaking and Cracking:	Minor breaking and cracking of less than a quarter in observed.			
	Missing Elements:	No missing elements observed.			
	Corrosion and Weathering:	Moderate corrosion and weathering observed.			
End Treatments	Alignment and Height:				
	Breaking and Cracking:				
	Missing Elements:				
	Corrosion and Weathering:

Repair Action:	REPAIR	FMSS Work Type:	DEFERRED MAINTENANCE	Repair Cost:	\$3493
Brief Workorder:	Raise 170 feet of barrier up to the 24 inch design height.				
Workorder:	Adjust Guardrail at \$10- per -Lin. Ft. for 170 LF = \$1700. Raise 170 feet of barrier up to the 24 inch design height. Low Speed Traffic Control at \$1475- per -Day for 1 Day(s) = \$1475.
