NPS Guardwall/Rail Inventory Program
Great Smoky Mountains National Park

Federal Highway Administration
Eastern Federal Lands Highway Division
Road Inventory Program (RIP)

Data Collection Date: September 2010
Report Date: December 2015

Great Smoky Mountains National Park in North Carolina and Tennessee

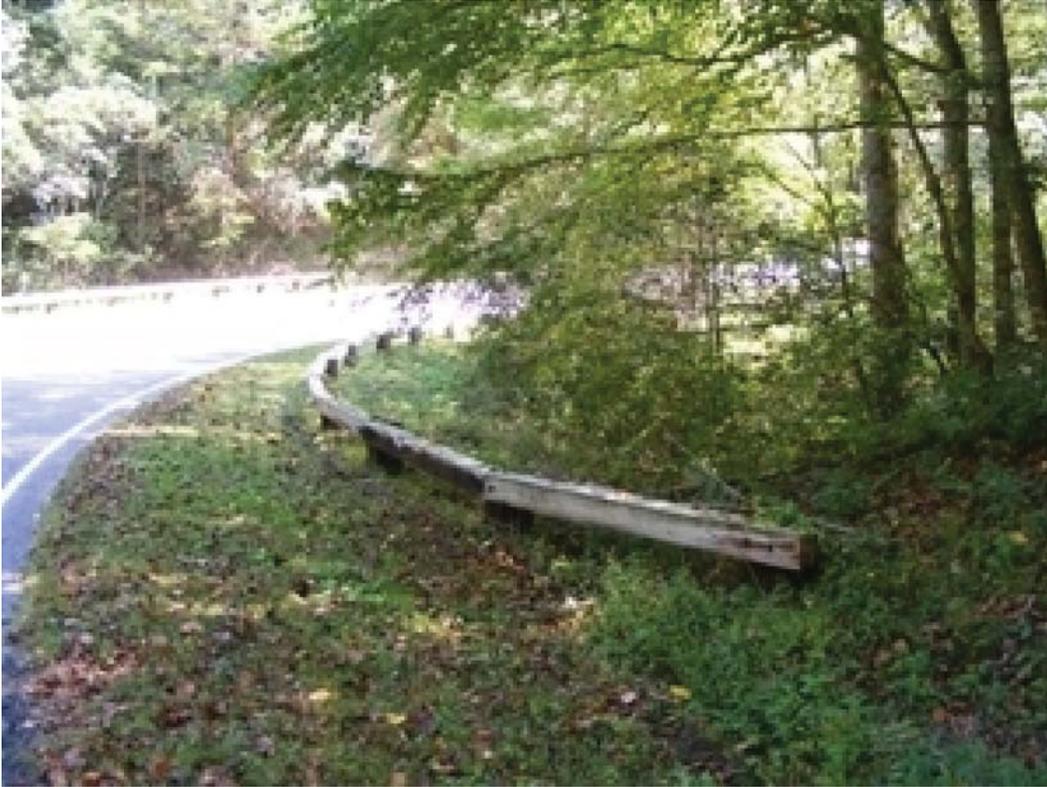
GRSM_0019_0.460_L_1.JPG

Barrier ID:	GRSM-0019-0.460-L				
Route Name:	LAKEVIEW DRIVE EAST				
Inspection Date:	09/21/2010	Barrier Rating:	39.50		
Barrier Description					
Type:	OTHER: TIMBER RAIL ON TIMBER POSTS	Barrier Function:	TRAFFIC		
Barrier Material:	LOG/TIMBER/WOOD	Post Material:	WOOD		
Blockout Type:	N/A	Length (ft.):	150		
Speed Limit (MPH):	35	Placement with Respect to Road:	INSIDE OF CURVE		
Hazard Behind Barrier:	MEDIUM				
Barrier Crashworthiness					
Appropriate Test Level:	TL-2	Barrier Test Level:	NCW	Is Barrier Crashworthy?:	NO
Beg. End Trtmt Type:	NONE	Is Beg. End Trtmt Crashworthy?:	N/A	Approach Transition Type:	NONE
Ending End Trtmt Type:	NONE	Ending End Trtmt Crashworthy?:	N/A		
Average Measurements					
Design Height (In.):	24	Width (In.):	0.0	Post Spacing (In.):	120.0
Height (In.):	21.6	Lateral Offset (In.):	99.3	Road Grade (%):	0.10
Physical Condition					
Barrier	Alignment and Height:	The alignment has no deviation and the height is 1-3 in below the 24 in design height.

Breaking and Cracking:	No breaking or cracking observed.			
	Missing Elements:	No missing elements observed.			
	Corrosion and Weathering:	There are 3 posts that rotten and hollowed out.			
End Treatments	Alignment and Height:				
	Breaking and Cracking:				
	Missing Elements:				
	Corrosion and Weathering:

Repair Action:	REPAIR	FMSS Work Type:	DEFERRED MAINTENANCE	Repair Cost:	\$5225
Brief Workorder:	Raise 150-ft of barrier up to 24-in design height and replace 3 posts.				
Workorder:	Replace Post at \$100- per -Each for 3 Post(s) = \$300. Replace rotten posts. Adjust Guardrail at \$10- per -Lin. Ft. for 150 LF = \$1500. Raise 150-ft of barrier up to 24-in design height. Low Speed Traffic Control at \$1475- per -Day for 2 Day(s) = \$2950.

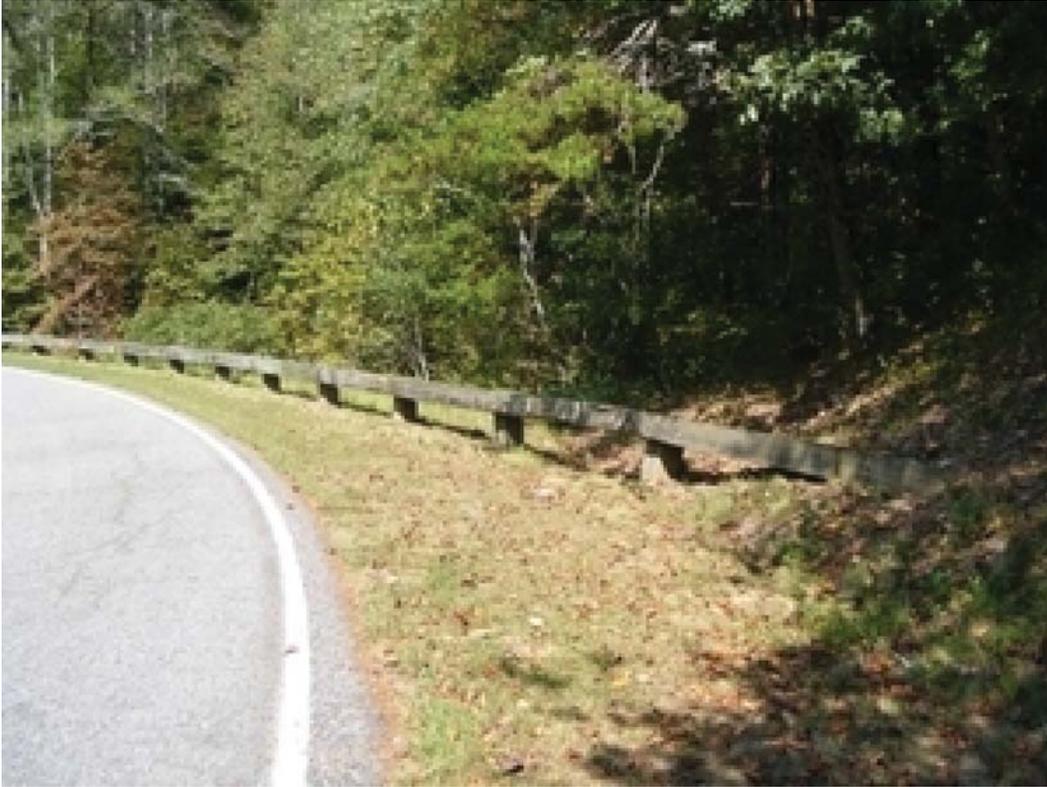
GRSM_0019_0.463_R_1.JPG

Barrier ID:	GRSM-0019-0.463-R				
Route Name:	LAKEVIEW DRIVE EAST				
Inspection Date:	09/21/2010	Barrier Rating:	26.60		
Barrier Description					
Type:	STEEL-BACKED TIMBER WITHOUT BLOCKOUT	Barrier Function:	TRAFFIC		
Barrier Material:	STEEL-BACKED TIMBER/LOG	Post Material:	WOOD		
Blockout Type:	N/A	Length (ft.):	196		
Speed Limit (MPH):	35	Placement with Respect to Road:	OUTSIDE OF CURVE		
Hazard Behind Barrier:	MEDIUM				
Barrier Crashworthiness					
Appropriate Test Level:	TL-2	Barrier Test Level:	TL-2	Is Barrier Crashworthy?:	YES
Beg. End Trtmt Type:	SBT/LOG BURIED	Is Beg. End Trtmt Crashworthy?:	YES	Approach Transition Type:	NONE
Ending End Trtmt Type:	SBT/LOG BURIED	Ending End Trtmt Crashworthy?:	YES		
Average Measurements					
Design Height (In.):	27	Width (In.):	0.0	Post Spacing (In.):	120.0
Height (In.):	27.2	Lateral Offset (In.):	95.0	Road Grade (%):	0.60
Physical Condition					
Barrier	Alignment and Height:	The alignment has no deviation and the height is within 1 in of the design height of 27 in.

Breaking and Cracking:	No breaking or cracking observed.			
	Missing Elements:	No missing elements observed.			
	Corrosion and Weathering:	No corrosion or weathering observed.			
End Treatments	Alignment and Height:	Alignment acceptable. Height is within 1 in of the 27-in design height.			
	Breaking and Cracking:	20-ft of broken rail and one bent post.			
	Missing Elements:	No missing elements observed.			
	Corrosion and Weathering:	No corrosion or weathering observed.

Repair Action:	REPAIR	FMSS Work Type:	DEFERRED MAINTENANCE	Repair Cost:	\$2008
Brief Workorder:	Replace 10 feet of rail and one post.				
Workorder:	Replace Rail at \$25- per -Lin. Ft. for 10 LF = \$250. Replace broken rail in impact zone. Replace Post at \$100- per -Each for 1 Post(s) = \$100. Replace 1 bent post. Low Speed Traffic Control at \$1475- per -Day for 1 Day(s) = \$1475.

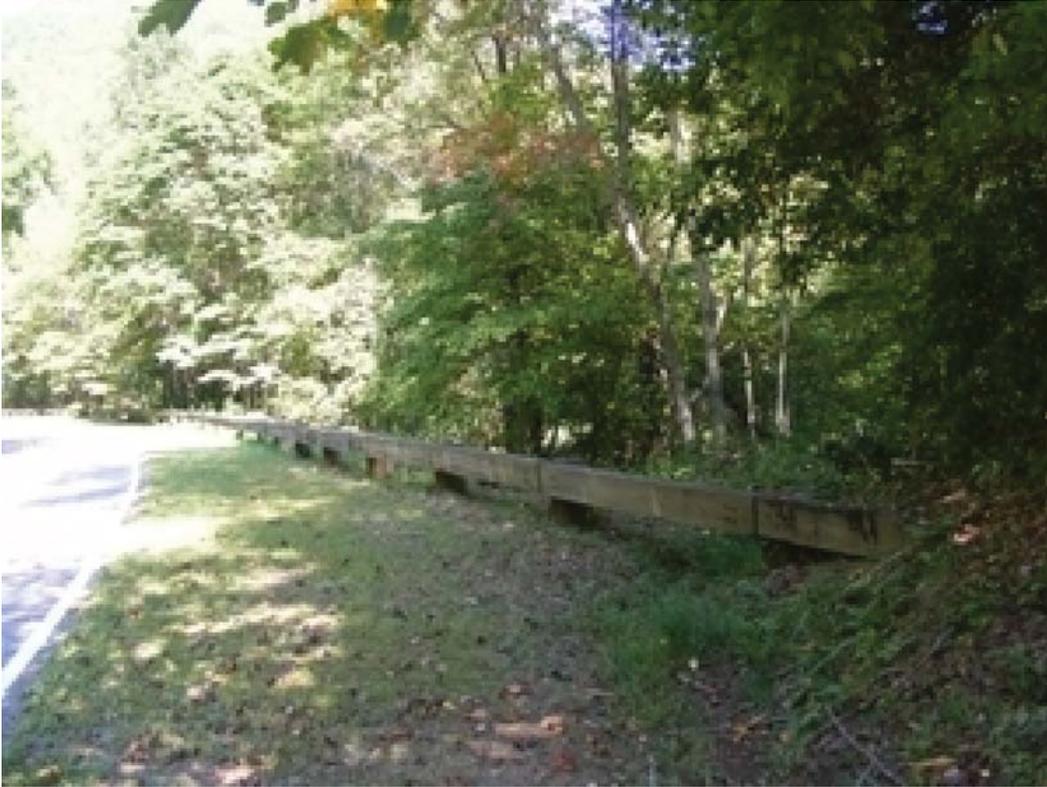
GRSM_0019_0.544_L_1.JPG

Barrier ID:	GRSM-0019-0.544-L				
Route Name:	LAKEVIEW DRIVE EAST				
Inspection Date:	09/21/2010	Barrier Rating:	31.20		
Barrier Description					
Type:	STEEL-BACKED TIMBER WITHOUT BLOCKOUT	Barrier Function:	TRAFFIC		
Barrier Material:	STEEL-BACKED TIMBER/LOG	Post Material:	WOOD		
Blockout Type:	N/A	Length (ft.):	570		
Speed Limit (MPH):	35	Placement with Respect to Road:	OUTSIDE OF CURVE		
Hazard Behind Barrier:	HIGH				
Barrier Crashworthiness					
Appropriate Test Level:	TL-2	Barrier Test Level:	TL-2	Is Barrier Crashworthy?:	YES
Beg. End Trtmt Type:	SBT/LOG FLARED	Is Beg. End Trtmt Crashworthy?:	NO	Approach Transition Type:	NONE
Ending End Trtmt Type:	SBT/LOG BURIED	Ending End Trtmt Crashworthy?:	YES		
Average Measurements					
Design Height (In.):	27	Width (In.):	0.0	Post Spacing (In.):	119.0
Height (In.):	26.6	Lateral Offset (In.):	105.5	Road Grade (%):	5.20
Physical Condition					
Barrier	Alignment and Height:	The alignment has no deviation and the height is within 1 in of the design height of 27 in.

Breaking and Cracking:	No breaking or cracking observed.			
	Missing Elements:	No missing elements observed.			
	Corrosion and Weathering:	No corrosion or weathering observed.			
End Treatments	Alignment and Height:	Alignment acceptable. Height is within 1 in of the 27-in design height.			
	Breaking and Cracking:	No breaking or cracking observed.			
	Missing Elements:	No missing elements observed.			
	Corrosion and Weathering:	No corrosion or weathering observed.

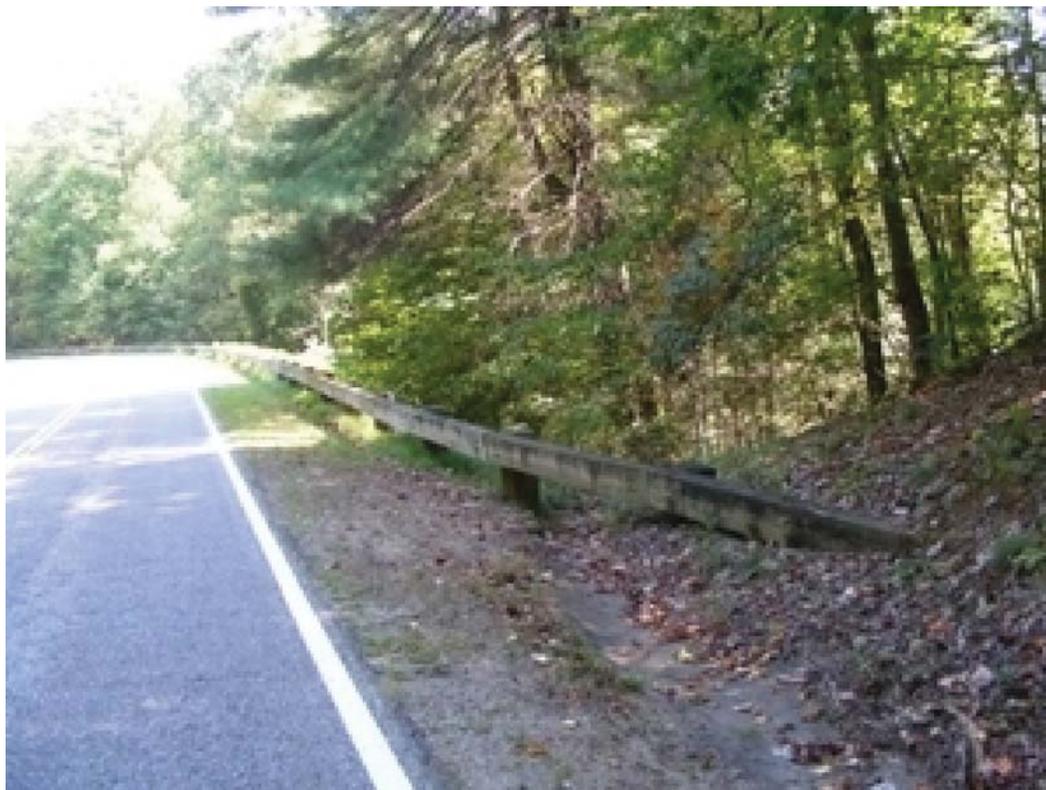
GRSM_0019_0.678_L_1.JPG

Barrier ID:	GRSM-0019-0.678-L				
Route Name:	LAKEVIEW DRIVE EAST				
Inspection Date:	09/21/2010	Barrier Rating:	25.10		
Barrier Description					
Type:	STEEL-BACKED TIMBER WITHOUT BLOCKOUT	Barrier Function:	TRAFFIC		
Barrier Material:	STEEL-BACKED TIMBER/LOG	Post Material:	WOOD		
Blockout Type:	N/A	Length (ft.):	403		
Speed Limit (MPH):	35	Placement with Respect to Road:	OUTSIDE OF CURVE		
Hazard Behind Barrier:	MEDIUM				
Barrier Crashworthiness					
Appropriate Test Level:	TL-2	Barrier Test Level:	TL-2	Is Barrier Crashworthy?:	YES
Beg. End Trtmt Type:	SBT/LOG BURIED	Is Beg. End Trtmt Crashworthy?:	YES	Approach Transition Type:	NONE
Ending End Trtmt Type:	SBT/LOG BURIED	Ending End Trtmt Crashworthy?:	YES		
Average Measurements					
Design Height (In.):	27	Width (In.):	0.0	Post Spacing (In.):	120.0
Height (In.):	26.6	Lateral Offset (In.):	79.0	Road Grade (%):	2.40
Physical Condition					
Barrier	Alignment and Height:	The alignment has no deviation and the height is 0-1 in below the design height of 27 in.

Breaking and Cracking:	No breaking or cracking observed.			
	Missing Elements:	No missing elements observed.			
	Corrosion and Weathering:	No corrosion or weathering observed.			
End Treatments	Alignment and Height:	Alignment acceptable. Height is within 1 in of the 27-in design height.			
	Breaking and Cracking:	No breaking or cracking observed.			
	Missing Elements:	No missing elements observed.			
	Corrosion and Weathering:	No corrosion or weathering observed.

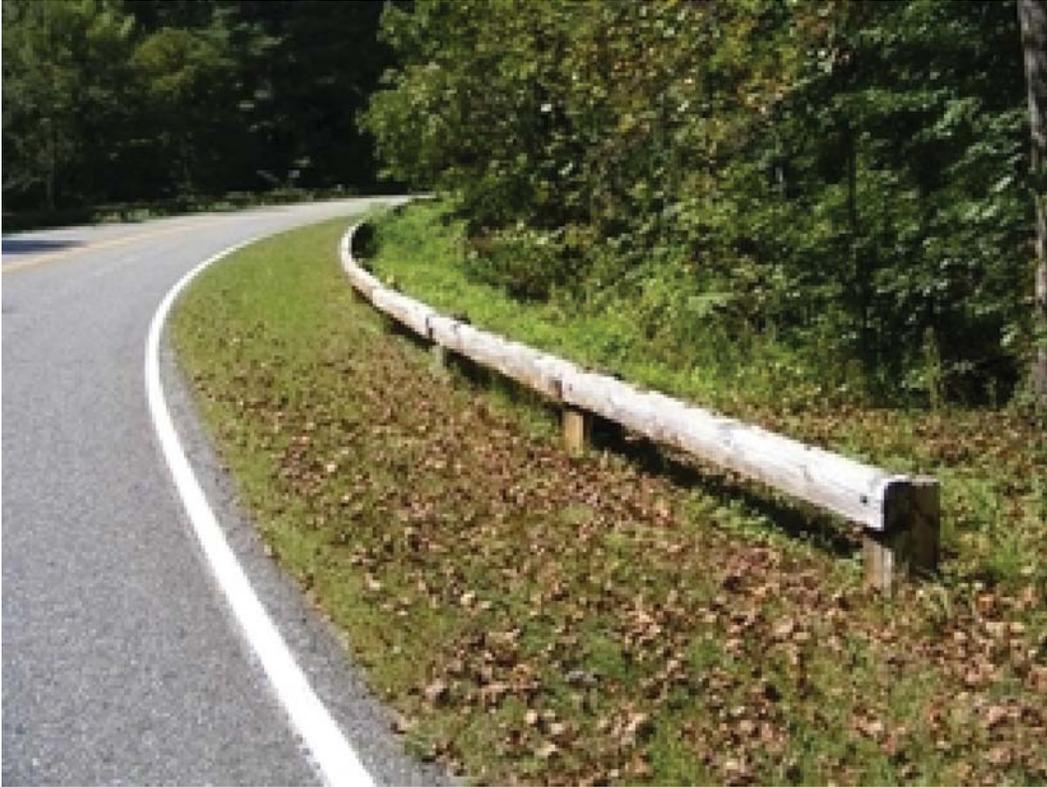
GRSM_0019_0.689_R_1.JPG

Barrier ID:	GRSM-0019-0.689-R				
Route Name:	LAKEVIEW DRIVE EAST				
Inspection Date:	09/21/2010	Barrier Rating:	29.50		
Barrier Description					
Type:	OTHER: TIMBER RAIL ON TIMBER POSTS	Barrier Function:	TRAFFIC		
Barrier Material:	LOG/TIMBER/WOOD	Post Material:	WOOD		
Blockout Type:	N/A	Length (ft.):	309		
Speed Limit (MPH):	35	Placement with Respect to Road:	INSIDE OF CURVE		
Hazard Behind Barrier:	MEDIUM				
Barrier Crashworthiness					
Appropriate Test Level:	TL-2	Barrier Test Level:	NCW	Is Barrier Crashworthy?:	NO
Beg. End Trtmt Type:	NONE	Is Beg. End Trtmt Crashworthy?:	N/A	Approach Transition Type:	NONE
Ending End Trtmt Type:	NONE	Ending End Trtmt Crashworthy?:	N/A		
Average Measurements					
Design Height (In.):	24	Width (In.):	0.0	Post Spacing (In.):	121.0
Height (In.):	22.2	Lateral Offset (In.):	95.0	Road Grade (%):	4.30
Physical Condition					
Barrier	Alignment and Height:	The alignment has no deviation and the height is 1-2 in below the 24 in design height.

Breaking and Cracking:	Major cracking over half an in. Breaking of post observed.			
	Missing Elements:	No missing elements observed.			
	Corrosion and Weathering:	Major corrosion and weathering of 16 posts.			
End Treatments	Alignment and Height:				
	Breaking and Cracking:				
	Missing Elements:				
	Corrosion and Weathering:

Repair Action:	REPLACE	FMSS Work Type:	CAPITAL IMPROVEMENT	Repair Cost:	\$37323
Brief Workorder:	Remove and replace existing timber guardrail with Steel-backed timber without blockouts guardrail and 2 Steel-backed timber flared end terminals.				
Workorder:	Remove Guardrail at \$10- per -Lin. Ft. for 309 LF = \$3090. Steel-Backed Timber w/o Blockout at \$60- per -Lin. Ft. for 249 LF = \$14940. SBT / Log Flared at \$5000- per -Each for 2 Unit(s) = \$10000. Low Speed Traffic Control at \$1475- per -Day for 4 Day(s) = \$5900. 2 days removal 2 days installation.

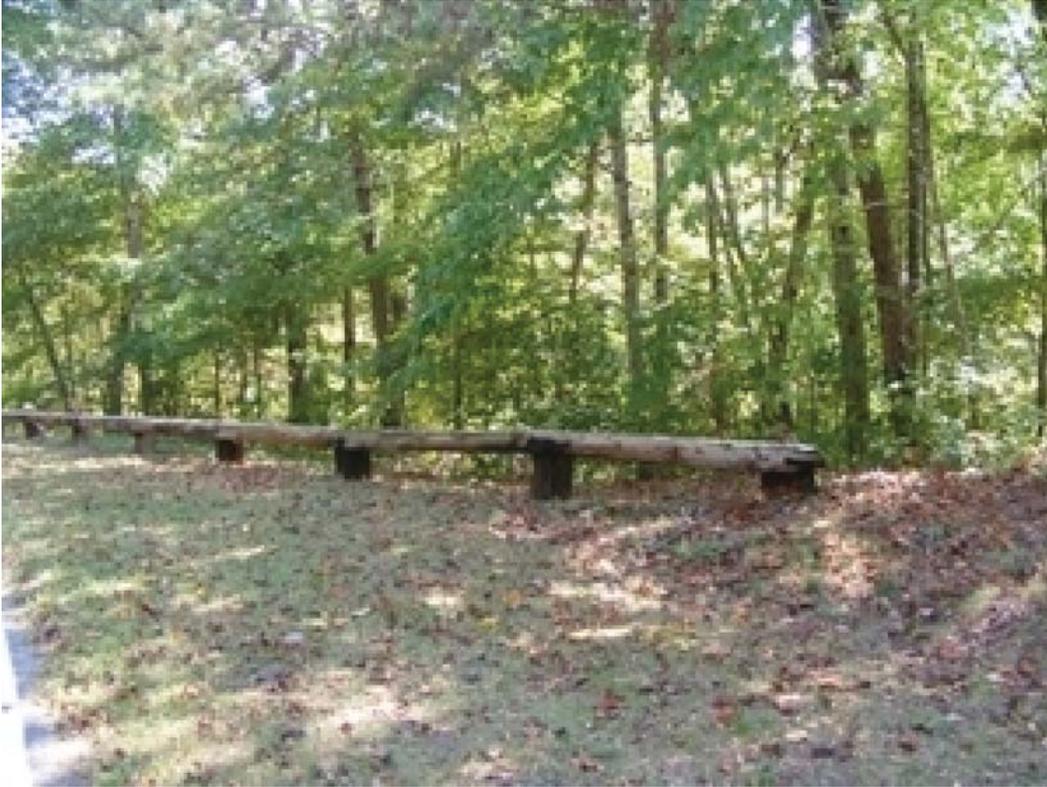
GRSM_0019_0.824_L_1.JPG

Barrier ID:	GRSM-0019-0.824-L				
Route Name:	LAKEVIEW DRIVE EAST				
Inspection Date:	09/21/2010	Barrier Rating:	39.50		
Barrier Description					
Type:	OTHER: TIMBER RAIL ON TIMBER POSTS	Barrier Function:	TRAFFIC		
Barrier Material:	LOG/TIMBER/WOOD	Post Material:	WOOD		
Blockout Type:	N/A	Length (ft.):	522		
Speed Limit (MPH):	35	Placement with Respect to Road:	OUTSIDE OF CURVE		
Hazard Behind Barrier:	MEDIUM				
Barrier Crashworthiness					
Appropriate Test Level:	TL-2	Barrier Test Level:	NCW	Is Barrier Crashworthy?:	NO
Beg. End Trtmt Type:	NONE	Is Beg. End Trtmt Crashworthy?:	N/A	Approach Transition Type:	NONE
Ending End Trtmt Type:	NONE	Ending End Trtmt Crashworthy?:	N/A		
Average Measurements					
Design Height (In.):	24	Width (In.):	0.0	Post Spacing (In.):	119.5
Height (In.):	21.2	Lateral Offset (In.):	98.5	Road Grade (%):	4.40
Physical Condition					
Barrier	Alignment and Height:	The alignment is deflected more than 12 in for 30 ft due to an impact. The height is 2-4 in below the 24 in design height.

Breaking and Cracking:	Ending end severely broken due to impact with two broken rails and broken posts. There were a total of 17 broken/cracked posts.			
	Missing Elements:	1 missing rail observed.			
	Corrosion and Weathering:	Moderate corrosion and weathering observed.			
End Treatments	Alignment and Height:				
	Breaking and Cracking:				
	Missing Elements:				
	Corrosion and Weathering:

Repair Action:	REPAIR	FMSS Work Type:	DEFERRED MAINTENANCE	Repair Cost:	\$4318
Brief Workorder:	Replace 30 feet of rail and 17 posts.				
Workorder:	Replace Rail at \$25- per -Lin. Ft. for 30 LF = \$750. Replace 30 feet of broken/missing rails. Replace Post at \$100- per -Each for 17 Post(s) = \$1700. 17 severely weathered with holes in the tops. Low Speed Traffic Control at \$1475- per -Day for 1 Day(s) = \$1475.

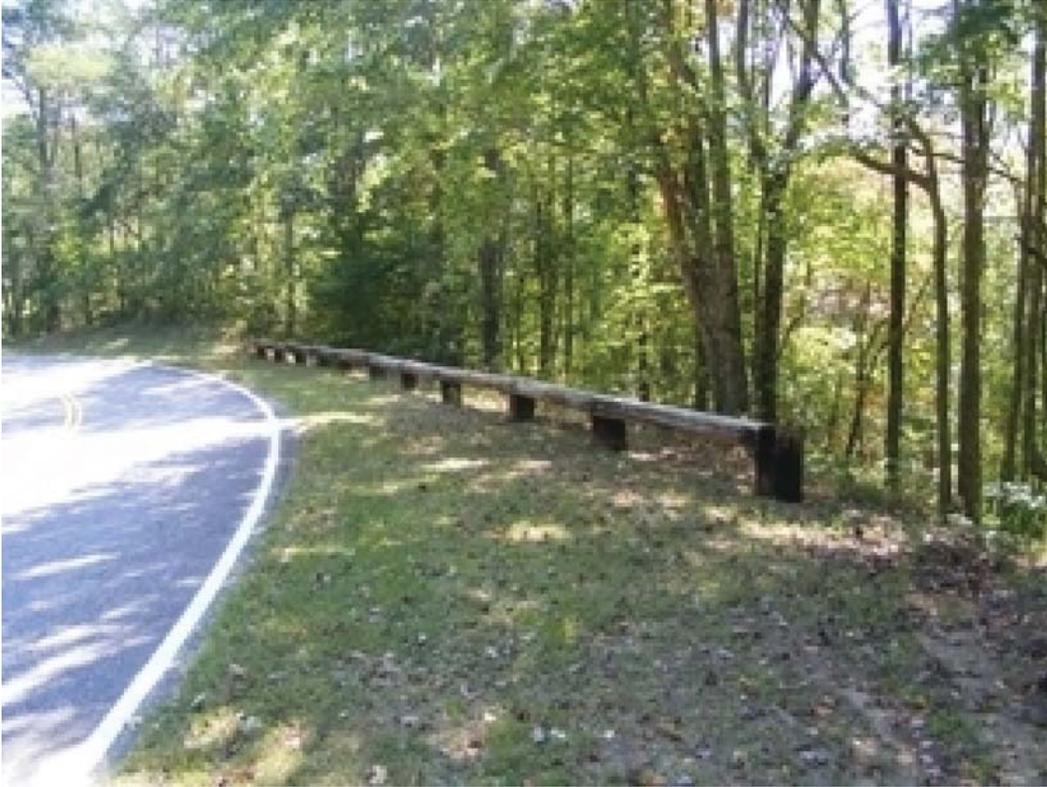
GRSM_0019_0.940_L_1.JPG

Barrier ID:	GRSM-0019-0.940-L				
Route Name:	LAKEVIEW DRIVE EAST				
Inspection Date:	09/21/2010	Barrier Rating:	36.50		
Barrier Description					
Type:	OTHER: TIMBER RAIL ON TIMBER POSTS	Barrier Function:	TRAFFIC		
Barrier Material:	LOG/TIMBER/WOOD	Post Material:	WOOD		
Blockout Type:	N/A	Length (ft.):	115		
Speed Limit (MPH):	35	Placement with Respect to Road:	OUTSIDE OF CURVE		
Hazard Behind Barrier:	MEDIUM				
Barrier Crashworthiness					
Appropriate Test Level:	TL-2	Barrier Test Level:	NCW	Is Barrier Crashworthy?:	NO
Beg. End Trtmt Type:	NONE	Is Beg. End Trtmt Crashworthy?:	N/A	Approach Transition Type:	NONE
Ending End Trtmt Type:	NONE	Ending End Trtmt Crashworthy?:	N/A		
Average Measurements					
Design Height (In.):	24	Width (In.):	0.0	Post Spacing (In.):	121.0
Height (In.):	22.2	Lateral Offset (In.):	110.3	Road Grade (%):	5.40
Physical Condition					
Barrier	Alignment and Height:	The barrier alignment is off by 6 - 12 in in 2 different places for a total of 20 ft. The height is 1-2 inches below the 24 in design height.

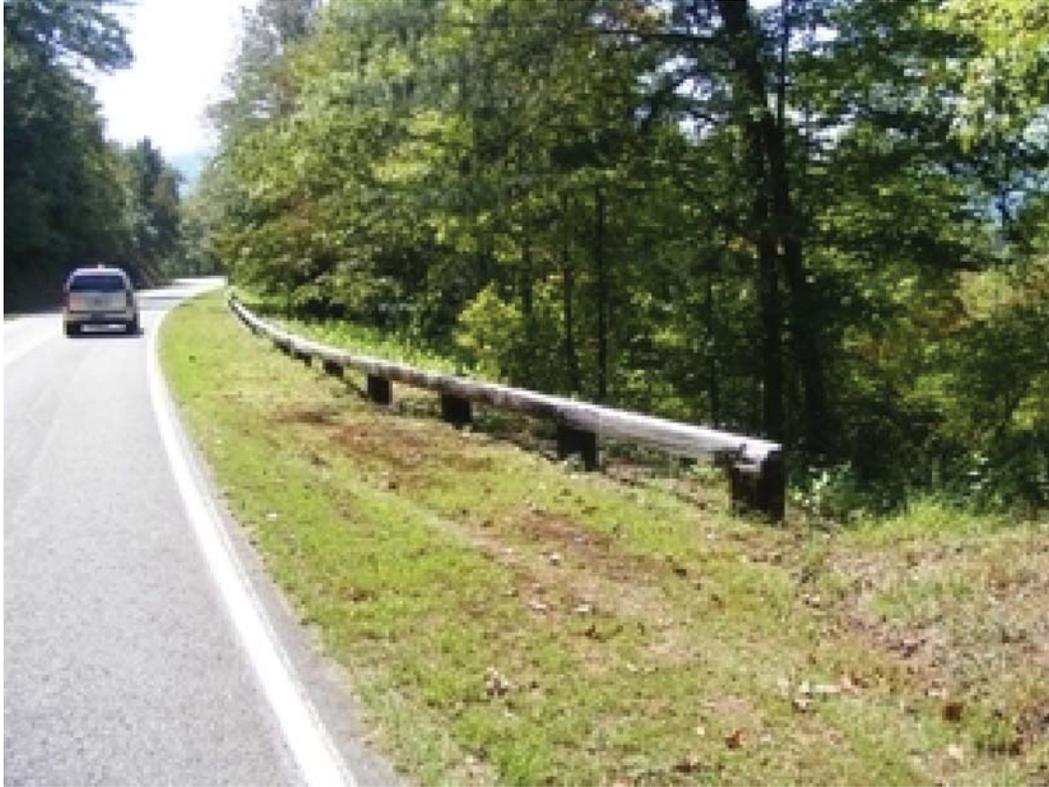
GRSM_0019_0.992_L_1.JPG

Barrier ID:	GRSM-0019-0.992-L				
Route Name:	LAKEVIEW DRIVE EAST				
Inspection Date:	09/21/2010	Barrier Rating:	33.70		
Barrier Description					
Type:	OTHER: TIMBER RAIL ON TIMBER POSTS	Barrier Function:	TRAFFIC		
Barrier Material:	LOG/TIMBER/WOOD	Post Material:	WOOD		
Blockout Type:	N/A	Length (ft.):	491		
Speed Limit (MPH):	35	Placement with Respect to Road:	INSIDE OF CURVE		
Hazard Behind Barrier:	MEDIUM				
Barrier Crashworthiness					
Appropriate Test Level:	TL-2	Barrier Test Level:	NCW	Is Barrier Crashworthy?:	NO
Beg. End Trtmt Type:	NONE	Is Beg. End Trtmt Crashworthy?:	N/A	Approach Transition Type:	NONE
Ending End Trtmt Type:	NONE	Ending End Trtmt Crashworthy?:	N/A		
Average Measurements					
Design Height (In.):	24	Width (In.):	0.0	Post Spacing (In.):	120.3
Height (In.):	21.6	Lateral Offset (In.):	101.0	Road Grade (%):	3.40
Physical Condition					
Barrier	Alignment and Height:	The alignment showed no deviation the height is 2-3 in below the design height of 24 in.

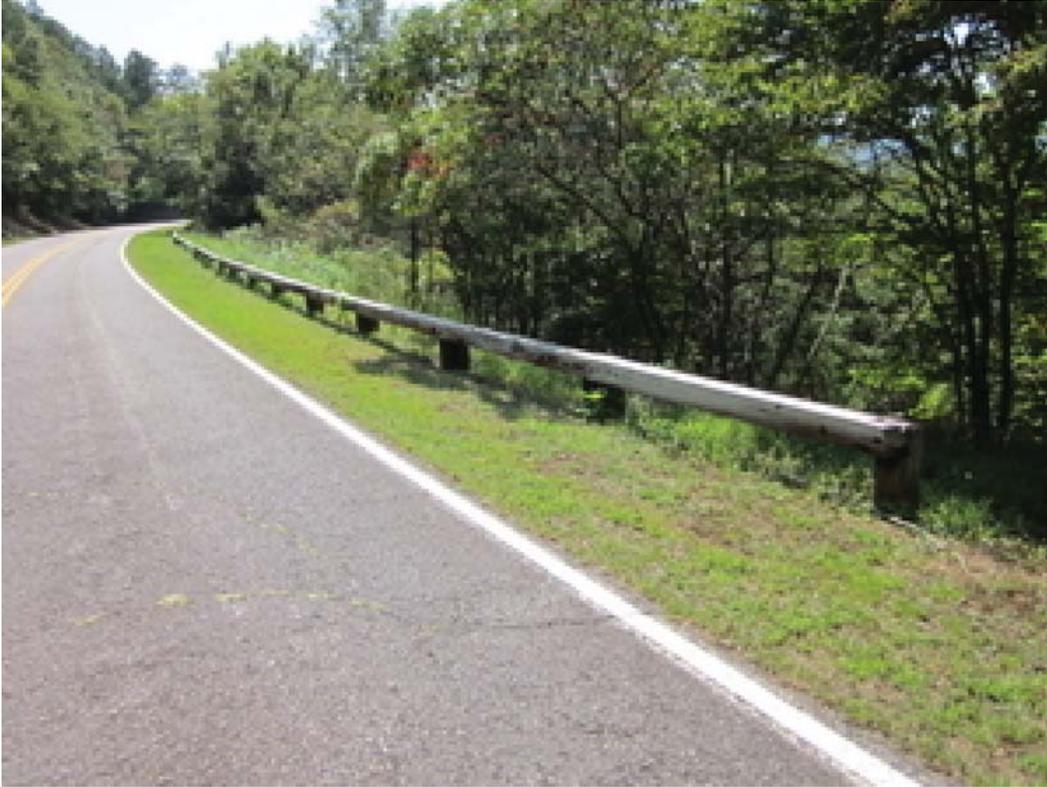
GRSM_0019_1.104_L_1.JPG

Barrier ID:	GRSM-0019-1.104-L				
Route Name:	LAKEVIEW DRIVE EAST				
Inspection Date:	09/21/2010	Barrier Rating:	28.30		
Barrier Description					
Type:	OTHER: TIMBER RAIL ON TIMBER POSTS	Barrier Function:	TRAFFIC		
Barrier Material:	LOG/TIMBER/WOOD	Post Material:	WOOD		
Blockout Type:	N/A	Length (ft.):	238		
Speed Limit (MPH):	35	Placement with Respect to Road:	INSIDE OF CURVE		
Hazard Behind Barrier:	HIGH				
Barrier Crashworthiness					
Appropriate Test Level:	TL-2	Barrier Test Level:	NCW	Is Barrier Crashworthy?:	NO
Beg. End Trtmt Type:	NONE	Is Beg. End Trtmt Crashworthy?:	N/A	Approach Transition Type:	NONE
Ending End Trtmt Type:	NONE	Ending End Trtmt Crashworthy?:	N/A		
Average Measurements					
Design Height (In.):	24	Width (In.):	0.0	Post Spacing (In.):	120.0
Height (In.):	22.2	Lateral Offset (In.):	98.6	Road Grade (%):	2.80
Physical Condition					
Barrier	Alignment and Height:	Alignment has no deviation and 135 ft was 1-3 in below the 24 in design height.

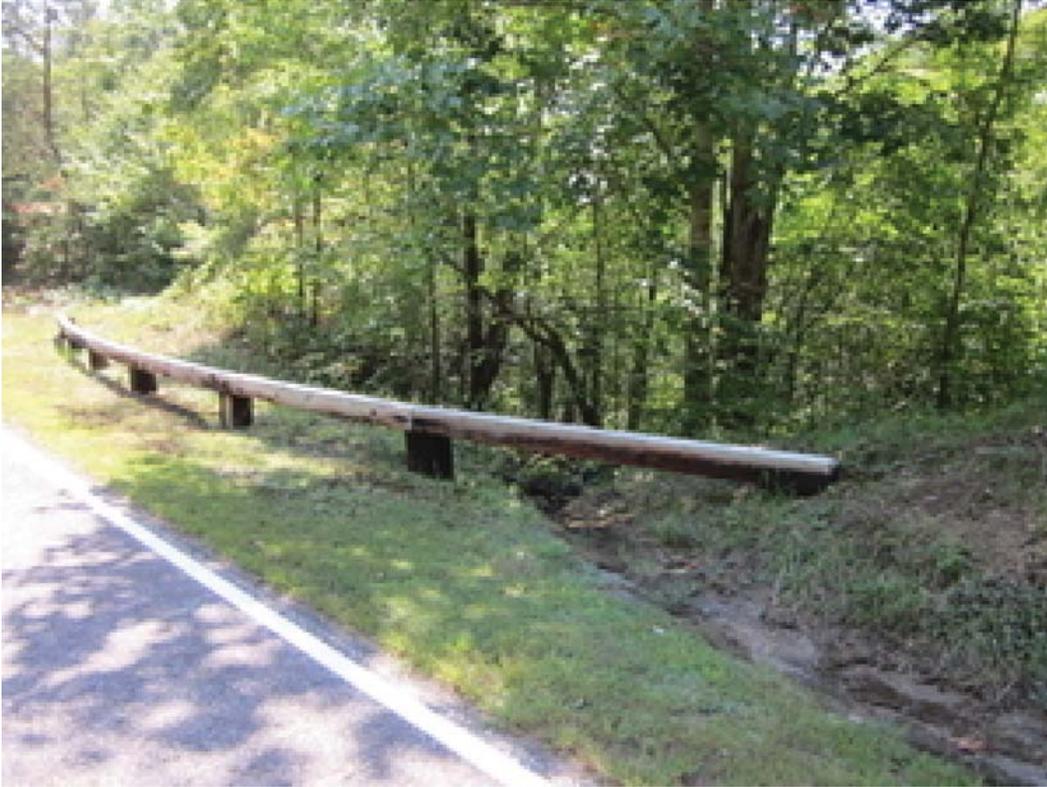
GRSM_0019_1.203_L_1.JPG

Barrier ID:	GRSM-0019-1.203-L				
Route Name:	LAKEVIEW DRIVE EAST				
Inspection Date:	09/21/2010	Barrier Rating:	25.30		
Barrier Description					
Type:	OTHER: TIMBER RAIL ON TIMBER POSTS	Barrier Function:	TRAFFIC		
Barrier Material:	LOG/TIMBER/WOOD	Post Material:	WOOD		
Blockout Type:	N/A	Length (ft.):	61		
Speed Limit (MPH):	35	Placement with Respect to Road:	TANGENT		
Hazard Behind Barrier:	HIGH				
Barrier Crashworthiness					
Appropriate Test Level:	TL-2	Barrier Test Level:	NCW	Is Barrier Crashworthy?:	NO
Beg. End Trtmt Type:	NONE	Is Beg. End Trtmt Crashworthy?:	N/A	Approach Transition Type:	NONE
Ending End Trtmt Type:	NONE	Ending End Trtmt Crashworthy?:	N/A		
Average Measurements					
Design Height (In.):	24	Width (In.):	0.0	Post Spacing (In.):	119.6
Height (In.):	21.7	Lateral Offset (In.):	88.0	Road Grade (%):	3.30
Physical Condition					
Barrier	Alignment and Height:	Alignment has no deviation and the height is 2-3 in below the 24 in design height.

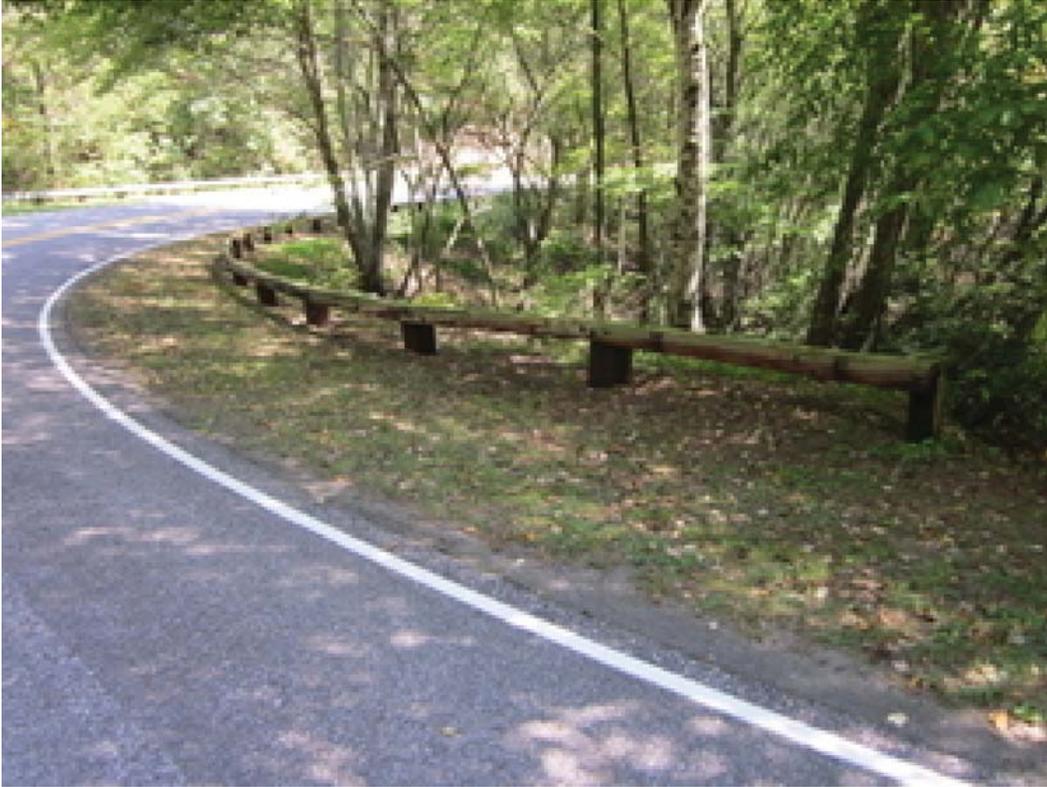
GRSM_0019_1.265_L_1.JPG

Barrier ID:	GRSM-0019-1.265-L				
Route Name:	LAKEVIEW DRIVE EAST				
Inspection Date:	09/21/2010	Barrier Rating:	33.70		
Barrier Description					
Type:	OTHER: TIMBER RAIL ON TIMBER POSTS	Barrier Function:	TRAFFIC		
Barrier Material:	LOG/TIMBER/WOOD	Post Material:	WOOD		
Blockout Type:	N/A	Length (ft.):	253		
Speed Limit (MPH):	35	Placement with Respect to Road:	INSIDE OF CURVE		
Hazard Behind Barrier:	MEDIUM				
Barrier Crashworthiness					
Appropriate Test Level:	TL-2	Barrier Test Level:	NCW	Is Barrier Crashworthy?:	NO
Beg. End Trtmt Type:	NONE	Is Beg. End Trtmt Crashworthy?:	N/A	Approach Transition Type:	NONE
Ending End Trtmt Type:	NONE	Ending End Trtmt Crashworthy?:	N/A		
Average Measurements					
Design Height (In.):	24	Width (In.):	0.0	Post Spacing (In.):	119.3
Height (In.):	20.6	Lateral Offset (In.):	95.0	Road Grade (%):	3.40
Physical Condition					
Barrier	Alignment and Height:	Alignment has no deviation and the height is 2-4 in below the 24 in design height.

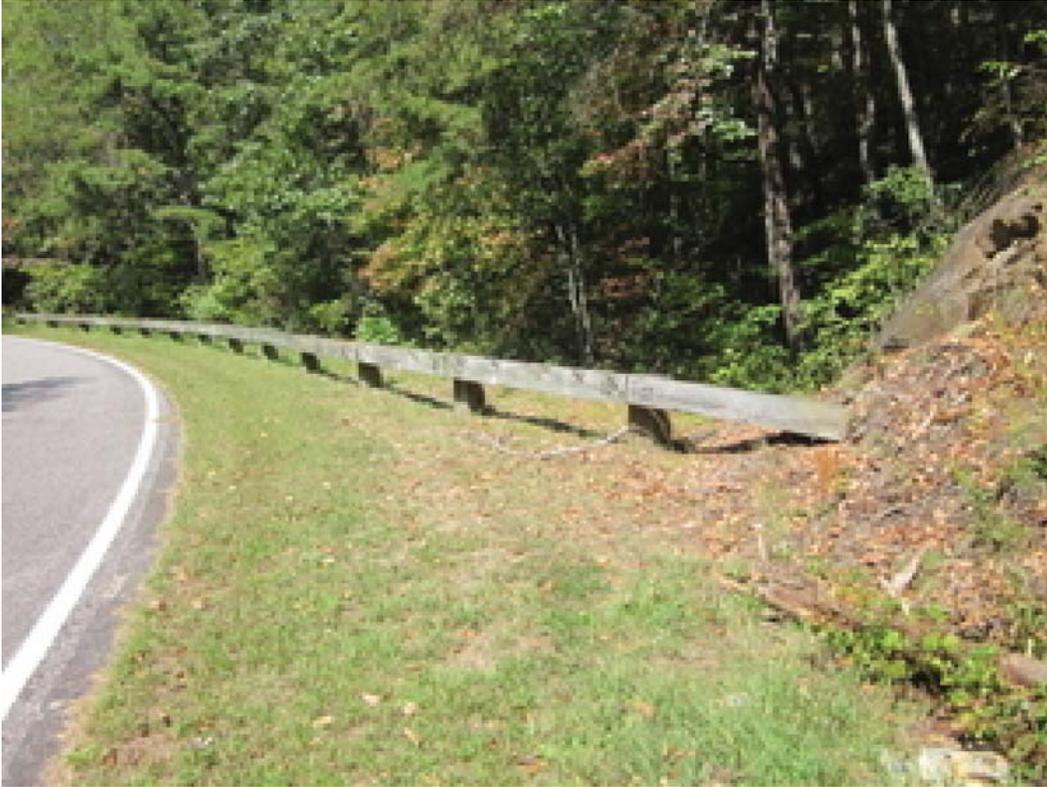
GRSM_0019_1.271_R_1.JPG

Barrier ID:	GRSM-0019-1.271-R				
Route Name:	LAKEVIEW DRIVE EAST				
Inspection Date:	09/21/2010	Barrier Rating:	25.10		
Barrier Description					
Type:	STEEL-BACKED TIMBER WITHOUT BLOCKOUT	Barrier Function:	TRAFFIC		
Barrier Material:	STEEL-BACKED TIMBER/LOG	Post Material:	WOOD		
Blockout Type:	N/A	Length (ft.):	267		
Speed Limit (MPH):	35	Placement with Respect to Road:	OUTSIDE OF CURVE		
Hazard Behind Barrier:	MEDIUM				
Barrier Crashworthiness					
Appropriate Test Level:	TL-2	Barrier Test Level:	TL-2	Is Barrier Crashworthy?:	YES
Beg. End Trtmt Type:	SBT/LOG BURIED	Is Beg. End Trtmt Crashworthy?:	YES	Approach Transition Type:	NONE
Ending End Trtmt Type:	SBT/LOG FLARED	Ending End Trtmt Crashworthy?:	NO		
Average Measurements					
Design Height (In.):	27	Width (In.):	0.0	Post Spacing (In.):	120.3
Height (In.):	27.6	Lateral Offset (In.):	91.6	Road Grade (%):	4.20
Physical Condition					
Barrier	Alignment and Height:	Alignment has no deviation and the height is within 1 in of the 27 in design height.

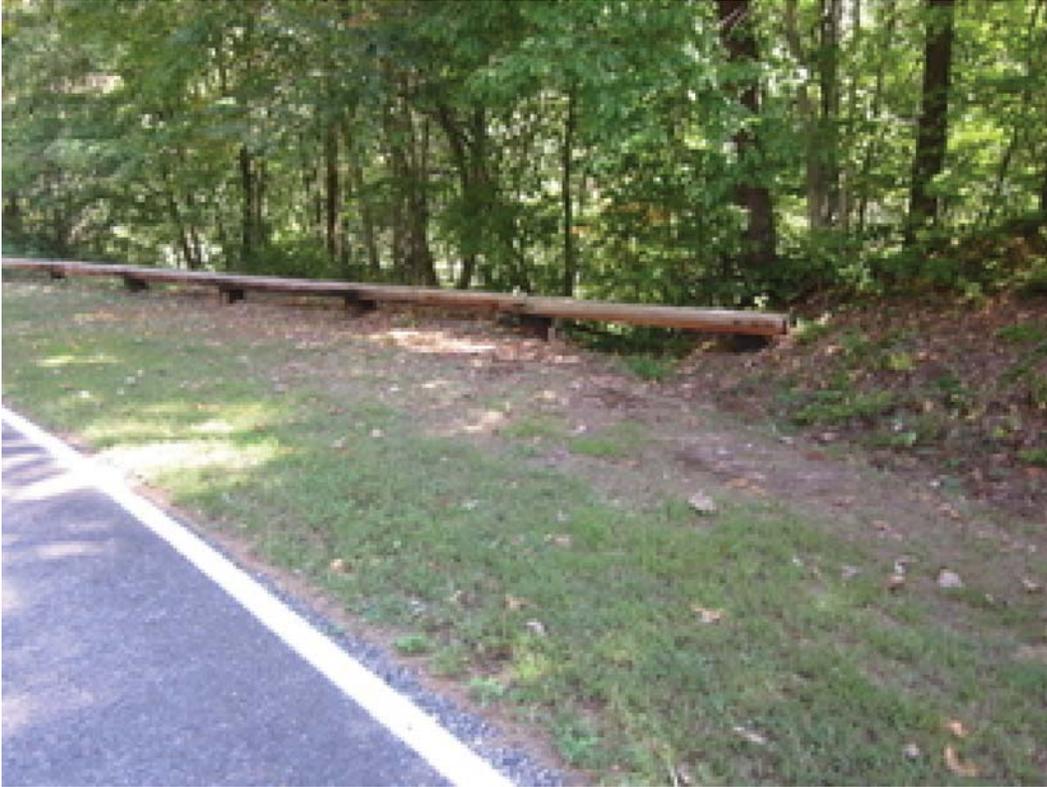
GRSM_0019_1.424_L_1.JPG

Barrier ID:	GRSM-0019-1.424-L				
Route Name:	LAKEVIEW DRIVE EAST				
Inspection Date:	09/21/2010	Barrier Rating:	32.20		
Barrier Description					
Type:	OTHER: TIMBER RAIL ON TIMBER POSTS	Barrier Function:	TRAFFIC		
Barrier Material:	LOG/TIMBER/WOOD	Post Material:	WOOD		
Blockout Type:	N/A	Length (ft.):	89		
Speed Limit (MPH):	35	Placement with Respect to Road:	OUTSIDE OF CURVE		
Hazard Behind Barrier:	MEDIUM				
Barrier Crashworthiness					
Appropriate Test Level:	TL-2	Barrier Test Level:	NCW	Is Barrier Crashworthy?:	NO
Beg. End Trtmt Type:	NONE	Is Beg. End Trtmt Crashworthy?:	N/A	Approach Transition Type:	NONE
Ending End Trtmt Type:	NONE	Ending End Trtmt Crashworthy?:	N/A		
Average Measurements					
Design Height (In.):	24	Width (In.):	0.0	Post Spacing (In.):	119.6
Height (In.):	20.7	Lateral Offset (In.):	170.6	Road Grade (%):	5.80
Physical Condition					
Barrier	Alignment and Height:	Alignment has no deviation and the height is 2-4 in below the 24 in design height.

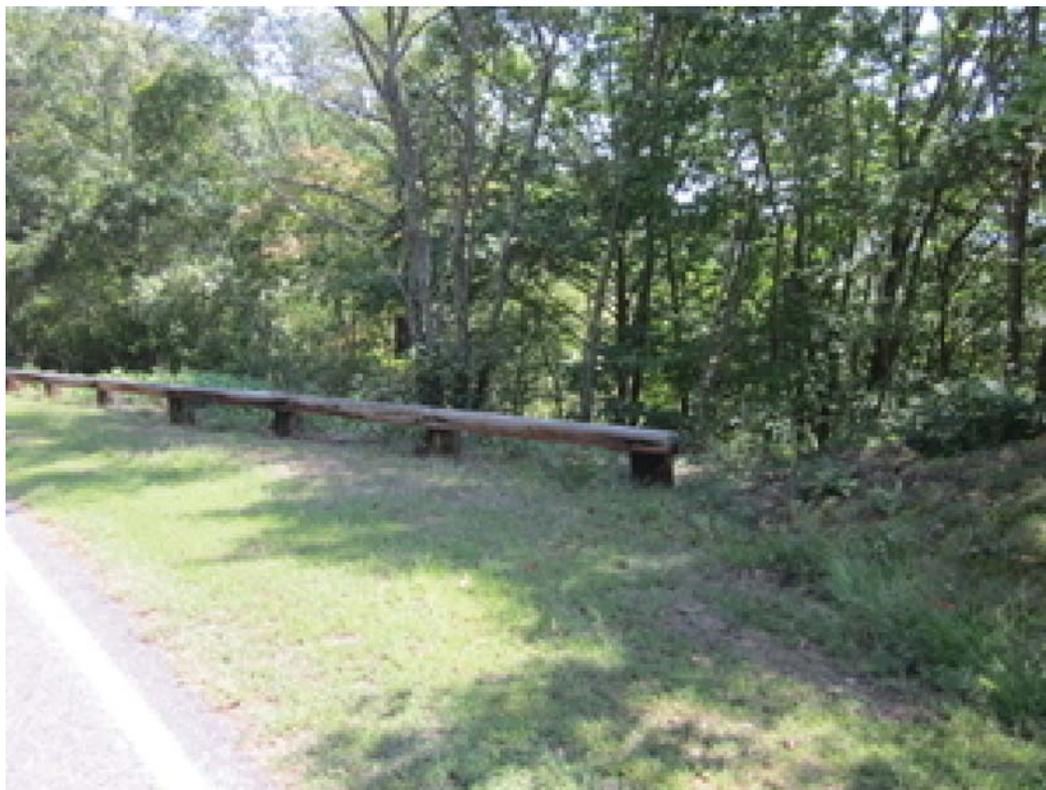
GRSM_0019_1.475_L_1.JPG

Barrier ID:	GRSM-0019-1.475-L				
Route Name:	LAKEVIEW DRIVE EAST				
Inspection Date:	09/21/2010	Barrier Rating:	36.50		
Barrier Description					
Type:	OTHER: TIMBER RAIL ON TIMBER POSTS	Barrier Function:	TRAFFIC		
Barrier Material:	LOG/TIMBER/WOOD	Post Material:	WOOD		
Blockout Type:	N/A	Length (ft.):	89		
Speed Limit (MPH):	35	Placement with Respect to Road:	OUTSIDE OF CURVE		
Hazard Behind Barrier:	MEDIUM				
Barrier Crashworthiness					
Appropriate Test Level:	TL-2	Barrier Test Level:	NCW	Is Barrier Crashworthy?:	NO
Beg. End Trtmt Type:	NONE	Is Beg. End Trtmt Crashworthy?:	N/A	Approach Transition Type:	NONE
Ending End Trtmt Type:	NONE	Ending End Trtmt Crashworthy?:	N/A		
Average Measurements					
Design Height (In.):	24	Width (In.):	0.0	Post Spacing (In.):	120.3
Height (In.):	22.6	Lateral Offset (In.):	132.0	Road Grade (%):	6.00
Physical Condition					
Barrier	Alignment and Height:	Alignment has no deviation and 60 ft is 1-2 in below the 24 in design height.

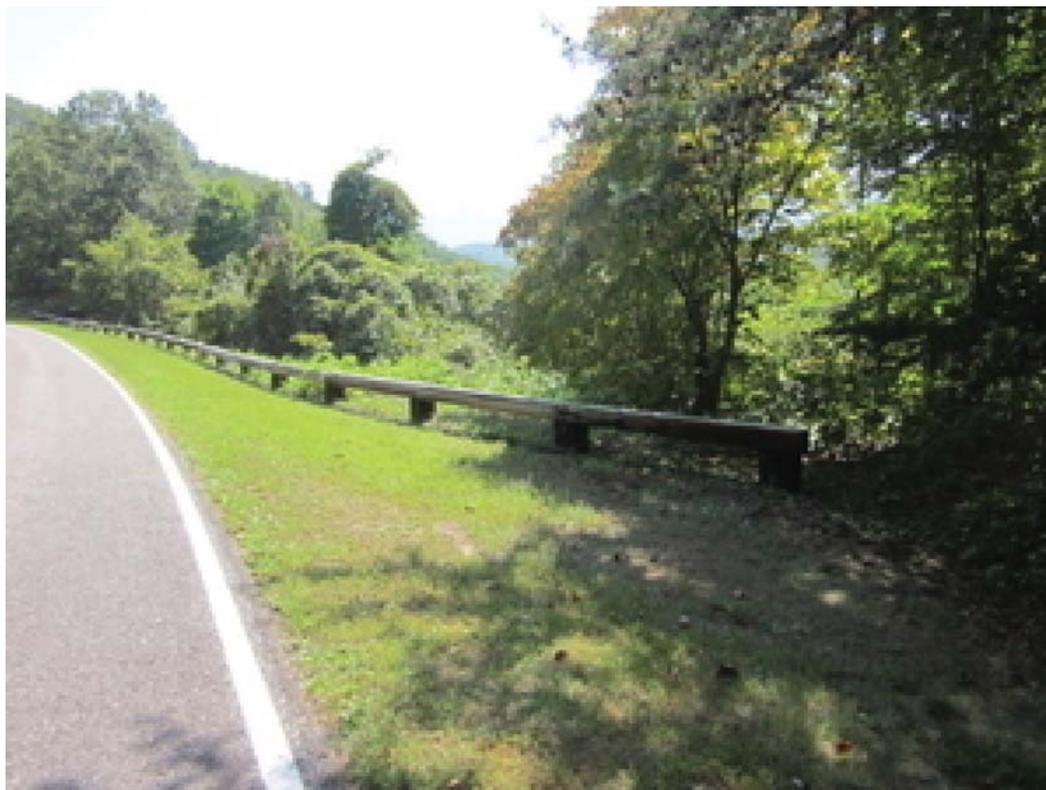
GRSM_0019_1.514_L_1.JPG

Barrier ID:	GRSM-0019-1.514-L				
Route Name:	LAKEVIEW DRIVE EAST				
Inspection Date:	09/21/2010	Barrier Rating:	38.40		
Barrier Description					
Type:	OTHER: TIMBER RAIL ON TIMBER POSTS	Barrier Function:	TRAFFIC		
Barrier Material:	LOG/TIMBER/WOOD	Post Material:	WOOD		
Blockout Type:	N/A	Length (ft.):	240		
Speed Limit (MPH):	35	Placement with Respect to Road:	OUTSIDE OF CURVE		
Hazard Behind Barrier:	HIGH				
Barrier Crashworthiness					
Appropriate Test Level:	TL-2	Barrier Test Level:	NCW	Is Barrier Crashworthy?:	NO
Beg. End Trtmt Type:	NONE	Is Beg. End Trtmt Crashworthy?:	N/A	Approach Transition Type:	NONE
Ending End Trtmt Type:	NONE	Ending End Trtmt Crashworthy?:	N/A		
Average Measurements					
Design Height (In.):	24	Width (In.):	0.0	Post Spacing (In.):	120.0
Height (In.):	21.0	Lateral Offset (In.):	98.3	Road Grade (%):	3.10
Physical Condition					
Barrier	Alignment and Height:	Alignment has no deviation and the height is 2-4 in below the 24 in design height.

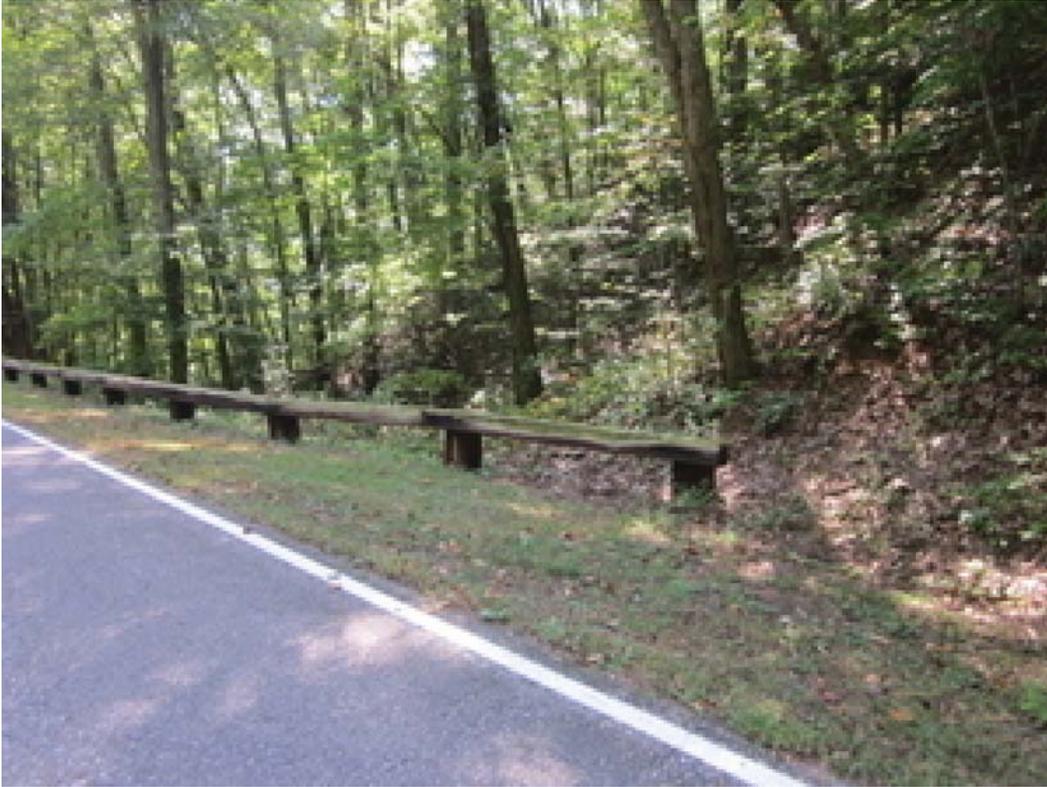
GRSM_0019_1.633_L_1.JPG

Barrier ID:	GRSM-0019-1.633-L				
Route Name:	LAKEVIEW DRIVE EAST				
Inspection Date:	09/21/2010	Barrier Rating:	31.20		
Barrier Description					
Type:	OTHER: TIMBER RAIL ON TIMBER POSTS	Barrier Function:	TRAFFIC		
Barrier Material:	LOG/TIMBER/WOOD	Post Material:	WOOD		
Blockout Type:	N/A	Length (ft.):	530		
Speed Limit (MPH):	35	Placement with Respect to Road:	INSIDE OF CURVE		
Hazard Behind Barrier:	HIGH				
Barrier Crashworthiness					
Appropriate Test Level:	TL-2	Barrier Test Level:	NCW	Is Barrier Crashworthy?:	NO
Beg. End Trtmt Type:	NONE	Is Beg. End Trtmt Crashworthy?:	N/A	Approach Transition Type:	NONE
Ending End Trtmt Type:	NONE	Ending End Trtmt Crashworthy?:	N/A		
Average Measurements					
Design Height (In.):	24	Width (In.):	0.0	Post Spacing (In.):	119.3
Height (In.):	22.2	Lateral Offset (In.):	92.0	Road Grade (%):	2.10
Physical Condition					
Barrier	Alignment and Height:	Alignment shows no deviation and the height is 1-3 in below the 24 in design height.

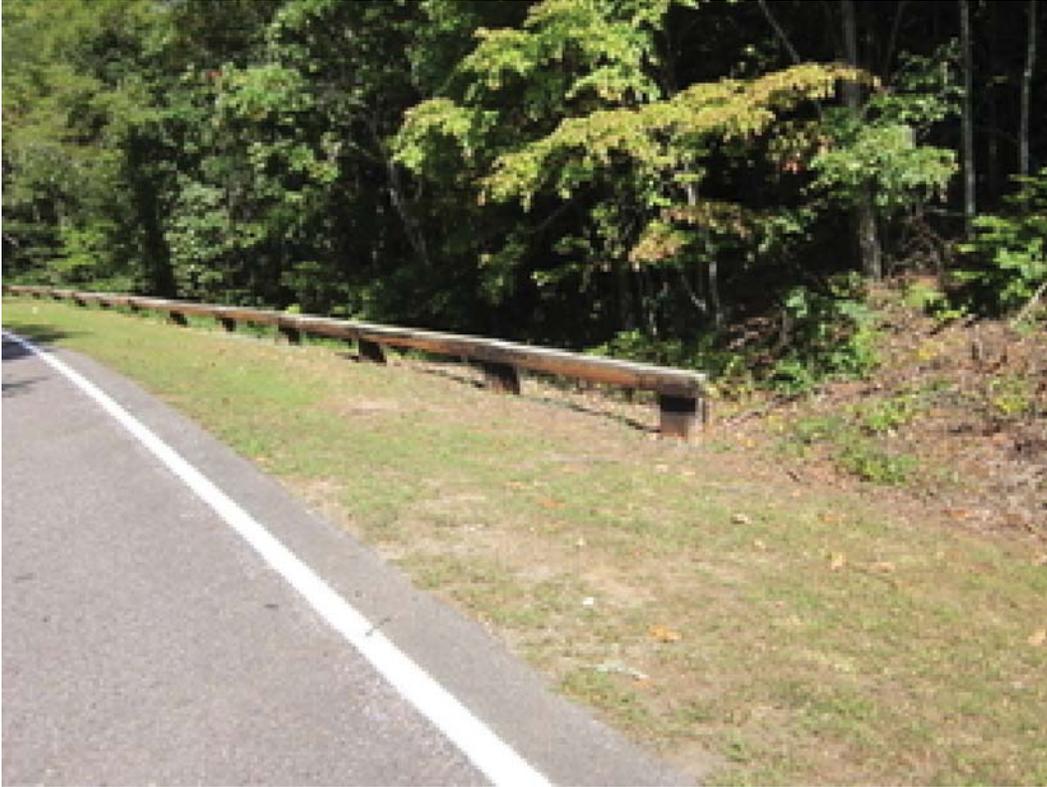
GRSM_0019_1.680_R_1.JPG

Barrier ID:	GRSM-0019-1.680-R				
Route Name:	LAKEVIEW DRIVE EAST				
Inspection Date:	09/21/2010	Barrier Rating:	28.20		
Barrier Description					
Type:	OTHER: TIMBER RAIL ON TIMBER POSTS	Barrier Function:	TRAFFIC		
Barrier Material:	LOG/TIMBER/WOOD	Post Material:	WOOD		
Blockout Type:	N/A	Length (ft.):	288		
Speed Limit (MPH):	35	Placement with Respect to Road:	BOTH INSIDE AND OUTSIDE		
Hazard Behind Barrier:	LOW				
Barrier Crashworthiness					
Appropriate Test Level:	TL-2	Barrier Test Level:	NCW	Is Barrier Crashworthy?:	NO
Beg. End Trtmt Type:	NONE	Is Beg. End Trtmt Crashworthy?:	N/A	Approach Transition Type:	NONE
Ending End Trtmt Type:	NONE	Ending End Trtmt Crashworthy?:	N/A		
Average Measurements					
Design Height (In.):	24	Width (In.):	0.0	Post Spacing (In.):	120.0
Height (In.):	23.0	Lateral Offset (In.):	114.3	Road Grade (%):	1.90
Physical Condition					
Barrier	Alignment and Height:	Alignment has no deviation and 100 ft is 1-2 in below the 24 in design height.

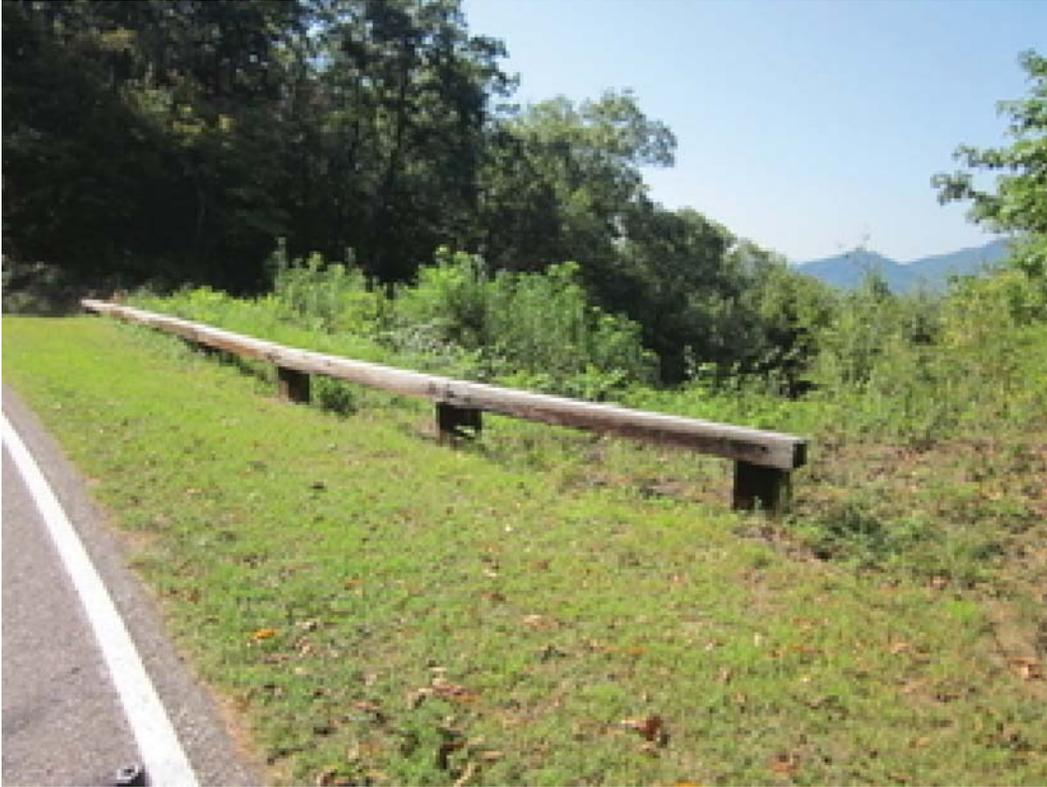
GRSM_0019_1.797_L_1.JPG

Barrier ID:	GRSM-0019-1.797-L				
Route Name:	LAKEVIEW DRIVE EAST				
Inspection Date:	09/21/2010	Barrier Rating:	34.00		
Barrier Description					
Type:	OTHER: TIMBER RAIL ON TIMBER POSTS	Barrier Function:	TRAFFIC		
Barrier Material:	LOG/TIMBER/WOOD	Post Material:	WOOD		
Blockout Type:	N/A	Length (ft.):	81		
Speed Limit (MPH):	35	Placement with Respect to Road:	OUTSIDE OF CURVE		
Hazard Behind Barrier:	HIGH				
Barrier Crashworthiness					
Appropriate Test Level:	TL-2	Barrier Test Level:	NCW	Is Barrier Crashworthy?:	NO
Beg. End Trtmt Type:	NONE	Is Beg. End Trtmt Crashworthy?:	N/A	Approach Transition Type:	NONE
Ending End Trtmt Type:	NONE	Ending End Trtmt Crashworthy?:	N/A		
Average Measurements					
Design Height (In.):	24	Width (In.):	0.0	Post Spacing (In.):	121.0
Height (In.):	21.2	Lateral Offset (In.):	118.6	Road Grade (%):	3.70
Physical Condition					
Barrier	Alignment and Height:	Alignment has no deviation and the height is 1-4 in below the 24 in design height.

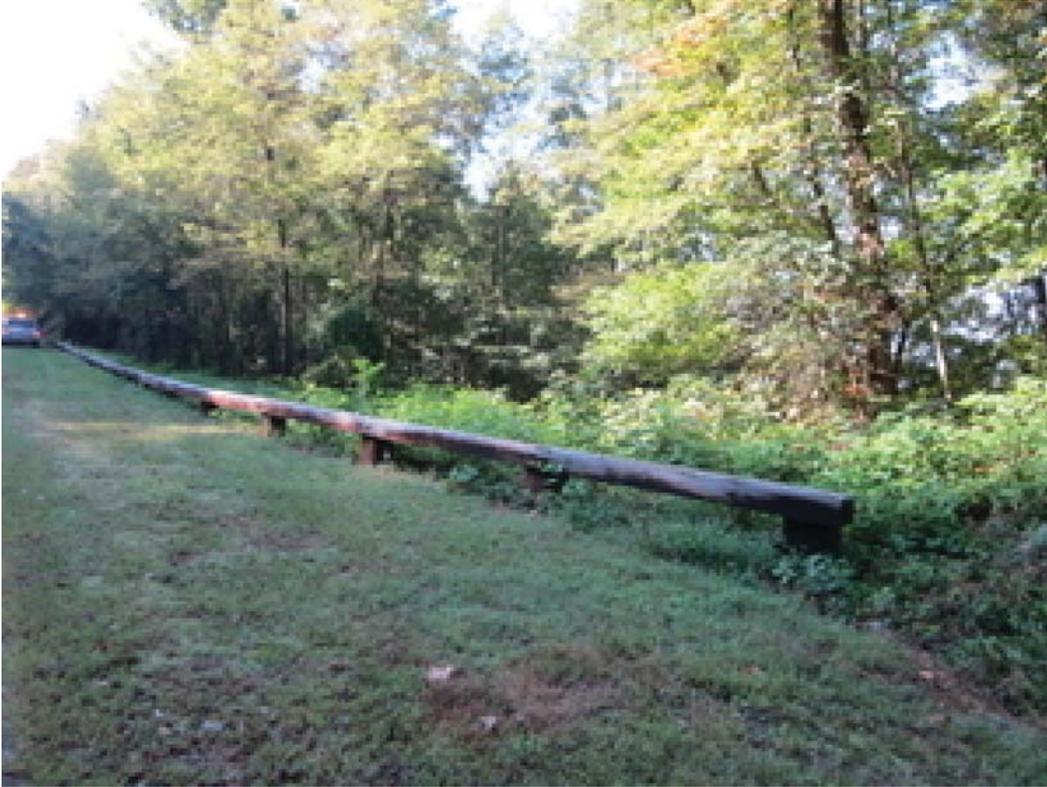
GRSM_0019_1.873_L_1.JPG

Barrier ID:	GRSM-0019-1.873-L				
Route Name:	LAKEVIEW DRIVE EAST				
Inspection Date:	09/21/2010	Barrier Rating:	19.20		
Barrier Description					
Type:	OTHER: TIMBER RAIL ON TIMBER POSTS	Barrier Function:	TRAFFIC		
Barrier Material:	LOG/TIMBER/WOOD	Post Material:	WOOD		
Blockout Type:	N/A	Length (ft.):	200		
Speed Limit (MPH):	35	Placement with Respect to Road:	TANGENT		
Hazard Behind Barrier:	MEDIUM				
Barrier Crashworthiness					
Appropriate Test Level:	TL-2	Barrier Test Level:	NCW	Is Barrier Crashworthy?:	NO
Beg. End Trtmt Type:	NONE	Is Beg. End Trtmt Crashworthy?:	N/A	Approach Transition Type:	NONE
Ending End Trtmt Type:	NONE	Ending End Trtmt Crashworthy?:	N/A		
Average Measurements					
Design Height (In.):	24	Width (In.):	0.0	Post Spacing (In.):	119.6
Height (In.):	22.0	Lateral Offset (In.):	123.6	Road Grade (%):	6.20
Physical Condition					
Barrier	Alignment and Height:	Alignment has no deviation and the 67 ft is 1-4 in below the 24 in design height.
