NPS Guardwall/Rail Inventory Program
Great Smoky Mountains National Park

Federal Highway Administration
Eastern Federal Lands Highway Division
Road Inventory Program (RIP)

Data Collection Date: September 2010
Report Date: December 2015

Great Smoky Mountains National Park in North Carolina and Tennessee

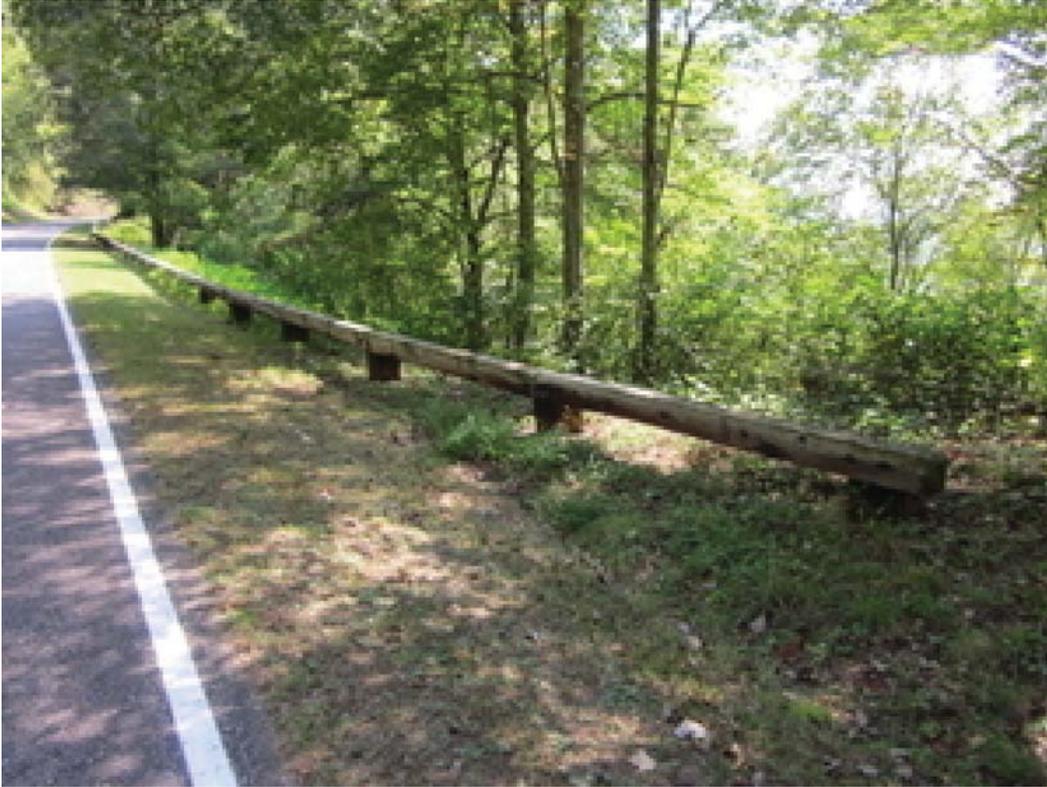
GRSM_0019_2.027_L_1.JPG

Barrier ID:	GRSM-0019-2.027-L				
Route Name:	LAKEVIEW DRIVE EAST				
Inspection Date:	09/21/2010	Barrier Rating:	31.20		
Barrier Description					
Type:	OTHER: TIMBER RAIL ON TIMBER POSTS	Barrier Function:	TRAFFIC		
Barrier Material:	LOG/TIMBER/WOOD	Post Material:	WOOD		
Blockout Type:	N/A	Length (ft.):	290		
Speed Limit (MPH):	35	Placement with Respect to Road:	INSIDE OF CURVE		
Hazard Behind Barrier:	HIGH				
Barrier Crashworthiness					
Appropriate Test Level:	TL-2	Barrier Test Level:	NCW	Is Barrier Crashworthy?:	NO
Beg. End Trtmt Type:	NONE	Is Beg. End Trtmt Crashworthy?:	N/A	Approach Transition Type:	NONE
Ending End Trtmt Type:	NONE	Ending End Trtmt Crashworthy?:	N/A		
Average Measurements					
Design Height (In.):	24	Width (In.):	0.0	Post Spacing (In.):	119.6
Height (In.):	22.0	Lateral Offset (In.):	93.6	Road Grade (%):	6.10
Physical Condition					
Barrier	Alignment and Height:	Alignment has no deviation and the height is 1-4 in below the 24 in design height.

Breaking and Cracking:	10 ft of rail broken in half due to tree that fell.			
	Missing Elements:	No missing elements observed.			
	Corrosion and Weathering:	No corrosion or weathering observed.			
End Treatments	Alignment and Height:				
	Breaking and Cracking:				
	Missing Elements:				
	Corrosion and Weathering:

Repair Action:	REPAIR	FMSS Work Type:	DEFERRED MAINTENANCE	Repair Cost:	\$5088
Brief Workorder:	Raise 290-ft of barrier up to 24-in design height and replace 10 feet of rail.				
Workorder:	Replace Rail at \$25- per -Lin. Ft. for 10 LF = \$250. Replace 10 feet of broken rail. Adjust Guardrail at \$10- per -Lin. Ft. for 290 LF = \$2900. Raise 290-ft of barrier up to 24-in design height. Low Speed Traffic Control at \$1475- per -Day for 1 Day(s) = \$1475.

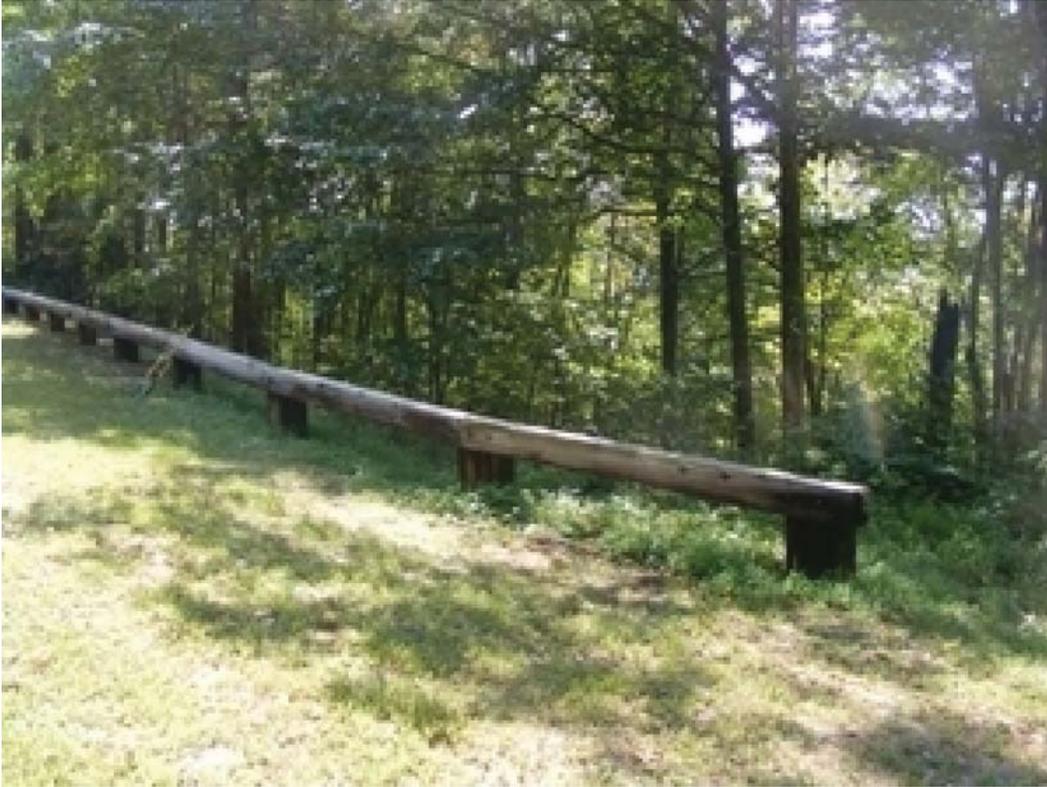
GRSM_0019_2.104_L_1.JPG

Barrier ID:	GRSM-0019-2.104-L				
Route Name:	LAKEVIEW DRIVE EAST				
Inspection Date:	09/17/2010	Barrier Rating:	29.70		
Barrier Description					
Type:	OTHER: TIMBER RAIL ON TIMBER POSTS	Barrier Function:	TRAFFIC		
Barrier Material:	LOG/TIMBER/WOOD	Post Material:	WOOD		
Blockout Type:	N/A	Length (ft.):	121		
Speed Limit (MPH):	35	Placement with Respect to Road:	OUTSIDE OF CURVE		
Hazard Behind Barrier:	HIGH				
Barrier Crashworthiness					
Appropriate Test Level:	TL-2	Barrier Test Level:	NCW	Is Barrier Crashworthy?:	NO
Beg. End Trtmt Type:	NONE	Is Beg. End Trtmt Crashworthy?:	N/A	Approach Transition Type:	NONE
Ending End Trtmt Type:	NONE	Ending End Trtmt Crashworthy?:	N/A		
Average Measurements					
Design Height (In.):	24	Width (In.):	0.0	Post Spacing (In.):	119.3
Height (In.):	22.6	Lateral Offset (In.):	110.0	Road Grade (%):	5.10
Physical Condition					
Barrier	Alignment and Height:	The alignment has no deviation and 50 ft is 1-2 in below the 24 in design height.

Breaking and Cracking:	6 posts rotted.			
	Missing Elements:	No missing elements observed.			
	Corrosion and Weathering:	Moderate corrosion and weathering observed on all posts and rails.			
End Treatments	Alignment and Height:				
	Breaking and Cracking:				
	Missing Elements:				
	Corrosion and Weathering:

Repair Action:	REPAIR	FMSS Work Type:	DEFERRED MAINTENANCE	Repair Cost:	\$2833
Brief Workorder:	Raise 50-ft of barrier up to 24-in design height and replace 6 posts.				
Workorder:	Replace Post at \$100- per -Each for 6 Post(s) = \$600. Replace 6 rotted posts. Adjust Guardrail at \$10- per -Lin. Ft. for 50 LF = \$500. Raise 50-ft of barrier up to 24-in design height. Low Speed Traffic Control at \$1475- per -Day for 1 Day(s) = \$1475.

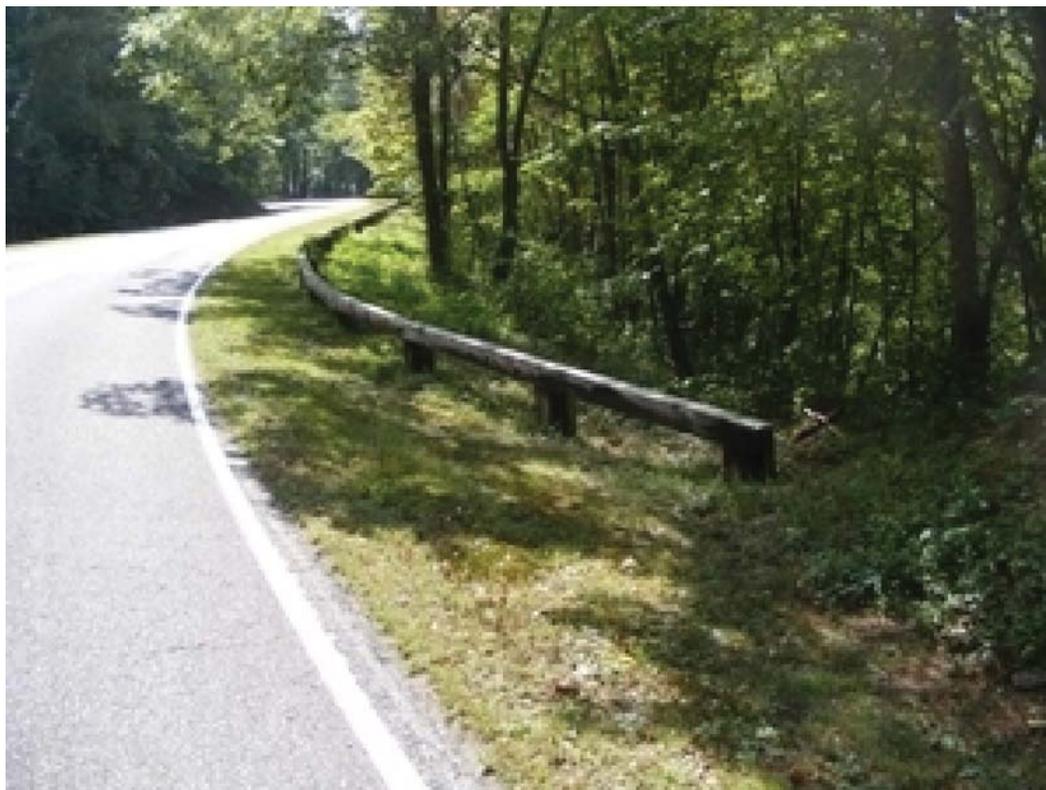
GRSM_0019_2.133_L_1.JPG

Barrier ID:	GRSM-0019-2.133-L				
Route Name:	LAKEVIEW DRIVE EAST				
Inspection Date:	09/17/2010	Barrier Rating:	35.20		
Barrier Description					
Type:	OTHER: TIMBER RAIL ON TIMBER POSTS	Barrier Function:	TRAFFIC		
Barrier Material:	LOG/TIMBER/WOOD	Post Material:	WOOD		
Blockout Type:	N/A	Length (ft.):	342		
Speed Limit (MPH):	35	Placement with Respect to Road:	BOTH INSIDE AND OUTSIDE		
Hazard Behind Barrier:	MEDIUM				
Barrier Crashworthiness					
Appropriate Test Level:	TL-2	Barrier Test Level:	NCW	Is Barrier Crashworthy?:	NO
Beg. End Trtmt Type:	NONE	Is Beg. End Trtmt Crashworthy?:	N/A	Approach Transition Type:	NONE
Ending End Trtmt Type:	NONE	Ending End Trtmt Crashworthy?:	N/A		
Average Measurements					
Design Height (In.):	24	Width (In.):	0.0	Post Spacing (In.):	117.5
Height (In.):	21.2	Lateral Offset (In.):	100.3	Road Grade (%):	6.60
Physical Condition					
Barrier	Alignment and Height:	The alignment has no deviation and the height is 2-4 in below the 24 in design height.

Breaking and Cracking:	13 broken/rotted posts.			
	Missing Elements:	No missing elements observed.			
	Corrosion and Weathering:	Moderate corrosion and weathering observed on all posts and rails.			
End Treatments	Alignment and Height:				
	Breaking and Cracking:				
	Missing Elements:				
	Corrosion and Weathering:

Repair Action:	REPAIR	FMSS Work Type:	DEFERRED MAINTENANCE	Repair Cost:	\$6815
Brief Workorder:	Raise 342-ft of barrier up to 24-in design height and replace 13 posts.				
Workorder:	Replace Post at \$100- per -Each for 13 Post(s) = \$1300. Replace 13 posts. Adjust Guardrail at \$10- per -Lin. Ft. for 342 LF = \$3420. Raise 342-ft of barrier up to 24-in design height. Low Speed Traffic Control at \$1475- per -Day for 1 Day(s) = \$1475.

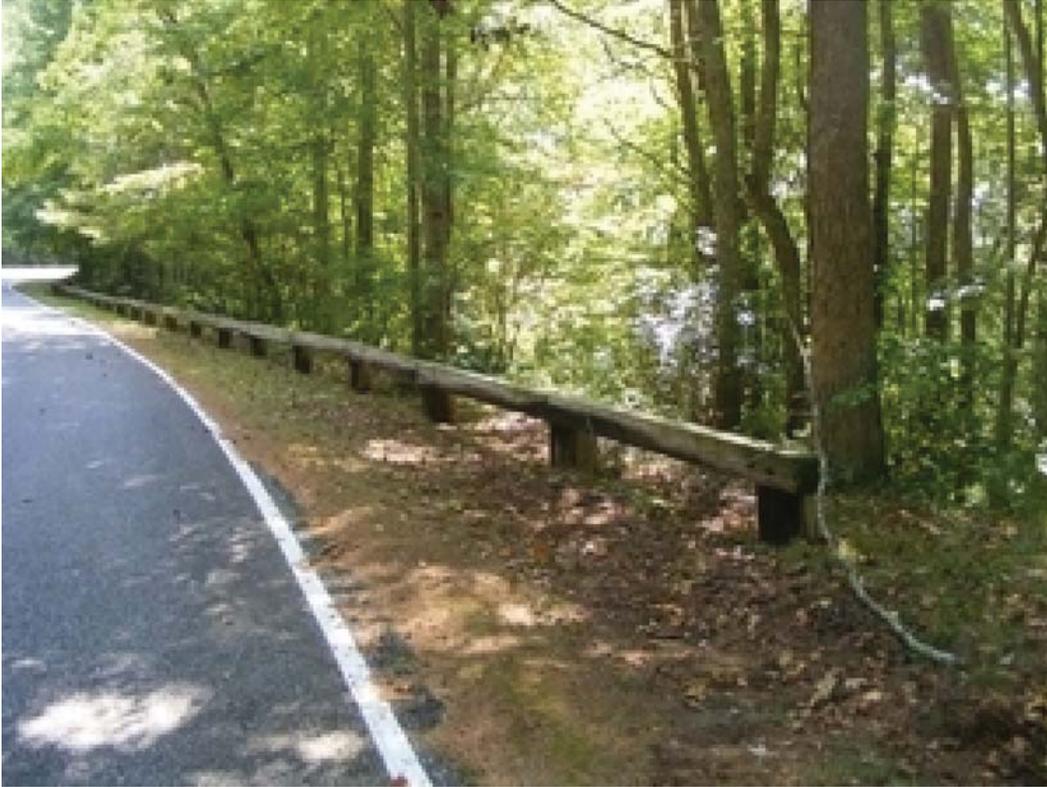
GRSM_0019_2.214_L_1.JPG

Barrier ID:	GRSM-0019-2.214-L				
Route Name:	LAKEVIEW DRIVE EAST				
Inspection Date:	09/17/2010	Barrier Rating:	37.00		
Barrier Description					
Type:	OTHER: TIMBER RAIL ON TIMBER POSTS	Barrier Function:	TRAFFIC		
Barrier Material:	LOG/TIMBER/WOOD	Post Material:	WOOD		
Blockout Type:	N/A	Length (ft.):	281		
Speed Limit (MPH):	35	Placement with Respect to Road:	OUTSIDE OF CURVE		
Hazard Behind Barrier:	HIGH				
Barrier Crashworthiness					
Appropriate Test Level:	TL-2	Barrier Test Level:	NCW	Is Barrier Crashworthy?:	NO
Beg. End Trtmt Type:	NONE	Is Beg. End Trtmt Crashworthy?:	N/A	Approach Transition Type:	NONE
Ending End Trtmt Type:	NONE	Ending End Trtmt Crashworthy?:	N/A		
Average Measurements					
Design Height (In.):	24	Width (In.):	0.0	Post Spacing (In.):	119.5
Height (In.):	23.2	Lateral Offset (In.):	79.0	Road Grade (%):	5.00
Physical Condition					
Barrier	Alignment and Height:	The alignment has no deviation and the height is within 1 in of the 24 in design height.

Breaking and Cracking:	No breaking of barrier minor cracking of 1/4 to 1/2 in wide observed.			
	Missing Elements:	No missing elements observed.			
	Corrosion and Weathering:	Moderate corrosion and weathering observed on all posts and rails. 12 posts rotten and hollowed out on top.			
End Treatments	Alignment and Height:				
	Breaking and Cracking:				
	Missing Elements:				
	Corrosion and Weathering:

Repair Action:	REPAIR	FMSS Work Type:	DEFERRED MAINTENANCE	Repair Cost:	\$2942
Brief Workorder:	Replace 12 posts.				
Workorder:	Replace Post at \$100- per -Each for 12 Post(s) = \$1200. Posts rotten and hollowed out. Low Speed Traffic Control at \$1475- per -Day for 1 Day(s) = \$1475.

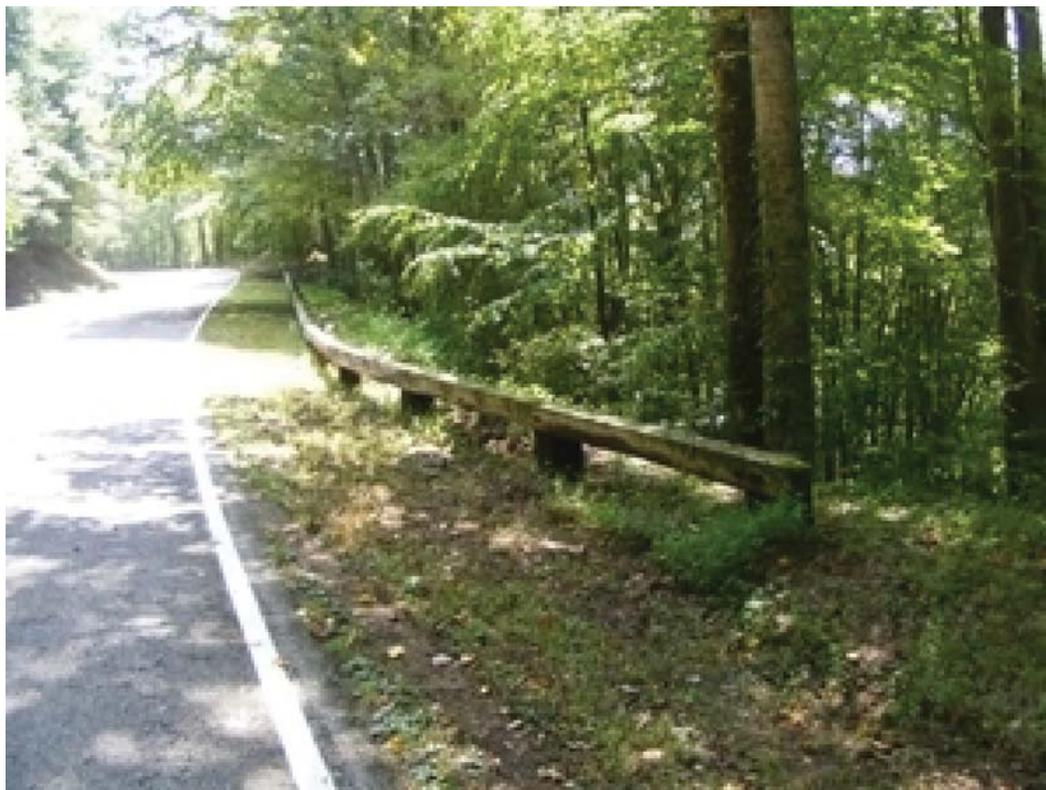
GRSM_0019_2.304_L_1.JPG

Barrier ID:	GRSM-0019-2.304-L				
Route Name:	LAKEVIEW DRIVE EAST				
Inspection Date:	09/17/2010	Barrier Rating:	25.50		
Barrier Description					
Type:	OTHER: TIMBER RAIL ON TIMBER POSTS	Barrier Function:	TRAFFIC		
Barrier Material:	LOG/TIMBER/WOOD	Post Material:	WOOD		
Blockout Type:	N/A	Length (ft.):	230		
Speed Limit (MPH):	35	Placement with Respect to Road:	TANGENT		
Hazard Behind Barrier:	HIGH				
Barrier Crashworthiness					
Appropriate Test Level:	TL-2	Barrier Test Level:	NCW	Is Barrier Crashworthy?:	NO
Beg. End Trtmt Type:	NONE	Is Beg. End Trtmt Crashworthy?:	N/A	Approach Transition Type:	NONE
Ending End Trtmt Type:	NONE	Ending End Trtmt Crashworthy?:	N/A		
Average Measurements					
Design Height (In.):	24	Width (In.):	0.0	Post Spacing (In.):	118.5
Height (In.):	22.2	Lateral Offset (In.):	89.0	Road Grade (%):	6.00
Physical Condition					
Barrier	Alignment and Height:	The alignment has no deviation and the height is 1-2 in below the 24 in design height.

Breaking and Cracking:	No breaking or cracking observed.			
	Missing Elements:	No missing elements observed.			
	Corrosion and Weathering:	Weathering observed on all posts and rails. 15 posts observed as rotten and hollow.			
End Treatments	Alignment and Height:				
	Breaking and Cracking:				
	Missing Elements:				
	Corrosion and Weathering:

Repair Action:	REPLACE	FMSS Work Type:	CAPITAL IMPROVEMENT	Repair Cost:	\$27995
Brief Workorder:	Remove and replace existing timber guardrail with Steel-backed timber without blockouts guardrail and 2 Steel-backed timber flared end treatments.				
Workorder:	Remove Guardrail at \$10- per -Lin. Ft. for 230 LF = \$2300. Steel-Backed Timber w/o Blockout at \$60- per -Lin. Ft. for 170 LF = \$10200. Steel-backed timber / Log Flared at \$5000- per -Each for 2 Unit(s) = \$10000. Low Speed Traffic Control at \$1475- per -Day for 2 Day(s) = \$2950. 1 day removal 1 day installation

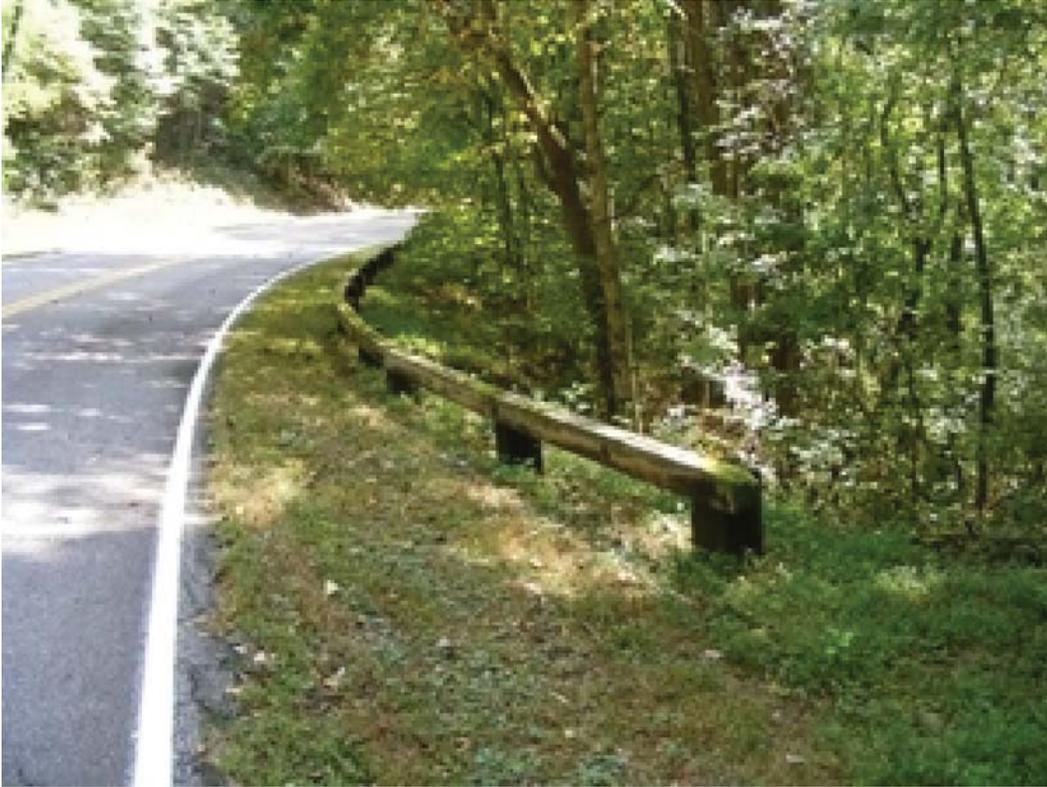
GRSM_0019_2.368_L_1.JPG

Barrier ID:	GRSM-0019-2.368-L				
Route Name:	LAKEVIEW DRIVE EAST				
Inspection Date:	09/17/2010	Barrier Rating:	30.80		
Barrier Description					
Type:	OTHER: TIMBER RAIL ON TIMBER POSTS	Barrier Function:	TRAFFIC		
Barrier Material:	LOG/TIMBER/WOOD	Post Material:	WOOD		
Blockout Type:	N/A	Length (ft.):	234		
Speed Limit (MPH):	35	Placement with Respect to Road:	INSIDE OF CURVE		
Hazard Behind Barrier:	MEDIUM				
Barrier Crashworthiness					
Appropriate Test Level:	TL-2	Barrier Test Level:	NCW	Is Barrier Crashworthy?:	NO
Beg. End Trtmt Type:	NONE	Is Beg. End Trtmt Crashworthy?:	N/A	Approach Transition Type:	NONE
Ending End Trtmt Type:	NONE	Ending End Trtmt Crashworthy?:	N/A		
Average Measurements					
Design Height (In.):	24	Width (In.):	0.0	Post Spacing (In.):	128.0
Height (In.):	21.2	Lateral Offset (In.):	75.0	Road Grade (%):	4.80
Physical Condition					
Barrier	Alignment and Height:	The alignment has no deviation and the height is 1-4 in below the 24 in design height.

Breaking and Cracking:	No breaking of barrier minor cracking of 1/4 to 1/2 in wide observed.			
	Missing Elements:	No missing elements observed.			
	Corrosion and Weathering:	Moderate corrosion and weathering observed on all posts and rails. 4 posts rotten and hollowed out on top.			
End Treatments	Alignment and Height:				
	Breaking and Cracking:				
	Missing Elements:				
	Corrosion and Weathering:

Repair Action:	REPAIR	FMSS Work Type:	DEFERRED MAINTENANCE	Repair Cost:	\$3014
Brief Workorder:	Raise 234-ft of barrier up to 24-in design height and replace 4 posts.				
Workorder:	Replace Post at \$100- per -Each for 4 Post(s) = \$400. Rotten and hollowed out on top. Adjust Guardrail at \$10- per -Lin. Ft. for 234 LF = \$2340. Raise 234-ft of barrier up to 24-in design height. Low Speed Traffic Control at \$1475- per -Day for 1 Day(s) = \$1475.

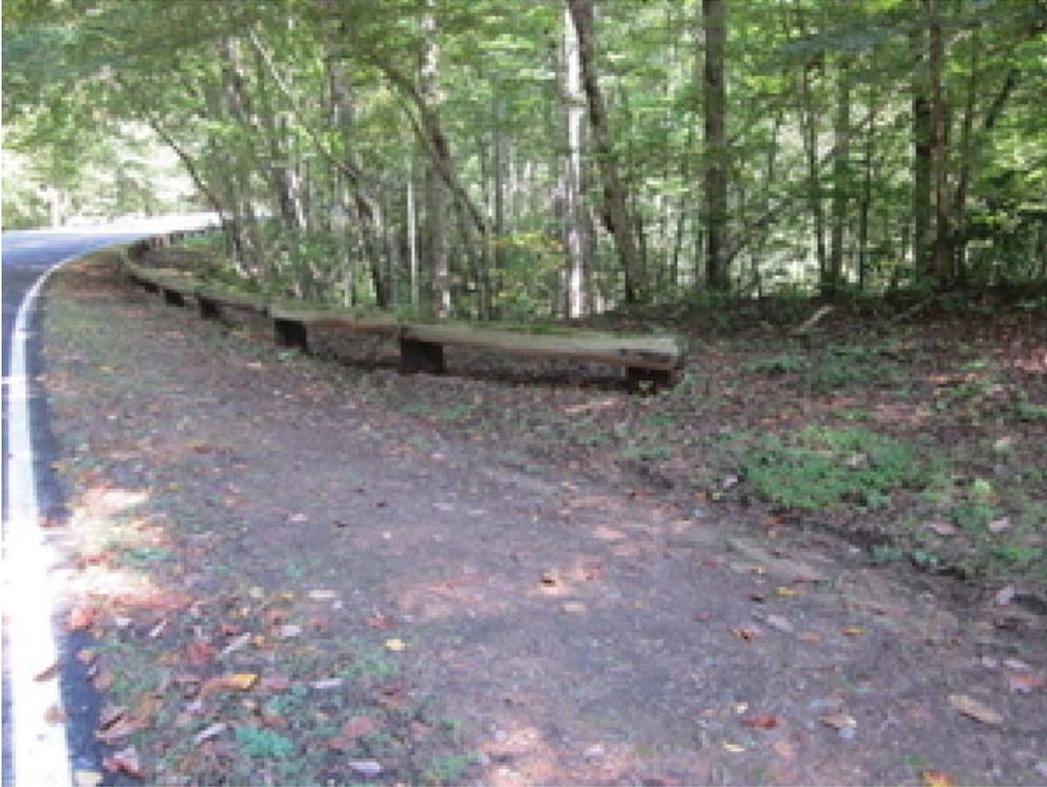
GRSM_0019_2.422_L_1.JPG

Barrier ID:	GRSM-0019-2.422-L				
Route Name:	LAKEVIEW DRIVE EAST				
Inspection Date:	09/17/2010	Barrier Rating:	39.40		
Barrier Description					
Type:	OTHER: TIMBER RAIL ON TIMBER POSTS	Barrier Function:	TRAFFIC		
Barrier Material:	LOG/TIMBER/WOOD	Post Material:	WOOD		
Blockout Type:	N/A	Length (ft.):	655		
Speed Limit (MPH):	35	Placement with Respect to Road:	OUTSIDE OF CURVE		
Hazard Behind Barrier:	MEDIUM				
Barrier Crashworthiness					
Appropriate Test Level:	TL-2	Barrier Test Level:	NCW	Is Barrier Crashworthy?:	NO
Beg. End Trtmt Type:	NONE	Is Beg. End Trtmt Crashworthy?:	N/A	Approach Transition Type:	NONE
Ending End Trtmt Type:	NONE	Ending End Trtmt Crashworthy?:	N/A		
Average Measurements					
Design Height (In.):	24	Width (In.):	0.0	Post Spacing (In.):	120.0
Height (In.):	21.7	Lateral Offset (In.):	73.1	Road Grade (%):	0.80
Physical Condition					
Barrier	Alignment and Height:	Alignment has no deviation and 555 ft is 1-4 in below the 24 in design height.

Breaking and Cracking:	No breaking or cracking observed.			
	Missing Elements:	No missing elements observed.			
	Corrosion and Weathering:	No corrosion or weathering observed.			
End Treatments	Alignment and Height:				
	Breaking and Cracking:				
	Missing Elements:				
	Corrosion and Weathering:

Repair Action:	REPAIR	FMSS Work Type:	DEFERRED MAINTENANCE	Repair Cost:	\$9378
Brief Workorder:	Raise 555-ft of barrier up to 24-in design height and replace 15 posts.				
Workorder:	Replace Post at \$100- per -Each for 15 Post(s) = \$1500. Adjust Guardrail at \$10- per -Lin. Ft. for 555 LF = \$5550. Raise 555-ft of barrier up to 24-in design height. Low Speed Traffic Control at \$1475- per -Day for 3 Day(s) = \$4425.

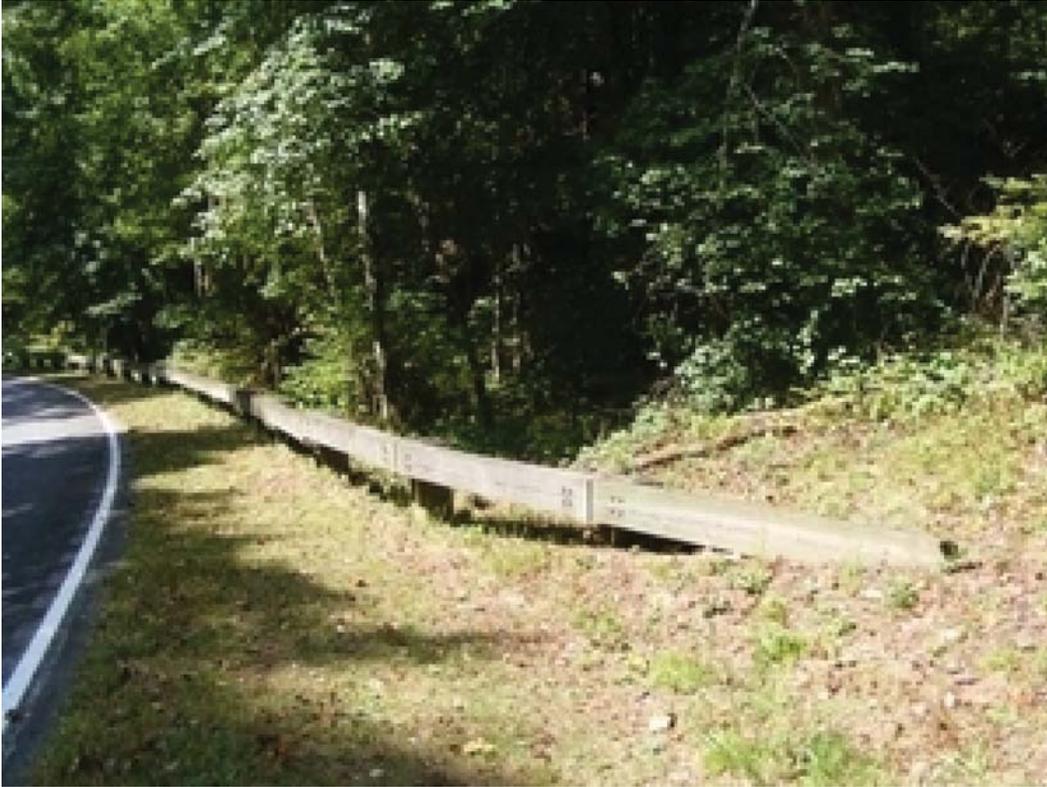
GRSM_0019_2.424_R_1.JPG

Barrier ID:	GRSM-0019-2.424-R				
Route Name:	LAKEVIEW DRIVE EAST				
Inspection Date:	09/17/2010	Barrier Rating:	25.10		
Barrier Description					
Type:	STEEL-BACKED TIMBER WITHOUT BLOCKOUT	Barrier Function:	TRAFFIC		
Barrier Material:	STEEL-BACKED TIMBER/LOG	Post Material:	WOOD		
Blockout Type:	N/A	Length (ft.):	278		
Speed Limit (MPH):	35	Placement with Respect to Road:	OUTSIDE OF CURVE		
Hazard Behind Barrier:	MEDIUM				
Barrier Crashworthiness					
Appropriate Test Level:	TL-2	Barrier Test Level:	TL-2	Is Barrier Crashworthy?:	YES
Beg. End Trtmt Type:	SBT/LOG BURIED	Is Beg. End Trtmt Crashworthy?:	YES	Approach Transition Type:	NONE
Ending End Trtmt Type:	SBT/LOG FLARED	Ending End Trtmt Crashworthy?:	NO		
Average Measurements					
Design Height (In.):	27	Width (In.):	0.0	Post Spacing (In.):	120.5
Height (In.):	26.6	Lateral Offset (In.):	71.3	Road Grade (%):	1.10
Physical Condition					
Barrier	Alignment and Height:	The barrier alignment has no deviation and the height is low by 2 in or less from the design height of 27 in for 82 LF.

Breaking and Cracking:	No breaking or cracking observed.			
	Missing Elements:	No missing elements observed.			
	Corrosion and Weathering:	No corrosion or weathering observed.			
End Treatments	Alignment and Height:	Alignment acceptable. Height is within 1 in of the 27-in design height.			
	Breaking and Cracking:	No breaking or cracking observed.			
	Missing Elements:	No missing elements observed.			
	Corrosion and Weathering:	No corrosion or weathering observed.

Repair Action:	REPAIR	FMSS Work Type:	DEFERRED MAINTENANCE	Repair Cost:	\$2524
Brief Workorder:	Raise 82 feet of barrier to the 27 inch design height.				
Workorder:	Adjust Guardrail at \$10- per -Lin. Ft. for 82 LF = \$820. Raise 82 feet of barrier to the 27 inch design height. Low Speed Traffic Control at \$1475- per -Day for 1 Day(s) = \$1475.

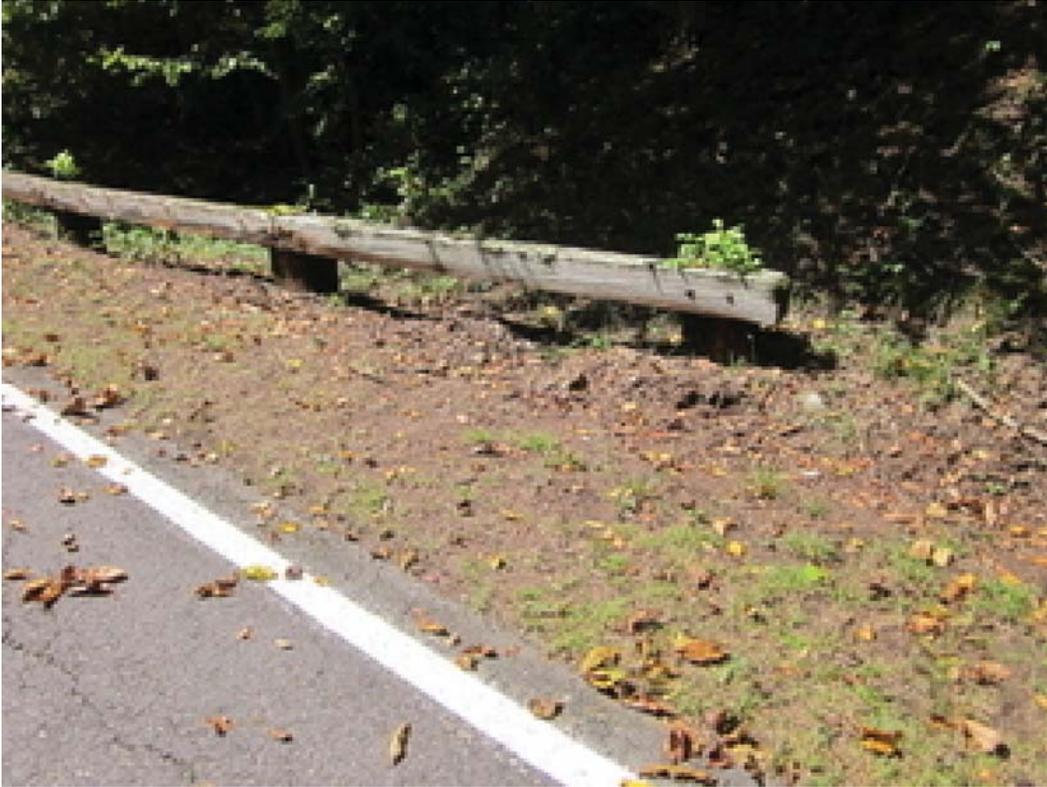
GRSM_0019_2.559_R_1.JPG

Barrier ID:	GRSM-0019-2.559-R				
Route Name:	LAKEVIEW DRIVE EAST				
Inspection Date:	09/17/2010	Barrier Rating:	16.70		
Barrier Description					
Type:	OTHER: TIMBER RAIL ON TIMBER POSTS	Barrier Function:	TRAFFIC		
Barrier Material:	LOG/TIMBER/WOOD	Post Material:	WOOD		
Blockout Type:	N/A	Length (ft.):	40		
Speed Limit (MPH):	35	Placement with Respect to Road:	TANGENT		
Hazard Behind Barrier:	LOW				
Barrier Crashworthiness					
Appropriate Test Level:	TL-2	Barrier Test Level:	NCW	Is Barrier Crashworthy?:	NO
Beg. End Trtmt Type:	NONE	Is Beg. End Trtmt Crashworthy?:	N/A	Approach Transition Type:	NONE
Ending End Trtmt Type:	NONE	Ending End Trtmt Crashworthy?:	N/A		
Average Measurements					
Design Height (In.):	24	Width (In.):	0.0	Post Spacing (In.):	123.0
Height (In.):	20.0	Lateral Offset (In.):	60.0	Road Grade (%):	2.80
Physical Condition					
Barrier	Alignment and Height:	Alignment has no deviation and the height is 2-4 in below the 24 in design height.

Breaking and Cracking:	No breaking or cracking observed.			
	Missing Elements:	No missing elements observed.			
	Corrosion and Weathering:	No corrosion or weathering observed.			
End Treatments	Alignment and Height:				
	Breaking and Cracking:				
	Missing Elements:				
	Corrosion and Weathering:

Repair Action:	REPAIR	FMSS Work Type:	DEFERRED MAINTENANCE	Repair Cost:	\$2063
Brief Workorder:	Raise 40-ft of barrier up to 24-in design height.				
Workorder:	Adjust Guardrail at \$10- per -Lin. Ft. for 40 LF = \$400. Raise 40-ft of barrier up to 24-in design height. Low Speed Traffic Control at \$1475- per -Day for 1 Day(s) = \$1475.

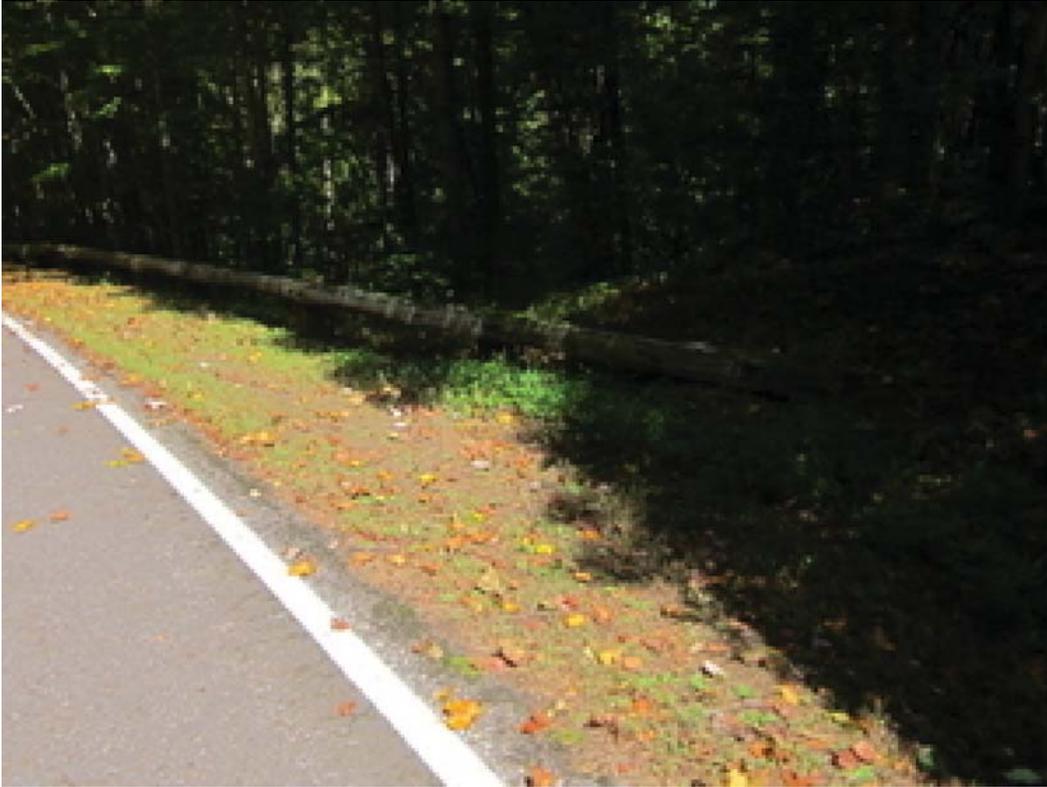
GRSM_0019_2.585_L_1.JPG

Barrier ID:	GRSM-0019-2.585-L				
Route Name:	LAKEVIEW DRIVE EAST				
Inspection Date:	09/17/2010	Barrier Rating:	55.00		
Barrier Description					
Type:	OTHER: TIMBER RAIL ON TIMBER POSTS	Barrier Function:	TRAFFIC		
Barrier Material:	LOG/TIMBER/WOOD	Post Material:	WOOD		
Blockout Type:	N/A	Length (ft.):	821		
Speed Limit (MPH):	35	Placement with Respect to Road:	TANGENT		
Hazard Behind Barrier:	MEDIUM				
Barrier Crashworthiness					
Appropriate Test Level:	TL-2	Barrier Test Level:	NCW	Is Barrier Crashworthy?:	NO
Beg. End Trtmt Type:	NONE	Is Beg. End Trtmt Crashworthy?:	N/A	Approach Transition Type:	NONE
Ending End Trtmt Type:	NONE	Ending End Trtmt Crashworthy?:	N/A		
Average Measurements					
Design Height (In.):	24	Width (In.):	0.0	Post Spacing (In.):	121.3
Height (In.):	19.5	Lateral Offset (In.):	84.8	Road Grade (%):	10.00
Physical Condition					
Barrier	Alignment and Height:	Alignment has no deviation and the height is 4-5 in below the 24 in design height.

Breaking and Cracking:	No breaking or cracking observed.			
	Missing Elements:	No missing elements observed.			
	Corrosion and Weathering:	80 ft of rail has moss growing on it. Monitor.			
End Treatments	Alignment and Height:				
	Breaking and Cracking:				
	Missing Elements:				
	Corrosion and Weathering:

Repair Action:	REPAIR	FMSS Work Type:	DEFERRED MAINTENANCE	Repair Cost:	\$15521
Brief Workorder:	Raise 821-ft of barrier up to 24-in design height.				
Workorder:	Adjust Guardrail at \$10- per -Lin. Ft. for 821 LF = \$8210. Raise 821-ft of barrier up to 24-in design height. Low Speed Traffic Control at \$1475- per -Day for 4 Day(s) = \$5900.

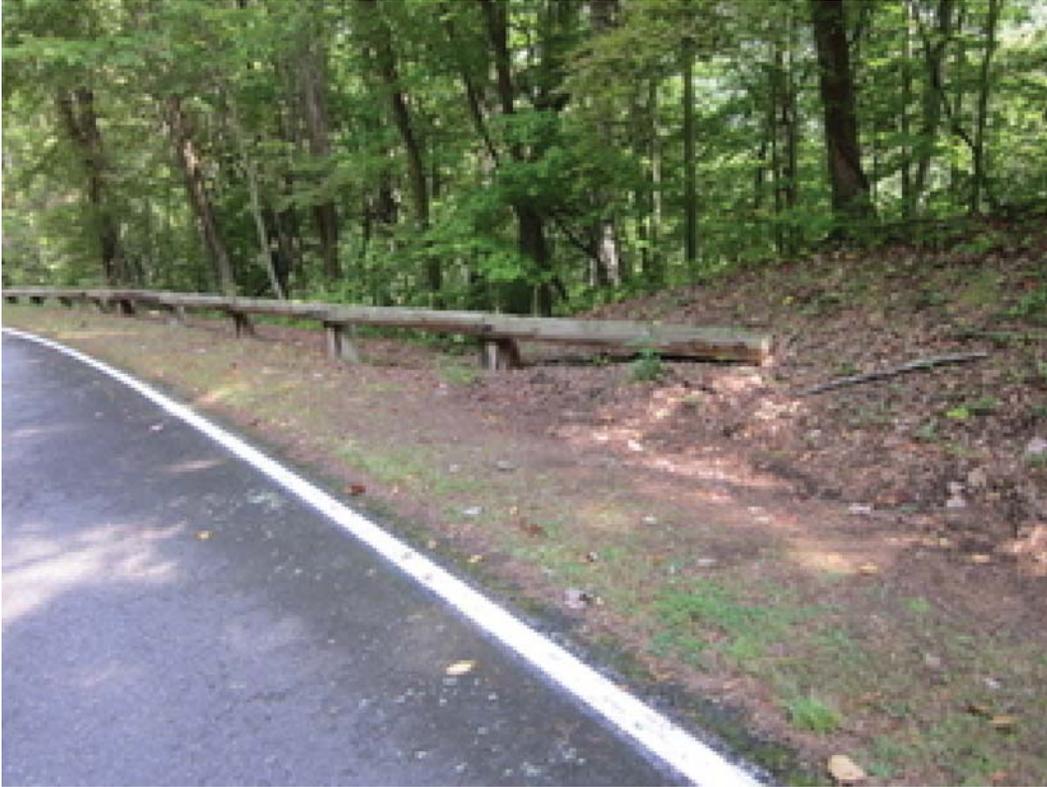
GRSM_0019_2.768_L_1.JPG

Barrier ID:	GRSM-0019-2.768-L				
Route Name:	LAKEVIEW DRIVE EAST				
Inspection Date:	09/17/2010	Barrier Rating:	39.50		
Barrier Description					
Type:	OTHER: TIMBER RAIL ON TIMBER POSTS	Barrier Function:	TRAFFIC		
Barrier Material:	LOG/TIMBER/WOOD	Post Material:	WOOD		
Blockout Type:	WOOD	Length (ft.):	258		
Speed Limit (MPH):	35	Placement with Respect to Road:	OUTSIDE OF CURVE		
Hazard Behind Barrier:	MEDIUM				
Barrier Crashworthiness					
Appropriate Test Level:	TL-2	Barrier Test Level:	NCW	Is Barrier Crashworthy?:	NO
Beg. End Trtmt Type:	NONE	Is Beg. End Trtmt Crashworthy?:	N/A	Approach Transition Type:	NONE
Ending End Trtmt Type:	NONE	Ending End Trtmt Crashworthy?:	N/A		
Average Measurements					
Design Height (In.):	24	Width (In.):	0.0	Post Spacing (In.):	119.3
Height (In.):	21.0	Lateral Offset (In.):	78.6	Road Grade (%):	5.70
Physical Condition					
Barrier	Alignment and Height:	Alignment has no deviation and the height is 2-4 in below the 24 in design height.

Breaking and Cracking:	Minor cracking less than 1/4 in			
	Missing Elements:	No missing elements observed.			
	Corrosion and Weathering:	4 posts were rotten and corroded.			
End Treatments	Alignment and Height:				
	Breaking and Cracking:				
	Missing Elements:				
	Corrosion and Weathering:

Repair Action:	REPAIR	FMSS Work Type:	DEFERRED MAINTENANCE	Repair Cost:	\$4901
Brief Workorder:	Raise 258-ft of barrier up to 24-in design height and replace 4 posts.				
Workorder:	Replace Post at \$100- per -Each for 4 Post(s) = \$400. Adjust Guardrail at \$10- per -Lin. Ft. for 258 LF = \$2580. Raise 258-ft of barrier up to 24-in design height. Low Speed Traffic Control at \$1475- per -Day for 2 Day(s) = \$2950.

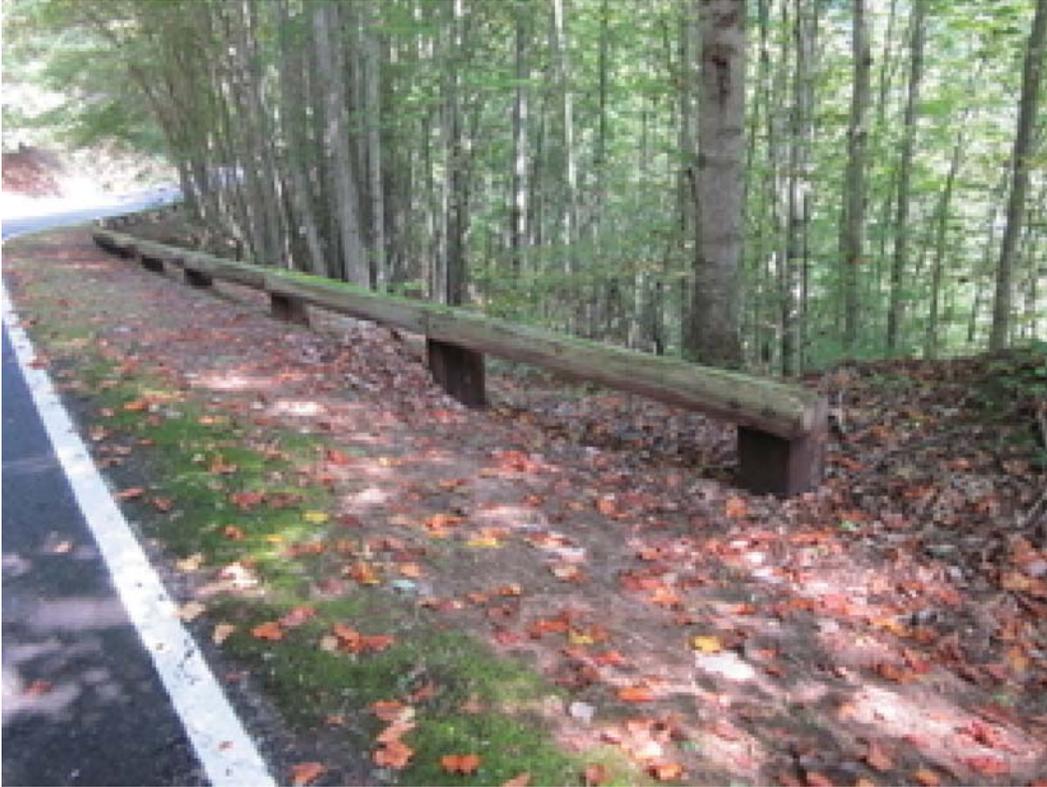
GRSM_0019_2.840_L_1.JPG

Barrier ID:	GRSM-0019-2.840-L				
Route Name:	LAKEVIEW DRIVE EAST				
Inspection Date:	09/17/2010	Barrier Rating:	39.40		
Barrier Description					
Type:	OTHER: TIMBER RAIL ON TIMBER POSTS	Barrier Function:	TRAFFIC		
Barrier Material:	LOG/TIMBER/WOOD	Post Material:	WOOD		
Blockout Type:	N/A	Length (ft.):	242		
Speed Limit (MPH):	35	Placement with Respect to Road:	INSIDE OF CURVE		
Hazard Behind Barrier:	MEDIUM				
Barrier Crashworthiness					
Appropriate Test Level:	TL-2	Barrier Test Level:	NCW	Is Barrier Crashworthy?:	NO
Beg. End Trtmt Type:	NONE	Is Beg. End Trtmt Crashworthy?:	N/A	Approach Transition Type:	NONE
Ending End Trtmt Type:	NONE	Ending End Trtmt Crashworthy?:	N/A		
Average Measurements					
Design Height (In.):	24	Width (In.):	0.0	Post Spacing (In.):	120.3
Height (In.):	19.6	Lateral Offset (In.):	81.0	Road Grade (%):	6.80
Physical Condition					
Barrier	Alignment and Height:	Alignment has no deviation and the height is 4-5 in below the 24 in design height.

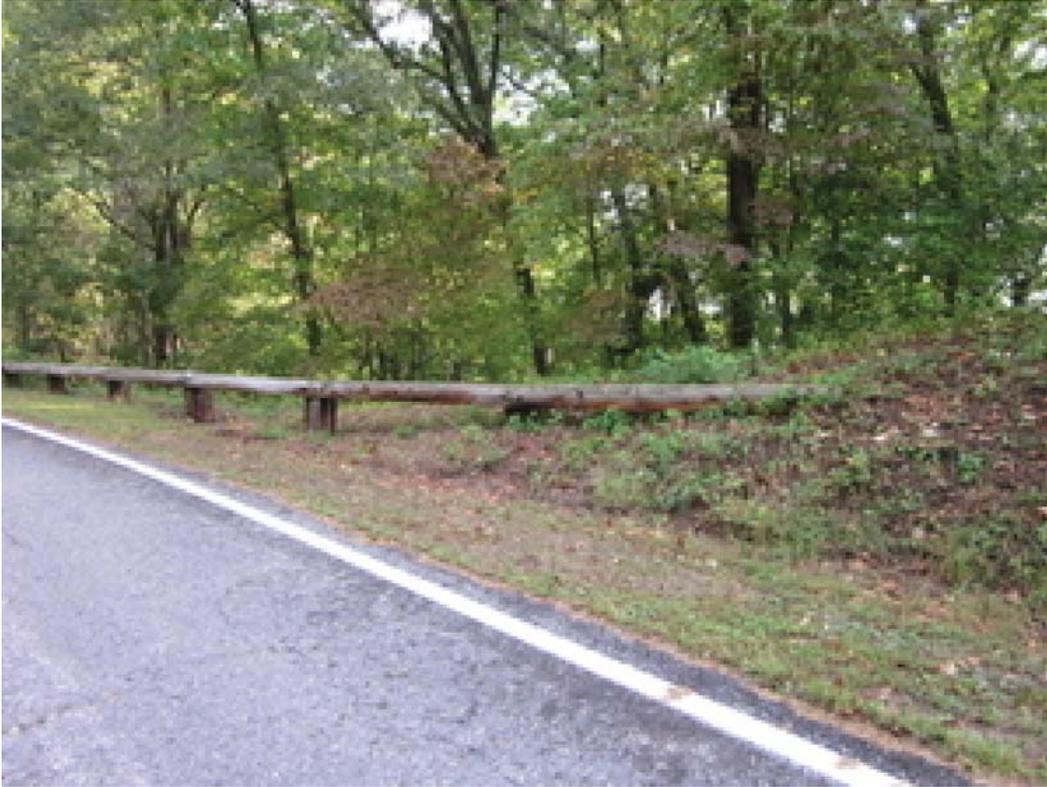
GRSM_0019_2.911_L_1.JPG

Barrier ID:	GRSM-0019-2.911-L				
Route Name:	LAKEVIEW DRIVE EAST				
Inspection Date:	09/17/2010	Barrier Rating:	36.50		
Barrier Description					
Type:	OTHER: TIMBER RAIL ON TIMBER POSTS	Barrier Function:	TRAFFIC		
Barrier Material:	LOG/TIMBER/WOOD	Post Material:	WOOD		
Blockout Type:	N/A	Length (ft.):	144		
Speed Limit (MPH):	35	Placement with Respect to Road:	OUTSIDE OF CURVE		
Hazard Behind Barrier:	MEDIUM				
Barrier Crashworthiness					
Appropriate Test Level:	TL-2	Barrier Test Level:	NCW	Is Barrier Crashworthy?:	NO
Beg. End Trtmt Type:	NONE	Is Beg. End Trtmt Crashworthy?:	N/A	Approach Transition Type:	NONE
Ending End Trtmt Type:	NONE	Ending End Trtmt Crashworthy?:	N/A		
Average Measurements					
Design Height (In.):	24	Width (In.):	0.0	Post Spacing (In.):	119.5
Height (In.):	25.6	Lateral Offset (In.):	83.5	Road Grade (%):	7.90
Physical Condition					
Barrier	Alignment and Height:	Alignment has no deviation and the height ranges from 1 in below to 4 in above the 24 in design height.

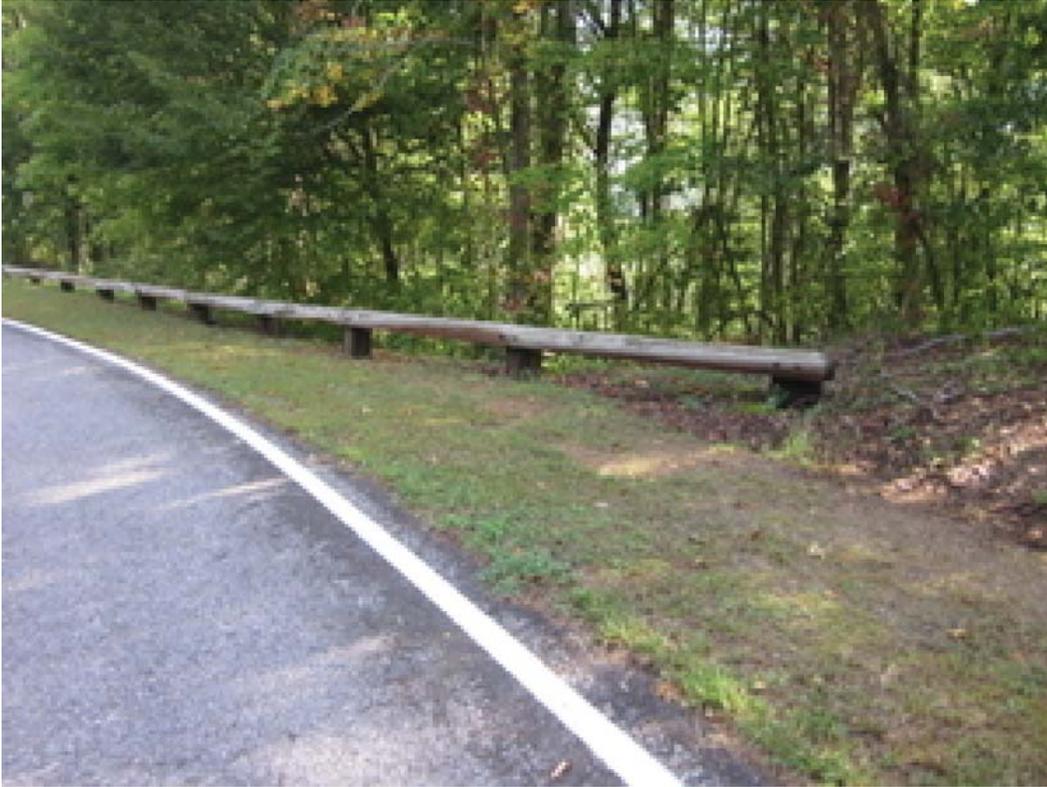
GRSM_0019_2.943_L_1.JPG

Barrier ID:	GRSM-0019-2.943-L				
Route Name:	LAKEVIEW DRIVE EAST				
Inspection Date:	09/17/2010	Barrier Rating:	36.50		
Barrier Description					
Type:	OTHER: TIMBER RAIL ON TIMBER POSTS	Barrier Function:	TRAFFIC		
Barrier Material:	LOG/TIMBER/WOOD	Post Material:	WOOD		
Blockout Type:	WOOD	Length (ft.):	231		
Speed Limit (MPH):	35	Placement with Respect to Road:	OUTSIDE OF CURVE		
Hazard Behind Barrier:	MEDIUM				
Barrier Crashworthiness					
Appropriate Test Level:	TL-2	Barrier Test Level:	NCW	Is Barrier Crashworthy?:	NO
Beg. End Trtmt Type:	NONE	Is Beg. End Trtmt Crashworthy?:	N/A	Approach Transition Type:	NONE
Ending End Trtmt Type:	NONE	Ending End Trtmt Crashworthy?:	N/A		
Average Measurements					
Design Height (In.):	24	Width (In.):	0.0	Post Spacing (In.):	116.6
Height (In.):	22.2	Lateral Offset (In.):	117.3	Road Grade (%):	6.00
Physical Condition					
Barrier	Alignment and Height:	Alignment has no deviation and 175 ft is 1-2 in below the 24 in design height.

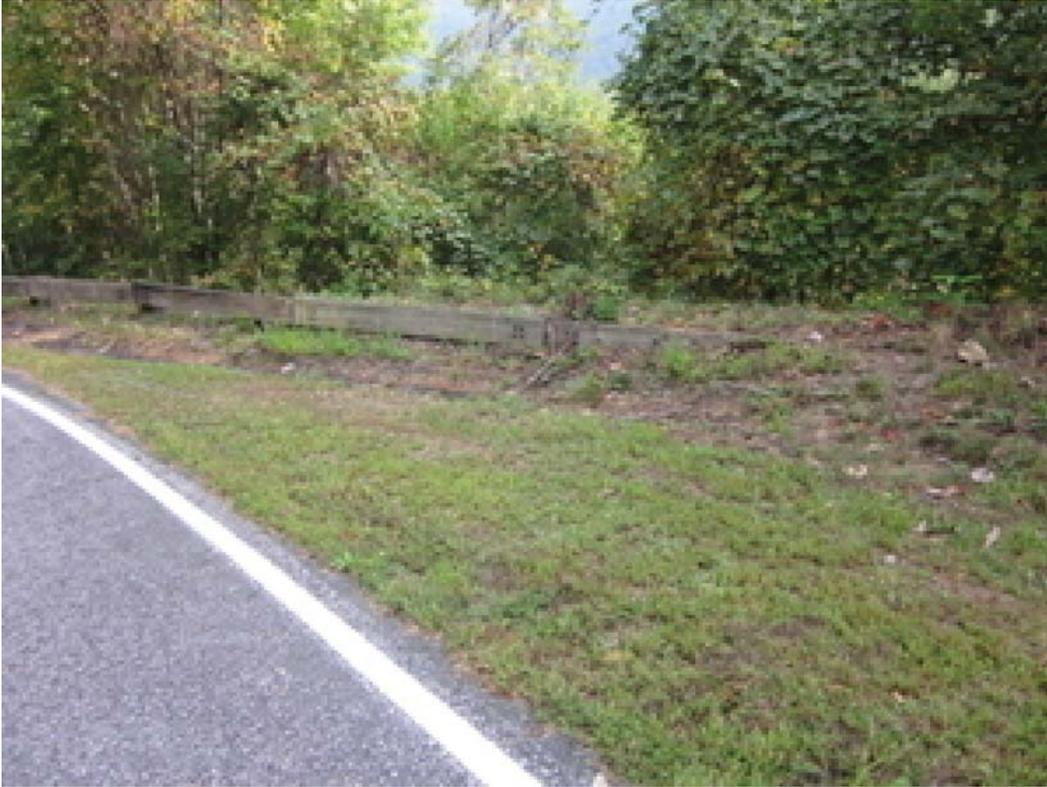
GRSM_0019_2.995_L_1.JPG

Barrier ID:	GRSM-0019-2.995-L				
Route Name:	LAKEVIEW DRIVE EAST				
Inspection Date:	09/17/2010	Barrier Rating:	26.80		
Barrier Description					
Type:	STEEL-BACKED TIMBER WITHOUT BLOCKOUT	Barrier Function:	TRAFFIC		
Barrier Material:	STEEL-BACKED TIMBER/LOG	Post Material:	WOOD		
Blockout Type:	N/A	Length (ft.):	748		
Speed Limit (MPH):	35	Placement with Respect to Road:	BOTH INSIDE AND OUTSIDE		
Hazard Behind Barrier:	HIGH				
Barrier Crashworthiness					
Appropriate Test Level:	TL-2	Barrier Test Level:	TL-2	Is Barrier Crashworthy?:	YES
Beg. End Trtmt Type:	SBT/LOG BURIED	Is Beg. End Trtmt Crashworthy?:	YES	Approach Transition Type:	NONE
Ending End Trtmt Type:	SBT/LOG FLARED	Ending End Trtmt Crashworthy?:	NO		
Average Measurements					
Design Height (In.):	27	Width (In.):	0.0	Post Spacing (In.):	119.5
Height (In.):	27.0	Lateral Offset (In.):	69.5	Road Grade (%):	1.60
Physical Condition					
Barrier	Alignment and Height:	Alignment has no deviation and the height is within 1 in of the 27 in design height.

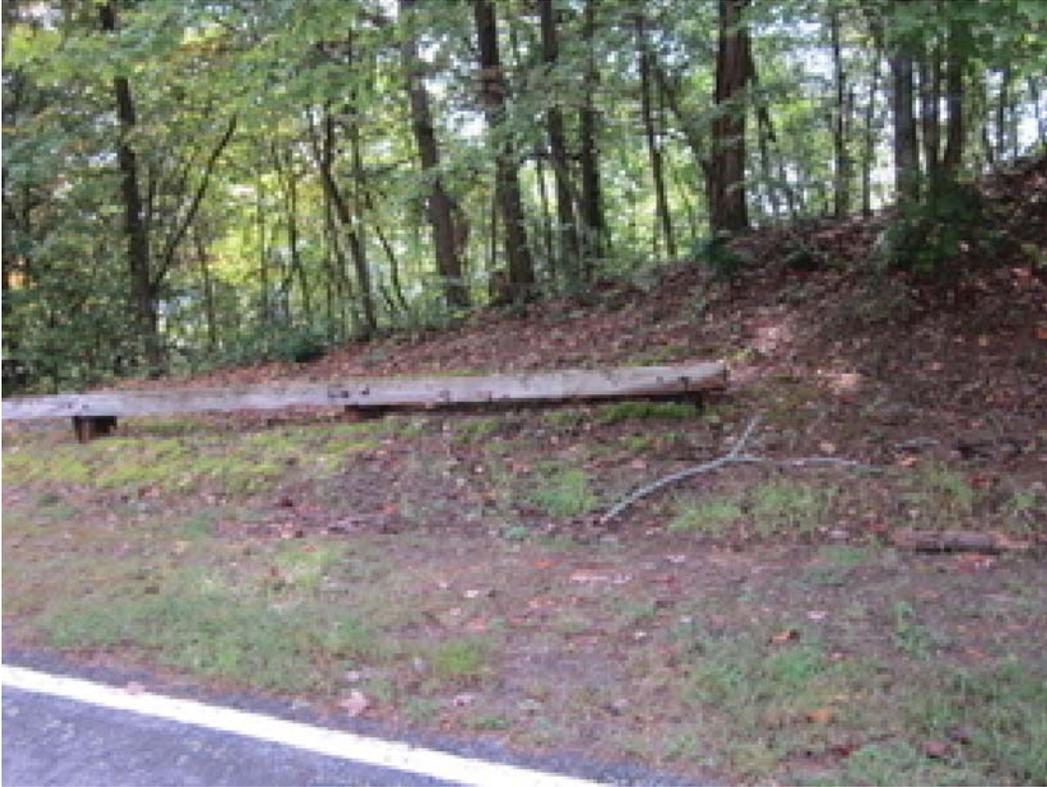
GRSM_0019_3.157_L_1.JPG

Barrier ID:	GRSM-0019-3.157-L				
Route Name:	LAKEVIEW DRIVE EAST				
Inspection Date:	09/17/2010	Barrier Rating:	32.20		
Barrier Description					
Type:	OTHER: TIMBER RAIL ON TIMBER POSTS	Barrier Function:	TRAFFIC		
Barrier Material:	LOG/TIMBER/WOOD	Post Material:	WOOD		
Blockout Type:	N/A	Length (ft.):	148		
Speed Limit (MPH):	35	Placement with Respect to Road:	OUTSIDE OF CURVE		
Hazard Behind Barrier:	MEDIUM				
Barrier Crashworthiness					
Appropriate Test Level:	TL-2	Barrier Test Level:	NCW	Is Barrier Crashworthy?:	NO
Beg. End Trtmt Type:	NONE	Is Beg. End Trtmt Crashworthy?:	N/A	Approach Transition Type:	NONE
Ending End Trtmt Type:	NONE	Ending End Trtmt Crashworthy?:	N/A		
Average Measurements					
Design Height (In.):	24	Width (In.):	0.0	Post Spacing (In.):	120.0
Height (In.):	25.0	Lateral Offset (In.):	103.0	Road Grade (%):	5.00
Physical Condition					
Barrier	Alignment and Height:	Alignment has no deviation and 75 ft is 1-3 in below the 24 in design height while the rest of the barrier is 0-4 in above.

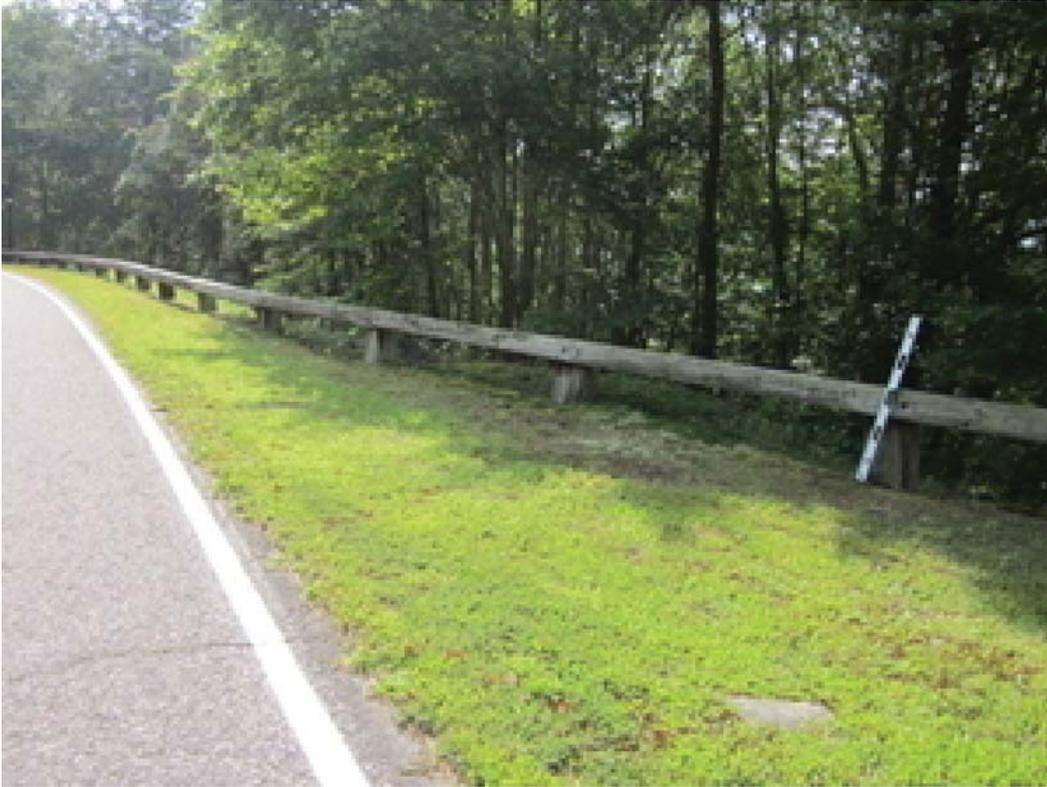
GRSM_0019_3.211_L_1.JPG

Barrier ID:	GRSM-0019-3.211-L				
Route Name:	LAKEVIEW DRIVE EAST				
Inspection Date:	09/16/2010	Barrier Rating:	35.20		
Barrier Description					
Type:	OTHER: TIMBER RAIL ON TIMBER POSTS	Barrier Function:	TRAFFIC		
Barrier Material:	LOG/TIMBER/WOOD	Post Material:	WOOD		
Blockout Type:	N/A	Length (ft.):	529		
Speed Limit (MPH):	35	Placement with Respect to Road:	BOTH INSIDE AND OUTSIDE		
Hazard Behind Barrier:	MEDIUM				
Barrier Crashworthiness					
Appropriate Test Level:	TL-2	Barrier Test Level:	NCW	Is Barrier Crashworthy?:	NO
Beg. End Trtmt Type:	NONE	Is Beg. End Trtmt Crashworthy?:	N/A	Approach Transition Type:	NONE
Ending End Trtmt Type:	NONE	Ending End Trtmt Crashworthy?:	N/A		
Average Measurements					
Design Height (In.):	24	Width (In.):	0.0	Post Spacing (In.):	212.0
Height (In.):	21.6	Lateral Offset (In.):	84.0	Road Grade (%):	1.70
Physical Condition					
Barrier	Alignment and Height:	Alignment has no deviation and the height is 1-4 in below the 24 in design height.

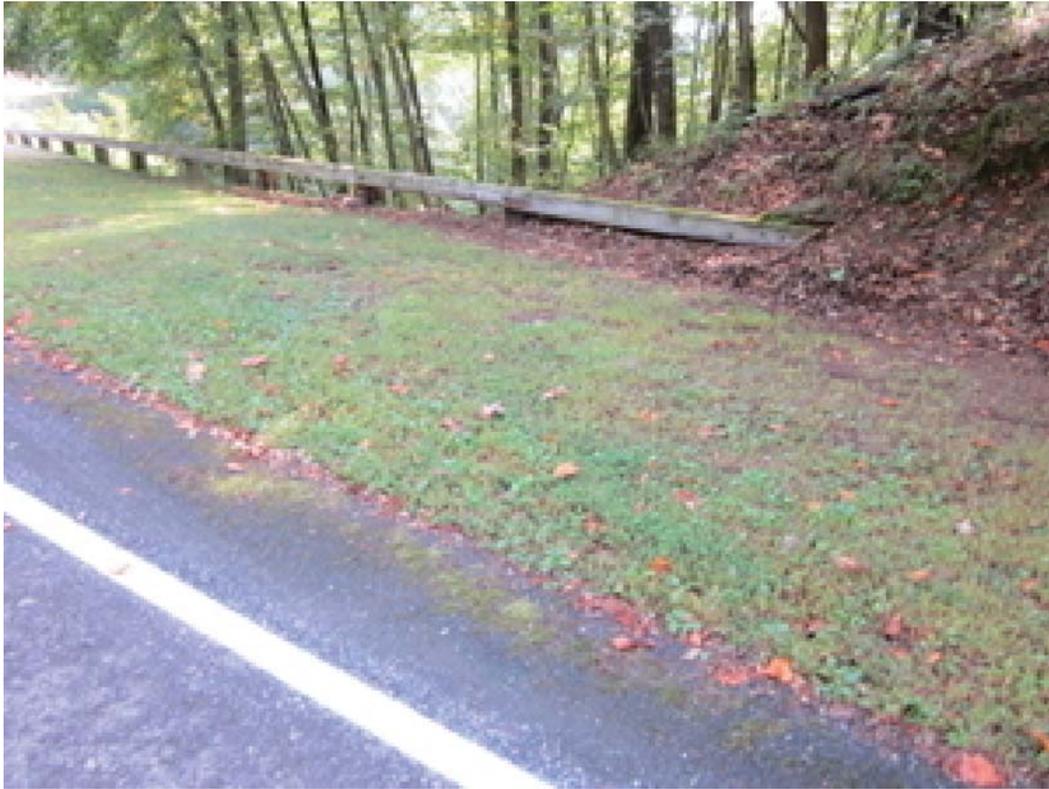
GRSM_0019_3.378_L_1.JPG

Barrier ID:	GRSM-0019-3.378-L				
Route Name:	LAKEVIEW DRIVE EAST				
Inspection Date:	09/17/2010	Barrier Rating:	22.20		
Barrier Description					
Type:	OTHER: TIMBER RAIL ON TIMBER POSTS	Barrier Function:	TRAFFIC		
Barrier Material:	LOG/TIMBER/WOOD	Post Material:	WOOD		
Blockout Type:	N/A	Length (ft.):	33		
Speed Limit (MPH):	35	Placement with Respect to Road:	INSIDE OF CURVE		
Hazard Behind Barrier:	MEDIUM				
Barrier Crashworthiness					
Appropriate Test Level:	TL-2	Barrier Test Level:	NCW	Is Barrier Crashworthy?:	NO
Beg. End Trtmt Type:	NONE	Is Beg. End Trtmt Crashworthy?:	N/A	Approach Transition Type:	NONE
Ending End Trtmt Type:	NONE	Ending End Trtmt Crashworthy?:	N/A		
Average Measurements					
Design Height (In.):	24	Width (In.):	0.0	Post Spacing (In.):	120.3
Height (In.):	22.0	Lateral Offset (In.):	274.7	Road Grade (%):	2.70
Physical Condition					
Barrier	Alignment and Height:	Alignment has no deviation and the height ranges from 4 in below to 1 in above the 24 in design height with 20 ft being 1-4 in below.
