NPS Guardwall/Rail Inventory Program
Great Smoky Mountains National Park

Federal Highway Administration
Eastern Federal Lands Highway Division
Road Inventory Program (RIP)

Data Collection Date: September 2010
Report Date: December 2015

Great Smoky Mountains National Park in North Carolina and Tennessee

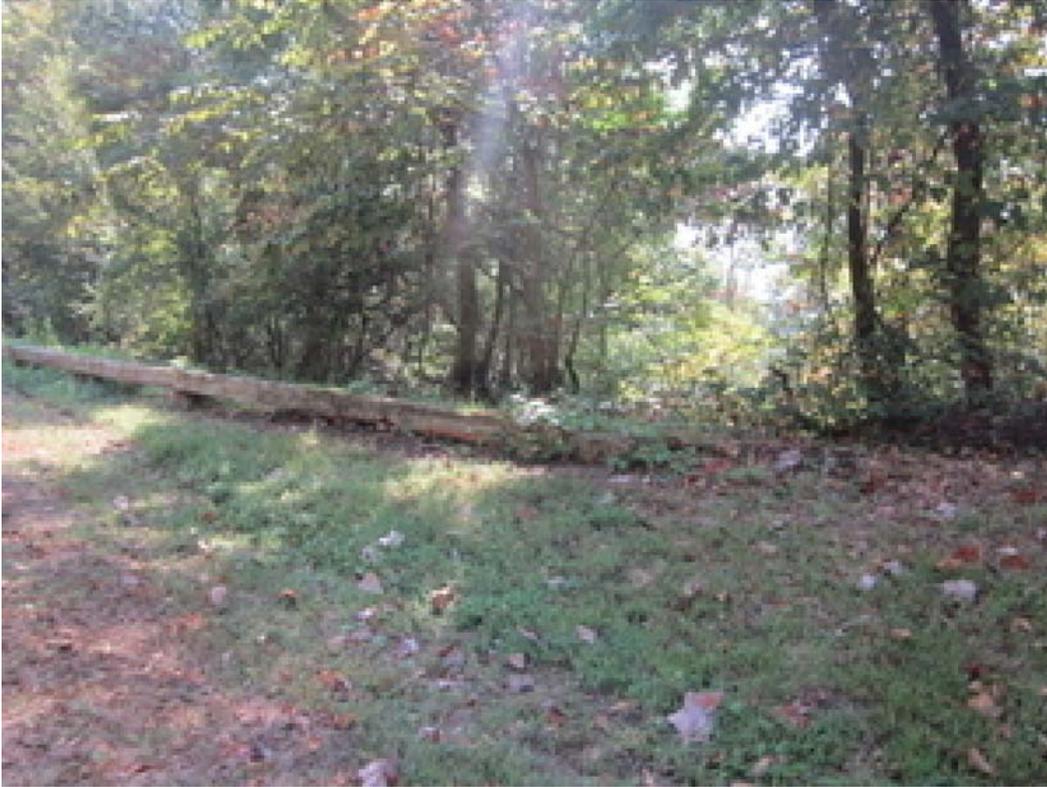
GRSM_0019_3.408_L_1.JPG

Barrier ID:	GRSM-0019-3.408-L				
Route Name:	LAKEVIEW DRIVE EAST				
Inspection Date:	09/17/2010	Barrier Rating:	26.60		
Barrier Description					
Type:	OTHER: TIMBER RAIL ON TIMBER POSTS	Barrier Function:	TRAFFIC		
Barrier Material:	LOG/TIMBER/WOOD	Post Material:	WOOD		
Blockout Type:	N/A	Length (ft.):	283		
Speed Limit (MPH):	35	Placement with Respect to Road:	TANGENT		
Hazard Behind Barrier:	MEDIUM				
Barrier Crashworthiness					
Appropriate Test Level:	TL-2	Barrier Test Level:	NCW	Is Barrier Crashworthy?:	NO
Beg. End Trtmt Type:	NONE	Is Beg. End Trtmt Crashworthy?:	N/A	Approach Transition Type:	NONE
Ending End Trtmt Type:	NONE	Ending End Trtmt Crashworthy?:	N/A		
Average Measurements					
Design Height (In.):	24	Width (In.):	0.0	Post Spacing (In.):	120.0
Height (In.):	23.0	Lateral Offset (In.):	66.6	Road Grade (%):	2.80
Physical Condition					
Barrier	Alignment and Height:	Alignment has no deviation and 200 ft is 1-2 in below the 24 in design height.

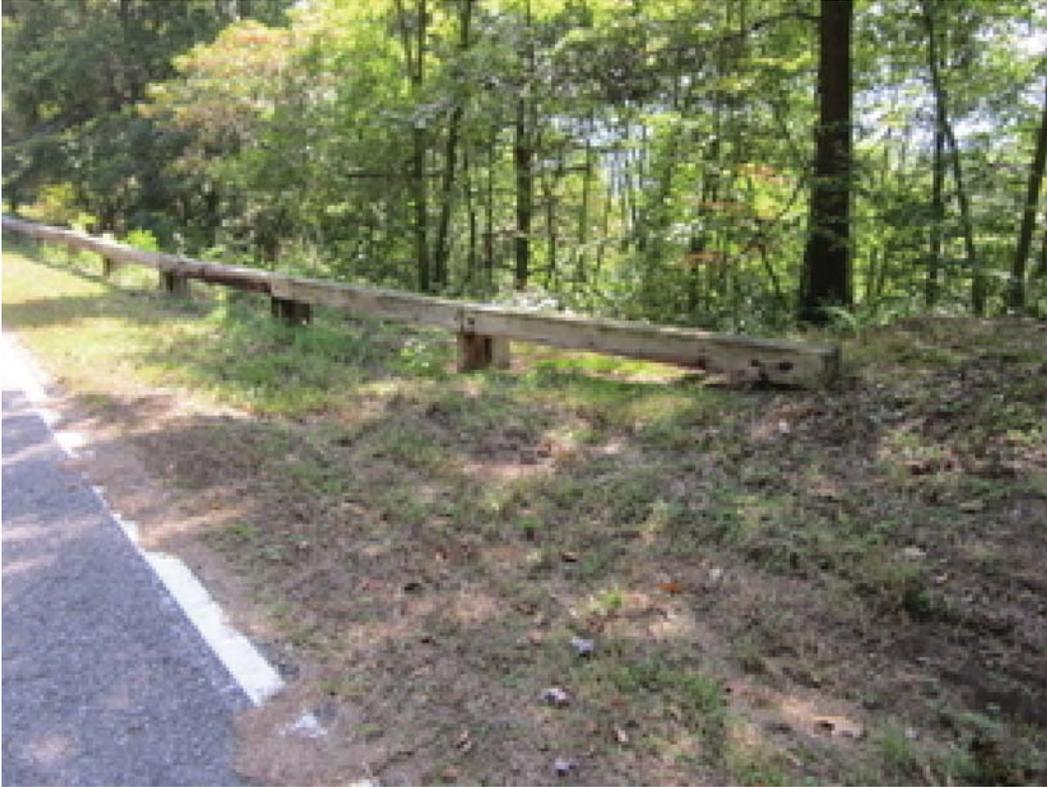
GRSM_0019_3.487_L_1.JPG

Barrier ID:	GRSM-0019-3.487-L				
Route Name:	LAKEVIEW DRIVE EAST				
Inspection Date:	09/17/2010	Barrier Rating:	36.50		
Barrier Description					
Type:	OTHER: TIMBER RAIL ON TIMBER POSTS	Barrier Function:	TRAFFIC		
Barrier Material:	LOG/TIMBER/WOOD	Post Material:	WOOD		
Blockout Type:	N/A	Length (ft.):	160		
Speed Limit (MPH):	35	Placement with Respect to Road:	OUTSIDE OF CURVE		
Hazard Behind Barrier:	MEDIUM				
Barrier Crashworthiness					
Appropriate Test Level:	TL-2	Barrier Test Level:	NCW	Is Barrier Crashworthy?:	NO
Beg. End Trtmt Type:	NONE	Is Beg. End Trtmt Crashworthy?:	N/A	Approach Transition Type:	NONE
Ending End Trtmt Type:	NONE	Ending End Trtmt Crashworthy?:	N/A		
Average Measurements					
Design Height (In.):	24	Width (In.):	0.0	Post Spacing (In.):	115.5
Height (In.):	21.2	Lateral Offset (In.):	70.0	Road Grade (%):	3.00
Physical Condition					
Barrier	Alignment and Height:	Alignment has no deviation and the height is 2-3 in below the 24 in design height.

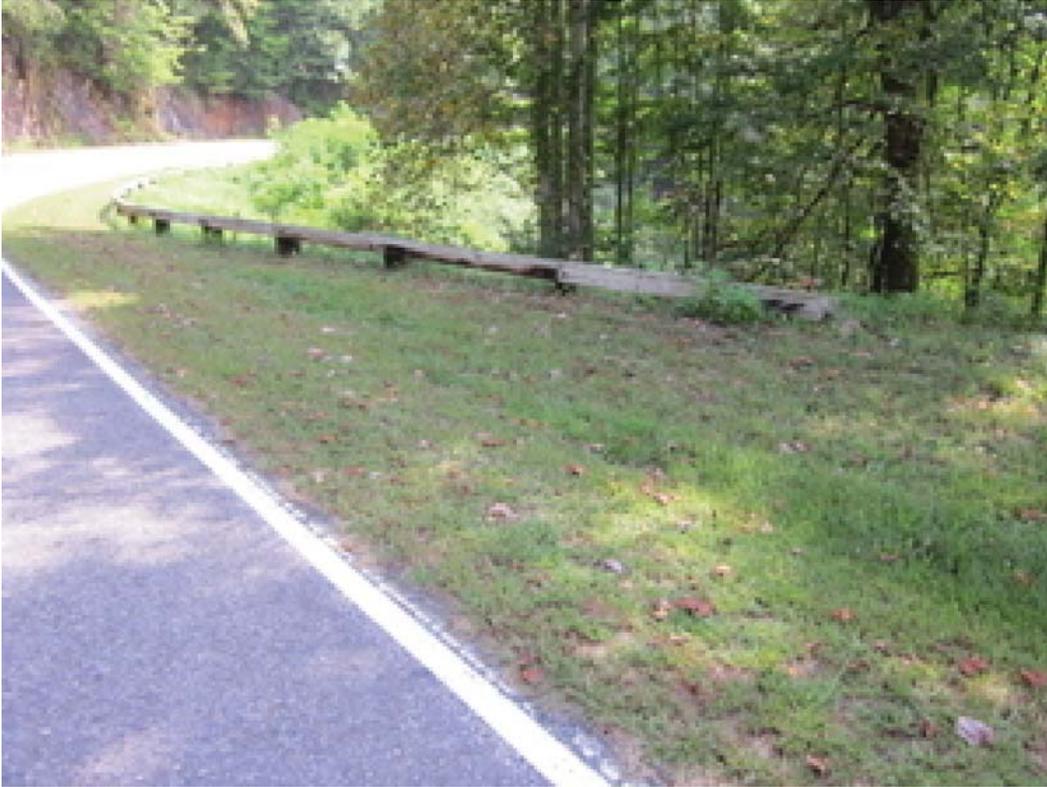
GRSM_0019_3.552_L_1.JPG

Barrier ID:	GRSM-0019-3.552-L				
Route Name:	LAKEVIEW DRIVE EAST				
Inspection Date:	09/17/2010	Barrier Rating:	35.20		
Barrier Description					
Type:	OTHER: TIMBER RAIL ON TIMBER POSTS	Barrier Function:	TRAFFIC		
Barrier Material:	LOG/TIMBER/WOOD	Post Material:	WOOD		
Blockout Type:	N/A	Length (ft.):	433		
Speed Limit (MPH):	35	Placement with Respect to Road:	OUTSIDE OF CURVE		
Hazard Behind Barrier:	MEDIUM				
Barrier Crashworthiness					
Appropriate Test Level:	TL-2	Barrier Test Level:	NCW	Is Barrier Crashworthy?:	NO
Beg. End Trtmt Type:	NONE	Is Beg. End Trtmt Crashworthy?:	N/A	Approach Transition Type:	NONE
Ending End Trtmt Type:	NONE	Ending End Trtmt Crashworthy?:	N/A		
Average Measurements					
Design Height (In.):	24	Width (In.):	0.0	Post Spacing (In.):	120.0
Height (In.):	24.6	Lateral Offset (In.):	113.3	Road Grade (%):	4.20
Physical Condition					
Barrier	Alignment and Height:	Alignment has no deviation and the height is 0-2 in below the 24 in design height.

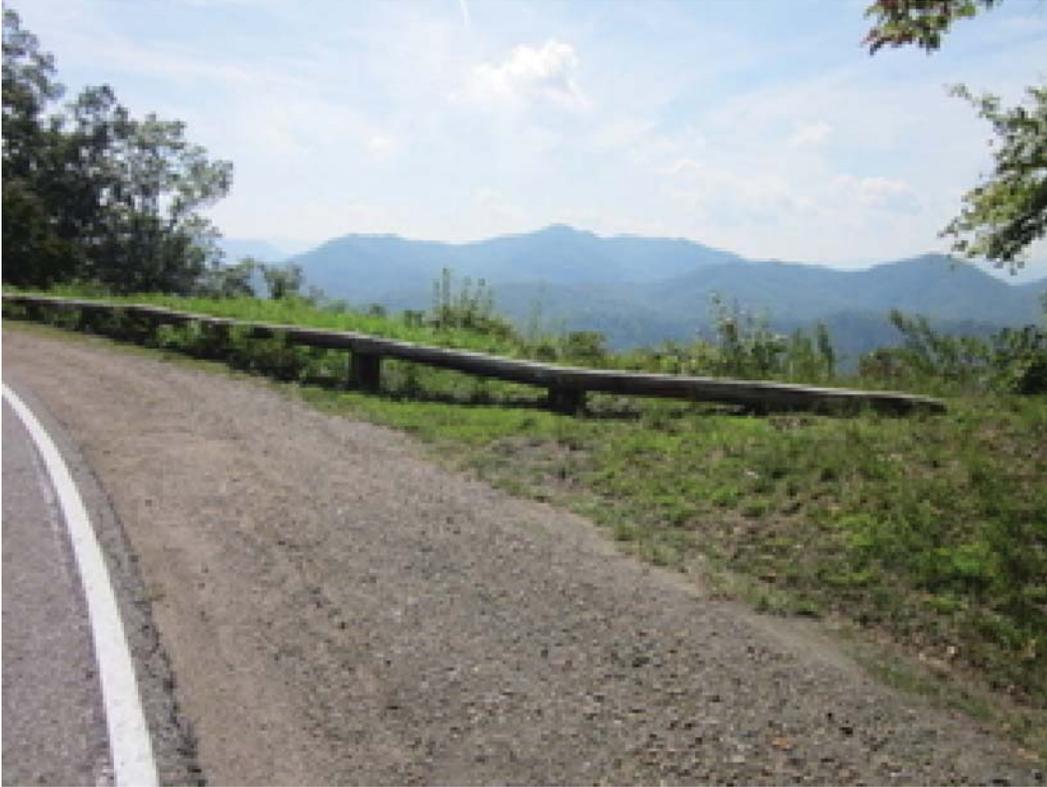
GRSM_0019_3.667_L_1.JPG

Barrier ID:	GRSM-0019-3.667-L				
Route Name:	LAKEVIEW DRIVE EAST				
Inspection Date:	09/17/2010	Barrier Rating:	37.00		
Barrier Description					
Type:	OTHER: TIMBER RAIL ON TIMBER POSTS	Barrier Function:	TRAFFIC		
Barrier Material:	LOG/TIMBER/WOOD	Post Material:	WOOD		
Blockout Type:	N/A	Length (ft.):	265		
Speed Limit (MPH):	35	Placement with Respect to Road:	OUTSIDE OF CURVE		
Hazard Behind Barrier:	HIGH				
Barrier Crashworthiness					
Appropriate Test Level:	TL-2	Barrier Test Level:	NCW	Is Barrier Crashworthy?:	NO
Beg. End Trtmt Type:	NONE	Is Beg. End Trtmt Crashworthy?:	N/A	Approach Transition Type:	NONE
Ending End Trtmt Type:	NONE	Ending End Trtmt Crashworthy?:	N/A		
Average Measurements					
Design Height (In.):	24	Width (In.):	0.0	Post Spacing (In.):	121.6
Height (In.):	21.7	Lateral Offset (In.):	97.0	Road Grade (%):	2.10
Physical Condition					
Barrier	Alignment and Height:	Alignment has no deviation and the height is 1-3 in below the 24 in design height.

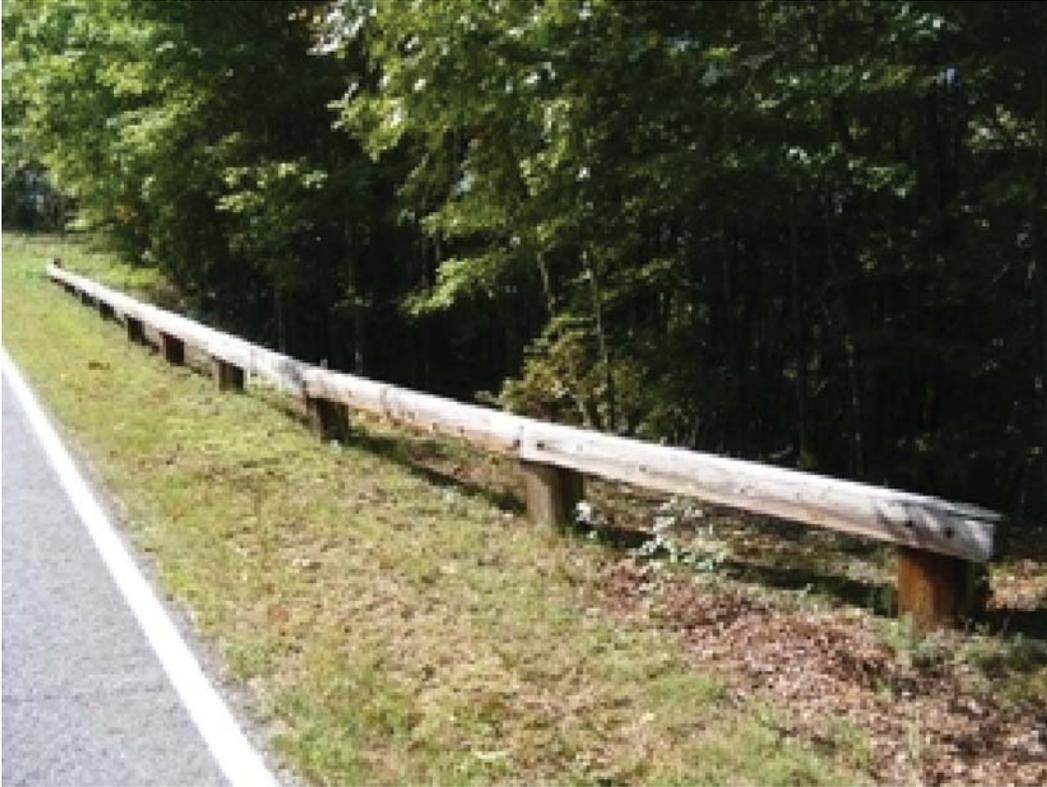
GRSM_0019_3.739_L_1.JPG

Barrier ID:	GRSM-0019-3.739-L				
Route Name:	LAKEVIEW DRIVE EAST				
Inspection Date:	09/17/2010	Barrier Rating:	29.70		
Barrier Description					
Type:	OTHER: TIMBER RAIL ON TIMBER POSTS	Barrier Function:	TRAFFIC		
Barrier Material:	LOG/TIMBER/WOOD	Post Material:	WOOD		
Blockout Type:	N/A	Length (ft.):	110		
Speed Limit (MPH):	35	Placement with Respect to Road:	OUTSIDE OF CURVE		
Hazard Behind Barrier:	HIGH				
Barrier Crashworthiness					
Appropriate Test Level:	TL-2	Barrier Test Level:	NCW	Is Barrier Crashworthy?:	NO
Beg. End Trtmt Type:	NONE	Is Beg. End Trtmt Crashworthy?:	N/A	Approach Transition Type:	NONE
Ending End Trtmt Type:	NONE	Ending End Trtmt Crashworthy?:	N/A		
Average Measurements					
Design Height (In.):	24	Width (In.):	0.0	Post Spacing (In.):	118.0
Height (In.):	22.0	Lateral Offset (In.):	75.6	Road Grade (%):	5.30
Physical Condition					
Barrier	Alignment and Height:	The alignment has no deviation and the height is 1-3 in below the 24 in design height.

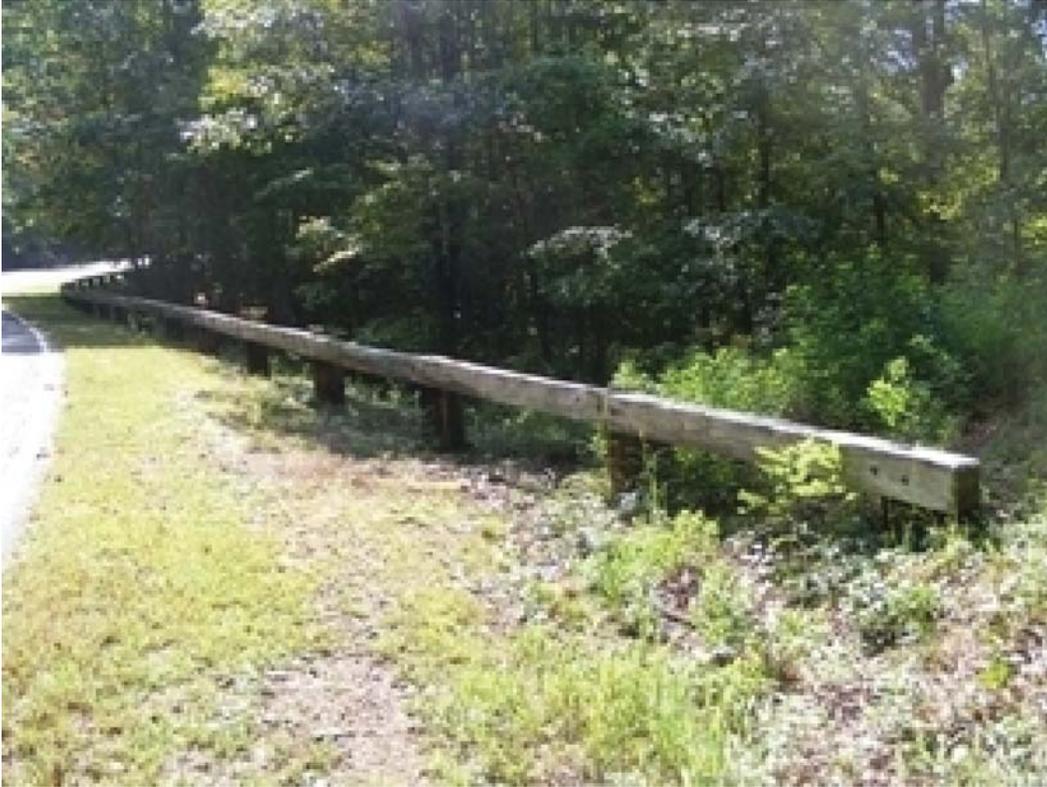
GRSM_0019_3.788_L_1.JPG

Barrier ID:	GRSM-0019-3.788-L				
Route Name:	LAKEVIEW DRIVE EAST				
Inspection Date:	09/17/2010	Barrier Rating:	37.00		
Barrier Description					
Type:	OTHER: TIMBER RAIL ON TIMBER POSTS	Barrier Function:	TRAFFIC		
Barrier Material:	LOG/TIMBER/WOOD	Post Material:	WOOD		
Blockout Type:	N/A	Length (ft.):	382		
Speed Limit (MPH):	35	Placement with Respect to Road:	BOTH INSIDE AND OUTSIDE		
Hazard Behind Barrier:	HIGH				
Barrier Crashworthiness					
Appropriate Test Level:	TL-2	Barrier Test Level:	NCW	Is Barrier Crashworthy?:	NO
Beg. End Trtmt Type:	NONE	Is Beg. End Trtmt Crashworthy?:	N/A	Approach Transition Type:	NONE
Ending End Trtmt Type:	NONE	Ending End Trtmt Crashworthy?:	N/A		
Average Measurements					
Design Height (In.):	24	Width (In.):	0.0	Post Spacing (In.):	120.6
Height (In.):	23.2	Lateral Offset (In.):	82.3	Road Grade (%):	9.90
Physical Condition					
Barrier	Alignment and Height:	The alignment has no deviation and 275 ft is 1-2 in below the 24 in design height. Remainder of barrier is 0-1 in above the design height.

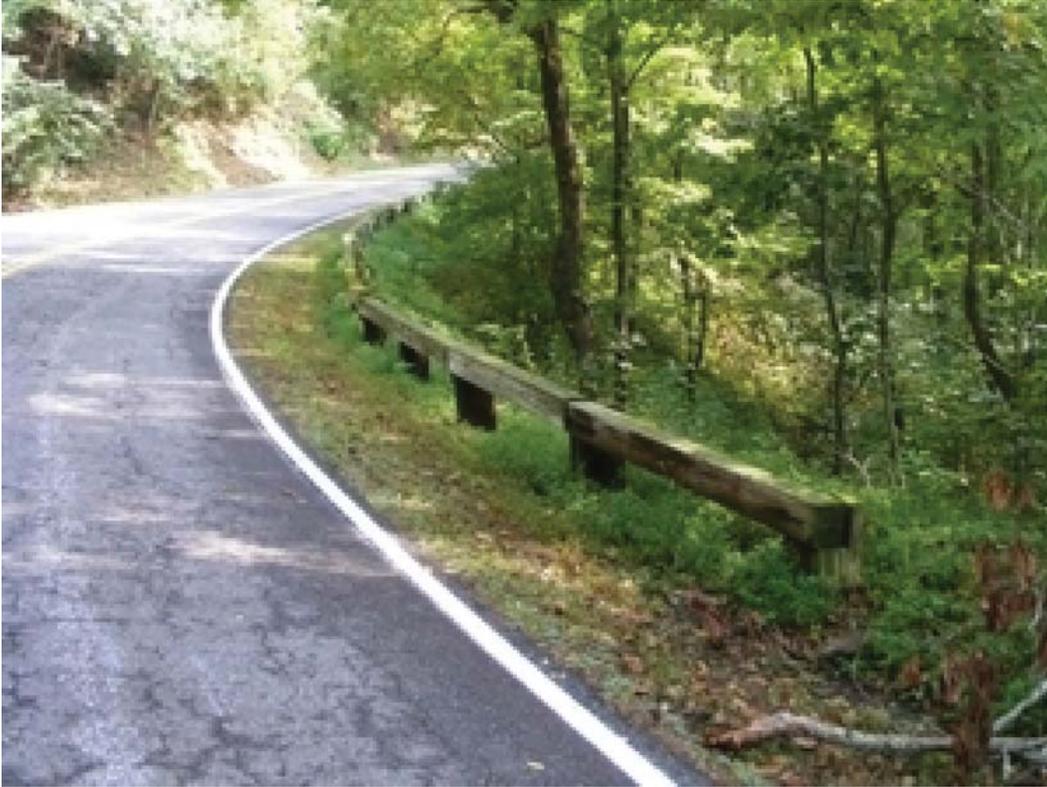
GRSM_0019_3.961_L_1.JPG

Barrier ID:	GRSM-0019-3.961-L				
Route Name:	LAKEVIEW DRIVE EAST				
Inspection Date:	09/17/2010	Barrier Rating:	51.20		
Barrier Description					
Type:	OTHER: TIMBER RAIL ON TIMBER POSTS	Barrier Function:	TRAFFIC		
Barrier Material:	LOG/TIMBER/WOOD	Post Material:	WOOD		
Blockout Type:	N/A	Length (ft.):	1309		
Speed Limit (MPH):	35	Placement with Respect to Road:	INSIDE OF CURVE		
Hazard Behind Barrier:	HIGH				
Barrier Crashworthiness					
Appropriate Test Level:	TL-2	Barrier Test Level:	NCW	Is Barrier Crashworthy?:	NO
Beg. End Trtmt Type:	NONE	Is Beg. End Trtmt Crashworthy?:	N/A	Approach Transition Type:	NONE
Ending End Trtmt Type:	NONE	Ending End Trtmt Crashworthy?:	N/A		
Average Measurements					
Design Height (In.):	24	Width (In.):	0.0	Post Spacing (In.):	120.0
Height (In.):	22.1	Lateral Offset (In.):	66.8	Road Grade (%):	7.50
Physical Condition					
Barrier	Alignment and Height:	The alignment has no deviation and 1100 ft is 1-3 in below the 24 in design height.

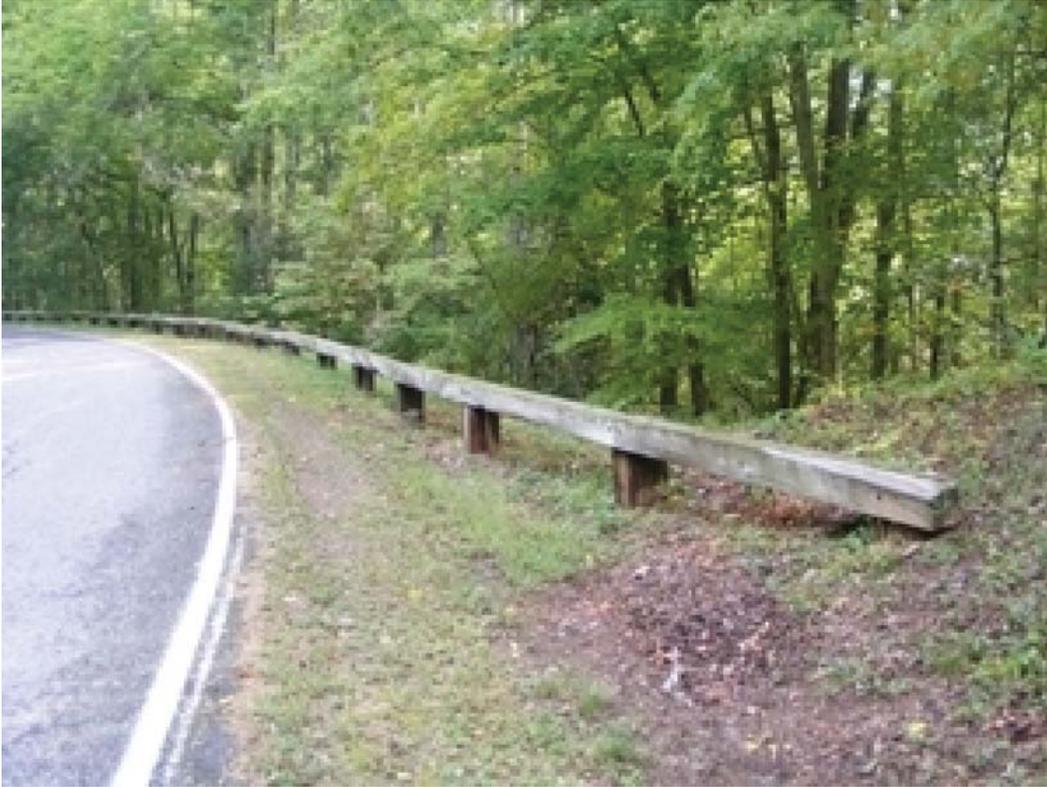
GRSM_0019_4.230_L_1.JPG

Barrier ID:	GRSM-0019-4.230-L				
Route Name:	LAKEVIEW DRIVE EAST				
Inspection Date:	09/17/2010	Barrier Rating:	30.70		
Barrier Description					
Type:	OTHER: TIMBER RAIL ON TIMBER POSTS	Barrier Function:	TRAFFIC		
Barrier Material:	LOG/TIMBER/WOOD	Post Material:	WOOD		
Blockout Type:	N/A	Length (ft.):	453		
Speed Limit (MPH):	35	Placement with Respect to Road:	BOTH INSIDE AND OUTSIDE		
Hazard Behind Barrier:	MEDIUM				
Barrier Crashworthiness					
Appropriate Test Level:	TL-2	Barrier Test Level:	NCW	Is Barrier Crashworthy?:	NO
Beg. End Trtmt Type:	NONE	Is Beg. End Trtmt Crashworthy?:	N/A	Approach Transition Type:	NONE
Ending End Trtmt Type:	NONE	Ending End Trtmt Crashworthy?:	N/A		
Average Measurements					
Design Height (In.):	24	Width (In.):	0.0	Post Spacing (In.):	120.5
Height (In.):	21.6	Lateral Offset (In.):	77.5	Road Grade (%):	5.10
Physical Condition					
Barrier	Alignment and Height:	The alignment has no deviation and 350 ft is 1-5 in below the 24 in design height.

Breaking and Cracking:	More than half the posts are rotted. 28 total posts.			
	Missing Elements:	1 missing bolt.			
	Corrosion and Weathering:	Moderate corrosion and weathering observed on all posts and rail.			
End Treatments	Alignment and Height:				
	Breaking and Cracking:				
	Missing Elements:				
	Corrosion and Weathering:

Repair Action:	REPLACE	FMSS Work Type:	CAPITAL IMPROVEMENT	Repair Cost:	\$48411
Brief Workorder:	Remove and replace existing timber guardrail with Steel-backed timber without blockouts guardrail and 2 Steel-backed timber end treatments.				
Workorder:	<p>Remove Guardrail at \$10- per -Lin. Ft. for 453 LF = \$4530. Remove entire 453 feet of barrier.</p> <p>Steel-Backed Timber w/o Blockout at \$60- per -Lin. Ft. for 393 LF = \$23580. Replace old barrier with Steel backed timber guardrail.</p> <p>Steel-backed timber / Log Flared at \$5000- per -Each for 1 Unit(s) = \$5000. Install a Steel backed timber flared end treatment on ending end.</p> <p>Steel-backed timber / Log Buried at \$5000- per -Each for 1 Unit(s) = \$5000. Install a steel backed timber buried end treatment on beginning end.</p> <p>Low Speed Traffic Control at \$1475- per -Day for 4 Day(s) = \$5900. 2 days removal 2 days installation.</p>

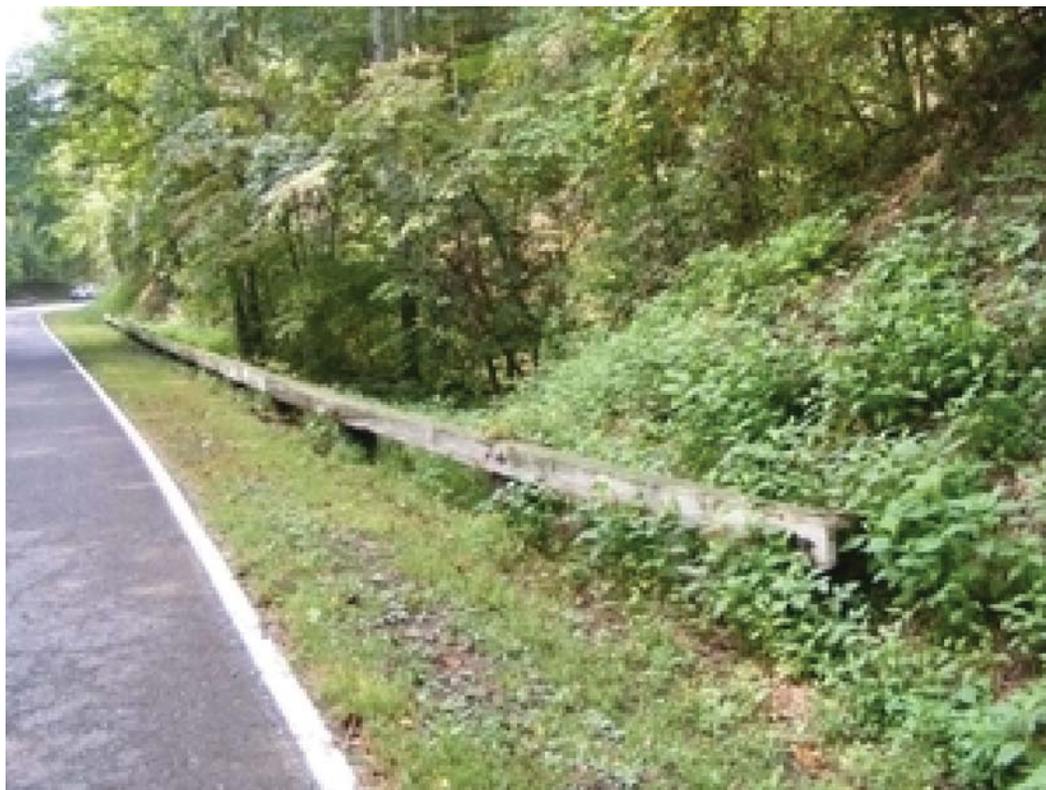
GRSM_0019_4.232_R_1.JPG

Barrier ID:	GRSM-0019-4.232-R				
Route Name:	LAKEVIEW DRIVE EAST				
Inspection Date:	09/17/2010	Barrier Rating:	36.50		
Barrier Description					
Type:	OTHER: TIMBER RAIL ON TIMBER POSTS	Barrier Function:	TRAFFIC		
Barrier Material:	LOG/TIMBER/WOOD	Post Material:	WOOD		
Blockout Type:	N/A	Length (ft.):	190		
Speed Limit (MPH):	35	Placement with Respect to Road:	OUTSIDE OF CURVE		
Hazard Behind Barrier:	MEDIUM				
Barrier Crashworthiness					
Appropriate Test Level:	TL-2	Barrier Test Level:	NCW	Is Barrier Crashworthy?:	NO
Beg. End Trtmt Type:	NONE	Is Beg. End Trtmt Crashworthy?:	N/A	Approach Transition Type:	NONE
Ending End Trtmt Type:	NONE	Ending End Trtmt Crashworthy?:	N/A		
Average Measurements					
Design Height (In.):	24	Width (In.):	0.0	Post Spacing (In.):	120.3
Height (In.):	22.0	Lateral Offset (In.):	74.0	Road Grade (%):	5.20
Physical Condition					
Barrier	Alignment and Height:	The alignment has no deviation and the height is 1-3 in below the 24 in design height.

Breaking and Cracking:	No breaking or cracking observed.			
	Missing Elements:	No missing elements observed.			
	Corrosion and Weathering:	6 posts observed as rotted and hollow.			
End Treatments	Alignment and Height:				
	Breaking and Cracking:				
	Missing Elements:				
	Corrosion and Weathering:

Repair Action:	REPAIR	FMSS Work Type:	DEFERRED MAINTENANCE	Repair Cost:	\$4373
Brief Workorder:	Raise 190-ft of barrier up to 24-in design height and replace 6 posts.				
Workorder:	Replace Post at \$100- per -Each for 6 Post(s) = \$600. Replace 6 rotted and hollow posts. Adjust Guardrail at \$10- per -Lin. Ft. for 190 LF = \$1900. Raise 190-ft of barrier up to 24-in design height. Low Speed Traffic Control at \$1475- per -Day for 1 Day(s) = \$1475.

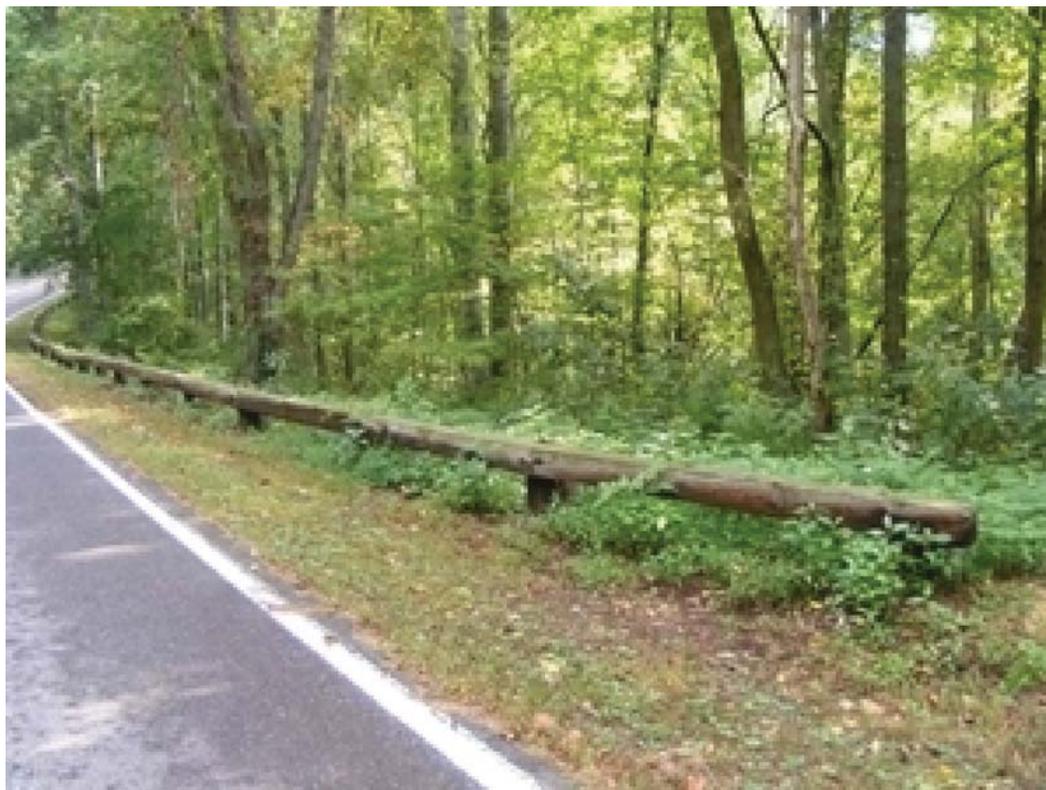
GRSM_0019_4.348_L_1.JPG

Barrier ID:	GRSM-0019-4.348-L				
Route Name:	LAKEVIEW DRIVE EAST				
Inspection Date:	09/17/2010	Barrier Rating:	39.70		
Barrier Description					
Type:	OTHER: TIMBER RAIL ON TIMBER POSTS	Barrier Function:	TRAFFIC		
Barrier Material:	LOG/TIMBER/WOOD	Post Material:	WOOD		
Blockout Type:	N/A	Length (ft.):	422		
Speed Limit (MPH):	35	Placement with Respect to Road:	INSIDE OF CURVE		
Hazard Behind Barrier:	HIGH				
Barrier Crashworthiness					
Appropriate Test Level:	TL-2	Barrier Test Level:	NCW	Is Barrier Crashworthy?:	NO
Beg. End Trtmt Type:	NONE	Is Beg. End Trtmt Crashworthy?:	N/A	Approach Transition Type:	NONE
Ending End Trtmt Type:	NONE	Ending End Trtmt Crashworthy?:	N/A		
Average Measurements					
Design Height (In.):	24	Width (In.):	0.0	Post Spacing (In.):	119.3
Height (In.):	23.0	Lateral Offset (In.):	72.3	Road Grade (%):	1.20
Physical Condition					
Barrier	Alignment and Height:	The alignment was deflected more than 12 in for 40 ft. 350 ft is 1-2 in below the 24 in design height.

Breaking and Cracking:	No breaking or cracking observed.			
	Missing Elements:	No missing elements observed.			
	Corrosion and Weathering:	Weathering observed on all posts and rail. 31 posts observed as rotten and hollow.			
End Treatments	Alignment and Height:				
	Breaking and Cracking:				
	Missing Elements:				
	Corrosion and Weathering:

Repair Action:	REPLACE	FMSS Work Type:	CAPITAL IMPROVEMENT	Repair Cost:	\$46024
Brief Workorder:	Remove and replace existing timber guardrail with Steel-backed timber without blockouts guardrail and 2 Steel-backed timber flared end treatments.				
Workorder:	<p>Remove Guardrail at \$10- per -Lin. Ft. for 422 LF = \$4220.</p> <p>Steel-Backed Timber w/o Blockout at \$60- per -Lin. Ft. for 362 LF = \$21720. Install 362 feet of Steel-Backed Timber w/o Blockout guardrail.</p> <p>Steel-backed timber / Log Flared at \$5000- per -Each for 2 Unit(s) = \$10000. Install 2 Steel backed timber flared end treatments.</p> <p>Low Speed Traffic Control at \$1475- per -Day for 4 Day(s) = \$5900. 2 days removal 2 days installation.</p>

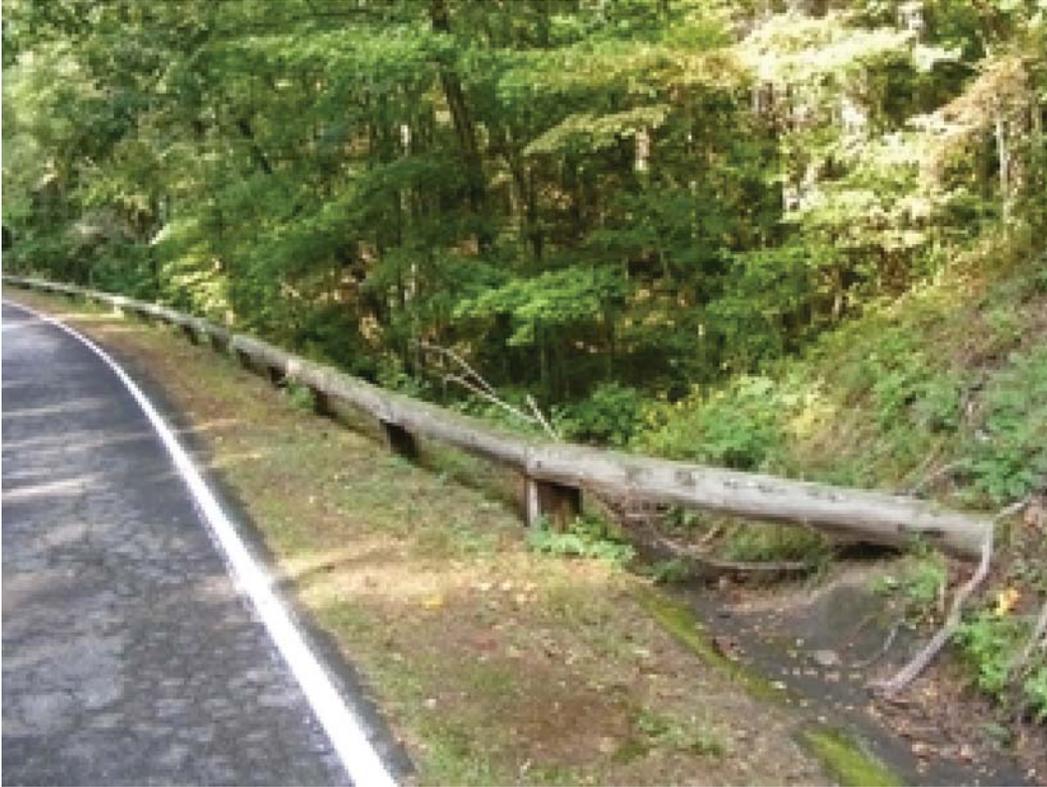
GRSM_0019_4.359_R_1.JPG

Barrier ID:	GRSM-0019-4.359-R				
Route Name:	LAKEVIEW DRIVE EAST				
Inspection Date:	09/17/2010	Barrier Rating:	39.40		
Barrier Description					
Type:	OTHER: TIMBER RAIL ON TIMBER POSTS	Barrier Function:	TRAFFIC		
Barrier Material:	LOG/TIMBER/WOOD	Post Material:	WOOD		
Blockout Type:	N/A	Length (ft.):	299		
Speed Limit (MPH):	35	Placement with Respect to Road:	OUTSIDE OF CURVE		
Hazard Behind Barrier:	MEDIUM				
Barrier Crashworthiness					
Appropriate Test Level:	TL-2	Barrier Test Level:	NCW	Is Barrier Crashworthy?:	NO
Beg. End Trtmt Type:	NONE	Is Beg. End Trtmt Crashworthy?:	N/A	Approach Transition Type:	NONE
Ending End Trtmt Type:	NONE	Ending End Trtmt Crashworthy?:	N/A		
Average Measurements					
Design Height (In.):	24	Width (In.):	0.0	Post Spacing (In.):	118.6
Height (In.):	21.7	Lateral Offset (In.):	71.0	Road Grade (%):	2.90
Physical Condition					
Barrier	Alignment and Height:	Alignment has no deviation and the height is 1-3 in below the 24 in design height.

Breaking and Cracking:	No breaking or cracking observed.			
	Missing Elements:	No missing elements observed.			
	Corrosion and Weathering:	All posts and rail observed as weathered. 29 posts observed as rotten and hollow.			
End Treatments	Alignment and Height:				
	Breaking and Cracking:				
	Missing Elements:				
	Corrosion and Weathering:

Repair Action:	REPLACE	FMSS Work Type:	CAPITAL IMPROVEMENT	Repair Cost:	\$36553
Brief Workorder:	Remove and replace existing timber guardrail with Steel-backed timber without blockouts and 2 Steel-backed timber flared end treatments.				
Workorder:	Remove Guardrail at \$10- per -Lin. Ft. for 299 LF = \$2990. Steel-Backed Timber w/o Blockout at \$60- per -Lin. Ft. for 239 LF = \$14340. Steel-backed timber / Log Flared at \$5000- per -Each for 2 Unit(s) = \$10000. Low Speed Traffic Control at \$1475- per -Day for 4 Day(s) = \$5900. 2 days removal 2 days installation.

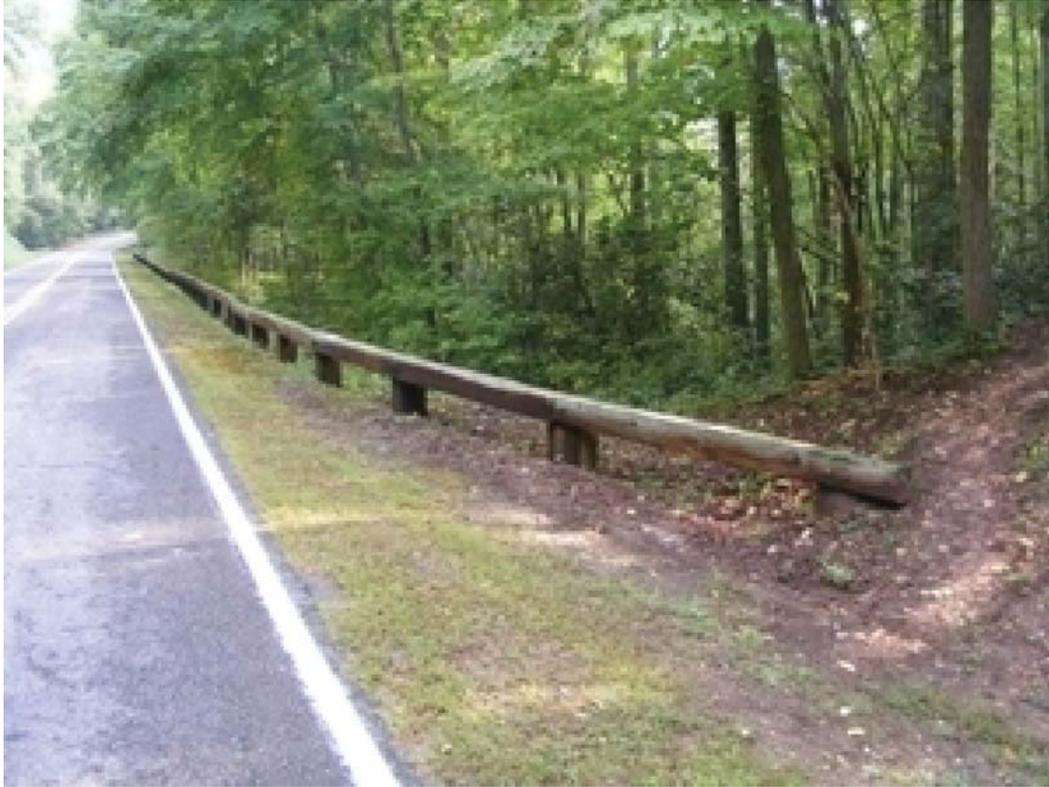
GRSM_0019_4.440_L_1.JPG

Barrier ID:	GRSM-0019-4.440-L				
Route Name:	LAKEVIEW DRIVE EAST				
Inspection Date:	09/17/2010	Barrier Rating:	39.50		
Barrier Description					
Type:	OTHER: TIMBER RAIL ON TIMBER POSTS	Barrier Function:	TRAFFIC		
Barrier Material:	LOG/TIMBER/WOOD	Post Material:	WOOD		
Blockout Type:	N/A	Length (ft.):	355		
Speed Limit (MPH):	35	Placement with Respect to Road:	OUTSIDE OF CURVE		
Hazard Behind Barrier:	MEDIUM				
Barrier Crashworthiness					
Appropriate Test Level:	TL-2	Barrier Test Level:	NCW	Is Barrier Crashworthy?:	NO
Beg. End Trtmt Type:	NONE	Is Beg. End Trtmt Crashworthy?:	N/A	Approach Transition Type:	NONE
Ending End Trtmt Type:	NONE	Ending End Trtmt Crashworthy?:	N/A		
Average Measurements					
Design Height (In.):	24	Width (In.):	0.0	Post Spacing (In.):	119.3
Height (In.):	22.2	Lateral Offset (In.):	67.0	Road Grade (%):	4.40
Physical Condition					
Barrier	Alignment and Height:	The barrier alignment has no deviation. 275 ft is 1-3 in below the 24 in design height.

Breaking and Cracking:	No breaking of barrier minor cracking of 1/4 to 1/2 in wide observed.			
	Missing Elements:	No missing elements observed.			
	Corrosion and Weathering:	Moderate corrosion and weathering observed on all posts and rail. 18 posts rotten and hollowed out on top.			
End Treatments	Alignment and Height:				
	Breaking and Cracking:				
	Missing Elements:				
	Corrosion and Weathering:

Repair Action:	REPAIR	FMSS Work Type:	DEFERRED MAINTENANCE	Repair Cost:	\$8250
Brief Workorder:	Raise 275-ft of barrier up to 24-in design height and replace 18 posts.				
Workorder:	Replace Post at \$100- per -Each for 18 Post(s) = \$1800. Replace rotten posts. Adjust Guardrail at \$10- per -Lin. Ft. for 275 LF = \$2750. Raise 275-ft of barrier up to 24-in design height. Low Speed Traffic Control at \$1475- per -Day for 2 Day(s) = \$2950.

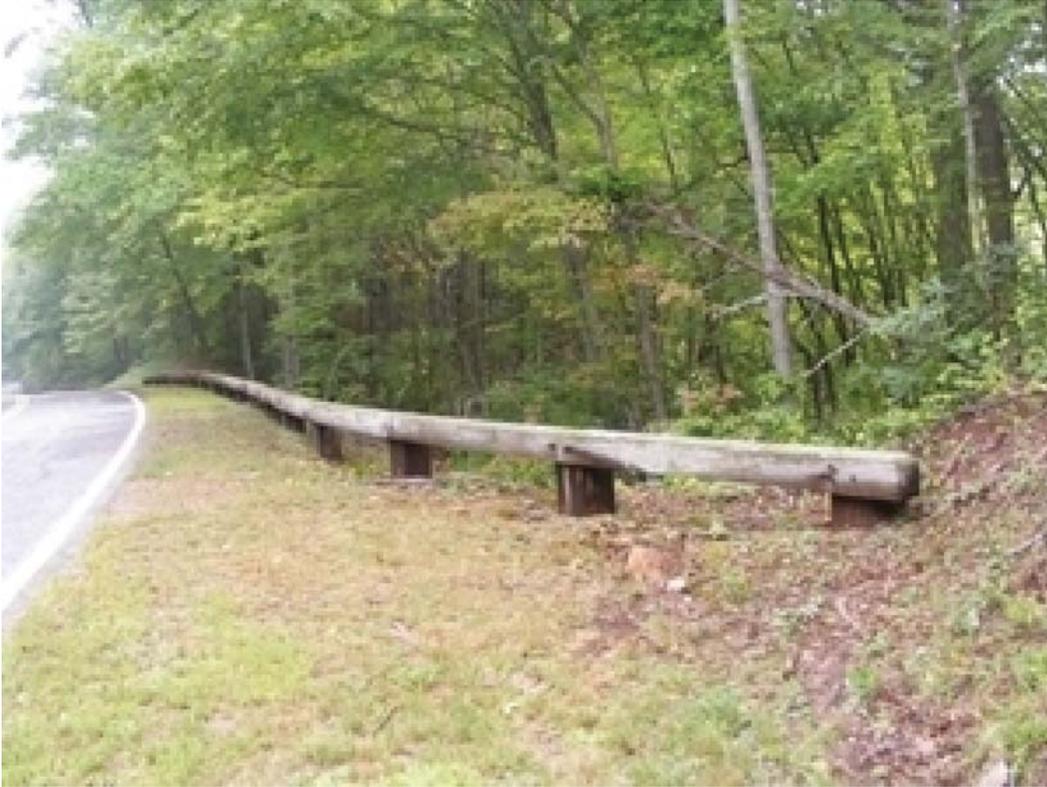
GRSM_0019_4.526_L_1.JPG

Barrier ID:	GRSM-0019-4.526-L				
Route Name:	LAKEVIEW DRIVE EAST				
Inspection Date:	09/17/2010	Barrier Rating:	32.20		
Barrier Description					
Type:	OTHER: TIMBER RAIL ON TIMBER POSTS	Barrier Function:	TRAFFIC		
Barrier Material:	LOG/TIMBER/WOOD	Post Material:	WOOD		
Blockout Type:	N/A	Length (ft.):	183		
Speed Limit (MPH):	35	Placement with Respect to Road:	OUTSIDE OF CURVE		
Hazard Behind Barrier:	MEDIUM				
Barrier Crashworthiness					
Appropriate Test Level:	TL-2	Barrier Test Level:	NCW	Is Barrier Crashworthy?:	NO
Beg. End Trtmt Type:	NONE	Is Beg. End Trtmt Crashworthy?:	N/A	Approach Transition Type:	NONE
Ending End Trtmt Type:	NONE	Ending End Trtmt Crashworthy?:	N/A		
Average Measurements					
Design Height (In.):	24	Width (In.):	0.0	Post Spacing (In.):	119.0
Height (In.):	19.2	Lateral Offset (In.):	75.5	Road Grade (%):	2.50
Physical Condition					
Barrier	Alignment and Height:	The alignment has no deviation and the height is 4-5 in below the 24 in design height.

Breaking and Cracking:	6 posts show breaking and cracking.			
	Missing Elements:	No missing elements observed.			
	Corrosion and Weathering:	Moderate corrosion and weathering observed on all posts and rails.			
End Treatments	Alignment and Height:				
	Breaking and Cracking:				
	Missing Elements:				
	Corrosion and Weathering:

Repair Action:	REPAIR	FMSS Work Type:	DEFERRED MAINTENANCE	Repair Cost:	\$4296
Brief Workorder:	Raise 183-ft of barrier up to 24-in design height and replace 6 posts.				
Workorder:	Replace Post at \$100- per -Each for 6 Post(s) = \$600. 6 rotten posts need replaced. Adjust Guardrail at \$10- per -Lin. Ft. for 183 LF = \$1830. Raise 183-ft of barrier up to 24-in design height. Low Speed Traffic Control at \$1475- per -Day for 1 Day(s) = \$1475.

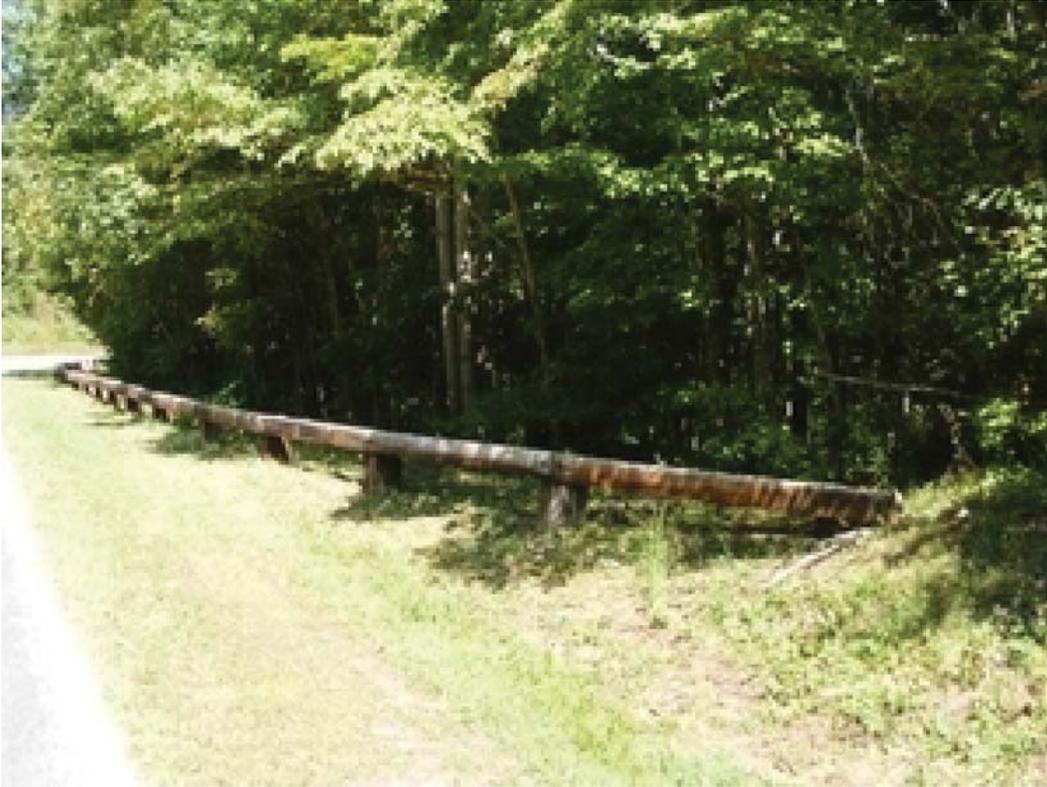
GRSM_0019_4.574_L_1.JPG

Barrier ID:	GRSM-0019-4.574-L				
Route Name:	LAKEVIEW DRIVE EAST				
Inspection Date:	09/15/2010	Barrier Rating:	47.90		
Barrier Description					
Type:	OTHER: TIMBER RAIL ON TIMBER POSTS	Barrier Function:	TRAFFIC		
Barrier Material:	LOG/TIMBER/WOOD	Post Material:	WOOD		
Blockout Type:	N/A	Length (ft.):	745		
Speed Limit (MPH):	35	Placement with Respect to Road:	OUTSIDE OF CURVE		
Hazard Behind Barrier:	MEDIUM				
Barrier Crashworthiness					
Appropriate Test Level:	TL-2	Barrier Test Level:	NCW	Is Barrier Crashworthy?:	NO
Beg. End Trtmt Type:	NONE	Is Beg. End Trtmt Crashworthy?:	N/A	Approach Transition Type:	NONE
Ending End Trtmt Type:	NONE	Ending End Trtmt Crashworthy?:	N/A		
Average Measurements					
Design Height (In.):	24	Width (In.):	0.0	Post Spacing (In.):	119.5
Height (In.):	18.0	Lateral Offset (In.):	89.1	Road Grade (%):	6.00
Physical Condition					
Barrier	Alignment and Height:	The alignment has no deviation and the height is 4-8 in below the 24 in design height.

Breaking and Cracking:	5 broken cracked or rotten rails and 26 rotten and hollow posts observed.			
	Missing Elements:	No missing elements observed.			
	Corrosion and Weathering:	Corrosion and weathering observed on all posts and rail.			
End Treatments	Alignment and Height:				
	Breaking and Cracking:				
	Missing Elements:				
	Corrosion and Weathering:

Repair Action:	REPLACE	FMSS Work Type:	CAPITAL IMPROVEMENT	Repair Cost:	\$74140
Brief Workorder:	Remove and replace existing timber guardrail with Steel-backed timber without blockouts and 2 Steel-backed timber flared end treatments.				
Workorder:	Remove Guardrail at \$10- per -Lin. Ft. for 745 LF = \$7450. Remove existing timber guardrail. Steel-Backed Timber w/o Blockout at \$60- per -Lin. Ft. for 685 LF = \$41100. 685 feet (745 ft - 60 ft) SBT / Log Flared at \$5000- per -Each for 2 Unit(s) = \$10000. Install 2 SBT flared end treatments. Low Speed Traffic Control at \$1475- per -Day for 6 Day(s) = \$8850. 3 days removal and 3 days installation.

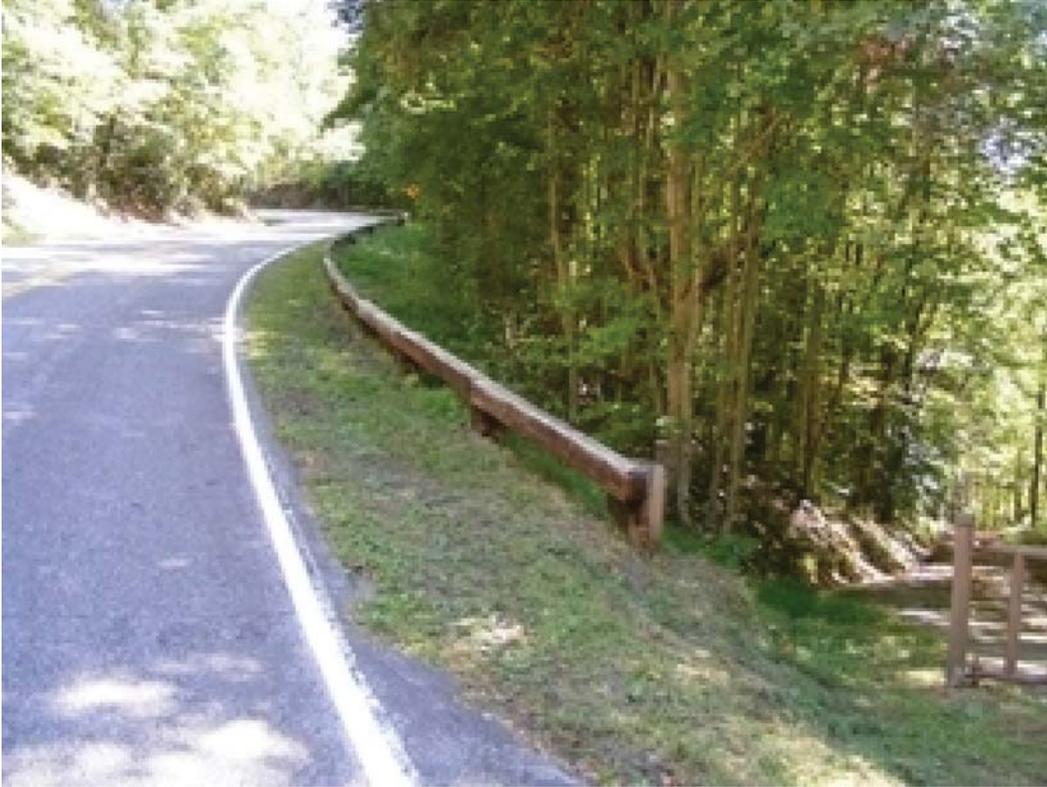
GRSM_0019_5.016_L_1.JPG

Barrier ID:	GRSM-0019-5.016-L				
Route Name:	LAKEVIEW DRIVE EAST				
Inspection Date:	09/15/2010	Barrier Rating:	41.20		
Barrier Description					
Type:	OTHER: TIMBER RAIL ON TIMBER POSTS	Barrier Function:	TRAFFIC		
Barrier Material:	LOG/TIMBER/WOOD	Post Material:	WOOD		
Blockout Type:	N/A	Length (ft.):	401		
Speed Limit (MPH):	35	Placement with Respect to Road:	BOTH INSIDE AND OUTSIDE		
Hazard Behind Barrier:	LOW				
Barrier Crashworthiness					
Appropriate Test Level:	TL-2	Barrier Test Level:	NCW	Is Barrier Crashworthy?:	NO
Beg. End Trtmt Type:	NONE	Is Beg. End Trtmt Crashworthy?:	N/A	Approach Transition Type:	NONE
Ending End Trtmt Type:	NONE	Ending End Trtmt Crashworthy?:	N/A		
Average Measurements					
Design Height (In.):	24	Width (In.):	0.0	Post Spacing (In.):	121.0
Height (In.):	22.0	Lateral Offset (In.):	71.0	Road Grade (%):	10.10
Physical Condition					
Barrier	Alignment and Height:	The alignment has no deviation and 300 ft is 1-3 in below the 24 in design height.

Breaking and Cracking:	1 broken rail and 12 rotten and hollowed out posts observed.			
	Missing Elements:	No missing elements observed.			
	Corrosion and Weathering:	Corrosion and weathering observed on all posts and rail.			
End Treatments	Alignment and Height:				
	Breaking and Cracking:				
	Missing Elements:				
	Corrosion and Weathering:

Repair Action:	REPAIR	FMSS Work Type:	DEFERRED MAINTENANCE	Repair Cost:	\$8140
Brief Workorder:	Raise 300-ft of barrier up to 24-in design height replace 12 posts and 10 feet of rail.				
Workorder:	Replace Rail at \$25- per -Lin. Ft. for 10 LF = \$250. Replace Post at \$100- per -Each for 12 Post(s) = \$1200. Adjust Guardrail at \$10- per -Lin. Ft. for 300 LF = \$3000. Raise 300-ft of barrier up to 24-in design height. Low Speed Traffic Control at \$1475- per -Day for 2 Day(s) = \$2950.

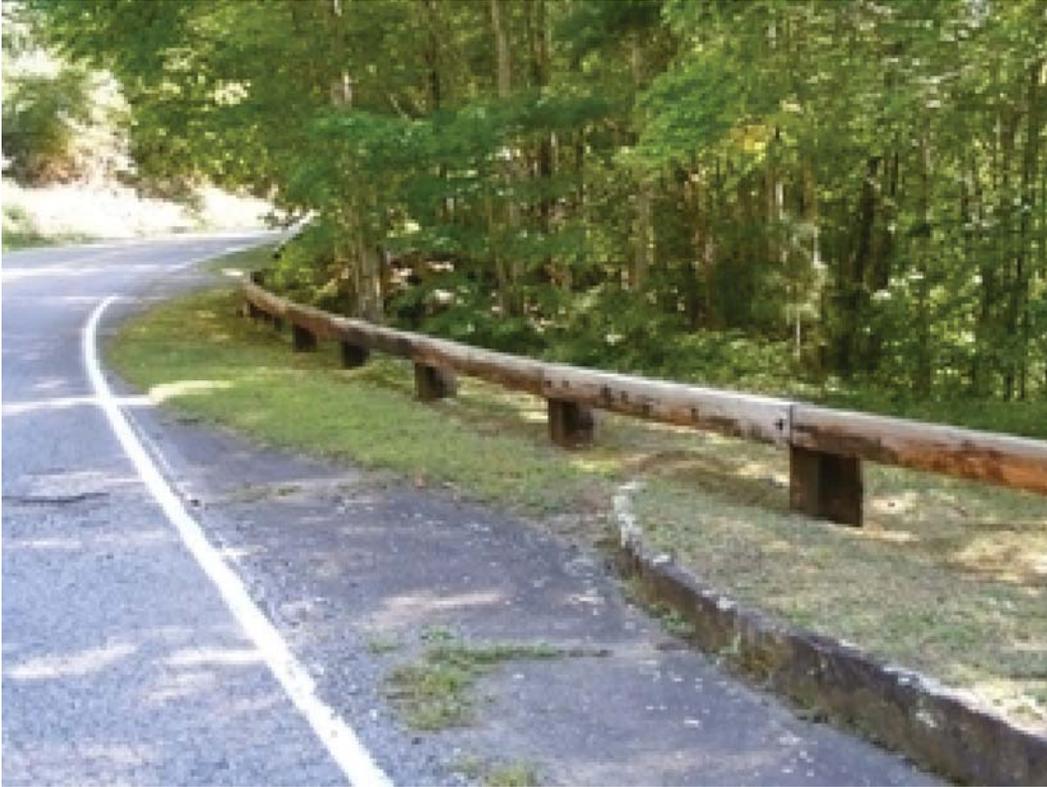
GRSM_0019_5.101_L_1.JPG

Barrier ID:	GRSM-0019-5.101-L				
Route Name:	LAKEVIEW DRIVE EAST				
Inspection Date:	09/15/2010	Barrier Rating:	22.20		
Barrier Description					
Type:	OTHER: TIMBER RAIL ON TIMBER POSTS	Barrier Function:	TRAFFIC		
Barrier Material:	LOG/TIMBER/WOOD	Post Material:	WOOD		
Blockout Type:	N/A	Length (ft.):	125		
Speed Limit (MPH):	35	Placement with Respect to Road:	INSIDE OF CURVE		
Hazard Behind Barrier:	MEDIUM				
Barrier Crashworthiness					
Appropriate Test Level:	TL-2	Barrier Test Level:	NCW	Is Barrier Crashworthy?:	NO
Beg. End Trtmt Type:	NONE	Is Beg. End Trtmt Crashworthy?:	N/A	Approach Transition Type:	NONE
Ending End Trtmt Type:	NONE	Ending End Trtmt Crashworthy?:	N/A		
Average Measurements					
Design Height (In.):	24	Width (In.):	0.0	Post Spacing (In.):	119.3
Height (In.):	21.0	Lateral Offset (In.):	92.0	Road Grade (%):	8.70
Physical Condition					
Barrier	Alignment and Height:	The alignment has no deviation and the height is 3 in below the 24 in design height.

Breaking and Cracking:	No breaking or cracking observed.			
	Missing Elements:	No missing elements observed.			
	Corrosion and Weathering:	6 posts observed as rotted and hollow.			
End Treatments	Alignment and Height:				
	Breaking and Cracking:				
	Missing Elements:				
	Corrosion and Weathering:

Repair Action:	REPAIR	FMSS Work Type:	DEFERRED MAINTENANCE	Repair Cost:	\$3658
Brief Workorder:	Raise 125-ft of barrier up to 24-in design height and replace 6 posts.				
Workorder:	Replace Post at \$100- per -Each for 6 Post(s) = \$600. Replace 6 rotted posts. Adjust Guardrail at \$10- per -Lin. Ft. for 125 LF = \$1250. Raise 125-ft of barrier up to 24-in design height. Low Speed Traffic Control at \$1475- per -Day for 1 Day(s) = \$1475.

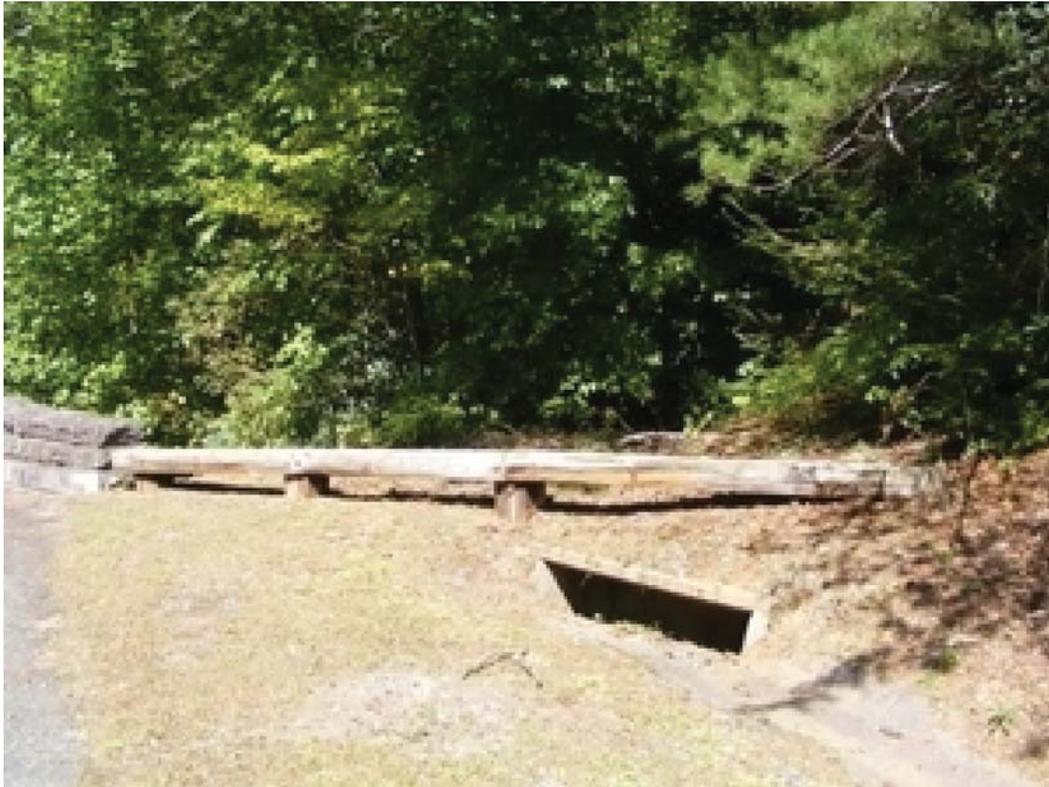
GRSM_0019_5.187_R_1.JPG

Barrier ID:	GRSM-0019-5.187-R				
Route Name:	LAKEVIEW DRIVE EAST				
Inspection Date:	09/15/2010	Barrier Rating:	30.80		
Barrier Description					
Type:	OTHER: TIMBER RAIL ON TIMBER POSTS	Barrier Function:	TRAFFIC		
Barrier Material:	LOG/TIMBER/WOOD	Post Material:	WOOD		
Blockout Type:	N/A	Length (ft.):	26		
Speed Limit (MPH):	35	Placement with Respect to Road:	INSIDE OF CURVE		
Hazard Behind Barrier:	MEDIUM				
Barrier Crashworthiness					
Appropriate Test Level:	TL-2	Barrier Test Level:	NCW	Is Barrier Crashworthy?:	NO
Beg. End Trtmt Type:	NONE	Is Beg. End Trtmt Crashworthy?:	N/A	Approach Transition Type:	NONE
Ending End Trtmt Type:	NONE	Ending End Trtmt Crashworthy?:	N/A		
Average Measurements					
Design Height (In.):	24	Width (In.):	0.0	Post Spacing (In.):	91.3
Height (In.):	17.0	Lateral Offset (In.):	163.3	Road Grade (%):	5.10
Physical Condition					
Barrier	Alignment and Height:	The alignment has no deviation and the height is 6-8 in below the 24 in design height.

Breaking and Cracking:	No breaking or cracking observed.			
	Missing Elements:	No missing elements observed.			
	Corrosion and Weathering:	No weathering observed.			
End Treatments	Alignment and Height:				
	Breaking and Cracking:				
	Missing Elements:				
	Corrosion and Weathering:

Repair Action:	REPAIR	FMSS Work Type:	DEFERRED MAINTENANCE	Repair Cost:	\$1821
Brief Workorder:	Raise 26-ft of barrier up to 24-in design height.				
Workorder:	Adjust Guardrail at \$10- per -Lin. Ft. for 26 LF = \$260. Raise 26-ft of barrier up to 24-in design height. Low Speed Traffic Control at \$1475- per -Day for 1 Day(s) = \$1475.
