NPS Guardwall/Rail Inventory Program
Great Smoky Mountains National Park

Federal Highway Administration
Eastern Federal Lands Highway Division
Road Inventory Program (RIP)

Data Collection Date: September 2010
Report Date: December 2015

Great Smoky Mountains National Park in North Carolina and Tennessee

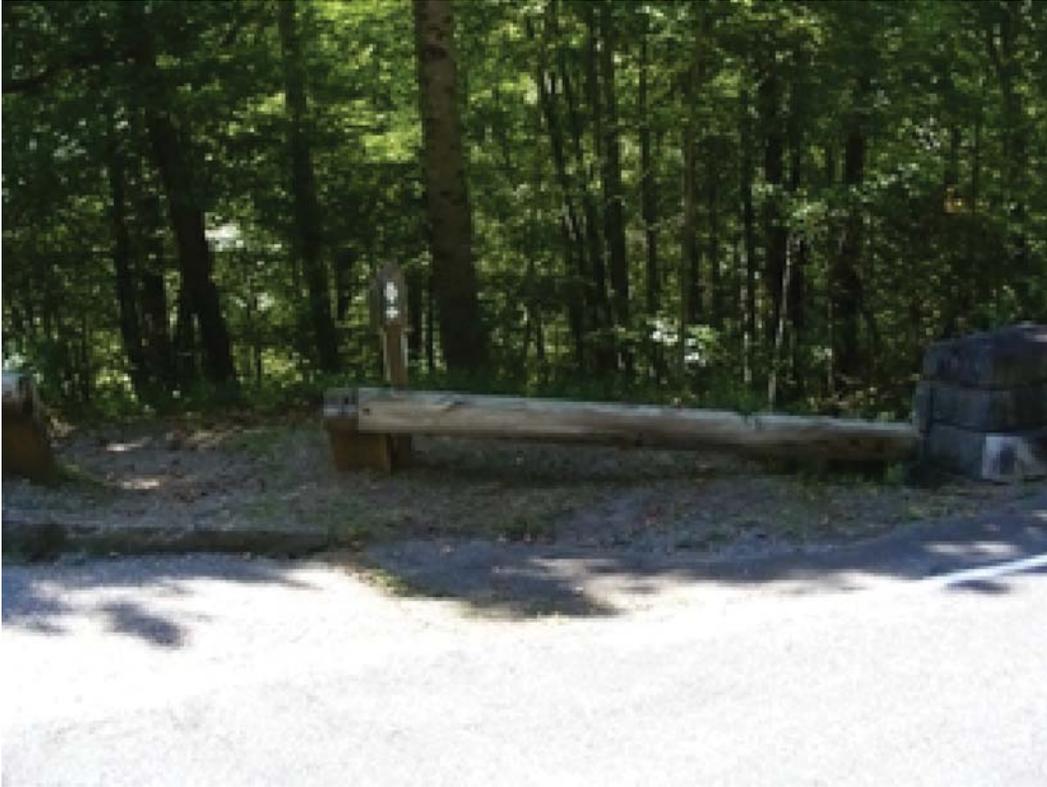
GRSM_0019_5.189_L_1.JPG

Barrier ID:	GRSM-0019-5.189-L				
Route Name:	LAKEVIEW DRIVE EAST				
Inspection Date:	09/15/2010	Barrier Rating:	22.20		
Barrier Description					
Type:	OTHER: TIMBER RAIL ON TIMBER POSTS	Barrier Function:	TRAFFIC		
Barrier Material:	LOG/TIMBER/WOOD	Post Material:	WOOD		
Blockout Type:	N/A	Length (ft.):	11		
Speed Limit (MPH):	35	Placement with Respect to Road:	INSIDE OF CURVE		
Hazard Behind Barrier:	MEDIUM				
Barrier Crashworthiness					
Appropriate Test Level:	TL-2	Barrier Test Level:	NCW	Is Barrier Crashworthy?:	NO
Beg. End Trtmt Type:	NONE	Is Beg. End Trtmt Crashworthy?:	N/A	Approach Transition Type:	NONE
Ending End Trtmt Type:	NONE	Ending End Trtmt Crashworthy?:	N/A		
Average Measurements					
Design Height (In.):	24	Width (In.):	0.0	Post Spacing (In.):	112.0
Height (In.):	16.2	Lateral Offset (In.):	74.0	Road Grade (%):	9.80
Physical Condition					
Barrier	Alignment and Height:	Alignment allows for opening in barrier due to trailhead. Height is 4-11 in below the 24 in design height.

Breaking and Cracking:	One end of rail is observed to be cracked.			
	Missing Elements:	No missing elements observed.			
	Corrosion and Weathering:	No corrosion or weathering observed.			
End Treatments	Alignment and Height:				
	Breaking and Cracking:				
	Missing Elements:				
	Corrosion and Weathering:

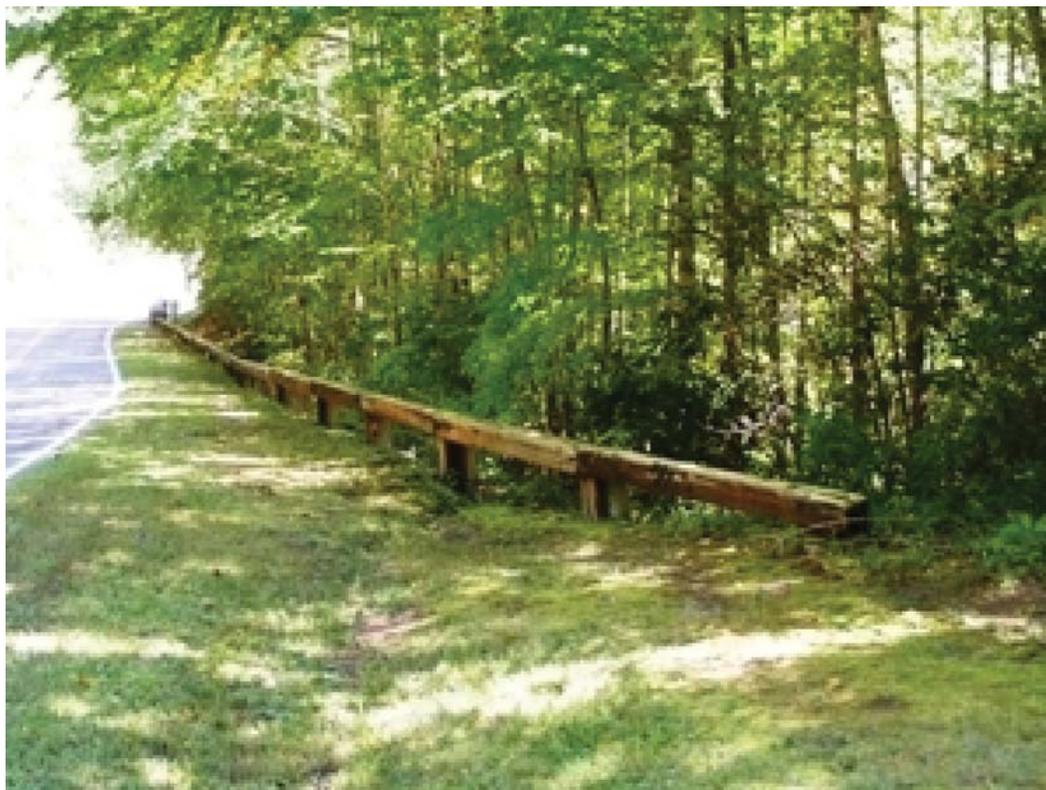
GRSM_0019_5.275_L_1.JPG

Barrier ID:	GRSM-0019-5.275-L				
Route Name:	LAKEVIEW DRIVE EAST				
Inspection Date:	09/15/2010	Barrier Rating:	48.00		
Barrier Description					
Type:	OTHER: TIMBER RAIL ON TIMBER POSTS	Barrier Function:	TRAFFIC		
Barrier Material:	LOG/TIMBER/WOOD	Post Material:	WOOD		
Blockout Type:	N/A	Length (ft.):	273		
Speed Limit (MPH):	35	Placement with Respect to Road:	OUTSIDE OF CURVE		
Hazard Behind Barrier:	MEDIUM				
Barrier Crashworthiness					
Appropriate Test Level:	TL-2	Barrier Test Level:	NCW	Is Barrier Crashworthy?:	NO
Beg. End Trtmt Type:	NONE	Is Beg. End Trtmt Crashworthy?:	N/A	Approach Transition Type:	NONE
Ending End Trtmt Type:	NONE	Ending End Trtmt Crashworthy?:	N/A		
Average Measurements					
Design Height (In.):	24	Width (In.):	0.0	Post Spacing (In.):	121.0
Height (In.):	19.0	Lateral Offset (In.):	98.5	Road Grade (%):	10.00
Physical Condition					
Barrier	Alignment and Height:	The alignment has no deviation and the height is 2-8 in below the 24 in design height.

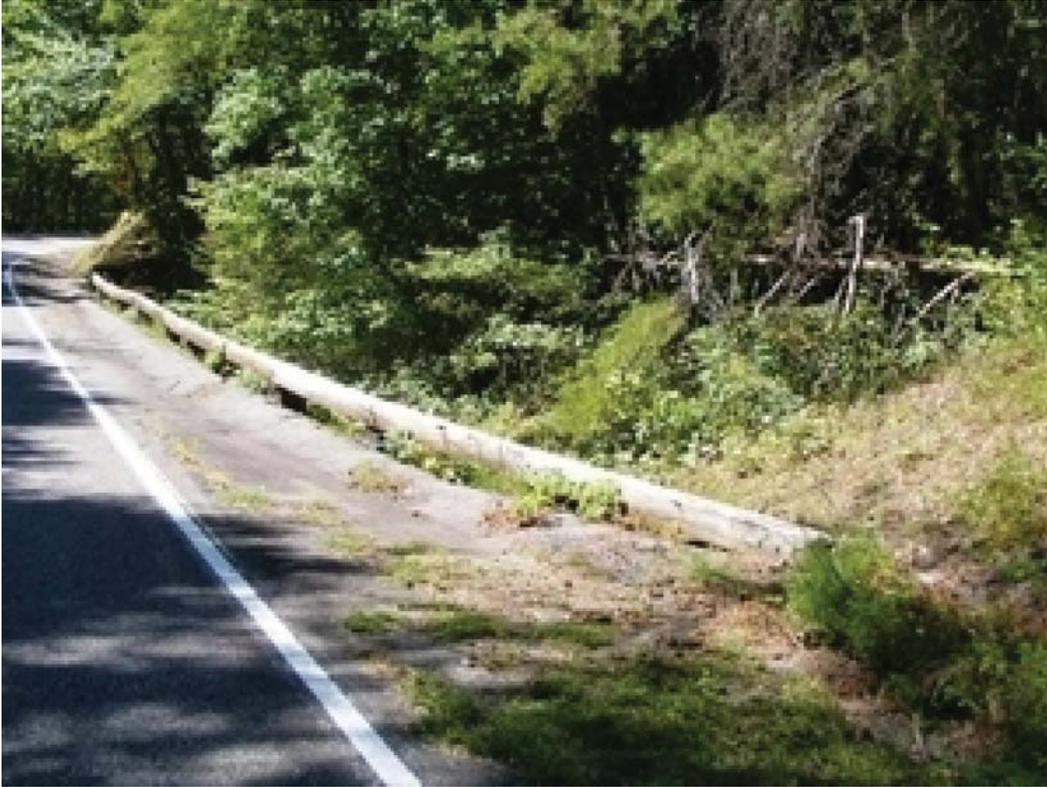
GRSM_0019_5.289_R_1.JPG

Barrier ID:	GRSM-0019-5.289-R				
Route Name:	LAKEVIEW DRIVE EAST				
Inspection Date:	09/15/2010	Barrier Rating:	23.70		
Barrier Description					
Type:	OTHER: TIMBER RAIL ON TIMBER POSTS	Barrier Function:	TRAFFIC		
Barrier Material:	LOG/TIMBER/WOOD	Post Material:	WOOD		
Blockout Type:	N/A	Length (ft.):	153		
Speed Limit (MPH):	35	Placement with Respect to Road:	TANGENT		
Hazard Behind Barrier:	MEDIUM				
Barrier Crashworthiness					
Appropriate Test Level:	TL-2	Barrier Test Level:	NCW	Is Barrier Crashworthy?:	NO
Beg. End Trtmt Type:	NONE	Is Beg. End Trtmt Crashworthy?:	N/A	Approach Transition Type:	NONE
Ending End Trtmt Type:	NONE	Ending End Trtmt Crashworthy?:	N/A		
Average Measurements					
Design Height (In.):	24	Width (In.):	0.0	Post Spacing (In.):	118.3
Height (In.):	15.0	Lateral Offset (In.):	76.0	Road Grade (%):	8.60
Physical Condition					
Barrier	Alignment and Height:	The alignment has no deviation and the height is 8-10 in below the 24 in design height.

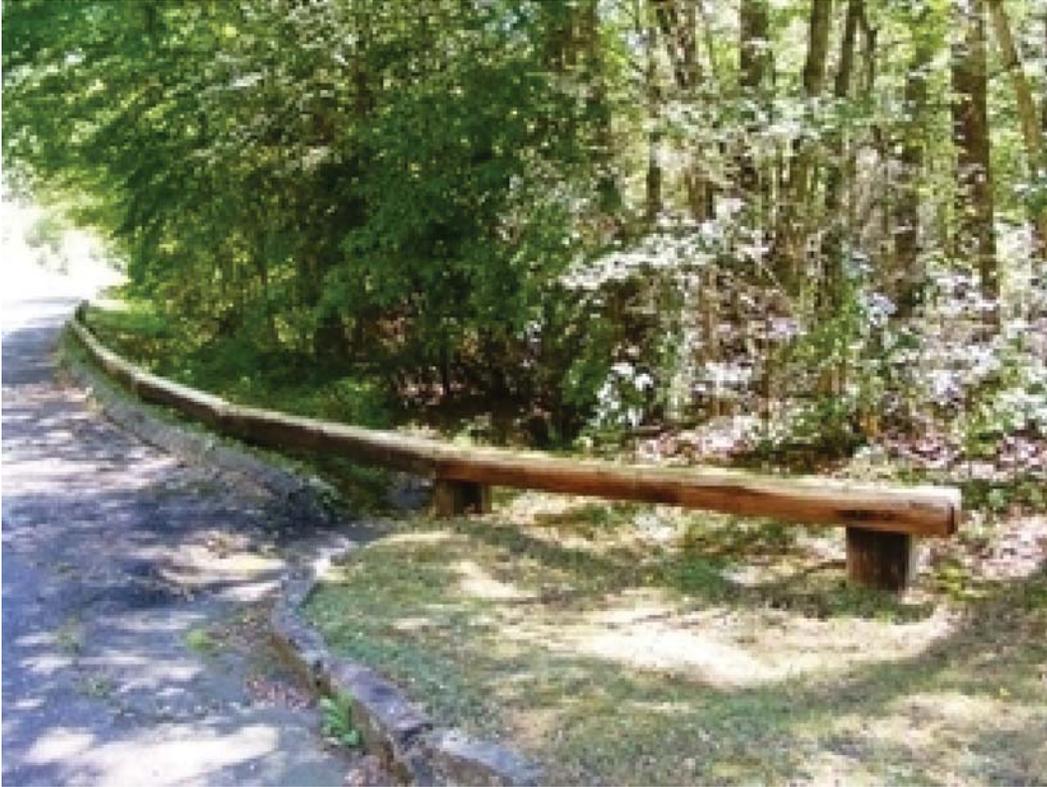
GRSM_0019_5.347_L_1.JPG

Barrier ID:	GRSM-0019-5.347-L				
Route Name:	LAKEVIEW DRIVE EAST				
Inspection Date:	09/15/2010	Barrier Rating:	42.50		
Barrier Description					
Type:	OTHER: TIMBER RAIL ON TIMBER POSTS	Barrier Function:	TRAFFIC		
Barrier Material:	LOG/TIMBER/WOOD	Post Material:	WOOD		
Blockout Type:	N/A	Length (ft.):	965		
Speed Limit (MPH):	35	Placement with Respect to Road:	INSIDE OF CURVE		
Hazard Behind Barrier:	HIGH				
Barrier Crashworthiness					
Appropriate Test Level:	TL-2	Barrier Test Level:	NCW	Is Barrier Crashworthy?:	NO
Beg. End Trtmt Type:	NONE	Is Beg. End Trtmt Crashworthy?:	N/A	Approach Transition Type:	NONE
Ending End Trtmt Type:	NONE	Ending End Trtmt Crashworthy?:	N/A		
Average Measurements					
Design Height (In.):	24	Width (In.):	0.0	Post Spacing (In.):	121.0
Height (In.):	21.7	Lateral Offset (In.):	70.1	Road Grade (%):	4.90
Physical Condition					
Barrier	Alignment and Height:	The alignment has no deviation and the height is 1-3 in below the 24 in design height.

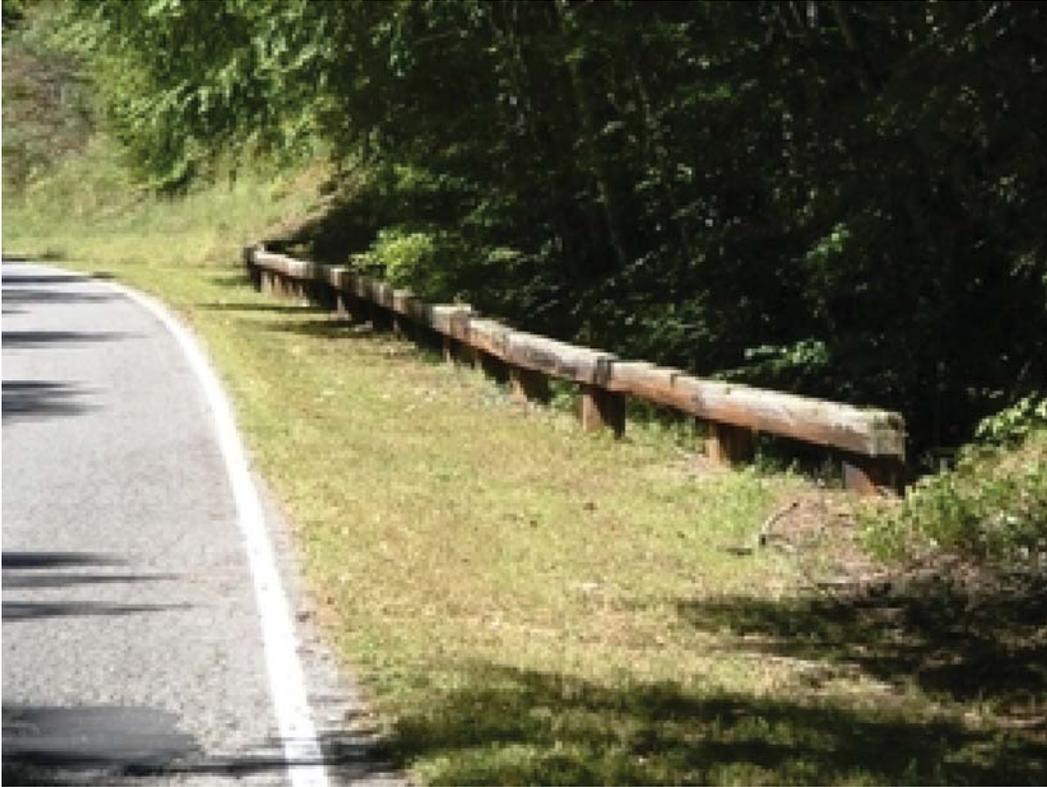
GRSM_0019_5.377_R_1.JPG

Barrier ID:	GRSM-0019-5.377-R				
Route Name:	LAKEVIEW DRIVE EAST				
Inspection Date:	09/15/2010	Barrier Rating:	21.20		
Barrier Description					
Type:	OTHER: TIMBER RAIL ON TIMBER POSTS	Barrier Function:	TRAFFIC		
Barrier Material:	LOG/TIMBER/WOOD	Post Material:	WOOD		
Blockout Type:	N/A	Length (ft.):	214		
Speed Limit (MPH):	35	Placement with Respect to Road:	TANGENT		
Hazard Behind Barrier:	LOW				
Barrier Crashworthiness					
Appropriate Test Level:	TL-2	Barrier Test Level:	NCW	Is Barrier Crashworthy?:	NO
Beg. End Trtmt Type:	NONE	Is Beg. End Trtmt Crashworthy?:	N/A	Approach Transition Type:	NONE
Ending End Trtmt Type:	NONE	Ending End Trtmt Crashworthy?:	N/A		
Average Measurements					
Design Height (In.):	24	Width (In.):	0.0	Post Spacing (In.):	120.0
Height (In.):	25.0	Lateral Offset (In.):	86.5	Road Grade (%):	9.10
Physical Condition					
Barrier	Alignment and Height:	The alignment has no deviation and the height ranges from 1 in below to 4 in above the 24 in design height.

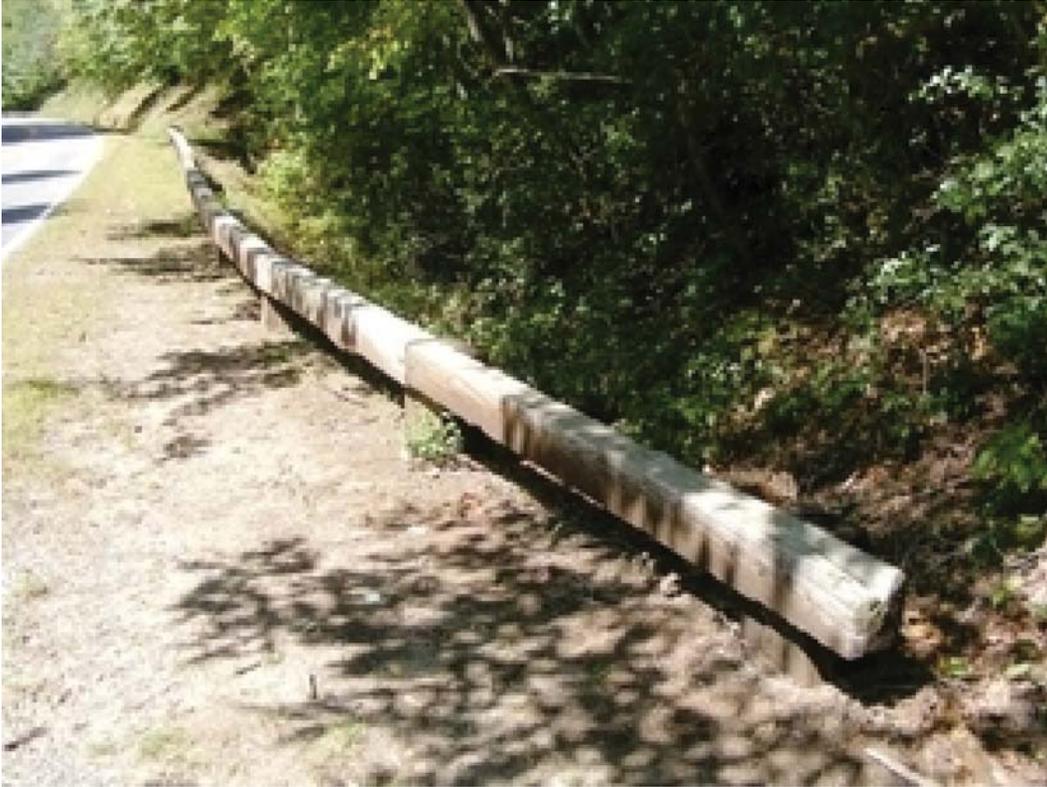
GRSM_0019_5.478_R_1.JPG

Barrier ID:	GRSM-0019-5.478-R				
Route Name:	LAKEVIEW DRIVE EAST				
Inspection Date:	09/15/2010	Barrier Rating:	27.80		
Barrier Description					
Type:	OTHER: TIMBER RAIL ON TIMBER POSTS	Barrier Function:	TRAFFIC		
Barrier Material:	LOG/TIMBER/WOOD	Post Material:	WOOD		
Blockout Type:	N/A	Length (ft.):	150		
Speed Limit (MPH):	35	Placement with Respect to Road:	OUTSIDE OF CURVE		
Hazard Behind Barrier:	MEDIUM				
Barrier Crashworthiness					
Appropriate Test Level:	TL-2	Barrier Test Level:	NCW	Is Barrier Crashworthy?:	NO
Beg. End Trtmt Type:	NONE	Is Beg. End Trtmt Crashworthy?:	N/A	Approach Transition Type:	NONE
Ending End Trtmt Type:	NONE	Ending End Trtmt Crashworthy?:	N/A		
Average Measurements					
Design Height (In.):	24	Width (In.):	0.0	Post Spacing (In.):	118.3
Height (In.):	26.0	Lateral Offset (In.):	78.6	Road Grade (%):	6.50
Physical Condition					
Barrier	Alignment and Height:	Barrier observed as 6 in or less off alignment for 20 ft. Height is 0-4 in above the 24 in design height.

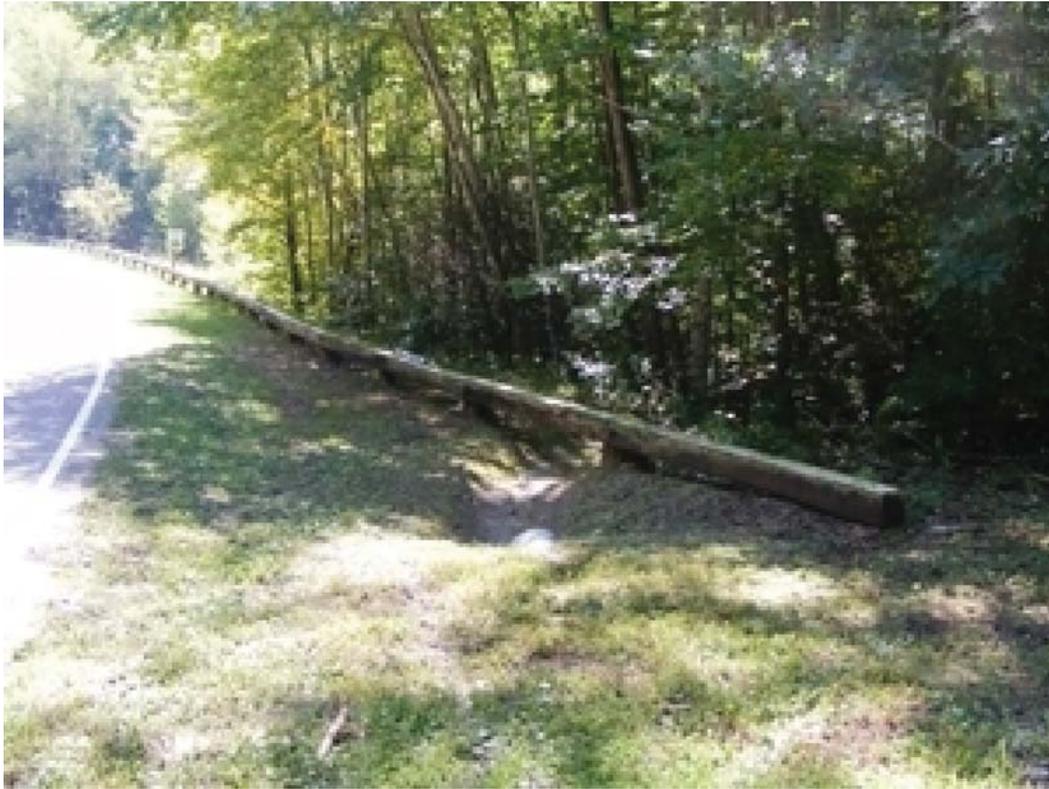
GRSM_0019_5.568_L_1.JPG

Barrier ID:	GRSM-0019-5.568-L				
Route Name:	LAKEVIEW DRIVE EAST				
Inspection Date:	09/15/2010	Barrier Rating:	46.90		
Barrier Description					
Type:	OTHER: TIMBER RAIL ON TIMBER POSTS	Barrier Function:	TRAFFIC		
Barrier Material:	LOG/TIMBER/WOOD	Post Material:	WOOD		
Blockout Type:	N/A	Length (ft.):	1447		
Speed Limit (MPH):	35	Placement with Respect to Road:	INSIDE OF CURVE		
Hazard Behind Barrier:	HIGH				
Barrier Crashworthiness					
Appropriate Test Level:	TL-2	Barrier Test Level:	NCW	Is Barrier Crashworthy?:	NO
Beg. End Trtmt Type:	NONE	Is Beg. End Trtmt Crashworthy?:	N/A	Approach Transition Type:	NONE
Ending End Trtmt Type:	NONE	Ending End Trtmt Crashworthy?:	N/A		
Average Measurements					
Design Height (In.):	24	Width (In.):	0.0	Post Spacing (In.):	119.4
Height (In.):	23.3	Lateral Offset (In.):	97.0	Road Grade (%):	5.00
Physical Condition					
Barrier	Alignment and Height:	The alignment has no deviation and the height ranges from 6 in below to 1 in above the 24 in design height with 800 ft being 1-6 in below.

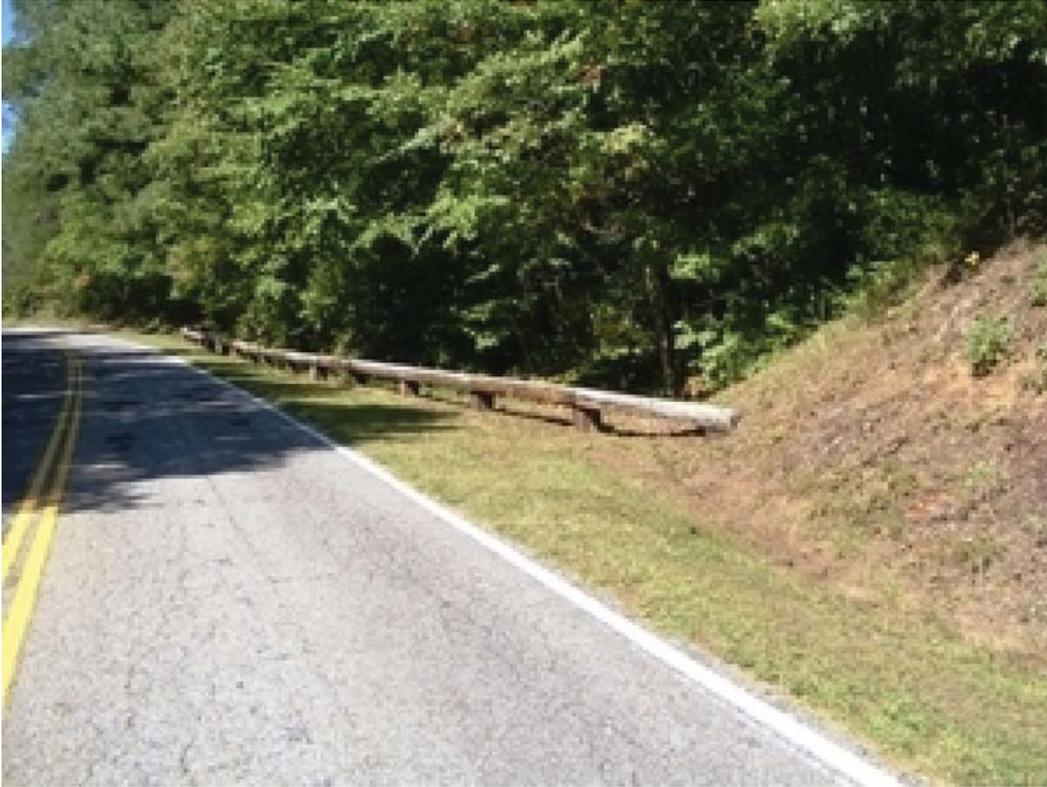
GRSM_0019_5.571_R_1.JPG

Barrier ID:	GRSM-0019-5.571-R				
Route Name:	LAKEVIEW DRIVE EAST				
Inspection Date:	09/15/2010	Barrier Rating:	25.30		
Barrier Description					
Type:	OTHER: TIMBER RAIL ON TIMBER POSTS	Barrier Function:	TRAFFIC		
Barrier Material:	LOG/TIMBER/WOOD	Post Material:	WOOD		
Blockout Type:	N/A	Length (ft.):	190		
Speed Limit (MPH):	35	Placement with Respect to Road:	OUTSIDE OF CURVE		
Hazard Behind Barrier:	LOW				
Barrier Crashworthiness					
Appropriate Test Level:	TL-2	Barrier Test Level:	NCW	Is Barrier Crashworthy?:	NO
Beg. End Trtmt Type:	NONE	Is Beg. End Trtmt Crashworthy?:	N/A	Approach Transition Type:	NONE
Ending End Trtmt Type:	OTHER: TIMBER BURIED	Ending End Trtmt Crashworthy?:	NO		
Average Measurements					
Design Height (In.):	24	Width (In.):	0.0	Post Spacing (In.):	118.0
Height (In.):	24.0	Lateral Offset (In.):	78.0	Road Grade (%):	6.40
Physical Condition					
Barrier	Alignment and Height:	The alignment has no deviation and the height ranges from 1 in below to 2 in above the 24 in design height.

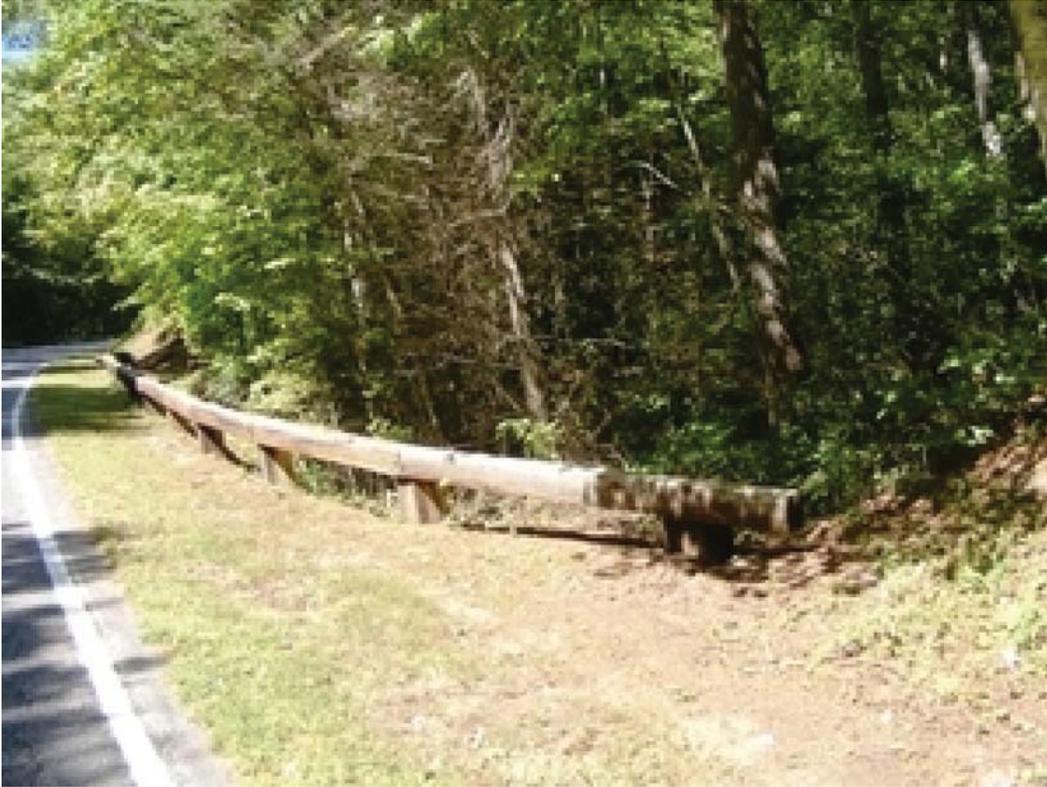
GRSM_0019_5.697_R_1.JPG

Barrier ID:	GRSM-0019-5.697-R				
Route Name:	LAKEVIEW DRIVE EAST				
Inspection Date:	09/15/2010	Barrier Rating:	22.20		
Barrier Description					
Type:	OTHER: TIMBER RAIL ON TIMBER POSTS	Barrier Function:	TRAFFIC		
Barrier Material:	LOG/TIMBER/WOOD	Post Material:	WOOD		
Blockout Type:	N/A	Length (ft.):	134		
Speed Limit (MPH):	35	Placement with Respect to Road:	INSIDE OF CURVE		
Hazard Behind Barrier:	MEDIUM				
Barrier Crashworthiness					
Appropriate Test Level:	TL-2	Barrier Test Level:	NCW	Is Barrier Crashworthy?:	NO
Beg. End Trtmt Type:	NONE	Is Beg. End Trtmt Crashworthy?:	N/A	Approach Transition Type:	NONE
Ending End Trtmt Type:	NONE	Ending End Trtmt Crashworthy?:	N/A		
Average Measurements					
Design Height (In.):	24	Width (In.):	0.0	Post Spacing (In.):	119.5
Height (In.):	24.2	Lateral Offset (In.):	72.3	Road Grade (%):	2.00
Physical Condition					
Barrier	Alignment and Height:	The alignment has no deviation and the height is 0-2 in below the 24 in design height.

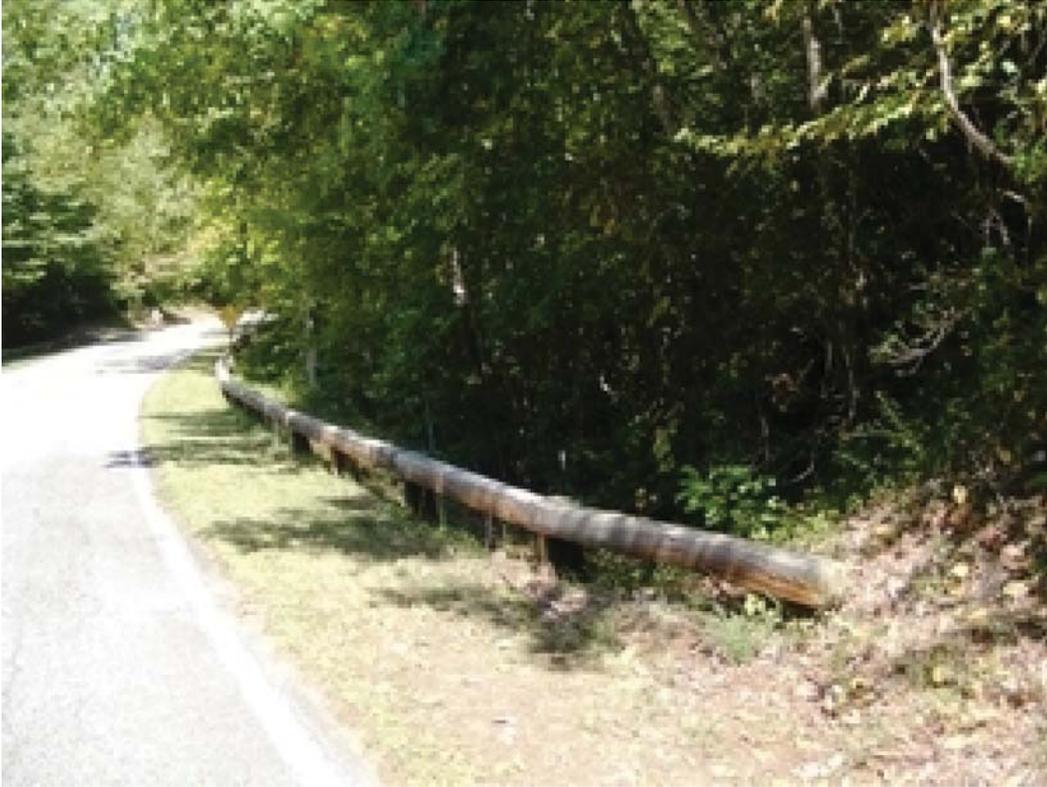
GRSM_0019_5.793_R_1.JPG

Barrier ID:	GRSM-0019-5.793-R				
Route Name:	LAKEVIEW DRIVE EAST				
Inspection Date:	09/15/2010	Barrier Rating:	25.10		
Barrier Description					
Type:	OTHER: TIMBER RAIL ON TIMBER POSTS	Barrier Function:	TRAFFIC		
Barrier Material:	LOG/TIMBER/WOOD	Post Material:	WOOD		
Blockout Type:	N/A	Length (ft.):	266		
Speed Limit (MPH):	35	Placement with Respect to Road:	INSIDE OF CURVE		
Hazard Behind Barrier:	MEDIUM				
Barrier Crashworthiness					
Appropriate Test Level:	TL-2	Barrier Test Level:	NCW	Is Barrier Crashworthy?:	NO
Beg. End Trtmt Type:	NONE	Is Beg. End Trtmt Crashworthy?:	N/A	Approach Transition Type:	NONE
Ending End Trtmt Type:	NONE	Ending End Trtmt Crashworthy?:	N/A		
Average Measurements					
Design Height (In.):	24	Width (In.):	0.0	Post Spacing (In.):	119.3
Height (In.):	25.0	Lateral Offset (In.):	86.3	Road Grade (%):	6.00
Physical Condition					
Barrier	Alignment and Height:	The alignment has no deviation and the height is 1 in above the 24 in design height.

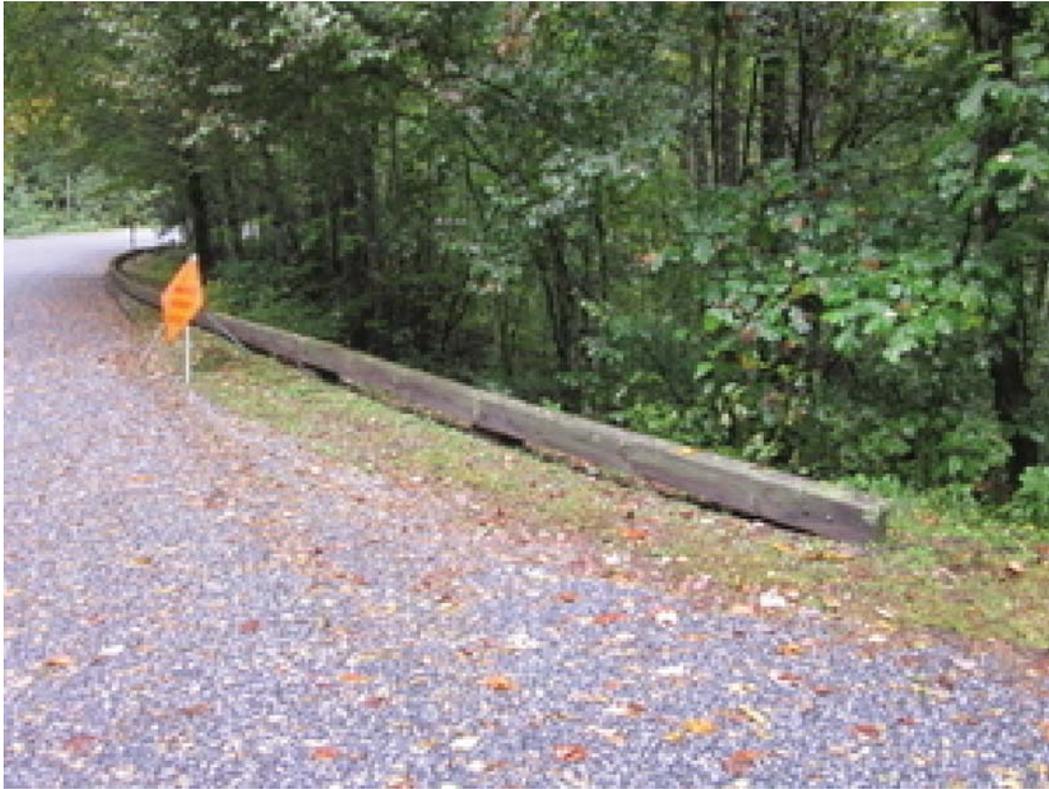
GRSM_0022_0.009_R_1.JPG

Barrier ID:	GRSM-0022-0.009-R				
Route Name:	CATALOOCHEE ENTRANCE ROAD				
Inspection Date:	09/27/2010	Barrier Rating:	29.50		
Barrier Description					
Type:	OTHER: TIMBER RAIL ON TIMBER POSTS	Barrier Function:	TRAFFIC		
Barrier Material:	LOG/TIMBER/WOOD	Post Material:	WOOD		
Blockout Type:	N/A	Length (ft.):	305		
Speed Limit (MPH):	25	Placement with Respect to Road:	INSIDE OF CURVE		
Hazard Behind Barrier:	MEDIUM				
Barrier Crashworthiness					
Appropriate Test Level:	TL-1	Barrier Test Level:	NCW	Is Barrier Crashworthy?:	NO
Beg. End Trtmt Type:	NONE	Is Beg. End Trtmt Crashworthy?:	N/A	Approach Transition Type:	NONE
Ending End Trtmt Type:	NONE	Ending End Trtmt Crashworthy?:	N/A		
Average Measurements					
Design Height (In.):	24	Width (In.):	0.0	Post Spacing (In.):	124.6
Height (In.):	19.7	Lateral Offset (In.):	95.0	Road Grade (%):	4.00
Physical Condition					
Barrier	Alignment and Height:	Alignment has no deviation and the height is 4-5 in below the 24 in design height.

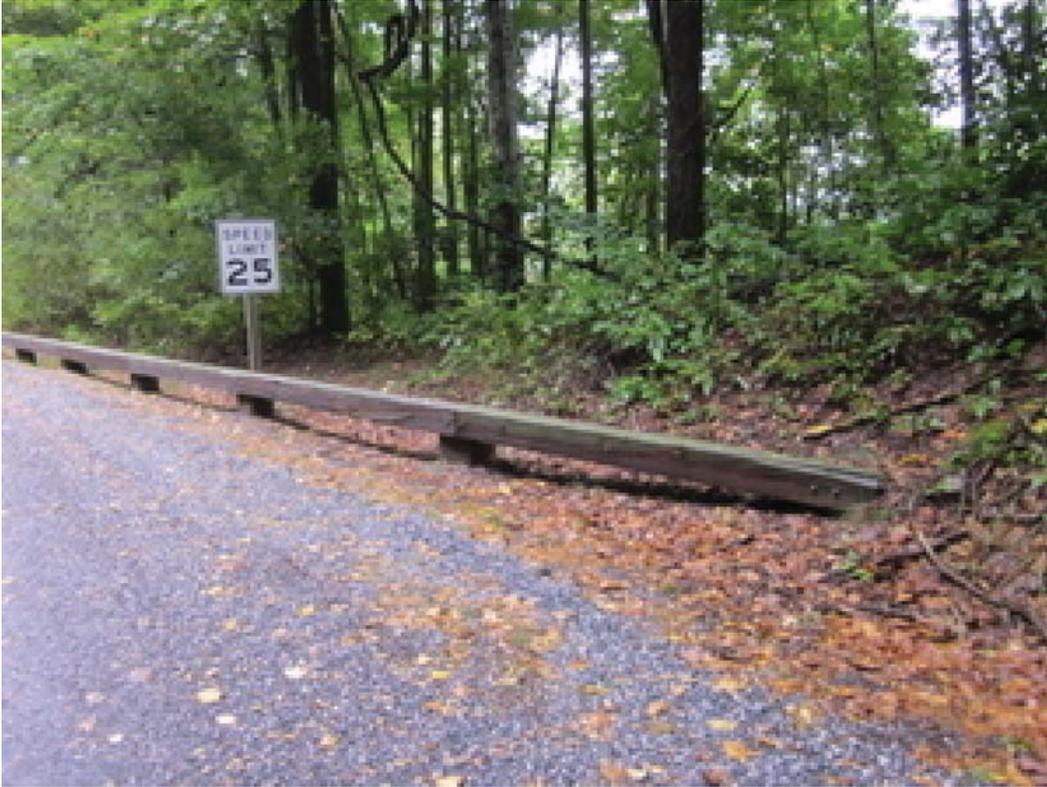
GRSM_0022_0.136_R_1.JPG

Barrier ID:	GRSM-0022-0.136-R				
Route Name:	CATALOOCHEE ENTRANCE ROAD				
Inspection Date:	09/27/2010	Barrier Rating:	21.20		
Barrier Description					
Type:	OTHER: TIMBER RAIL ON TIMBER POSTS	Barrier Function:	TRAFFIC		
Barrier Material:	LOG/TIMBER/WOOD	Post Material:	WOOD		
Blockout Type:	N/A	Length (ft.):	120		
Speed Limit (MPH):	25	Placement with Respect to Road:	OUTSIDE OF CURVE		
Hazard Behind Barrier:	LOW				
Barrier Crashworthiness					
Appropriate Test Level:	TL-1	Barrier Test Level:	NCW	Is Barrier Crashworthy?:	NO
Beg. End Trtmt Type:	NONE	Is Beg. End Trtmt Crashworthy?:	N/A	Approach Transition Type:	NONE
Ending End Trtmt Type:	NONE	Ending End Trtmt Crashworthy?:	N/A		
Average Measurements					
Design Height (In.):	24	Width (In.):	0.0	Post Spacing (In.):	123.0
Height (In.):	20.0	Lateral Offset (In.):	63.2	Road Grade (%):	2.90
Physical Condition					
Barrier	Alignment and Height:	Alignment has no deviation and the height is 3-5 in below the 24 in design height.

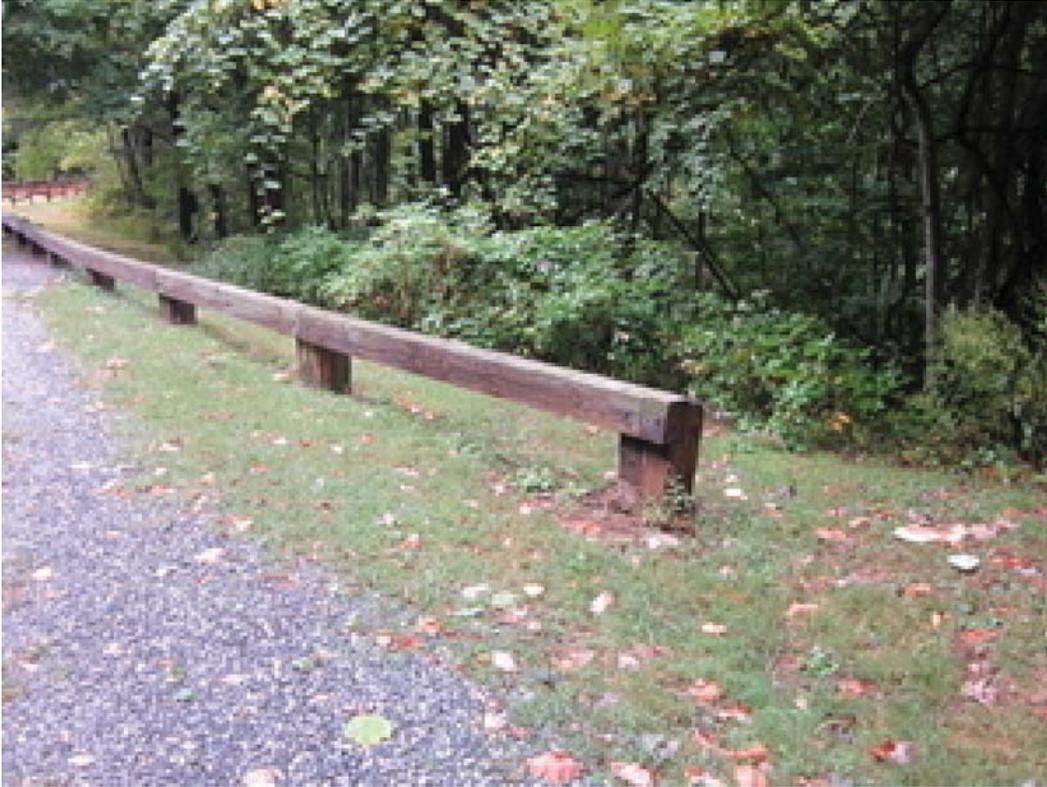
GRSM_0022_0.234_R_1.JPG

Barrier ID:	GRSM-0022-0.234-R				
Route Name:	CATALOOCHEE ENTRANCE ROAD				
Inspection Date:	09/27/2010	Barrier Rating:	25.60		
Barrier Description					
Type:	OTHER: TIMBER RAIL ON TIMBER POSTS	Barrier Function:	TRAFFIC		
Barrier Material:	LOG/TIMBER/WOOD	Post Material:	WOOD		
Blockout Type:	N/A	Length (ft.):	137		
Speed Limit (MPH):	25	Placement with Respect to Road:	OUTSIDE OF CURVE		
Hazard Behind Barrier:	LOW				
Barrier Crashworthiness					
Appropriate Test Level:	TL-1	Barrier Test Level:	NCW	Is Barrier Crashworthy?:	NO
Beg. End Trtmt Type:	NONE	Is Beg. End Trtmt Crashworthy?:	N/A	Approach Transition Type:	NONE
Ending End Trtmt Type:	NONE	Ending End Trtmt Crashworthy?:	N/A		
Average Measurements					
Design Height (In.):	24	Width (In.):	0.0	Post Spacing (In.):	117.5
Height (In.):	23.2	Lateral Offset (In.):	91.3	Road Grade (%):	4.00
Physical Condition					
Barrier	Alignment and Height:	Alignment has no deviation and the height ranges from 3 in below to 2 in above the 24 in design height with 75 ft being 1-3 ins below.

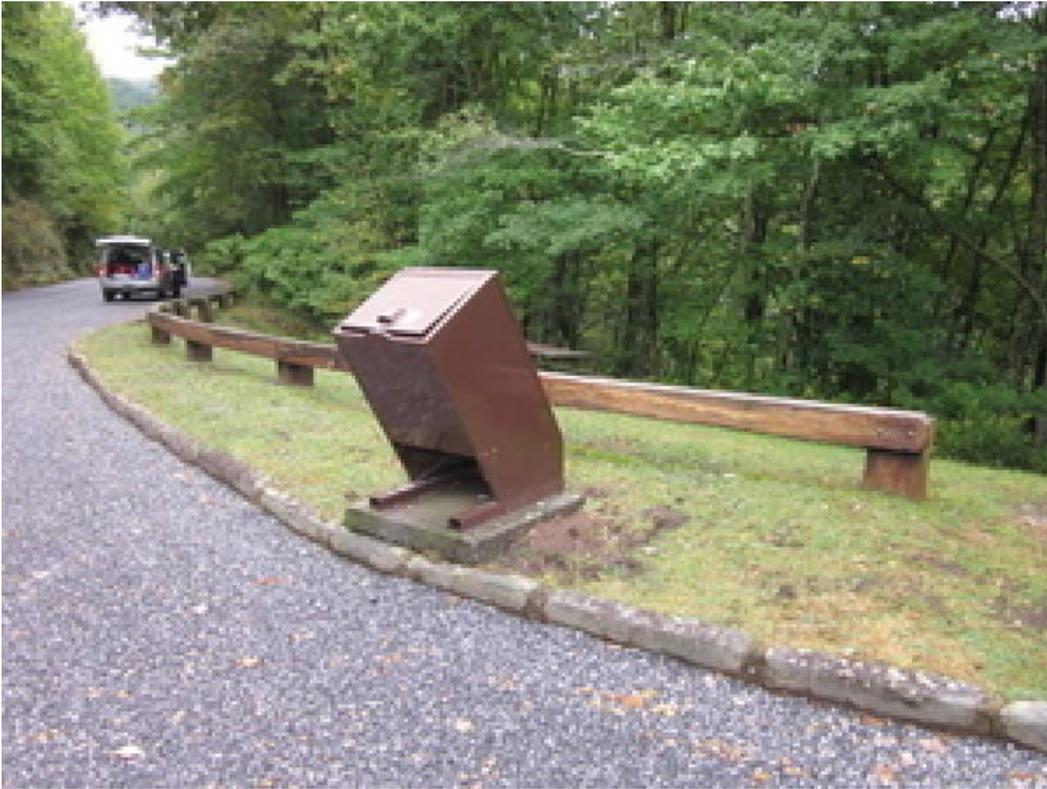
GRSM_0022_0.303_R_1.JPG

Barrier ID:	GRSM-0022-0.303-R				
Route Name:	CATALOOCHEE ENTRANCE ROAD				
Inspection Date:	09/27/2010	Barrier Rating:	28.10		
Barrier Description					
Type:	OTHER: TIMBER RAIL ON TIMBER POSTS	Barrier Function:	TRAFFIC		
Barrier Material:	LOG/TIMBER/WOOD	Post Material:	WOOD		
Blockout Type:	N/A	Length (ft.):	98		
Speed Limit (MPH):	25	Placement with Respect to Road:	OUTSIDE OF CURVE		
Hazard Behind Barrier:	MEDIUM				
Barrier Crashworthiness					
Appropriate Test Level:	TL-1	Barrier Test Level:	NCW	Is Barrier Crashworthy?:	NO
Beg. End Trtmt Type:	NONE	Is Beg. End Trtmt Crashworthy?:	N/A	Approach Transition Type:	NONE
Ending End Trtmt Type:	NONE	Ending End Trtmt Crashworthy?:	N/A		
Average Measurements					
Design Height (In.):	24	Width (In.):	0.0	Post Spacing (In.):	117.0
Height (In.):	22.0	Lateral Offset (In.):	120.6	Road Grade (%):	3.90
Physical Condition					
Barrier	Alignment and Height:	Alignment has no deviation and the height ranges from 4 in below to 1 in above the 24 in design height with 75 ft being 1-4 in below.

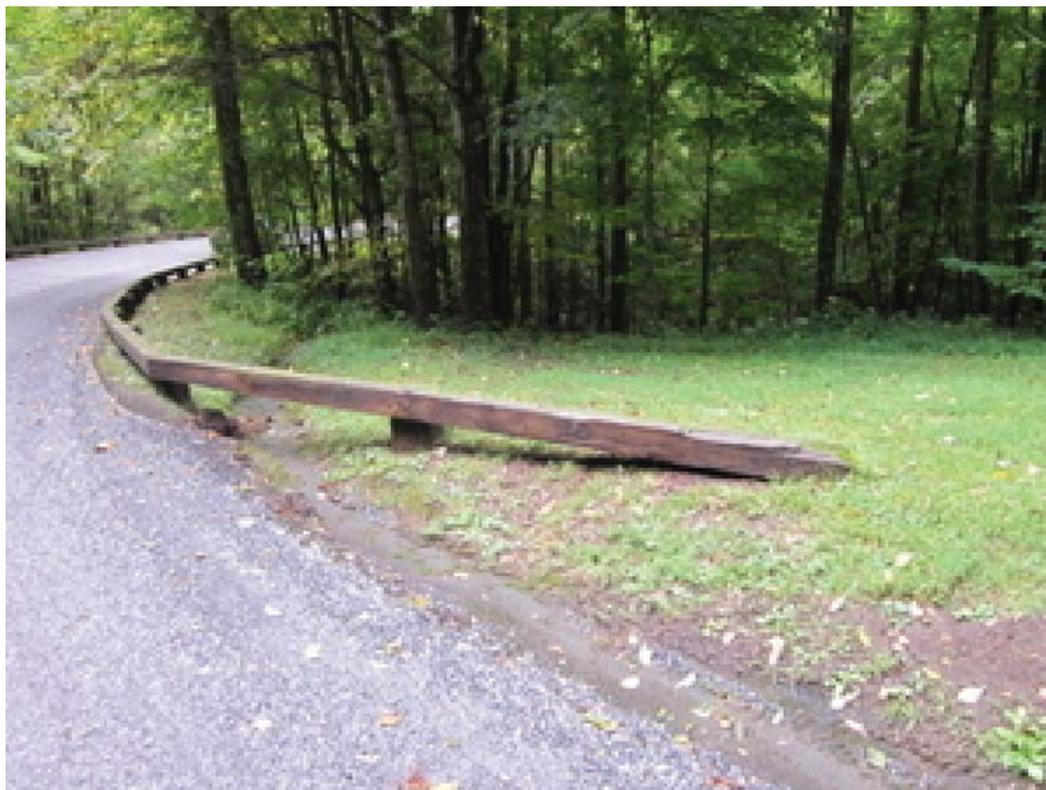
GRSM_0022_0.565_R_1.JPG

Barrier ID:	GRSM-0022-0.565-R				
Route Name:	CATALOOCHEE ENTRANCE ROAD				
Inspection Date:	09/27/2010	Barrier Rating:	42.20		
Barrier Description					
Type:	OTHER: TIMBER RAIL ON TIMBER POSTS	Barrier Function:	TRAFFIC		
Barrier Material:	LOG/TIMBER/WOOD	Post Material:	WOOD		
Blockout Type:	N/A	Length (ft.):	730		
Speed Limit (MPH):	25	Placement with Respect to Road:	INSIDE OF CURVE		
Hazard Behind Barrier:	MEDIUM				
Barrier Crashworthiness					
Appropriate Test Level:	TL-1	Barrier Test Level:	NCW	Is Barrier Crashworthy?:	NO
Beg. End Trtmt Type:	NONE	Is Beg. End Trtmt Crashworthy?:	N/A	Approach Transition Type:	NONE
Ending End Trtmt Type:	NONE	Ending End Trtmt Crashworthy?:	N/A		
Average Measurements					
Design Height (In.):	24	Width (In.):	0.0	Post Spacing (In.):	115.3
Height (In.):	21.2	Lateral Offset (In.):	60.0	Road Grade (%):	6.50
Physical Condition					
Barrier	Alignment and Height:	Alignment has no deviation and the height is 2-4 in below the 24 in design height.

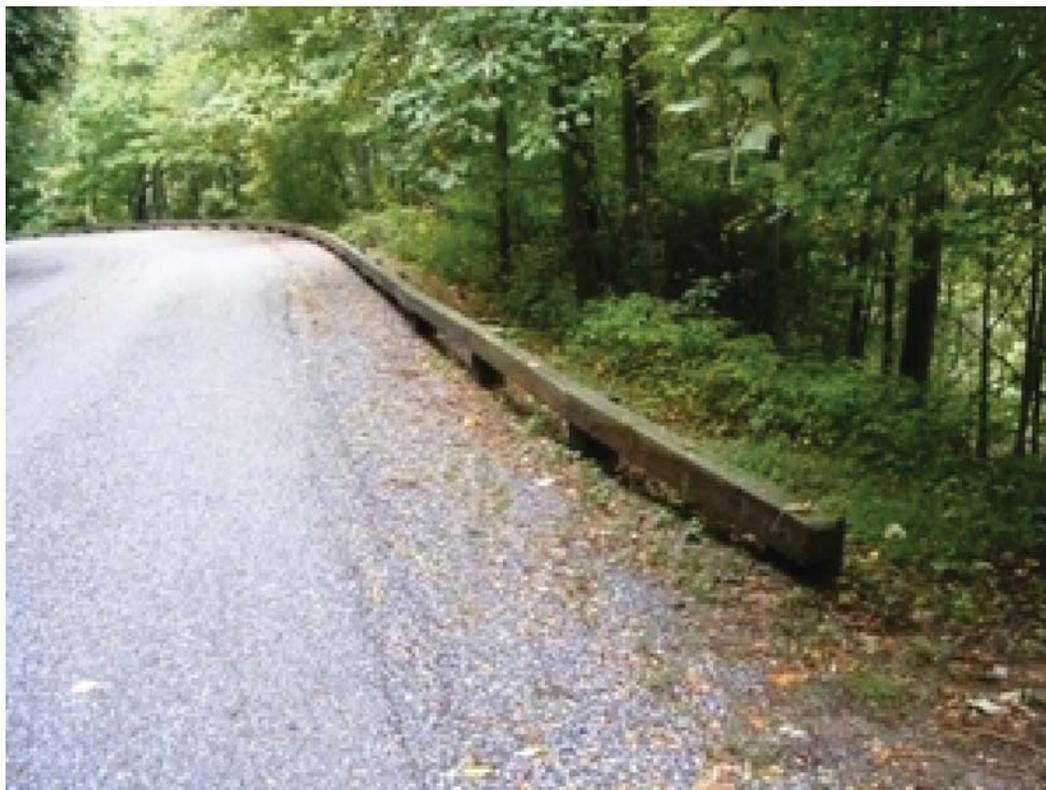
GRSM_0022_0.867_R_1.JPG

Barrier ID:	GRSM-0022-0.867-R				
Route Name:	CATALOOCHEE ENTRANCE ROAD				
Inspection Date:	09/27/2010	Barrier Rating:	40.70		
Barrier Description					
Type:	OTHER: TIMBER RAIL ON TIMBER POSTS	Barrier Function:	TRAFFIC		
Barrier Material:	LOG/TIMBER/WOOD	Post Material:	WOOD		
Blockout Type:	N/A	Length (ft.):	773		
Speed Limit (MPH):	25	Placement with Respect to Road:	INSIDE OF CURVE		
Hazard Behind Barrier:	MEDIUM				
Barrier Crashworthiness					
Appropriate Test Level:	TL-1	Barrier Test Level:	NCW	Is Barrier Crashworthy?:	NO
Beg. End Trtmt Type:	NONE	Is Beg. End Trtmt Crashworthy?:	N/A	Approach Transition Type:	NONE
Ending End Trtmt Type:	NONE	Ending End Trtmt Crashworthy?:	N/A		
Average Measurements					
Design Height (In.):	24	Width (In.):	0.0	Post Spacing (In.):	118.3
Height (In.):	17.2	Lateral Offset (In.):	59.5	Road Grade (%):	5.70
Physical Condition					
Barrier	Alignment and Height:	The alignment has no deviation and the height is 4 to 8 in below the 24 in design height.

Breaking and Cracking:	No breaking some cracking observed with ¼ to ½ in wide cracks.			
	Missing Elements:	No missing elements observed.			
	Corrosion and Weathering:	54 posts have extreme weathering and corrosion.			
End Treatments	Alignment and Height:				
	Breaking and Cracking:				
	Missing Elements:				
	Corrosion and Weathering:

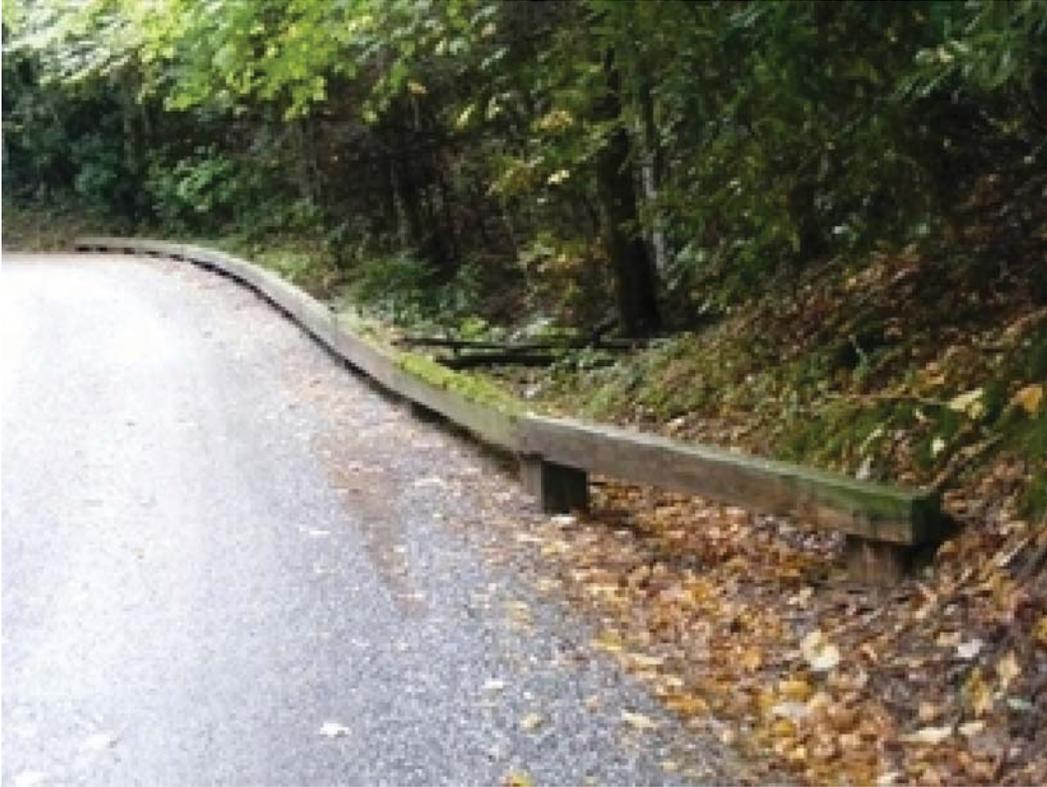
GRSM_0022_0.970_L_1.JPG

Barrier ID:	GRSM-0022-0.970-L				
Route Name:	CATALOOCHEE ENTRANCE ROAD				
Inspection Date:	09/27/2010	Barrier Rating:	21.20		
Barrier Description					
Type:	OTHER: TIMBER RAIL ON TIMBER POSTS	Barrier Function:	TRAFFIC		
Barrier Material:	LOG/TIMBER/WOOD	Post Material:	WOOD		
Blockout Type:	N/A	Length (ft.):	166		
Speed Limit (MPH):	25	Placement with Respect to Road:	OUTSIDE OF CURVE		
Hazard Behind Barrier:	LOW				
Barrier Crashworthiness					
Appropriate Test Level:	TL-1	Barrier Test Level:	NCW	Is Barrier Crashworthy?:	NO
Beg. End Trtmt Type:	NONE	Is Beg. End Trtmt Crashworthy?:	N/A	Approach Transition Type:	NONE
Ending End Trtmt Type:	NONE	Ending End Trtmt Crashworthy?:	N/A		
Average Measurements					
Design Height (In.):	24	Width (In.):	0.0	Post Spacing (In.):	118.3
Height (In.):	17.0	Lateral Offset (In.):	50.2	Road Grade (%):	6.50
Physical Condition					
Barrier	Alignment and Height:	The alignment has no deviation and height is 7 in below the design height of 24 in.

Breaking and Cracking:	No breaking or cracking observed.			
	Missing Elements:	No missing elements observed.			
	Corrosion and Weathering:	19 posts observed as rotten and hollow weathering on all rails and post.			
End Treatments	Alignment and Height:				
	Breaking and Cracking:				
	Missing Elements:				
	Corrosion and Weathering:

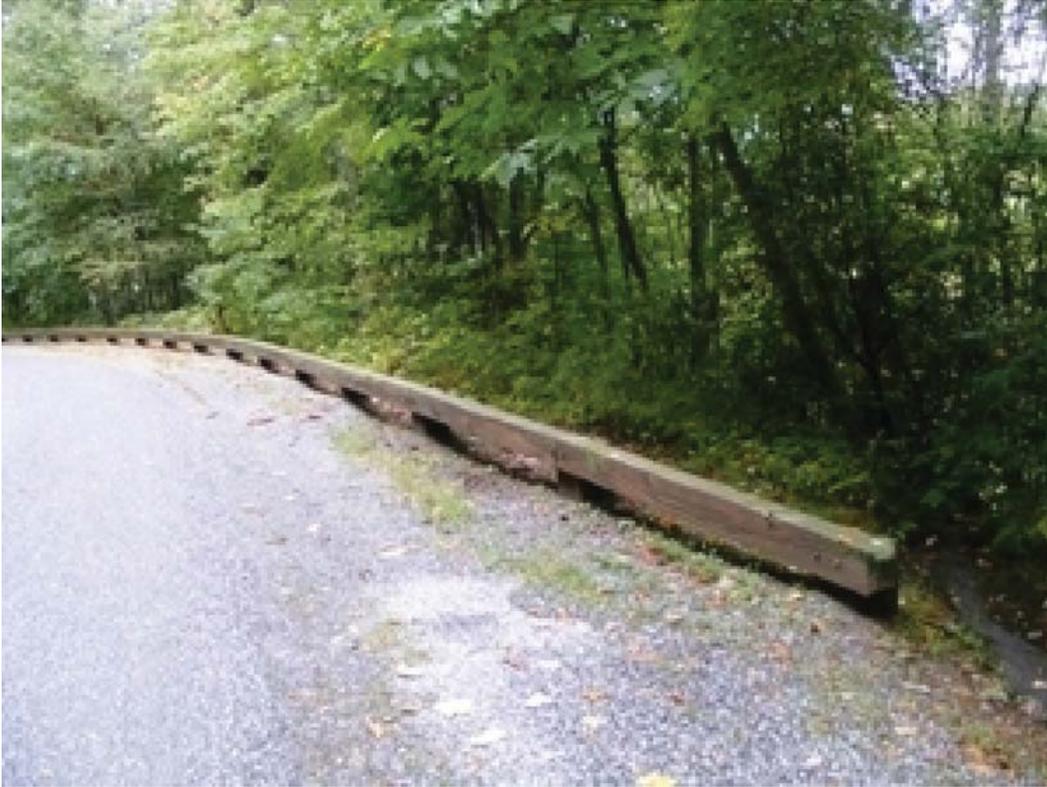
GRSM_0022_1.013_R_1.JPG

Barrier ID:	GRSM-0022-1.013-R				
Route Name:	CATALOOCHEE ENTRANCE ROAD				
Inspection Date:	09/27/2010	Barrier Rating:	39.50		
Barrier Description					
Type:	OTHER: TIMBER RAIL ON TIMBER POSTS	Barrier Function:	TRAFFIC		
Barrier Material:	LOG/TIMBER/WOOD	Post Material:	WOOD		
Blockout Type:	N/A	Length (ft.):	689		
Speed Limit (MPH):	25	Placement with Respect to Road:	OUTSIDE OF CURVE		
Hazard Behind Barrier:	MEDIUM				
Barrier Crashworthiness					
Appropriate Test Level:	TL-1	Barrier Test Level:	NCW	Is Barrier Crashworthy?:	NO
Beg. End Trtmt Type:	NONE	Is Beg. End Trtmt Crashworthy?:	N/A	Approach Transition Type:	NONE
Ending End Trtmt Type:	NONE	Ending End Trtmt Crashworthy?:	N/A		
Average Measurements					
Design Height (In.):	24	Width (In.):	0.0	Post Spacing (In.):	117.8
Height (In.):	19.2	Lateral Offset (In.):	56.5	Road Grade (%):	5.50
Physical Condition					
Barrier	Alignment and Height:	The alignment has no deviation and the height is 2-5 in below the 24 in design height.

Breaking and Cracking:	No breaking minor cracking observed. ¼ to ½ in wide.			
	Missing Elements:	No missing elements observed.			
	Corrosion and Weathering:	Moderate corrosion and weathering observed on all posts and rails. 56 posts are rotten and hollow.			
End Treatments	Alignment and Height:				
	Breaking and Cracking:				
	Missing Elements:				
	Corrosion and Weathering:

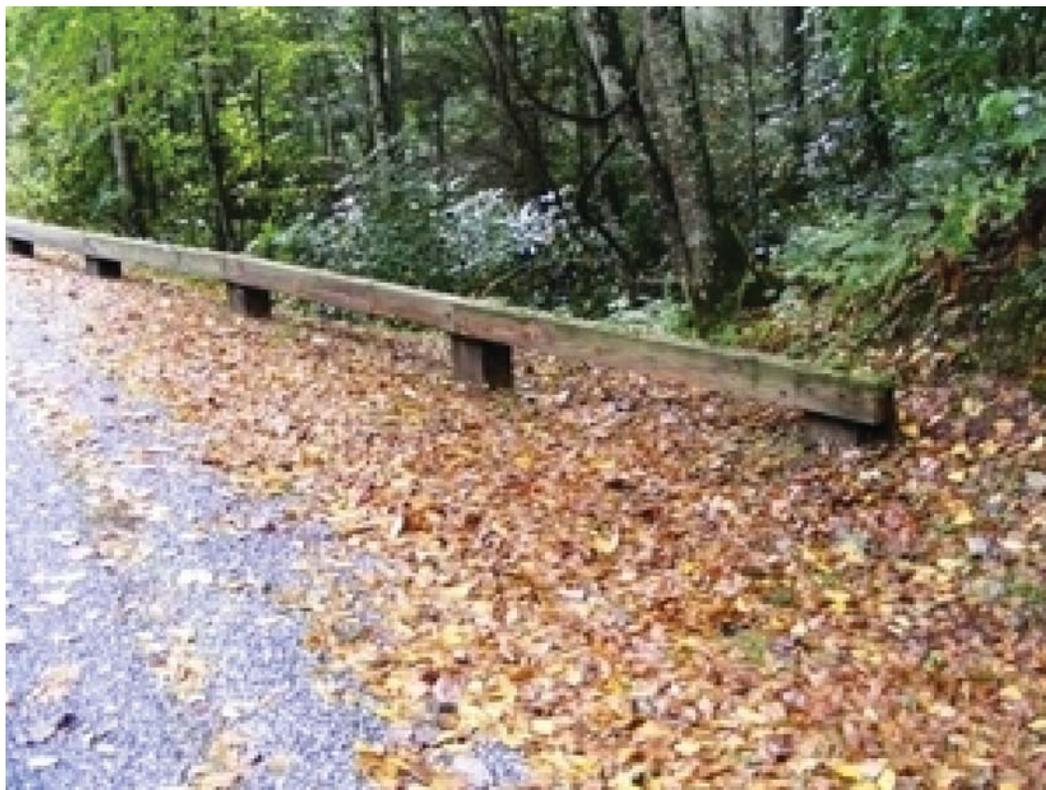
GRSM_0022_1.194_L_1.JPG

Barrier ID:	GRSM-0022-1.194-L				
Route Name:	CATALOOCHEE ENTRANCE ROAD				
Inspection Date:	09/27/2010	Barrier Rating:	36.50		
Barrier Description					
Type:	OTHER: TIMBER RAIL ON TIMBER POSTS	Barrier Function:	TRAFFIC		
Barrier Material:	LOG/TIMBER/WOOD	Post Material:	WOOD		
Blockout Type:	N/A	Length (ft.):	310		
Speed Limit (MPH):	25	Placement with Respect to Road:	OUTSIDE OF CURVE		
Hazard Behind Barrier:	MEDIUM				
Barrier Crashworthiness					
Appropriate Test Level:	TL-1	Barrier Test Level:	NCW	Is Barrier Crashworthy?:	NO
Beg. End Trtmt Type:	NONE	Is Beg. End Trtmt Crashworthy?:	N/A	Approach Transition Type:	NONE
Ending End Trtmt Type:	NONE	Ending End Trtmt Crashworthy?:	N/A		
Average Measurements					
Design Height (In.):	24	Width (In.):	0.0	Post Spacing (In.):	119.0
Height (In.):	20.7	Lateral Offset (In.):	5.8	Road Grade (%):	7.20
Physical Condition					
Barrier	Alignment and Height:	The alignment has no deviation and the height is 2-4 in below the 24 in design height.

Breaking and Cracking:	No breaking some cracking observed. ¼ to ½ in wide.			
	Missing Elements:	No missing elements observed.			
	Corrosion and Weathering:	22 posts have extreme weathering and corrosion.			
End Treatments	Alignment and Height:				
	Breaking and Cracking:				
	Missing Elements:				
	Corrosion and Weathering:
