NPS Guardwall/Rail Inventory Program
Great Smoky Mountains National Park

Federal Highway Administration
Eastern Federal Lands Highway Division
Road Inventory Program (RIP)

Data Collection Date: September 2010
Report Date: December 2015

Great Smoky Mountains National Park in North Carolina and Tennessee

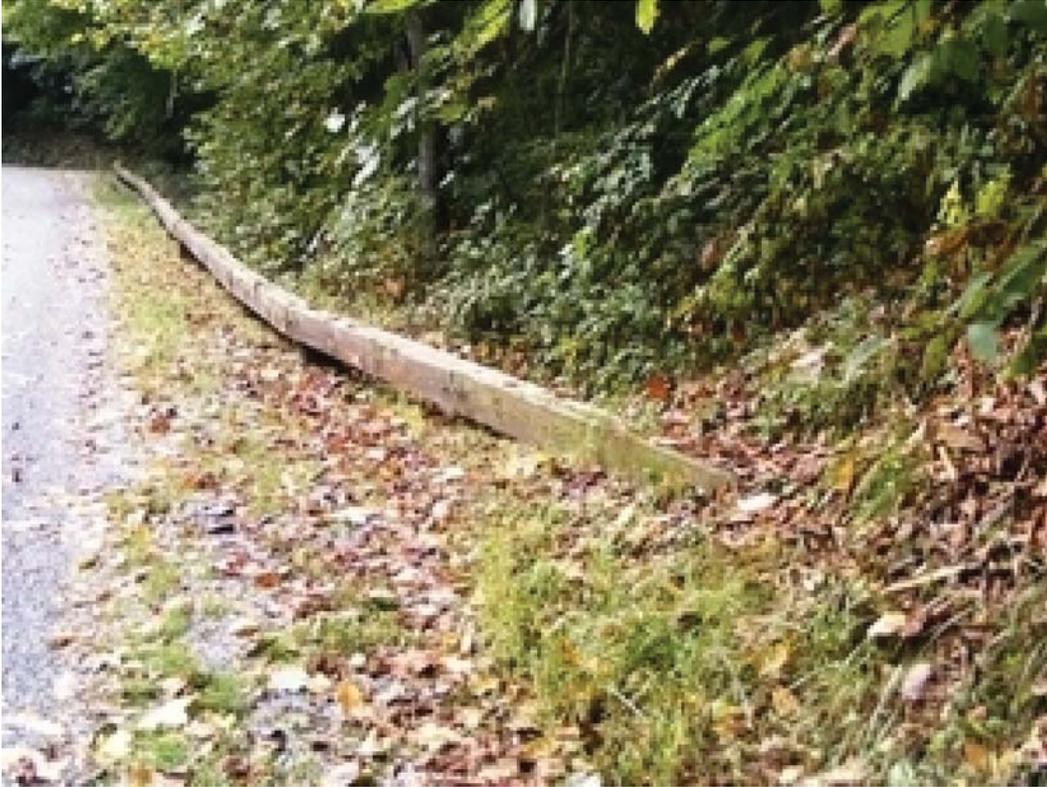
GRSM_0022_1.288_L_1.JPG

Barrier ID:	GRSM-0022-1.288-L				
Route Name:	CATALOOCHEE ENTRANCE ROAD				
Inspection Date:	09/27/2010	Barrier Rating:	23.70		
Barrier Description					
Type:	OTHER: TIMBER RAIL ON TIMBER POSTS	Barrier Function:	TRAFFIC		
Barrier Material:	LOG/TIMBER/WOOD	Post Material:	WOOD		
Blockout Type:	N/A	Length (ft.):	157		
Speed Limit (MPH):	25	Placement with Respect to Road:	OUTSIDE OF CURVE		
Hazard Behind Barrier:	MEDIUM				
Barrier Crashworthiness					
Appropriate Test Level:	TL-1	Barrier Test Level:	NCW	Is Barrier Crashworthy?:	NO
Beg. End Trtmt Type:	NONE	Is Beg. End Trtmt Crashworthy?:	N/A	Approach Transition Type:	NONE
Ending End Trtmt Type:	NONE	Ending End Trtmt Crashworthy?:	N/A		
Average Measurements					
Design Height (In.):	24	Width (In.):	0.0	Post Spacing (In.):	117.3
Height (In.):	19.0	Lateral Offset (In.):	55.0	Road Grade (%):	6.50
Physical Condition					
Barrier	Alignment and Height:	The alignment has no deviation and the height is 3-6 in below the 24 in design height.

Breaking and Cracking:	No breaking or cracking observed.			
	Missing Elements:	No missing elements observed.			
	Corrosion and Weathering:	13 posts observed as rotten and hollow some corrosion and weathering on all posts and rails observed.			
End Treatments	Alignment and Height:				
	Breaking and Cracking:				
	Missing Elements:				
	Corrosion and Weathering:

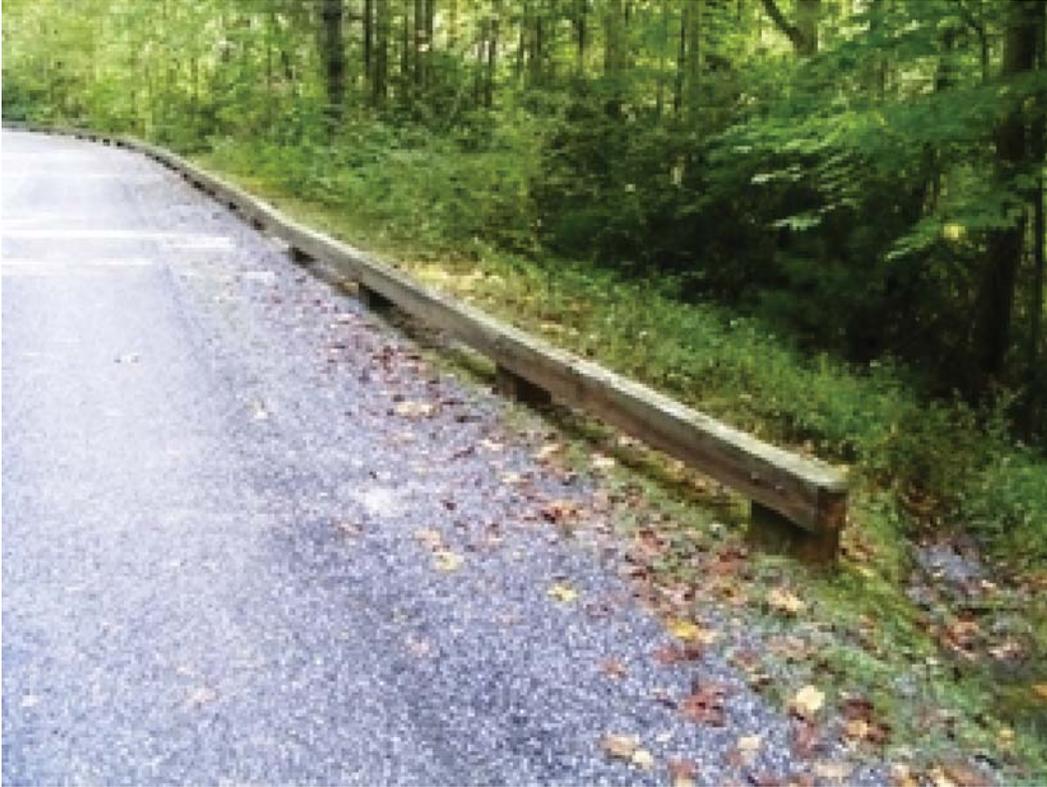
GRSM_0022_1.441_R_1.JPG

Barrier ID:	GRSM-0022-1.441-R				
Route Name:	CATALOOCHEE ENTRANCE ROAD				
Inspection Date:	09/27/2010	Barrier Rating:	39.50		
Barrier Description					
Type:	OTHER: TIMBER RAIL ON TIMBER POSTS	Barrier Function:	TRAFFIC		
Barrier Material:	LOG/TIMBER/WOOD	Post Material:	WOOD		
Blockout Type:	N/A	Length (ft.):	251		
Speed Limit (MPH):	25	Placement with Respect to Road:	OUTSIDE OF CURVE		
Hazard Behind Barrier:	MEDIUM				
Barrier Crashworthiness					
Appropriate Test Level:	TL-1	Barrier Test Level:	NCW	Is Barrier Crashworthy?:	NO
Beg. End Trtmt Type:	NONE	Is Beg. End Trtmt Crashworthy?:	N/A	Approach Transition Type:	NONE
Ending End Trtmt Type:	NONE	Ending End Trtmt Crashworthy?:	N/A		
Average Measurements					
Design Height (In.):	24	Width (In.):	0.0	Post Spacing (In.):	118.0
Height (In.):	15.3	Lateral Offset (In.):	54.5	Road Grade (%):	6.40
Physical Condition					
Barrier	Alignment and Height:	The alignment has no deviation and the height is 8-10 in below the 24 in design height.

Breaking and Cracking:	No breaking some cracking observed. ¼ to ½ in wide.			
	Missing Elements:	No missing elements observed.			
	Corrosion and Weathering:	Moderate corrosion and weathering observed on all posts and rails. 23 posts are rotten and hollow on top.			
End Treatments	Alignment and Height:				
	Breaking and Cracking:				
	Missing Elements:				
	Corrosion and Weathering:

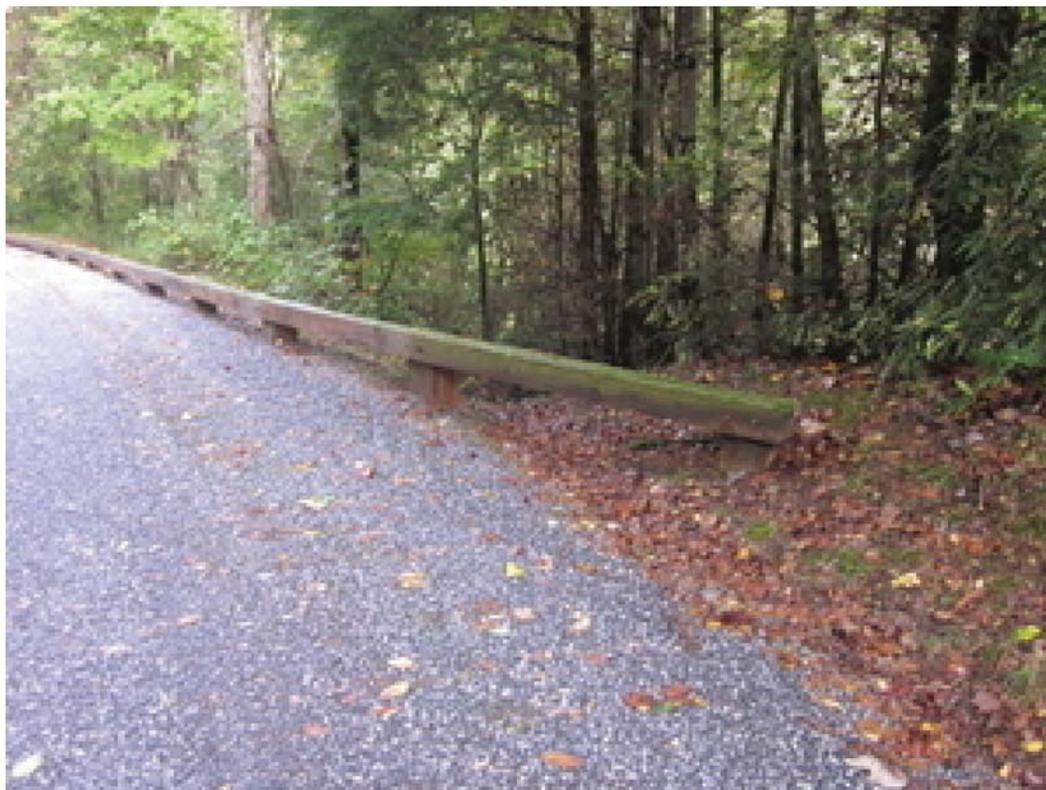
GRSM_0022_1.519_R_1.JPG

Barrier ID:	GRSM-0022-1.519-R				
Route Name:	CATALOOCHEE ENTRANCE ROAD				
Inspection Date:	09/27/2010	Barrier Rating:	32.20		
Barrier Description					
Type:	OTHER: TIMBER RAIL ON TIMBER POSTS	Barrier Function:	TRAFFIC		
Barrier Material:	LOG/TIMBER/WOOD	Post Material:	WOOD		
Blockout Type:	N/A	Length (ft.):	248		
Speed Limit (MPH):	25	Placement with Respect to Road:	OUTSIDE OF CURVE		
Hazard Behind Barrier:	MEDIUM				
Barrier Crashworthiness					
Appropriate Test Level:	TL-1	Barrier Test Level:	NCW	Is Barrier Crashworthy?:	NO
Beg. End Trtmt Type:	NONE	Is Beg. End Trtmt Crashworthy?:	N/A	Approach Transition Type:	NONE
Ending End Trtmt Type:	NONE	Ending End Trtmt Crashworthy?:	N/A		
Average Measurements					
Design Height (In.):	24	Width (In.):	0.0	Post Spacing (In.):	117.0
Height (In.):	17.2	Lateral Offset (In.):	66.6	Road Grade (%):	5.80
Physical Condition					
Barrier	Alignment and Height:	Alignment has no deviation and the height is 3-10 in below the 24 in design height.

Breaking and Cracking:	No breaking or cracking observed.			
	Missing Elements:	No missing elements observed.			
	Corrosion and Weathering:	23 posts are rotten due to corrosion.			
End Treatments	Alignment and Height:				
	Breaking and Cracking:				
	Missing Elements:				
	Corrosion and Weathering:

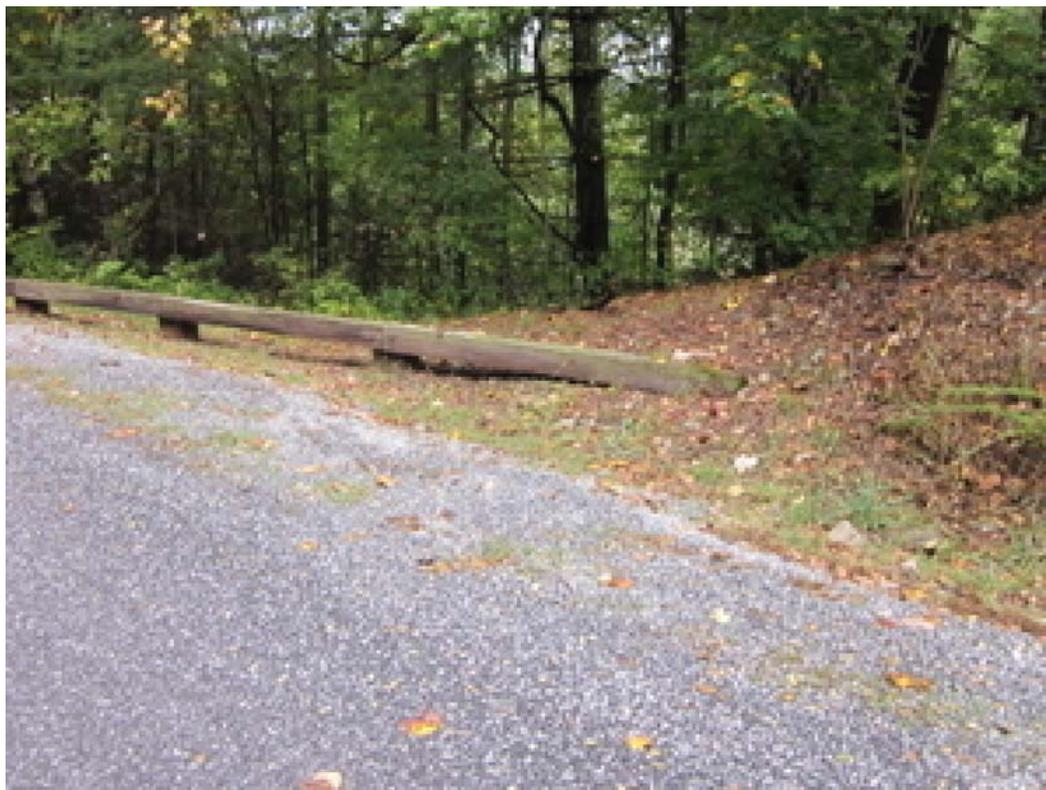
GRSM_0022_1.612_R_1.JPG

Barrier ID:	GRSM-0022-1.612-R				
Route Name:	CATALOOCHEE ENTRANCE ROAD				
Inspection Date:	09/27/2010	Barrier Rating:	44.00		
Barrier Description					
Type:	OTHER: TIMBER RAIL ON TIMBER POSTS	Barrier Function:	TRAFFIC		
Barrier Material:	LOG/TIMBER/WOOD	Post Material:	WOOD		
Blockout Type:	N/A	Length (ft.):	649		
Speed Limit (MPH):	25	Placement with Respect to Road:	INSIDE OF CURVE		
Hazard Behind Barrier:	HIGH				
Barrier Crashworthiness					
Appropriate Test Level:	TL-1	Barrier Test Level:	NCW	Is Barrier Crashworthy?:	NO
Beg. End Trtmt Type:	NONE	Is Beg. End Trtmt Crashworthy?:	N/A	Approach Transition Type:	NONE
Ending End Trtmt Type:	NONE	Ending End Trtmt Crashworthy?:	N/A		
Average Measurements					
Design Height (In.):	24	Width (In.):	0.0	Post Spacing (In.):	118.5
Height (In.):	15.6	Lateral Offset (In.):	64.0	Road Grade (%):	7.00
Physical Condition					
Barrier	Alignment and Height:	Alignment has no deviation and the height is 8-9 in below the 24 in design height.

Breaking and Cracking:	No breaking or cracking observed.			
	Missing Elements:	No missing elements observed.			
	Corrosion and Weathering:	1 rail corroded with over 1 in gaps. 47 posts are rotten due to corrosion			
End Treatments	Alignment and Height:				
	Breaking and Cracking:				
	Missing Elements:				
	Corrosion and Weathering:

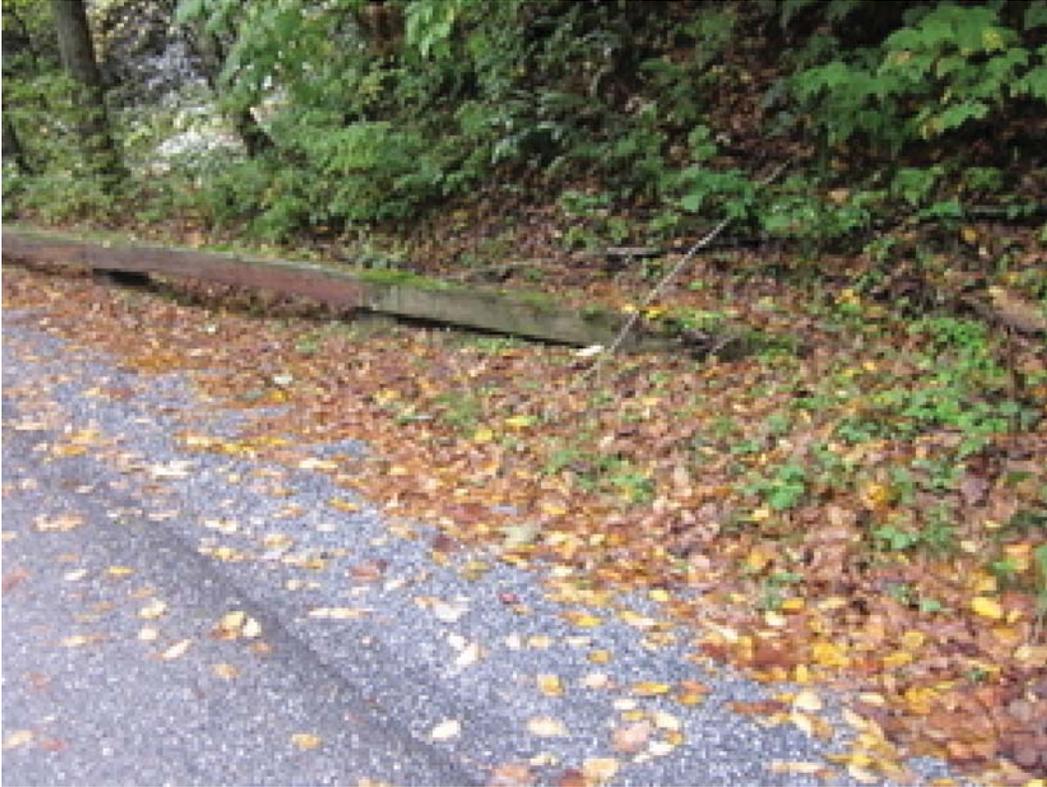
GRSM_0022_1.685_L_1.JPG

Barrier ID:	GRSM-0022-1.685-L				
Route Name:	CATALOOCHEE ENTRANCE ROAD				
Inspection Date:	09/27/2010	Barrier Rating:	21.20		
Barrier Description					
Type:	OTHER: TIMBER RAIL ON TIMBER POSTS	Barrier Function:	TRAFFIC		
Barrier Material:	LOG/TIMBER/WOOD	Post Material:	WOOD		
Blockout Type:	N/A	Length (ft.):	224		
Speed Limit (MPH):	25	Placement with Respect to Road:	OUTSIDE OF CURVE		
Hazard Behind Barrier:	LOW				
Barrier Crashworthiness					
Appropriate Test Level:	TL-1	Barrier Test Level:	NCW	Is Barrier Crashworthy?:	NO
Beg. End Trtmt Type:	NONE	Is Beg. End Trtmt Crashworthy?:	N/A	Approach Transition Type:	NONE
Ending End Trtmt Type:	NONE	Ending End Trtmt Crashworthy?:	N/A		
Average Measurements					
Design Height (In.):	24	Width (In.):	0.0	Post Spacing (In.):	118.6
Height (In.):	17.0	Lateral Offset (In.):	64.3	Road Grade (%):	7.40
Physical Condition					
Barrier	Alignment and Height:	Alignment has no deviation and the height is 5-10 in below the 24 in design height.

Breaking and Cracking:	No breaking or cracking observed.			
	Missing Elements:	No missing elements observed.			
	Corrosion and Weathering:	Approach end heavily weathered and 22 posts are rotten due to corrosion.			
End Treatments	Alignment and Height:				
	Breaking and Cracking:				
	Missing Elements:				
	Corrosion and Weathering:

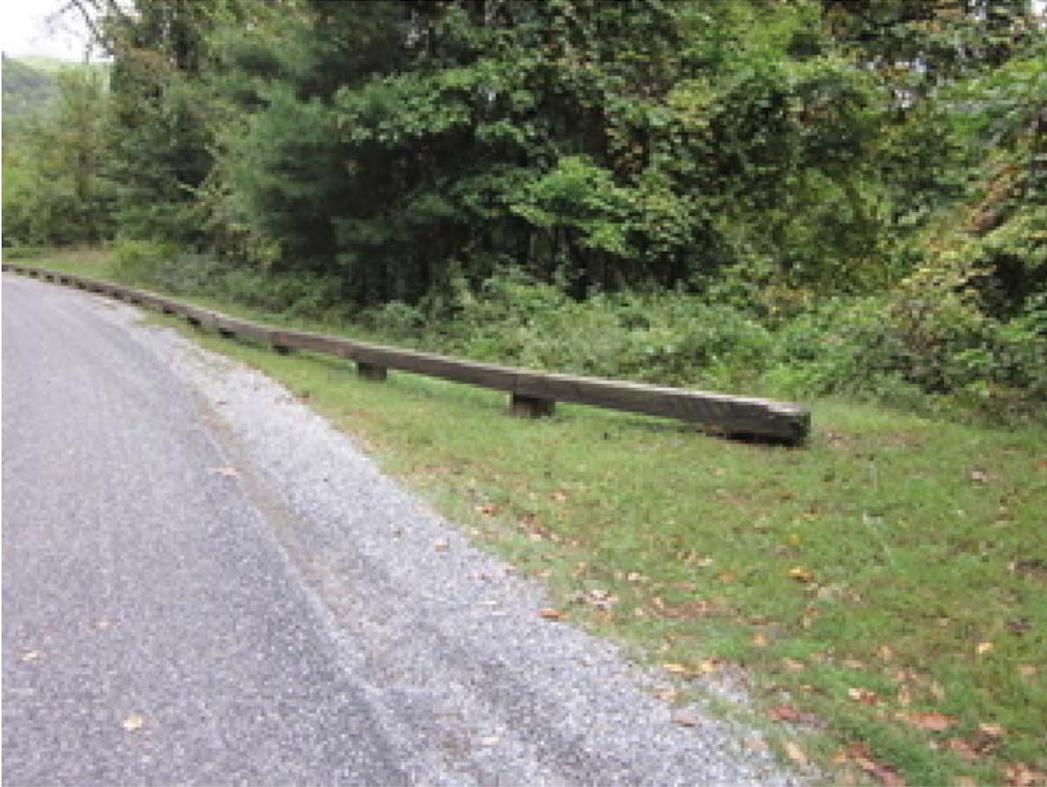
GRSM_0022_1.763_R_1.JPG

Barrier ID:	GRSM-0022-1.763-R				
Route Name:	CATALOOCHEE ENTRANCE ROAD				
Inspection Date:	09/27/2010	Barrier Rating:	41.20		
Barrier Description					
Type:	OTHER: TIMBER RAIL ON TIMBER POSTS	Barrier Function:	TRAFFIC		
Barrier Material:	LOG/TIMBER/WOOD	Post Material:	WOOD		
Blockout Type:	N/A	Length (ft.):	502		
Speed Limit (MPH):	25	Placement with Respect to Road:	OUTSIDE OF CURVE		
Hazard Behind Barrier:	HIGH				
Barrier Crashworthiness					
Appropriate Test Level:	TL-1	Barrier Test Level:	NCW	Is Barrier Crashworthy?:	NO
Beg. End Trtmt Type:	NONE	Is Beg. End Trtmt Crashworthy?:	N/A	Approach Transition Type:	NONE
Ending End Trtmt Type:	NONE	Ending End Trtmt Crashworthy?:	N/A		
Average Measurements					
Design Height (In.):	24	Width (In.):	0.0	Post Spacing (In.):	117.0
Height (In.):	15.0	Lateral Offset (In.):	63.7	Road Grade (%):	5.50
Physical Condition					
Barrier	Alignment and Height:	Alignment has no deviation and the height is 8-10 in below the 24 in design height.

Breaking and Cracking:	No breaking or cracking observed.			
	Missing Elements:	No missing elements observed.			
	Corrosion and Weathering:	35 posts and rails are rotten due to corrosion.			
End Treatments	Alignment and Height:				
	Breaking and Cracking:				
	Missing Elements:				
	Corrosion and Weathering:

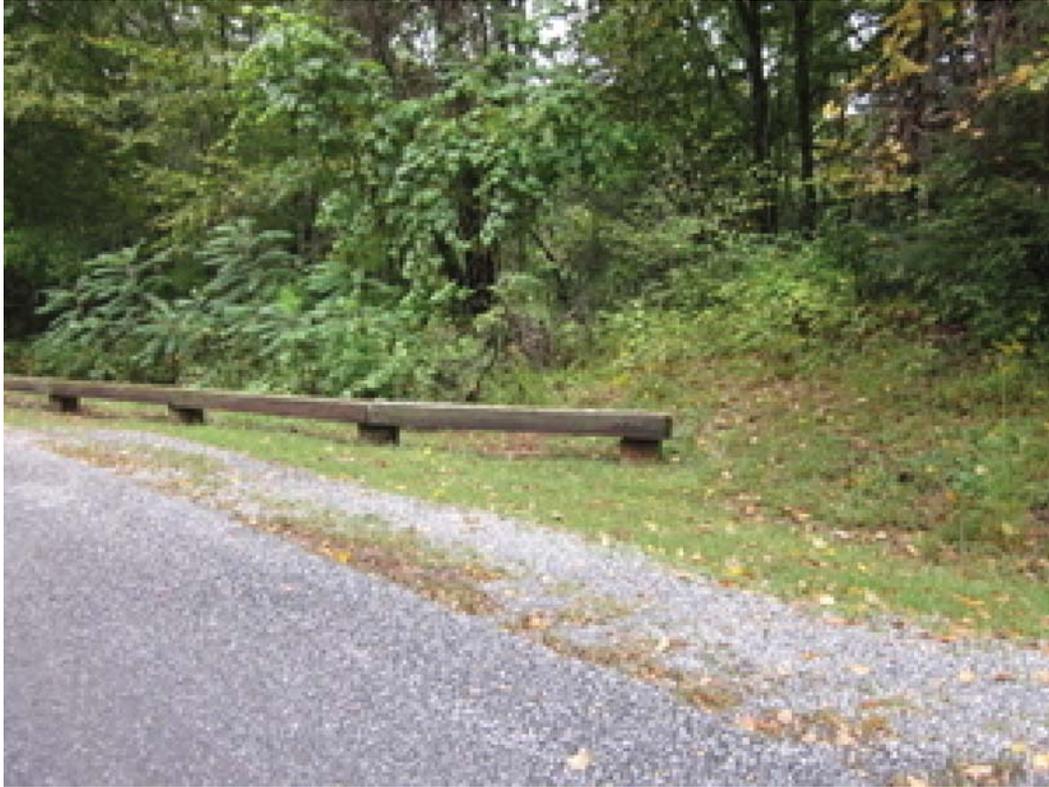
GRSM_0022_1.895_R_1.JPG

Barrier ID:	GRSM-0022-1.895-R				
Route Name:	CATALOOCHEE ENTRANCE ROAD				
Inspection Date:	09/27/2010	Barrier Rating:	40.00		
Barrier Description					
Type:	OTHER: TIMBER RAIL ON TIMBER POSTS	Barrier Function:	TRAFFIC		
Barrier Material:	LOG/TIMBER/WOOD	Post Material:	WOOD		
Blockout Type:	N/A	Length (ft.):	237		
Speed Limit (MPH):	25	Placement with Respect to Road:	OUTSIDE OF CURVE		
Hazard Behind Barrier:	EXTREME				
Barrier Crashworthiness					
Appropriate Test Level:	TL-1	Barrier Test Level:	NCW	Is Barrier Crashworthy?:	NO
Beg. End Trtmt Type:	NONE	Is Beg. End Trtmt Crashworthy?:	N/A	Approach Transition Type:	NONE
Ending End Trtmt Type:	NONE	Ending End Trtmt Crashworthy?:	N/A		
Average Measurements					
Design Height (In.):	24	Width (In.):	0.0	Post Spacing (In.):	118.3
Height (In.):	16.0	Lateral Offset (In.):	80.3	Road Grade (%):	6.50
Physical Condition					
Barrier	Alignment and Height:	Alignment has no deviation and the height is 6-8 in below the 24 in design height.

Breaking and Cracking:	No breaking or cracking observed.			
	Missing Elements:	No missing elements observed.			
	Corrosion and Weathering:	35 posts and rails are severely corroded and weathered.			
End Treatments	Alignment and Height:				
	Breaking and Cracking:				
	Missing Elements:				
	Corrosion and Weathering:

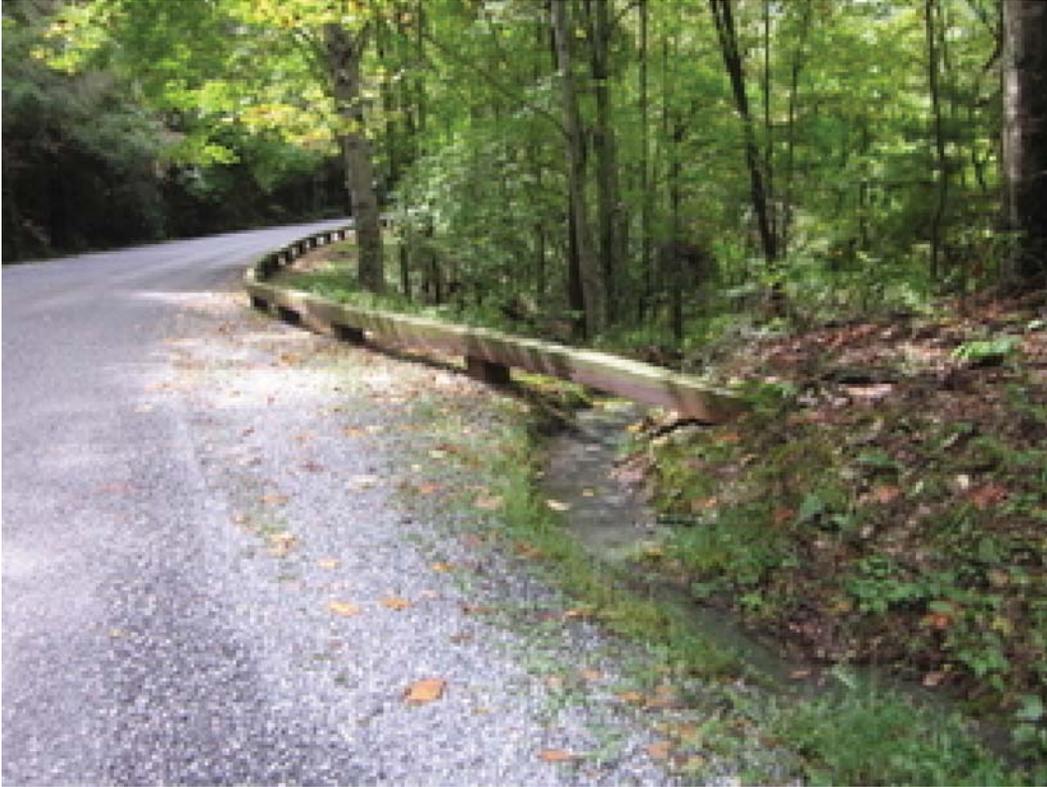
GRSM_0022_2.016_L_1.JPG

Barrier ID:	GRSM-0022-2.016-L				
Route Name:	CATALOOCHEE ENTRANCE ROAD				
Inspection Date:	09/27/2010	Barrier Rating:	33.70		
Barrier Description					
Type:	OTHER: TIMBER RAIL ON TIMBER POSTS	Barrier Function:	TRAFFIC		
Barrier Material:	LOG/TIMBER/WOOD	Post Material:	WOOD		
Blockout Type:	N/A	Length (ft.):	406		
Speed Limit (MPH):	25	Placement with Respect to Road:	INSIDE OF CURVE		
Hazard Behind Barrier:	MEDIUM				
Barrier Crashworthiness					
Appropriate Test Level:	TL-1	Barrier Test Level:	NCW	Is Barrier Crashworthy?:	NO
Beg. End Trtmt Type:	NONE	Is Beg. End Trtmt Crashworthy?:	N/A	Approach Transition Type:	NONE
Ending End Trtmt Type:	NONE	Ending End Trtmt Crashworthy?:	N/A		
Average Measurements					
Design Height (In.):	24	Width (In.):	0.0	Post Spacing (In.):	116.3
Height (In.):	19.7	Lateral Offset (In.):	53.2	Road Grade (%):	5.90
Physical Condition					
Barrier	Alignment and Height:	Alignment has no deviation and the height is 4-6 in below the 24 in design height.

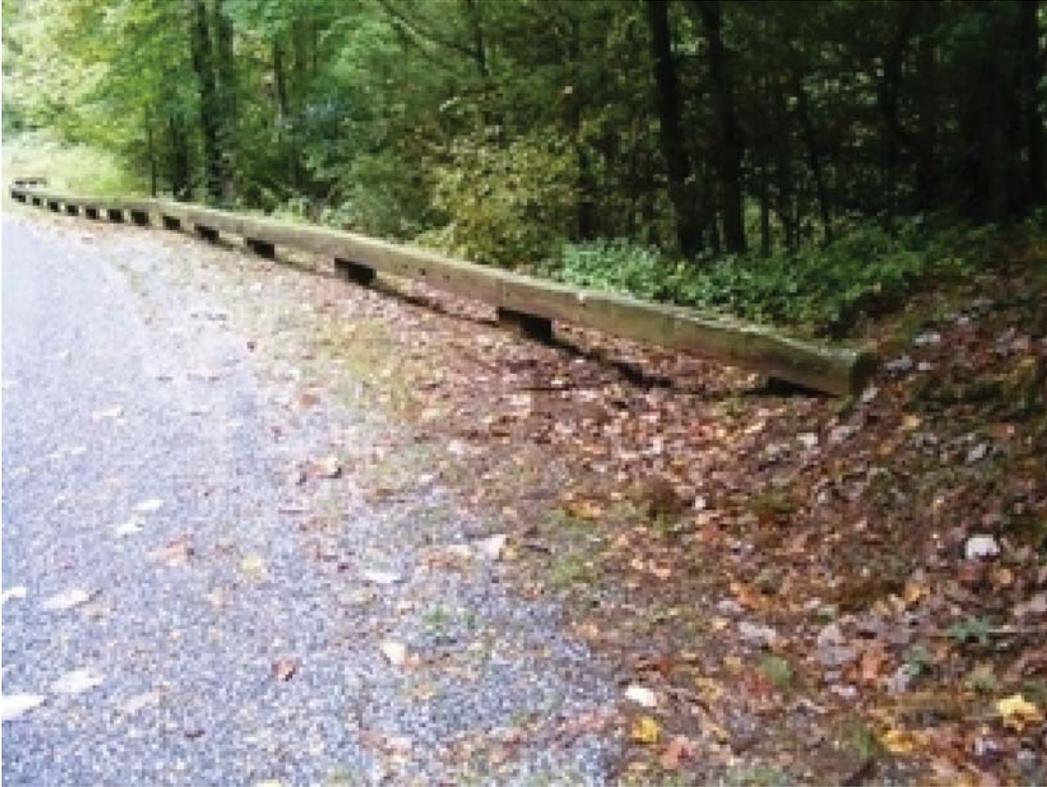
GRSM_0022_2.106_R_1.JPG

Barrier ID:	GRSM-0022-2.106-R				
Route Name:	CATALOOCHEE ENTRANCE ROAD				
Inspection Date:	09/27/2010	Barrier Rating:	32.40		
Barrier Description					
Type:	OTHER: TIMBER RAIL ON TIMBER POSTS	Barrier Function:	TRAFFIC		
Barrier Material:	LOG/TIMBER/WOOD	Post Material:	WOOD		
Blockout Type:	N/A	Length (ft.):	165		
Speed Limit (MPH):	25	Placement with Respect to Road:	OUTSIDE OF CURVE		
Hazard Behind Barrier:	MEDIUM				
Barrier Crashworthiness					
Appropriate Test Level:	TL-1	Barrier Test Level:	NCW	Is Barrier Crashworthy?:	NO
Beg. End Trtmt Type:	NONE	Is Beg. End Trtmt Crashworthy?:	N/A	Approach Transition Type:	NONE
Ending End Trtmt Type:	NONE	Ending End Trtmt Crashworthy?:	N/A		
Average Measurements					
Design Height (In.):	24	Width (In.):	0.0	Post Spacing (In.):	118.6
Height (In.):	20.0	Lateral Offset (In.):	65.0	Road Grade (%):	8.30
Physical Condition					
Barrier	Alignment and Height:	The alignment has no deviation and the height is 3-5 in below the 24 in design height.

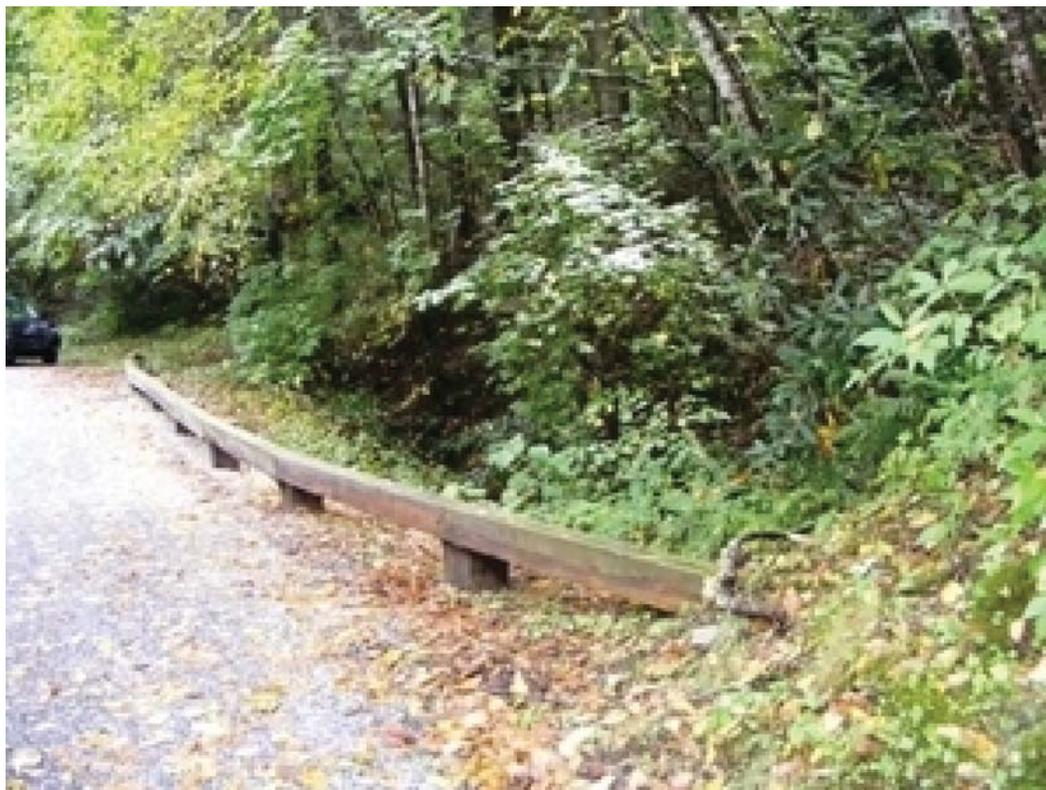
GRSM_0022_2.190_L_1.JPG

Barrier ID:	GRSM-0022-2.190-L				
Route Name:	CATALOOCHEE ENTRANCE ROAD				
Inspection Date:	09/27/2010	Barrier Rating:	23.70		
Barrier Description					
Type:	OTHER: TIMBER RAIL ON TIMBER POSTS	Barrier Function:	TRAFFIC		
Barrier Material:	LOG/TIMBER/WOOD	Post Material:	WOOD		
Blockout Type:	N/A	Length (ft.):	79		
Speed Limit (MPH):	25	Placement with Respect to Road:	OUTSIDE OF CURVE		
Hazard Behind Barrier:	MEDIUM				
Barrier Crashworthiness					
Appropriate Test Level:	TL-1	Barrier Test Level:	NCW	Is Barrier Crashworthy?:	NO
Beg. End Trtmt Type:	NONE	Is Beg. End Trtmt Crashworthy?:	N/A	Approach Transition Type:	NONE
Ending End Trtmt Type:	NONE	Ending End Trtmt Crashworthy?:	N/A		
Average Measurements					
Design Height (In.):	24	Width (In.):	0.0	Post Spacing (In.):	117.5
Height (In.):	17.2	Lateral Offset (In.):	59.5	Road Grade (%):	6.10
Physical Condition					
Barrier	Alignment and Height:	The alignment has no deviation and the height is 6-8 in below the 24 in design height.

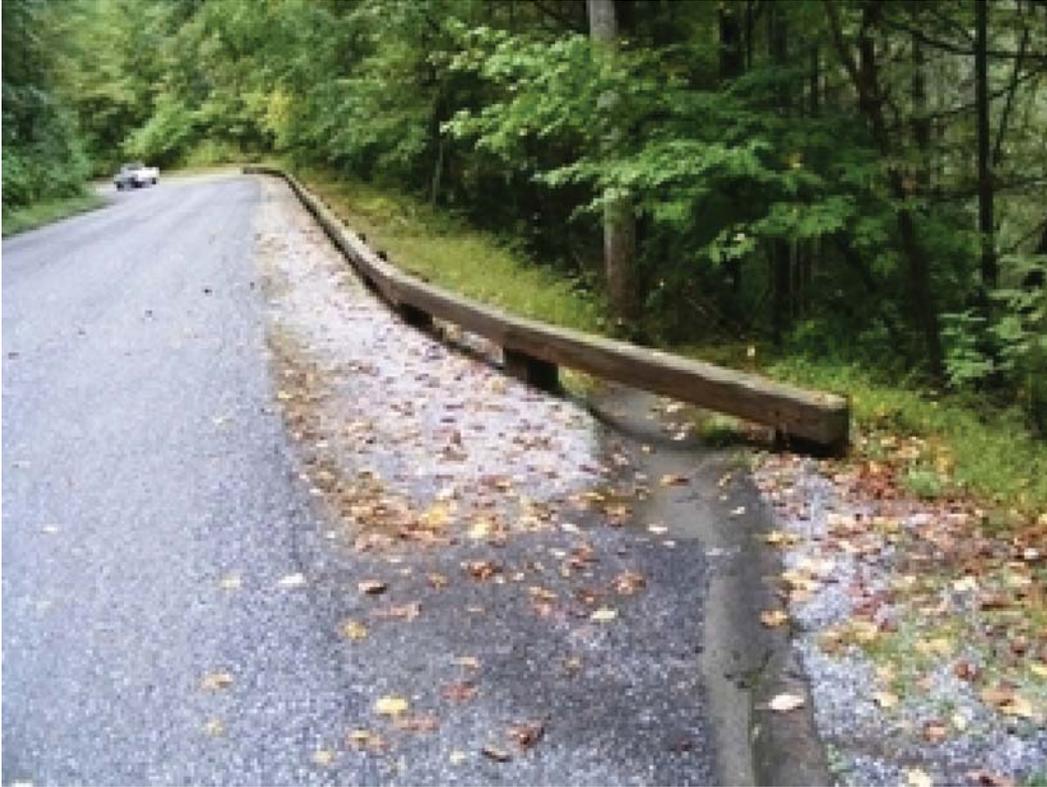
GRSM_0022_2.223_R_1.JPG

Barrier ID:	GRSM-0022-2.223-R				
Route Name:	CATALOOCHEE ENTRANCE ROAD				
Inspection Date:	09/27/2010	Barrier Rating:	32.20		
Barrier Description					
Type:	OTHER: TIMBER RAIL ON TIMBER POSTS	Barrier Function:	TRAFFIC		
Barrier Material:	LOG/TIMBER/WOOD	Post Material:	WOOD		
Blockout Type:	N/A	Length (ft.):	238		
Speed Limit (MPH):	25	Placement with Respect to Road:	OUTSIDE OF CURVE		
Hazard Behind Barrier:	MEDIUM				
Barrier Crashworthiness					
Appropriate Test Level:	TL-1	Barrier Test Level:	NCW	Is Barrier Crashworthy?:	NO
Beg. End Trtmt Type:	NONE	Is Beg. End Trtmt Crashworthy?:	N/A	Approach Transition Type:	NONE
Ending End Trtmt Type:	NONE	Ending End Trtmt Crashworthy?:	N/A		
Average Measurements					
Design Height (In.):	24	Width (In.):	0.0	Post Spacing (In.):	118.5
Height (In.):	18.2	Lateral Offset (In.):	58.0	Road Grade (%):	5.50
Physical Condition					
Barrier	Alignment and Height:	The alignment has no deviation and the height is 5-7 in below the 24 in design height.

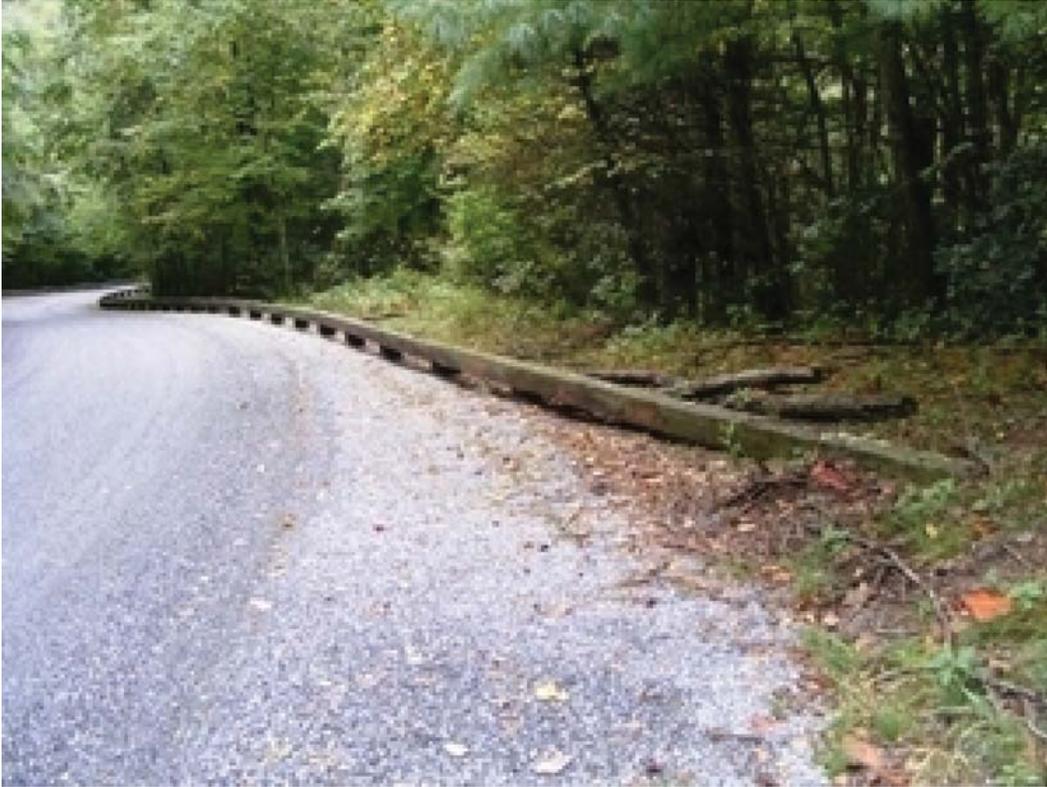
GRSM_0022_2.303_R_1.JPG

Barrier ID:	GRSM-0022-2.303-R				
Route Name:	CATALOOCHEE ENTRANCE ROAD				
Inspection Date:	09/27/2010	Barrier Rating:	49.50		
Barrier Description					
Type:	OTHER: TIMBER RAIL ON TIMBER POSTS	Barrier Function:	TRAFFIC		
Barrier Material:	LOG/TIMBER/WOOD	Post Material:	WOOD		
Blockout Type:	N/A	Length (ft.):	1327		
Speed Limit (MPH):	25	Placement with Respect to Road:	INSIDE OF CURVE		
Hazard Behind Barrier:	MEDIUM				
Barrier Crashworthiness					
Appropriate Test Level:	TL-1	Barrier Test Level:	NCW	Is Barrier Crashworthy?:	NO
Beg. End Trtmt Type:	NONE	Is Beg. End Trtmt Crashworthy?:	N/A	Approach Transition Type:	NONE
Ending End Trtmt Type:	NONE	Ending End Trtmt Crashworthy?:	N/A		
Average Measurements					
Design Height (In.):	24	Width (In.):	0.0	Post Spacing (In.):	118.0
Height (In.):	19.7	Lateral Offset (In.):	52.4	Road Grade (%):	6.60
Physical Condition					
Barrier	Alignment and Height:	The alignment has no deviation and the height is 2-5 in below the 24 in design height.

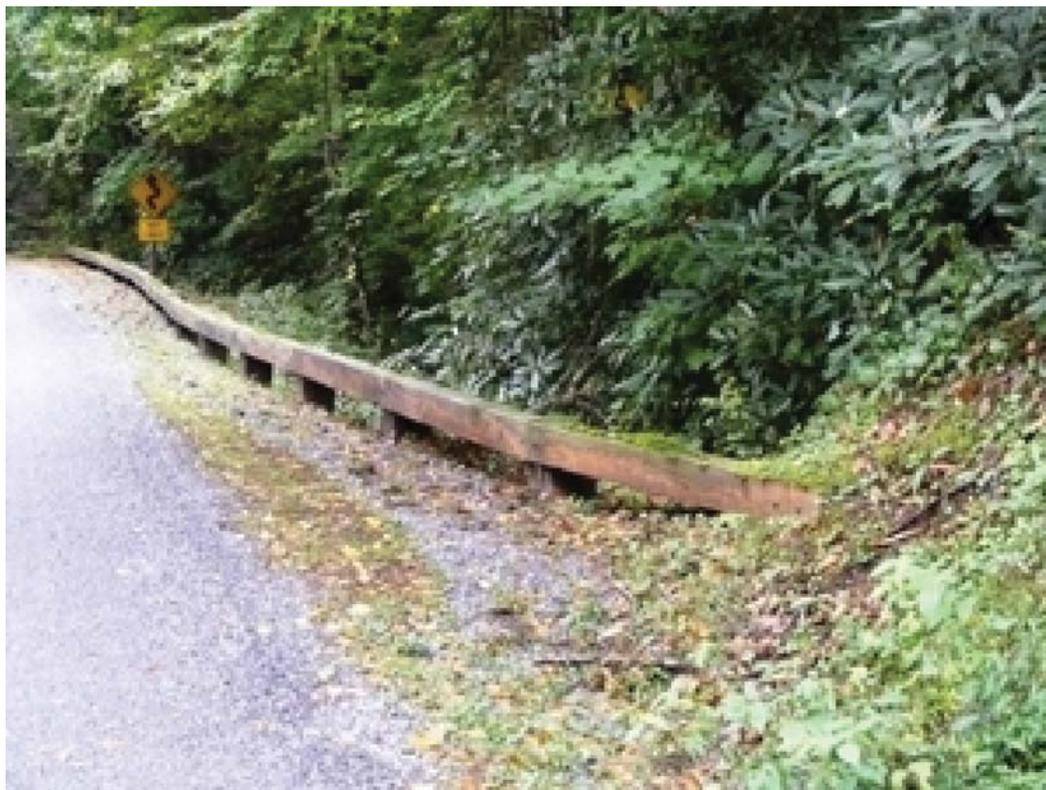
GRSM_0022_2.347_L_1.JPG

Barrier ID:	GRSM-0022-2.347-L				
Route Name:	CATALOOCHIE ENTRANCE ROAD				
Inspection Date:	09/27/2010	Barrier Rating:	23.70		
Barrier Description					
Type:	OTHER: TIMBER RAIL ON TIMBER POSTS	Barrier Function:	TRAFFIC		
Barrier Material:	LOG/TIMBER/WOOD	Post Material:	WOOD		
Blockout Type:	N/A	Length (ft.):	189		
Speed Limit (MPH):	25	Placement with Respect to Road:	OUTSIDE OF CURVE		
Hazard Behind Barrier:	MEDIUM				
Barrier Crashworthiness					
Appropriate Test Level:	TL-1	Barrier Test Level:	NCW	Is Barrier Crashworthy?:	NO
Beg. End Trtmt Type:	NONE	Is Beg. End Trtmt Crashworthy?:	N/A	Approach Transition Type:	NONE
Ending End Trtmt Type:	NONE	Ending End Trtmt Crashworthy?:	N/A		
Average Measurements					
Design Height (In.):	24	Width (In.):	0.0	Post Spacing (In.):	119.0
Height (In.):	16.0	Lateral Offset (In.):	58.0	Road Grade (%):	5.00
Physical Condition					
Barrier	Alignment and Height:	The alignment has no deviation and the height is 8 in below the 24 in design height.

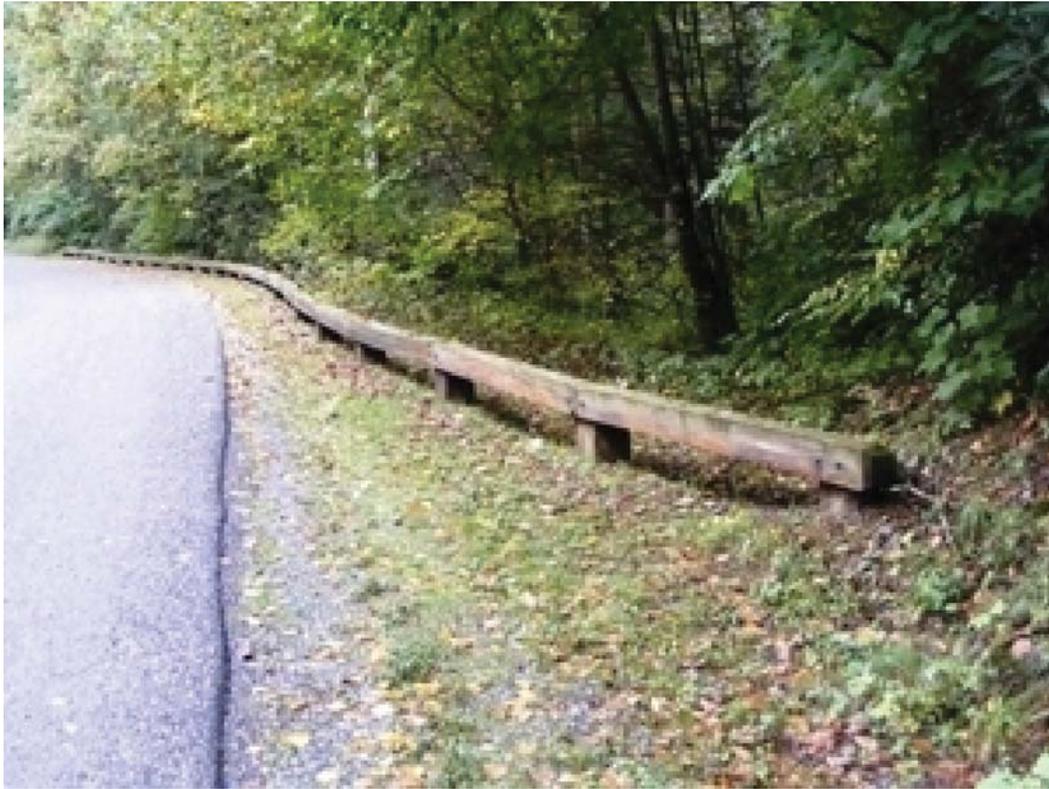
GRSM_0022_2.409_L_1.JPG

Barrier ID:	GRSM-0022-2.409-L				
Route Name:	CATALOOCHEE ENTRANCE ROAD				
Inspection Date:	09/27/2010	Barrier Rating:	35.20		
Barrier Description					
Type:	OTHER: TIMBER RAIL ON TIMBER POSTS	Barrier Function:	TRAFFIC		
Barrier Material:	LOG/TIMBER/WOOD	Post Material:	WOOD		
Blockout Type:	N/A	Length (ft.):	262		
Speed Limit (MPH):	25	Placement with Respect to Road:	OUTSIDE OF CURVE		
Hazard Behind Barrier:	MEDIUM				
Barrier Crashworthiness					
Appropriate Test Level:	TL-1	Barrier Test Level:	NCW	Is Barrier Crashworthy?:	NO
Beg. End Trtmt Type:	NONE	Is Beg. End Trtmt Crashworthy?:	N/A	Approach Transition Type:	NONE
Ending End Trtmt Type:	NONE	Ending End Trtmt Crashworthy?:	N/A		
Average Measurements					
Design Height (In.):	24	Width (In.):	0.0	Post Spacing (In.):	117.6
Height (In.):	17.0	Lateral Offset (In.):	54.2	Road Grade (%):	6.10
Physical Condition					
Barrier	Alignment and Height:	The alignment has no deviation and the height is 5-9 in below the 24 in design height.

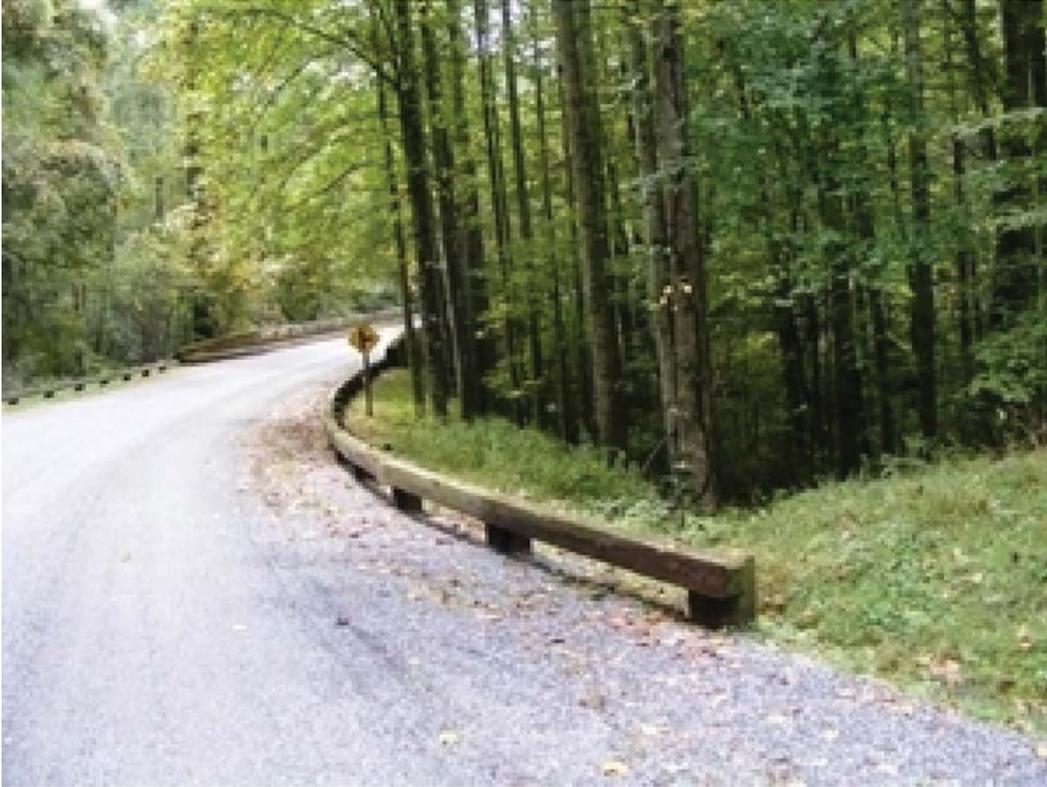
GRSM_0022_2.740_R_1.JPG

Barrier ID:	GRSM-0022-2.740-R				
Route Name:	CATALOOCHEE ENTRANCE ROAD				
Inspection Date:	09/27/2010	Barrier Rating:	22.30		
Barrier Description					
Type:	OTHER: TIMBER RAIL ON TIMBER POSTS	Barrier Function:	TRAFFIC		
Barrier Material:	LOG/TIMBER/WOOD	Post Material:	WOOD		
Blockout Type:	N/A	Length (ft.):	153		
Speed Limit (MPH):	25	Placement with Respect to Road:	INSIDE OF CURVE		
Hazard Behind Barrier:	MEDIUM				
Barrier Crashworthiness					
Appropriate Test Level:	TL-1	Barrier Test Level:	NCW	Is Barrier Crashworthy?:	NO
Beg. End Trtmt Type:	NONE	Is Beg. End Trtmt Crashworthy?:	N/A	Approach Transition Type:	NONE
Ending End Trtmt Type:	NONE	Ending End Trtmt Crashworthy?:	N/A		
Average Measurements					
Design Height (In.):	24	Width (In.):	0.0	Post Spacing (In.):	118.5
Height (In.):	19.0	Lateral Offset (In.):	65.0	Road Grade (%):	3.40
Physical Condition					
Barrier	Alignment and Height:	The alignment has no deviation and the height is 5 in below the 24 in design height.

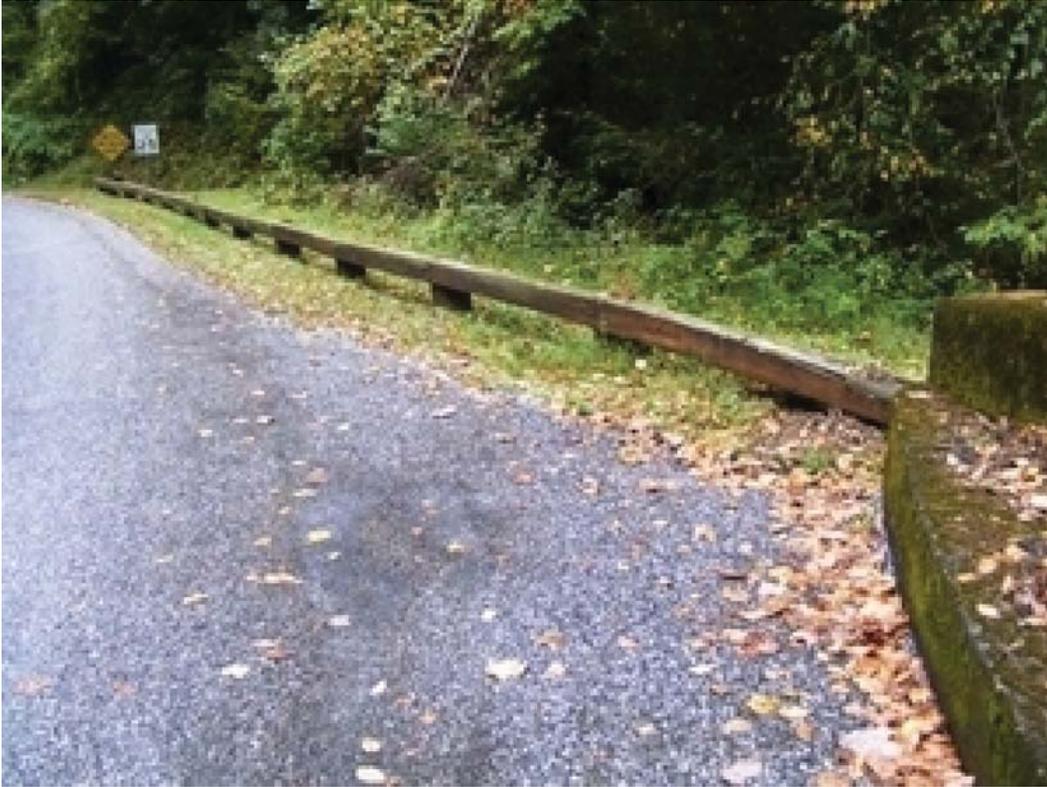
GRSM_0022_2.751_L_1.JPG

Barrier ID:	GRSM-0022-2.751-L				
Route Name:	CATALOOCHEE ENTRANCE ROAD				
Inspection Date:	09/27/2010	Barrier Rating:	25.60		
Barrier Description					
Type:	OTHER: TIMBER RAIL ON TIMBER POSTS	Barrier Function:	TRAFFIC		
Barrier Material:	LOG/TIMBER/WOOD	Post Material:	WOOD		
Blockout Type:	N/A	Length (ft.):	130		
Speed Limit (MPH):	25	Placement with Respect to Road:	OUTSIDE OF CURVE		
Hazard Behind Barrier:	LOW				
Barrier Crashworthiness					
Appropriate Test Level:	TL-1	Barrier Test Level:	NCW	Is Barrier Crashworthy?:	NO
Beg. End Trtmt Type:	NONE	Is Beg. End Trtmt Crashworthy?:	N/A	Approach Transition Type:	NONE
Ending End Trtmt Type:	NONE	Ending End Trtmt Crashworthy?:	N/A		
Average Measurements					
Design Height (In.):	24	Width (In.):	0.0	Post Spacing (In.):	118.0
Height (In.):	18.2	Lateral Offset (In.):	63.0	Road Grade (%):	4.30
Physical Condition					
Barrier	Alignment and Height:	The alignment has no deviation and the height is 5-7 in below the 24 in design height.

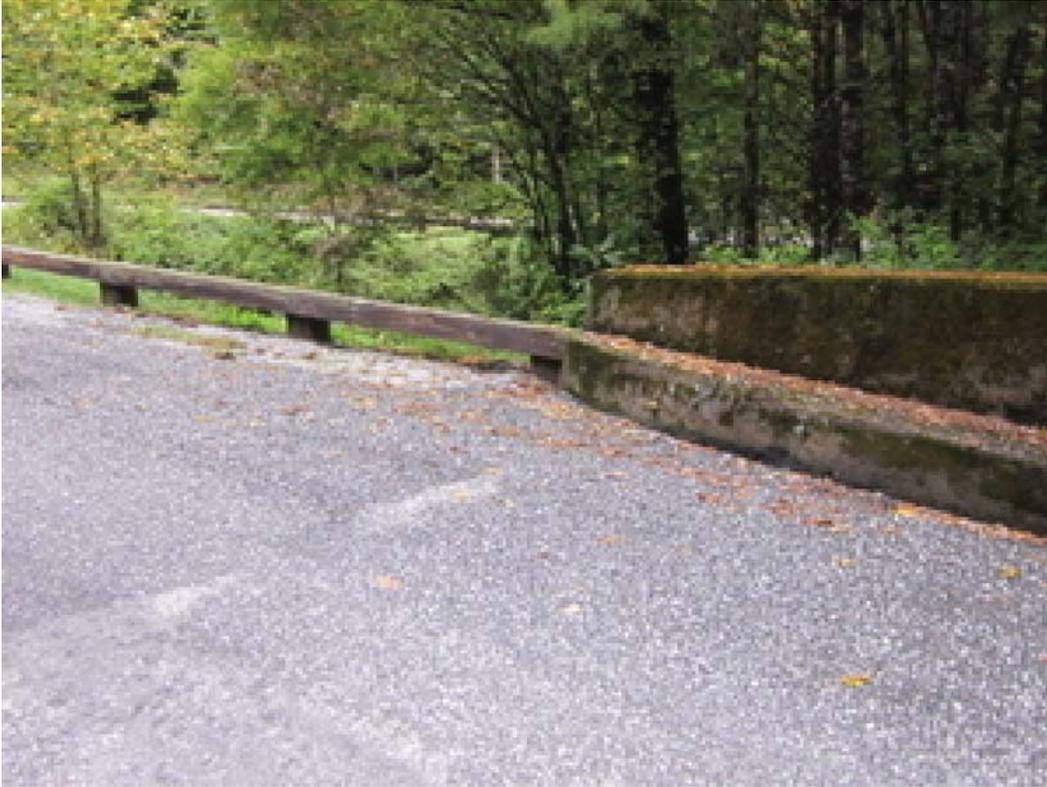
GRSM_0022_2.812_R_1.JPG

Barrier ID:	GRSM-0022-2.812-R				
Route Name:	CATALOOCHEE ENTRANCE ROAD				
Inspection Date:	09/27/2010	Barrier Rating:	12.60		
Barrier Description					
Type:	OTHER: TIMBER RAIL ON TIMBER POSTS	Barrier Function:	TRAFFIC		
Barrier Material:	LOG/TIMBER/WOOD	Post Material:	WOOD		
Blockout Type:	N/A	Length (ft.):	174		
Speed Limit (MPH):	25	Placement with Respect to Road:	TANGENT		
Hazard Behind Barrier:	LOW				
Barrier Crashworthiness					
Appropriate Test Level:	TL-1	Barrier Test Level:	NCW	Is Barrier Crashworthy?:	NO
Beg. End Trtmt Type:	NONE	Is Beg. End Trtmt Crashworthy?:	N/A	Approach Transition Type:	NONE
Ending End Trtmt Type:	NONE	Ending End Trtmt Crashworthy?:	N/A		
Average Measurements					
Design Height (In.):	24	Width (In.):	0.0	Post Spacing (In.):	111.6
Height (In.):	18.7	Lateral Offset (In.):	82.3	Road Grade (%):	2.30
Physical Condition					
Barrier	Alignment and Height:	The alignment has no deviation and the height is 4-6 in below the 24 in design height.

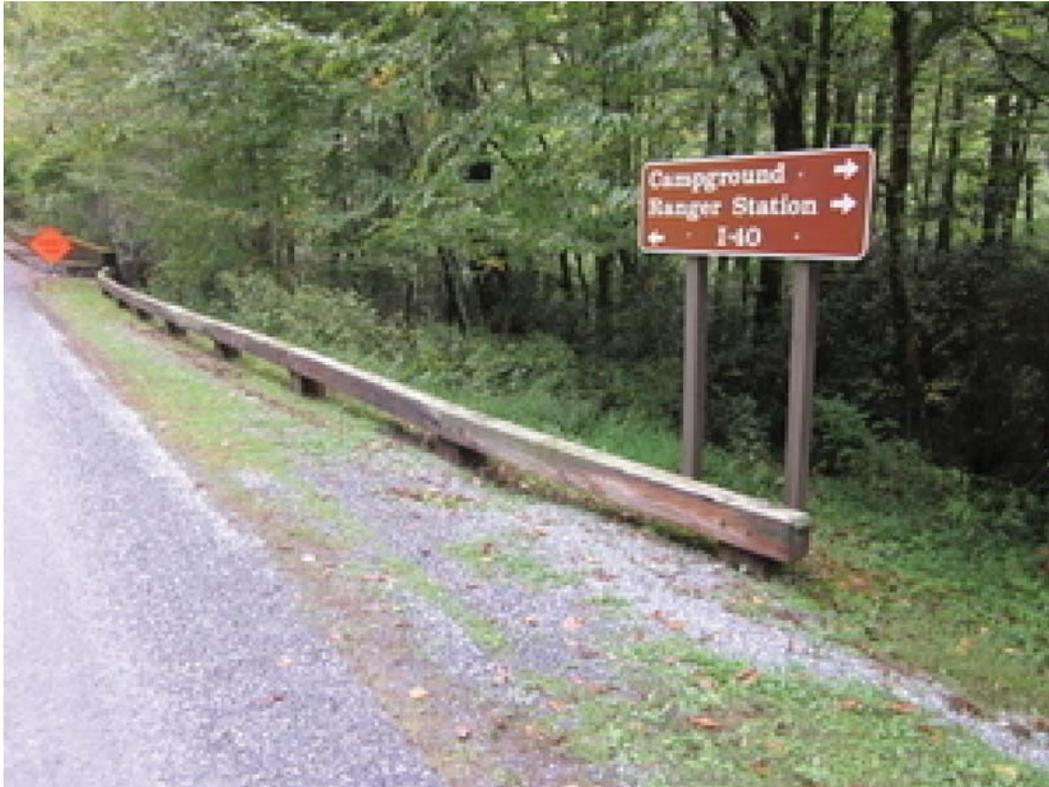
GRSM_0022_2.818_L_1.JPG

Barrier ID:	GRSM-0022-2.818-L				
Route Name:	CATALOOCHEE ENTRANCE ROAD				
Inspection Date:	09/27/2010	Barrier Rating:	12.60		
Barrier Description					
Type:	OTHER: TIMBER RAIL ON TIMBER POSTS	Barrier Function:	TRAFFIC		
Barrier Material:	LOG/TIMBER/WOOD	Post Material:	WOOD		
Blockout Type:	N/A	Length (ft.):	100		
Speed Limit (MPH):	25	Placement with Respect to Road:	TANGENT		
Hazard Behind Barrier:	LOW				
Barrier Crashworthiness					
Appropriate Test Level:	TL-1	Barrier Test Level:	NCW	Is Barrier Crashworthy?:	NO
Beg. End Trtmt Type:	NONE	Is Beg. End Trtmt Crashworthy?:	N/A	Approach Transition Type:	NONE
Ending End Trtmt Type:	NONE	Ending End Trtmt Crashworthy?:	N/A		
Average Measurements					
Design Height (In.):	24	Width (In.):	0.0	Post Spacing (In.):	118.3
Height (In.):	18.7	Lateral Offset (In.):	71.6	Road Grade (%):	1.30
Physical Condition					
Barrier	Alignment and Height:	The alignment has no deviation and the height is 4-6 in below the 24 in design height.

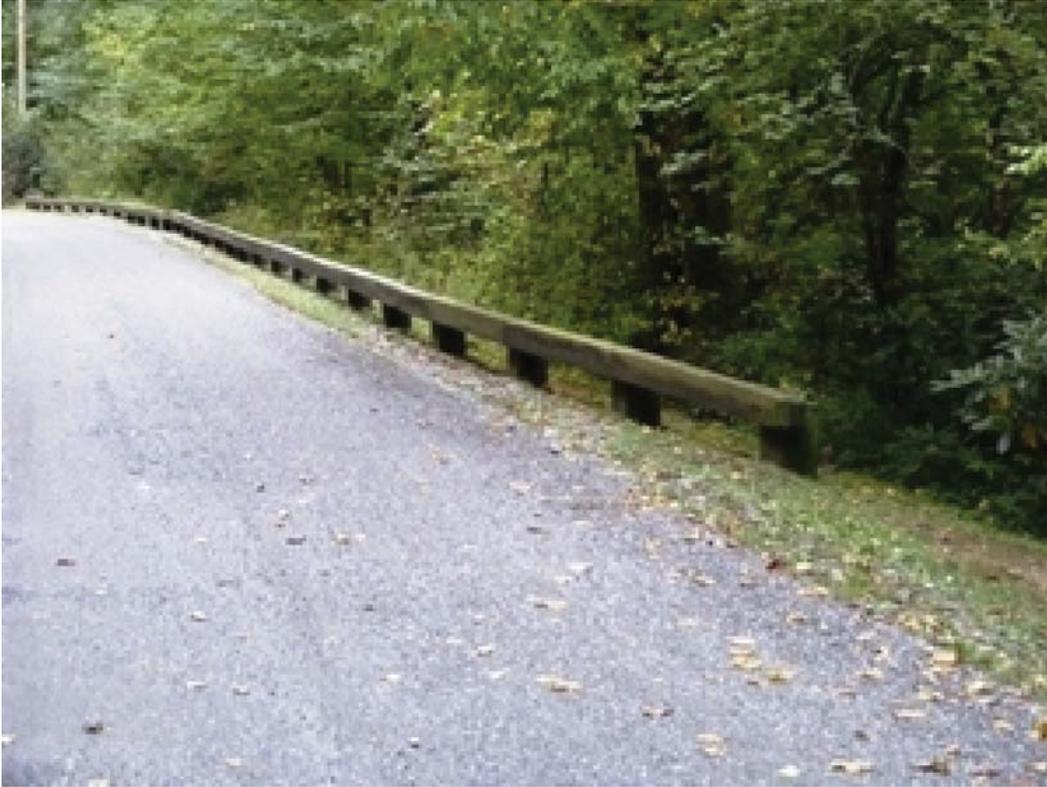
GRSM_0022_3.114_L_1.JPG

Barrier ID:	GRSM-0022-3.114-L				
Route Name:	CATALOOCHEE ENTRANCE ROAD				
Inspection Date:	09/27/2010	Barrier Rating:	31.20		
Barrier Description					
Type:	OTHER: TIMBER RAIL ON TIMBER POSTS	Barrier Function:	TRAFFIC		
Barrier Material:	LOG/TIMBER/WOOD	Post Material:	WOOD		
Blockout Type:	N/A	Length (ft.):	275		
Speed Limit (MPH):	25	Placement with Respect to Road:	OUTSIDE OF CURVE		
Hazard Behind Barrier:	LOW				
Barrier Crashworthiness					
Appropriate Test Level:	TL-1	Barrier Test Level:	NCW	Is Barrier Crashworthy?:	NO
Beg. End Trtmt Type:	NONE	Is Beg. End Trtmt Crashworthy?:	N/A	Approach Transition Type:	NONE
Ending End Trtmt Type:	NONE	Ending End Trtmt Crashworthy?:	N/A		
Average Measurements					
Design Height (In.):	24	Width (In.):	0.0	Post Spacing (In.):	119.0
Height (In.):	19.0	Lateral Offset (In.):	34.2	Road Grade (%):	0.70
Physical Condition					
Barrier	Alignment and Height:	The alignment has no deviation and the height is 5 in below the 24 in design height.
