NPS Guardwall/Rail Inventory Program
Great Smoky Mountains National Park

Federal Highway Administration
Eastern Federal Lands Highway Division
Road Inventory Program (RIP)

Data Collection Date: September 2010
Report Date: December 2015

Great Smoky Mountains National Park in North Carolina and Tennessee

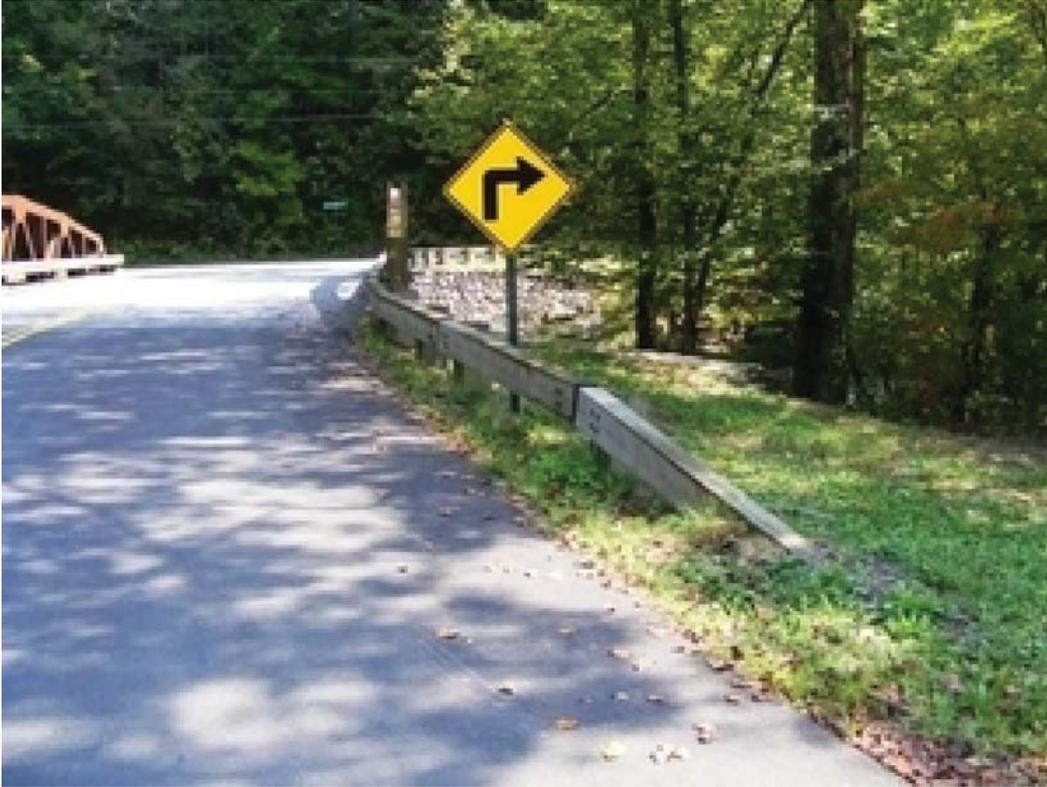
GRSM_0101_0.084_R_1.JPG

Barrier ID:	GRSM-0101-0.084-R				
Route Name:	TOW STRING ROAD				
Inspection Date:	09/23/2010	Barrier Rating:	19.50		
Barrier Description					
Type:	STEEL-BACKED TIMBER WITHOUT BLOCKOUT	Barrier Function:	TRAFFIC		
Barrier Material:	STEEL-BACKED TIMBER/LOG	Post Material:	WOOD		
Blockout Type:	N/A	Length (ft.):	40		
Speed Limit (MPH):	25	Placement with Respect to Road:	INSIDE OF CURVE		
Hazard Behind Barrier:	MEDIUM				
Barrier Crashworthiness					
Appropriate Test Level:	TL-1	Barrier Test Level:	TL-2	Is Barrier Crashworthy?:	YES
Beg. End Trtmt Type:	SBT/LOG FLARED	Is Beg. End Trtmt Crashworthy?:	NO	Approach Transition Type:	RIGID SBT WALL - SBT
Ending End Trtmt Type:	NONE	Ending End Trtmt Crashworthy?:	N/A		
Average Measurements					
Design Height (In.):	27	Width (In.):	0.0	Post Spacing (In.):	80.5
Height (In.):	23.2	Lateral Offset (In.):	33.5	Road Grade (%):	1.50
Physical Condition					
Barrier	Alignment and Height:	While the Steel-backed timber on the bridge is part of the Bridge Inventory Program (BIP) it was noted that the barrier's height was more than 1 in below the 27 in design height.

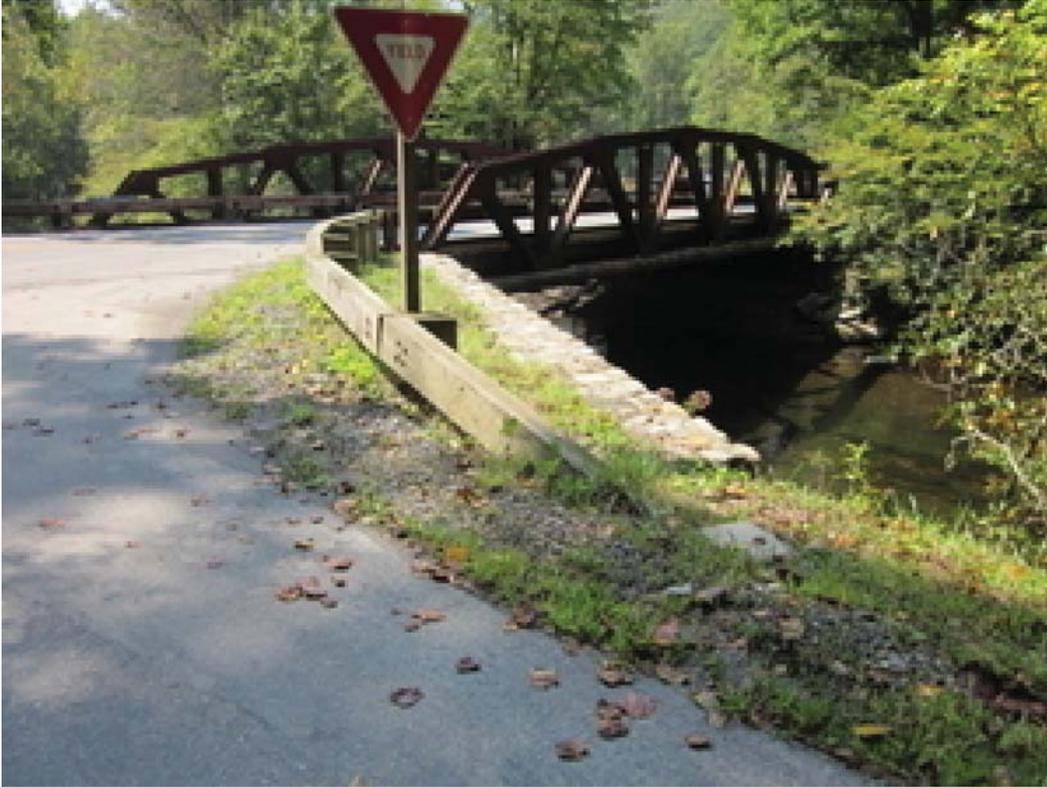
GRSM_0101_0.106_L_1.JPG

Barrier ID:	GRSM-0101-0.106-L				
Route Name:	TOW STRING ROAD				
Inspection Date:	09/23/2010	Barrier Rating:	30.70		
Barrier Description					
Type:	STEEL-BACKED TIMBER WITHOUT BLOCKOUT	Barrier Function:	TRAFFIC		
Barrier Material:	STEEL-BACKED TIMBER/LOG	Post Material:	WOOD		
Blockout Type:	N/A	Length (ft.):	42		
Speed Limit (MPH):	25	Placement with Respect to Road:	OUTSIDE OF CURVE		
Hazard Behind Barrier:	MEDIUM				
Barrier Crashworthiness					
Appropriate Test Level:	TL-1	Barrier Test Level:	TL-2	Is Barrier Crashworthy?:	YES
Beg. End Trtmt Type:	NONE	Is Beg. End Trtmt Crashworthy?:	N/A	Approach Transition Type:	RIGID SBT WALL - SBT
Ending End Trtmt Type:	SBT/LOG FLARED	Ending End Trtmt Crashworthy?:	NO		
Average Measurements					
Design Height (In.):	27	Width (In.):	0.0	Post Spacing (In.):	80.0
Height (In.):	22.7	Lateral Offset (In.):	111.3	Road Grade (%):	1.00
Physical Condition					
Barrier	Alignment and Height:	Transition and end treatment only.

Breaking and Cracking:	Transition and end treatment only.			
	Missing Elements:	Transition and end treatment only.			
	Corrosion and Weathering:	Transition and end treatment only.			
End Treatments	Alignment and Height:	Alignment acceptable. Height is 1 to 8 in below the 27-in design height.			
	Breaking and Cracking:	No breaking or cracking observed.			
	Missing Elements:	No missing elements observed.			
	Corrosion and Weathering:	No corrosion or weathering observed.

Barrier ID:	GRSM-0101-0.106-L				
Route Name:	TOW STRING ROAD				
Inspection Date:	09/23/2010	Barrier Rating:		30.70	
Repair Recommendations					
Repair Action:	NO ACTION	FMSS Work Type:	N/A	Repair Cost:	\$0
Brief Workorder:	N/A				
Workorder:

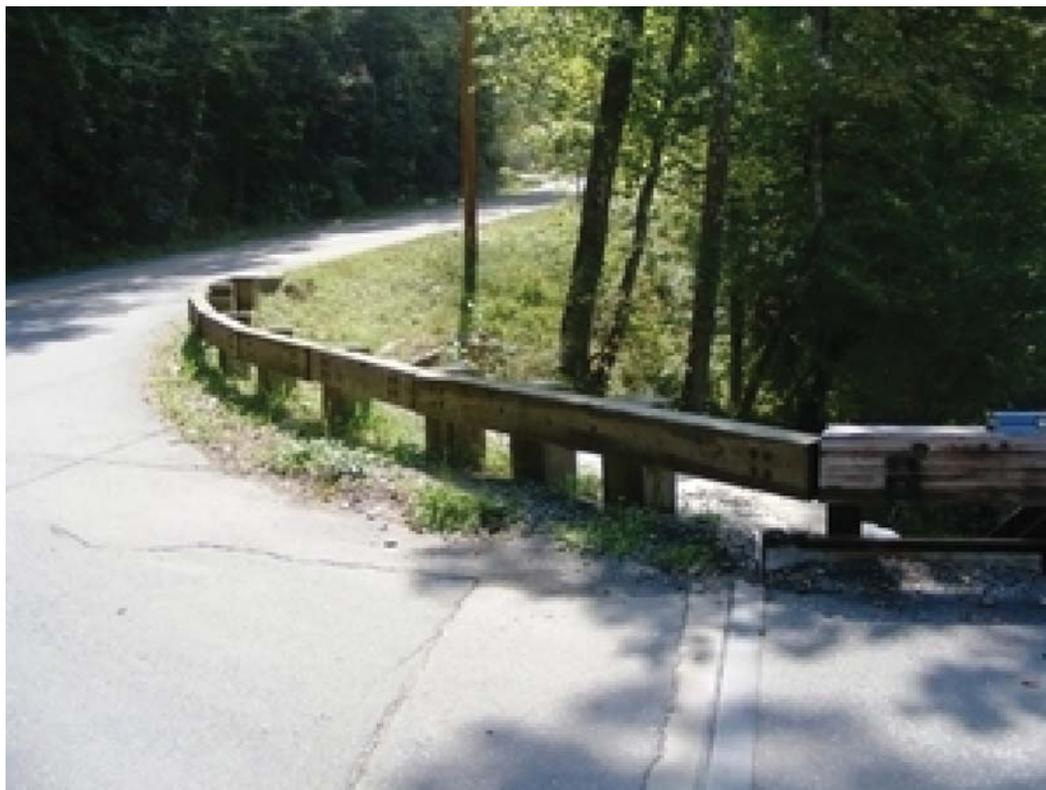
GRSM_0101_0.106_R_1.JPG

Barrier ID:	GRSM-0101-0.106-R				
Route Name:	TOW STRING ROAD				
Inspection Date:	09/23/2010	Barrier Rating:	32.40		
Barrier Description					
Type:	STEEL-BACKED TIMBER WITHOUT BLOCKOUT	Barrier Function:	TRAFFIC		
Barrier Material:	STEEL-BACKED TIMBER/LOG	Post Material:	WOOD		
Blockout Type:	N/A	Length (ft.):	54		
Speed Limit (MPH):	25	Placement with Respect to Road:	INSIDE OF CURVE		
Hazard Behind Barrier:	MEDIUM				
Barrier Crashworthiness					
Appropriate Test Level:	TL-1	Barrier Test Level:	TL-2	Is Barrier Crashworthy?:	YES
Beg. End Trtmt Type:	NONE	Is Beg. End Trtmt Crashworthy?:	N/A	Approach Transition Type:	RIGID SBT WALL - SBT
Ending End Trtmt Type:	SBT/LOG FLARED	Ending End Trtmt Crashworthy?:	NO		
Average Measurements					
Design Height (In.):	27	Width (In.):	0.0	Post Spacing (In.):	54.7
Height (In.):	22.2	Lateral Offset (In.):	29.2	Road Grade (%):	3.00
Physical Condition					
Barrier	Alignment and Height:	Transition and end treatment only.

Breaking and Cracking:	Transition and end treatment only.			
	Missing Elements:	Transition and end treatment only.			
	Corrosion and Weathering:	Transition and end treatment only.			
End Treatments	Alignment and Height:	Alignment acceptable. Height is 2-8 in below the 27 in design height.			
	Breaking and Cracking:	No breaking or cracking observed.			
	Missing Elements:	No missing elements observed.			
	Corrosion and Weathering:	No corrosion or weathering observed.

Repair Action:	NO ACTION	FMSS Work Type:	N/A	Repair Cost:	\$0
Brief Workorder:	N/A				
Workorder:

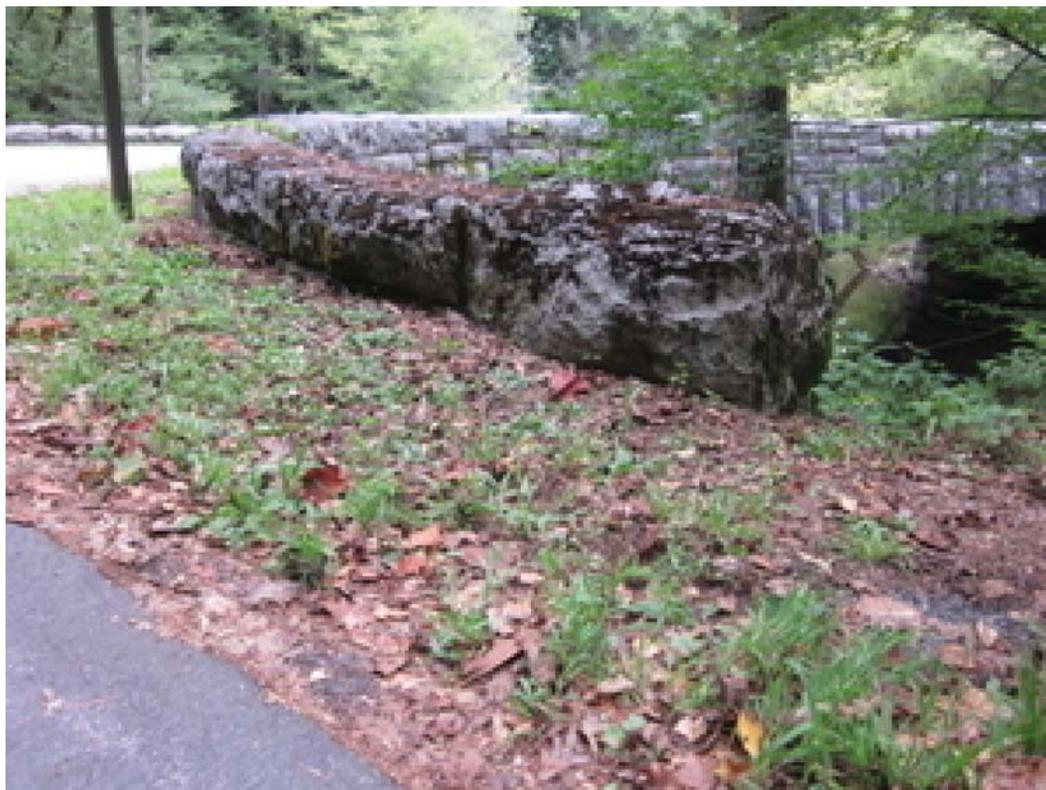
GRSM_0128_0.009_L_1.JPG

Barrier ID:	GRSM-0128-0.009-L				
Route Name:	TREMONT ROAD				
Inspection Date:	09/10/2010	Barrier Rating:	24.10		
Barrier Description					
Type:	STONE MASONRY WITHOUT CONCRETE CORE WALL	Barrier Function:	TRAFFIC		
Barrier Material:	STONE	Post Material:	N/A		
Blockout Type:	N/A	Length (ft.):	8		
Speed Limit (MPH):	25	Placement with Respect to Road:	INSIDE OF CURVE		
Hazard Behind Barrier:	HIGH				
Barrier Crashworthiness					
Appropriate Test Level:	TL-1	Barrier Test Level:	NCW	Is Barrier Crashworthy?:	NO
Beg. End Trtmt Type:	NONE	Is Beg. End Trtmt Crashworthy?:	N/A	Approach Transition Type:	NONE
Ending End Trtmt Type:	NONE	Ending End Trtmt Crashworthy?:	N/A		
Average Measurements					
Design Height (In.):	24	Width (In.):	28.0	Post Spacing (In.):	0.0
Height (In.):	22.2	Lateral Offset (In.):	69.6	Road Grade (%):	0.40
Physical Condition					
Barrier	Alignment and Height:	The alignment has no deviation and the height is 3-6 in below the 24 in design height.

Breaking and Cracking:	No breaking or cracking observed.			
	Missing Elements:	No missing elements observed.			
	Corrosion and Weathering:	No corrosion or weathering observed.			
End Treatments	Alignment and Height:				
	Breaking and Cracking:				
	Missing Elements:				
	Corrosion and Weathering:

Barrier ID:	GRSM-0128-0.009-L				
Route Name:	TREMONT ROAD				
Inspection Date:	09/10/2010	Barrier Rating:		24.10	
Repair Recommendations					
Repair Action:	NO ACTION	FMSS Work Type:	N/A	Repair Cost:	\$0
Brief Workorder:	N/A				
Workorder:

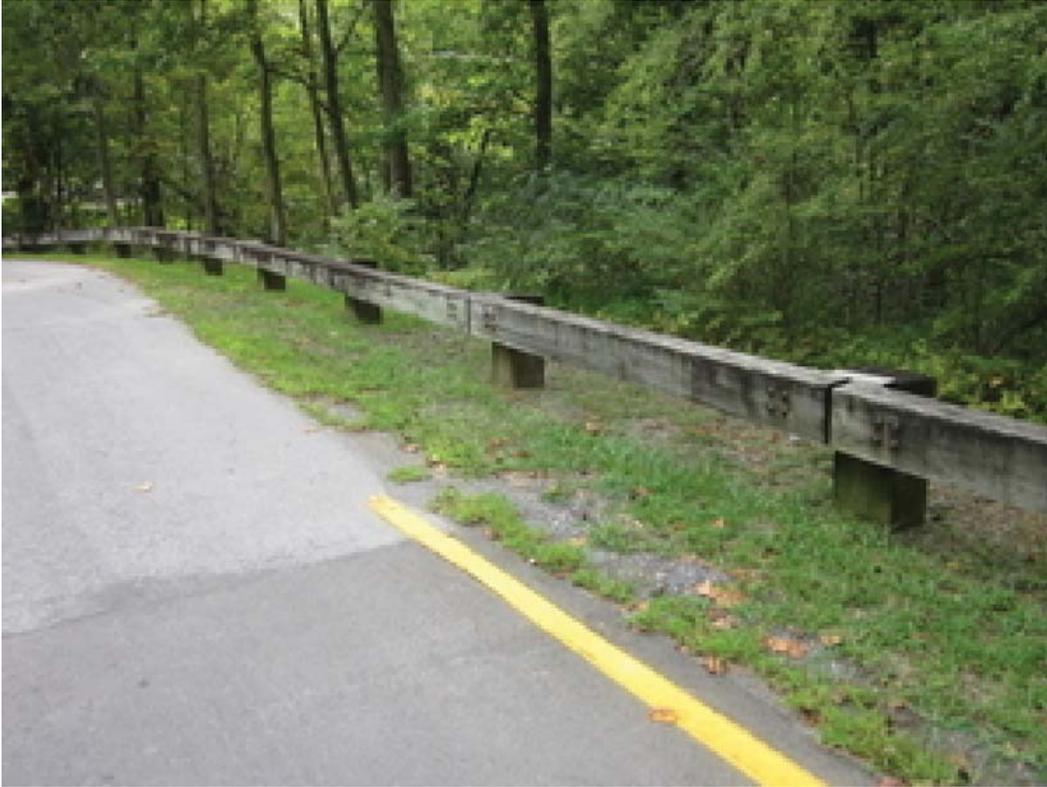
GRSM_0160_0.013_R_1.JPG

Barrier ID:	GRSM-0160-0.013-R				
Route Name:	HUSKEY GROVE ROAD				
Inspection Date:	09/10/2010	Barrier Rating:	31.20		
Barrier Description					
Type:	STEEL-BACKED TIMBER WITH BLOCKOUT	Barrier Function:	TRAFFIC		
Barrier Material:	STEEL-BACKED TIMBER/LOG	Post Material:	WOOD		
Blockout Type:	WOOD	Length (ft.):	102		
Speed Limit (MPH):	25	Placement with Respect to Road:	OUTSIDE OF CURVE		
Hazard Behind Barrier:	HIGH				
Barrier Crashworthiness					
Appropriate Test Level:	TL-1	Barrier Test Level:	TL-3	Is Barrier Crashworthy?:	YES
Beg. End Trtmt Type:	NONE	Is Beg. End Trtmt Crashworthy?:	N/A	Approach Transition Type:	NONE
Ending End Trtmt Type:	SBT/LOG FLARED	Ending End Trtmt Crashworthy?:	NO		
Average Measurements					
Design Height (In.):	27	Width (In.):	0.0	Post Spacing (In.):	120.0
Height (In.):	24.2	Lateral Offset (In.):	40.0	Road Grade (%):	3.40
Physical Condition					
Barrier	Alignment and Height:	No deviation in alignment & height is 1 to 3 in below the 27 in design height for 70 ft.

Breaking and Cracking:	No breaking or cracking observed.			
	Missing Elements:	No missing elements observed.			
	Corrosion and Weathering:	No corrosion or weathering observed.			
End Treatments	Alignment and Height:	Alignment acceptable. Height is within 1 in of the 27-in design height.			
	Breaking and Cracking:	No breaking or cracking observed.			
	Missing Elements:	No missing elements observed.			
	Corrosion and Weathering:	No corrosion or weathering observed.

Repair Action:	REPAIR	FMSS Work Type:	DEFERRED MAINTENANCE	Repair Cost:	\$2392
Brief Workorder:	Raise 70 feet of guardrail up to the 27 inch design height.				
Workorder:	Adjust Guardrail at \$10- per -Lin. Ft. for 70 LF = \$700. Raise 70 feet of guardrail up to the 27 inch design height. Low Speed Traffic Control at \$1475- per -Day for 1 Day(s) = \$1475.

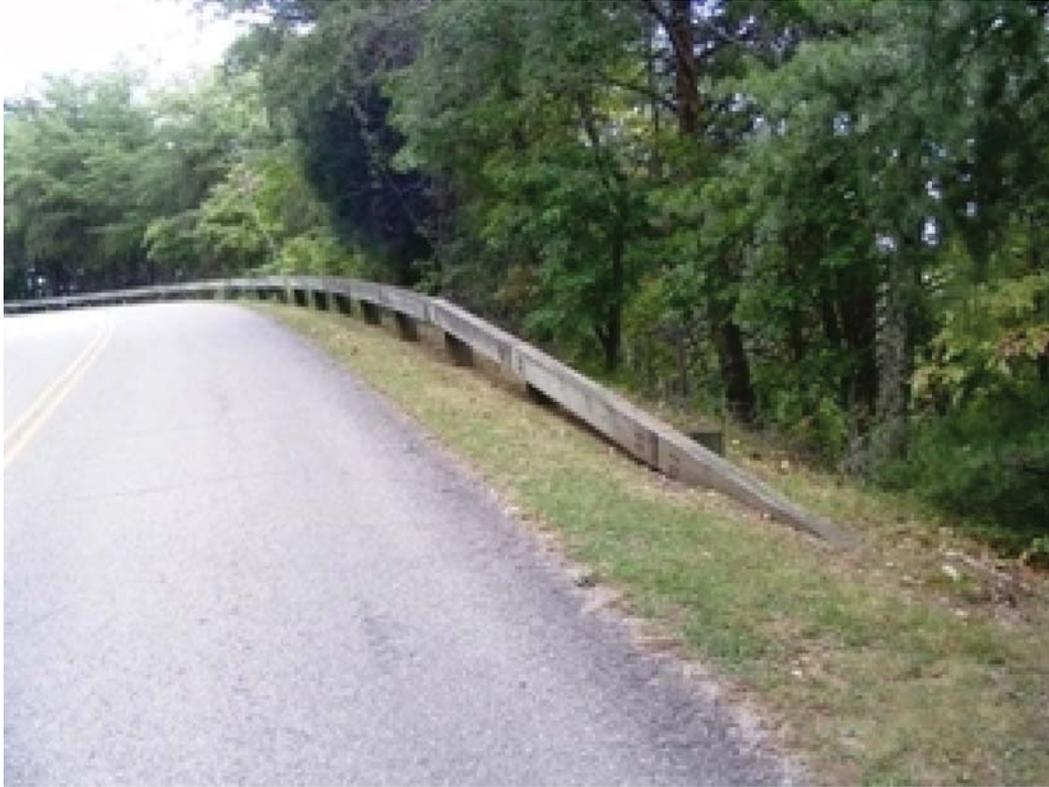
GRSM_0221_0.008_L_1.JPG

Barrier ID:	GRSM-0221-0.008-L				
Route Name:	LOOK ROCK MAINTENANCE ACCESS				
Inspection Date:	09/24/2010	Barrier Rating:	20.70		
Barrier Description					
Type:	STEEL-BACKED TIMBER WITHOUT BLOCKOUT	Barrier Function:	TRAFFIC		
Barrier Material:	STEEL-BACKED TIMBER/LOG	Post Material:	WOOD		
Blockout Type:	N/A	Length (ft.):	185		
Speed Limit (MPH):	25	Placement with Respect to Road:	OUTSIDE OF CURVE		
Hazard Behind Barrier:	MEDIUM				
Barrier Crashworthiness					
Appropriate Test Level:	TL-1	Barrier Test Level:	TL-2	Is Barrier Crashworthy?:	YES
Beg. End Trtmt Type:	SBT/LOG FLARED	Is Beg. End Trtmt Crashworthy?:	NO	Approach Transition Type:	NONE
Ending End Trtmt Type:	SBT/LOG FLARED	Ending End Trtmt Crashworthy?:	NO		
Average Measurements					
Design Height (In.):	27	Width (In.):	0.0	Post Spacing (In.):	120.0
Height (In.):	26.7	Lateral Offset (In.):	46.0	Road Grade (%):	5.80
Physical Condition					
Barrier	Alignment and Height:	The alignment has no deviation and the height is 0-1 in below the 27 in design height.

Breaking and Cracking:	No breaking or cracking observed.			
	Missing Elements:	No missing elements observed.			
	Corrosion and Weathering:	No corrosion or weathering observed.			
End Treatments	Alignment and Height:	Alignment acceptable. Height is within 1 in of the 27-in design height.			
	Breaking and Cracking:	No breaking or cracking observed.			
	Missing Elements:	No missing elements observed.			
	Corrosion and Weathering:	No corrosion or weathering observed.

Repair Action:	NO ACTION	FMSS Work Type:	N/A	Repair Cost:	\$0
Brief Workorder:	N/A				
Workorder:

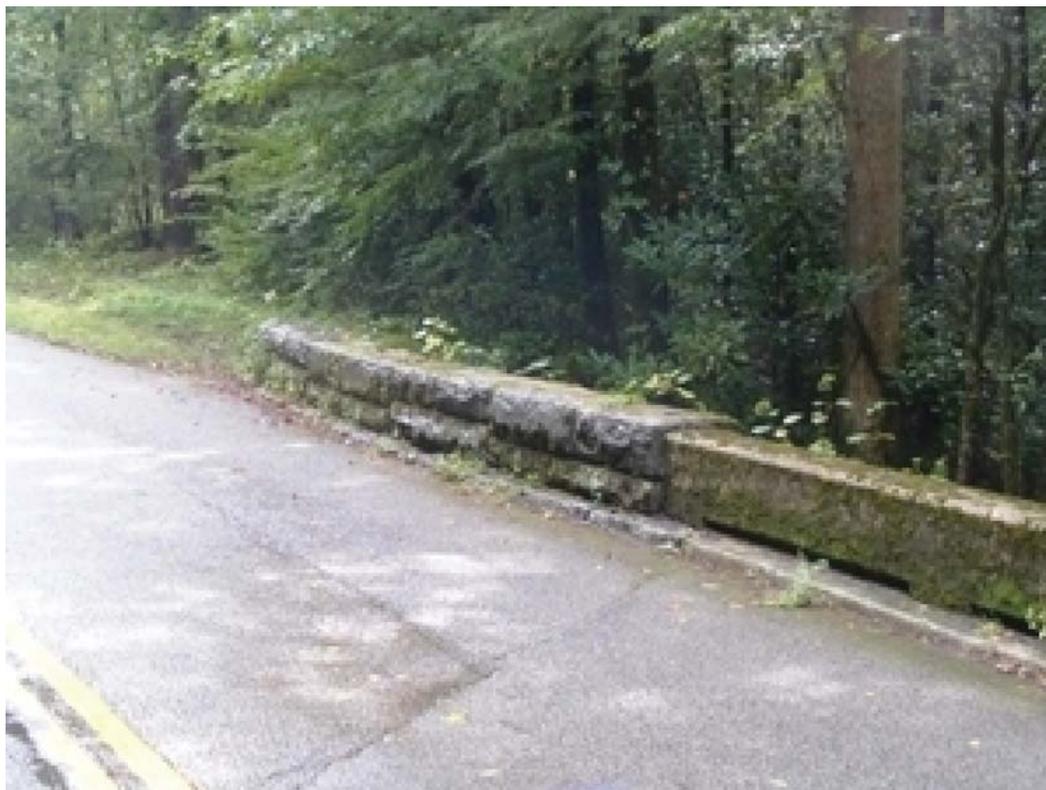
GRSM_0405_0.232_L_1.JPG

Barrier ID:	GRSM-0405-0.232-L				
Route Name:	SUGARLANDS HEADQUARTERS ROAD				
Inspection Date:	09/11/2010	Barrier Rating:	25.10		
Barrier Description					
Type:	STONE MASONRY WITHOUT CONCRETE CORE WALL	Barrier Function:	TRAFFIC		
Barrier Material:	STONE	Post Material:	N/A		
Blockout Type:	N/A	Length (ft.):	28		
Speed Limit (MPH):	25	Placement with Respect to Road:	TANGENT		
Hazard Behind Barrier:	MEDIUM				
Barrier Crashworthiness					
Appropriate Test Level:	TL-1	Barrier Test Level:	NCW	Is Barrier Crashworthy?:	NO
Beg. End Trtmt Type:	NONE	Is Beg. End Trtmt Crashworthy?:	N/A	Approach Transition Type:	NONE
Ending End Trtmt Type:	NONE	Ending End Trtmt Crashworthy?:	N/A		
Average Measurements					
Design Height (In.):	24	Width (In.):	21.2	Post Spacing (In.):	0.0
Height (In.):	21.6	Lateral Offset (In.):	8.0	Road Grade (%):	1.60
Physical Condition					
Barrier	Alignment and Height:	The alignment has no deviation and the height is 1 to 3 in below the 24 in design height.

Breaking and Cracking:	No breaking or cracking observed.			
	Missing Elements:	No missing elements observed.			
	Corrosion and Weathering:	Moderate weathering of the grout.			
End Treatments	Alignment and Height:				
	Breaking and Cracking:				
	Missing Elements:				
	Corrosion and Weathering:

Repair Action:	NO ACTION	FMSS Work Type:	N/A	Repair Cost:	\$0
Brief Workorder:	N/A				
Workorder:

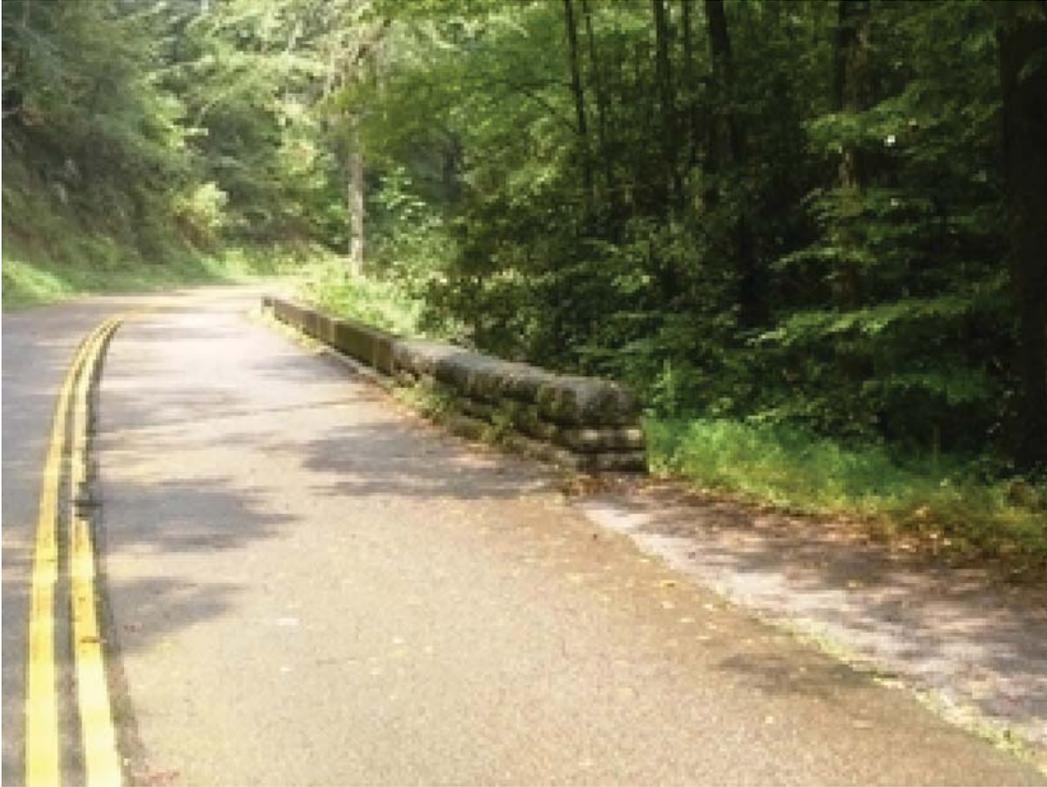
GRSM_0405_0.237_R_1.JPG

Barrier ID:	GRSM-0405-0.237-R				
Route Name:	SUGARLANDS HEADQUARTERS ROAD				
Inspection Date:	09/11/2010	Barrier Rating:	20.70		
Barrier Description					
Type:	STONE MASONRY WITHOUT CONCRETE CORE WALL	Barrier Function:	TRAFFIC		
Barrier Material:	STONE	Post Material:	N/A		
Blockout Type:	N/A	Length (ft.):	26		
Speed Limit (MPH):	25	Placement with Respect to Road:	TANGENT		
Hazard Behind Barrier:	MEDIUM				
Barrier Crashworthiness					
Appropriate Test Level:	TL-1	Barrier Test Level:	NCW	Is Barrier Crashworthy?:	NO
Beg. End Trtmt Type:	NONE	Is Beg. End Trtmt Crashworthy?:	N/A	Approach Transition Type:	NONE
Ending End Trtmt Type:	NONE	Ending End Trtmt Crashworthy?:	N/A		
Average Measurements					
Design Height (In.):	24	Width (In.):	22.0	Post Spacing (In.):	0.0
Height (In.):	24.0	Lateral Offset (In.):	8.0	Road Grade (%):	1.70
Physical Condition					
Barrier	Alignment and Height:	The alignment has no deviation and the height is at the 24 in design height.

Breaking and Cracking:	No breaking or cracking observed.			
	Missing Elements:	No missing elements observed.			
	Corrosion and Weathering:	Moderate weathering of the grout observed.			
End Treatments	Alignment and Height:				
	Breaking and Cracking:				
	Missing Elements:				
	Corrosion and Weathering:

Repair Action:	NO ACTION	FMSS Work Type:	N/A	Repair Cost:	\$0
Brief Workorder:	N/A				
Workorder:

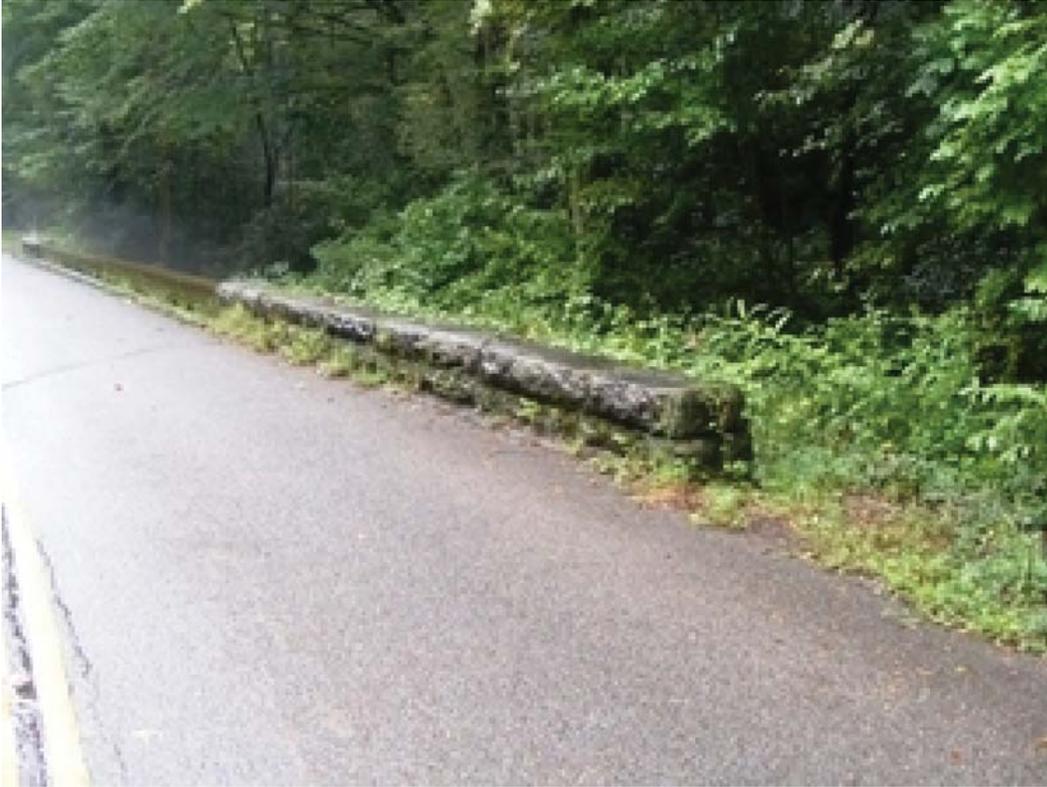
GRSM_0405_0.249_L_1.JPG

Barrier ID:	GRSM-0405-0.249-L				
Route Name:	SUGARLANDS HEADQUARTERS ROAD				
Inspection Date:	09/11/2010	Barrier Rating:	25.10		
Barrier Description					
Type:	STONE MASONRY WITHOUT CONCRETE CORE WALL	Barrier Function:	TRAFFIC		
Barrier Material:	STONE	Post Material:	N/A		
Blockout Type:	N/A	Length (ft.):	32		
Speed Limit (MPH):	25	Placement with Respect to Road:	TANGENT		
Hazard Behind Barrier:	MEDIUM				
Barrier Crashworthiness					
Appropriate Test Level:	TL-1	Barrier Test Level:	NCW	Is Barrier Crashworthy?:	NO
Beg. End Trtmt Type:	NONE	Is Beg. End Trtmt Crashworthy?:	N/A	Approach Transition Type:	NONE
Ending End Trtmt Type:	NONE	Ending End Trtmt Crashworthy?:	N/A		
Average Measurements					
Design Height (In.):	24	Width (In.):	21.2	Post Spacing (In.):	0.0
Height (In.):	21.0	Lateral Offset (In.):	6.0	Road Grade (%):	1.20
Physical Condition					
Barrier	Alignment and Height:	The alignment has no deviation and the height is 1 to 4 in below the 24 in design height.

Breaking and Cracking:	No breaking or cracking observed.			
	Missing Elements:	No missing elements observed.			
	Corrosion and Weathering:	No corrosion or weathering observed.			
End Treatments	Alignment and Height:				
	Breaking and Cracking:				
	Missing Elements:				
	Corrosion and Weathering:

Repair Action:	NO ACTION	FMSS Work Type:	N/A	Repair Cost:	\$0
Brief Workorder:	N/A				
Workorder:

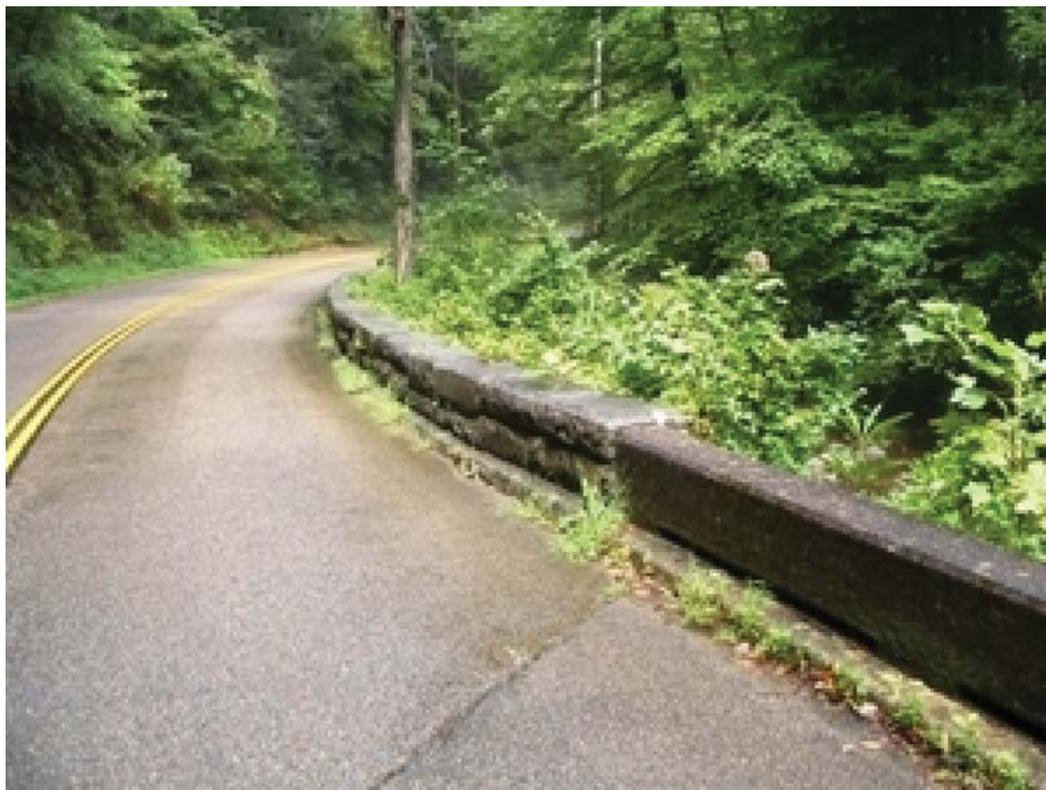
GRSM_0405_0.254_R_1.JPG

Barrier ID:	GRSM-0405-0.254-R				
Route Name:	SUGARLANDS HEADQUARTERS ROAD				
Inspection Date:	09/11/2010	Barrier Rating:	33.70		
Barrier Description					
Type:	STONE MASONRY WITHOUT CONCRETE CORE WALL	Barrier Function:	TRAFFIC		
Barrier Material:	STONE	Post Material:	N/A		
Blockout Type:	N/A	Length (ft.):	72		
Speed Limit (MPH):	25	Placement with Respect to Road:	OUTSIDE OF CURVE		
Hazard Behind Barrier:	MEDIUM				
Barrier Crashworthiness					
Appropriate Test Level:	TL-1	Barrier Test Level:	NCW	Is Barrier Crashworthy?:	NO
Beg. End Trtmt Type:	NONE	Is Beg. End Trtmt Crashworthy?:	N/A	Approach Transition Type:	NONE
Ending End Trtmt Type:	NONE	Ending End Trtmt Crashworthy?:	N/A		
Average Measurements					
Design Height (In.):	24	Width (In.):	20.6	Post Spacing (In.):	0.0
Height (In.):	21.2	Lateral Offset (In.):	6.0	Road Grade (%):	2.40
Physical Condition					
Barrier	Alignment and Height:	The alignment has no deviation and the height is 1 to 3 in below the 24 in design height.

Breaking and Cracking:	No breaking or cracking observed.			
	Missing Elements:	No missing elements observed.			
	Corrosion and Weathering:	Moderate weathering of the barrier and grout observed.			
End Treatments	Alignment and Height:				
	Breaking and Cracking:				
	Missing Elements:				
	Corrosion and Weathering:

Repair Action:	NO ACTION	FMSS Work Type:	N/A	Repair Cost:	\$0
Brief Workorder:	N/A				
Workorder:

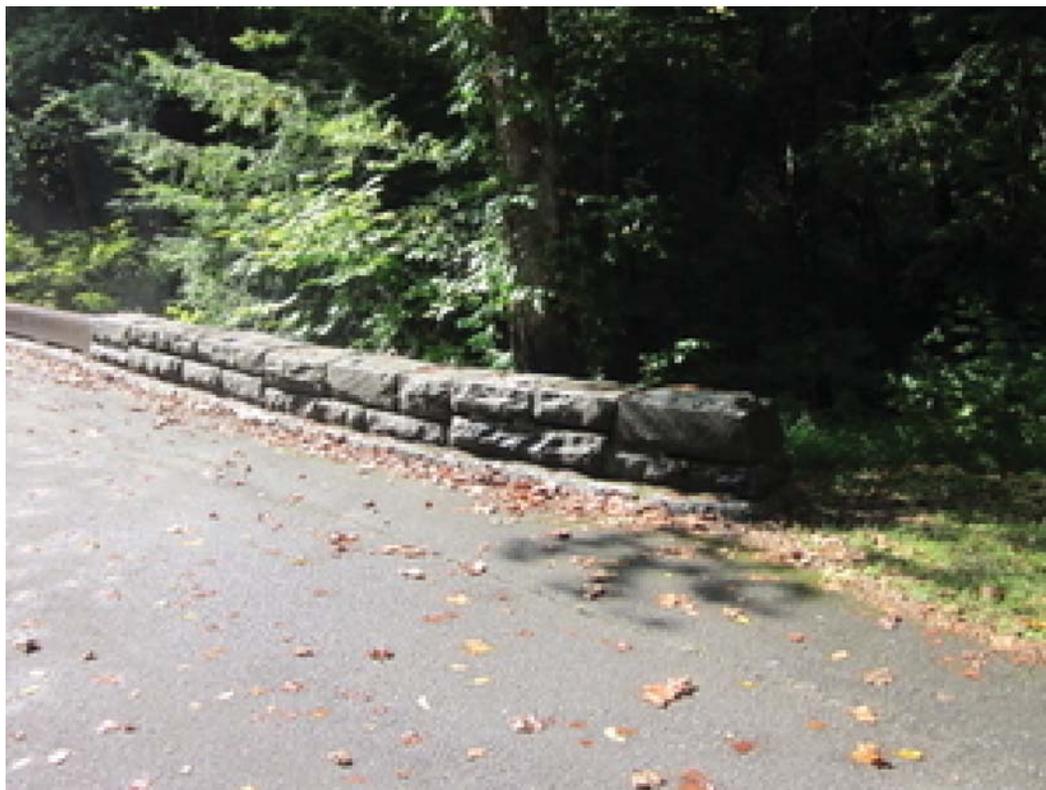
GRSM_0430_0.051_R_1.JPG

Barrier ID:	GRSM-0430-0.051-R				
Route Name:	SUGARLANDS RESIDENCE ROAD				
Inspection Date:	09/11/2010	Barrier Rating:	10.80		
Barrier Description					
Type:	STONE MASONRY WITHOUT CONCRETE CORE WALL	Barrier Function:	TRAFFIC		
Barrier Material:	STONE	Post Material:	N/A		
Blockout Type:	N/A	Length (ft.):	27		
Speed Limit (MPH):	20	Placement with Respect to Road:	TANGENT		
Hazard Behind Barrier:	MEDIUM				
Barrier Crashworthiness					
Appropriate Test Level:	TL-1	Barrier Test Level:	NCW	Is Barrier Crashworthy?:	NO
Beg. End Trtmt Type:	NONE	Is Beg. End Trtmt Crashworthy?:	N/A	Approach Transition Type:	NONE
Ending End Trtmt Type:	NONE	Ending End Trtmt Crashworthy?:	N/A		
Average Measurements					
Design Height (In.):	24	Width (In.):	23.6	Post Spacing (In.):	0.0
Height (In.):	23.0	Lateral Offset (In.):	51.0	Road Grade (%):	3.40
Physical Condition					
Barrier	Alignment and Height:	No deviation in alignment and height is within 1 in of the 24 in design height.

Breaking and Cracking:	27 ft of severe breaking and cracking of 1/2 in to 2 in in the grout observed.			
	Missing Elements:	No missing elements observed			
	Corrosion and Weathering:	No corrosion or weathering observed.			
End Treatments	Alignment and Height:				
	Breaking and Cracking:				
	Missing Elements:				
	Corrosion and Weathering:

Repair Action:	REPAIR	FMSS Work Type:	DEFERRED MAINTENANCE	Repair Cost:	\$4394
Brief Workorder:	Repoint 18 sy of stone masonry guardwall.				
Workorder:	Re-Point Stone Masonry Barrier at \$140- per -Sq. Yd. for 18 SY = \$2520. [(1.9ft + 1.9ft + 1.9ft)(27ft) /9 = 17.1 SY. Low Speed Traffic Control at \$1475- per -Day for 1 Day(s) = \$1475.

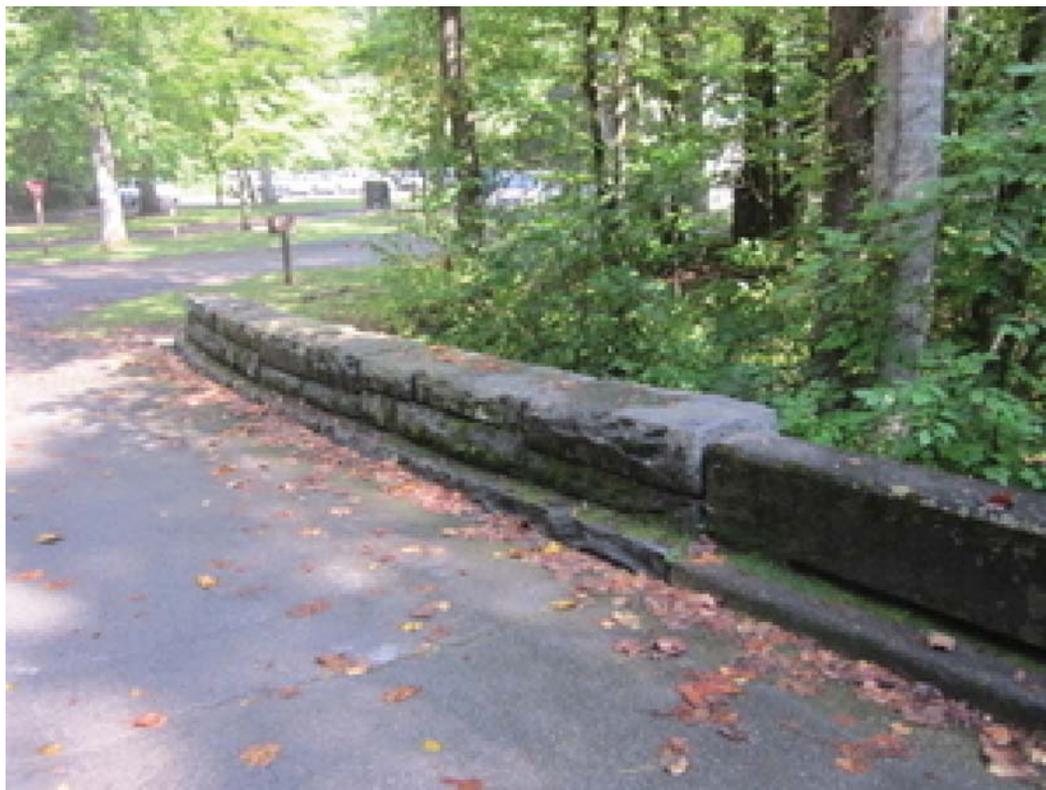
GRSM_0430_0.052_L_1.JPG

Barrier ID:	GRSM-0430-0.052-L				
Route Name:	SUGARLANDS RESIDENCE ROAD				
Inspection Date:	09/11/2010	Barrier Rating:	13.60		
Barrier Description					
Type:	STONE MASONRY WITHOUT CONCRETE CORE WALL	Barrier Function:	TRAFFIC		
Barrier Material:	STONE	Post Material:	N/A		
Blockout Type:	N/A	Length (ft.):	27		
Speed Limit (MPH):	20	Placement with Respect to Road:	TANGENT		
Hazard Behind Barrier:	MEDIUM				
Barrier Crashworthiness					
Appropriate Test Level:	TL-1	Barrier Test Level:	NCW	Is Barrier Crashworthy?:	NO
Beg. End Trtmt Type:	NONE	Is Beg. End Trtmt Crashworthy?:	N/A	Approach Transition Type:	NONE
Ending End Trtmt Type:	NONE	Ending End Trtmt Crashworthy?:	N/A		
Average Measurements					
Design Height (In.):	24	Width (In.):	23.2	Post Spacing (In.):	0.0
Height (In.):	24.0	Lateral Offset (In.):	30.6	Road Grade (%):	2.80
Physical Condition					
Barrier	Alignment and Height:	No deviation in alignment and height is at the 24 in design height.

Breaking and Cracking:	27 ft of severe breaking and cracking of 1/2 in to 2 in in the grout observed.			
	Missing Elements:	No missing elements observed.			
	Corrosion and Weathering:	No corrosion or weathering observed.			
End Treatments	Alignment and Height:				
	Breaking and Cracking:				
	Missing Elements:				
	Corrosion and Weathering:

Repair Action:	REPAIR	FMSS Work Type:	DEFERRED MAINTENANCE	Repair Cost:	\$4394
Brief Workorder:	Repoint 18 sy of stone masonry guardwall.				
Workorder:	Re-Point Stone Masonry Barrier at \$140- per -Sq. Yd. for 18 SY = \$2520. [(2ft + 1.9ft + 2ft)(27ft) /9 = 17.7 SY. Low Speed Traffic Control at \$1475- per -Day for 1 Day(s) = \$1475.

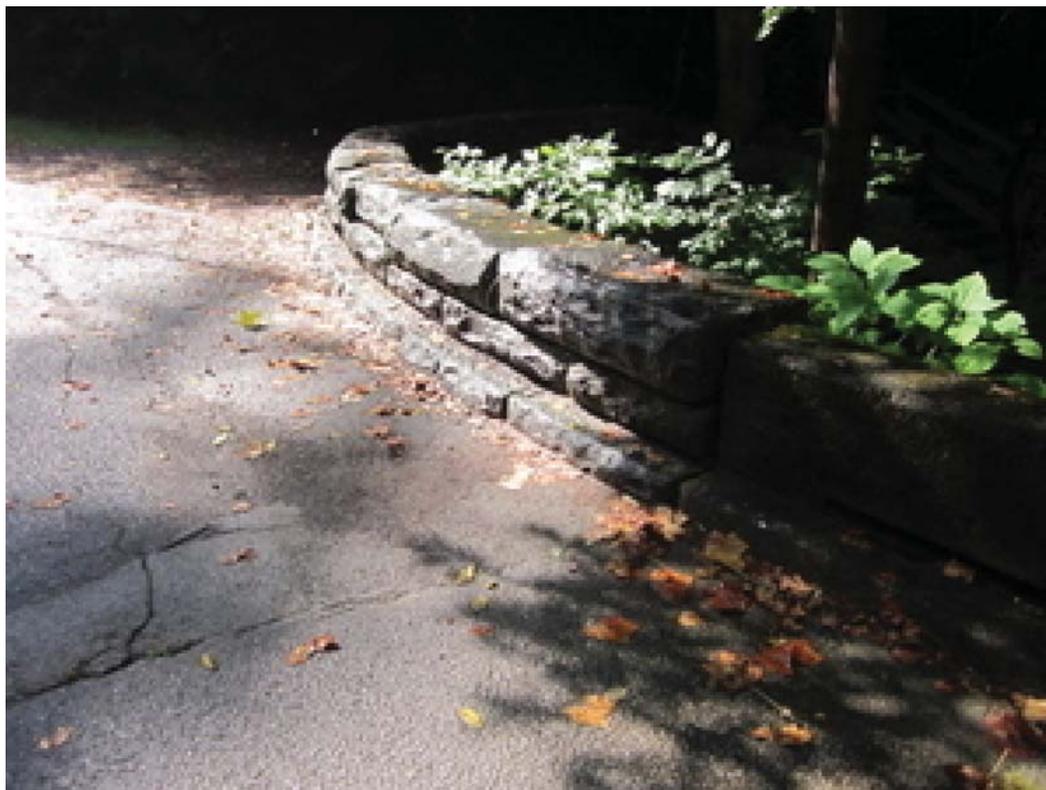
GRSM_0430_0.066_R_1.JPG

Barrier ID:	GRSM-0430-0.066-R				
Route Name:	SUGARLANDS RESIDENCE ROAD				
Inspection Date:	09/11/2010	Barrier Rating:	16.80		
Barrier Description					
Type:	STONE MASONRY WITHOUT CONCRETE CORE WALL	Barrier Function:	TRAFFIC		
Barrier Material:	STONE	Post Material:	N/A		
Blockout Type:	N/A	Length (ft.):	40		
Speed Limit (MPH):	20	Placement with Respect to Road:	OUTSIDE OF CURVE		
Hazard Behind Barrier:	LOW				
Barrier Crashworthiness					
Appropriate Test Level:	TL-1	Barrier Test Level:	NCW	Is Barrier Crashworthy?:	NO
Beg. End Trtmt Type:	NONE	Is Beg. End Trtmt Crashworthy?:	N/A	Approach Transition Type:	NONE
Ending End Trtmt Type:	NONE	Ending End Trtmt Crashworthy?:	N/A		
Average Measurements					
Design Height (In.):	24	Width (In.):	20.7	Post Spacing (In.):	0.0
Height (In.):	24.0	Lateral Offset (In.):	77.0	Road Grade (%):	3.30
Physical Condition					
Barrier	Alignment and Height:	The alignment has no deviation and the height is at the 24 in design height.

Breaking and Cracking:	Severe breaking and cracking of the grout over 1/2 in observed for entire length of barrier.			
	Missing Elements:	No missing elements observed.			
	Corrosion and Weathering:	No corrosion or weathering observed.			
End Treatments	Alignment and Height:				
	Breaking and Cracking:				
	Missing Elements:				
	Corrosion and Weathering:

Repair Action:	REPAIR	FMSS Work Type:	DEFERRED MAINTENANCE	Repair Cost:	\$5627
Brief Workorder:	Repoint 26 SY of stone masonry barrier.				
Workorder:	Re-Point Masonry Barrier at \$140- per -Sq. Yd. for 26 = \$3640. [(2ft + 1.7ft + 2ft)(40ft)] /9 = 25.3 SY. Low Speed Traffic Control at \$1475- per -Day for 1 Day(s) = \$1475.

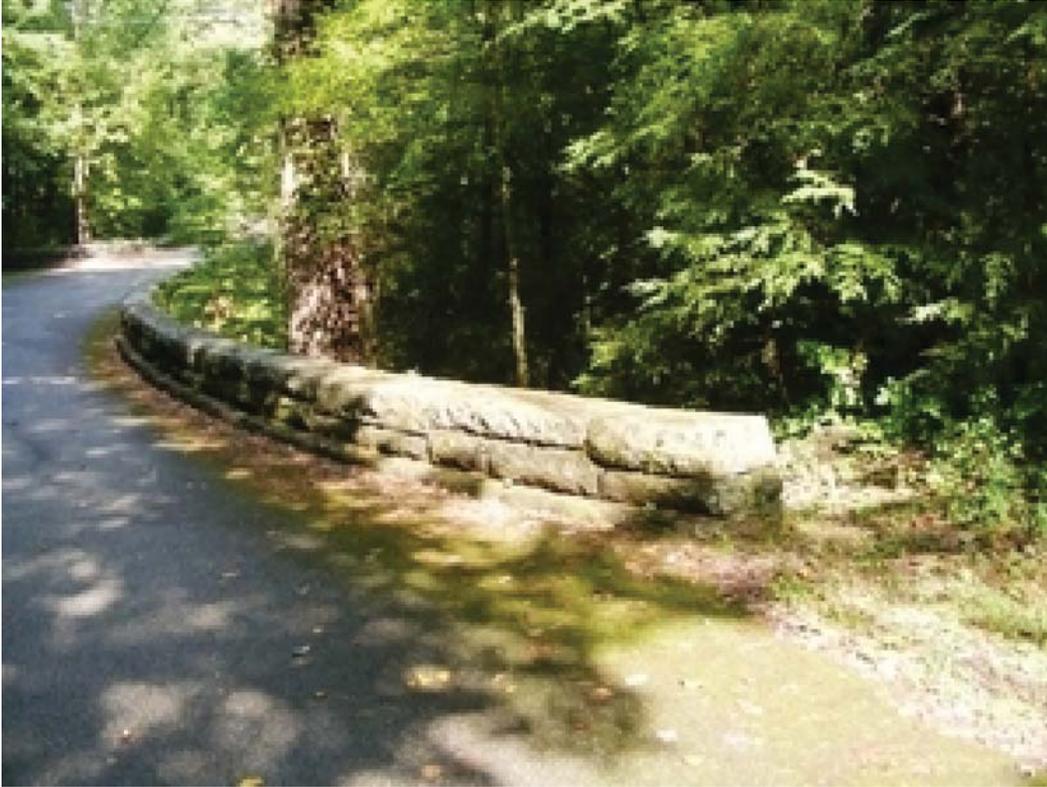
GRSM_0430_0.067_L_1.JPG

Barrier ID:	GRSM-0430-0.067-L				
Route Name:	SUGARLANDS RESIDENCE ROAD				
Inspection Date:	09/11/2010	Barrier Rating:	23.70		
Barrier Description					
Type:	STONE MASONRY WITHOUT CONCRETE CORE WALL	Barrier Function:	TRAFFIC		
Barrier Material:	STONE	Post Material:	N/A		
Blockout Type:	N/A	Length (ft.):	160		
Speed Limit (MPH):	20	Placement with Respect to Road:	INSIDE OF CURVE		
Hazard Behind Barrier:	MEDIUM				
Barrier Crashworthiness					
Appropriate Test Level:	TL-1	Barrier Test Level:	NCW	Is Barrier Crashworthy?:	NO
Beg. End Trtmt Type:	NONE	Is Beg. End Trtmt Crashworthy?:	N/A	Approach Transition Type:	NONE
Ending End Trtmt Type:	NONE	Ending End Trtmt Crashworthy?:	N/A		
Average Measurements					
Design Height (In.):	24	Width (In.):	22.2	Post Spacing (In.):	0.0
Height (In.):	23.2	Lateral Offset (In.):	18.0	Road Grade (%):	4.60
Physical Condition					
Barrier	Alignment and Height:	No deviation in alignment and height is within 3 in of the 24 in design height.

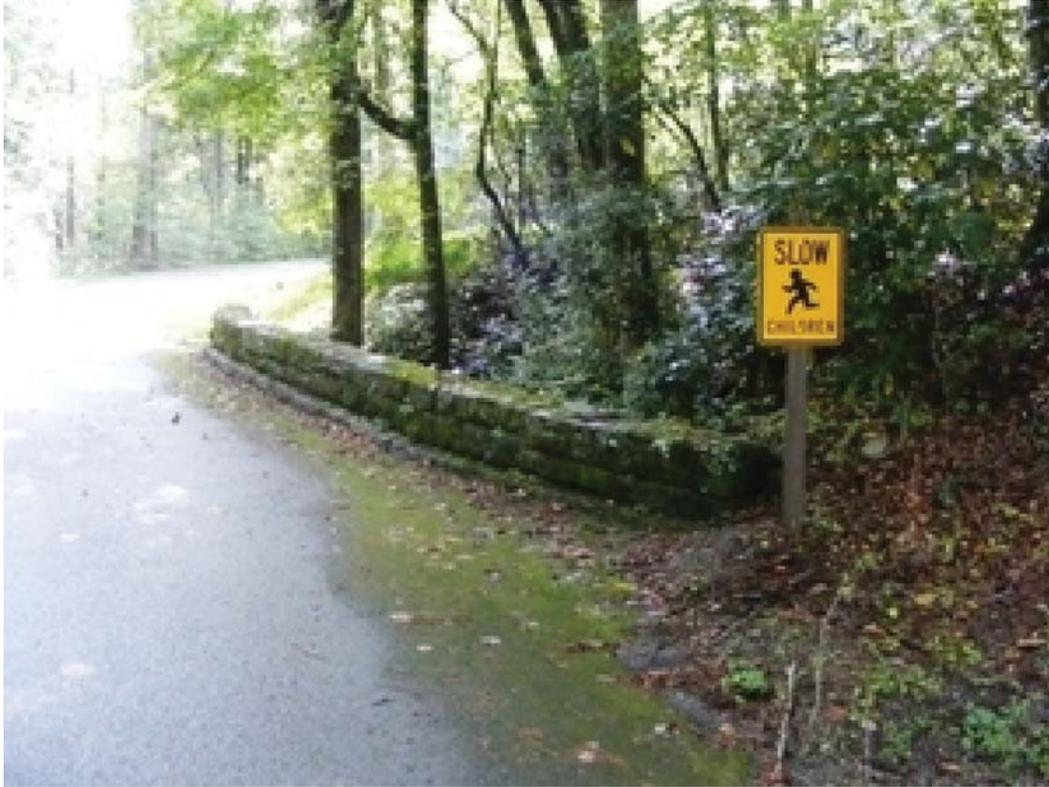
GRSM_0430_0.096_R_1.JPG

Barrier ID:	GRSM-0430-0.096-R				
Route Name:	SUGARLANDS RESIDENCE ROAD				
Inspection Date:	09/11/2010	Barrier Rating:	25.10		
Barrier Description					
Type:	STONE MASONRY WITHOUT CONCRETE CORE WALL	Barrier Function:	TRAFFIC		
Barrier Material:	STONE	Post Material:	N/A		
Blockout Type:	N/A	Length (ft.):	46		
Speed Limit (MPH):	20	Placement with Respect to Road:	OUTSIDE OF CURVE		
Hazard Behind Barrier:	MEDIUM				
Barrier Crashworthiness					
Appropriate Test Level:	TL-1	Barrier Test Level:	NCW	Is Barrier Crashworthy?:	NO
Beg. End Trtmt Type:	NONE	Is Beg. End Trtmt Crashworthy?:	N/A	Approach Transition Type:	NONE
Ending End Trtmt Type:	NONE	Ending End Trtmt Crashworthy?:	N/A		
Average Measurements					
Design Height (In.):	24	Width (In.):	20.6	Post Spacing (In.):	0.0
Height (In.):	24.2	Lateral Offset (In.):	18.0	Road Grade (%):	6.80
Physical Condition					
Barrier	Alignment and Height:	The alignment has no deviation and the height is 0-1 in above the 24 in design height.

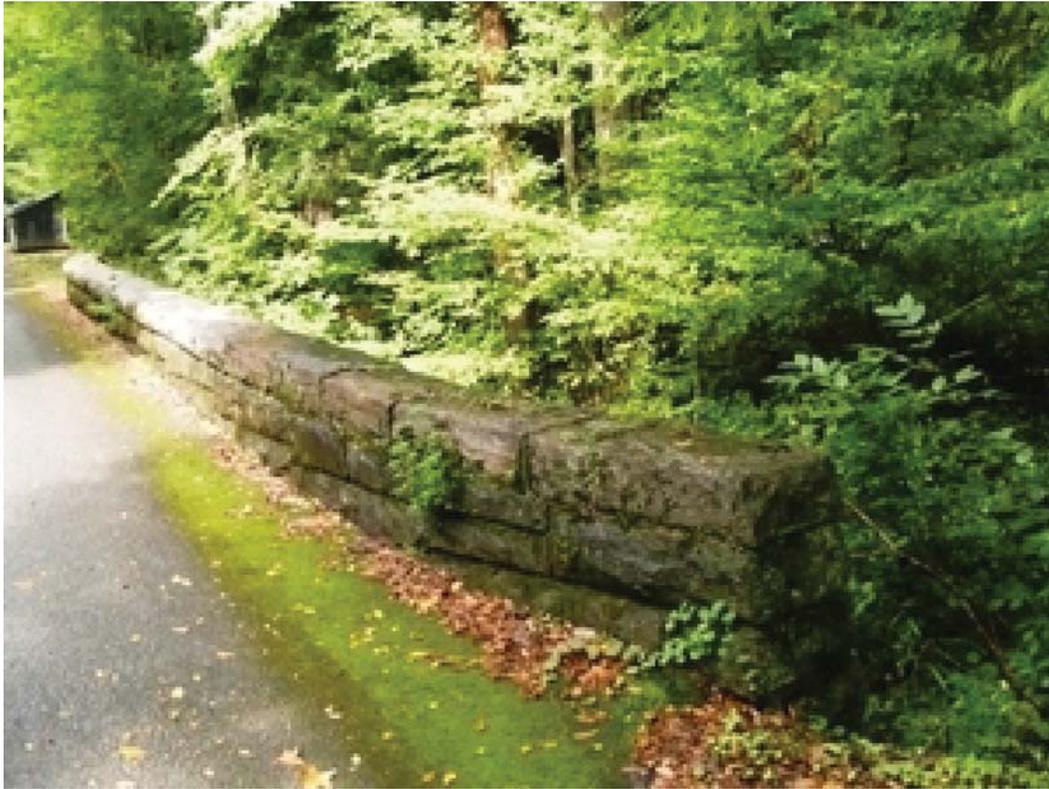
GRSM_0430_0.189_R_1.JPG

Barrier ID:	GRSM-0430-0.189-R				
Route Name:	SUGARLANDS RESIDENCE ROAD				
Inspection Date:	09/11/2010	Barrier Rating:	16.50		
Barrier Description					
Type:	STONE MASONRY WITHOUT CONCRETE CORE WALL	Barrier Function:	TRAFFIC		
Barrier Material:	STONE	Post Material:	N/A		
Blockout Type:	N/A	Length (ft.):	60		
Speed Limit (MPH):	20	Placement with Respect to Road:	TANGENT		
Hazard Behind Barrier:	MEDIUM				
Barrier Crashworthiness					
Appropriate Test Level:	TL-1	Barrier Test Level:	NCW	Is Barrier Crashworthy?:	NO
Beg. End Trtmt Type:	NONE	Is Beg. End Trtmt Crashworthy?:	N/A	Approach Transition Type:	NONE
Ending End Trtmt Type:	NONE	Ending End Trtmt Crashworthy?:	N/A		
Average Measurements					
Design Height (In.):	24	Width (In.):	18.2	Post Spacing (In.):	0.0
Height (In.):	23.2	Lateral Offset (In.):	12.0	Road Grade (%):	7.60
Physical Condition					
Barrier	Alignment and Height:	The alignment has no deviation and the height is 0-2 in below the 24 in design height.

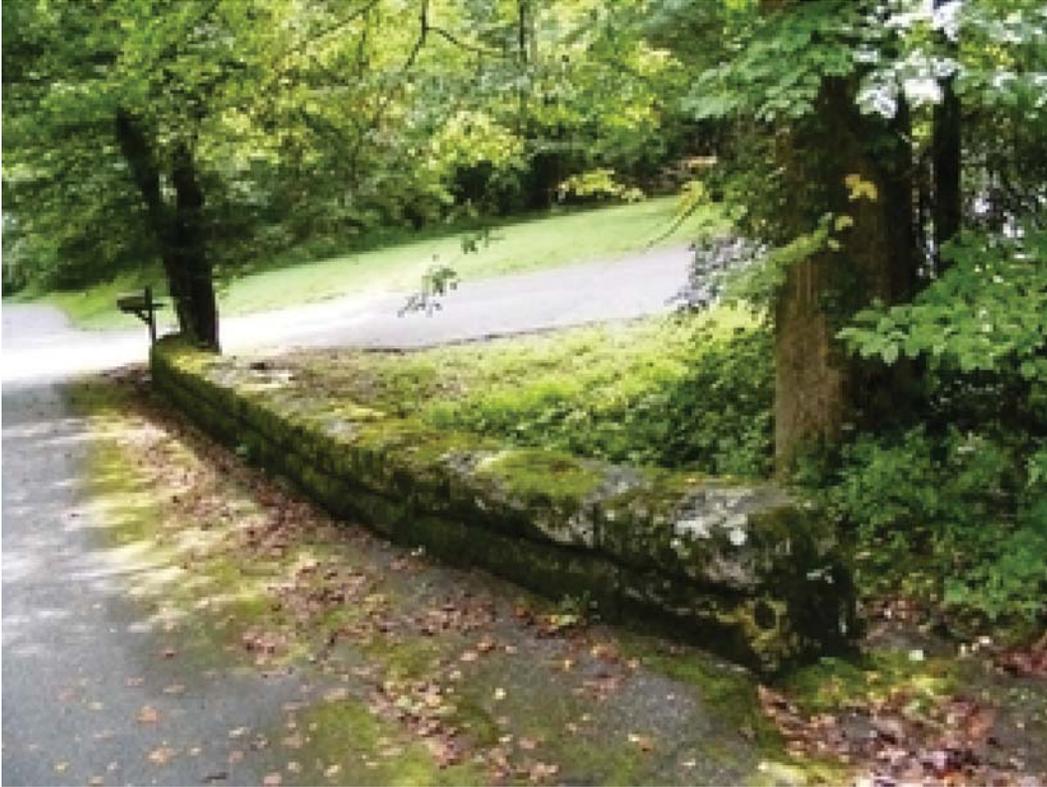
GRSM_0430_0.194_L_1.JPG

Barrier ID:	GRSM-0430-0.194-L				
Route Name:	SUGARLANDS RESIDENCE ROAD				
Inspection Date:	09/11/2010	Barrier Rating:	29.50		
Barrier Description					
Type:	STONE MASONRY WITHOUT CONCRETE CORE WALL	Barrier Function:	TRAFFIC		
Barrier Material:	STONE	Post Material:	N/A		
Blockout Type:	N/A	Length (ft.):	52		
Speed Limit (MPH):	20	Placement with Respect to Road:	TANGENT		
Hazard Behind Barrier:	MEDIUM				
Barrier Crashworthiness					
Appropriate Test Level:	TL-1	Barrier Test Level:	NCW	Is Barrier Crashworthy?:	NO
Beg. End Trtmt Type:	NONE	Is Beg. End Trtmt Crashworthy?:	N/A	Approach Transition Type:	NONE
Ending End Trtmt Type:	NONE	Ending End Trtmt Crashworthy?:	N/A		
Average Measurements					
Design Height (In.):	24	Width (In.):	18.0	Post Spacing (In.):	0.0
Height (In.):	22.2	Lateral Offset (In.):	12.0	Road Grade (%):	8.50
Physical Condition					
Barrier	Alignment and Height:	The alignment has no deviation and the height is 0-3 in below the 24 in design height.

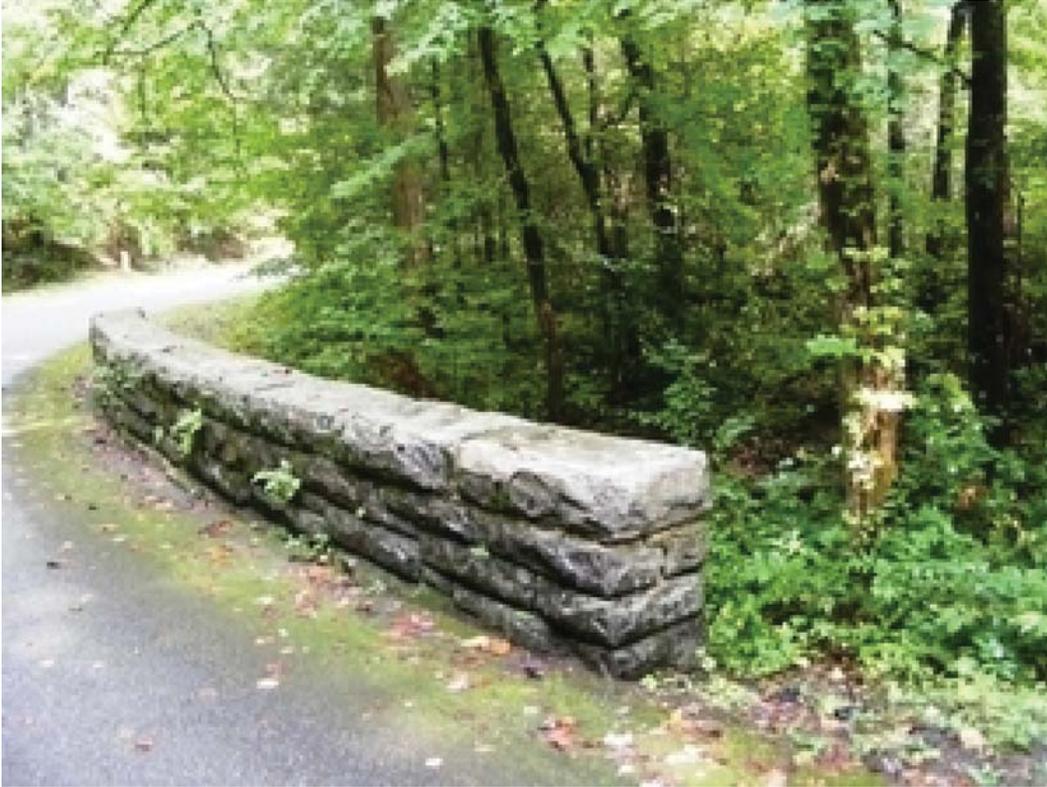
GRSM_0430_0.281_L_1.JPG

Barrier ID:	GRSM-0430-0.281-L				
Route Name:	SUGARLANDS RESIDENCE ROAD				
Inspection Date:	09/11/2010	Barrier Rating:	23.70		
Barrier Description					
Type:	STONE MASONRY WITHOUT CONCRETE CORE WALL	Barrier Function:	TRAFFIC		
Barrier Material:	STONE	Post Material:	N/A		
Blockout Type:	N/A	Length (ft.):	30		
Speed Limit (MPH):	20	Placement with Respect to Road:	INSIDE OF CURVE		
Hazard Behind Barrier:	MEDIUM				
Barrier Crashworthiness					
Appropriate Test Level:	TL-1	Barrier Test Level:	NCW	Is Barrier Crashworthy?:	NO
Beg. End Trtmt Type:	NONE	Is Beg. End Trtmt Crashworthy?:	N/A	Approach Transition Type:	NONE
Ending End Trtmt Type:	NONE	Ending End Trtmt Crashworthy?:	N/A		
Average Measurements					
Design Height (In.):	24	Width (In.):	20.0	Post Spacing (In.):	0.0
Height (In.):	30.0	Lateral Offset (In.):	6.7	Road Grade (%):	5.10
Physical Condition					
Barrier	Alignment and Height:	The alignment has no deviation and the height is 1 to 8 in above the 24 in design height.
