NPS Guardwall/Rail Inventory Program
Great Smoky Mountains National Park

Federal Highway Administration
Eastern Federal Lands Highway Division
Road Inventory Program (RIP)

Data Collection Date: September 2010
Report Date: December 2015

Great Smoky Mountains National Park in North Carolina and Tennessee

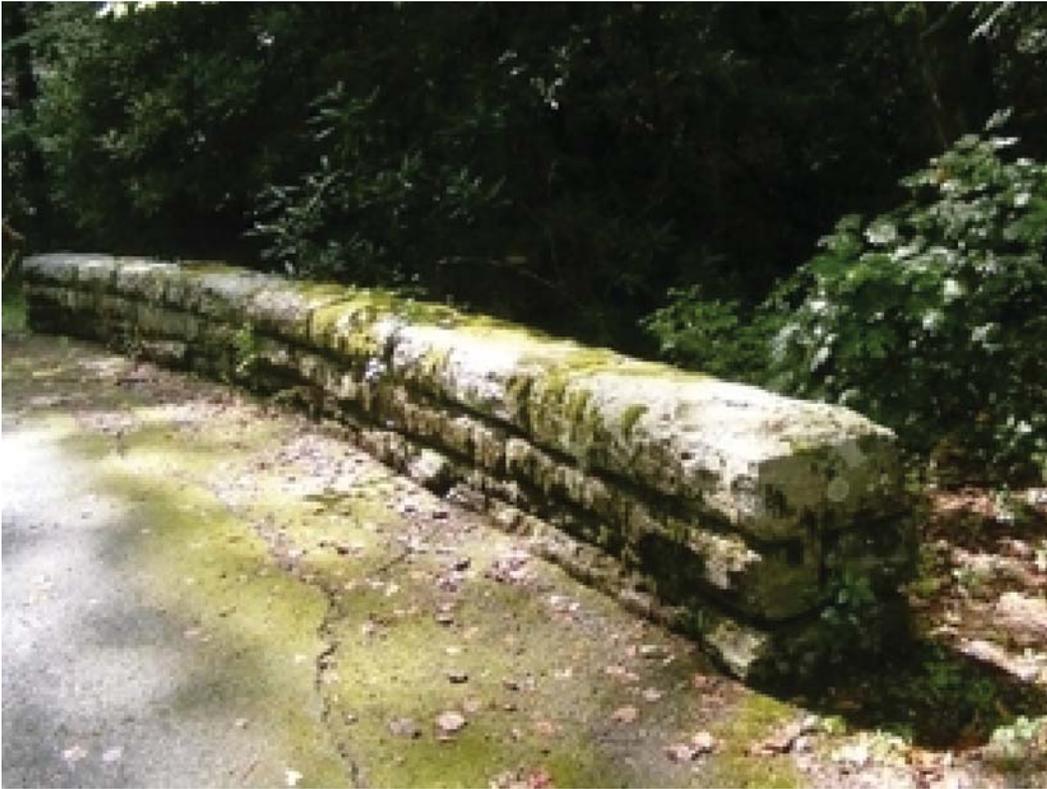
GRSM_0430_0.282_R_1.JPG

Barrier ID:	GRSM-0430-0.282-R				
Route Name:	SUGARLANDS RESIDENCE ROAD				
Inspection Date:	09/11/2010	Barrier Rating:	25.10		
Barrier Description					
Type:	STONE MASONRY WITHOUT CONCRETE CORE WALL	Barrier Function:	TRAFFIC		
Barrier Material:	STONE	Post Material:	N/A		
Blockout Type:	N/A	Length (ft.):	35		
Speed Limit (MPH):	20	Placement with Respect to Road:	OUTSIDE OF CURVE		
Hazard Behind Barrier:	MEDIUM				
Barrier Crashworthiness					
Appropriate Test Level:	TL-1	Barrier Test Level:	NCW	Is Barrier Crashworthy?:	NO
Beg. End Trtmt Type:	NONE	Is Beg. End Trtmt Crashworthy?:	N/A	Approach Transition Type:	NONE
Ending End Trtmt Type:	NONE	Ending End Trtmt Crashworthy?:	N/A		
Average Measurements					
Design Height (In.):	24	Width (In.):	20.0	Post Spacing (In.):	0.0
Height (In.):	28.0	Lateral Offset (In.):	8.3	Road Grade (%):	3.80
Physical Condition					
Barrier	Alignment and Height:	The alignment has no deviation and the height is 1 to 7 in above the 24 in design height.
