The Road Inventory of Hawaii Volcanoes National Park HAVO – 8300

Road Inventory Program

Prepared By:
Federal Highway Administration
Eastern Federal Lands Highway Division
Cycle 3

Hawaii Volcanoes National Park in Hawaii

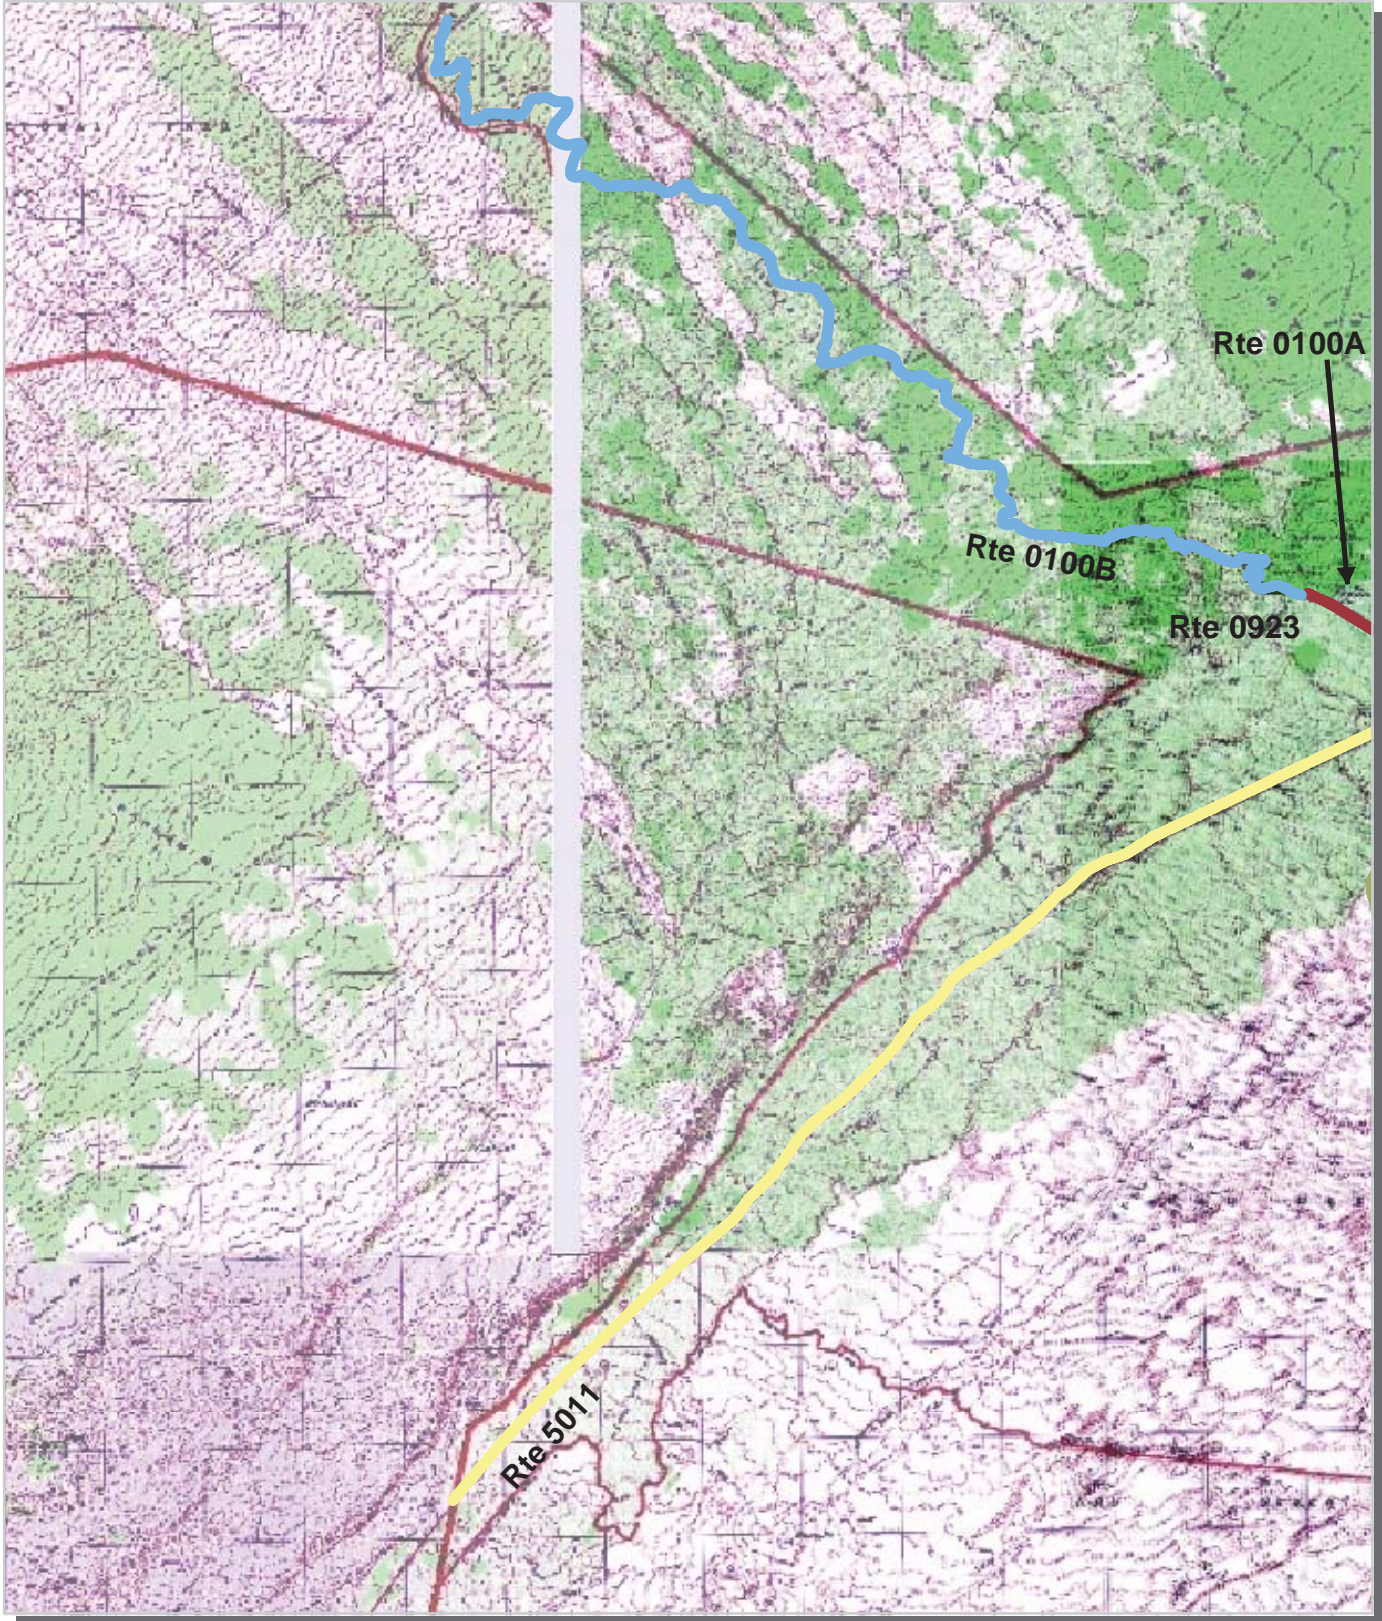
Hawaii Volcanoes National Park Route Location Area Map 1

Unique colors used to differentiate routes

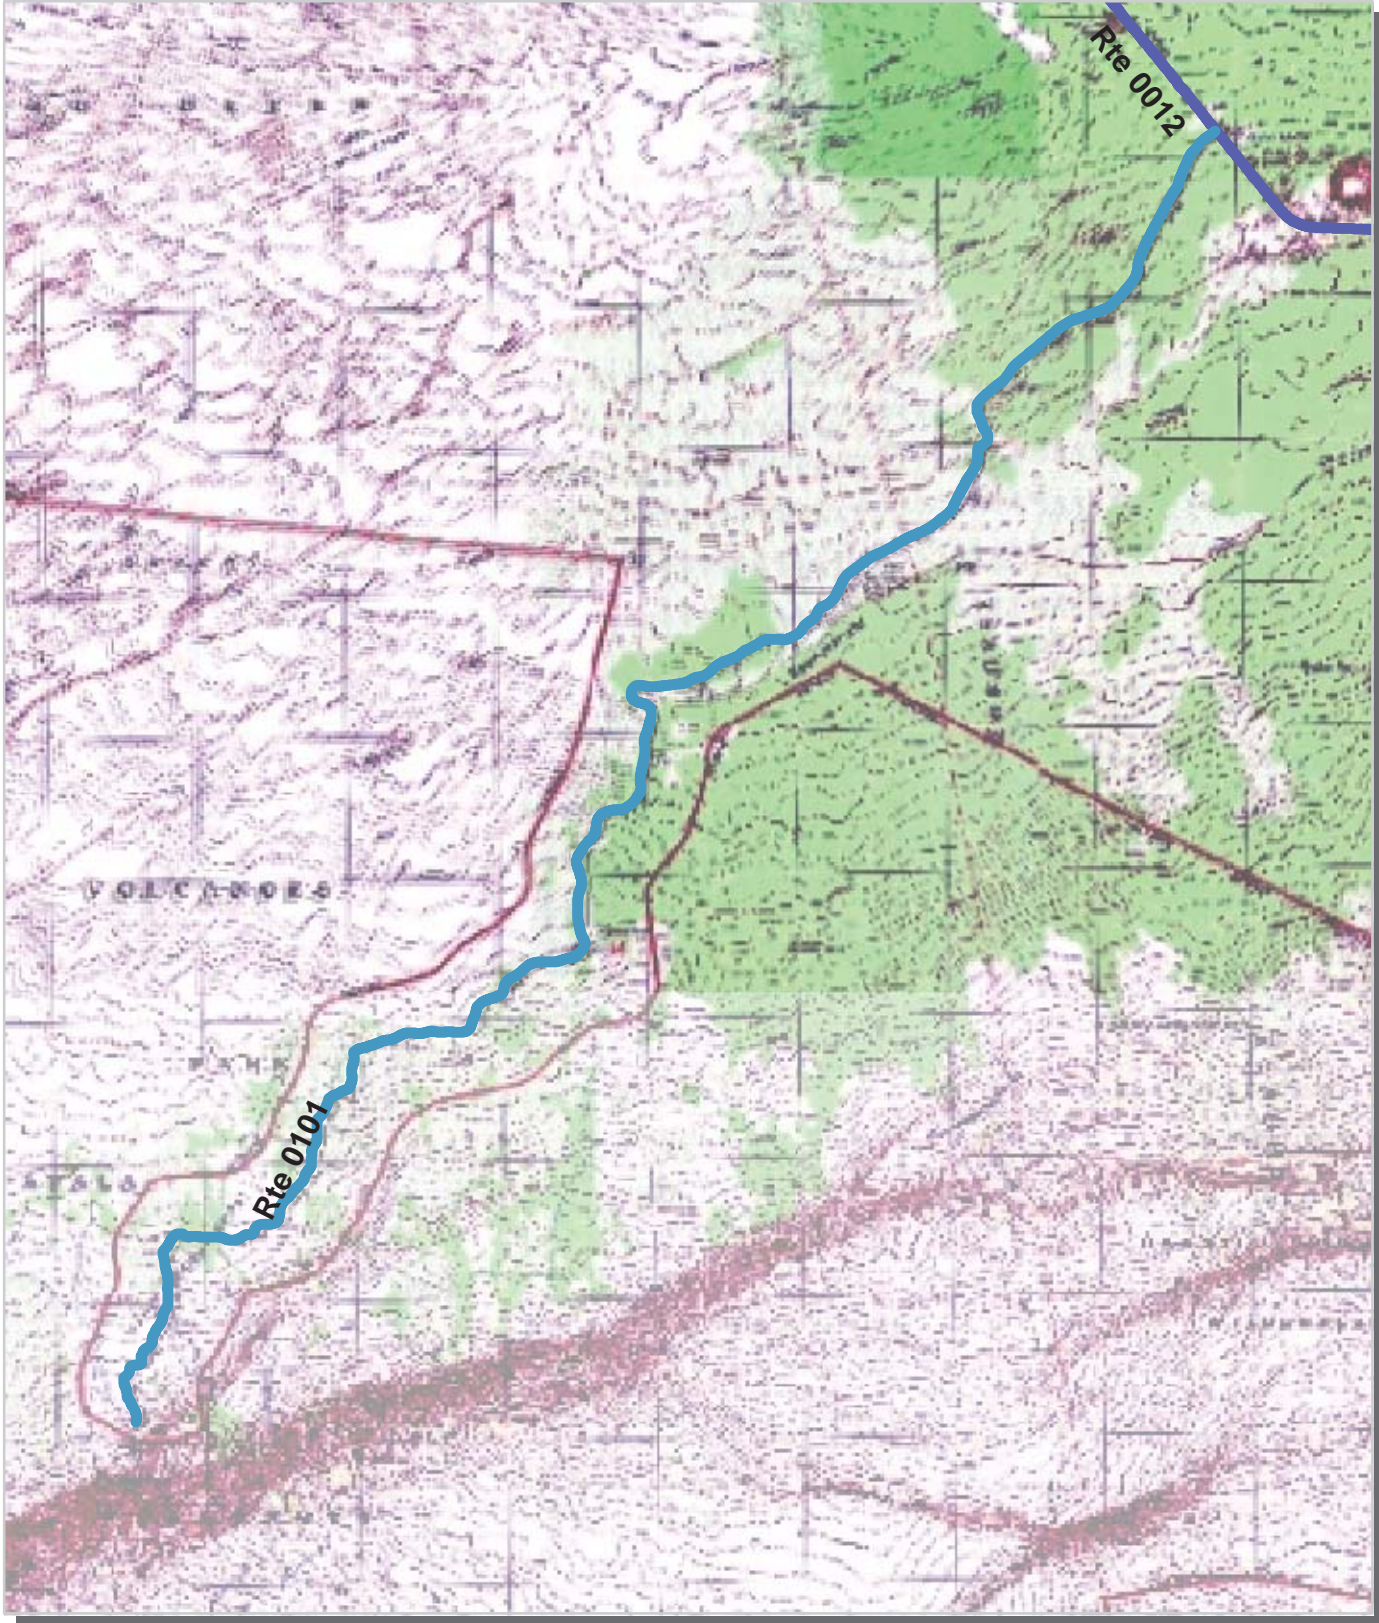
Hawaii Volcanoes National Park Route Location Area Map 3

Unique colors used to differentiate routes

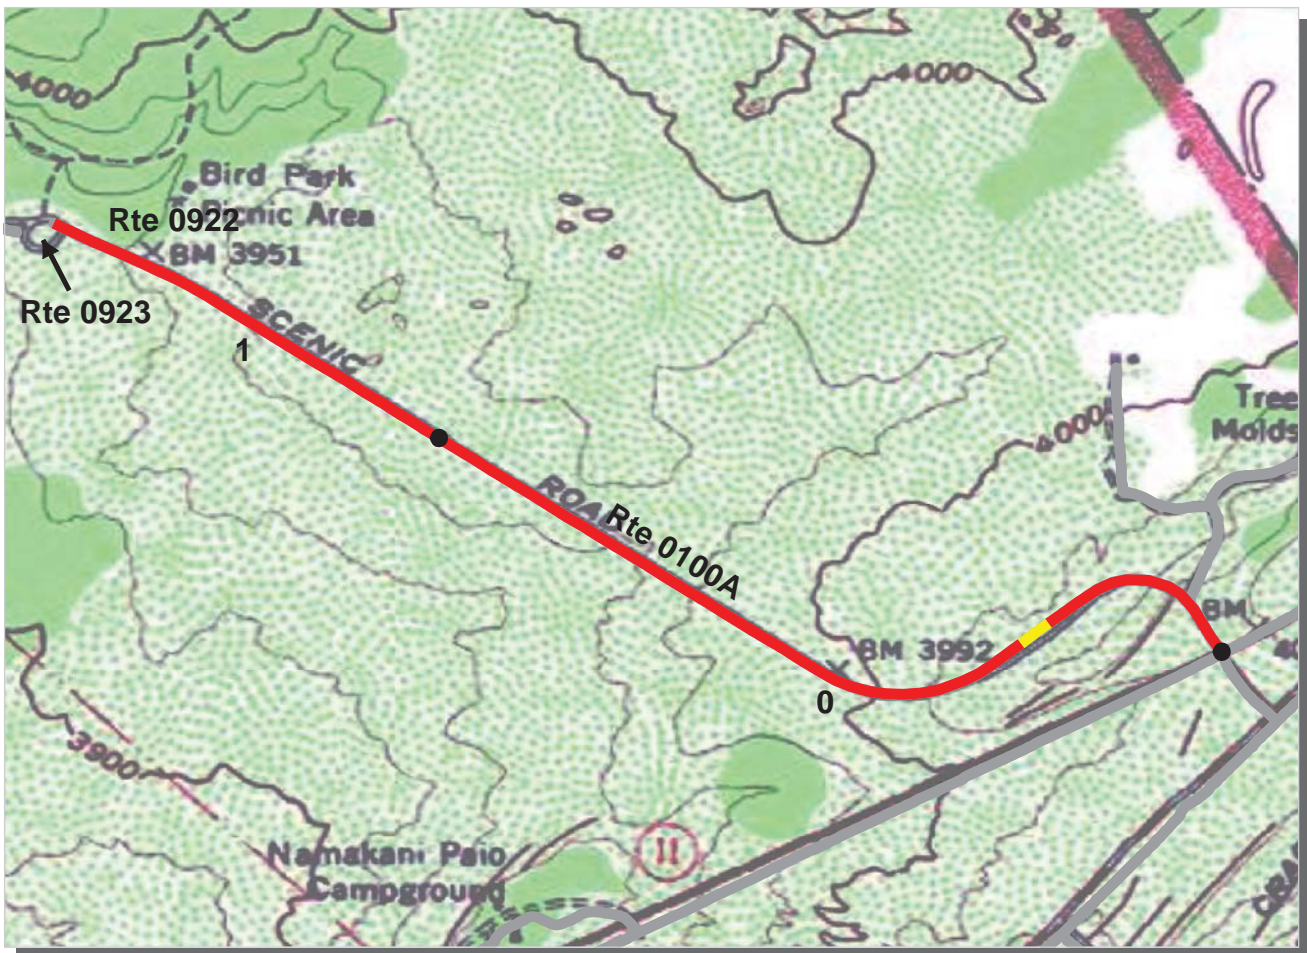
ROUTE: 0100A Mauna Loa Road **TOTAL LENGTH: 1.49 Miles**

Section Number	0	1			
Section Length (mi)	1.00	0.49			
AADT	**				
SADT	**				
ADT Date	**				
Cross Section Information					
Number of Lanes	2	2			
Paved Width (ft)	21	19			
Lane Width (ft)	10	11			
Shoulder Width (ft)	0	0			
Roadway Condition Information					
PCR (Pavement Condition Rating)	33	12			
RCI (Roughness Condition Index)	62	25			
SCR (Surface Condition Rating)	17	6			
Alligator Cracking Index	90	40			
Rutting Index	42	44			
Patching Index	99	99			
Transverse Cracking Index	78	72			
Longitudinal Cracking Index	96	97			
Shoulder Condition Rating	N/A	N/A			
Drainage Condition Rating	GOOD	GOOD

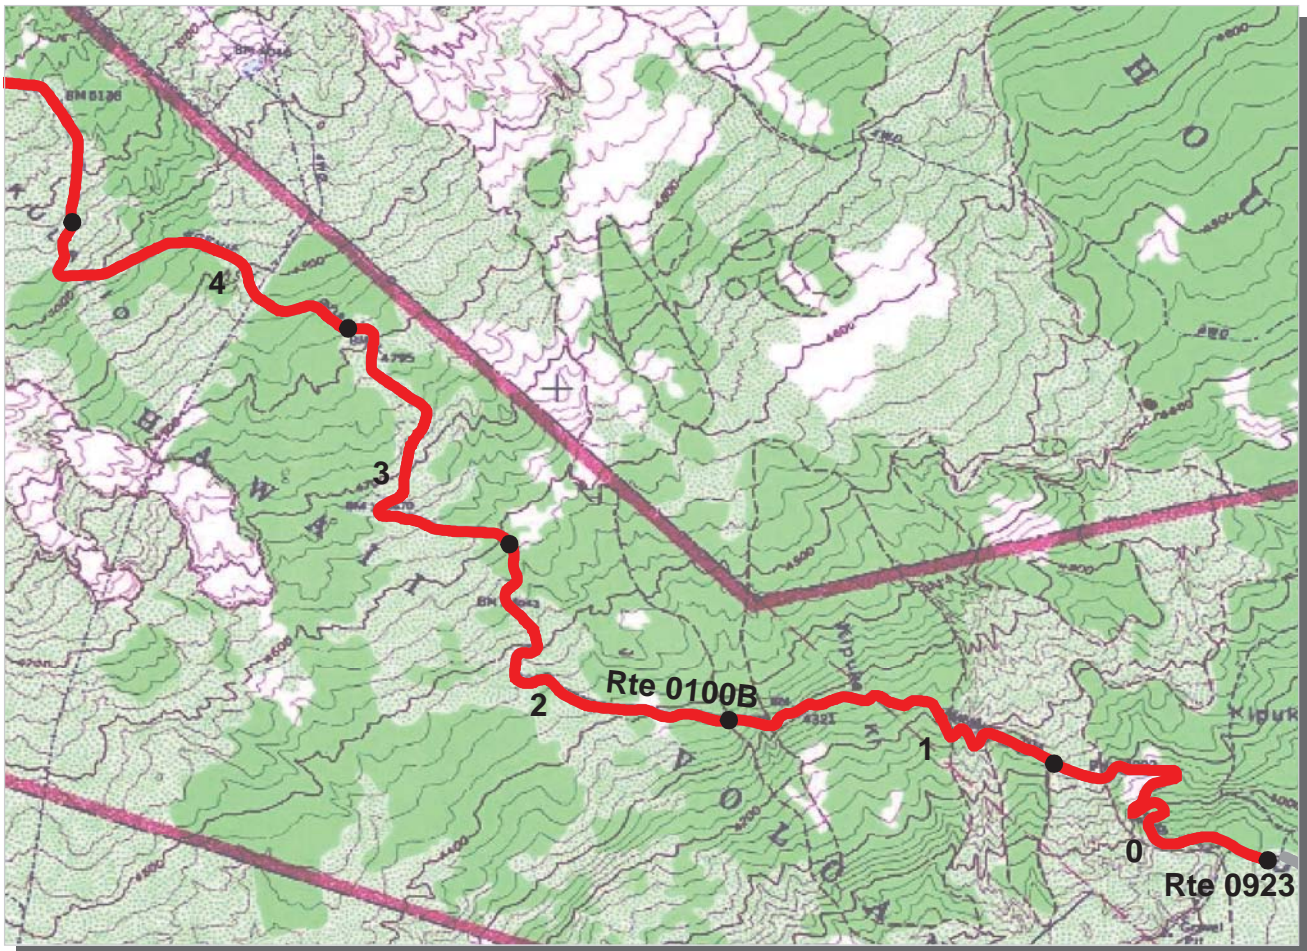
ROUTE: 0100B Mauna Loa Lookout Road **TOTAL LENGTH: 9.78 Miles**

Section Number	0	1	2	3	4
Section Length (mi)	1.00	1.00	1.00	1.00	1.00
AADT	**				
SADT	**				
ADT Date	**				
Cross Section Information					
Number of Lanes	2	2	2	1	1
Paved Width (ft)	16	16	16	10	11
Lane Width (ft)	8	8	8	10	11
Shoulder Width (ft)	0	0	0	0	0
Roadway Condition Information					
PCR (Pavement Condition Rating)	19	16	11	8	10
RCI (Roughness Condition Index)	40	36	53	33	31
SCR (Surface Condition Rating)	15	12	4	0	5
Alligator Cracking Index	87	88	22	5	27
Rutting Index	20	18	27	23	27
Patching Index	99	100	99	99	99
Transverse Cracking Index	97	97	95	95	93
Longitudinal Cracking Index	98	99	99	98	97
Shoulder Condition Rating	N/A	N/A	N/A	N/A	N/A
Drainage Condition Rating	GOOD	GOOD	GOOD	GOOD	GOOD

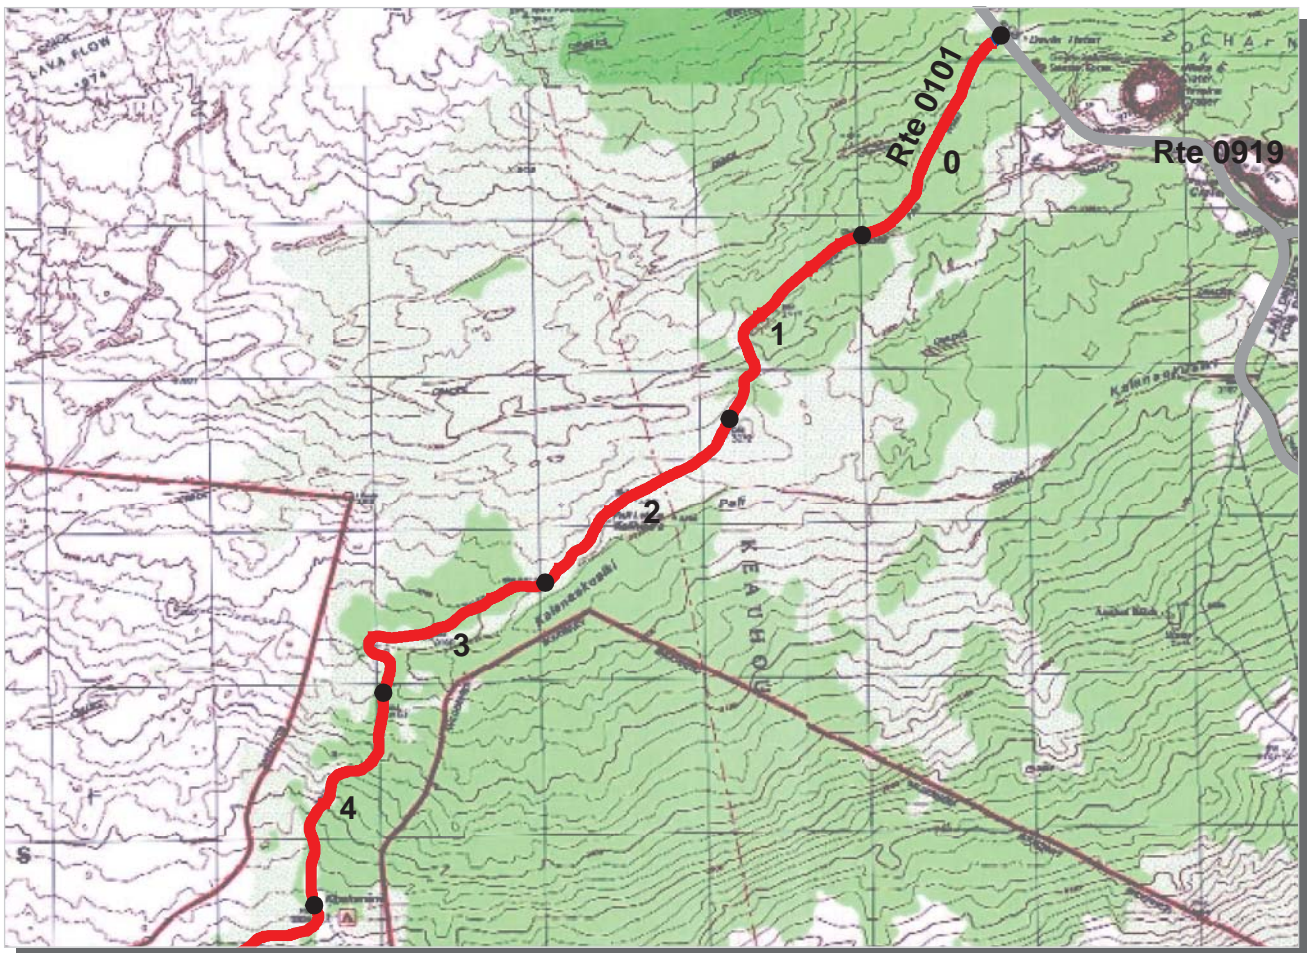
ROUTE: 0101 Hilina Pali Road **TOTAL LENGTH: 8.50 Miles**

Section Number	0	1	2	3	4
Section Length (mi)	1.00	1.00	1.00	1.00	1.00
AADT	**				
SADT	**				
ADT Date	**				
Cross Section Information					
Number of Lanes	1	1	1	1	1
Paved Width (ft)	11	11	13	10	12
Lane Width (ft)	11	11	13	10	12
Shoulder Width (ft)	0	0	0	0	0
Roadway Condition Information					
PCR (Pavement Condition Rating)	35	13	25	22	20
RCI (Roughness Condition Index)	21	19	30	18	21
SCR (Surface Condition Rating)	39	13	23	23	19
Alligator Cracking Index	97	77	93	93	86
Rutting Index	47	45	38	38	39
Patching Index	99	99	99	99	99
Transverse Cracking Index	95	78	88	88	86
Longitudinal Cracking Index	98	95	96	96	97
Shoulder Condition Rating	N/A	N/A	N/A	N/A	N/A
Drainage Condition Rating	GOOD	GOOD	GOOD	GOOD	GOOD

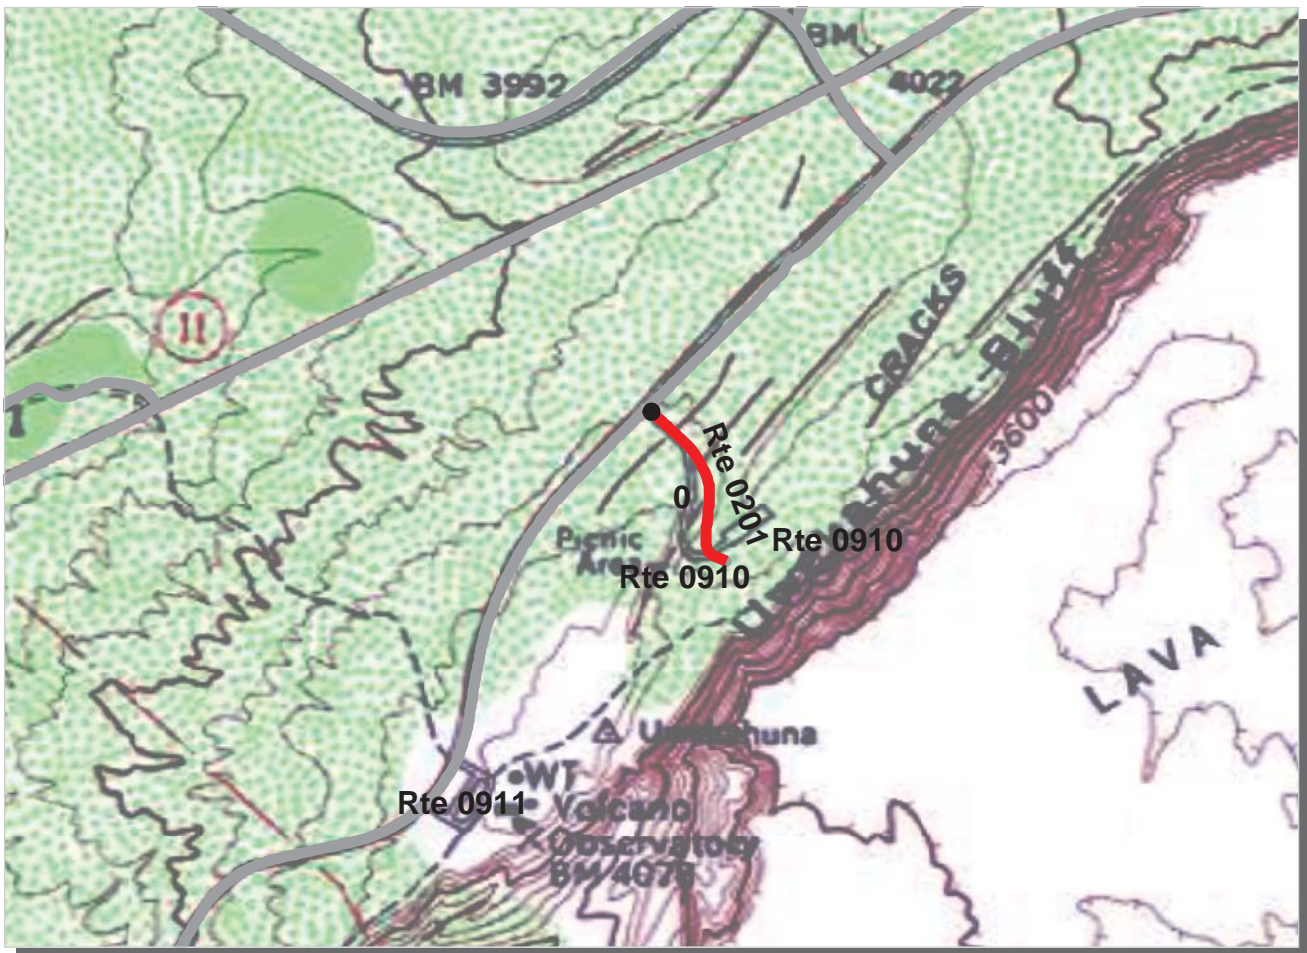
ROUTE: 0201 Kilauea Overlook Road **TOTAL LENGTH: 0.20 Miles**

Section Number	0				
Section Length (mi)	0.20				
AADT	**				
SADT	**				
ADT Date	**				
Cross Section Information					
Number of Lanes	2				
Paved Width (ft)	19				
Lane Width (ft)	9				
Shoulder Width (ft)	0				
Roadway Condition Information					
PCR (Pavement Condition Rating)	33				
RCI (Roughness Condition Index)	44				
SCR (Surface Condition Rating)	25				
Alligator Cracking Index	100				
Rutting Index	32				
Patching Index	98				
Transverse Cracking Index	95				
Longitudinal Cracking Index	99				
Shoulder Condition Rating	N/A				
Drainage Condition Rating	GOOD

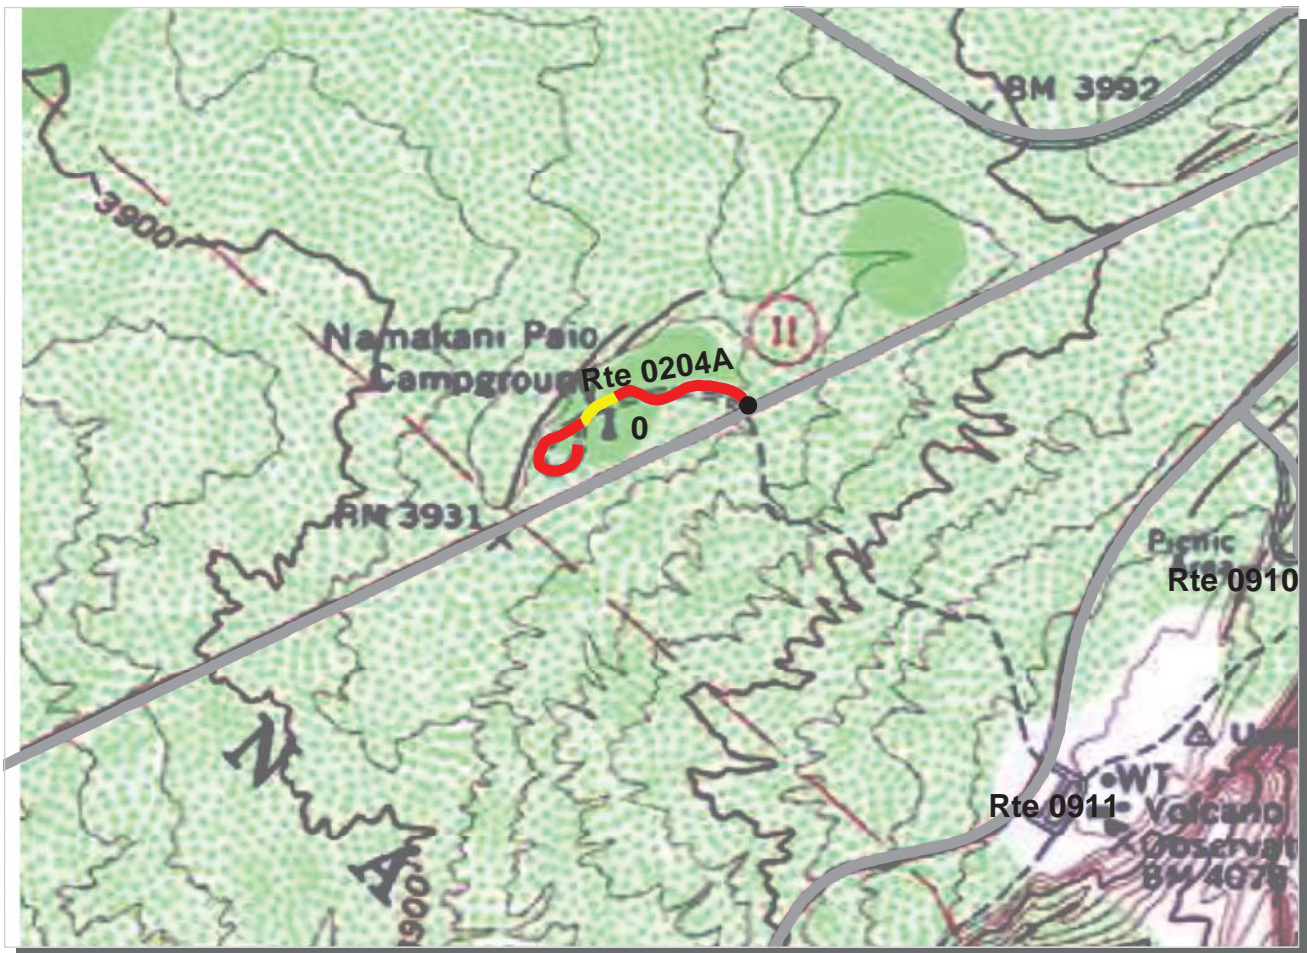
ROUTE: 0204A Namakani Paio Campground Road **TOTAL LENGTH: 0.31 Miles**

Section Number	0				
Section Length (mi)	0.31				
AADT	**				
SADT	**				
ADT Date	**				
Cross Section Information					
Number of Lanes	2				
Paved Width (ft)	19				
Lane Width (ft)	8				
Shoulder Width (ft)	0				
Roadway Condition Information					
PCR (Pavement Condition Rating)	38				
RCI (Roughness Condition Index)	29				
SCR (Surface Condition Rating)	39				
Alligator Cracking Index	100				
Rutting Index	39				
Patching Index	100				
Transverse Cracking Index	100				
Longitudinal Cracking Index	99				
Shoulder Condition Rating	N/A				
Drainage Condition Rating	GOOD

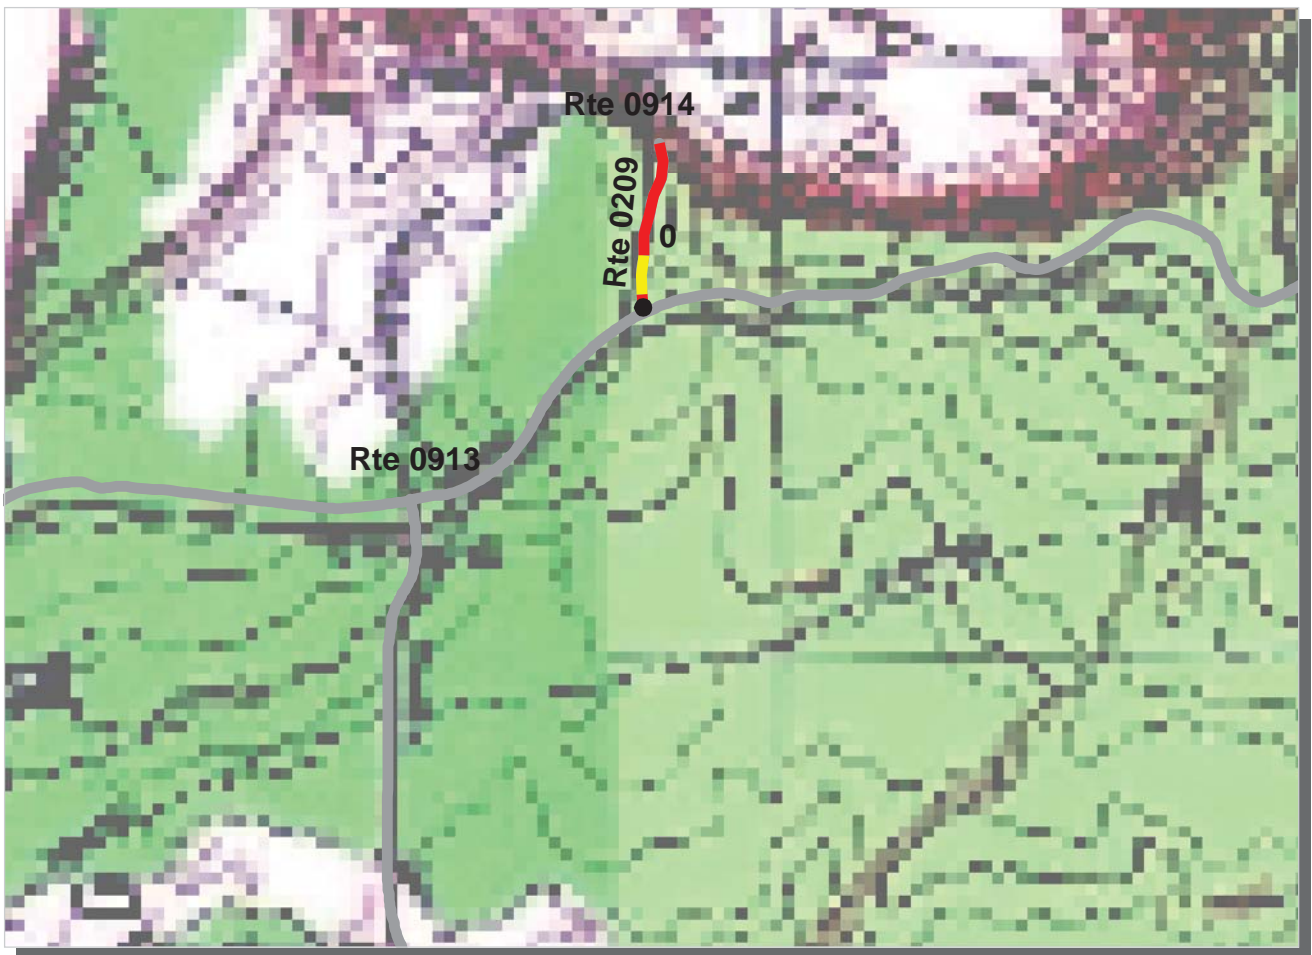
ROUTE: 0209 Puu Puai Overlook Road **TOTAL LENGTH: 0.20 Miles**

Section Number	0				
Section Length (mi)	0.20				
AADT	**				
SADT	**				
ADT Date	**				
Cross Section Information					
Number of Lanes	2				
Paved Width (ft)	20				
Lane Width (ft)	10				
Shoulder Width (ft)	0				
Roadway Condition Information					
PCR (Pavement Condition Rating)	34				
RCI (Roughness Condition Index)	38				
SCR (Surface Condition Rating)	30				
Alligator Cracking Index	79				
Rutting Index	48				
Patching Index	100				
Transverse Cracking Index	94				
Longitudinal Cracking Index	97				
Shoulder Condition Rating	N/A				
Drainage Condition Rating	GOOD

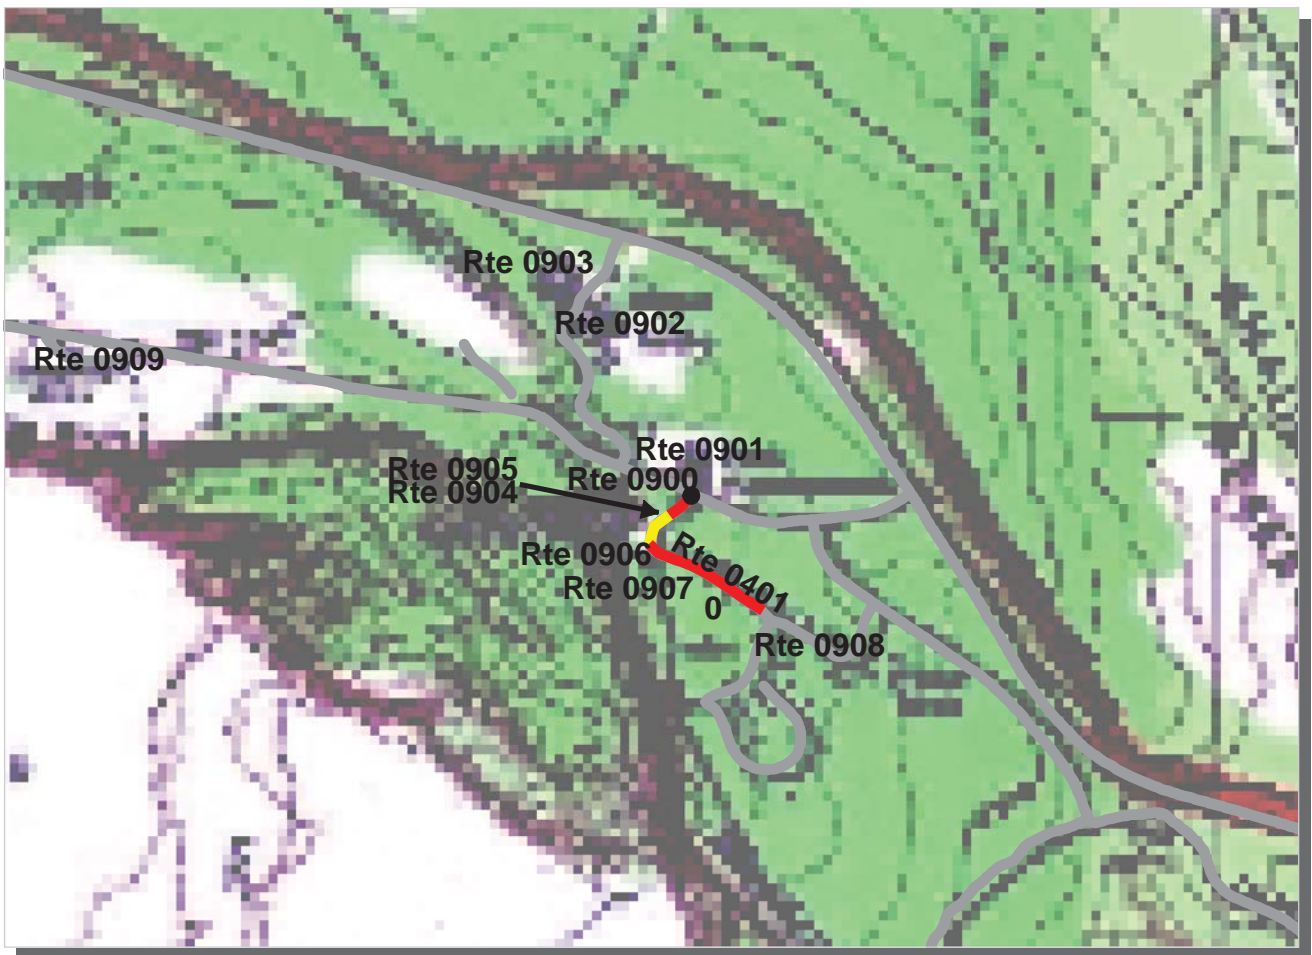
ROUTE: 0401 North Residence Road **TOTAL LENGTH: 0.26 Miles**

Section Number	0			
Section Length (mi)	0.26			
AADT	**			
SADT	**			
ADT Date	**			
Cross Section Information				
Number of Lanes	2			
Paved Width (ft)	23			
Lane Width (ft)	11			
Shoulder Width (ft)	0			
Roadway Condition Information				
PCR (Pavement Condition Rating)	32			
RCI (Roughness Condition Index)	NC			
SCR (Surface Condition Rating)	32			
Alligator Cracking Index	96			
Rutting Index	37			
Patching Index	99			
Transverse Cracking Index	97			
Longitudinal Cracking Index	98			
Shoulder Condition Rating	N/A			
Drainage Condition Rating	GOOD

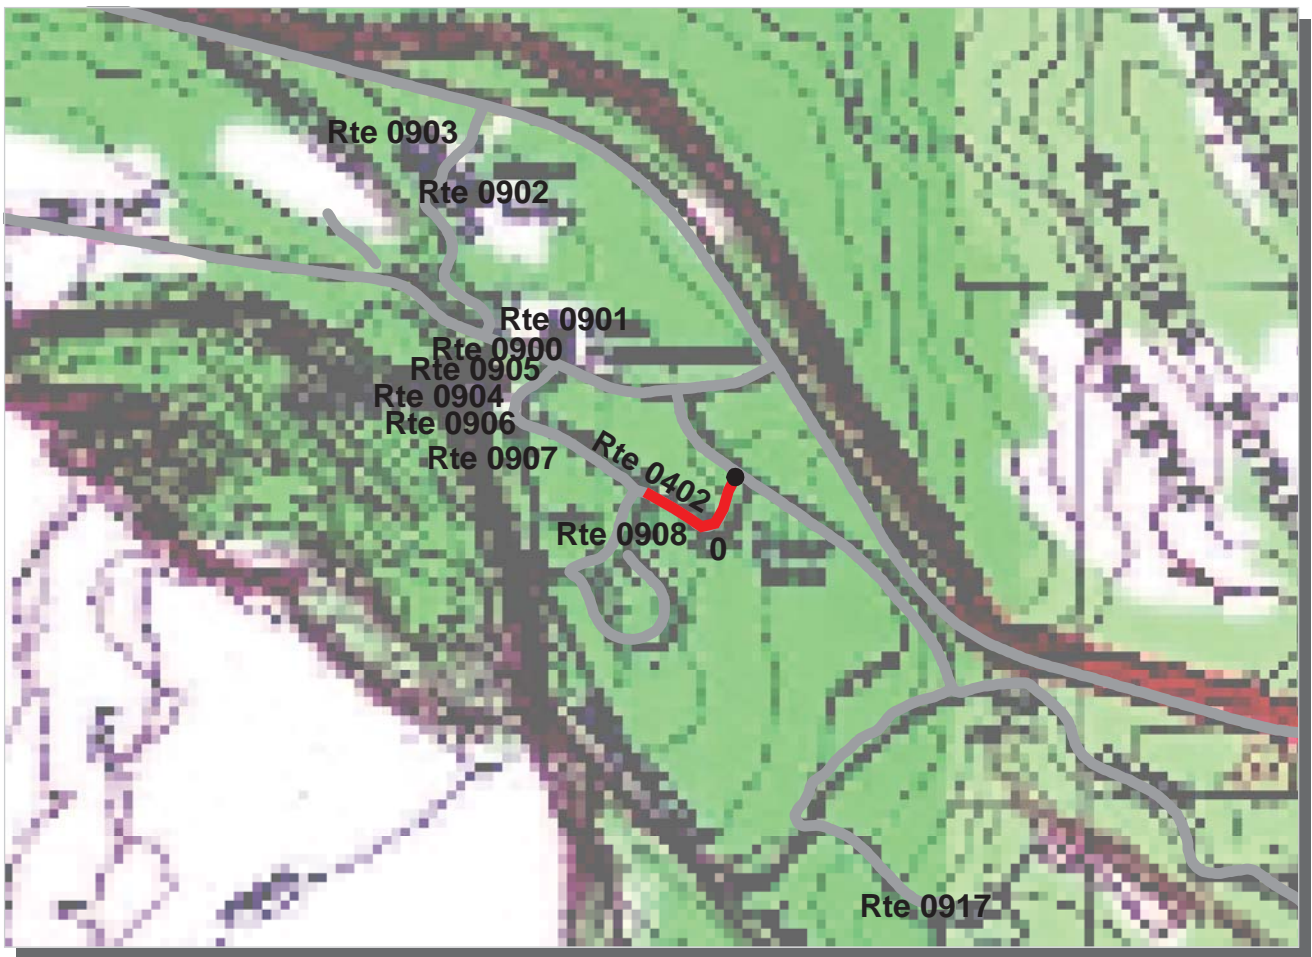
ROUTE: 0402 South Residence Road **TOTAL LENGTH: 0.17 Miles**

Section Number	0				
Section Length (mi)	0.17				
AADT	**				
SADT	**				
ADT Date	**				
Cross Section Information					
Number of Lanes	2				
Paved Width (ft)	19				
Lane Width (ft)	9				
Shoulder Width (ft)	0				
Roadway Condition Information					
PCR (Pavement Condition Rating)	5				
RCI (Roughness Condition Index)	NC				
SCR (Surface Condition Rating)	5				
Alligator Cracking Index	93				
Rutting Index	8				
Patching Index	99				
Transverse Cracking Index	98				
Longitudinal Cracking Index	98				
Shoulder Condition Rating	N/A				
Drainage Condition Rating	GOOD

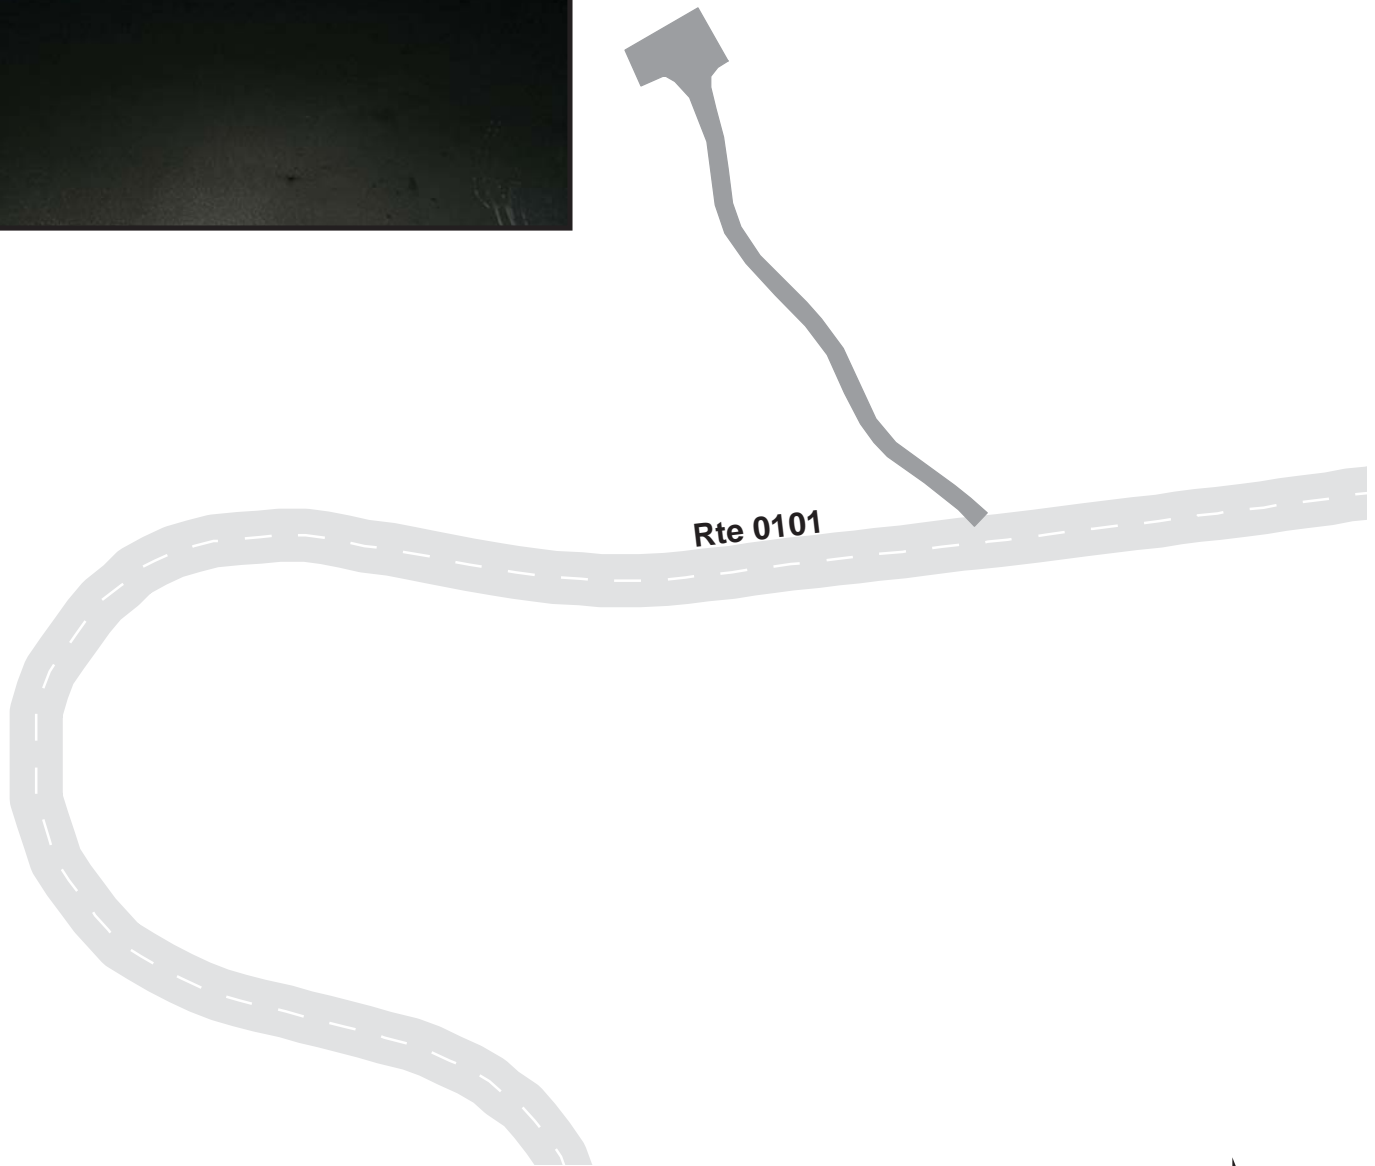
Route 0900

Route	Public / NonPublic	Date Visited	Area (sq ft)	Lane Miles *	Surface Type	Condition / PCR
0900	Public	5/8/2001	58720	1.01	AS	GOOD / 90

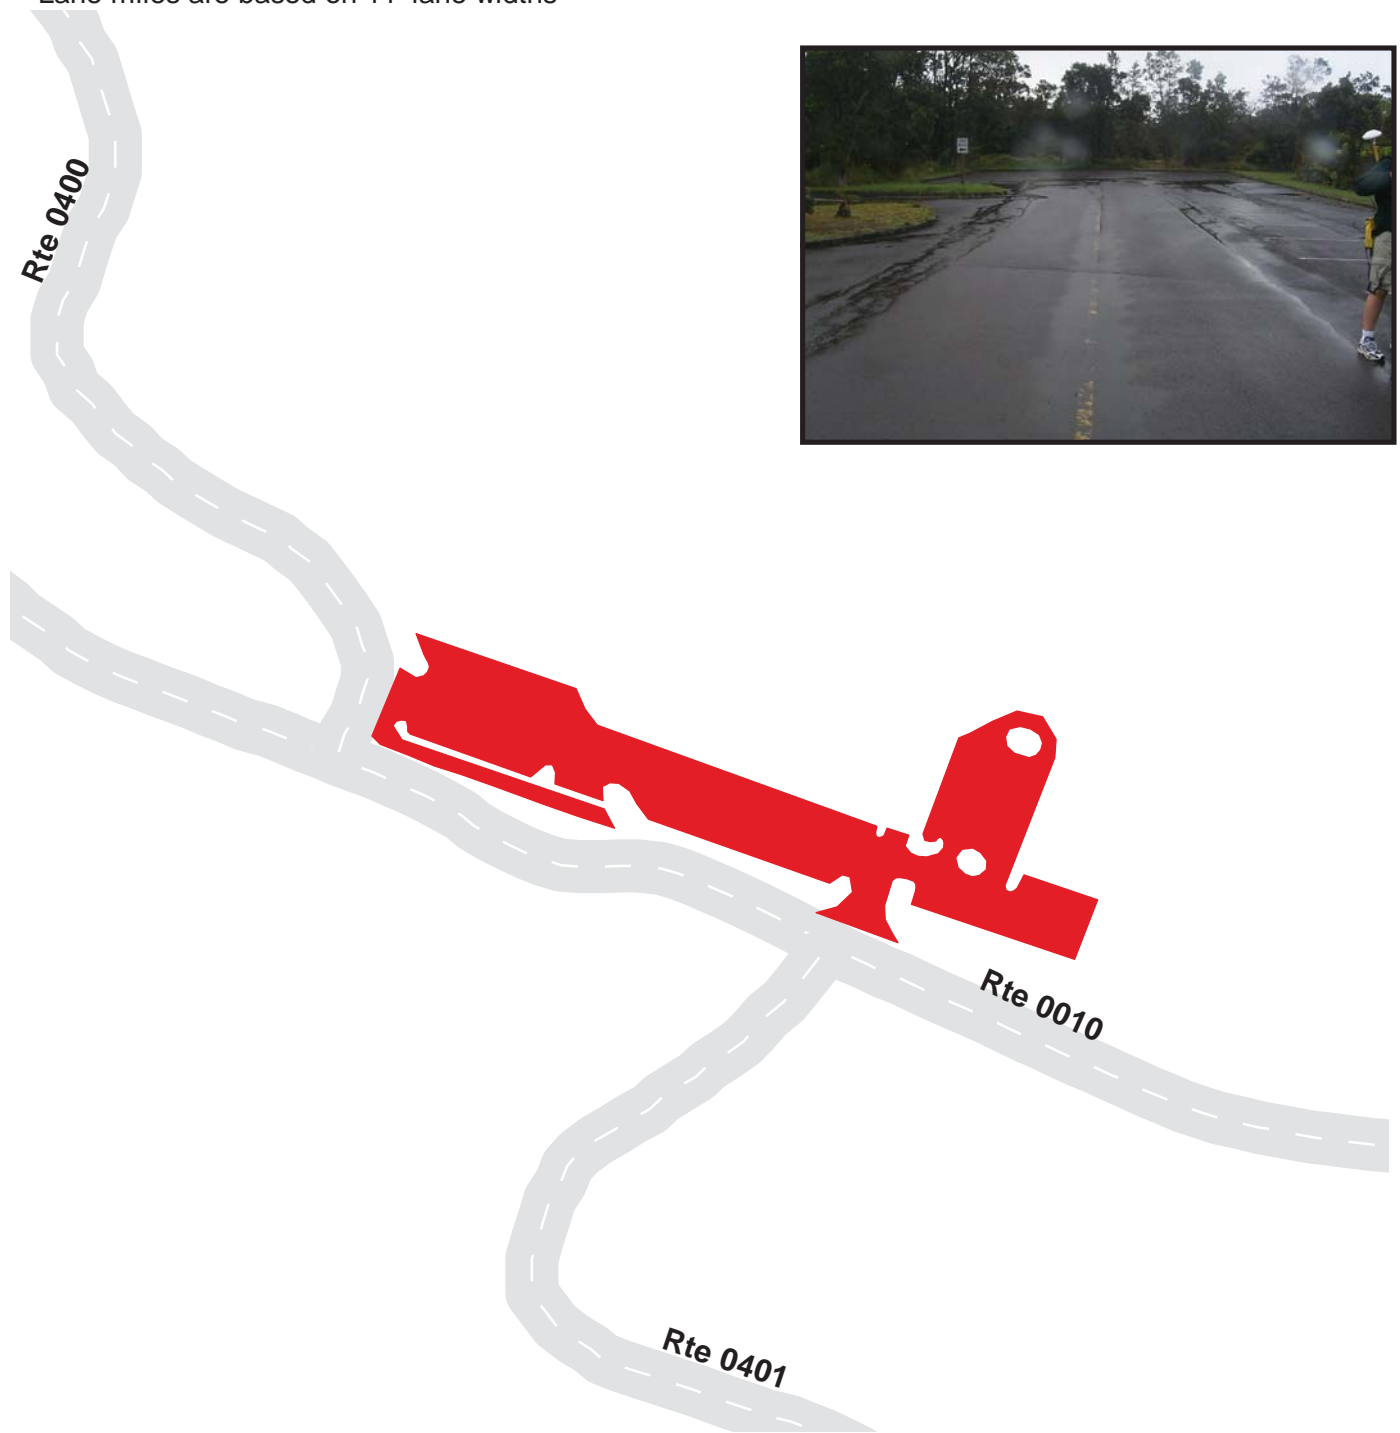
Route 0901

Route	Public / NonPublic	Date Visited	Area (sq ft)	Lane Miles *	Surface Type	Condition / PCR
0901	NonPublic	5/8/2001	11251	0.19	AS	GOOD / 90

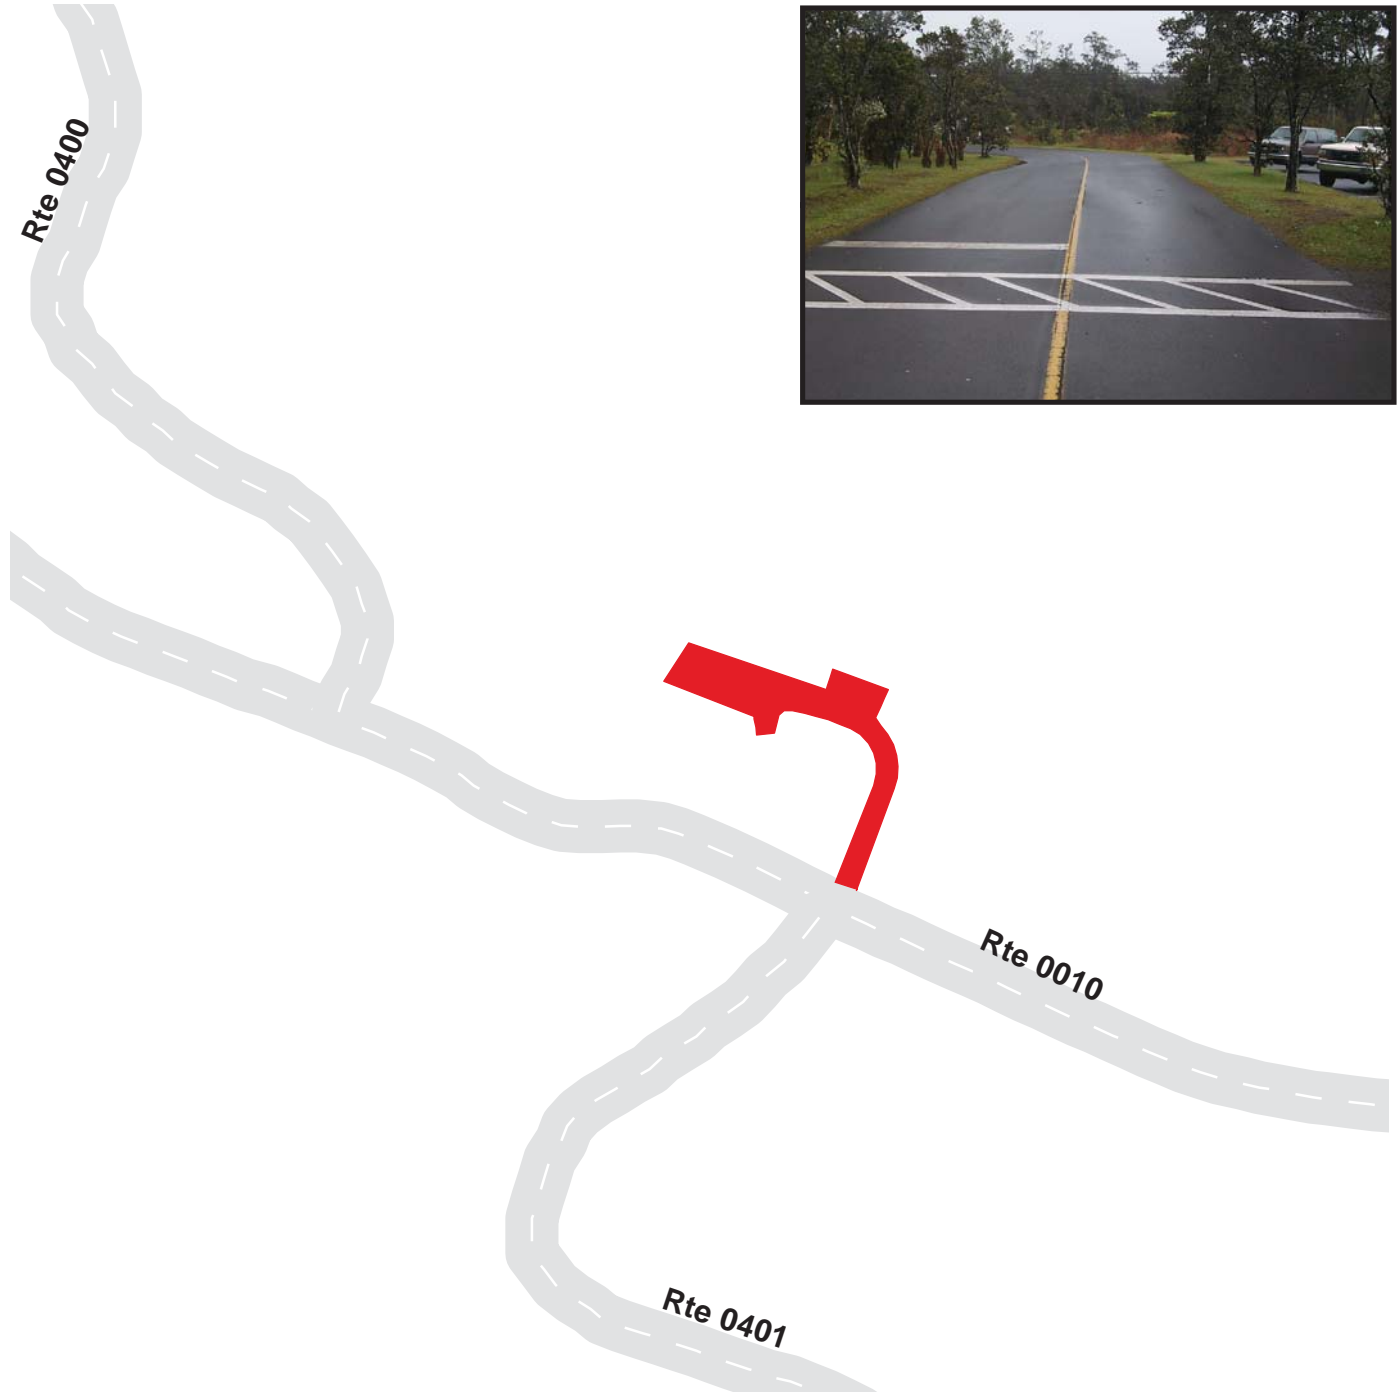
Route 0902

Route	Public / NonPublic	Date Visited	Area (sq ft)	Lane Miles *	Surface Type	Condition / PCR
0902	NonPublic	5/8/2001	48691	0.84	AS	FAIR / 73
