The Road Inventory of Hawaii Volcanoes National Park HAVO – 8300

Road Inventory Program

Prepared By:
Federal Highway Administration
Eastern Federal Lands Highway Division
Cycle 3

Hawaii Volcanoes National Park in Hawaii

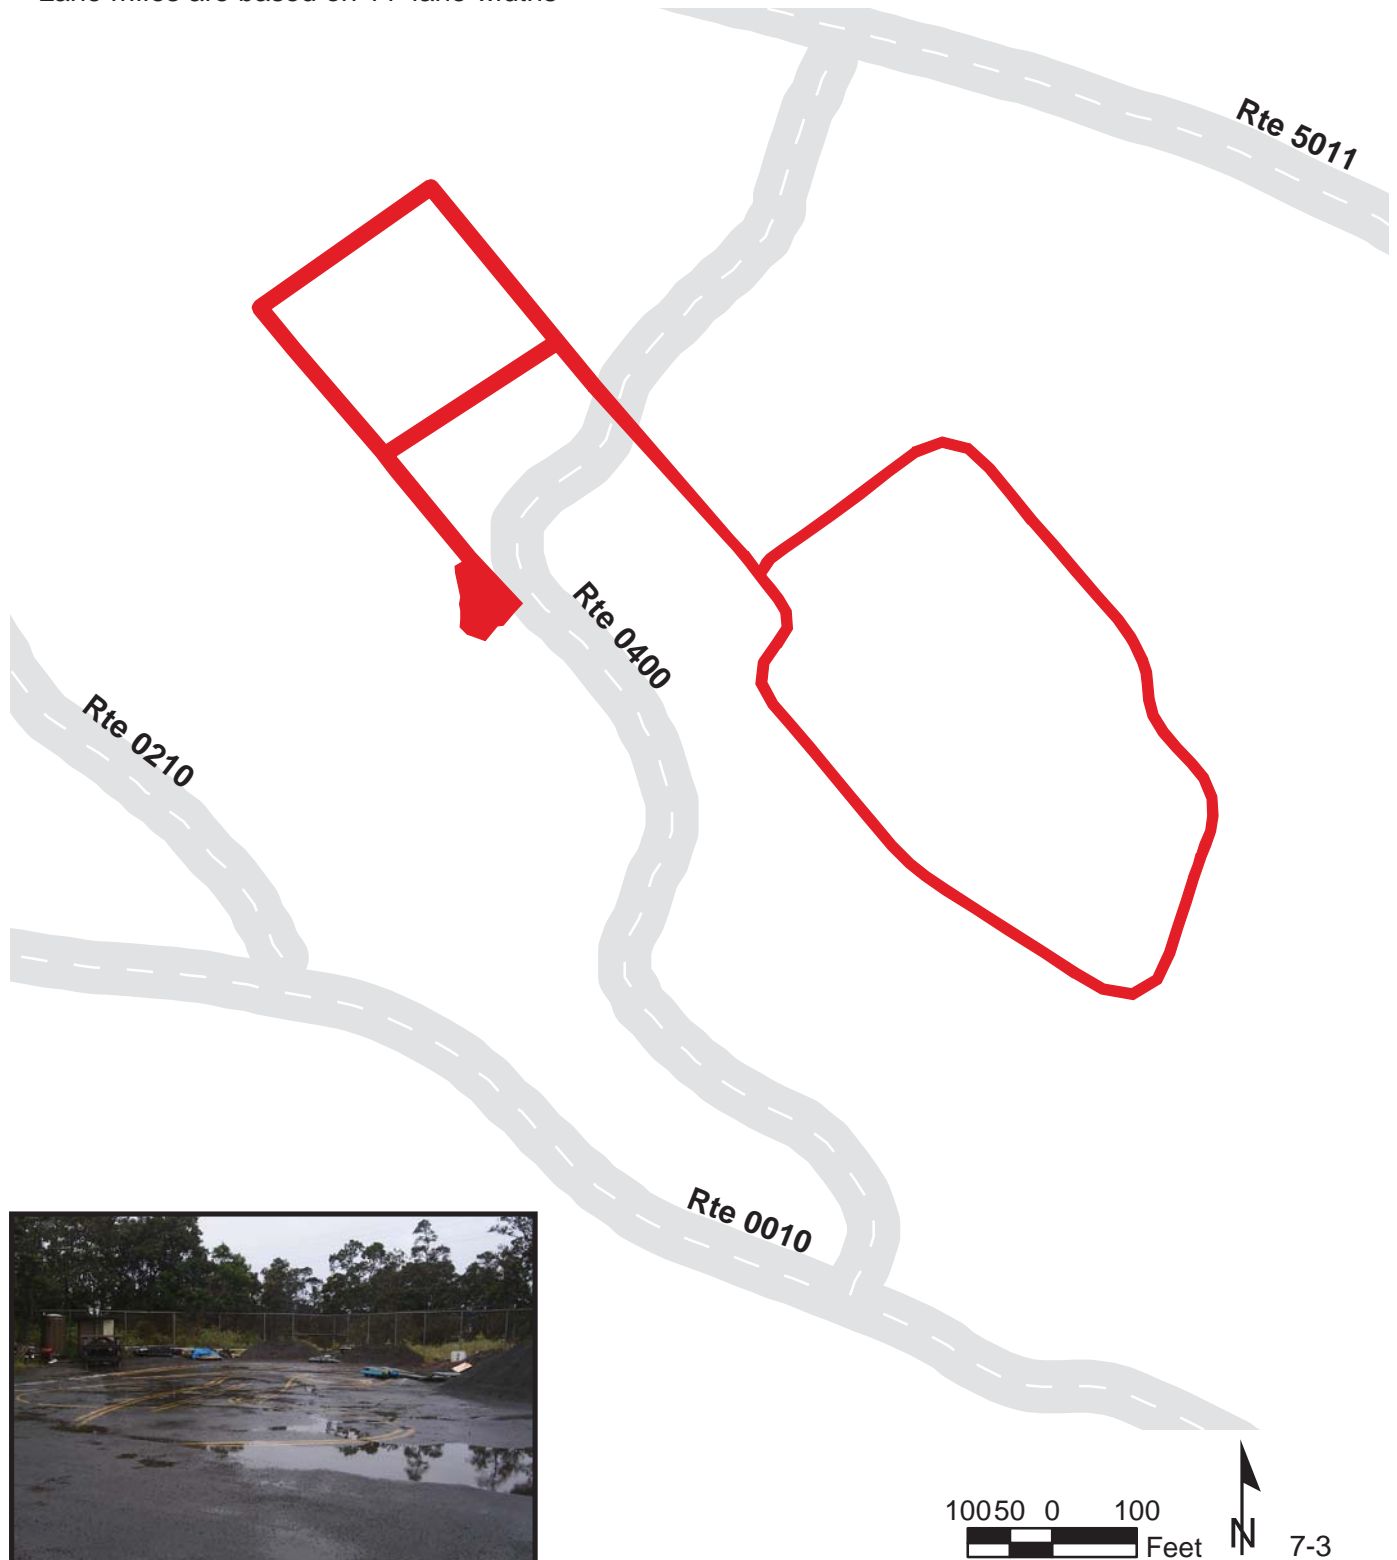
Route 0903

Route	Public / NonPublic	Date Visited	Area (sq ft)	Lane Miles *	Surface Type	Condition / PCR
0903	NonPublic	5/8/2001	10386	0.18	AS	FAIR / 73

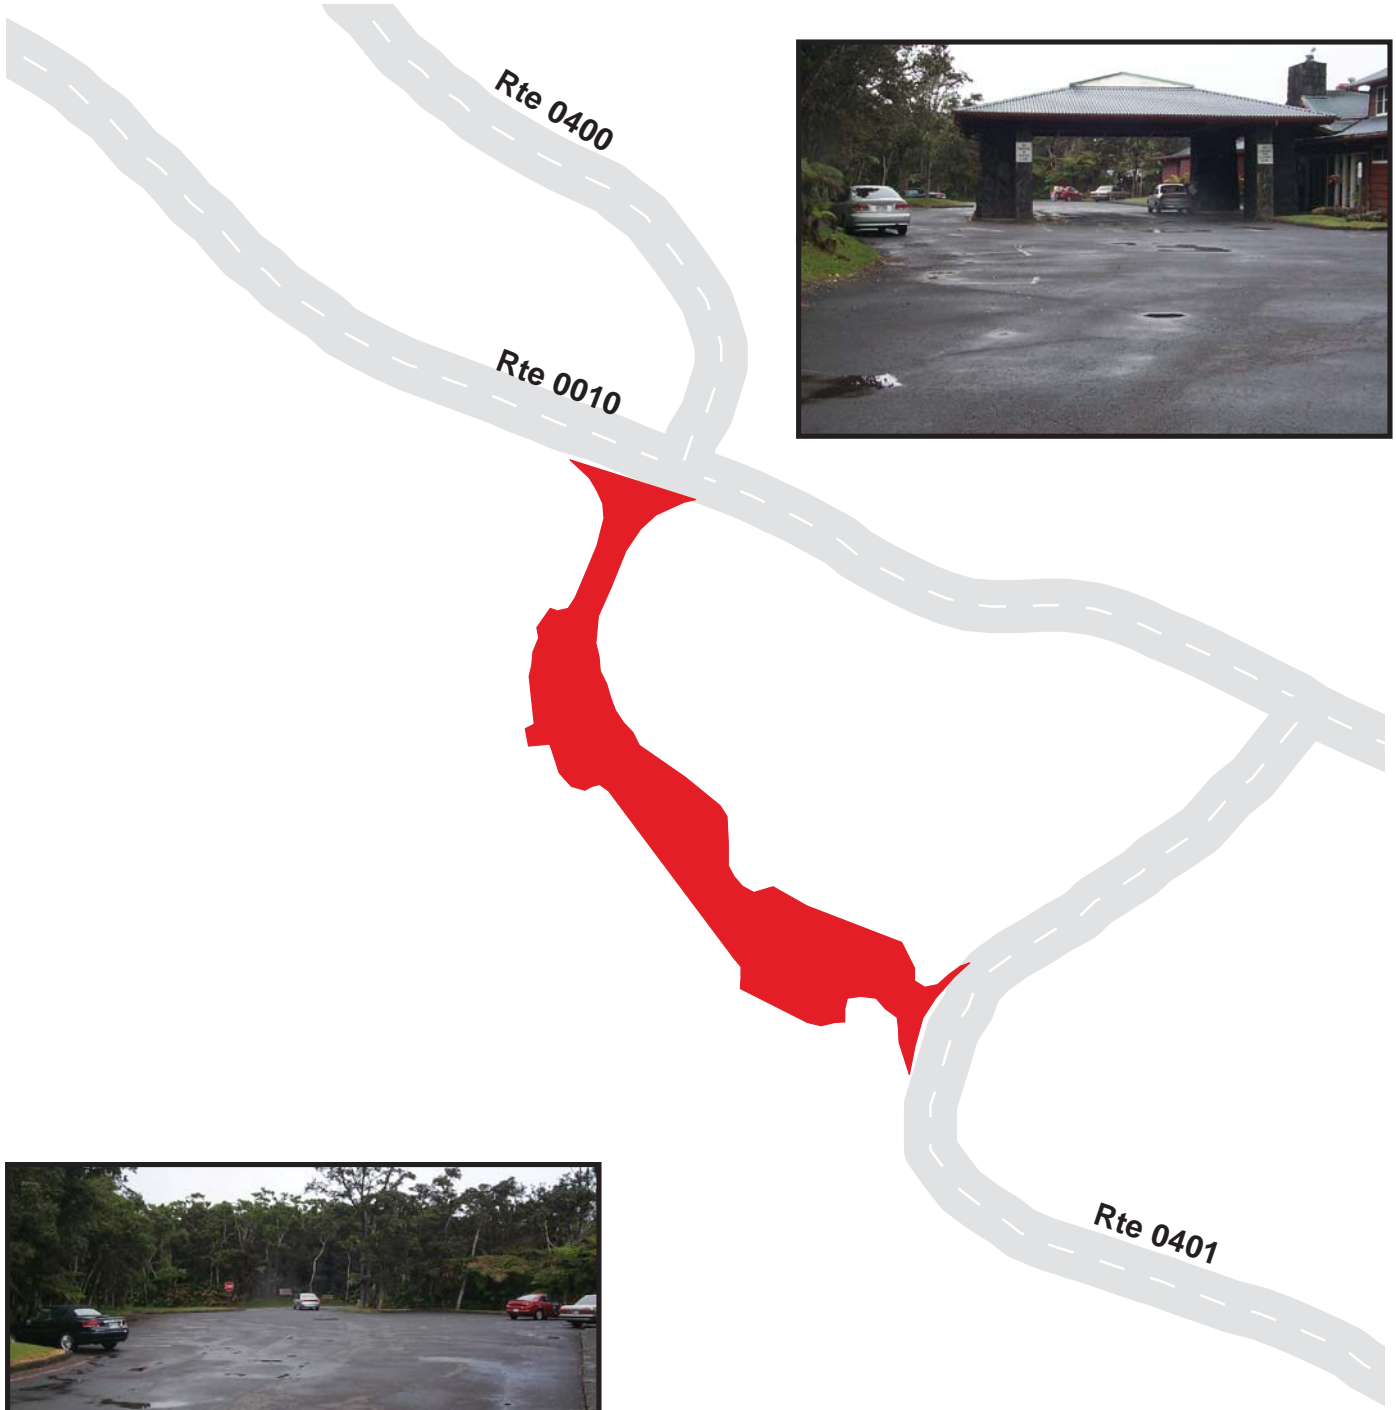
Route 0905

Route	Public / NonPublic	Date Visited	Area (sq ft)	Lane Miles *	Surface Type	Condition / PCR
0905	NonPublic	10/29/2002	2733	0.05	AS	GOOD / 90

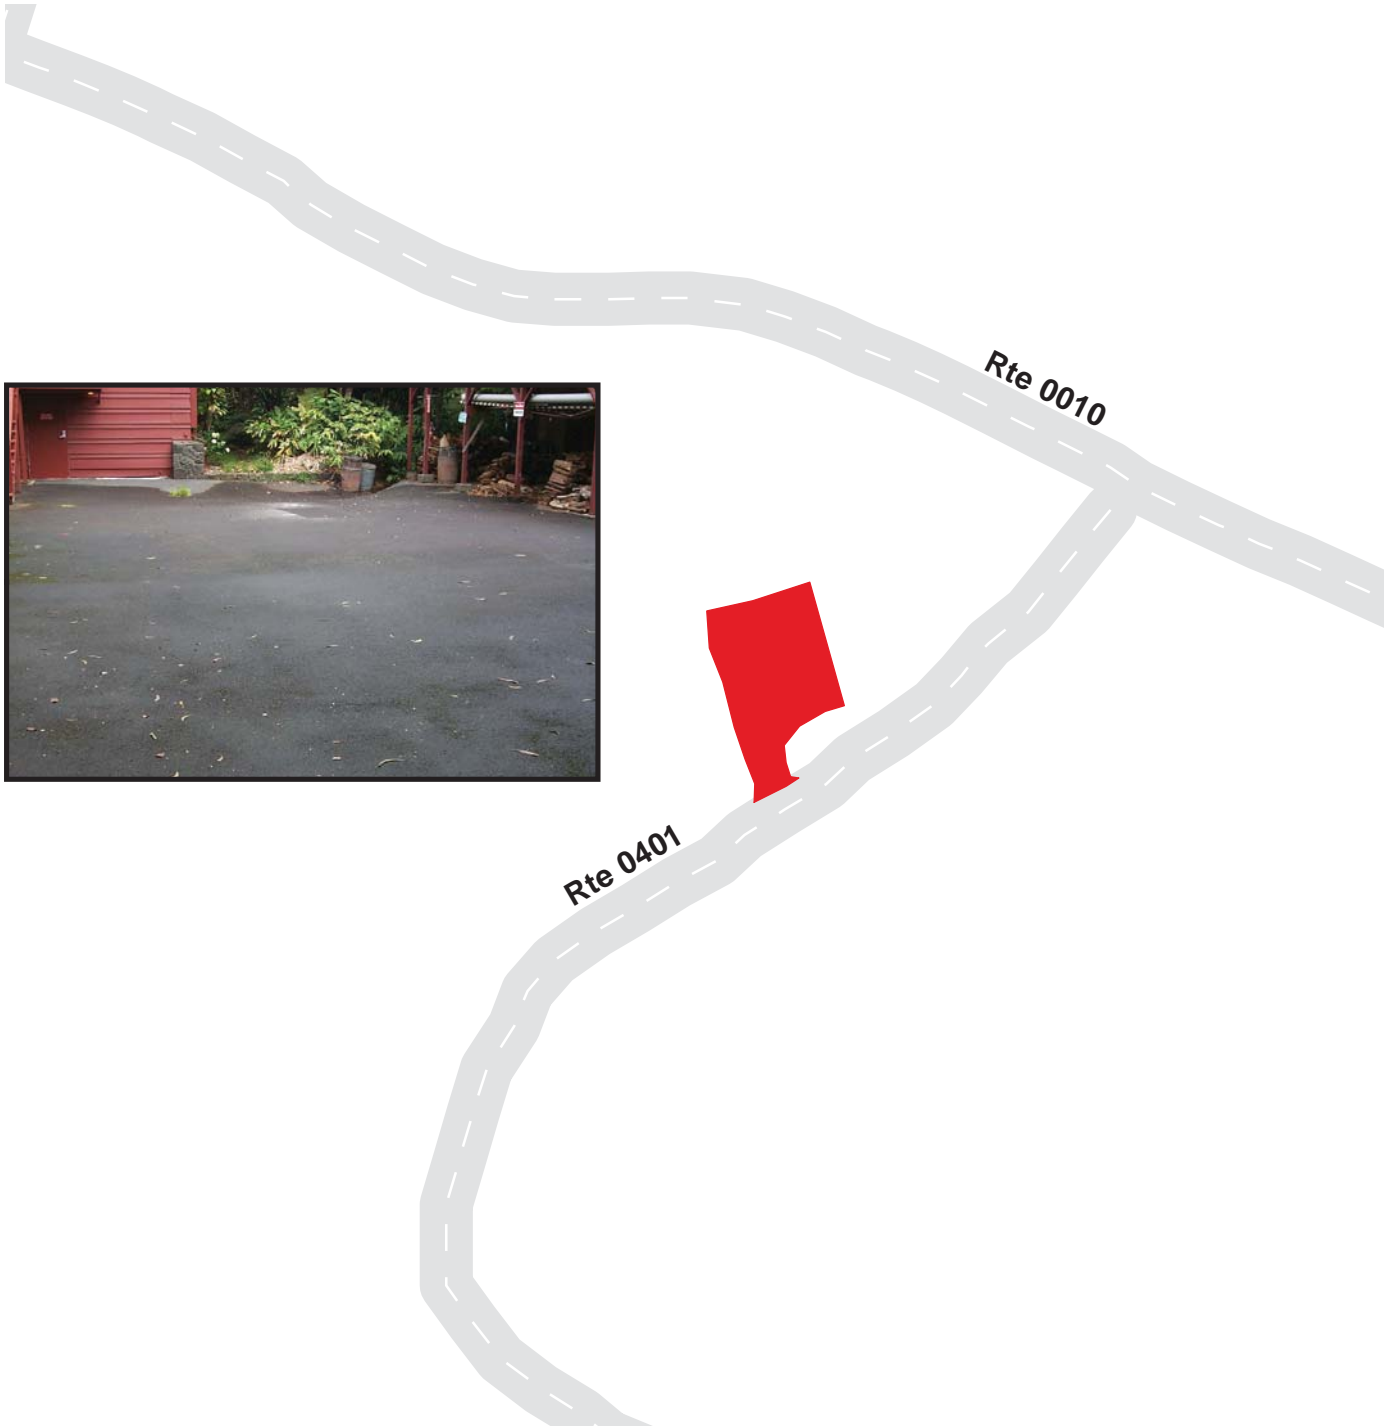
Route 0906

Route	Public / NonPublic	Date Visited	Area (sq ft)	Lane Miles *	Surface Type	Condition / PCR
0906	NonPublic	10/29/2002	7378	0.13	AS	FAIR / 73

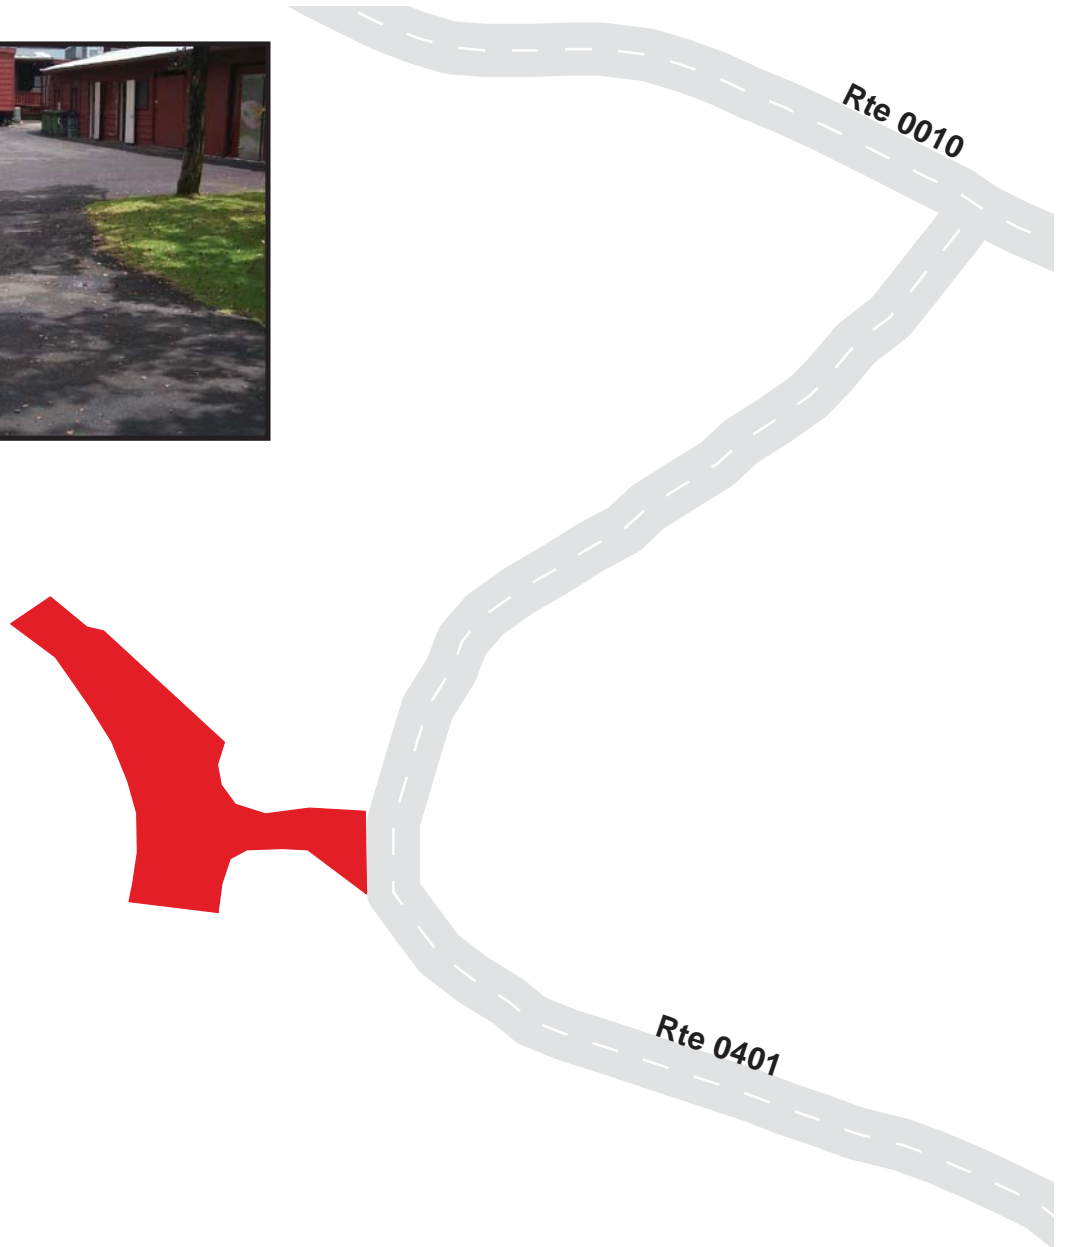
Route 0907

Route	Public / NonPublic	Date Visited	Area (sq ft)	Lane Miles *	Surface Type	Condition / PCR
0907	NonPublic	10/29/2002	7617	0.13	AS	FAIR / 73

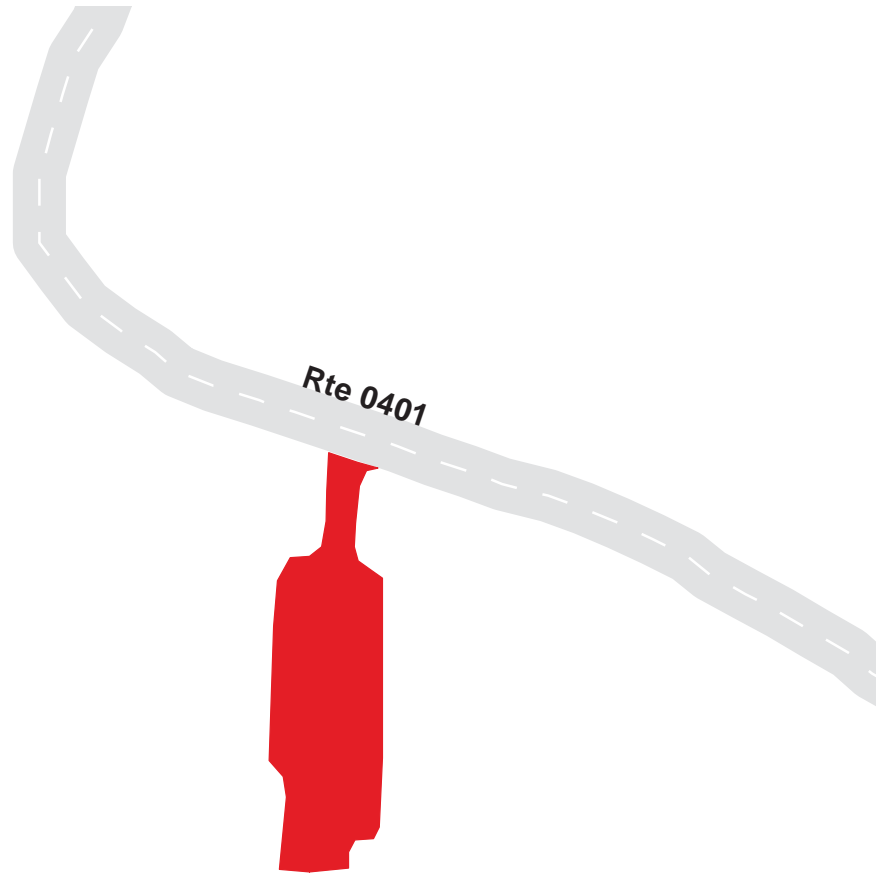
Route 0908

Route	Public / NonPublic	Date Visited	Area (sq ft)	Lane Miles *	Surface Type	Condition / PCR
0908	NonPublic	10/29/2002	15295	0.26	AS	FAIR / 73

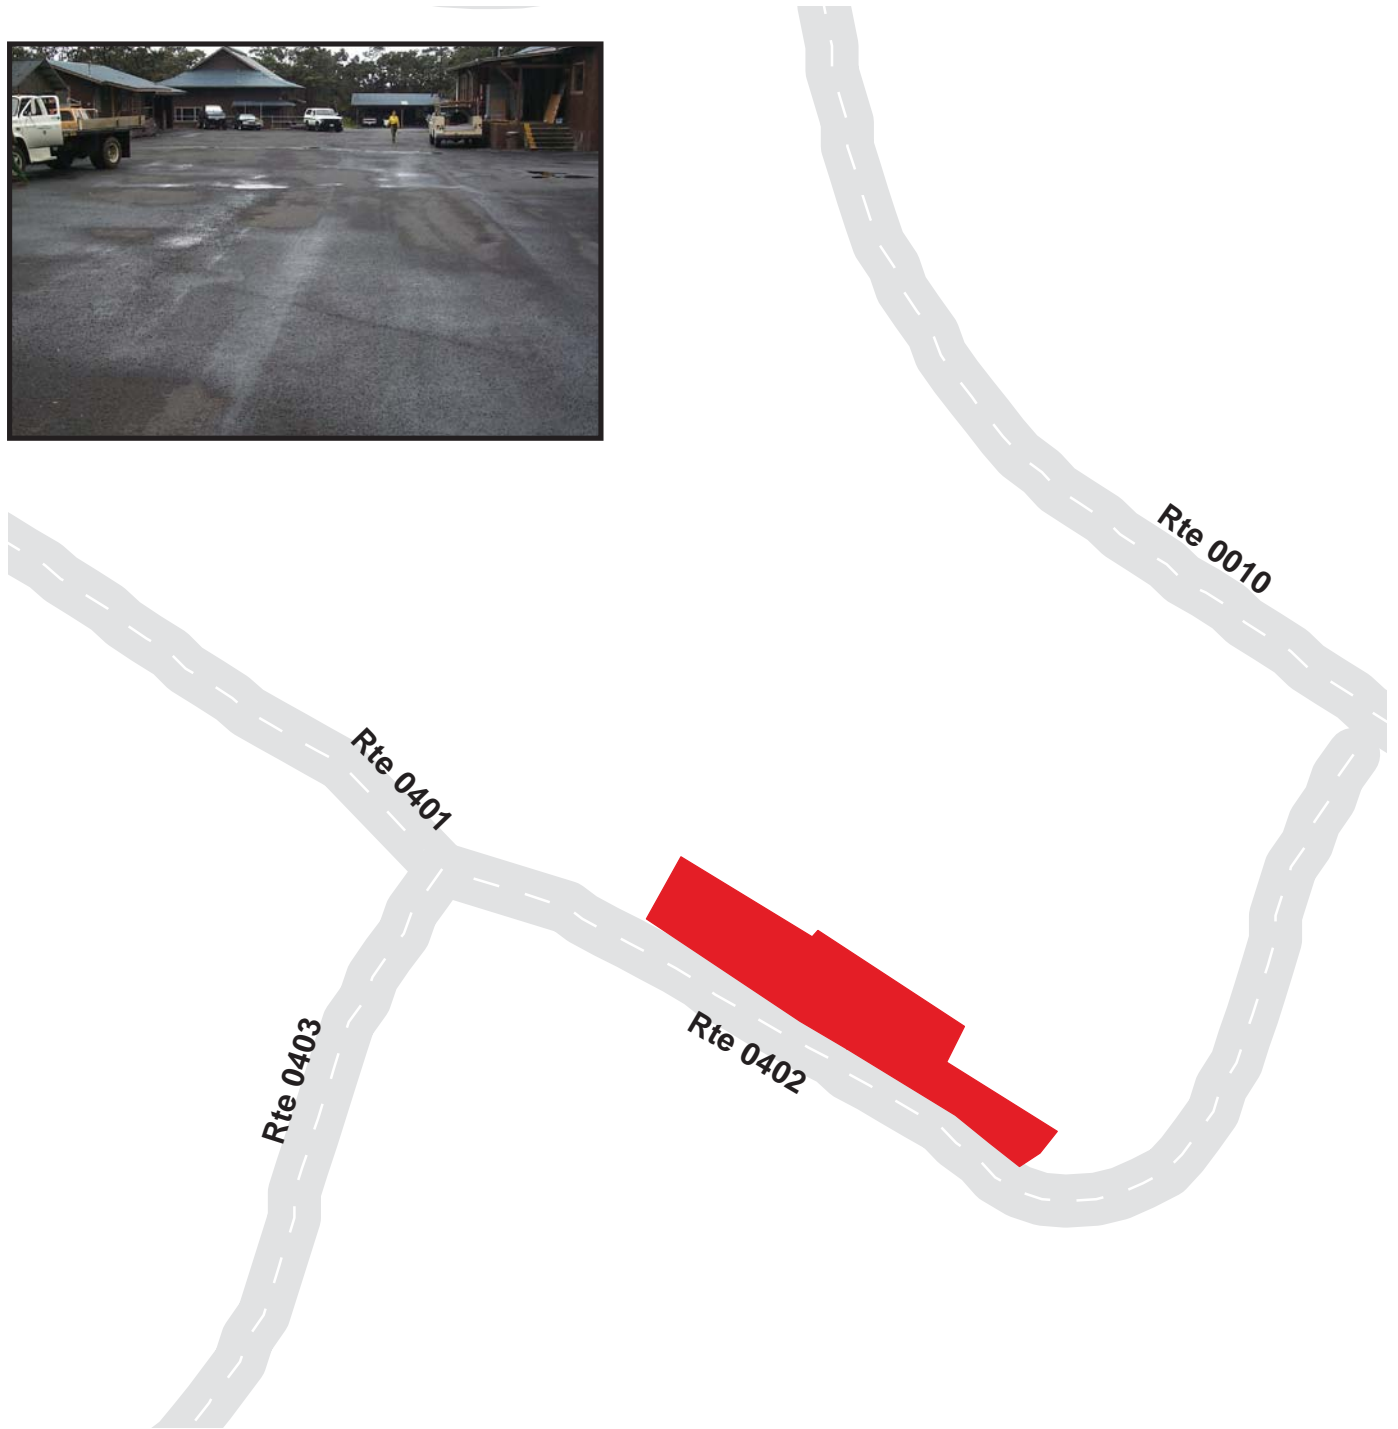
Route 0909

Route	Public / NonPublic	Date Visited	Area (sq ft)	Lane Miles *	Surface Type	Condition / PCR
0909	Public	5/8/2001	1937	0.03	AS	GOOD / 90

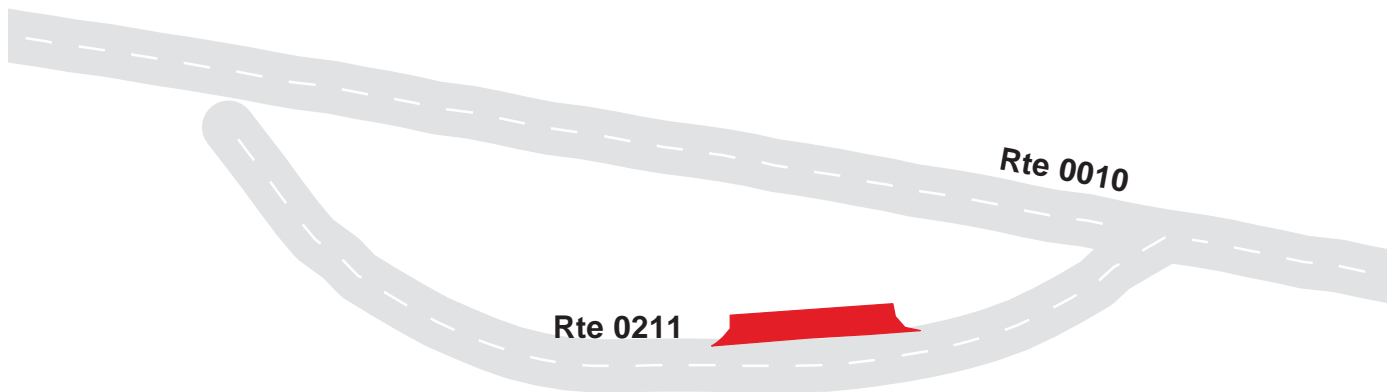
Route 0910

Route	Public / NonPublic	Date Visited	Area (sq ft)	Lane Miles *	Surface Type	Condition / PCR
0910	Public	5/8/2001	24393	0.42	AS	GOOD / 90

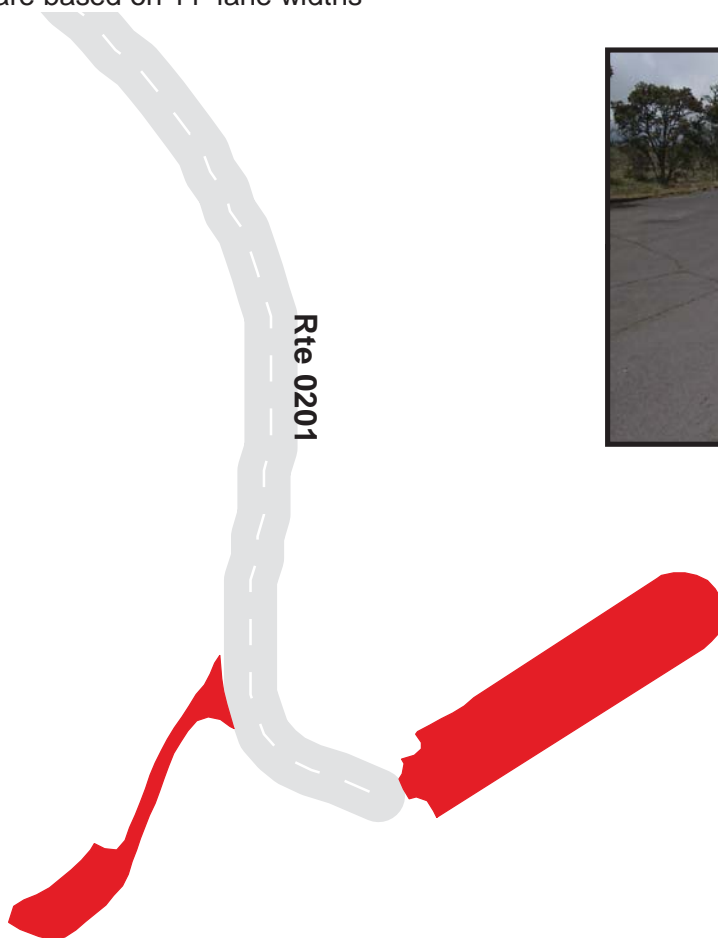
Route 0911

Route	Public / NonPublic	Date Visited	Area (sq ft)	Lane Miles *	Surface Type	Condition / PCR
0911	Public	5/8/2001	44751	0.77	AS	GOOD / 90

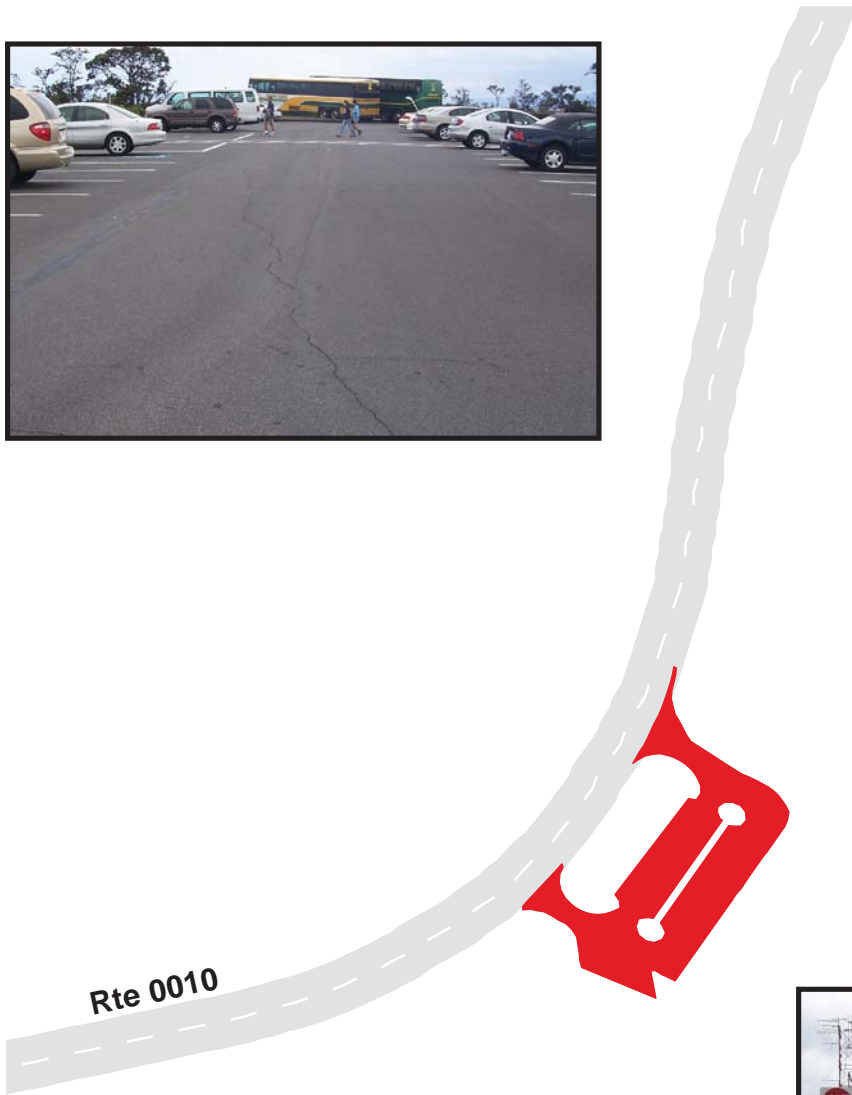
Route 0912

Route	Public / NonPublic	Date Visited	Area (sq ft)	Lane Miles *	Surface Type	Condition / PCR
0912	Public	5/8/2001	153543	2.64	OC	GOOD / 90

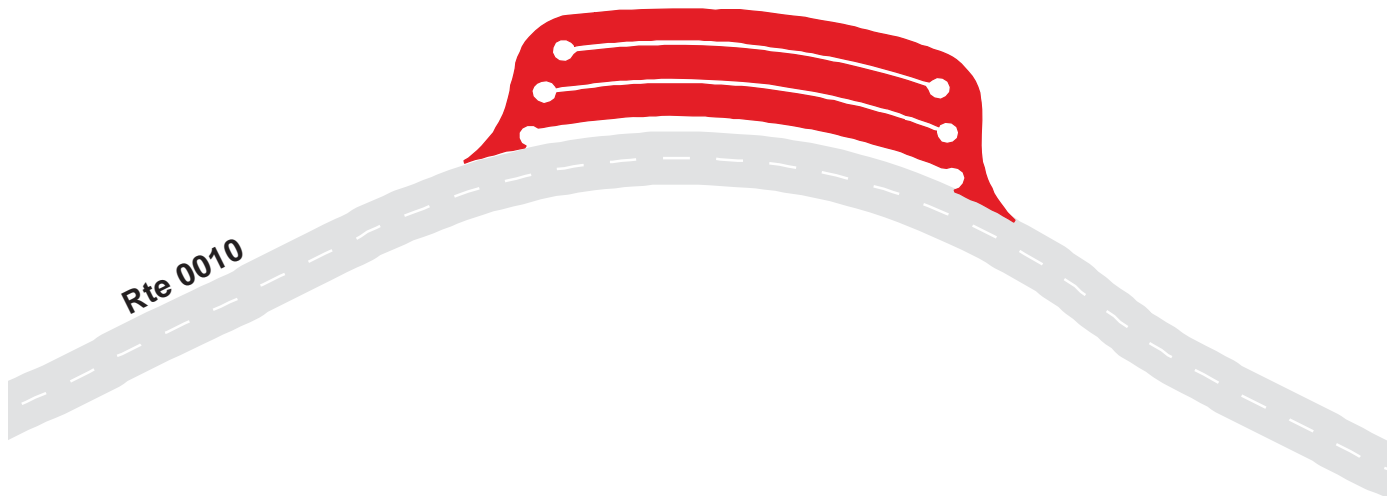
Route 0913

Route	Public / NonPublic	Date Visited	Area (sq ft)	Lane Miles *	Surface Type	Condition / PCR
0913	Public	5/8/2001	23578	0.41	AS	GOOD / 90

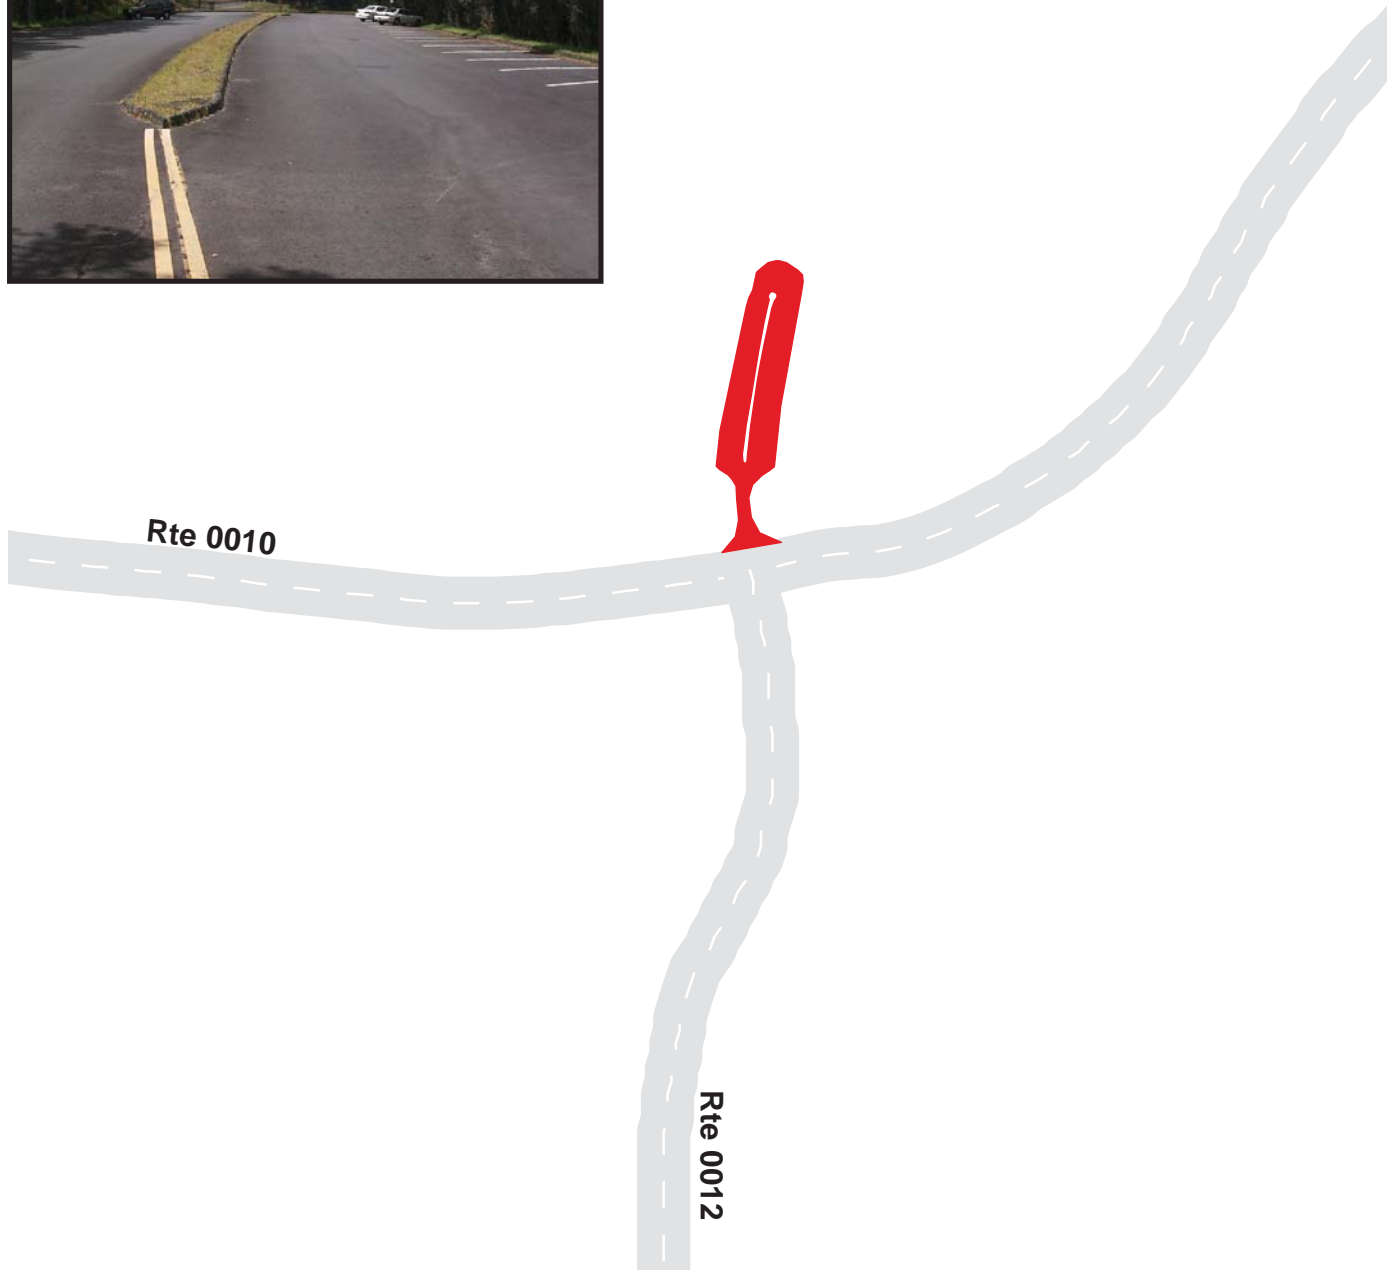
Route 0914

Route	Public / NonPublic	Date Visited	Area (sq ft)	Lane Miles *	Surface Type	Condition / PCR
0914	Public	5/8/2001	21426	0.37	AS	GOOD / 90

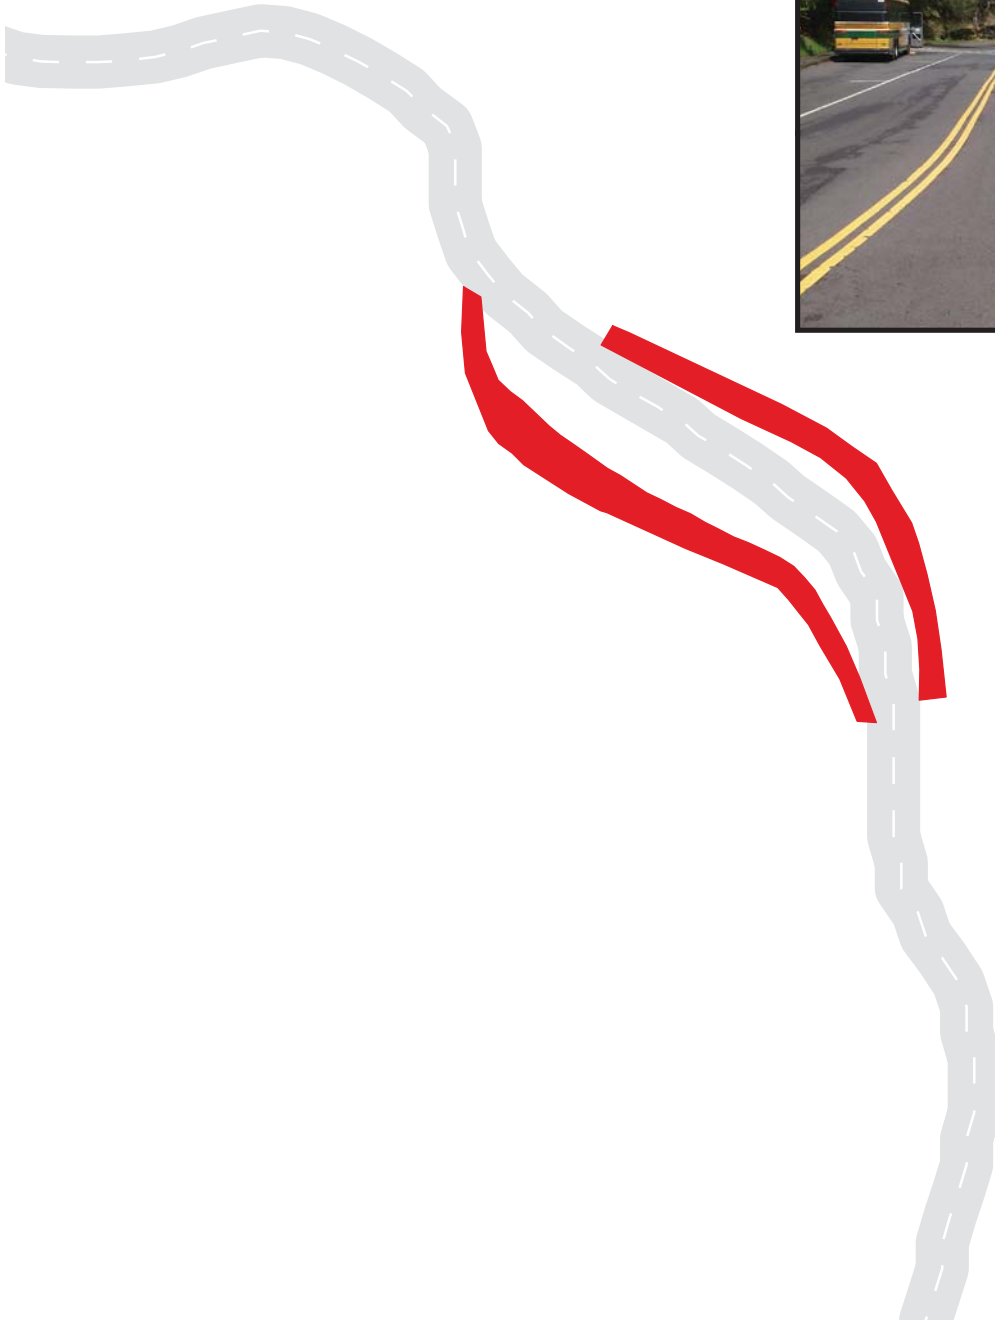
Route 0916

Route	Public / NonPublic	Date Visited	Area (sq ft)	Lane Miles *	Surface Type	Condition / PCR
0916	Public	5/8/2001	23710	0.41	AS	GOOD / 90

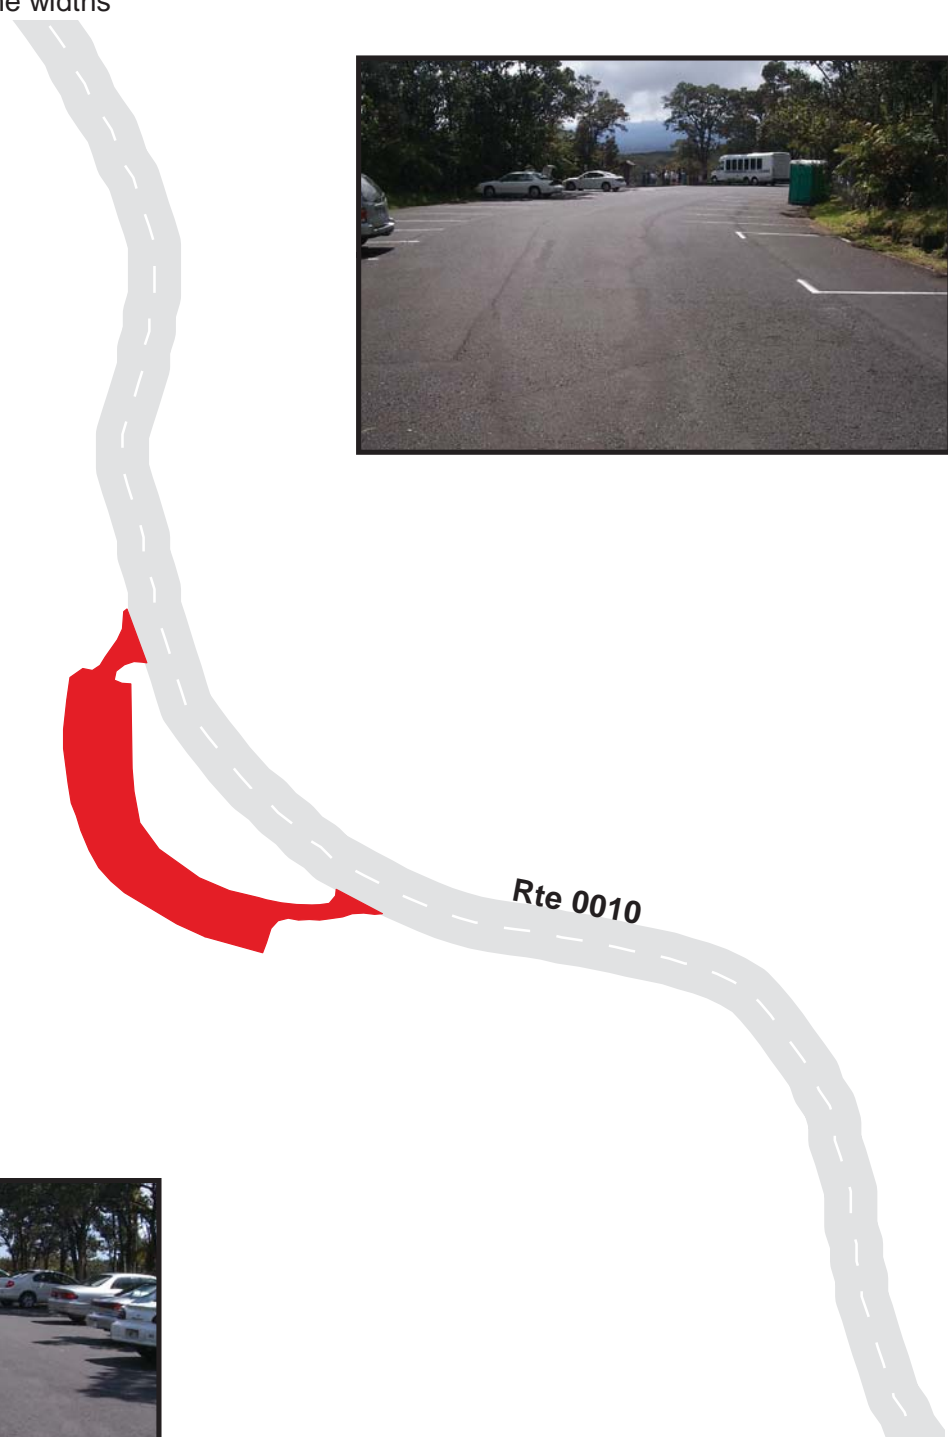
Route 0917

Route	Public / NonPublic	Date Visited	Area (sq ft)	Lane Miles *	Surface Type	Condition / PCR
0917	NonPublic	5/8/2001	34608	0.60	AS	POOR / 45

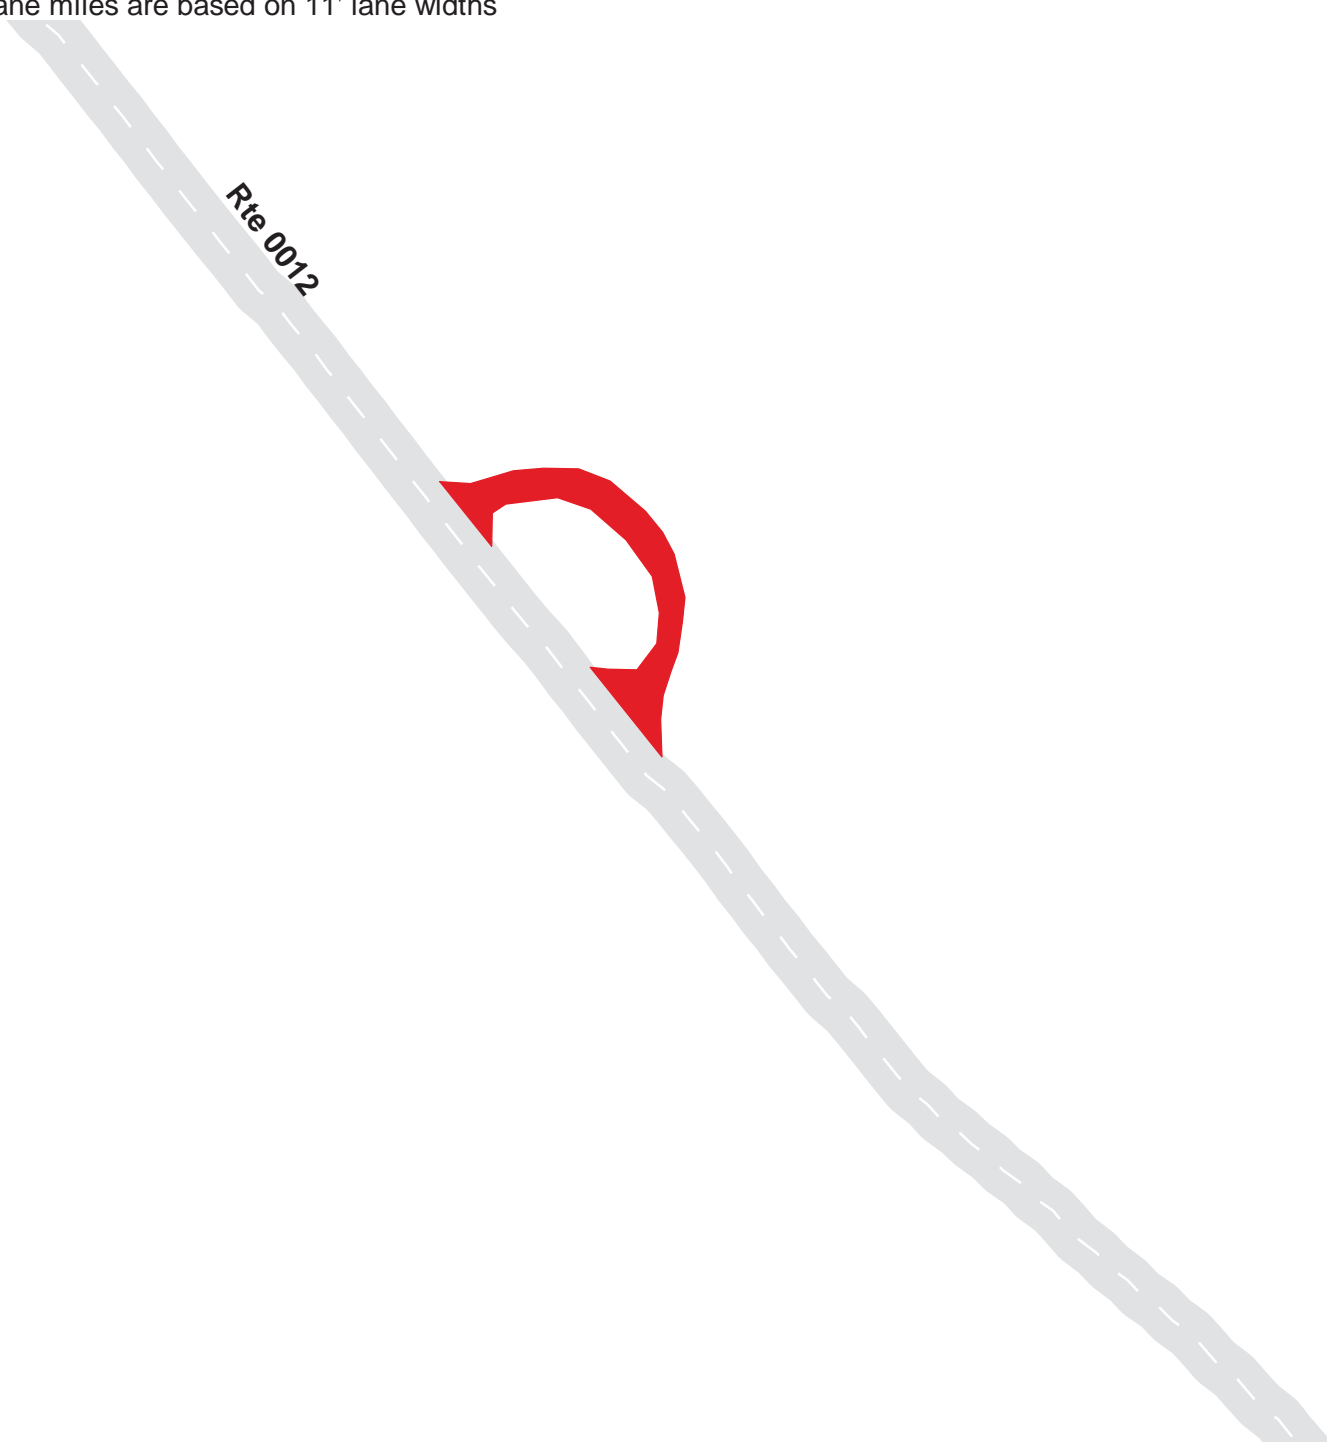
Route 0919

Route	Public / NonPublic	Date Visited	Area (sq ft)	Lane Miles *	Surface Type	Condition / PCR
0919	Public	5/8/2001	16121	0.28	AS	GOOD / 90

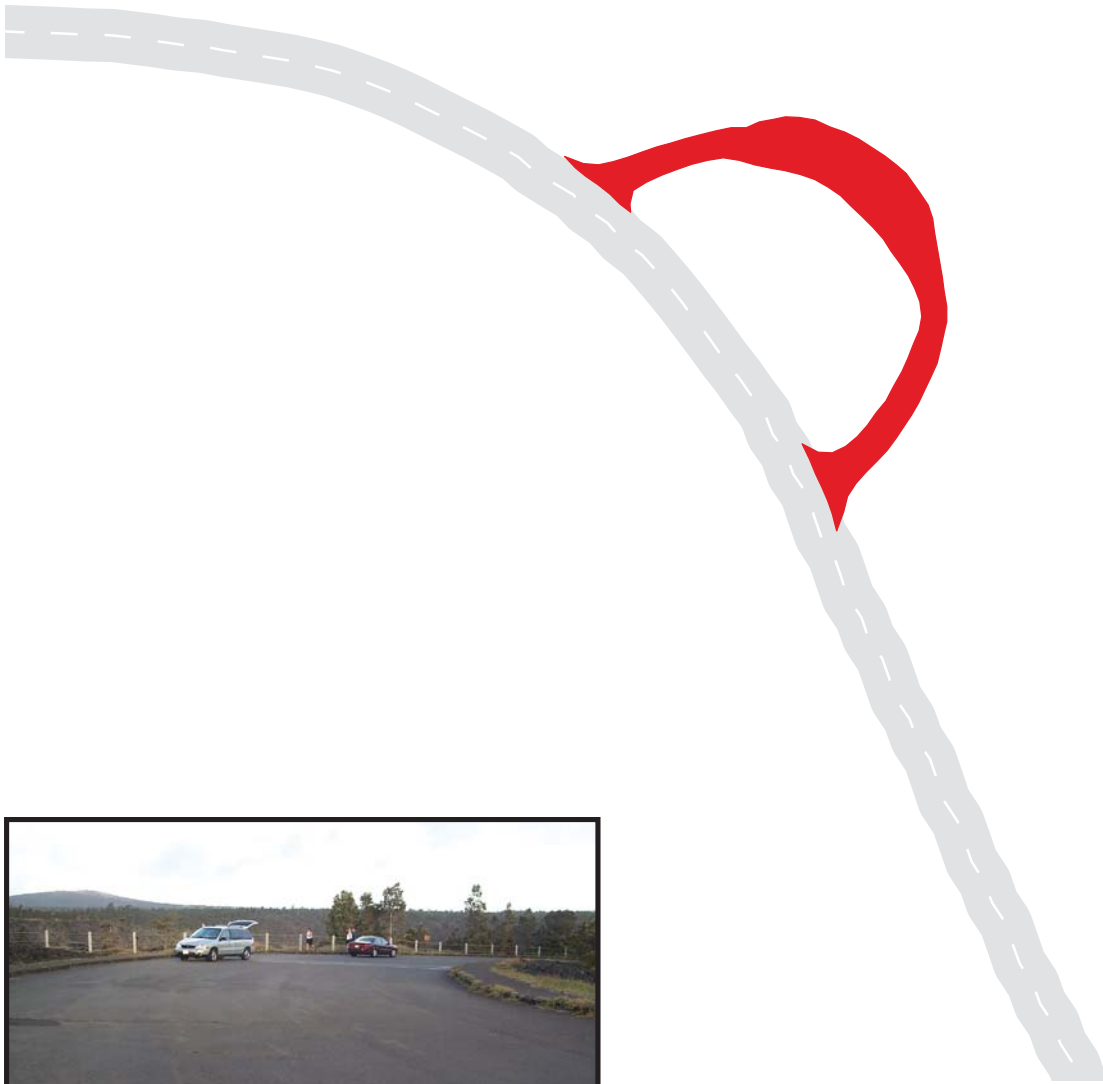
Route	Public / NonPublic	Date Visited	Area (sq ft)	Lane Miles *	Surface Type	Condition / PCR
0920	Public	5/8/2001	7342	0.13	AS	GOOD / 90

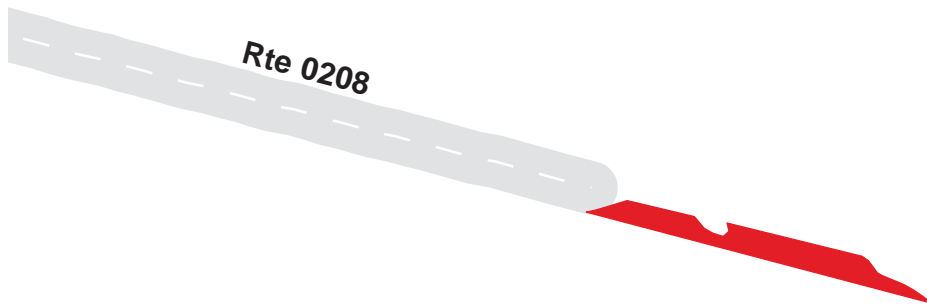
Route 0921

Route	Public / NonPublic	Date Visited	Area (sq ft)	Lane Miles *	Surface Type	Condition / PCR
0921	Public	5/8/2001	16993	0.29	AS	GOOD / 90

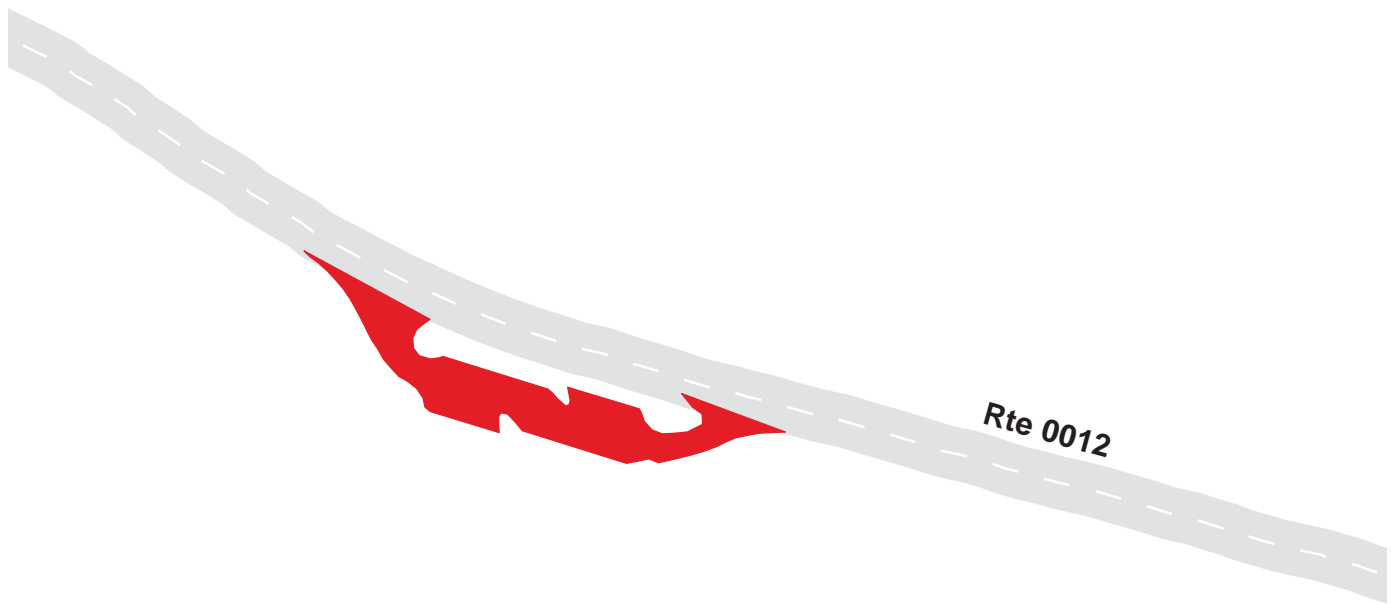
Route 0922

Route	Public / NonPublic	Date Visited	Area (sq ft)	Lane Miles *	Surface Type	Condition / PCR
0922	Public	5/9/2001	2992	0.05	AS	FAIR / 73
