The Road Inventory of Hawaii Volcanoes National Park HAVO – 8300

Road Inventory Program

Prepared By:
Federal Highway Administration
Eastern Federal Lands Highway Division
Cycle 3

Hawaii Volcanoes National Park in Hawaii

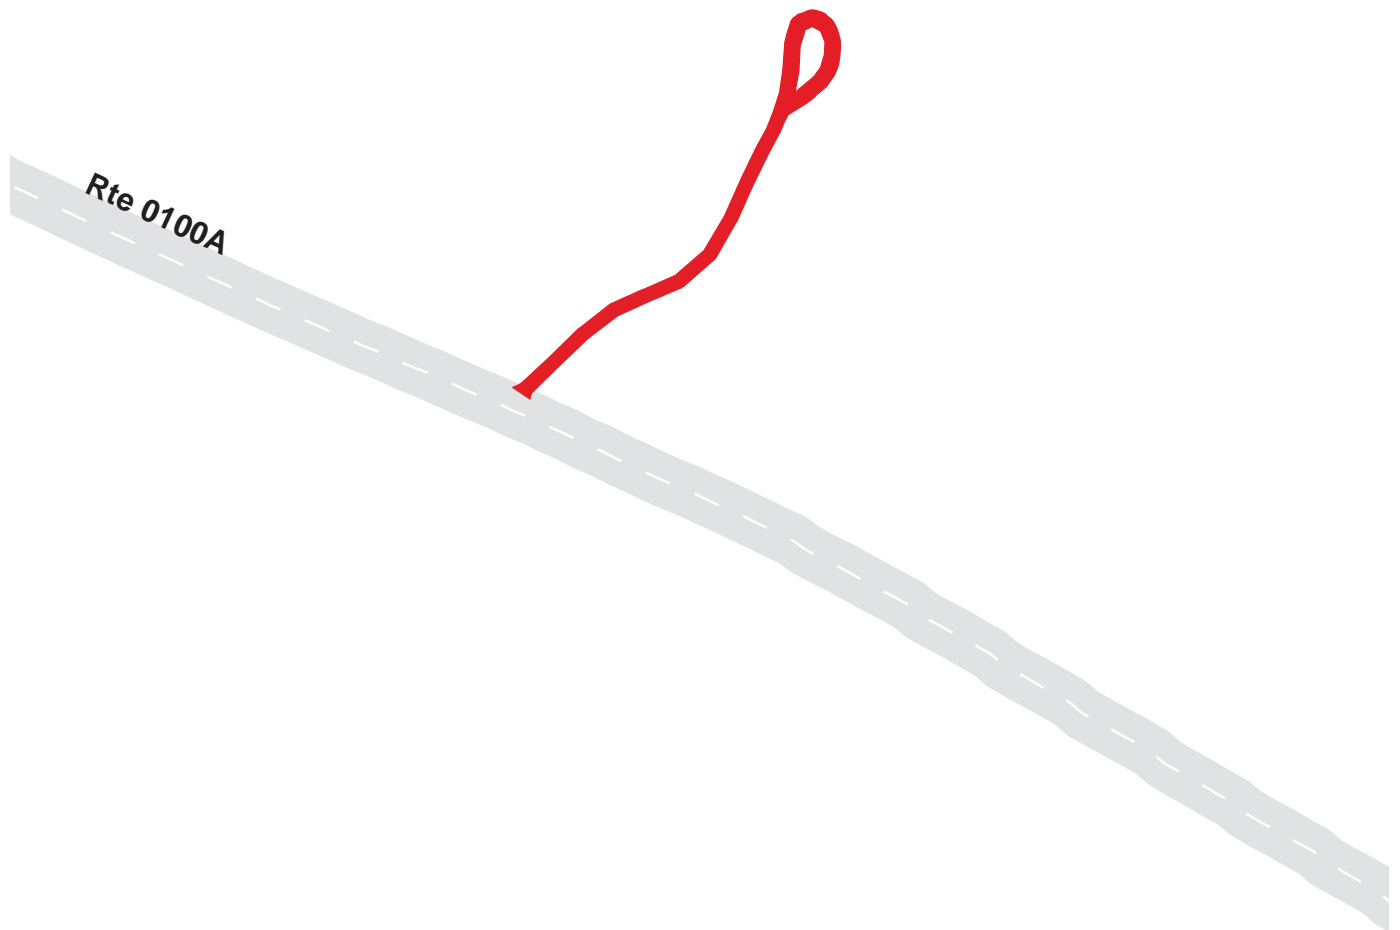
Route 0923

Route	Public / NonPublic	Date Visited	Area (sq ft)	Lane Miles *	Surface Type	Condition / PCR
0923	Public	5/9/2001	25350	0.44	AS	POOR / 45
