The Road Inventory of Lassen Volcanic National Park LAVO - 8400

Road Inventory Program

Prepared By:
Federal Highway Administration
Eastern Federal Lands Highway Division
Cycle 3

Lassen Volcanic National Park in California

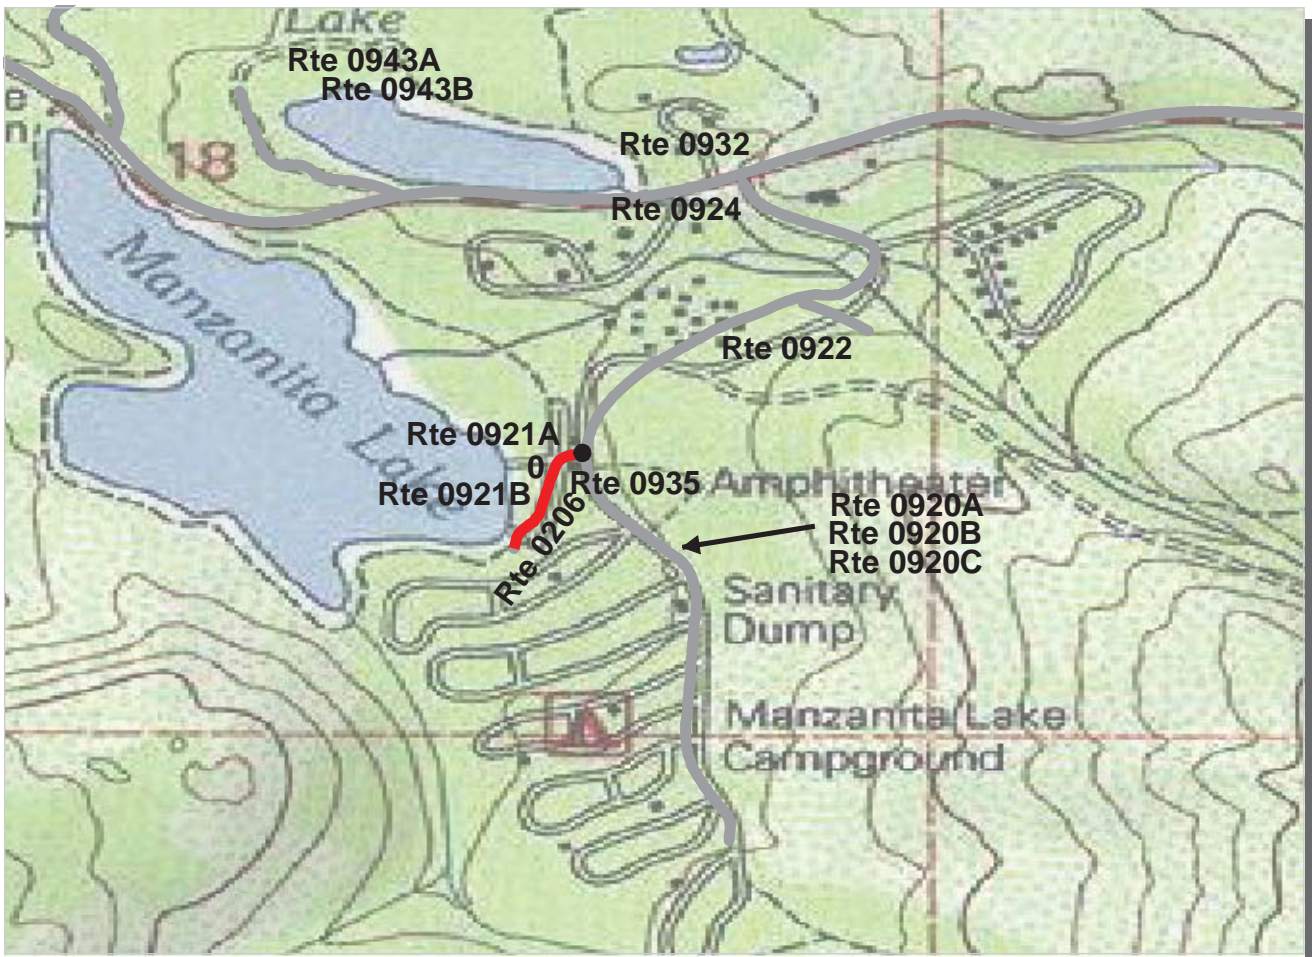
ROUTE: 0206 Manzanita Lake Access Road **TOTAL LENGTH: 0.14 Miles**

Section Number	0				
Section Length (mi)	0.14				
AADT	**				
SADT	**				
ADT Date	**				
Cross Section Information					
Number of Lanes	2				
Paved Width (ft)	20				
Lane Width (ft)	10				
Shoulder Width (ft)	0				
Roadway Condition Information					
PCR (Pavement Condition Rating)	38				
RCI (Roughness Condition Index)	NC				
SCR (Surface Condition Rating)	38				
Alligator Cracking Index	99				
Rutting Index	55				
Patching Index	100				
Transverse Cracking Index	90				
Longitudinal Cracking Index	93				
Shoulder Condition Rating	N/A				
Drainage Condition Rating	GOOD

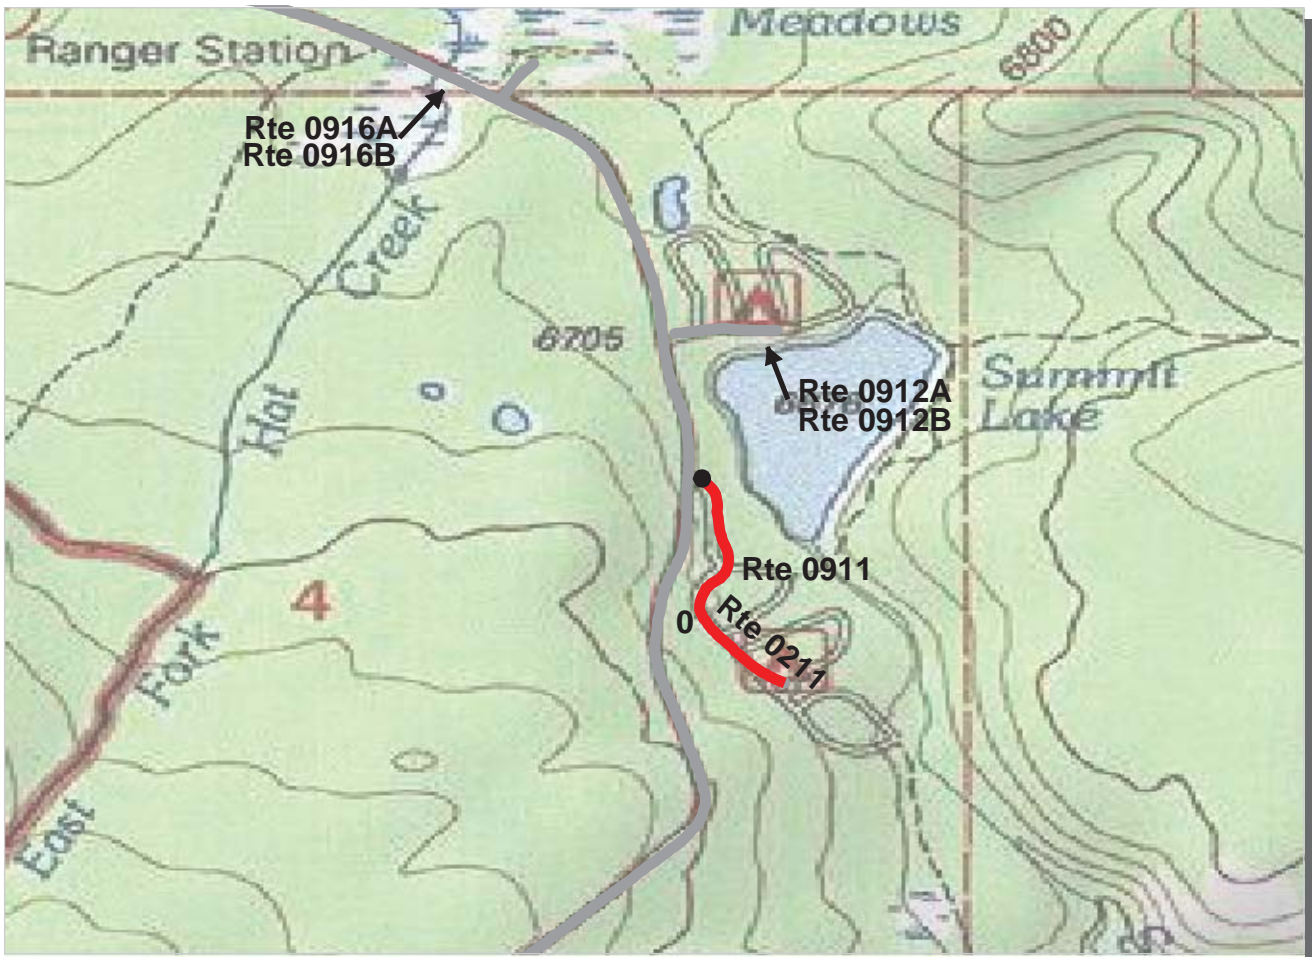
ROUTE: 0211 Summit Lake South Campground **TOTAL LENGTH: 0.25 Miles**

Section Number	0				
Section Length (mi)	0.25				
AADT	**				
SADT	**				
ADT Date	**				
Cross Section Information					
Number of Lanes	2				
Paved Width (ft)	16				
Lane Width (ft)	8				
Shoulder Width (ft)	0				
Roadway Condition Information					
PCR (Pavement Condition Rating)	7				
RCI (Roughness Condition Index)	NC				
SCR (Surface Condition Rating)	7				
Alligator Cracking Index	78				
Rutting Index	34				
Patching Index	96				
Transverse Cracking Index	90				
Longitudinal Cracking Index	94				
Shoulder Condition Rating	N/A				
Drainage Condition Rating	GOOD

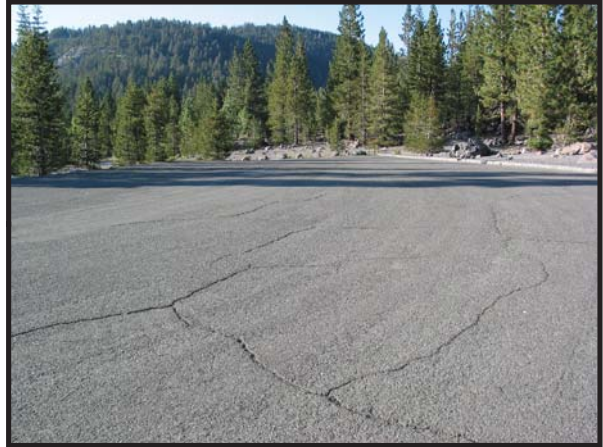
Route 0915

Route	Public / NonPublic	Date Visited	Area (sq ft)	Lane Miles *	Surface Type	Condition / PCR
0915	Public	8/28/2002	6373	0.11	AS	FAIR / 73

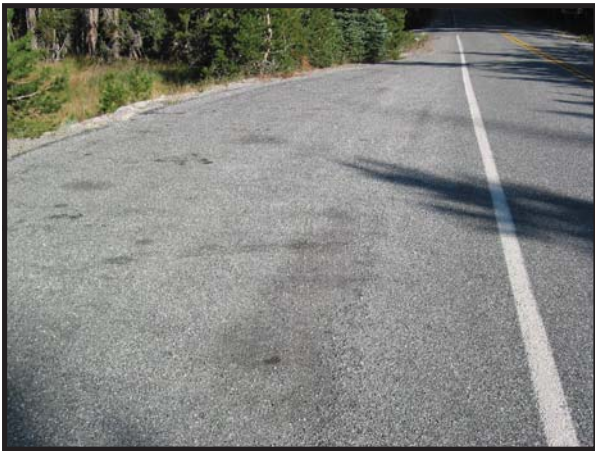
Route 0916B

Route	Public / NonPublic	Date Visited	Area (sq ft)	Lane Miles *	Surface Type	Condition / PCR
0916B	Public	8/28/2002	1253	0.02	AS	FAIR / 73

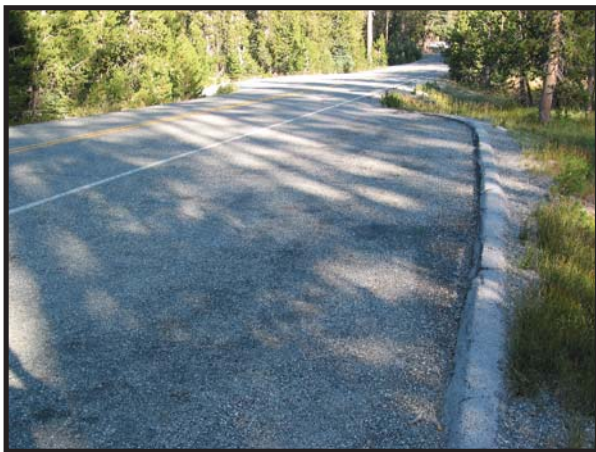
Route 0917

Route	Public / NonPublic	Date Visited	Area (sq ft)	Lane Miles *	Surface Type	Condition / PCR
0917	Public	8/28/2002	5564	0.10	AS	FAIR / 73

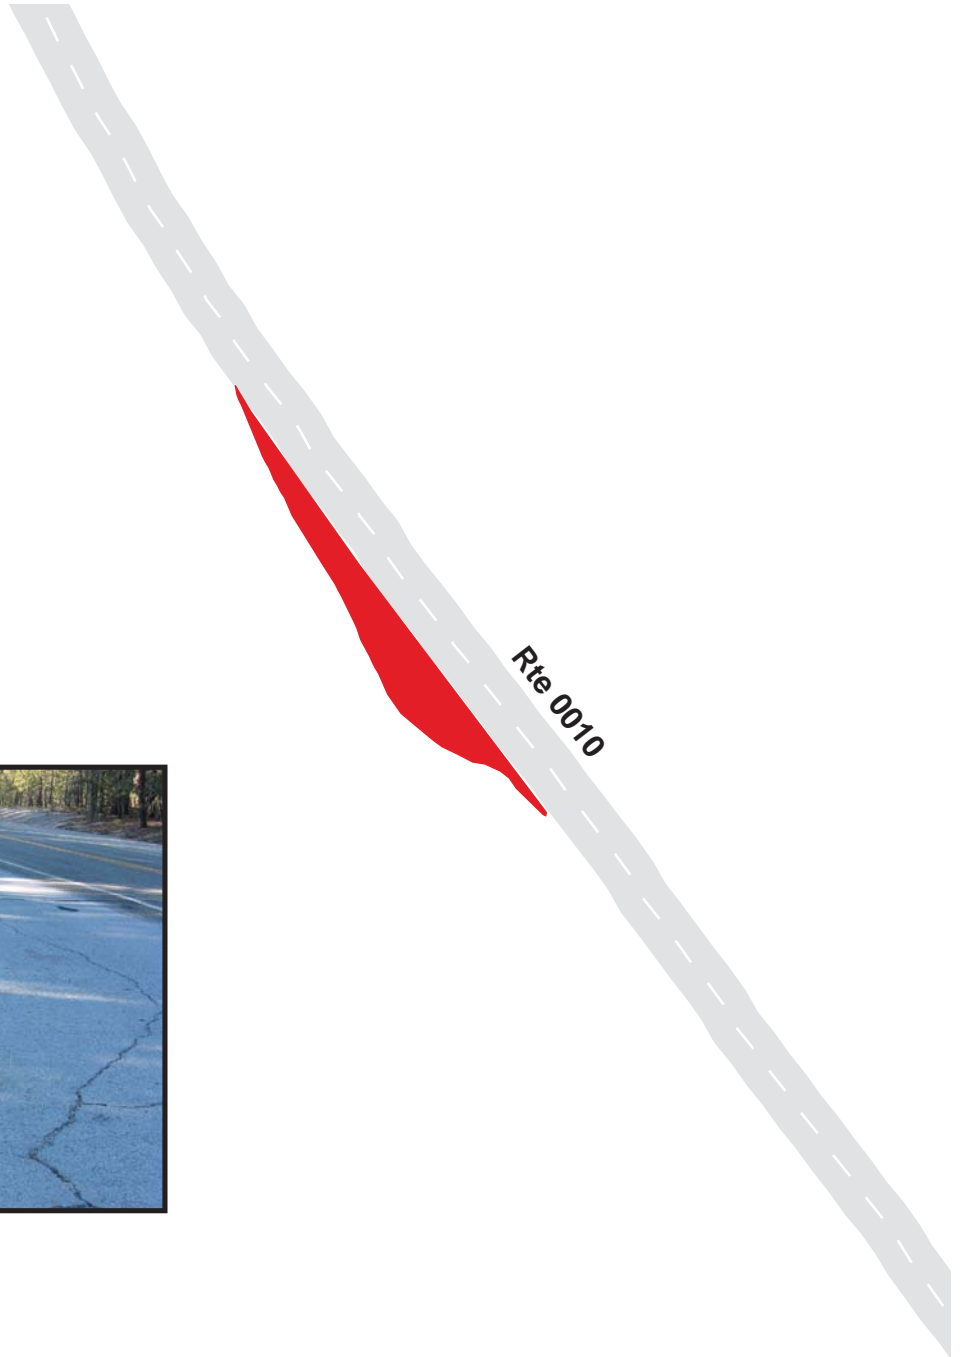
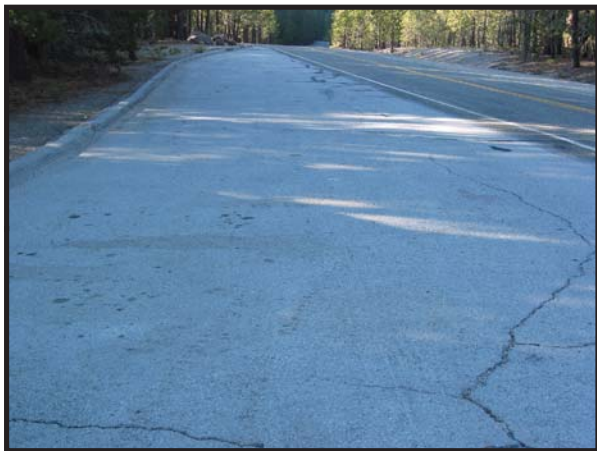
Route 0918

Route	Public / NonPublic	Date Visited	Area (sq ft)	Lane Miles *	Surface Type	Condition / PCR
0918	Public	8/28/2002	1696	0.03	AS	FAIR / 73

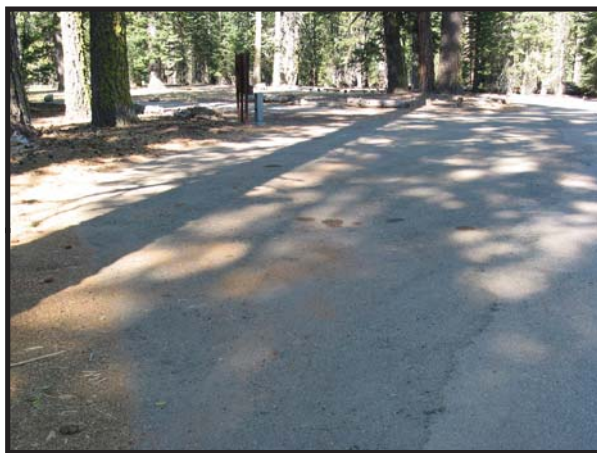
Route 0920A

Route	Public / NonPublic	Date Visited	Area (sq ft)	Lane Miles *	Surface Type	Condition / PCR
0920A	Public	8/28/2002	4913	0.08	AS	EXCELLENT / 97

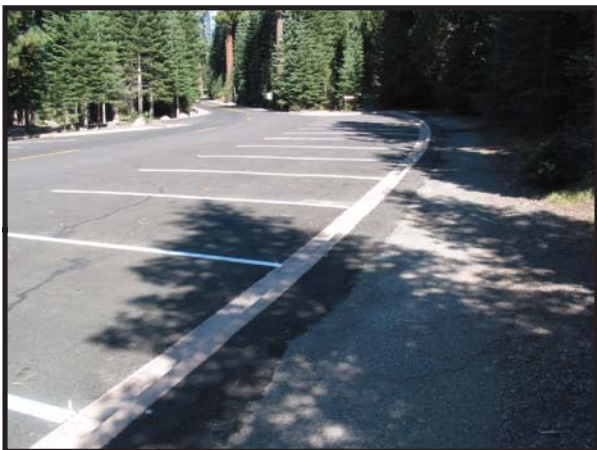
Route 0920B

Route	Public / NonPublic	Date Visited	Area (sq ft)	Lane Miles *	Surface Type	Condition / PCR
0920B	Public	8/28/2002	3733	0.06	AS	EXCELLENT / 97

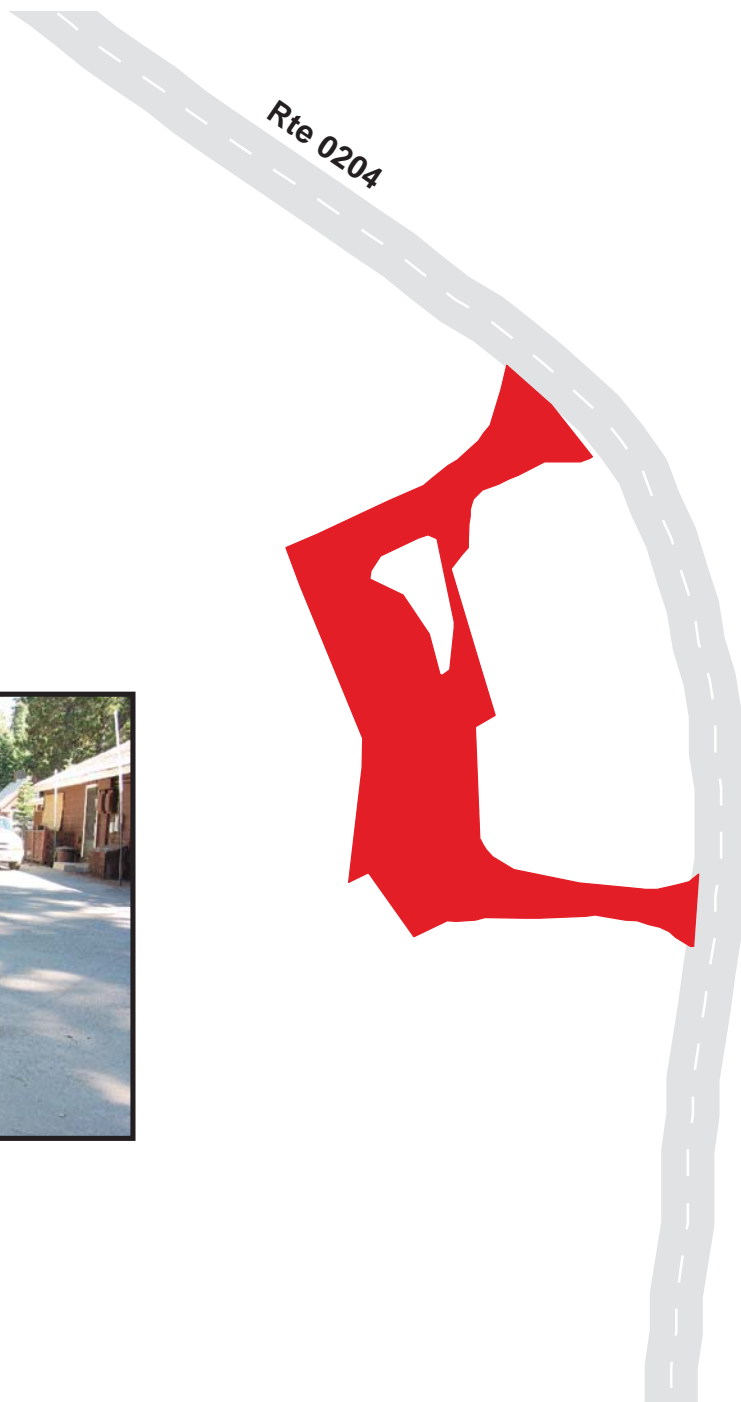
Route 0921A

Route	Public / NonPublic	Date Visited	Area (sq ft)	Lane Miles *	Surface Type	Condition / PCR
0921A	Public	8/28/2002	5701	0.10	AS	GOOD / 90

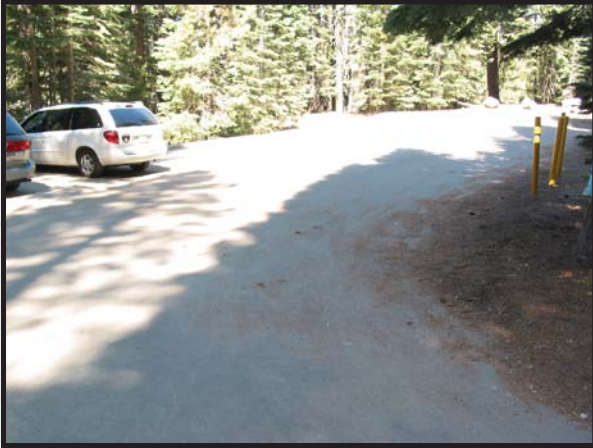
Route 0921B

Route	Public / NonPublic	Date Visited	Area (sq ft)	Lane Miles *	Surface Type	Condition / PCR
0921B	Public	8/28/2002	6757	0.12	AS	FAIR / 73

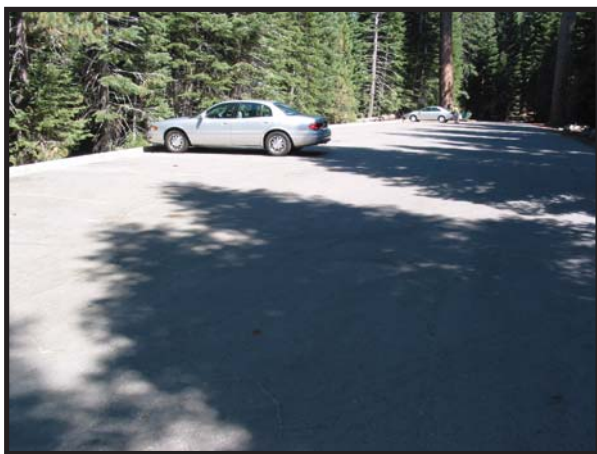
Route 0922

Route	Public / NonPublic	Date Visited	Area (sq ft)	Lane Miles *	Surface Type	Condition / PCR
0922	Public	8/28/2002	10863	0.19	AS	EXCELLENT / 97

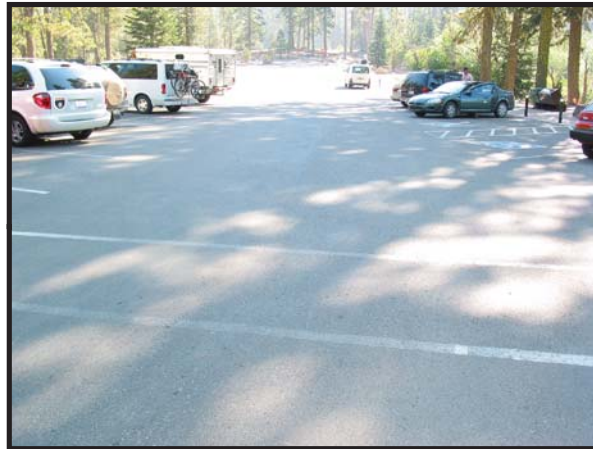
Route 0925

Route	Public / NonPublic	Date Visited	Area (sq ft)	Lane Miles *	Surface Type	Condition / PCR
0925	Public	8/28/2002	4032	0.07	AS	EXCELLENT / 97

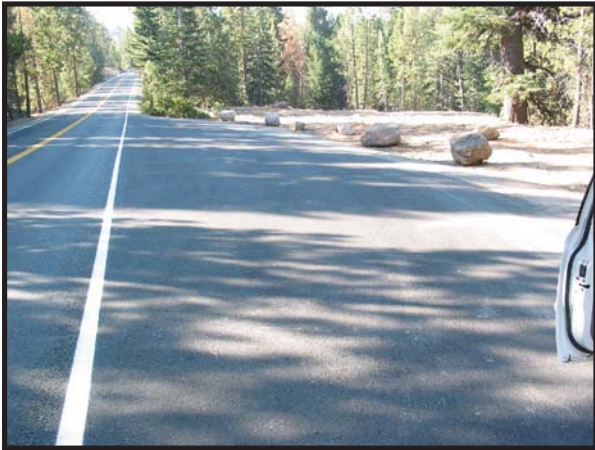
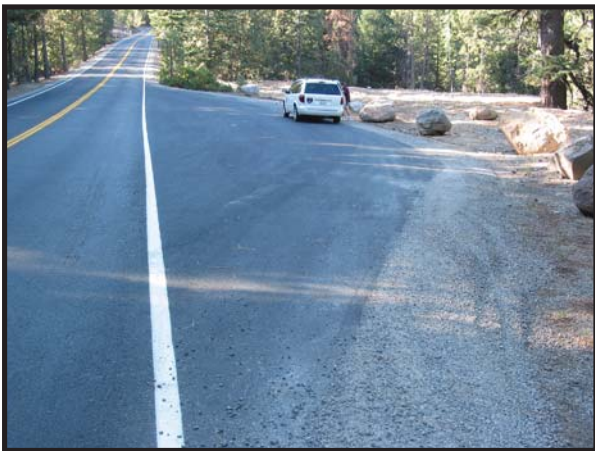
Route 0926

Route	Public / NonPublic	Date Visited	Area (sq ft)	Lane Miles *	Surface Type	Condition / PCR
0926	Public	8/28/2002	36679	0.63	AS	GOOD / 90

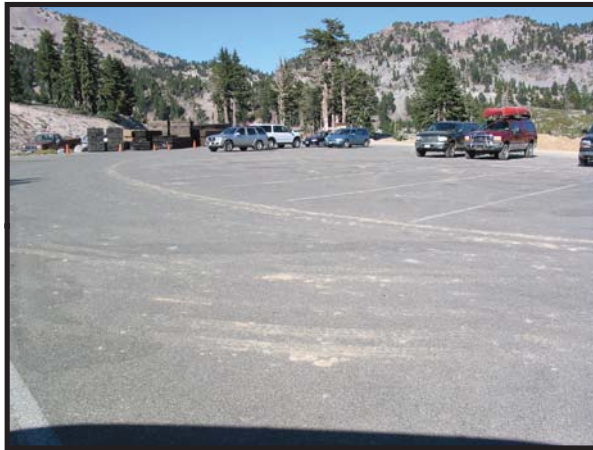
Route 0929A

Route	Public / NonPublic	Date Visited	Area (sq ft)	Lane Miles *	Surface Type	Condition / PCR
0929A	Public	8/28/2002	5029	0.09	AS	GOOD / 90

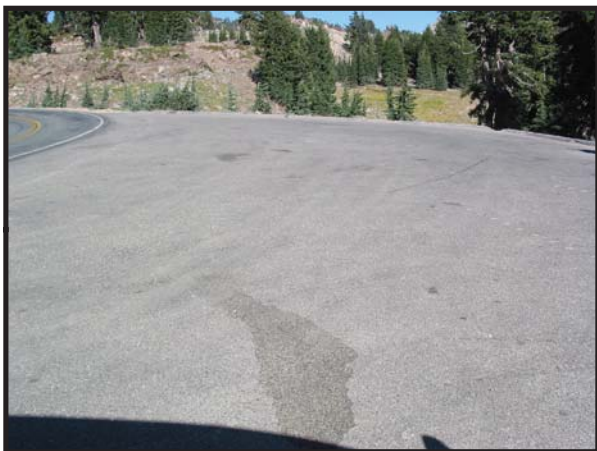
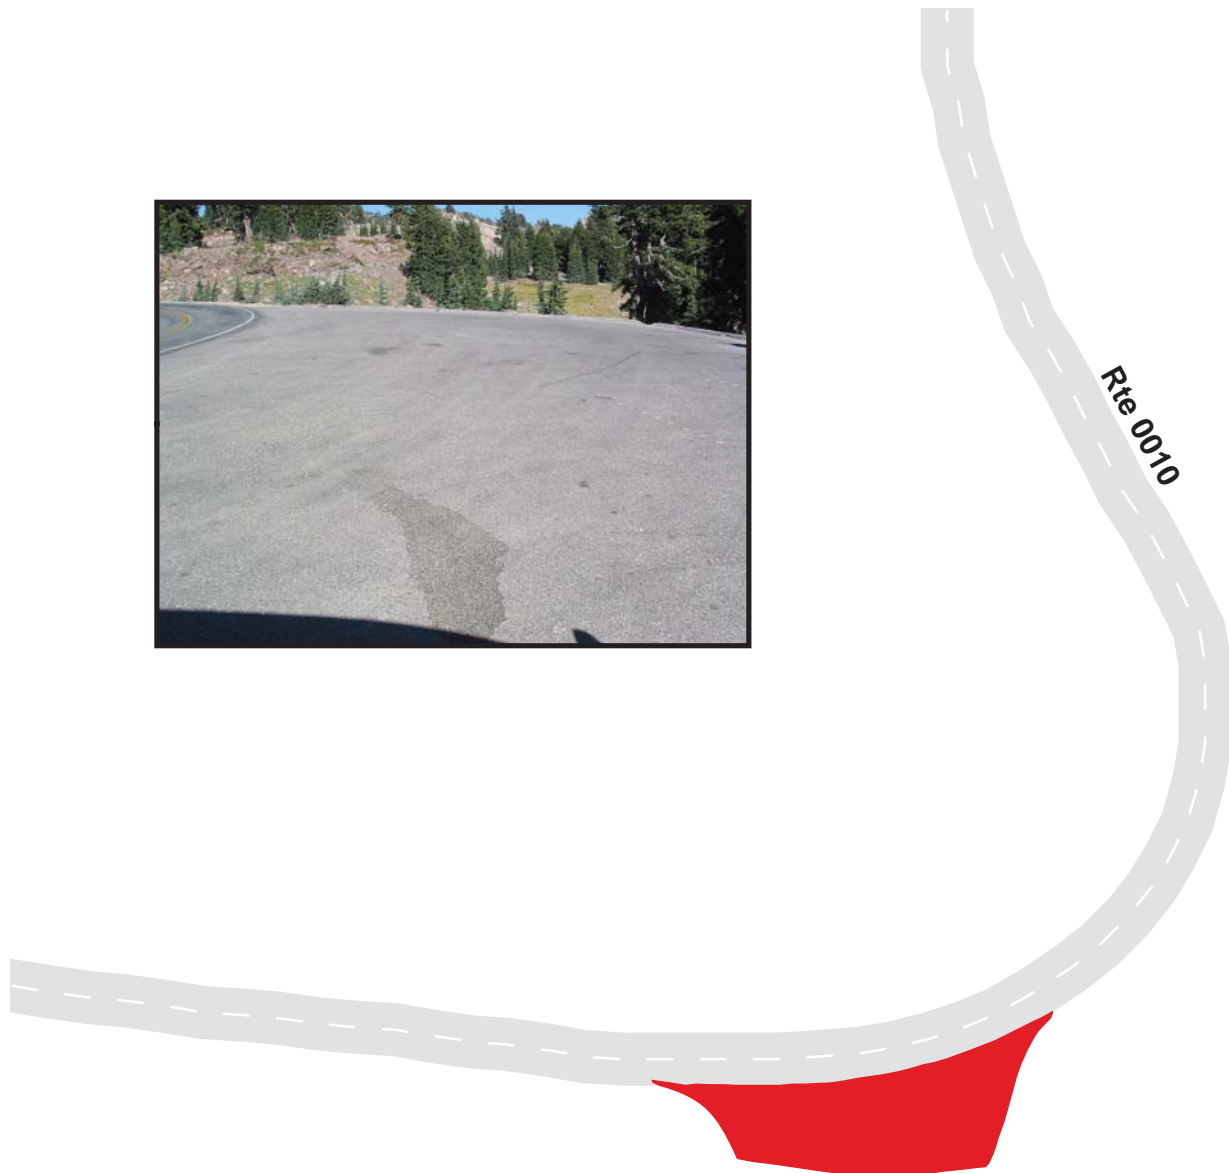
Route 0929B

Route	Public / NonPublic	Date Visited	Area (sq ft)	Lane Miles *	Surface Type	Condition / PCR
0929B	Public	8/28/2002	4766	0.08	AS	GOOD / 90

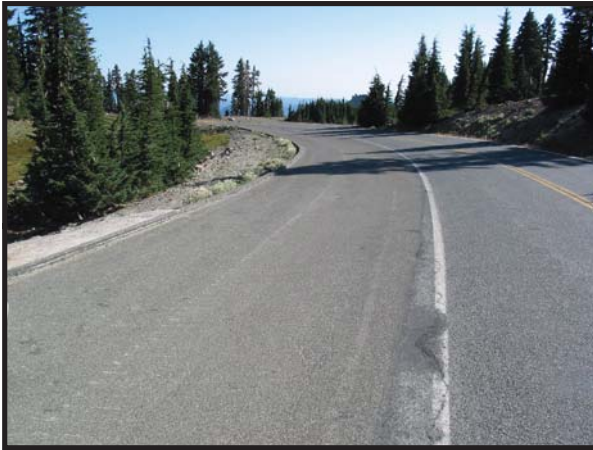
Route 0931

Route	Public / NonPublic	Date Visited	Area (sq ft)	Lane Miles *	Surface Type	Condition / PCR
0931	Public	8/28/2002	8569	0.15	AS	EXCELLENT / 97

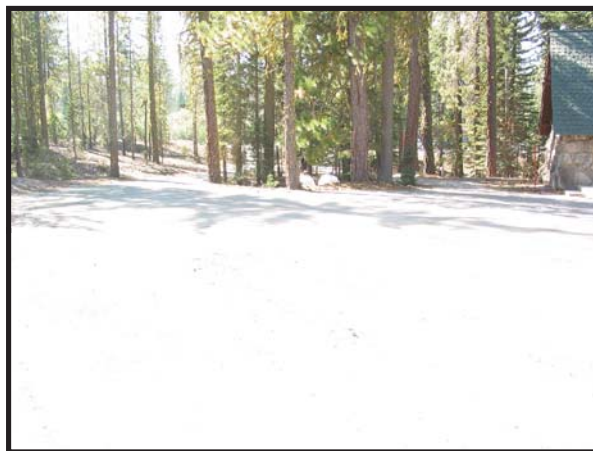
Route 0932

Route	Public / NonPublic	Date Visited	Area (sq ft)	Lane Miles *	Surface Type	Condition / PCR
0932	Public	8/28/2002	6467	0.11	OC	POOR / 45

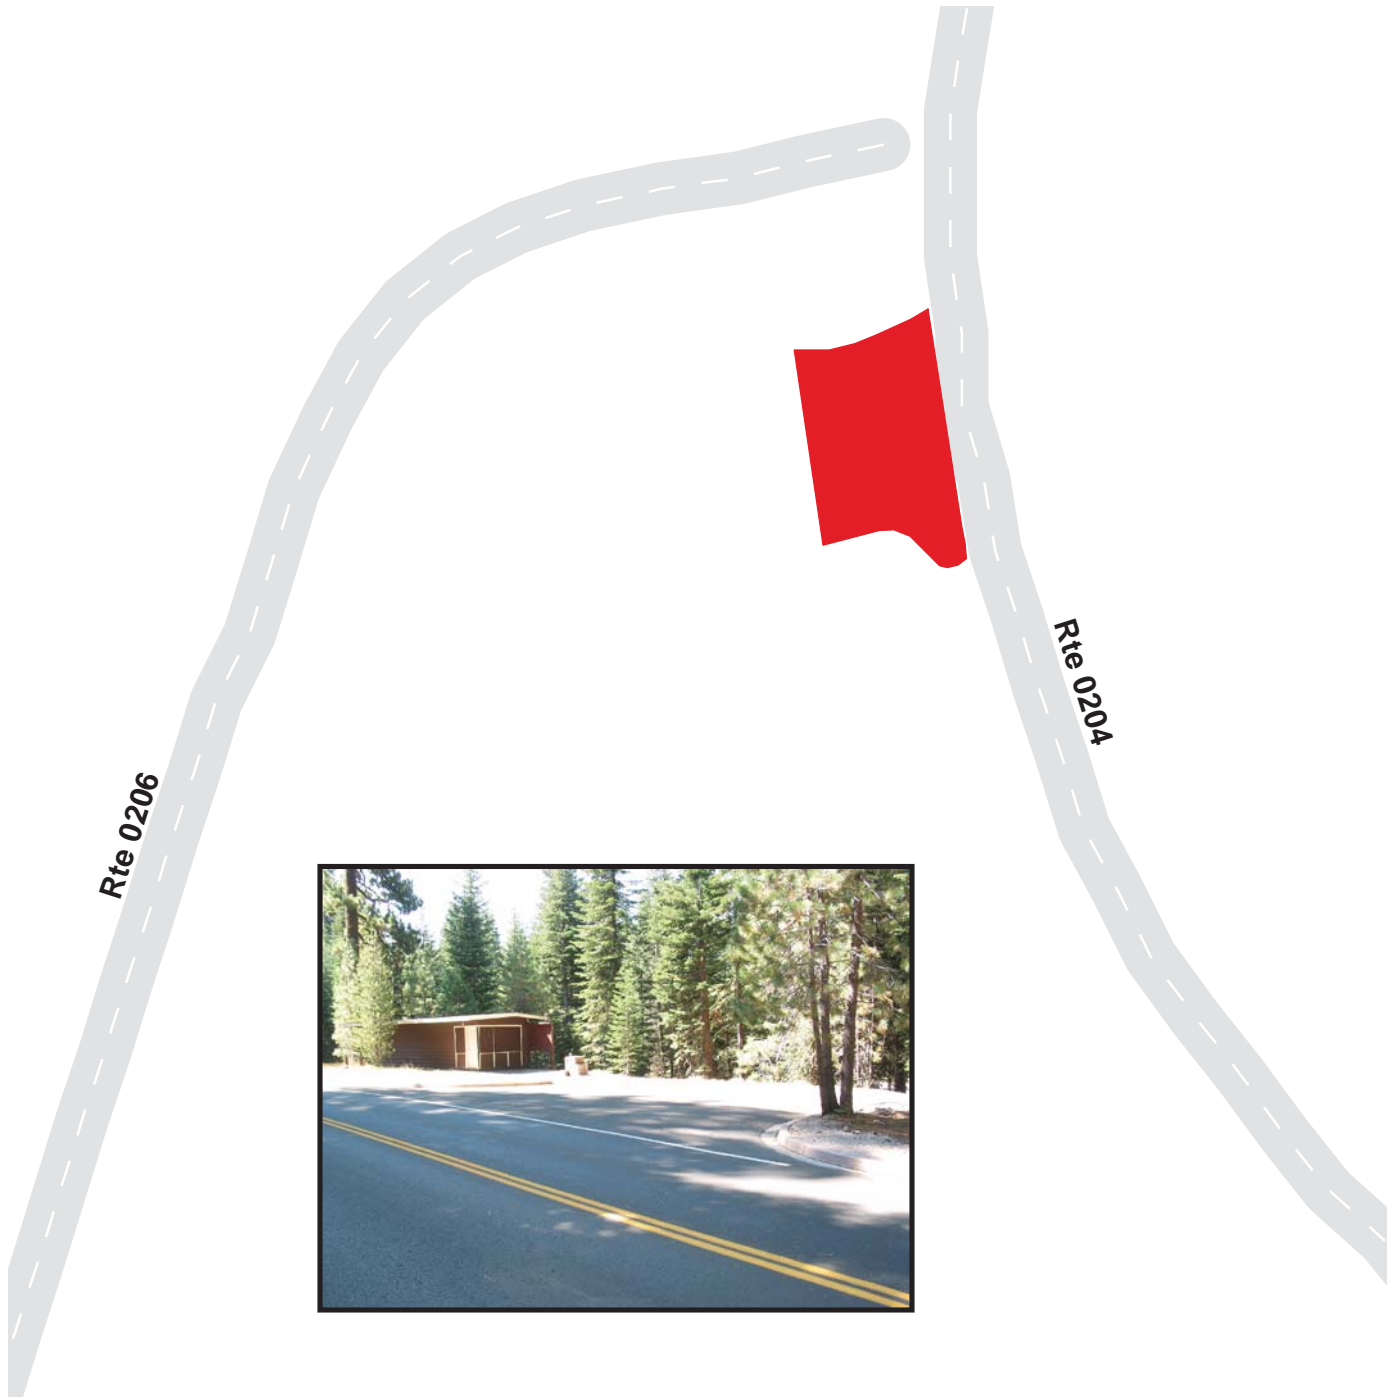
Route 0935

Route	Public / NonPublic	Date Visited	Area (sq ft)	Lane Miles *	Surface Type	Condition / PCR
0935	Public	8/28/2002	1390	0.02	AS	EXCELLENT / 97

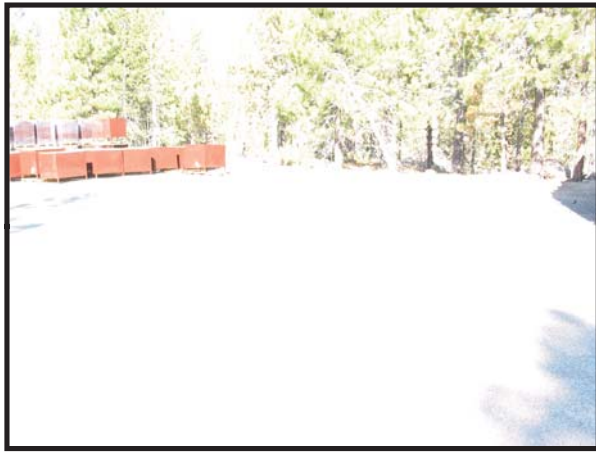
Route 0941

Route	Public / NonPublic	Date Visited	Area (sq ft)	Lane Miles *	Surface Type	Condition / PCR
0941	NonPublic	8/28/2002	3121	0.05	OC	POOR / 45

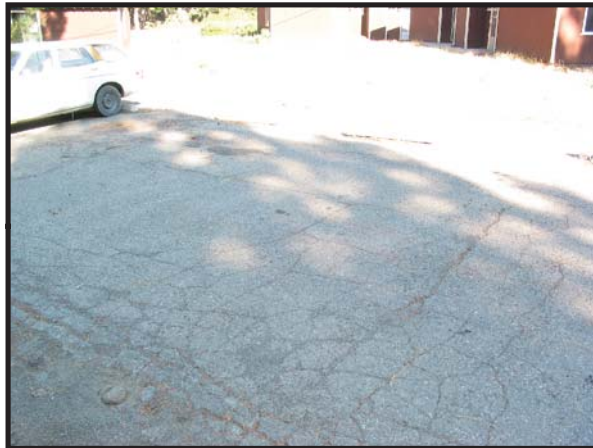
Lassen Volcanic National Park
Route 0942A
Manzanita Residence Parking A
Adjacent to Route 0404 at MP 0.08 on right

Route	Public / NonPublic	Date Visited	Area (sq ft)	Lane Miles *	Surface Type	Condition / PCR
0942A	Public	8/28/2002	2056	0.04	AS	POOR / 45

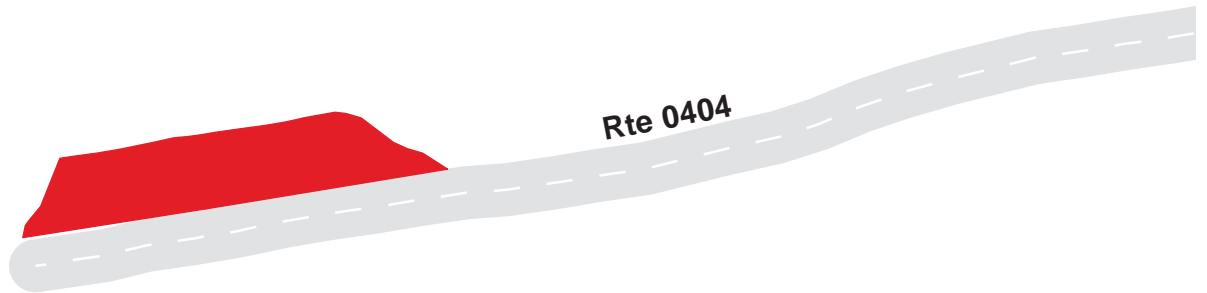
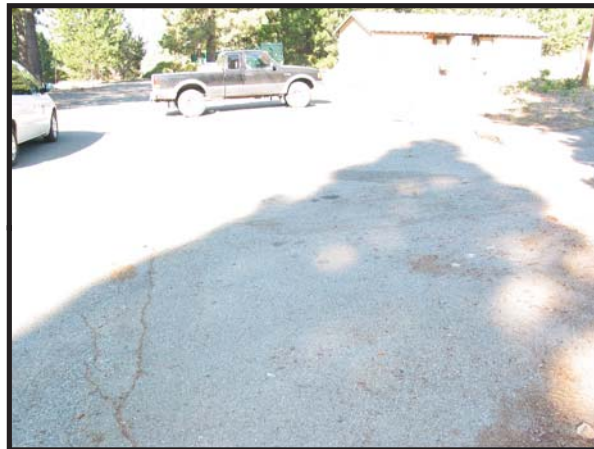
Lassen Volcanic National Park
Route 0942B
Manzanita Residence Parking B
Adjacent to Route 0404 at MP 0.16 on right

Route	Public / NonPublic	Date Visited	Area (sq ft)	Lane Miles *	Surface Type	Condition / PCR
0942B	Public	8/28/2002	3213	0.06	AS	FAIR / 73

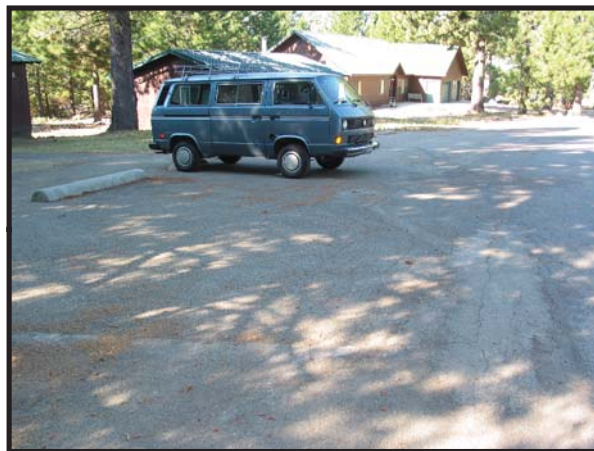
Route 0942C

Route	Public / NonPublic	Date Visited	Area (sq ft)	Lane Miles *	Surface Type	Condition / PCR
0942C	Public	8/28/2002	4894	0.08	AS	POOR / 45

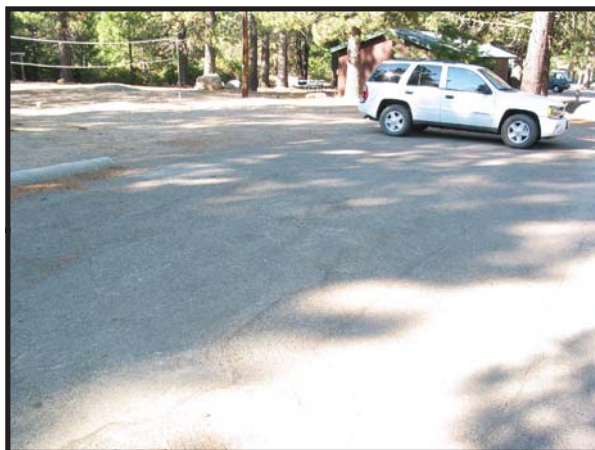
Route 0942D

Route	Public / NonPublic	Date Visited	Area (sq ft)	Lane Miles *	Surface Type	Condition / PCR
0942D	Public	8/28/2002	2194	0.04	AS	FAIR / 73

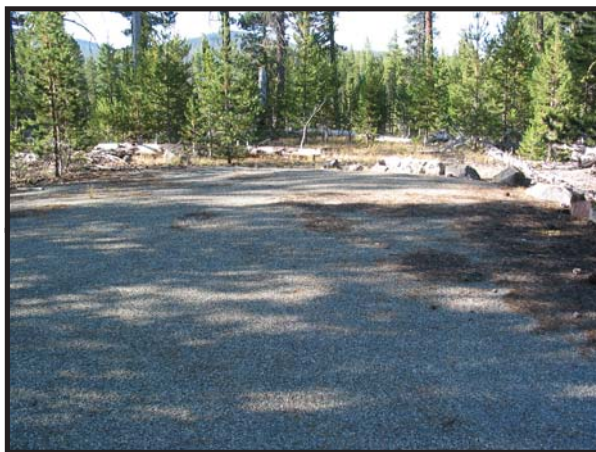
Route 0943A

Route	Public / NonPublic	Date Visited	Area (sq ft)	Lane Miles *	Surface Type	Condition / PCR
0943A	NonPublic	8/28/2002	1182	0.02	OC	POOR / 45

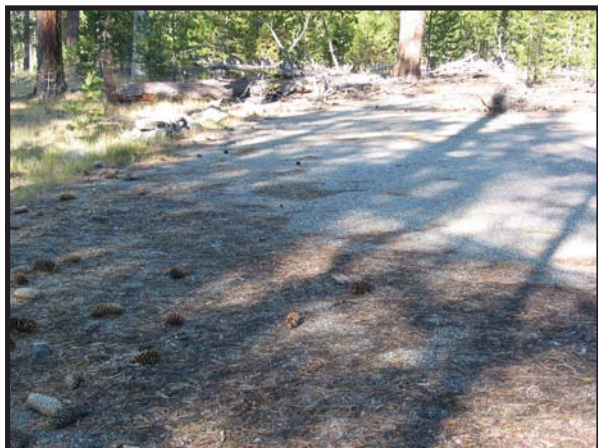
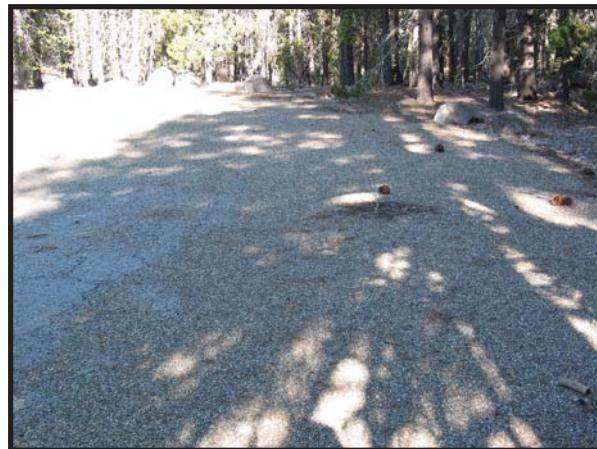
Route 0943B

Route	Public / NonPublic	Date Visited	Area (sq ft)	Lane Miles *	Surface Type	Condition / PCR
0943B	NonPublic	8/28/2002	5249	0.09	OC	POOR / 45

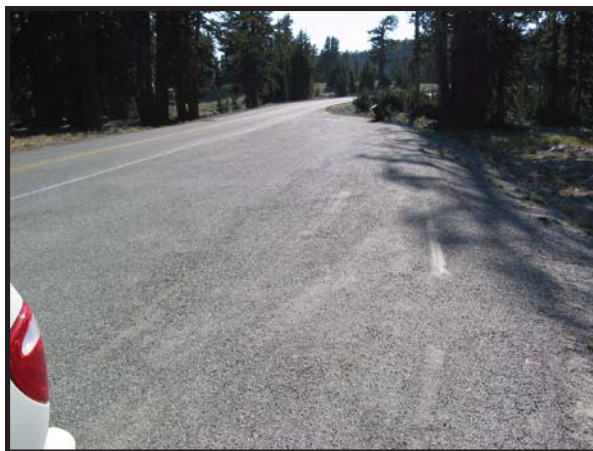
Route 0945

Route	Public / NonPublic	Date Visited	Area (sq ft)	Lane Miles *	Surface Type	Condition / PCR
0945	Public	8/28/2002	5270	0.09	AS	GOOD / 90
