Federal Lands Highway Road Inventory Program

Road Inventory and Condition Assessment

Assateague Island National Seashore ASIS

Cycle 5 Report

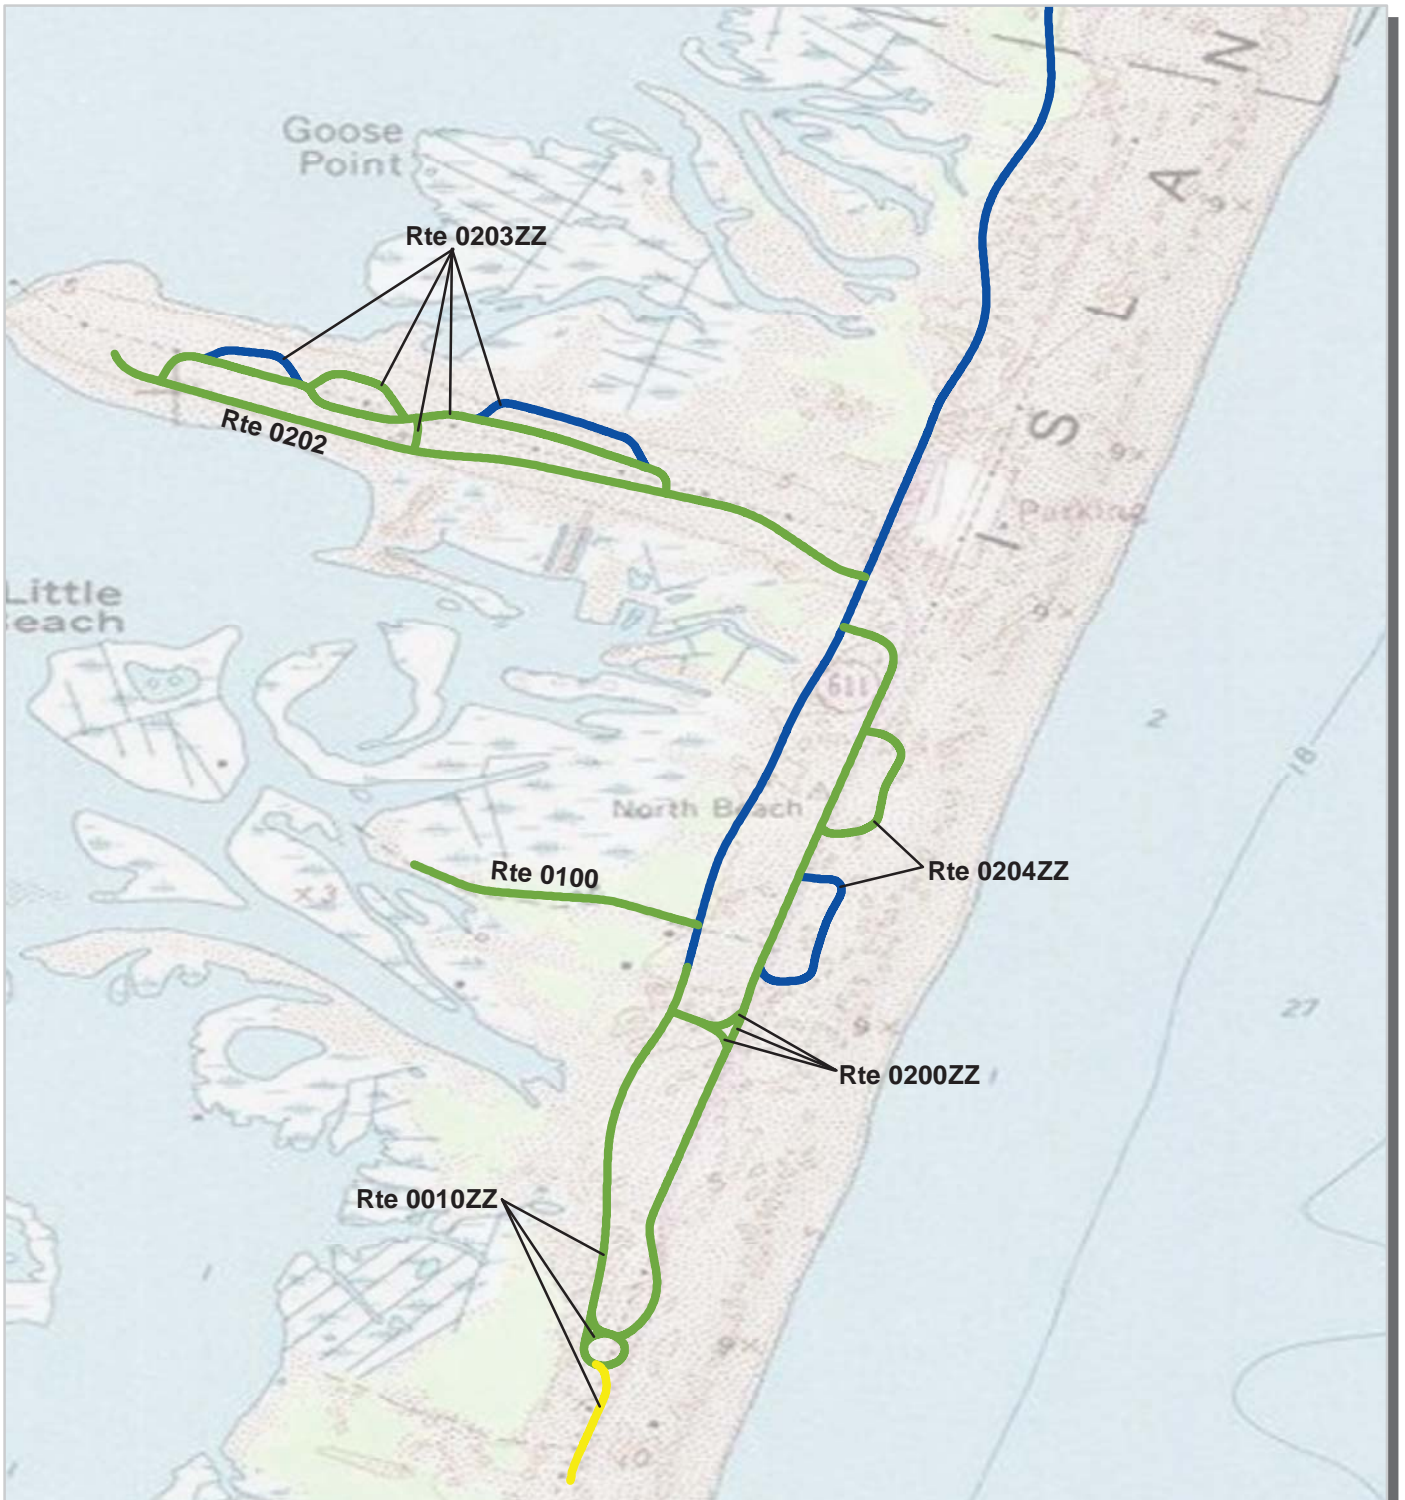
Assateague Island National Seashore Route Condition Map PCR - Mile by Mile Area 2

PCR	Poor	█	Fair	█	Good	█	Excellent	█	No Data	█
	(0 - 60)		(61 - 84)	(85 - 94)	(95 - 100)

* If the PCR rating is not available for a section, the SCR rating will be displayed. See appendix for definitions and formulas.

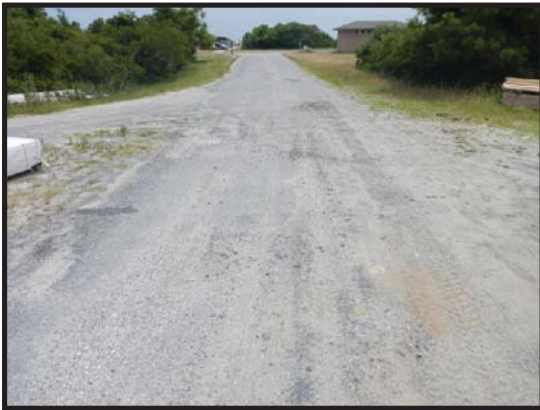
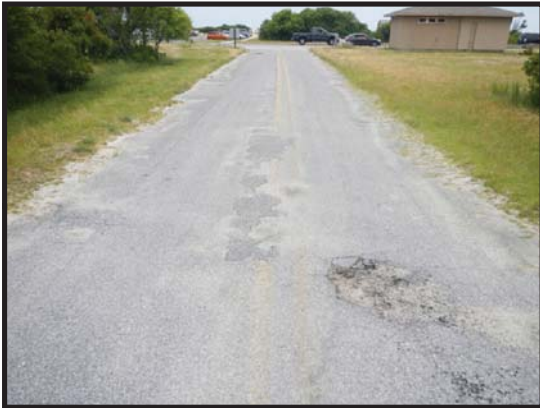
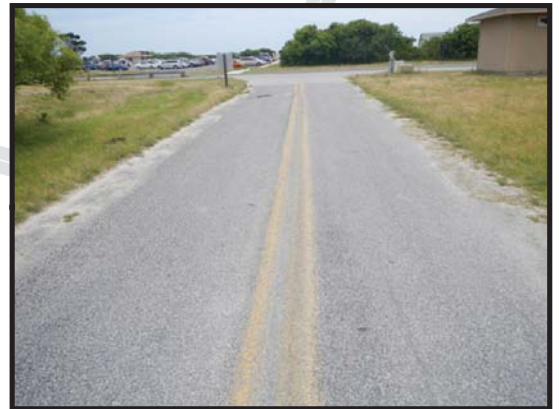
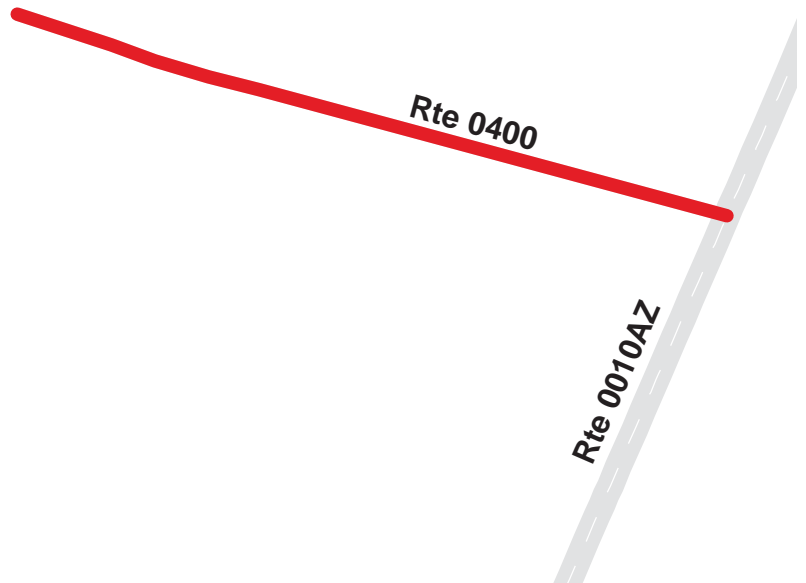
Route Number	Public / NonPublic	Date Visited	Area (sq ft)	Lane Miles *	Paved Length (mi)	Paved Width (ft)
0400	NONPUBLIC	7/1/2013	4,251	0.07	0.04	18.3
Culverts	Drop Inlets	Gates	Curb & Gutter	Curb	PCR	Surface Type
0	1	0	NO CURB AND GUTTER	NO CURB	POOR/45	AS

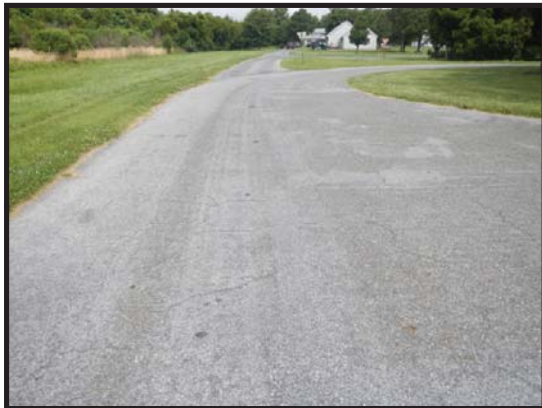
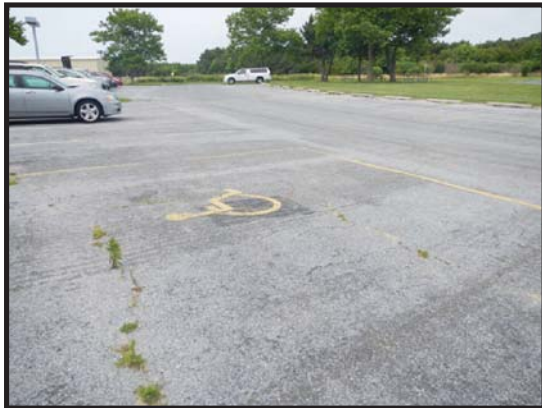
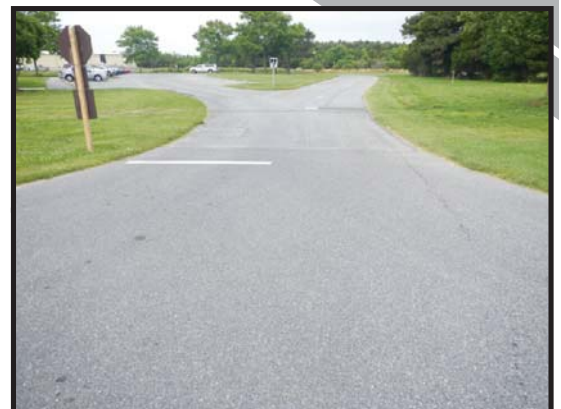
Route Number	Public / NonPublic	Date Visited	Area (sq ft)	Lane Miles *	Surface Type
0900	PUBLIC	7/1/2013	22,363	0.39	AS
Culverts	Drop Inlets	Gates	Curb & Gutter	Curb	PCR
0	1	0	NO CURB AND GUTTER	NO CURB	POOR/45

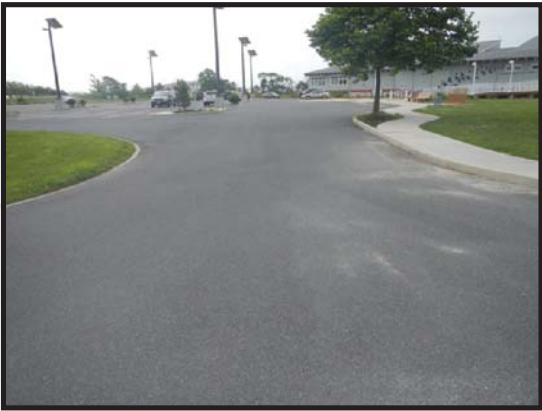
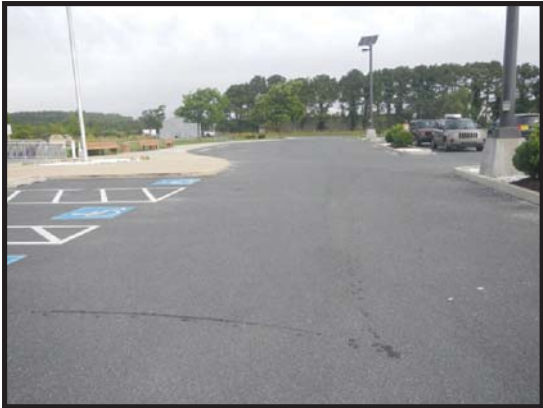
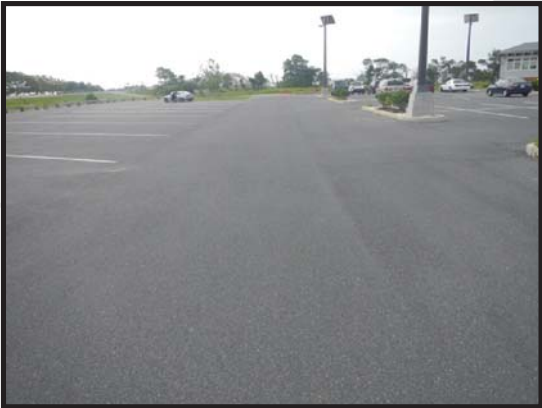
Route 0903

Route Number	Public / NonPublic	Date Visited	Area (sq ft)	Lane Miles *	Surface Type
0903	PUBLIC	7/1/2013	57,268	0.99	AS
Culverts	Drop Inlets	Gates	Curb & Gutter	Curb	PCR
0	0	0	NO CURB AND GUTTER	CONCRETE CURB	GOOD/90

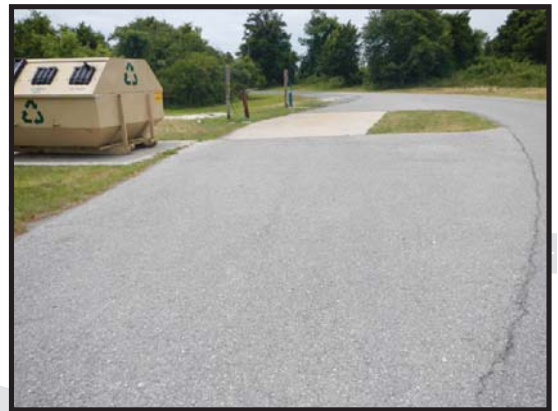
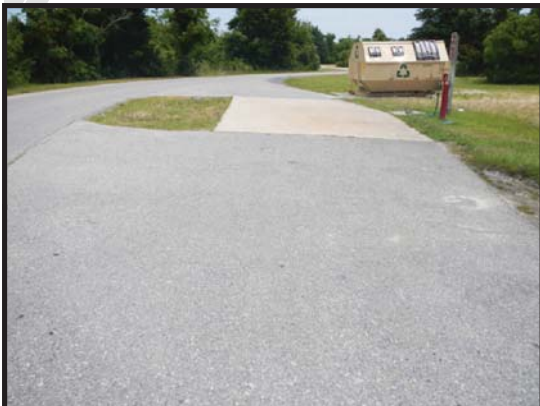
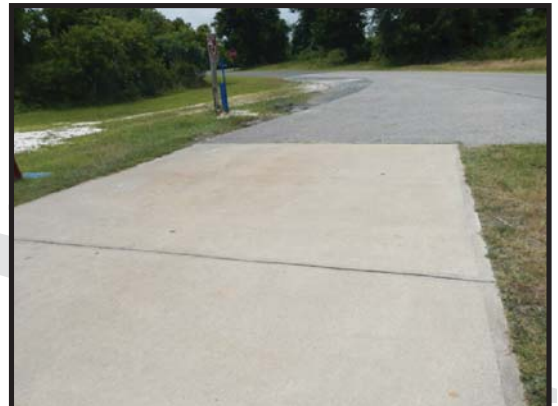
Route 0904

Route Number	Public / NonPublic	Date Visited	Area (sq ft)	Lane Miles *	Surface Type
0904	PUBLIC	7/1/2013	1,330	0.02	AS
Culverts	Drop Inlets	Gates	Curb & Gutter	Curb	PCR
0	0	0	NO CURB AND GUTTER	NO CURB	GOOD/90

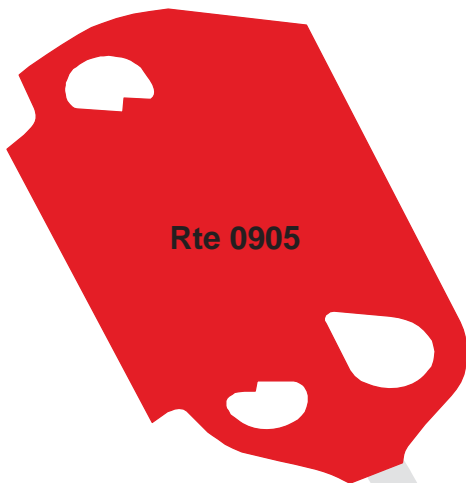
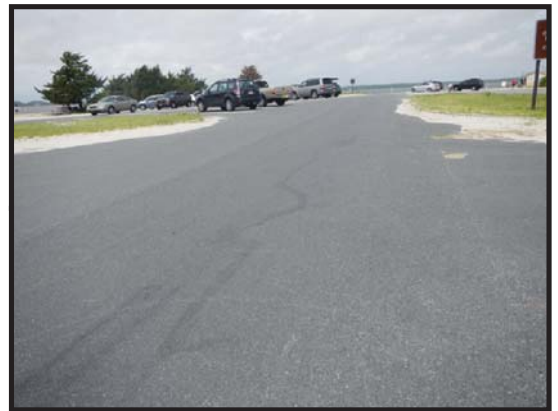
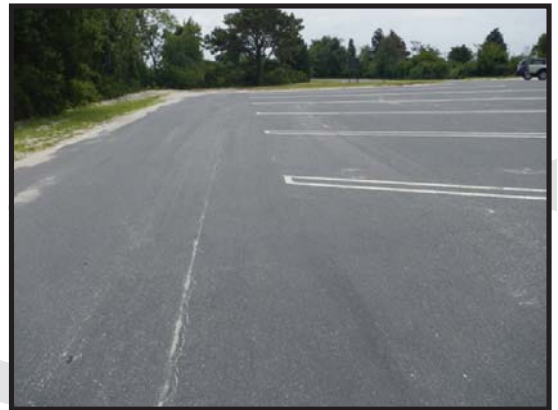
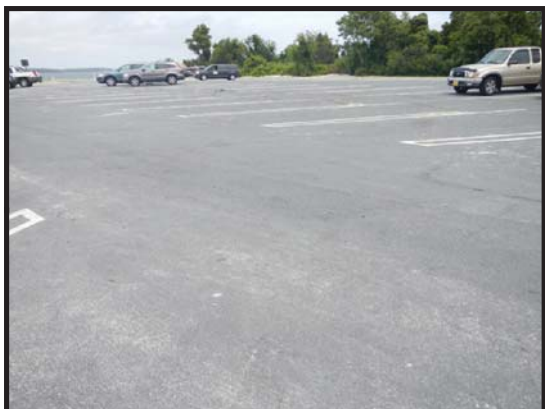
Route 0905

Route Number	Public / NonPublic	Date Visited	Area (sq ft)	Lane Miles *	Surface Type
0905	PUBLIC	7/1/2013	43,219	0.74	AS
Culverts	Drop Inlets	Gates	Curb & Gutter	Curb	PCR
0	0	0	NO CURB AND GUTTER	CONCRETE CURB	POOR/45

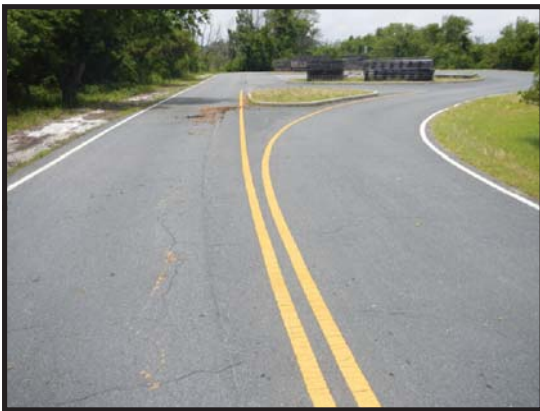
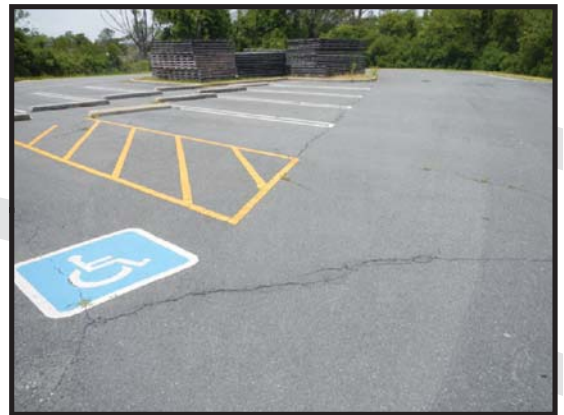
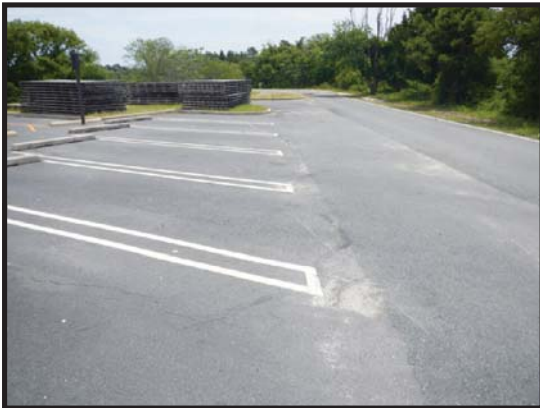
Route 0909

Route Number	Public / NonPublic	Date Visited	Area (sq ft)	Lane Miles *	Surface Type
0909	PUBLIC	7/1/2013	18,632	0.32	AS
Culverts	Drop Inlets	Gates	Curb & Gutter	Curb	PCR
0	0	0	NO CURB AND GUTTER	CONCRETE CURB	POOR/45

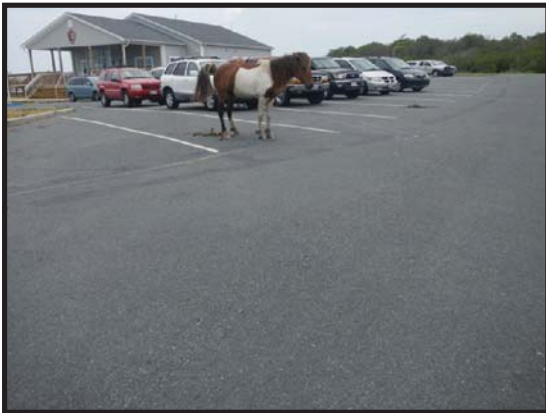
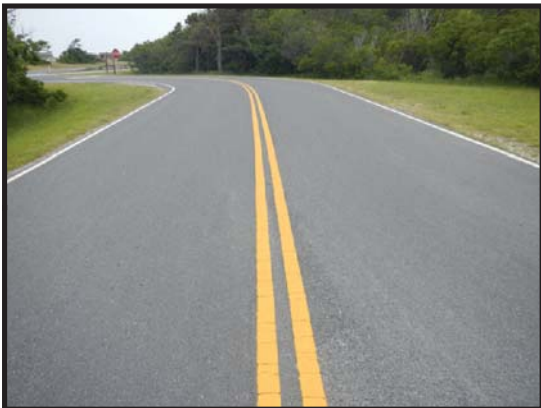
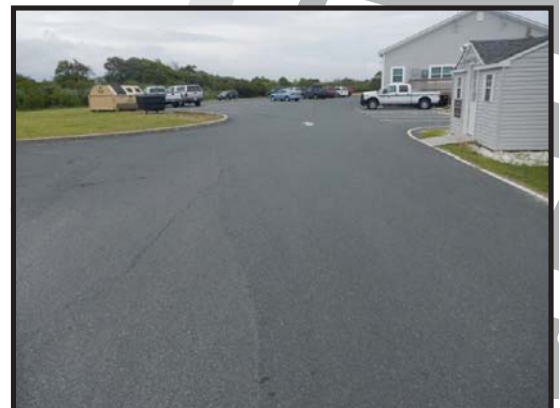
Route 0910

Route Number	Public / NonPublic	Date Visited	Area (sq ft)	Lane Miles *	Surface Type
0910	PUBLIC	7/1/2013	42,579	0.73	AS
Culverts	Drop Inlets	Gates	Curb & Gutter	Curb	PCR
0	0	0	NO CURB AND GUTTER	CONCRETE CURB	POOR/45

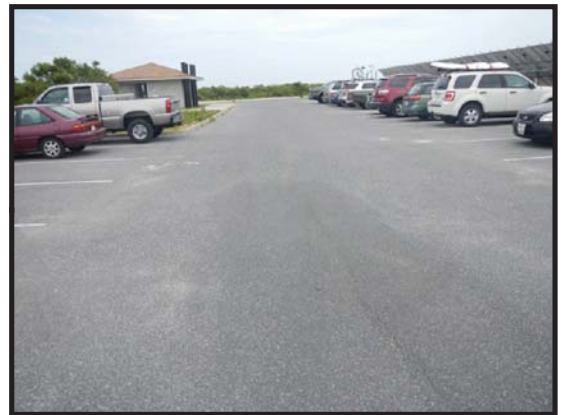
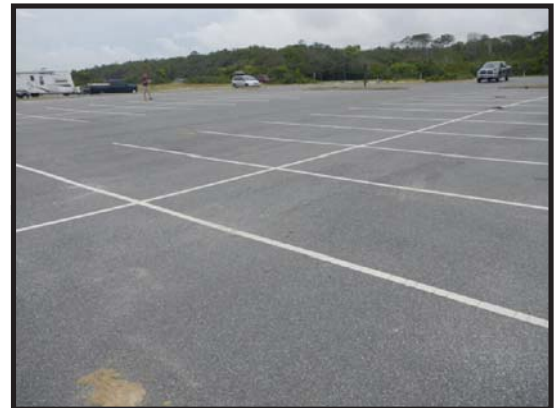
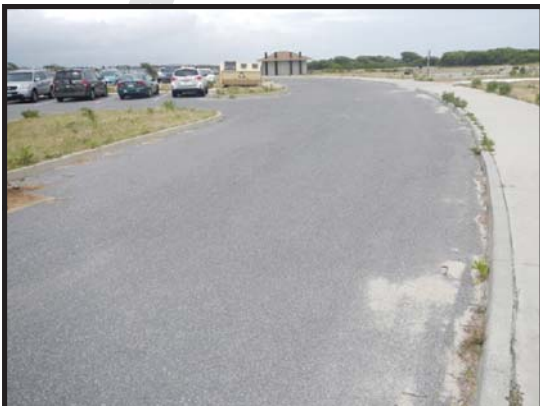
Route 0911

Route Number	Public / NonPublic	Date Visited	Area (sq ft)	Lane Miles *	Surface Type
0911	PUBLIC	7/1/2013	244,653	4.21	AS
Culverts	Drop Inlets	Gates	Curb & Gutter	Curb	PCR
0	20	0	NO CURB AND GUTTER	CONCRETE CURB	GOOD/90

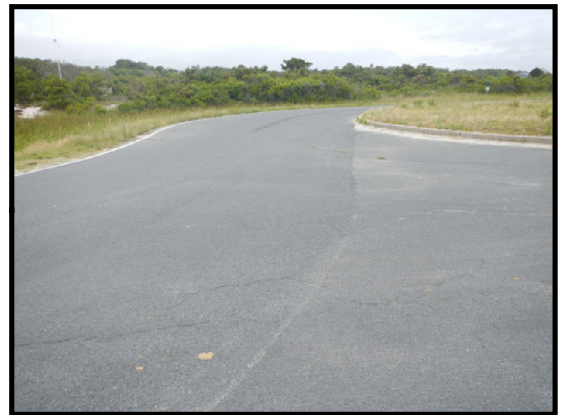
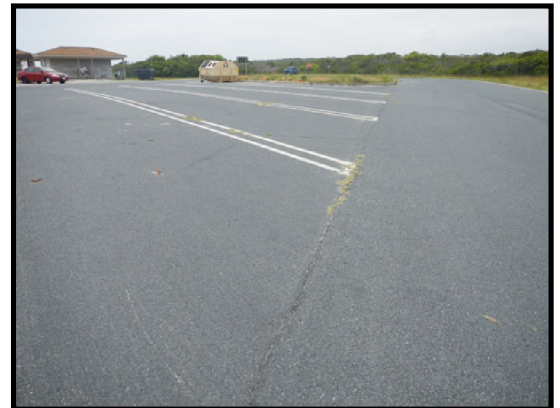
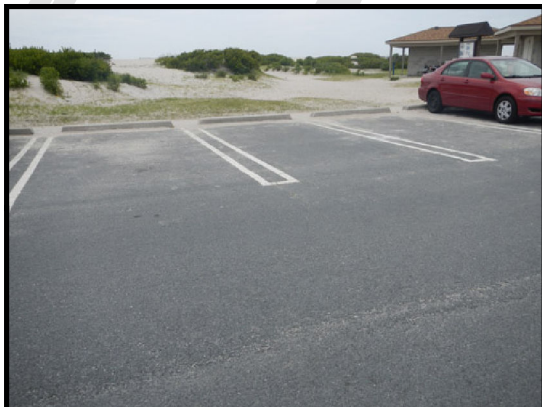
Route 0914

Route Number	Public / NonPublic	Date Visited	Area (sq ft)	Lane Miles *	Surface Type
0914	PUBLIC	7/1/2013	28,647	0.49	AS
Culverts	Drop Inlets	Gates	Curb & Gutter	Curb	PCR
0	0	0	NO CURB AND GUTTER	CONCRETE CURB	POOR/45

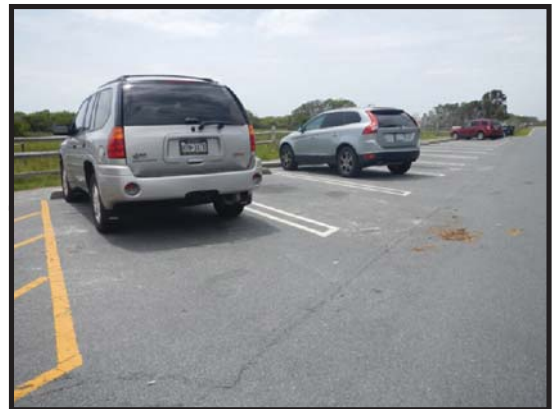
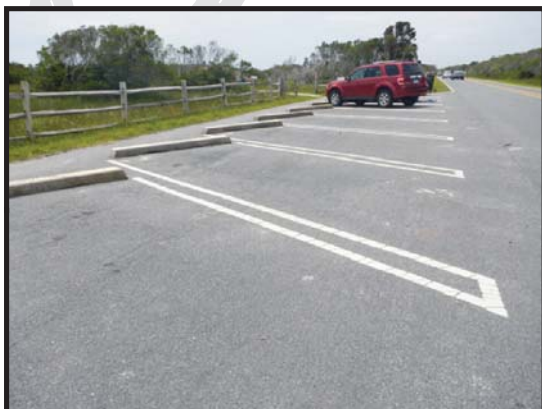
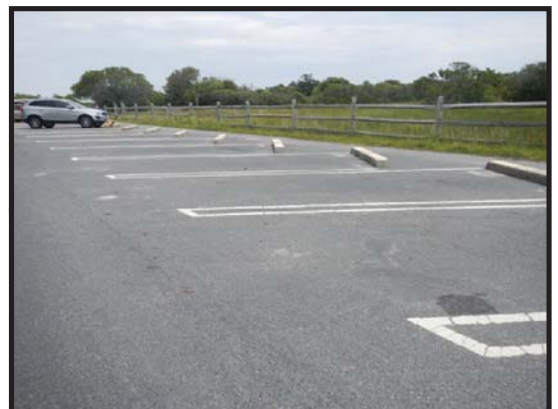
Route Number	Public / NonPublic	Date Visited	Area (sq ft)	Lane Miles *	Surface Type
0918Z	PUBLIC	7/1/2013	7,072	0.12	AS
Culverts	Drop Inlets	Gates	Curb & Gutter	Curb	PCR
0	0	0	NO CURB AND GUTTER	NO CURB	POOR/45

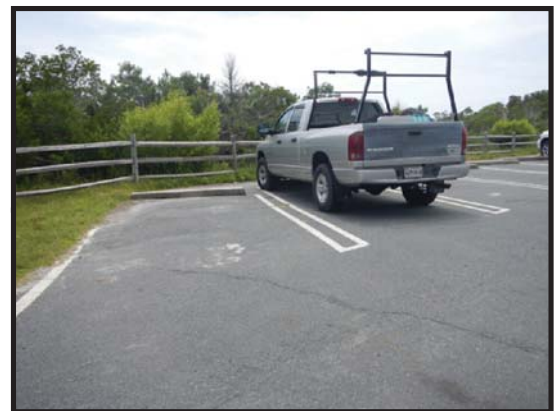
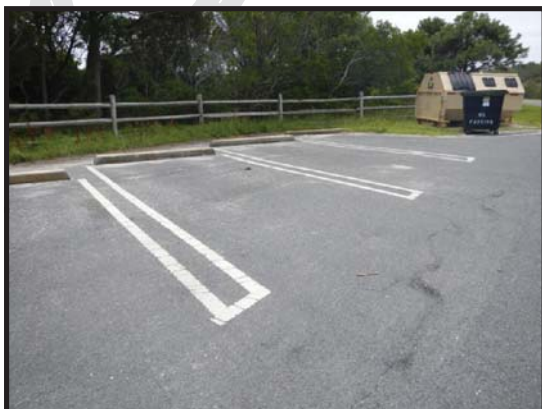
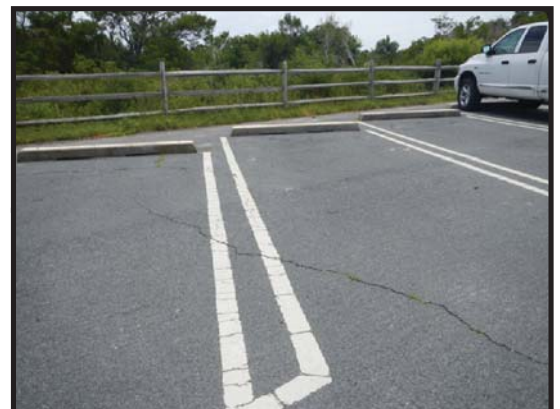
Route 0919Z

Route Number	Public / NonPublic	Date Visited	Area (sq ft)	Lane Miles *	Surface Type
0919Z	PUBLIC	7/1/2013	6,441	0.11	AS
Culverts	Drop Inlets	Gates	Curb & Gutter	Curb	PCR
0	0	0	NO CURB AND GUTTER	NO CURB	POOR/45

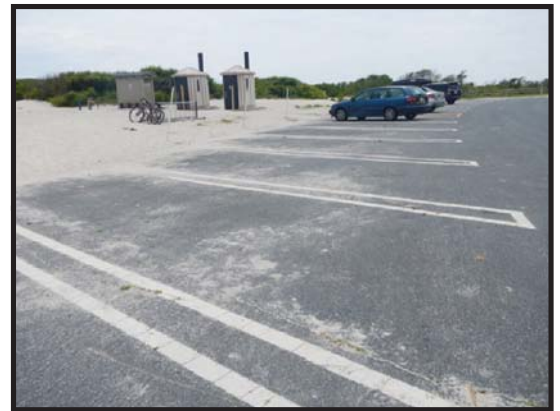
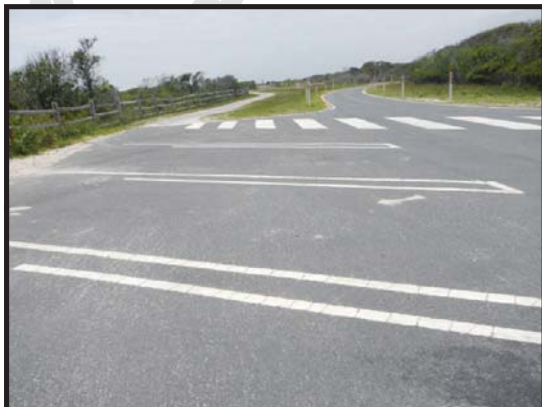
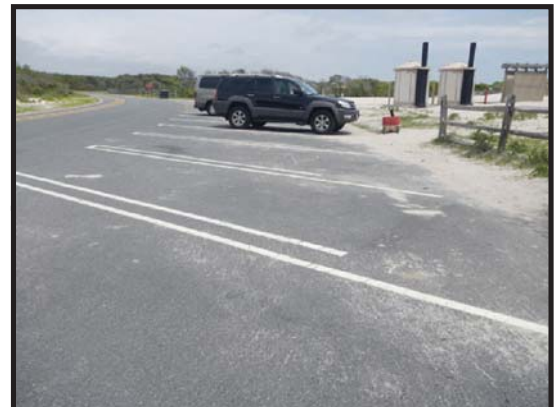
Route 0920Z

Route Number	Public / NonPublic	Date Visited	Area (sq ft)	Lane Miles *	Surface Type
0920Z	PUBLIC	7/1/2013	5,843	0.10	AS
Culverts	Drop Inlets	Gates	Curb & Gutter	Curb	PCR
0	0	0	NO CURB AND GUTTER	NO CURB	POOR/45

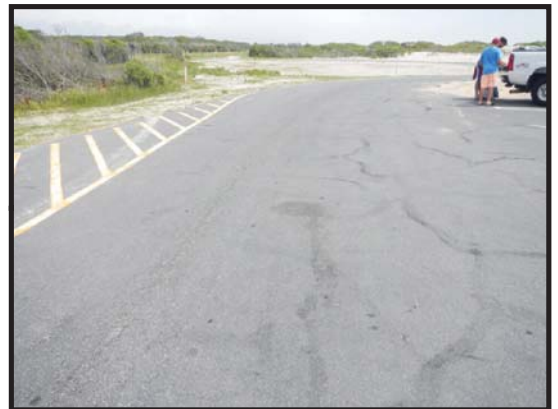
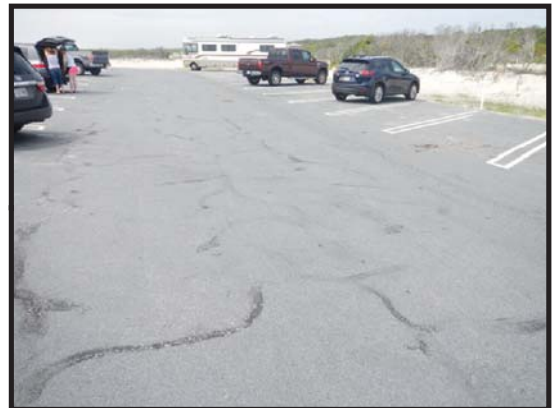
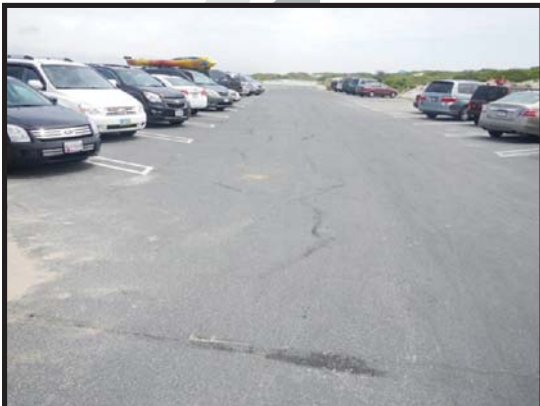
Route 0921

Route Number	Public / NonPublic	Date Visited	Area (sq ft)	Lane Miles *	Surface Type
0921	PUBLIC	7/1/2013	38,360	0.66	AS
Culverts	Drop Inlets	Gates	Curb & Gutter	Curb	PCR
0	0	0	NO CURB AND GUTTER	NO CURB	POOR/45

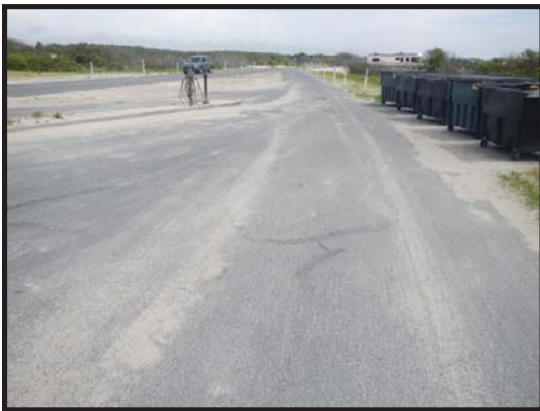
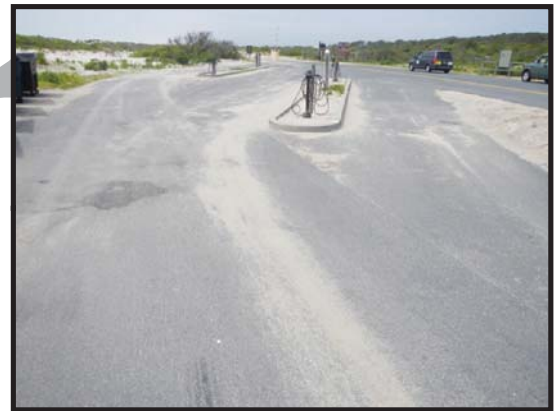
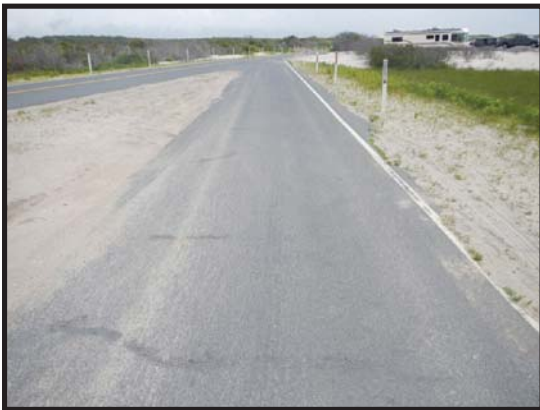
Route 0923

Route Number	Public / NonPublic	Date Visited	Area (sq ft)	Lane Miles *	Surface Type
0923	PUBLIC	7/1/2013	8,270	0.14	AS
Culverts	Drop Inlets	Gates	Curb & Gutter	Curb	PCR
0	0	0	NO CURB AND GUTTER	CONCRETE CURB	FAIR/73

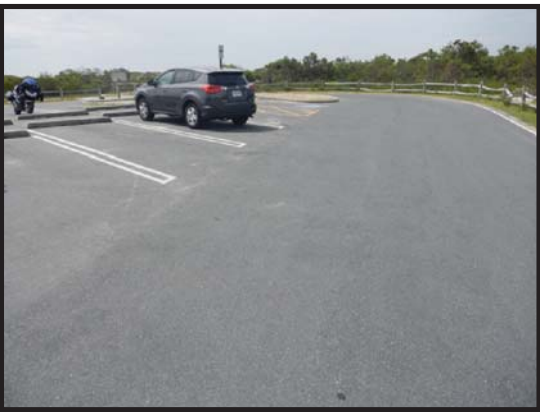
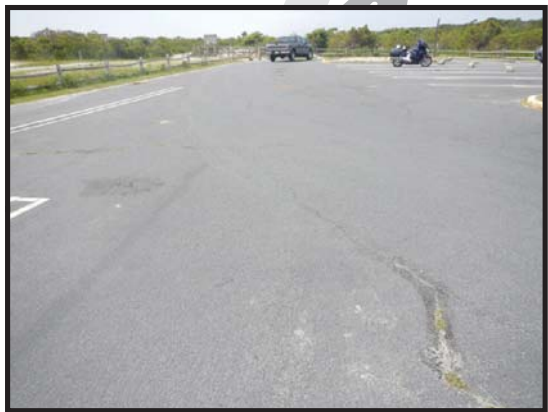
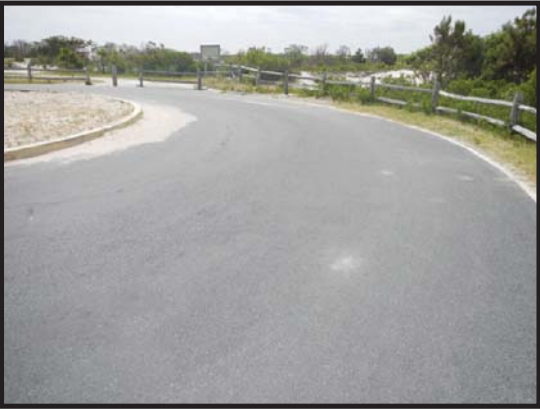
Route 0924

Route Number	Public / NonPublic	Date Visited	Area (sq ft)	Lane Miles *	Surface Type
0924	PUBLIC	7/1/2013	20,499	0.35	AS
Culverts	Drop Inlets	Gates	Curb & Gutter	Curb	PCR
0	0	0	NO CURB AND GUTTER	CONCRETE CURB	FAIR/73

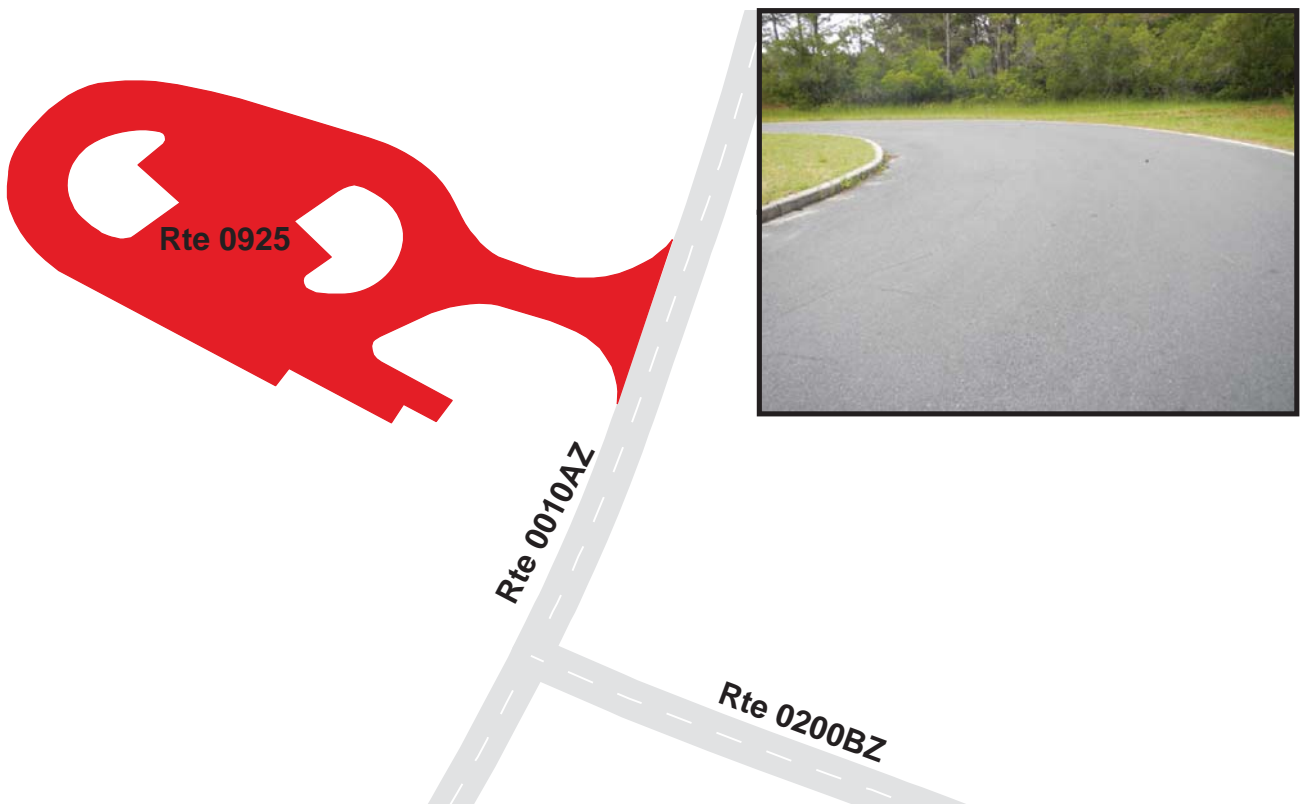
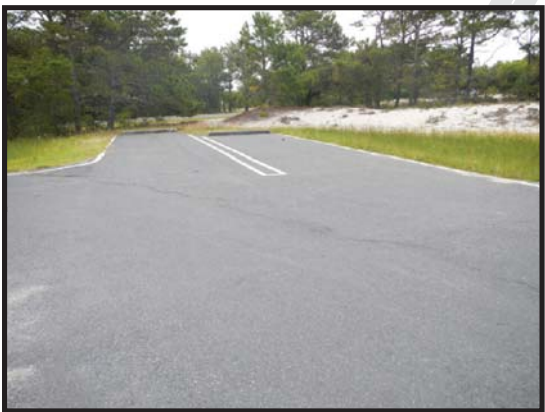
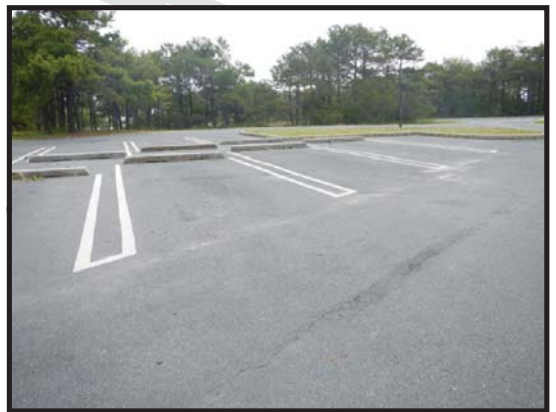
Route 0925

Route Number	Public / NonPublic	Date Visited	Area (sq ft)	Lane Miles *	Surface Type
0925	PUBLIC	7/1/2013	14,135	0.24	AS
Culverts	Drop Inlets	Gates	Curb & Gutter	Curb	PCR
0	0	0	NO CURB AND GUTTER	CONCRETE CURB	POOR/45

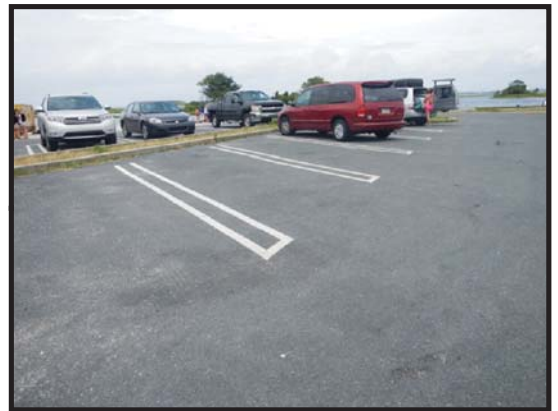
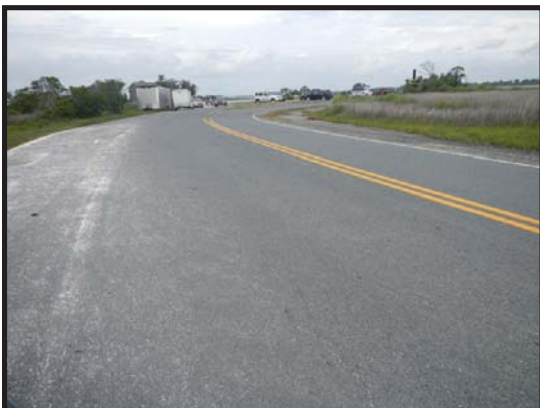
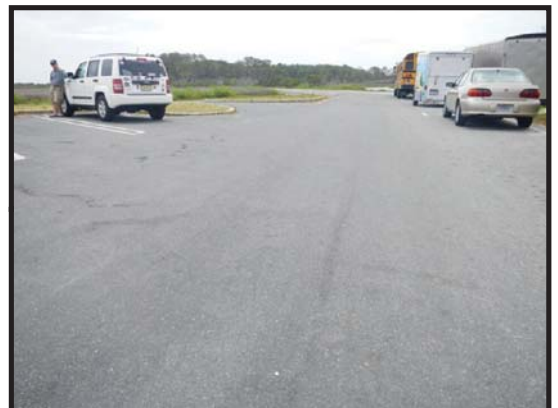
Route 0926

Route Number	Public / NonPublic	Date Visited	Area (sq ft)	Lane Miles *	Surface Type
0926	PUBLIC	7/1/2013	22,072	0.38	AS
Culverts	Drop Inlets	Gates	Curb & Gutter	Curb	PCR
0	0	0	NO CURB AND GUTTER	CONCRETE CURB	POOR/45

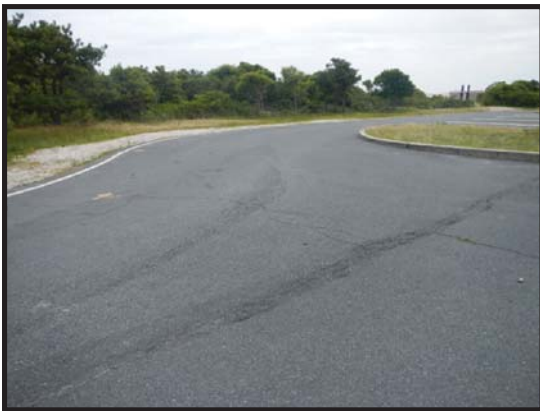
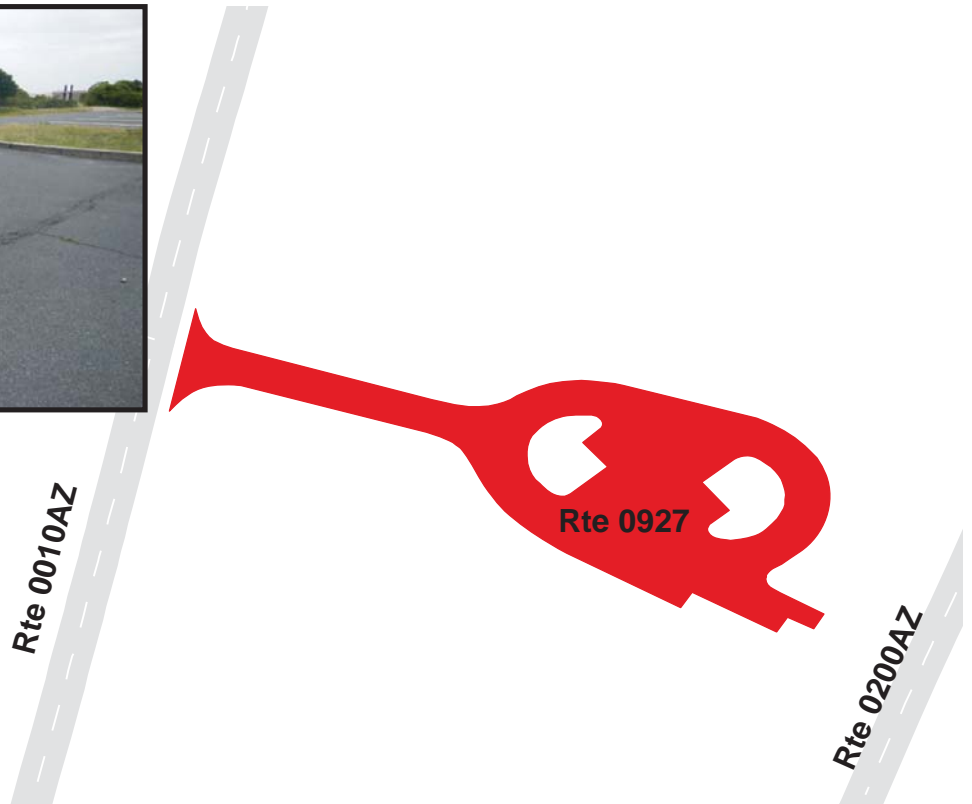
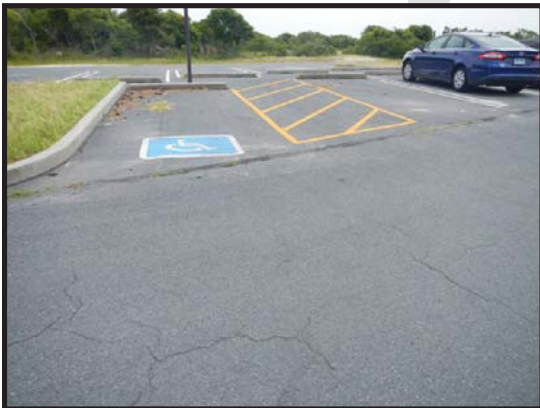
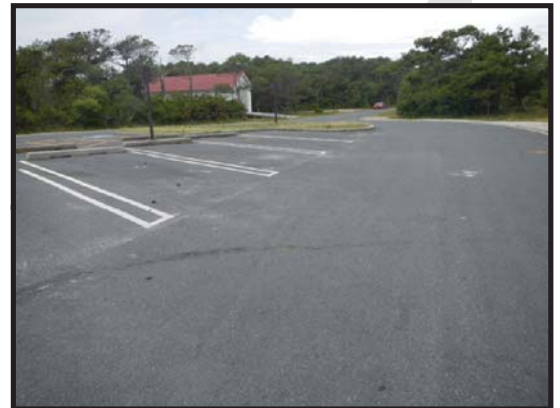
Route 0927

Route Number	Public / NonPublic	Date Visited	Area (sq ft)	Lane Miles *	Surface Type
0927	PUBLIC	7/1/2013	15,210	0.26	AS
Culverts	Drop Inlets	Gates	Curb & Gutter	Curb	PCR
0	0	0	NO CURB AND GUTTER	CONCRETE CURB	POOR/45

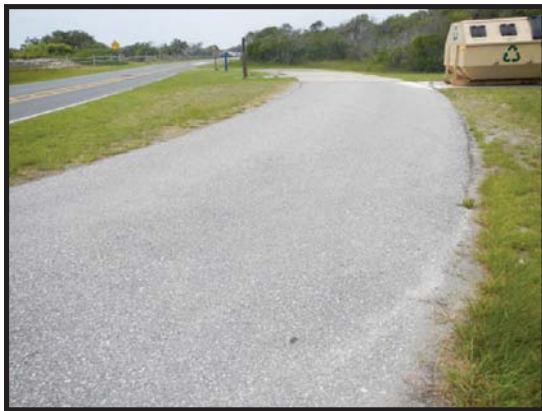
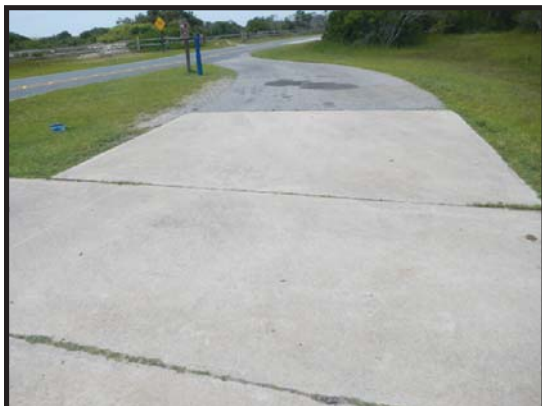
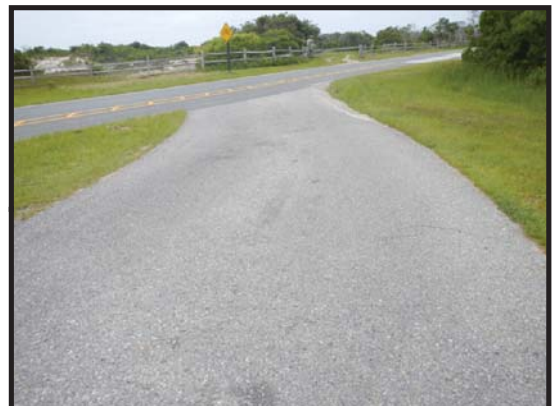
Route 0936

Route Number	Public / NonPublic	Date Visited	Area (sq ft)	Lane Miles *	Surface Type
0936	PUBLIC	7/1/2013	2,069	0.04	AS
Culverts	Drop Inlets	Gates	Curb & Gutter	Curb	PCR
0	0	0	NO CURB AND GUTTER	NO CURB	GOOD/90
