Federal Lands Highway Road Inventory Program

Road Inventory and Condition Assessment

Badlands National Park
BADL - 1300

Cycle 5 Report

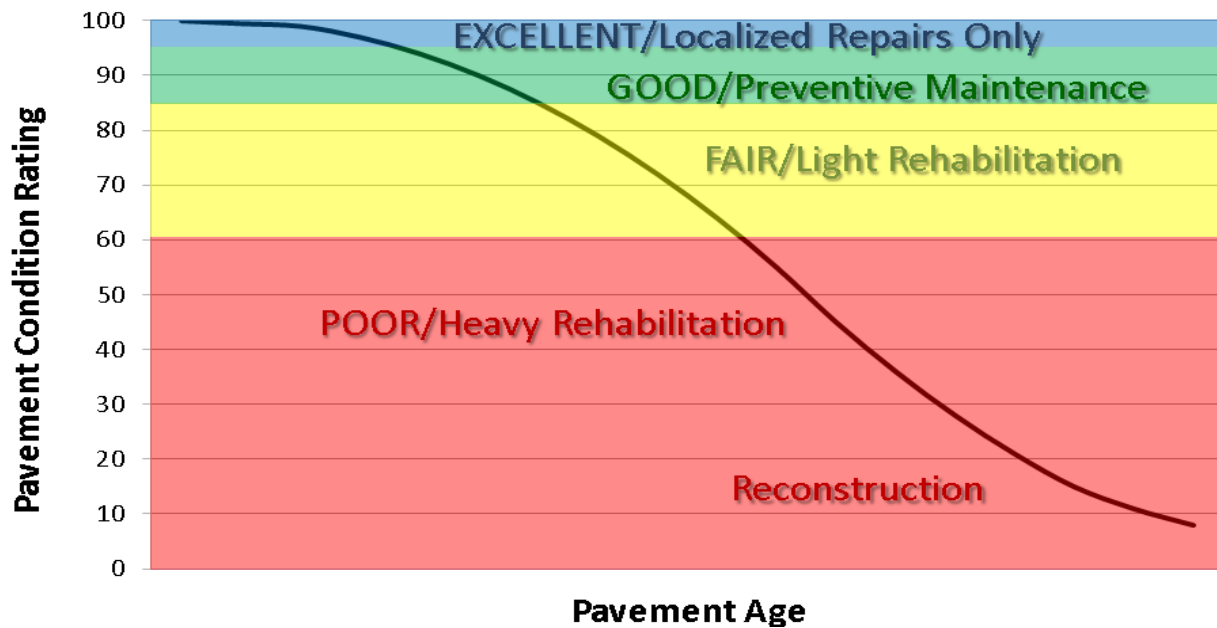
- Excellent/New: PCR of 95-100. Pavements in this range will require only spot repairs
- Good: PCR of 85-94. Pavements in this range will likely be candidates for Preventive Maintenance. Examples include Chip and Slurry Seals, Micro Surfacing and Thin Overlays.
- Fair: PCR of 61-84. Pavements in this range will likely be candidates of Light Rehabilitation (L3R). Examples include single-lift overlays up to 2.5 inches in total thickness, milling and overlays.
- Poor: PCR of 0-60. Pavements in this range will likely be candidates of Heavy Rehabilitation or Reconstruction (H3R or 4R). Examples include Pulverization, Multiple Lift Overlays, and Reconstruction.

Condition Categories and Treatments

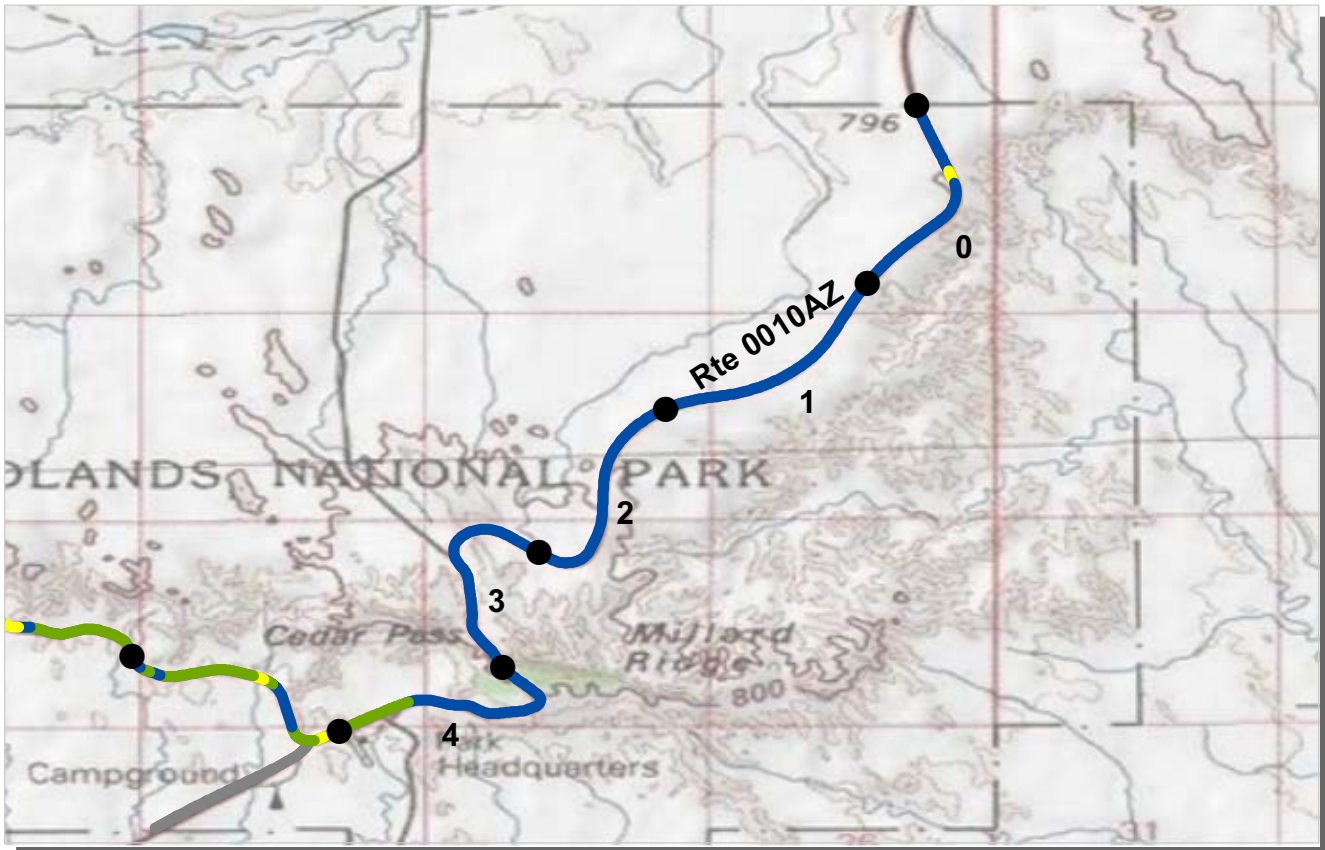
ROUTE: 0010AZ BADLANDS LOOP (ROAD 240)

PCR Poor ■ (0 - 60) Fair ■ (61 - 84) Good ■ (85 - 94) Excellent ■ (95 - 100) No Data ■

* If the PCR rating is not available for a section, the SCR rating will be displayed. See appendix for definitions and formulas.

<i>Section Number</i>	0	1	2	3	4
<i>Section Length (mi)</i>	1.00	1.00	1.00	1.00	1.00
<i>Cross Section Information</i>					
Number of Lanes	2	2	2	2	2
Paved Width (ft)	34	22	24	23	25
Lane Width (ft)	13	10	10	10	11
<i>Roadway Condition Information</i>					
SCR (Surface Condition Rating)	99	100	100	100	99
PCR (Pavement Condition Rating)	99	100	100	100	99
<i>Distress Index Values</i>					
Structural Crack Index	100	100	100	100	99
Transverse Cracking Index	100	100	100	100	99
Patching Index	100	100	100	100	100
Rutting Index	99	100	100	100	99
Roughness Condition Index (RCI)	100	100	100	100	100

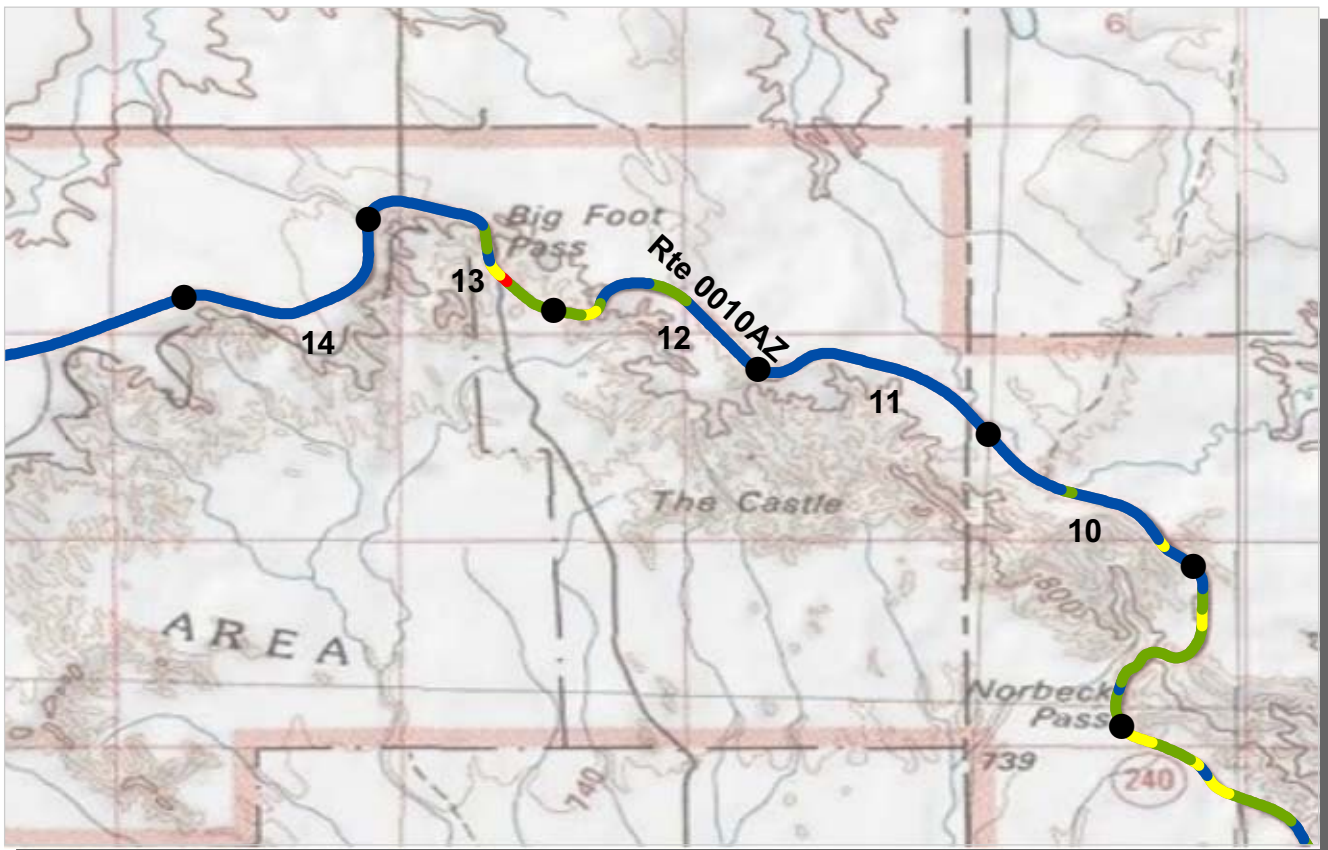
ROUTE: 0010AZ BADLANDS LOOP (ROAD 240)

PCR Poor ■ Fair ■ Good ■ Excellent ■ No Data ■
 (0 - 60) (61 - 84) (85 - 94) (95 - 100)

* If the PCR rating is not available for a section, the SCR rating will be displayed. See appendix for definitions and formulas.

Section Number	10	11	12	13	14
Section Length (mi)	1.00	1.00	1.00	1.00	1.00
Cross Section Information					
Number of Lanes	2	2	2	2	2
Paved Width (ft)	26	25	28	28	23
Lane Width (ft)	11	11	11	11	10
Roadway Condition Information					
SCR (Surface Condition Rating)	100	99	99	98	100
PCR (Pavement Condition Rating)	100	99	99	92	100
Distress Index Values					
Structural Crack Index	100	100	100	98	100
Transverse Cracking Index	100	100	99	99	100
Patching Index	100	100	100	99	100
Rutting Index	100	99	100	98	100
Roughness Condition Index (RCI)	100	100	98	83	100

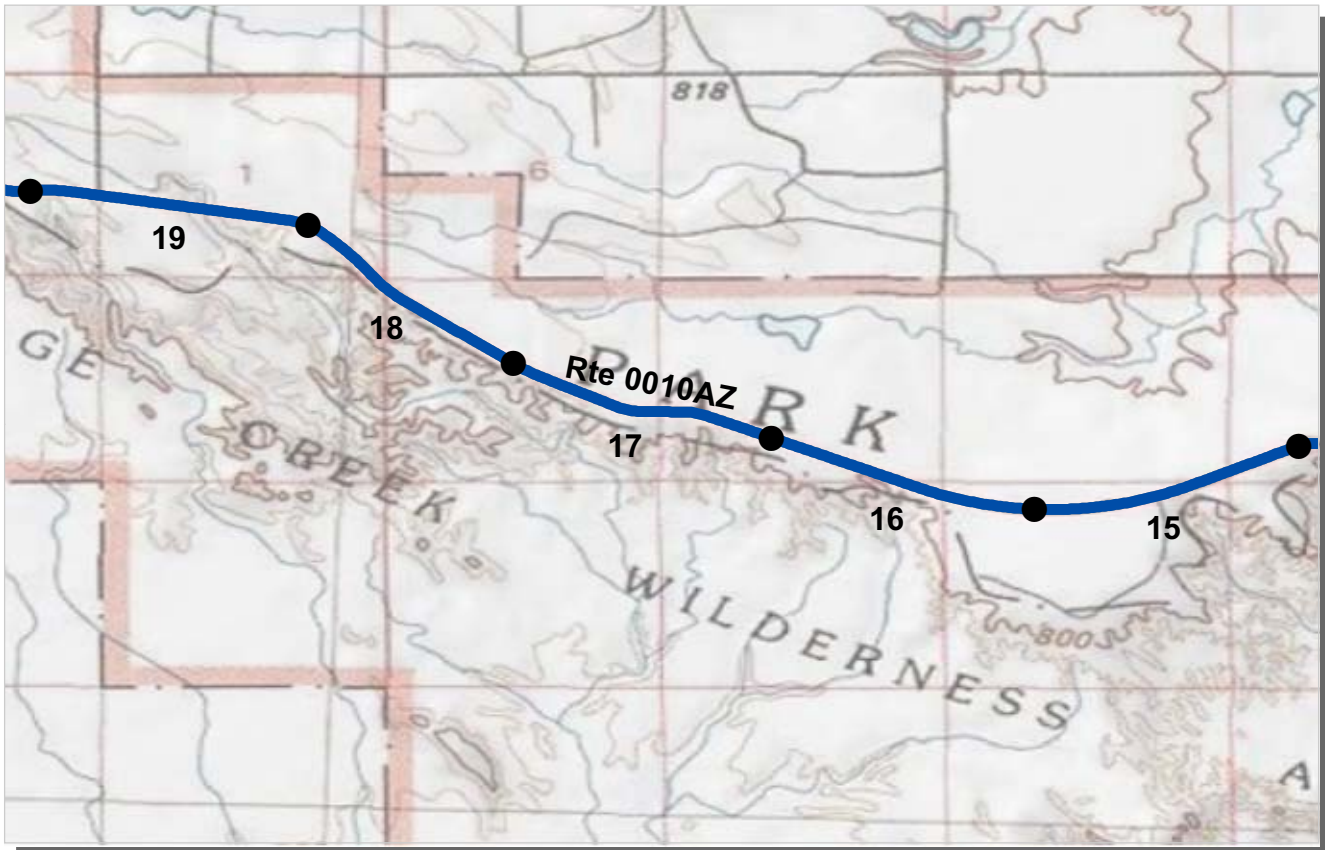
ROUTE: 0010AZ BADLANDS LOOP (ROAD 240)

PCR Poor ■ (0 - 60) Fair ■ (61 - 84) Good ■ (85 - 94) Excellent ■ (95 - 100) No Data ■

* If the PCR rating is not available for a section, the SCR rating will be displayed. See appendix for definitions and formulas.

Section Number	15	16	17	18	19
Section Length (mi)	1.00	1.00	1.00	1.00	1.00
Cross Section Information					
Number of Lanes	2	2	2	2	2
Paved Width (ft)	22	22	20	21	22
Lane Width (ft)	9	9	9	9	9
Roadway Condition Information					
SCR (Surface Condition Rating)	100	100	100	100	100
PCR (Pavement Condition Rating)	100	100	100	100	100
Distress Index Values					
Structural Crack Index	100	100	100	100	100
Transverse Cracking Index	100	100	100	100	100
Patching Index	100	100	100	100	100
Rutting Index	100	100	100	100	100
Roughness Condition Index (RCI)	100	100	100	100	100

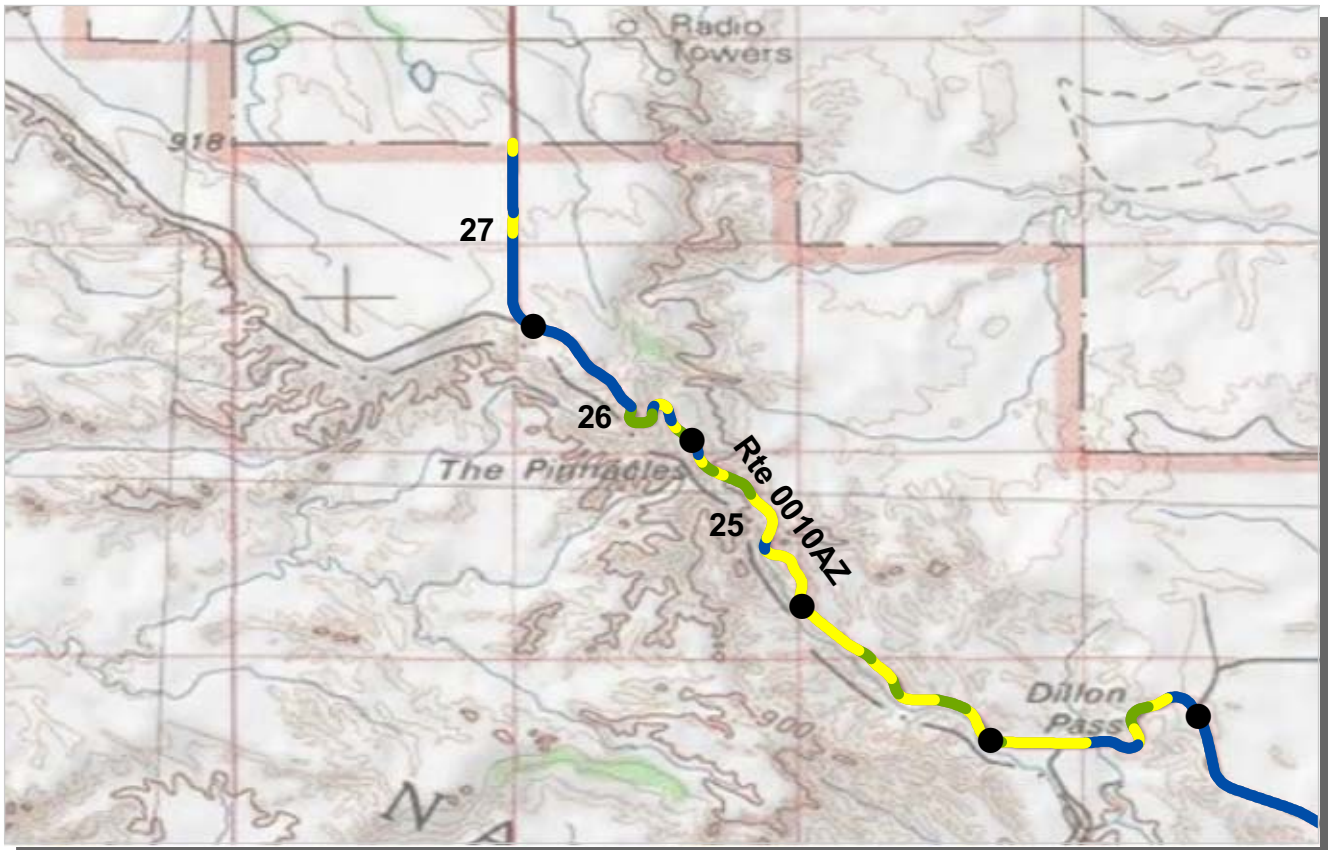
ROUTE: 0010AZ BADLANDS LOOP (ROAD 240)

PCR Poor ■ Fair ■ Good ■ Excellent ■ No Data ■
 (0 - 60) (61 - 84) (85 - 94) (95 - 100)

* If the PCR rating is not available for a section, the SCR rating will be displayed. See appendix for definitions and formulas.

Section Number	25	26	27		
Section Length (mi)	1.00	1.00	0.92		
Cross Section Information					
Number of Lanes	2	2	2		
Paved Width (ft)	28	27	33		
Lane Width (ft)	11	11	11		
Roadway Condition Information					
SCR (Surface Condition Rating)	97	97	99		
PCR (Pavement Condition Rating)	82	95	99		
Distress Index Values					
Structural Crack Index	97	97	99		
Transverse Cracking Index	99	99	99		
Patching Index	100	100	100		
Rutting Index	99	100	99		
Roughness Condition Index (RCI)	60	93	98

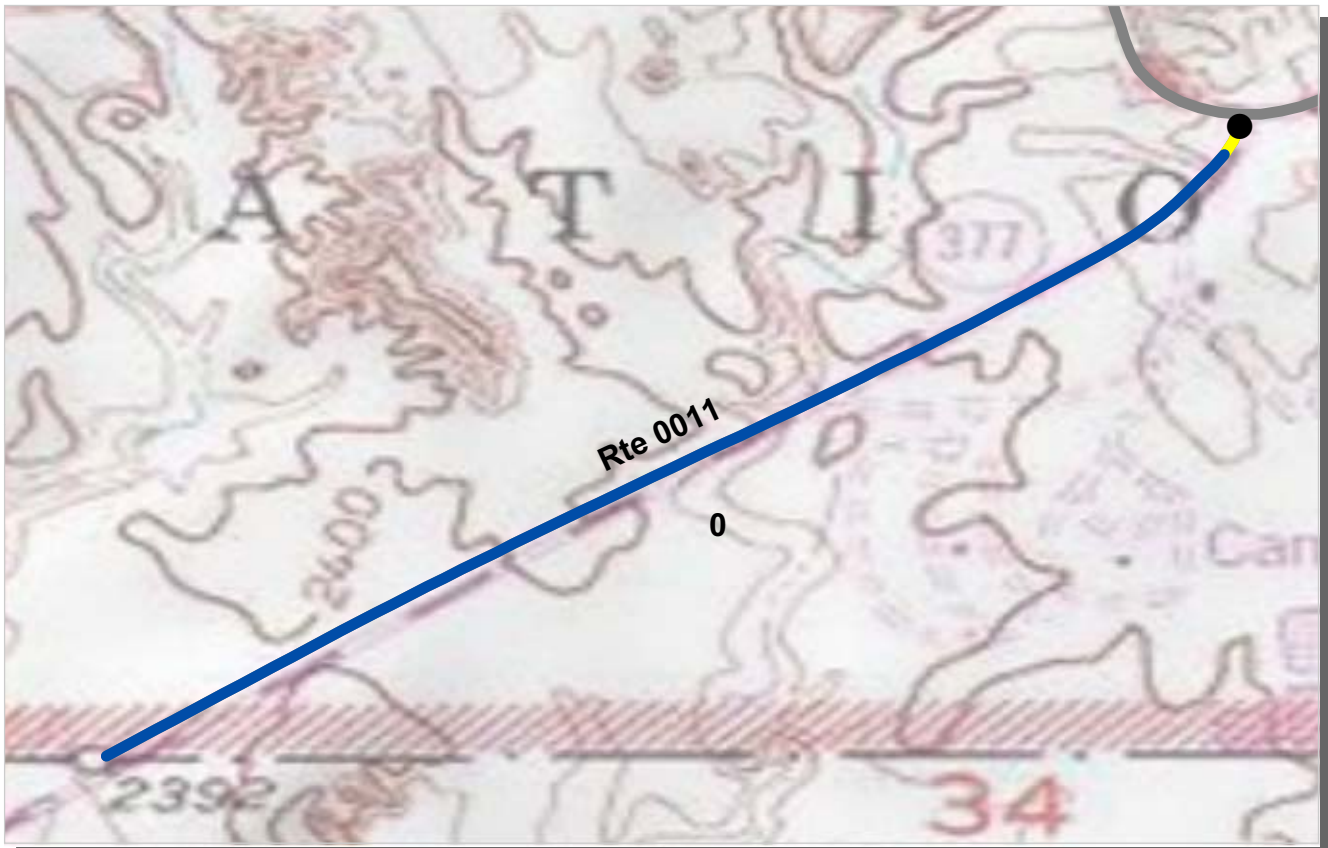
ROUTE: 0011 ENTRANCE ROAD (HIGHWAY 377)

PCR Poor ■ Fair ■ Good ■ Excellent ■ No Data ■
 (0 - 60) (61 - 84) (85 - 94) (95 - 100)

* If the PCR rating is not available for a section, the SCR rating will be displayed. See appendix for definitions and formulas.

Section Number	0				
Section Length (mi)	0.69				
Cross Section Information					
Number of Lanes	2				
Paved Width (ft)	28				
Lane Width (ft)	11				
Roadway Condition Information					
SCR (Surface Condition Rating)	100				
PCR (Pavement Condition Rating)	97				
Distress Index Values					
Structural Crack Index	100				
Transverse Cracking Index	100				
Patching Index	100				
Rutting Index	100				
Roughness Condition Index (RCI)	93

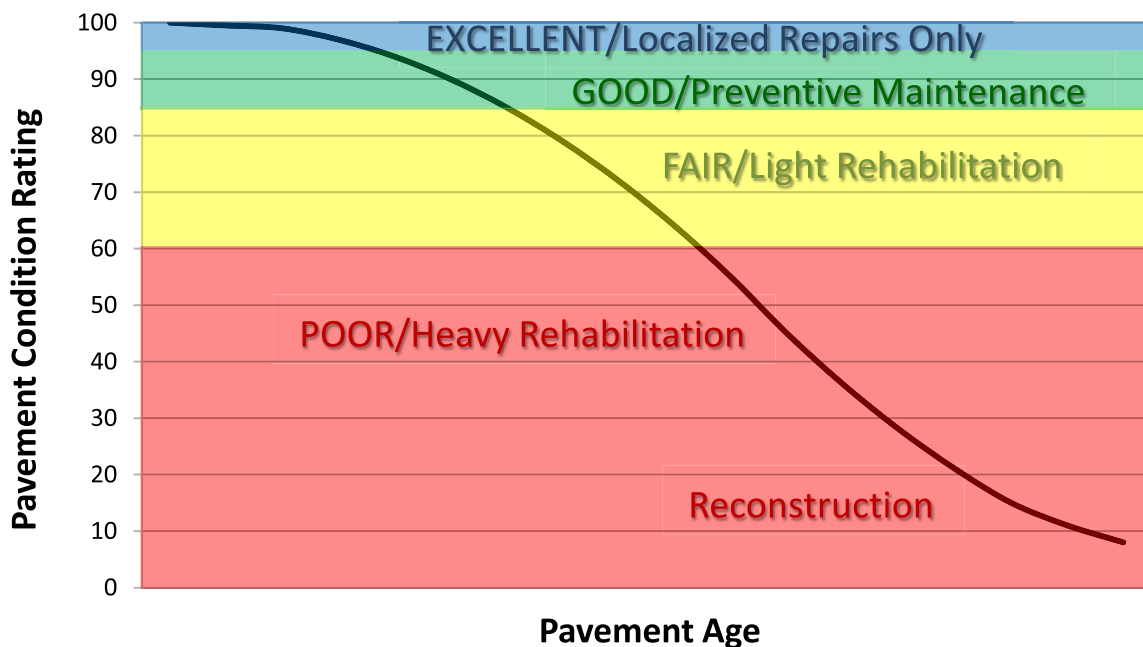
- Excellent/New: PCR of 95-100. Pavements in this range will require only spot repairs
- Good: PCR of 85-94. Pavements in this range will likely be candidates for Preventive Maintenance. Examples include Chip and Slurry Seals, Micro Surfacing and Thin Overlays.
- Fair: PCR of 61-84. Pavements in this range will likely be candidates of Light Rehabilitation (L3R). Examples include single-lift overlays up to 2.5 inches in total thickness, milling and overlays.
- Poor: PCR of 60 or below. Pavements in this range will likely be candidates of Heavy Rehabilitation or Reconstruction (H3R or 4R). Examples include Pulverization, Multiple Lift Overlays, and Reconstruction.
