Federal Lands Highway Road Inventory Program

Road Inventory and Condition Assessment

Big Bend National Park
BIBE - 7130

Cycle 5 Report

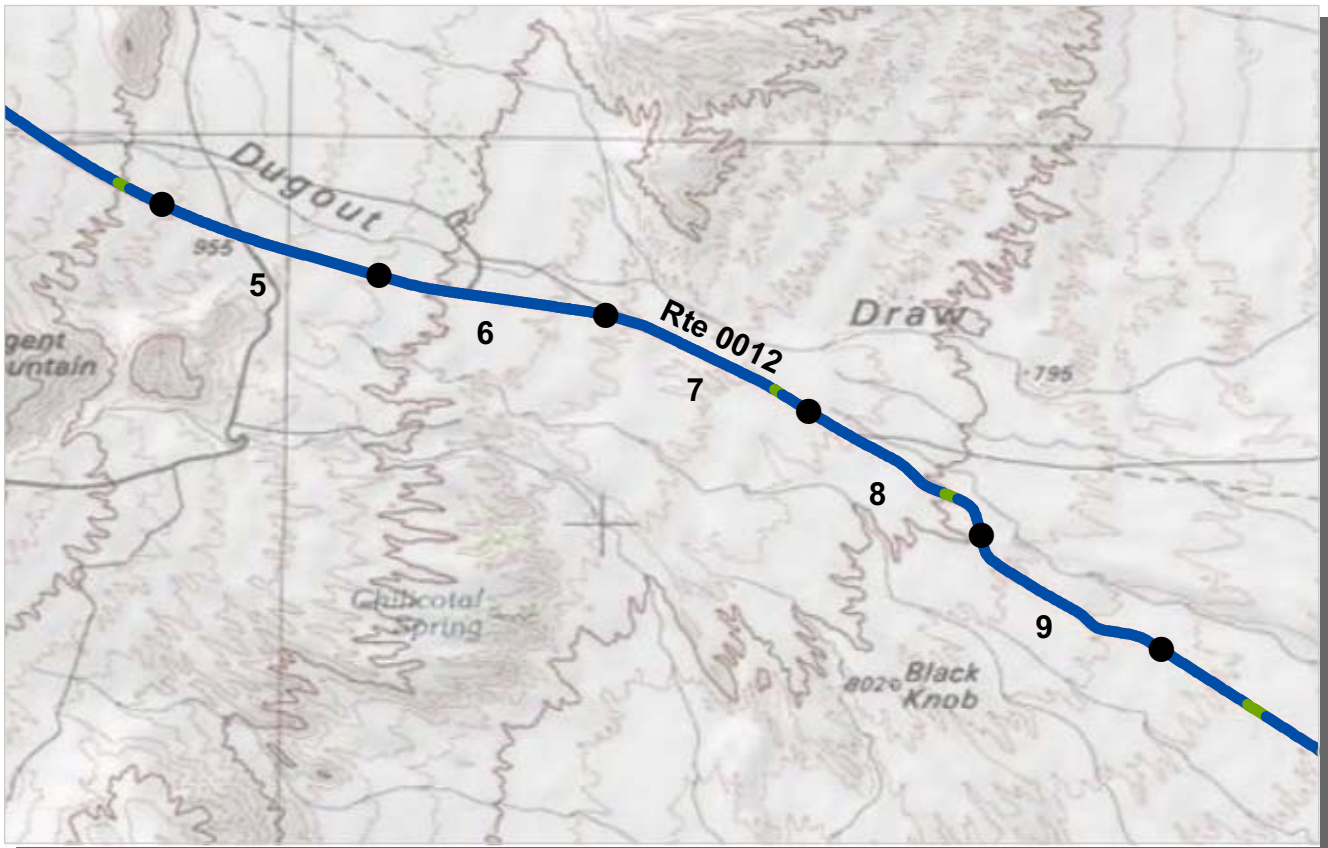
ROUTE: 0012 RIO GRANDE ROAD

PCR Poor ■ Fair ■ Good ■ Excellent ■ No Data ■
 (0 - 60) (61 - 84) (85 - 94) (95 - 100)

* If the PCR rating is not available for a section, the SCR rating will be displayed. See appendix for definitions and formulas.

<i>Section Number</i>	5	6	7	8	9
<i>Section Length (mi)</i>	1.00	1.00	1.00	1.00	1.00
<i>Cross Section Information</i>					
Number of Lanes	2	2	2	2	2
Paved Width (ft)	24	24	24	24	24
Lane Width (ft)	10	10	10	10	10
<i>Roadway Condition Information</i>					
SCR (Surface Condition Rating)	98	99	99	100	99
PCR (Pavement Condition Rating)	99	99	99	100	99
<i>Distress Index Values</i>					
Structural Crack Index	100	100	100	100	100
Transverse Cracking Index	100	100	100	100	100
Patching Index	100	100	100	100	100
Rutting Index	98	99	99	100	99
Roughness Condition Index (RCI)	100	100	100	100	100

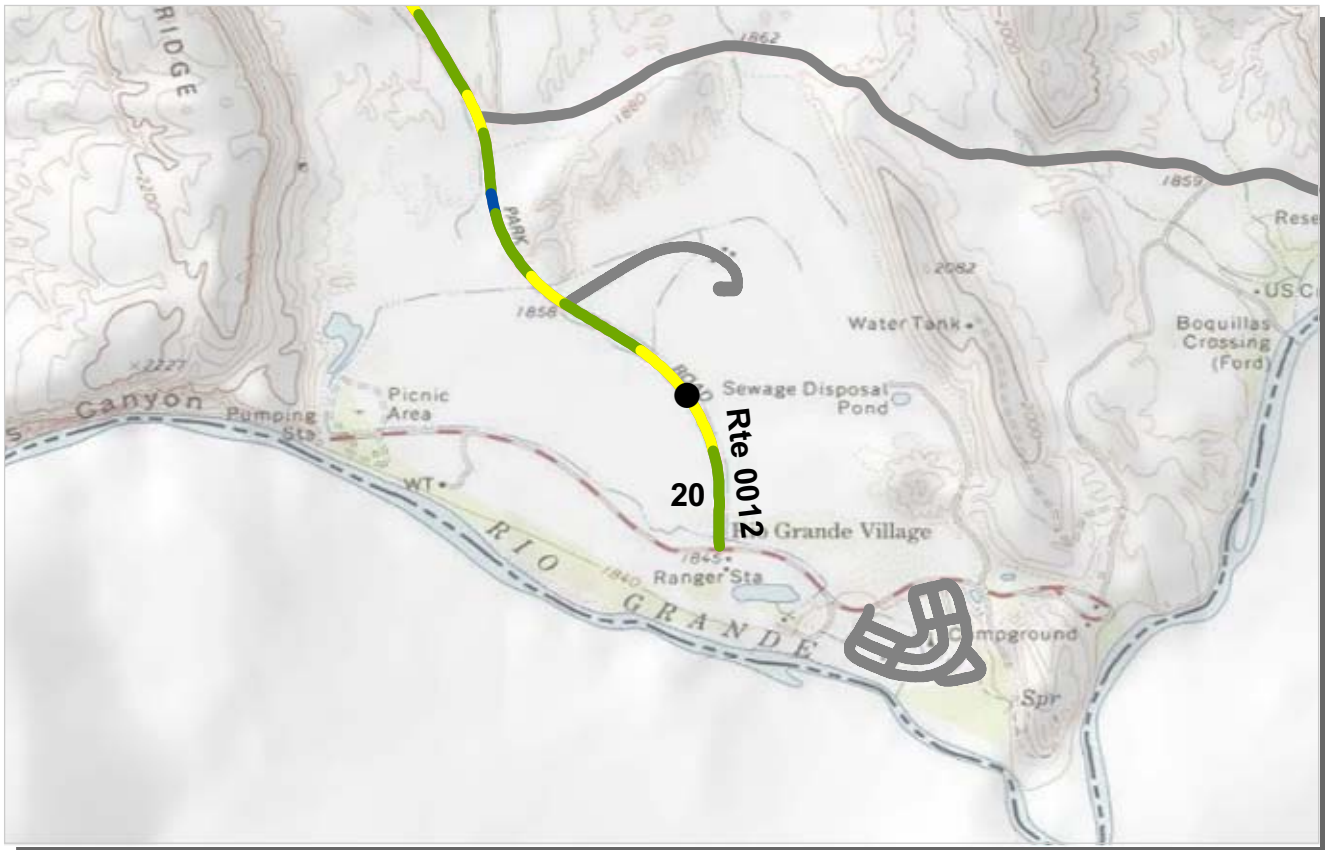
ROUTE: 0012 RIO GRANDE ROAD

PCR Poor ■ Fair ■ Good ■ Excellent ■ No Data ■
 (0 - 60) (61 - 84) (85 - 94) (95 - 100)

* If the PCR rating is not available for a section, the SCR rating will be displayed. See appendix for definitions and formulas.

Section Number	20				
Section Length (mi)	0.31				
Cross Section Information					
Number of Lanes	2				
Paved Width (ft)	21				
Lane Width (ft)	10				
Roadway Condition Information					
SCR (Surface Condition Rating)	93				
PCR (Pavement Condition Rating)	85				
Distress Index Values					
Structural Crack Index	100				
Transverse Cracking Index	100				
Patching Index	100				
Rutting Index	93				
Roughness Condition Index (RCI)	74

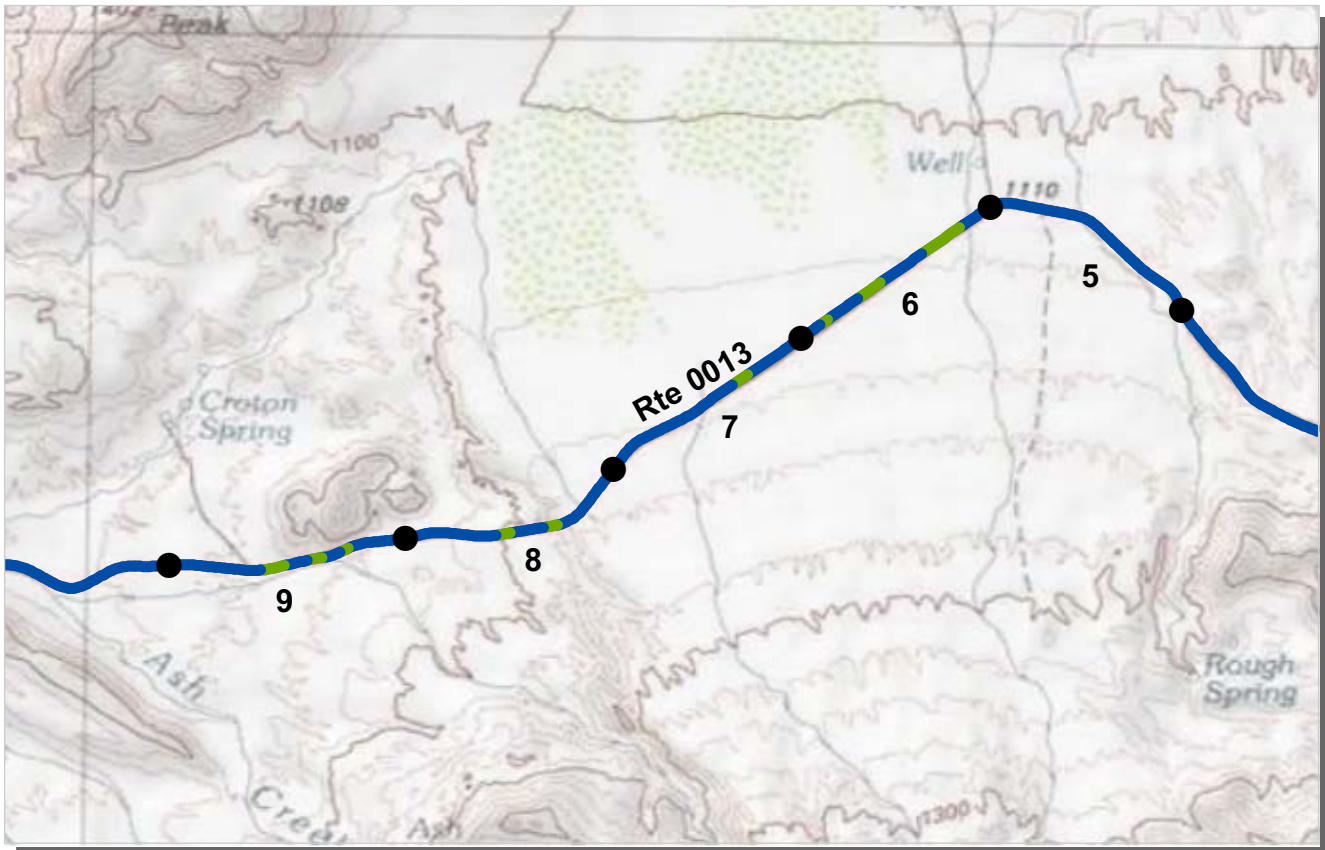
ROUTE: 0013 WEST ENTRANCE ROAD

PCR Poor ■ Fair ■ Good ■ Excellent ■ No Data ■
 (0 - 60) (61 - 84) (85 - 94) (95 - 100)

* If the PCR rating is not available for a section, the SCR rating will be displayed. See appendix for definitions and formulas.

<i>Section Number</i>	5	6	7	8	9
<i>Section Length (mi)</i>	1.00	1.00	1.00	1.00	1.00
<i>Cross Section Information</i>					
Number of Lanes	2	2	2	2	2
Paved Width (ft)	22	22	22	27	22
Lane Width (ft)	10	10	10	10	10
<i>Roadway Condition Information</i>					
SCR (Surface Condition Rating)	95	93	95	96	94
PCR (Pavement Condition Rating)	97	96	97	98	96
<i>Distress Index Values</i>					
Structural Crack Index	100	100	100	100	100
Transverse Cracking Index	95	93	95	96	94
Patching Index	100	100	100	100	100
Rutting Index	100	97	99	99	98
Roughness Condition Index (RCI)	100	100	100	100	100

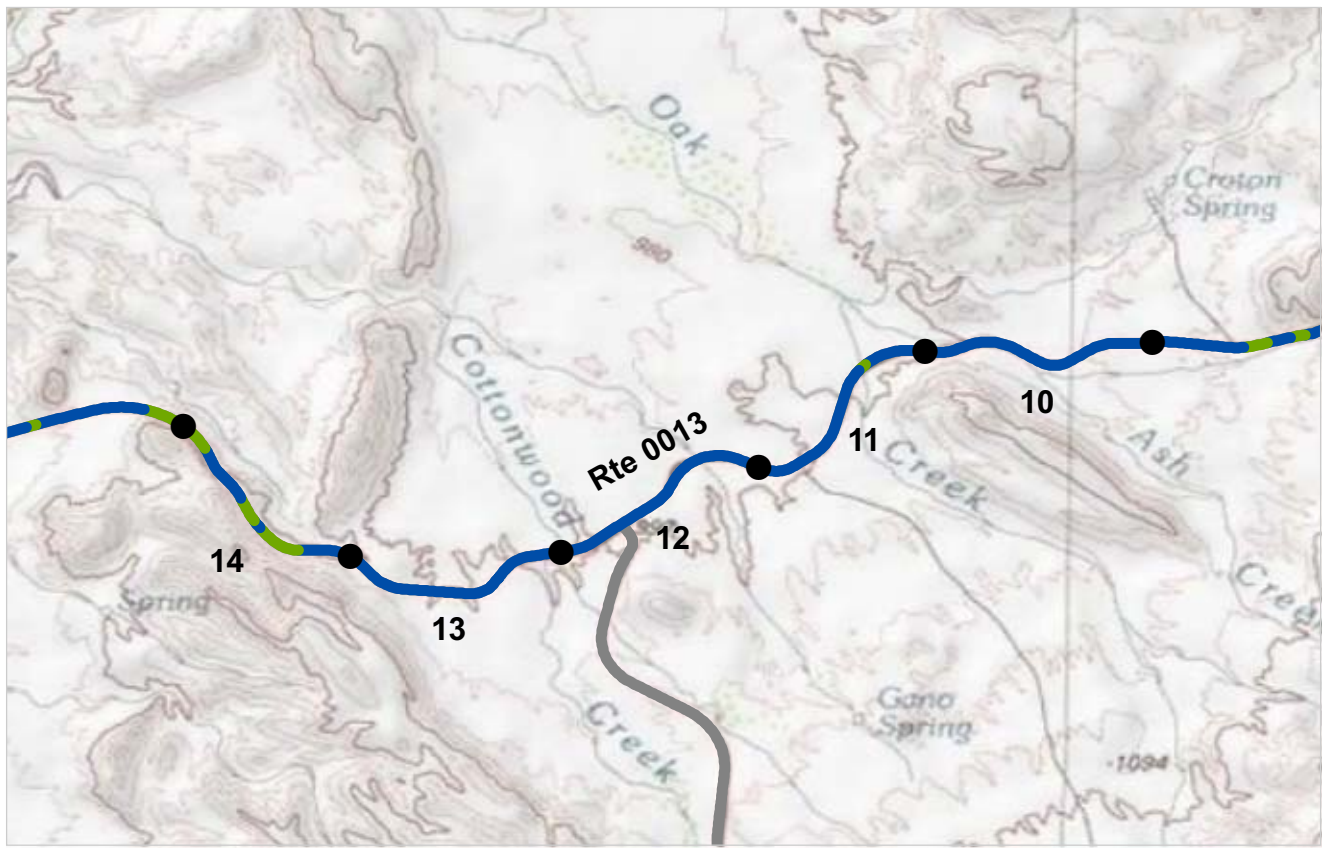
ROUTE: 0013 WEST ENTRANCE ROAD

PCR Poor ■ Fair ■ Good ■ Excellent ■ No Data ■
 (0 - 60) (61 - 84) (85 - 94) (95 - 100)

* If the PCR rating is not available for a section, the SCR rating will be displayed. See appendix for definitions and formulas.

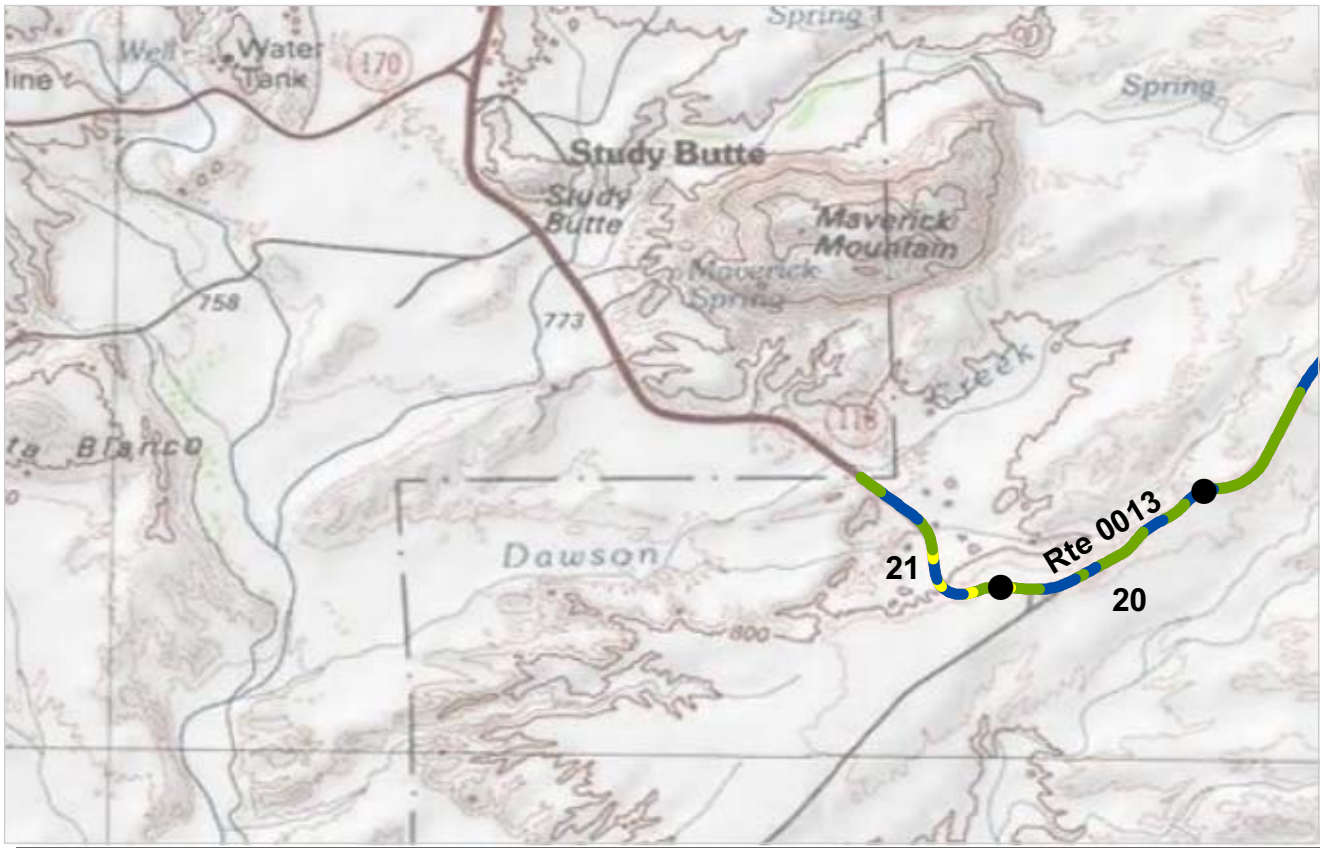
ROUTE: 0013 WEST ENTRANCE ROAD

PCR Poor ■ Fair ■ Good ■ Excellent ■ No Data ■
 (0 - 60) (61 - 84) (85 - 94) (95 - 100)

* If the PCR rating is not available for a section, the SCR rating will be displayed. See appendix for definitions and formulas.

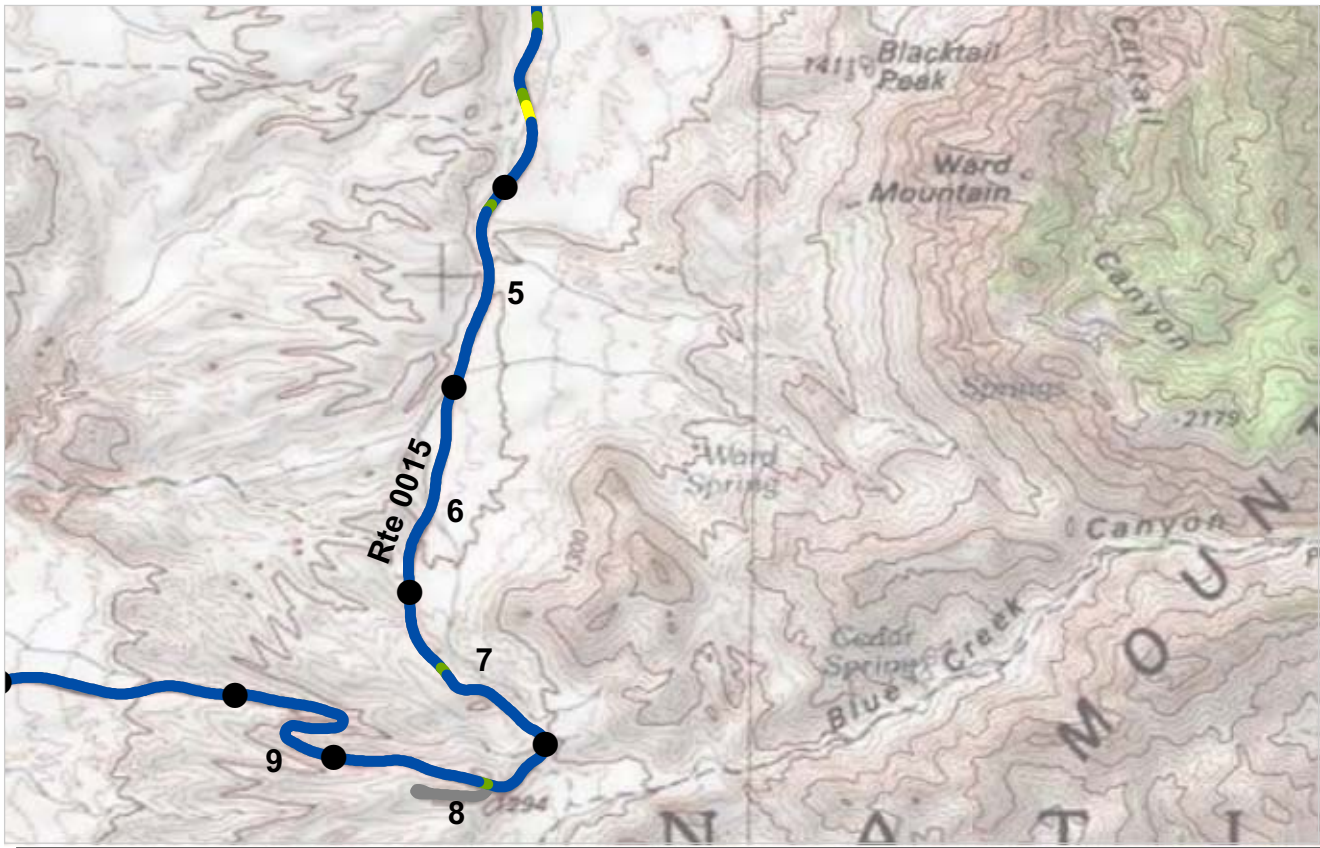
ROUTE: 0015 ROSS MAXWELL SCENIC DRIVE

<i>Section Number</i>	5	6	7	8	9
<i>Section Length (mi)</i>	1.00	1.00	1.00	1.00	1.00
<i>Cross Section Information</i>					
Number of Lanes	2	2	2	2	2
Paved Width (ft)	21	22	22	22	24
Lane Width (ft)	9	9	9	9	10
<i>Roadway Condition Information</i>					
SCR (Surface Condition Rating)	99	99	99	100	100
PCR (Pavement Condition Rating)	99	99	99	100	100
<i>Distress Index Values</i>					
Structural Crack Index	100	100	100	100	100
Transverse Cracking Index	99	99	100	100	100
Patching Index	100	100	100	100	100
Rutting Index	100	100	99	100	100
Roughness Condition Index (RCI)	100	100	100	100	100

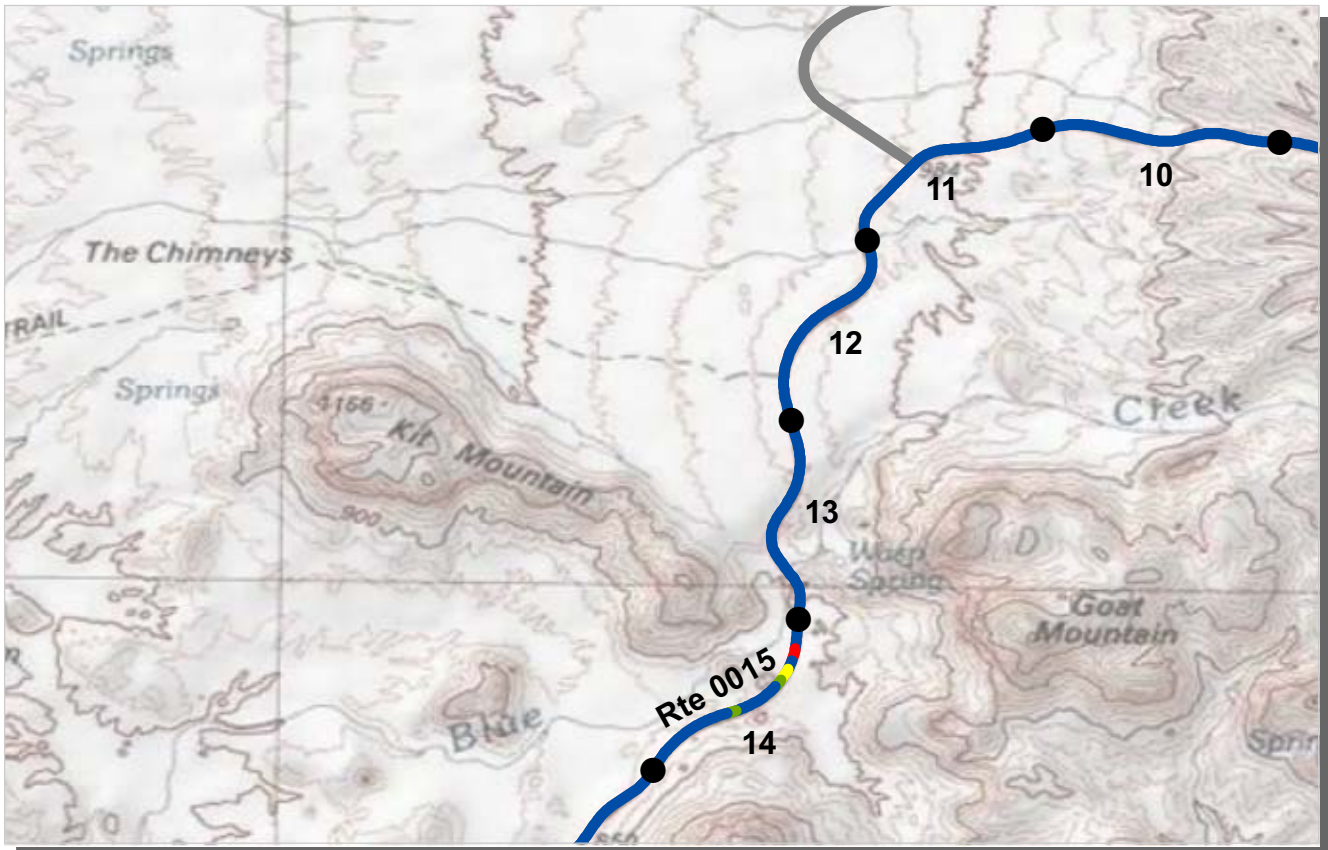
ROUTE: 0015 ROSS MAXWELL SCENIC DRIVE

<i>Section Number</i>	10	11	12	13	14
<i>Section Length (mi)</i>	1.00	1.00	1.00	1.00	1.00
<i>Cross Section Information</i>					
Number of Lanes	2	2	2	2	2
Paved Width (ft)	21	22	22	22	23
Lane Width (ft)	9	9	9	10	9
<i>Roadway Condition Information</i>					
SCR (Surface Condition Rating)	100	99	99	99	98
PCR (Pavement Condition Rating)	100	99	99	99	96
<i>Distress Index Values</i>					
Structural Crack Index	100	100	100	100	98
Transverse Cracking Index	100	99	99	99	98
Patching Index	100	100	100	100	100
Rutting Index	100	100	100	100	100
Roughness Condition Index (RCI)	100	100	100	100	93

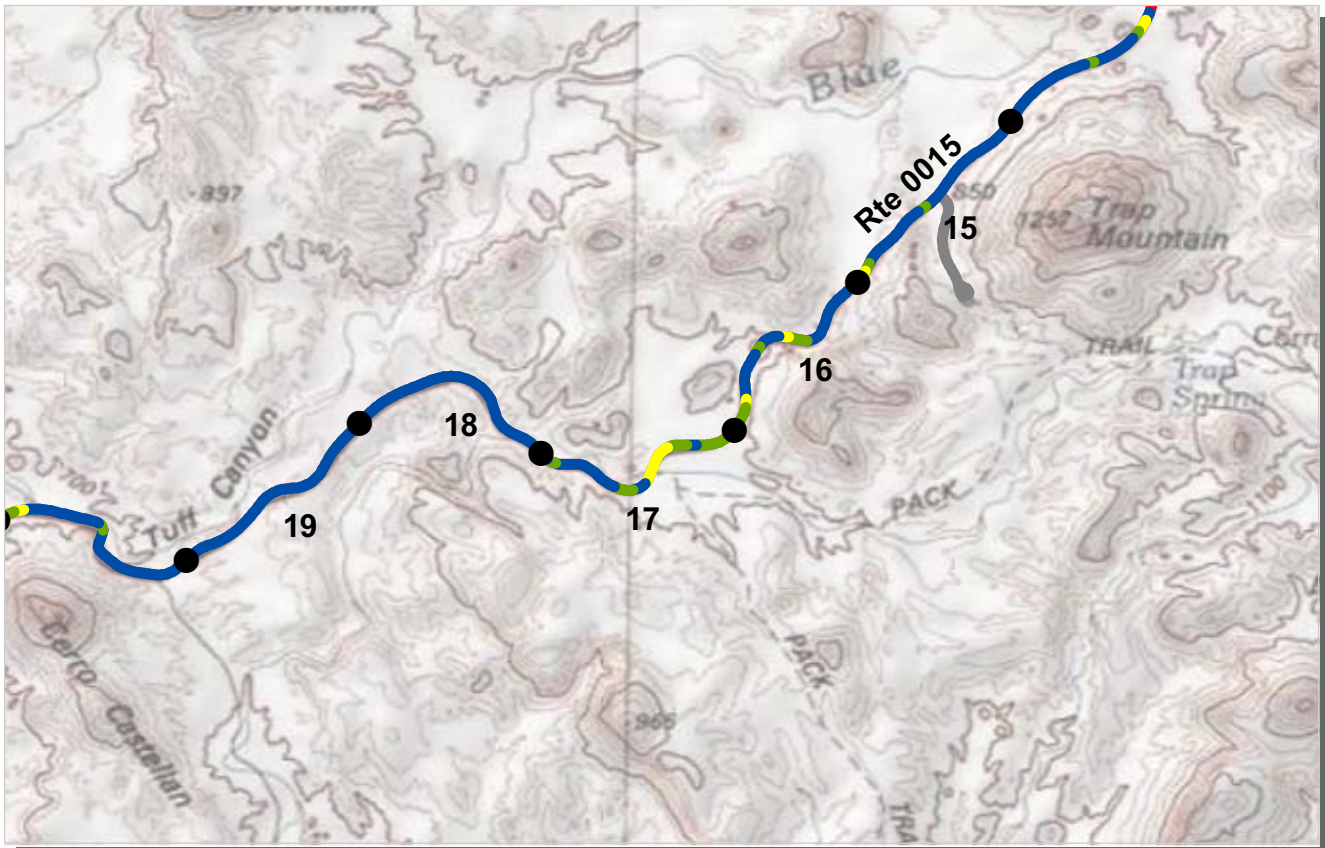
ROUTE: 0015 ROSS MAXWELL SCENIC DRIVE

<i>Section Number</i>	15	16	17	18	19
<i>Section Length (mi)</i>	1.00	1.00	1.00	1.00	1.00
<i>Cross Section Information</i>					
Number of Lanes	2	2	2	2	2
Paved Width (ft)	23	24	23	22	22
Lane Width (ft)	9	10	9	9	9
<i>Roadway Condition Information</i>					
SCR (Surface Condition Rating)	99	97	92	96	97
PCR (Pavement Condition Rating)	99	95	93	98	98
<i>Distress Index Values</i>					
Structural Crack Index	99	99	97	100	100
Transverse Cracking Index	99	97	92	96	97
Patching Index	100	100	100	100	100
Rutting Index	100	99	98	99	98
Roughness Condition Index (RCI)	100	92	94	100	100

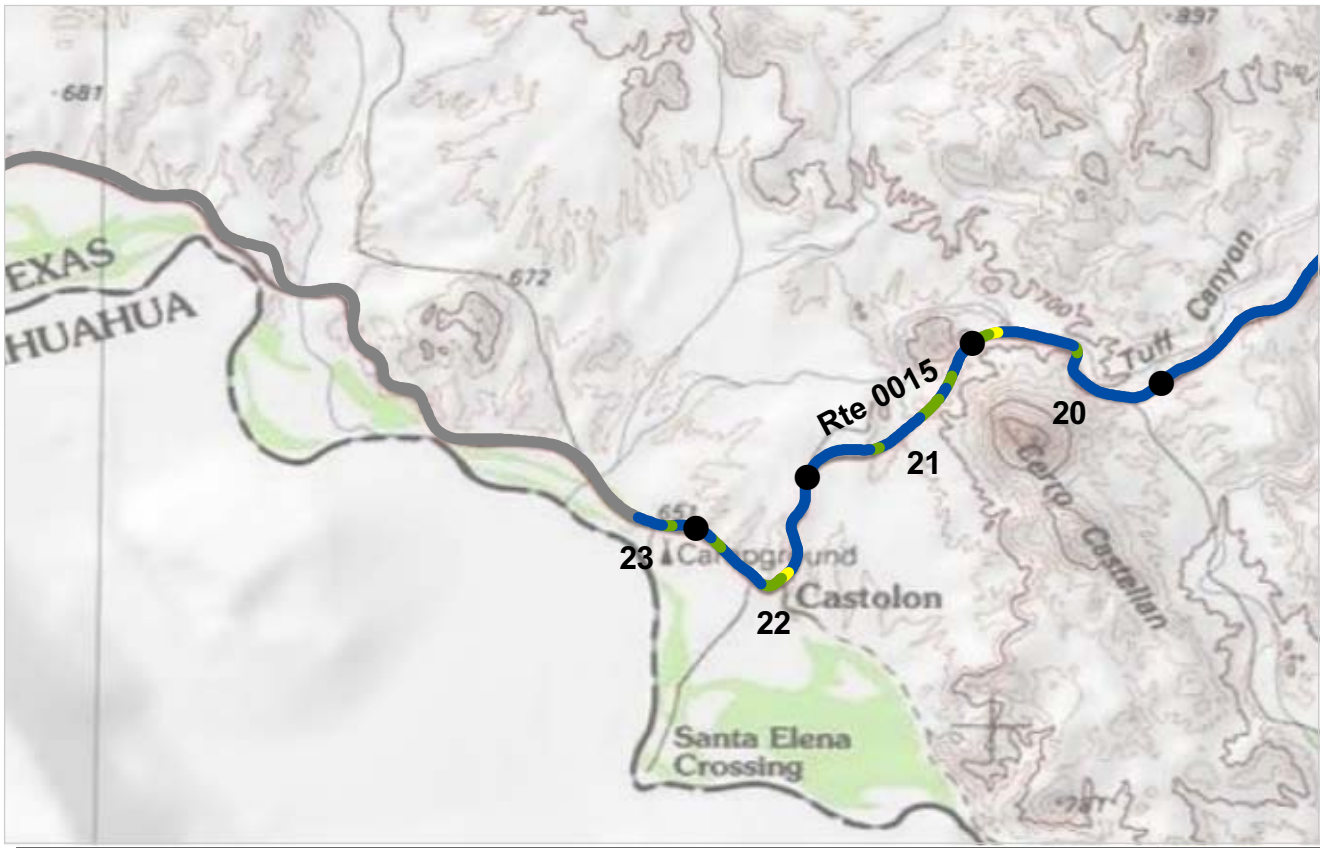
ROUTE: 0015 ROSS MAXWELL SCENIC DRIVE

<i>Section Number</i>	20	21	22	23	
<i>Section Length (mi)</i>	1.00	1.00	1.00	0.25	
<i>Cross Section Information</i>					
Number of Lanes	2	2	2	2	
Paved Width (ft)	23	23	22	22	
Lane Width (ft)	9	9	9	9	
<i>Roadway Condition Information</i>					
SCR (Surface Condition Rating)	96	95	94	93	
PCR (Pavement Condition Rating)	98	97	96	96	
<i>Distress Index Values</i>					
Structural Crack Index	98	99	97	95	
Transverse Cracking Index	96	95	94	93	
Patching Index	100	100	100	100	
Rutting Index	100	100	100	99	
Roughness Condition Index (RCI)	100	100	100	100

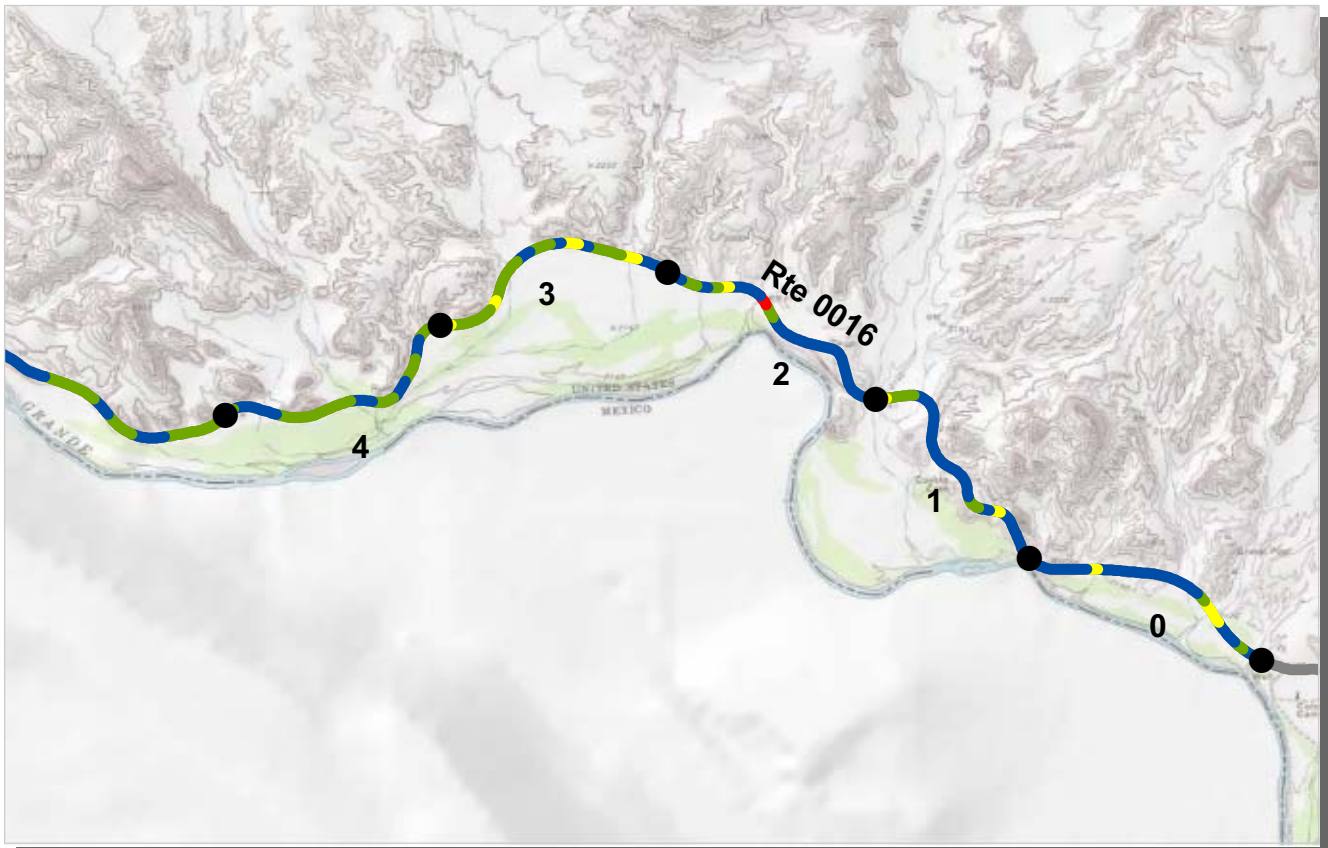
ROUTE: 0015 ROSS MAXWELL SCENIC DRIVE

<i>Section Number</i>	0	1	2	3	4
<i>Section Length (mi)</i>	1.00	1.00	1.00	1.00	1.00
<i>Cross Section Information</i>					
Number of Lanes	2	2	2	2	2
Paved Width (ft)	23	22	23	23	23
Lane Width (ft)	9	9	9	9	9
<i>Roadway Condition Information</i>					
SCR (Surface Condition Rating)	96	98	99	97	97
PCR (Pavement Condition Rating)	94	94	95	90	91
<i>Distress Index Values</i>					
Structural Crack Index	100	100	100	99	100
Transverse Cracking Index	100	100	100	99	100
Patching Index	96	98	99	100	100
Rutting Index	98	99	99	97	97
Roughness Condition Index (RCI)	91	89	90	79	83

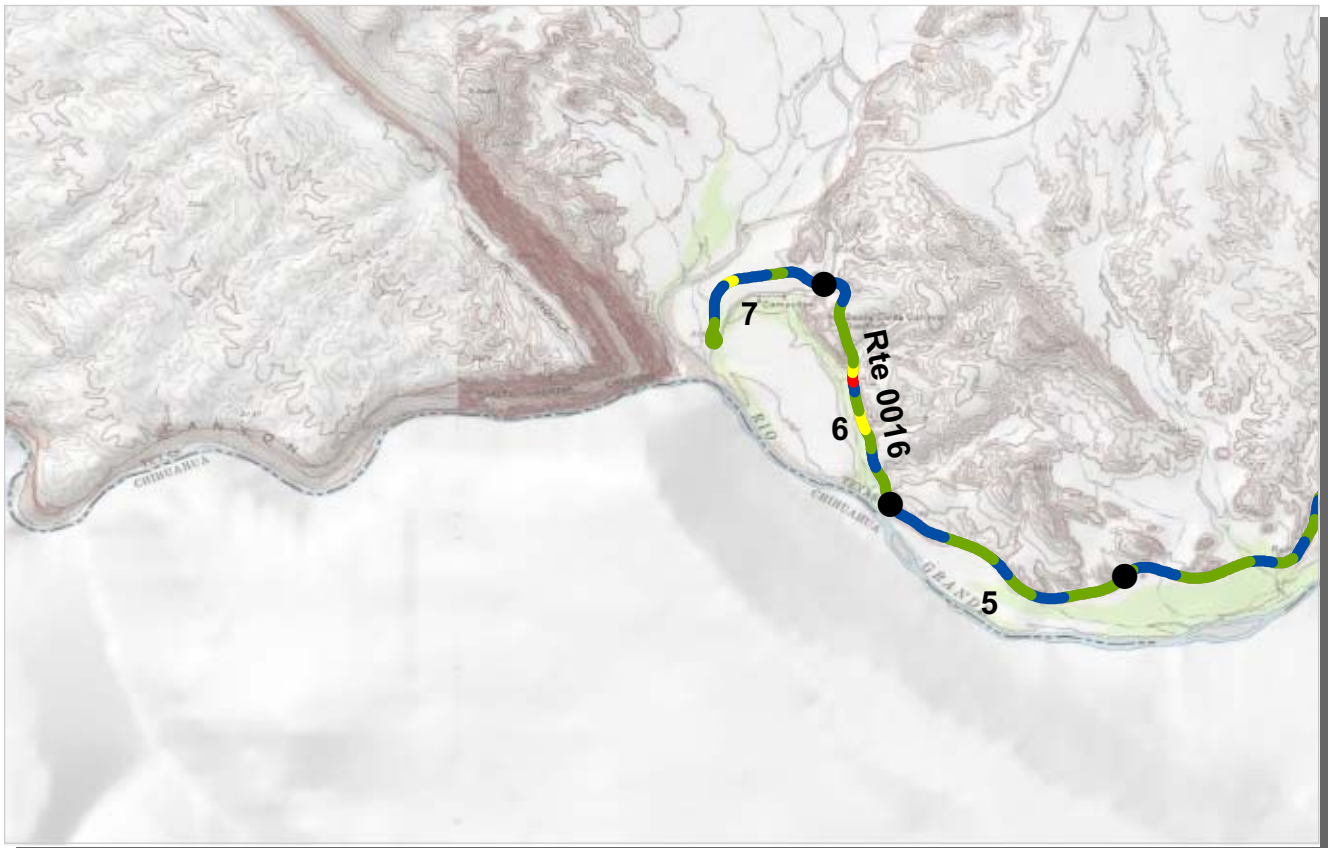
ROUTE: 0016 SANTA ELENA CANYON ROAD

<i>Section Number</i>	5	6	7		
<i>Section Length (mi)</i>	1.00	1.00	0.70		
<i>Cross Section Information</i>					
Number of Lanes	2	2	2		
Paved Width (ft)	23	22	24		
Lane Width (ft)	9	9	13		
<i>Roadway Condition Information</i>					
SCR (Surface Condition Rating)	97	97	97		
PCR (Pavement Condition Rating)	93	88	94		
<i>Distress Index Values</i>					
Structural Crack Index	100	100	100		
Transverse Cracking Index	100	100	100		
Patching Index	100	100	100		
Rutting Index	97	97	97		
Roughness Condition Index (RCI)	88	75	90

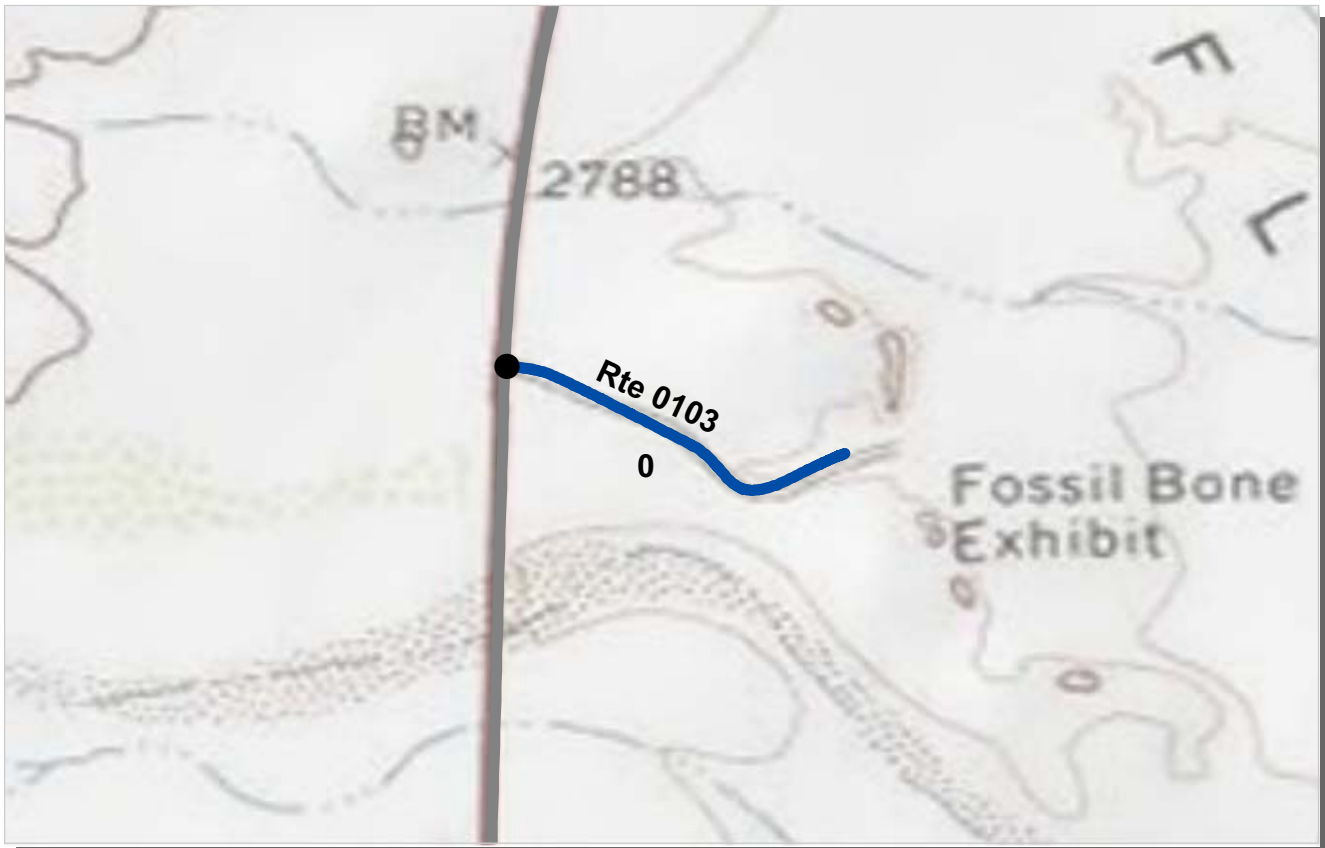
ROUTE: 0016 SANTA ELENA CANYON ROAD

Section Number	0				
Section Length (mi)	0.23				
Cross Section Information					
Number of Lanes	2				
Paved Width (ft)	23				
Lane Width (ft)	11				
Roadway Condition Information					
SCR (Surface Condition Rating)	98				
PCR (Pavement Condition Rating)	98				
Distress Index Values					
Structural Crack Index	98				
Transverse Cracking Index	98				
Patching Index	100				
Rutting Index	98				
Roughness Condition Index (RCI)	NC

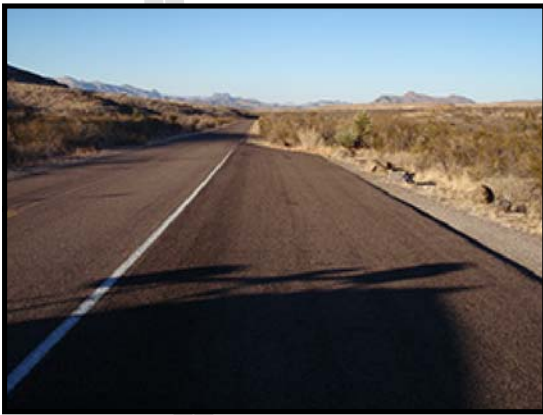
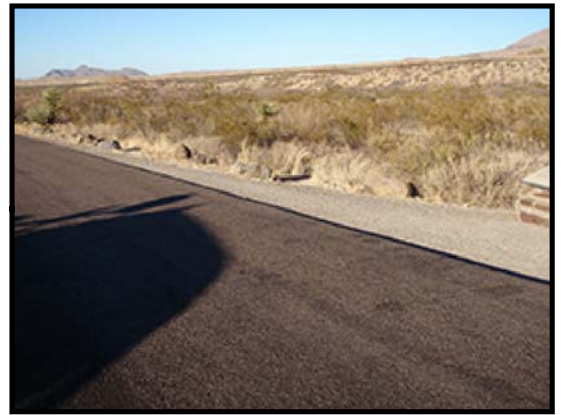
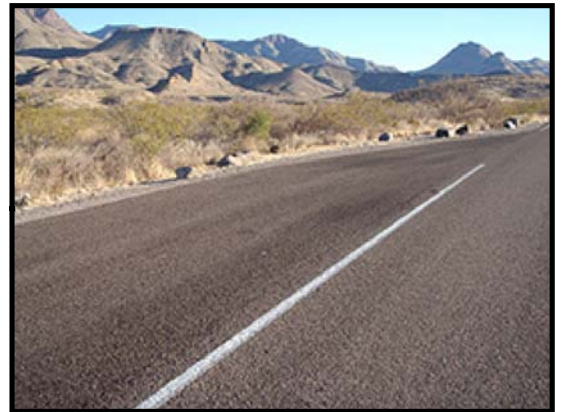
Route Number	Public / NonPublic	Date Visited	Area (sq ft)	Lane Miles *	Surface Type
1003	PUBLIC	1/13/2012	3,635	0.06	AS
Culverts	Drop Inlets	Gates	Curb & Gutter	Curb	PCR
0	0	0	NO CURB AND GUTTER	NO CURB	EXCELLENT/97

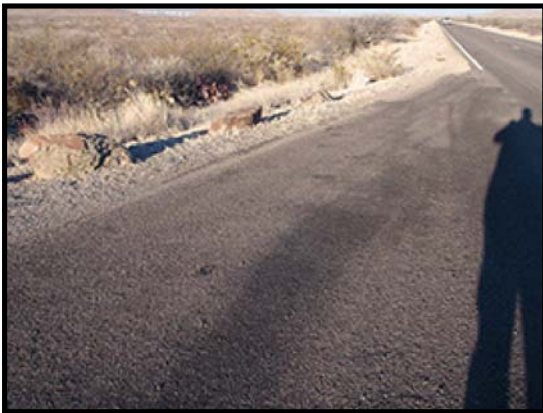
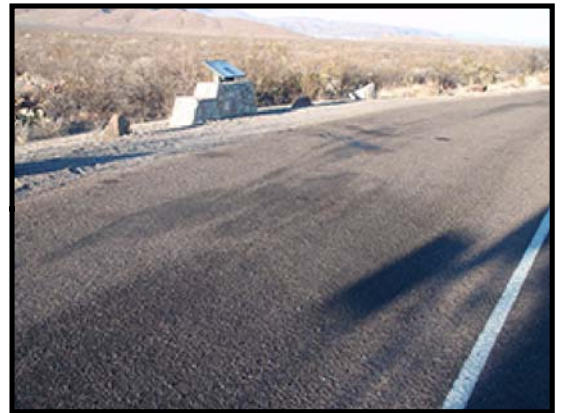
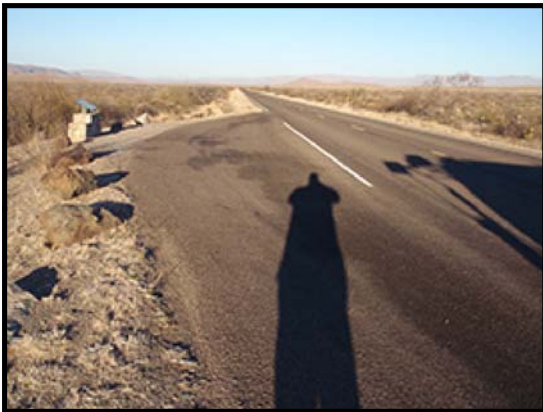
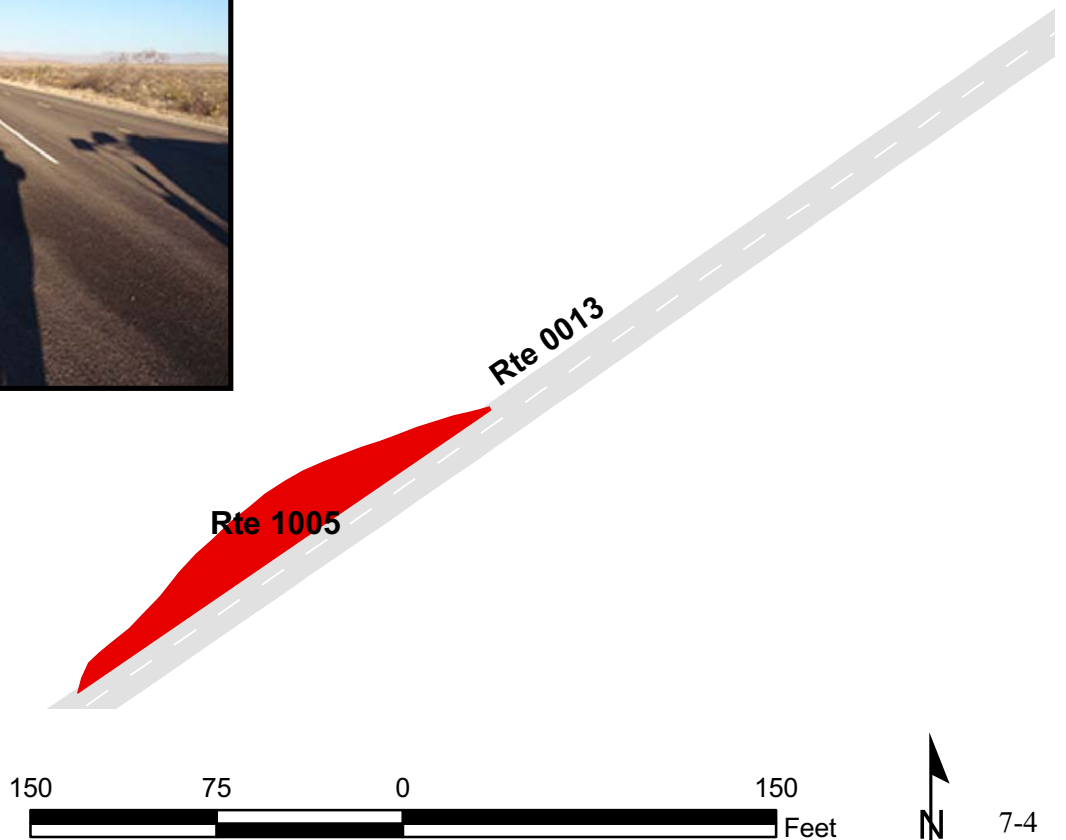
Route 1005

Route Number	Public / NonPublic	Date Visited	Area (sq ft)	Lane Miles *	Surface Type
1005	PUBLIC	1/13/2012	2,589	0.05	AS
Culverts	Drop Inlets	Gates	Curb & Gutter	Curb	PCR
0	0	0	NO CURB AND GUTTER	NO CURB	EXCELLENT/97

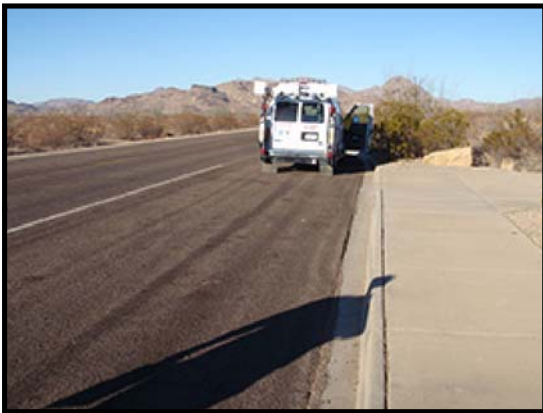
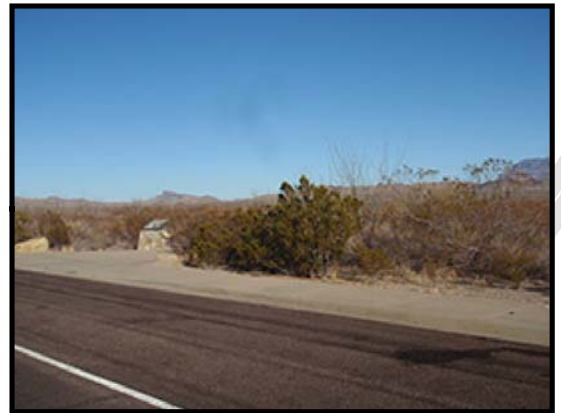
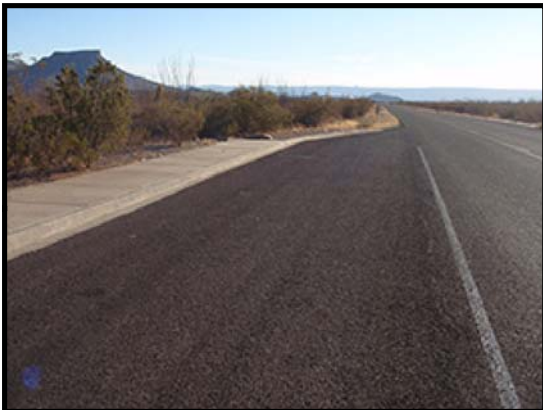
Route 1006

Route Number	Public / NonPublic	Date Visited	Area (sq ft)	Lane Miles *	Surface Type
1006	PUBLIC	1/13/2012	2,643	0.05	AS
Culverts	Drop Inlets	Gates	Curb & Gutter	Curb	PCR
0	0	0	CONCRETE CURB AND GUTTER	NO CURB	EXCELLENT/97

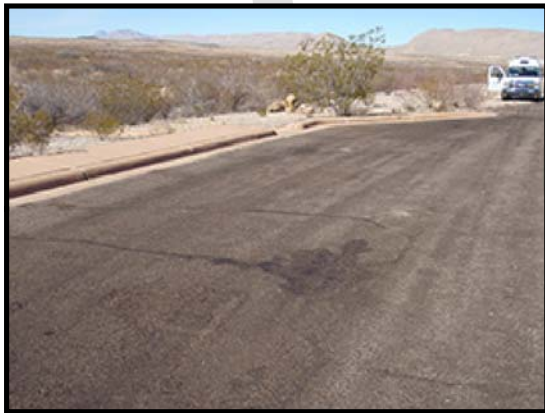
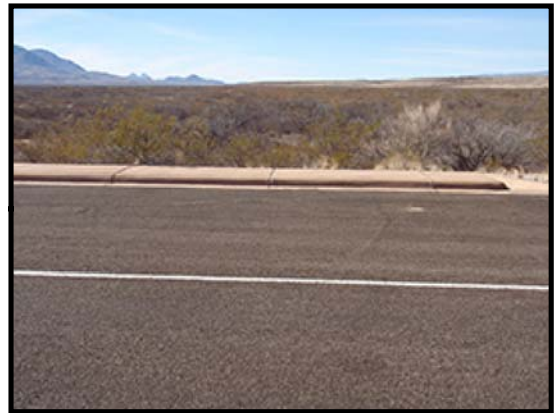
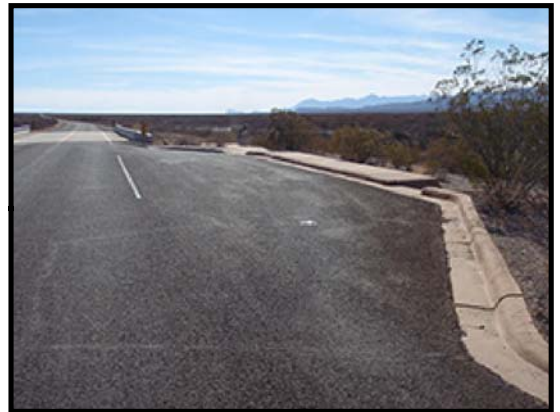
Route 1009

Route Number	Public / NonPublic	Date Visited	Area (sq ft)	Lane Miles *	Surface Type
1009	PUBLIC	1/14/2012	1,097	0.02	AS
Culverts	Drop Inlets	Gates	Curb & Gutter	Curb	PCR
0	0	0	CONCRETE CURB AND GUTTER	NO CURB	FAIR/73

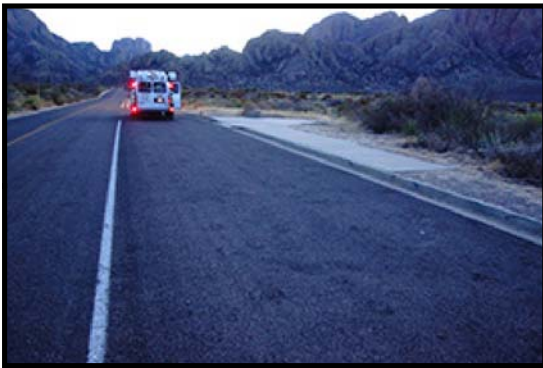
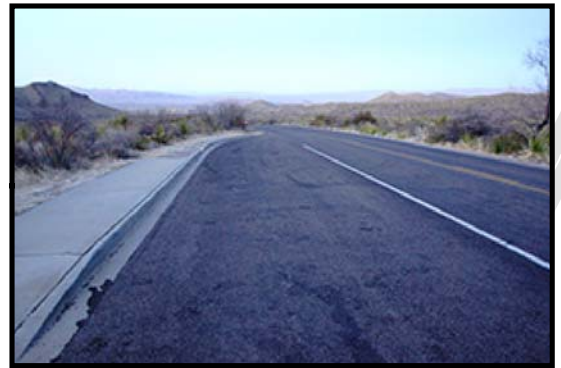
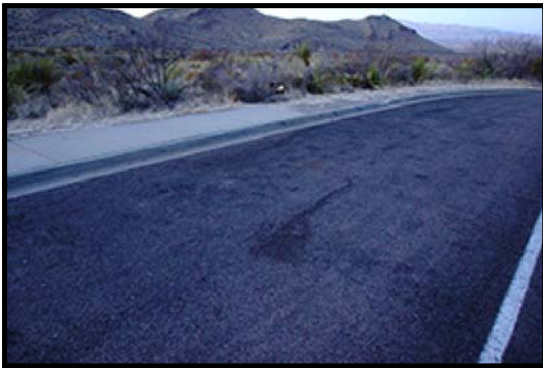
Route 1013

Route Number	Public / NonPublic	Date Visited	Area (sq ft)	Lane Miles *	Surface Type
1013	PUBLIC	1/13/2012	2,128	0.04	AS
Culverts	Drop Inlets	Gates	Curb & Gutter	Curb	PCR
0	0	0	CONCRETE CURB AND GUTTER	NO CURB	GOOD/90

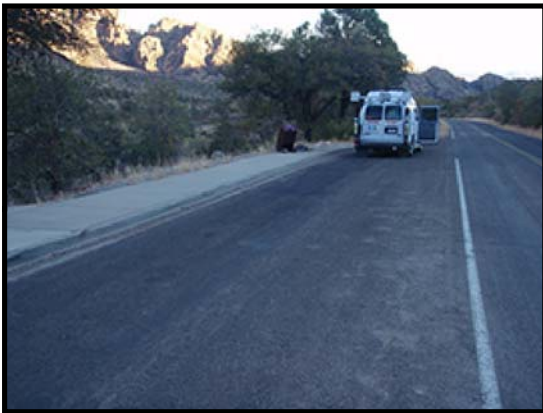
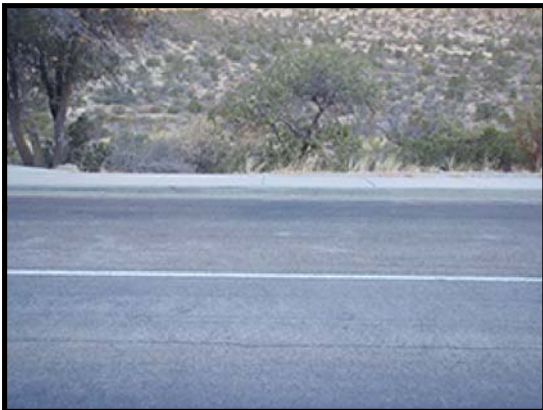
Route 1014

Route Number	Public / NonPublic	Date Visited	Area (sq ft)	Lane Miles *	Surface Type
1014	PUBLIC	1/13/2012	2,464	0.04	AS
Culverts	Drop Inlets	Gates	Curb & Gutter	Curb	PCR
0	0	0	CONCRETE CURB AND GUTTER	NO CURB	GOOD/90

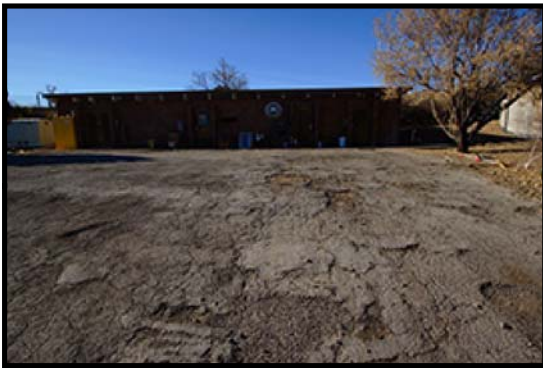
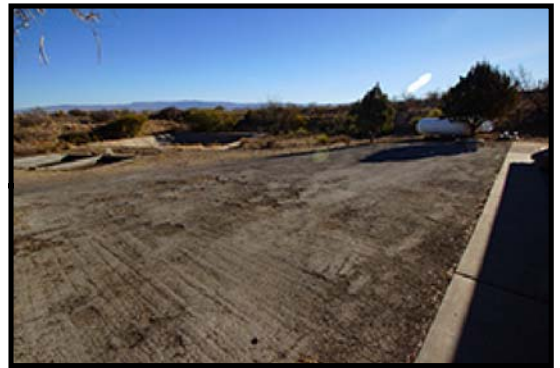
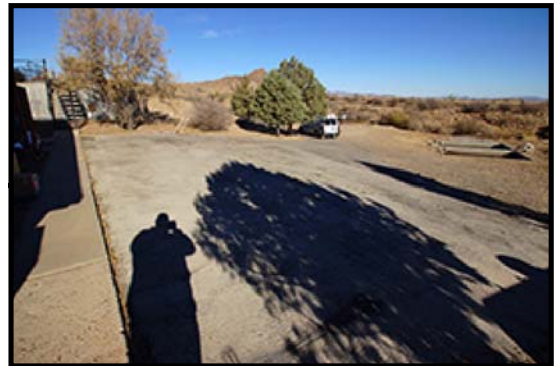
Route 1020

Route Number	Public / NonPublic	Date Visited	Area (sq ft)	Lane Miles *	Surface Type
1020	NONPUBLIC	1/13/2012	1,745	0.03	AS
Culverts	Drop Inlets	Gates	Curb & Gutter	Curb	PCR
0	0	0	NO CURB AND GUTTER	NO CURB	POOR/45

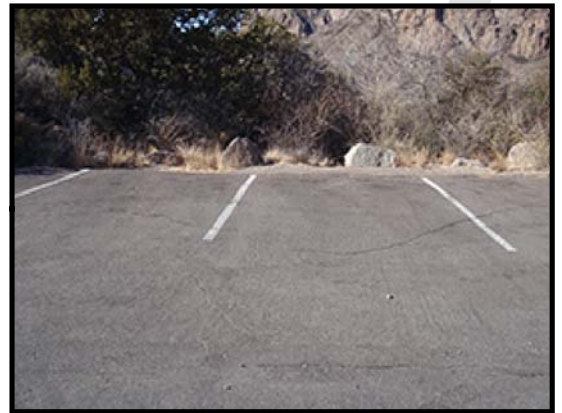
Route 1026

Route Number	Public / NonPublic	Date Visited	Area (sq ft)	Lane Miles *	Surface Type
1026	PUBLIC	1/14/2012	1,194	0.02	AS
Culverts	Drop Inlets	Gates	Curb & Gutter	Curb	PCR
0	0	0	NO CURB AND GUTTER	NO CURB	FAIR/73
