Federal Lands Highway Road Inventory Program

Road Inventory and Condition Assessment

Gauley River National Recreation Area GARI

Cycle 5 Report

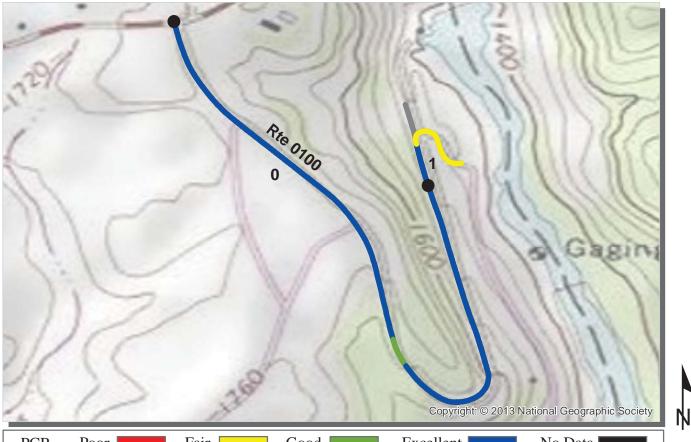
ROUTE: 0100 GAULEY TAILWATERS ACCESS ROAD GARI : GAULEY RIVER NATIONAL RECREATION AREA

PCR	Poor		Fair	Good	Excellent	No Data
			(0 - 60)	(61 - 84)	(85 - 94)	(95 - 10)0)
*	If the PCI	R rating i	s not availab	le for a section, the	SCR rating will be di	splayed. See appendix for	or definitions and formulas.

COLLECTED:	11/4/2013
NORTHEAST REGION			TOTAL LENGTH:	1.15 Miles
Section Number	0	1		
Section Length (mi)	1.00	0.15		
Cross Section Information				
Number of Lanes	2	2		
Paved Width (ft)	19	22		
Lane Width (ft)	9	9		
Roadway Condition Information				
SCR (Surface Condition Rating)	99	98		
PCR (Pavement Condition Rating)	99	84		
Distress Index Values				
Structural Crack Index	99	98		
Transverse Cracking Index	100	99		
Patching Index	100	100		
Rutting Index	100	99		
Roughness Condition Index (RCI)	100	63

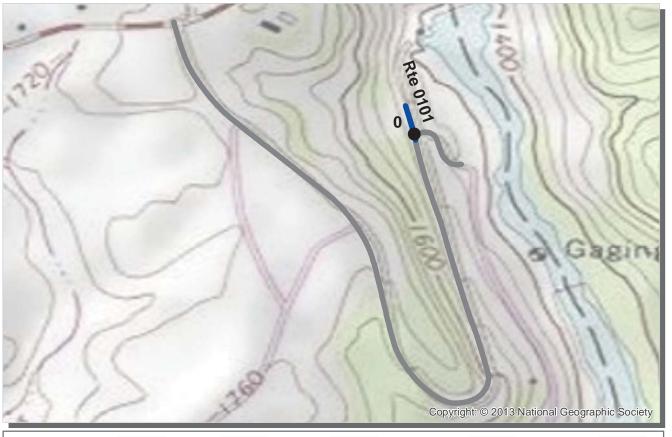
ROUTE: 0101 HYDROPLANT ROAD GARI : GAULEY RIVER NATIONAL RECREATION AREA

PCR	Poor		Fair	Good	Excellent	No Data
		(0 - 60)	(61 - 84)	(85 - 94)	(95 - 10)0)
* If the PC	R rating	is not availal	ble for a section, the	SCR rating will be di	splayed. See appendix for	or definitions and formulas.

NORTHEAST REGION		TOTAL	LENGTH:	0.04 Miles
Section Number	0			
Section Length (mi)	0.04			
Cross Section Information				
Number of Lanes	2			
Paved Width (ft)	17			
Lane Width (ft)	9			
Roadway Condition Information				
SCR (Surface Condition Rating)	99			
PCR (Pavement Condition Rating)	99			
Distress Index Values				
Structural Crack Index	100			
Transverse Cracking Index	100			
Patching Index	100			
Rutting Index	99			
Roughness Condition Index (RCI)	NC

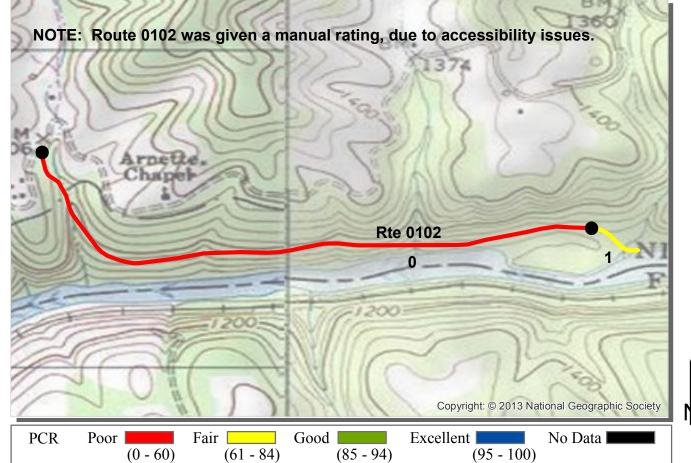
* If the PCR rating is not available for a section, the SCR rating will be displayed. See appendix for definitions and formulas.

COLLECTED:	8/5/2013
NORTHEAST REGION			TOTAL LENGTH:	1.09 Miles
Section Number	0	1		
Section Length (mi)	1.00	0.09		
Cross Section Information				
Number of Lanes	1	1		
Paved Width (ft)	9	9		
Lane Width (ft)	9	9		
Roadway Condition Information				
SCR (Surface Condition Rating)	41	63		
PCR (Pavement Condition Rating)	41	63		
Distress Index Values				
Structural Crack Index	41	63		
Transverse Cracking Index	82	90		
Patching Index	59	73		
Rutting Index	59	73		
Roughness Condition Index (RCI)	NC	NC
