Final Report

Road Inventory and Condition Assessment of Paved Routes Assateague Island National Seashore

**Federal Highway Administration
Eastern Federal Lands Highway Division
Road Inventory Program (RIP)**

Report Date: January 2022

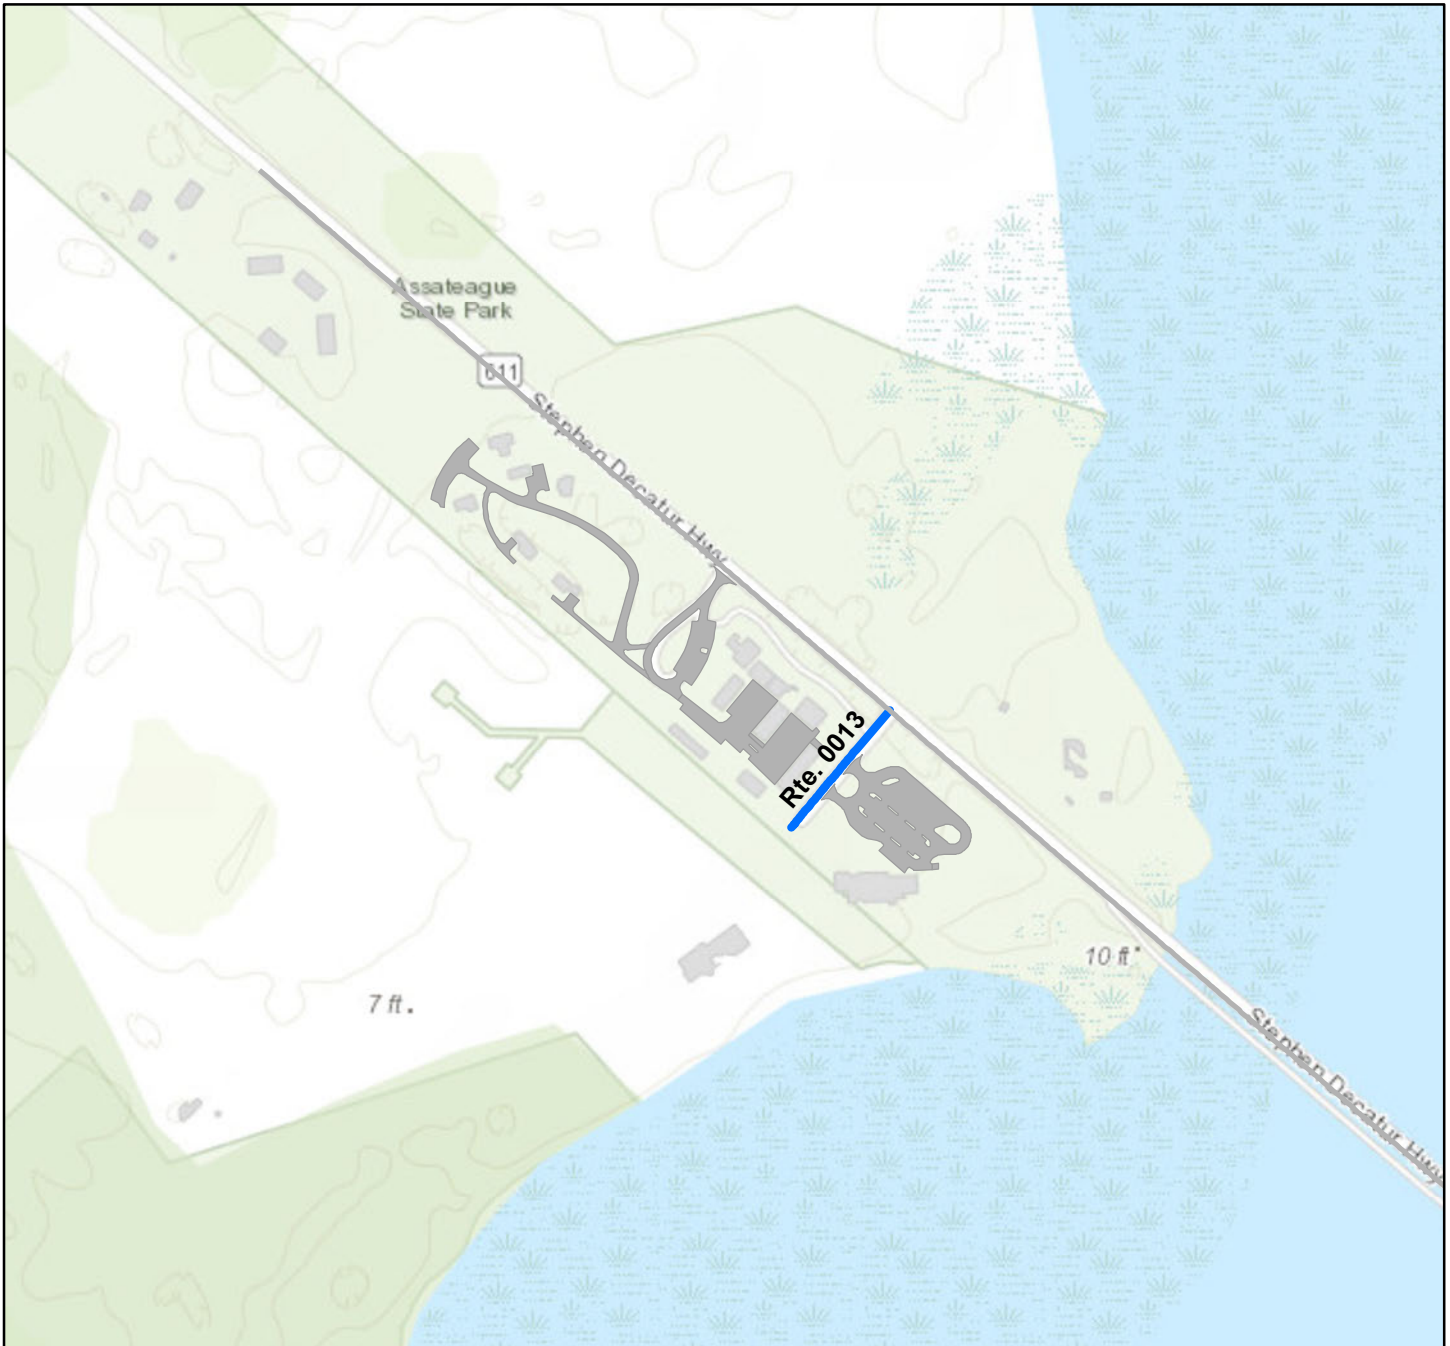
Area Map 1A

ROUTE CONDITION MAP

PCR - MILE BY MILE

Colors on map represent condition scores at 1-mile intervals. See Appendix for definitions and formulas
Only Data Collection Vehicle and Manually Rated Roads are displayed

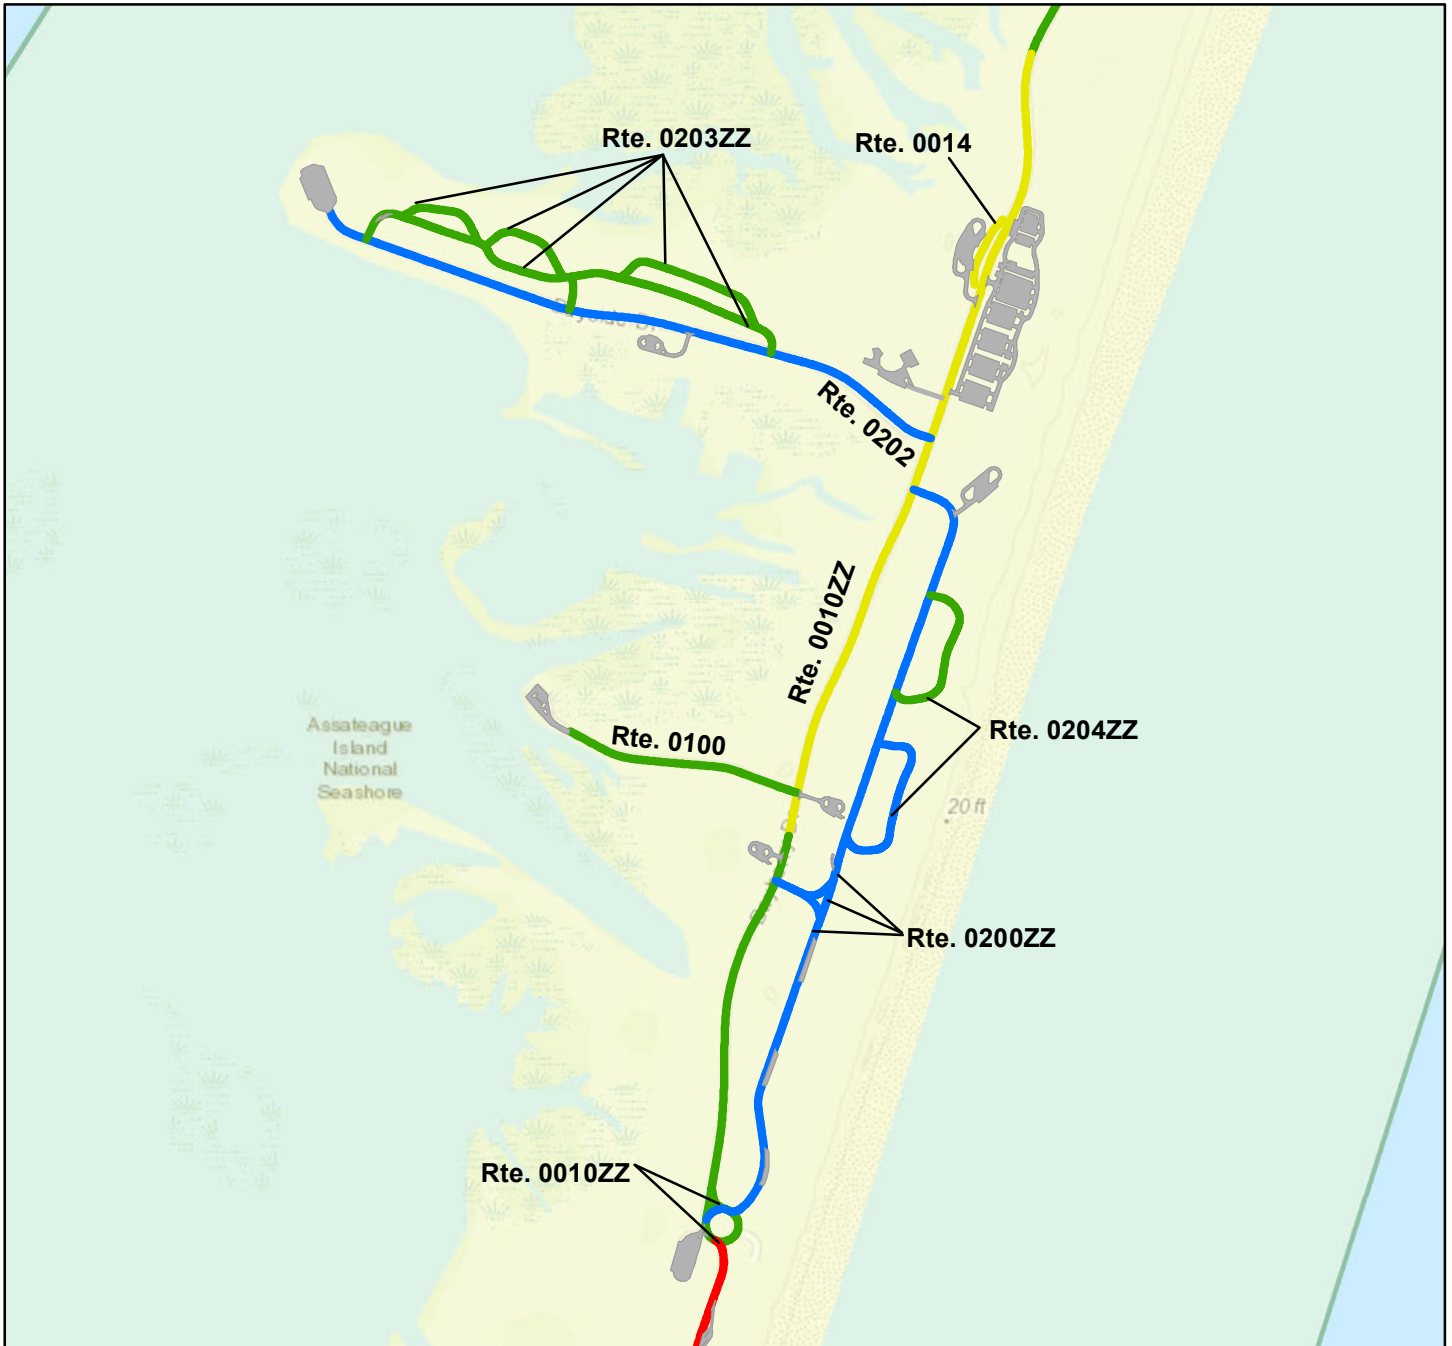
Area Map 1B

ROUTE CONDITION MAP

PCR - MILE BY MILE

Colors on map represent condition scores at 1-mile intervals. See Appendix for definitions and formulas
Only Data Collection Vehicle and Manually Rated Roads are displayed

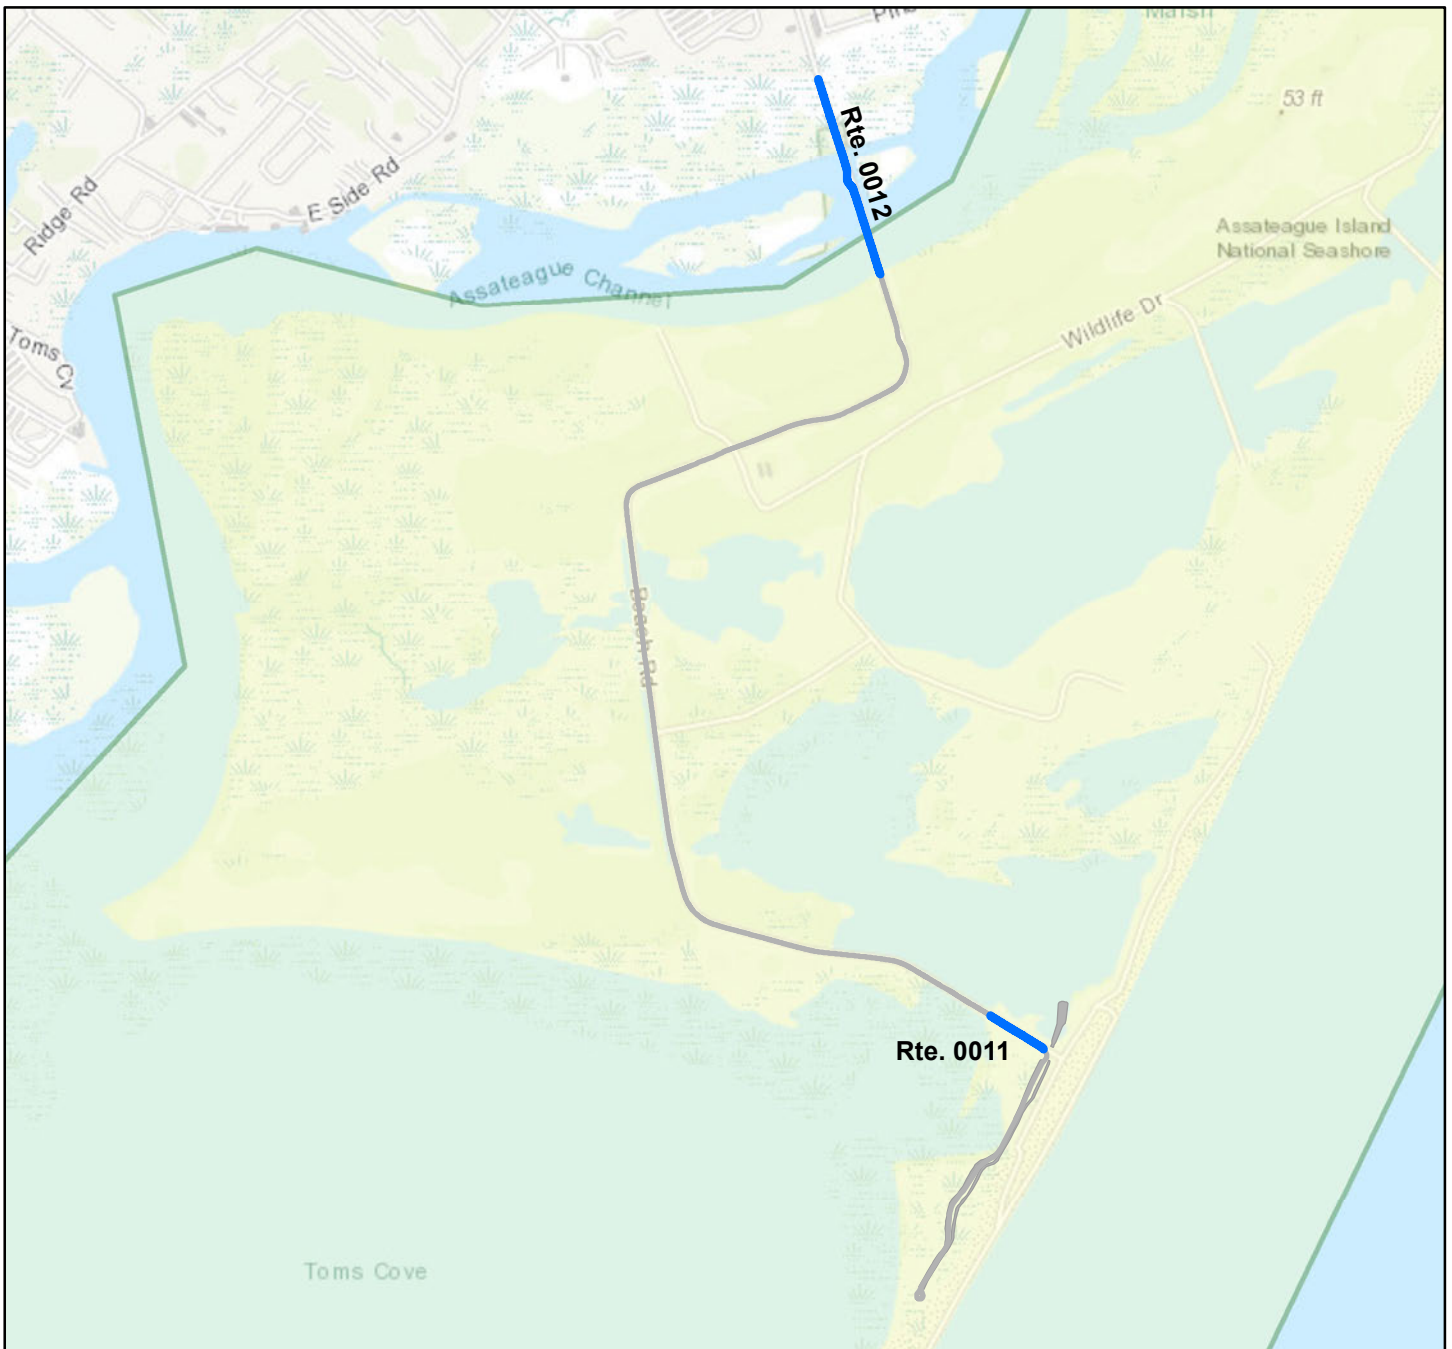
Area Map 3

ROUTE CONDITION MAP

PCR - MILE BY MILE

Colors on map represent condition scores at 1-mile intervals. See Appendix for definitions and formulas
Only Data Collection Vehicle and Manually Rated Roads are displayed

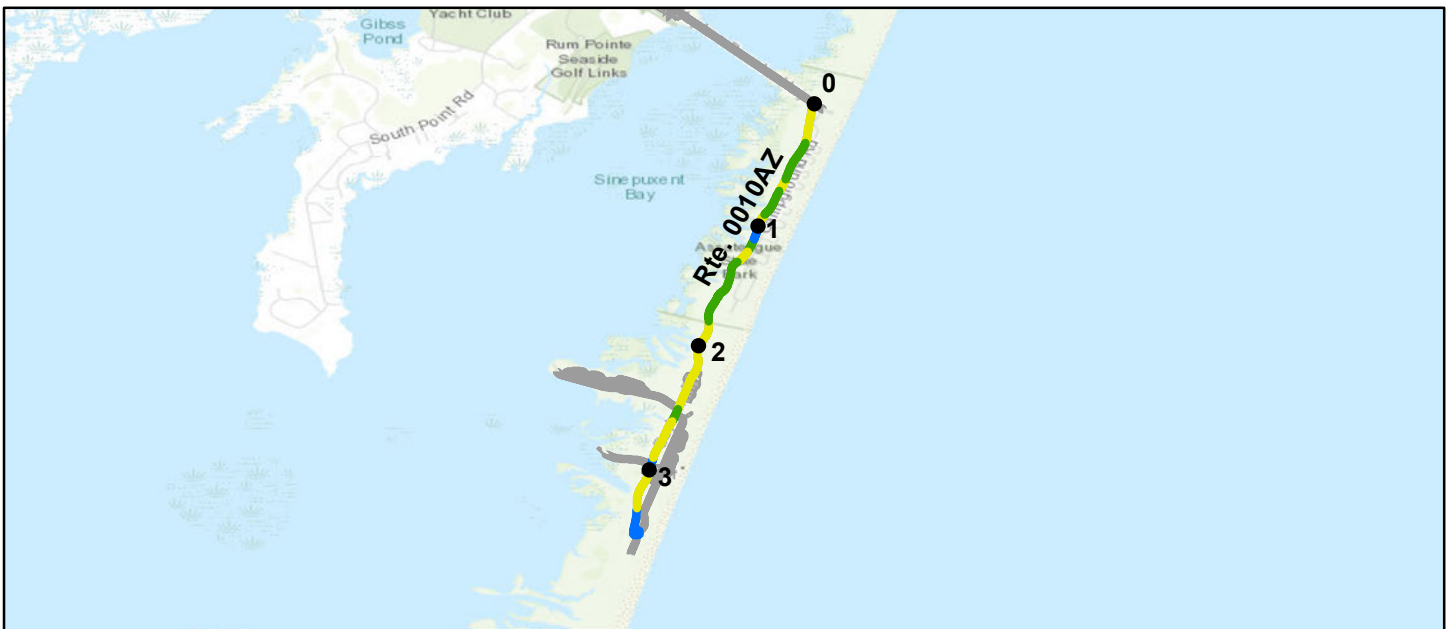
ROUTE 0010AZ: BAYBERRY DRIVE MAIN PARK ACCESS

Subcomponent of Route ASIS-0010ZZ
 Data Collection Vehicle (DCV) Rating

Route Condition Legend – Pavement Condition Rating (PCR)						
Poor (0 - 60)	Fair (61- 84)	Good (85 - 94)	Excellent (95 - 100)	Not Rated		
Colors on map represent condition scores at 0.10-mile intervals. See Appendix for definitions and formulas.						
Inspection Date: 4/20/2021	Beginning Section MP	0	1	2	3	
Paved Length (Miles): 3.6	Section Length (MI)	1	1	1	0.6	
Surface Type: ASPHALT	Route Summary					
Roadway Condition Information						
Pavement Condition Rating (PCR)	85	86	86	82	89	
Surface Condition Rating (SCR)	75	76	76	70	82	
Roughness Condition Index (RCI)	100	100	100	100	100	
Distress Index Values						
Structural Crack Index	96	94	99	94	96	
Alligator Crack Index	100	100	100	100	100	
Longitudinal Crack Index	96	94	99	94	96	
Transverse Cracking Index	75	76	76	70	82	
Patching Index	100	100	100	100	100	
Rutting Index	99	99	99	98	100	
International Roughness Index (IRI)	101	109	100	95	97	
Lane & Width Information

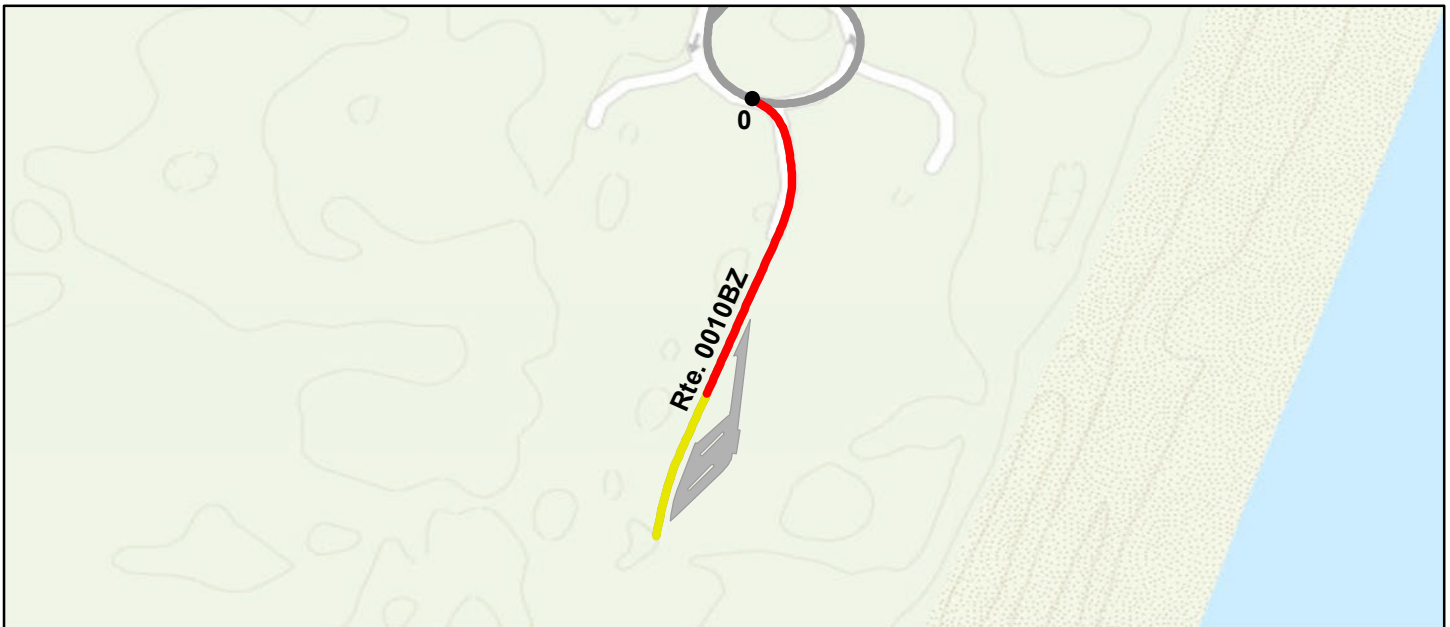
ROUTE 0010BZ: BAYBERRY DRIVE OSV ROAD ACCESS

Subcomponent of Route ASIS-0010ZZ
Data Collection Vehicle (DCV) Rating

Route Condition Legend – Pavement Condition Rating (PCR)						
Poor (0 - 60)	Fair (61- 84)	Good (85 - 94)	Excellent (95 - 100)	Not Rated		
Colors on map represent condition scores at 0.10-mile intervals. See Appendix for definitions and formulas.						
Inspection Date: 4/20/2021	Beginning Section MP	0				
Paved Length (Miles): 0.15	Section Length (MI)	0.15				
Surface Type: ASPHALT	Route Summary					
Roadway Condition Information						
Pavement Condition Rating (PCR)	40	40				
Surface Condition Rating (SCR)	40	40				
Roughness Condition Index (RCI)	N/A	N/A				
Distress Index Values						
Structural Crack Index	81	81				
Alligator Crack Index	100	100				
Longitudinal Crack Index	81	81				
Transverse Cracking Index	40	40				
Patching Index	100	100				
Rutting Index	96	96				
International Roughness Index (IRI)	N/A	N/A				
Lane & Width Information						
Number of Lanes	2	2				
Paved Width (ft)	20.5	20.5				
Lane Width (ft)	9.3	9.3

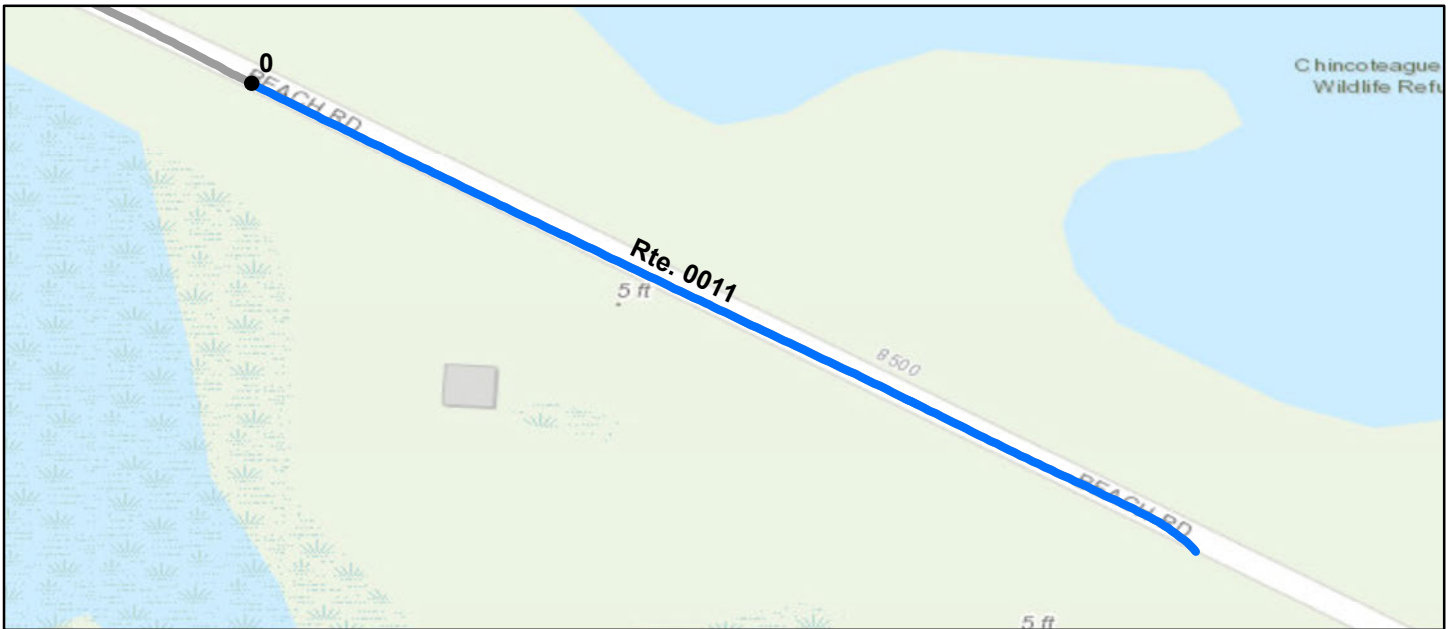
ROUTE 0011: PARK ENTRANCE BEACH ROAD

Colors on map represent condition scores at 0.10-mile intervals. See Appendix for definitions and formulas.

Inspection Date:	4/20/2021	Beginning Section MP	0				
Paved Length (Miles):	0.15	Section Length (MI)	0.15				
Surface Type:	ASPHALT	Route Summary					
Roadway Condition Information							
Pavement Condition Rating (PCR)	100	100					
Surface Condition Rating (SCR)	100	100					
Roughness Condition Index (RCI)	N/A	N/A					
Distress Index Values							
Structural Crack Index	100	100					
Alligator Crack Index	100	100					
Longitudinal Crack Index	100	100					
Transverse Cracking Index	100	100					
Patching Index	100	100					
Rutting Index	100	100					
International Roughness Index (IRI)	N/A	N/A					
Lane & Width Information							
Number of Lanes	2	2					
Paved Width (ft)	21.3	21.3					
Lane Width (ft)	10.3	10.3

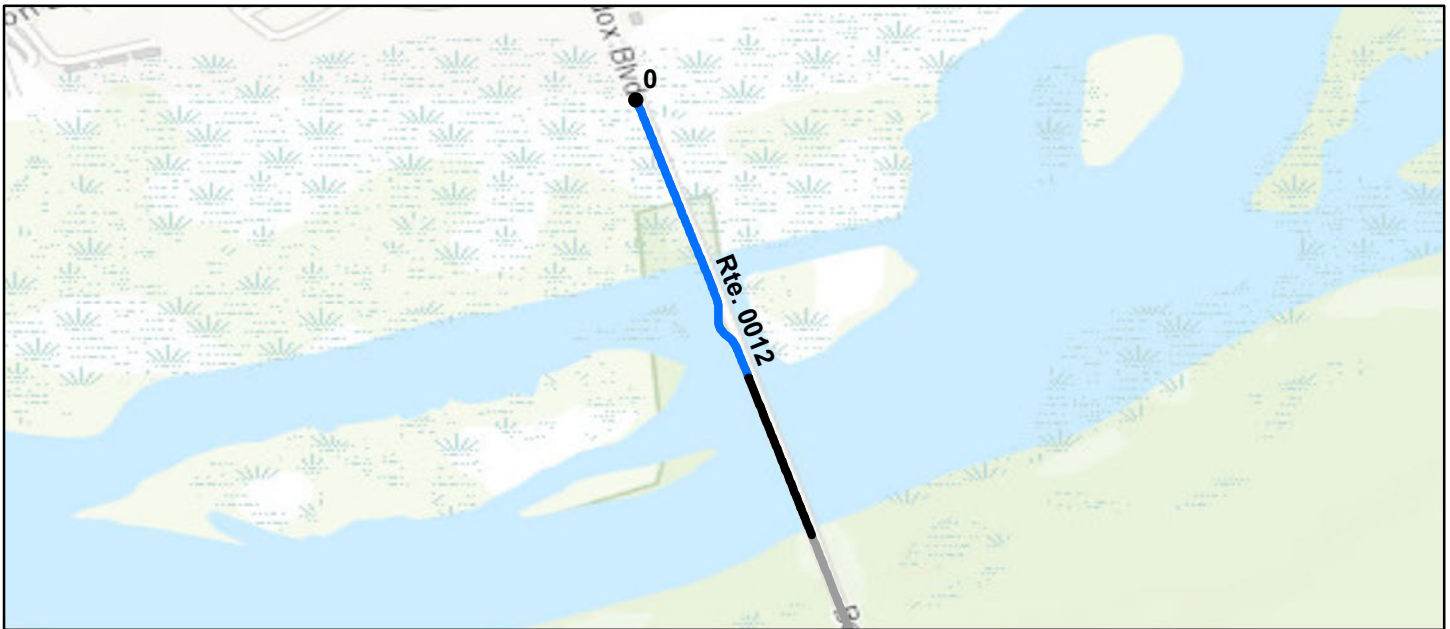
ROUTE 0012: MADDOX BOULEVARD

Route Condition Legend – Pavement Condition Rating (PCR)						
Poor (0 - 60)	Fair (61- 84)	Good (85 - 94)	Excellent (95 - 100)	Not Rated		
Colors on map represent condition scores at 0.10-mile intervals. See Appendix for definitions and formulas.						
Inspection Date: 4/20/2021	Beginning Section MP	0				
Paved Length (Miles): 0.47	Section Length (MI)	0.47				
Surface Type: ASPHALT	Route Summary					
Roadway Condition Information						
Pavement Condition Rating (PCR)	99	99				
Surface Condition Rating (SCR)	99	99				
Roughness Condition Index (RCI)	N/A	N/A				
Distress Index Values						
Structural Crack Index	100	100				
Alligator Crack Index	100	100				
Longitudinal Crack Index	100	100				
Transverse Cracking Index	100	100				
Patching Index	100	100				
Rutting Index	99	99				
International Roughness Index (IRI)	N/A	N/A				
Lane & Width Information						
Number of Lanes	2	2				
Paved Width (ft)	21.3	21.3

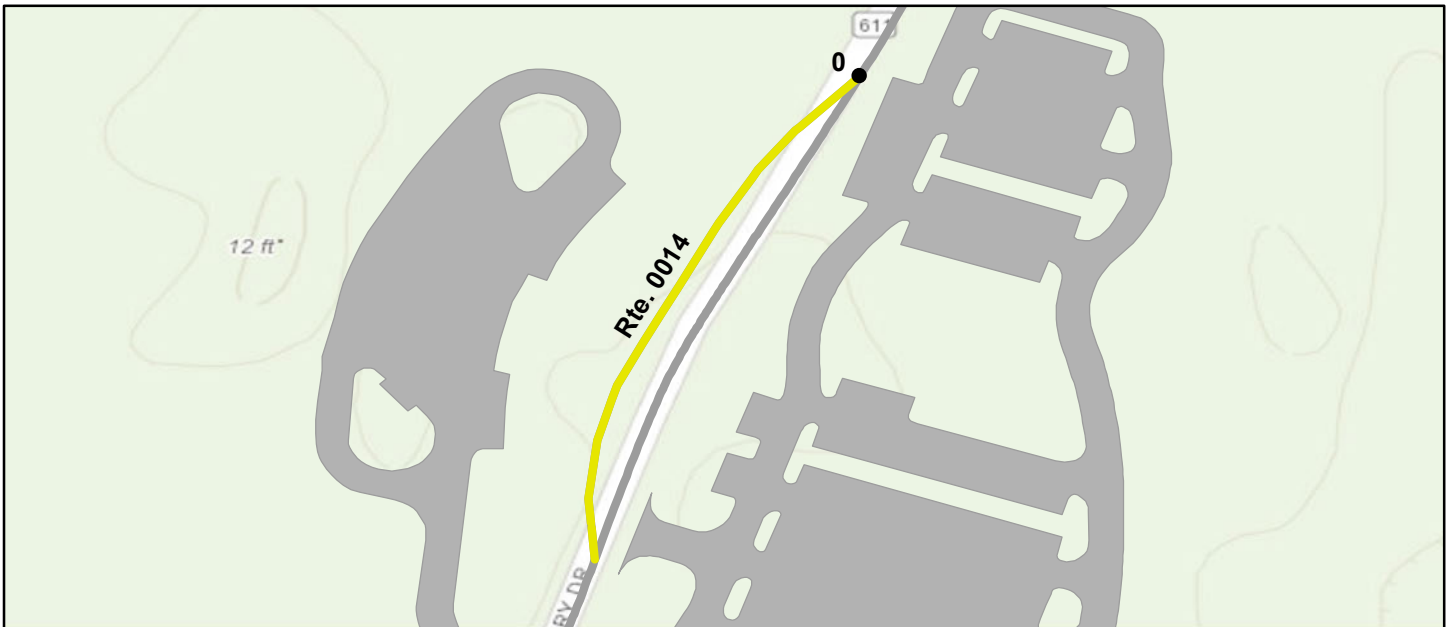
ROUTE 0014: ENTRANCE STATION ROAD SPUR

Colors on map represent condition scores at 0.10-mile intervals. See Appendix for definitions and formulas.

Inspection Date:	4/20/2021	Beginning Section MP	0				
Paved Length (Miles):	0.08	Section Length (MI)	0.08				
Surface Type:	ASPHALT	Route Summary					
Roadway Condition Information							
Pavement Condition Rating (PCR)	67	67					
Surface Condition Rating (SCR)	67	67					
Roughness Condition Index (RCI)	N/A	N/A					
Distress Index Values							
Structural Crack Index	88	88					
Alligator Crack Index	100	100					
Longitudinal Crack Index	88	88					
Transverse Cracking Index	67	67					
Patching Index	100	100					
Rutting Index	93	93					
International Roughness Index (IRI)	N/A	N/A					
Lane & Width Information							
Number of Lanes	1	1					
Paved Width (ft)	30.2	30.2					
Lane Width (ft)	15.6	15.6

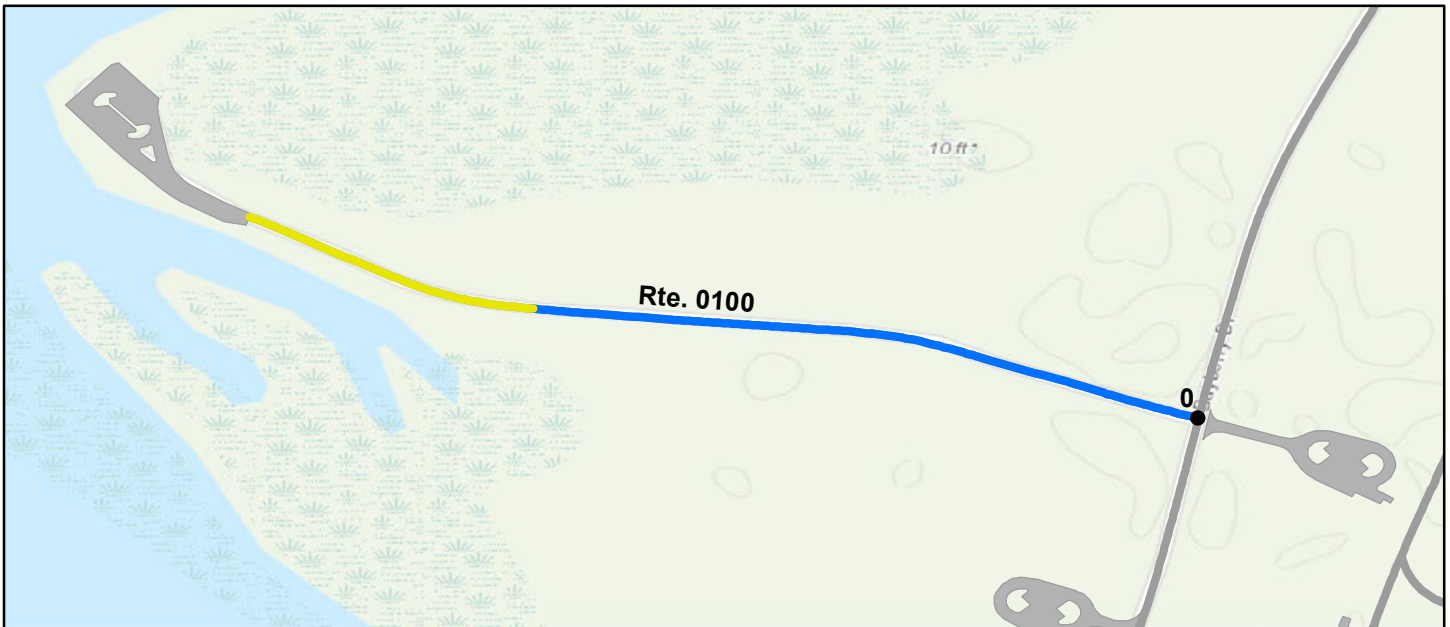
ROUTE 0100: OLD FERRY LANDING ROAD

Route Condition Legend – Pavement Condition Rating (PCR)									
Poor (0 - 60)		Fair (61- 84)		Good (85 - 94)		Excellent (95 - 100)		Not Rated	
Colors on map represent condition scores at 0.10-mile intervals. See Appendix for definitions and formulas.									
Inspection Date:	4/20/2021	Beginning Section MP	0						
Paved Length (Miles):	0.29	Section Length (MI)	0.29						
Surface Type:	ASPHALT	Route Summary							
Roadway Condition Information									
Pavement Condition Rating (PCR)		91	91						
Surface Condition Rating (SCR)		91	91						
Roughness Condition Index (RCI)		N/A	N/A						
Distress Index Values									
Structural Crack Index		98	98						
Alligator Crack Index		100	100						
Longitudinal Crack Index		98	98						
Transverse Cracking Index		91	91						
Patching Index		100	100						
Rutting Index		99	99						
International Roughness Index (IRI)		N/A	N/A						
Lane & Width Information									
Number of Lanes		2	2

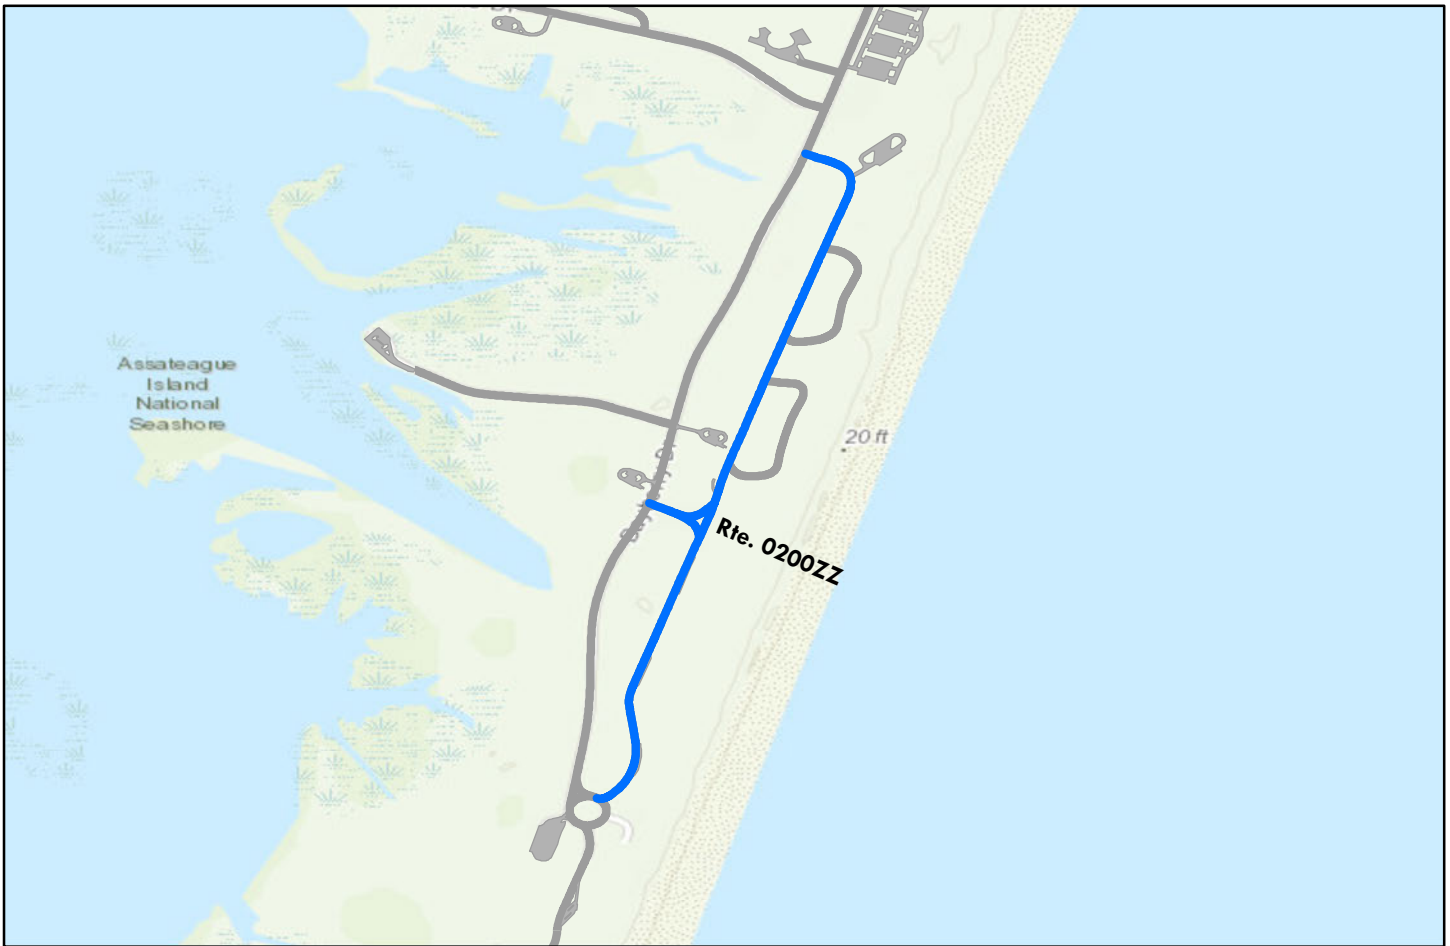
ROUTE 0200ZZ: OCEANSIDE DRIVE

Note: The weighted average summary PCR value is calculated from only the sections of road where the PCR was collected. The overall PCR for the summary route may not reflect individual subcomponent ratings.

Route Condition Legend – Pavement Condition Rating (PCR)						
Poor (0 - 60)	Fair (61- 84)	Good (85 - 94)	Excellent (95 - 100)	Not Rated		
See Appendix for definitions and formulas						
Inspection Date:	4/20/2021					
Paved Length (Miles):	1.06					
Surface Type:	ASPHALT	Route Summary				
Roadway Condition Information						
Pavement Condition Rating (PCR)	99					
Lane & Width Information						
Number of Lanes	1					
Paved Width (ft)	20.8					
Lane Width (ft)	11.2

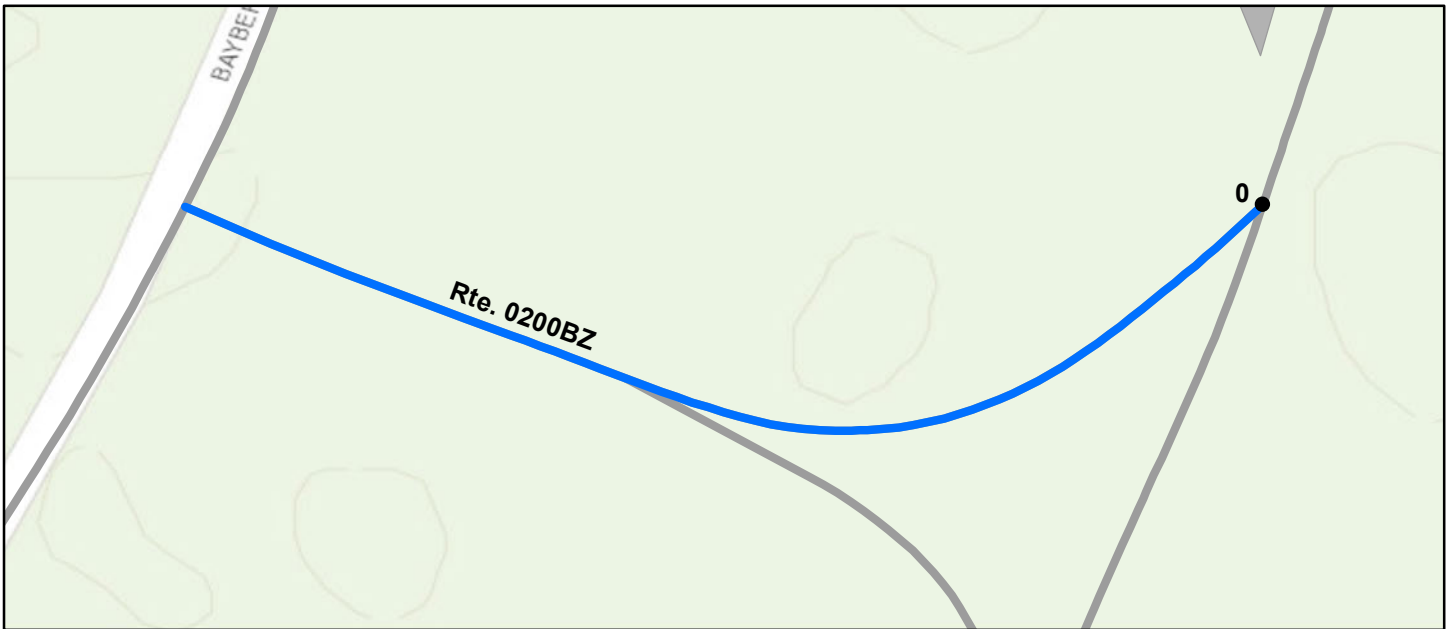
Subcomponent of Route ASIS-0200ZZ

Data Collection Vehicle (DCV) Rating

Colors on map represent condition scores at 0.10-mile intervals. See Appendix for definitions and formulas.

Inspection Date:	4/20/2021	Beginning Section MP	0				
Paved Length (Miles):	0.07	Section Length (MI)	0.07				
Surface Type:	ASPHALT	Route Summary					
Roadway Condition Information							
Pavement Condition Rating (PCR)	98	98					
Surface Condition Rating (SCR)	98	98					
Roughness Condition Index (RCI)	N/A	N/A					
Distress Index Values							
Structural Crack Index	100	100					
Alligator Crack Index	100	100					
Longitudinal Crack Index	100	100					
Transverse Cracking Index	100	100					
Patching Index	100	100					
Rutting Index	98	98					
International Roughness Index (IRI)	N/A	N/A					
Lane & Width Information							
Number of Lanes	1	1					
Paved Width (ft)	16.5	16.5					
Lane Width (ft)	12.9	12.9

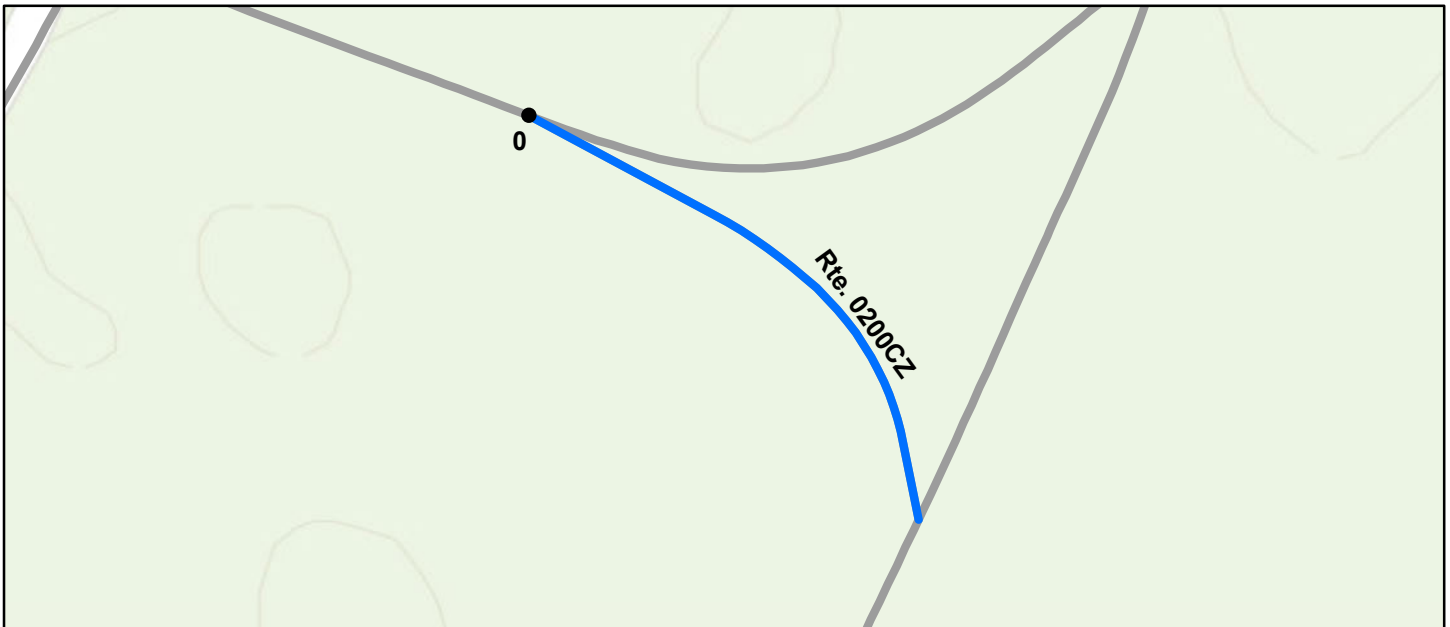
Subcomponent of Route ASIS-0200ZZ

Data Collection Vehicle (DCV) Rating

Colors on map represent condition scores at 0.10-mile intervals. See Appendix for definitions and formulas.

Inspection Date: 4/20/2021	Beginning Section MP	0				
Paved Length (Miles): 0.03	Section Length (MI)	0.03				
Surface Type: ASPHALT	Route Summary					
Roadway Condition Information						
Pavement Condition Rating (PCR)	99	99				
Surface Condition Rating (SCR)	99	99				
Roughness Condition Index (RCI)	N/A	N/A				
Distress Index Values						
Structural Crack Index	100	100				
Alligator Crack Index	100	100				
Longitudinal Crack Index	100	100				
Transverse Cracking Index	99	99				
Patching Index	100	100				
Rutting Index	100	100				
International Roughness Index (IRI)	N/A	N/A				
Lane & Width Information						
Number of Lanes	1	1				
Paved Width (ft)	13.5	13.5				
Lane Width (ft)	10.3	10.3

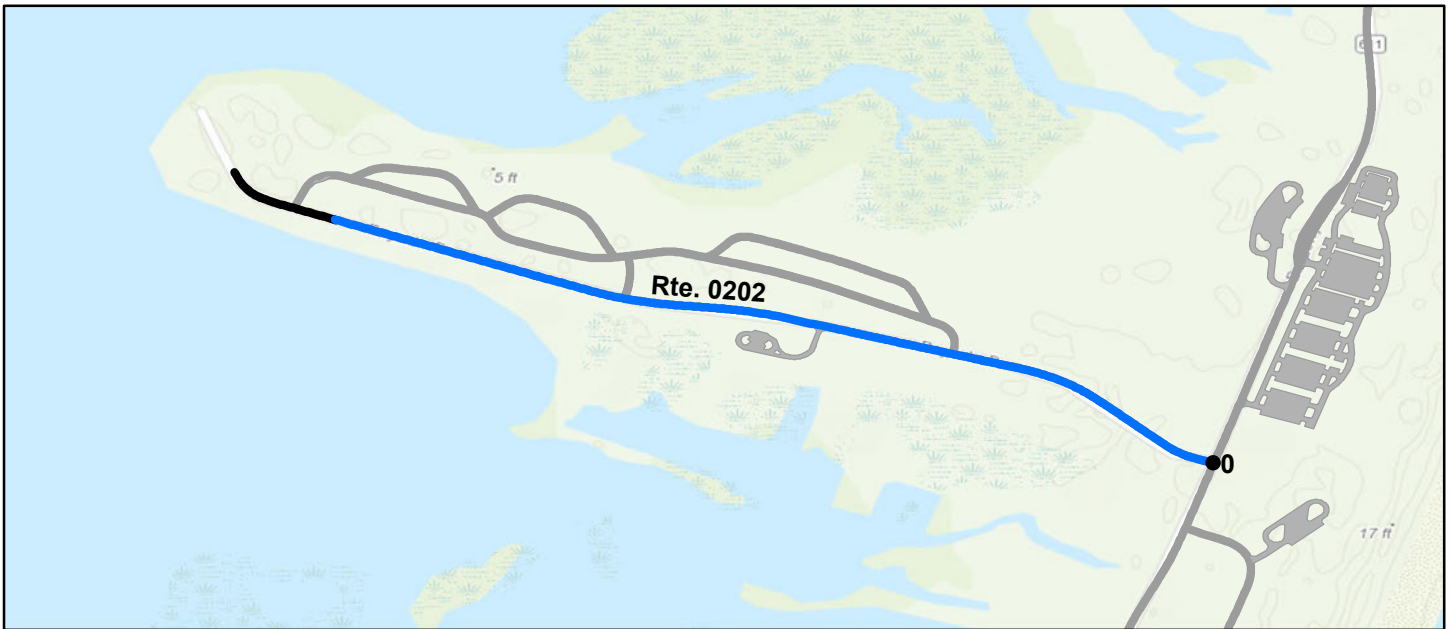
ROUTE 0202: BAYSIDE DRIVE

Data Collection Vehicle (DCV) Rating

Route Condition Legend – Pavement Condition Rating (PCR)										
Poor (0 - 60)		Fair (61- 84)		Good (85 - 94)		Excellent (95 - 100)		Not Rated		
Colors on map represent condition scores at 0.10-mile intervals. See Appendix for definitions and formulas.										
Inspection Date:	4/20/2021	Beginning Section MP	0							
Paved Length (Miles):	0.7	Section Length (MI)	0.7							
Surface Type:	ASPHALT	Route Summary								
Roadway Condition Information										
Pavement Condition Rating (PCR)		100	100							
Surface Condition Rating (SCR)		100	100							
Roughness Condition Index (RCI)		100	100							
Distress Index Values										
Structural Crack Index		100	100							
Alligator Crack Index		100	100							
Longitudinal Crack Index		100	100							
Transverse Cracking Index		100	100							
Patching Index		100	100							
Rutting Index		100	100							
International Roughness Index (IRI)		95	95							
Lane & Width Information

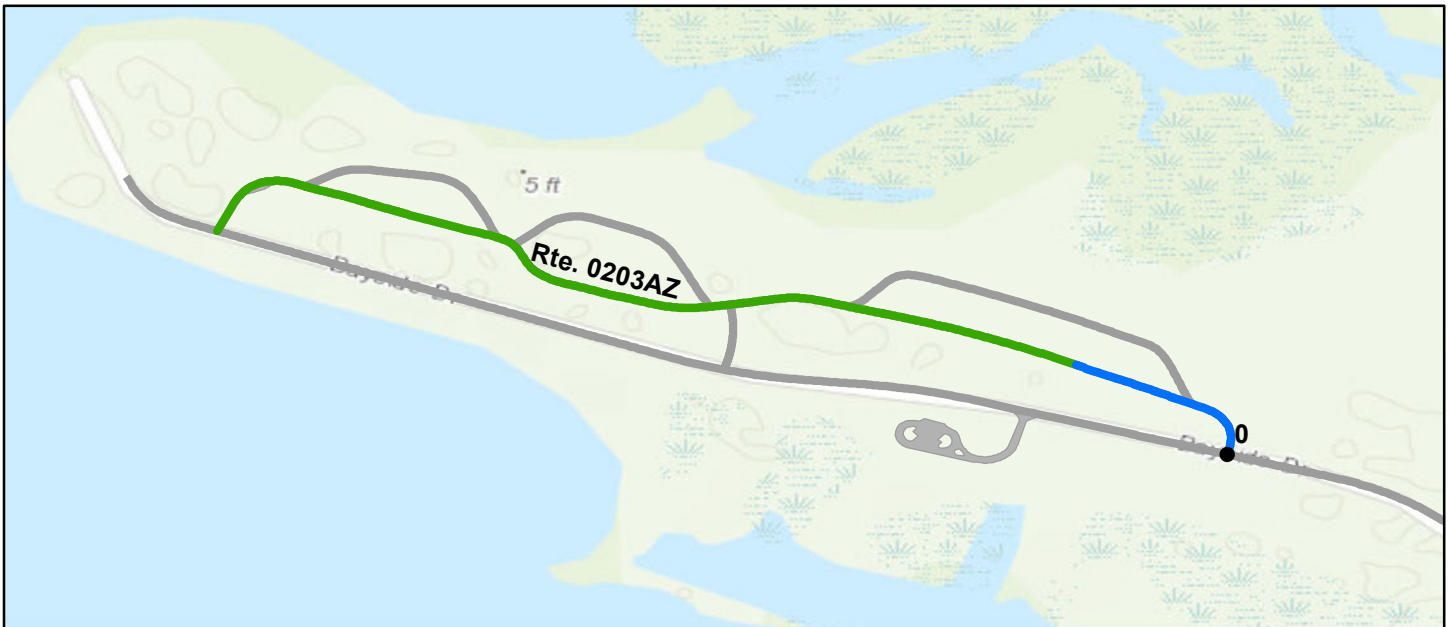
Subcomponent of Route ASIS-0203ZZ

Data Collection Vehicle (DCV) Rating

Colors on map represent condition scores at 0.10-mile intervals. See Appendix for definitions and formulas.

Inspection Date:	4/20/2021	Beginning Section MP	0				
Paved Length (Miles):	0.56	Section Length (MI)	0.56				
Surface Type:	ASPHALT	Route Summary					
Roadway Condition Information							
Pavement Condition Rating (PCR)	92	92					
Surface Condition Rating (SCR)	92	92					
Roughness Condition Index (RCI)	N/A	N/A					
Distress Index Values							
Structural Crack Index	98	98					
Alligator Crack Index	100	100					
Longitudinal Crack Index	98	98					
Transverse Cracking Index	92	92					
Patching Index	100	100					
Rutting Index	97	97					
International Roughness Index (IRI)	N/A	N/A					
Lane & Width Information							
Number of Lanes	1	1					
Paved Width (ft)	12.3	12.3					
Lane Width (ft)	12.3	12.3

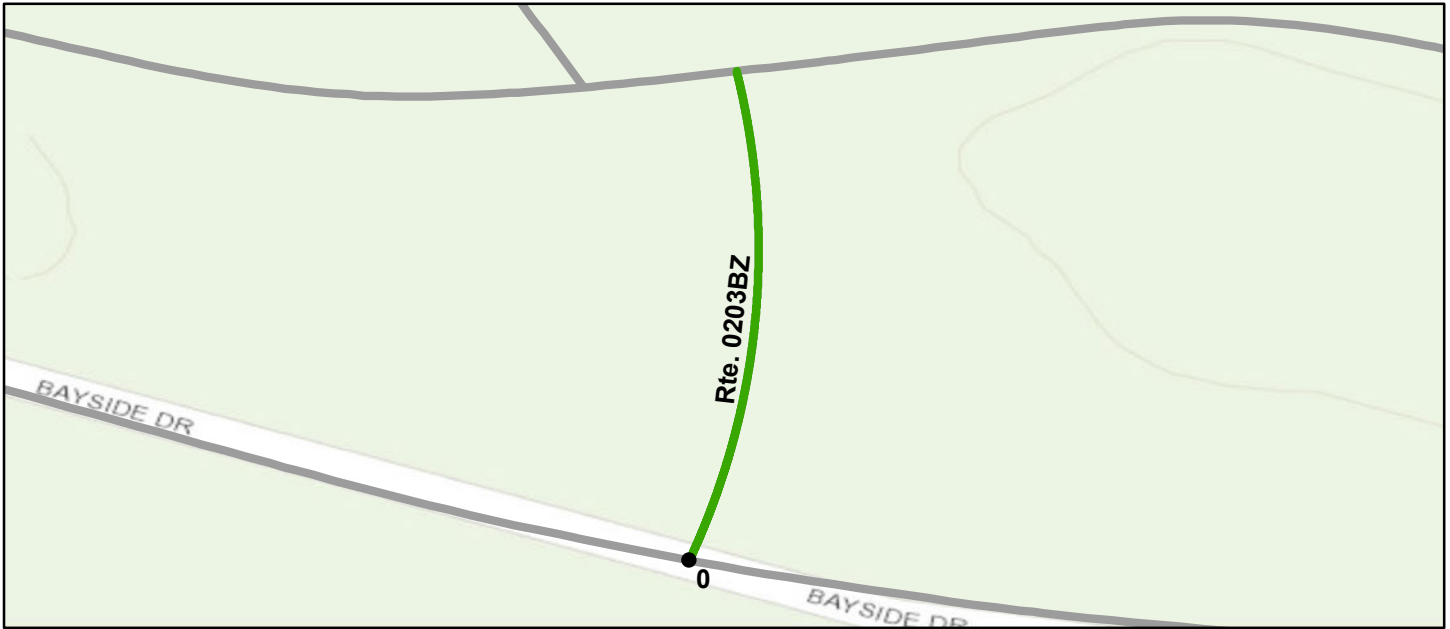
ROUTE 0203BZ: BAYSIDE CAMPGROUND - MIDDLE ACCESS

Subcomponent of Route ASIS-0203ZZ
Data Collection Vehicle (DCV) Rating

Route Condition Legend – Pavement Condition Rating (PCR)						
Poor (0 - 60)	Fair (61- 84)	Good (85 - 94)	Excellent (95 - 100)	Not Rated		
Colors on map represent condition scores at 0.10-mile intervals. See Appendix for definitions and formulas.						
Inspection Date: 4/20/2021	Beginning Section MP	0				
Paved Length (Miles): 0.04	Section Length (MI)	0.04				
Surface Type: ASPHALT	Route Summary					
Roadway Condition Information						
Pavement Condition Rating (PCR)	91	91				
Surface Condition Rating (SCR)	91	91				
Roughness Condition Index (RCI)	N/A	N/A				
Distress Index Values						
Structural Crack Index	96	96				
Alligator Crack Index	100	100				
Longitudinal Crack Index	96	96				
Transverse Cracking Index	91	91				
Patching Index	100	100				
Rutting Index	93	93				
International Roughness Index (IRI)	N/A	N/A				
Lane & Width Information						
Number of Lanes	2	2				
Paved Width (ft)	21	21				
Lane Width (ft)	9.3	9.3

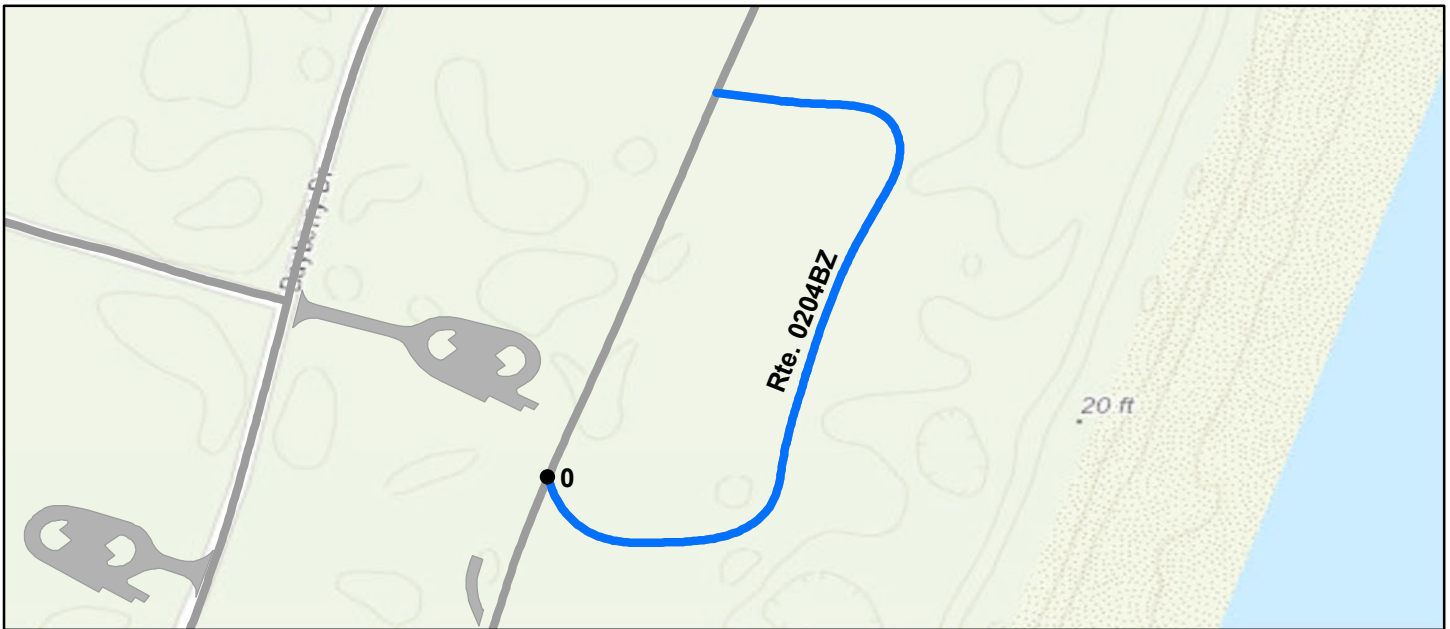
ROUTE 0204BZ: OCEANSIDE CAMPGROUND LOOP 2, SITES 20-41

Subcomponent of Route ASIS-0204ZZ
 Data Collection Vehicle (DCV) Rating

Route Condition Legend – Pavement Condition Rating (PCR)						
Poor (0 - 60)	Fair (61- 84)	Good (85 - 94)	Excellent (95 - 100)	Not Rated		
Colors on map represent condition scores at 0.10-mile intervals. See Appendix for definitions and formulas.						
Inspection Date: 4/20/2021	Beginning Section MP	0				
Paved Length (Miles): 0.21	Section Length (MI)	0.21				
Surface Type: ASPHALT	Route Summary					
Roadway Condition Information						
Pavement Condition Rating (PCR)	95	95				
Surface Condition Rating (SCR)	95	95				
Roughness Condition Index (RCI)	N/A	N/A				
Distress Index Values						
Structural Crack Index	99	99				
Alligator Crack Index	100	100				
Longitudinal Crack Index	99	99				
Transverse Cracking Index	95	95				
Patching Index	100	100				
Rutting Index	99	99				
International Roughness Index (IRI)	N/A	N/A				
Lane & Width Information						
Number of Lanes	1	1				
Paved Width (ft)	13.7	13.7				
Lane Width (ft)	13.7	13.7

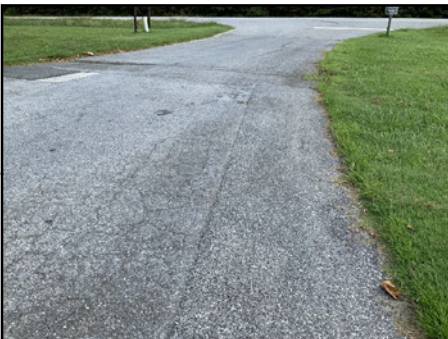
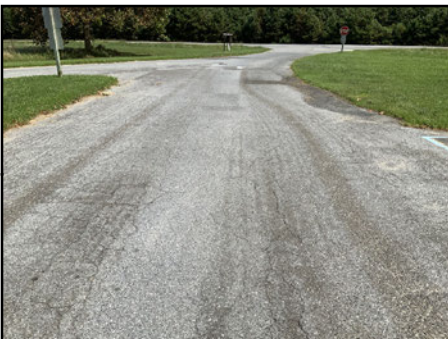
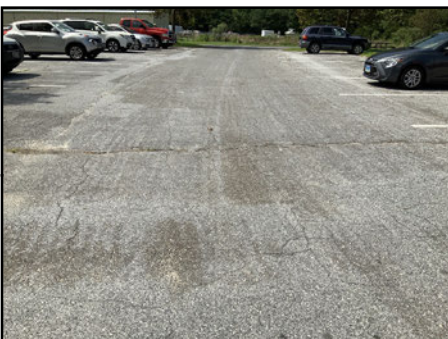
Inspection Date	FMSS Number	User Access	Surface Type
8/11/2020	47220	PUBLIC	ASPHALT
Area (Sq. Ft.)	Lane Miles (11' Widths)	Curb Reveal (Inches)	Curb Recommendation
22,345	0.385	NOT APPLICABLE	NOT APPLICABLE
Curb Type		Curb & Gutter Type	
NO CURB		NO CURB AND GUTTER	
Pavement Recommendation		Condition Rating / PCR	
RECONSTRUCTION		POOR / 30

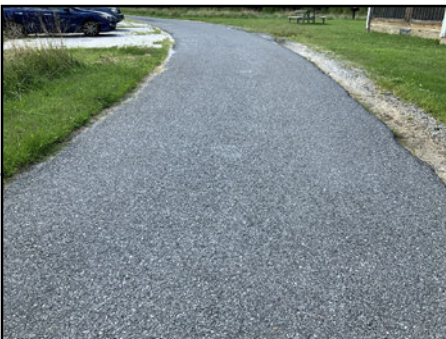
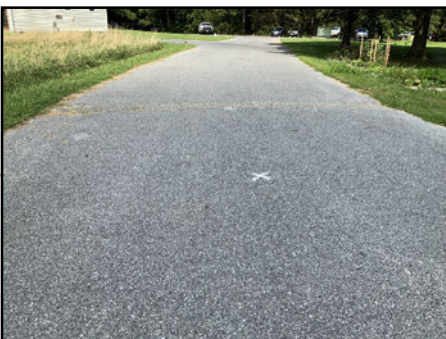
ROUTE 0901: HOUSING ACCESS ROAD AND PARKING

Inspection Date	FMSS Number	User Access	Surface Type
8/11/2020	102569	NONPUBLIC	ASPHALT
Area (Sq. Ft.)	Lane Miles (11' Widths)	Curb Reveal (Inches)	Curb Recommendation
37,021	0.637	NOT APPLICABLE	NOT APPLICABLE
Curb Type		Curb & Gutter Type	
NO CURB		NO CURB AND GUTTER	
Pavement Recommendation		Condition Rating / PCR	
LIGHT 3R TREATMENTS		FAIR / 73
