Final Report

Road Inventory and Condition Assessment of Paved Routes Assateague Island National Seashore

**Federal Highway Administration
Eastern Federal Lands Highway Division
Road Inventory Program (RIP)**

Report Date: January 2022

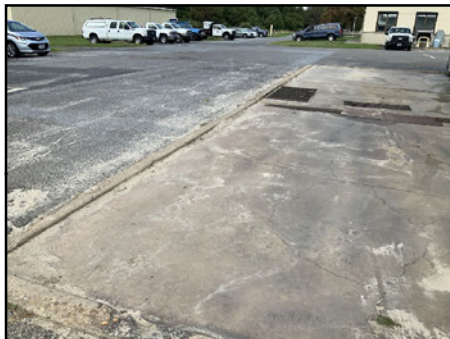
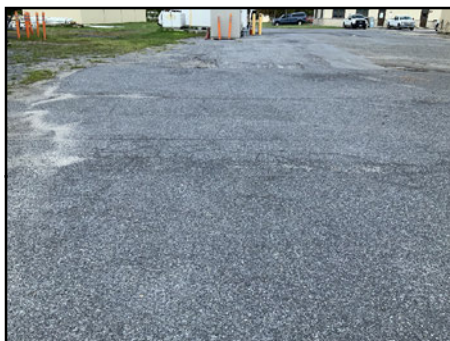
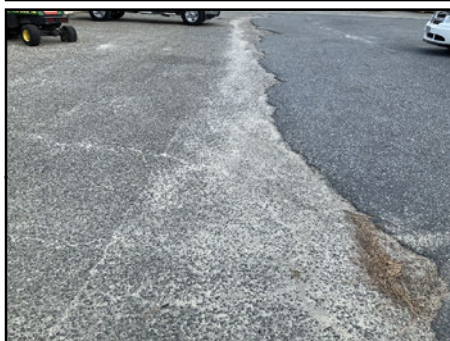
ROUTE 0902: HEADQUARTERS PARKING

Inspection Date	FMSS Number	User Access	Surface Type
8/11/2020	81033	NONPUBLIC	ASPHALT
Area (Sq. Ft.)	Lane Miles (11' Widths)	Curb Reveal (Inches)	Curb Recommendation
37,517	0.646	1	DO NOTHING
Curb Type		Curb & Gutter Type	
CONCRETE		NO CURB AND GUTTER	
Pavement Recommendation		Condition Rating / PCR	
RECONSTRUCTION		POOR / 30

Note: Parking area consists of multiple surface types: 1 part Asphalt at 36,483 square feet; 2 parts Concrete at 1,034 square feet.

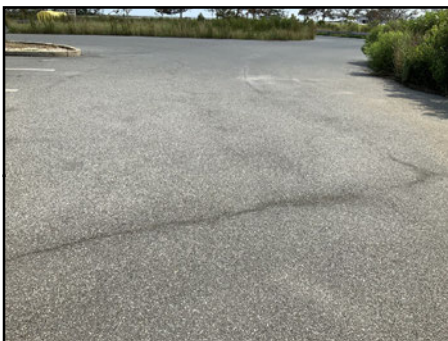
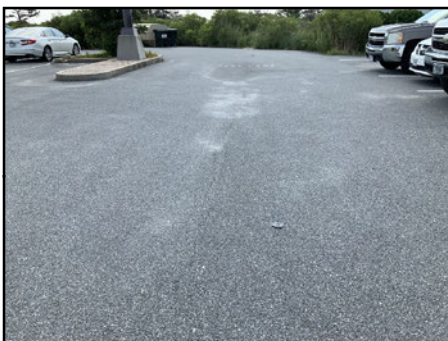
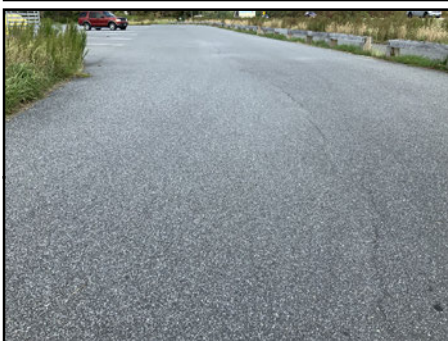
ROUTE 0903: VISITOR CENTER ACCESS PARKING

Inspection Date	FMSS Number	User Access	Surface Type
8/11/2020	47219	PUBLIC	ASPHALT
Area (Sq. Ft.)	Lane Miles (11' Widths)	Curb Reveal (Inches)	Curb Recommendation
57,253	0.986	6	DO NOTHING
Curb Type		Curb & Gutter Type	
CONCRETE		NO CURB AND GUTTER	
Pavement Recommendation		Condition Rating / PCR	
PREVENTIVE MAINTENANCE		GOOD / 90

Note: Parking area consists of multiple surface types: 1 part Asphalt at 56,989 square feet; 1 part Concrete at 264 square feet.

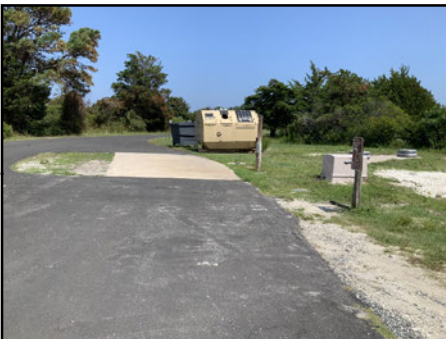
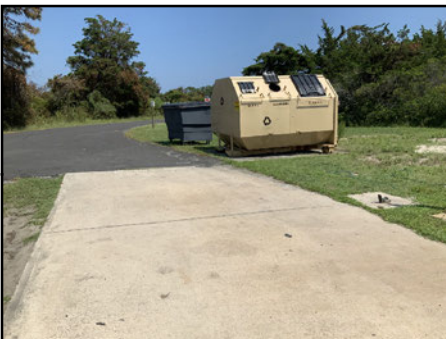
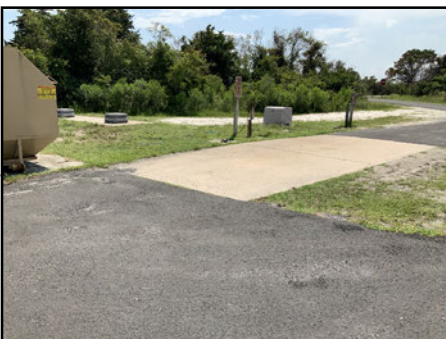
ROUTE 0904: BAYSIDE DUMP STATION

Inspection Date	FMSS Number	User Access	Surface Type
8/11/2020	102616	PUBLIC	ASPHALT
Area (Sq. Ft.)	Lane Miles (11' Widths)	Curb Reveal (Inches)	Curb Recommendation
1,317	0.023	NOT APPLICABLE	NOT APPLICABLE
Curb Type		Curb & Gutter Type	
NO CURB		NO CURB AND GUTTER	
Pavement Recommendation		Condition Rating / PCR	
PREVENTIVE MAINTENANCE		GOOD / 90

Note: Parking area consists of multiple surface types: 2 parts Asphalt at 1,029 square feet; 1 part Concrete at 288 square feet.

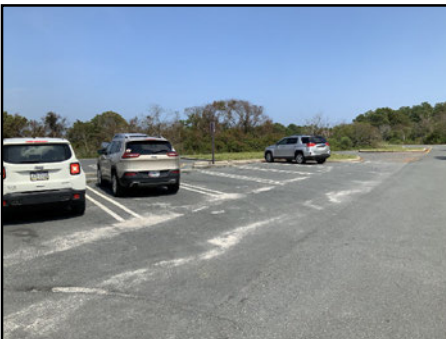
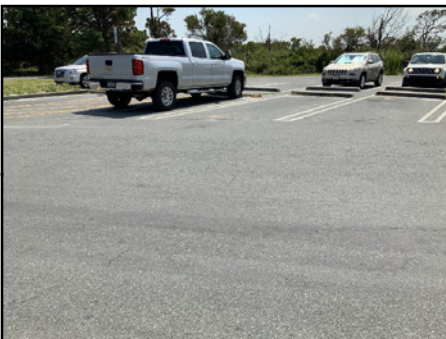
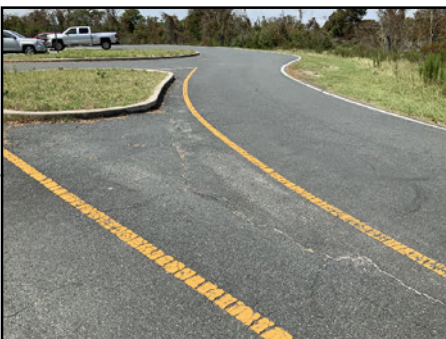
ROUTE 0909: LIFE OF THE MARSH TRAIL PARKING

Inspection Date	FMSS Number	User Access	Surface Type
8/11/2020	81022	PUBLIC	ASPHALT
Area (Sq. Ft.)	Lane Miles (11' Widths)	Curb Reveal (Inches)	Curb Recommendation
18,289	0.315	5	DO NOTHING
Curb Type		Curb & Gutter Type	
CONCRETE		NO CURB AND GUTTER	
Pavement Recommendation		Condition Rating / PCR	
HEAVY 3R TREATMENTS		POOR / 53

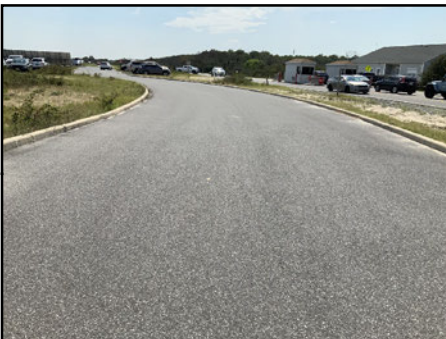
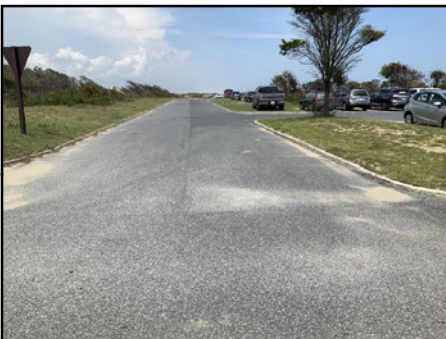
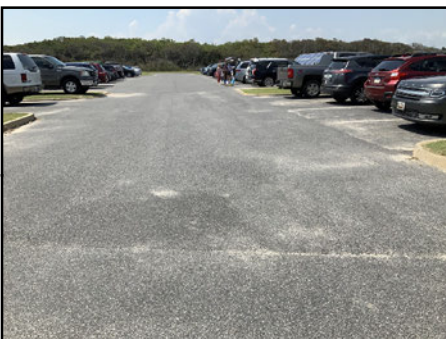
ROUTE 0911: NORTH BEACH PARKING

Inspection Date	FMSS Number	User Access	Surface Type
8/11/2020	47243	PUBLIC	ASPHALT
Area (Sq. Ft.)	Lane Miles (11' Widths)	Curb Reveal (Inches)	Curb Recommendation
244,778	4.214	4	DO NOTHING
Curb Type		Curb & Gutter Type	
CONCRETE		NO CURB AND GUTTER	
Pavement Recommendation		Condition Rating / PCR	
PREVENTIVE MAINTENANCE		GOOD / 90

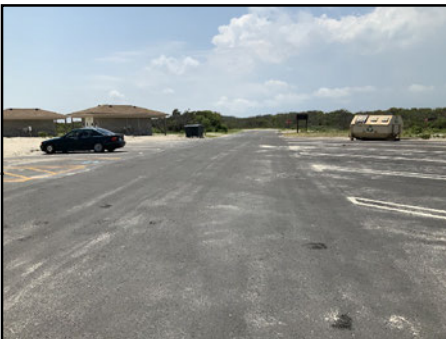
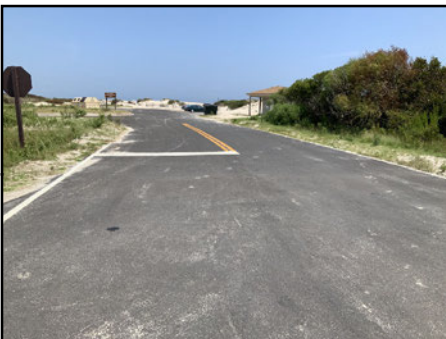
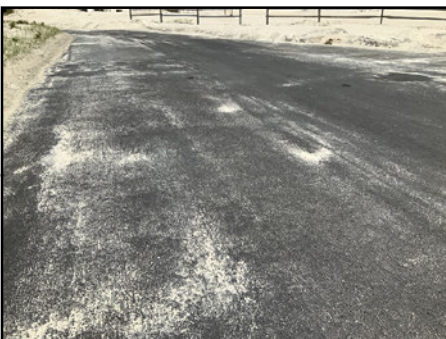
ROUTE 0914: OCEANSIDE GROUP CAMPSITE PARKING

Inspection Date	FMSS Number	User Access	Surface Type
8/11/2020	81023	PUBLIC	ASPHALT
Area (Sq. Ft.)	Lane Miles (11' Widths)	Curb Reveal (Inches)	Curb Recommendation
28,882	0.497	5	DO NOTHING
Curb Type		Curb & Gutter Type	
CONCRETE		NO CURB AND GUTTER	
Pavement Recommendation		Condition Rating / PCR	
PREVENTIVE MAINTENANCE		GOOD / 90

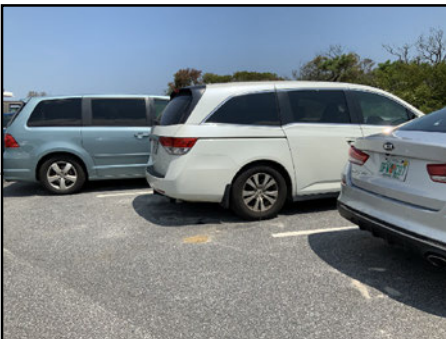
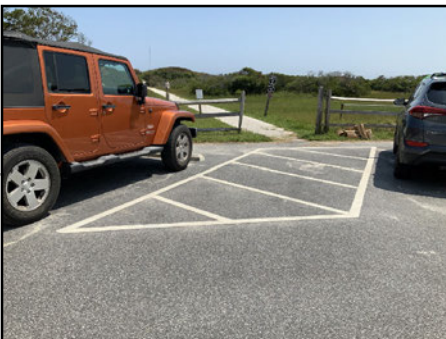
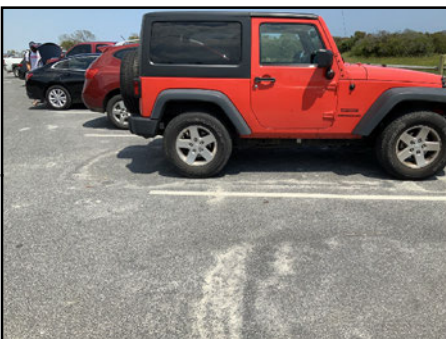
ROUTE 0918Z: OCEANSIDE WALK-IN CAMPGROUND 42-65 PARKING

Inspection Date	FMSS Number	User Access	Surface Type
8/11/2020	102721	PUBLIC	ASPHALT
Area (Sq. Ft.)	Lane Miles (11' Widths)	Curb Reveal (Inches)	Curb Recommendation
6,742	0.116	NOT APPLICABLE	NOT APPLICABLE
Curb Type		Curb & Gutter Type	
NO CURB		NO CURB AND GUTTER	
Pavement Recommendation		Condition Rating / PCR	
PREVENTIVE MAINTENANCE		GOOD / 90

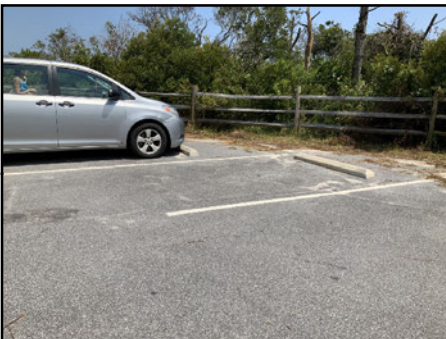
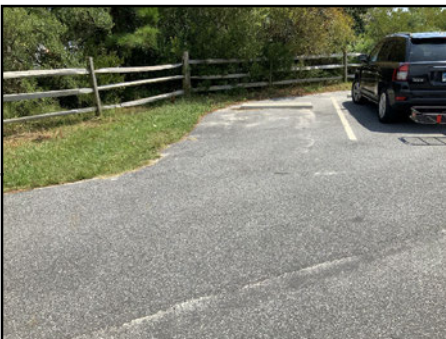
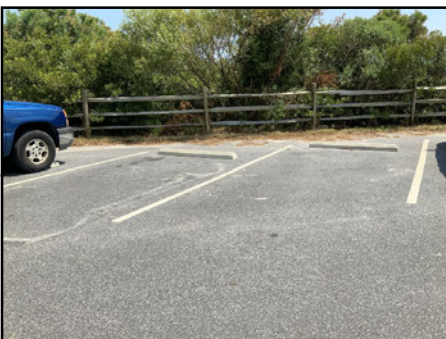
ROUTE 0919Z: OCEANSIDE WALK-IN CAMPGROUND 66-85 PARKING

Inspection Date	FMSS Number	User Access	Surface Type
8/11/2020	102721	PUBLIC	ASPHALT
Area (Sq. Ft.)	Lane Miles (11' Widths)	Curb Reveal (Inches)	Curb Recommendation
5,935	0.102	NOT APPLICABLE	NOT APPLICABLE
Curb Type		Curb & Gutter Type	
NO CURB		NO CURB AND GUTTER	
Pavement Recommendation		Condition Rating / PCR	
PREVENTIVE MAINTENANCE		GOOD / 90

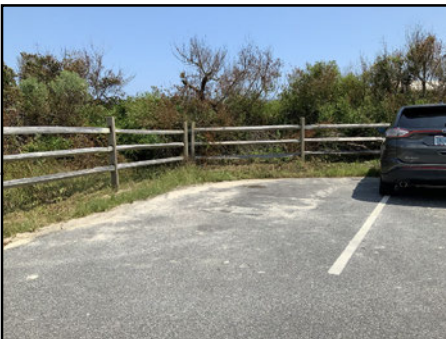
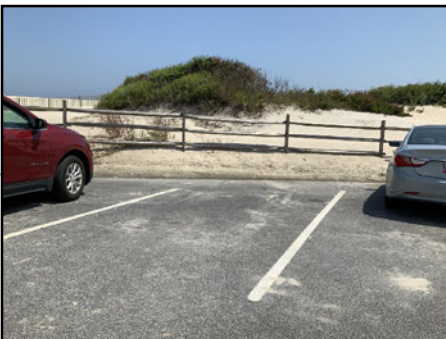
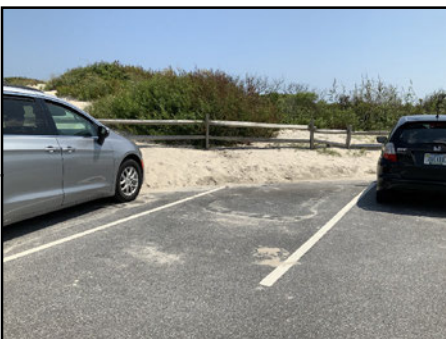
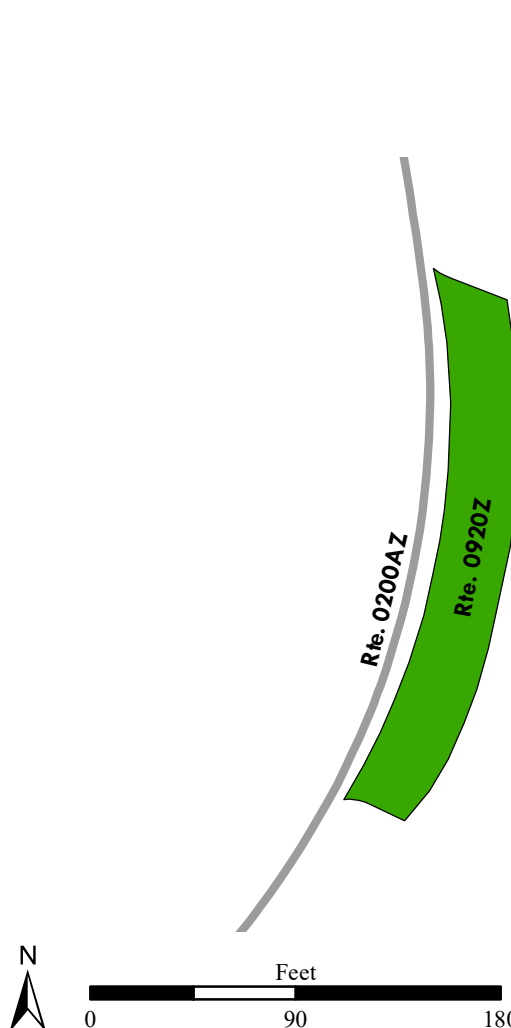
ROUTE 0920Z: OCEANSIDE WALK-IN CAMPGROUND 86-104 PARKING

Inspection Date	FMSS Number	User Access	Surface Type
8/11/2020	102721	PUBLIC	ASPHALT
Area (Sq. Ft.)	Lane Miles (11' Widths)	Curb Reveal (Inches)	Curb Recommendation
5,754	0.099	NOT APPLICABLE	NOT APPLICABLE
Curb Type		Curb & Gutter Type	
NO CURB		NO CURB AND GUTTER	
Pavement Recommendation		Condition Rating / PCR	
PREVENTIVE MAINTENANCE		GOOD / 90

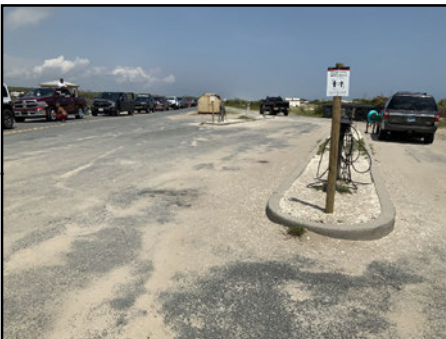
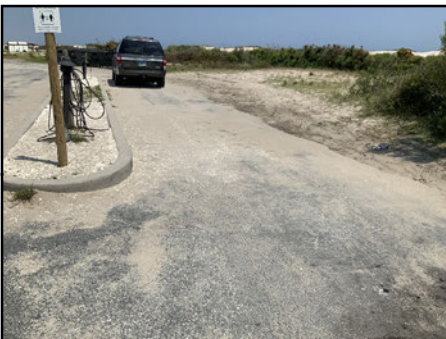
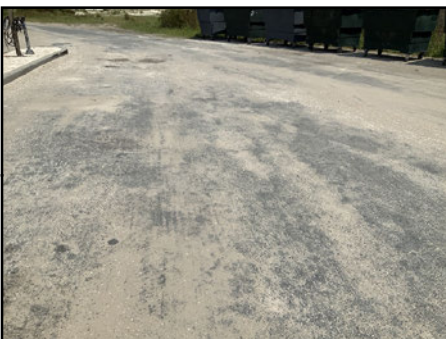
ROUTE 0923: AIR PUMP STATION PARKING

Inspection Date	FMSS Number	User Access	Surface Type
8/11/2020	102742	PUBLIC	ASPHALT
Area (Sq. Ft.)	Lane Miles (11' Widths)	Curb Reveal (Inches)	Curb Recommendation
8,379	0.144	5	DO NOTHING
Curb Type		Curb & Gutter Type	
CONCRETE		NO CURB AND GUTTER	
Pavement Recommendation		Condition Rating / PCR	
NOT APPLICABLE		NOT RATED

Note: Parking area covered with sand and not rated.

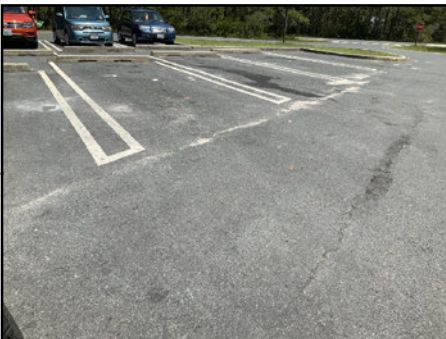
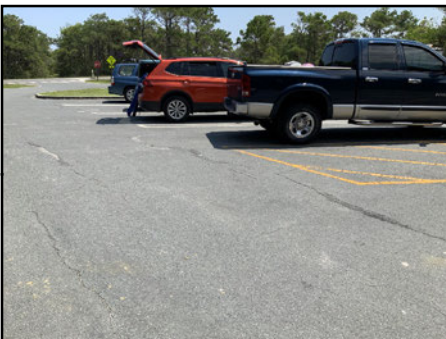
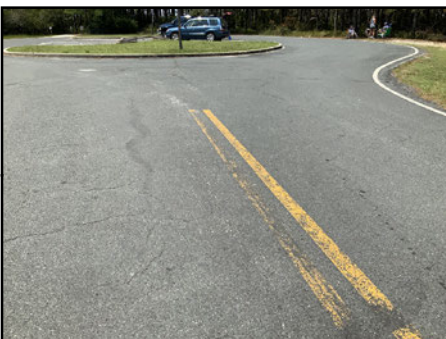
ROUTE 0925: LIFE OF THE FOREST TRAIL PARKING

Inspection Date	FMSS Number	User Access	Surface Type
8/11/2020	81020	PUBLIC	ASPHALT
Area (Sq. Ft.)	Lane Miles (11' Widths)	Curb Reveal (Inches)	Curb Recommendation
14,020	0.241	5	LIGHT REPAIR
Curb Type		Curb & Gutter Type	
CONCRETE		NO CURB AND GUTTER	
Pavement Recommendation		Condition Rating / PCR	
LIGHT 3R TREATMENTS		FAIR / 73

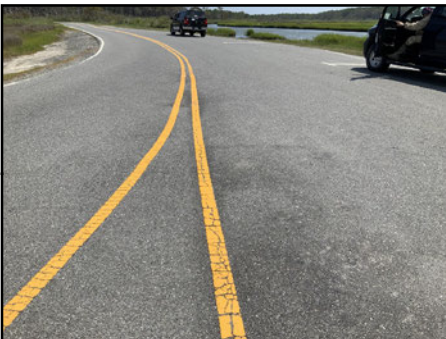
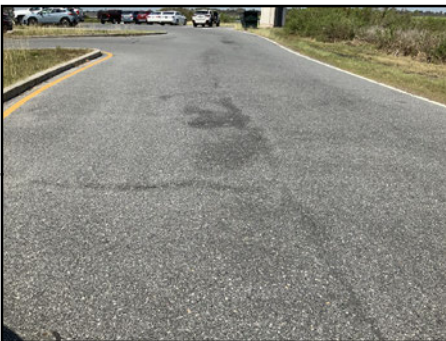
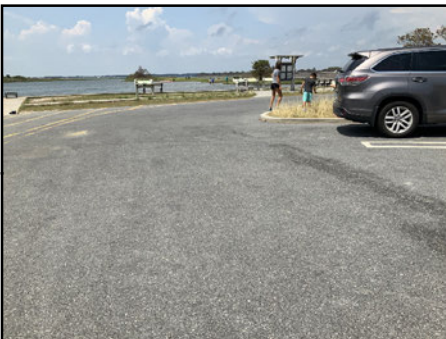
ROUTE 0926: OLD FERRY LANDING PARKING

Inspection Date	FMSS Number	User Access	Surface Type
8/11/2020	244172	PUBLIC	ASPHALT
Area (Sq. Ft.)	Lane Miles (11' Widths)	Curb Reveal (Inches)	Curb Recommendation
22,392	0.386	5	DO NOTHING
Curb Type		Curb & Gutter Type	
CONCRETE		NO CURB AND GUTTER	
Pavement Recommendation		Condition Rating / PCR	
PREVENTIVE MAINTENANCE		GOOD / 90

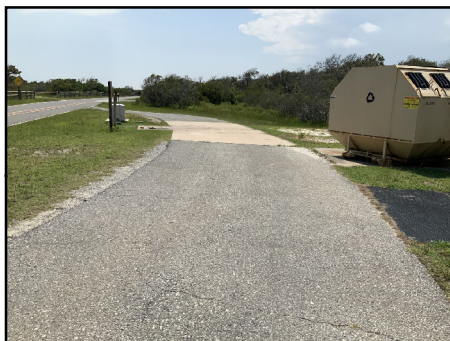
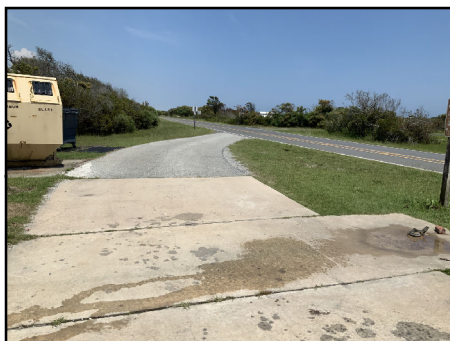
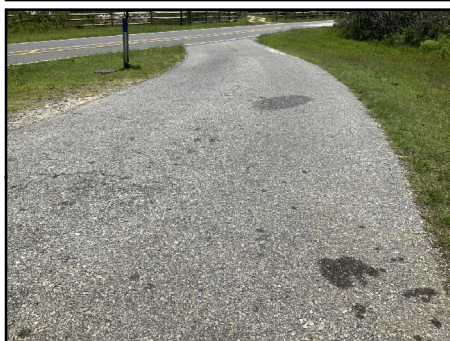
Note: Parking area consists of multiple surface types: 2 parts Asphalt at 1,747 square feet; 1 part Concrete at 378 square feet.
