# BIBE Cycle 6

# **Final Report**

# Road Inventory and Condition Assessment of Paved Routes Big Bend National Park

**Report Date: October 2017**

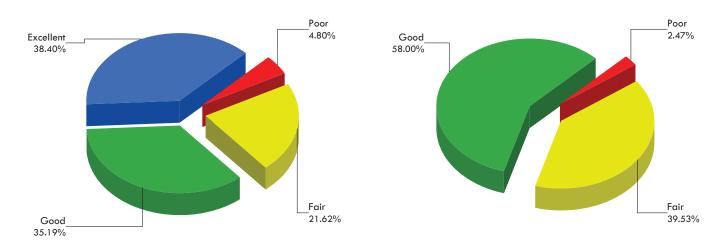
Figure 1: Pavement Condition Rating Breakdown for Paved Roads and Parking Areas

#### **Road Condition Percentages**

**Parking Area Condition Percentages**

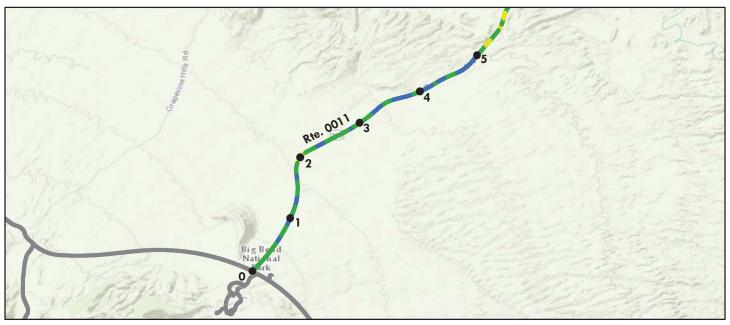
ROUTE 0011: NORTH ENTRANCE ROAD

Route C	Condition Legend – Pavo	ement Condi	tion Rating (	PCR)		
Poor (0 - 60) Fair (6)	1-84) Good (	85 - 94)	Excellent (	95 - 100)	Not Ra	ted
	See Appendix for def	initions and f	ormulas			_
<b>Inspection Date:</b> 3/20/2017	Beginning Section MP	0	1	2	3	4
Paved Length (Miles): 27.46	Section Length (MI)	1	1	1	1	1
Surface Type: ASPHALT	Route Summary					
Roadway Condition Information						
Pavement Condition Rating (PCR)	88	91	90	90	95	96
Surface Condition Rating (SCR)	85	95	93	94	96	96
Roughness Condition Index (RCI)	92	86	86	84	93	95
Distress Index Values						
Structural Crack Index	92	100	100	99	100	100
Alligator Crack Index	100	100	100	100	100	100
Longitudinal Crack Index	92	100	100	99	100	100
Transverse Cracking Index	85	100	100	100	100	100
Patching Index	100	100	100	100	100	100
Rutting Index	98	95	93	94	96	96
International Roughness Index (IRI)	135	152	152	157	133	126
Lane & Width Information						
Number of Lanes	2	2	2	2	2	2

Paved Width (ft)	23	24.9	24.7	23.9	24.3	24.3
Lane Width (ft)	9.9	10.3	10.4	10	9.9	10.1

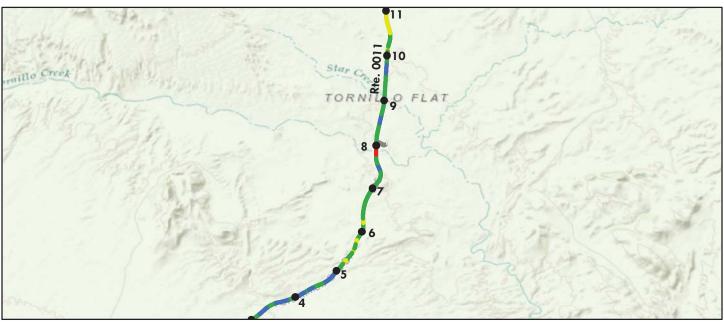
ROUTE 0011: NORTH ENTRANCE ROAD

Route (	Condition Legend – Pav	ement Condi	tion Rating (	PCR)		
Poor (0 - 60) Fair (6	1- 84) Good (	(85 - 94)	Excellent (	95 - 100)	Not Ra	ted
	See Appendix for def	initions and f	ormulas			
<b>Inspection Date:</b> 3/20/2017	<b>Beginning Section MP</b>	5	6	7	8	9
Paved Length (Miles): 27.46	Section Length (MI)	1	1	1	1	1
Surface Type: ASPHALT	Route Summary					
Roadway Condition Information						
Pavement Condition Rating (PCR)	88	87	88	90	93	93
Surface Condition Rating (SCR)	85	92	92	94	88	89
Roughness Condition Index (RCI)	92	80	81	83	100	98
Distress Index Values						
Structural Crack Index	92	99	98	99	93	95
Alligator Crack Index	100	100	100	100	100	100
Longitudinal Crack Index	92	99	98	99	93	95
Transverse Cracking Index	85	100	99	98	88	89
Patching Index	100	100	100	100	100	100
Rutting Index	98	92	92	94	100	100
International Roughness Index (IRI)	135	169	167	161	111	119
Lane & Width Information						
Number of Lanes	2	2	2	2	2	2

Paved Width (ft)	23	24.3	24.2	25.2	23.2	22.3
Lane Width (ft)	9.9	10.1	10.2	9.9	9.8	9.7

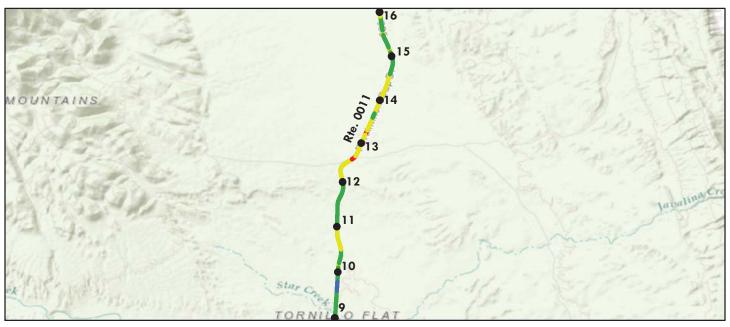
ROUTE 0011: NORTH ENTRANCE ROAD

Rou	Route Condition Legend – Pavement Condition Rating (PCR)								
		(85 - 94)	Excellent (		Not Ra	ted			
	See Appendix for de	finitions and f	ormulas						
<b>Inspection Date:</b> 3/20/2017	Beginning Section MP	10	11	12	13	14			
Paved Length (Miles): 27.46	Section Length (MI)	1	1	1	1	1			
Surface Type: ASPHALT	Route Summary			•	•	•			
Roadway Condition Information									
Pavement Condition Rating (PCR)	88	86	89	77	74	84			
Surface Condition Rating (SCR)	85	79	82	75	74	81			
Roughness Condition Index (RCI)	92	97	100	81	74	88			
Distress Index Values									
Structural Crack Index	92	79	90	80	75	89			
Alligator Crack Index	100	100	100	100	100	100			
Longitudinal Crack Index	92	79	90	80	75	89			
Transverse Cracking Index	85	83	82	75	74	81			
Patching Index	100	100	100	100	100	100			
Rutting Index	98	100	100	99	97	98			
International Roughness Index (IRI)	135	123	98	167	188	145			
Lane & Width Information

Number of Lanes	2	2	2	2	2	2			
Paved Width (ft)	23	22.4	22.5	23	22.2	22.7			
Lane Width (ft)	9.9	9.8	9.9	9.8	9.6	9.6

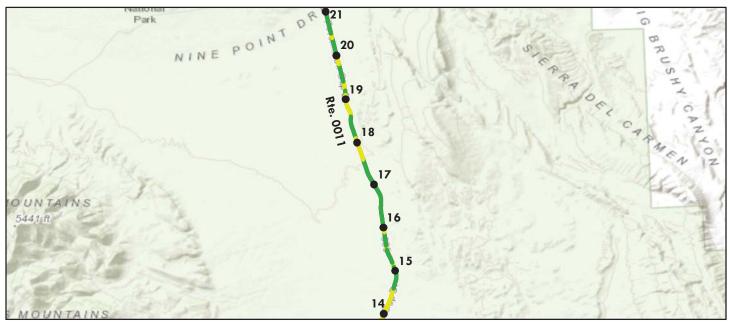
#### ROUTE 0011: NORTH ENTRANCE ROAD

Route C	Route Condition Legend – Pavement Condition Rating (PCR)								
Poor (0 - 60) Fair (6	1- 84) Good (	(85 - 94)	Excellent (	95 - 100)	Not Ra	ted			
	See Appendix for def	initions and f	ormulas			_			
<b>Inspection Date:</b> 3/20/2017	<b>Beginning Section MP</b>	15	16	17	18	19			
Paved Length (Miles): 27.46	Section Length (MI)	1	1	1	1	1			
Surface Type: ASPHALT	Route Summary								
Roadway Condition Information									
Pavement Condition Rating (PCR)	88	87	89	86	86	85			
Surface Condition Rating (SCR)	85	79	81	78	78	78			
Roughness Condition Index (RCI)	92	100	100	98	98	95			
Distress Index Values									
Structural Crack Index	92	98	98	94	92	84			
Alligator Crack Index	100	100	100	100	100	100			
Longitudinal Crack Index	92	98	98	94	92	84			
Transverse Cracking Index	85	79	81	78	78	78			
Patching Index	100	100	100	100	100	100			
Rutting Index	98	100	100	100	100	99			
International Roughness Index (IRI)	135	114	93	121	120	128

Lane & Width Information									
Number of Lanes	2	2	2	2	2	2			
Paved Width (ft)	23	22.3	22.3	22.4	22.2	22.5			
Lane Width (ft)	9.9	9.6	9.8	9.5	9.6	10

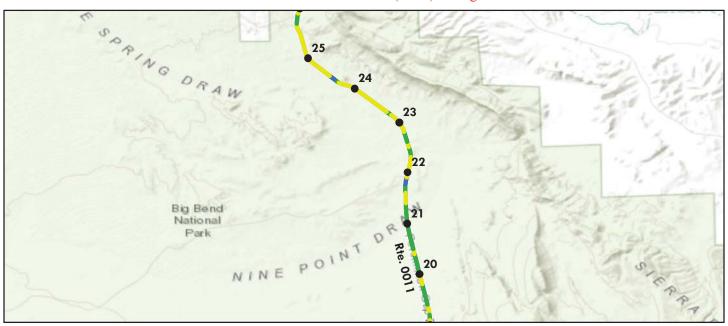
#### ROUTE 0011: NORTH ENTRANCE ROAD

Route (	Condition Legend – Pav	ement Condi	tion Rating (	PCR)		
Poor (0 - 60	_		(85 - 94)	Excellent (		Not Ra	ted
		See Appendix for def	finitions and f	ormulas			
Inspection Date:	3/20/2017	<b>Beginning Section MP</b>	20	21	22	23	24
Paved Length (Mile	es): 27.46	Section Length (MI)	1	1	1	1	1
Surface Type:	ASPHALT	Route Summary				!	
Roadway Condition	Information						
Pavement Condition	n Rating (PCR)	88	89	91	82	78	81
Surface Condition R	ating (SCR)	85	82	87	74	71	81
Roughness Condition	n Index (RCI)	92	100	96	93	89	80
Distress Index Value	es						
Structural Crack In-	dex	92	91	89	87	83	85
Alligator Crack Ind	lex	100	100	100	100	100	100
Longitudinal Crack	Index	92	91	89	87	83	85
Transverse Crackin	g Index	85	82	87	74	71	81
Patching Index		100	100	100	100	100	100
Rutting Index		98	100	99	99	99	99
International Rough	nness Index (IRI)	135	108	123	133	143	169
Lane & Width Info	rmation						
Number of Lanes		2	2	2	2	2	2

Paved Width (ft)		23	22.5	22.3	22.6	21.9	21.8
Lane Width (ft)		9.9	10	9.8	9.8	9.7	9.8

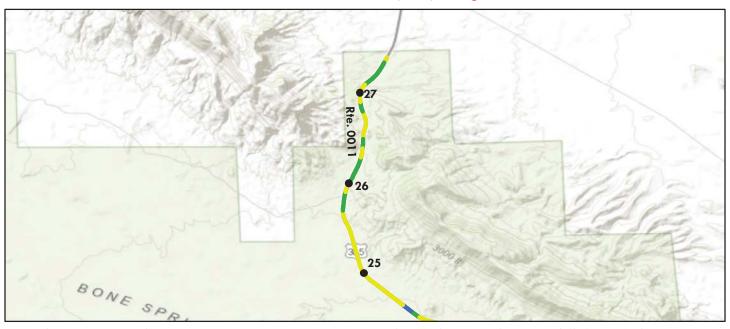
#### ROUTE 0011: NORTH ENTRANCE ROAD

Route (	Condition Legend – Pav	ement Condi	tion Rating (	PCR)		
Poor (0 - 60			(85 - 94)	Excellent (		Not Rate	d
		See Appendix for def	initions and f	ormulas			
Inspection Date:	3/20/2017	<b>Beginning Section MP</b>	25	26	27		
Paved Length (Mile	es): 27.46	Section Length (MI)	1	1	0.46		
Surface Type:	ASPHALT	Route Summary					
Roadway Condition	n Information						
Pavement Condition	on Rating (PCR)	88	77	85	86		
Surface Condition R	Rating (SCR)	85	65	75	76		
Roughness Condition	on Index (RCI)	92	94	100	100		
Distress Index Valu	ies						
Structural Crack In	ıdex	92	88	97	99		
Alligator Crack Inc	dex	100	100	100	100		
Longitudinal Crack	x Index	92	88	97	99		
Transverse Crackin	ng Index	85	65	75	76		
Patching Index		100	100	100	100		
Rutting Index		98	99	99	100		
International Roug	hness Index (IRI)	135	130	108	98		
Lane & Width Info	rmation						•
Number of Lanes		2	2	2	2		
Paved Width (ft)		23	22.4	22.9	22.2	1

Lane Width (ft)		9.9	9.7	9.8	9.5

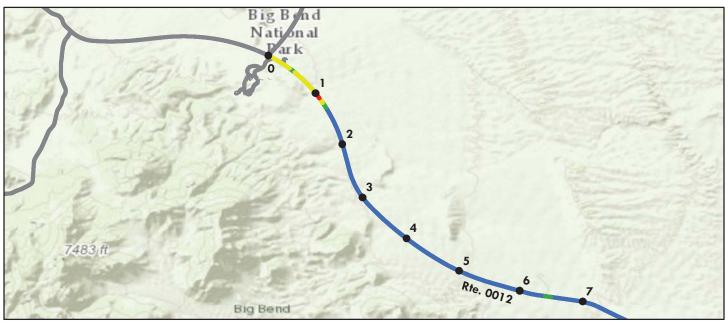
ROUTE 0012: RIO GRANDE ROAD

Route (	Condition Legend – Pav	ement Condi	tion Rating (	PCR)		
Poor (0 - 6	_			<b>Excellent (95 - 100)</b>		Not Rated	
		See Appendix for def	initions and f	ormulas			
Inspection Date:	3/20/2017	<b>Beginning Section MP</b>	0	1	2	3	4
Paved Length (Mile	es): 20.31	Section Length (MI)	1	1	1	1	1
Surface Type:	ASPHALT	Route Summary		•	•	•	
Roadway Condition	n Information						
Pavement Condition	on Rating (PCR)	97	75	92	99	99	98
Surface Condition F	Rating (SCR)	95	66	86	99	99	97
Roughness Condition Index (RCI)		100	89	100	100	100	100
Distress Index Valu	ies						
Structural Crack In	ıdex	95	66	86	100	100	100
Alligator Crack Inc	dex	100	99	100	100	100	100
Longitudinal Cracl	k Index	95	67	86	100	100	100
Transverse Crackin	ng Index	97	81	91	100	100	100
Patching Index		100	100	100	100	100	100
Rutting Index		98	97	99	99	99	97
International Roug	hness Index (IRI)	112	142	104	74	81	90
Lane & Width Info	rmation

Number of Lanes		2	2	2	2	2	2
Paved Width (ft)		24.2	23.9	24.2	24.6	24.4	24.6
Lane Width (ft)		10.4	11.4	11	10.1	10.2	10.4

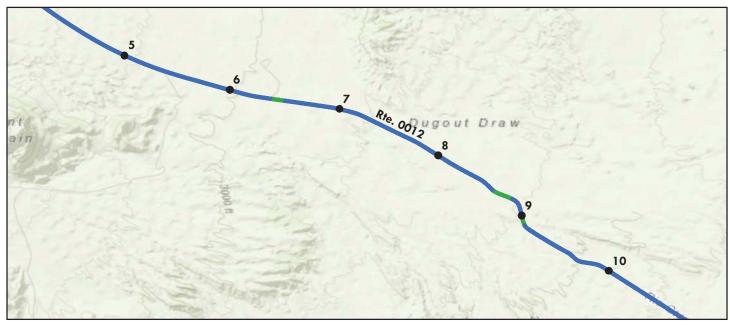
ROUTE 0012: RIO GRANDE ROAD

Route Condition Legend – Pavement Condition Rating (PCR)								
				Excellent (95 - 100)		ted		
See Appendix for definitions and formulas								
<b>Inspection Date:</b> 3/20/2017	Beginning Section MF	5	6	7	8	9		
Paved Length (Miles): 20.31	Section Length (MI)	1	1	1	1	1		
Surface Type: ASPHALT	Route Summary							
Roadway Condition Information								
Pavement Condition Rating (PCR)	97	99	99	99	99	99		
Surface Condition Rating (SCR)	95	98	99	99	98	98		
Roughness Condition Index (RCI)	100	100	100	100	100	100		
Distress Index Values								
Structural Crack Index	95	100	100	100	100	100		
Alligator Crack Index	100	100	100	100	100	100		
Longitudinal Crack Index	95	100	100	100	100	100		
Transverse Cracking Index	97	100	100	100	100	100		
Patching Index	100	100	100	100	100	100		
Rutting Index	98	98	99	99	98	98		
International Roughness Index (IR	112	101	101	91	102	98		
Lane & Width Information								
Number of Lanes	2	2	2	2	2	2

Paved Width (ft)	24.2	24.4	24.2	24.2	24	24		
Lane Width (ft)	10.4	10.4	10.4	10.3	10.3	10.3

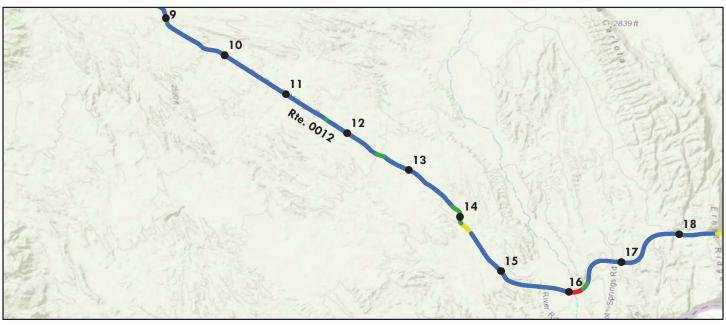
ROUTE 0012: RIO GRANDE ROAD

Route Condition Legend – Pavement Condition Rating (PCR)								
Poor (0 - 60) Fair (61- 84) Go		(85 - 94) Excellent (95 - 100)		95 - 100)	Not Rated			
	See Appendix for definitions and formulas							
<b>Inspection Date:</b> 3/20/2017	<b>Beginning Section MP</b>	10	11	12	13	14		
Paved Length (Miles): 20.31	Section Length (MI)	1	1	1	1	1		
Surface Type: ASPHALT	Route Summary							
Roadway Condition Information								
Pavement Condition Rating (PCR)	97	99	99	98	95	94		
Surface Condition Rating (SCR)	95	98	98	97	96	97		
Roughness Condition Index (RCI)	100	100	100	100	94	90		
Distress Index Values								
Structural Crack Index	95	100	100	100	100	100		
Alligator Crack Index	100	100	100	100	100	100		
Longitudinal Crack Index	95	100	100	100	100	100		
Transverse Cracking Index	97	100	100	100	100	100		
Patching Index	100	100	100	100	100	100		
Rutting Index	98	98	98	97	96	97		
International Roughness Index (IRI)	112	107	99	104	131	140

Lane & Width Information								
Number of Lanes	2	2	2	2	2	2		
Paved Width (ft)	24.2	24.7	24.7	24.9	24.9	24.5		
Lane Width (ft)	10.4	10.2	10.3	10.2	10.1	10.2

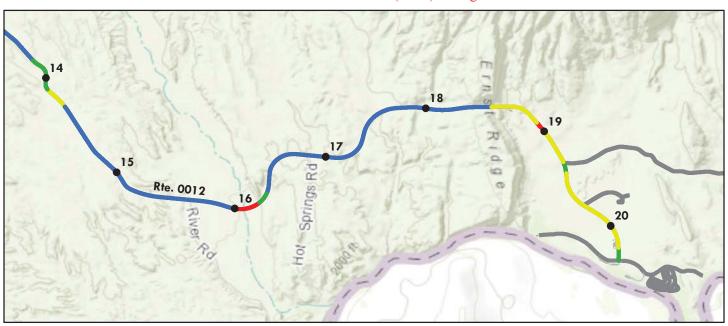
ROUTE 0012: RIO GRANDE ROAD

#### Data Collection Vehicle (DCV) Rating

Route Condition Legend – Pavement Condition Rating (PCR)								
				Excellent (95 - 100)		ted		
See Appendix for definitions and formulas								
<b>Inspection Date:</b> 3/20/2017	Beginning Section MP	15	16	17	18	19		
Paved Length (Miles): 20.31	Section Length (MI)	1	1	1	1	1		
Surface Type: ASPHALT	Route Summary		•		•			
Roadway Condition Information								
Pavement Condition Rating (PCR)	97	99	96	99	86	73		
Surface Condition Rating (SCR)	95	99	98	99	85	75		
Roughness Condition Index (RCI)	100	100	93	100	88	71		
Distress Index Values								
Structural Crack Index	95	100	99	100	85	75		
Alligator Crack Index	100	100	100	100	100	100		
Longitudinal Crack Index	95	100	99	100	85	75		
Transverse Cracking Index	97	100	100	100	89	78		
Patching Index	100	100	100	100	100	99		
Rutting Index	98	99	98	99	96	96		
International Roughness Index (IRI)	112	87	132	88	147	200		
Lane & Width Information								
Number of Lanes	2	2	2	2	2	2

Paved Width (ft)	24.2	24.9	25.1	24.1	23.4	21.6		
Lane Width (ft)	10.4	10.1	11	10.3	10.8	10.3

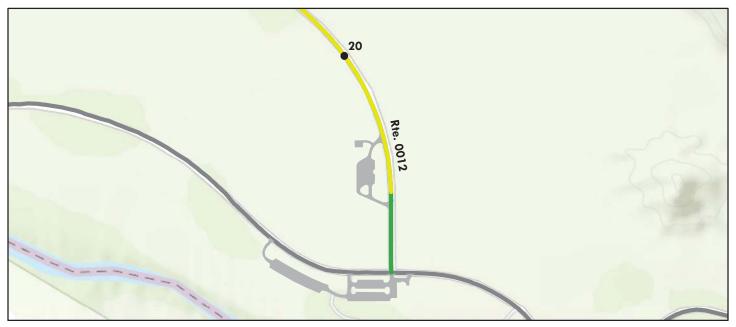
ROUTE 0012: RIO GRANDE ROAD

#### Data Collection Vehicle (DCV) Rating

Route (	Condition Legend – Pav	ement Cond	ition Rating (	PCR)			
Poor (0 - 60) Fair (61			(85 - 94)	<b>Excellent (95 - 100)</b>		Not Rated		
		See Appendix for def	finitions and f	formulas				
Inspection Date:	3/20/2017	<b>Beginning Section MP</b>	20					
Paved Length (Mil	es): 20.31	Section Length (MI)	0.31					
Surface Type:	ASPHALT	Route Summary		•				
Roadway Conditio	n Information							
Pavement Condition	on Rating (PCR)	97	84					
Surface Condition I	Rating (SCR)	95	88					
Roughness Condition	on Index (RCI)	100	77					
Distress Index Valu	ies							
Structural Crack In	ndex	95	88					
Alligator Crack In	dex	100	100					
Longitudinal Crac	k Index	95	88					
Transverse Cracking	ng Index	97	90					
Patching Index		100	100					
Rutting Index		98	95					
International Roughness Index (IRI)		112	179					
Lane & Width Info	ormation							
Number of Lanes		2	2					
Paved Width (ft)		24.2	20.8					
Lane Width (ft)		10.4	10.2

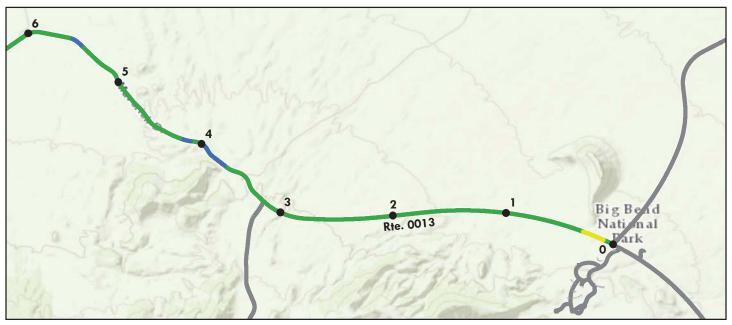
#### ROUTE 0013: WEST ENTRANCE ROAD

#### Data Collection Vehicle (DCV) Rating

Route Condition Legend – Pavement Condition Rating (PCR)								
Poor (0 - 60) Fair (6	1- 84) Good (85 - 94)		<b>Excellent (95 - 100)</b>		Not Rated			
See Appendix for definitions and formulas								
Inspection Date: 3/20/2017 Beginning Section MP 0 1 2 3 4								
Paved Length (Miles): 21.91	Section Length (MI)	1	1	1	1	1		
Surface Type: ASPHALT	Route Summary							
Roadway Condition Information								
Pavement Condition Rating (PCR)	93	87	88	90	92	94		
Surface Condition Rating (SCR)	88	78	80	83	86	90		
Roughness Condition Index (RCI)	100	100	100	100	100	100		
Distress Index Values								
Structural Crack Index	97	91	98	97	97	100		
Alligator Crack Index	100	100	100	100	100	100		
Longitudinal Crack Index	97	91	98	97	97	100		
Transverse Cracking Index	88	78	80	83	86	90		
Patching Index	100	100	100	100	100	100		
Rutting Index	99	100	100	100	99	100		
International Roughness Index (IRI)	88	73	67	71	80	58

Lane & Width Information								
Number of Lanes	2	2	2	2	2	2		
Paved Width (ft)	23.4	23.8	23.4	23.4	23	22.5		
Lane Width (ft)	10	10.4	10.2	10	9.9	9.5

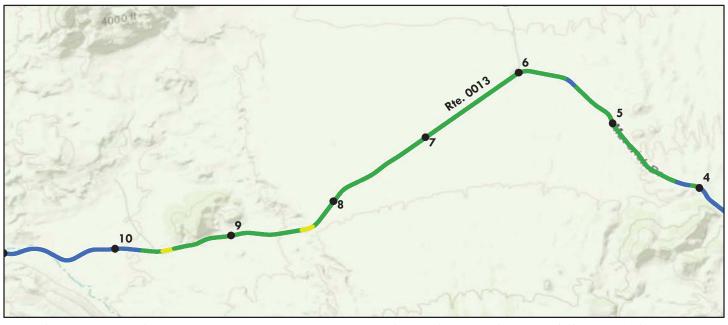
ROUTE 0013: WEST ENTRANCE ROAD

#### Data Collection Vehicle (DCV) Rating

Route Condition Legend – Pavement Condition Rating (PCR)									
Poor (0 - 60) Fair (6	1- 84) Good (85 - 94)		<b>Excellent (95 - 100)</b>		Not Rated				
See Appendix for definitions and formulas									
Inspection Date:         3/20/2017         Beginning Section MP         5         6         7         8         9									
Paved Length (Miles): 21.91	Section Length (MI)	1	1	1	1	1			
Surface Type: ASPHALT	Route Summary								
Roadway Condition Information									
Pavement Condition Rating (PCR)	93	93	90	91	91	93			
Surface Condition Rating (SCR)	88	88	84	85	85	88			
Roughness Condition Index (RCI)	100	100	100	100	100	100			
Distress Index Values									
Structural Crack Index	97	100	96	97	94	96			
Alligator Crack Index	100	100	100	100	100	100			
Longitudinal Crack Index	97	100	96	97	94	96			
Transverse Cracking Index	88	88	84	85	85	88			
Patching Index	100	100	100	100	100	100			
Rutting Index	99	100	97	99	98	97

International Roughness Index (IRI)	88	65	84	80	109	113			
Lane & Width Information									
Number of Lanes	2	2	2	2	2	2			
Paved Width (ft)	23.4	22.3	22.4	22.1	26.5	22.2			
Lane Width (ft)	10	9.6	10	10	9.8	9.7

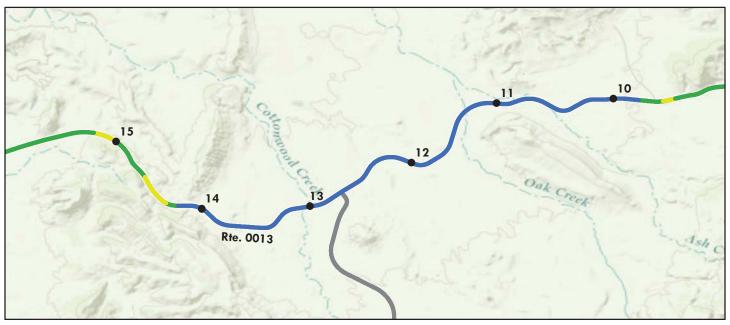
#### ROUTE 0013: WEST ENTRANCE ROAD

#### Data Collection Vehicle (DCV) Rating

Route (	Condition Legend – Pav	ement Condi	tion Rating (	PCR)				
Poor (0 - 60	_				Excellent (95 - 100)		ted		
	See Appendix for definitions and formulas								
Inspection Date:	3/20/2017	<b>Beginning Section MP</b>	10	11	12	13	14		
Paved Length (Mile	es): 21.91	Section Length (MI)	1	1	1	1	1		
Surface Type:	ASPHALT	Route Summary				!			
Roadway Condition Information									
Pavement Condition	n Rating (PCR)	93	100	99	100	99	90		
Surface Condition R	ating (SCR)	88	100	99	100	99	83		
Roughness Condition Index (RCI)		100	100	100	100	100	100		
Distress Index Values									
Structural Crack In-	dex	97	100	99	100	99	94		
Alligator Crack Ind	lex	100	100	100	100	100	100		
Longitudinal Crack	Index	97	100	99	100	99	94		
Transverse Crackin	g Index	88	100	100	100	99	83		
Patching Index		100	100	100	100	100	100		
Rutting Index		99	100	100	100	100	98		
International Rough	nness Index (IRI)	88	71	68	69	81	114		
Lane & Width Info	rmation

Number of Lanes		2	2	2	2	2	2		
Paved Width (ft)		23.4	23.4	23.2	24.7	24.5	23.8		
Lane Width (ft)		10	10	9.8	10	10.2	10.2

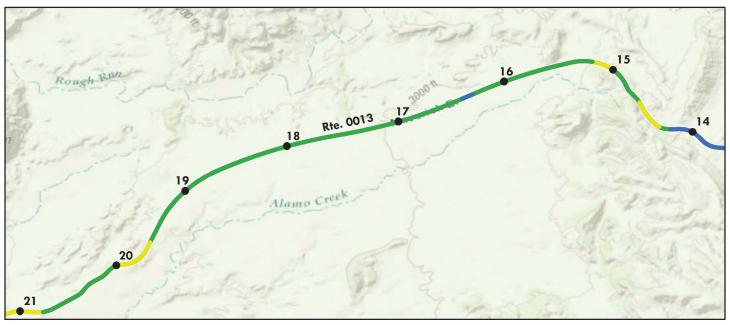
ROUTE 0013: WEST ENTRANCE ROAD

#### Data Collection Vehicle (DCV) Rating

Route Condition Legend – Pavement Condition Rating (PCR)									
Poor (0 - 60) Fair (6	1-84) Good (85 - 94)		<b>Excellent (95 - 100)</b>		Not Rated				
See Appendix for definitions and formulas									
Inspection Date:         3/20/2017         Beginning Section MP         15         16         17         18         19									
Paved Length (Miles): 21.91	Section Length (MI)	1	1	1	1	1			
Surface Type: ASPHALT	Route Summary								
Roadway Condition Information									
Pavement Condition Rating (PCR)	93	90	92	93	92	91			
Surface Condition Rating (SCR)	88	84	87	88	87	85			
Roughness Condition Index (RCI)	100	100	100	100	100	100			
Distress Index Values									
Structural Crack Index	97	97	95	96	97	96			
Alligator Crack Index	100	100	100	100	100	100			
Longitudinal Crack Index	97	97	95	96	97	96			
Transverse Cracking Index	88	84	87	88	87	85			
Patching Index	100	100	100	100	100	100			
Rutting Index	99	100	98	98	99	99

International Roughness Index (IRI)	88	97	78	78	72	113			
Lane & Width Information									
Number of Lanes	2	2	2	2	2	2			
Paved Width (ft)	23.4	22.6	22.6	22.4	22.2	23.5			
Lane Width (ft)	10	10	10.4	10.5	10.2	10

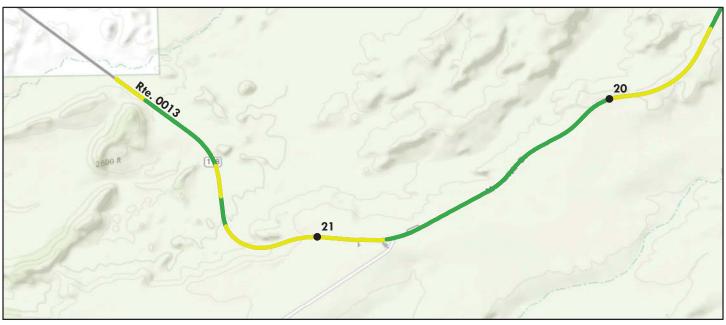
### ROUTE 0013: WEST ENTRANCE ROAD

### Data Collection Vehicle (DCV) Rating

Route (	Condition Legend – Pav	ement Condi	tion Rating (	PCR)		
Poor (0 - 60			(85 - 94)	Excellent (		Not Rat	ed
		See Appendix for def	finitions and f	ormulas			
Inspection Date:	3/20/2017	<b>Beginning Section MP</b>	20	21			
Paved Length (Mile	es): 21.91	Section Length (MI)	1	0.91			
Surface Type:	ASPHALT	Route Summary				'	
Roadway Condition	n Information						
Pavement Condition	n Rating (PCR)	93	92	80			
Surface Condition R	Surface Condition Rating (SCR)		87	84			
Roughness Condition	n Index (RCI)	100	100	75			
Distress Index Valu	es						
Structural Crack In	dex	97	97	86			
Alligator Crack Inc	lex	100	100	100			
Longitudinal Crack	Index	97	97	86			
Transverse Crackin	ig Index	88	87	84			
Patching Index		100	100	100			
Rutting Index		99	99	95			
International Roug	hness Index (IRI)	88	114	185			
Lane & Width Info	rmation						
Number of Lanes		2	2	2			
Paved Width (ft)		23.4	25	25			
Lane Width (ft)		10	10.3	10.2

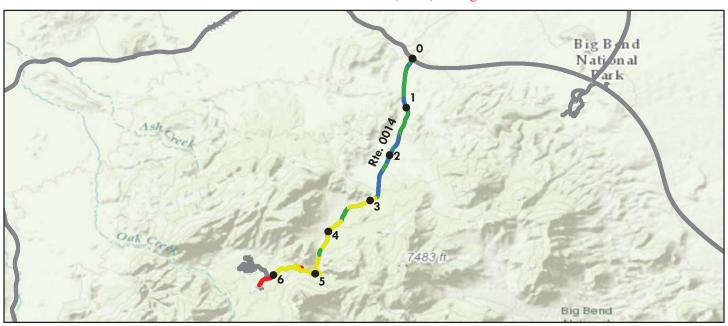
ROUTE 0014: CHISOS BASIN ROAD

### Data Collection Vehicle (DCV) Rating

Ro	ıte Condition Legend – Pav	ement Condi	ition Rating (	PCR)		
		(85 - 94)	Excellent (		Not Ra	ted
	See Appendix for de	finitions and f	ormulas			
<b>Inspection Date:</b> 3/20/2017	Beginning Section MP	0	1	2	3	4
Paved Length (Miles): 6.34	Section Length (MI)	1	1	1	1	1
Surface Type: ASPHALT	Route Summary		•	•	•	•
Roadway Condition Information						
Pavement Condition Rating (PCR)	88	93	93	95	86	81
Surface Condition Rating (SCR)	82	89	89	91	76	73
Roughness Condition Index (RCI)	98	100	100	100	100	92
Distress Index Values						
Structural Crack Index	82	98	94	93	76	73
Alligator Crack Index	100	100	100	100	100	100
Longitudinal Crack Index	82	98	94	93	76	73
Transverse Cracking Index	88	89	89	91	90	91
Patching Index	100	100	100	100	100	100
Rutting Index	98	100	100	98	99	98
International Roughness Index (IRI)	119	76	78	80	104	134
Lane & Width Information						
Number of Lanes	2	2	2	2	2	2
Paved Width (ft)	20.8	22	20	20.2	20.6	21.1

Lane Width (ft)	9.2	10	8.8	9.1	8.8	9

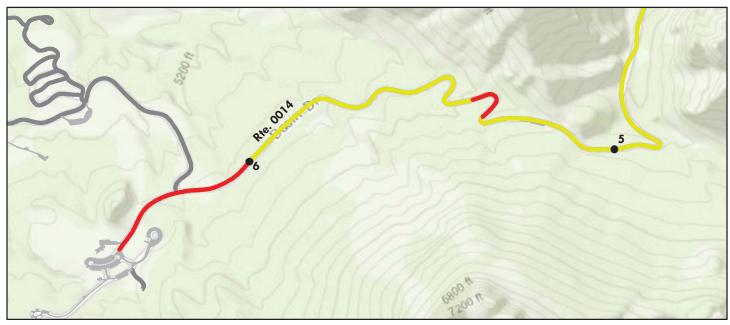
ROUTE 0014: CHISOS BASIN ROAD

### Data Collection Vehicle (DCV) Rating

Route (	Condition Legend – Pav	ement Condi	tion Rating (	PCR)	
Poor (0 - 6			(85 - 94)	Excellent (9		Not Rated
		See Appendix for def	initions and f	ormulas		
Inspection Date:	3/20/2017	<b>Beginning Section MP</b>	5	6		
Paved Length (Mile	es): 6.34	Section Length (MI)	1	0.34		
Surface Type:	ASPHALT	Route Summary				'
Roadway Condition	n Information					
Pavement Condition	on Rating (PCR)	88	69	54		
Surface Condition I	Rating (SCR)	82	66	62		
Roughness Condition	on Index (RCI)	98	73	41		
Distress Index Valu	ies					
Structural Crack Ir	ndex	82	66	62		
Alligator Crack Inc	dex	100	100	100		
Longitudinal Cracl	k Index	82	66	62		
Transverse Crackin	ng Index	88	76	90		
Patching Index		100	100	100		
Rutting Index		98	97	93		
International Roug	hness Index (IRI)	119	192	330		
Lane & Width Info	ormation					
Number of Lanes		2	2	2		
Paved Width (ft)		20.8	21	21.2		
Lane Width (ft)		9.2	9.2	9.2

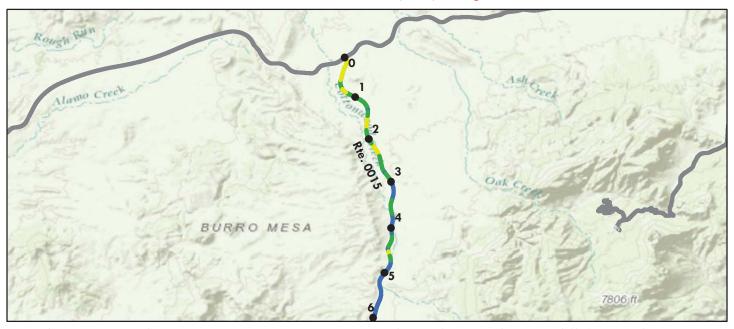
### ROUTE 0015: ROSS MAXWELL SCENIC DRIVE

### Data Collection Vehicle (DCV) Rating

Route Condition Legend – Pavement Condition Rating (PCR)							
Poor (0 - 60) Fair (6	1- 84) Good (	85 - 94)	Excellent (	95 - 100)	Not Ra	ted	
	See Appendix for def	initions and f	ormulas			_	
<b>Inspection Date:</b> 3/20/2017	Beginning Section MP	0	1	2	3	4	
Paved Length (Miles): 23.25	Section Length (MI)	1	1	1	1	1	
Surface Type: ASPHALT	Route Summary						
Roadway Condition Information							
Pavement Condition Rating (PCR)	96	82	88	88	97	93	
Surface Condition Rating (SCR)	94	94	95	97	97	94	
Roughness Condition Index (RCI)	99	64	77	74	96	92	
Distress Index Values							
Structural Crack Index	98	96	98	99	100	100	
Alligator Crack Index	100	100	100	100	100	100	
Longitudinal Crack Index	98	96	98	99	100	100	
Transverse Cracking Index	94	94	95	97	97	94	
Patching Index	100	100	100	100	100	100	
Rutting Index	100	98	100	100	100	100	
International Roughness Index (IRI)	118	225	178	190	125	136	
Lane & Width Information

Number of Lanes	2	2	2	2	2	2	
Paved Width (ft)	22.2	22.6	21.3	20.9	21.4	21.1	
Lane Width (ft)	9.2	9.3	9.1	9.1	9.1	8.9

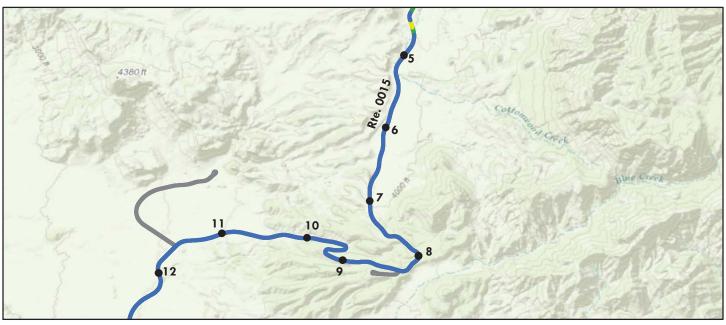
### ROUTE 0015: ROSS MAXWELL SCENIC DRIVE

### Data Collection Vehicle (DCV) Rating

Route Condition Legend – Pavement Condition Rating (PCR)							
Poor (0 - 60) Fair (6	1- 84) Good (	85 - 94)	Excellent (	95 - 100)	Not Ra	ted	
	See Appendix for def	initions and f	ormulas			_	
<b>Inspection Date:</b> 3/20/2017	Beginning Section MP	5	6	7	8	9	
Paved Length (Miles): 23.25	Section Length (MI)	1	1	1	1	1	
Surface Type: ASPHALT	Route Summary						
Roadway Condition Information							
Pavement Condition Rating (PCR)	96	99	99	99	99	100	
Surface Condition Rating (SCR)	94	98	98	98	99	100	
Roughness Condition Index (RCI)	99	100	100	100	100	100	
Distress Index Values							
Structural Crack Index	98	100	100	100	100	100	
Alligator Crack Index	100	100	100	100	100	100	
Longitudinal Crack Index	98	100	100	100	100	100	
Transverse Cracking Index	94	98	98	98	99	100	
Patching Index	100	100	100	100	100	100	
Rutting Index	100	100	100	99	100	100	
International Roughness Index (IRI)	118	92	100	94	85	81	
Lane & Width Information

Number of Lanes	2	2	2	2	2	2	
Paved Width (ft)	22.2	21.4	21.8	21.7	22.2	24	
Lane Width (ft)	9.2	9	9.2	9.3	9.1	9.5

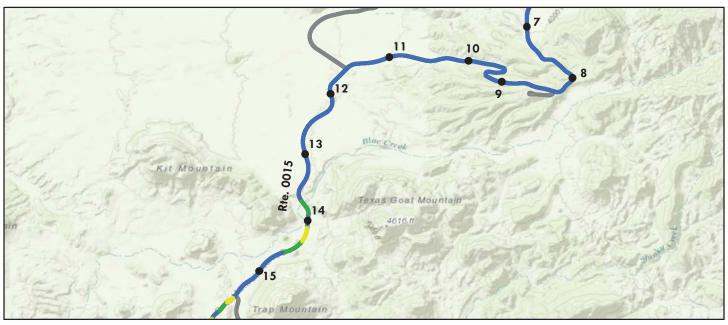
### ROUTE 0015: ROSS MAXWELL SCENIC DRIVE

### Data Collection Vehicle (DCV) Rating

Route Condition Legend – Pavement Condition Rating (PCR)							
Poor (0 - 60) Fair (6	1- 84) Good (	85 - 94)	Excellent (	95 - 100)	Not Ra	ted	
	See Appendix for def	initions and f	ormulas			_	
<b>Inspection Date:</b> 3/20/2017	Beginning Section MP	10	11	12	13	14	
Paved Length (Miles): 23.25	Section Length (MI)	1	1	1	1	1	
Surface Type: ASPHALT	Route Summary						
Roadway Condition Information							
Pavement Condition Rating (PCR)	96	100	99	99	98	90	
Surface Condition Rating (SCR)	94	100	98	99	97	94	
Roughness Condition Index (RCI)	99	100	100	100	100	84	
Distress Index Values							
Structural Crack Index	98	100	100	100	100	94	
Alligator Crack Index	100	100	100	100	100	100	
Longitudinal Crack Index	98	100	100	100	100	94	
Transverse Cracking Index	94	100	98	99	97	96	
Patching Index	100	100	100	100	100	100	
Rutting Index	100	100	100	100	100	99	
International Roughness Index (IRI)	118	65	69	62	97	157	
Lane & Width Information

Number of Lanes	2	2	2	2	2	2	
Paved Width (ft)	22.2	21.4	22.1	21.7	22.3	23.2	
Lane Width (ft)	9.2	9.1	9.4	9.1	9.6	9.2

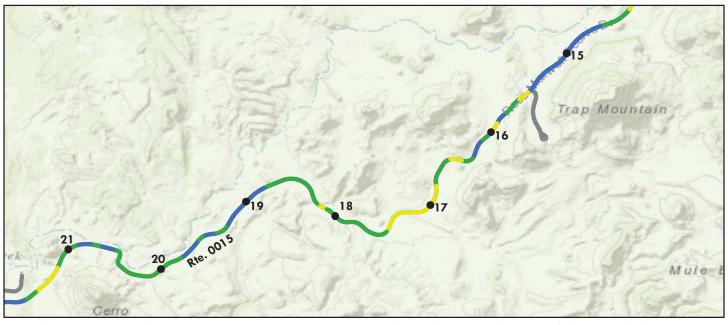
### ROUTE 0015: ROSS MAXWELL SCENIC DRIVE

### Data Collection Vehicle (DCV) Rating

Route Condition Legend – Pavement Condition Rating (PCR)							
Poor (0 - 60) Fair (6)	1- 84) Good (	(85 - 94)	Excellent (	95 - 100)	Not Ra	ted	
	See Appendix for def	initions and f	ormulas			_	
<b>Inspection Date:</b> 3/20/2017	Beginning Section MP	15	16	17	18	19	
Paved Length (Miles): 23.25	Section Length (MI)	1	1	1	1	1	
Surface Type: ASPHALT	Route Summary						
Roadway Condition Information							
Pavement Condition Rating (PCR)	96	96	87	80	92	95	
Surface Condition Rating (SCR)	94	97	92	80	87	91	
Roughness Condition Index (RCI)	99	94	80	81	100	100	
Distress Index Values							
Structural Crack Index	98	98	96	94	98	100	
Alligator Crack Index	100	100	100	100	100	100	
Longitudinal Crack Index	98	98	96	94	98	100	
Transverse Cracking Index	94	97	92	80	87	91	
Patching Index	100	100	100	100	100	100	
Rutting Index	100	100	99	99	100	100	
International Roughness Index (IRI)	118	128	168	165	86	77	
Lane & Width Information

Number of Lanes	2	2	2	2	2	2	
Paved Width (ft)	22.2	22.6	24.3	22.7	22.3	21.8	
Lane Width (ft)	9.2	9.1	9.7	9.3	9.4	9.3

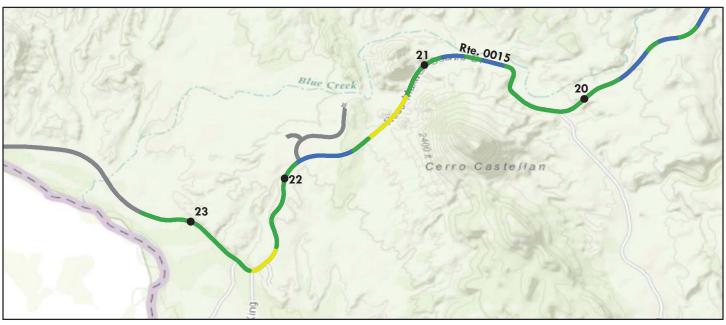
### ROUTE 0015: ROSS MAXWELL SCENIC DRIVE

### Data Collection Vehicle (DCV) Rating

Route Condition Legend – Pavement Condition Rating (PCR)							
Poor (0 - 60) Fair (6	1-84) Good (	(85 - 94)	Excellent (	95 - 100)	Not Ra	ted	
	See Appendix for def	initions and f	ormulas				
<b>Inspection Date:</b> 3/20/2017	<b>Beginning Section MP</b>	20	21	22	23		
Paved Length (Miles): 23.25	Section Length (MI)	1	1	1	0.25		
Surface Type: ASPHALT	Route Summary						
Roadway Condition Information							
Pavement Condition Rating (PCR)	96	92	89	91	92		
Surface Condition Rating (SCR)	94	86	87	85	87		
Roughness Condition Index (RCI)	99	100	93	100	100		
Distress Index Values							
Structural Crack Index	98	96	98	97	97		
Alligator Crack Index	100	100	100	100	100		
Longitudinal Crack Index	98	96	98	97	97		
Transverse Cracking Index	94	86	87	85	87		
Patching Index	100	100	100	100	100		
Rutting Index	100	100	100	100	100		
International Roughness Index (IRI)	118	106	131	112	104		
Lane & Width Information							
Number of Lanes	2	2	2	2	2

Paved Width (ft)	22.2	22.6	22.7	22.3	22.2		
Lane Width (ft)	9.2	9.3	9.2	9.4	9.1

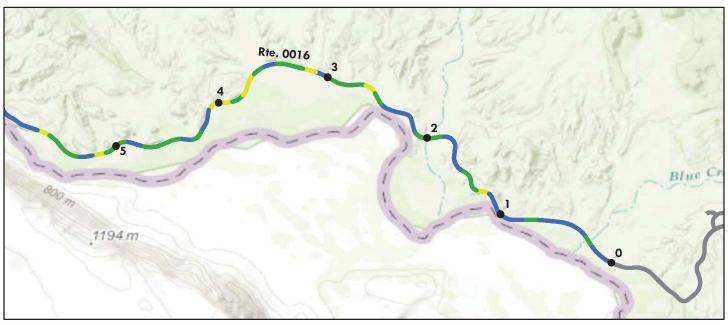
### ROUTE 0016: SANTA ELENA CANYON ROAD

### Data Collection Vehicle (DCV) Rating

Route	Condition Legend – Pav	ement Condi	ition Rating (	PCR)		
Poor (0 - 60) Fair (6		(85 - 94)	Excellent (		Not Ra	ted
	See Appendix for def	initions and f	ormulas			
<b>Inspection Date:</b> 3/20/2017	<b>Beginning Section MP</b>	0	1	2	3	4
Paved Length (Miles): 7.70	Section Length (MI)	1	1	1	1	1
Surface Type: ASPHALT	Route Summary			•		•
Roadway Condition Information						
Pavement Condition Rating (PCR)	93	97	95	94	85	93
Surface Condition Rating (SCR)	96	98	97	96	90	97
Roughness Condition Index (RCI)	88	95	92	91	78	86
Distress Index Values						
Structural Crack Index	98	99	99	99	94	99
Alligator Crack Index	100	100	100	100	100	100
Longitudinal Crack Index	98	99	99	99	94	99
Transverse Cracking Index	96	98	97	96	90	97
Patching Index	100	100	100	100	100	100
Rutting Index	98	99	99	99	98	98
International Roughness Index (IRI)	146	128	135	138	174	151
Lane & Width Information						
Number of Lanes	2	2	2	2	2	2
Paved Width (ft)	22.9	22.8	22.4	22.7	22.7	23.1

Lane Width (ft)	9.5	9.4	9.1	9.2	9.2	9.2

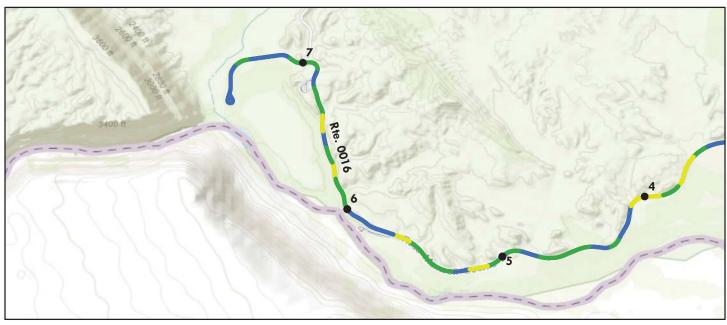
### ROUTE 0016: SANTA ELENA CANYON ROAD

### Data Collection Vehicle (DCV) Rating

Route Condition Legend – Pavement Condition Rating (PCR)								
Poor (0 - 60) Fair (6	1-84) Good (	85 - 94)	Excellent (	95 - 100)	Not Rated			
	See Appendix for def	initions and f	ormulas					
<b>Inspection Date:</b> 3/20/2017	<b>Beginning Section MP</b>	5	6	7				
Paved Length (Miles): 7.70	Section Length (MI)	1	1	0.70				
Surface Type: ASPHALT	Route Summary							
Roadway Condition Information								
Pavement Condition Rating (PCR)	93	94	90	97				
Surface Condition Rating (SCR)	96	97	97	98				
Roughness Condition Index (RCI)	88	90	80	96				
Distress Index Values								
Structural Crack Index	98	99	97	100				
Alligator Crack Index	100	100	100	100				
Longitudinal Crack Index	98	99	97	100				
Transverse Cracking Index	96	98	97	100				
Patching Index	100	100	100	100				
Rutting Index	98	97	98	98				
International Roughness Index (IRI)	146	140	168	126				
Lane & Width Information								
Number of Lanes	2	2	2	2

Paved Width (ft)	22.9	22.7	22.4	24.4				
Lane Width (ft)	9.5	9.2	9.1	12.9

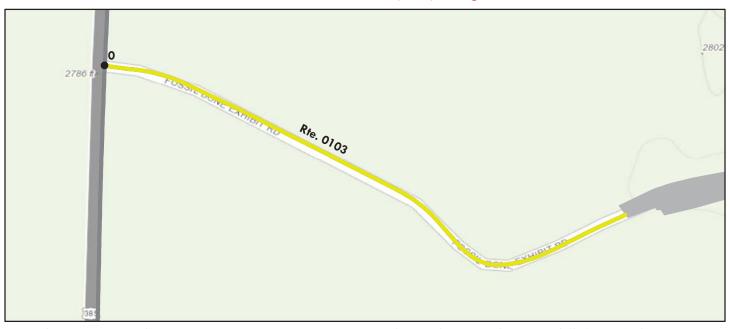
**ROUTE 0103: FOSSIL BONE ROAD**

### Data Collection Vehicle (DCV) Rating

Route C	Condition Legend – Pav	ement Condi	tion Rating (PCR)	
Poor (0 - 60) Fair (6	1- 84) Good (	(85 - 94)	<b>Excellent (95 - 100)</b>	Not Rated
	See Appendix for def	initions and f	ormulas	,
<b>Inspection Date:</b> 3/20/2017	<b>Beginning Section MP</b>	0		
Paved Length (Miles): 0.23	Section Length (MI)	0.23		
Surface Type: ASPHALT	Route Summary			
Roadway Condition Information				
Pavement Condition Rating (PCR)	83	83		
Surface Condition Rating (SCR)	83	83		
Roughness Condition Index (RCI)	N/A	N/A		
Distress Index Values				
Structural Crack Index	84	84		
Alligator Crack Index	100	100		
Longitudinal Crack Index	84	84		
Transverse Cracking Index	83	83		
Patching Index	100	100		
Rutting Index	98	98		
International Roughness Index (IRI)	N/A	N/A		
Lane & Width Information				
Number of Lanes	2	2		
Paved Width (ft)	22.5	22.5		
Lane Width (ft)	11.3	11.3

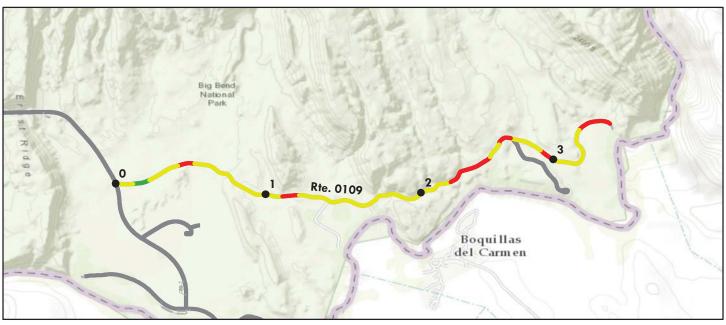
### ROUTE 0109: BOQUILLAS CANYON ROAD

### Data Collection Vehicle (DCV) Rating

Route C	Route Condition Legend – Pavement Condition Rating (PCR)							
Poor (0 - 60) Fair (6)	1-84) Good (	85 - 94)	Excellent (	95 - 100)	Not Ra	ted		
	See Appendix for def	initions and f	ormulas					
<b>Inspection Date:</b> 3/20/2017	Beginning Section MP	0	1	2	3			
Paved Length (Miles): 3.61	Section Length (MI)	1	1	1	0.61			
Surface Type: ASPHALT	Route Summary							
Roadway Condition Information								
Pavement Condition Rating (PCR)	68	76	75	58	51			
Surface Condition Rating (SCR)	74	80	87	66	40			
Roughness Condition Index (RCI)	59	70	58	47	67			
Distress Index Values								
Structural Crack Index	81	80	87	79	77			
Alligator Crack Index	100	100	99	100	100			
Longitudinal Crack Index	81	80	88	79	77			
Transverse Cracking Index	74	86	92	66	40			
Patching Index	100	100	100	100	100			
Rutting Index	89	90	88	88	90			
International Roughness Index (IRI)	242	200	247	298	214			
Lane & Width Information

Number of Lanes	2	2	2	2	2			
Paved Width (ft)	18.9	19	18.7	18.9	19.1			
Lane Width (ft)	8.6	8.7	8.6	8.5	8.7

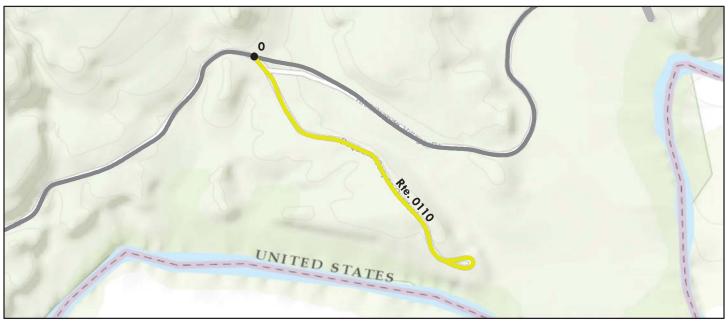
### ROUTE 0110: BOQUILLAS CANYON OVERLOOK

### Data Collection Vehicle (DCV) Rating

Route (	Condition Legend – Pav	ement Cond	ition Rating (	PCR)		
Poor (0 - 6			(85 - 94)	Excellent (9		Not Ra	ted
		See Appendix for def	finitions and f	Formulas			
Inspection Date:	3/20/2017	<b>Beginning Section MP</b>	0				
Paved Length (Mil	es): 0.57	Section Length (MI)	0.57				
Surface Type:	ASPHALT	Route Summary					
Roadway Conditio	n Information						
Pavement Condition	on Rating (PCR)	73	73				
Surface Condition I	Rating (SCR)	89	89				
Roughness Condition	on Index (RCI)	49	49				
Distress Index Valu	ies						
Structural Crack In	ndex	90	90				
Alligator Crack In	dex	100	100				
Longitudinal Crac	k Index	90	90				
Transverse Cracking	ng Index	89	89				
Patching Index		99	99				
Rutting Index		92	92				
International Roug	ghness Index (IRI)	289	289				
Lane & Width Info	ormation						
Number of Lanes		2	2				
Paved Width (ft)		17.8	17.8				
Lane Width (ft)		9.5	9.5

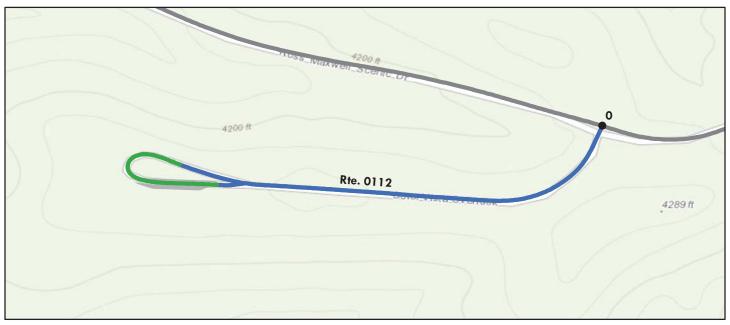
### ROUTE 0112: SOTOL VISTA OVERLOOK ROAD

### Data Collection Vehicle (DCV) Rating

Route (	Condition Legend – Pav	ement Condi	ition Rating (	PCR)		
Poor (0 - 6			(85 - 94)	Excellent (		Not Ra	ted
		See Appendix for def	initions and f	ormulas			
Inspection Date:	3/20/2017	<b>Beginning Section MP</b>	0				
Paved Length (Mile	<b>es):</b> 0.41	Section Length (MI)	0.41				
Surface Type:	ASPHALT	Route Summary					
Roadway Condition	n Information						
Pavement Condition	on Rating (PCR)	98	98				
Surface Condition I	Rating (SCR)	98	98				
Roughness Condition	on Index (RCI)	N/A	N/A				
Distress Index Valu	ies						
Structural Crack Ir	ndex	100	100				
Alligator Crack Inc	dex	100	100				
Longitudinal Cracl	k Index	100	100				
Transverse Crackin	ng Index	100	100				
Patching Index		100	100				
Rutting Index		98	98				
International Roug	hness Index (IRI)	N/A	N/A				
Lane & Width Info	ormation						
Number of Lanes		2	2				
Paved Width (ft)		19.7	19.7				
Lane Width (ft)		10.2	10.2

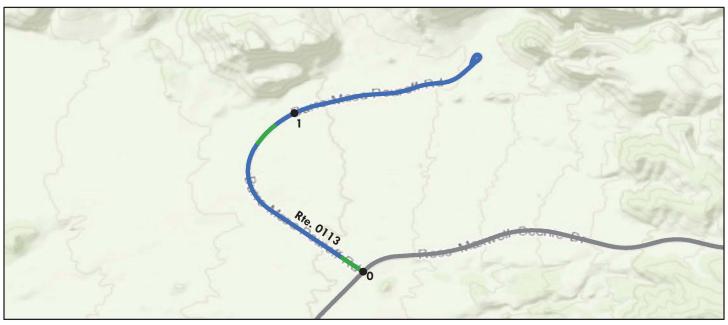
### ROUTE 0113: BURRO MESA POUROFF ROAD

### Data Collection Vehicle (DCV) Rating

Route	Condition Legend – Pav	ement Condi	tion Rating (P	PCR)	
Poor (0 - 60) Fair (6	Good (	(85 - 94)	Excellent (9	5 - 100)	Not Rated
	See Appendix for def	initions and f	ormulas		
<b>Inspection Date:</b> 3/20/2017	<b>Beginning Section MP</b>	0	1		
Paved Length (Miles): 1.86	Section Length (MI)	1	0.86		
Surface Type: ASPHALT	Route Summary				
Roadway Condition Information					
Pavement Condition Rating (PCR)	98	98	98		
Surface Condition Rating (SCR)	96	96	97		
Roughness Condition Index (RCI)	100	100	100		
Distress Index Values					
Structural Crack Index	100	100	100		
Alligator Crack Index	100	100	100		
Longitudinal Crack Index	100	100	100		
Transverse Cracking Index	96	96	97		
Patching Index	100	100	100		
Rutting Index	99	99	99		
International Roughness Index (IRI)	95	104	82		
Lane & Width Information					
Number of Lanes	2	2	2		
Paved Width (ft)	22.1	22.6	21.5		
Lane Width (ft)	11.5	11.3	11.7

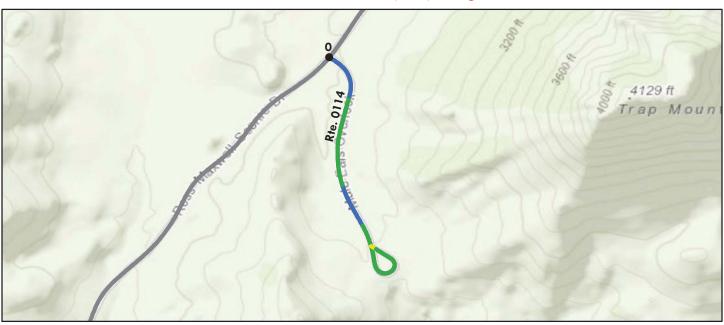
### ROUTE 0114: MULE EARS OVERLOOK ROAD

### Data Collection Vehicle (DCV) Rating

Route	Condition Legend – Pav	ement Condi	tion Rating (PCR)	
Poor (0 - 60) Fair (6	Good (	(85 - 94)	<b>Excellent (95 - 100)</b>	Not Rated
	See Appendix for def	finitions and f	ormulas	
<b>Inspection Date:</b> 3/20/2017	<b>Beginning Section MP</b>	0		
Paved Length (Miles): 0.61	Section Length (MI)	0.61		
Surface Type: ASPHALT	Route Summary		•	•
Roadway Condition Information				
Pavement Condition Rating (PCR)	93	93		
Surface Condition Rating (SCR)	95	95		
Roughness Condition Index (RCI)	91	91		
Distress Index Values				
Structural Crack Index	97	97		
Alligator Crack Index	100	100		
Longitudinal Crack Index	97	97		
Transverse Cracking Index	95	95		
Patching Index	100	100		
Rutting Index	96	96		
International Roughness Index (IRI)	138	138		
Lane & Width Information				
Number of Lanes	2	2		
Paved Width (ft)	22	22		
Lane Width (ft)	13.8	13.8

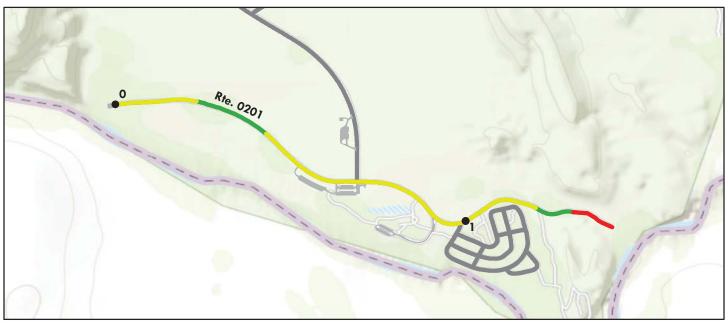
ROUTE 0201: RIO GRANDE VILLAGE ROAD

### Data Collection Vehicle (DCV) Rating

Route (	Condition Legend – Pav	ement Condi	tion Rating (	PCR)		
Poor (0 - 60			(85 - 94)	Excellent (		Not Rat	ed
		See Appendix for def	finitions and f	ormulas			
Inspection Date:	3/20/2017	<b>Beginning Section MP</b>	0	1		Ĭ	
Paved Length (Mile	es): 1.41	Section Length (MI)	1	0.41			
Surface Type:	ASPHALT	Route Summary					
Roadway Condition	n Information						
Pavement Condition	n Rating (PCR)	77	82	63			
Surface Condition R	tating (SCR)	88	94	63			
Roughness Condition	n Index (RCI)	60	63	N/A			
Distress Index Valu	es						
Structural Crack In	dex	90	95	71			
Alligator Crack Inc	lex	100	100	100			
Longitudinal Crack	Index	90	95	71			
Transverse Crackin	ig Index	88	95	63			
Patching Index		97	96	100			
Rutting Index		94	94	94			
International Roug	hness Index (IRI)	240	226	N/A			
Lane & Width Info	rmation						
Number of Lanes		2	2	2			
Paved Width (ft)		16.6	16.7	15.9			
Lane Width (ft)		8.4	8.3	8.4

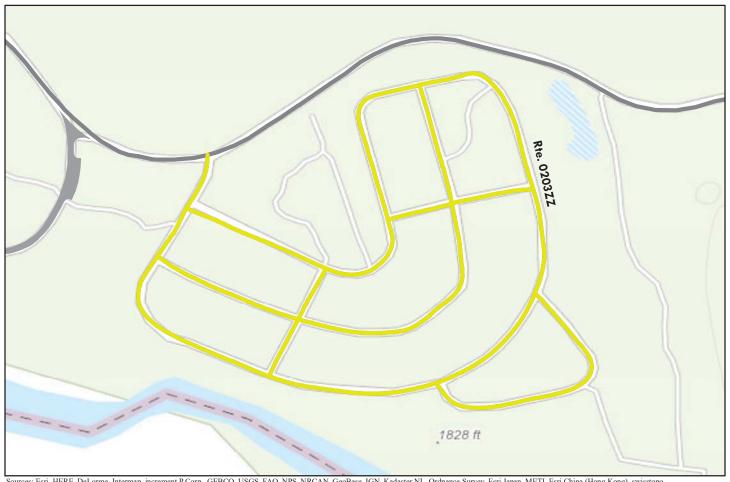
### ROUTE 0203ZZ: RIO GRANDE VILLAGE CAMPGROUND

Note: The weighted average summary PCR value is calculated from only the sections of road where the PCR was collected. The overall PCR for the summary route may not reflect individual subcomponent ratings

summary route may not re	Ticct marvidual subcom	ponent ratings.						
	Route C	Condition Lege	end – Pav	ement Condi	ition Rating (	PCR)		
Poor (0 - 60)	Fair (6)	1- 84) Good (		(85 - 94)	<b>Excellent (95 - 100)</b>		Not Ra	ted
See Appendix for definitions and formulas								
Inspection Date:	3/20/2017							
Paved Length (Miles)	<b>):</b> 1.31							
Surface Type:	ASPHALT	Route Summ	ary					
Roadway Condition I	Information							
Pavement Condition	Rating (PCR)	81						
Lane & Width Inform	nation							
Number of Lanes		1						
Paved Width (ft)		15.3						
Lane Width (ft)		9

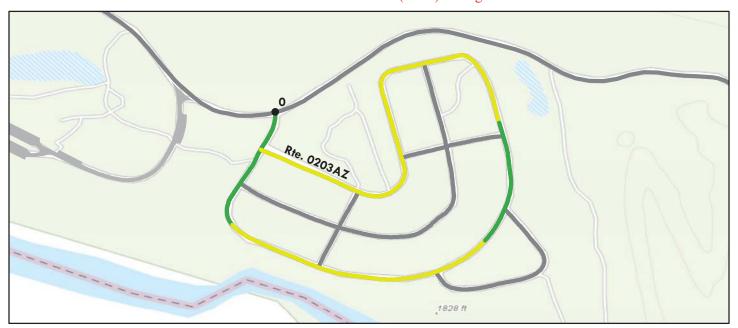
### ROUTE 0203AZ: RIO GRANDE VILLAGE CAMPGROUND LOOP A

Subcomponent of Route BIBE-0203ZZ Data Collection Vehicle (DCV) Rating

Route C	Condition Legend – Pav	ement Condi	tion Rating (	PCR)		
Poor (0 - 6			(85 - 94)	Excellent (		Not Ra	ted
		See Appendix for def	finitions and f	ormulas			
Inspection Date:	3/20/2017	<b>Beginning Section MP</b>	0				
Paved Length (Mil	<b>(es):</b> 0.73	Section Length (MI)	0.73				
Surface Type:	ASPHALT	Route Summary					
Roadway Conditio	n Information						
Pavement Condition	on Rating (PCR)	82	82				
Surface Condition I	Rating (SCR)	82	82				
Roughness Condition	on Index (RCI)	N/A	N/A				
Distress Index Valu	ies						
Structural Crack In	ndex	89	89				
Alligator Crack In	dex	100	100				
Longitudinal Crac	k Index	89	89				
Transverse Cracking	ng Index	82	82				
Patching Index		98	98				
Rutting Index		87	87				
International Roug	ghness Index (IRI)	N/A	N/A				
Lane & Width Info	ormation						
Number of Lanes		2	2				
Paved Width (ft)		16.3	16.3				
Lane Width (ft)		8.2	8.2

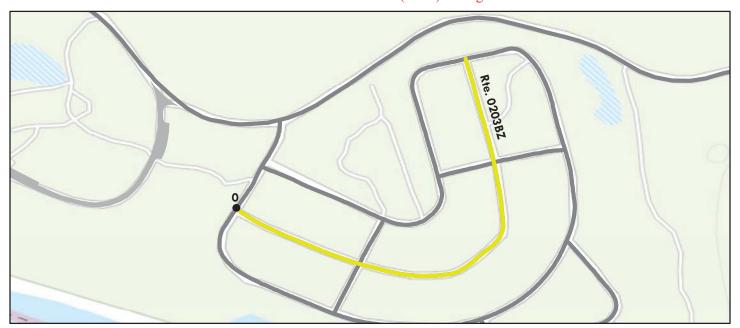
### ROUTE 0203BZ: RIO GRANDE VILLAGE CAMPGROUND LOOP B

Subcomponent of Route BIBE-0203ZZ Data Collection Vehicle (DCV) Rating

Route (	Condition Legend – Pav	ement Condi	tion Rating (	PCR)		
Poor (0 - 6			(85 - 94)	Excellent (		Not Ra	ted
		See Appendix for def	finitions and f	ormulas			
Inspection Date:	3/20/2017	<b>Beginning Section MP</b>	0				
Paved Length (Mil	les): 0.29	Section Length (MI)	0.29				
Surface Type:	ASPHALT	Route Summary					
Roadway Conditio	n Information						
Pavement Condition	on Rating (PCR)	78	78				
Surface Condition l	Rating (SCR)	78	78				
Roughness Condition	on Index (RCI)	N/A	N/A				
Distress Index Valu	ues						
Structural Crack In	ndex	89	89				
Alligator Crack In	dex	100	100				
Longitudinal Crac	k Index	89	89				
Transverse Cracki	ng Index	78	78				
Patching Index		98	98				
Rutting Index		86	86				
International Roug	ghness Index (IRI)	N/A	N/A				
Lane & Width Info	ormation						
Number of Lanes		2	2				
Paved Width (ft)		15.3	15.3				
Lane Width (ft)		7.6	7.6

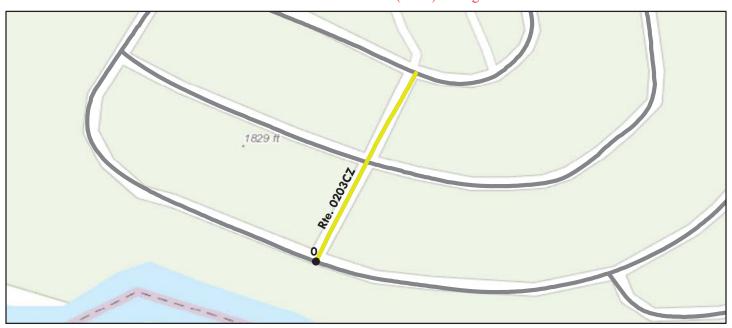
### ROUTE 0203CZ: RIO GRANDE VILLAGE CAMPGROUND LOOP C

Subcomponent of Route BIBE-0203ZZ Data Collection Vehicle (DCV) Rating

Route (	Condition Legend – Pav	ement Condi	ition Rating (	PCR)		
Poor (0 - 6			(85 - 94)	Excellent (		Not Ra	ted
		See Appendix for def	initions and f	ormulas			
Inspection Date:	3/20/2017	<b>Beginning Section MP</b>	0				
Paved Length (Mil	<b>es):</b> 0.07	Section Length (MI)	0.07				
Surface Type:	ASPHALT	Route Summary					
Roadway Conditio	n Information						
Pavement Condition	on Rating (PCR)	75	75				
Surface Condition I	Rating (SCR)	75	75				
Roughness Condition	on Index (RCI)	N/A	N/A				
Distress Index Valu	ies						
Structural Crack In	ndex	93	93				
Alligator Crack In	dex	100	100				
Longitudinal Crac	k Index	93	93				
Transverse Crackin	ng Index	82	82				
Patching Index		100	100				
Rutting Index		75	75				
International Roug	hness Index (IRI)	N/A	N/A				
Lane & Width Info	ormation						
Number of Lanes		1	1				
Paved Width (ft)		13.3	13.3				
Lane Width (ft)		13.3	13.3

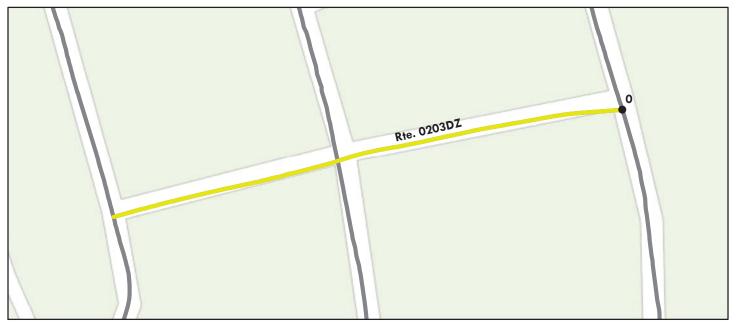
### ROUTE 0203DZ: RIO GRANDE VILLAGE CAMPGROUND LOOP D

Subcomponent of Route BIBE-0203ZZ Data Collection Vehicle (DCV) Rating

Route C	Condition Legend – Pav	ement Condi	tion Rating (PCR)	
Poor (0 - 60) Fair (6	1- 84) Good (	(85 - 94)	<b>Excellent (95 - 10</b>	0) Not Rated
	See Appendix for def	initions and f	ormulas	
<b>Inspection Date:</b> 3/20/2017	<b>Beginning Section MP</b>	0		
Paved Length (Miles): 0.08	Section Length (MI)	0.08		
Surface Type: ASPHALT	Route Summary			
Roadway Condition Information				
Pavement Condition Rating (PCR)	79	79		
Surface Condition Rating (SCR)	79	79		
Roughness Condition Index (RCI)	N/A	N/A		
Distress Index Values				
Structural Crack Index	84	84		
Alligator Crack Index	97	97		
Longitudinal Crack Index	87	87		
Transverse Cracking Index	79	79		
Patching Index	98	98		
Rutting Index	86	86		
International Roughness Index (IRI)	N/A	N/A		
Lane & Width Information				
Number of Lanes	1	1		
Paved Width (ft)	11.5	11.5		
Lane Width (ft)	11.5	11.5

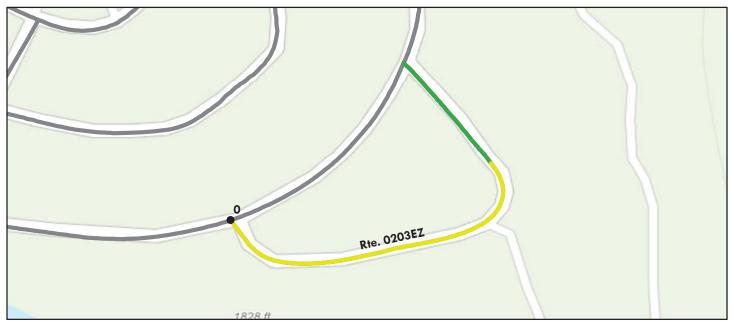
### ROUTE 0203EZ: RIO GRANDE VILLAGE CAMPGROUND LOOP E

Subcomponent of Route BIBE-0203ZZ Data Collection Vehicle (DCV) Rating

Route (	Condition Legend – Pav	ement Condi	ition Rating (	PCR)		
Poor (0 - 6			(85 - 94)	Excellent (		Not Ra	ted
		See Appendix for def	finitions and f	ormulas			
Inspection Date:	3/20/2017	<b>Beginning Section MP</b>	0				
Paved Length (Mil	<b>es):</b> 0.14	Section Length (MI)	0.14				
Surface Type:	ASPHALT	Route Summary					
Roadway Conditio	n Information						
Pavement Condition	on Rating (PCR)	82	82				
Surface Condition I	Rating (SCR)	82	82				
Roughness Condition	on Index (RCI)	N/A	N/A				
Distress Index Valu	ies						
Structural Crack In	ndex	89	89				
Alligator Crack In	dex	100	100				
Longitudinal Crac	k Index	89	89				
Transverse Cracking	ng Index	82	82				
Patching Index		100	100				
Rutting Index		87	87				
International Roug	hness Index (IRI)	N/A	N/A				
Lane & Width Info	ormation						
Number of Lanes		1	1				
Paved Width (ft)		12.8	12.8				
Lane Width (ft)		12.8	12.8

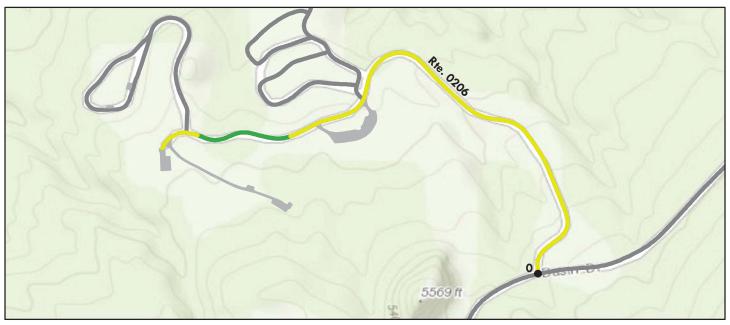
### ROUTE 0206: LOWER BASIN CAMPGROUND ROAD

### Data Collection Vehicle (DCV) Rating

Route (	Condition Legend – Pav	ement Condi	tion Rating (	PCR)		
Poor (0 - 6			(85 - 94)	Excellent (		Not Ra	ted
		See Appendix for det	finitions and f	ormulas			
Inspection Date:	3/20/2017	<b>Beginning Section MP</b>	0				
Paved Length (Mil	<b>es):</b> 0.63	Section Length (MI)	0.63				
Surface Type:	ASPHALT	Route Summary					
Roadway Conditio	n Information						
Pavement Condition	on Rating (PCR)	82	82				
Surface Condition I	Rating (SCR)	82	82				
Roughness Condition	on Index (RCI)	N/A	N/A				
Distress Index Valu	ies						
Structural Crack In	ndex	92	92				
Alligator Crack In	dex	100	100				
Longitudinal Crac	k Index	92	92				
Transverse Cracking	ng Index	82	82				
Patching Index		100	100				
Rutting Index		98	98				
International Roug	ghness Index (IRI)	N/A	N/A				
Lane & Width Info	ormation						
Number of Lanes		2	2				
Paved Width (ft)		20.9	20.9				
Lane Width (ft)		9	9

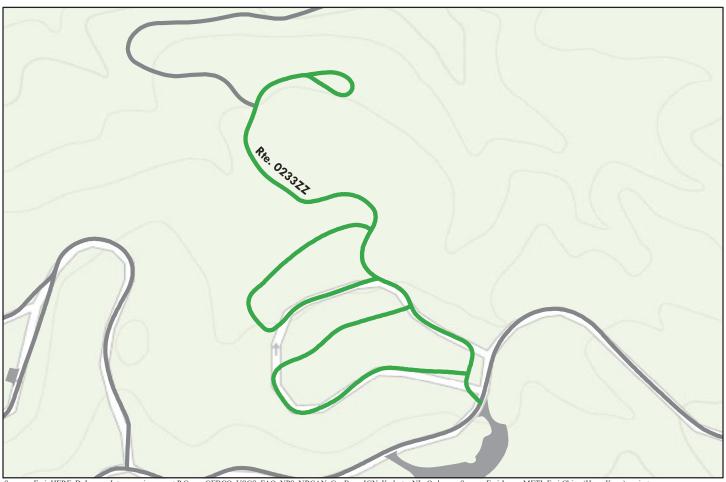
### ROUTE 0233ZZ: CLASS A CAMPGROUND - CHISOS BASIN

Note: The weighted average summary PCR value is calculated from only the sections of road where the PCR was collected. The overall PCR for the summary route may not reflect individual subcomponent ratings

summary route may not re	cricci marviduai subcom	ponent ratings.						
	Route Condition Legend – Pavement Condition Rating (PCR)							
Poor (0 - 60)	Fair (6)	1-84)	Good	(85 - 94)	Excellent (	95 - 100)	Not Ra	ted
		See Apper	ndix for def	initions and f	ormulas			
Inspection Date:	3/20/2017							
Paved Length (Miles)	<b>):</b> 0.71							
Surface Type:	ASPHALT	Route Sumn	nary					
Roadway Condition 1	Information							
Pavement Condition	Rating (PCR)	94	ļ					
Lane & Width Inform	mation							
Number of Lanes		1						
Paved Width (ft)		18.	3					
Lane Width (ft)		14.	2
