# BIBE Cycle 6

# **Final Report**

# Road Inventory and Condition Assessment of Paved Routes Big Bend National Park

**Report Date: October 2017**

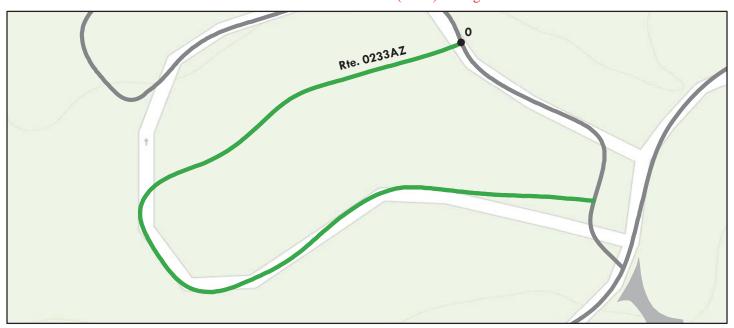
### ROUTE 0233AZ: CLASS A CAMPGROUND - CHISOS BASIN LOOP A

Subcomponent of Route BIBE-0233ZZ Data Collection Vehicle (DCV) Rating

Route (	Condition Legend – Pav	ement Cond	ition Rating (	PCR)		
Poor (0 - 6			(85 - 94)	Excellent (		Not Ra	ted
		See Appendix for def	finitions and	formulas			
Inspection Date:	3/20/2017	<b>Beginning Section MP</b>	0				
Paved Length (Mil	es): 0.20	Section Length (MI)	0.20				
Surface Type:	ASPHALT	Route Summary					
Roadway Conditio	n Information						
Pavement Condition	on Rating (PCR)	93	93				
Surface Condition I	Rating (SCR)	93	93				
Roughness Condition	on Index (RCI)	N/A	N/A				
Distress Index Valu	ies						
Structural Crack In	ndex	97	97				
Alligator Crack In	dex	99	99				
Longitudinal Crac	k Index	98	98				
Transverse Cracking	ng Index	98	98				
Patching Index		100	100				
Rutting Index		93	93				
International Roug	ghness Index (IRI)	N/A	N/A				
Lane & Width Info	ormation						
Number of Lanes		1	1				
Paved Width (ft)		18.8	18.8				
Lane Width (ft)		18.8	18.8

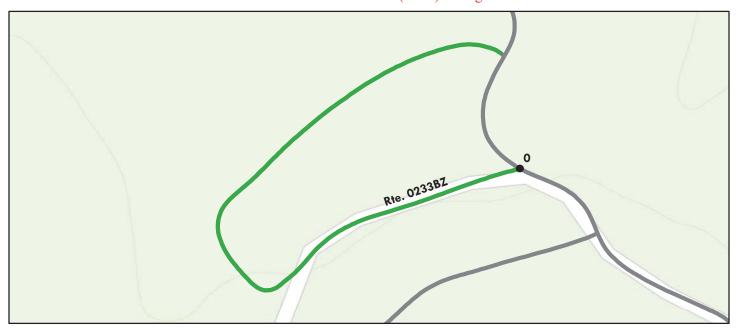
### ROUTE 0233BZ: CLASS A CAMPGROUND - CHISOS BASIN LOOP B

Subcomponent of Route BIBE-0233ZZ Data Collection Vehicle (DCV) Rating

Route (	Condition Legend – Pav	ement Condi	ition Rating (	PCR)		
Poor (0 - 6			(85 - 94)	Excellent (		Not Rated	
		See Appendix for def	finitions and f	ormulas			
Inspection Date:	3/20/2017	<b>Beginning Section MP</b>	0				
Paved Length (Mil	<b>es):</b> 0.17	Section Length (MI)	0.17				
Surface Type:	ASPHALT	Route Summary				•	
Roadway Conditio	n Information						
Pavement Condition	on Rating (PCR)	90	90				
Surface Condition I	Rating (SCR)	90	90				
Roughness Condition	on Index (RCI)	N/A	N/A				
Distress Index Valu	ies						
Structural Crack In	ndex	98	98				
Alligator Crack In	dex	100	100				
Longitudinal Crac	k Index	98	98				
Transverse Crackin	ng Index	98	98				
Patching Index		98	98				
Rutting Index		90	90				
International Roug	hness Index (IRI)	N/A	N/A				
Lane & Width Info	ormation						
Number of Lanes		1	1				
Paved Width (ft)		17.1	17.1				
Lane Width (ft)		17.1	17.1

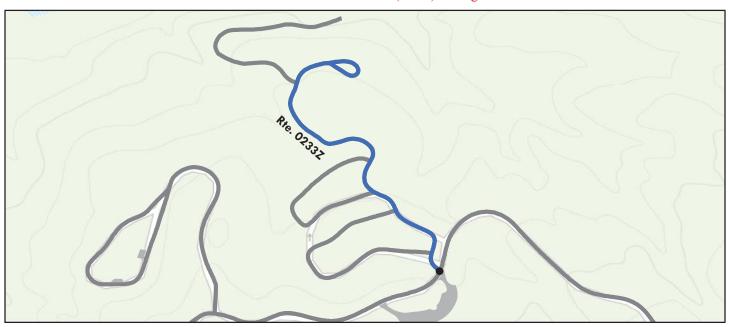
### ROUTE 0233Z: CLASS A CAMPGROUND - CHISOS BASIN MAIN LOOP

Subcomponent of Route BIBE-0233ZZ Data Collection Vehicle (DCV) Rating

Route C	Condition Legend – Pav	ement Condi	tion Rating (PCR)	
Poor (0 - 60) Fair (6	1-84) Good (	(85 - 94)	<b>Excellent (95 - 100)</b>	Not Rated
	See Appendix for def	initions and f	ormulas	
<b>Inspection Date:</b> 3/20/2017	<b>Beginning Section MP</b>	0		
Paved Length (Miles): 0.34	Section Length (MI)	0.34		
Surface Type: ASPHALT	Route Summary			
Roadway Condition Information				
Pavement Condition Rating (PCR)	96	96		
Surface Condition Rating (SCR)	96	96		
Roughness Condition Index (RCI)	N/A	N/A		
Distress Index Values				
Structural Crack Index	97	97		
Alligator Crack Index	100	100		
Longitudinal Crack Index	97	97		
Transverse Cracking Index	97	97		
Patching Index	100	100		
Rutting Index	96	96		
International Roughness Index (IRI)	N/A	N/A		
Lane & Width Information				
Number of Lanes	2	2		
Paved Width (ft)	18.7	18.7		
Lane Width (ft)	10	10

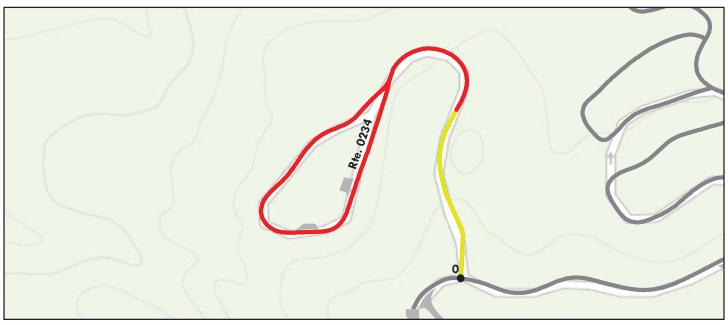
### ROUTE 0234: BASIN GROUP CAMPGROUND

### Data Collection Vehicle (DCV) Rating

Route (	Condition Legend – Pav	ement Cond	ition Rating (	PCR)		
Poor (0 - 6			(85 - 94)	Excellent (		Not Ra	ted
		See Appendix for def	finitions and	formulas			
Inspection Date:	3/20/2017	<b>Beginning Section MP</b>	0				
Paved Length (Mil	<b>es):</b> 0.40	Section Length (MI)	0.40				
Surface Type:	ASPHALT	Route Summary		•			
Roadway Conditio	n Information						
Pavement Condition	on Rating (PCR)	51	51				
Surface Condition I	Rating (SCR)	51	51				
Roughness Condition	on Index (RCI)	N/A	N/A				
Distress Index Valu	ies						
Structural Crack In	ndex	51	51				
Alligator Crack In	dex	99	99				
Longitudinal Crac	k Index	52	52				
Transverse Crackin	ng Index	54	54				
Patching Index		100	100				
Rutting Index		93	93				
International Roug	ghness Index (IRI)	N/A	N/A				
Lane & Width Info	ormation						
Number of Lanes		2	2				
Paved Width (ft)		18.8	18.8				
Lane Width (ft)		12.4	12.4

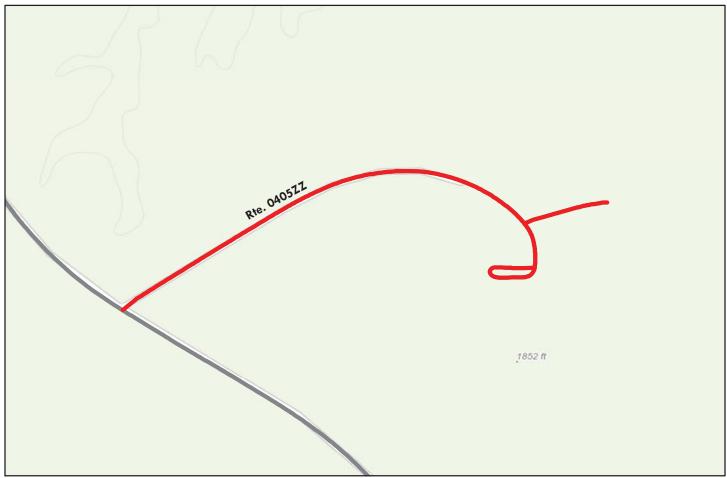
**ROUTE 0405ZZ: HUISACHE DRIVE**

Note: The weighted average summary PCR value is calculated from only the sections of road where the PCR was collected. The overall PCR for the summary route may not reflect individual subcomponent ratings.

summary route may not re	cheet marvidual subcom	ponent ratings.						
	Route Condition Legend – Pavement Condition Rating (PCR)							
Poor (0 - 60)	Fair (6)	1-84)	Good	(85 - 94)	Excellent (	95 - 100)	Not Ra	ted
		See Apper	ndix for def	initions and f	ormulas			
Inspection Date:	3/20/2017							
Paved Length (Miles)	<b>):</b> 0.51							
Surface Type:	ASPHALT	Route Sumn	nary					
Roadway Condition 1	Information							
Pavement Condition	Rating (PCR)	44	•					
Lane & Width Inform	nation							
Number of Lanes		1						
Paved Width (ft)		17.	3					
Lane Width (ft)		8.7	7

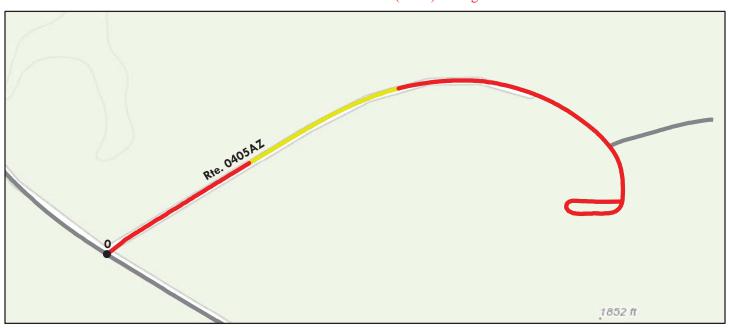
ROUTE 0405AZ: HUISACHE DRIVE A

Subcomponent of Route BIBE-0405ZZ Data Collection Vehicle (DCV) Rating

Route C	Condition Legend – Pav	ement Condi	tion Rating (PCR)	
Poor (0 - 60) Fair (6	1- 84) Good (	(85 - 94)	<b>Excellent (95 - 100</b>	Not Rated
	See Appendix for def	initions and f	ormulas	
<b>Inspection Date:</b> 3/20/2017	<b>Beginning Section MP</b>	0		
Paved Length (Miles): 0.45	Section Length (MI)	0.45		
Surface Type: ASPHALT	Route Summary			
Roadway Condition Information				
Pavement Condition Rating (PCR)	42	42		
Surface Condition Rating (SCR)	42	42		
Roughness Condition Index (RCI)	N/A	N/A		
Distress Index Values				
Structural Crack Index	46	46		
Alligator Crack Index	98	98		
Longitudinal Crack Index	48	48		
Transverse Cracking Index	42	42		
Patching Index	99	99		
Rutting Index	94	94		
International Roughness Index (IRI)	N/A	N/A		
Lane & Width Information				
Number of Lanes	2	2		
Paved Width (ft)	17	17		
Lane Width (ft)	8.5	8.5

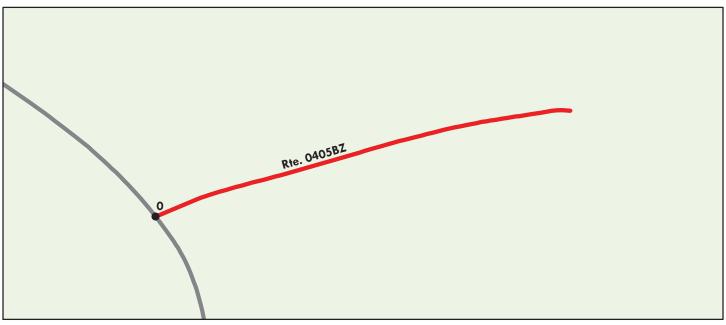
**ROUTE 0405BZ: HUISACHE DRIVE B**

Subcomponent of Route BIBE-0405ZZ Data Collection Vehicle (DCV) Rating

Route C	Condition Legend – Pav	ement Condi	ition Rating (PCR)	
Poor (0 - 60) Fair (6	1- 84) Good (	(85 - 94)	<b>Excellent (95 - 10</b>	0) Not Rated
	See Appendix for def	initions and f	ormulas	
<b>Inspection Date:</b> 3/20/2017	<b>Beginning Section MP</b>	0		
Paved Length (Miles): 0.06	Section Length (MI)	0.06		
Surface Type: ASPHALT	Route Summary			·
Roadway Condition Information				
Pavement Condition Rating (PCR)	56	56		
Surface Condition Rating (SCR)	56	56		
Roughness Condition Index (RCI)	N/A	N/A		
Distress Index Values				
Structural Crack Index	56	56		
Alligator Crack Index	85	85		
Longitudinal Crack Index	71	71		
Transverse Cracking Index	95	95		
Patching Index	100	100		
Rutting Index	88	88		
International Roughness Index (IRI)	N/A	N/A		
Lane & Width Information				
Number of Lanes	2	2		
Paved Width (ft)	19.8	19.8		
Lane Width (ft)	9.9	9.9

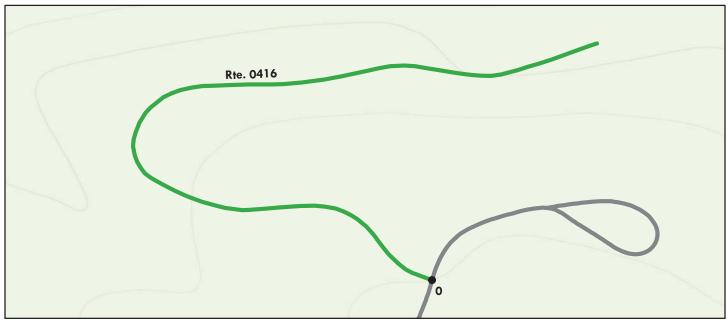
### ROUTE 0416: LOWER BASIN LAGOON ROAD

#### Manual Rating

Route C	Condition Legend – Pav	ement Condi	tion Rating (	PCR)		
Poor (0 - 60)	Fair (6)	1- 84) Good (	(85 - 94)	Excellent (9	95 - 100)	Not Ra	ted
		See Appendix for def	initions and f	ormulas			
Inspection Date:	2/23/2017	<b>Beginning Section MP</b>	0.00				
Paved Length (Miles):	0.19	Section Length (MI)	0.19				
Surface Type:	ASPHALT	Route Summary					
Roadway Condition In	formation						
Pavement Condition R	ating (PCR)	90	90				
Surface Condition Ratin	ng (SCR)	90	90				
Roughness Condition In	ndex (RCI)	N/A	N/A				
Distress Index Values							
Structural Crack Index		N/A	N/A				
Alligator Crack Index		90	90				
Longitudinal Crack Inc	dex	97	97				
Transverse Cracking In	ndex	90	90				
Patching Index		97	97				
Rutting Index		90	90				
International Roughne	ss Index (IRI)	N/A	N/A				
Lane & Width Informa	ation						
Number of Lanes		1	1				
Paved Width (ft)		10.9	10.9				
Lane Width (ft)		10.9	10.9

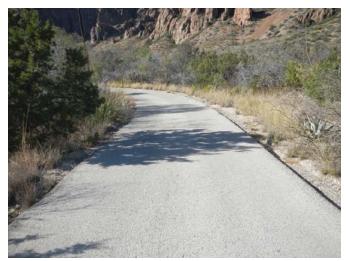
BIBE\_0416\_6959.JPG

Condition photos are shown only for manually rated roads. Use the PathView program to see images of DCV rated roads.

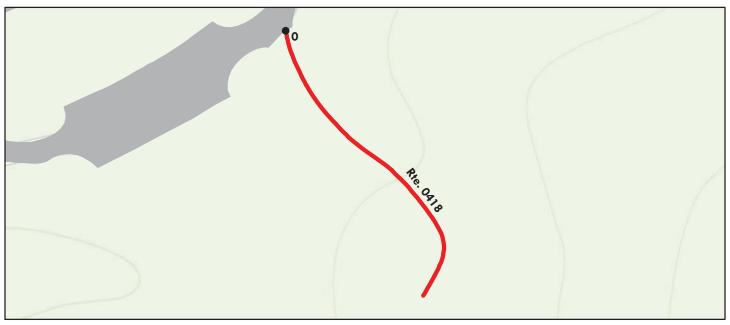
### ROUTE 0418: CHISOS BASIN RESIDENCE ROAD

### Data Collection Vehicle (DCV) Rating

Route (	Condition Legend – Pav	ement Condi	tion Rating (	PCR)		
Poor (0 - 6			(85 - 94)	Excellent (		Not Ra	ted
		See Appendix for def	finitions and f	ormulas			
Inspection Date:	3/20/2017	<b>Beginning Section MP</b>	0				
Paved Length (Mil	<b>es):</b> 0.05	Section Length (MI)	0.05				
Surface Type:	ASPHALT	Route Summary					
Roadway Conditio	n Information						
Pavement Condition	on Rating (PCR)	53	53				
Surface Condition I	Rating (SCR)	53	53				
Roughness Condition	on Index (RCI)	N/A	N/A				
Distress Index Valu	ies						
Structural Crack In	ndex	53	53				
Alligator Crack In	dex	100	100				
Longitudinal Crac	k Index	53	53				
Transverse Cracking	ng Index	69	69				
Patching Index		99	99				
Rutting Index		88	88				
International Roug	ghness Index (IRI)	N/A	N/A				
Lane & Width Info	ormation						
Number of Lanes		2	2				
Paved Width (ft)		17.1	17.1				
Lane Width (ft)		8.6	8.6

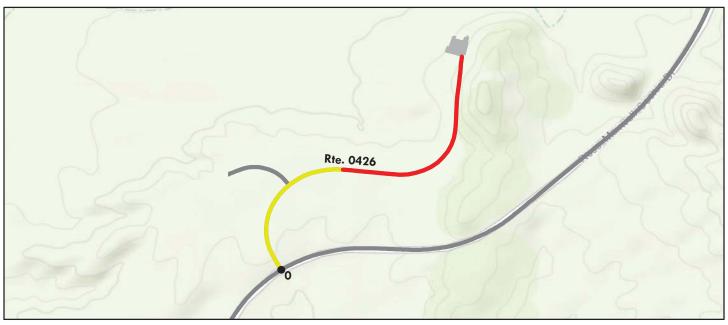
ROUTE 0426: MESA DRIVE

### Data Collection Vehicle (DCV) Rating

Route (	Condition Legend – Pav	ement Condi	tion Rating (	PCR)		
Poor (0 - 6			(85 - 94)	Excellent (		Not Ra	ted
		See Appendix for det	finitions and f	ormulas			
Inspection Date:	3/20/2017	<b>Beginning Section MP</b>	0				
Paved Length (Mil	<b>es):</b> 0.47	Section Length (MI)	0.47				
Surface Type:	ASPHALT	Route Summary					
Roadway Conditio	n Information						
Pavement Condition	on Rating (PCR)	50	50				
Surface Condition I	Rating (SCR)	50	50				
Roughness Condition	on Index (RCI)	N/A	N/A				
Distress Index Valu	ies						
Structural Crack In	ndex	79	79				
Alligator Crack In	dex	100	100				
Longitudinal Crac	k Index	79	79				
Transverse Cracking	ng Index	50	50				
Patching Index		100	100				
Rutting Index		97	97				
International Roug	ghness Index (IRI)	N/A	N/A				
Lane & Width Info	ormation						
Number of Lanes		2	2				
Paved Width (ft)		21.9	21.9				
Lane Width (ft)		10.9	10.9

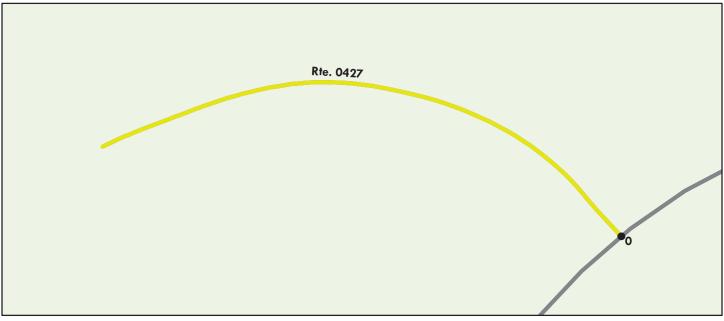
**ROUTE 0427: PALO VERDE DRIVE**

### Data Collection Vehicle (DCV) Rating

Route C	Condition Legend – Pav	ement Condi	tion Rating (PCR)	
Poor (0 - 60) Fair (6	1- 84) Good (	(85 - 94)	<b>Excellent (95 - 100)</b>	Not Rated
	See Appendix for def	initions and f	ormulas	
<b>Inspection Date:</b> 3/20/2017	<b>Beginning Section MP</b>	0		
Paved Length (Miles): 0.09	Section Length (MI)	0.09		
Surface Type: ASPHALT	Route Summary			
Roadway Condition Information				
Pavement Condition Rating (PCR)	69	69		
Surface Condition Rating (SCR)	69	69		
Roughness Condition Index (RCI)	N/A	N/A		
Distress Index Values				
Structural Crack Index	92	92		
Alligator Crack Index	100	100		
Longitudinal Crack Index	92	92		
Transverse Cracking Index	69	69		
Patching Index	100	100		
Rutting Index	96	96		
International Roughness Index (IRI)	N/A	N/A		
Lane & Width Information				
Number of Lanes	1	1		
Paved Width (ft)	13.6	13.6		
Lane Width (ft)	13.6	13.6

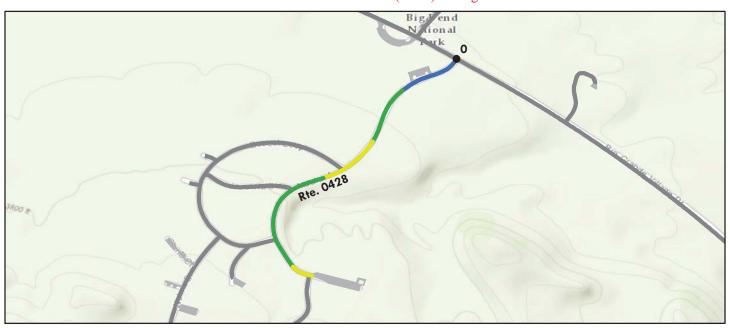
ROUTE 0428: ALSATE AVENUE

### Data Collection Vehicle (DCV) Rating

Route (	Condition Legend – Pav	ement Condi	tion Rating (	PCR)			
Poor (0 - 6						Not Rated		
		See Appendix for def	initions and f	ormulas				
Inspection Date:	3/20/2017	<b>Beginning Section MP</b>	0					
Paved Length (Mile	<b>es):</b> 0.53	Section Length (MI)	0.53					
Surface Type:	ASPHALT	Route Summary						
Roadway Condition	n Information							
Pavement Condition	on Rating (PCR)	91	91					
Surface Condition F	Rating (SCR)	91	91					
Roughness Condition	on Index (RCI)	N/A	N/A					
Distress Index Valu	ies							
Structural Crack Ir	ndex	91	91					
Alligator Crack Inc	dex	100	100					
Longitudinal Cracl	k Index	91	91					
Transverse Crackin	ng Index	96	96					
Patching Index		100	100					
Rutting Index		91	91					
International Roug	hness Index (IRI)	N/A	N/A					
Lane & Width Info	ormation							
Number of Lanes		2	2					
Paved Width (ft)		19.8	19.8					
Lane Width (ft)		9.9	9.9

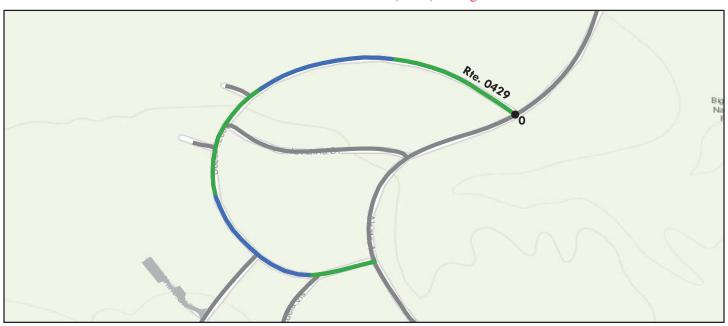
**ROUTE 0429: BOBCAT LOOP**

### Data Collection Vehicle (DCV) Rating

Route (	Condition Legend – Pav	ement Cond	ition Rating (	PCR)		
Poor (0 - 6			(85 - 94)	Excellent (		Not Ra	ted
		See Appendix for def	finitions and f	ormulas			
Inspection Date:	3/20/2017	<b>Beginning Section MP</b>	0				
Paved Length (Mile	es): 0.44	Section Length (MI)	0.44				
Surface Type:	ASPHALT	Route Summary				•	
Roadway Condition	n Information						
Pavement Condition	on Rating (PCR)	94	94				
Surface Condition F	Rating (SCR)	94	94				
Roughness Condition	on Index (RCI)	N/A	N/A				
Distress Index Valu	ies						
Structural Crack In	ndex	95	95				
Alligator Crack Inc	dex	100	100				
Longitudinal Cracl	k Index	95	95				
Transverse Crackin	ng Index	94	94				
Patching Index		99	99				
Rutting Index		94	94				
International Roug	hness Index (IRI)	N/A	N/A				
Lane & Width Info	ormation						
Number of Lanes		2	2				
Paved Width (ft)		17.4	17.4				
Lane Width (ft)		8.7	8.7

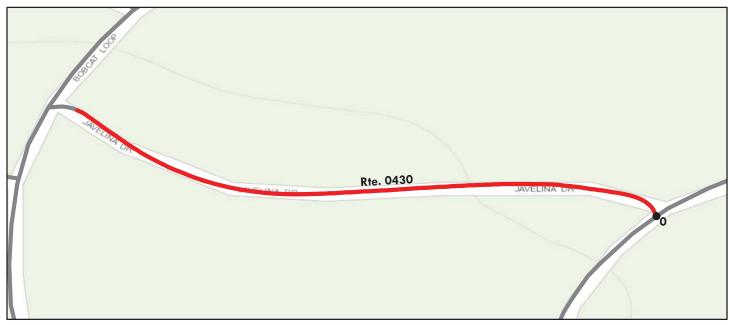
ROUTE 0430: JAVELINA DRIVE

### Data Collection Vehicle (DCV) Rating

Route C	Condition Leg	end – Pavo	ement Condi	ition Rating (	PCR)		
Poor (0 - 60)	Fair (6			85 - 94)	Excellent (		Not Ra	ted
		7	`	initions and f	`			
<b>Inspection Date:</b> 3/20	/2017	Beginning Se	ction MP	0				
Paved Length (Miles): 0.13		Section Leng	th (MI)	0.13				
Surface Type: ASF	HALT	Route Summ	ary					
Roadway Condition Inform	nation							
Pavement Condition Rating	g (PCR)	46		46				
Surface Condition Rating (S	CR)	46		46				
Roughness Condition Index	(RCI)	N/A		N/A				
Distress Index Values								
Structural Crack Index		46		46				
Alligator Crack Index		100		100				
Longitudinal Crack Index		46		46				
Transverse Cracking Index		58		58				
Patching Index		100		100				
Rutting Index		93		93				
International Roughness In	dex (IRI)	N/A		N/A				
Lane & Width Information	1							
Number of Lanes		2		2				
Paved Width (ft)		17.1		17.1				
Lane Width (ft)		8.6		8.6

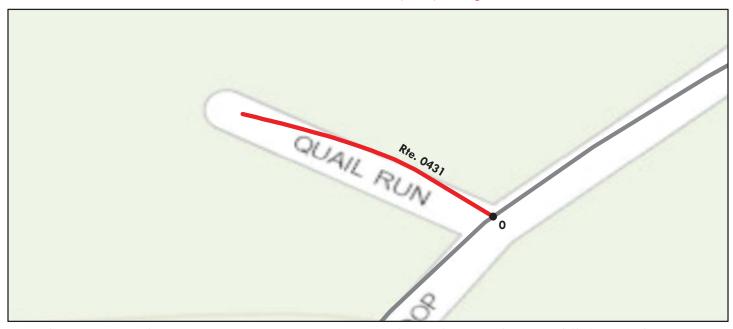
**ROUTE 0431: QUAIL RUN**

### Data Collection Vehicle (DCV) Rating

Route C	Condition Legend – Pav	ement Condi	tion Rating (PCR)	
Poor (0 - 60) Fair (6	1- 84) Good (	(85 - 94)	Excellent (95 - 1	Not Rated
	See Appendix for def	initions and f	ormulas	
<b>Inspection Date:</b> 3/20/2017	<b>Beginning Section MP</b>	0		
Paved Length (Miles): 0.02	Section Length (MI)	0.02		
Surface Type: ASPHALT	Route Summary			•
Roadway Condition Information				
Pavement Condition Rating (PCR)	23	23		
Surface Condition Rating (SCR)	23	23		
Roughness Condition Index (RCI)	N/A	N/A		
Distress Index Values				
Structural Crack Index	23	23		
Alligator Crack Index	100	100		
Longitudinal Crack Index	23	23		
Transverse Cracking Index	53	53		
Patching Index	100	100		
Rutting Index	65	65		
International Roughness Index (IRI)	N/A	N/A		
Lane & Width Information				
Number of Lanes	2	2		
Paved Width (ft)	20.6	20.6		
Lane Width (ft)	10.3	10.3

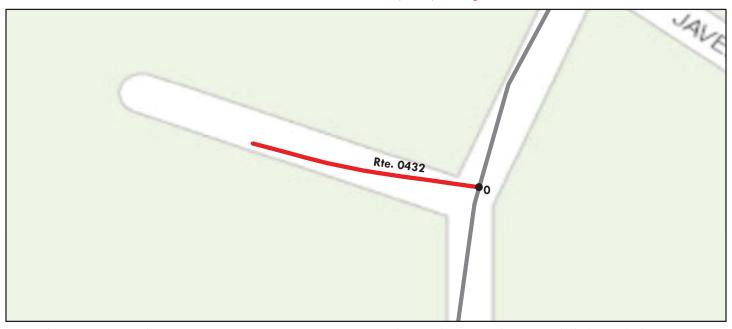
ROUTE 0432: CHUPAROSA

### Data Collection Vehicle (DCV) Rating

Route	Condition Legend – Pav	ement Condi	tion Rating (PCR)	
Poor (0 - 60) Fair (6	Good (	(85 - 94)	<b>Excellent (95 - 10</b>	Not Rated
	See Appendix for det	finitions and f	ormulas	
<b>Inspection Date:</b> 3/20/2017	<b>Beginning Section MP</b>	0		
Paved Length (Miles): 0.02	Section Length (MI)	0.02		
Surface Type: ASPHALT	Route Summary			•
Roadway Condition Information				
Pavement Condition Rating (PCR)	0	0		
Surface Condition Rating (SCR)	0	0		
Roughness Condition Index (RCI)	N/A	N/A		
Distress Index Values				
Structural Crack Index	0	0		
Alligator Crack Index	100	100		
Longitudinal Crack Index	0	0		
Transverse Cracking Index	9	9		
Patching Index	100	100		
Rutting Index	91	91		
International Roughness Index (IRI)	N/A	N/A		
Lane & Width Information				
Number of Lanes	2	2		
Paved Width (ft)	19.3	19.3		
Lane Width (ft)	9.6	9.6

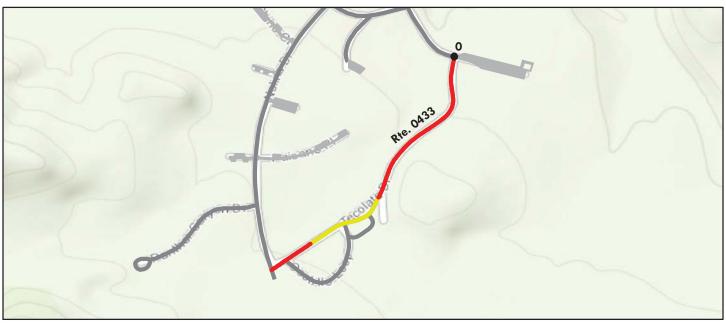
ROUTE 0433: TECOLOTE DRIVE

Route (	Condition Legend – Pav	ement Condi	tion Rating (	PCR)			
Poor (0 - 6			Good (85 - 94) Excellent (95 - 100)			Not Rated		
		See Appendix for def	initions and f	ormulas				
Inspection Date:	3/20/2017	<b>Beginning Section MP</b>	0					
Paved Length (Mil	es): 0.35	Section Length (MI)	0.35					
Surface Type:	ASPHALT	Route Summary						
Roadway Conditio	n Information							
Pavement Condition	on Rating (PCR)	0	0					
Surface Condition I	Rating (SCR)	0	0					
Roughness Condition	on Index (RCI)	N/A	N/A					
Distress Index Valu	ies							
Structural Crack In	ndex	0	0					
Alligator Crack In	dex	93	93					
Longitudinal Crac	k Index	6	6					
Transverse Crackin	ng Index	46	46					
Patching Index		100	100					
Rutting Index		94	94					
International Roug	hness Index (IRI)	N/A	N/A					
Lane & Width Info	ormation							
Number of Lanes		1	1					
Paved Width (ft)		14	14					
Lane Width (ft)		14	14

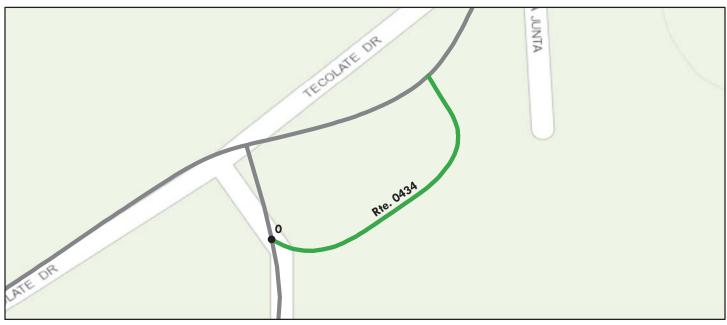
ROUTE 0434: LA JUNTA CIRCLE

Route C	Condition Legend – Pav	ement Condi	tion Rating (PCR)	
Poor (0 - 60) Fair (6	1- 84) Good (	(85 - 94)	<b>Excellent (95 - 10</b>	Not Rated
	See Appendix for def	initions and f	ormulas	
<b>Inspection Date:</b> 3/20/2017	<b>Beginning Section MP</b>	0		
Paved Length (Miles): 0.05	Section Length (MI)	0.05		
Surface Type: ASPHALT	Route Summary			·
Roadway Condition Information				
Pavement Condition Rating (PCR)	91	91		
Surface Condition Rating (SCR)	91	91		
Roughness Condition Index (RCI)	N/A	N/A		
Distress Index Values				
Structural Crack Index	93	93		
Alligator Crack Index	100	100		
Longitudinal Crack Index	93	93		
Transverse Cracking Index	99	99		
Patching Index	100	100		
Rutting Index	91	91		
International Roughness Index (IRI)	N/A	N/A		
Lane & Width Information				
Number of Lanes	2	2		
Paved Width (ft)	16.8	16.8		
Lane Width (ft)	8.4	8.4

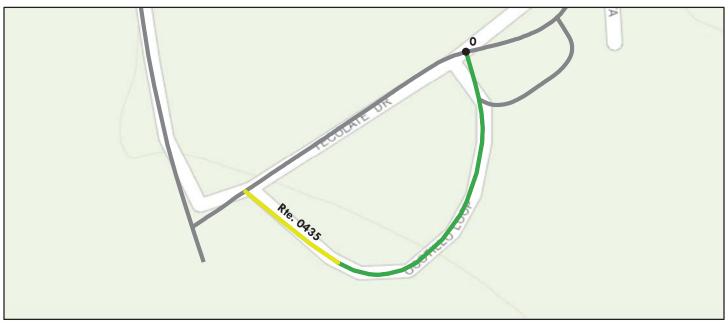
**ROUTE 0435: OCOTILLO LOOP**

Route (	Condition Legend – Pav	ement Condi	ition Rating (	PCR)		
Poor (0 - 6			(85 - 94)	Excellent (9		Not Ra	ted
		See Appendix for def	initions and f	ormulas			
Inspection Date:	3/20/2017	<b>Beginning Section MP</b>	0				
Paved Length (Mil	<b>es):</b> 0.13	Section Length (MI)	0.13				
Surface Type:	ASPHALT	Route Summary					
Roadway Conditio	n Information						
Pavement Condition	on Rating (PCR)	84	84				
Surface Condition I	Rating (SCR)	84	84				
Roughness Condition	on Index (RCI)	N/A	N/A				
Distress Index Valu	ies						
Structural Crack In	ndex	84	84				
Alligator Crack In	dex	100	100				
Longitudinal Crac	k Index	84	84				
Transverse Crackin	ng Index	90	90				
Patching Index		99	99				
Rutting Index		92	92				
International Roug	hness Index (IRI)	N/A	N/A				
Lane & Width Info	ormation						
Number of Lanes		2	2				
Paved Width (ft)		20.2	20.2				
Lane Width (ft)		10.1	10.1

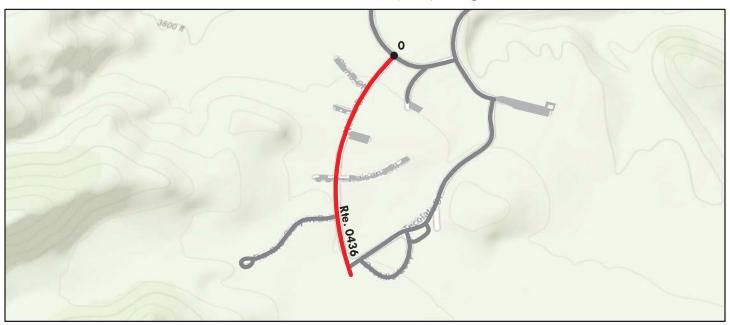
ROUTE 0436: NOLINA DRIVE

Route (	Condition Legend – Pav	ement Condi	ition Rating (	PCR)			
Poor (0 - 6			Excellent (95 - 100)			Not Rated		
		See Appendix for def	initions and f	ormulas				
Inspection Date:	3/20/2017	<b>Beginning Section MP</b>	0					
Paved Length (Mile	<b>es):</b> 0.36	Section Length (MI)	0.36					
Surface Type:	ASPHALT	Route Summary						
Roadway Condition	n Information							
Pavement Condition	on Rating (PCR)	0	0					
Surface Condition F	Rating (SCR)	0	0					
Roughness Condition	on Index (RCI)	N/A	N/A					
Distress Index Valu	ies							
Structural Crack Ir	ndex	0	0					
Alligator Crack Inc	dex	96	96					
Longitudinal Cracl	k Index	0	0					
Transverse Crackin	ng Index	32	32					
Patching Index		98	98					
Rutting Index		97	97					
International Roug	hness Index (IRI)	N/A	N/A					
Lane & Width Info	ormation							
Number of Lanes		2	2					
Paved Width (ft)		18.1	18.1					
Lane Width (ft)		9	9

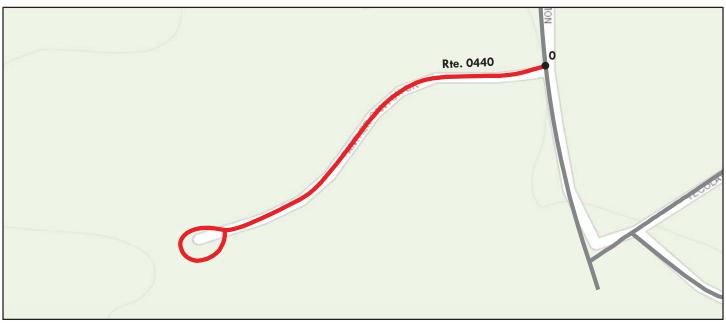
ROUTE 0440: PANTHER CANYON DRIVE

Route (	Condition Legend – Pav	ement Condi	ition Rating (PCR)	
Poor (0 - 60) Fair (6	1- 84) Good (	(85 - 94)	<b>Excellent (95 - 100)</b>	Not Rated
	See Appendix for def	finitions and f	ormulas	
<b>Inspection Date:</b> 3/20/2017	<b>Beginning Section MP</b>	0		
Paved Length (Miles): 0.18	Section Length (MI)	0.18		
Surface Type: ASPHALT	Route Summary			•
Roadway Condition Information				
Pavement Condition Rating (PCR)	53	53		
Surface Condition Rating (SCR)	53	53		
Roughness Condition Index (RCI)	N/A	N/A		
Distress Index Values				
Structural Crack Index	53	53		
Alligator Crack Index	100	100		
Longitudinal Crack Index	53	53		
Transverse Cracking Index	82	82		
Patching Index	99	99		
Rutting Index	92	92		
International Roughness Index (IRI)	N/A	N/A		
Lane & Width Information				
Number of Lanes	2	2		
Paved Width (ft)	17.3	17.3		
Lane Width (ft)	10.5	10.5

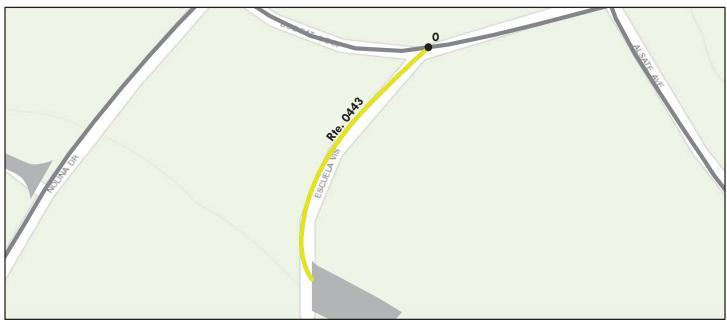
**ROUTE 0443: ESCUELA ROAD**

Route (	Condition Legend – Pav	ement Cond	ition Rating (	PCR)		
Poor (0 - 6			(85 - 94)	Excellent (		Not Ra	ted
		See Appendix for def	finitions and f	formulas			
Inspection Date:	3/20/2017	<b>Beginning Section MP</b>	0				
Paved Length (Mil	es): 0.06	Section Length (MI)	0.06				
Surface Type:	ASPHALT	Route Summary					
Roadway Conditio	n Information						
Pavement Condition	on Rating (PCR)	63	63				
Surface Condition I	Rating (SCR)	63	63				
Roughness Condition	on Index (RCI)	N/A	N/A				
Distress Index Valu	ies						
Structural Crack In	ndex	63	63				
Alligator Crack In	dex	100	100				
Longitudinal Crac	k Index	63	63				
Transverse Cracking	ng Index	70	70				
Patching Index		100	100				
Rutting Index		95	95				
International Roug	ghness Index (IRI)	N/A	N/A				
Lane & Width Info	ormation						
Number of Lanes		1	1				
Paved Width (ft)		13.2	13.2				
Lane Width (ft)		13.2	13.2

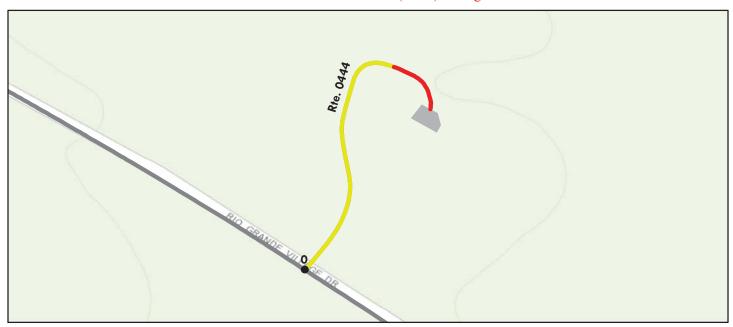
### ROUTE 0444: PJ SEWAGE TREATMENT PLANT ROAD

Route Condition Legend – Pavement Condition Rating (PCR)					
Poor (0 - 60) Fair (6	1- 84) Good (	(85 - 94)	<b>Excellent (95 - 100</b>	Not Rated	
	See Appendix for definitions and formulas				
<b>Inspection Date:</b> 3/20/2017	<b>Beginning Section MP</b>	0			
Paved Length (Miles): 0.12	Section Length (MI)	0.12			
Surface Type: ASPHALT	Route Summary				
Roadway Condition Information					
Pavement Condition Rating (PCR)	73	73			
Surface Condition Rating (SCR)	73	73			
Roughness Condition Index (RCI)	N/A	N/A			
Distress Index Values					
Structural Crack Index	73	73			
Alligator Crack Index	100	100			
Longitudinal Crack Index	73	73			
Transverse Cracking Index	82	82			
Patching Index	100	100			
Rutting Index	89	89			
International Roughness Index (IRI)	N/A	N/A			
Lane & Width Information					
Number of Lanes	1	1			
Paved Width (ft)	13.5	13.5			
Lane Width (ft)	13.5	13.5

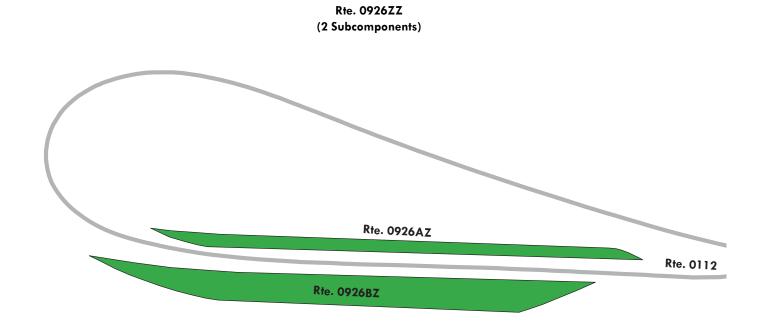
#### ROUTE 0926ZZ: SOTOL VISTA OVERLOOK PARKING

Inspection Date	FMSS Number	User Access	Surface Type
2/24/2017	54644	PUBLIC	ASPHALT
Area (Sq. Ft.)	Lane Miles (11' Widths)	Condition R	ating / PCR
5,518	0.095	SUMMA	RY / 90
Route Condition Legend – Pavement Condition Rating (PCR)			
Poor (0 - 60)	Fair (61- 84) Good (	(85 - 94) Excellent (95 - 10	0) Not Rated
See Appendix for definitions and formulas

The condition shown on this page reflects the overall route condition and may not reflect individual subcomponent ratings.

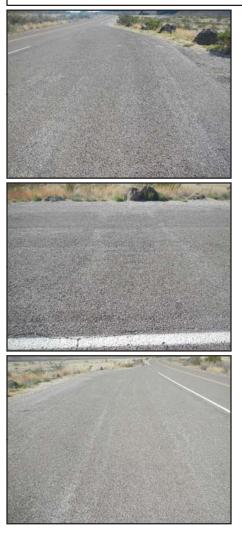
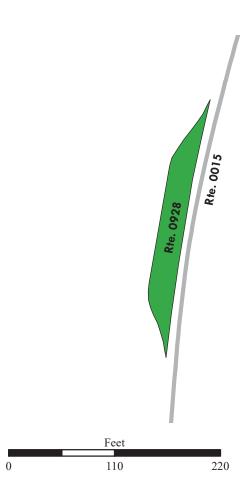
### ROUTE 0928: CHIMNEY TRAILS PARKING

#### ADJACENT TO ROUTE 0015 (ROSS MAXWELL SCENIC DRIVE) AT MP 12.75

<b>Inspection Date</b>	FMSS Number	User Access	Surface Type	
2/24/2017	54647	PUBLIC	ASPHALT	
Area (Sq. Ft.)	Lane Miles (11' Widths)	Curb Reveal (Inches)	Curb Recommendation	
4,719	0.081	NOT APPLICABLE	NOT APPLICABLE	
Curb	Curb Type		Curb & Gutter Type	
NO CURB		NO CURB AND GUTTER		
Pavement Recommendation Condition Rating / PCR		Rating / PCR		
PREVENTIVE MAINTENANCE		GOOI	O / 90	
Route Condition Legend – Pavement Condition Rating (PCR)				
Poor (0 - 60)	· /	(85 - 94) Excellent (95 - 10	0) Not Rated	
	See Appendix for definitions and formulas

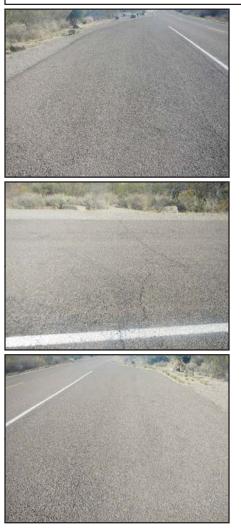
### ROUTE 1004: THE CAMEL EXPERIMENT INTERPRETIVE PULLOFF

#### ADJACENT TO ROUTE 0011 (NORTH ENTRANCE ROAD) AT MP 22.57

<b>Inspection Date</b>	FMSS Number	User Access	Surface Type		
2/22/2017	54678	PUBLIC	ASPHALT		
Area (Sq. Ft.)	Lane Miles (11' Widths)	Curb Reveal (Inches)	Curb Recommendation		
2,664	0.046	NOT APPLICABLE	DO NOTHING		
Curb Type		Curb & Gutter Type			
NO CURB		CONCRETE			
Pavement Recommendation		Condition Rating / PCR			
PREVENTIVE N	PREVENTIVE MAINTENANCE		GOOD / 90		
	Route Condition Legend – Pavement Condition Rating (PCR)				
Poor (0 - 60)	, ,	(85 - 94) Excellent (95 - 10	0) Not Rated		
See Appendix for definitions and formulas
