BUFF Cycle 6

Final Report

Road Inventory and Condition Assessment of Paved Routes Buffalo National River

**Federal Highway Administration
Eastern Federal Lands Highway Division
Road Inventory Program (RIP)**

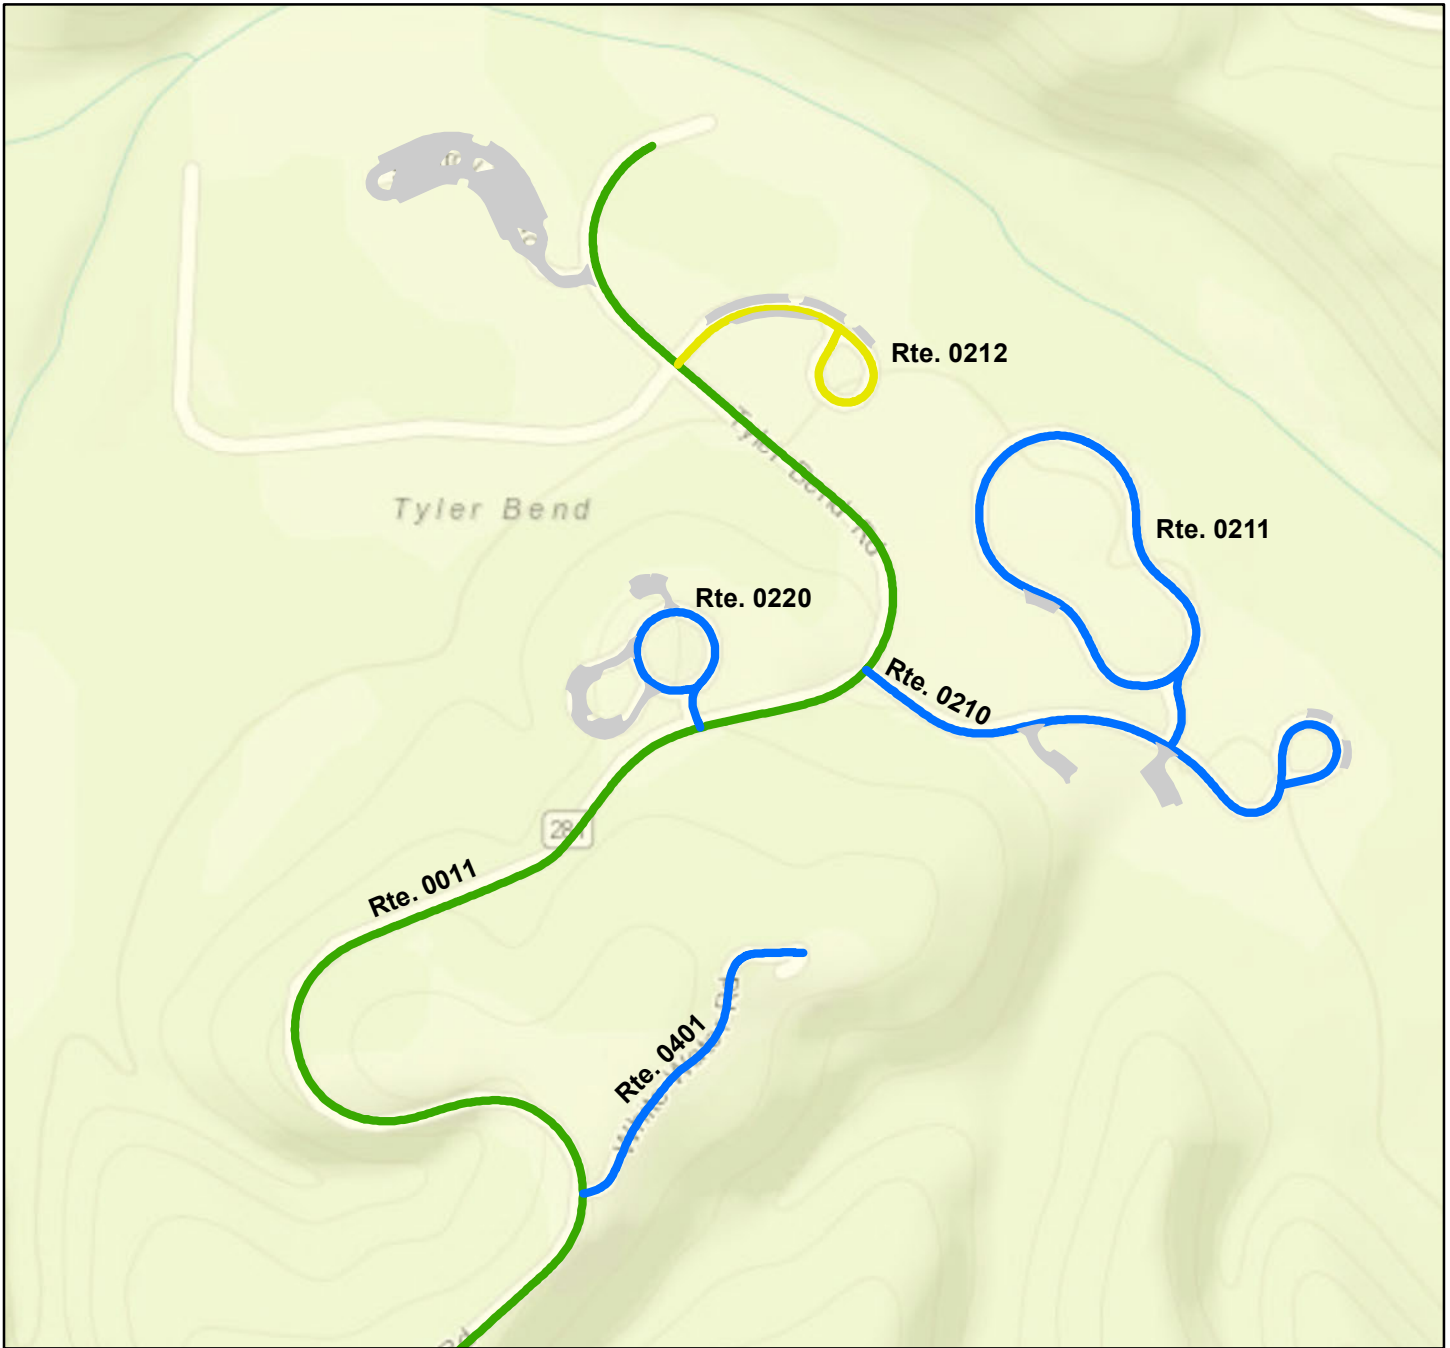
Area Map 3A

ROUTE CONDITION MAP

PCR - MILE BY MILE

Colors on map represent condition scores at 1-mile intervals. See Appendix for definitions and formulas
Only Data Collection Vehicle and Manually Rated Roads are displayed

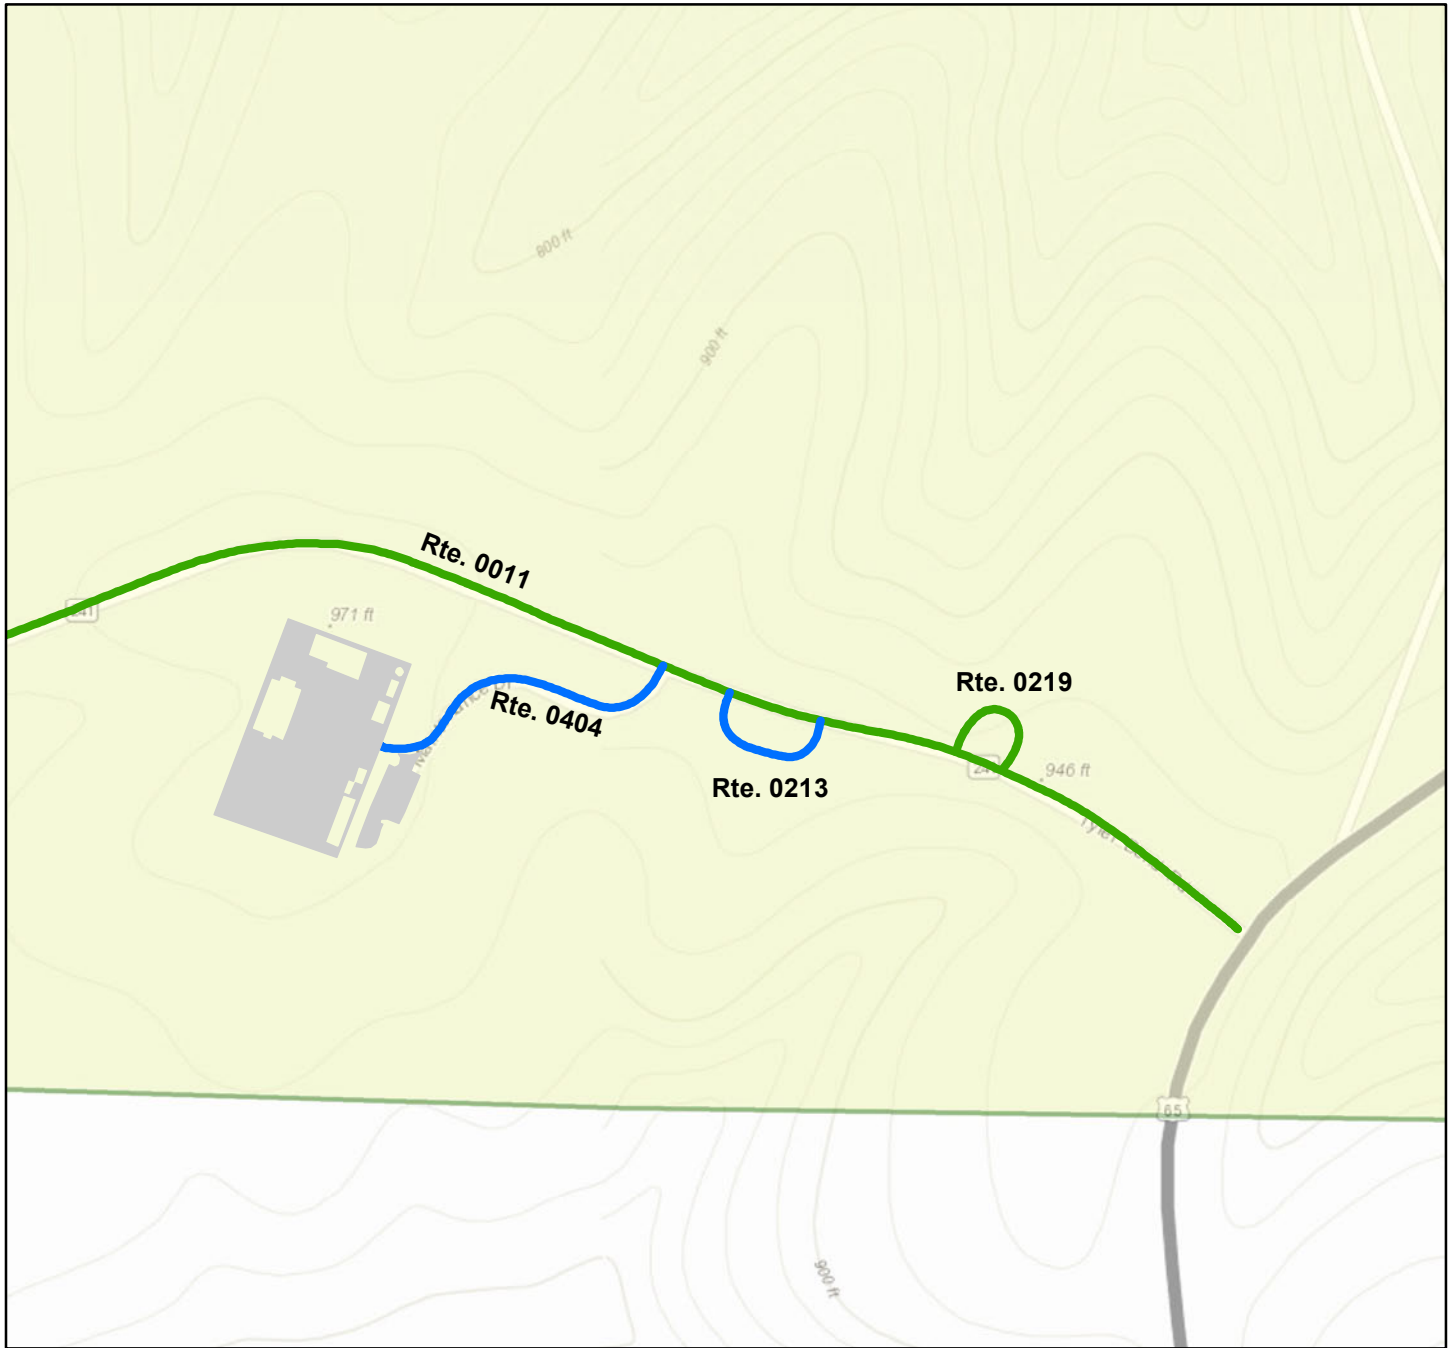
Area Map 3B

ROUTE CONDITION MAP

PCR - MILE BY MILE

Colors on map represent condition scores at 1-mile intervals. See Appendix for definitions and formulas
Only Data Collection Vehicle and Manually Rated Roads are displayed

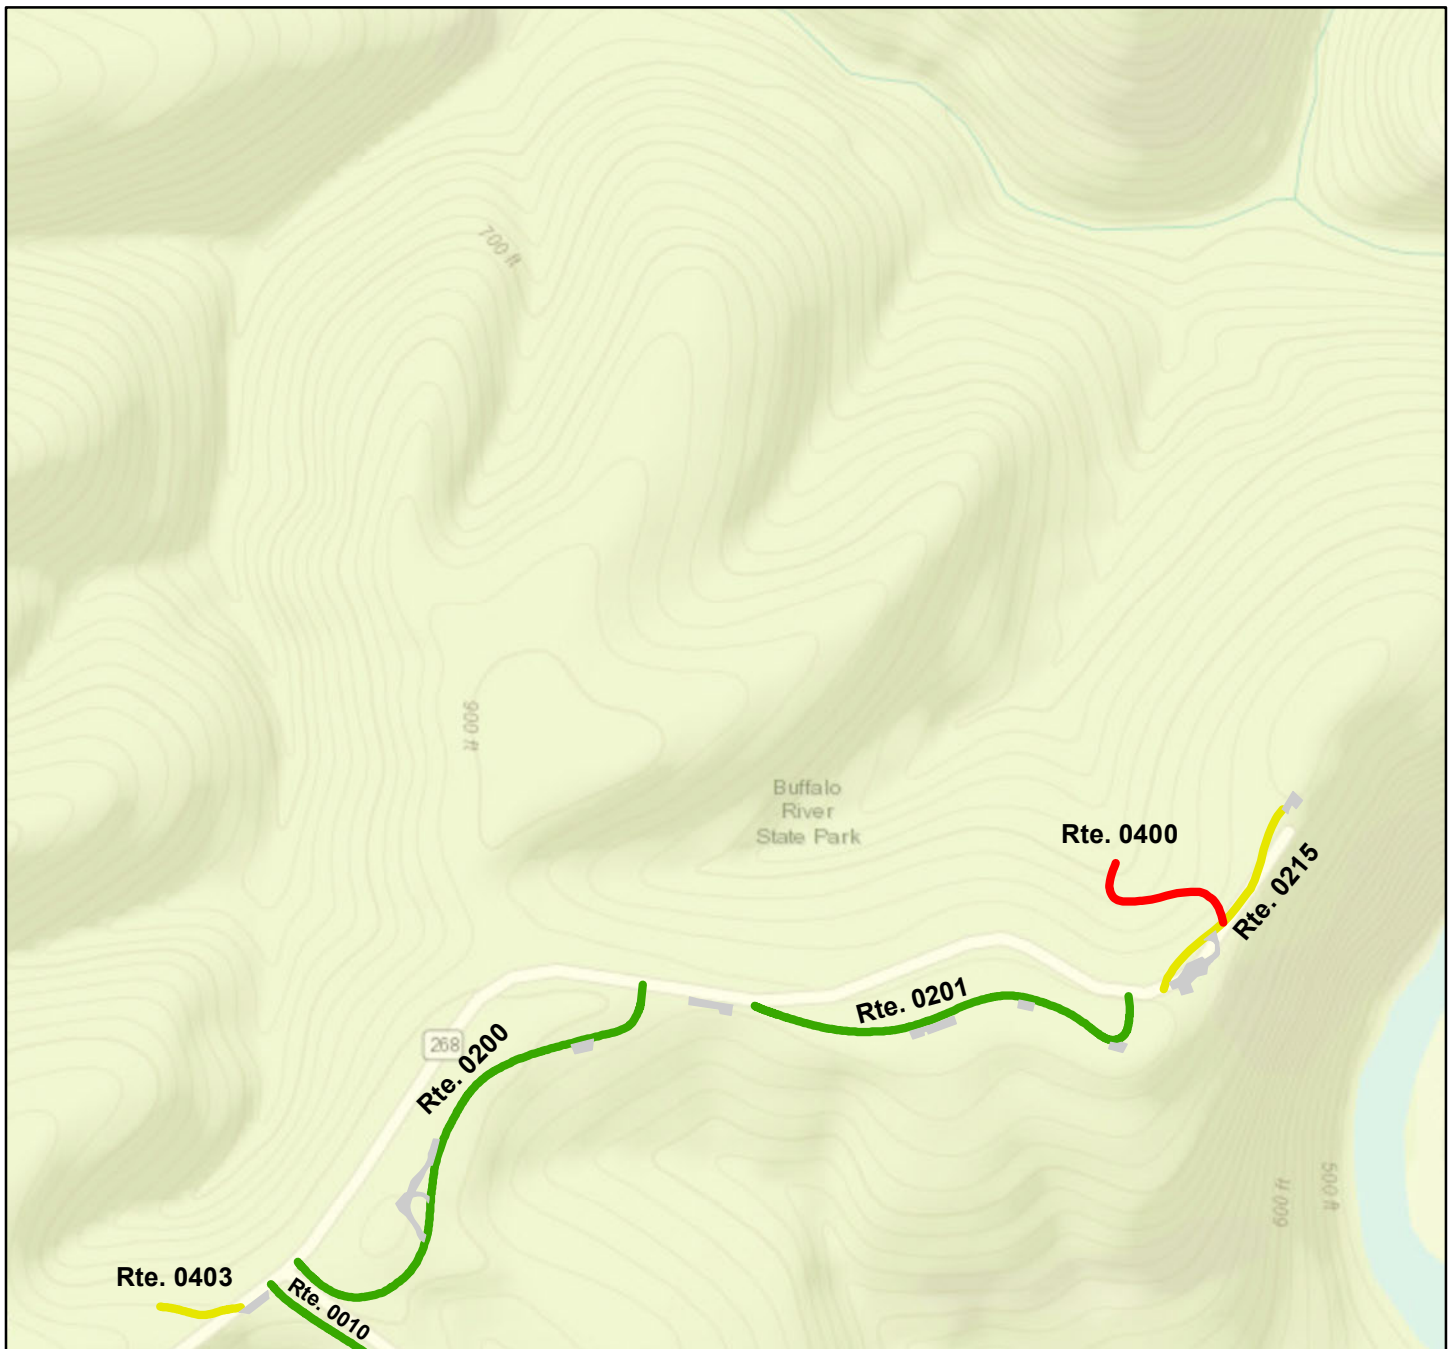
Area Map 4B

ROUTE CONDITION MAP

PCR - MILE BY MILE

Colors on map represent condition scores at 1-mile intervals. See Appendix for definitions and formulas
Only Data Collection Vehicle and Manually Rated Roads are displayed

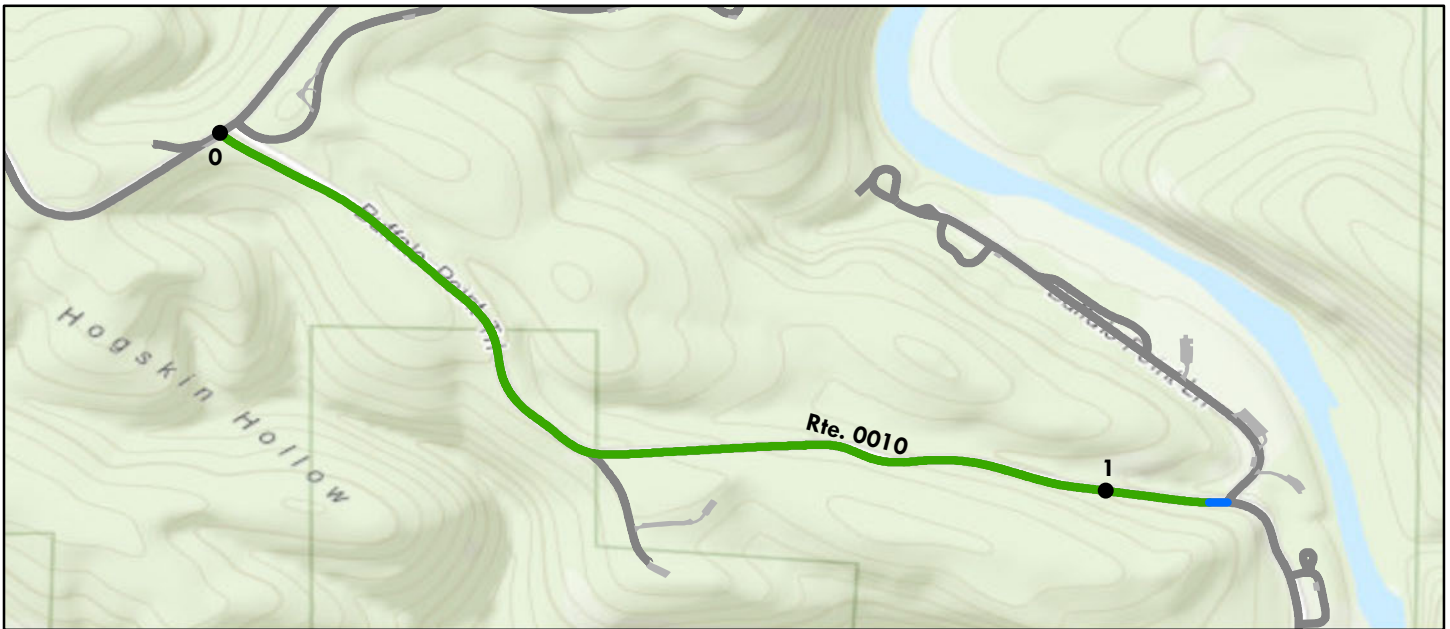
ROUTE 0010: BUFFALO POINT ROAD

Data Collection Vehicle (DCV) Rating

Route Condition Legend – Pavement Condition Rating (PCR)						
Poor (0 - 60)	Fair (61- 84)	Good (85 - 94)	Excellent (95 - 100)	Not Rated		
Colors on map represent condition scores at 0.10-mile intervals. See Appendix for definitions and formulas.						
Inspection Date: 5/10/2019	Beginning Section MP	0	1			
Paved Length (Miles): 1.12	Section Length (MI)	1	0.12			
Surface Type: ASPHALT	Route Summary					
Roadway Condition Information						
Pavement Condition Rating (PCR)	90	90	91			
Surface Condition Rating (SCR)	98	98	99			
Roughness Condition Index (RCI)	77	77	80			
Distress Index Values						
Structural Crack Index	100	100	100			
Alligator Crack Index	100	100	100			
Longitudinal Crack Index	100	100	100			
Transverse Cracking Index	99	99	100			
Patching Index	100	100	100			
Rutting Index	98	98	99			
International Roughness Index (IRI)	177	178	170			
Lane & Width Information						
Number of Lanes	2	2	2			
Paved Width (ft)	21.5	21.5	21.7

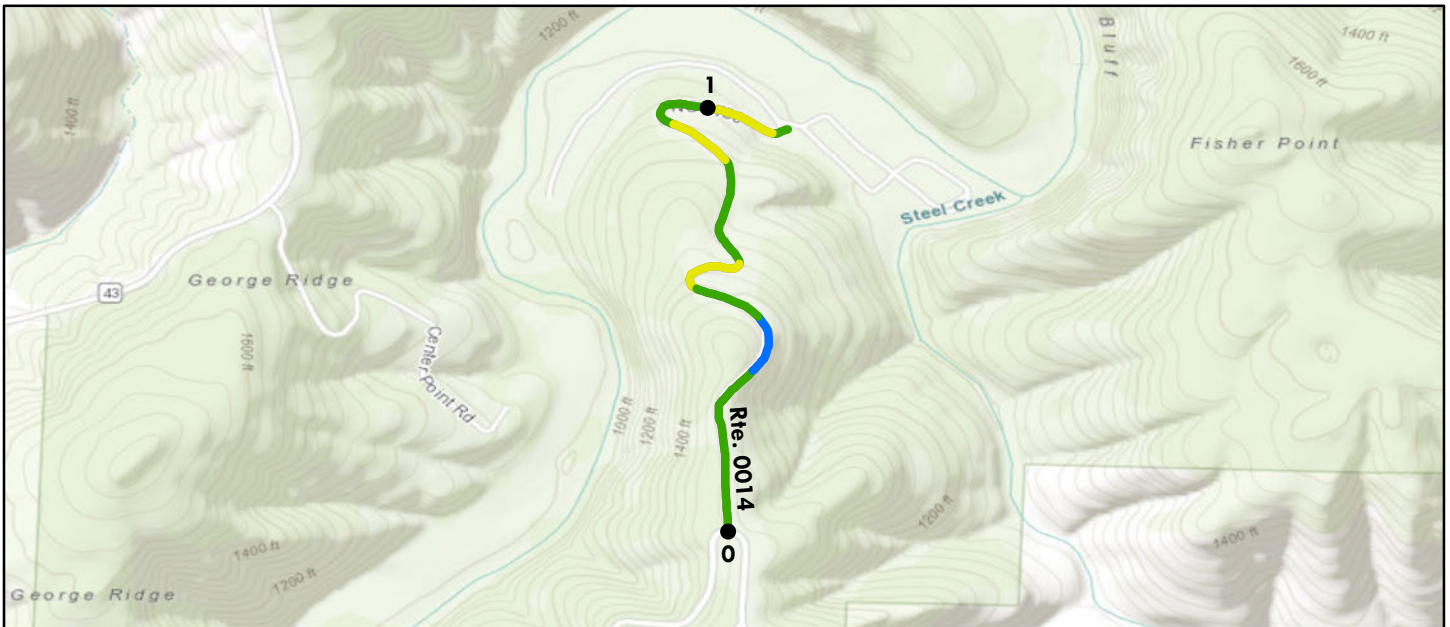
ROUTE 0014: UD SC STEEL CREEK ROAD 143

Data Collection Vehicle (DCV) Rating

Route Condition Legend – Pavement Condition Rating (PCR)						
Poor (0 - 60)	Fair (61- 84)	Good (85 - 94)	Excellent (95 - 100)	Not Rated		
Colors on map represent condition scores at 0.10-mile intervals. See Appendix for definitions and formulas.						
Inspection Date: 5/10/2019	Beginning Section MP	0	1			
Paved Length (Miles): 1.14	Section Length (MI)	1	0.14			
Surface Type: ASPHALT	Route Summary					
Roadway Condition Information						
Pavement Condition Rating (PCR)	90	90	81			
Surface Condition Rating (SCR)	94	94	90			
Roughness Condition Index (RCI)	83	85	68			
Distress Index Values						
Structural Crack Index	94	94	90			
Alligator Crack Index	98	98	95			
Longitudinal Crack Index	96	96	95			
Transverse Cracking Index	97	97	97			
Patching Index	99	99	98			
Rutting Index	99	99	99			
International Roughness Index (IRI)	161	155	210			
Lane & Width Information						
Number of Lanes	2	2	2			
Paved Width (ft)	19.3	19.4	18.6

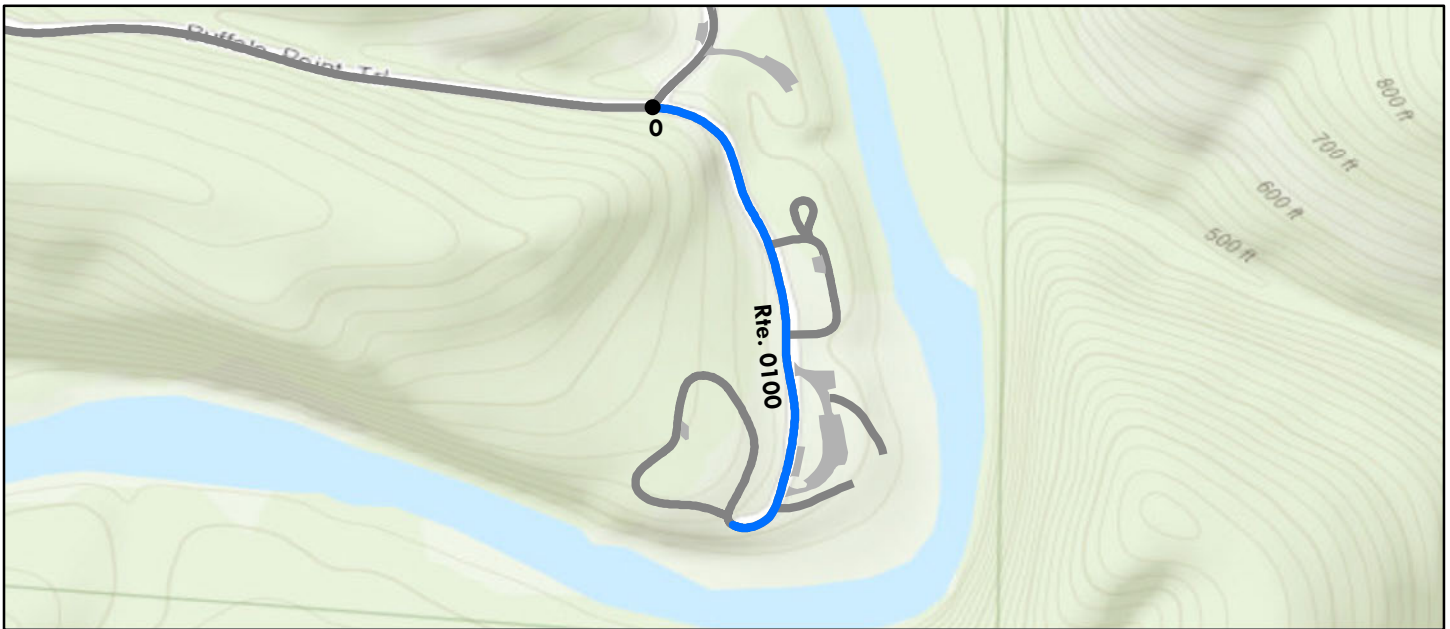
ROUTE 0100: BUFFALO POINT RIVER ACCESS ROAD

Data Collection Vehicle (DCV) Rating

Route Condition Legend – Pavement Condition Rating (PCR)						
Poor (0 - 60)	Fair (61- 84)	Good (85 - 94)	Excellent (95 - 100)	Not Rated		
Colors on map represent condition scores at 0.10-mile intervals. See Appendix for definitions and formulas.						
Inspection Date: 5/10/2019	Beginning Section MP	0				
Paved Length (Miles): 0.3	Section Length (MI)	0.3				
Surface Type: ASPHALT	Route Summary					
Roadway Condition Information						
Pavement Condition Rating (PCR)	98	98				
Surface Condition Rating (SCR)	98	98				
Roughness Condition Index (RCI)	N/A	N/A				
Distress Index Values						
Structural Crack Index	98	98				
Alligator Crack Index	100	100				
Longitudinal Crack Index	98	98				
Transverse Cracking Index	100	100				
Patching Index	100	100				
Rutting Index	99	99				
International Roughness Index (IRI)	N/A	N/A				
Lane & Width Information						
Number of Lanes	2	2				
Paved Width (ft)	22	22				
Lane Width (ft)	9.8	9.8

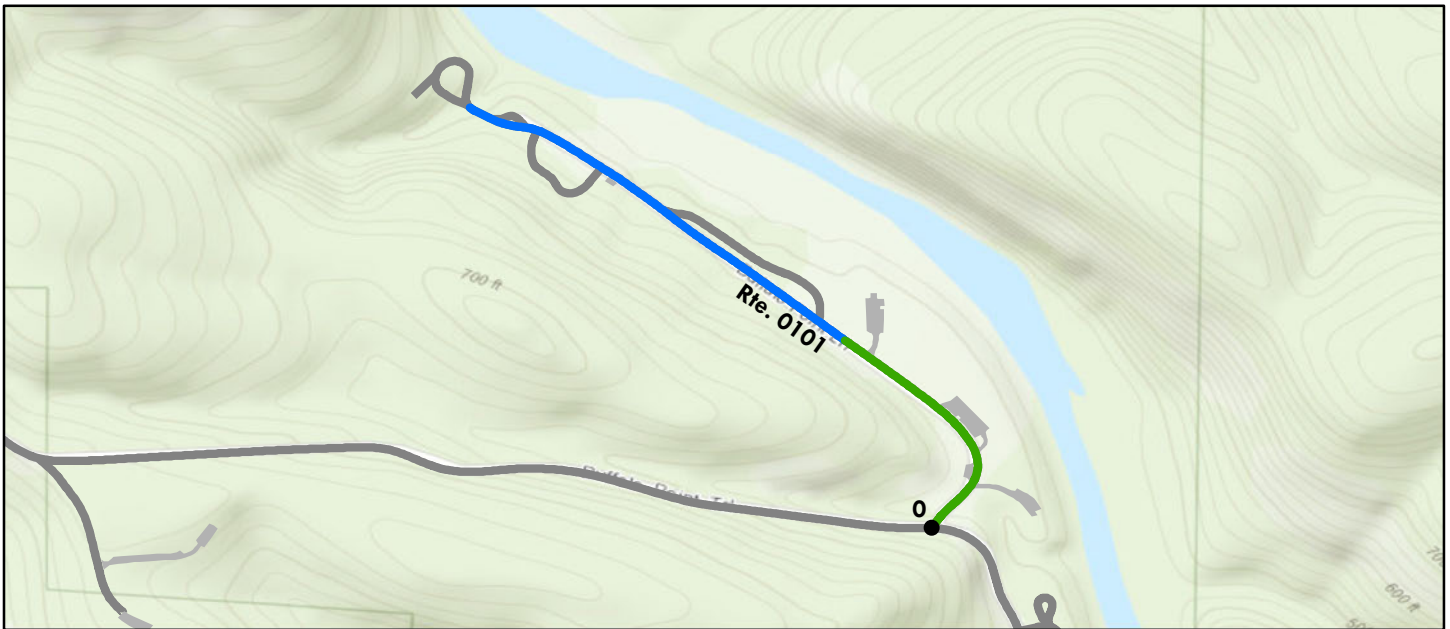
ROUTE 0101: BUFFALO POINT CAMPGROUND ROAD

Data Collection Vehicle (DCV) Rating

Route Condition Legend – Pavement Condition Rating (PCR)						
Poor (0 - 60)	Fair (61- 84)	Good (85 - 94)	Excellent (95 - 100)	Not Rated		
Colors on map represent condition scores at 0.10-mile intervals. See Appendix for definitions and formulas.						
Inspection Date: 5/10/2019	Beginning Section MP	0				
Paved Length (Miles): 0.51	Section Length (MI)	0.51				
Surface Type: ASPHALT	Route Summary					
Roadway Condition Information						
Pavement Condition Rating (PCR)	94	94				
Surface Condition Rating (SCR)	94	94				
Roughness Condition Index (RCI)	N/A	N/A				
Distress Index Values						
Structural Crack Index	98	98				
Alligator Crack Index	100	100				
Longitudinal Crack Index	98	98				
Transverse Cracking Index	94	94				
Patching Index	100	100				
Rutting Index	97	97				
International Roughness Index (IRI)	N/A	N/A				
Lane & Width Information						
Number of Lanes	2	2				
Paved Width (ft)	19.1	19.1				
Lane Width (ft)	9.2	9.2

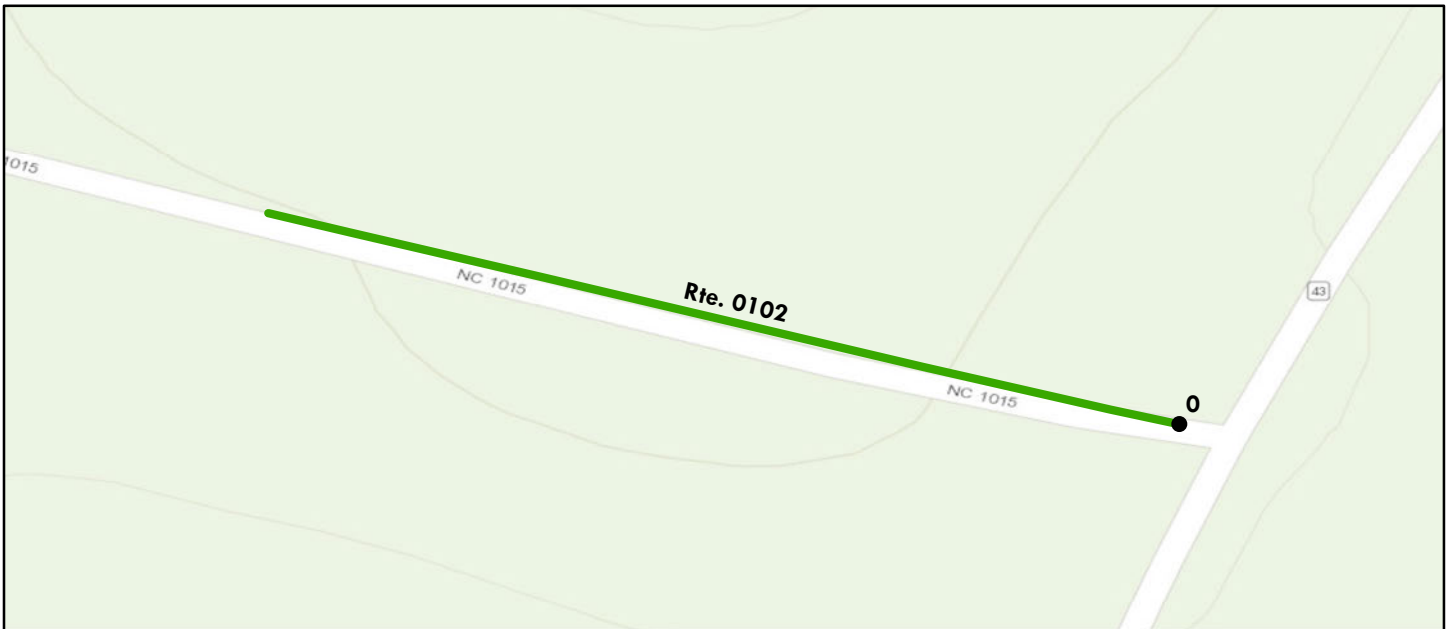
ROUTE 0102: LOST VALLEY ROAD

Manual Rating

Route Condition Legend – Pavement Condition Rating (PCR)						
Poor (0 - 60)	Fair (61- 84)	Good (85 - 94)	Excellent (95 - 100)	Not Rated		
See Appendix for definitions and formulas						
Inspection Date: 5/4/2018	Beginning Section MP	0.00				
Paved Length (Miles): 0.10	Section Length (MI)	0.10				
Surface Type: ASPHALT	Route Summary					
Roadway Condition Information						
Pavement Condition Rating (PCR)	90	90				
Surface Condition Rating (SCR)	90	90				
Roughness Condition Index (RCI)	N/A	N/A				
Distress Index Values						
Structural Crack Index	N/A	N/A				
Alligator Crack Index	97	97				
Longitudinal Crack Index	90	90				
Transverse Cracking Index	90	90				
Patching Index	97	97				
Rutting Index	90	90				
International Roughness Index (IRI)	N/A	N/A				
Lane & Width Information						
Number of Lanes	2	2				
Paved Width (ft)	22	22				
Lane Width (ft)	11	11

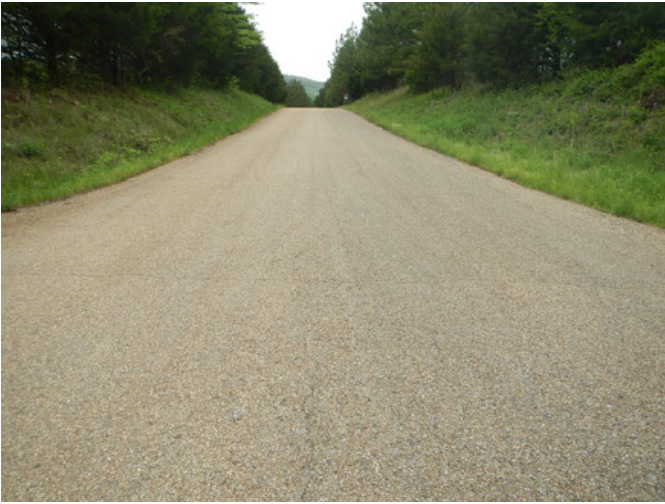
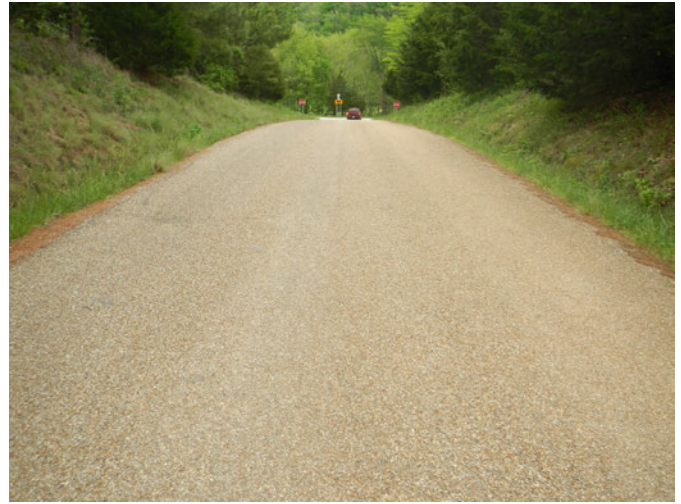
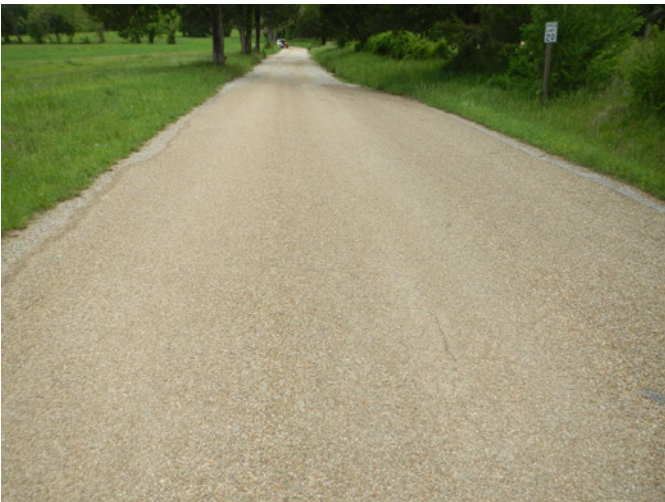
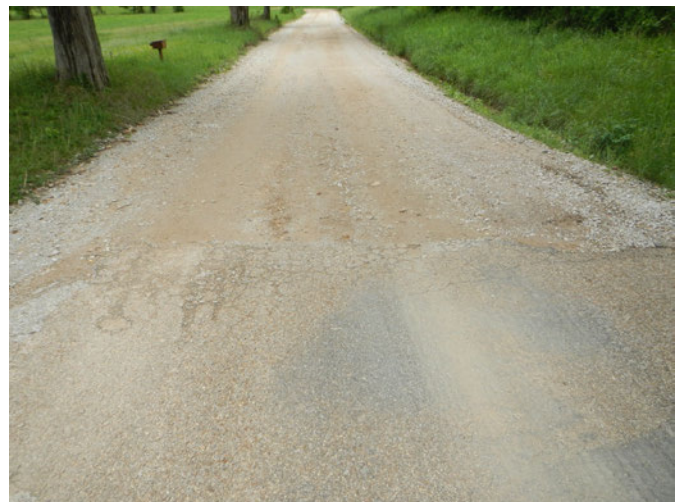
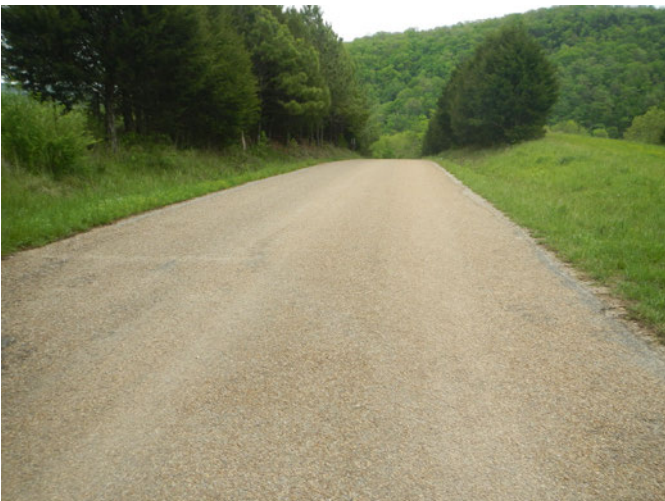
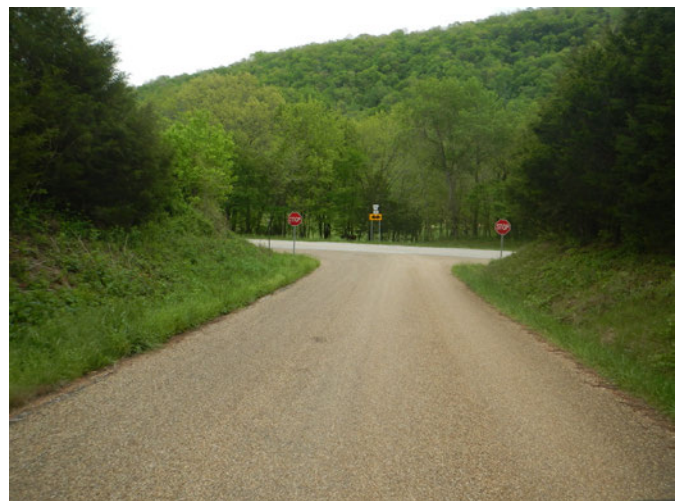
Condition Photos

Condition photos are shown only for manually rated roads. Use the PathView program to see images of DCV rated roads.

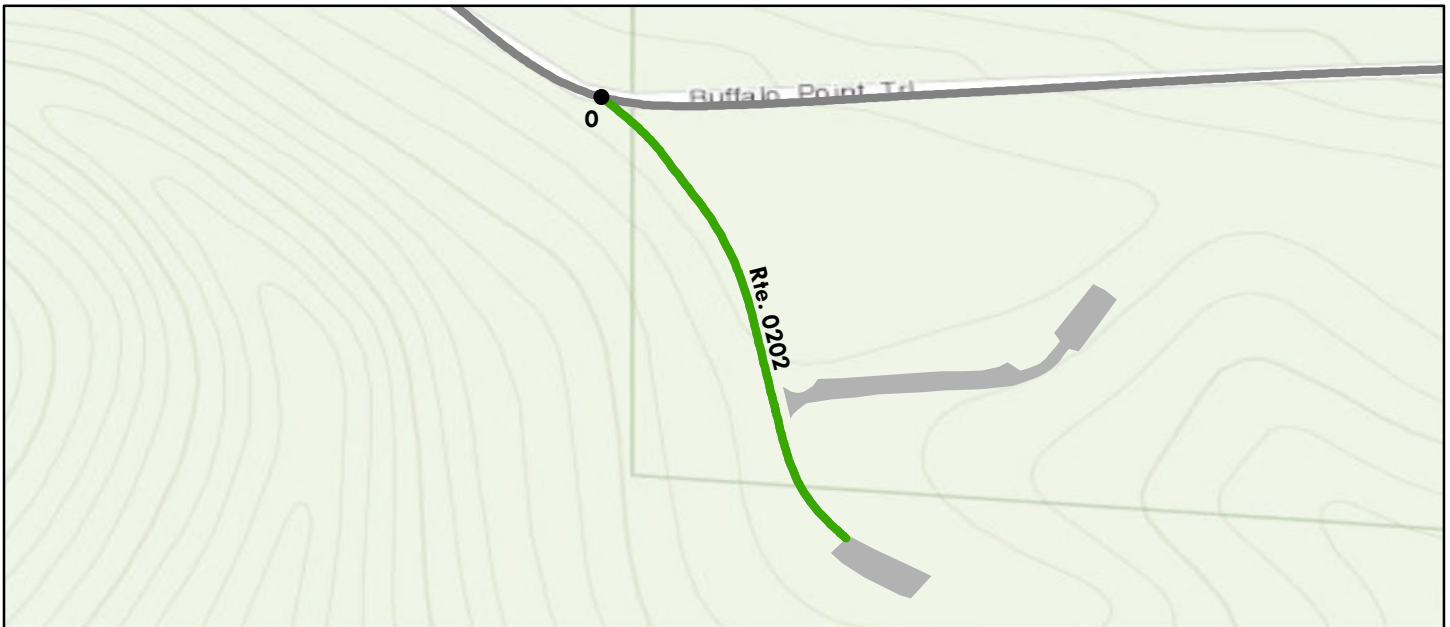
ROUTE 0202: MID LEVEL GROUP CAMPGROUND ROAD

Data Collection Vehicle (DCV) Rating

Route Condition Legend – Pavement Condition Rating (PCR)						
Poor (0 - 60)	Fair (61- 84)	Good (85 - 94)	Excellent (95 - 100)	Not Rated		
Colors on map represent condition scores at 0.10-mile intervals. See Appendix for definitions and formulas.						
Inspection Date: 5/10/2019	Beginning Section MP	0				
Paved Length (Miles): 0.14	Section Length (MI)	0.14				
Surface Type: ASPHALT	Route Summary					
Roadway Condition Information						
Pavement Condition Rating (PCR)	92	92				
Surface Condition Rating (SCR)	92	92				
Roughness Condition Index (RCI)	N/A	N/A				
Distress Index Values						
Structural Crack Index	99	99				
Alligator Crack Index	100	100				
Longitudinal Crack Index	99	99				
Transverse Cracking Index	92	92				
Patching Index	100	100				
Rutting Index	94	94				
International Roughness Index (IRI)	N/A	N/A				
Lane & Width Information						
Number of Lanes	2	2				
Paved Width (ft)	19.2	19.2				
Lane Width (ft)	9.6	9.6

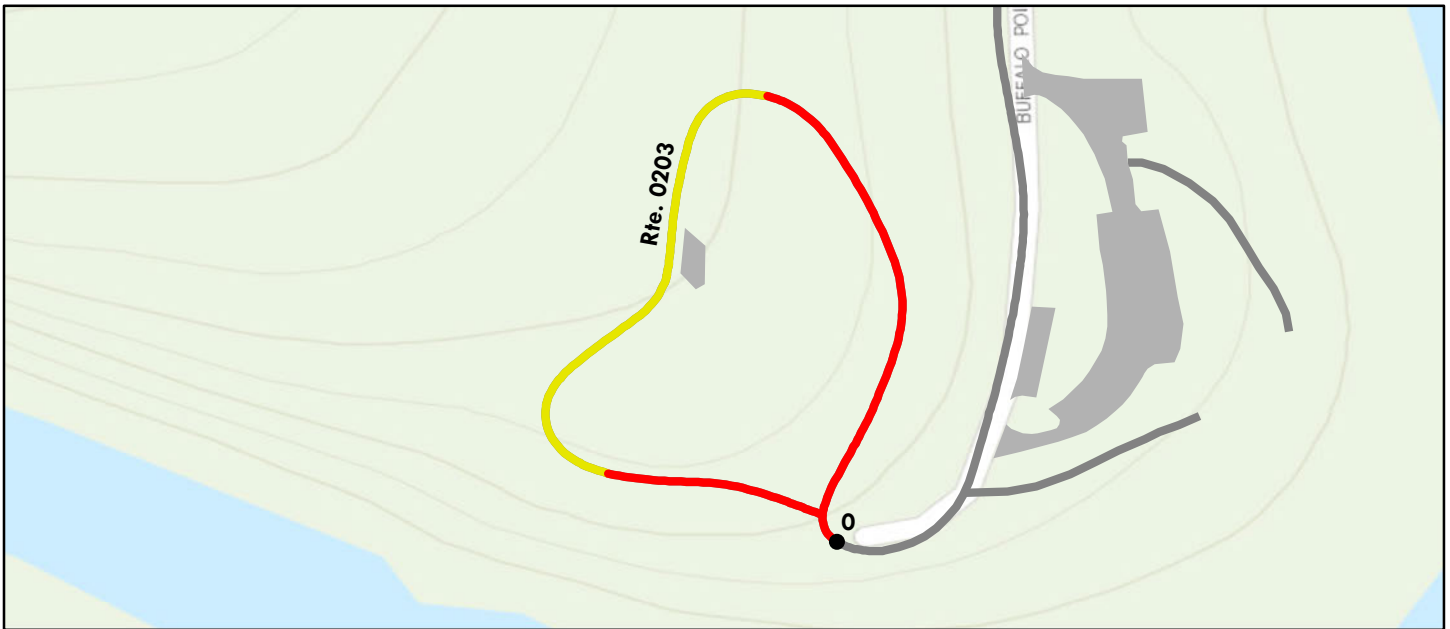
ROUTE 0203: BUFFALO POINT CAMPGROUND LOOP A

Data Collection Vehicle (DCV) Rating

Route Condition Legend – Pavement Condition Rating (PCR)						
Poor (0 - 60)	Fair (61- 84)	Good (85 - 94)	Excellent (95 - 100)	Not Rated		
Colors on map represent condition scores at 0.10-mile intervals. See Appendix for definitions and formulas.						
Inspection Date: 5/10/2019	Beginning Section MP	0				
Paved Length (Miles): 0.24	Section Length (MI)	0.24				
Surface Type: ASPHALT	Route Summary					
Roadway Condition Information						
Pavement Condition Rating (PCR)	63	63				
Surface Condition Rating (SCR)	63	63				
Roughness Condition Index (RCI)	N/A	N/A				
Distress Index Values						
Structural Crack Index	78	78				
Alligator Crack Index	100	100				
Longitudinal Crack Index	78	78				
Transverse Cracking Index	63	63				
Patching Index	99	99				
Rutting Index	96	96				
International Roughness Index (IRI)	N/A	N/A				
Lane & Width Information						
Number of Lanes	1	1				
Paved Width (ft)	14.5	14.5				
Lane Width (ft)	14.5	14.5

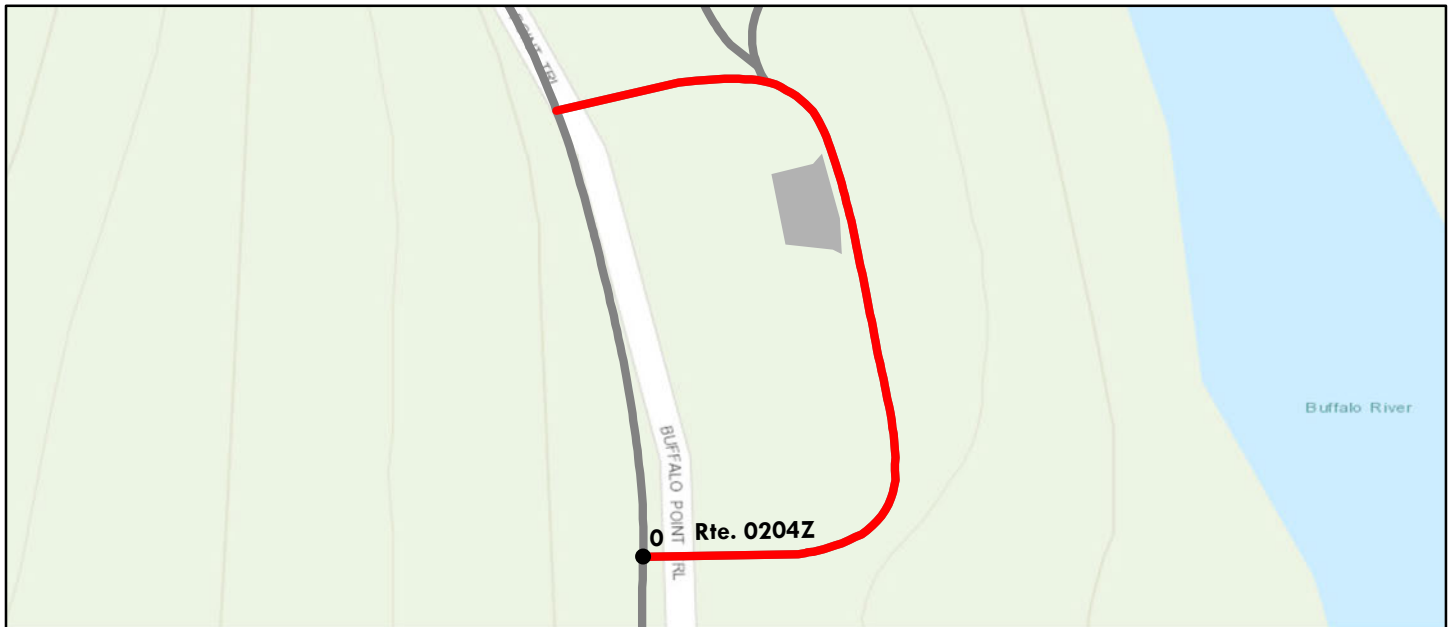
ROUTE 0204Z: BUFFALO POINT CAMPGROUND LOOP B

Subcomponent of Route BUFF-0204ZZ
Data Collection Vehicle (DCV) Rating

Colors on map represent condition scores at 0.10-mile intervals. See Appendix for definitions and formulas.

Inspection Date: 5/10/2019	Beginning Section MP	0				
Paved Length (Miles): 0.1	Section Length (MI)	0.1				
Surface Type: ASPHALT	Route Summary					
Roadway Condition Information						
Pavement Condition Rating (PCR)	53	53				
Surface Condition Rating (SCR)	53	53				
Roughness Condition Index (RCI)	N/A	N/A				
Distress Index Values						
Structural Crack Index	54	54				
Alligator Crack Index	95	95				
Longitudinal Crack Index	59	59				
Transverse Cracking Index	53	53				
Patching Index	99	99				
Rutting Index	91	91				
International Roughness Index (IRI)	N/A	N/A				
Lane & Width Information						
Number of Lanes	2	2				
Paved Width (ft)	17.8	17.8				
Lane Width (ft)	8.9	8.9

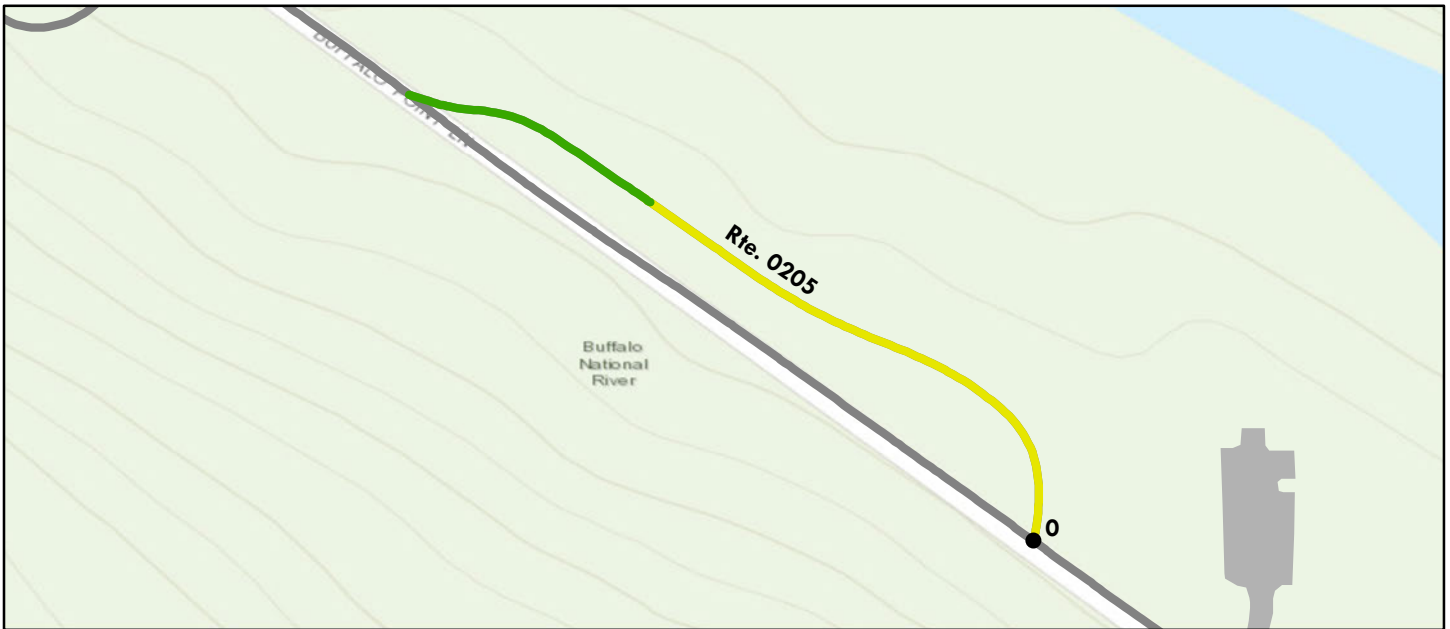
ROUTE 0205: BUFFALO POINT CAMPGROUND LOOP C

Data Collection Vehicle (DCV) Rating

Route Condition Legend – Pavement Condition Rating (PCR)						
Poor (0 - 60)	Fair (61- 84)	Good (85 - 94)	Excellent (95 - 100)	Not Rated		
Colors on map represent condition scores at 0.10-mile intervals. See Appendix for definitions and formulas.						
Inspection Date: 5/10/2019	Beginning Section MP	0				
Paved Length (Miles): 0.14	Section Length (MI)	0.14				
Surface Type: ASPHALT	Route Summary					
Roadway Condition Information						
Pavement Condition Rating (PCR)	80	80				
Surface Condition Rating (SCR)	80	80				
Roughness Condition Index (RCI)	N/A	N/A				
Distress Index Values						
Structural Crack Index	91	91				
Alligator Crack Index	100	100				
Longitudinal Crack Index	91	91				
Transverse Cracking Index	80	80				
Patching Index	100	100				
Rutting Index	95	95				
International Roughness Index (IRI)	N/A	N/A				
Lane & Width Information						
Number of Lanes	1	1				
Paved Width (ft)	12.8	12.8				
Lane Width (ft)	12.8	12.8

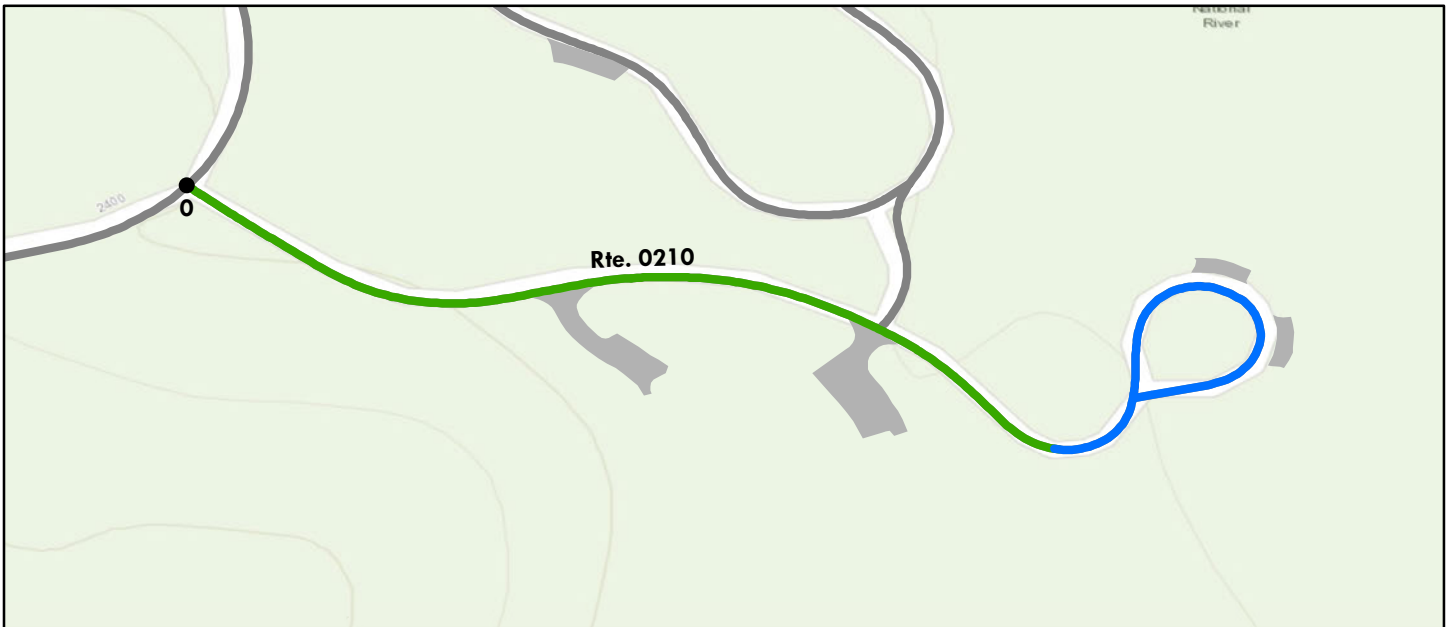
ROUTE 0210: TYLER BEND CAMPGROUND LOOP A

Data Collection Vehicle (DCV) Rating

Route Condition Legend – Pavement Condition Rating (PCR)						
Poor (0 - 60)	Fair (61- 84)	Good (85 - 94)	Excellent (95 - 100)	Not Rated		
Colors on map represent condition scores at 0.10-mile intervals. See Appendix for definitions and formulas.						
Inspection Date: 5/10/2019	Beginning Section MP	0				
Paved Length (Miles): 0.3	Section Length (MI)	0.3				
Surface Type: ASPHALT	Route Summary					
Roadway Condition Information						
Pavement Condition Rating (PCR)	95	95				
Surface Condition Rating (SCR)	95	95				
Roughness Condition Index (RCI)	N/A	N/A				
Distress Index Values						
Structural Crack Index	97	97				
Alligator Crack Index	100	100				
Longitudinal Crack Index	97	97				
Transverse Cracking Index	95	95				
Patching Index	100	100				
Rutting Index	95	95				
International Roughness Index (IRI)	N/A	N/A				
Lane & Width Information						
Number of Lanes	2	2				
Paved Width (ft)	20.1	20.1				
Lane Width (ft)	9.5	9.5

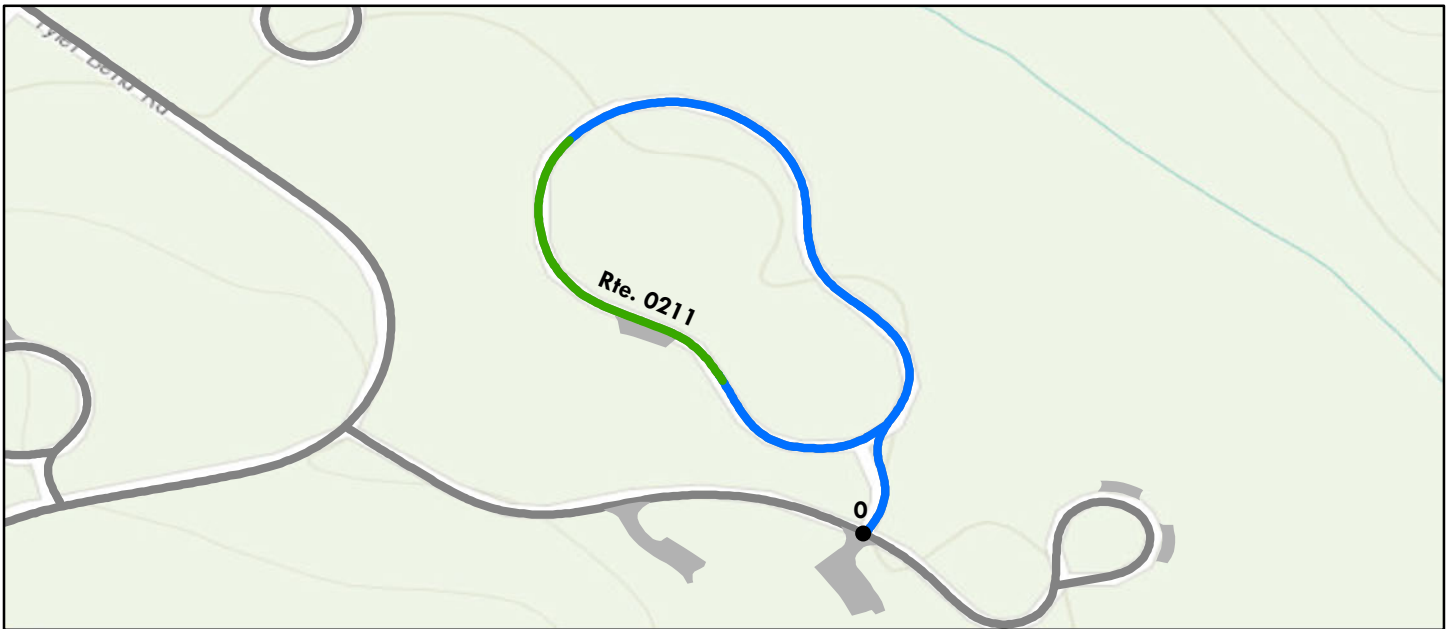
ROUTE 0211: TYLER BEND CAMPGROUND LOOP B

Data Collection Vehicle (DCV) Rating

Route Condition Legend – Pavement Condition Rating (PCR)						
Poor (0 - 60)	Fair (61- 84)	Good (85 - 94)	Excellent (95 - 100)	Not Rated		
Colors on map represent condition scores at 0.10-mile intervals. See Appendix for definitions and formulas.						
Inspection Date: 5/10/2019	Beginning Section MP	0				
Paved Length (Miles): 0.36	Section Length (MI)	0.36				
Surface Type: ASPHALT	Route Summary					
Roadway Condition Information						
Pavement Condition Rating (PCR)	96	96				
Surface Condition Rating (SCR)	96	96				
Roughness Condition Index (RCI)	N/A	N/A				
Distress Index Values						
Structural Crack Index	99	99				
Alligator Crack Index	100	100				
Longitudinal Crack Index	99	99				
Transverse Cracking Index	99	99				
Patching Index	100	100				
Rutting Index	96	96				
International Roughness Index (IRI)	N/A	N/A				
Lane & Width Information						
Number of Lanes	1	1				
Paved Width (ft)	17.6	17.6				
Lane Width (ft)	13.3	13.3

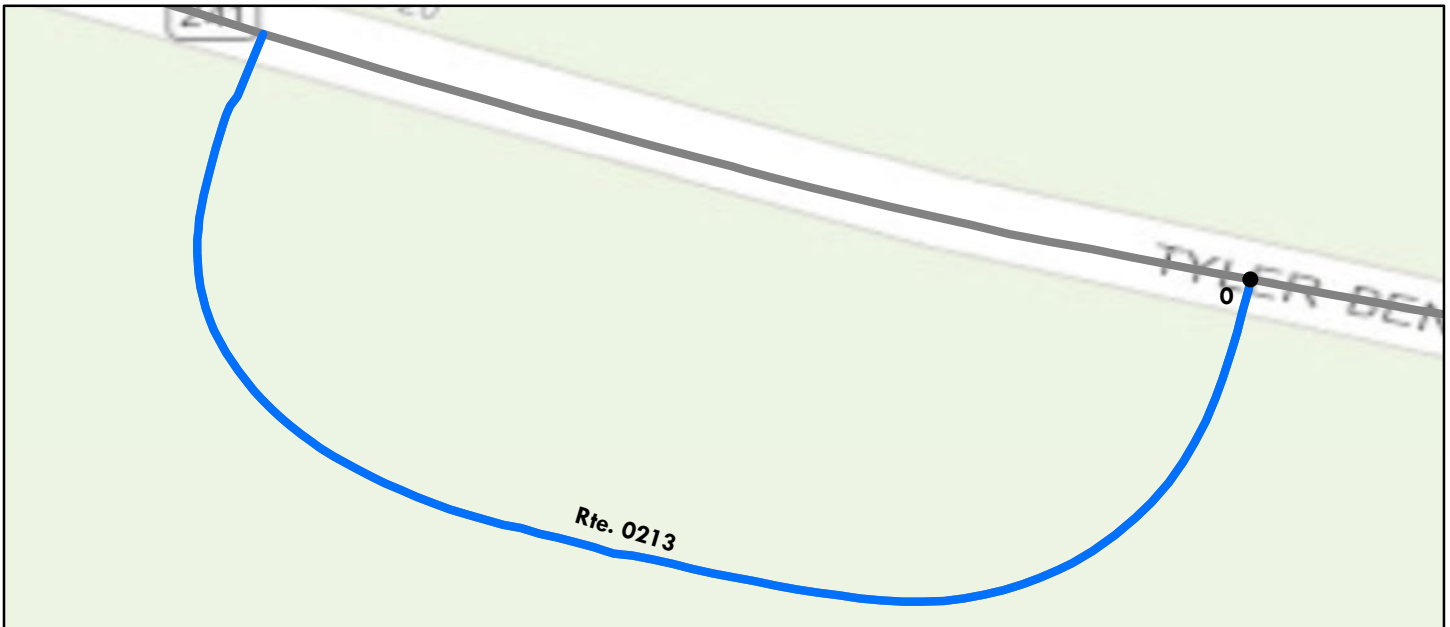
ROUTE 0213: TYLER BEND RV DUMP STATION

Data Collection Vehicle (DCV) Rating

Route Condition Legend – Pavement Condition Rating (PCR)						
Poor (0 - 60)	Fair (61- 84)	Good (85 - 94)	Excellent (95 - 100)	Not Rated		
Colors on map represent condition scores at 0.10-mile intervals. See Appendix for definitions and formulas.						
Inspection Date: 5/10/2019	Beginning Section MP	0				
Paved Length (Miles): 0.06	Section Length (MI)	0.06				
Surface Type: ASPHALT	Route Summary					
Roadway Condition Information						
Pavement Condition Rating (PCR)	95	95				
Surface Condition Rating (SCR)	95	95				
Roughness Condition Index (RCI)	N/A	N/A				
Distress Index Values						
Structural Crack Index	95	95				
Alligator Crack Index	100	100				
Longitudinal Crack Index	95	95				
Transverse Cracking Index	99	99				
Patching Index	100	100				
Rutting Index	95	95				
International Roughness Index (IRI)	N/A	N/A				
Lane & Width Information						
Number of Lanes	2	2				
Paved Width (ft)	17.8	17.8				
Lane Width (ft)	8.9	8.9
