BUFF Cycle 6

Final Report

Road Inventory and Condition Assessment of Paved Routes Buffalo National River

**Federal Highway Administration
Eastern Federal Lands Highway Division
Road Inventory Program (RIP)**

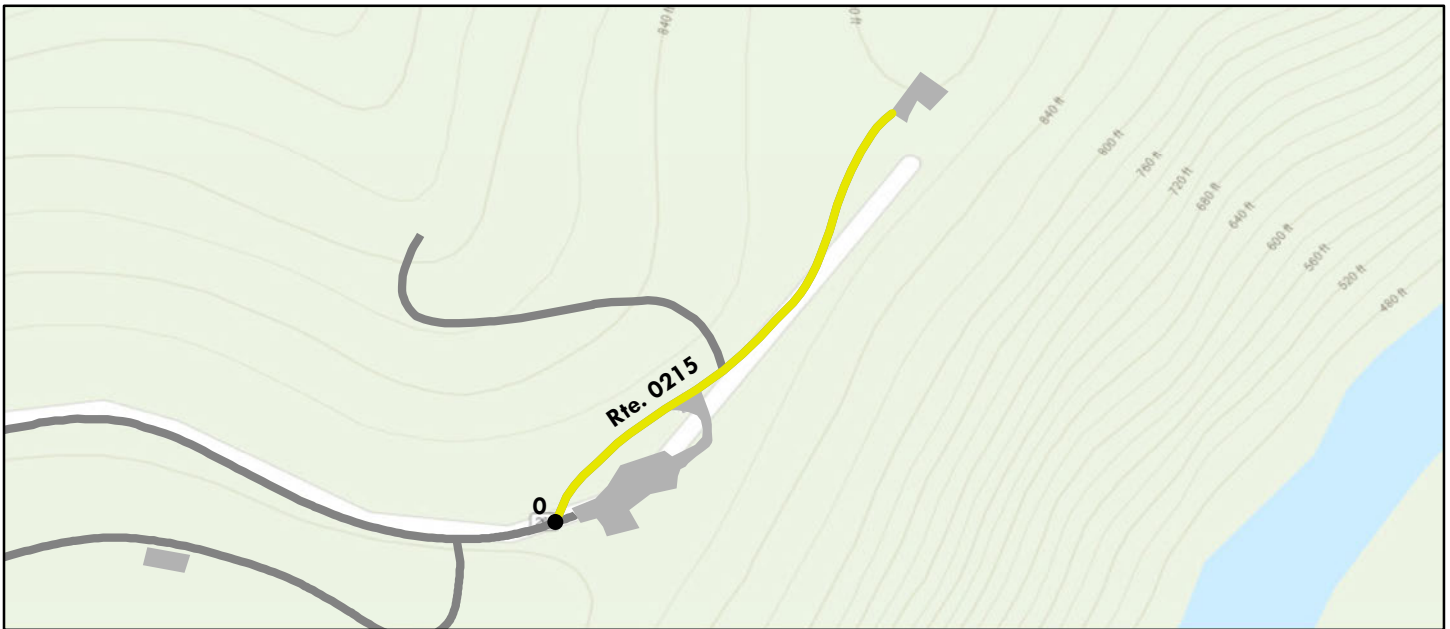
ROUTE 0215: CABIN 13 AND 14 ACCESS ROAD

Data Collection Vehicle (DCV) Rating

Colors on map represent condition scores at 0.10-mile intervals. See Appendix for definitions and formulas.

Inspection Date: 5/10/2019	Beginning Section MP	0				
Paved Length (Miles): 0.13	Section Length (MI)	0.13				
Surface Type: ASPHALT	Route Summary					
Roadway Condition Information						
Pavement Condition Rating (PCR)	80	80				
Surface Condition Rating (SCR)	80	80				
Roughness Condition Index (RCI)	N/A	N/A				
Distress Index Values						
Structural Crack Index	95	95				
Alligator Crack Index	100	100				
Longitudinal Crack Index	95	95				
Transverse Cracking Index	96	96				
Patching Index	98	98				
Rutting Index	80	80				
International Roughness Index (IRI)	N/A	N/A				
Lane & Width Information						
Number of Lanes	1	1				
Paved Width (ft)	12.3	12.3				
Lane Width (ft)	12.3	12.3

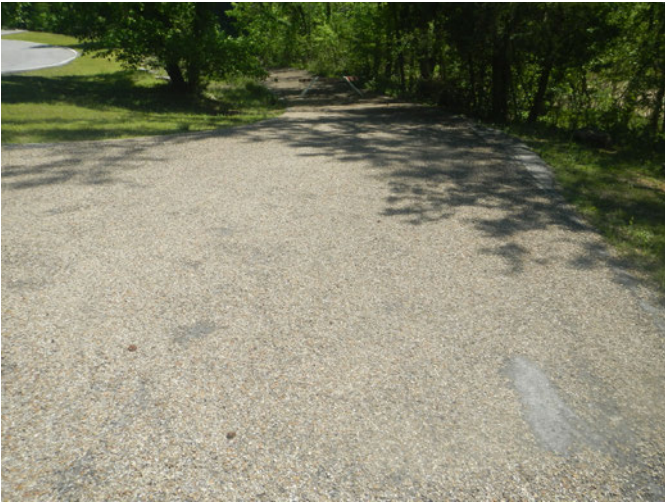
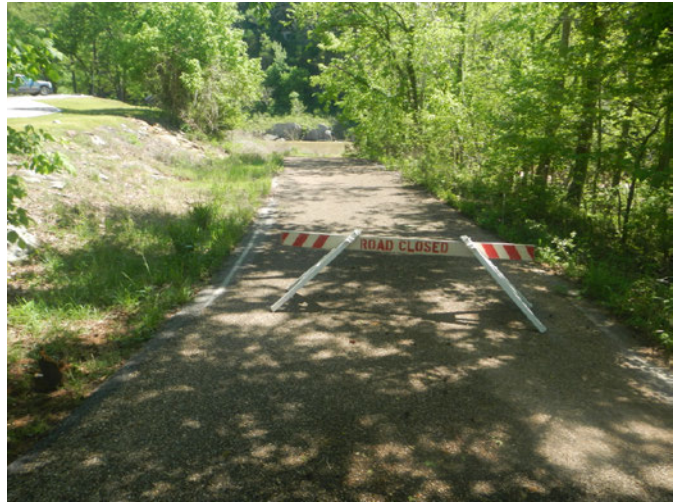
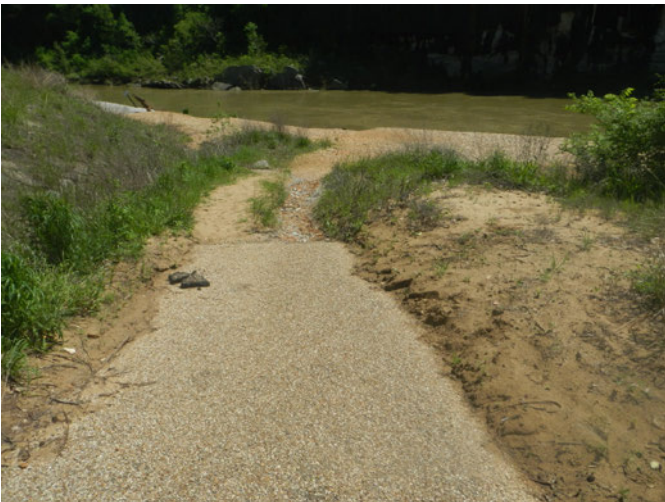
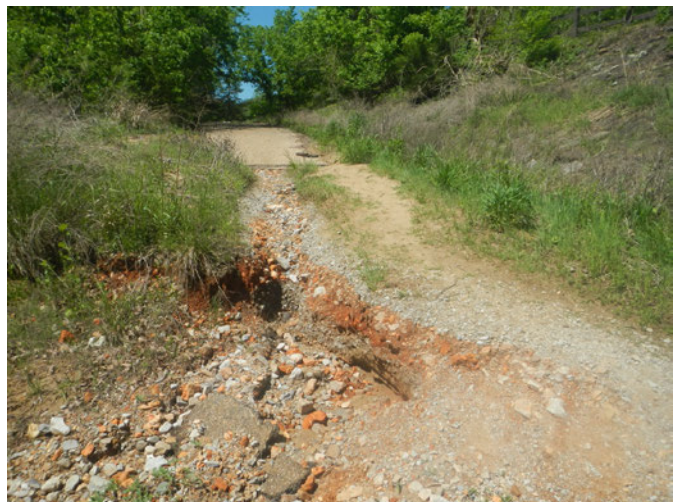
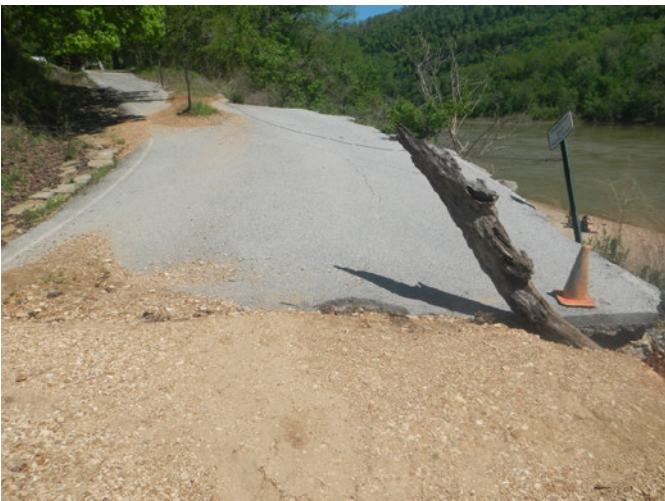
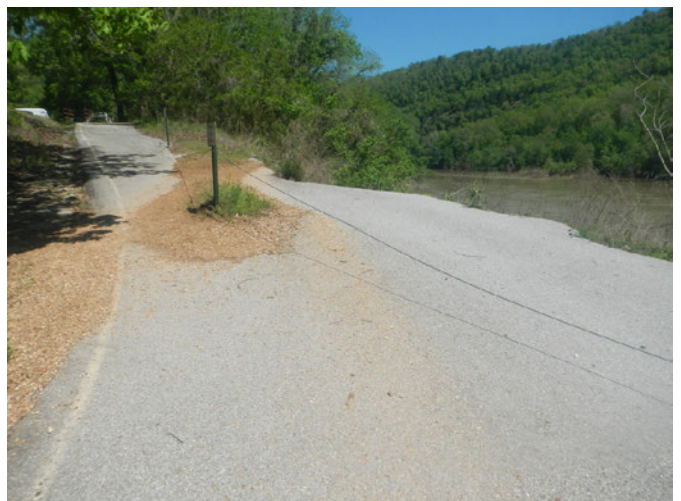
Condition Photos

Condition photos are shown only for manually rated roads. Use the PathView program to see images of DCV rated roads.

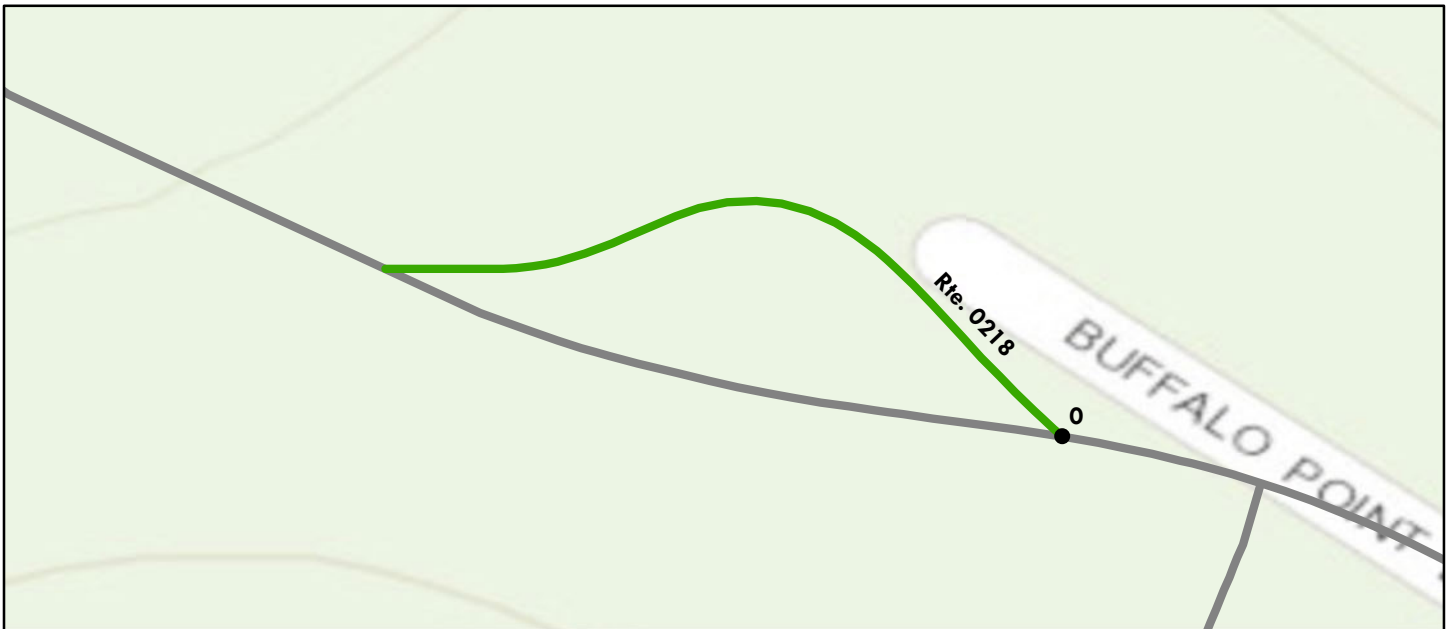
ROUTE 0218: BUFFALO POINT CAMPGROUND SITES 63-65 ACCESS

Route Condition Legend – Pavement Condition Rating (PCR)						
Poor (0 - 60)	Fair (61- 84)	Good (85 - 94)	Excellent (95 - 100)	Not Rated		
See Appendix for definitions and formulas						
Inspection Date: 5/5/2018	Beginning Section MP	0.00				
Paved Length (Miles): 0.03	Section Length (MI)	0.03				
Surface Type: ASPHALT	Route Summary					
Roadway Condition Information						
Pavement Condition Rating (PCR)	90	90				
Surface Condition Rating (SCR)	90	90				
Roughness Condition Index (RCI)	N/A	N/A				
Distress Index Values						
Structural Crack Index	N/A	N/A				
Alligator Crack Index	90	90				
Longitudinal Crack Index	90	90				
Transverse Cracking Index	90	90				
Patching Index	97	97				
Rutting Index	90	90				
International Roughness Index (IRI)	N/A	N/A				
Lane & Width Information						
Number of Lanes	1	1				
Paved Width (ft)	11	11				
Lane Width (ft)	11	11

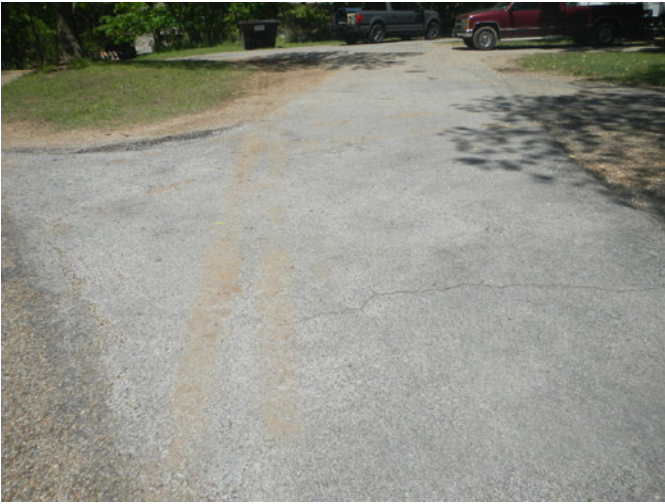
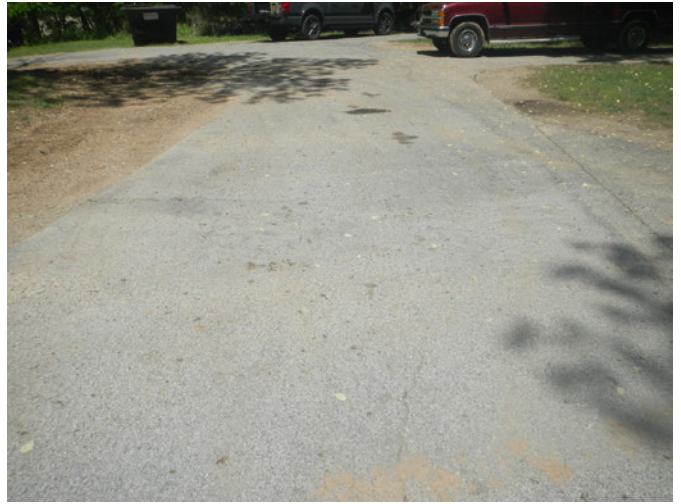
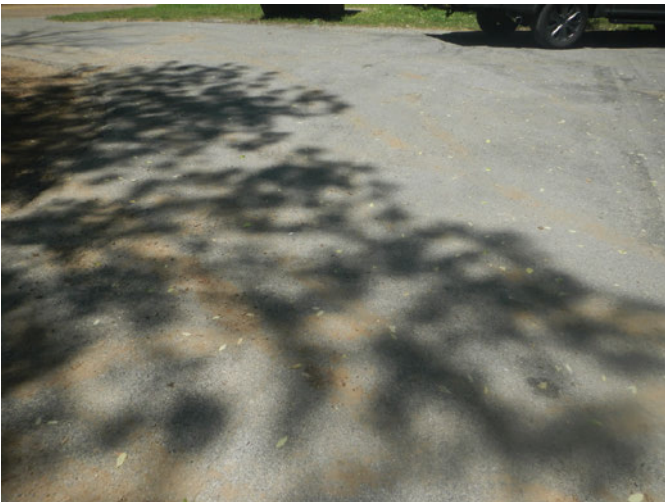
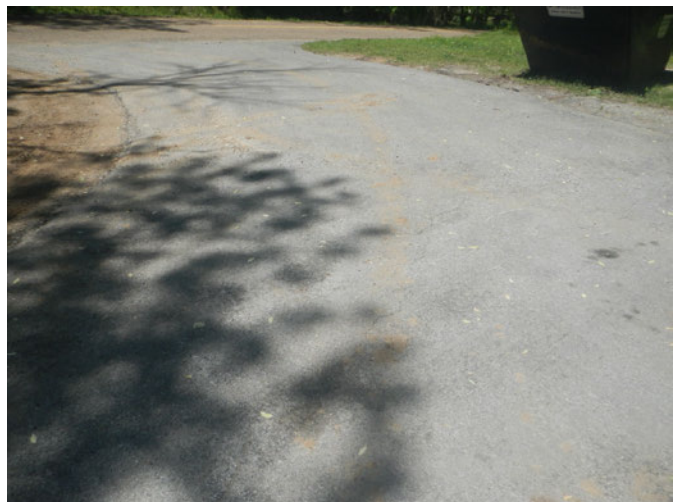
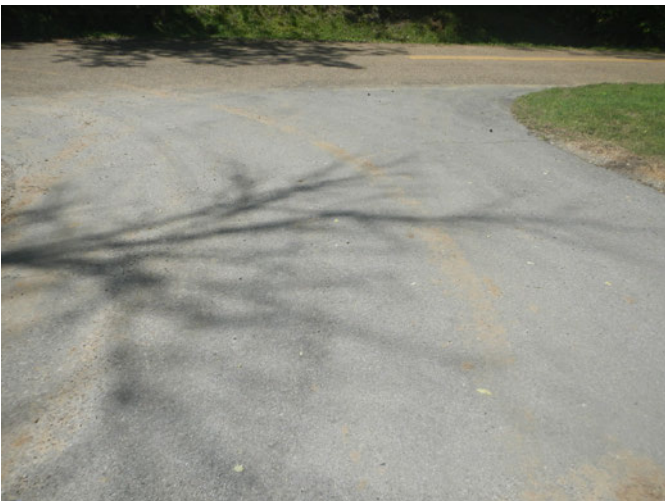
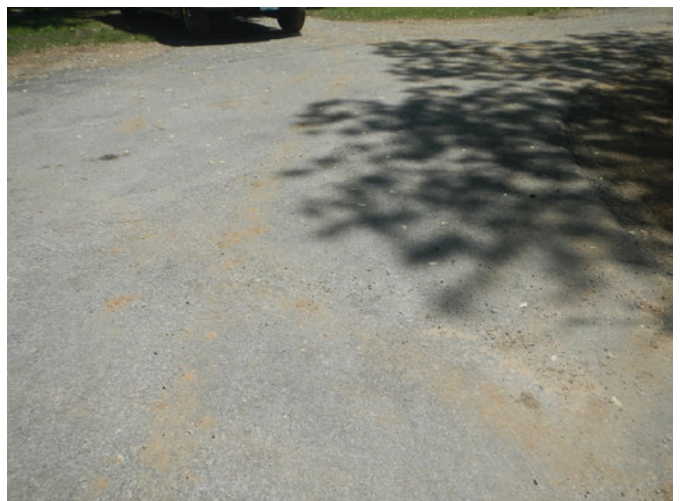
Condition Photos

Condition photos are shown only for manually rated roads. Use the PathView program to see images of DCV rated roads.

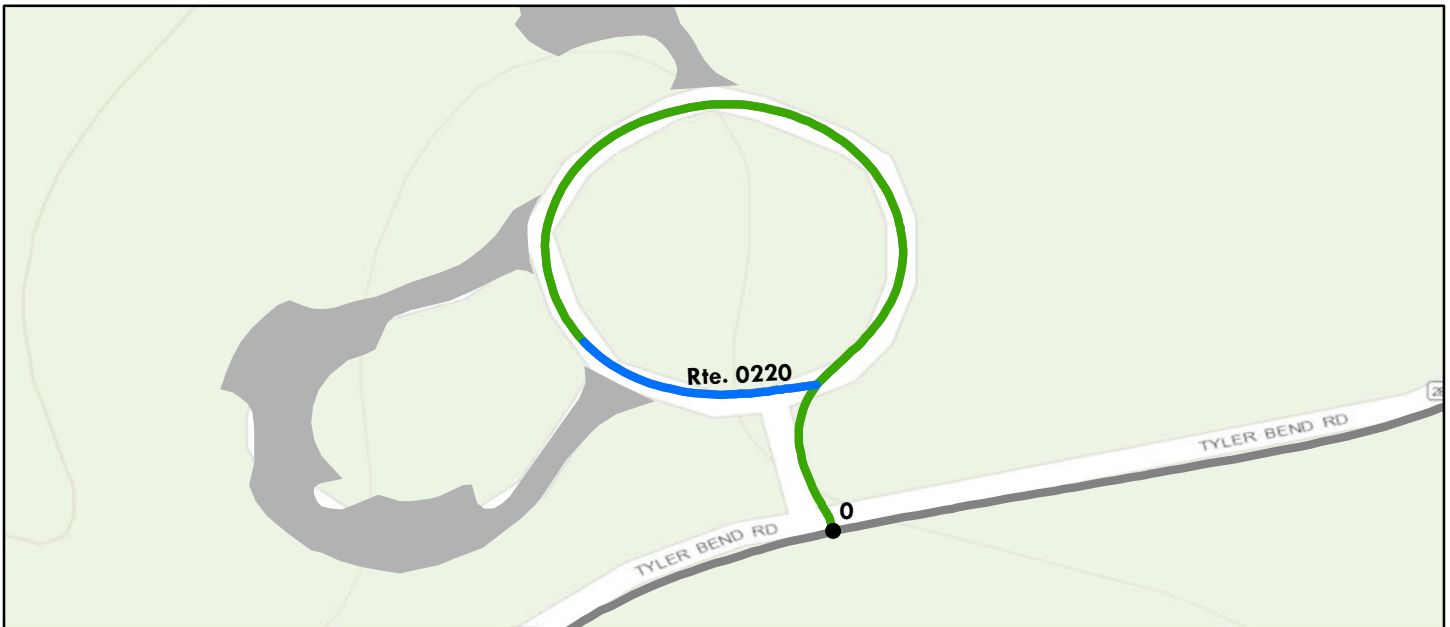
ROUTE 0220: TYLER BEND VISITOR CENTER LOOP

Route Condition Legend – Pavement Condition Rating (PCR)						
Poor (0 - 60)	Fair (61- 84)	Good (85 - 94)	Excellent (95 - 100)	Not Rated		
Colors on map represent condition scores at 0.10-mile intervals. See Appendix for definitions and formulas.						
Inspection Date: 5/10/2019	Beginning Section MP	0				
Paved Length (Miles): 0.13	Section Length (MI)	0.13				
Surface Type: ASPHALT	Route Summary					
Roadway Condition Information						
Pavement Condition Rating (PCR)	95	95				
Surface Condition Rating (SCR)	95	95				
Roughness Condition Index (RCI)	N/A	N/A				
Distress Index Values						
Structural Crack Index	95	95				
Alligator Crack Index	100	100				
Longitudinal Crack Index	95	95				
Transverse Cracking Index	95	95				
Patching Index	100	100				
Rutting Index	98	98				
International Roughness Index (IRI)	N/A	N/A				
Lane & Width Information						
Number of Lanes	1	1				
Paved Width (ft)	22.3	22.3				
Lane Width (ft)	14.7	14.7

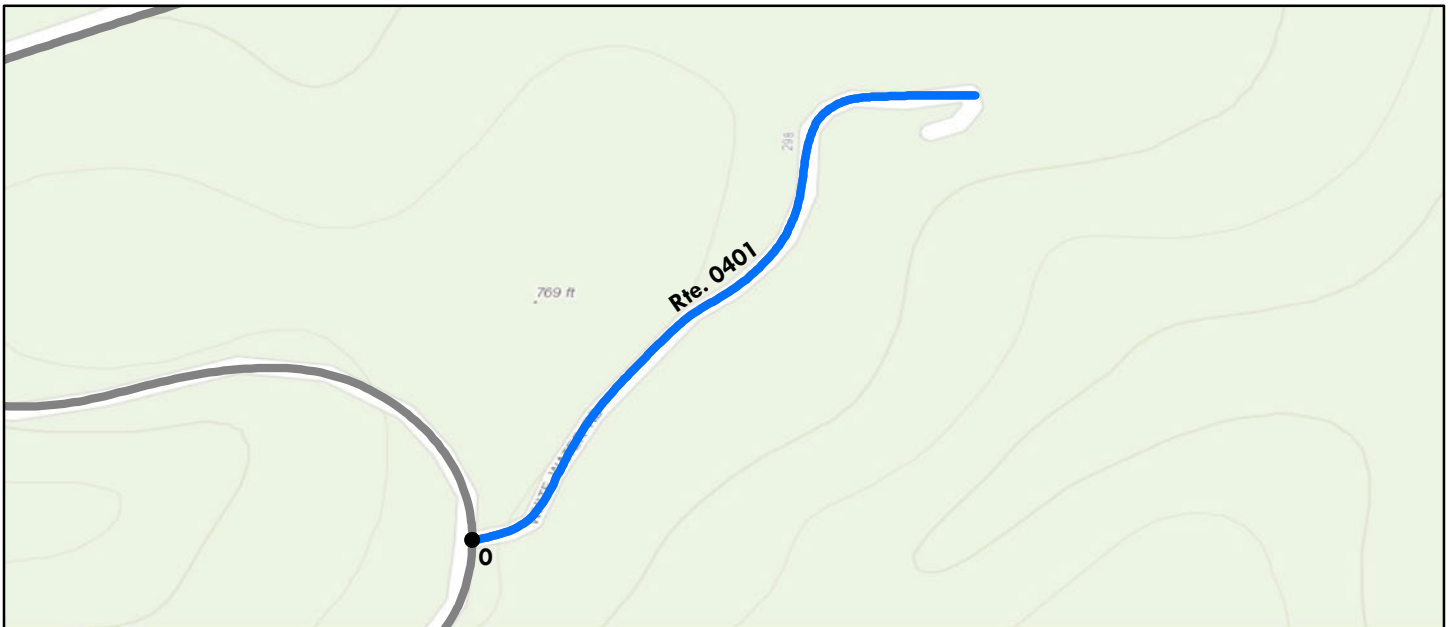
ROUTE 0401: TYLER BEND WASTEWATER TREATMENT PLANT ROAD

Inspection Date: 5/10/2019	Beginning Section MP	0				
Paved Length (Miles): 0.16	Section Length (MI)	0.16				
Surface Type: ASPHALT	Route Summary					
Roadway Condition Information						
Pavement Condition Rating (PCR)	97	97				
Surface Condition Rating (SCR)	97	97				
Roughness Condition Index (RCI)	N/A	N/A				
Distress Index Values						
Structural Crack Index	100	100				
Alligator Crack Index	100	100				
Longitudinal Crack Index	100	100				
Transverse Cracking Index	98	98				
Patching Index	100	100				
Rutting Index	97	97				
International Roughness Index (IRI)	N/A	N/A				
Lane & Width Information						
Number of Lanes	1	1				
Paved Width (ft)	13.3	13.3				
Lane Width (ft)	13.3	13.3

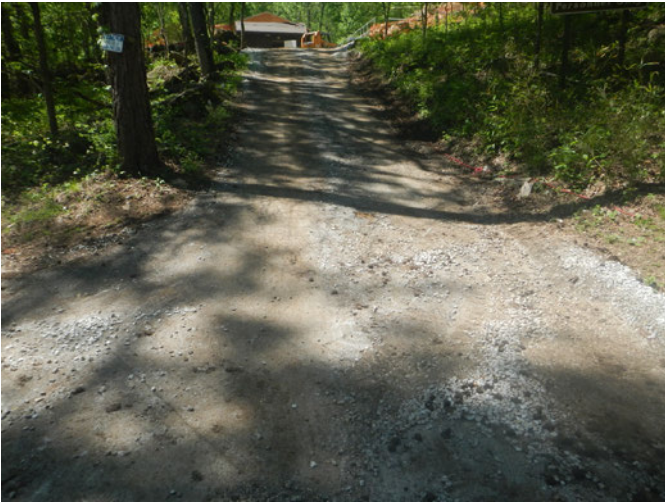
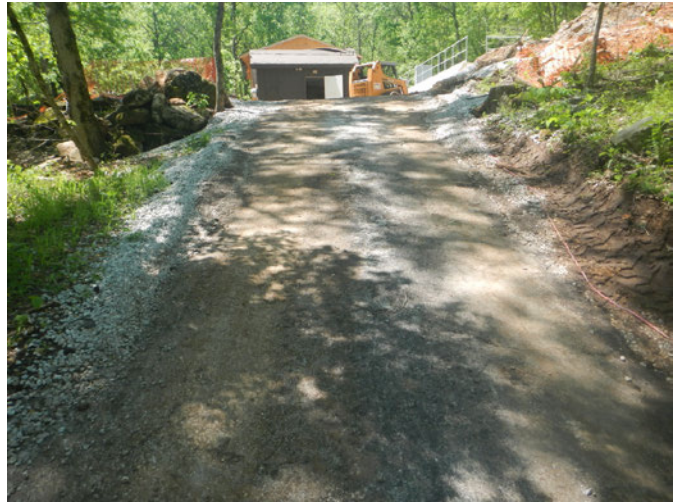
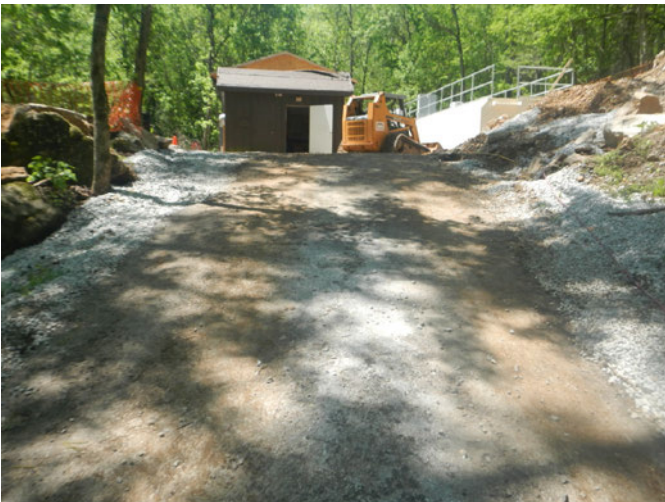
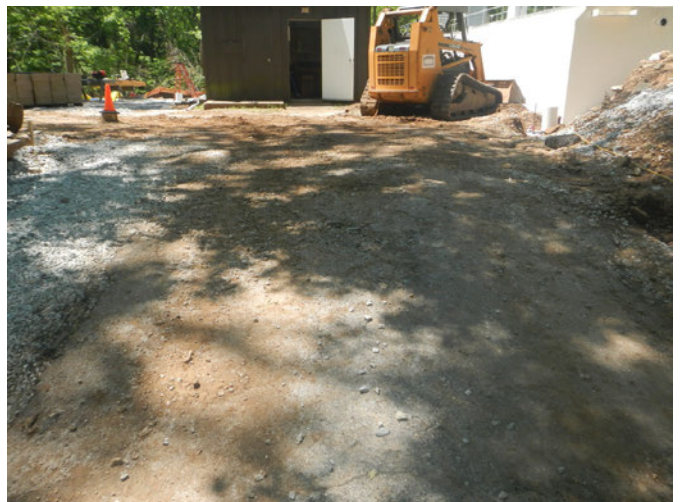
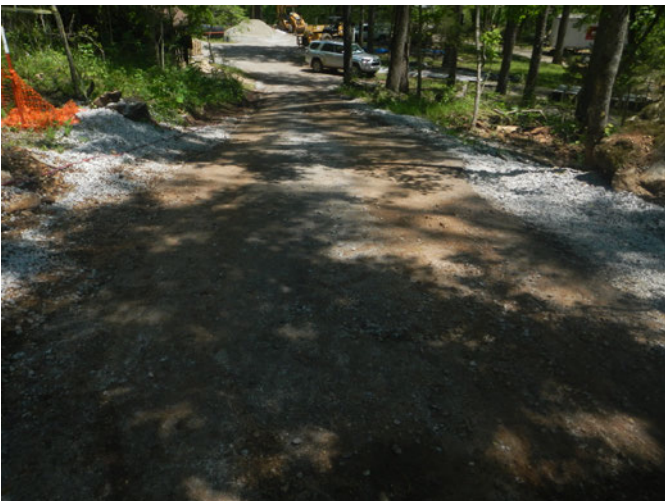
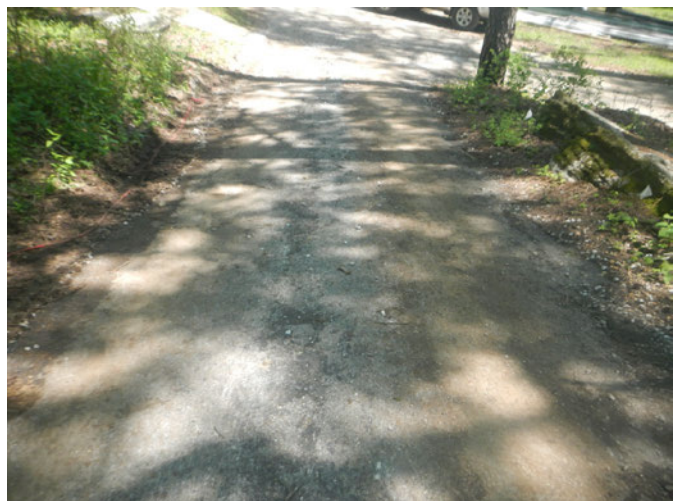
Condition Photos

Condition photos are shown only for manually rated roads. Use the PathView program to see images of DCV rated roads.

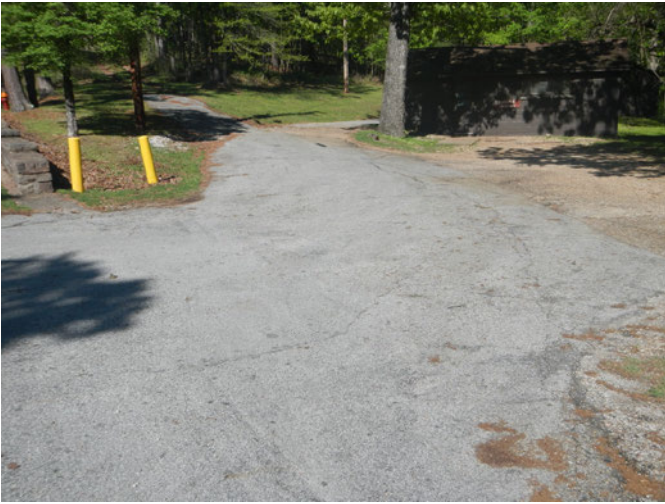
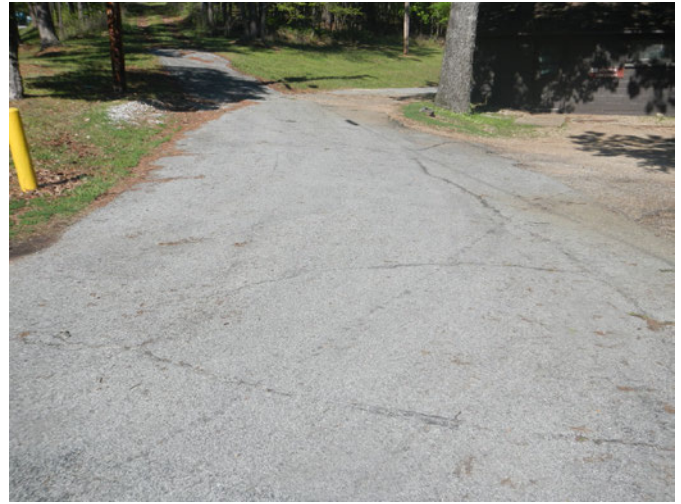
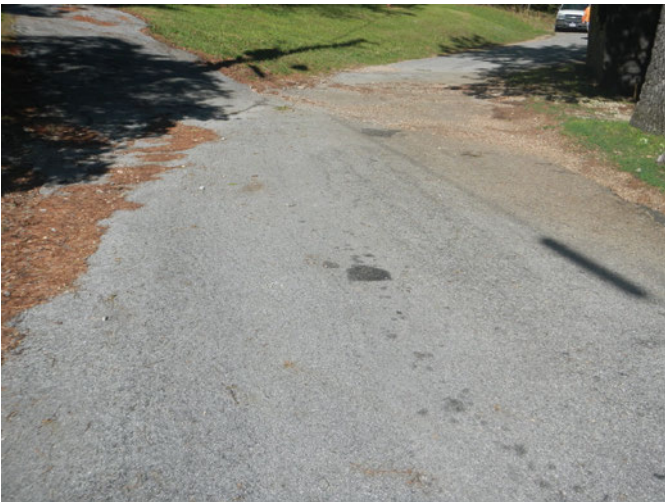
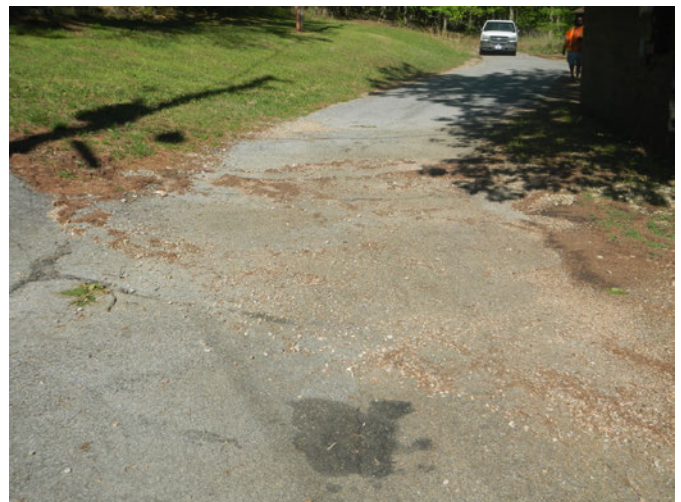
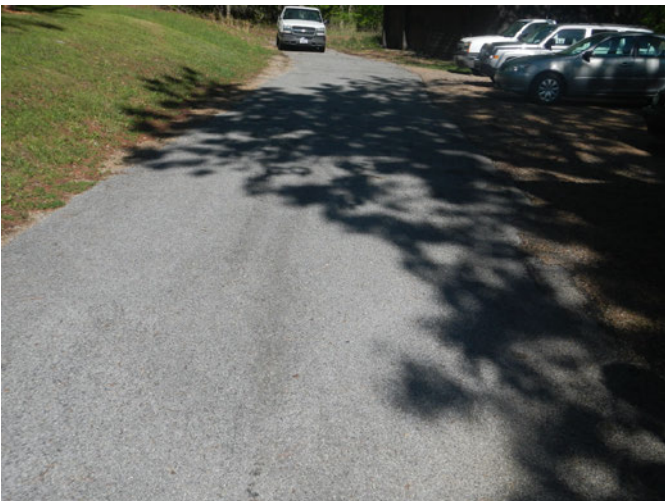
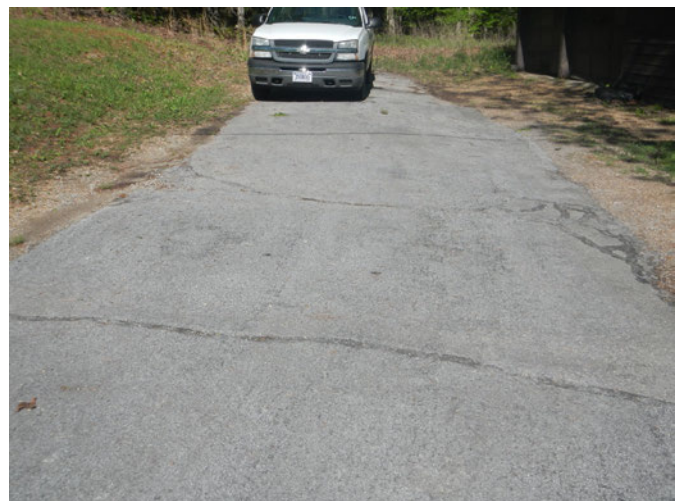
Condition Photos

Condition photos are shown only for manually rated roads. Use the PathView program to see images of DCV rated roads.

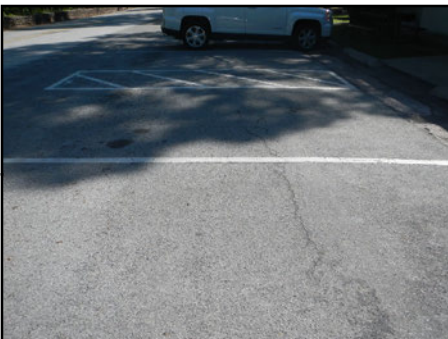
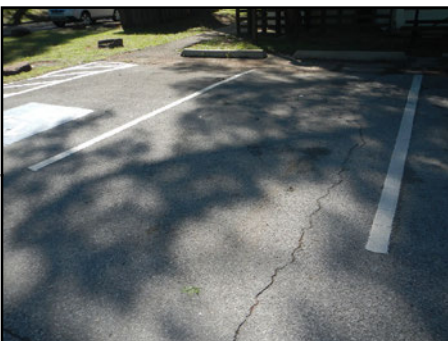
Inspection Date	FMSS Number	User Access	Surface Type
5/5/2018	101240	PUBLIC	ASPHALT
Area (Sq. Ft.)	Lane Miles (11' Widths)	Curb Reveal (Inches)	Curb Recommendation
1,912	0.033	NOT APPLICABLE	NOT APPLICABLE
Curb Type		Curb & Gutter Type	
NO CURB		NO CURB AND GUTTER	
Pavement Recommendation		Condition Rating / PCR	
LIGHT 3R TREATMENTS		FAIR / 73

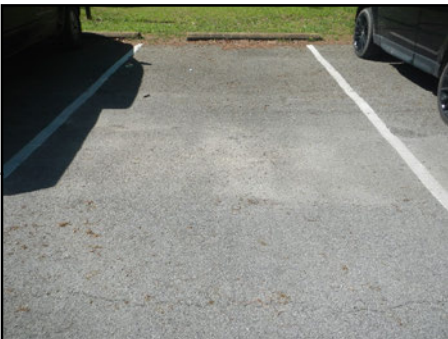
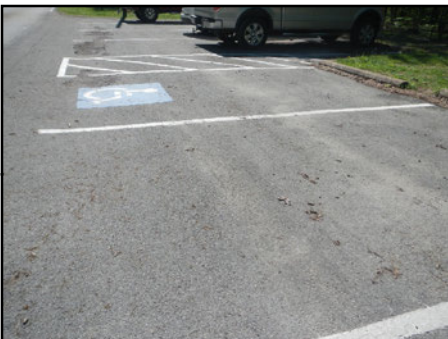
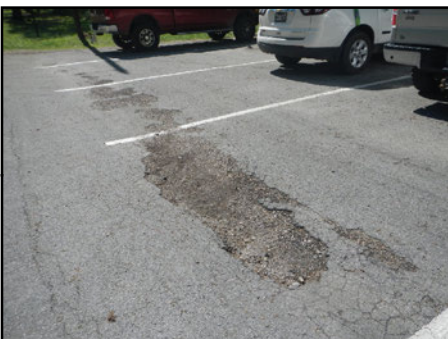
Inspection Date	FMSS Number	User Access	Surface Type
5/5/2018	101281	PUBLIC	ASPHALT
Area (Sq. Ft.)	Lane Miles (11' Widths)	Curb Reveal (Inches)	Curb Recommendation
2,985	0.051	NOT APPLICABLE	NOT APPLICABLE
Curb Type		Curb & Gutter Type	
NO CURB		NO CURB AND GUTTER	
Pavement Recommendation		Condition Rating / PCR	
LIGHT 3R TREATMENTS		FAIR / 73

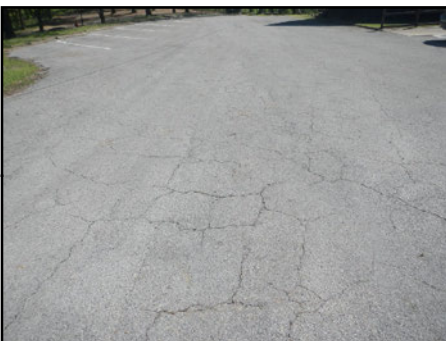
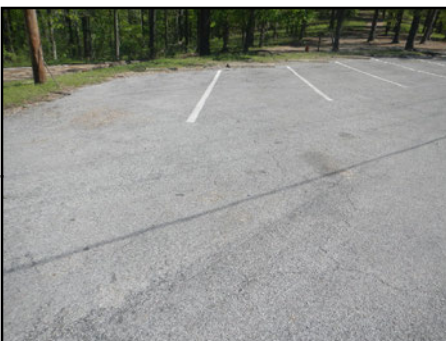
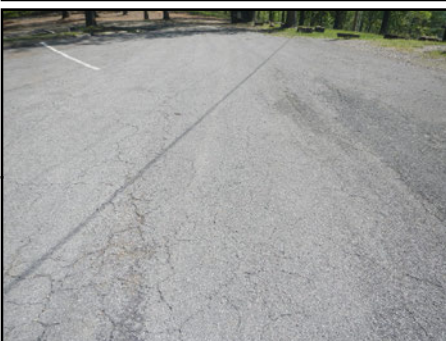
ROUTE 0902: BUFFALO POINT RESTAURANT PARKING

Inspection Date	FMSS Number	User Access	Surface Type
5/5/2018	101283	PUBLIC	ASPHALT
Area (Sq. Ft.)	Lane Miles (11' Widths)	Curb Reveal (Inches)	Curb Recommendation
7,380	0.127	3	DO NOTHING
Curb Type		Curb & Gutter Type	
CONCRETE		NO CURB AND GUTTER	
Pavement Recommendation		Condition Rating / PCR	
HEAVY 3R TREATMENTS		POOR / 53

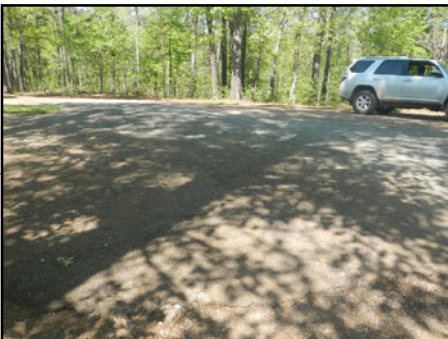
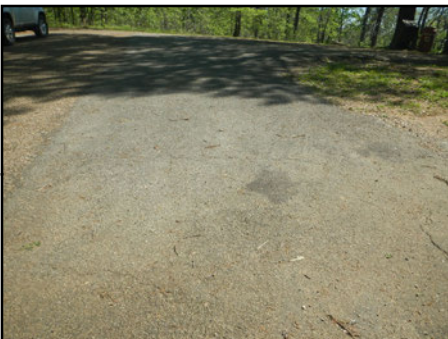
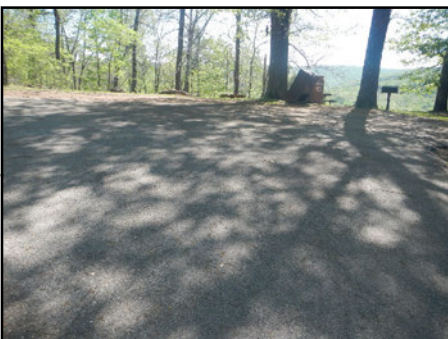
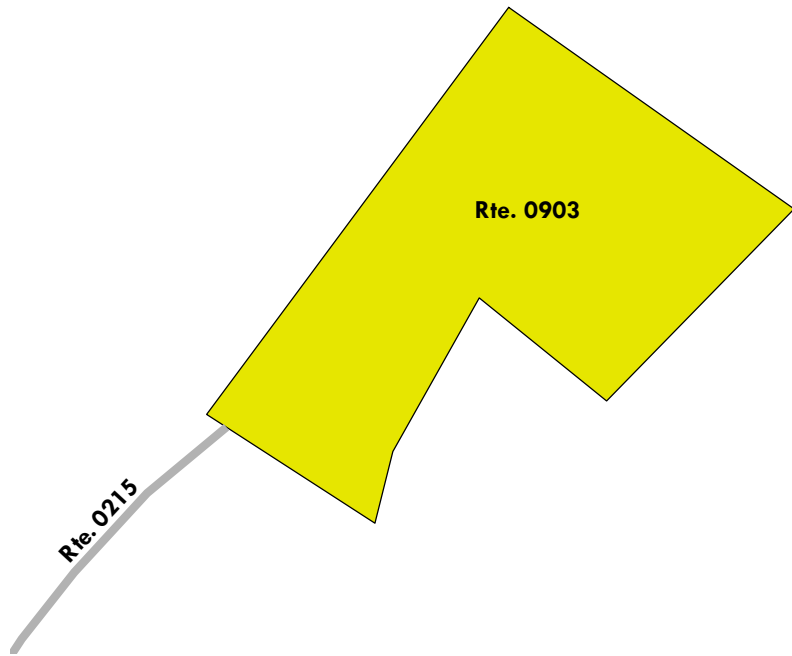
ROUTE 0903: CABIN 13 AND 14 PARKING

Inspection Date	FMSS Number	User Access	Surface Type
5/5/2018	101284	PUBLIC	ASPHALT
Area (Sq. Ft.)	Lane Miles (11' Widths)	Curb Reveal (Inches)	Curb Recommendation
1,703	0.029	NOT APPLICABLE	NOT APPLICABLE
Curb Type		Curb & Gutter Type	
NO CURB		NO CURB AND GUTTER	
Pavement Recommendation		Condition Rating / PCR	
LIGHT 3R TREATMENTS		FAIR / 73

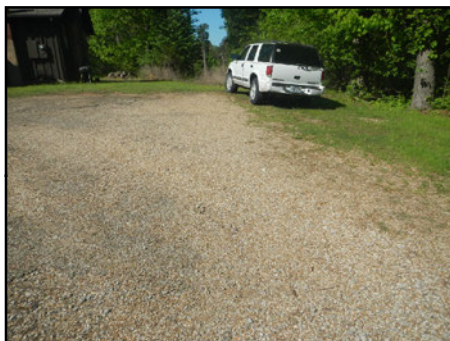
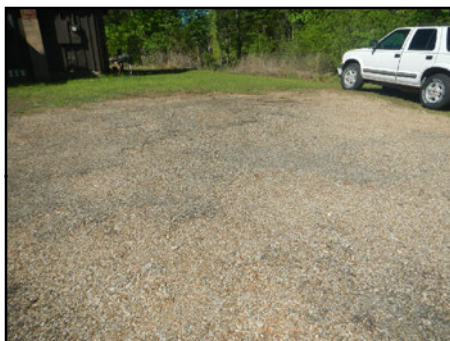
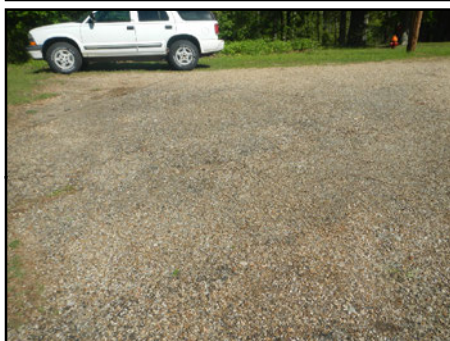
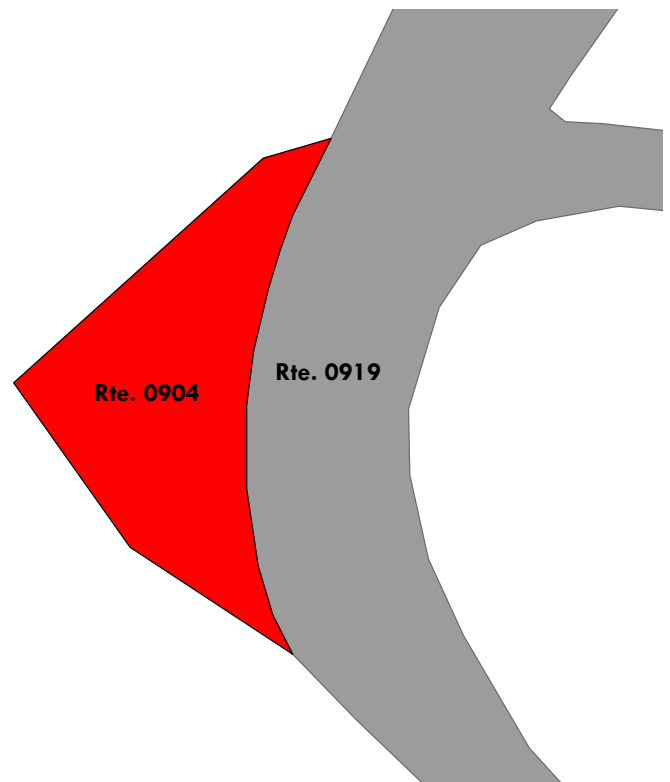
ROUTE 0904: CONCESSION OFFICE PARKING

ADJACENT TO ROUTE 0919 (CABIN OFFICE / RUSTIC CABINS 4 AND 5 PARKING AREA)

Inspection Date	FMSS Number	User Access	Surface Type
5/5/2018	101303	PUBLIC	ASPHALT
Area (Sq. Ft.)	Lane Miles (11' Widths)	Curb Reveal (Inches)	Curb Recommendation
951	0.016	NOT APPLICABLE	NOT APPLICABLE
Curb Type		Curb & Gutter Type	
NO CURB		NO CURB AND GUTTER	
Pavement Recommendation		Condition Rating / PCR	
RECONSTRUCTION		POOR / 0

Note: Almost no visible pavement to rate.

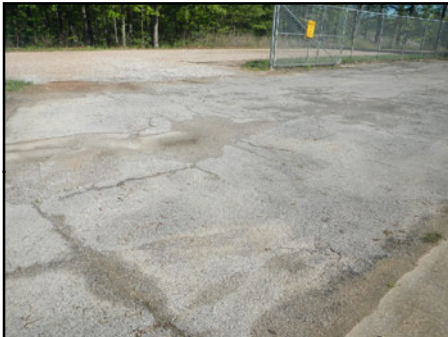
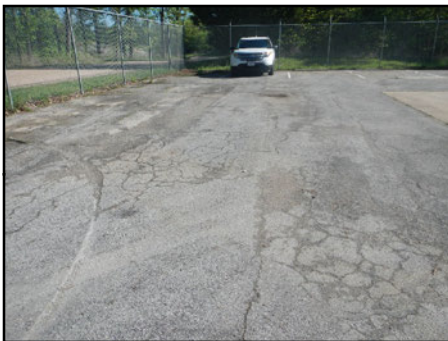
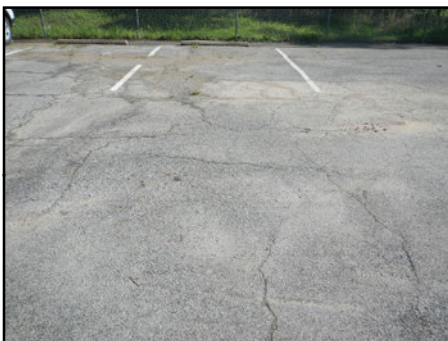
ROUTE 0905: FIRE CACHE PARKING

Inspection Date	FMSS Number	User Access	Surface Type
5/5/2018	101304	NONPUBLIC	ASPHALT
Area (Sq. Ft.)	Lane Miles (11' Widths)	Curb Reveal (Inches)	Curb Recommendation
13,787	0.237	NOT APPLICABLE	NOT APPLICABLE
Curb Type		Curb & Gutter Type	
NO CURB		NO CURB AND GUTTER	
Pavement Recommendation		Condition Rating / PCR	
RECONSTRUCTION		POOR / 30

Note: Parking area consists of multiple surface types: 1 part Asphalt at 11,683 square feet; 1 part Concrete at 2,104 square feet.

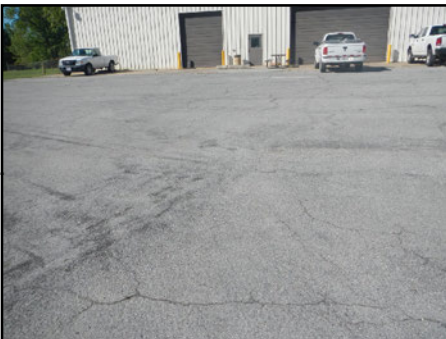
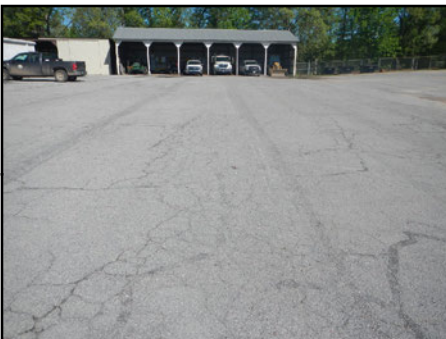
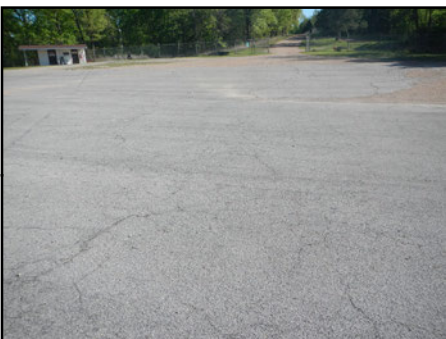
ROUTE 0906: BUFFALO POINT MAINTENANCE PARKING

Inspection Date	FMSS Number	User Access	Surface Type
5/5/2018	101305	NONPUBLIC	ASPHALT
Area (Sq. Ft.)	Lane Miles (11' Widths)	Curb Reveal (Inches)	Curb Recommendation
35,674	0.614	NOT APPLICABLE	NOT APPLICABLE
Curb Type		Curb & Gutter Type	
NO CURB		NO CURB AND GUTTER	
Pavement Recommendation		Condition Rating / PCR	
RECONSTRUCTION		POOR / 30

Note: Parking area consists of multiple surface types: 1 part Asphalt at 33,579 square feet; 1 part Concrete at 2,095 square feet.

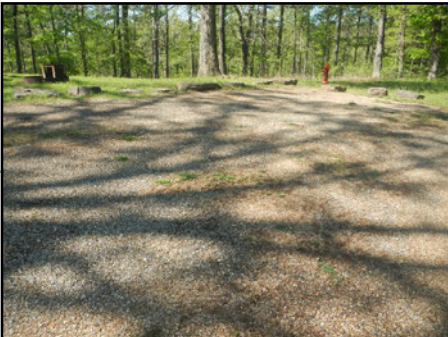
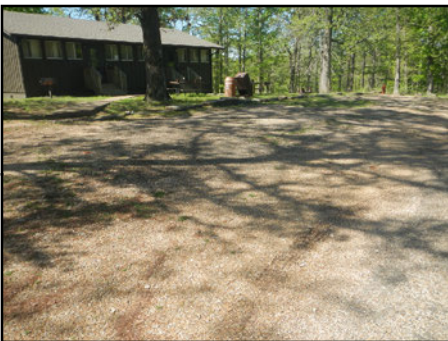
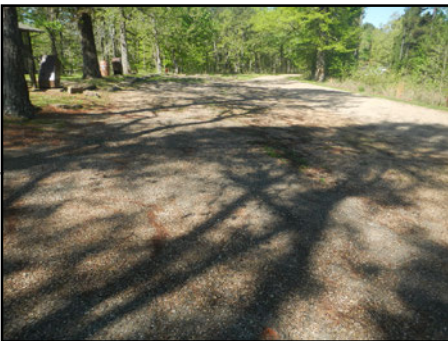
ROUTE 0907: MODERN CABINS PARKING A

Inspection Date	FMSS Number	User Access	Surface Type
5/5/2018	101306	PUBLIC	ASPHALT
Area (Sq. Ft.)	Lane Miles (11' Widths)	Curb Reveal (Inches)	Curb Recommendation
3,157	0.054	NOT APPLICABLE	NOT APPLICABLE
Curb Type		Curb & Gutter Type	
NO CURB		NO CURB AND GUTTER	
Pavement Recommendation		Condition Rating / PCR	
RECONSTRUCTION		POOR / 0

Note: Almost no visible pavement to rate.

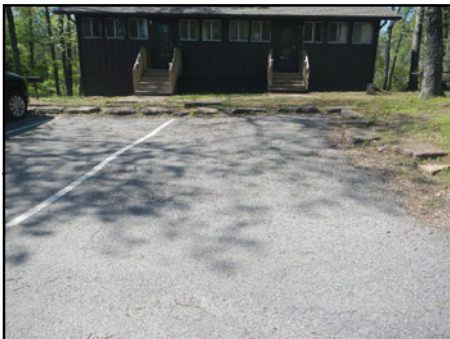
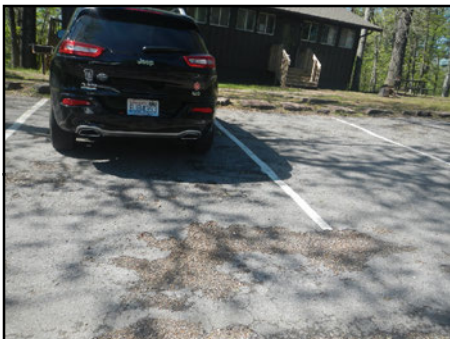
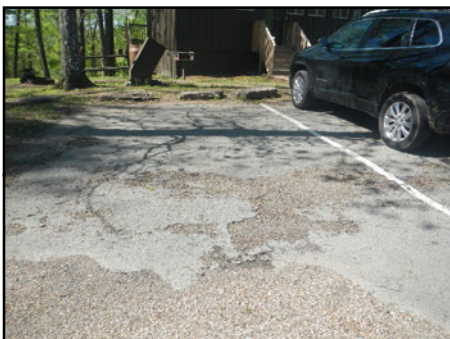
ROUTE 0908: MODERN CABINS PARKING B

Inspection Date	FMSS Number	User Access	Surface Type
5/5/2018	101307	PUBLIC	ASPHALT
Area (Sq. Ft.)	Lane Miles (11' Widths)	Curb Reveal (Inches)	Curb Recommendation
1,082	0.019	NOT APPLICABLE	NOT APPLICABLE
Curb Type		Curb & Gutter Type	
NO CURB		NO CURB AND GUTTER	
Pavement Recommendation		Condition Rating / PCR	
LIGHT 3R TREATMENTS		FAIR / 73

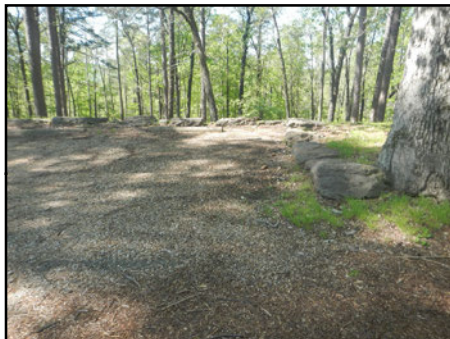
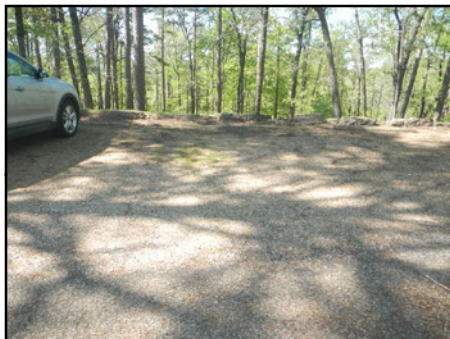
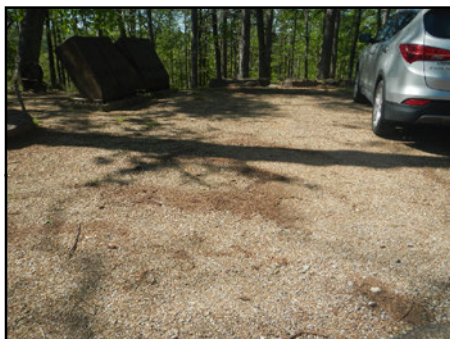
ROUTE 0909: MODERN CABINS PARKING C

Inspection Date	FMSS Number	User Access	Surface Type
5/5/2018	101308	PUBLIC	ASPHALT
Area (Sq. Ft.)	Lane Miles (11' Widths)	Curb Reveal (Inches)	Curb Recommendation
1,117	0.019	NOT APPLICABLE	NOT APPLICABLE
Curb Type		Curb & Gutter Type	
NO CURB		NO CURB AND GUTTER	
Pavement Recommendation		Condition Rating / PCR	
RECONSTRUCTION		POOR / 0

Note: Almost no visible pavement to rate.

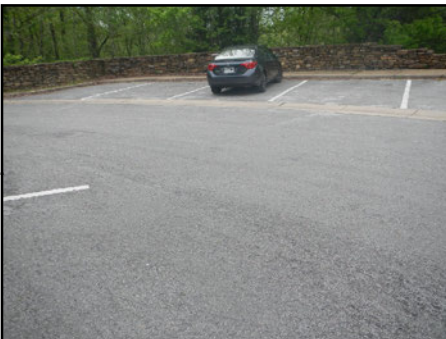
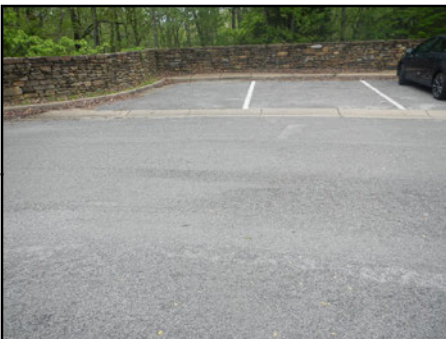
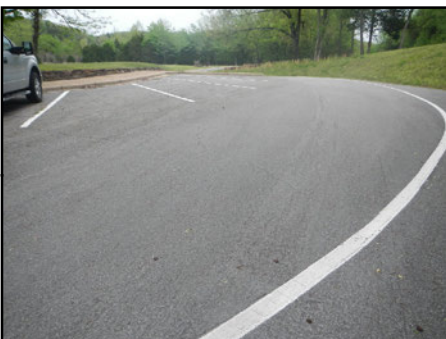
ROUTE 0913: TYLER BEND VISITOR CENTER PARKING

Inspection Date	FMSS Number	User Access	Surface Type
5/4/2018	101332	PUBLIC	ASPHALT
Area (Sq. Ft.)	Lane Miles (11' Widths)	Curb Reveal (Inches)	Curb Recommendation
14,513	0.25	NOT APPLICABLE	DO NOTHING
Curb Type		Curb & Gutter Type	
NO CURB		CONCRETE	
Pavement Recommendation		Condition Rating / PCR	
PREVENTIVE MAINTENANCE		GOOD / 90

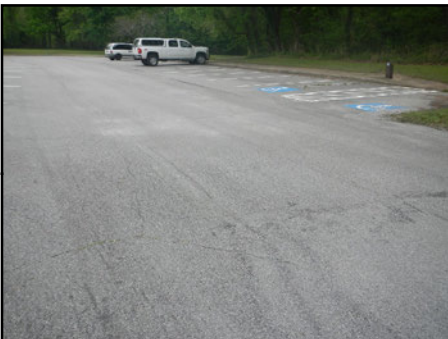
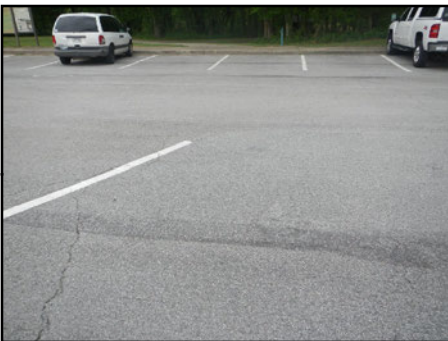
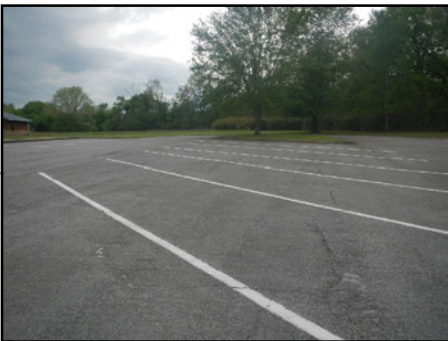
Inspection Date	FMSS Number	User Access	Surface Type
5/4/2018	101333	PUBLIC	ASPHALT
Area (Sq. Ft.)	Lane Miles (11' Widths)	Curb Reveal (Inches)	Curb Recommendation
58,592	1.009	NOT APPLICABLE	DO NOTHING
Curb Type		Curb & Gutter Type	
NO CURB		CONCRETE	
Pavement Recommendation		Condition Rating / PCR	
PREVENTIVE MAINTENANCE		GOOD / 90

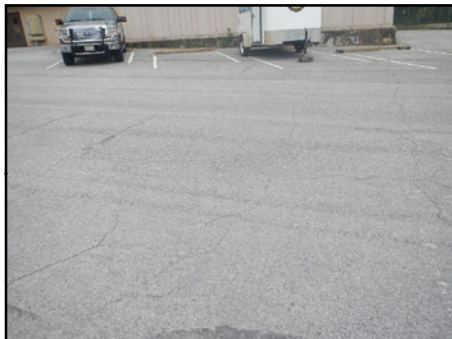
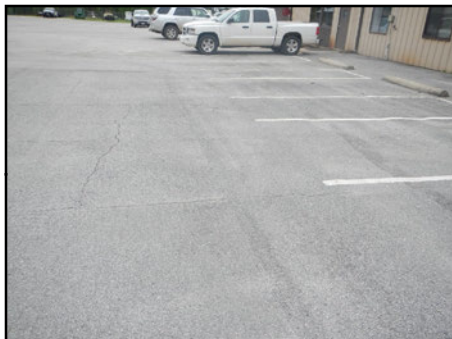
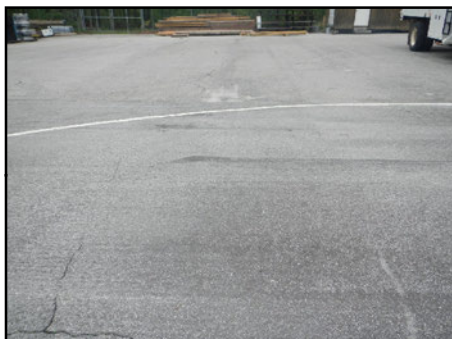
ROUTE 0915: TYLER BEND MAINTENANCE PARKING

Inspection Date	FMSS Number	User Access	Surface Type
5/4/2018	101334	NONPUBLIC	ASPHALT
Area (Sq. Ft.)	Lane Miles (11' Widths)	Curb Reveal (Inches)	Curb Recommendation
80,324	1.383	NOT APPLICABLE	NOT APPLICABLE
Curb Type		Curb & Gutter Type	
NO CURB		NO CURB AND GUTTER	
Pavement Recommendation		Condition Rating / PCR	
LIGHT 3R TREATMENTS		FAIR / 73

Note: Parking area consists of multiple surface types: 1 part Asphalt at 77,357 square feet; 4 parts Concrete at 2,967 square feet.

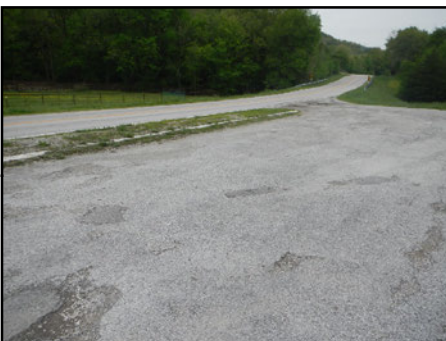
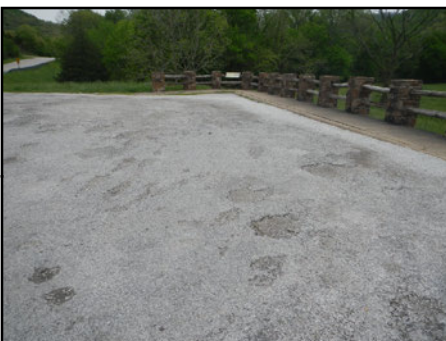
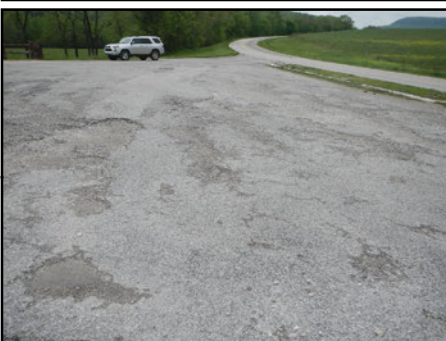
ROUTE 0916: BOXLEY VALLEY OVERLOOK PARKING

Inspection Date	FMSS Number	User Access	Surface Type
5/4/2018	101356	PUBLIC	ASPHALT
Area (Sq. Ft.)	Lane Miles (11' Widths)	Curb Reveal (Inches)	Curb Recommendation
8,065	0.139	4	DO NOTHING
Curb Type		Curb & Gutter Type	
CONCRETE		NO CURB AND GUTTER	
Pavement Recommendation		Condition Rating / PCR	
RECONSTRUCTION		POOR / 30

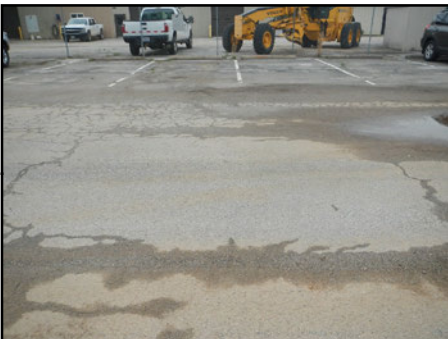
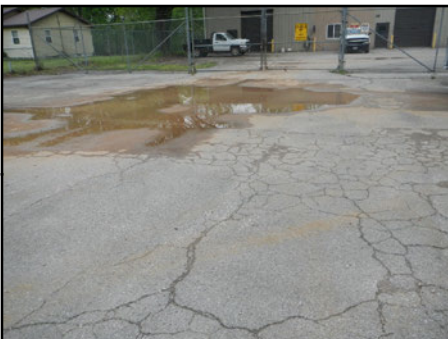
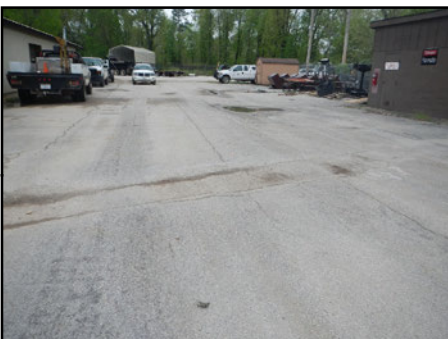
ROUTE 0917: PRUITT MAINTENANCE PARKING

Inspection Date	FMSS Number	User Access	Surface Type
5/4/2018	101357	NONPUBLIC	ASPHALT
Area (Sq. Ft.)	Lane Miles (11' Widths)	Curb Reveal (Inches)	Curb Recommendation
37,257	0.641	NOT APPLICABLE	NOT APPLICABLE
Curb Type		Curb & Gutter Type	
NO CURB		NO CURB AND GUTTER	
Pavement Recommendation		Condition Rating / PCR	
RECONSTRUCTION		POOR / 30

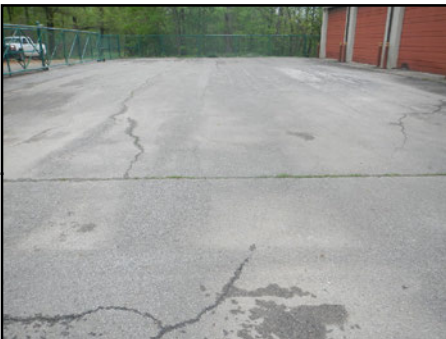
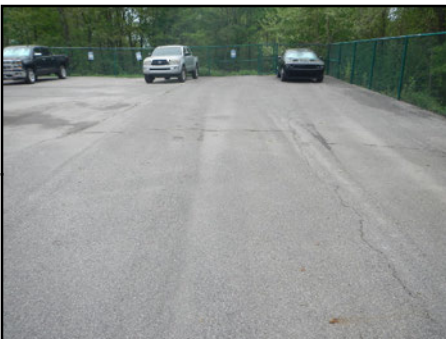
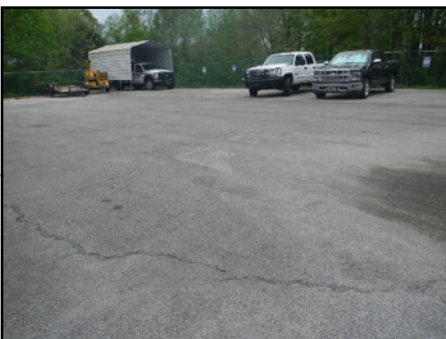
ROUTE 0918: PRUITT FIRE CACHE PARKING

Inspection Date	FMSS Number	User Access	Surface Type
5/4/2018	101358	NONPUBLIC	ASPHALT
Area (Sq. Ft.)	Lane Miles (11' Widths)	Curb Reveal (Inches)	Curb Recommendation
18,356	0.316	NOT APPLICABLE	NOT APPLICABLE
Curb Type		Curb & Gutter Type	
NO CURB		NO CURB AND GUTTER	
Pavement Recommendation		Condition Rating / PCR	
LIGHT 3R TREATMENTS		FAIR / 73
