BUFF Cycle 6

Final Report

Road Inventory and Condition Assessment of Paved Routes Buffalo National River

**Federal Highway Administration
Eastern Federal Lands Highway Division
Road Inventory Program (RIP)**

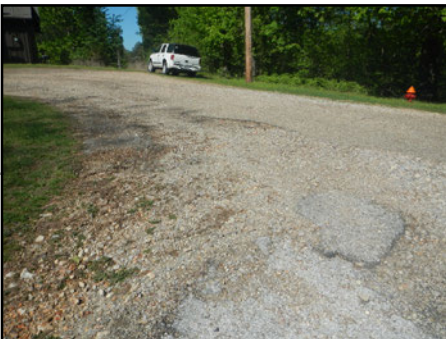
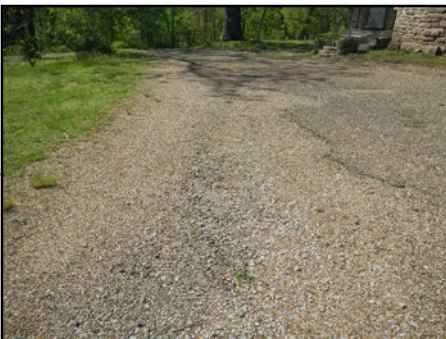
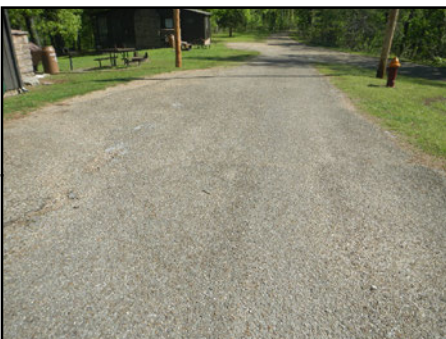
ROUTE 0919: CABIN OFFICE / RUSTIC CABINS 4 AND 5 PARKING AREA

Inspection Date	FMSS Number	User Access	Surface Type
5/5/2018	101309	PUBLIC	ASPHALT
Area (Sq. Ft.)	Lane Miles (11' Widths)	Curb Reveal (Inches)	Curb Recommendation
6,331	0.109	NOT APPLICABLE	NOT APPLICABLE
Curb Type		Curb & Gutter Type	
NO CURB		NO CURB AND GUTTER	
Pavement Recommendation		Condition Rating / PCR	
RECONSTRUCTION		POOR / 30

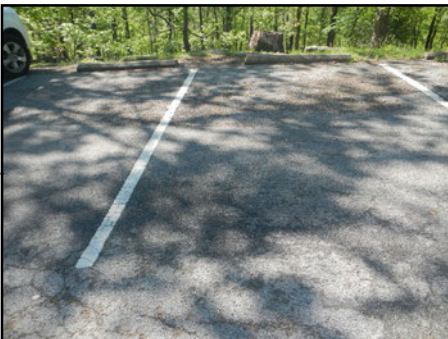
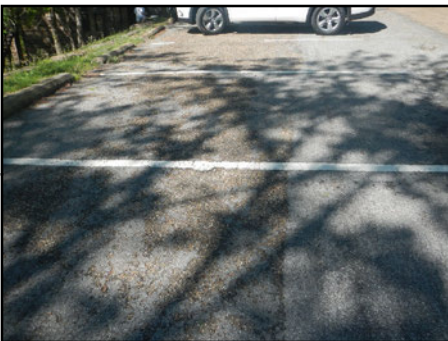
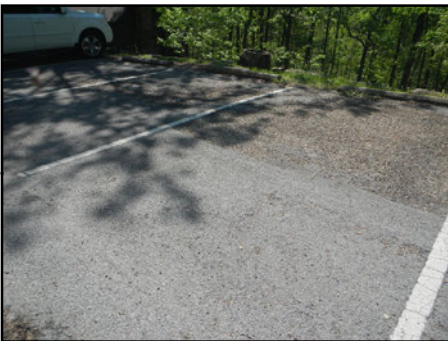
ROUTE 0920: RUSTIC CABINS 1, 2 AND 3 PARKING AREA

Inspection Date	FMSS Number	User Access	Surface Type
5/5/2018	101310	PUBLIC	ASPHALT
Area (Sq. Ft.)	Lane Miles (11' Widths)	Curb Reveal (Inches)	Curb Recommendation
1,763	0.03	NOT APPLICABLE	NOT APPLICABLE
Curb Type		Curb & Gutter Type	
NO CURB		NO CURB AND GUTTER	
Pavement Recommendation		Condition Rating / PCR	
LIGHT 3R TREATMENTS		FAIR / 73

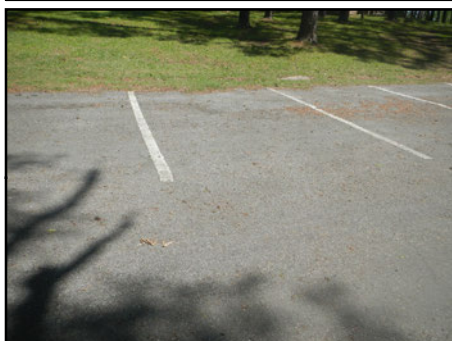
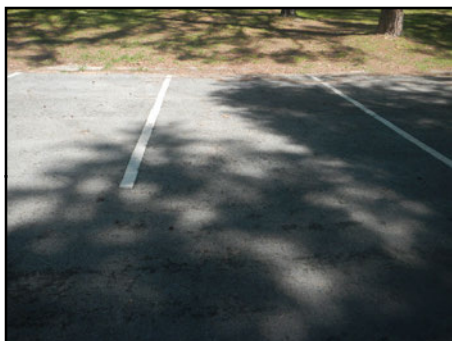
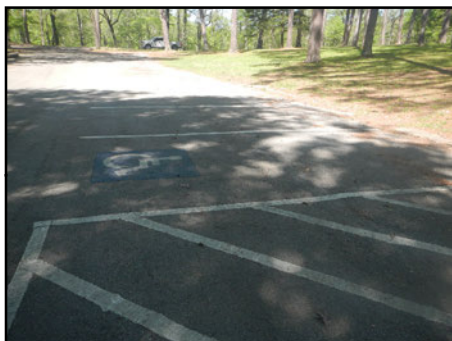
ROUTE 0921: GROUP 1, 2, 5 AND PAVILION PARKING AREA

Inspection Date	FMSS Number	User Access	Surface Type
5/5/2018	101311	PUBLIC	ASPHALT
Area (Sq. Ft.)	Lane Miles (11' Widths)	Curb Reveal (Inches)	Curb Recommendation
13,391	0.231	3	DO NOTHING
Curb Type		Curb & Gutter Type	
STONE		NO CURB AND GUTTER	
Pavement Recommendation		Condition Rating / PCR	
LIGHT 3R TREATMENTS		FAIR / 73

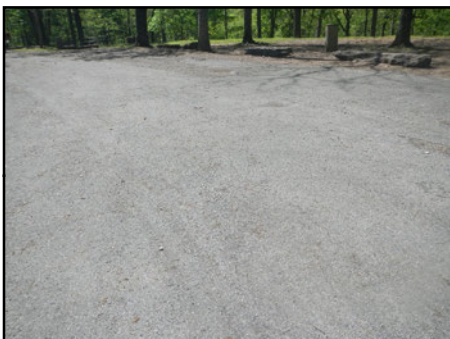
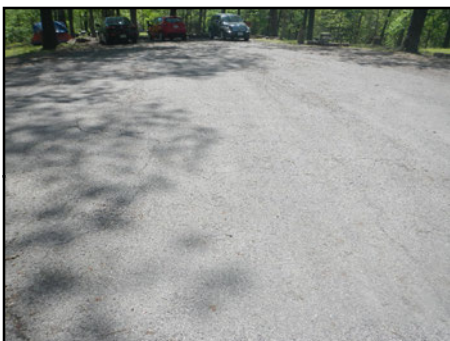
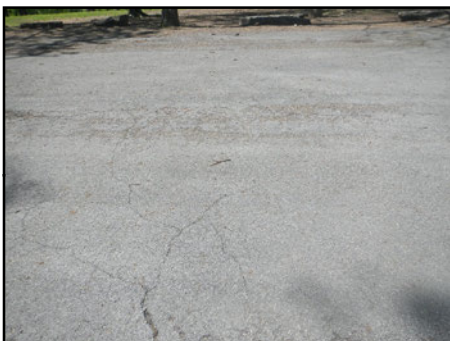
ROUTE 0922: GROUP 3 AND 4 PARKING AREA

Inspection Date	FMSS Number	User Access	Surface Type
5/5/2018	101312	PUBLIC	ASPHALT
Area (Sq. Ft.)	Lane Miles (11' Widths)	Curb Reveal (Inches)	Curb Recommendation
5,019	0.086	NOT APPLICABLE	NOT APPLICABLE
Curb Type		Curb & Gutter Type	
NO CURB		NO CURB AND GUTTER	
Pavement Recommendation		Condition Rating / PCR	
LIGHT 3R TREATMENTS		FAIR / 73

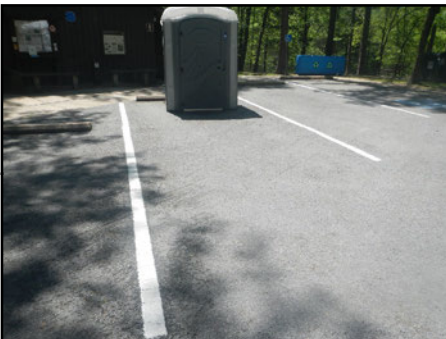
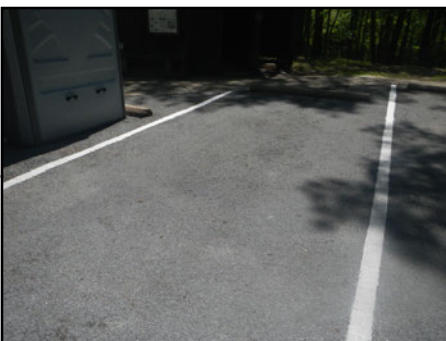
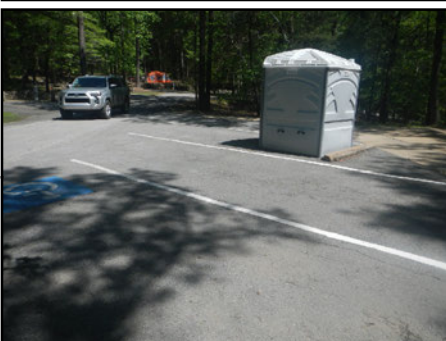
ROUTE 0923: BUFFALO POINT CAMPGROUND LOOP A BATHROOM PARKING

Inspection Date	FMSS Number	User Access	Surface Type
5/5/2018	101313	PUBLIC	ASPHALT
Area (Sq. Ft.)	Lane Miles (11' Widths)	Curb Reveal (Inches)	Curb Recommendation
1,029	0.018	NOT APPLICABLE	NOT APPLICABLE
Curb Type		Curb & Gutter Type	
NO CURB		NO CURB AND GUTTER	
Pavement Recommendation		Condition Rating / PCR	
PREVENTIVE MAINTENANCE		GOOD / 90

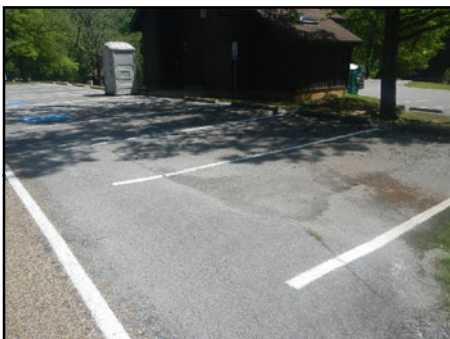
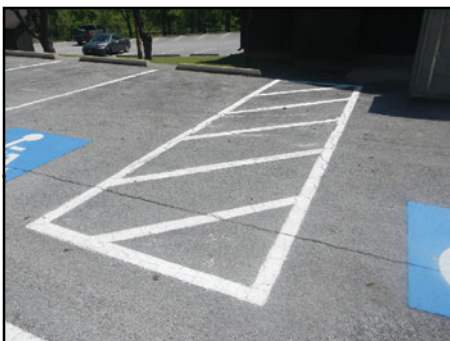
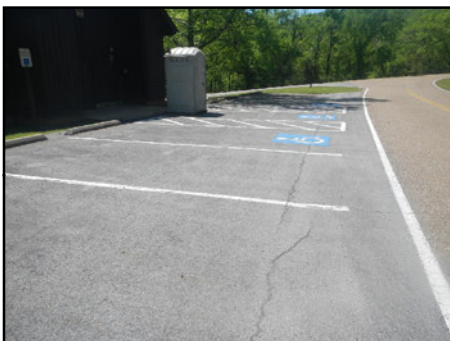
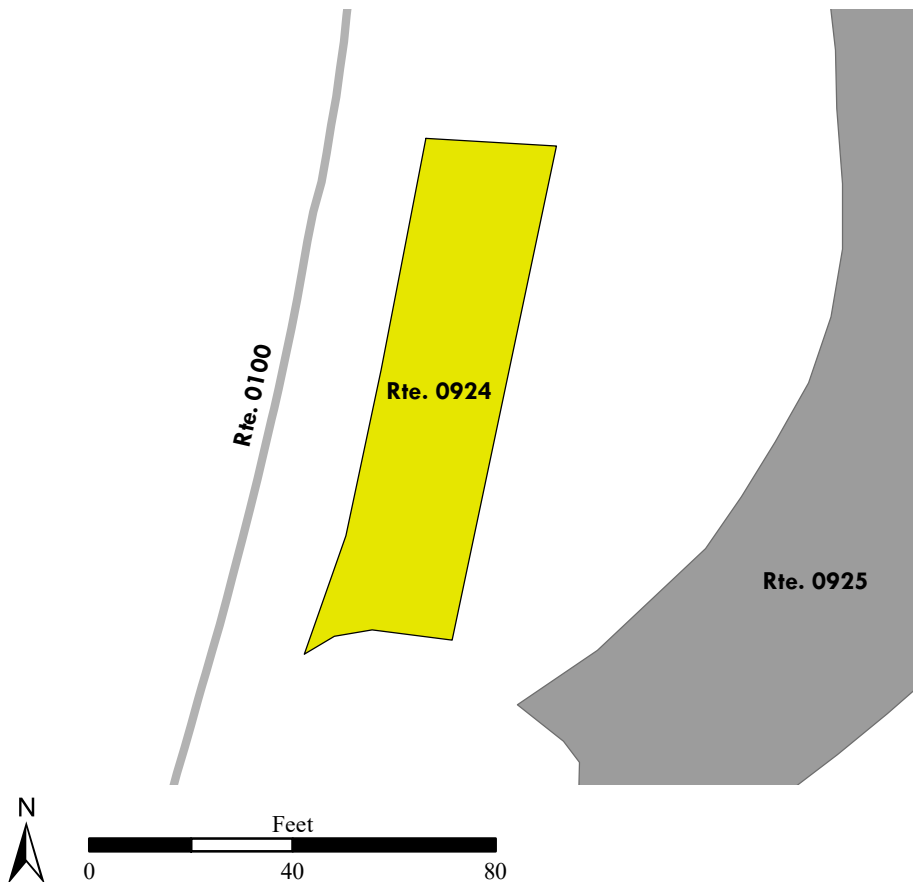
ROUTE 0925: BUFFALO POINT BOAT LAUNCH PARKING

Inspection Date	FMSS Number	User Access	Surface Type
5/5/2018	101322	PUBLIC	ASPHALT
Area (Sq. Ft.)	Lane Miles (11' Widths)	Curb Reveal (Inches)	Curb Recommendation
22,647	0.39	NOT APPLICABLE	NOT APPLICABLE
Curb Type		Curb & Gutter Type	
NO CURB		NO CURB AND GUTTER	
Pavement Recommendation		Condition Rating / PCR	
LIGHT 3R TREATMENTS		FAIR / 73

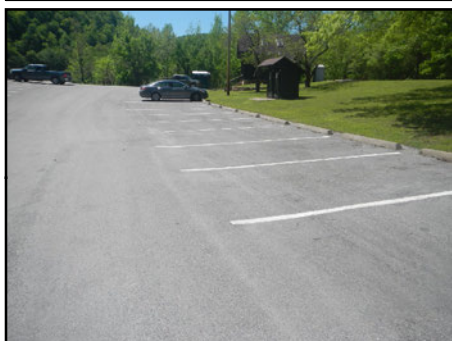
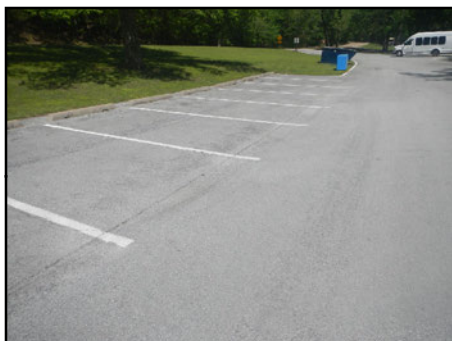
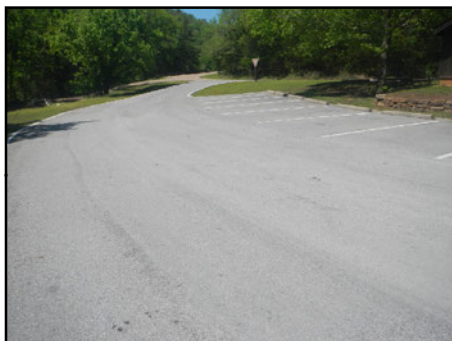
ROUTE 0926: BUFFALO POINT CAMPGROUND LOOP B BATHROOM PARKING

Inspection Date	FMSS Number	User Access	Surface Type
5/5/2018	101323	PUBLIC	ASPHALT
Area (Sq. Ft.)	Lane Miles (11' Widths)	Curb Reveal (Inches)	Curb Recommendation
1,593	0.027	NOT APPLICABLE	NOT APPLICABLE
Curb Type		Curb & Gutter Type	
NO CURB		NO CURB AND GUTTER	
Pavement Recommendation		Condition Rating / PCR	
PREVENTIVE MAINTENANCE		GOOD / 90

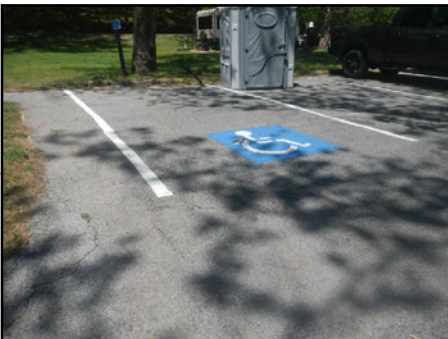
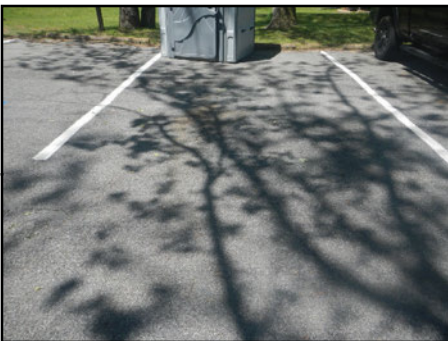
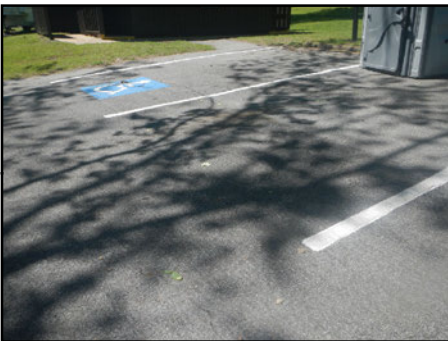
ROUTE 0927: BUFFALO POINT PAVILION 2 PARKING

Inspection Date	FMSS Number	User Access	Surface Type
5/5/2018	101325	PUBLIC	ASPHALT
Area (Sq. Ft.)	Lane Miles (11' Widths)	Curb Reveal (Inches)	Curb Recommendation
8,942	0.154	NOT APPLICABLE	NOT APPLICABLE
Curb Type		Curb & Gutter Type	
NO CURB		NO CURB AND GUTTER	
Pavement Recommendation		Condition Rating / PCR	
RECONSTRUCTION		POOR / 0

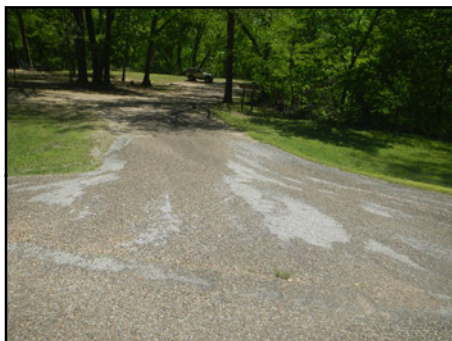
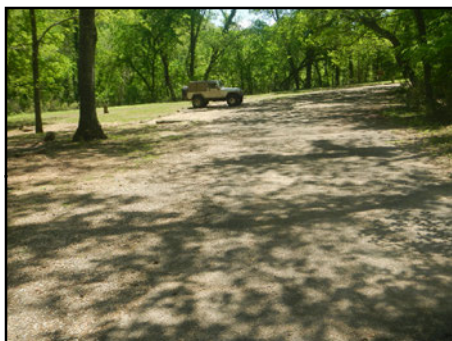
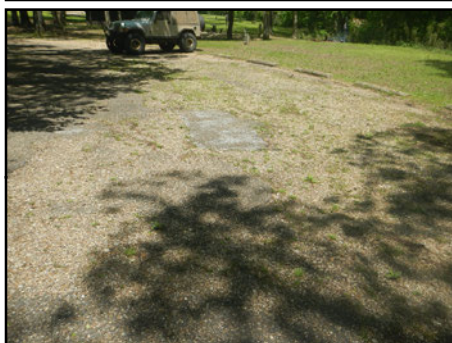
ROUTE 0928: BUFFALO POINT INFORMATION PARKING

Inspection Date	FMSS Number	User Access	Surface Type
5/5/2018	101328	PUBLIC	ASPHALT
Area (Sq. Ft.)	Lane Miles (11' Widths)	Curb Reveal (Inches)	Curb Recommendation
1,777	0.031	NOT APPLICABLE	NOT APPLICABLE
Curb Type		Curb & Gutter Type	
NO CURB		NO CURB AND GUTTER	
Pavement Recommendation		Condition Rating / PCR	
LIGHT 3R TREATMENTS		FAIR / 73

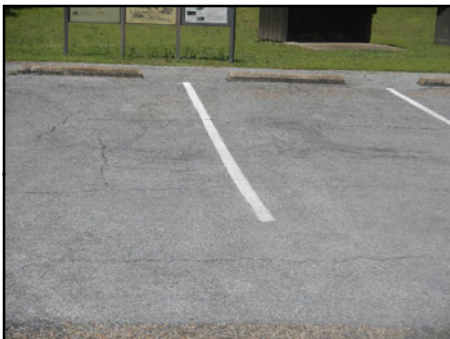
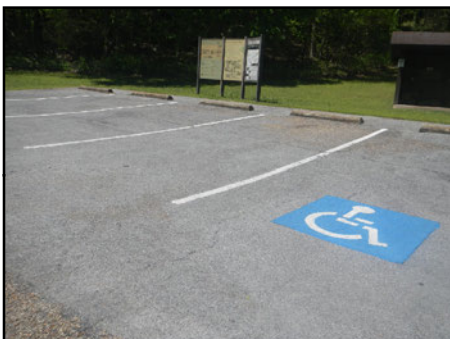
ROUTE 0929: BUFFALO POINT TENT CAMPING PARKING

Inspection Date	FMSS Number	User Access	Surface Type
5/5/2018	101329	PUBLIC	ASPHALT
Area (Sq. Ft.)	Lane Miles (11' Widths)	Curb Reveal (Inches)	Curb Recommendation
13,427	0.231	NOT APPLICABLE	NOT APPLICABLE
Curb Type		Curb & Gutter Type	
NO CURB		NO CURB AND GUTTER	
Pavement Recommendation		Condition Rating / PCR	
RECONSTRUCTION		POOR / 0

Note: No pavement to rate, currently gravel.

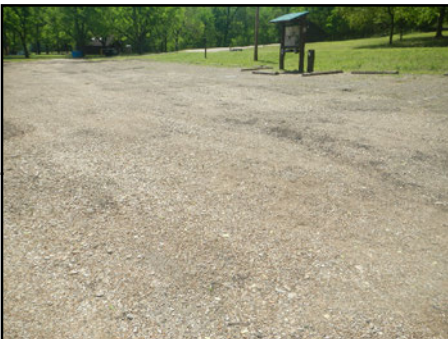
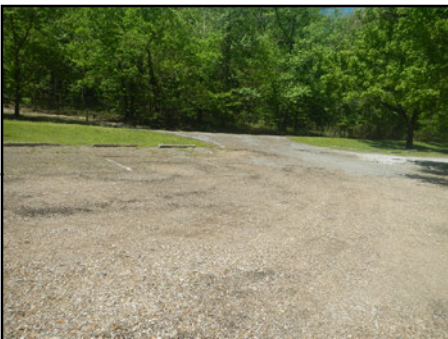
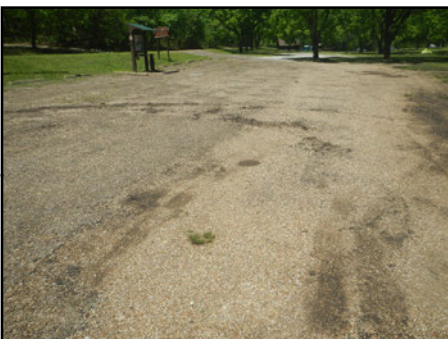
ROUTE 0930: BUFFALO POINT PAVILION 3 PARKING

Inspection Date	FMSS Number	User Access	Surface Type
5/5/2018	101330	PUBLIC	ASPHALT
Area (Sq. Ft.)	Lane Miles (11' Widths)	Curb Reveal (Inches)	Curb Recommendation
11,773	0.203	NOT APPLICABLE	NOT APPLICABLE
Curb Type		Curb & Gutter Type	
NO CURB		NO CURB AND GUTTER	
Pavement Recommendation		Condition Rating / PCR	
PREVENTIVE MAINTENANCE		GOOD / 90

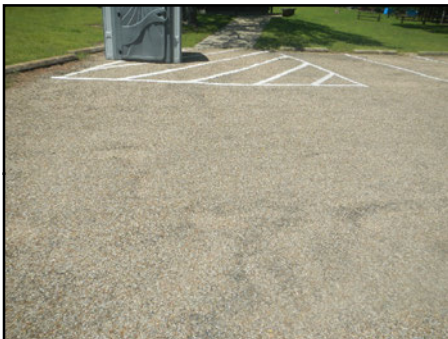
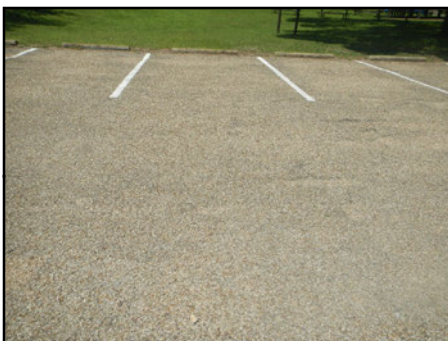
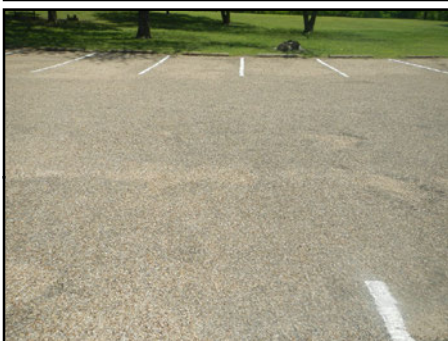
ROUTE 0931: BUFFALO POINT LOOP D BATHROOM AND FEE STATION PARKING

Inspection Date	FMSS Number	User Access	Surface Type
5/5/2018	101331	PUBLIC	ASPHALT
Area (Sq. Ft.)	Lane Miles (11' Widths)	Curb Reveal (Inches)	Curb Recommendation
825	0.014	NOT APPLICABLE	NOT APPLICABLE
Curb Type		Curb & Gutter Type	
NO CURB		NO CURB AND GUTTER	
Pavement Recommendation		Condition Rating / PCR	
PREVENTIVE MAINTENANCE		GOOD / 90

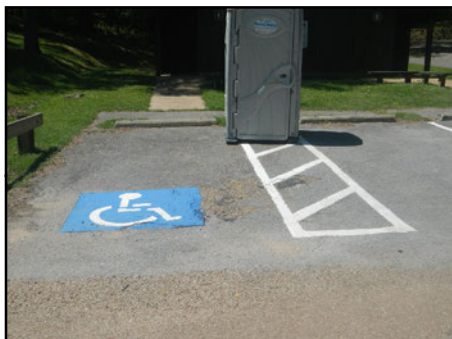
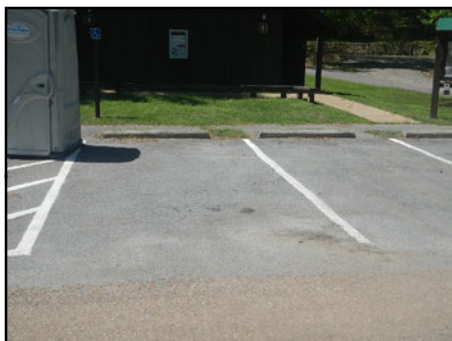
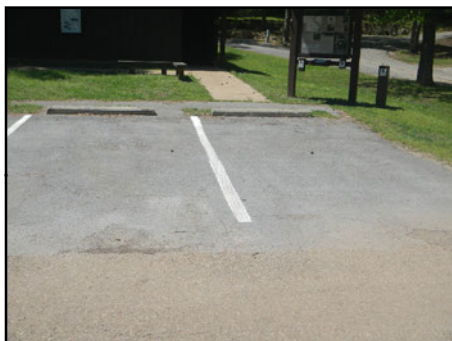
ROUTE 0932: TYLER BEND MAINTENANCE DUMPSTER PARKING

Inspection Date	FMSS Number	User Access	Surface Type
5/4/2018	101335	NONPUBLIC	ASPHALT
Area (Sq. Ft.)	Lane Miles (11' Widths)	Curb Reveal (Inches)	Curb Recommendation
9,153	0.158	NOT APPLICABLE	NOT APPLICABLE
Curb Type		Curb & Gutter Type	
NO CURB		NO CURB AND GUTTER	
Pavement Recommendation		Condition Rating / PCR	
RECONSTRUCTION		POOR / 30

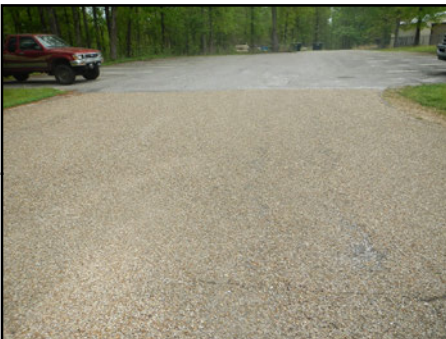
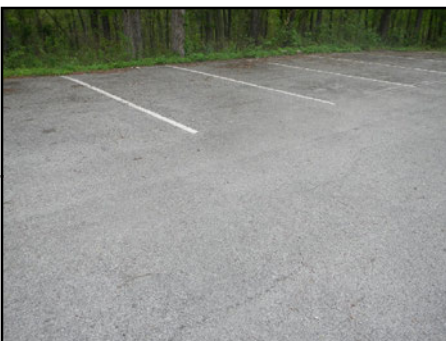
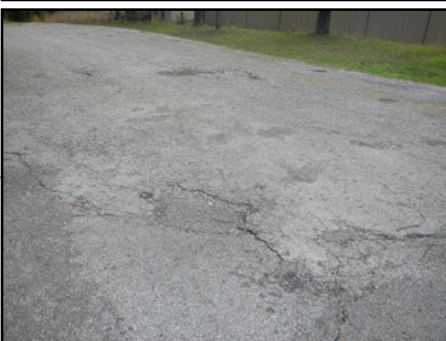
ROUTE 0933: TYLER BEND ADMINISTRATIVE PARKING

Inspection Date	FMSS Number	User Access	Surface Type
5/4/2018	101336	NONPUBLIC	ASPHALT
Area (Sq. Ft.)	Lane Miles (11' Widths)	Curb Reveal (Inches)	Curb Recommendation
4,626	0.08	NOT APPLICABLE	NOT APPLICABLE
Curb Type		Curb & Gutter Type	
NO CURB		NO CURB AND GUTTER	
Pavement Recommendation		Condition Rating / PCR	
PREVENTIVE MAINTENANCE		GOOD / 90

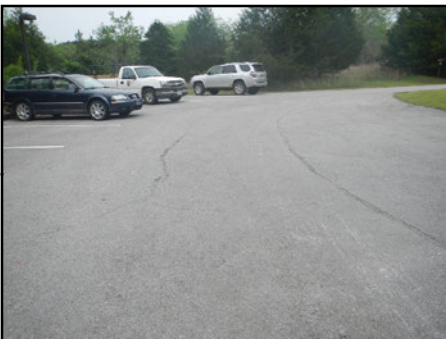
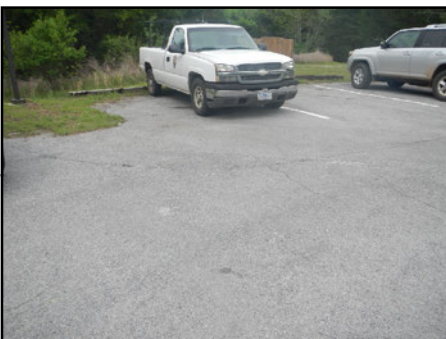
ROUTE 0934: TYLER BEND UPPER AMPHITHEATHER PARKING

Inspection Date	FMSS Number	User Access	Surface Type
5/4/2018	101337	PUBLIC	ASPHALT
Area (Sq. Ft.)	Lane Miles (11' Widths)	Curb Reveal (Inches)	Curb Recommendation
5,287	0.091	5	DO NOTHING
Curb Type		Curb & Gutter Type	
STONE		NO CURB AND GUTTER	
Pavement Recommendation		Condition Rating / PCR	
PREVENTIVE MAINTENANCE		GOOD / 90

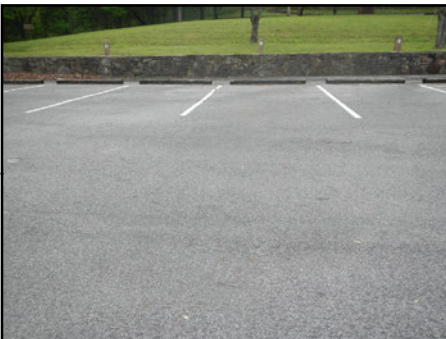
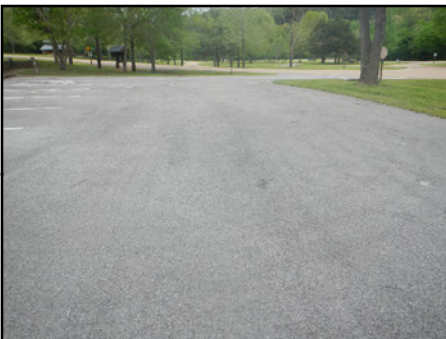
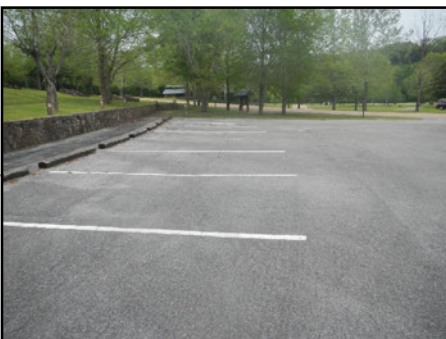
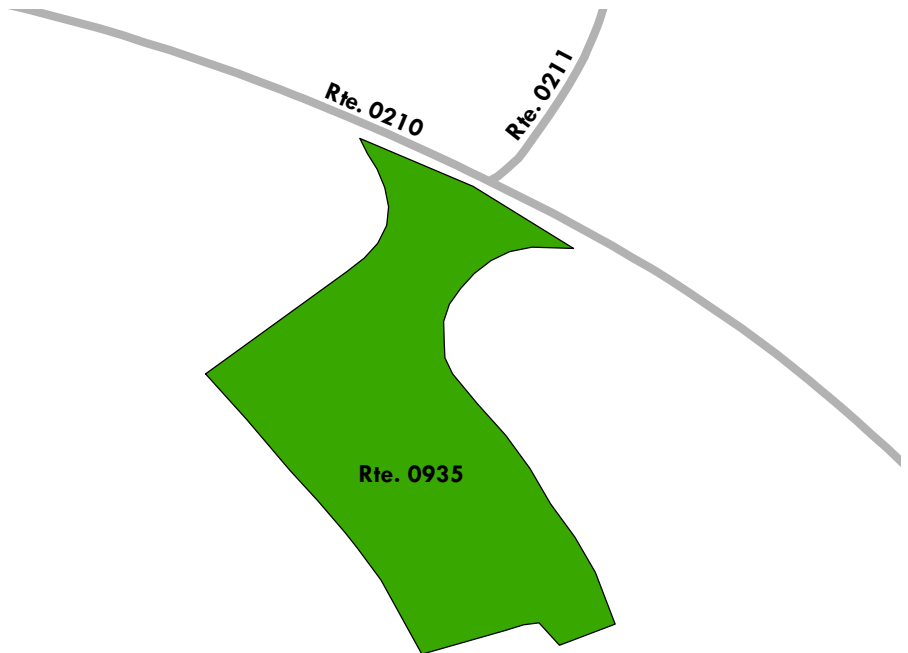
ROUTE 0935: TYLER BEND LOWER AMPHITHEATER PARKING

Inspection Date	FMSS Number	User Access	Surface Type
5/4/2018	101338	PUBLIC	ASPHALT
Area (Sq. Ft.)	Lane Miles (11' Widths)	Curb Reveal (Inches)	Curb Recommendation
6,775	0.117	NOT APPLICABLE	NOT APPLICABLE
Curb Type		Curb & Gutter Type	
NO CURB		NO CURB AND GUTTER	
Pavement Recommendation		Condition Rating / PCR	
PREVENTIVE MAINTENANCE		GOOD / 90

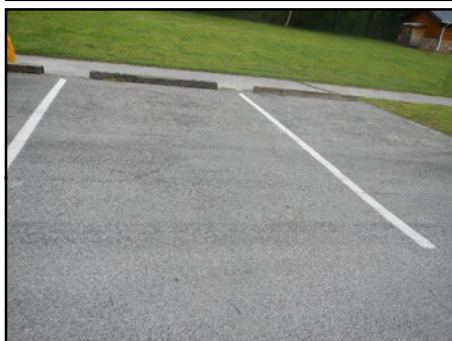
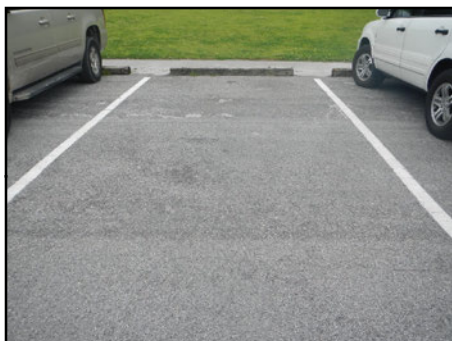
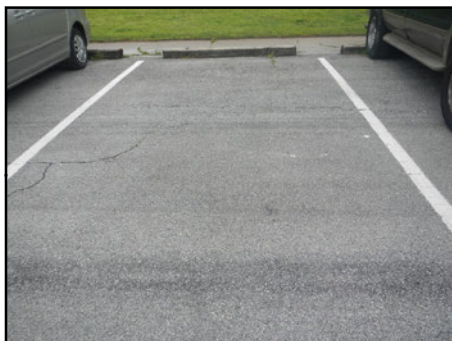
ROUTE 0936: TYLER BEND GROUP CAMPSITE PARKING A

Inspection Date	FMSS Number	User Access	Surface Type
5/4/2018	101339	PUBLIC	ASPHALT
Area (Sq. Ft.)	Lane Miles (11' Widths)	Curb Reveal (Inches)	Curb Recommendation
4,020	0.069	NOT APPLICABLE	NOT APPLICABLE
Curb Type		Curb & Gutter Type	
NO CURB		NO CURB AND GUTTER	
Pavement Recommendation		Condition Rating / PCR	
LIGHT 3R TREATMENTS		FAIR / 73

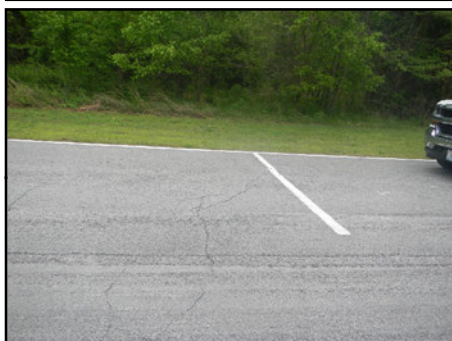
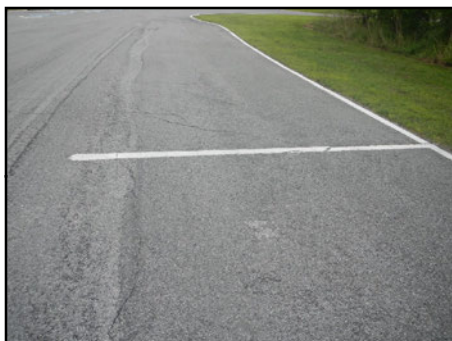
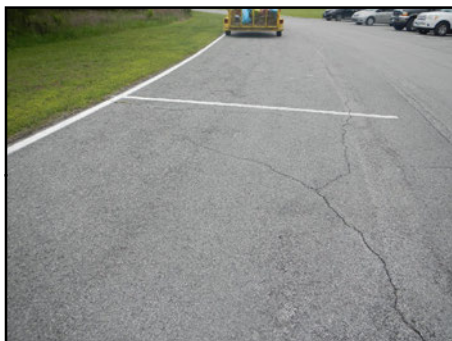
ROUTE 0937: TYLER BEND GROUP CAMPSITE PARKING B

Inspection Date	FMSS Number	User Access	Surface Type
5/4/2018	101341	PUBLIC	ASPHALT
Area (Sq. Ft.)	Lane Miles (11' Widths)	Curb Reveal (Inches)	Curb Recommendation
2,375	0.041	NOT APPLICABLE	NOT APPLICABLE
Curb Type		Curb & Gutter Type	
NO CURB		NO CURB AND GUTTER	
Pavement Recommendation		Condition Rating / PCR	
LIGHT 3R TREATMENTS		FAIR / 73

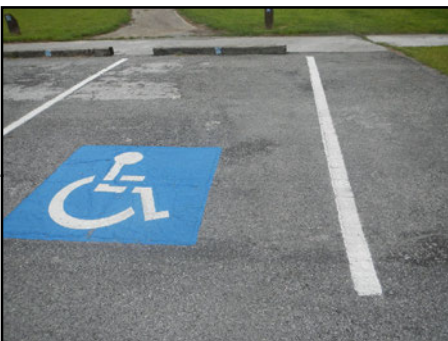
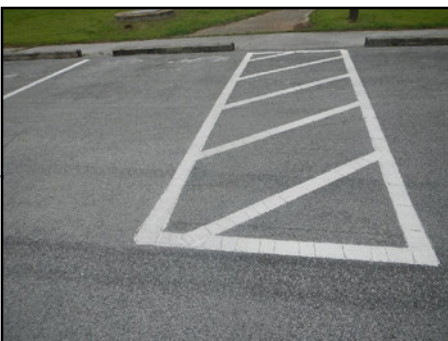
ROUTE 0938: TYLER BEND GROUP CAMPSITE PARKING C

Inspection Date	FMSS Number	User Access	Surface Type
5/4/2018	101342	PUBLIC	ASPHALT
Area (Sq. Ft.)	Lane Miles (11' Widths)	Curb Reveal (Inches)	Curb Recommendation
1,920	0.033	NOT APPLICABLE	NOT APPLICABLE
Curb Type		Curb & Gutter Type	
NO CURB		NO CURB AND GUTTER	
Pavement Recommendation		Condition Rating / PCR	
LIGHT 3R TREATMENTS		FAIR / 73

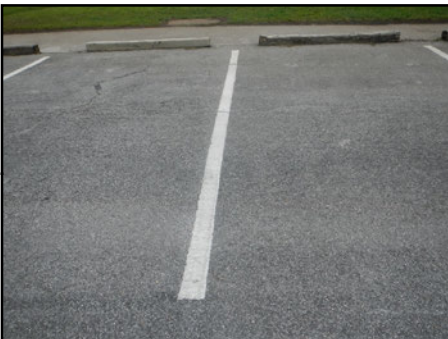
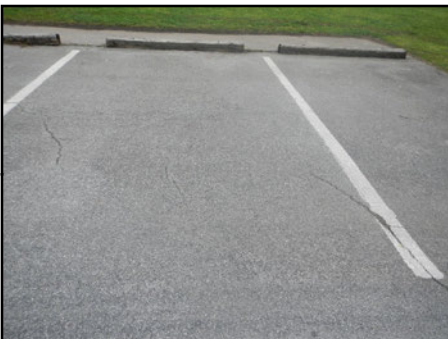
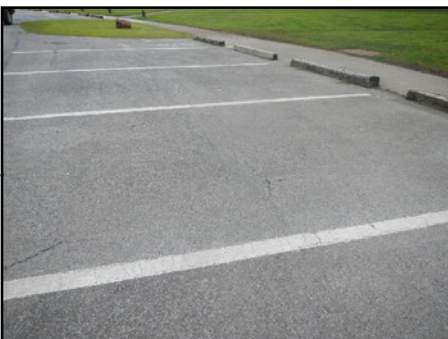
ROUTE 0939: TYLER BEND GROUP CAMPSITE PARKING D

Inspection Date	FMSS Number	User Access	Surface Type
5/4/2018	101343	PUBLIC	ASPHALT
Area (Sq. Ft.)	Lane Miles (11' Widths)	Curb Reveal (Inches)	Curb Recommendation
1,035	0.018	NOT APPLICABLE	NOT APPLICABLE
Curb Type		Curb & Gutter Type	
NO CURB		NO CURB AND GUTTER	
Pavement Recommendation		Condition Rating / PCR	
LIGHT 3R TREATMENTS		FAIR / 73

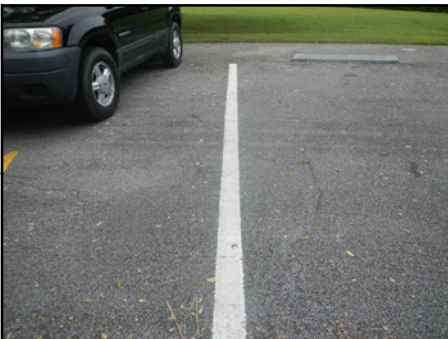
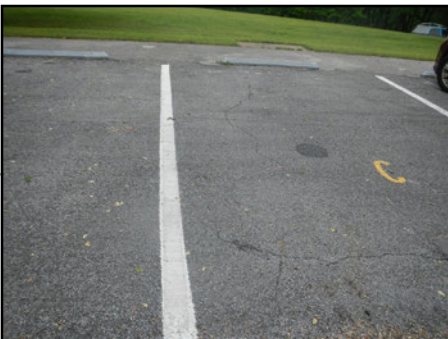
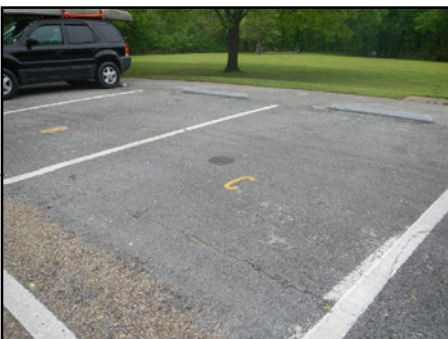
ROUTE 0940: TYLER BEND WALKIN CAMPSITE PARKING A

Inspection Date	FMSS Number	User Access	Surface Type
5/4/2018	101344	PUBLIC	ASPHALT
Area (Sq. Ft.)	Lane Miles (11' Widths)	Curb Reveal (Inches)	Curb Recommendation
1,110	0.019	NOT APPLICABLE	NOT APPLICABLE
Curb Type		Curb & Gutter Type	
NO CURB		NO CURB AND GUTTER	
Pavement Recommendation		Condition Rating / PCR	
PREVENTIVE MAINTENANCE		GOOD / 90

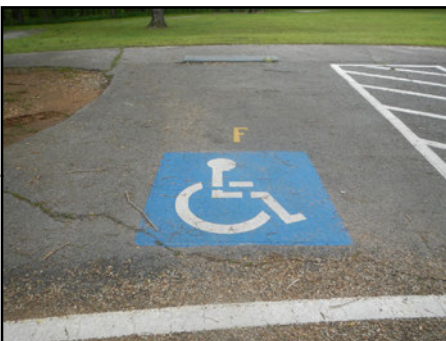
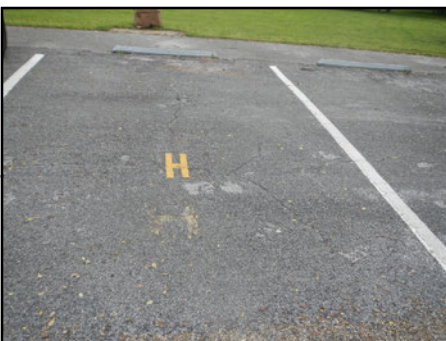
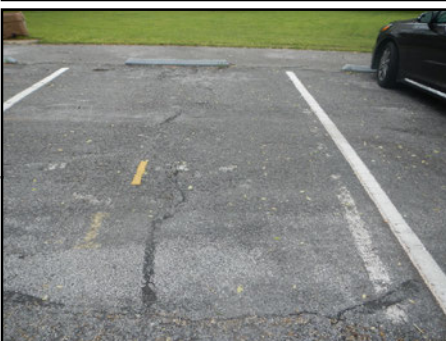
ROUTE 0941: TYLER BEND WALKIN CAMPSITE PARKING B

Inspection Date	FMSS Number	User Access	Surface Type
5/4/2018	101345	PUBLIC	ASPHALT
Area (Sq. Ft.)	Lane Miles (11' Widths)	Curb Reveal (Inches)	Curb Recommendation
1,212	0.021	NOT APPLICABLE	NOT APPLICABLE
Curb Type		Curb & Gutter Type	
NO CURB		NO CURB AND GUTTER	
Pavement Recommendation		Condition Rating / PCR	
PREVENTIVE MAINTENANCE		GOOD / 90

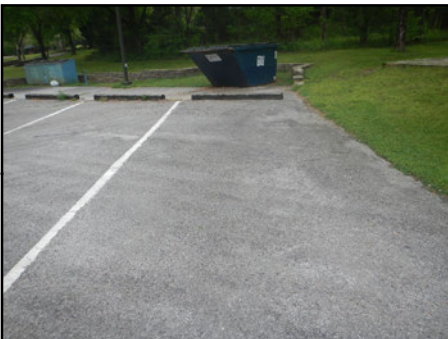
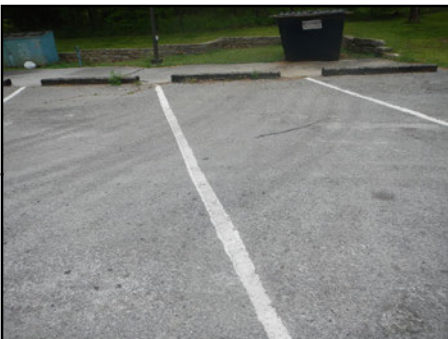
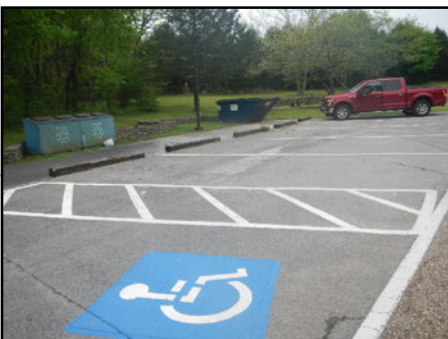
ROUTE 0942: TYLER BEND CAMPGROUND LOOP B BATHROOM PARKING

Inspection Date	FMSS Number	User Access	Surface Type
5/4/2018	101346	PUBLIC	ASPHALT
Area (Sq. Ft.)	Lane Miles (11' Widths)	Curb Reveal (Inches)	Curb Recommendation
1,897	0.033	NOT APPLICABLE	NOT APPLICABLE
Curb Type		Curb & Gutter Type	
NO CURB		NO CURB AND GUTTER	
Pavement Recommendation		Condition Rating / PCR	
PREVENTIVE MAINTENANCE		GOOD / 90
