Road Inventory and Condition Assessment of Paved Routes Cape Hatteras National Seashore

**Federal Lands Highway
Road Inventory Program**

**Federal Highway Administration
Eastern Federal Lands Highway Division
Road Inventory Program (RIP)**

Report Date: March 2022

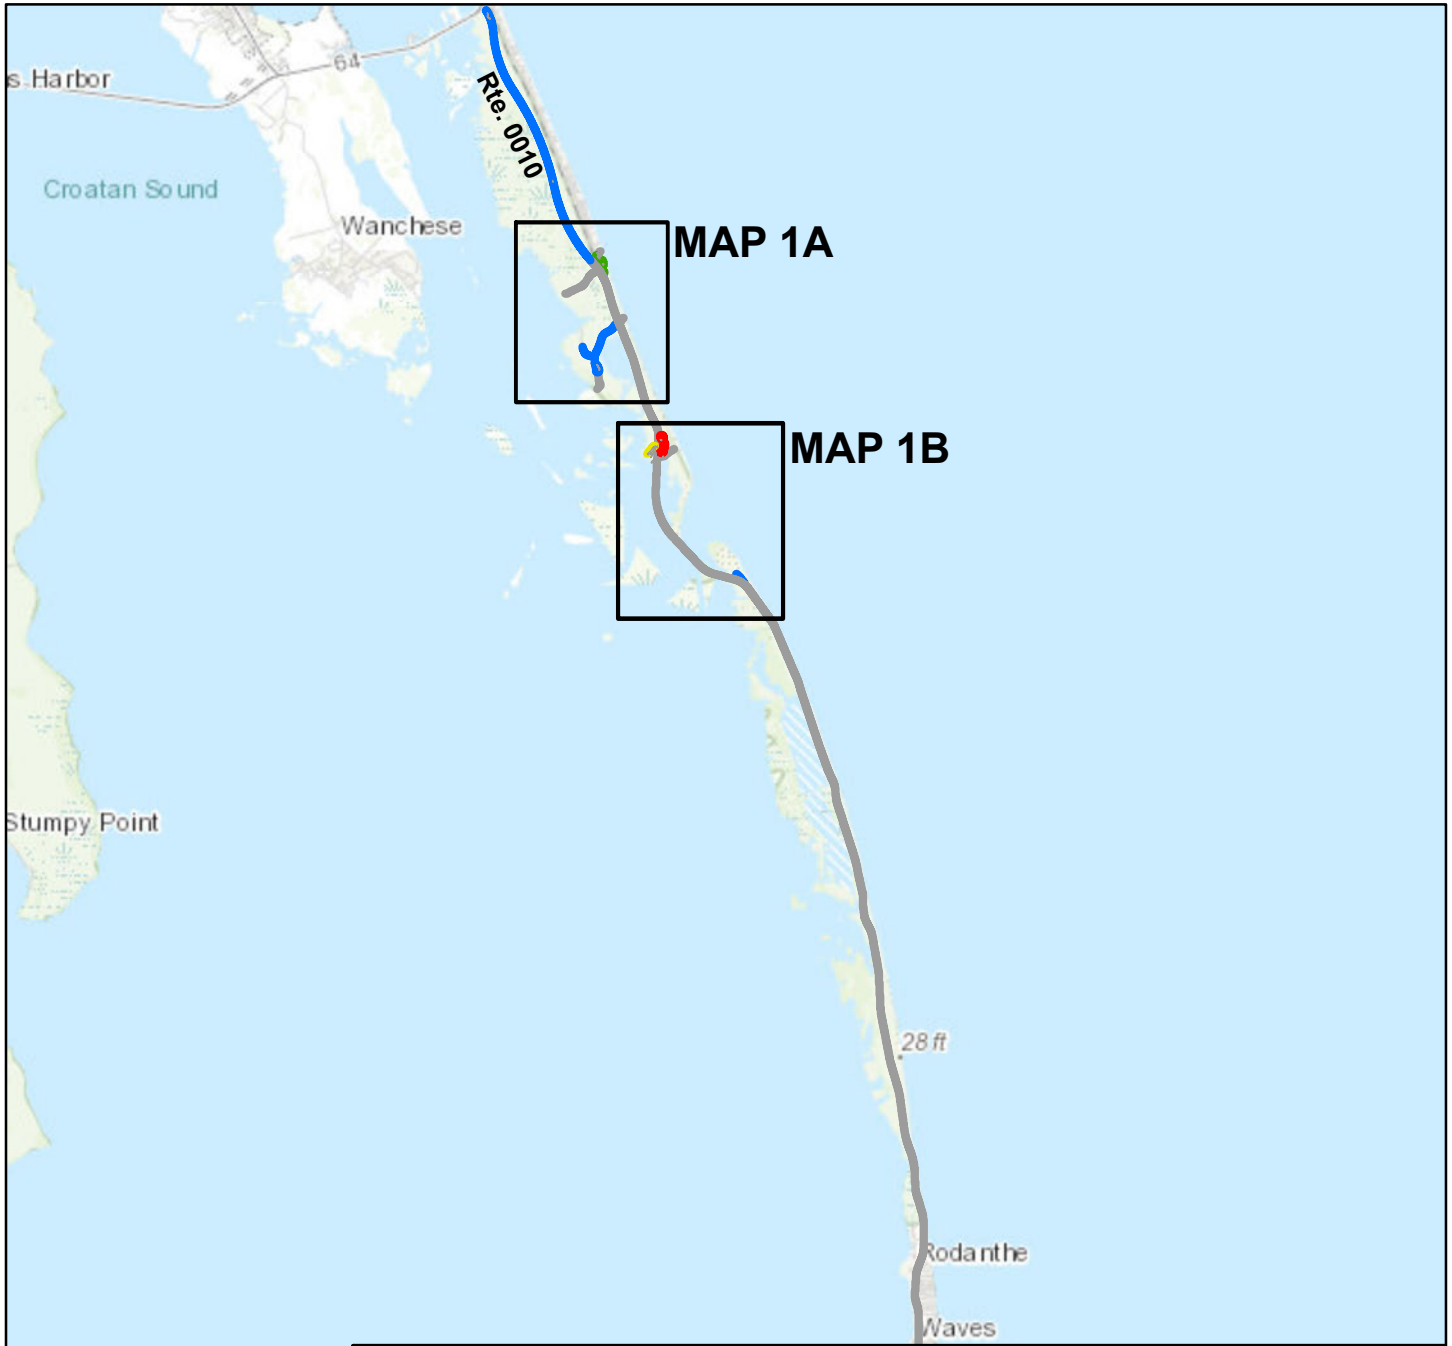
Area Map 1

ROUTE CONDITION MAP

PCR - MILE BY MILE

Route Condition Legend – Pavement Condition Rating (PCR)

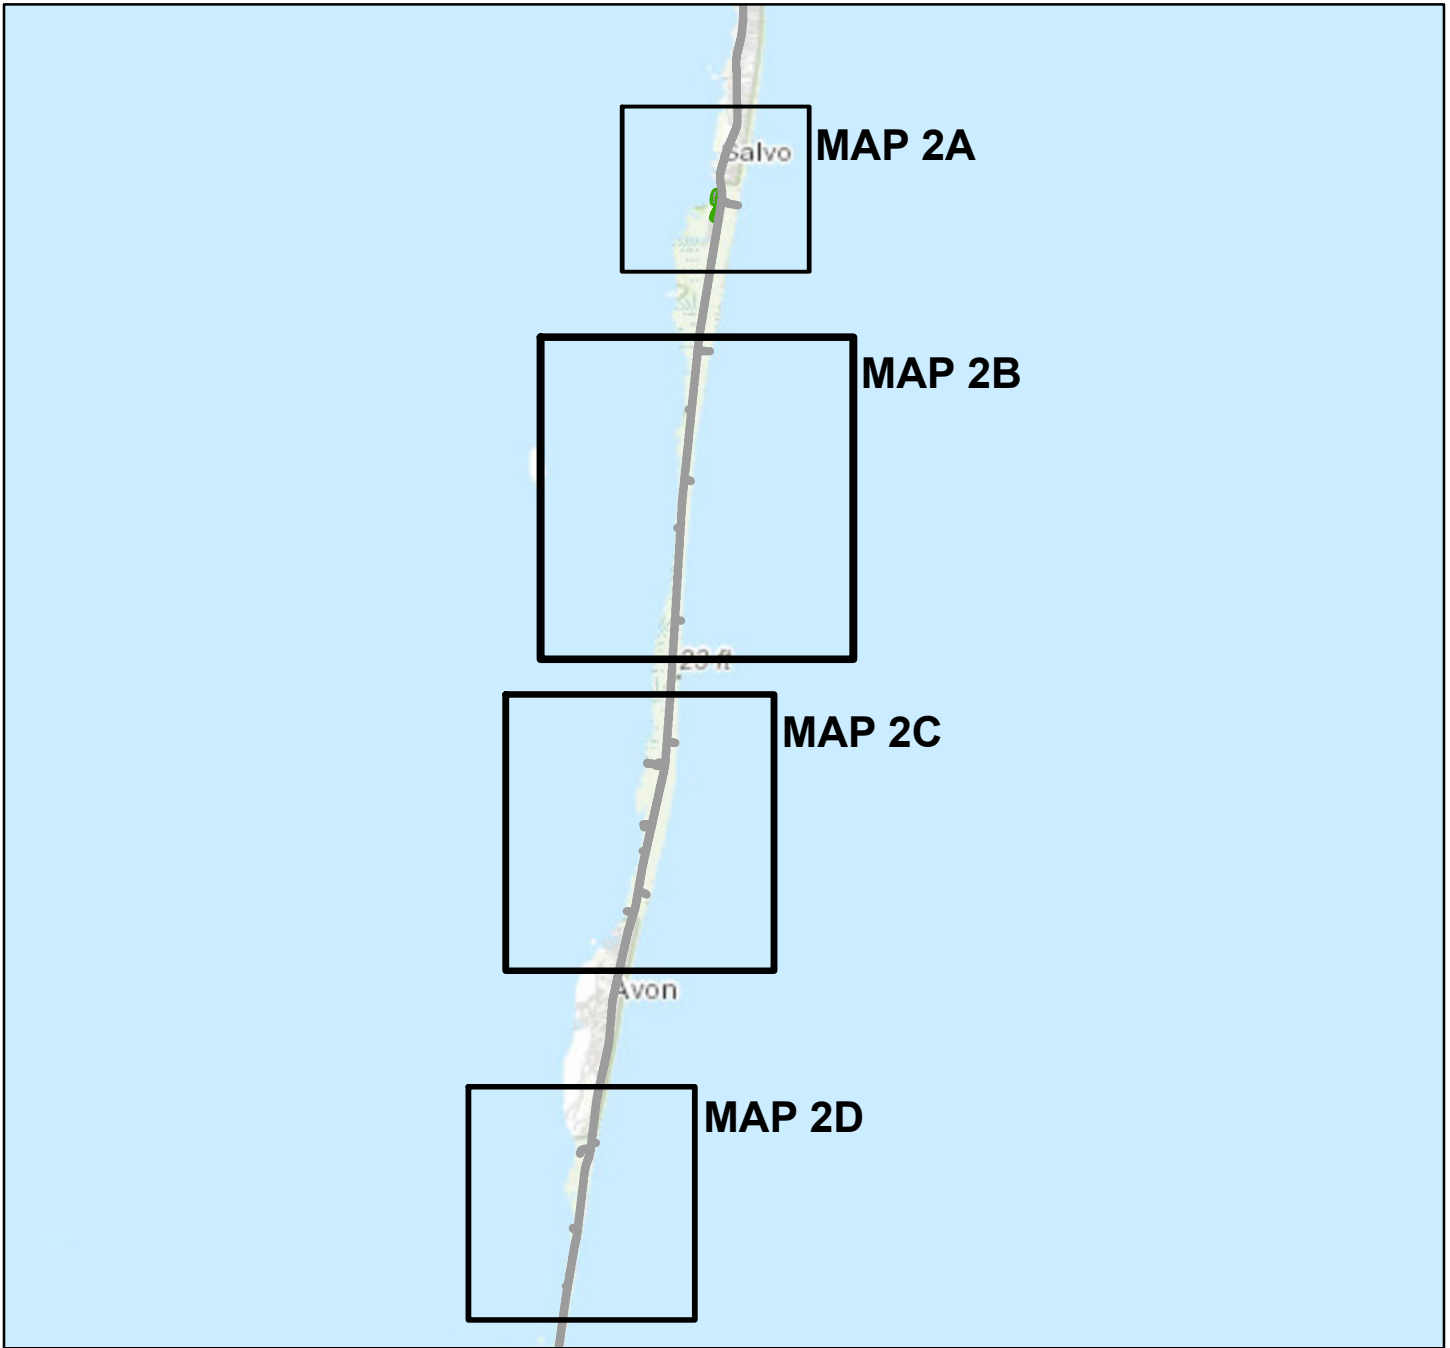
Area Map 2

ROUTE CONDITION MAP

PCR - MILE BY MILE

Route Condition Legend – Pavement Condition Rating (PCR)

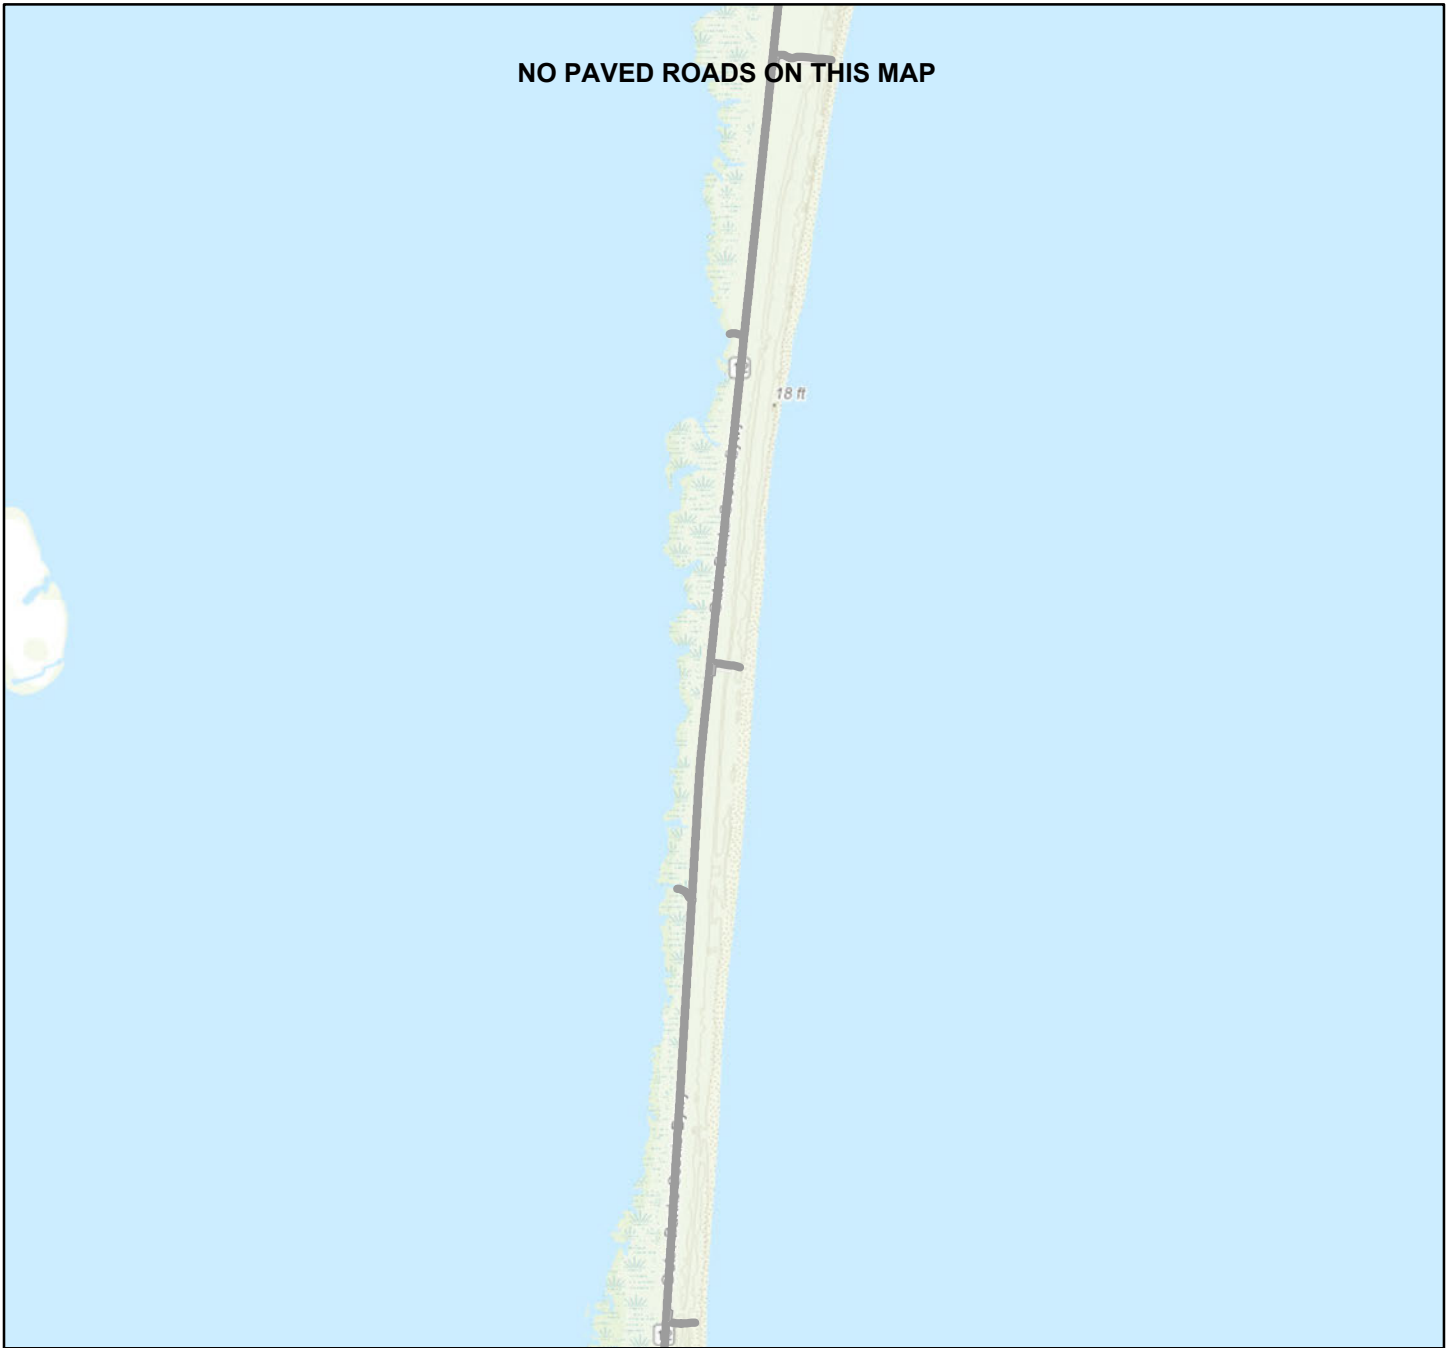
Area Map 2B

PCR - MILE BY MILE

Route Condition Legend – Pavement Condition Rating (PCR)

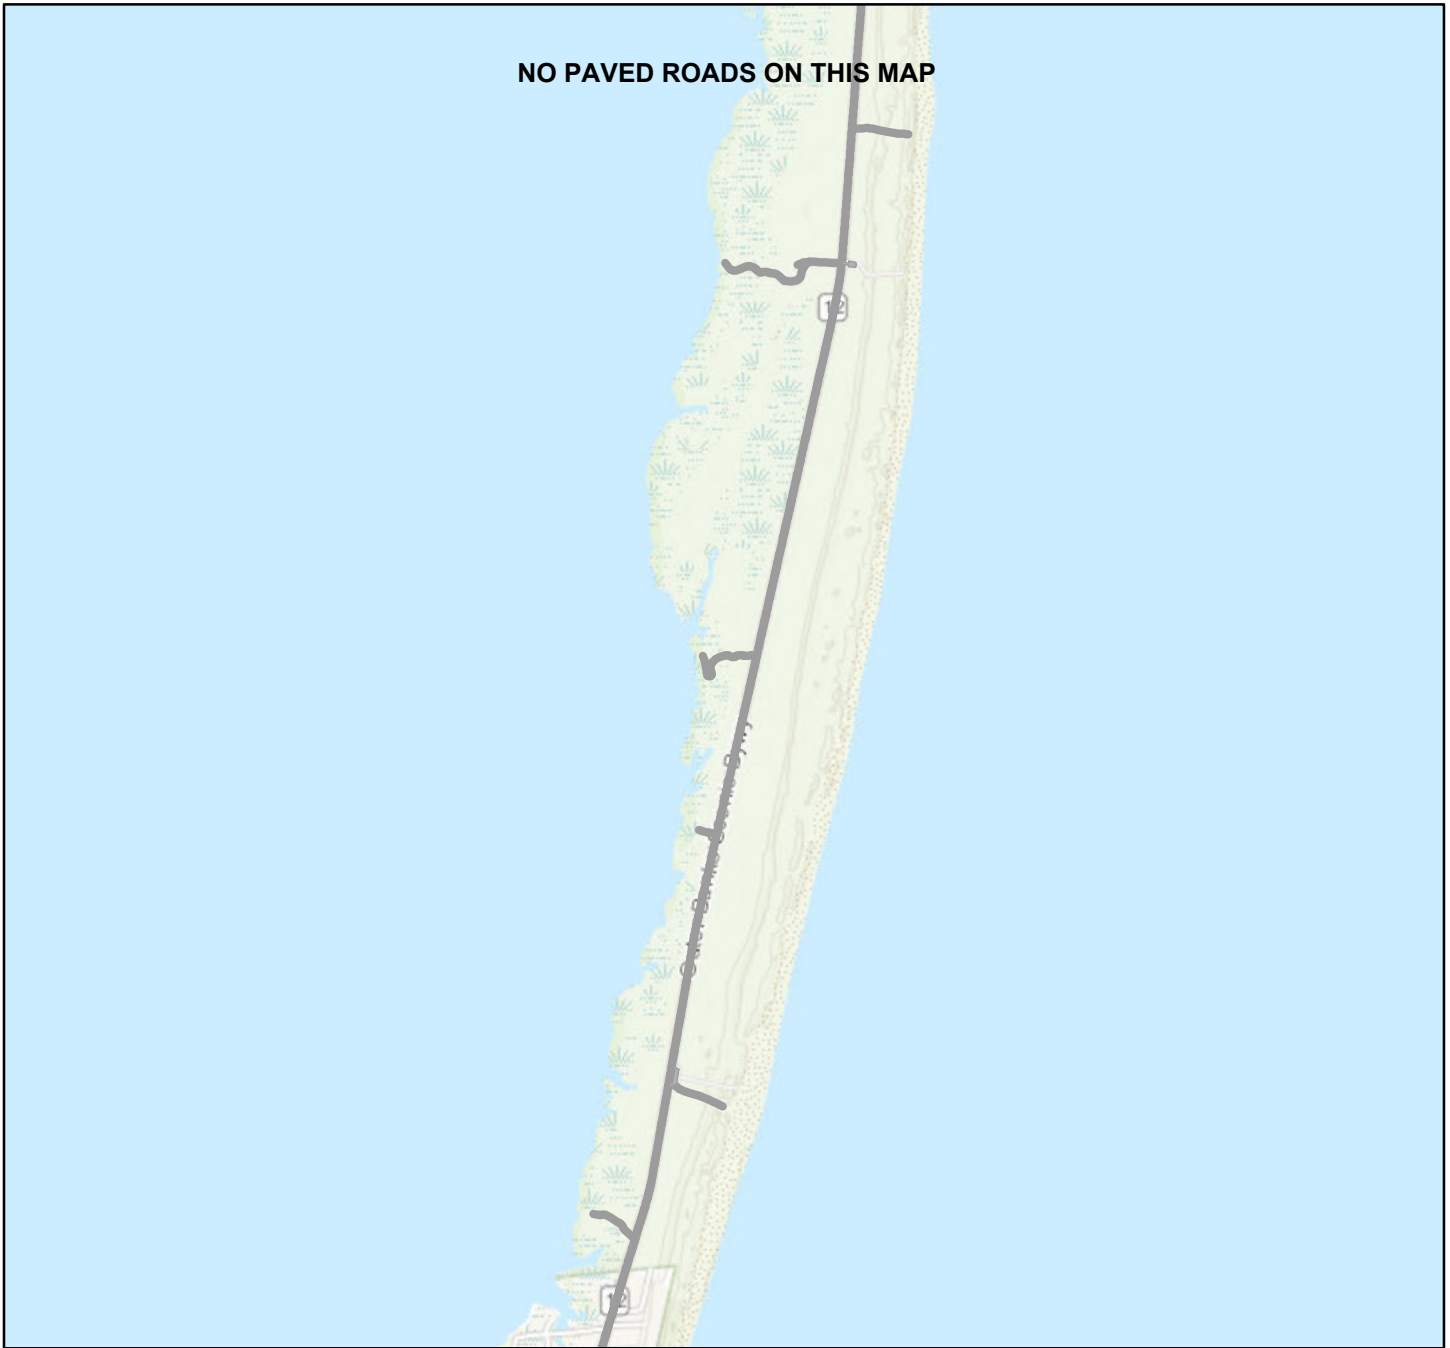
Area Map 2C

PCR - MILE BY MILE

Route Condition Legend – Pavement Condition Rating (PCR)

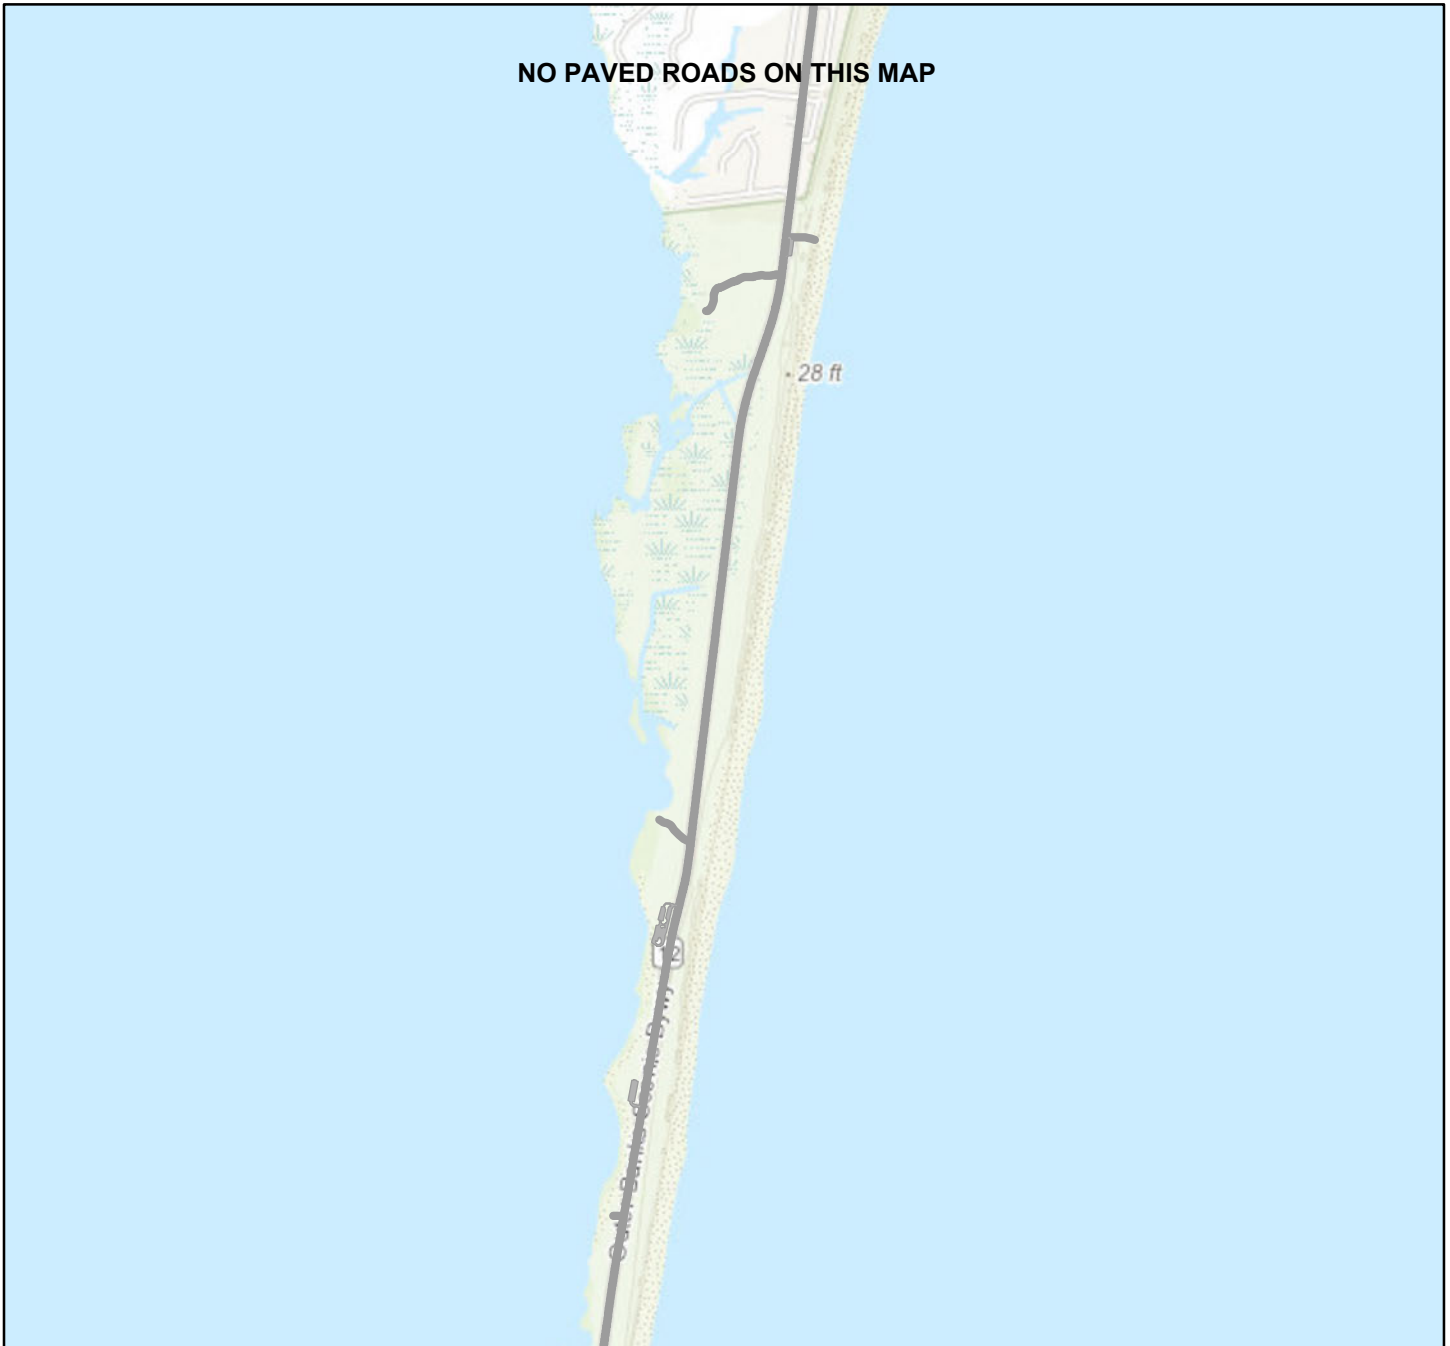
Area Map 2D

PCR - MILE BY MILE

Route Condition Legend – Pavement Condition Rating (PCR)

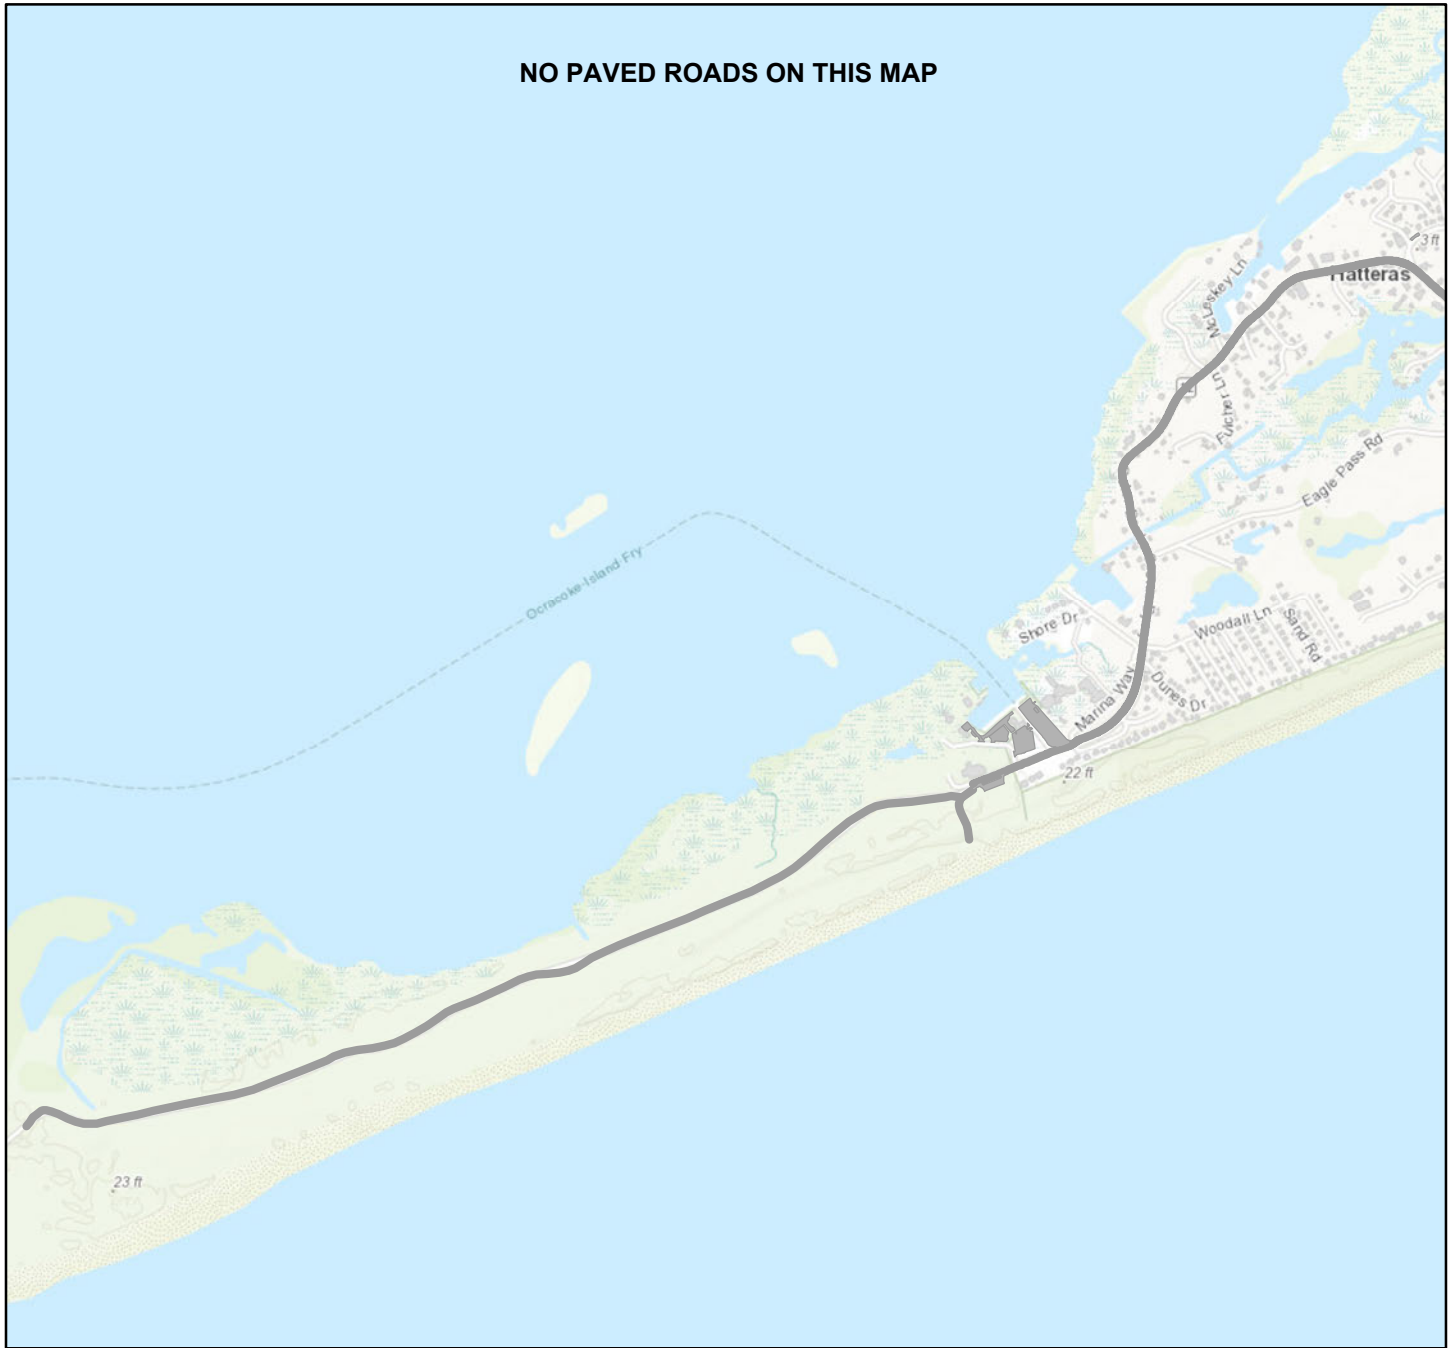
Area Map 3D

ROUTE CONDITION MAP

PCR - MILE BY MILE

Colors on map represent condition scores at 1-mile intervals. See Appendix for definitions and formulas
Only Data Collection Vehicle and Manually Rated Roads are displayed

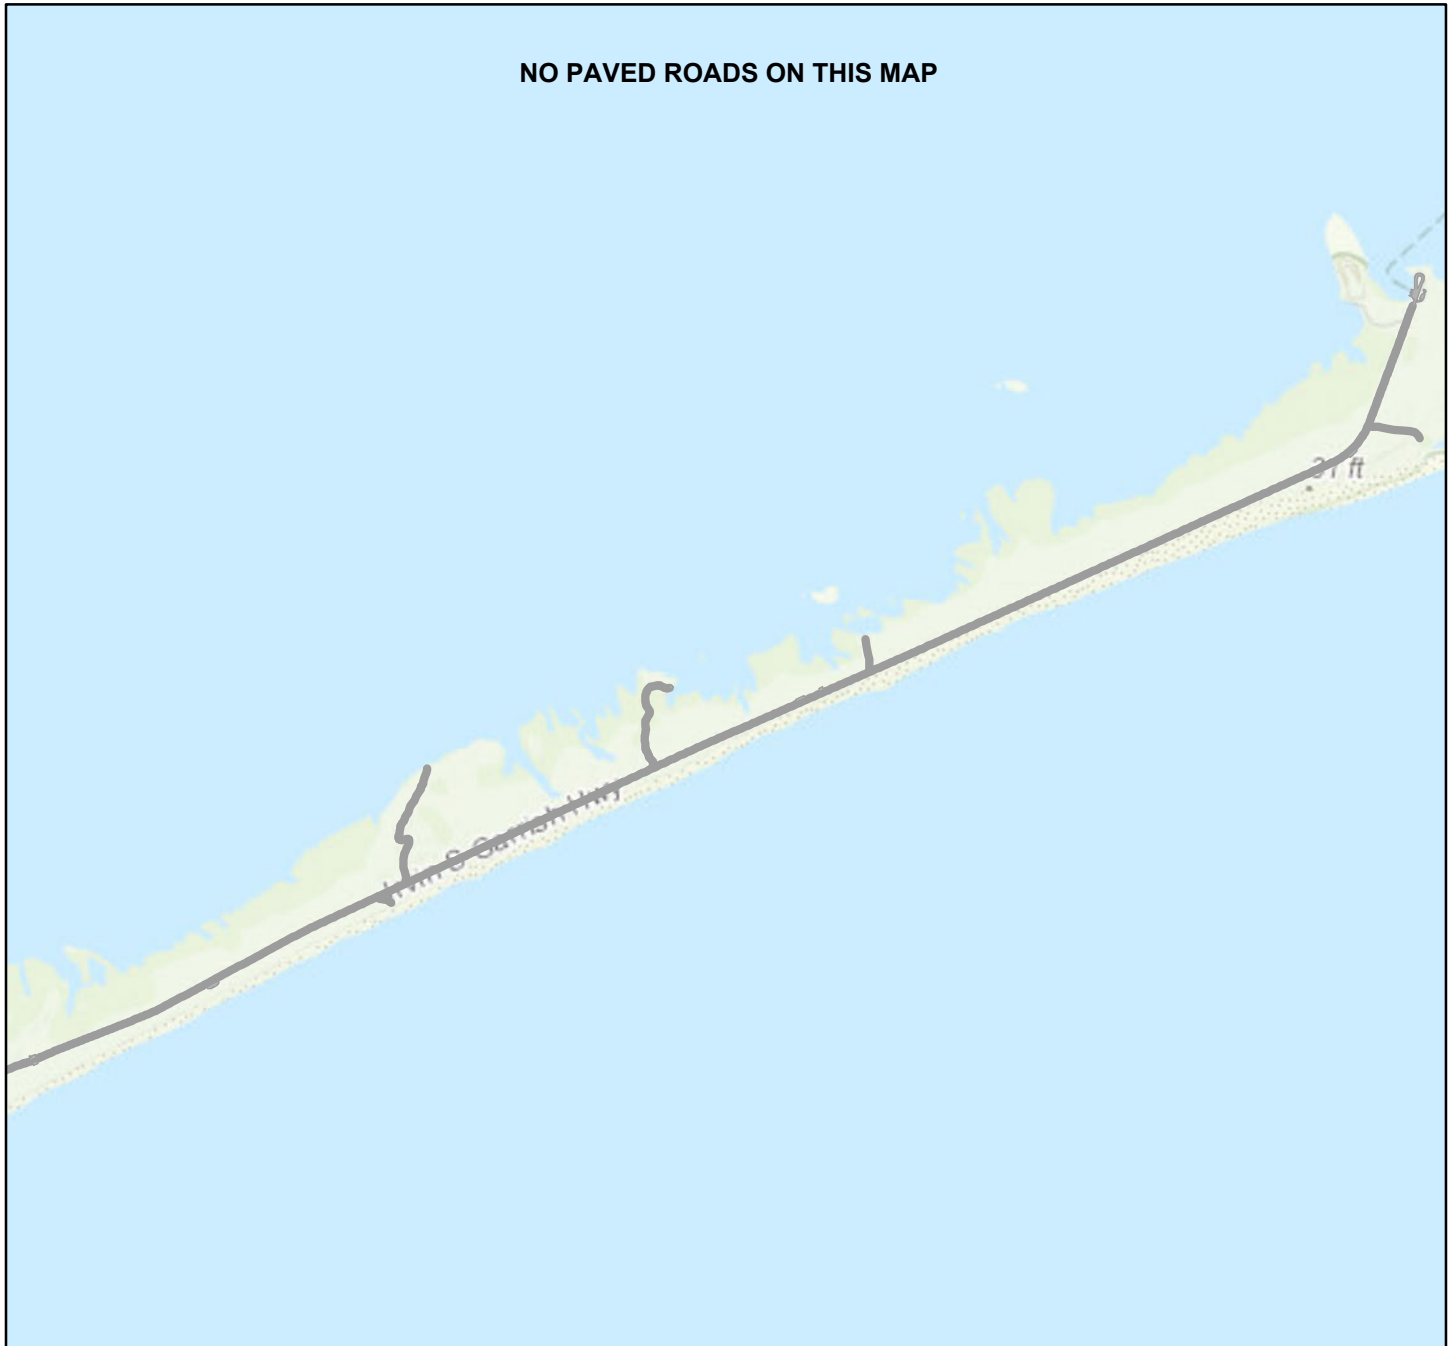
Area Map 4A

ROUTE CONDITION MAP

PCR - MILE BY MILE

Colors on map represent condition scores at 1-mile intervals. See Appendix for definitions and formulas

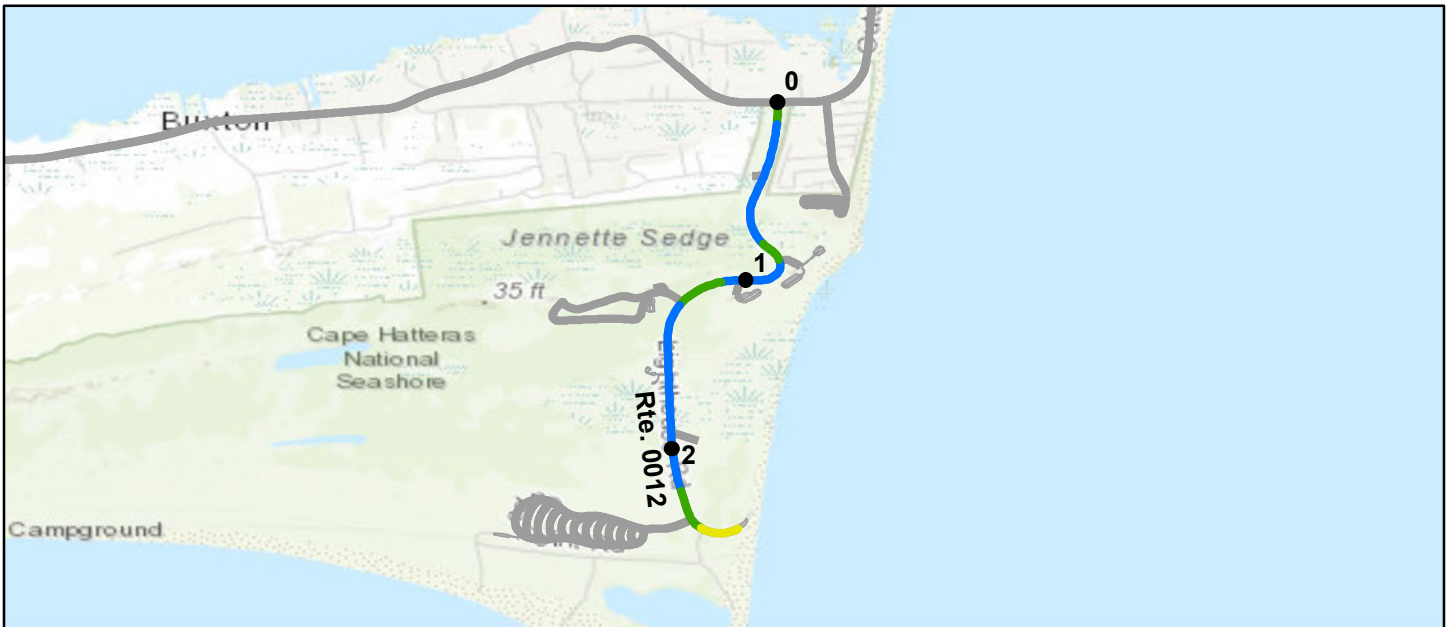
ROUTE 0012: HI RD LIGHTHOUSE ROAD

Data Collection Vehicle (DCV) Rating

Route Condition Legend – Pavement Condition Rating (PCR)						
Poor (0 - 60)	Fair (61- 84)	Good (85 - 94)	Excellent (95 - 100)	Not Rated		
Colors on map represent condition scores at 0.10-mile intervals. See Appendix for definitions and formulas.						
Inspection Date: 5/26/2021	Beginning Section MP	0	1	2		
Paved Length (Miles): 2.56	Section Length (MI)	1	1	0.56		
Surface Type: ASPHALT	Route Summary					
Roadway Condition Information						
Pavement Condition Rating (PCR)	97	99	98	91		
Surface Condition Rating (SCR)	98	99	98	96		
Roughness Condition Index (RCI)	95	98	99	83		
Distress Index Values						
Structural Crack Index	100	99	100	99		
Alligator Crack Index	100	100	100	100		
Longitudinal Crack Index	100	99	100	99		
Transverse Cracking Index	99	100	100	97		
Patching Index	100	100	100	100		
Rutting Index	98	99	98	96		
International Roughness Index (IRI)	128	120	117	159		
Lane & Width Information						
Number of Lanes	2	2	2	2

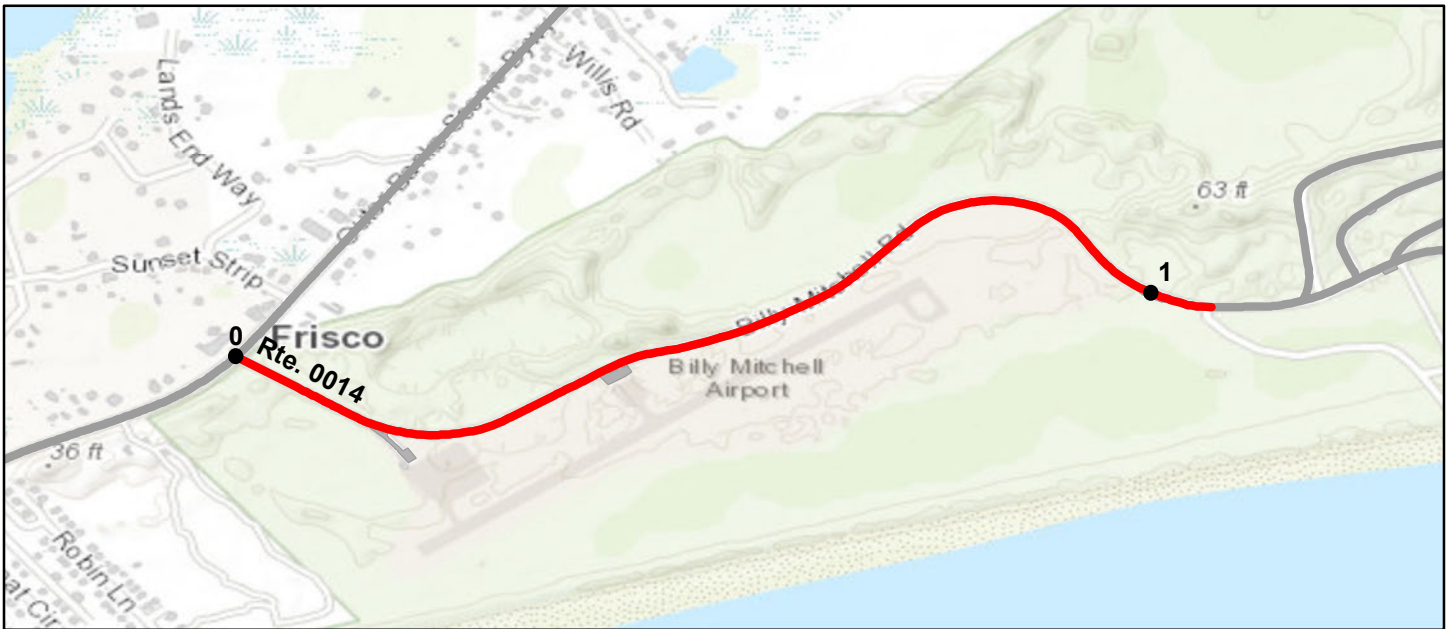
ROUTE 0014: HI RD FRISCO CAMPGROUND ACCESS / BILLY MITCHELL ROAD

Data Collection Vehicle (DCV) Rating

Colors on map represent condition scores at 0.10-mile intervals. See Appendix for definitions and formulas.

Inspection Date: 5/26/2021		Beginning Section MP	0	1			
Paved Length (Miles): 1.06		Section Length (MI)	1	0.06			
Surface Type: ASPHALT		Route Summary					
Roadway Condition Information							
Pavement Condition Rating (PCR)		45	47	30			
Surface Condition Rating (SCR)		27	29	0			
Roughness Condition Index (RCI)		73	73	75			
Distress Index Values							
Structural Crack Index		45	45	46			
Alligator Crack Index		100	100	100			
Longitudinal Crack Index		45	45	46			
Transverse Cracking Index		27	29	0			
Patching Index		100	100	100			
Rutting Index		99	99	98			
International Roughness Index (IRI)		193	193	184			
Lane & Width Information							
Number of Lanes		2	2	2			
Paved Width (ft)		22.2	22.5	19.2			
Lane Width (ft)		10.5	10.6	10

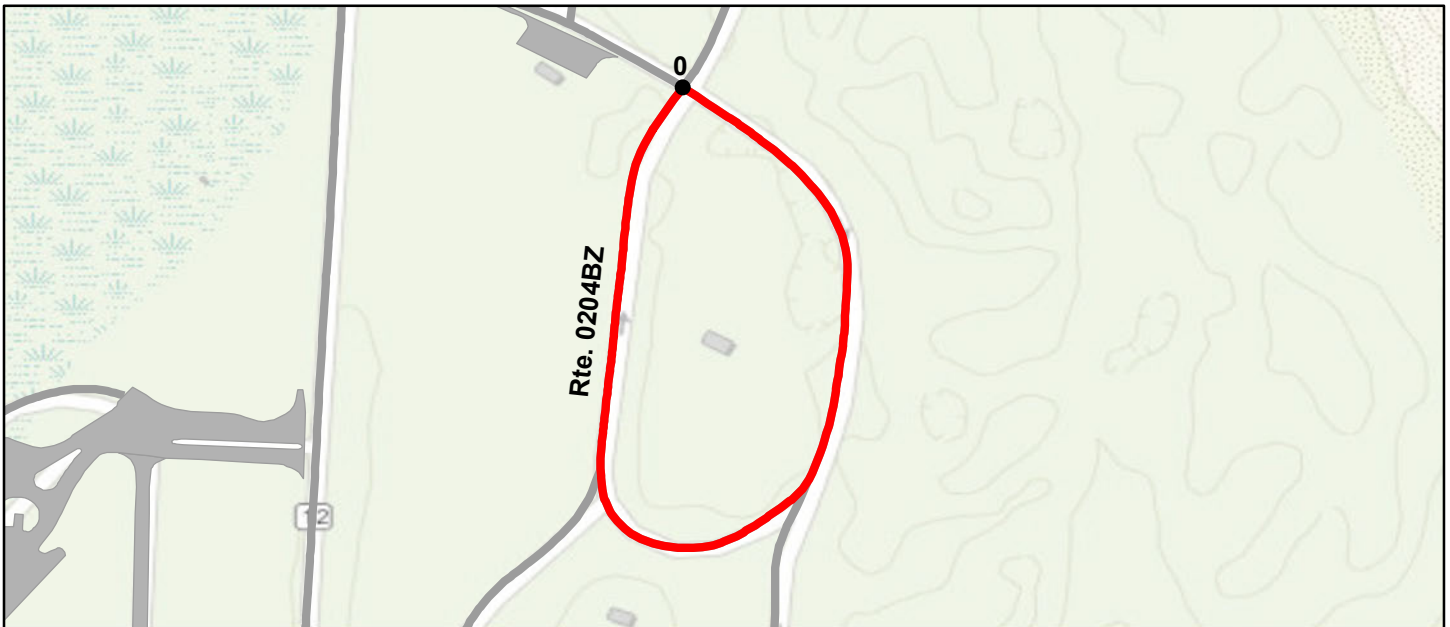
ROUTE 0204BZ: BI RD OREGON INLET CAMPGROUND LOOP B

Subcomponent of Route CAHA-0204ZZ
Data Collection Vehicle (DCV) Rating

Route Condition Legend – Pavement Condition Rating (PCR)						
Poor (0 - 60)	Fair (61- 84)	Good (85 - 94)	Excellent (95 - 100)	Not Rated		
Colors on map represent condition scores at 0.10-mile intervals. See Appendix for definitions and formulas.						
Inspection Date: 5/26/2021	Beginning Section MP	0				
Paved Length (Miles): 0.31	Section Length (MI)	0.31				
Surface Type: ASPHALT	Route Summary					
Roadway Condition Information						
Pavement Condition Rating (PCR)	17	17				
Surface Condition Rating (SCR)	17	17				
Roughness Condition Index (RCI)	N/A	N/A				
Distress Index Values						
Structural Crack Index	85	85				
Alligator Crack Index	100	100				
Longitudinal Crack Index	85	85				
Transverse Cracking Index	17	17				
Patching Index	100	100				
Rutting Index	96	96				
International Roughness Index (IRI)	N/A	N/A				
Lane & Width Information						
Number of Lanes	1	1				
Paved Width (ft)	9.8	9.8				
Lane Width (ft)	9.8	9.8

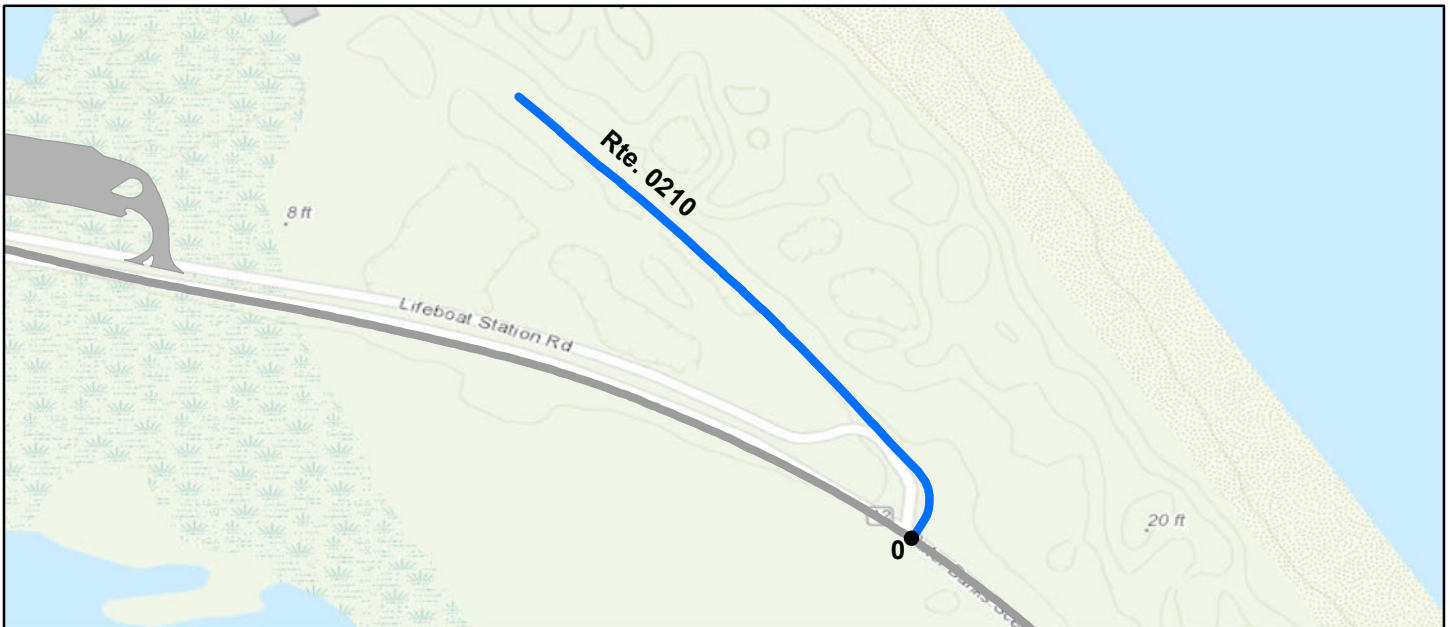
ROUTE 0210: BI RD LIFEBOAT STATION ROAD

Data Collection Vehicle (DCV) Rating

Colors on map represent condition scores at 0.10-mile intervals. See Appendix for definitions and formulas.

Inspection Date: 5/26/2021	Beginning Section MP	0				
Paved Length (Miles): 0.23	Section Length (MI)	0.23				
Surface Type: ASPHALT	Route Summary					
Roadway Condition Information						
Pavement Condition Rating (PCR)	99	99				
Surface Condition Rating (SCR)	99	99				
Roughness Condition Index (RCI)	N/A	N/A				
Distress Index Values						
Structural Crack Index	100	100				
Alligator Crack Index	100	100				
Longitudinal Crack Index	100	100				
Transverse Cracking Index	100	100				
Patching Index	100	100				
Rutting Index	99	99				
International Roughness Index (IRI)	N/A	N/A				
Lane & Width Information						
Number of Lanes	2	2				
Paved Width (ft)	22.1	22.1				
Lane Width (ft)	9.4	9.4

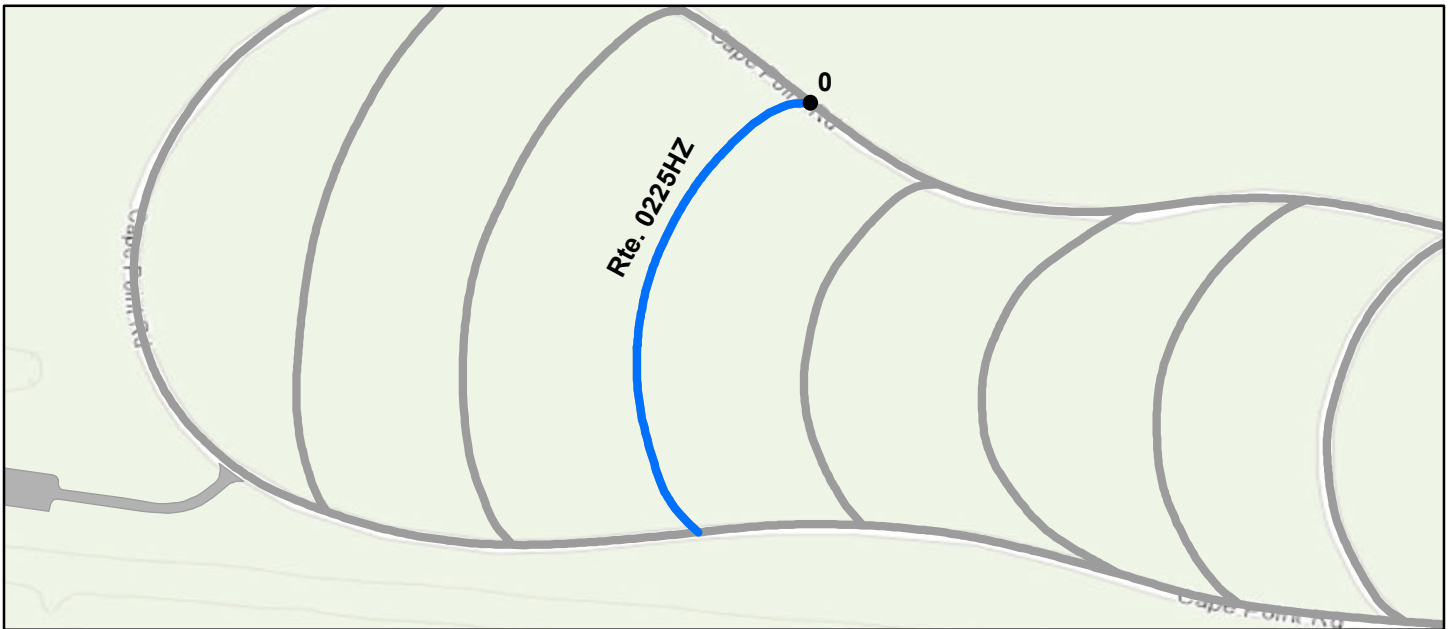
Subcomponent of Route CAHA-0225ZZ

Data Collection Vehicle (DCV) Rating

Colors on map represent condition scores at 0.10-mile intervals. See Appendix for definitions and formulas.

Inspection Date: 5/26/2021	Beginning Section MP	0				
Paved Length (Miles): 0.16	Section Length (MI)	0.16				
Surface Type: ASPHALT	Route Summary					
Roadway Condition Information						
Pavement Condition Rating (PCR)	97	97				
Surface Condition Rating (SCR)	97	97				
Roughness Condition Index (RCI)	N/A	N/A				
Distress Index Values						
Structural Crack Index	100	100				
Alligator Crack Index	100	100				
Longitudinal Crack Index	100	100				
Transverse Cracking Index	99	99				
Patching Index	100	100				
Rutting Index	97	97				
International Roughness Index (IRI)	N/A	N/A				
Lane & Width Information						
Number of Lanes	1	1				
Paved Width (ft)	11	11				
Lane Width (ft)	11	11

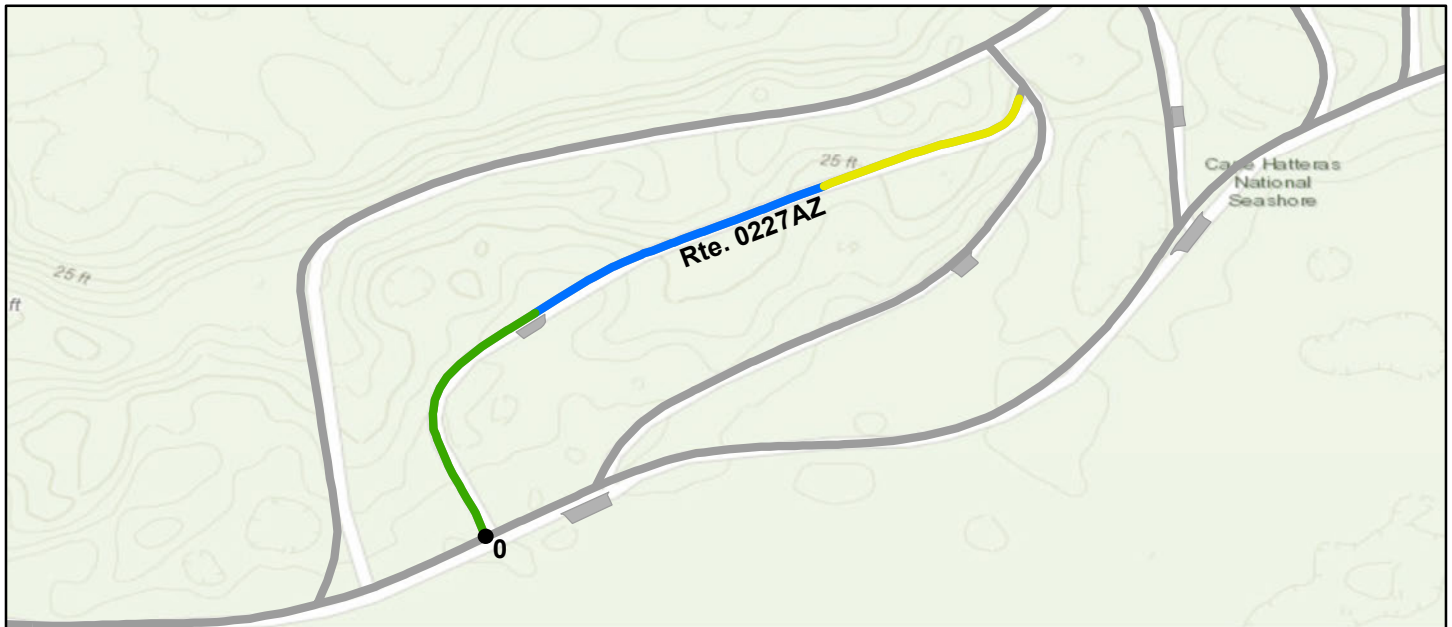
ROUTE 0227AZ: HI RD FRISCO CAMPGROUND CROSSOVER A

Subcomponent of Route CAHA-0227ZZ
Data Collection Vehicle (DCV) Rating

Route Condition Legend – Pavement Condition Rating (PCR)						
Poor (0 - 60)	Fair (61- 84)	Good (85 - 94)	Excellent (95 - 100)	Not Rated		
Colors on map represent condition scores at 0.10-mile intervals. See Appendix for definitions and formulas.						
Inspection Date: 5/26/2021	Beginning Section MP	0				
Paved Length (Miles): 0.27	Section Length (MI)	0.27				
Surface Type: ASPHALT	Route Summary					
Roadway Condition Information						
Pavement Condition Rating (PCR)	91	91				
Surface Condition Rating (SCR)	91	91				
Roughness Condition Index (RCI)	N/A	N/A				
Distress Index Values						
Structural Crack Index	100	100				
Alligator Crack Index	100	100				
Longitudinal Crack Index	100	100				
Transverse Cracking Index	91	91				
Patching Index	100	100				
Rutting Index	99	99				
International Roughness Index (IRI)	N/A	N/A				
Lane & Width Information						
Number of Lanes	1	1				
Paved Width (ft)	14.1	14.1

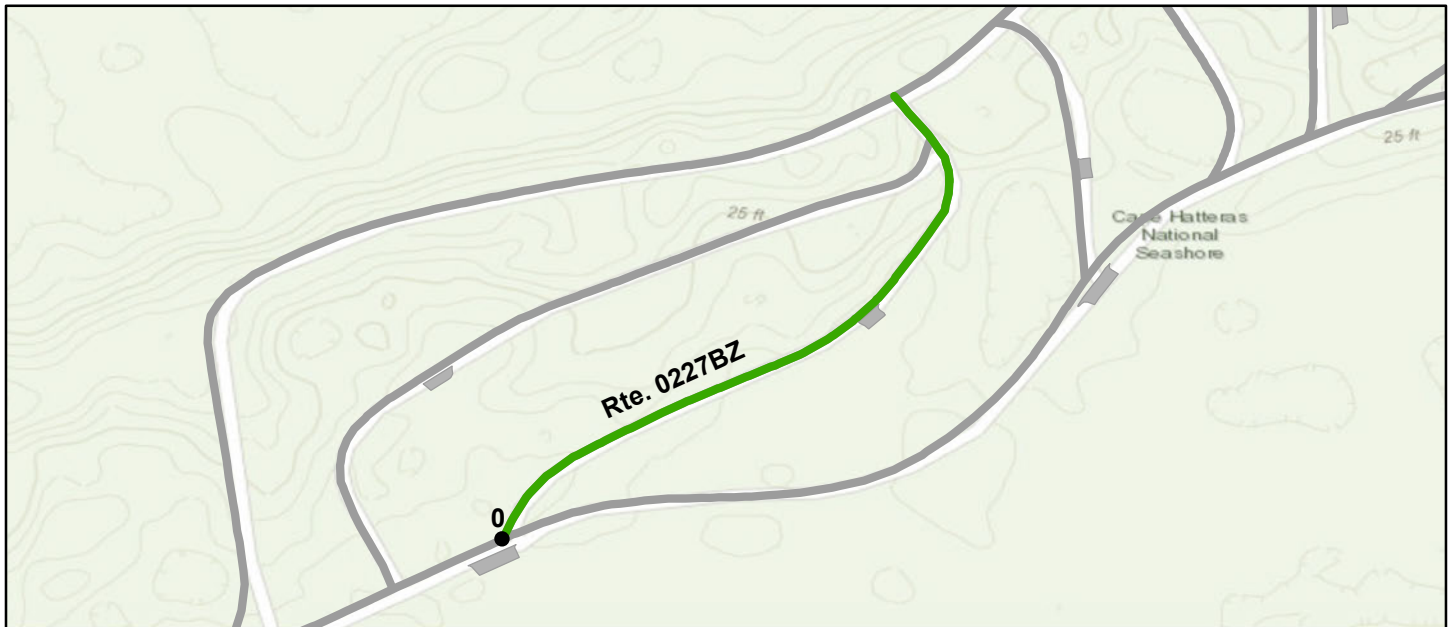
ROUTE 0227BZ: HI RD FRISCO CAMPGROUND CROSSOVER B

Subcomponent of Route CAHA-0227ZZ
 Data Collection Vehicle (DCV) Rating

Route Condition Legend – Pavement Condition Rating (PCR)						
Poor (0 - 60)	Fair (61- 84)	Good (85 - 94)	Excellent (95 - 100)	Not Rated		
Colors on map represent condition scores at 0.10-mile intervals. See Appendix for definitions and formulas.						
Inspection Date: 5/26/2021	Beginning Section MP	0				
Paved Length (Miles): 0.23	Section Length (MI)	0.23				
Surface Type: ASPHALT	Route Summary					
Roadway Condition Information						
Pavement Condition Rating (PCR)	91	91				
Surface Condition Rating (SCR)	91	91				
Roughness Condition Index (RCI)	N/A	N/A				
Distress Index Values						
Structural Crack Index	99	99				
Alligator Crack Index	100	100				
Longitudinal Crack Index	99	99				
Transverse Cracking Index	91	91				
Patching Index	100	100				
Rutting Index	98	98				
International Roughness Index (IRI)	N/A	N/A				
Lane & Width Information						
Number of Lanes	1	1				
Paved Width (ft)	11.9	11.9				
Lane Width (ft)	11.9	11.9
