Road Inventory and Condition Assessment of Paved Routes Cape Hatteras National Seashore

**Federal Lands Highway
Road Inventory Program**

**Federal Highway Administration
Eastern Federal Lands Highway Division
Road Inventory Program (RIP)**

Report Date: March 2022

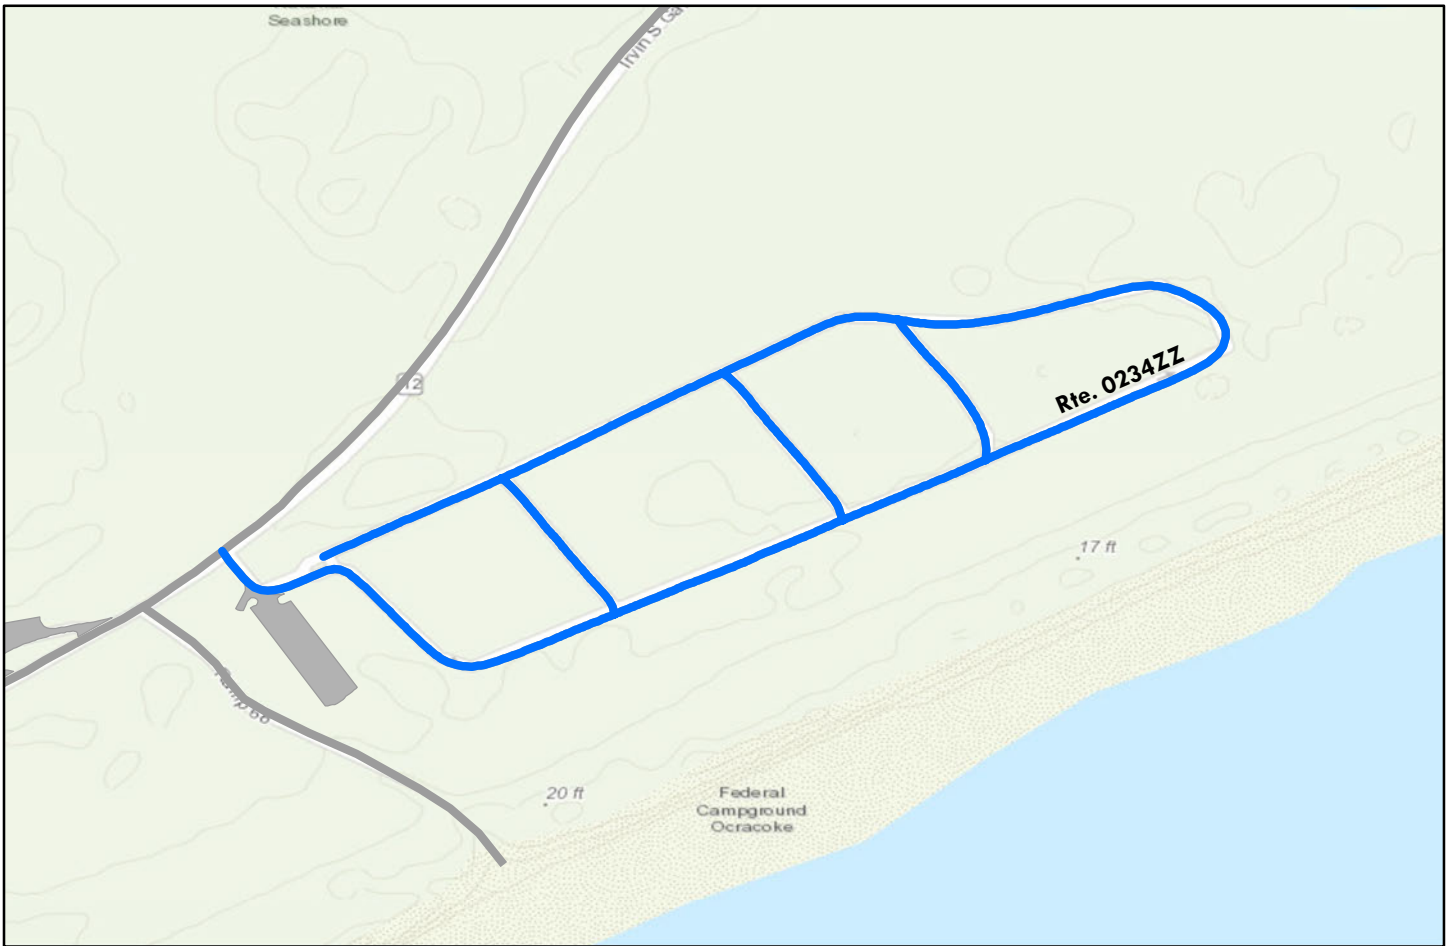
ROUTE 0234ZZ: OI RD OCRACOKE CAMPGROUND ROADS

Summary Route

Note: The weighted average summary PCR value is calculated from only the sections of road where the PCR was collected. The overall PCR for the summary route may not reflect individual subcomponent ratings.

Route Condition Legend – Pavement Condition Rating (PCR)						
Poor (0 - 60)	Fair (61- 84)	Good (85 - 94)	Excellent (95 - 100)	Not Rated		
See Appendix for definitions and formulas						
Inspection Date: 5/26/2021						
Paved Length (Miles): 0.93						
Surface Type: ASPHALT	Route Summary					
Roadway Condition Information						
Pavement Condition Rating (PCR)	100					
Lane & Width Information						
Number of Lanes	1					
Paved Width (ft)	14.4					
Lane Width (ft)	14.4

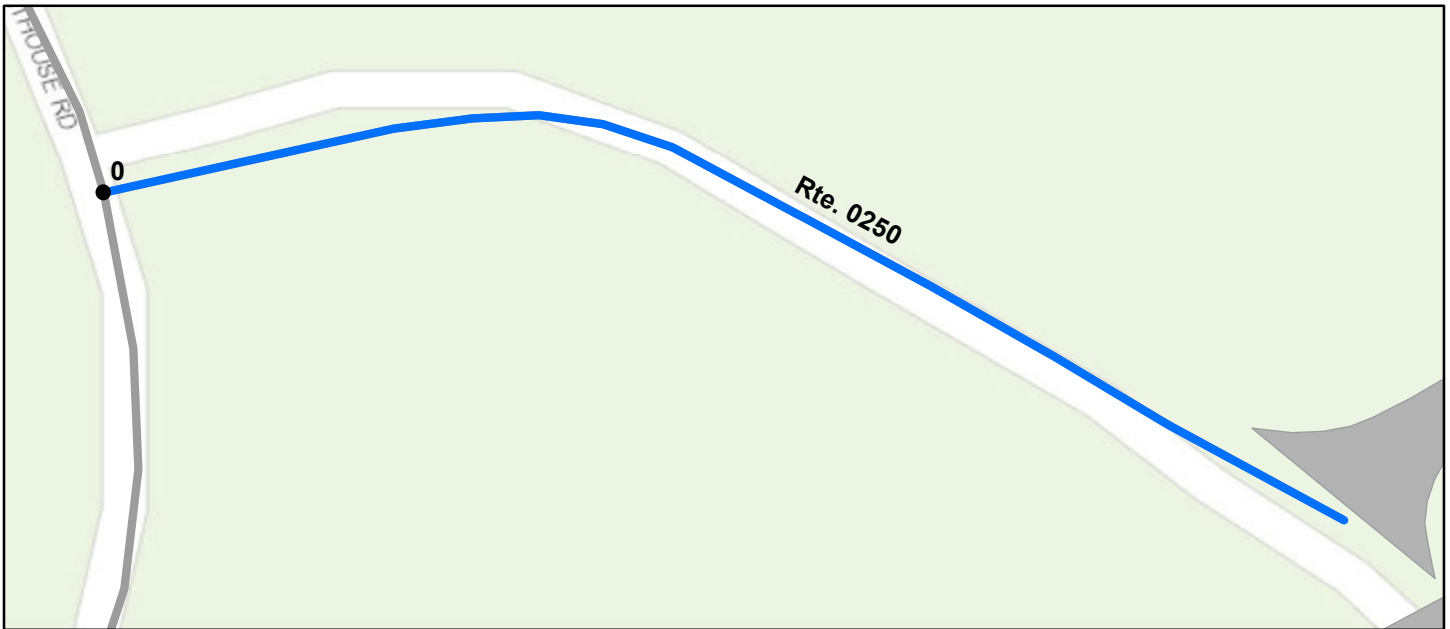
ROUTE 0250: HI RD OLD LIGHTHOUSE SITE ROAD

Data Collection Vehicle (DCV) Rating

Route Condition Legend – Pavement Condition Rating (PCR)						
Poor (0 - 60)	Fair (61- 84)	Good (85 - 94)	Excellent (95 - 100)	Not Rated		
Colors on map represent condition scores at 0.10-mile intervals. See Appendix for definitions and formulas.						
Inspection Date: 5/26/2021	Beginning Section MP	0				
Paved Length (Miles): 0.08	Section Length (MI)	0.08				
Surface Type: ASPHALT	Route Summary					
Roadway Condition Information						
Pavement Condition Rating (PCR)	97	97				
Surface Condition Rating (SCR)	97	97				
Roughness Condition Index (RCI)	N/A	N/A				
Distress Index Values						
Structural Crack Index	98	98				
Alligator Crack Index	100	100				
Longitudinal Crack Index	98	98				
Transverse Cracking Index	97	97				
Patching Index	100	100				
Rutting Index	98	98				
International Roughness Index (IRI)	N/A	N/A				
Lane & Width Information						
Number of Lanes	2	2				
Paved Width (ft)	28.8	28.8				
Lane Width (ft)	10.4	10.4

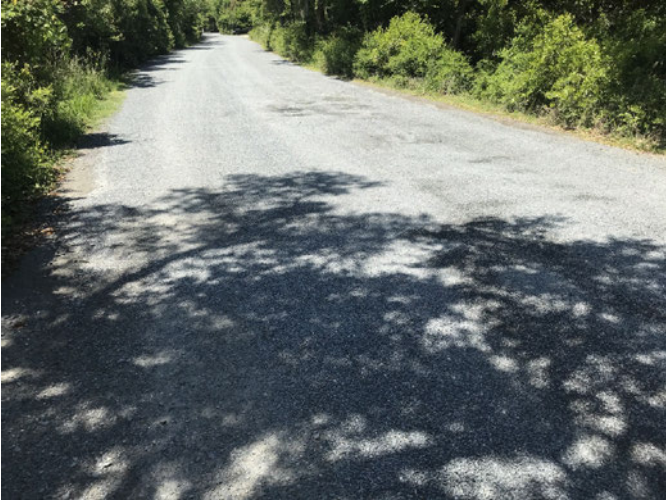
CAHA_0285_1.jpg

Condition Photos

Condition photos are shown only for manually rated roads. Use the PathView program to see images of DCV rated roads.

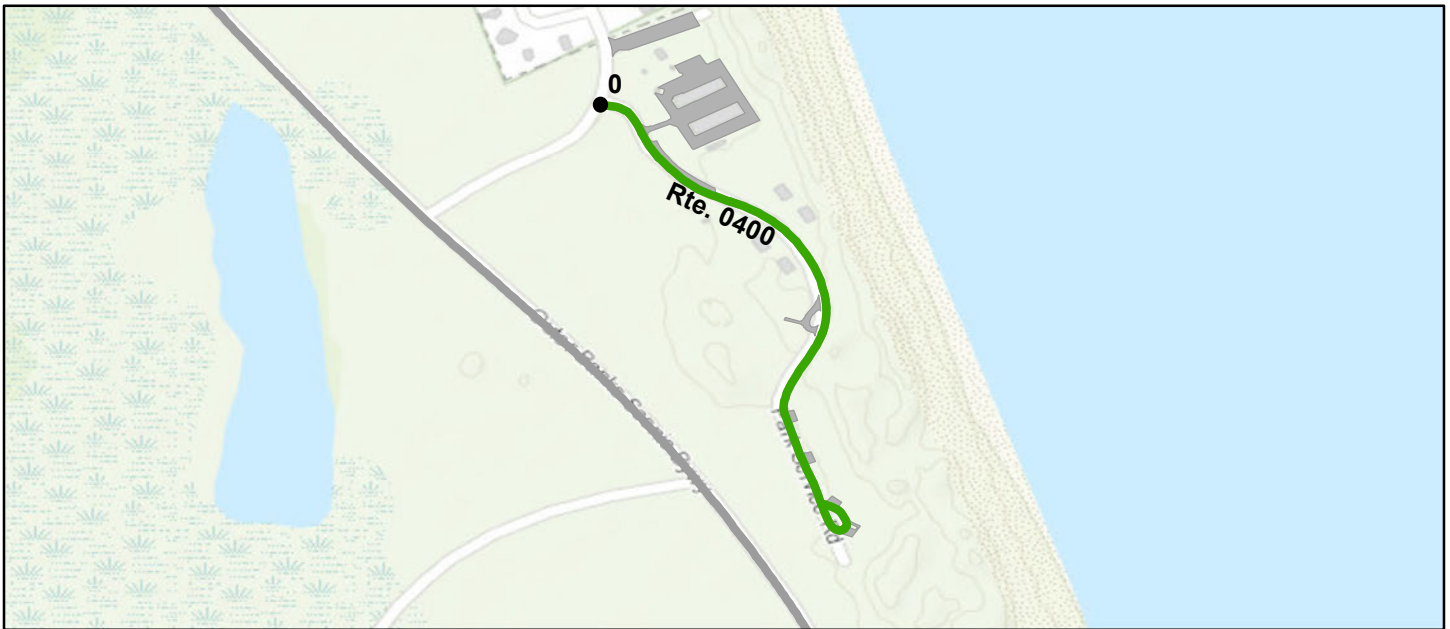
ROUTE 0400: BI RD PARK SERVICE ROAD

Data Collection Vehicle (DCV) Rating

Route Condition Legend – Pavement Condition Rating (PCR)									
Poor (0 - 60)		Fair (61- 84)		Good (85 - 94)		Excellent (95 - 100)		Not Rated	
Colors on map represent condition scores at 0.10-mile intervals. See Appendix for definitions and formulas.									
Inspection Date:	5/27/2021	Beginning Section MP	0						
Paved Length (Miles):	0.39	Section Length (MI)	0.39						
Surface Type:	ASPHALT	Route Summary							
Roadway Condition Information									
Pavement Condition Rating (PCR)		91	91						
Surface Condition Rating (SCR)		91	91						
Roughness Condition Index (RCI)		N/A	N/A						
Distress Index Values									
Structural Crack Index		97	97						
Alligator Crack Index		100	100						
Longitudinal Crack Index		97	97						
Transverse Cracking Index		91	91						
Patching Index		100	100						
Rutting Index		98	98						
International Roughness Index (IRI)		N/A	N/A						
Lane & Width Information									
Number of Lanes		2	2

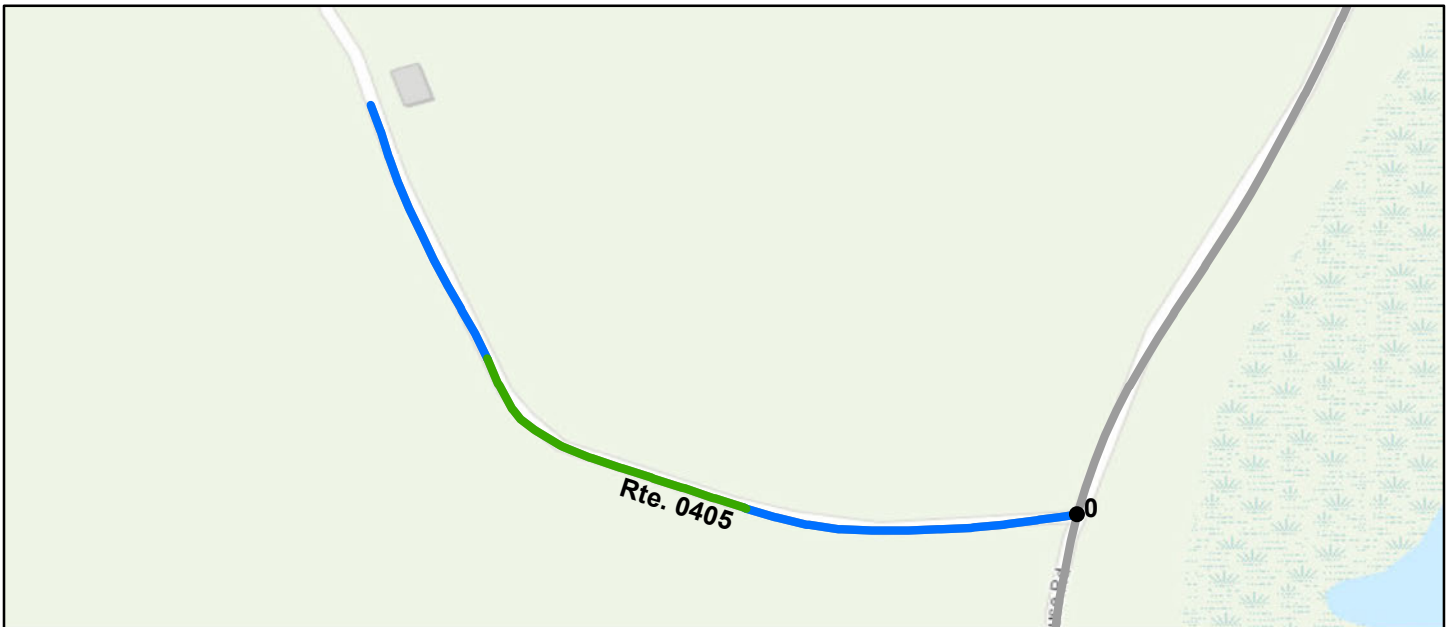
ROUTE 0405: BI RD BODIE ISLAND BONE YARD ROAD

Data Collection Vehicle (DCV) Rating

Route Condition Legend – Pavement Condition Rating (PCR)						
Poor (0 - 60)	Fair (61- 84)	Good (85 - 94)	Excellent (95 - 100)	Not Rated		
Colors on map represent condition scores at 0.10-mile intervals. See Appendix for definitions and formulas.						
Inspection Date: 5/27/2021	Beginning Section MP	0				
Paved Length (Miles): 0.28	Section Length (MI)	0.3				
Surface Type: ASPHALT	Route Summary					
Roadway Condition Information						
Pavement Condition Rating (PCR)	96	96				
Surface Condition Rating (SCR)	96	96				
Roughness Condition Index (RCI)	N/A	N/A				
Distress Index Values						
Structural Crack Index	98	98				
Alligator Crack Index	100	100				
Longitudinal Crack Index	98	98				
Transverse Cracking Index	99	99				
Patching Index	97	97				
Rutting Index	96	96				
International Roughness Index (IRI)	N/A	N/A				
Lane & Width Information						
Number of Lanes	1	1				
Paved Width (ft)	9.2	9.2				
Lane Width (ft)	9.2	9.2

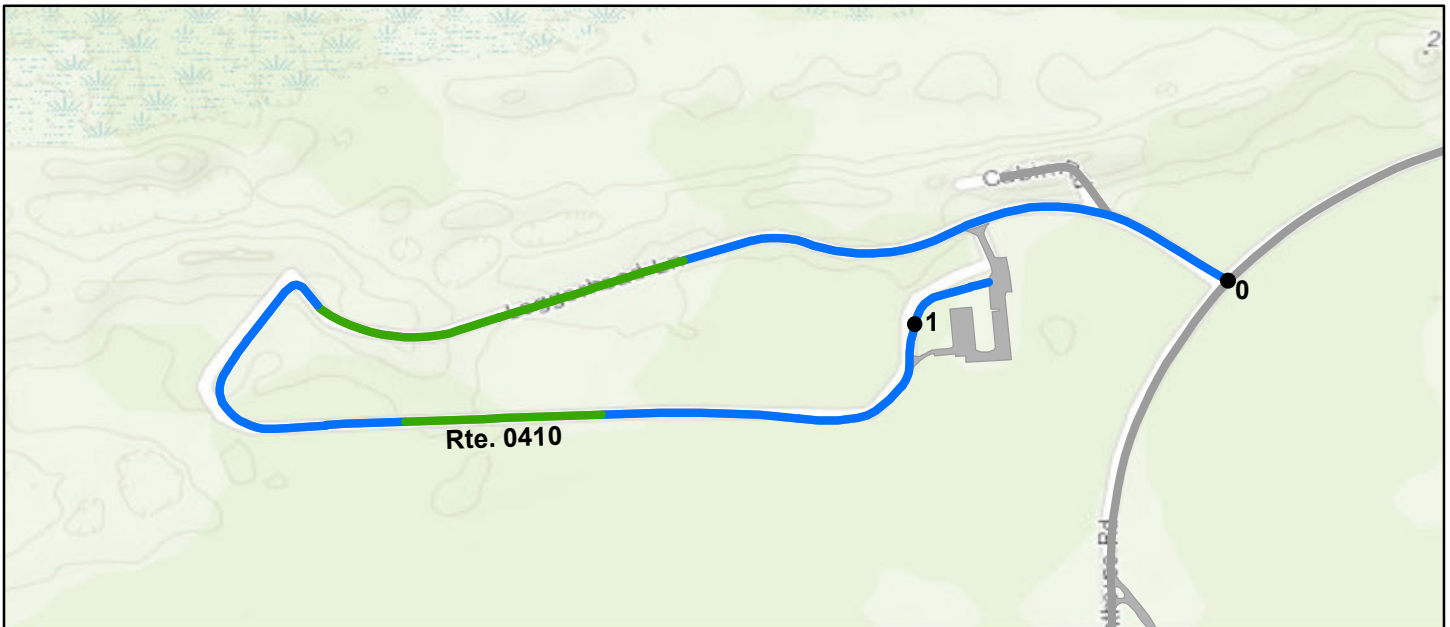
ROUTE 0410: HI RD LOGGERHEAD LANE

Data Collection Vehicle (DCV) Rating

Route Condition Legend – Pavement Condition Rating (PCR)										
Poor (0 - 60)		Fair (61- 84)		Good (85 - 94)		Excellent (95 - 100)		Not Rated		
Colors on map represent condition scores at 0.10-mile intervals. See Appendix for definitions and formulas.										
Inspection Date:	5/26/2021	Beginning Section MP	0	1						
Paved Length (Miles):	1.06	Section Length (MI)	1	0.06						
Surface Type:	ASPHALT	Route Summary								
Roadway Condition Information										
Pavement Condition Rating (PCR)		96	96	97						
Surface Condition Rating (SCR)		96	96	97						
Roughness Condition Index (RCI)		N/A	N/A	N/A						
Distress Index Values										
Structural Crack Index		99	99	100						
Alligator Crack Index		100	100	100						
Longitudinal Crack Index		99	99	100						
Transverse Cracking Index		96	96	100						
Patching Index		100	100	100						
Rutting Index		99	99	97						
International Roughness Index (IRI)		N/A	N/A	N/A

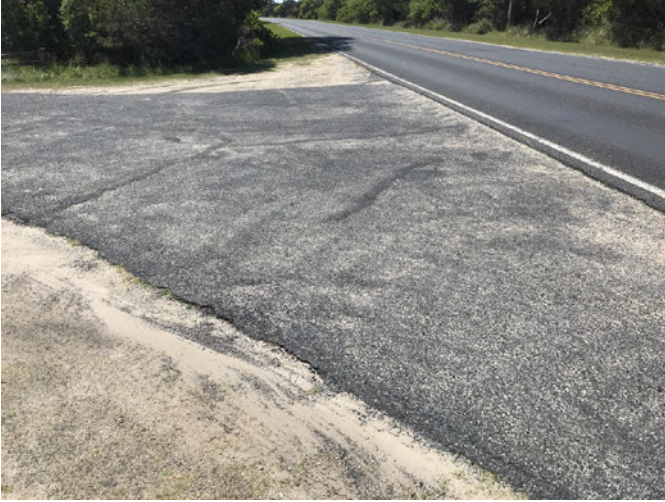
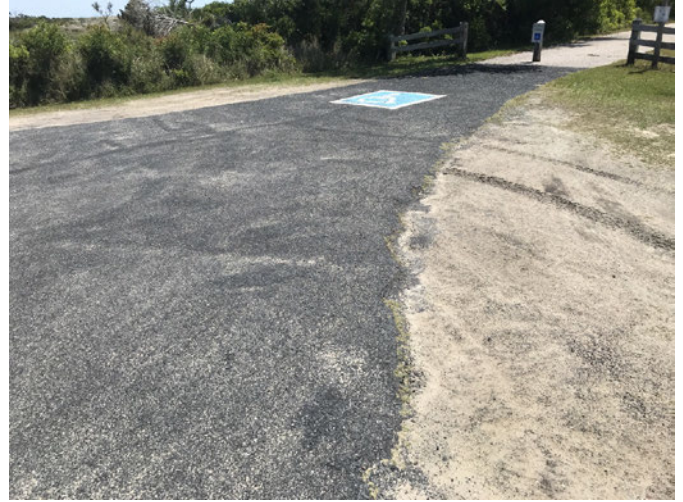
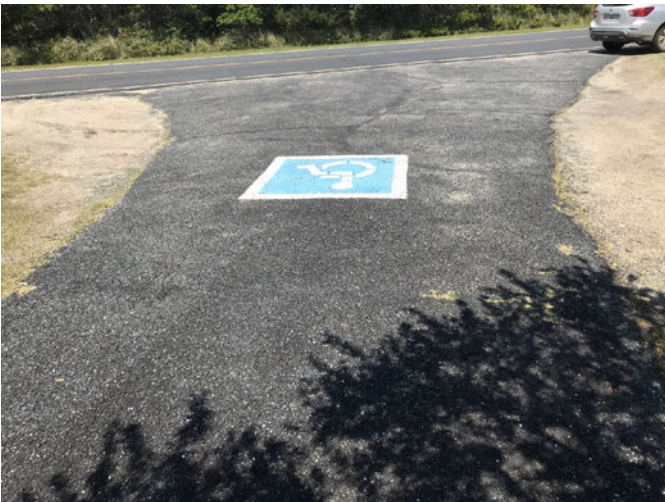
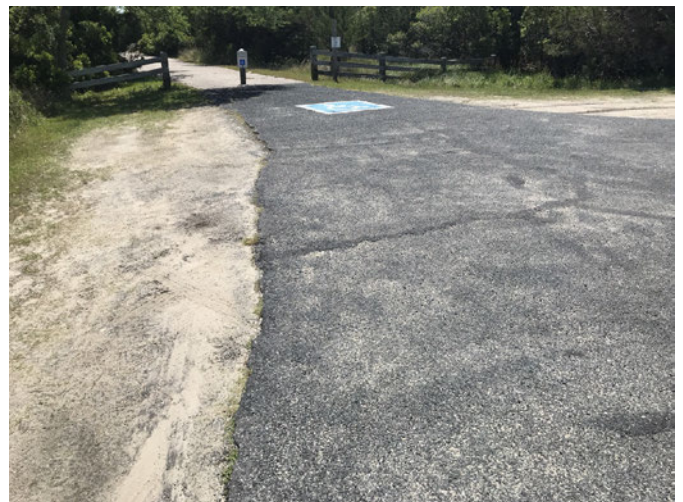
Condition Photos

Condition photos are shown only for manually rated roads. Use the PathView program to see images of DCV rated roads.

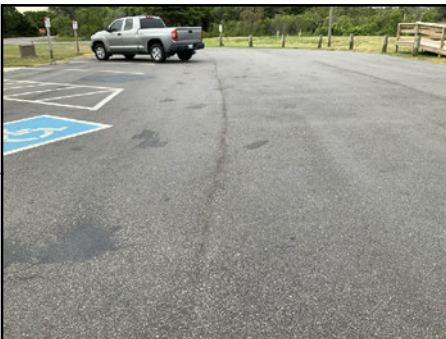
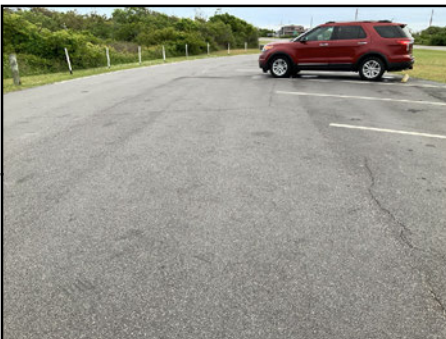
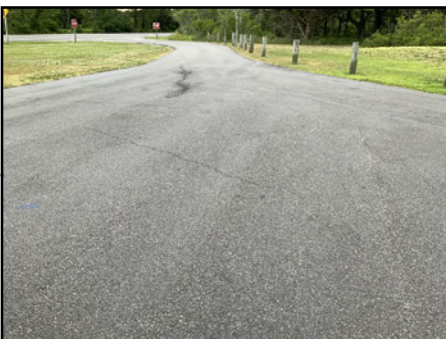
Inspection Date	FMSS Number	User Access	Surface Type
5/9/2021	28885	PUBLIC	ASPHALT
Area (Sq. Ft.)	Lane Miles (11' Widths)	Curb Reveal (Inches)	Curb Recommendation
14,747	0.254	NOT APPLICABLE	NOT APPLICABLE
Curb Type		Curb & Gutter Type	
NO CURB		NO CURB AND GUTTER	
Pavement Recommendation		Condition Rating / PCR	
PREVENTIVE MAINTENANCE		GOOD / 90

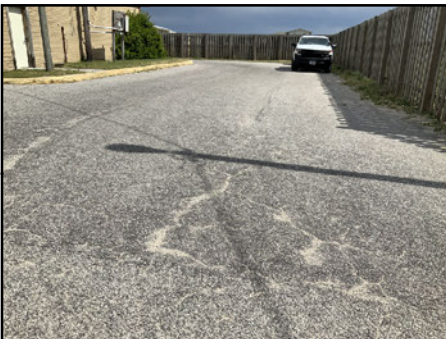
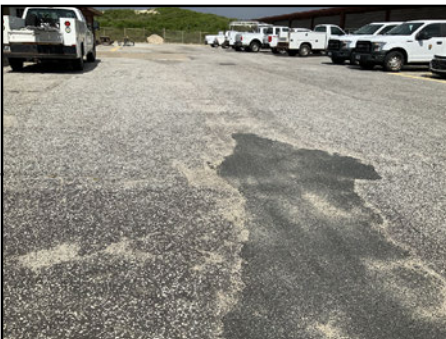
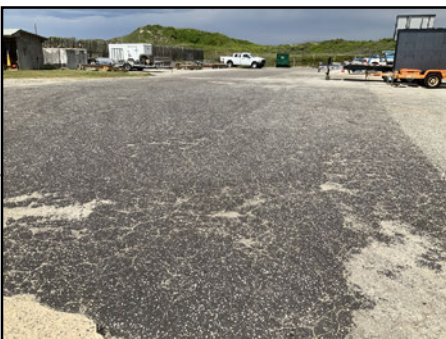
ROUTE 0902: BI RD BODIE ISLAND MAINTENANCE ACCESS AND PARKING

Inspection Date	FMSS Number	User Access	Surface Type
5/7/2021	28895	NONPUBLIC	ASPHALT
Area (Sq. Ft.)	Lane Miles (11' Widths)	Curb Reveal (Inches)	Curb Recommendation
47,037	0.81	5	DO NOTHING
Curb Type		Curb & Gutter Type	
CONCRETE		NO CURB AND GUTTER	
Pavement Recommendation		Condition Rating / PCR	
RECONSTRUCTION		POOR / 30

NOTE: MULTIPLE SURFACE TYPES:
ASPHALT IS 45,951 SQ FT;
CONCRETE IS 1,086 SQ FT.

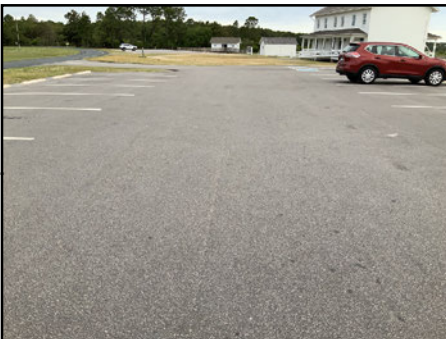
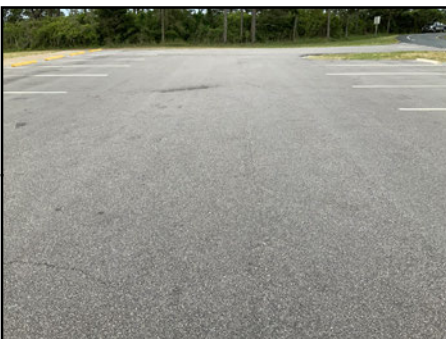
ROUTE 0903AZ: BI RD BODIE ISLAND LIGHTHOUSE A PARKING

Inspection Date	FMSS Number	User Access	Surface Type
5/9/2021	28910	PUBLIC	ASPHALT
Area (Sq. Ft.)	Lane Miles (11' Widths)	Curb Reveal (Inches)	Curb Recommendation
12,429	0.214	NOT APPLICABLE	NOT APPLICABLE
Curb Type		Curb & Gutter Type	
NO CURB		NO CURB AND GUTTER	
Pavement Recommendation		Condition Rating / PCR	
PREVENTIVE MAINTENANCE		GOOD / 90

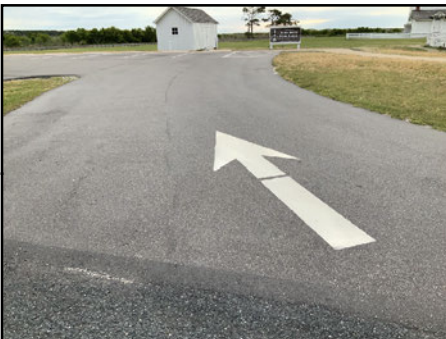
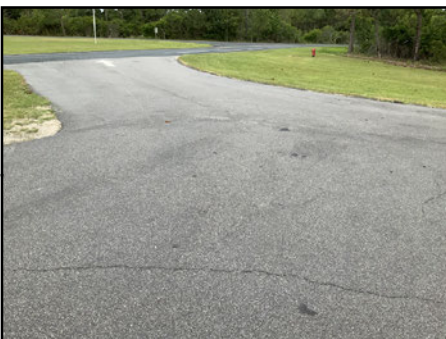
ROUTE 0903BZ: BI RD BODIE ISLAND LIGHTHOUSE B PARKING

Inspection Date	FMSS Number	User Access	Surface Type
5/9/2021	28910	PUBLIC	ASPHALT
Area (Sq. Ft.)	Lane Miles (11' Widths)	Curb Reveal (Inches)	Curb Recommendation
12,210	0.21	NOT APPLICABLE	NOT APPLICABLE
Curb Type		Curb & Gutter Type	
NO CURB		NO CURB AND GUTTER	
Pavement Recommendation		Condition Rating / PCR	
PREVENTIVE MAINTENANCE		GOOD / 90

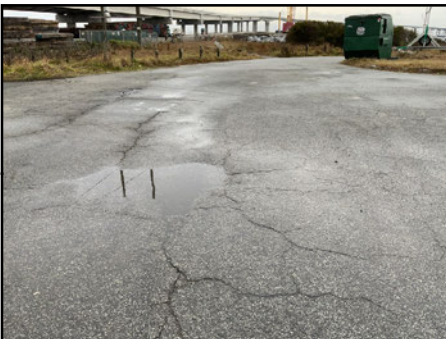
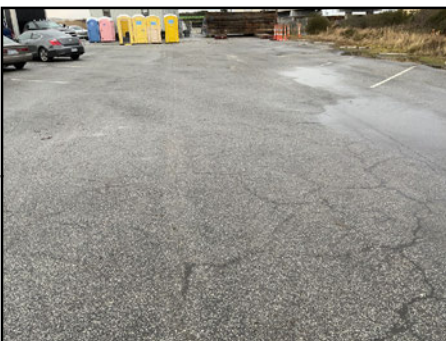
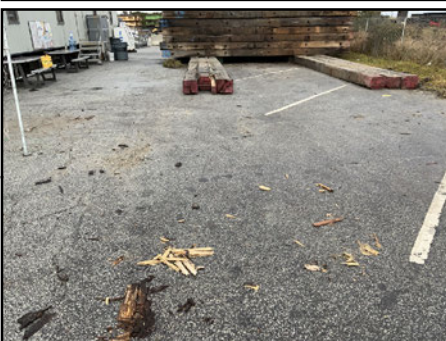
ROUTE 0906: BI RD OREGON INLET BRIDGE ACCESS AND PARKING

Inspection Date	FMSS Number	User Access	Surface Type
5/9/2021	28973	PUBLIC	ASPHALT
Area (Sq. Ft.)	Lane Miles (11' Widths)	Curb Reveal (Inches)	Curb Recommendation
49,439	0.851	6	REPLACE
Curb Type		Curb & Gutter Type	
CONCRETE		NO CURB AND GUTTER	
Pavement Recommendation		Condition Rating / PCR	
RECONSTRUCTION		POOR / 30

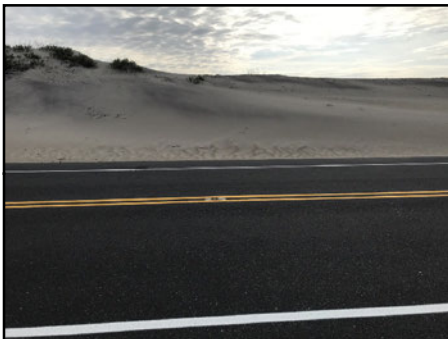
ROUTE 0908: BI RD PEA ISLAND OBSERVATION TURNOUT NO 2

Inspection Date	FMSS Number	User Access	Surface Type
5/9/2021	28972	PUBLIC	ASPHALT
Area (Sq. Ft.)	Lane Miles (11' Widths)	Curb Reveal (Inches)	Curb Recommendation
13,066	0.225	NOT APPLICABLE	NOT APPLICABLE
Curb Type		Curb & Gutter Type	
NOT APPLICABLE		NOT APPLICABLE	
Pavement Recommendation		Condition Rating / PCR	
NOT APPLICABLE		NOT RATED / N/A

NOTE: THIS PARKING NO LONGER EXISTS. SUPERINTENDENT WANTS IT TO REMAIN IN THE INVENTORY TO TRACK LOCATION.

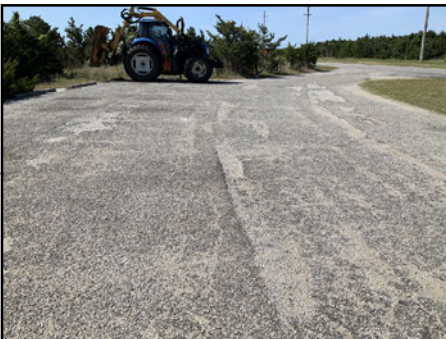
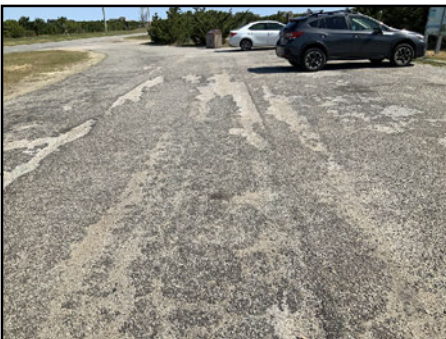
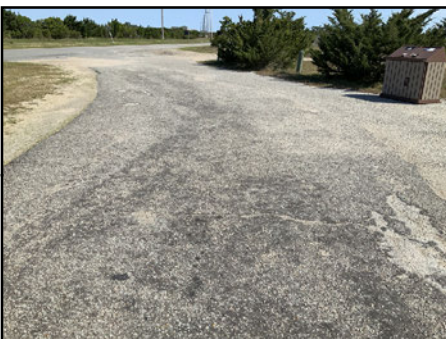
Inspection Date	FMSS Number	User Access	Surface Type
5/9/2021	36792	PUBLIC	ASPHALT
Area (Sq. Ft.)	Lane Miles (11' Widths)	Curb Reveal (Inches)	Curb Recommendation
9,956	0.171	NOT APPLICABLE	NOT APPLICABLE
Curb Type		Curb & Gutter Type	
NO CURB		NO CURB AND GUTTER	
Pavement Recommendation		Condition Rating / PCR	
RECONSTRUCTION		POOR / 30

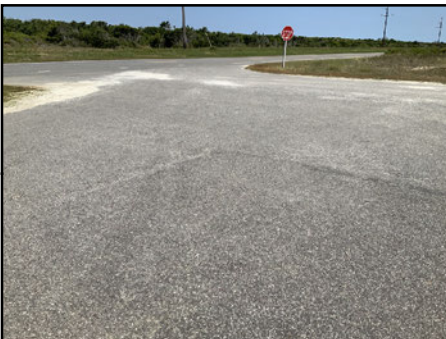
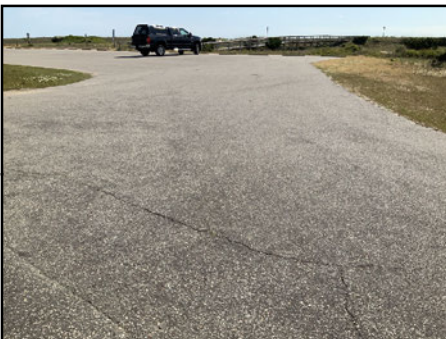
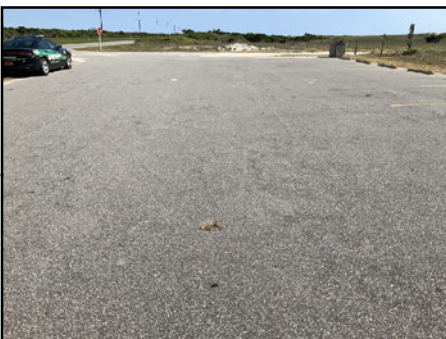
ROUTE 0910: HI RD RAMP 27 PARKING

Inspection Date	FMSS Number	User Access	Surface Type
5/9/2021	28868	PUBLIC	ASPHALT
Area (Sq. Ft.)	Lane Miles (11' Widths)	Curb Reveal (Inches)	Curb Recommendation
14,418	0.248	NOT APPLICABLE	NOT APPLICABLE
Curb Type		Curb & Gutter Type	
NO CURB		NO CURB AND GUTTER	
Pavement Recommendation		Condition Rating / PCR	
PREVENTIVE MAINTENANCE		GOOD / 90

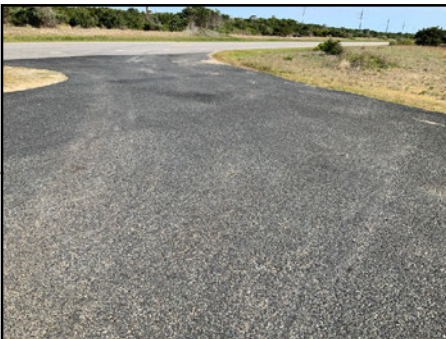
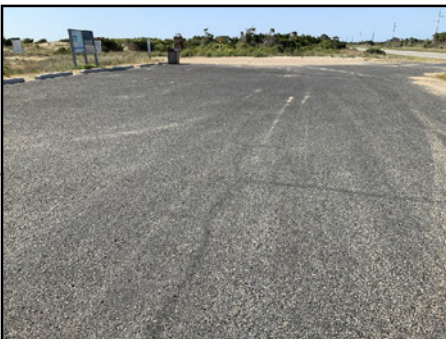
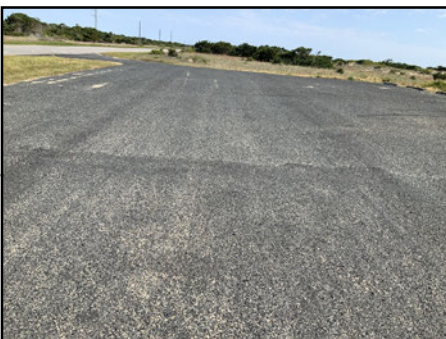
ROUTE 0911: HI RD RAMP 30 PARKING

Inspection Date	FMSS Number	User Access	Surface Type
5/9/2021	28870	PUBLIC	ASPHALT
Area (Sq. Ft.)	Lane Miles (11' Widths)	Curb Reveal (Inches)	Curb Recommendation
13,748	0.237	NOT APPLICABLE	NOT APPLICABLE
Curb Type		Curb & Gutter Type	
NO CURB		NO CURB AND GUTTER	
Pavement Recommendation		Condition Rating / PCR	
LIGHT 3R TREATMENTS		FAIR / 73

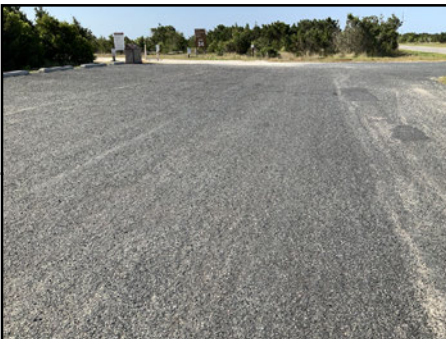
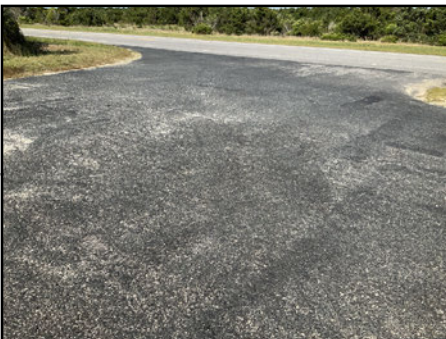
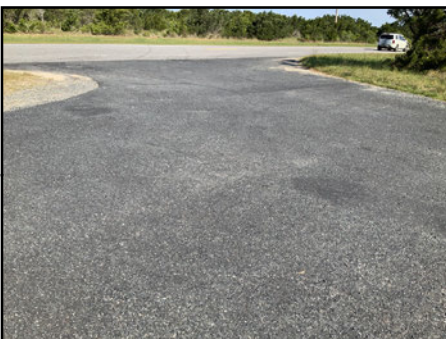
ROUTE 0912: HI RD RAMP 34 PARKING

Inspection Date	FMSS Number	User Access	Surface Type
5/9/2021	28871	PUBLIC	ASPHALT
Area (Sq. Ft.)	Lane Miles (11' Widths)	Curb Reveal (Inches)	Curb Recommendation
14,108	0.243	NOT APPLICABLE	NOT APPLICABLE
Curb Type		Curb & Gutter Type	
NO CURB		NO CURB AND GUTTER	
Pavement Recommendation		Condition Rating / PCR	
LIGHT 3R TREATMENTS		FAIR / 73

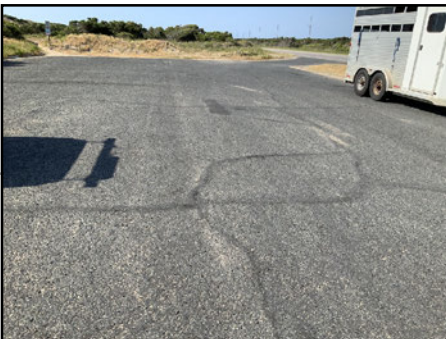
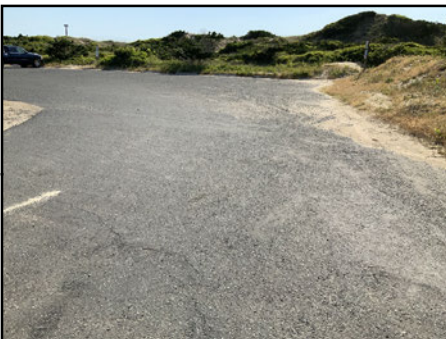
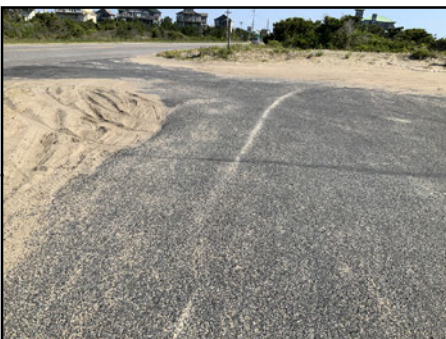
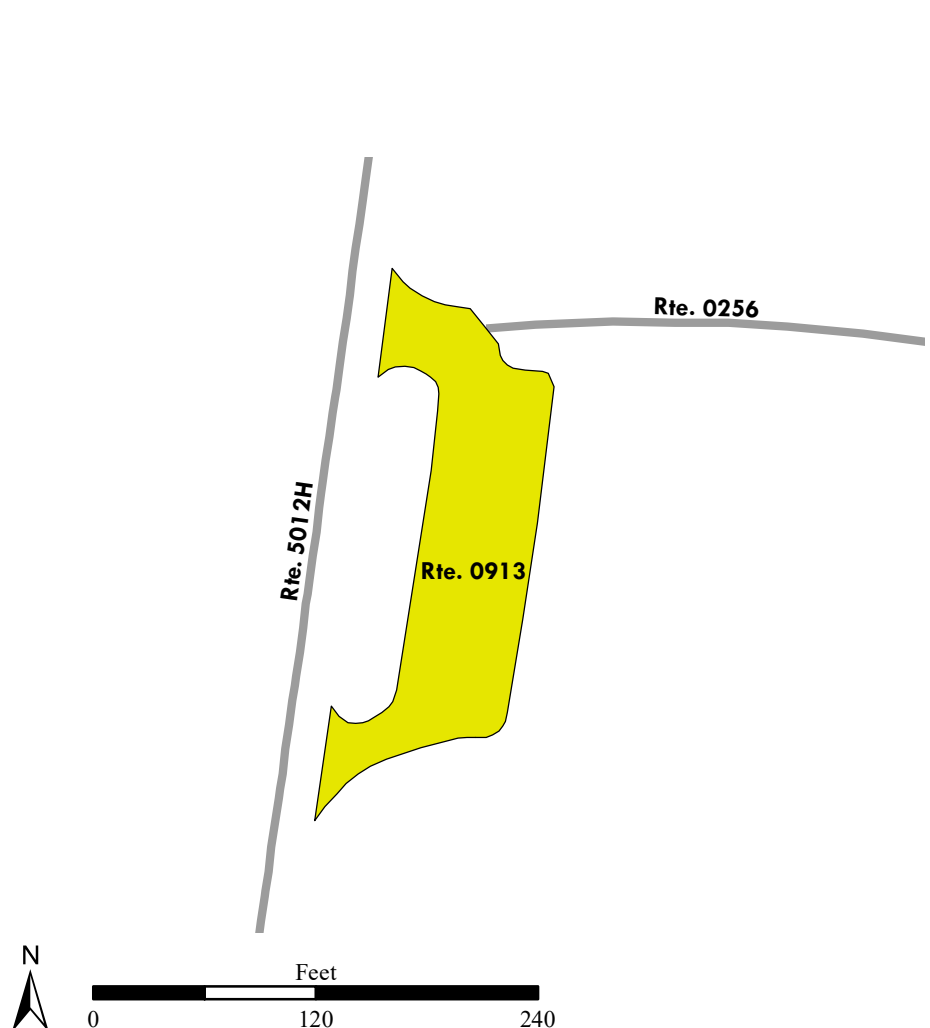
ROUTE 0913: HI RD RAMP 38 PARKING

Inspection Date	FMSS Number	User Access	Surface Type
5/9/2021	28872	PUBLIC	ASPHALT
Area (Sq. Ft.)	Lane Miles (11' Widths)	Curb Reveal (Inches)	Curb Recommendation
12,932	0.223	NOT APPLICABLE	NOT APPLICABLE
Curb Type		Curb & Gutter Type	
NO CURB		NO CURB AND GUTTER	
Pavement Recommendation		Condition Rating / PCR	
LIGHT 3R TREATMENTS		FAIR / 73

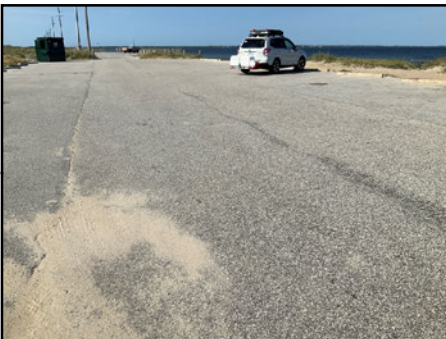
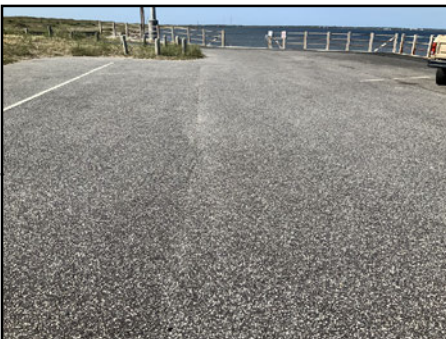
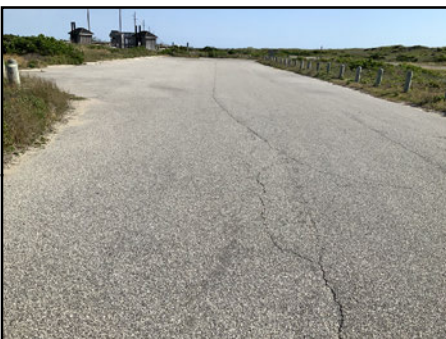
ROUTE 0914: HI RD HAULOVER PARKING

Inspection Date	FMSS Number	User Access	Surface Type
5/9/2021	28656	PUBLIC	ASPHALT
Area (Sq. Ft.)	Lane Miles (11' Widths)	Curb Reveal (Inches)	Curb Recommendation
55,098	0.949	NOT APPLICABLE	NOT APPLICABLE
Curb Type		Curb & Gutter Type	
NO CURB		NO CURB AND GUTTER	
Pavement Recommendation		Condition Rating / PCR	
HEAVY 3R TREATMENTS		POOR / 53

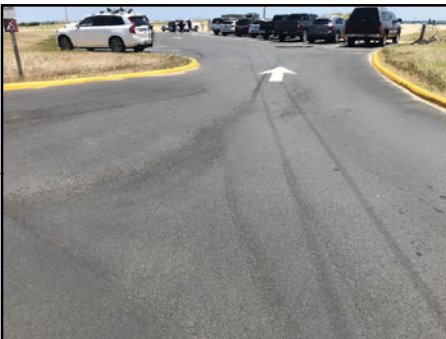
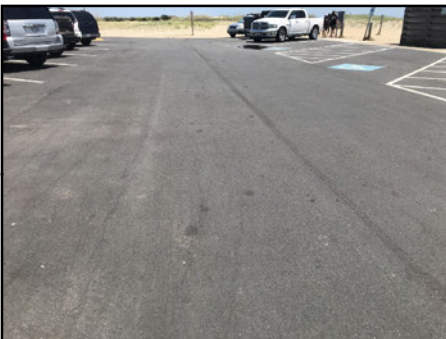
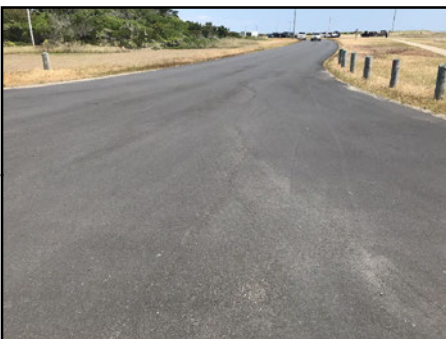
ROUTE 0916: HI RD OLD LIGHTHOUSE FOUNDATION PARKING

Inspection Date	FMSS Number	User Access	Surface Type
5/8/2021	28677	PUBLIC	ASPHALT
Area (Sq. Ft.)	Lane Miles (11' Widths)	Curb Reveal (Inches)	Curb Recommendation
36,244	0.624	6	DO NOTHING
Curb Type		Curb & Gutter Type	
CONCRETE		NO CURB AND GUTTER	
Pavement Recommendation		Condition Rating / PCR	
PREVENTIVE MAINTENANCE		GOOD / 90

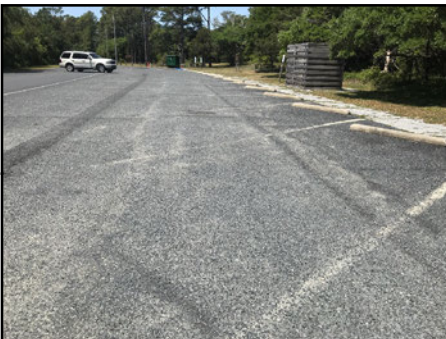
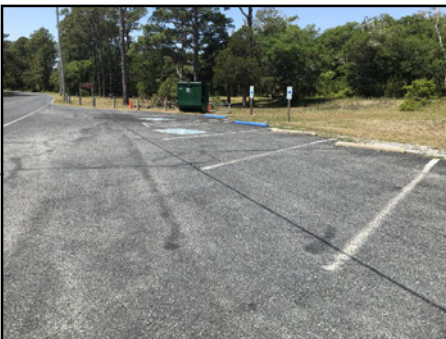
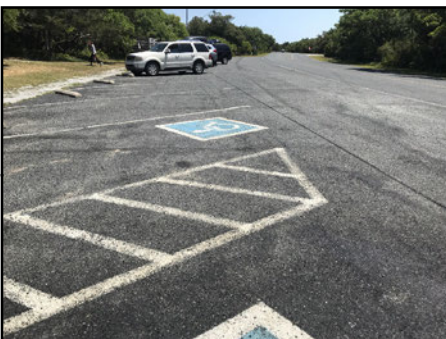
ROUTE 0917: HI RD BUXTON WOODS TRAILHEAD PARKING

Inspection Date	FMSS Number	User Access	Surface Type
5/8/2021	28680	PUBLIC	ASPHALT
Area (Sq. Ft.)	Lane Miles (11' Widths)	Curb Reveal (Inches)	Curb Recommendation
10,822	0.186	NOT APPLICABLE	NOT APPLICABLE
Curb Type		Curb & Gutter Type	
NO CURB		NO CURB AND GUTTER	
Pavement Recommendation		Condition Rating / PCR	
LIGHT 3R TREATMENTS		FAIR / 73

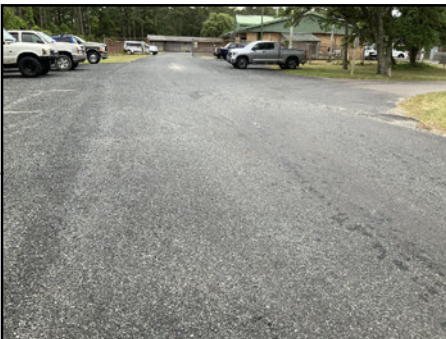
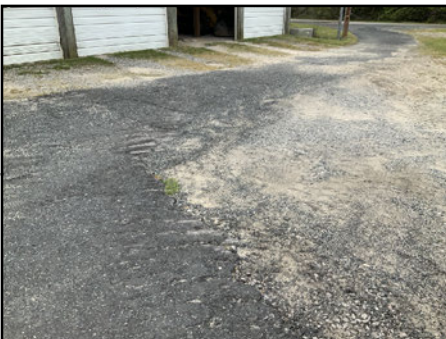
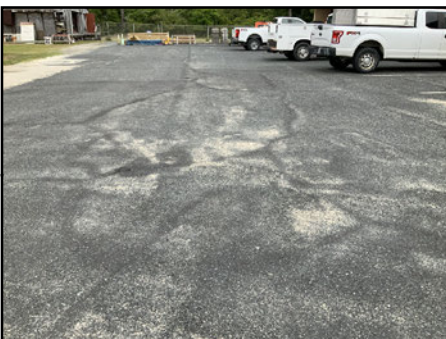
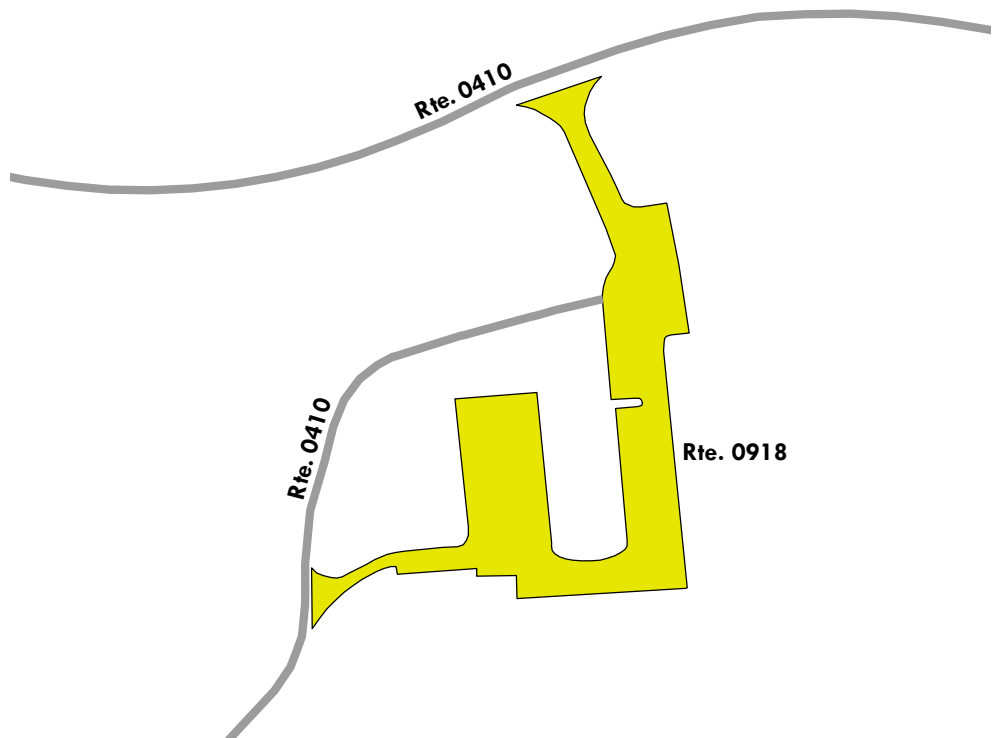
ROUTE 0918: HI RD BUXTON MAINTENANCE ACCESS

Inspection Date	FMSS Number	User Access	Surface Type
5/7/2021	28694	NONPUBLIC	ASPHALT
Area (Sq. Ft.)	Lane Miles (11' Widths)	Curb Reveal (Inches)	Curb Recommendation
30,065	0.518	6	REPLACE
Curb Type		Curb & Gutter Type	
CONCRETE		NO CURB AND GUTTER	
Pavement Recommendation		Condition Rating / PCR	
LIGHT 3R TREATMENTS		FAIR / 73

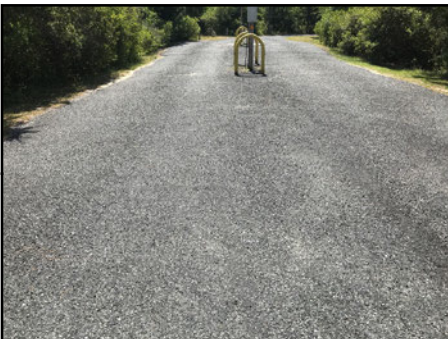
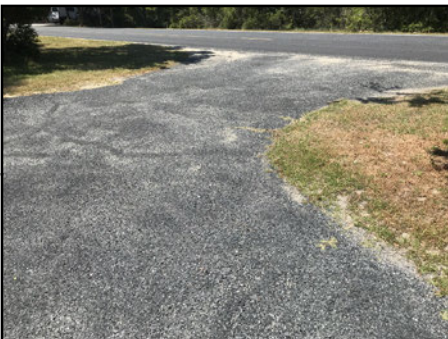
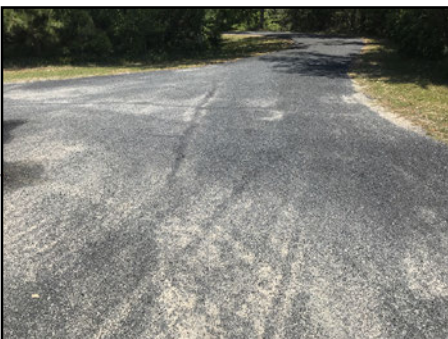
ROUTE 0919: HI RD BUXTON WOODS DUMP STATION

Inspection Date	FMSS Number	User Access	Surface Type
5/8/2021	28760	NONPUBLIC	ASPHALT
Area (Sq. Ft.)	Lane Miles (11' Widths)	Curb Reveal (Inches)	Curb Recommendation
7,634	0.131	NOT APPLICABLE	NOT APPLICABLE
Curb Type		Curb & Gutter Type	
NO CURB		NO CURB AND GUTTER	
Pavement Recommendation		Condition Rating / PCR	
LIGHT 3R TREATMENTS		FAIR / 73

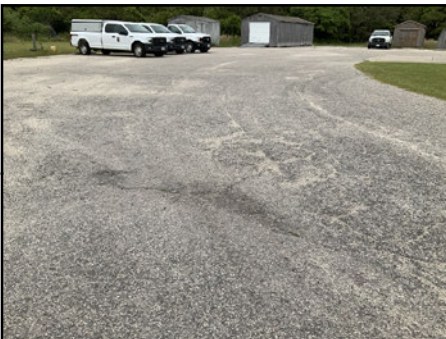
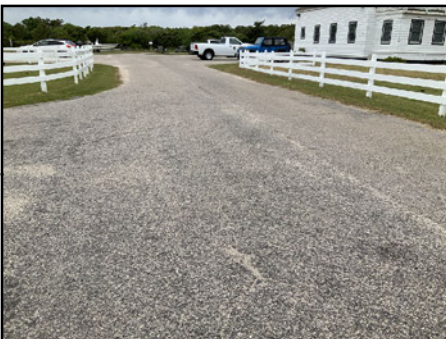
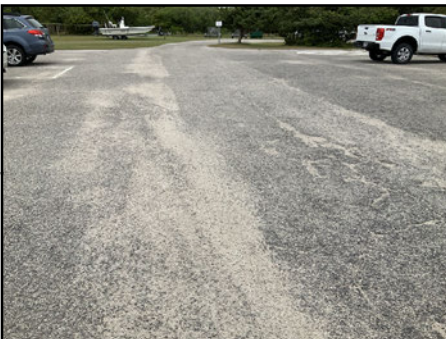
Inspection Date	FMSS Number	User Access	Surface Type
5/7/2021	28761	PUBLIC	ASPHALT
Area (Sq. Ft.)	Lane Miles (11' Widths)	Curb Reveal (Inches)	Curb Recommendation
31,037	0.534	NOT APPLICABLE	NOT APPLICABLE
Curb Type		Curb & Gutter Type	
NO CURB		NO CURB AND GUTTER	
Pavement Recommendation		Condition Rating / PCR	
HEAVY 3R TREATMENTS		POOR / 53

NOTE: MULTIPLE SURFACE TYPES:
 ASPHALT IS 29,341 SQ FT;
 CONCRETE IS 1,696 SQ FT.

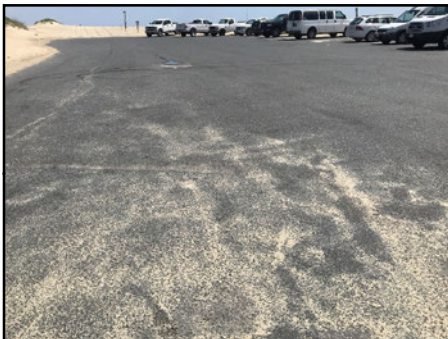
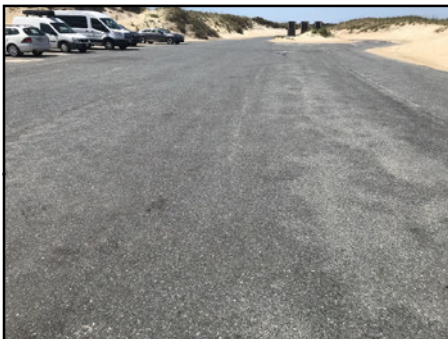
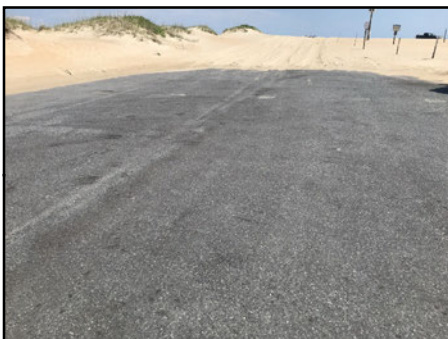
ROUTE 0921: HI RD RAMP 43 PARKING

Inspection Date	FMSS Number	User Access	Surface Type
5/8/2021	28873	PUBLIC	ASPHALT
Area (Sq. Ft.)	Lane Miles (11' Widths)	Curb Reveal (Inches)	Curb Recommendation
22,473	0.387	6	MODERATE REPAIR
Curb Type		Curb & Gutter Type	
CONCRETE		NO CURB AND GUTTER	
Pavement Recommendation		Condition Rating / PCR	
LIGHT 3R TREATMENTS		FAIR / 73

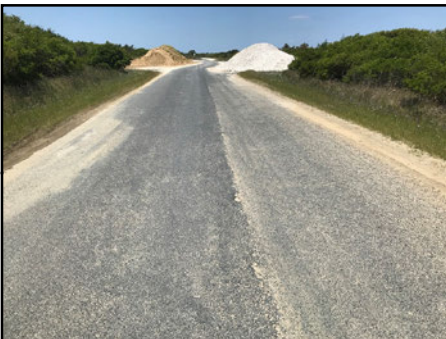
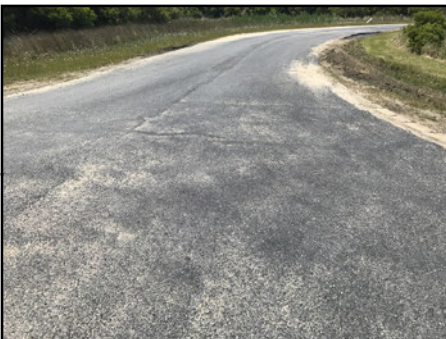
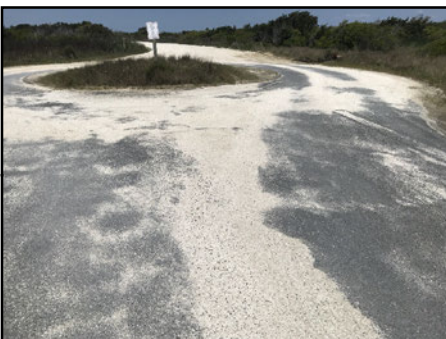
ROUTE 0922: HI RD RAMP 45 PARKING

Inspection Date	FMSS Number	User Access	Surface Type
5/8/2021	28876	PUBLIC	ASPHALT
Area (Sq. Ft.)	Lane Miles (11' Widths)	Curb Reveal (Inches)	Curb Recommendation
23,407	0.403	2	REPLACE
Curb Type		Curb & Gutter Type	
CONCRETE		NO CURB AND GUTTER	
Pavement Recommendation		Condition Rating / PCR	
LIGHT 3R TREATMENTS		FAIR / 73

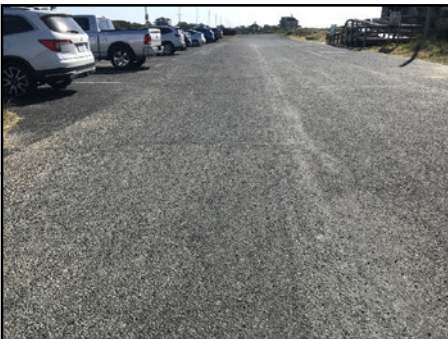
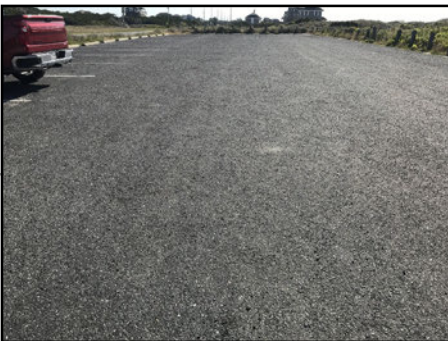
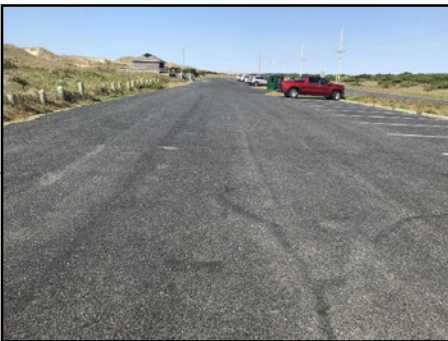
ROUTE 0923: HI RD FRISCO BEACH ACCESS PARKING

Inspection Date	FMSS Number	User Access	Surface Type
5/8/2021	28840	PUBLIC	ASPHALT
Area (Sq. Ft.)	Lane Miles (11' Widths)	Curb Reveal (Inches)	Curb Recommendation
34,433	0.593	NOT APPLICABLE	NOT APPLICABLE
Curb Type		Curb & Gutter Type	
NO CURB		NO CURB AND GUTTER	
Pavement Recommendation		Condition Rating / PCR	
LIGHT 3R TREATMENTS		FAIR / 73

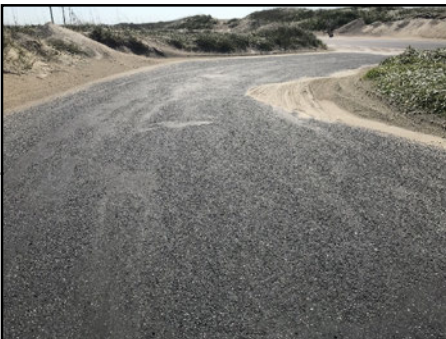
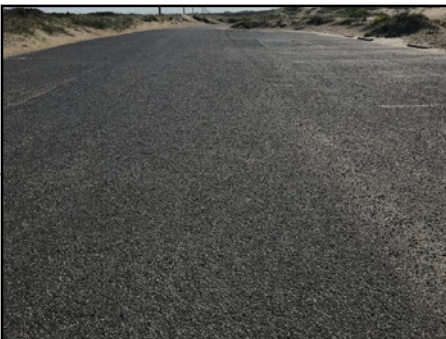
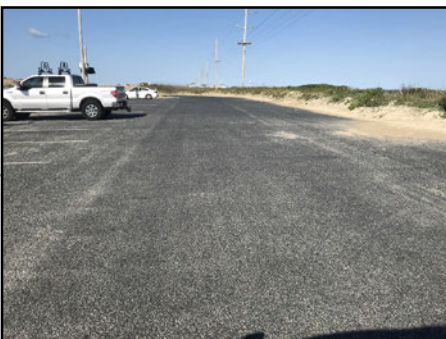
ROUTE 0924: HI RD SANDY BAY SOUNDSIDE PARKING

Inspection Date	FMSS Number	User Access	Surface Type
5/8/2021	28842	PUBLIC	ASPHALT
Area (Sq. Ft.)	Lane Miles (11' Widths)	Curb Reveal (Inches)	Curb Recommendation
19,823	0.341	NOT APPLICABLE	NOT APPLICABLE
Curb Type		Curb & Gutter Type	
NO CURB		NO CURB AND GUTTER	
Pavement Recommendation		Condition Rating / PCR	
LIGHT 3R TREATMENTS		FAIR / 73

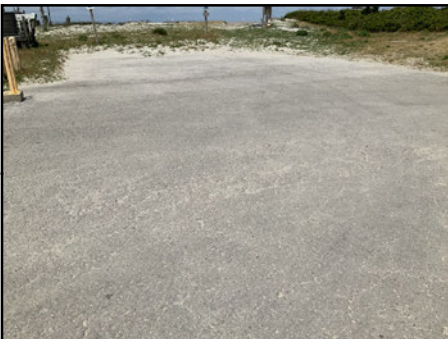
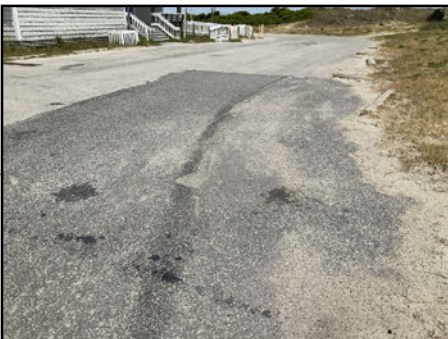
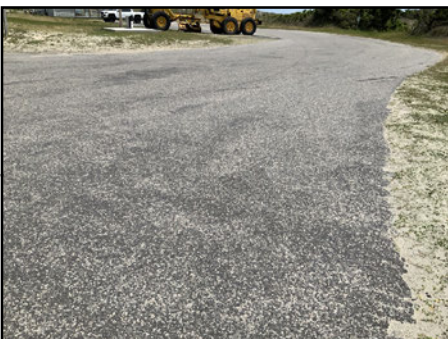
ROUTE 0926: OI RD HATTERAS INLET FERRY COMFORT STATION

Inspection Date	FMSS Number	User Access	Surface Type
5/7/2021	29752	PUBLIC	ASPHALT
Area (Sq. Ft.)	Lane Miles (11' Widths)	Curb Reveal (Inches)	Curb Recommendation
14,899	0.257	NOT APPLICABLE	NOT APPLICABLE
Curb Type		Curb & Gutter Type	
NO CURB		NO CURB AND GUTTER	
Pavement Recommendation		Condition Rating / PCR	
LIGHT 3R TREATMENTS		FAIR / 73

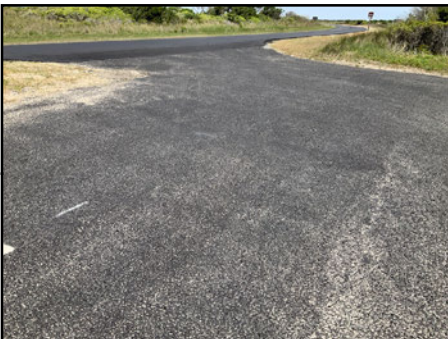
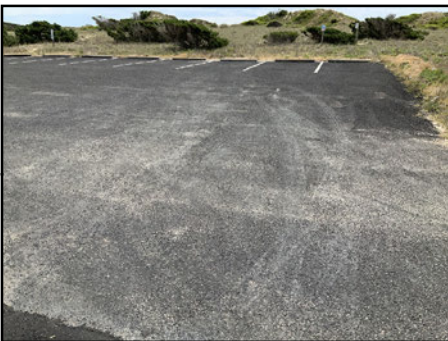
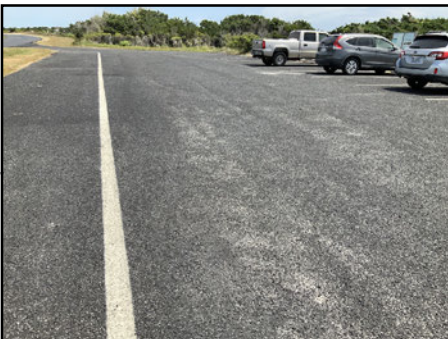
ROUTE 0927: OI RD RAMP 59 PARKING

Inspection Date	FMSS Number	User Access	Surface Type
5/7/2021	29753	PUBLIC	ASPHALT
Area (Sq. Ft.)	Lane Miles (11' Widths)	Curb Reveal (Inches)	Curb Recommendation
10,976	0.189	NOT APPLICABLE	NOT APPLICABLE
Curb Type		Curb & Gutter Type	
NO CURB		NO CURB AND GUTTER	
Pavement Recommendation		Condition Rating / PCR	
LIGHT 3R TREATMENTS		FAIR / 73

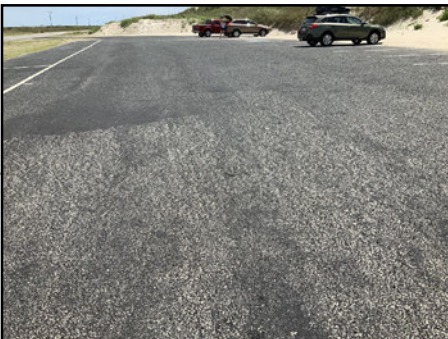
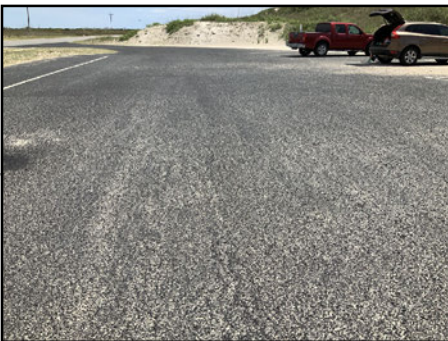
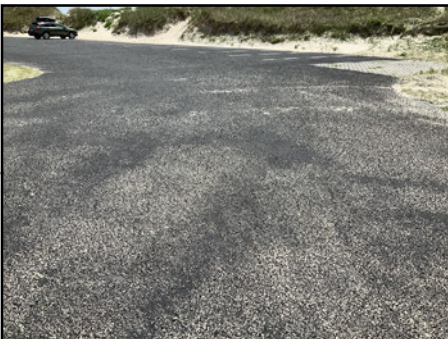
ROUTE 0928: OI RD TURNOUT AT MP 64

Inspection Date	FMSS Number	User Access	Surface Type
5/7/2021	29755	PUBLIC	ASPHALT
Area (Sq. Ft.)	Lane Miles (11' Widths)	Curb Reveal (Inches)	Curb Recommendation
17,790	0.306	NOT APPLICABLE	NOT APPLICABLE
Curb Type		Curb & Gutter Type	
NO CURB		NO CURB AND GUTTER	
Pavement Recommendation		Condition Rating / PCR	
LIGHT 3R TREATMENTS		FAIR / 73
